LaSalle Causeway Bascule Bridge 2018 Comprehensive Detailed Inspection Report

Project Number: R. 090045.001

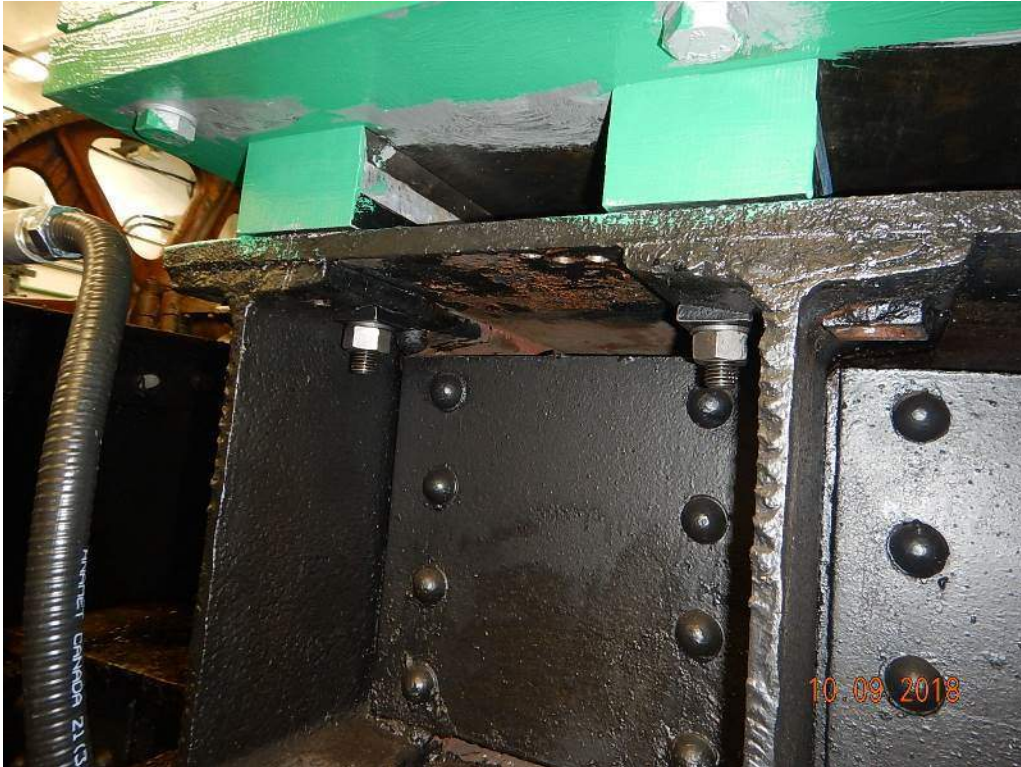
Photo M3: Span Drive Machinery South Motor. The underside of the motor mounting support is unpainted. The span drive north motor is similar. View Photo M4 for a detailed view under the mounting plate.

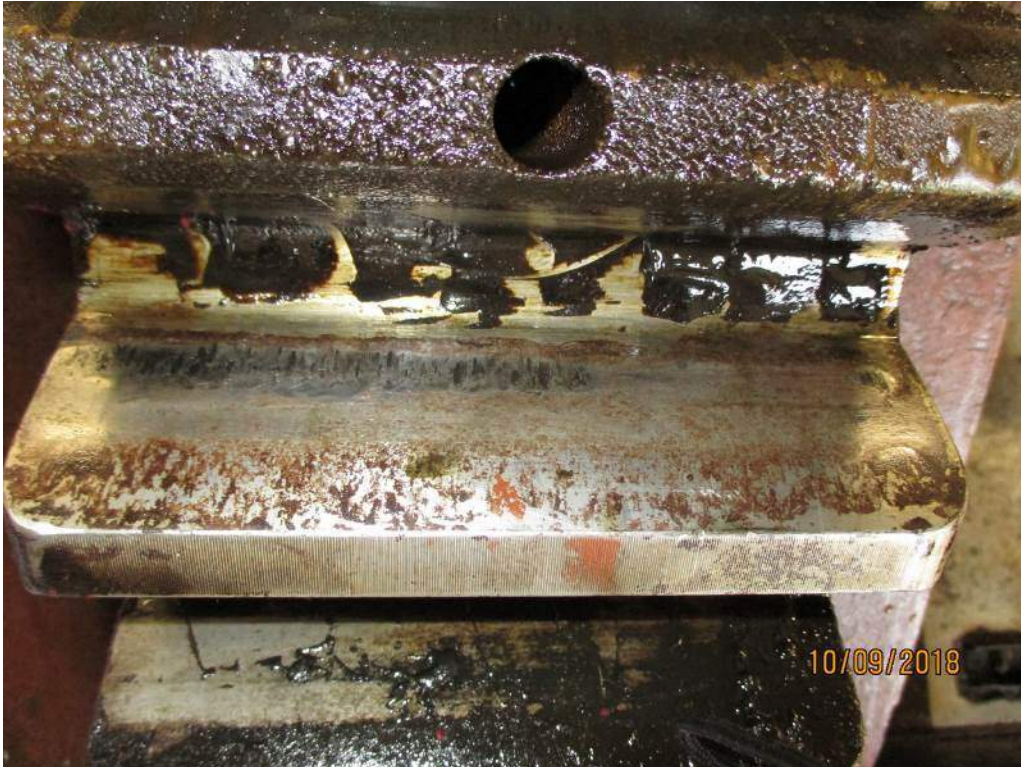
Photo M5: Span Drive Machinery Gear D. Note the light damage on the south side of the closing face of this gear.

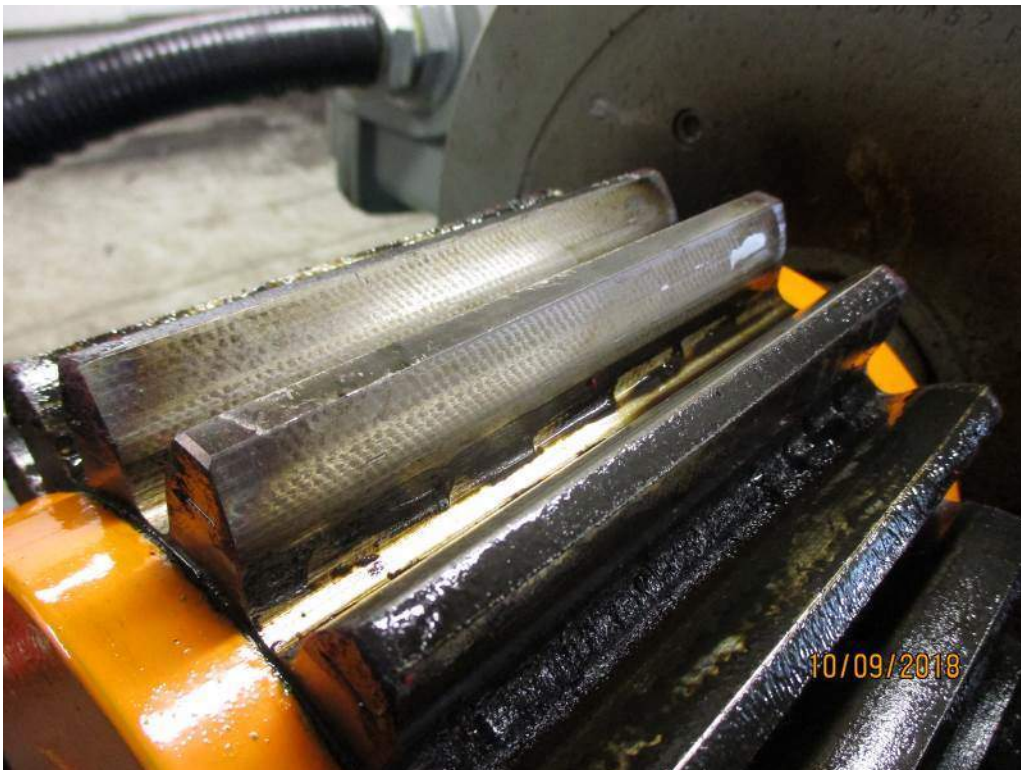
Photo M6: Span Drive Machinery North Pinon G. The contact wear pattern at the north G pinion indicates light cross bearing with heavier contact on the north side of the opening face and heavier contact on the south side of the closing face.

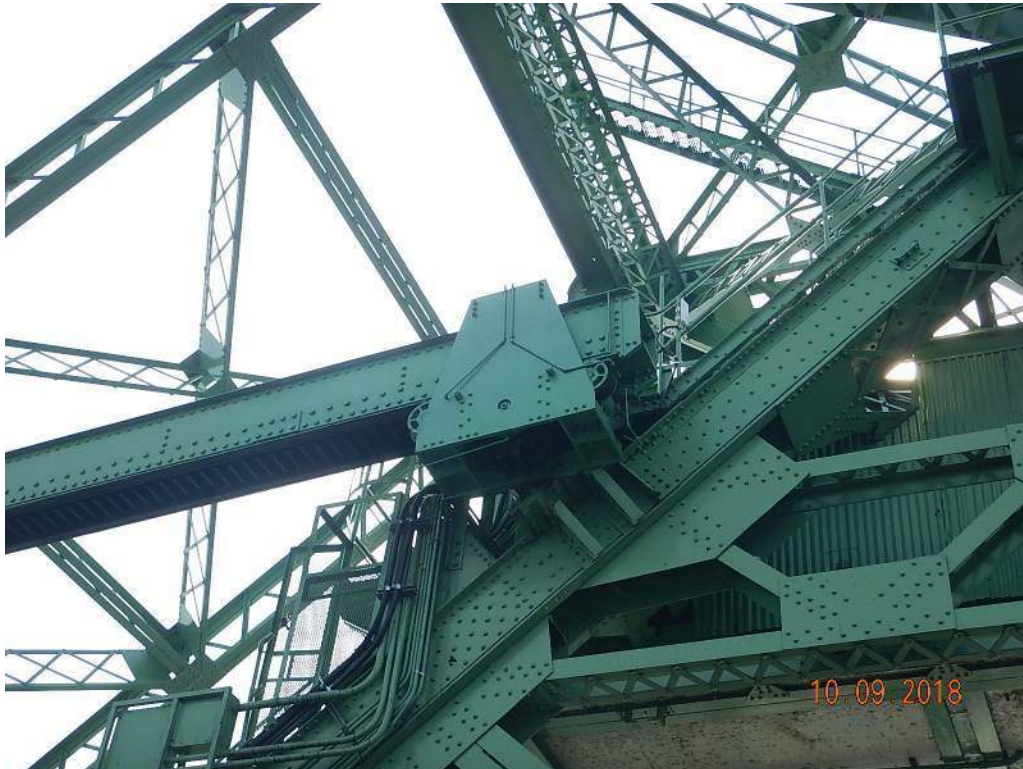
Photo M7: North Operating Strut Guide Assembly. There is no access to inspect many of the machinery interfaces internal to the guide assembly.

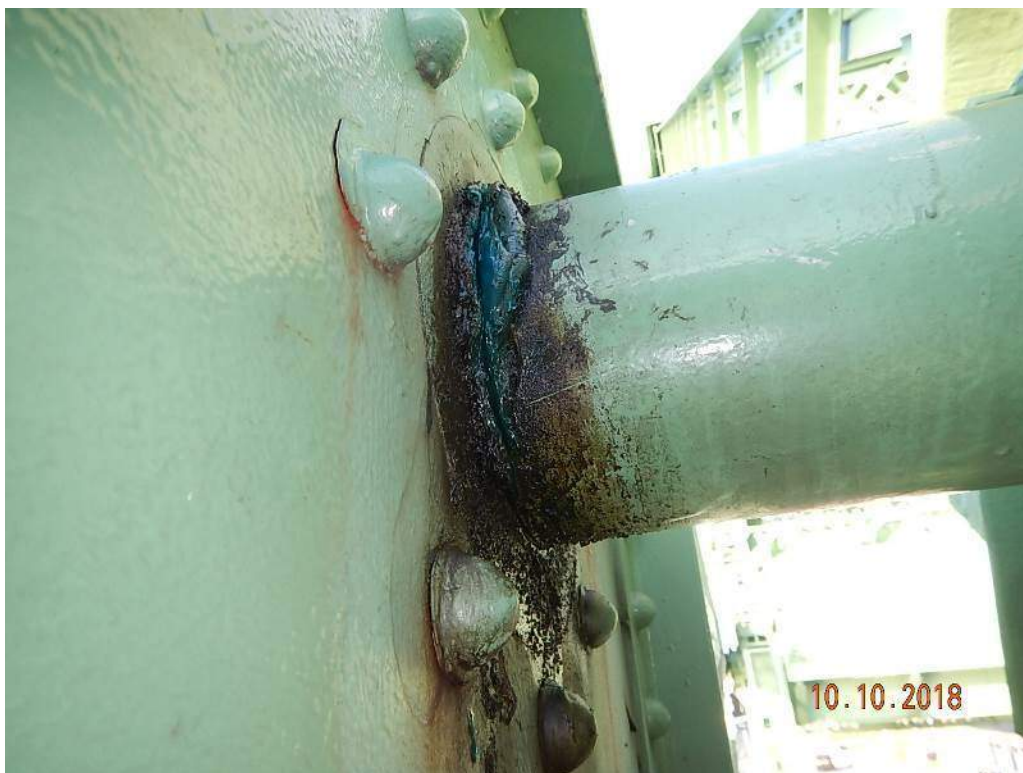
Photo M8: South Operating Strut, Inboard Bearing. The cracked paint and fretting corrosion at the rivets indicate that the connection is loose.

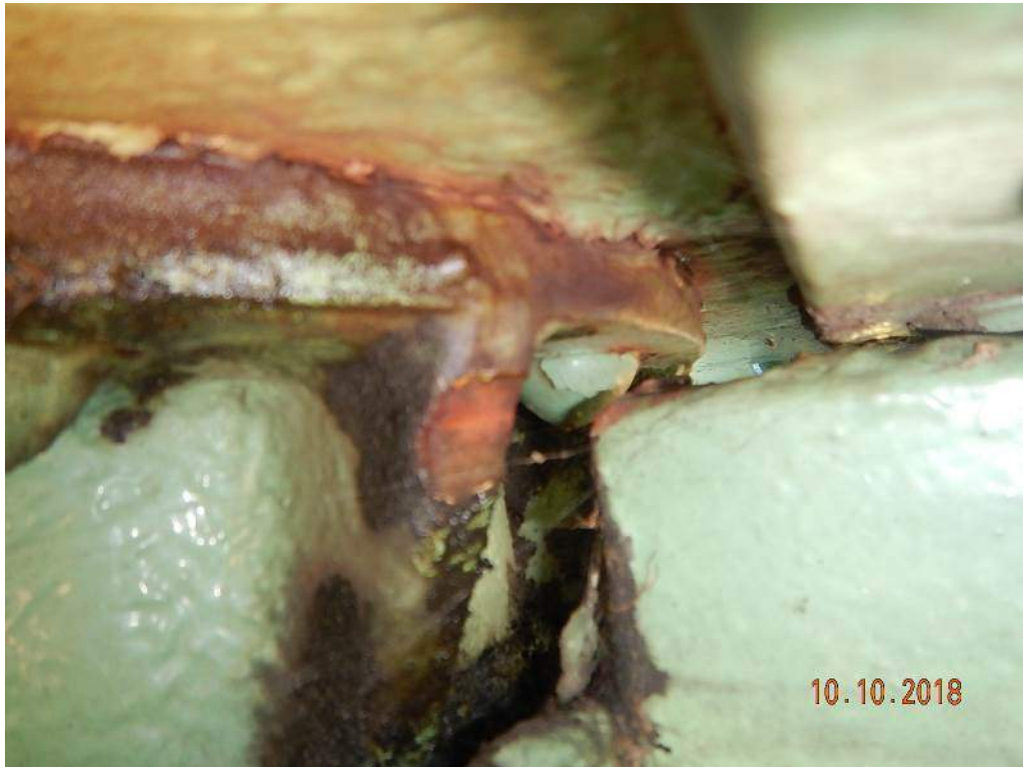
Photo M9: South Operating Strut, Outboard Bearing. The bearing housing stiffener is rubbing on the structure.

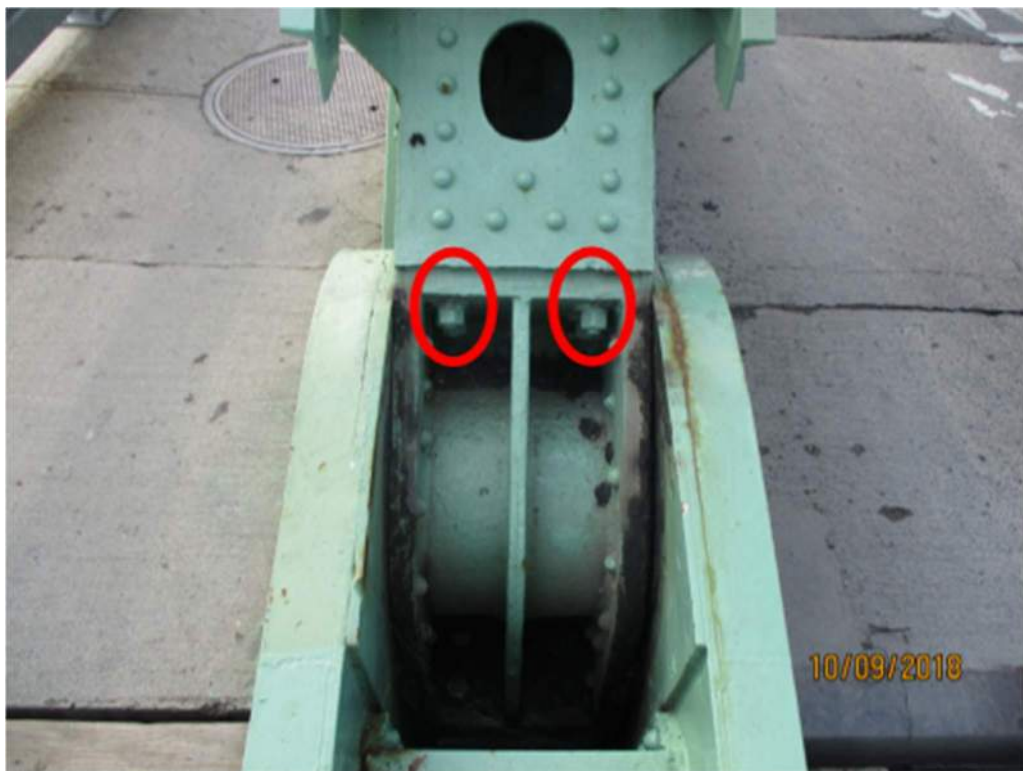
Photo M12: South Main Trunnion Bearing. The head end of the four bolts that secure the bearing housing to the structure has 100% section loss due to corrosion. The nut end of these bolts (circled) are pictured in this photo.

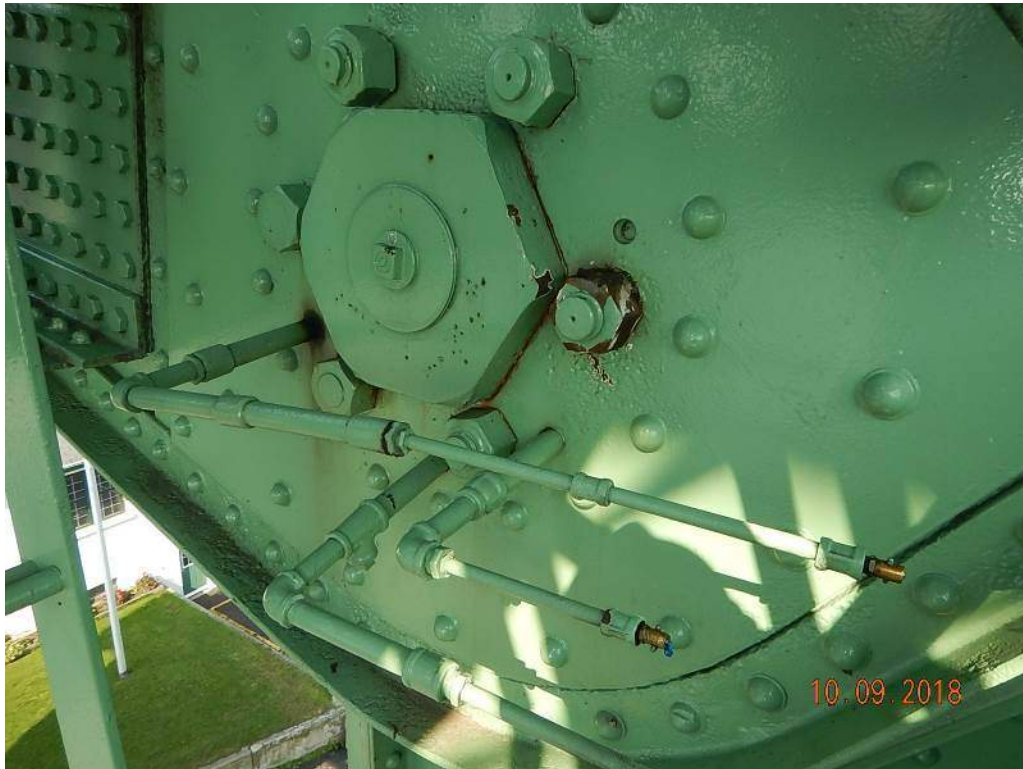
Photo M13: North Counterweight Trunnion Bearing, Inboard Side. All of the sleeve stud nuts are either not tight or show signs of movement. Paint removal from some of the nuts shows that an attempt at tightening these bolts has been made.

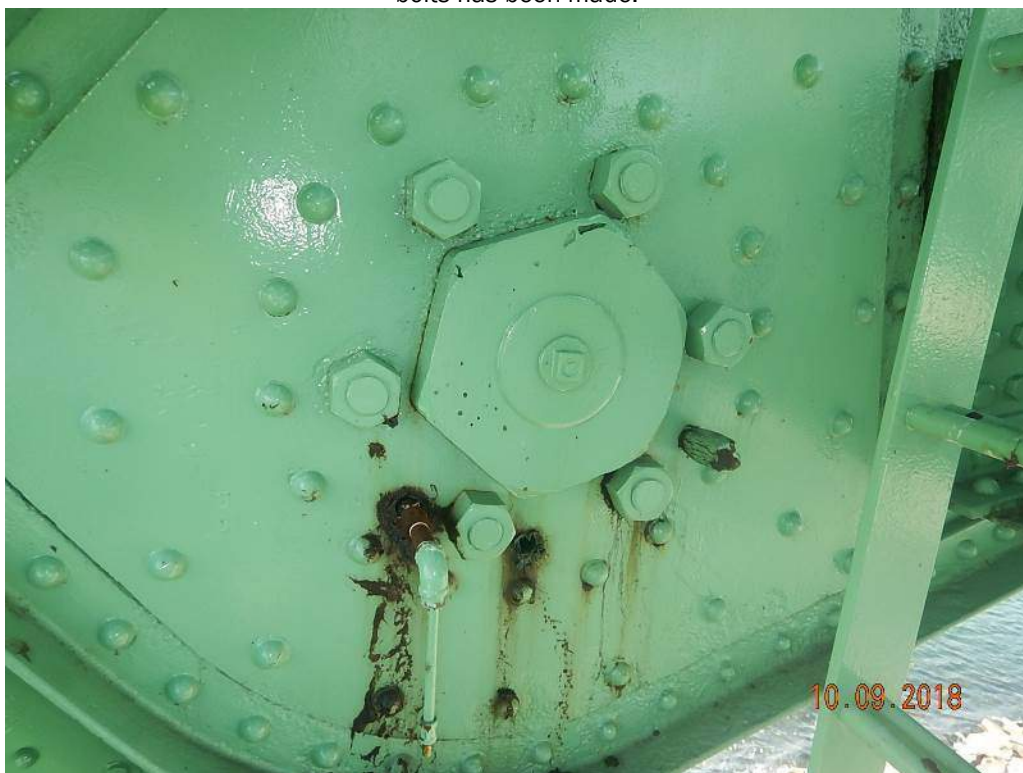
Photo M14: South Counterweight Trunnion Bearing, Inboard Side. All of the sleeve stud nuts are either not tight or show signs of movement. The east lubrication line has evidence of leakage, the center lubrication port has shear off, and the west lubrication port is plugged.

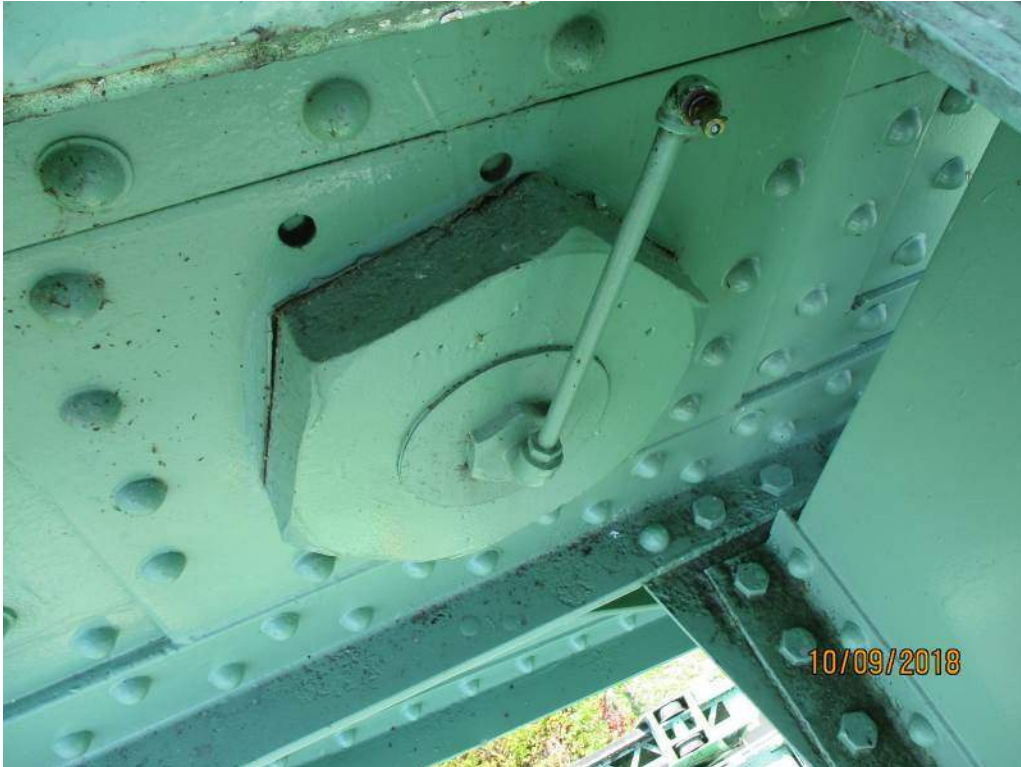
Photo M15: South First Link Pin. There is cracked paint and fretting between the nut and the structure indicating slight movement.

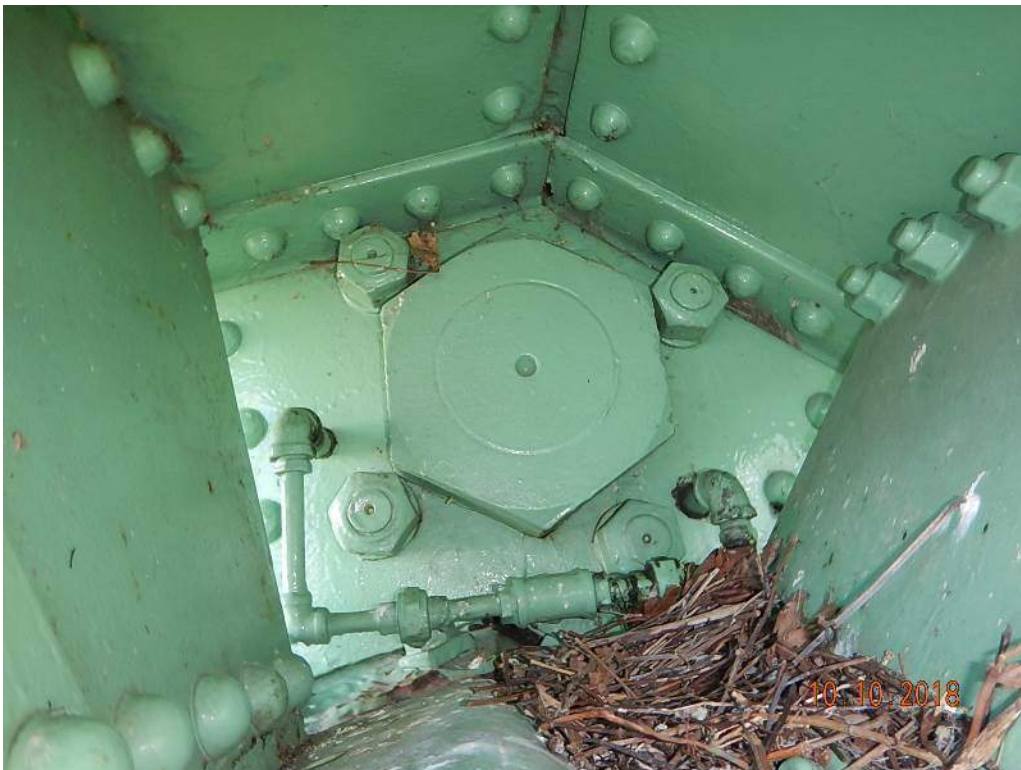
Photo M16: South Second Link Pin, Inboard Side. The lube ports at the inboard side of the second link pins are piped together to a common fitting. This is not good practice. Additionally, note the bird nest near the second link pin.

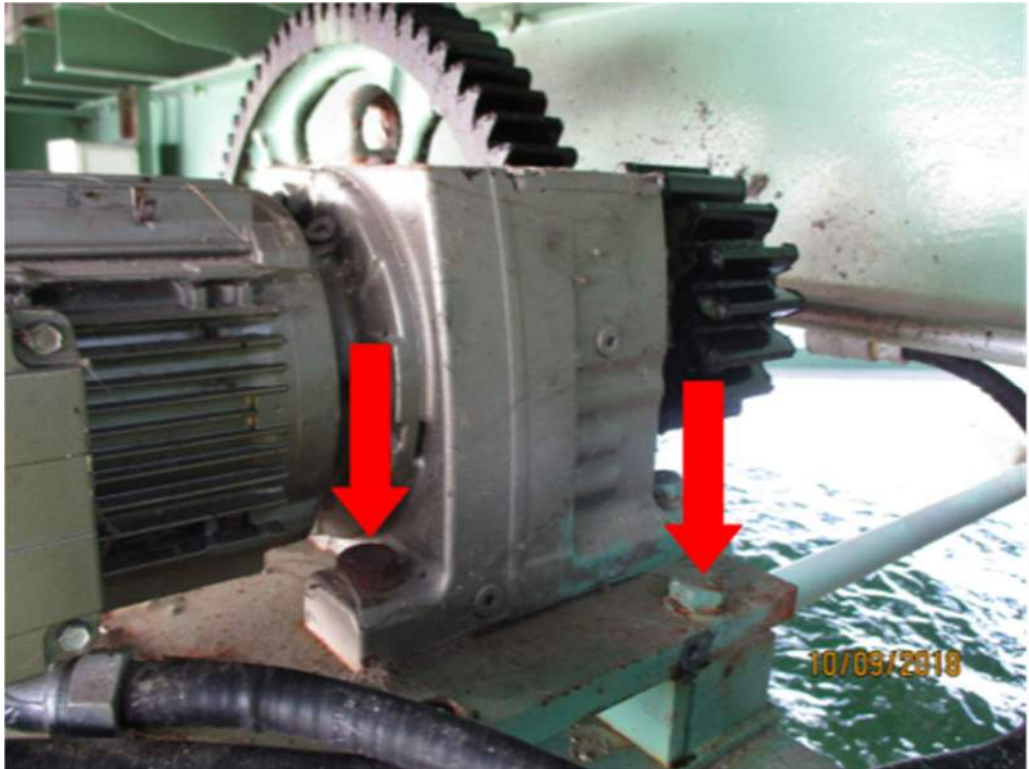
Photo M17: Span Lock Motor and Enclosed Speed Reducer. The mounting bolts and support for the motor and speed reducer are not fully painted and corroded.

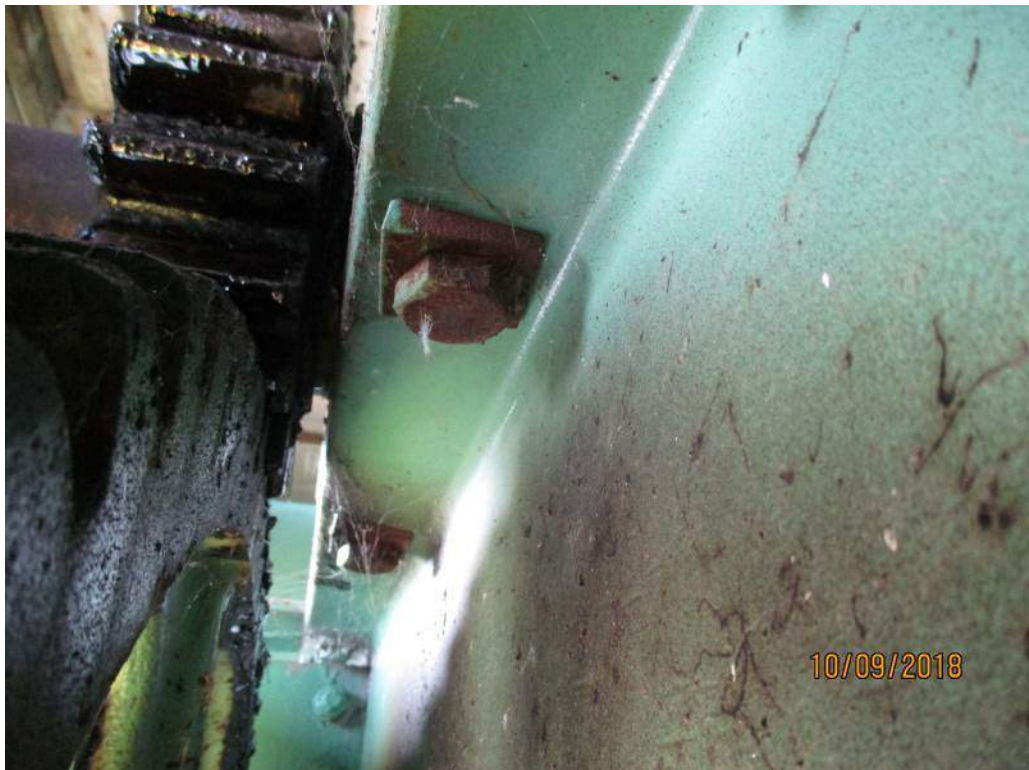
Photo M18: Span Lock Bearing B3. The span lock mounting bolt underside is not fully painted and corroded. The underside of bearing B4 mounting bolts are similar.

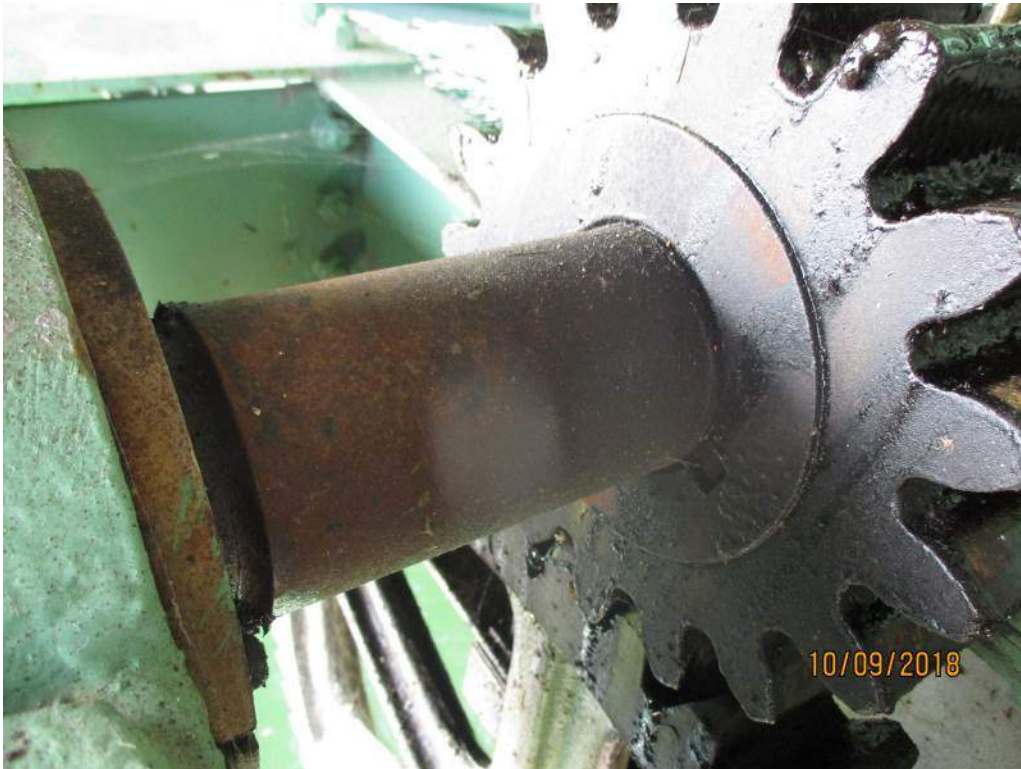
Photo M19: Span Lock Shaft. The span lock drive shaft between bearings B3 and B4 is not painted and corroded.

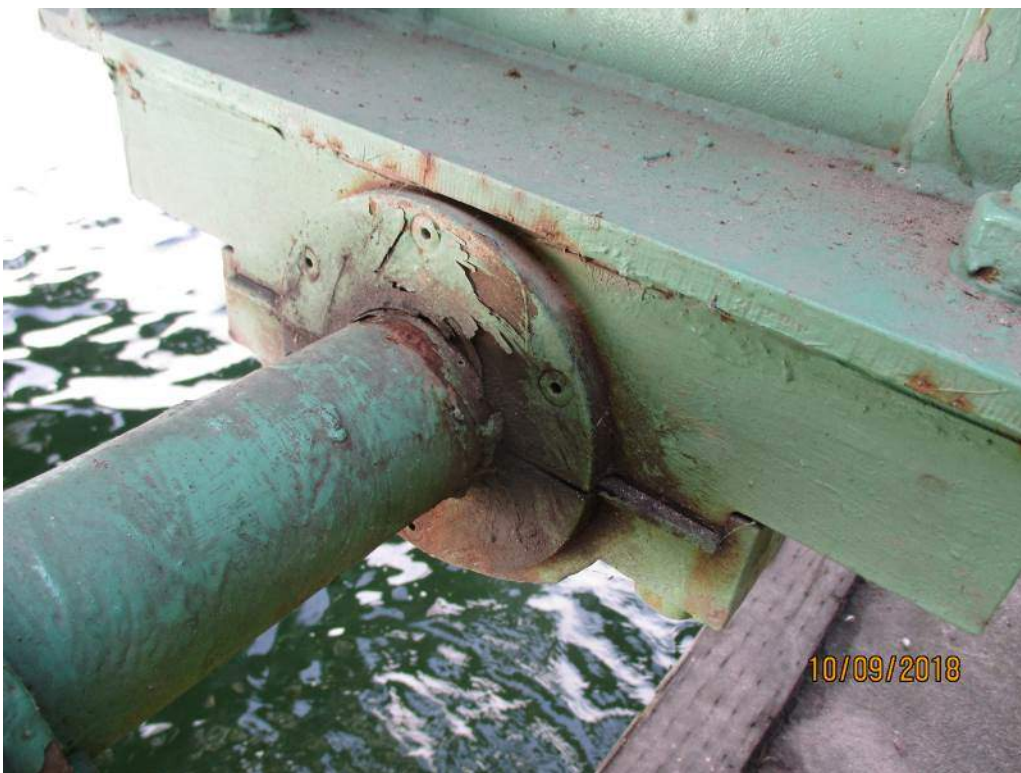
Photo M20: Span Lock Cross Shaft Bearing B1-S. The housing for the bearing exhibits paint deterioration and light corrosion. All of the span lock cross shaft bearings are similar.

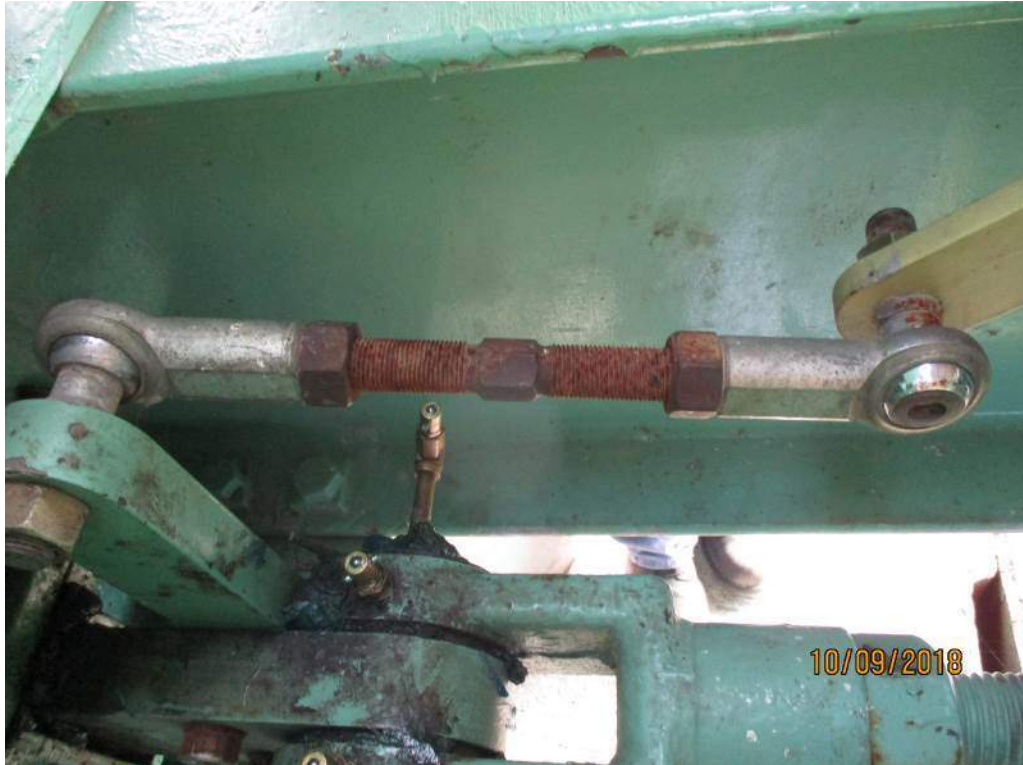
Photo M21: South Span Lock Crank Shaft CR1. The position indication shaft threads are not painted and corroded. The north location is similar.

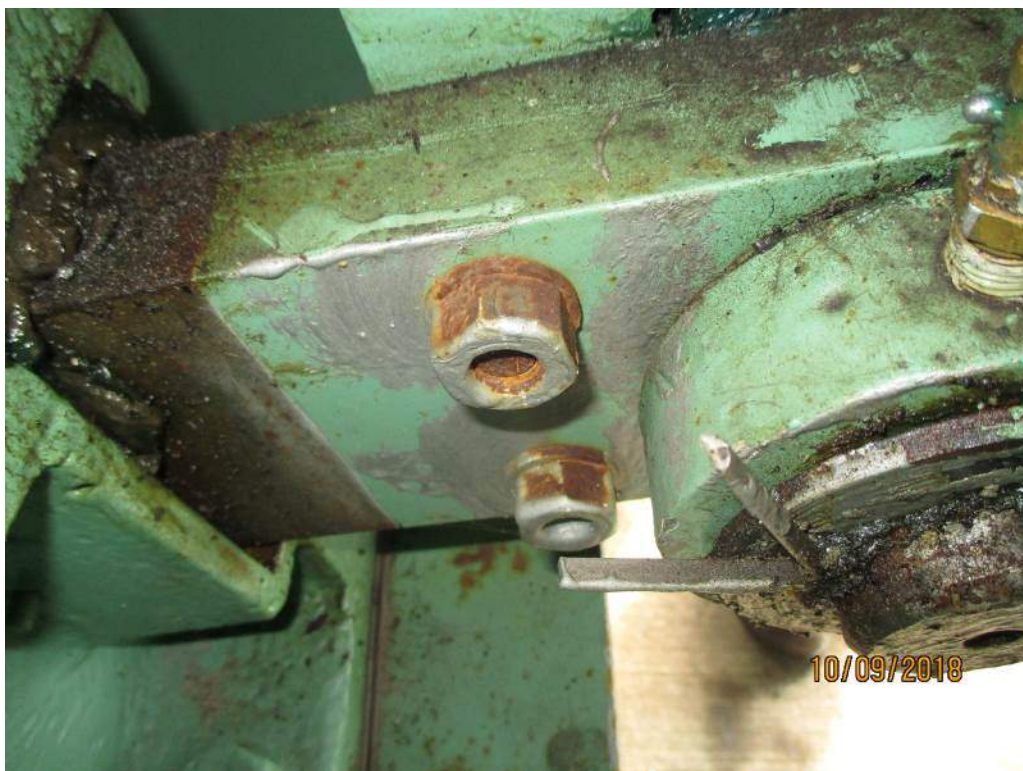
Photo M22: South Span Lock Crank Shaft CR2. The mounting bolts for the rotary cam position crank CR2 located on the lock bar are not fully painted and exhibit light corrosion. North Span Lock Crank Shaft CR2 is similar.

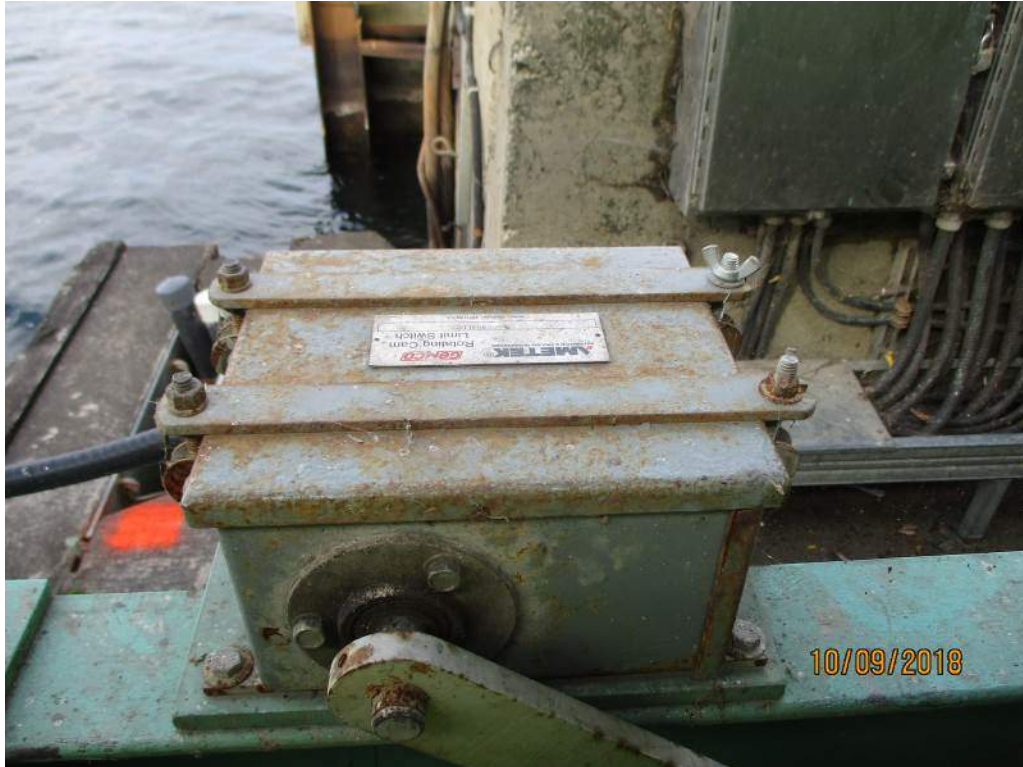
Photo M23: North Span Lock Rotary Cam. The rotary cam limit switch cover exhibits paint deterioration and light corrosion.

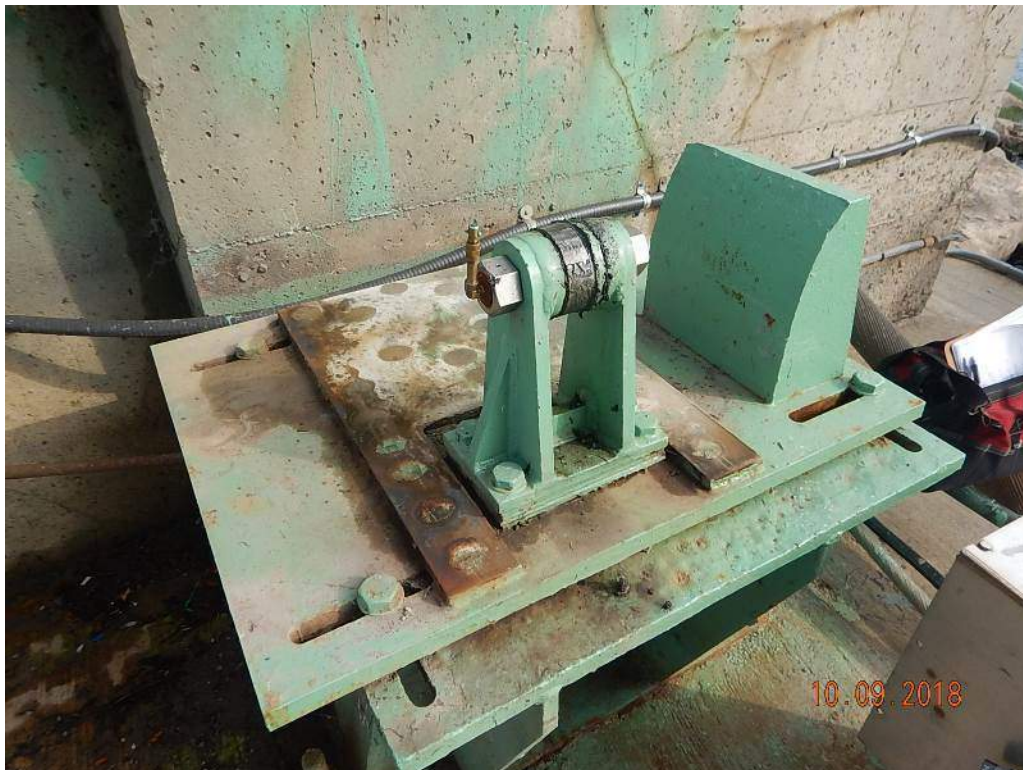
Photo M24: South Live Load Strike Plate. General view of strike plate and span lock receiver.

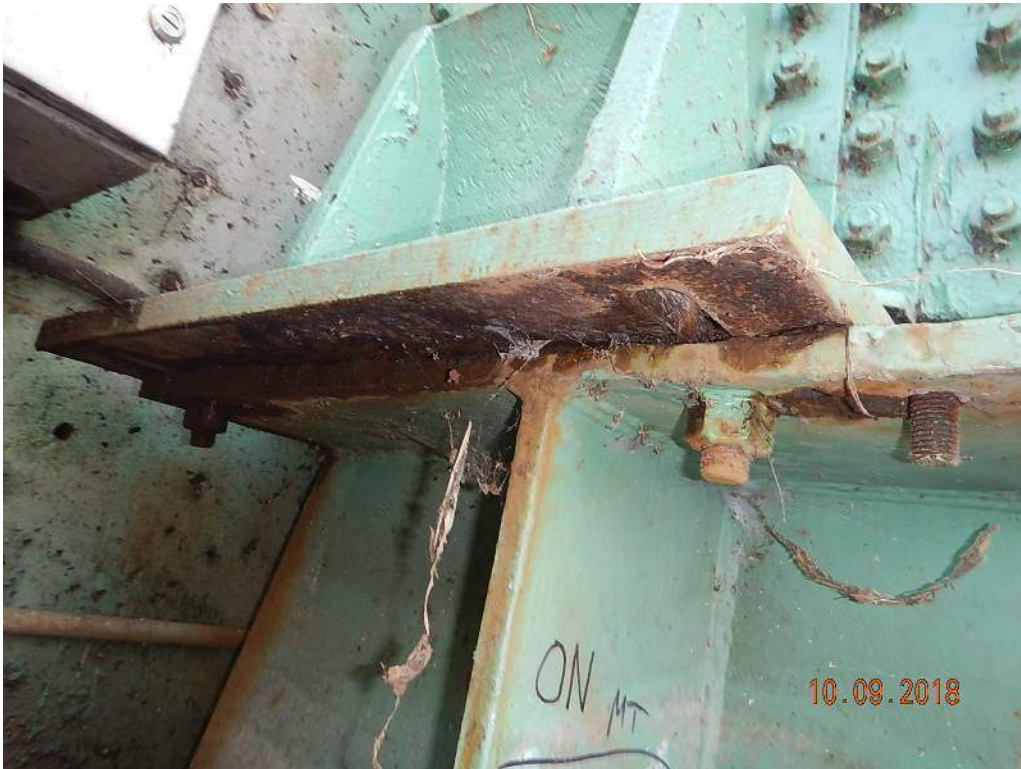
Photo M25: North Live Load Strike Plate. The underside of the strike plate support and mounting bolts are corroded. The south live load strike plate assembly is similar.

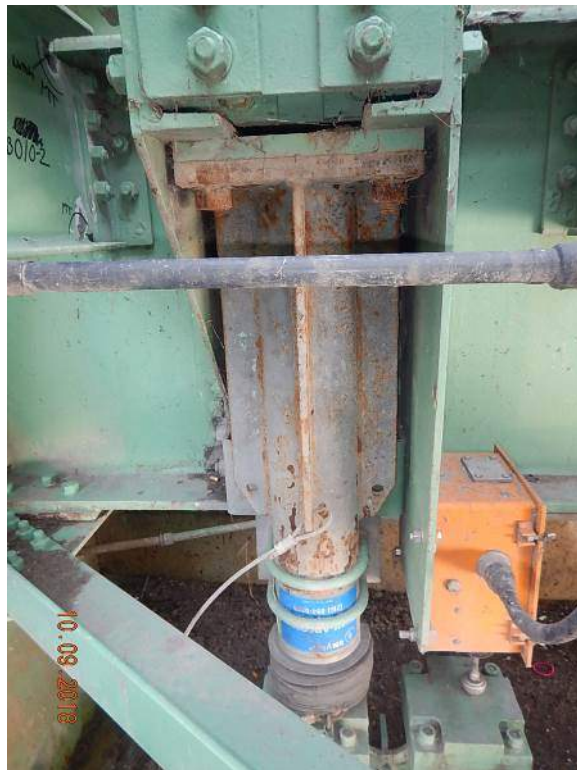
Photo M26: South Buffer. General View of the buffer, strike plate and seated limit switch. Note, the cylinder body has light to moderate spotty corrosion. The north buffer is similar.

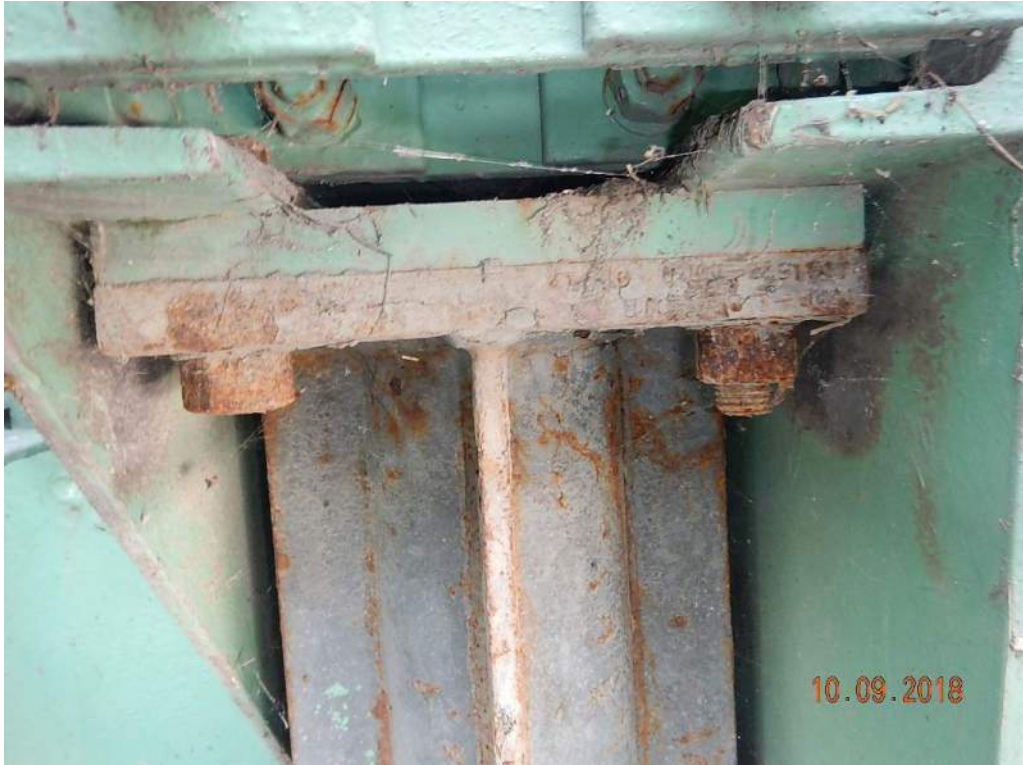
Photo M27: South Buffer. There is light corrosion between the top plate and the cylinder body. The mounting bolts exhibit moderate corrosion. The north buffer is similar.

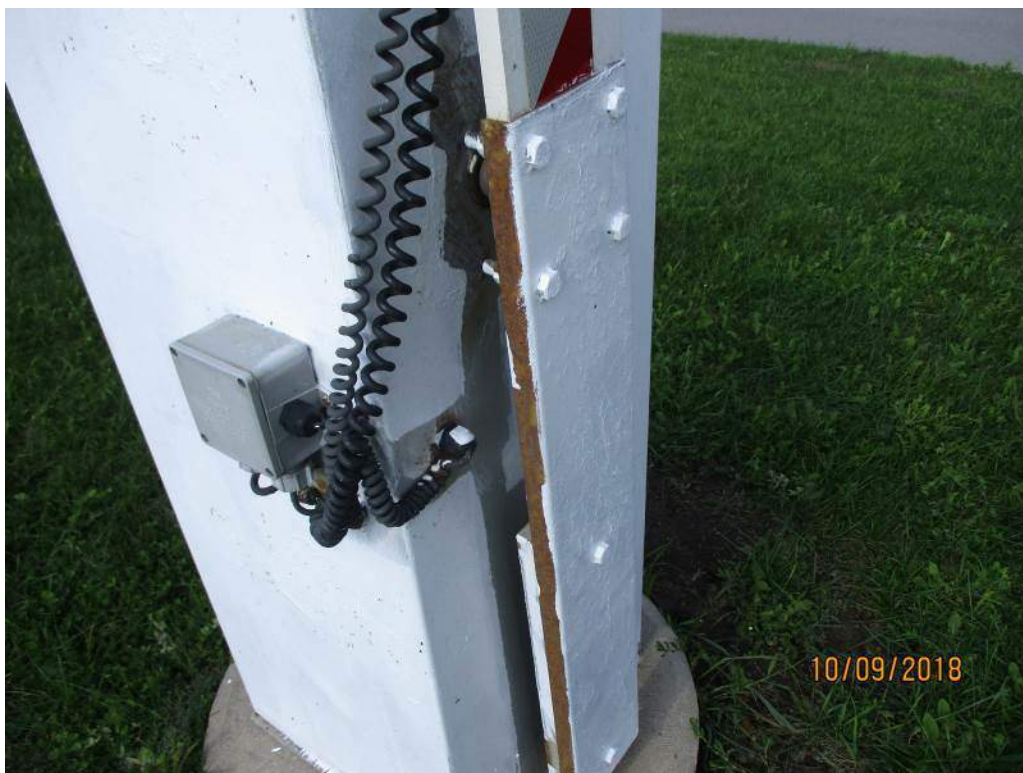
Photo M28: Northeast Warning Gate. The warning gate arms are not fully painted, and corrosion is still evident under the paint. The southeast warning gate is similar.

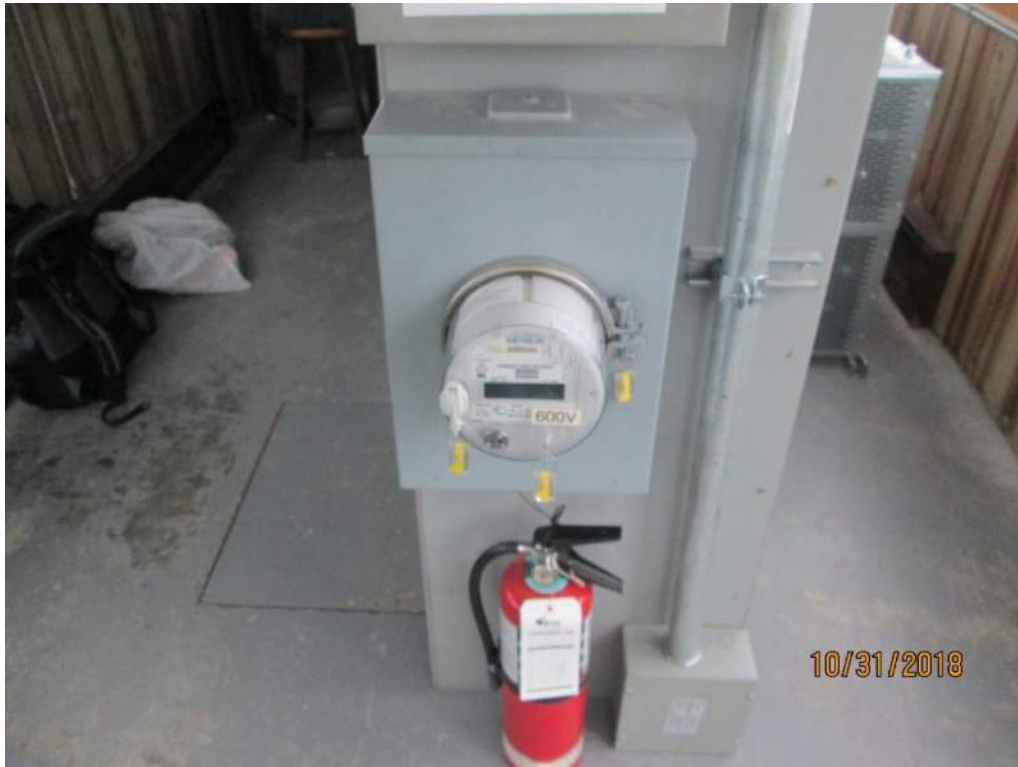
Photo E1: Utility Meter. The bridge electric service is provided with a utility meter that is located inside the operator’s control house and is mounted on the side of the MCC. Note both the meter and metering pan are in good condition.

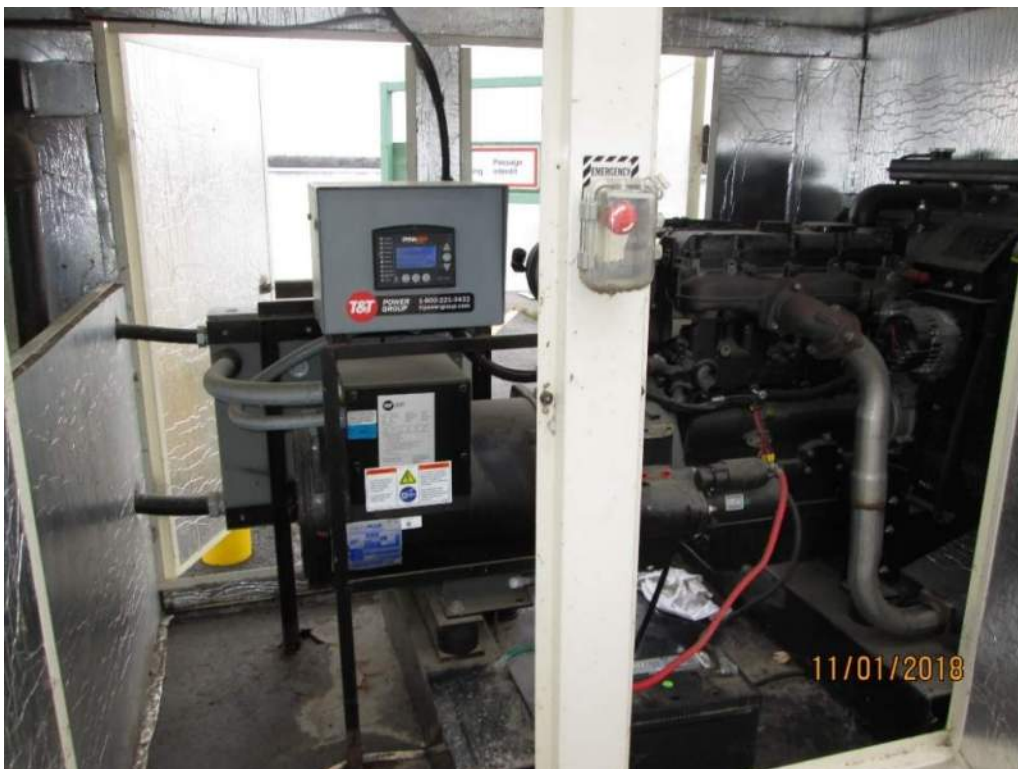
Photo E2: Standby Generator. The standby generator was installed in 2015 to provide a backup source of power for the bridge facilities in the event of utility power failure. Note that the generator, since the original drives and motors were replaced, is now capable of handling of span operation with one operating drive motor. Also note the generator and generator housing is in excellent physical condition.

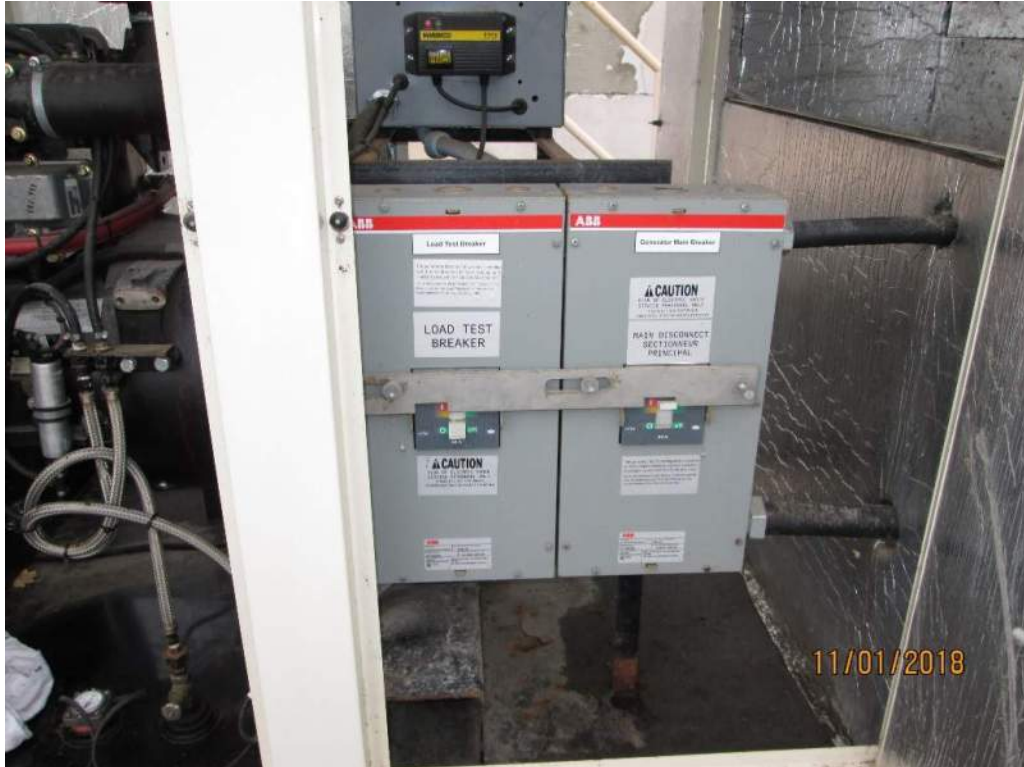
Photo E3: Standby Generator Breakers. The standby generator is provided with a 60A main disconnect breaker and a 60A load test breaker. Note the generator is not provided with a load bank and the load test breaker is not connected.

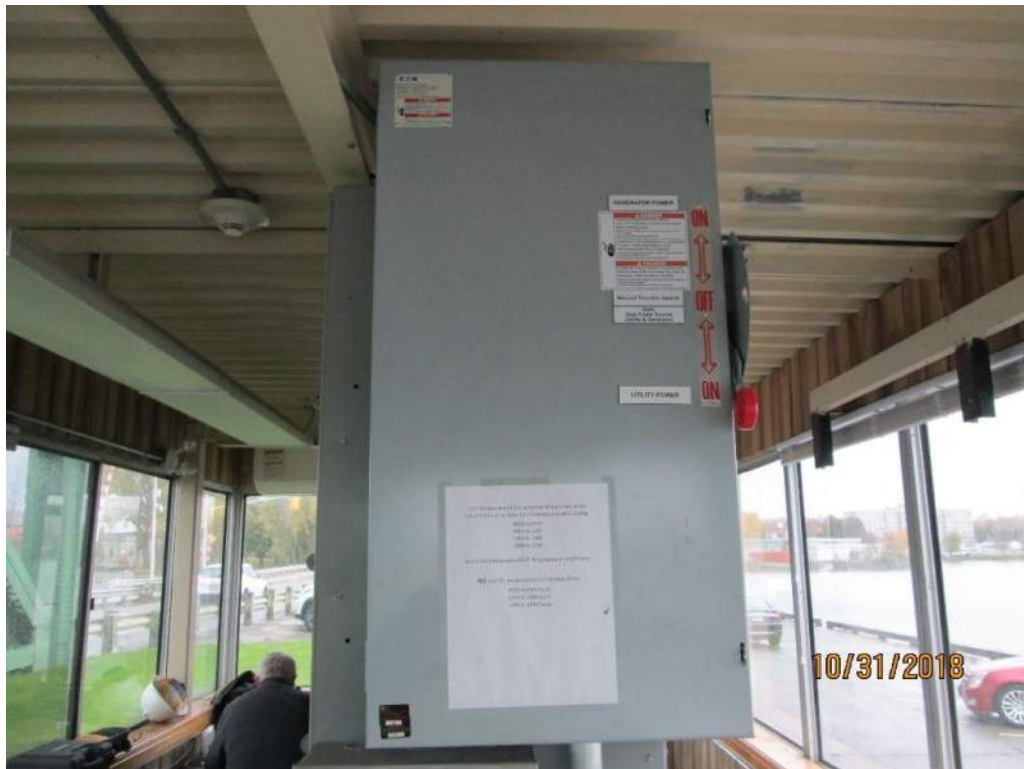
Photo E4: Manual Transfer Switch (MTS). A manual transfer switch has been mounted on the side of MCC in the operators control house to allow the transfer of power between utility power and the generator power. This MTS is in excellent physical and operational condition.

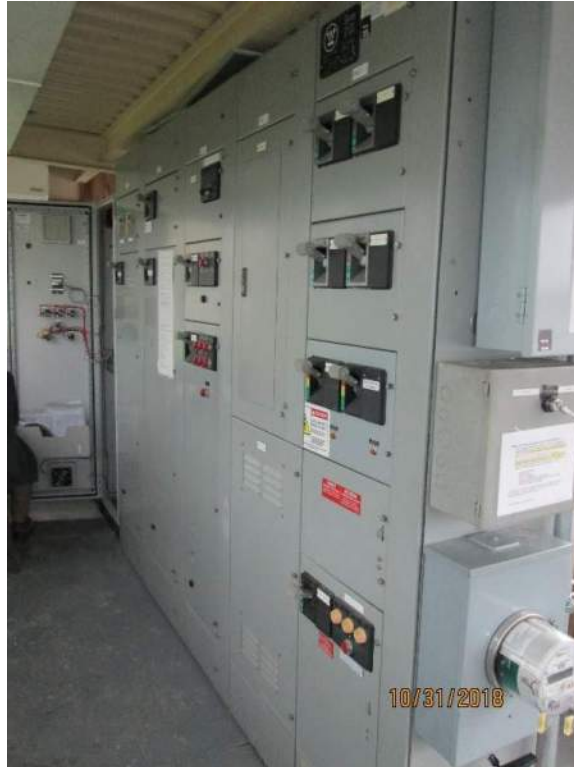
Photo E5: Motor Control Centre (MCC). The bridge is provided with a motor control center (MCC) for bridge power distribution. The MCC is located inside the operator’s control house. The MCC was installed in 1994 and is in good serviceable condition.
