LaSalle Causeway Bascule Bridge 2018 Comprehensive Detailed Inspection Report

Project Number: R. 090045.001

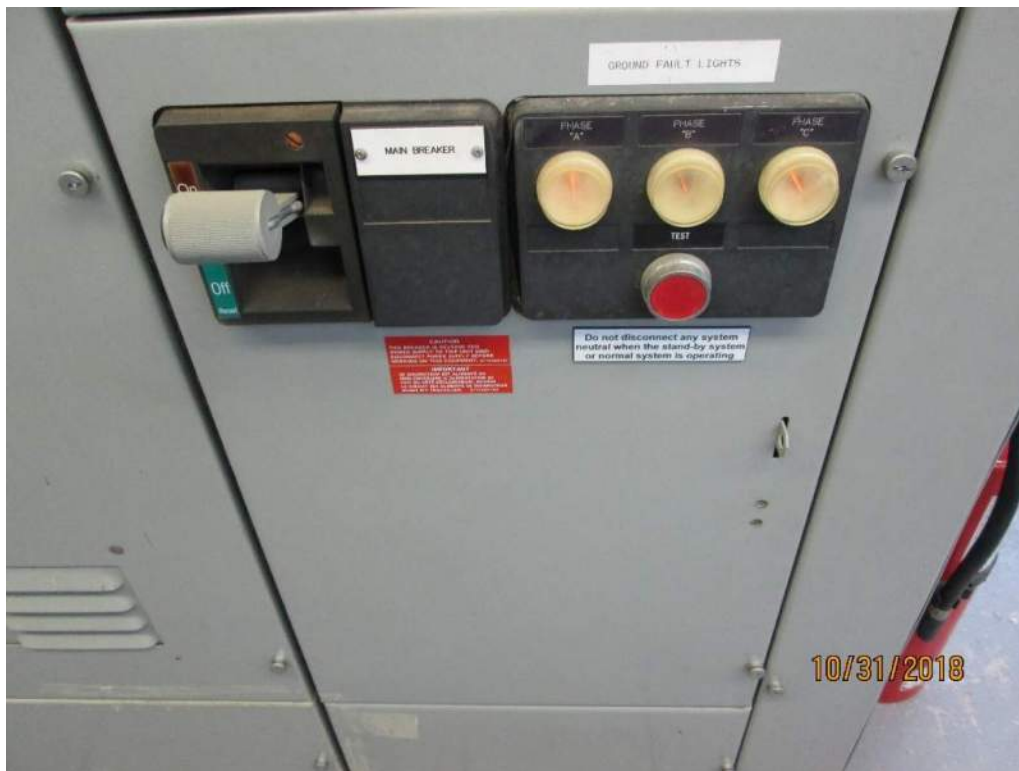
Photo E6: Ground Fault Indicators. A ground fault indicator light is provided for each phase of the 3-phase power. These indicator lights are provided on the MCC main breaker cubicle and were in an operational condition at the time of the inspection.

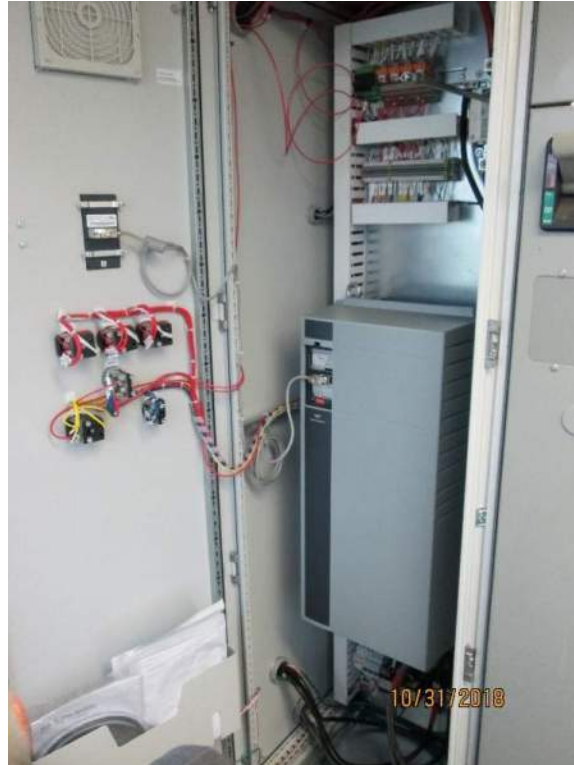
Photo E7: Span VFD Drive Cabinet. The span variable frequency drives are newly installed and replace the original drive motor controllers for the span drive. The new VFD drives are located in their respective drive enclosures and provide excellent and variable speed and torque control for the operating bridge.

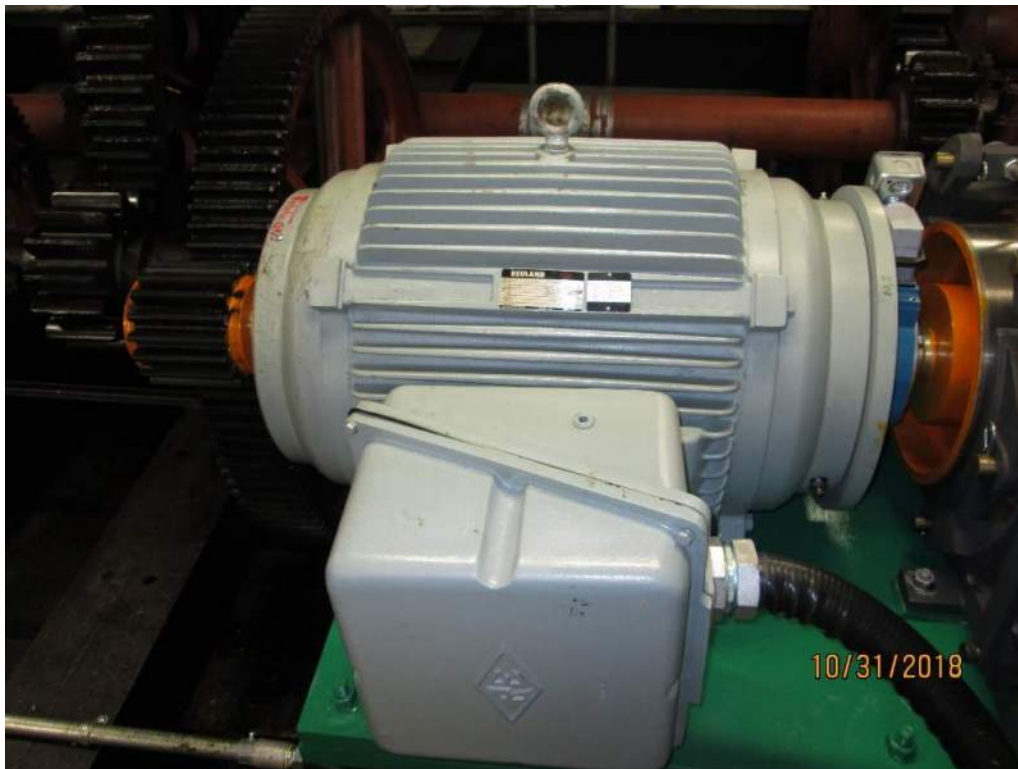
Photo E8: Typical Span Drive Motor. The bridge is provided with two span drive motors, the two motors can be configured to operate the span simultaneously or they can be configured to operate the span individually. These span drive motors are squirrel-cage induction type and replaced the original wound rotor motors when the new VFD drives were installed.

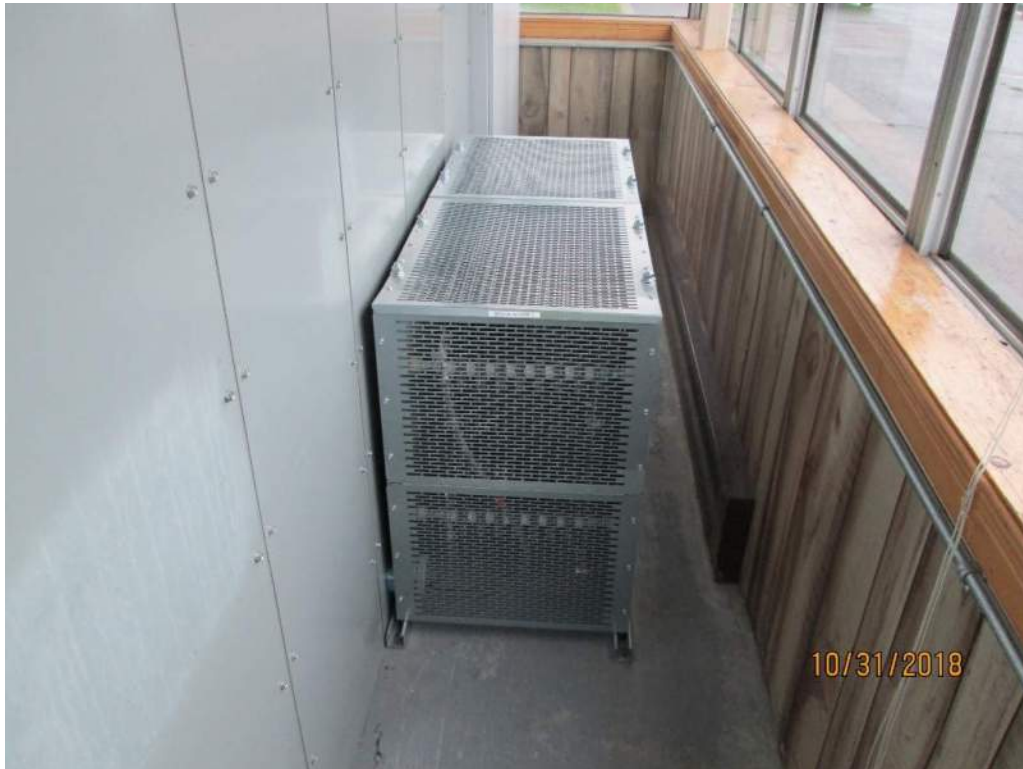
Photo E9: Typical Dynamic Braking Resistors. Dynamic braking resistors have been installed in conjunction with the VFD drives to provide speed and torque braking control for the span drive motors. These resistors were installed when the VFD drives were installed and are in freestanding enclosures located behind the MCC.

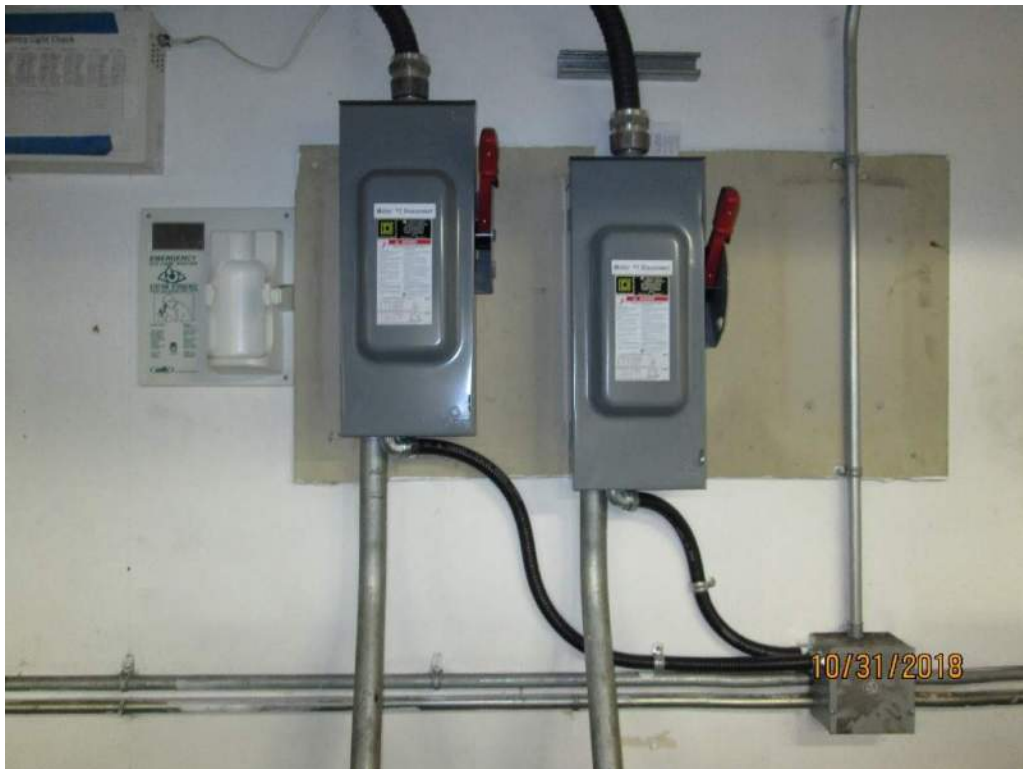
Photo E10: Span Drive Motor Disconnects. The span drive motors are provided with local disconnect switches as per Canadian Electrical Code. These disconnect switches were installed as the same time as the new drive motors and are in as new condition.

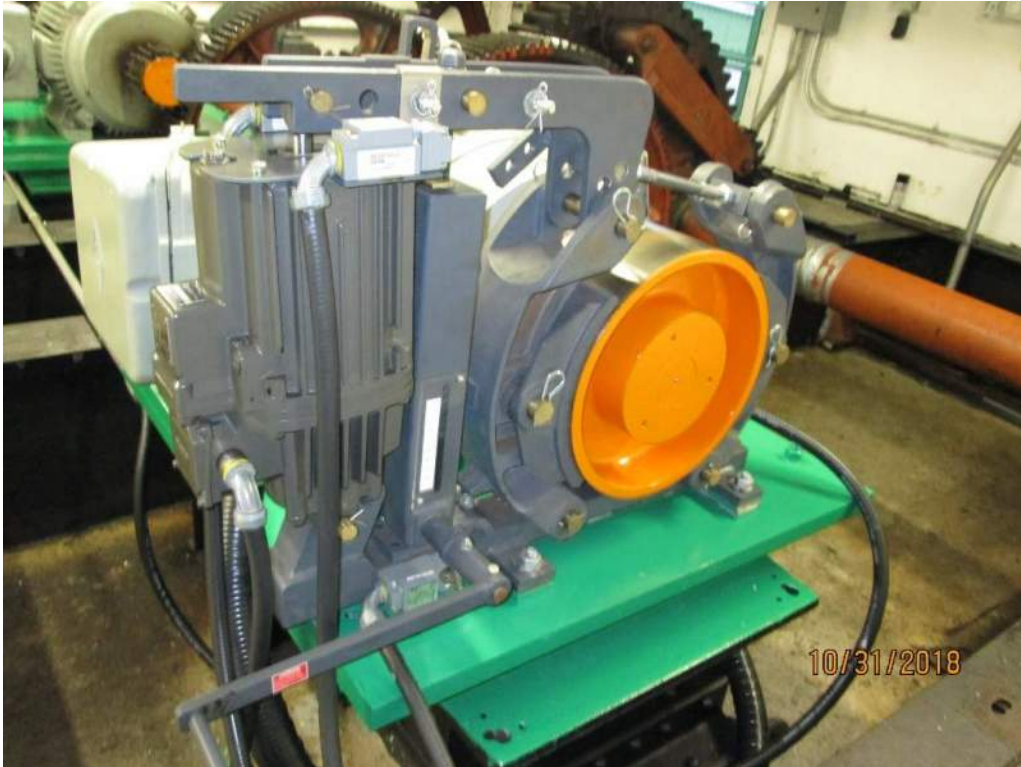
Photo E11: Typical Motor Brake. The motor brakes are in as-new physical and operational condition and are provided with set, released, and hand released limit switches as per code.

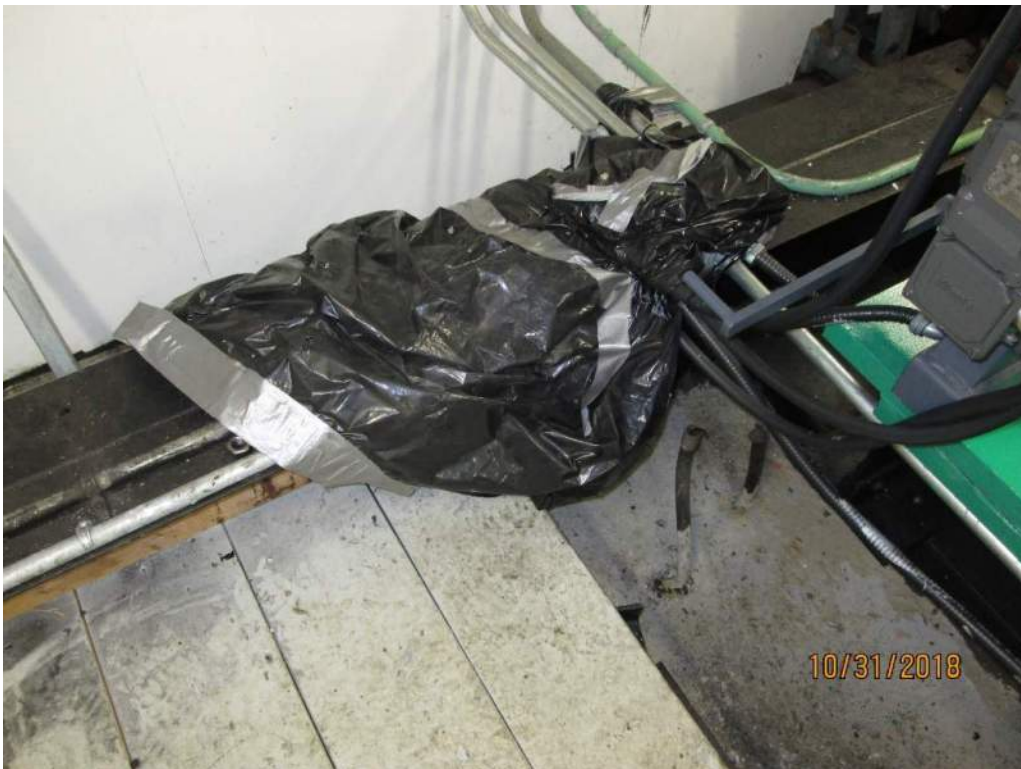
Photo E12: A black plastic bag is covering the junction box near motor brake #2. No water was observed at the time of the inspection, but traces of water stains indicate leaking of the roof is occurring.

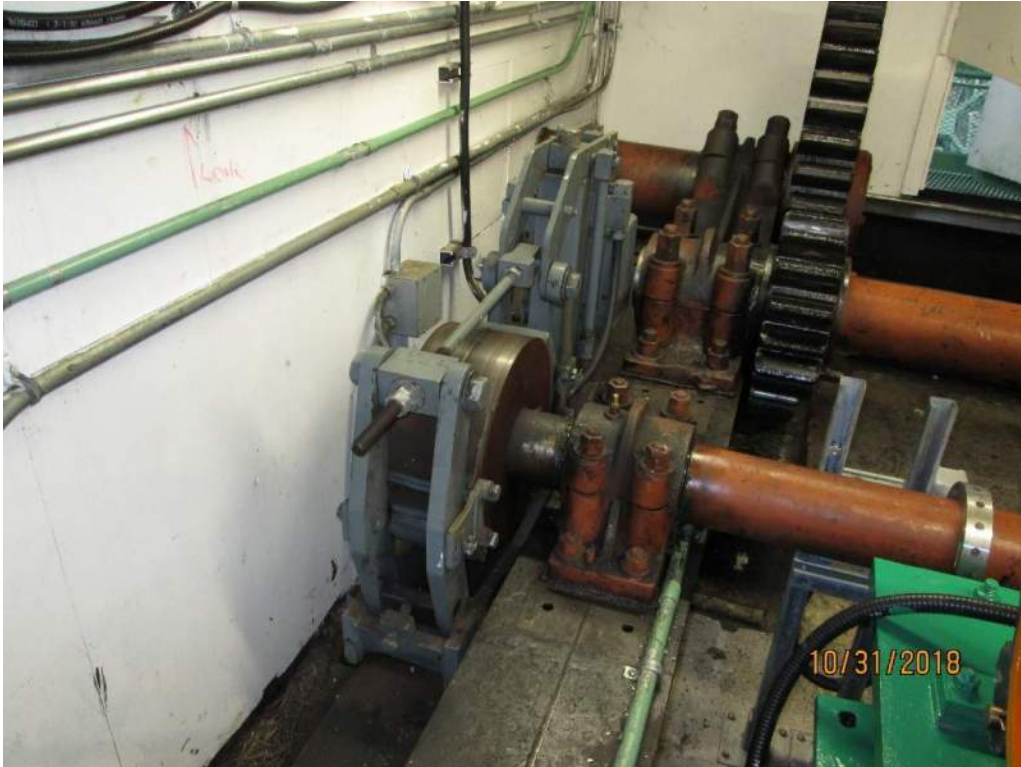
Photo E13: Manual (Machinery) Brake & Disconnect. A manual brake with a local disconnect switch is provided in the bridge machinery space. Only set and released limit switches have been provided for this brake; the code-required brake hand released limit switch has not been provided.

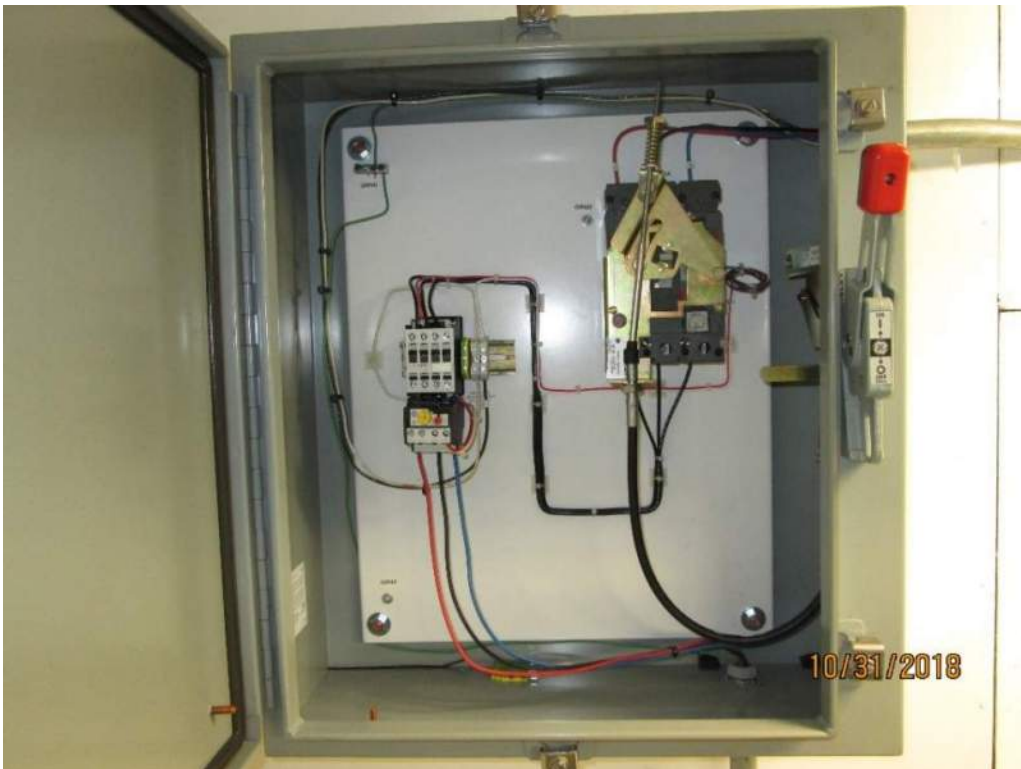
Photo E14: Motor Brake Disconnect and Starter enclosures. New motor brake starters were recently installed in the bridge machinery space and are in excellent condition. The MCP of the motor brake starter also serves as the local disconnect switch. The wires in the enclosure have not been labelled to aid troubleshooting.

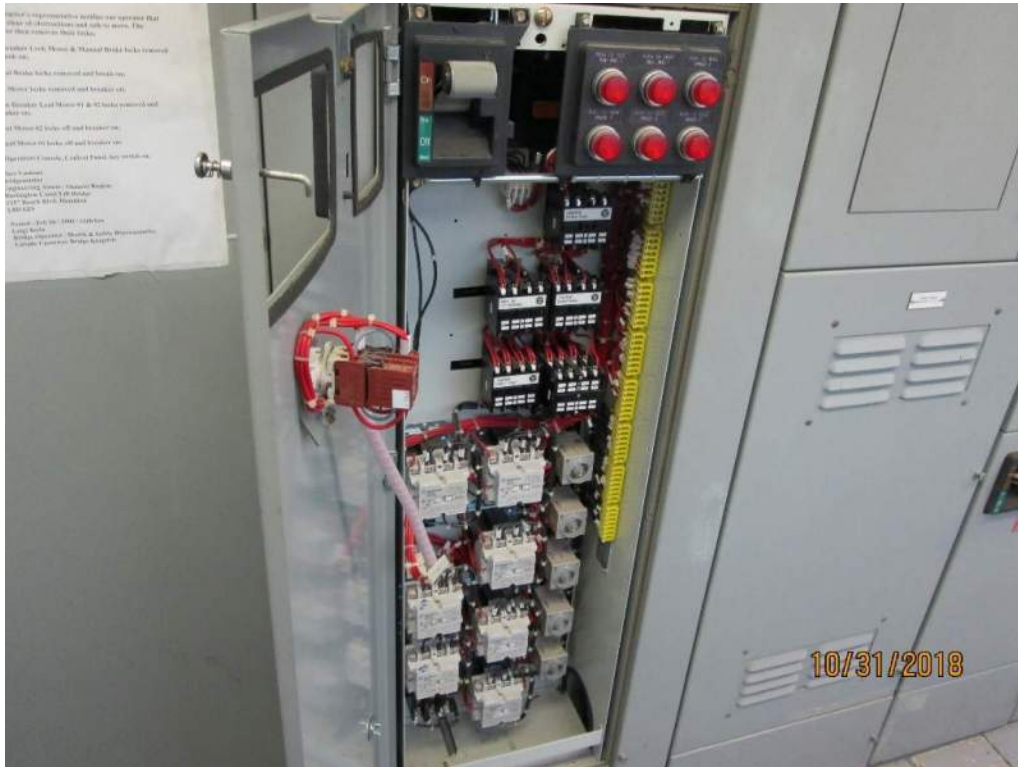
Photo E15: Span Lock Starter Compartment. Note the span lock was originally designed with 6-speed operating steps. However, at the time of the inspection the span lock was operating at single speed only and the speed stepping contactor and resistor circuit had been disabled.

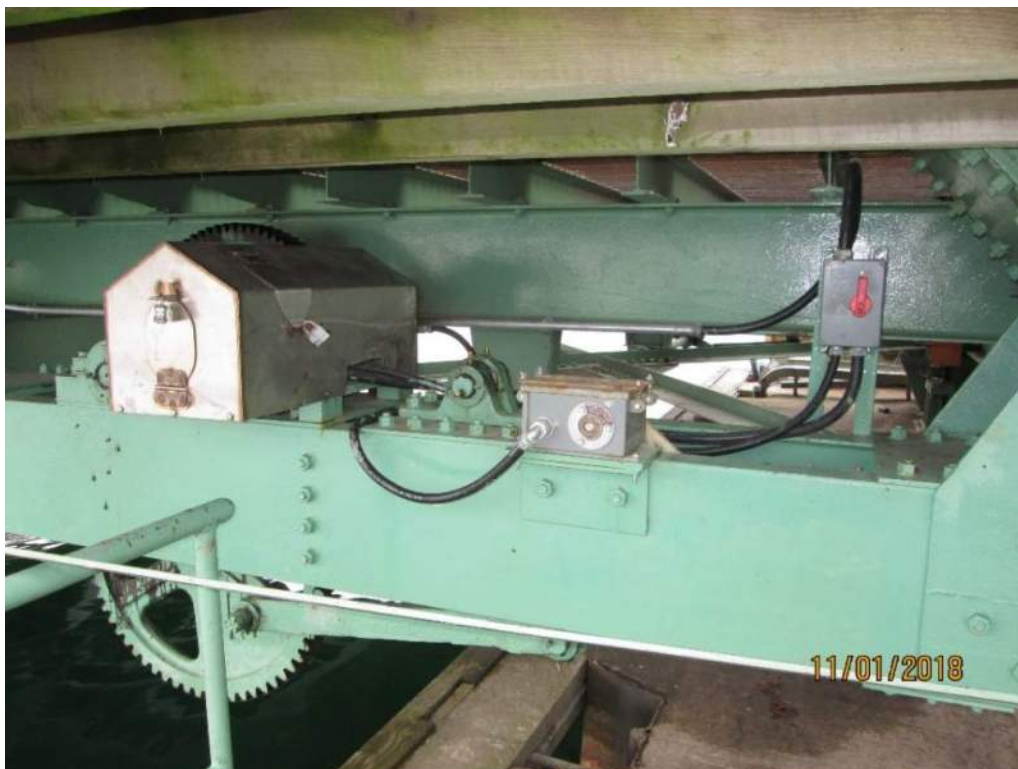
Photo E16: Span Lock Motor, Rotary Cam Limit Switch (RCLS) and Disconnect Switch. The span lock motor is housed in a stainless-steel enclosure and is provided with a local disconnect switch. The span lock is also provided with a two-cam limit switch for control, interlock and indication during bridge operation. Note the minor corrosion on the RCLS enclosure.

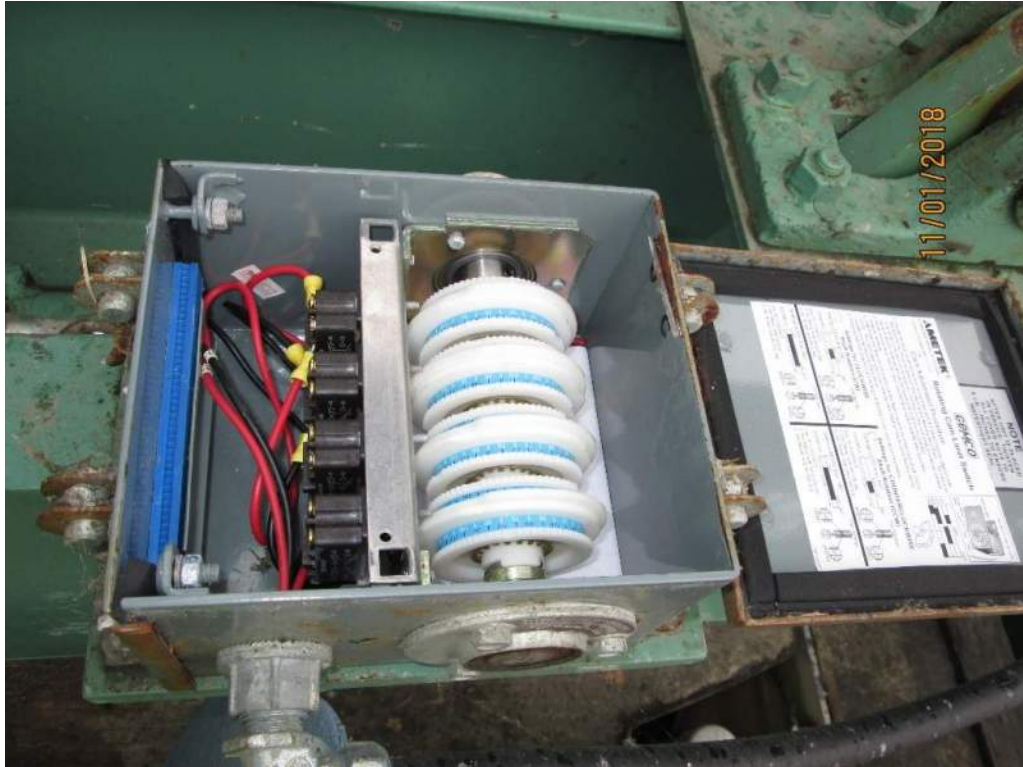
Photo E17: North Side Span Lock Rotary Cam Switch. The span lock is provided with a second RCLS to monitor the position of the north lock bar. The cam switches inside the enclosure are in very good physical and operational condition.

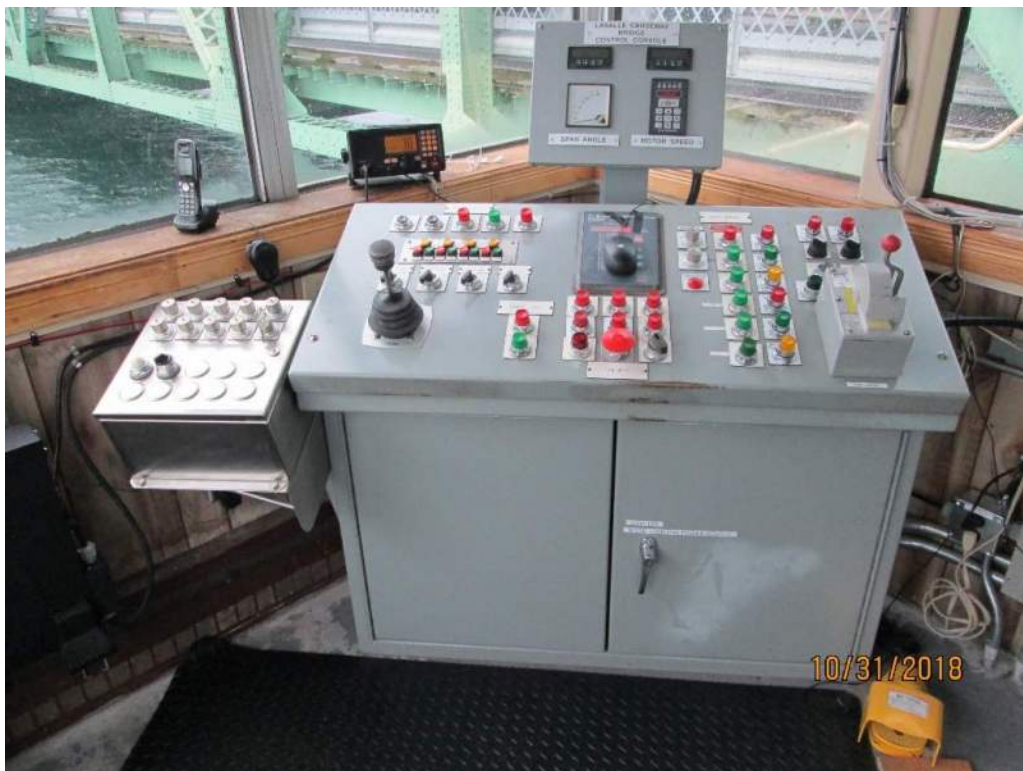
Photo E18: Control Desk. The location of the control desk provides the operator with a complete view of the channel and vehicular and pedestrian roadway traffic. The control desk is in acceptable condition. Note the foot switch next to the control desk on the floor is in good operational condition.

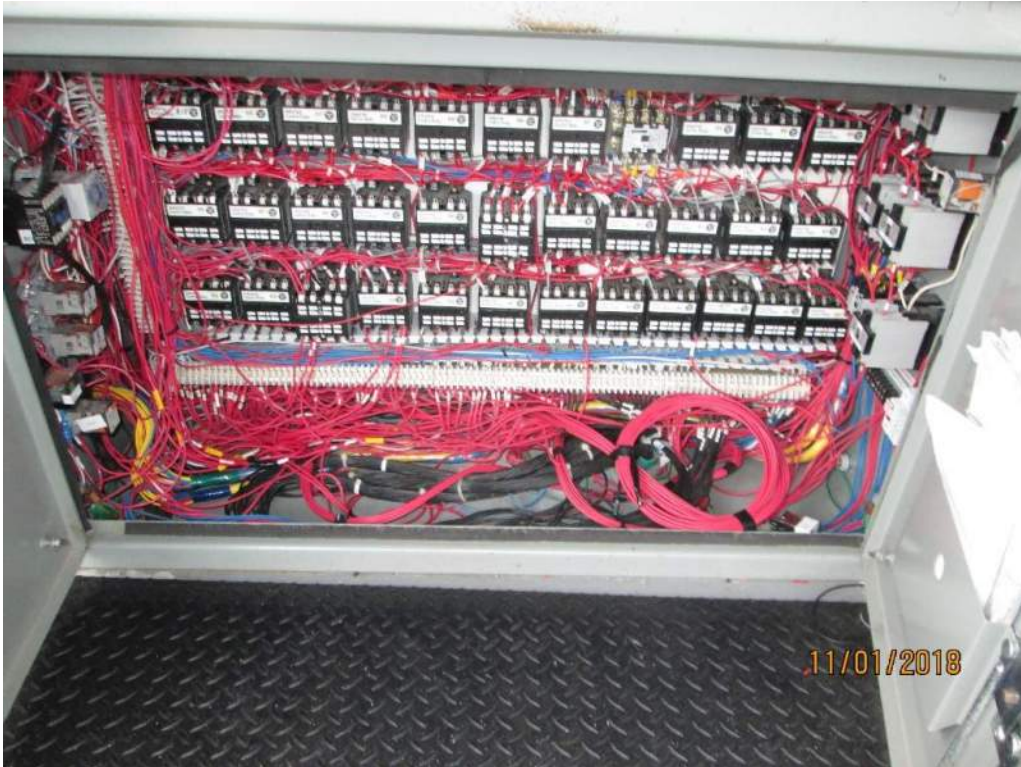
Photo E19: Relay Control Inside the Control Desk. This relay cabinet was modified during the drive/motor replacement project to accommodate the new control required for the new drive system.

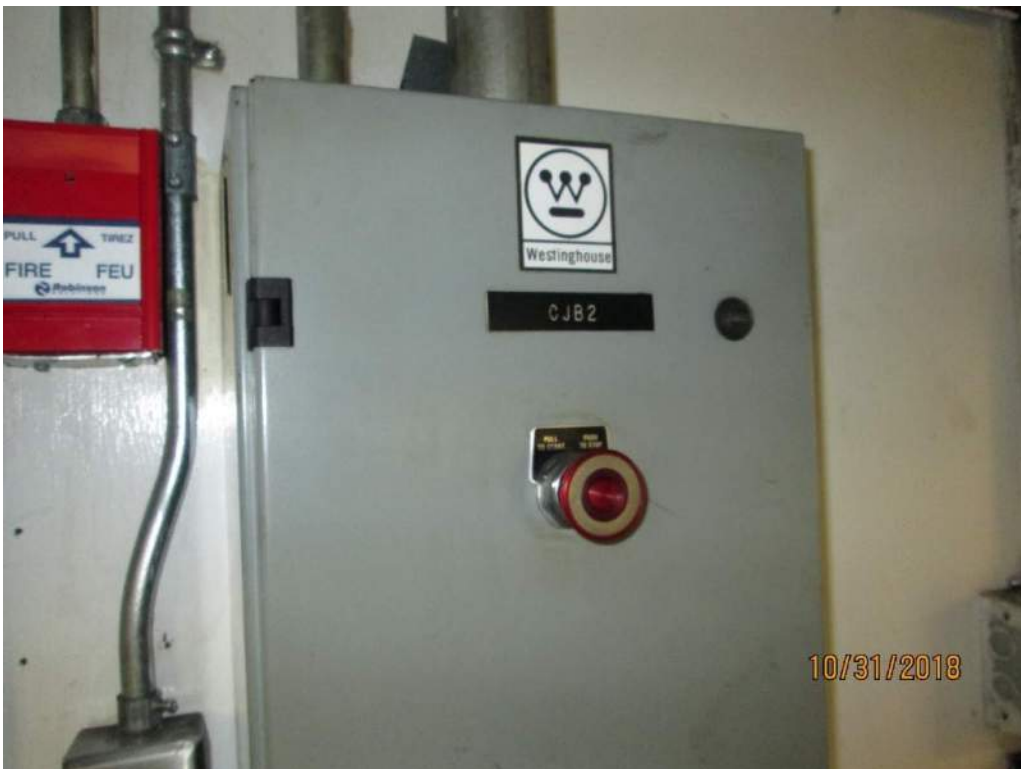
Photo E20: Machinery Space Local E-Stop. This E-Stop switch is located near the machinery space entrance. It allows maintenance personnel to prevent or stop bridge operation when work is being performed in the machinery space.

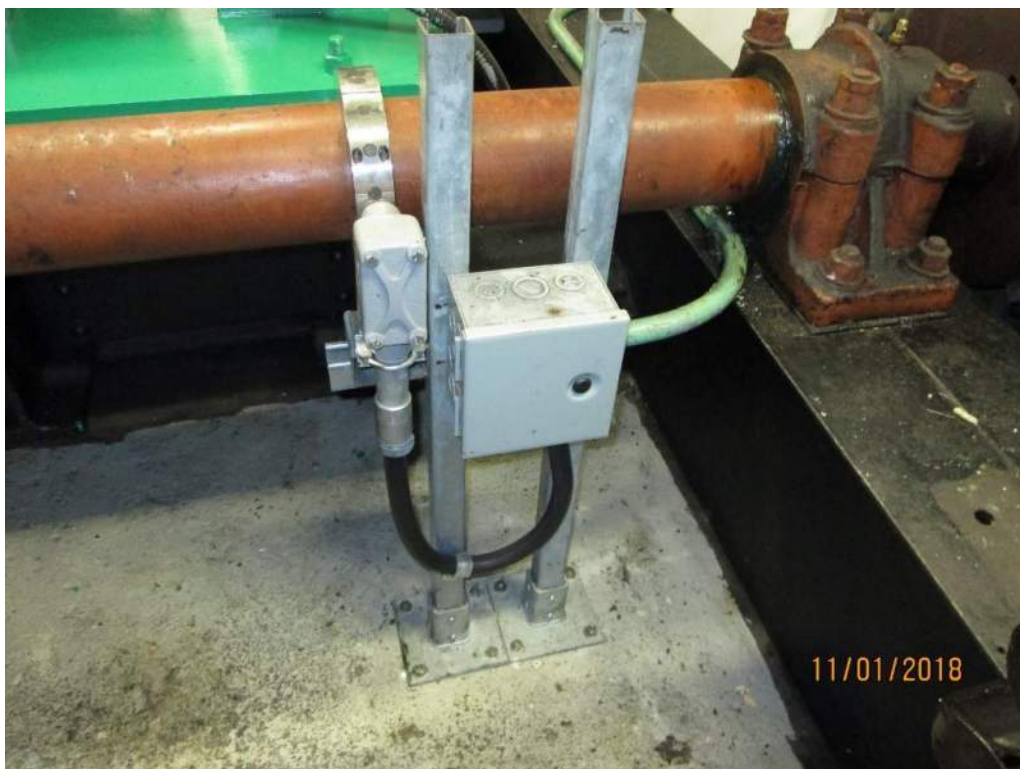
Photo E22: Speed Switch Sensor. A Hall Effect speed switch was installed as part of a 2012 rehabilitation project to provide span position and motor speed indication on the operator's control desk. The speed switch sensor is in excellent condition.

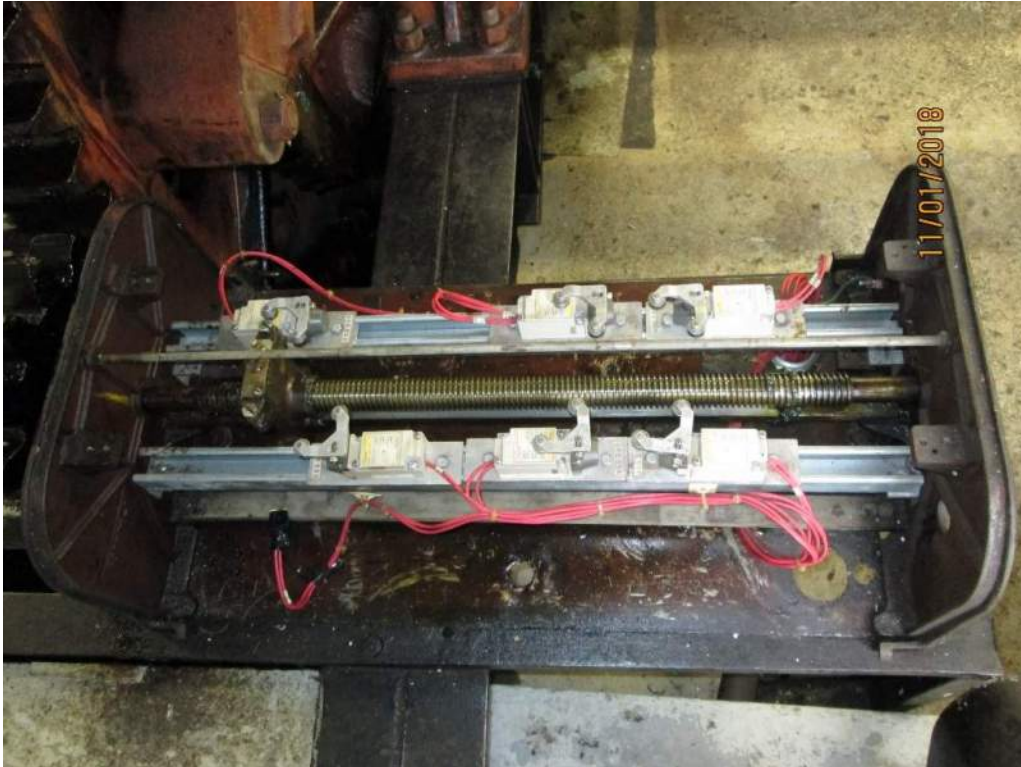
Photo E23: Span Position Limit Switches. The targets on the auxiliary threaded shaft are used to toggle the lever type limit switches and provide discrete signals of the bridge position. The limit switch housing exhibits signs of corrosion, but the limit switches inside are in good operational condition.

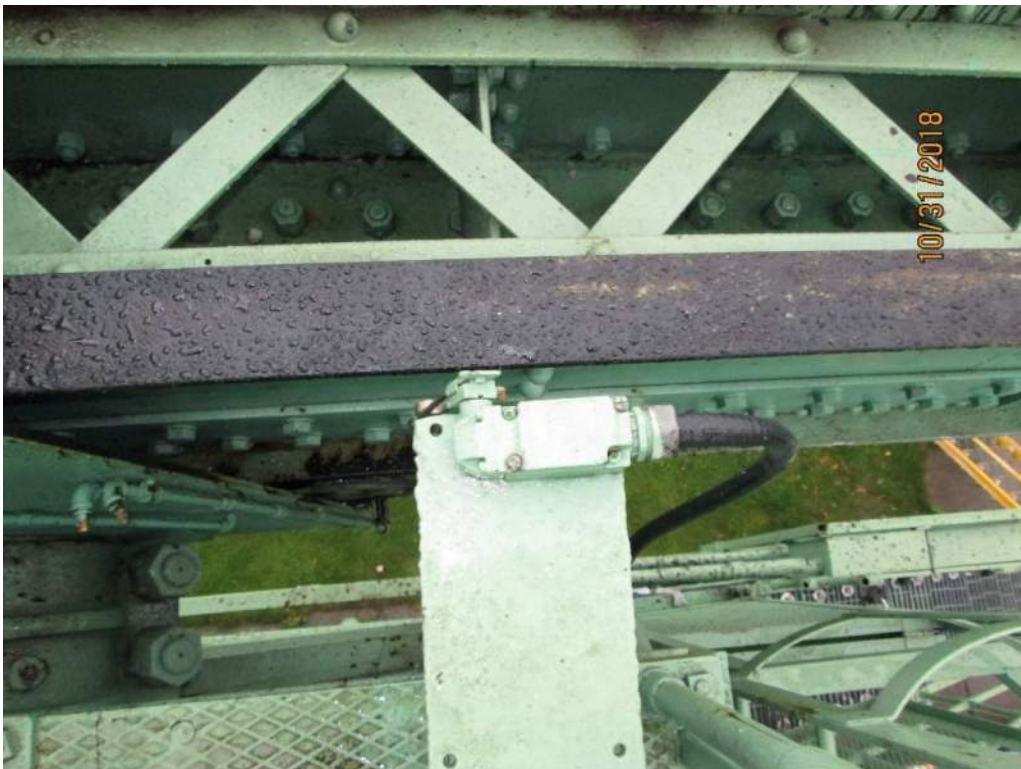
Photo E24: Span Over-Travel Limit Switch. The span control is provided with an over-travel limit switch to stop bridge operation in the event of span over travel.

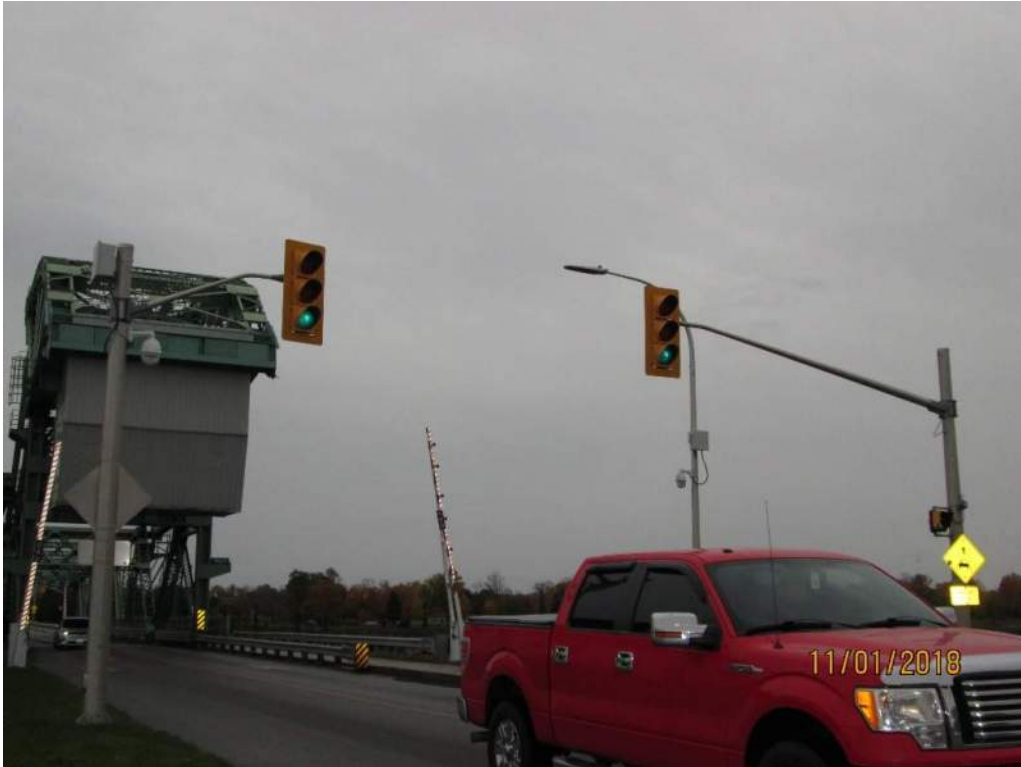
Photo E25: Typical Traffic Signal (West Shown). Each bridge approach is provided with two sets of traffic signal fixtures mounted on cantilevered arms and suspended over the roadway. Additionally, a warning gong and a pedestrian signal light have been provided at each of the south traffic signal poles. The traffic signal equipment was installed as part of a recent rehabilitation project and is in excellent condition.

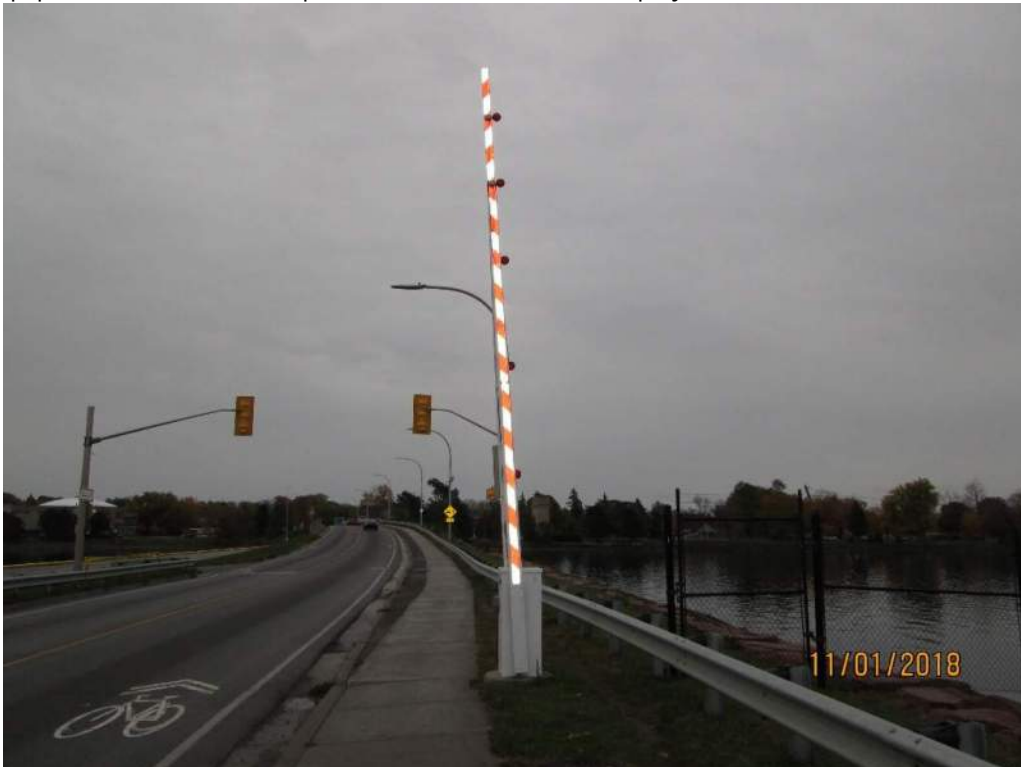
Photo E26: Typical Traffic Gate (Fully Raised). The bridge is provided with four (4) traffic gates, one at each approach to the span. All gates and gate arm lights were in good operational condition at the time of the inspection.

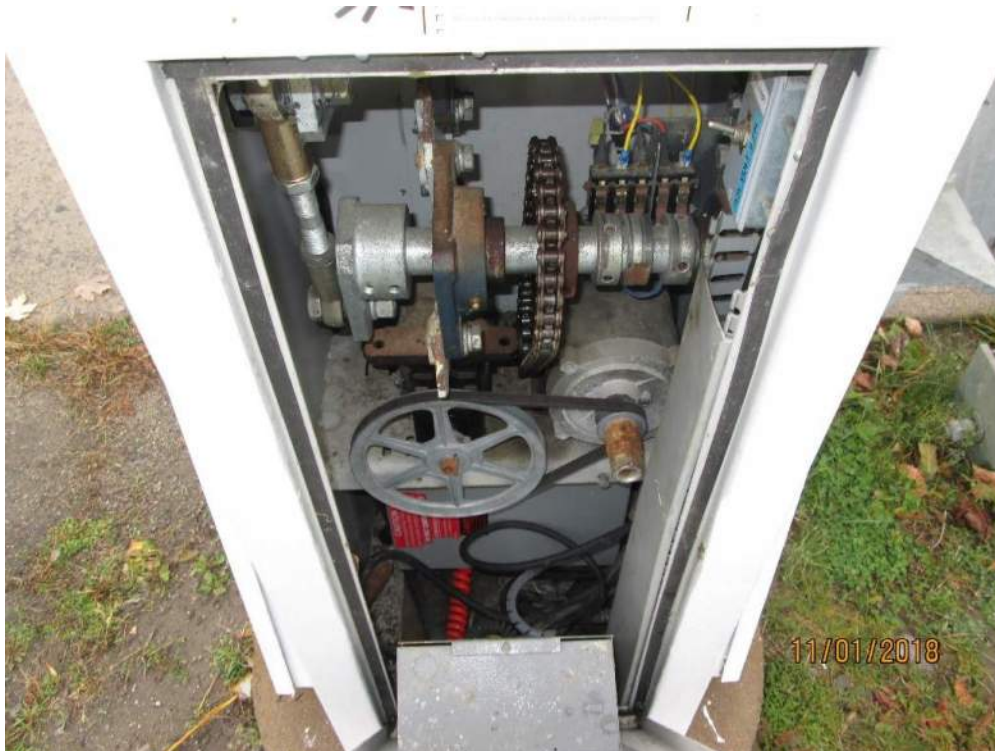
Photo E27: Typical Traffic Gate Housing. The motor starter is located inside the gate housing. Note that no door limit switches have been provided to prevent gate operation when the gate door(s) are open for maintenance or troubleshooting but a sign has been installed to indicate that the gate is powered and should be disconnected at the MCC prior to maintenance being performed. Also note no hand crank limit switch has been provided in accordance with code.

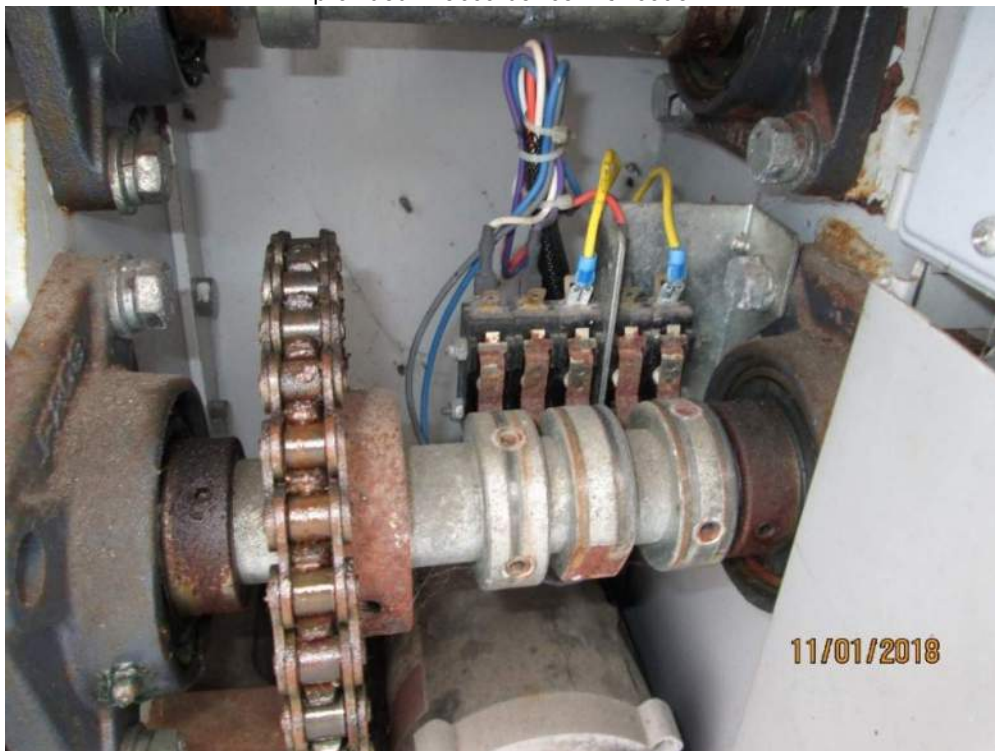
Photo E28: Typical Traffic Gate Limit Switches. The traffic gates are provided with a cam type limit switch. Although these limit switches were in operational condition at the time of the inspection, they are missing protective covers, switch contacts exhibit excessive corrosions due to the exposure which might cause premature failure.

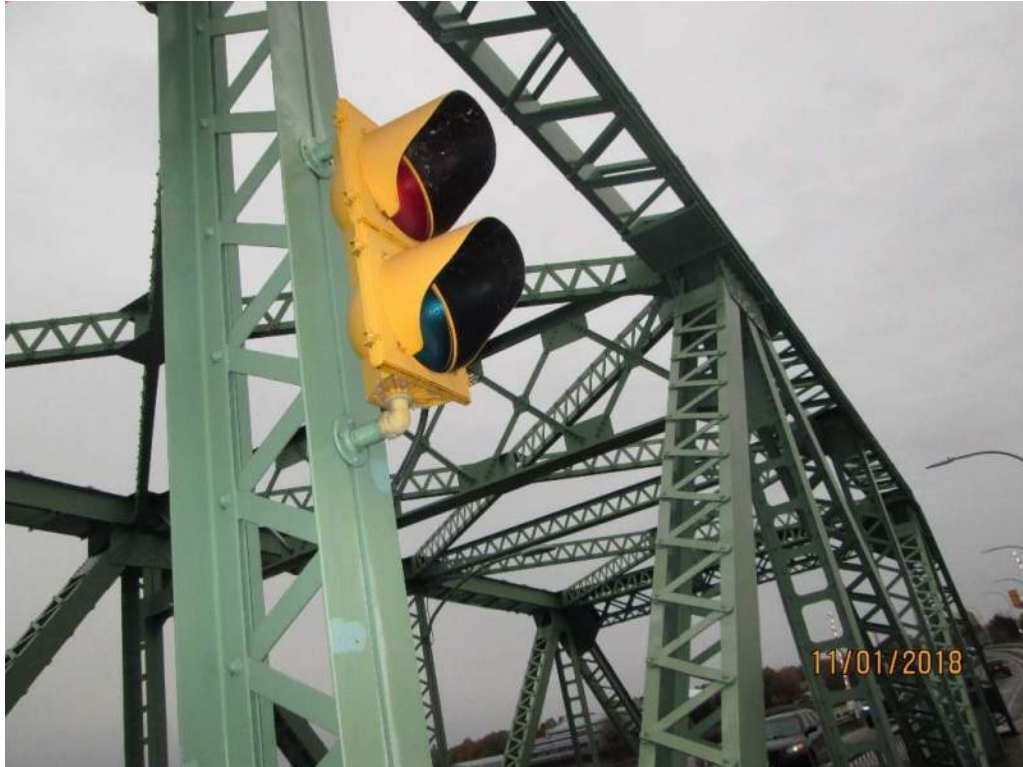
Photo E29: Typical Span Navigation Light. Note that roadway type lights are being used. The location of the navigation lights does not provide marine traffic with a clear visual indication as to when the span has been raised and it is safe to proceed.

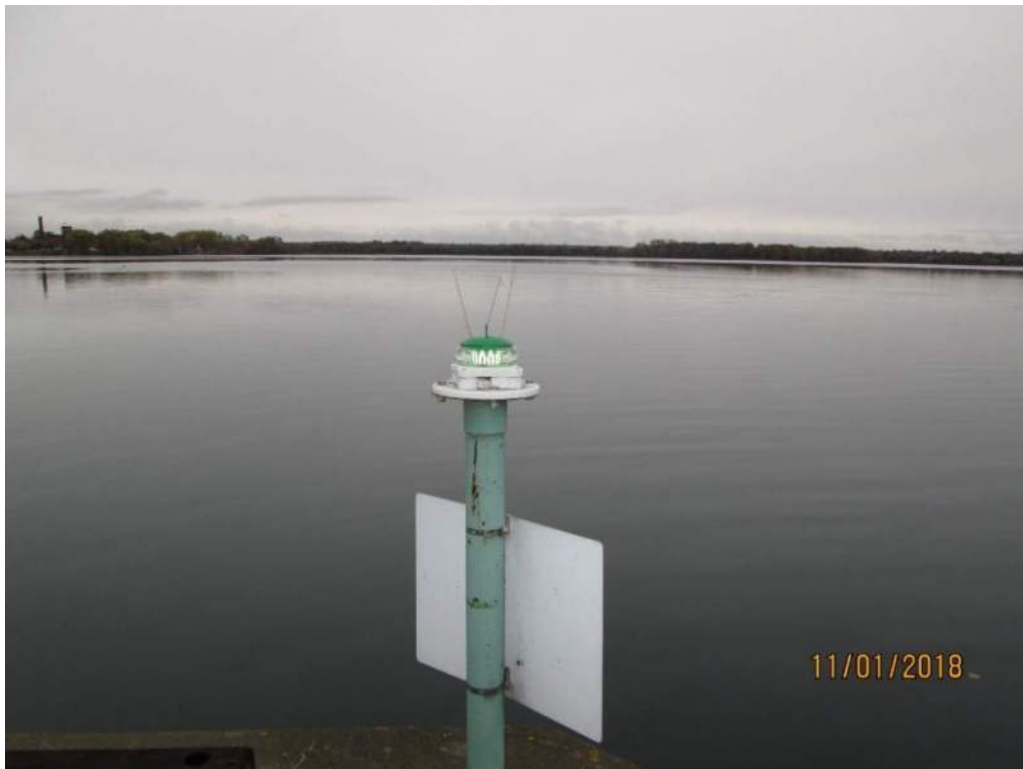
Photo E30: Typical Fender Light. The bridge is provided with 4 fender light fixtures, one at each corner of the fender. The north fender lights are flash red and the south fender lights are flash green. The fender lights are of LED type and are in good operational condition.

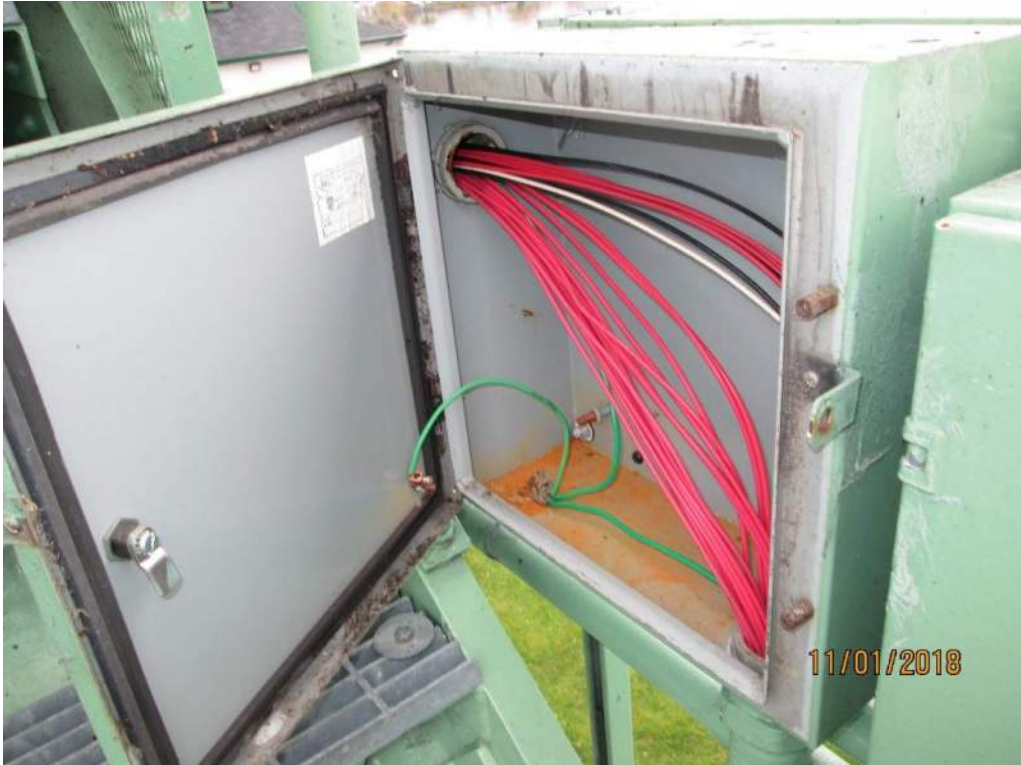
Photo E31: Typical Outdoor Junction Box. Many of the outdoor junction/pull boxes are NEMA 4X boxes. Note the junction/pull boxes are in good physical condition, but some of the boxes do exhibit signs of corrosion inside the boxes.

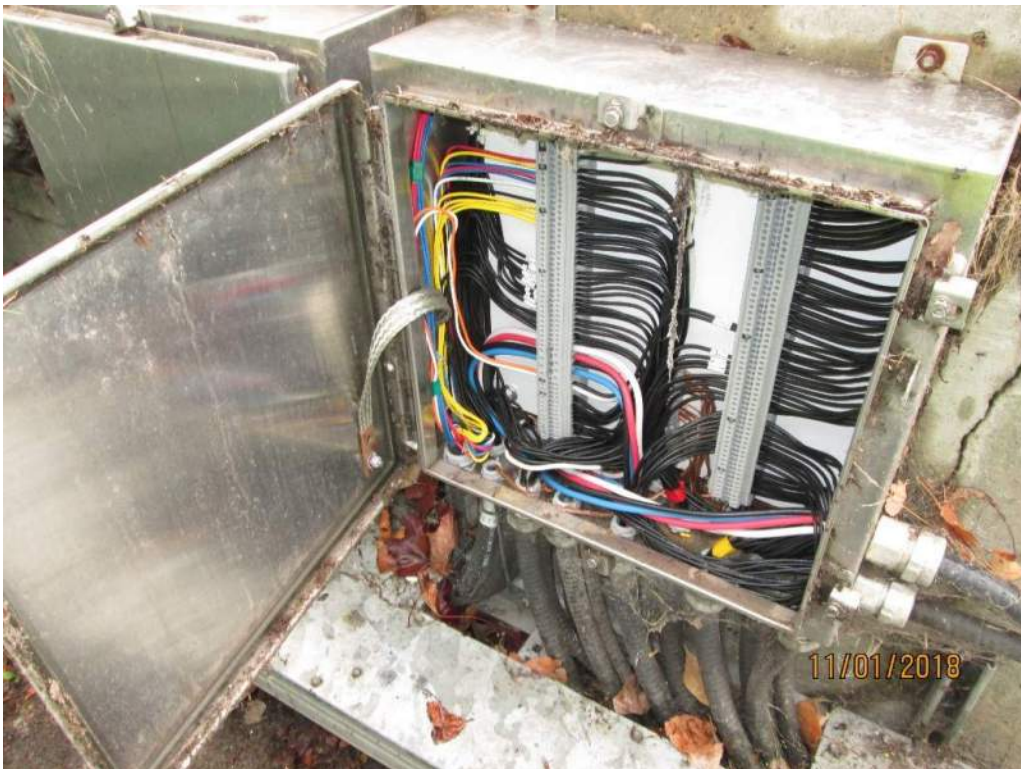
Photo E32: Typical Submarine Cable Junction Box. The submarine cable junction box is in good condition with proper grounding and bonding but covered with debris both internally and externally. Note the wires inside the submarine cable junction boxes are not properly labelled.

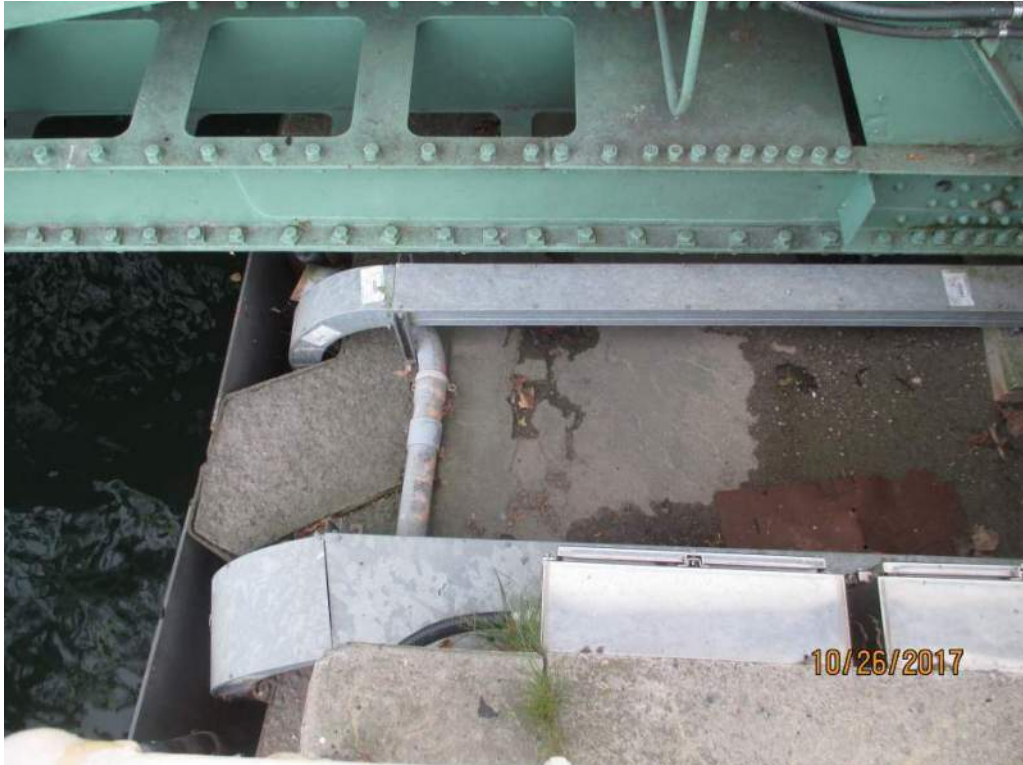
Photo E33: Typical Submarine Power Cables. The submarine cable is used to carry control and power across the channel. Both recently installed and originally installed submarine cables were found at the bridge. It was unclear if the old submarine cable was abandoned or still in service. Note the new submarine cable is of the Teck cable type and is protected with wireways above water level on the pier.
