LaSalle Causeway Bascule Bridge 2018 Comprehensive Detailed Inspection Report

Project Number: R. 090045.001

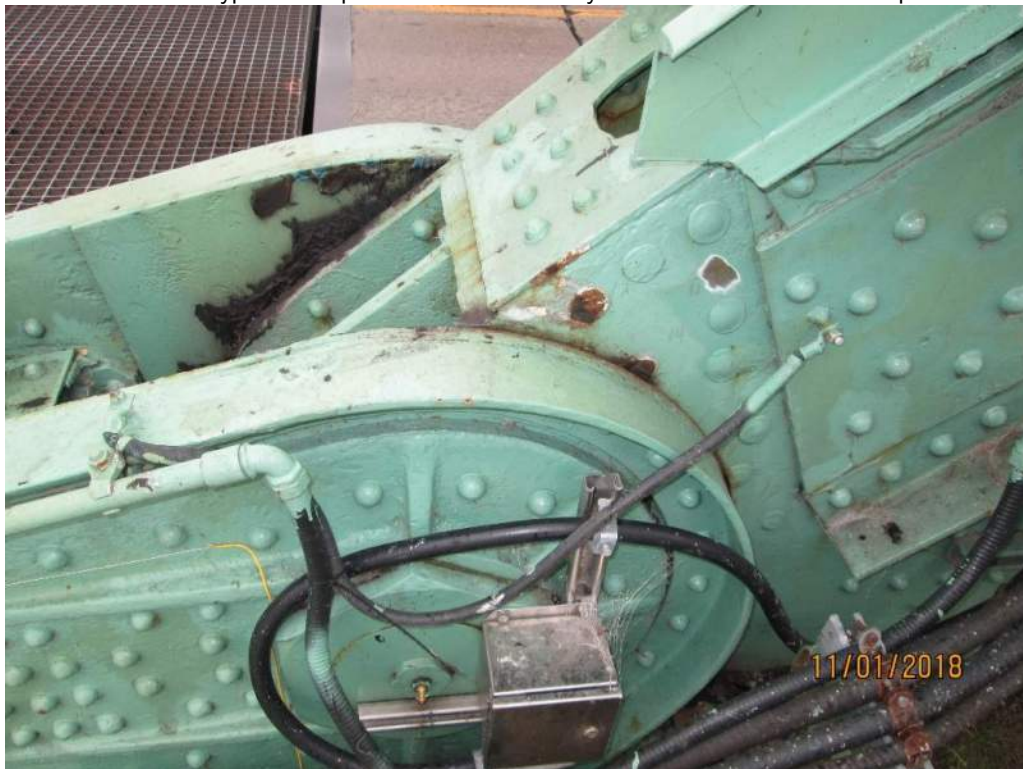
Photo E34: Bridge Grounding & Bonding System. The bridge steel structures are provided with proper grounding and bonding system in accordance with code.

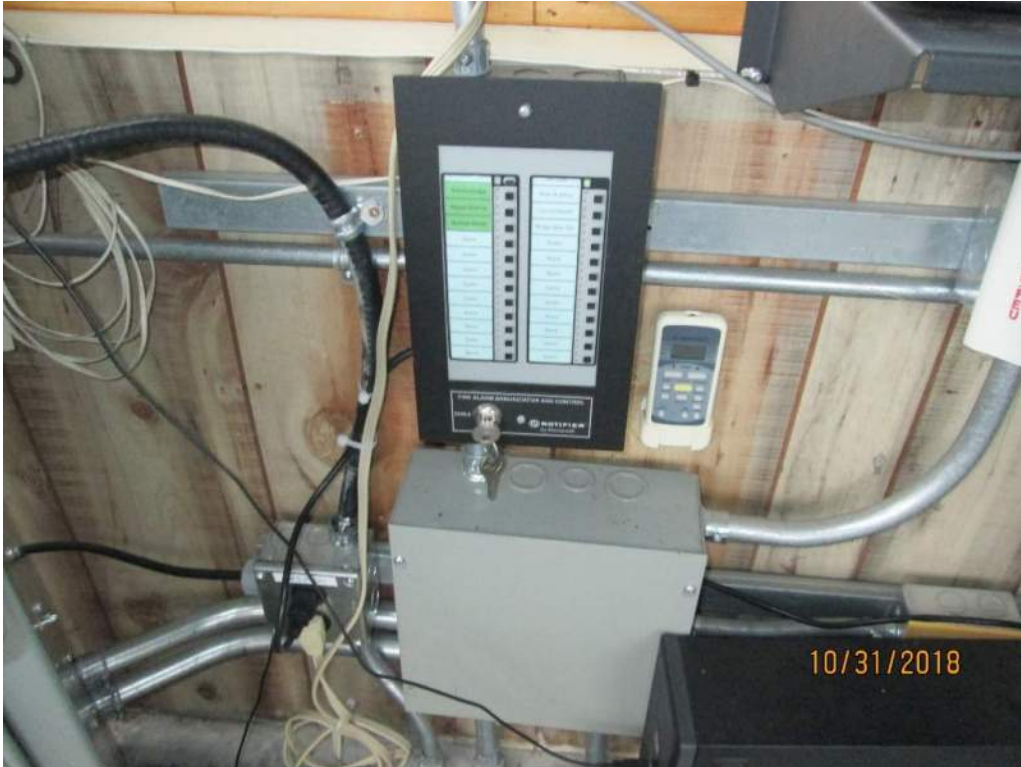
Photo E35: Fire Alarm System. The bridge is equipped with a fire alarm system. Fire detection devices are provided in the bridge maintenance building, the bridge control house and machinery space. The main fire alarm control panel is located in the bridge maintenance facility with a remote annunciator located in the bridge operators control house. All fire alarm equipment was in good serviceable condition at the time of the inspection.

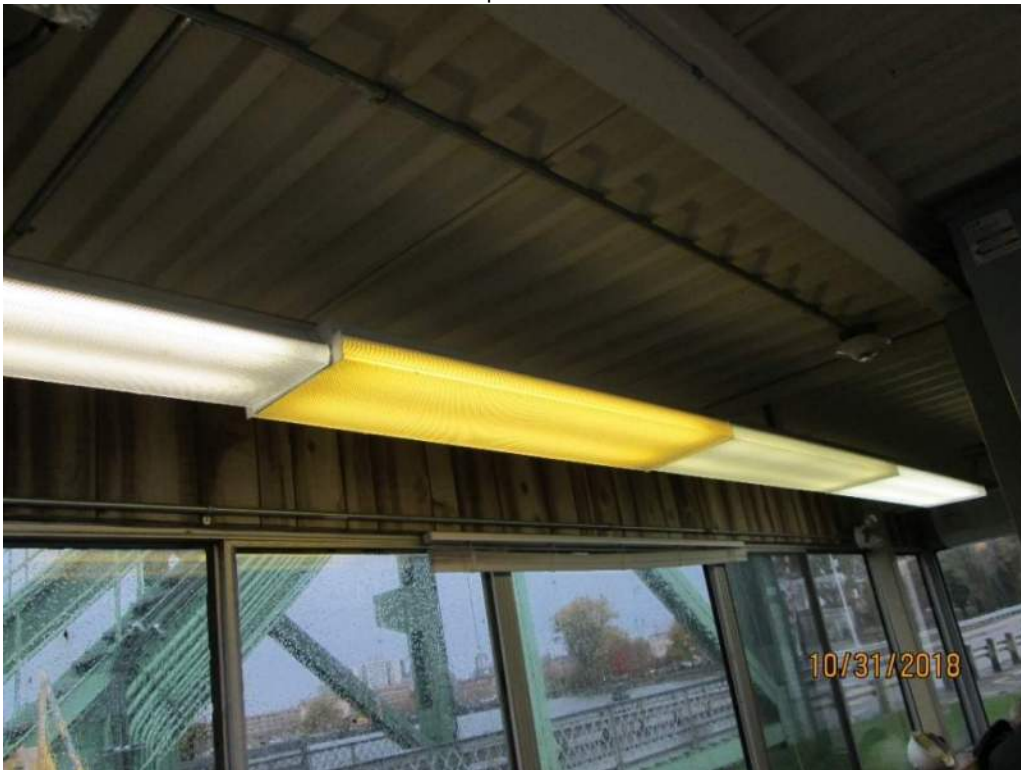
Photo E36: General and Emergency Lighting. The lighting in the operator's control house provides sufficient illumination level for both operation and maintenance and is in good working condition. The emergency lights were tested at the time of inspection and are operational.

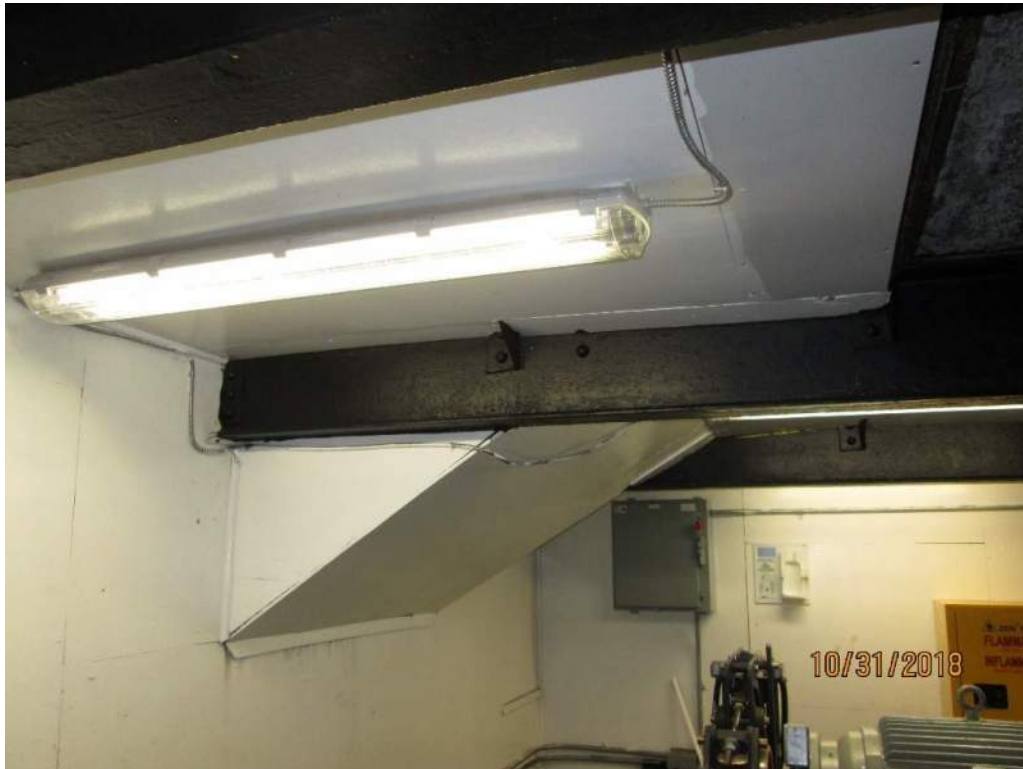
Photo E37: Machinery Space Lighting. The machinery space is provided with T5 light fixtures. These fixtures are in excellent operational condition and provide adequate lighting levels for maintenance and troubleshooting.

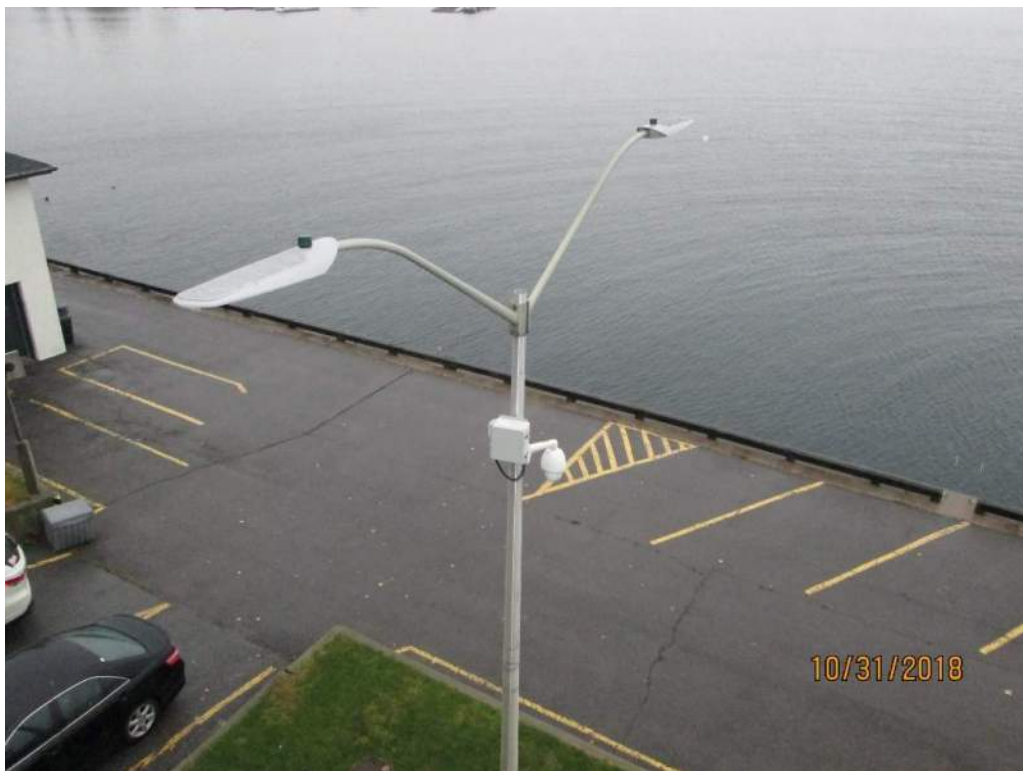
Photo E38: CCTV System and Roadway Lighting. A CCTV system was installed at the bridge for monitoring of the bridge roadway, waterway and machinery space from the maintenance facility and the operators control house. The CCTV installation is in excellent condition. LED type roadway lighting is provided on the bridge and is photocell controlled.

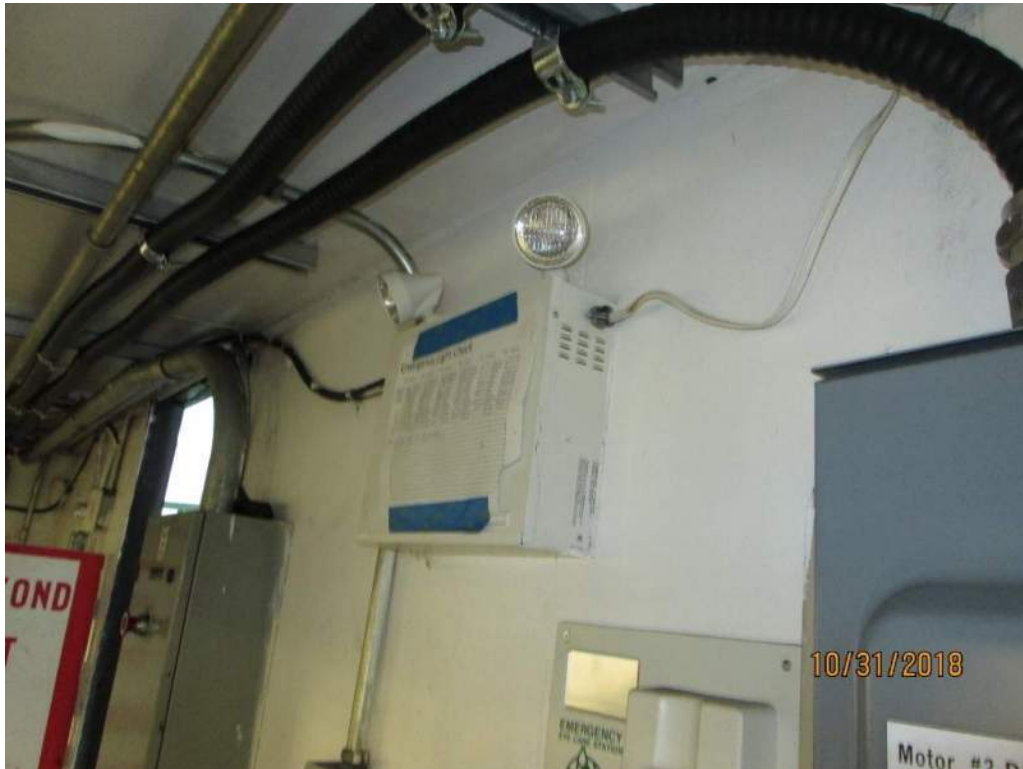
Photo E39: General Indoor Electrical Installation (Machinery Space Shown). Indoor electrical raceway installation in the machinery space and operators control house generally consists of rigid steel conduits. These conduits are in good condition. The bridge cable installation consists of wire in conduit and with Teck cables that were recently installed to feed the new drive motors.

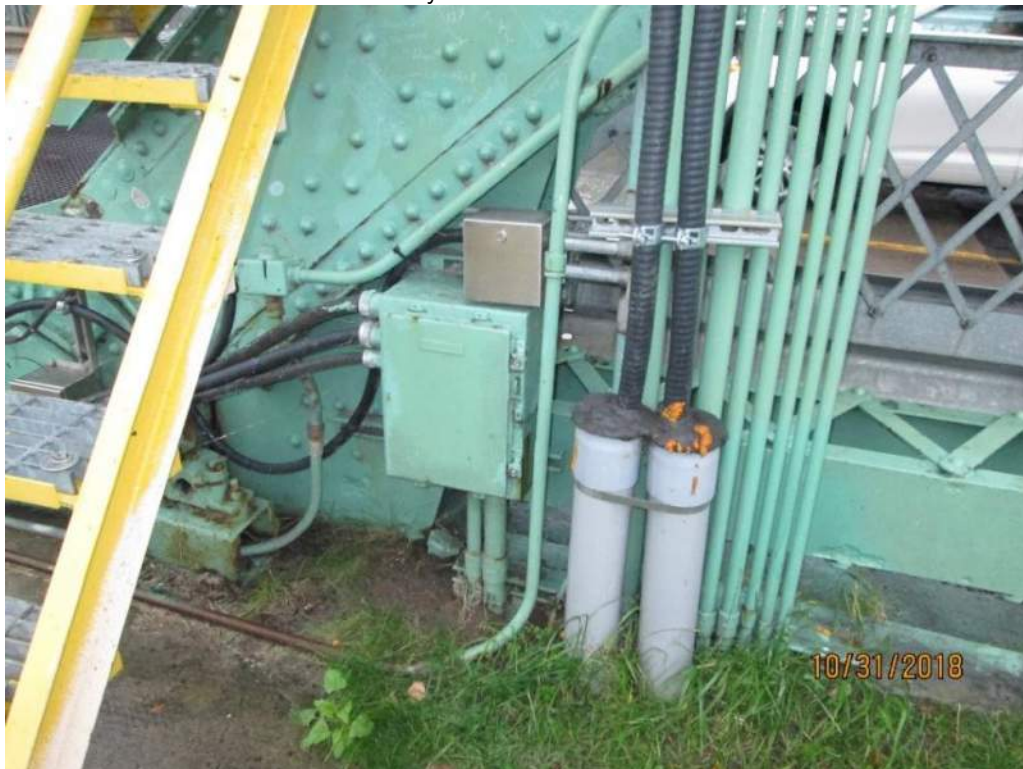
Photo E40: General Outdoor Installation. The bridge outdoor installation generally consists of Teck cable, painted RGS conduits, and stainless-steel junction boxes. The installation is generally in good serviceable condition but with some of the cable/conduit support brackets exhibiting moderate signs of corrosion.

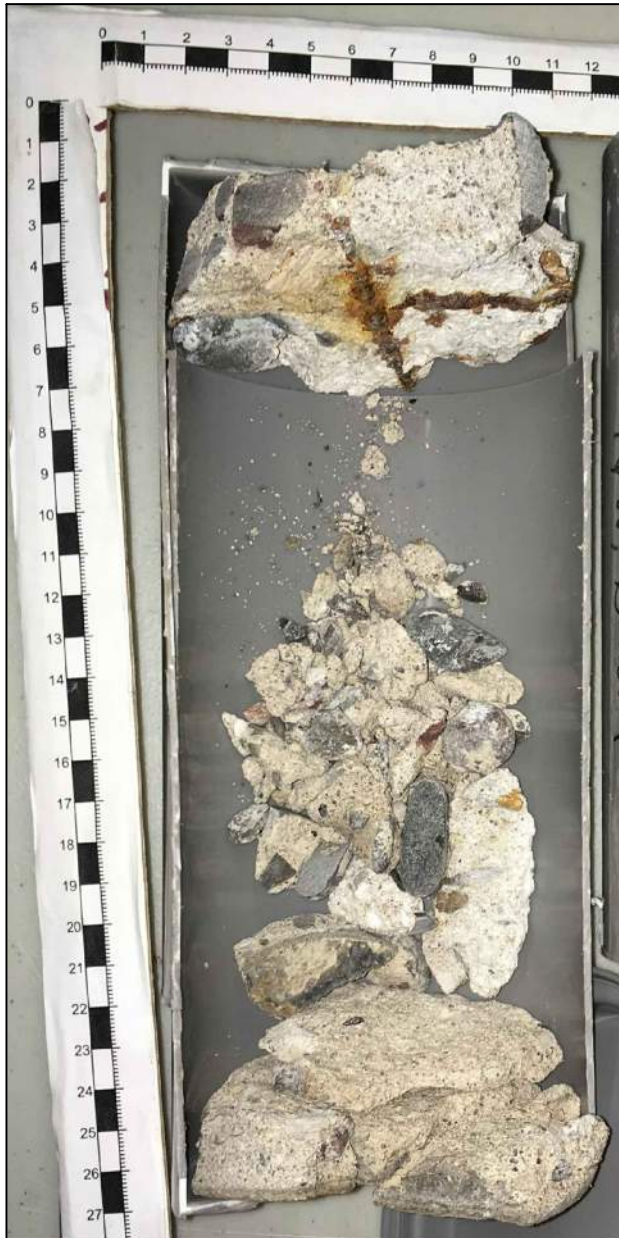
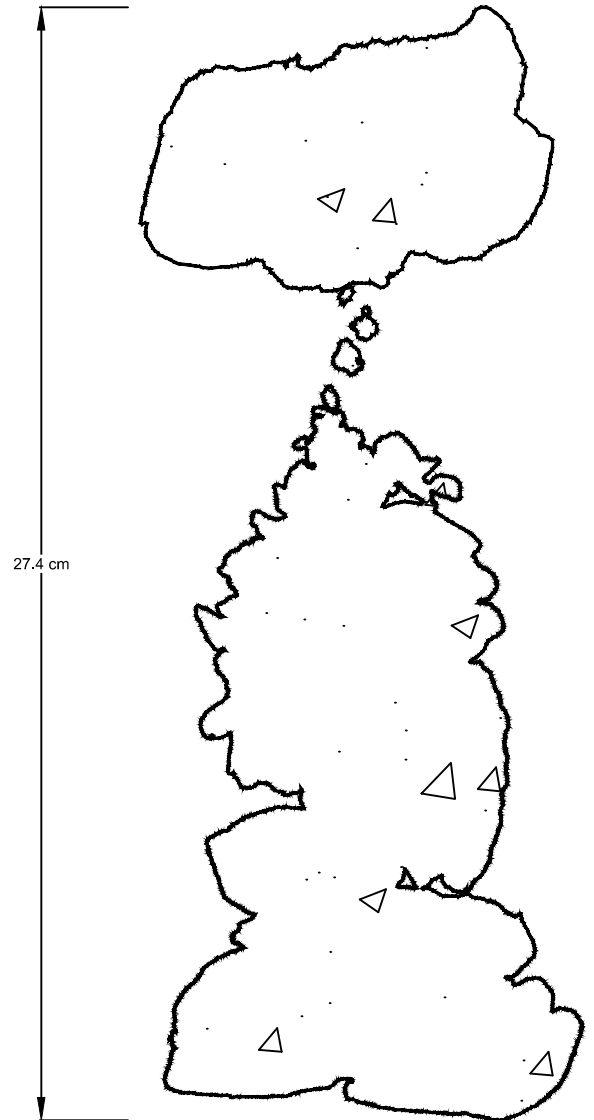
32 Steacie Drive, Ottawa, ON K2K 2A9
T: (613) 836-1422 | www.gemtec.ca | ottawa@gemtec.ca

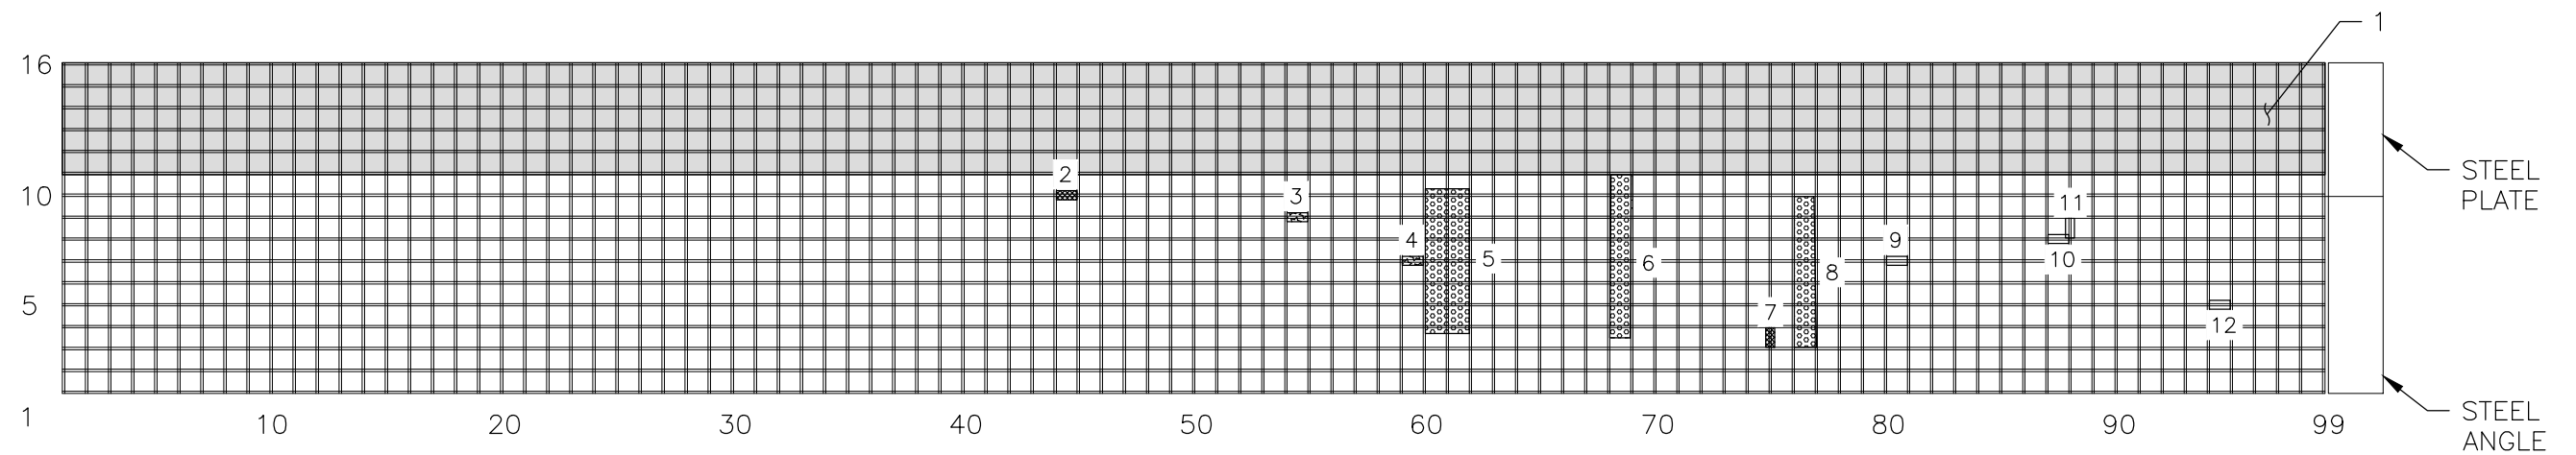
Appendix G– Deck Grating Inspection Drawings

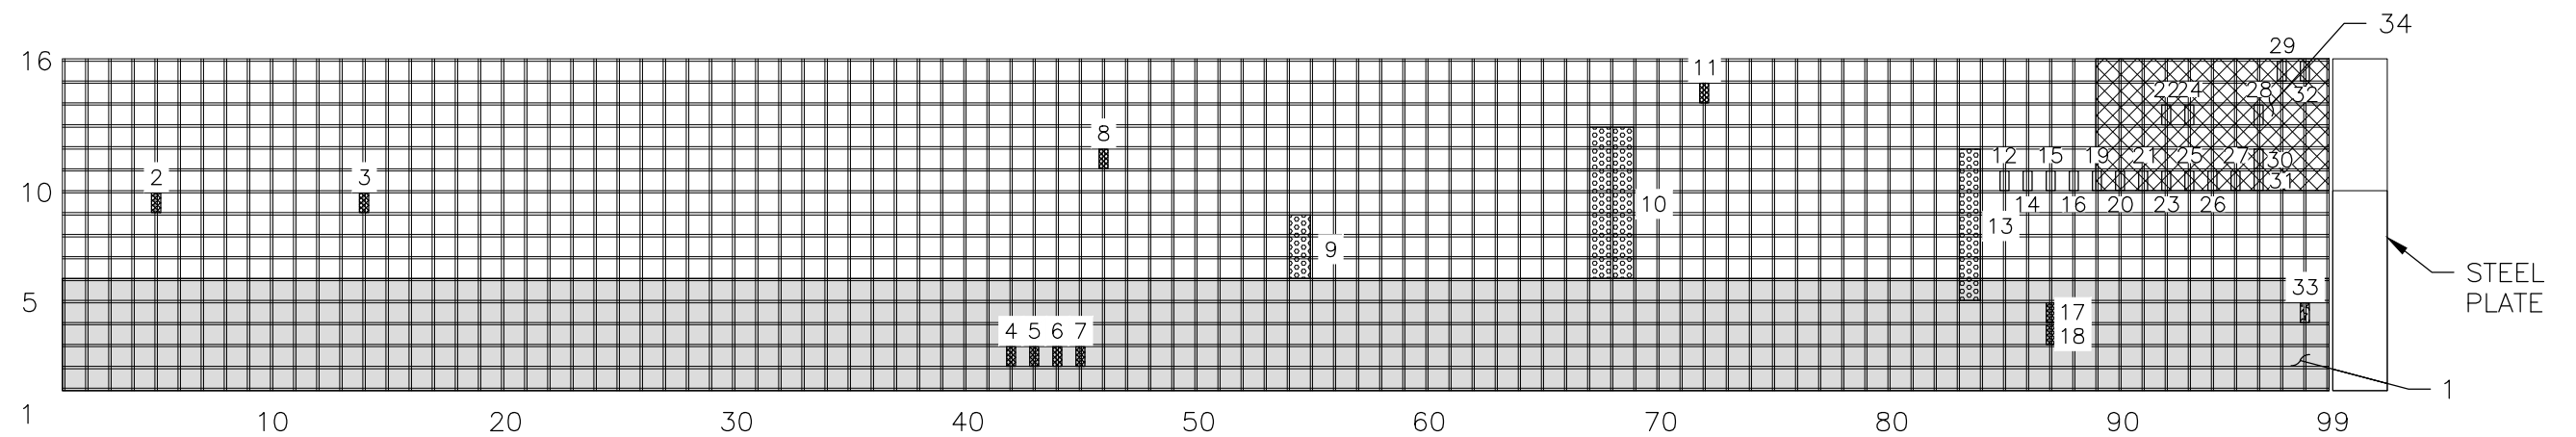
18-11-05
project date date du projet
R.090045.001
project no. no. du projet
01 OF 63
drawing no. dessine no.

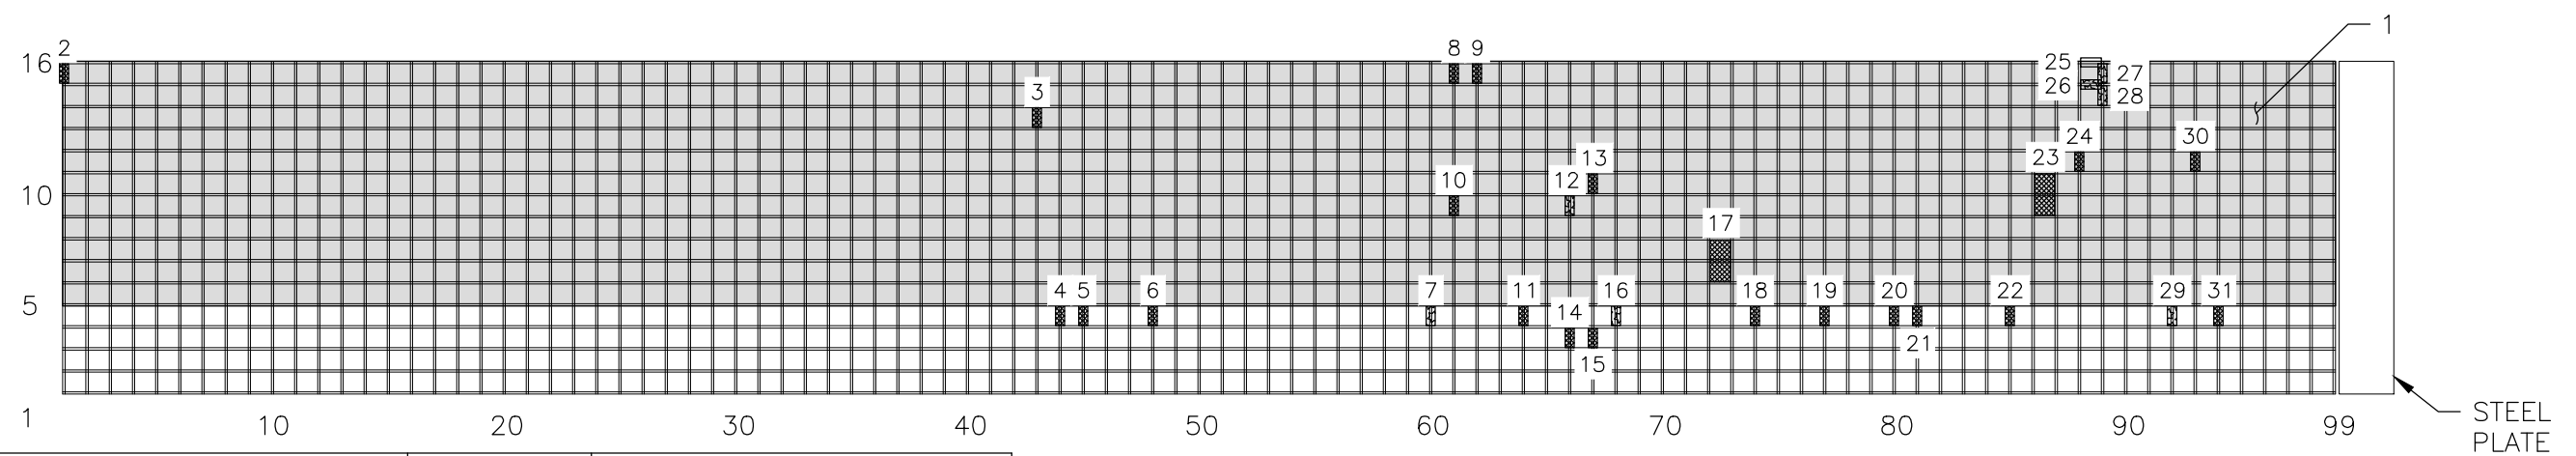
DEFECT No.	DESCRIPTION	DEFECT No.	DESCRIPTION
1	WORN SERRATIONS	17	BROKEN AND BENT BARS
2	BENT TRANSVERSE BAR	18	BENT TRANSVERSE BAR
3	BENT TRANSVERSE BAR	19	BENT TRANSVERSE BAR
4	BENT TRANSVERSE BAR	20	BENT TRANSVERSE BAR
5	BENT TRANSVERSE BAR	21	BENT TRANSVERSE BAR
6	BENT TRANSVERSE BAR	22	BENT TRANSVERSE BAR
7	BROKEN TRANSVERSE BAR	23	BENT AND BROKEN BARS
8	BENT TRANSVERSE BAR	24	BENT TRANSVERSE BAR
9	BENT TRANSVERSE BAR	25	STEEL BAR REPAIR
10	BENT TRANSVERSE BAR	26	BROKEN LONGITUDINAL BAR
11	BENT TRANSVERSE BAR	27	BROKEN TRANSVERSE BAR
12	BROKEN TRANSVERSE BAR	28	BROKEN TRANSVERSE BAR
13	BENT TRANSVERSE BAR	29	BROKEN TRANSVERSE BAR
14	BENT TRANSVERSE BAR	30	BENT TRANSVERSE BAR
15	BENT TRANSVERSE BAR	31	BENT TRANSVERSE BAR
16	BROKEN TRANSVERSE BAR

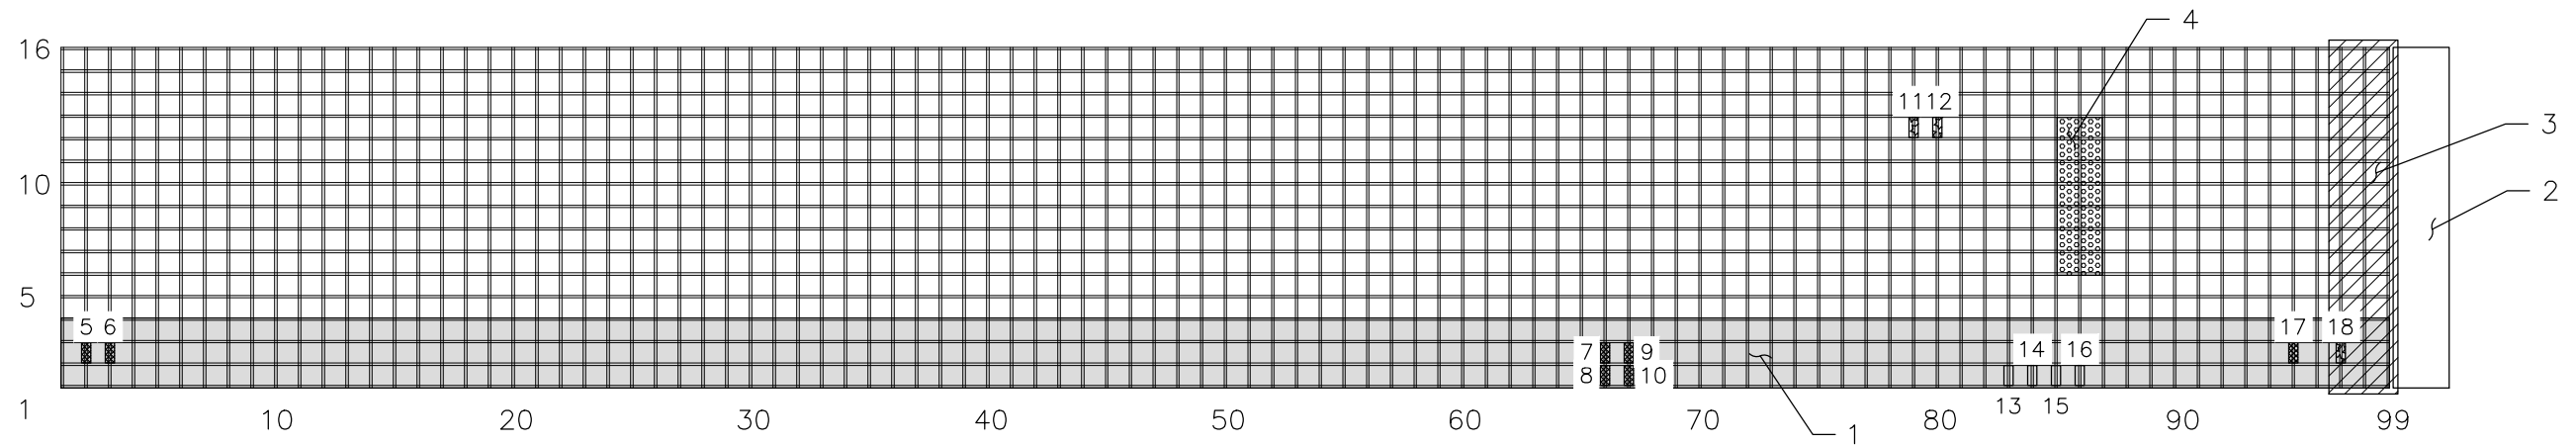
JS drawn by	dessine par	18-11-05 project date	date du projet
CW designed by	conc par	R.090045.001 project no.	no. du projet
PH approved by	approuve par	06 OF 63 drawing no.	dessine no.
tender soumission	project manager administrateur de projets

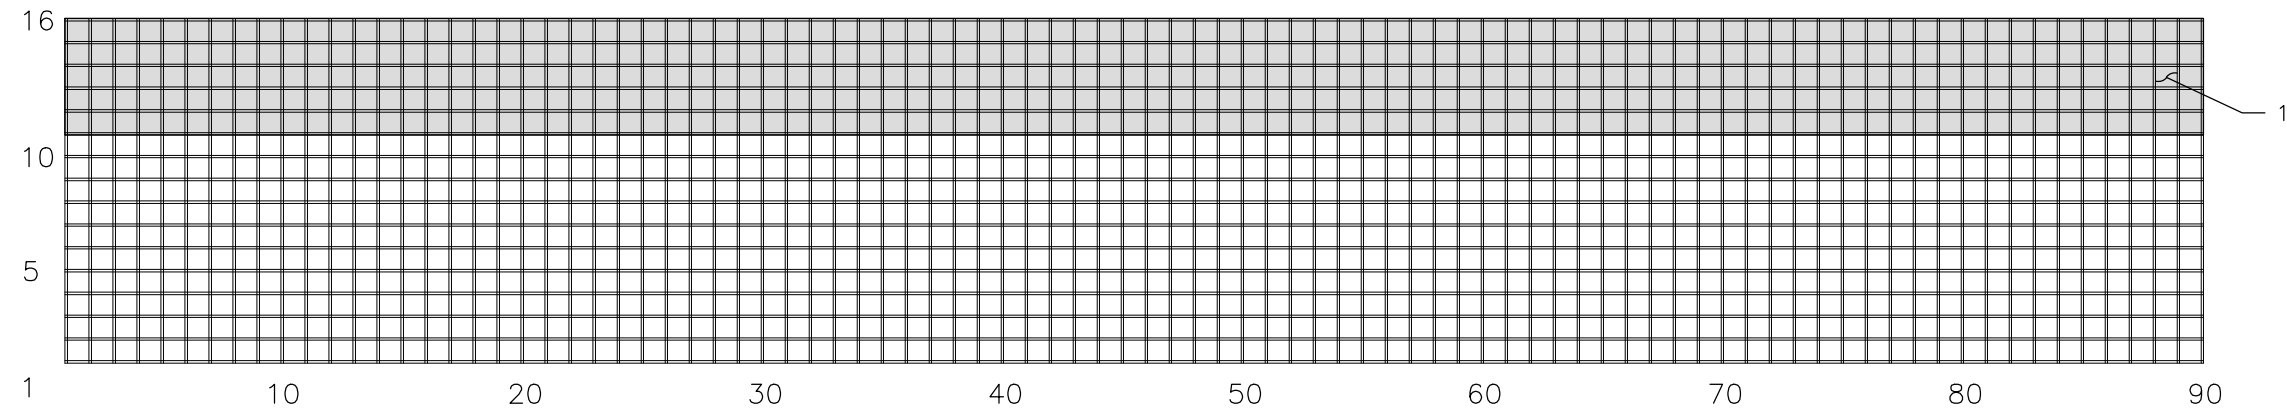
18-11-05
project date date du projet
R.090045.001
project no. no. du projet
07 OF 63
drawing no. dessine no.

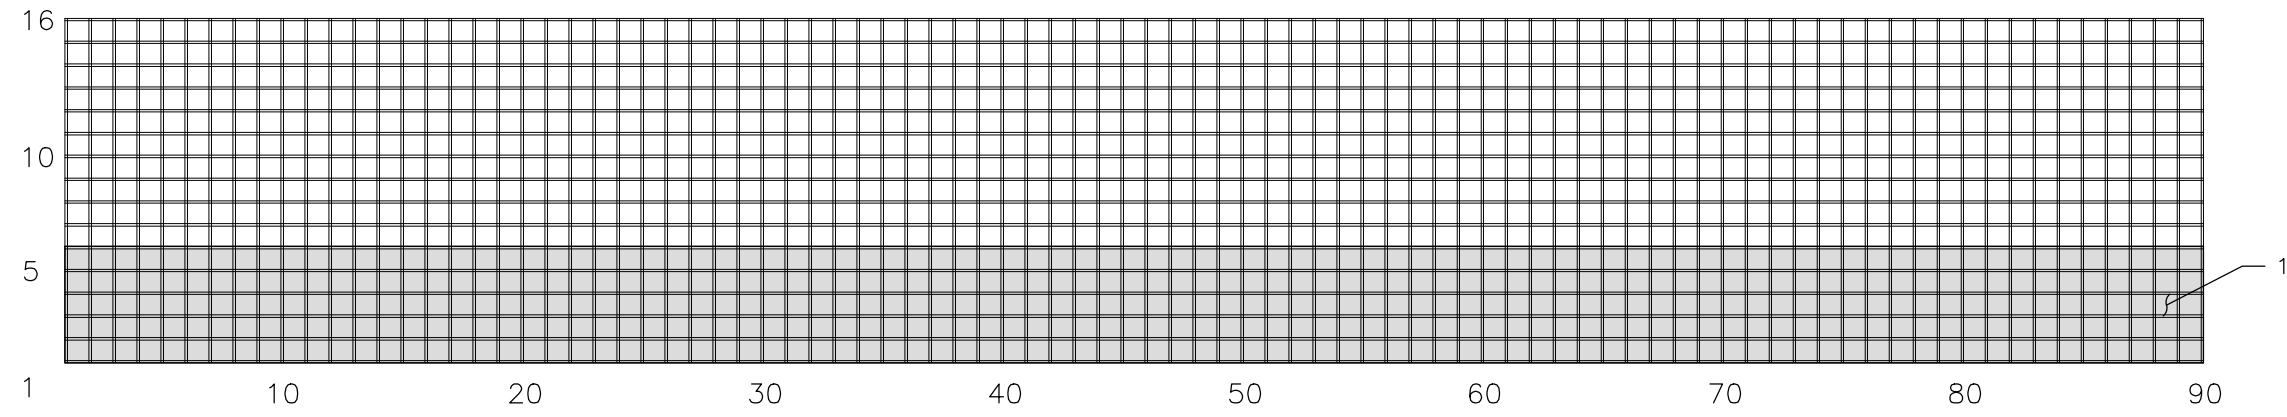
JS drawn by / dessine par	18-11-05 project date / date du projet
CW designed by / conc par	R.090045.001 project no. / no. du projet
PH approved by / approuve par	08 OF 63 drawing no. / dessine no.
tender / soumission	project manager / administrateur de projets

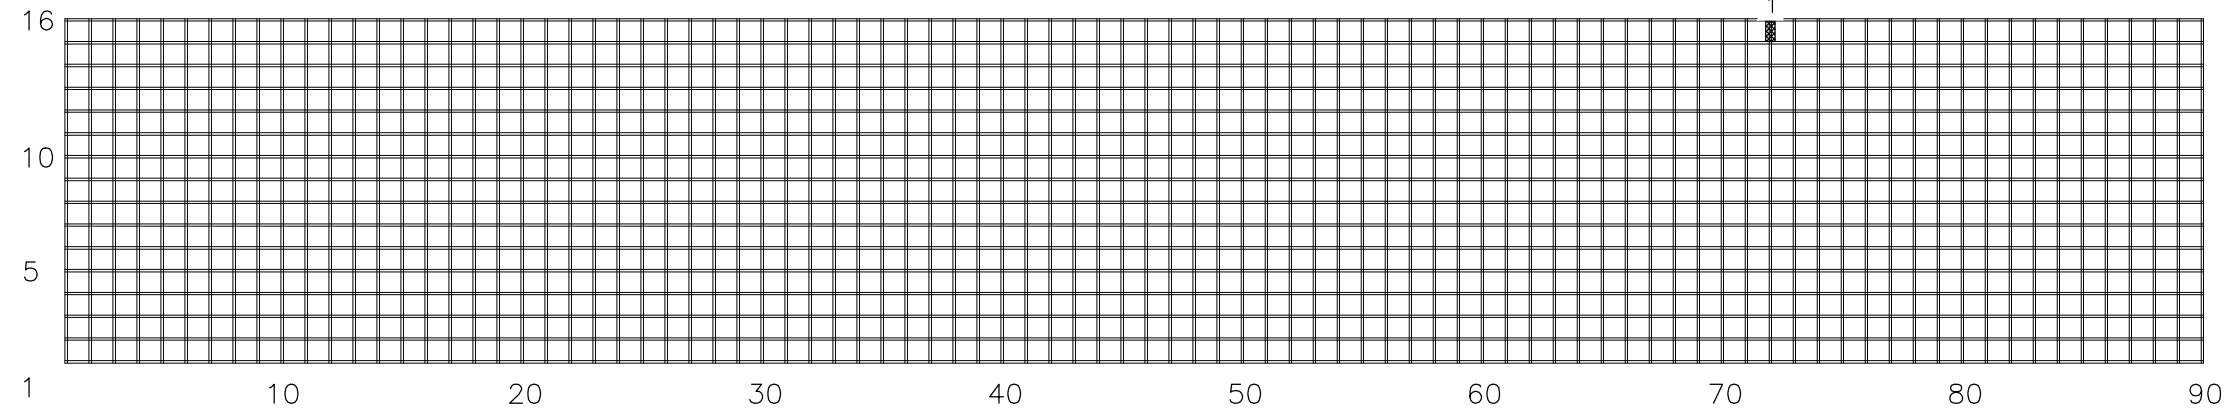
JS drawn by / dessine par	18-11-05 project date / date du projet
CW designed by / conc par	R.090045.001 project no. / no. du projet
PH approved by / approuve par	10 OF 63 drawing no. / dessine no.
tender / soumission	project manager / administrateur de projets

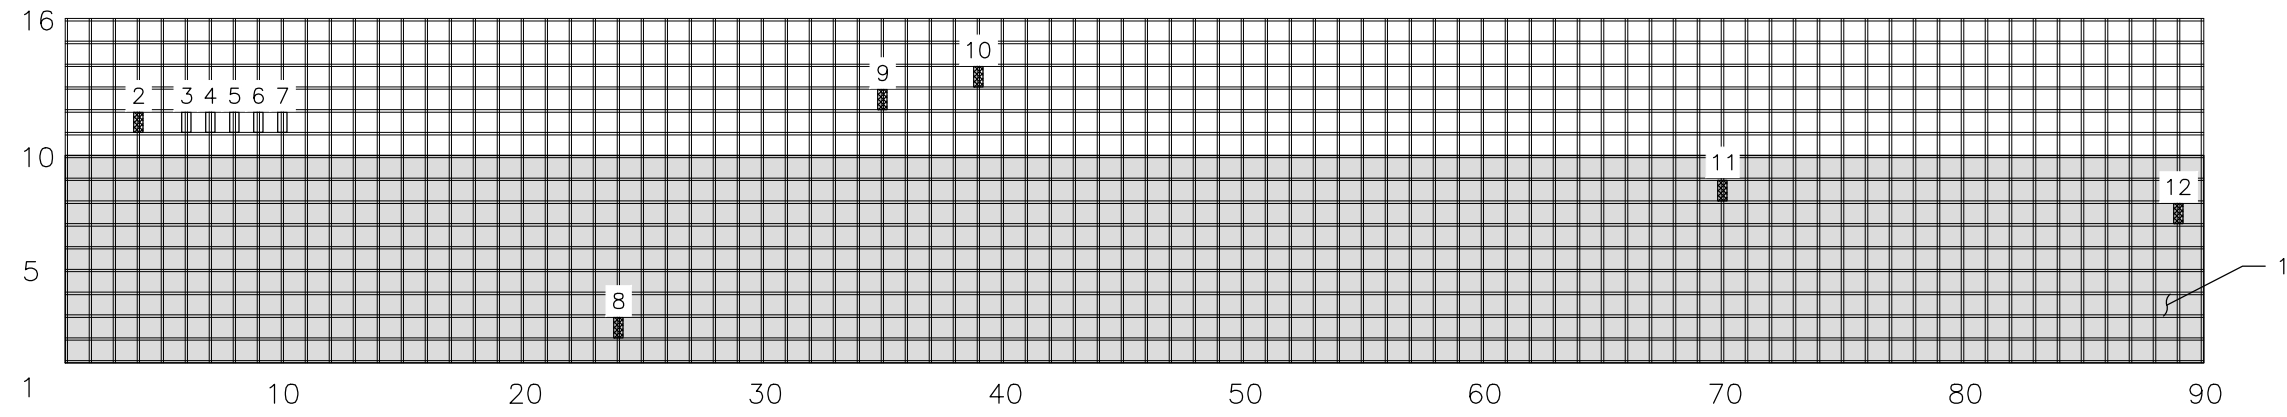
JS drawn by / dessine par	18-11-05 project date / date du projet
CW designed by / conc par	R.090045.001 project no. / no. du projet
PH approved by / approuve par	11 OF 63 drawing no. / dessine no.
tender / soumission	project manager / administrateur de projets

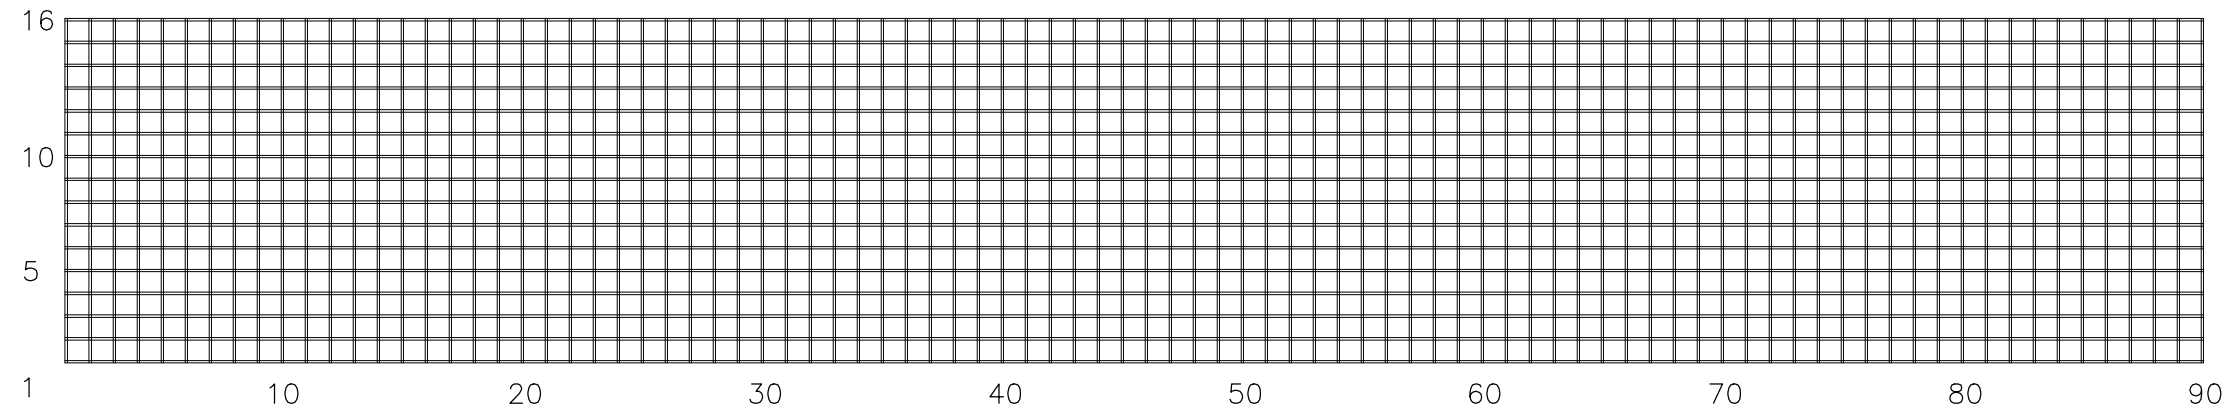
JS drawn by	dessine par	18-11-05 project date	date du projet
CW designed by	conc par	R.090045.001 project no.	no. du projet
PH approved by	approuve par	17 OF 63 drawing no.	dessine no.
tender soumission	project manager administrateur de projets

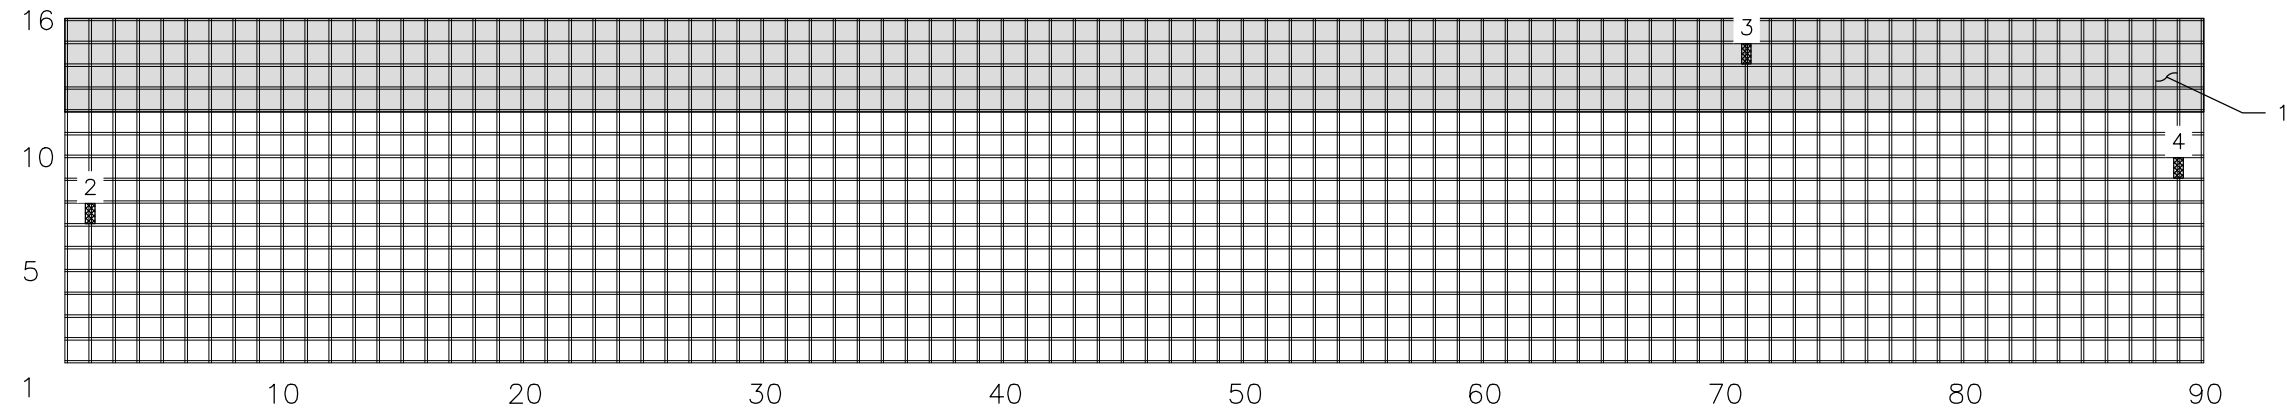
JS drawn by	dessine par	18-11-05 project date	date du projet
CW designed by	conc par	R.090045.001 project no.	no. du projet
PH approved by	approuve par	19 OF 63 drawing no.	dessine no.
tender / soumission	project manager / administrateur de projets

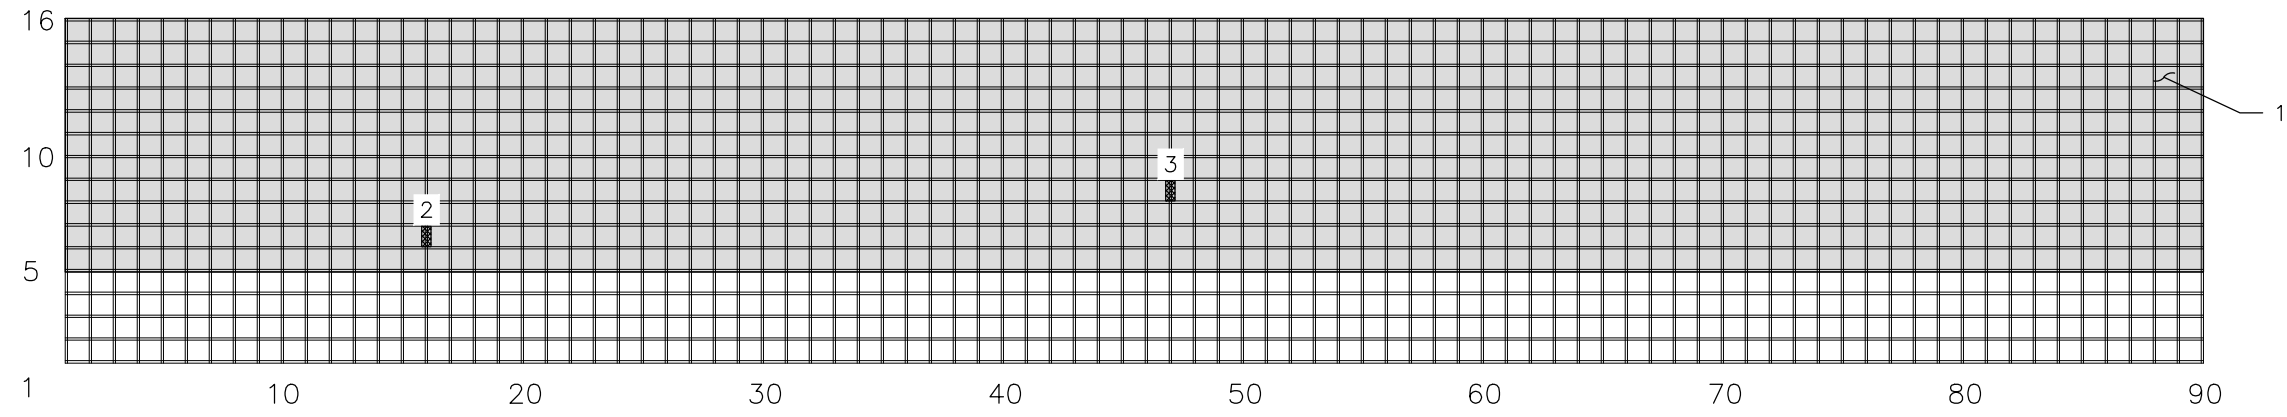
JS drawn by / dessine par	18-11-05 project date / date du projet
CW designed by / conc par	R.090045.001 project no. / no. du projet
PH approved by / approuve par	23 OF 63 drawing no. / dessine no.
tender / soumission	project manager / administrateur de projets

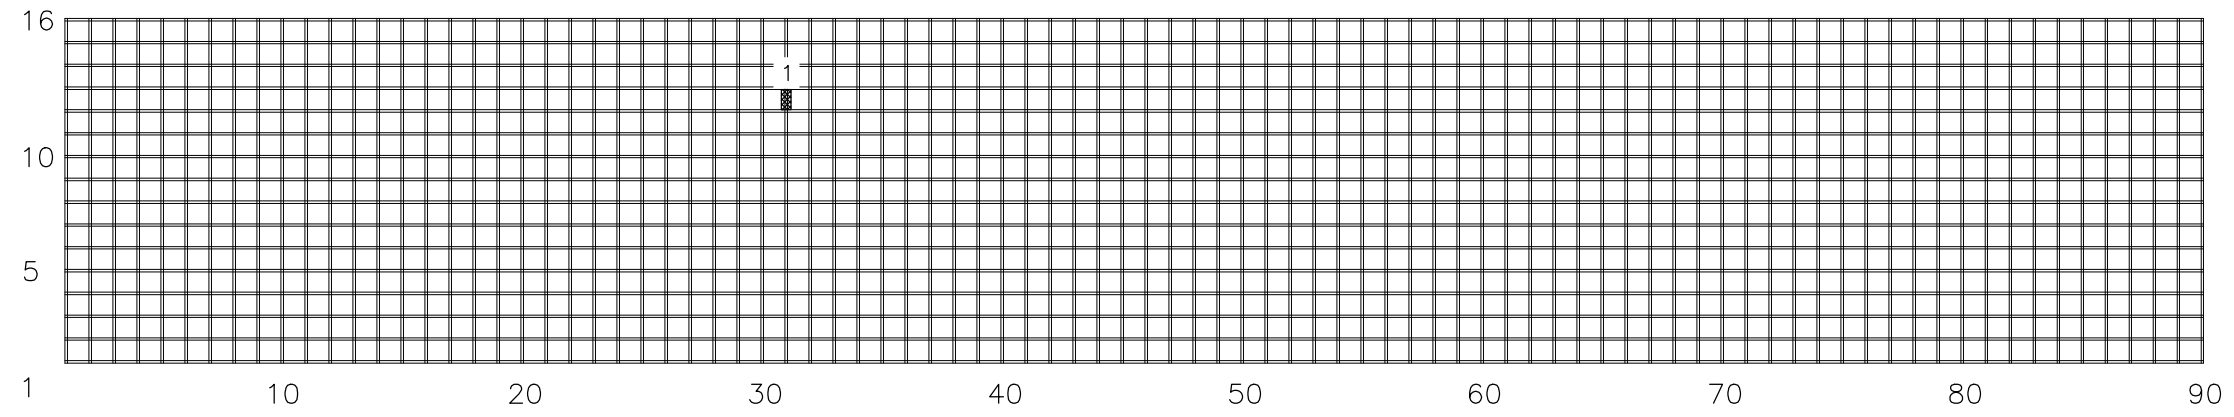
18-11-05 project date	date du projet
R.090045.001 project no.	no. du projet
24 OF 63 drawing no.	dessine no.

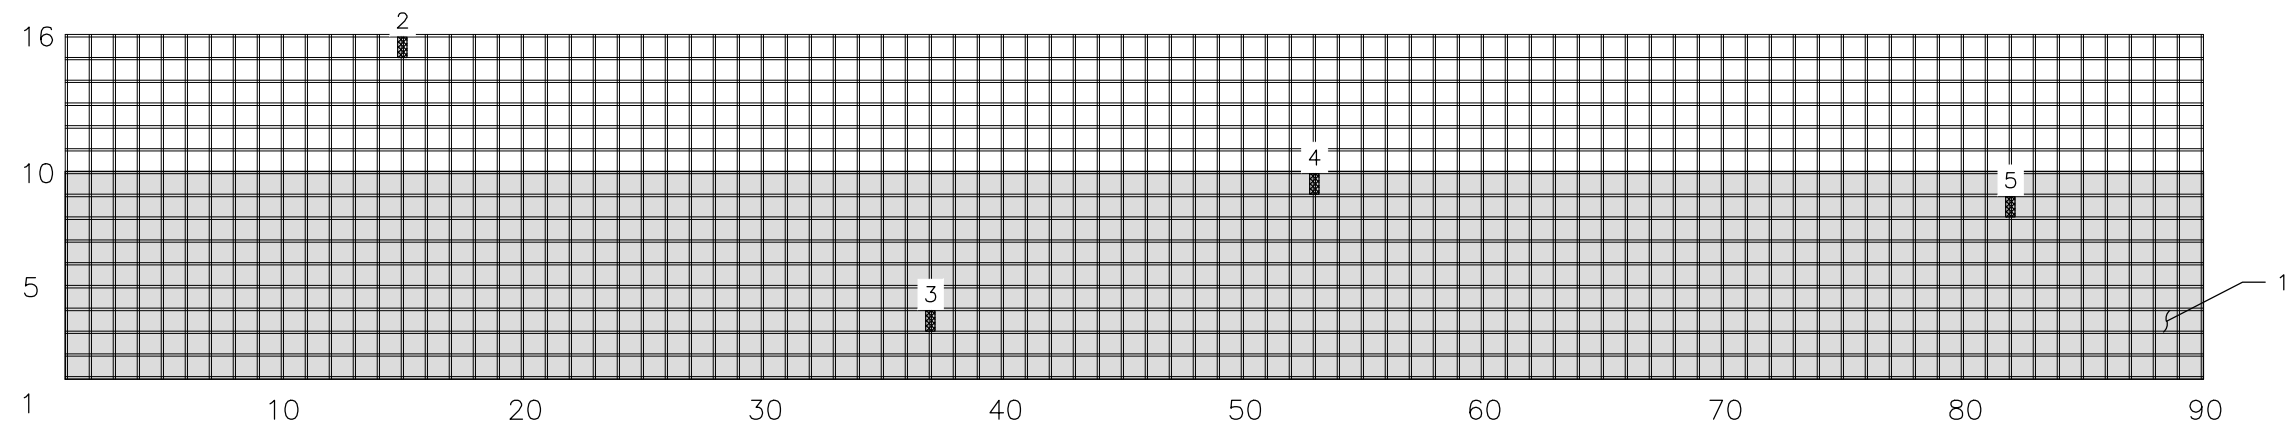
JS drawn by	dessine par	18-11-05 project date	date du projet
CW designed by	conc par	R.090045.001 project no.	no. du projet
PH approved by	approuve par	25 OF 63 drawing no.	dessine no.
tender soumission	project manager administrateur de projets

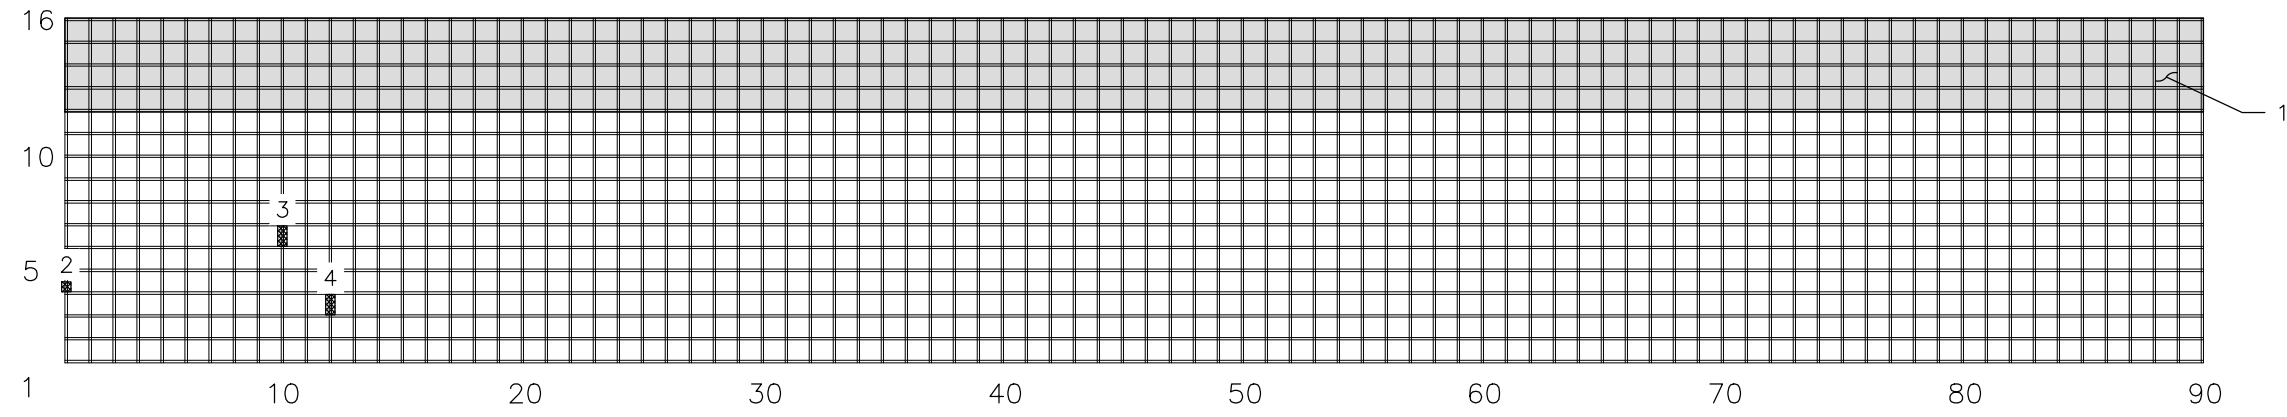
18-11-05 project date	date du projet
R.090045.001 project no.	no. du projet
26 OF 63 drawing no.	dessine no.
