LaSalle Causeway Bascule Bridge 2018 Comprehensive Detailed Inspection Report

Project Number: R. 090045.001

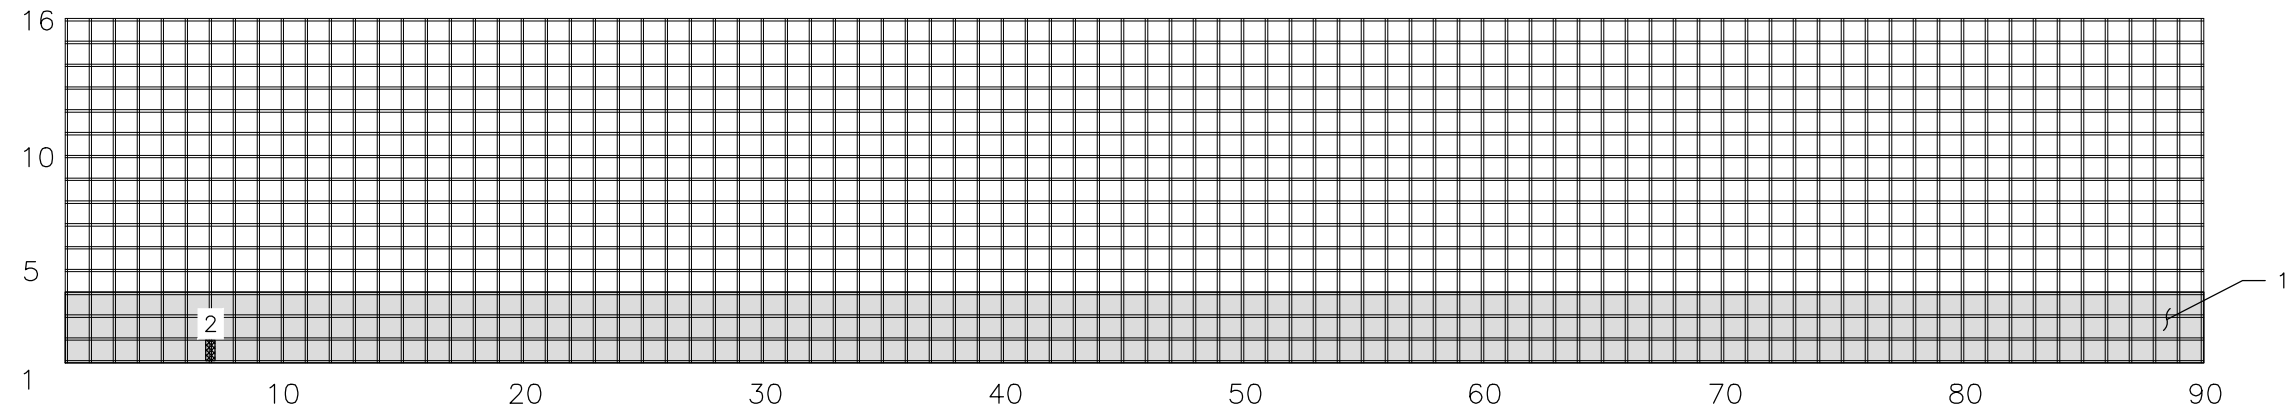
JS drawn by	dessine par	18-11-05 project date	date du projet
CW designed by	conc par	R.090045.001 project no.	no. du projet
PH approved by	approuve par	27 OF 63 drawing no.	dessine no.
tender soumission	project manager administrateur de projets

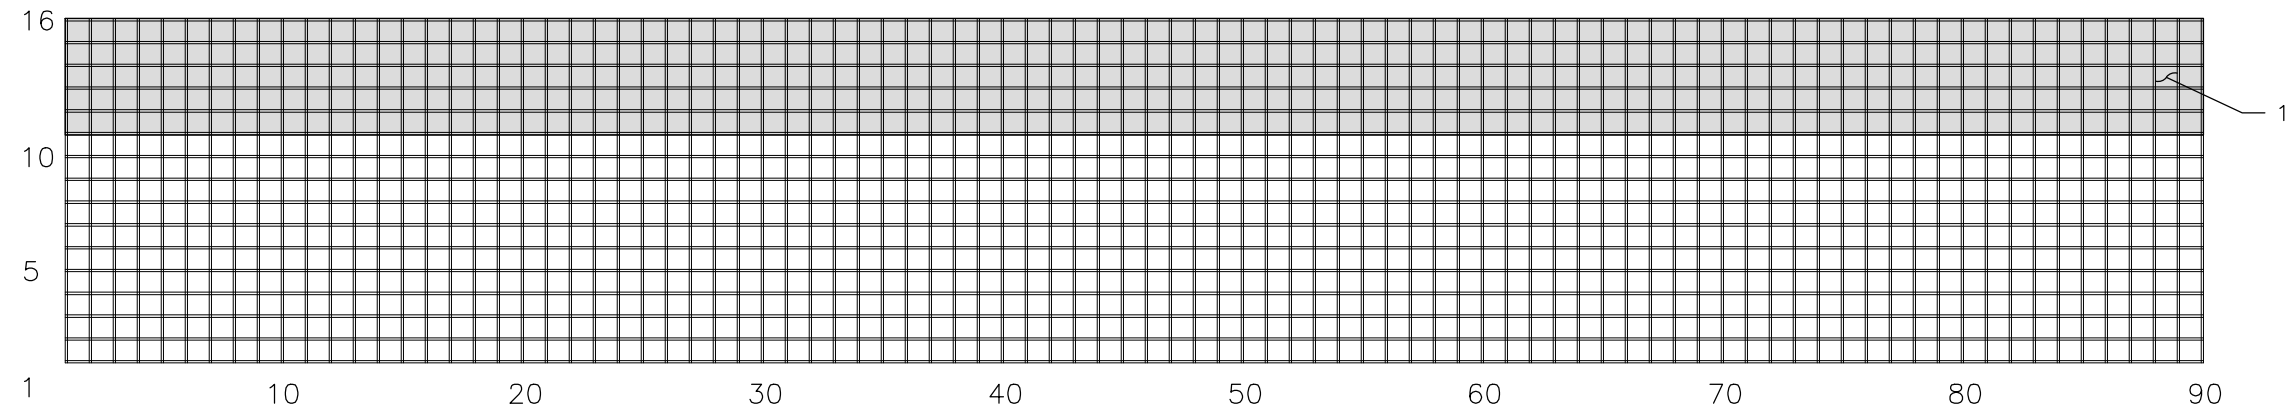
18-11-05 project date	date du projet
R.090045.001 project no.	no. du projet
28 OF 63 drawing no.	dessine no.

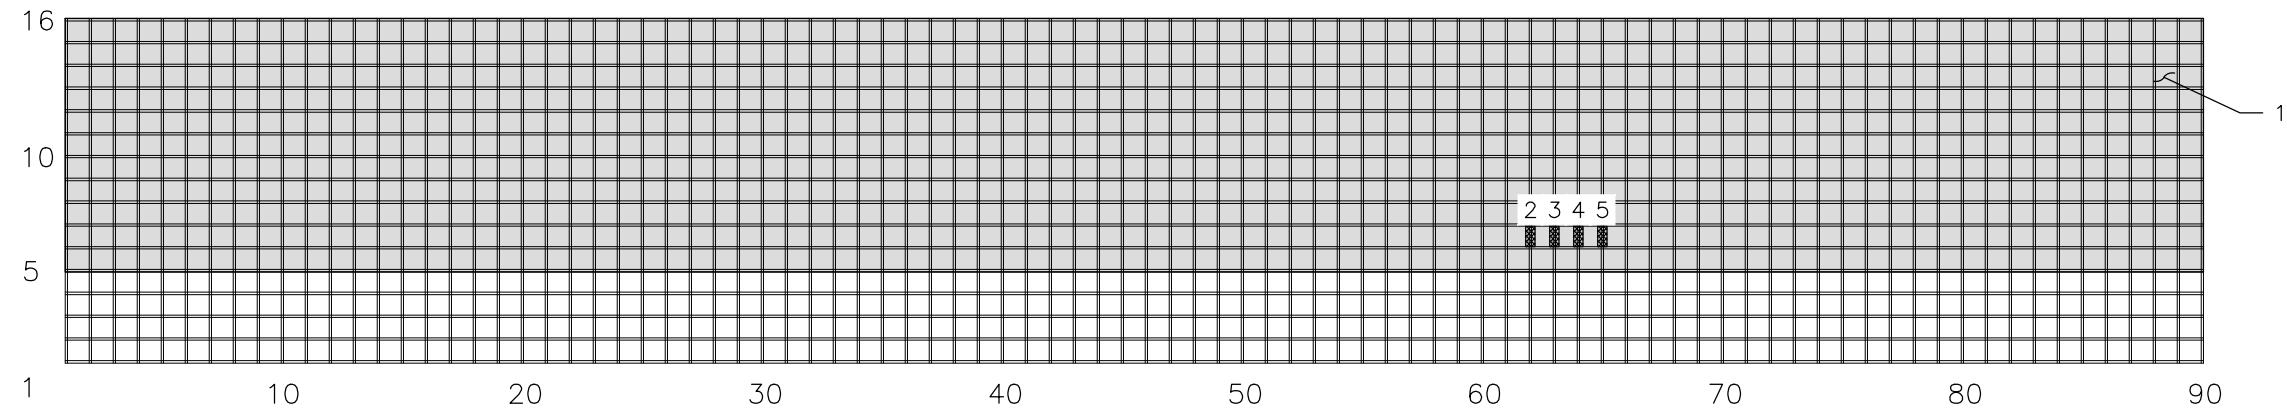
18-11-05 project date	date du projet
R.090045.001 project no.	no. du projet
30 OF 63 drawing no.	dessine no.

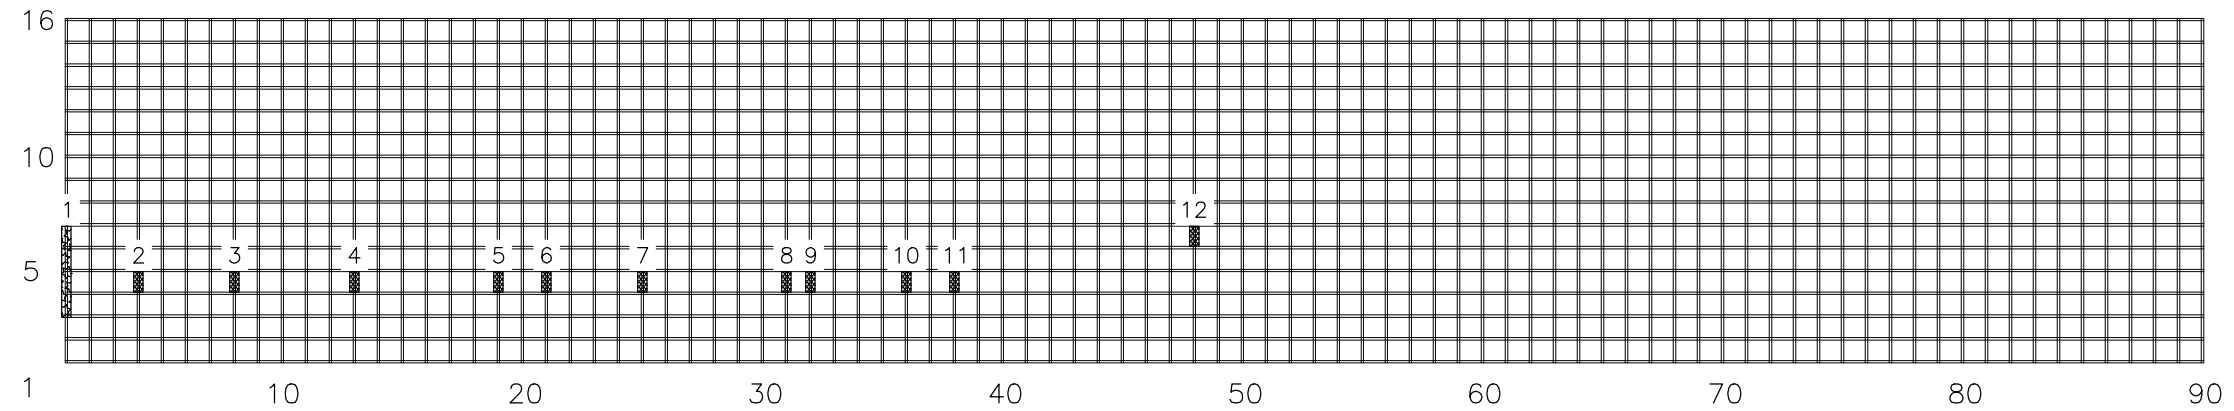
18-11-05 project date	date du projet
R.090045.001 project no.	no. du projet
31 OF 63 drawing no.	dessine no.

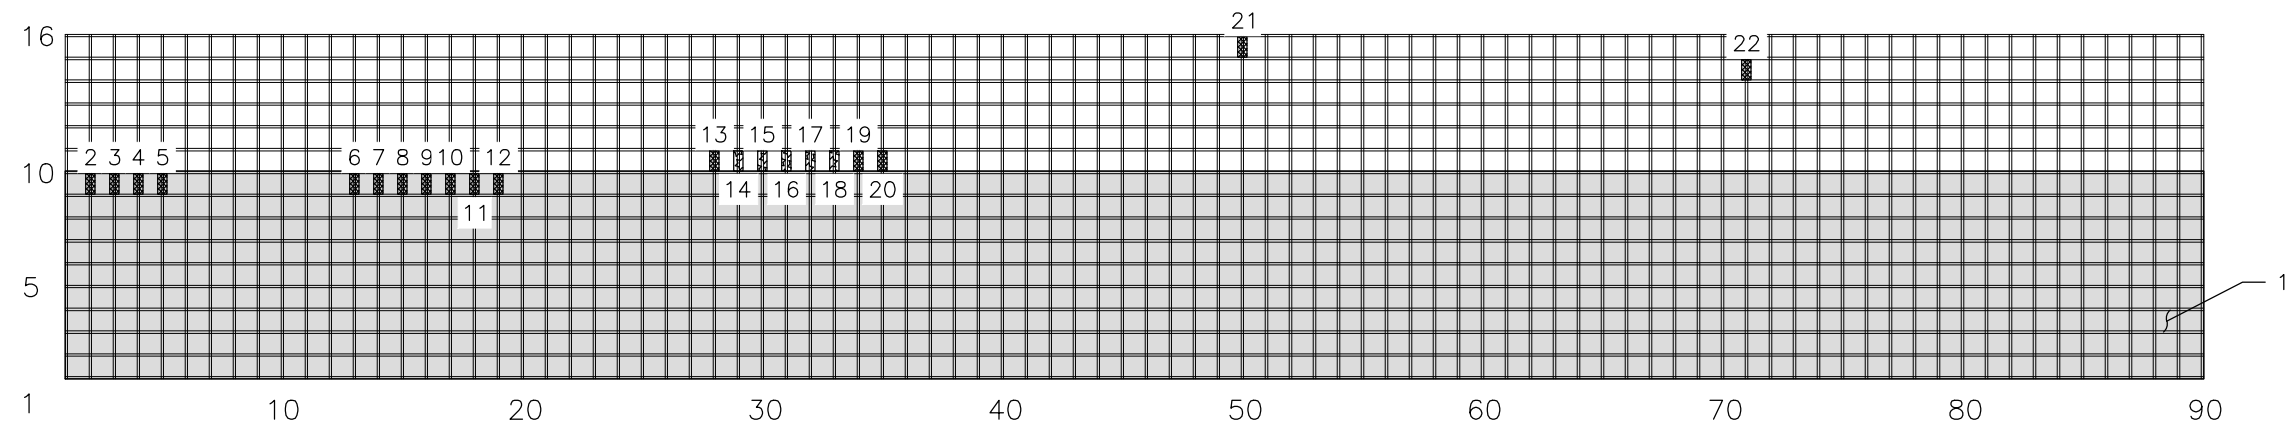
JS drawn by	dessine par	18-11-05 project date	date du projet
CW designed by	conc par	R.090045.001 project no.	no. du projet
PH approved by	approuve par	32 OF 63 drawing no.	dessine no.
tender soumission	project manager administrateur de projets

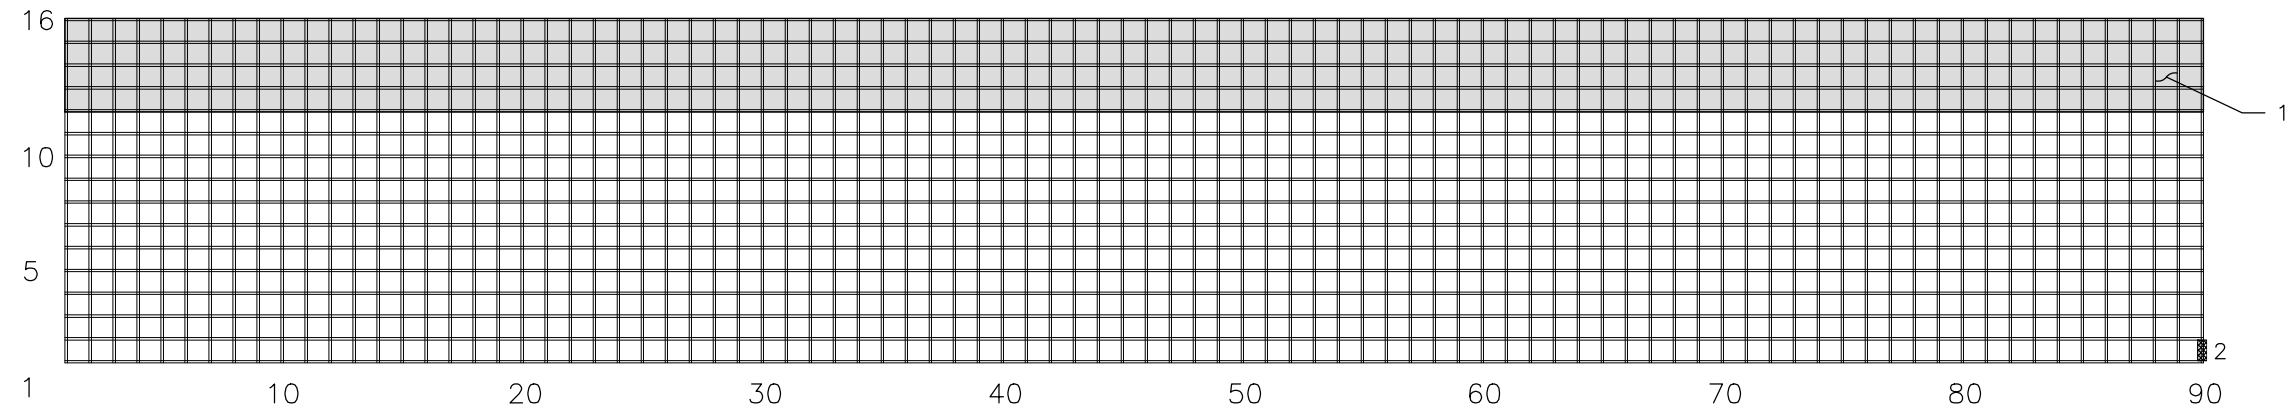
18-11-05 project date	date du projet
R.090045.001 project no.	no. du projet
33 OF 63 drawing no.	dessine no.

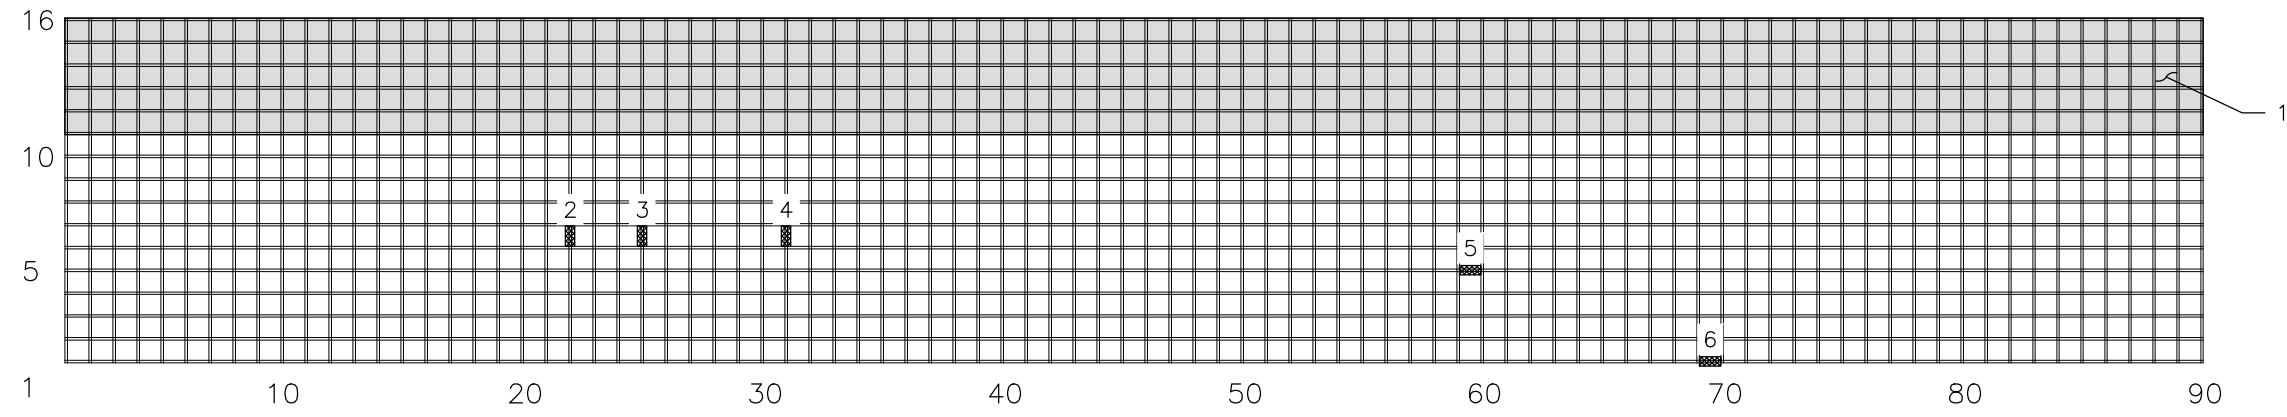
18-11-05 project date	date du projet
R.090045.001 project no.	no. du projet
35 OF 63 drawing no.	dessine no.

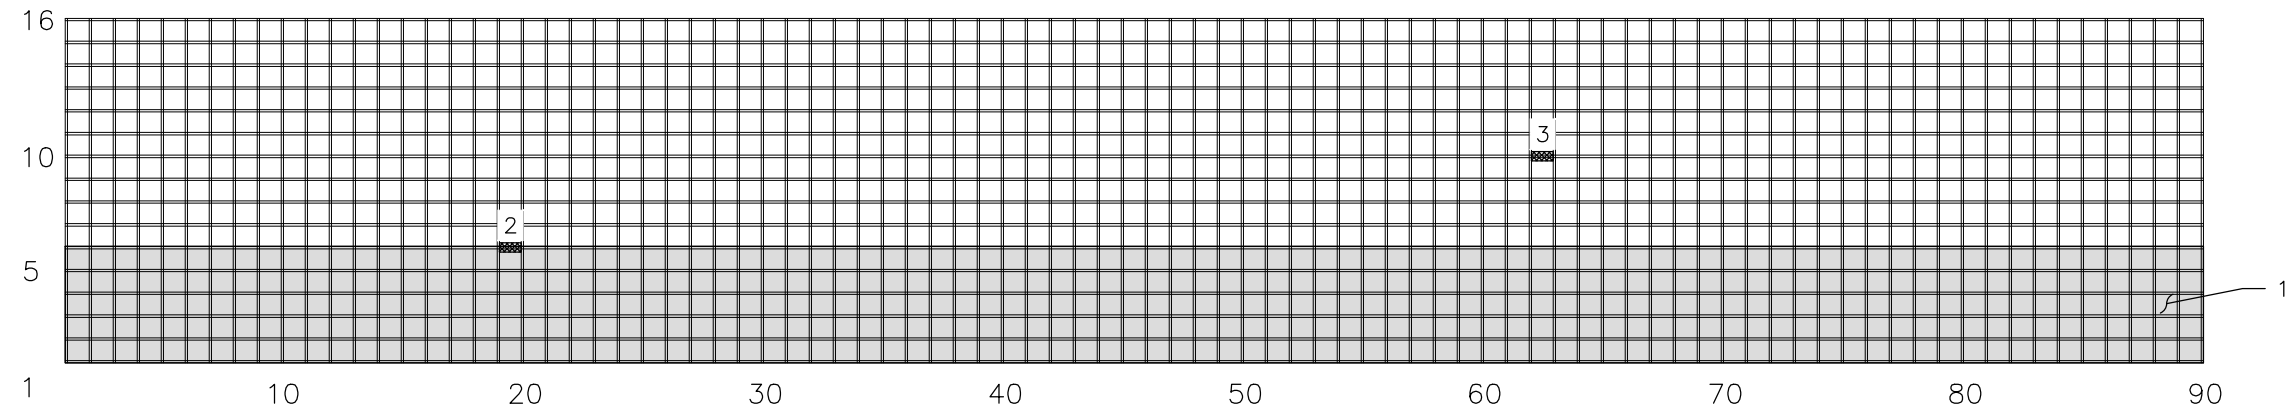
JS drawn by / dessine par	18-11-05 project date / date du projet
CW designed by / conc par	R.090045.001 project no. / no. du projet
PH approved by / approuve par	36 OF 63 drawing no. / dessine no.
tender / soumission	project manager / administrateur de projets

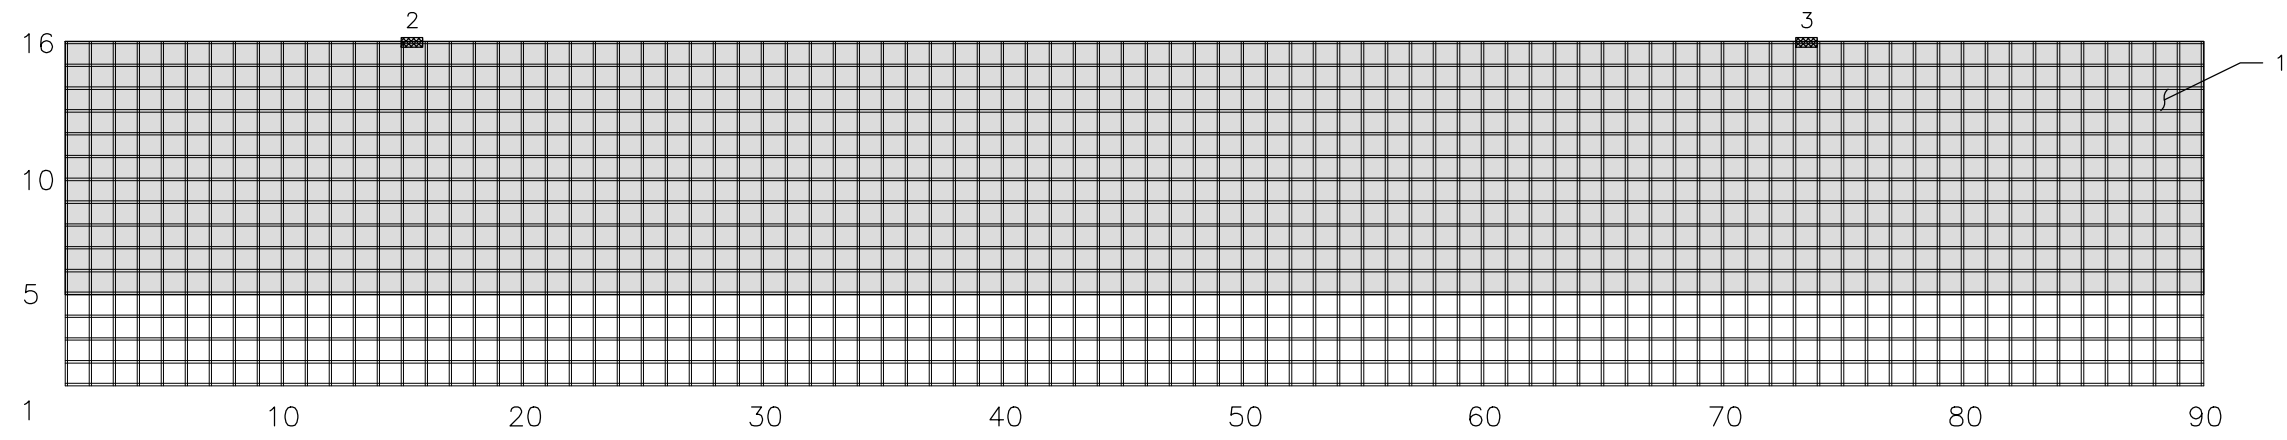
JS drawn by	dessine par	18-11-05 project date	date du projet
CW designed by	conc par	R.090045.001 project no.	no. du projet
PH approved by	approuve par	37 OF 63 drawing no.	
tender soumission	project manager administrateur de projets	dessine no.

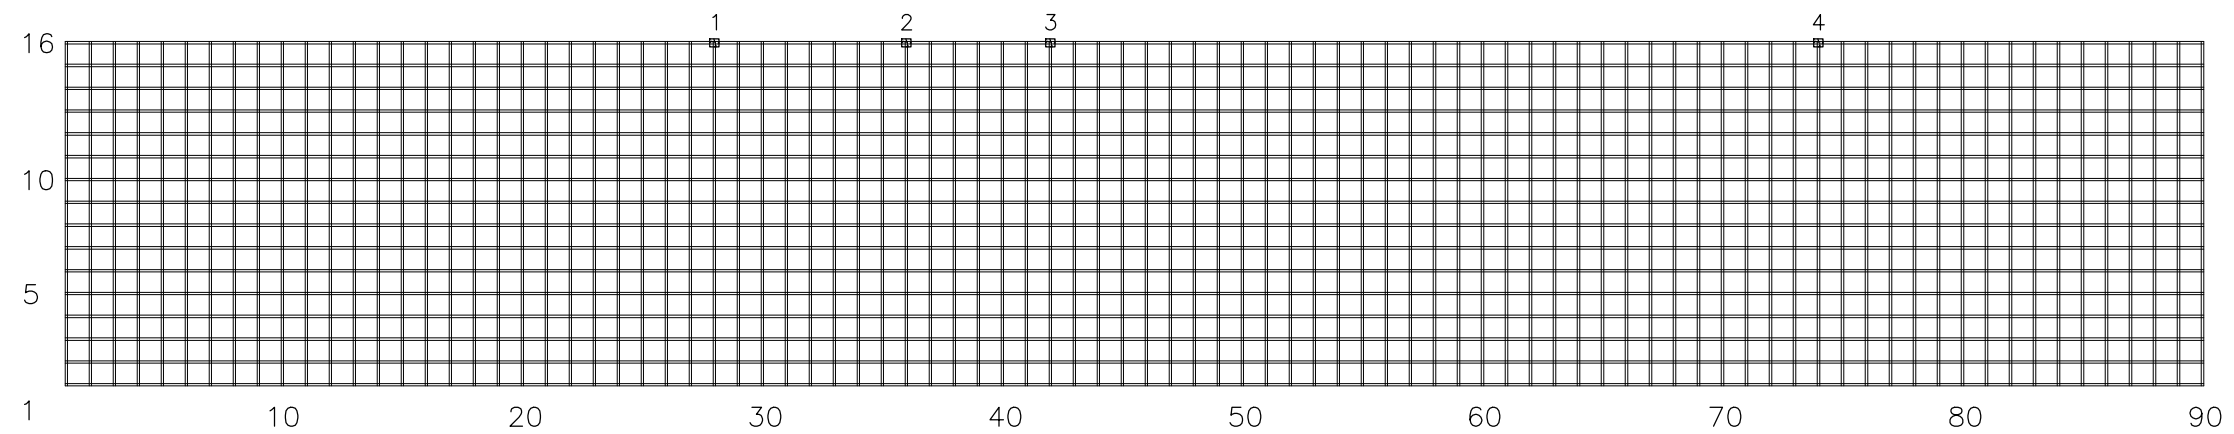
JS drawn by	dessine par	18-11-05 project date	date du projet
CW designed by	conc par	R.090045.001 project no.	no. du projet
PH approved by	approuve par	38 OF 63 drawing no.	dessine no.
tender soumission	project manager administrateur de projets

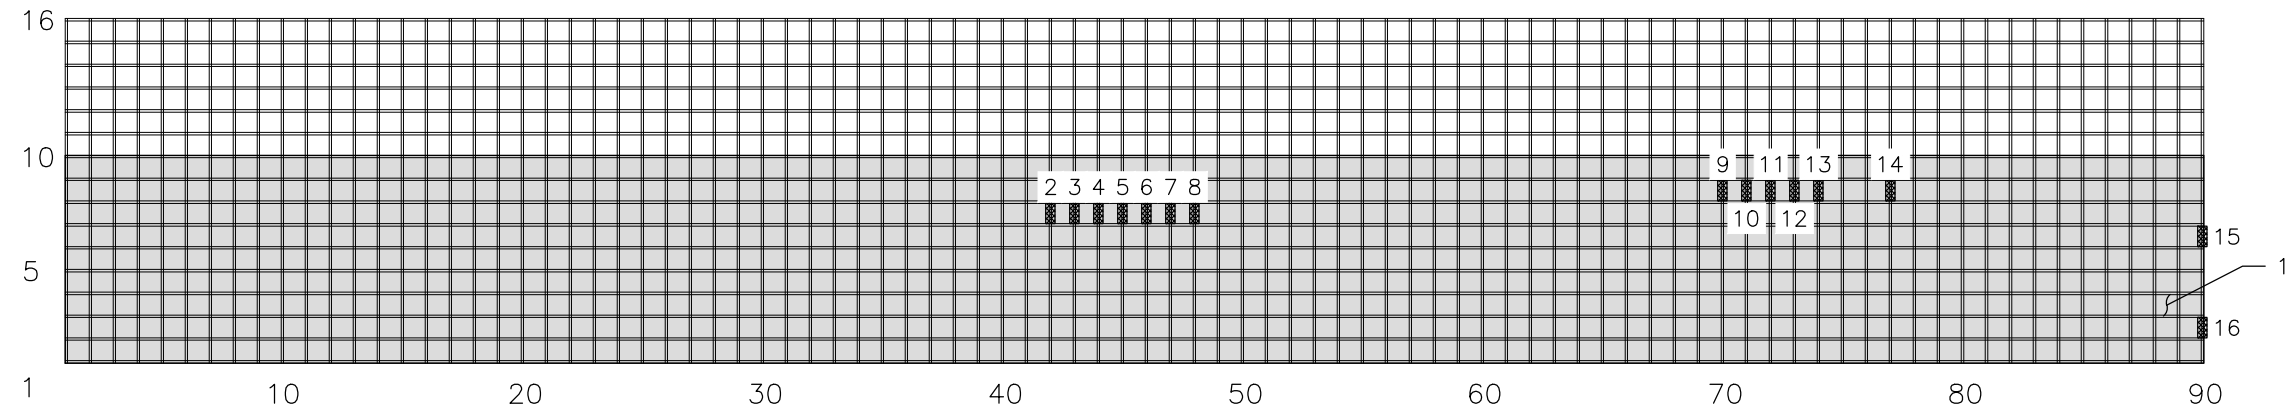
JS drawn by / dessine par	18-11-05 project date / date du projet
CW designed by / conc par	R.090045.001 project no. / no. du projet
PH approved by / approuve par	39 OF 63 drawing no. / dessine no.
tender / soumission	project manager / administrateur de projets

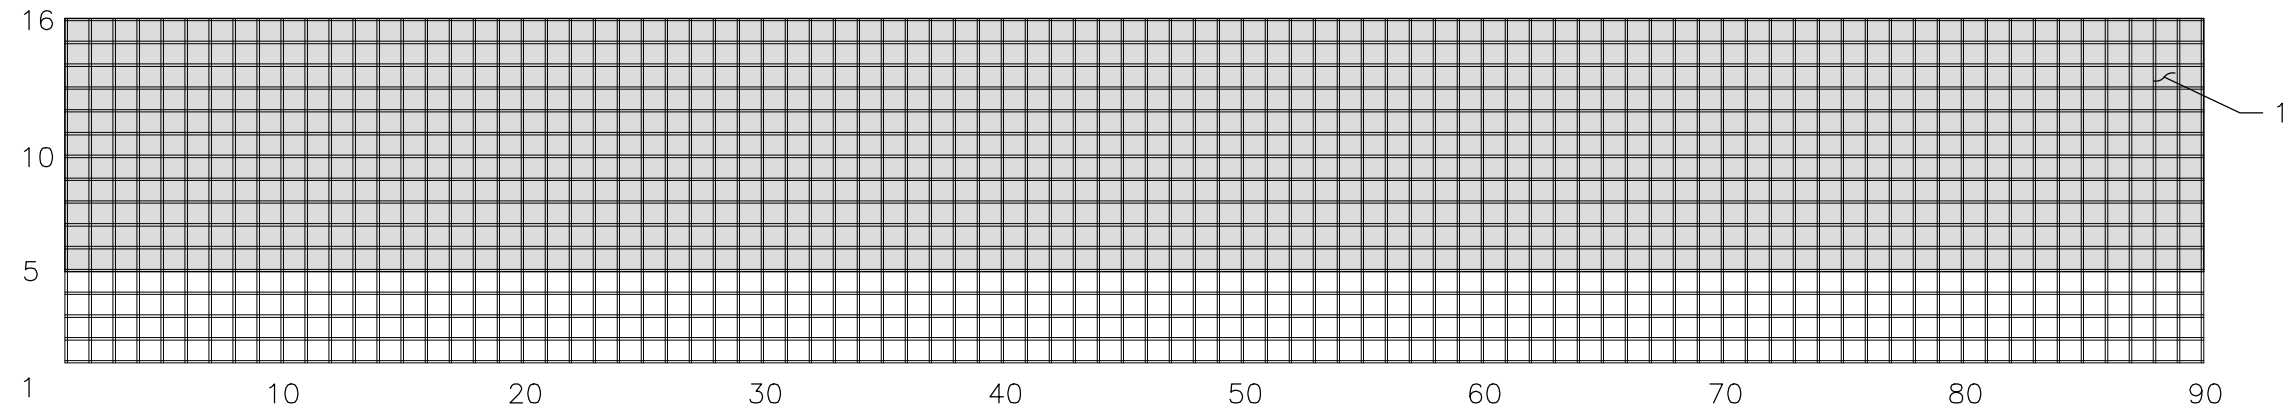
18-11-05 project date	date du projet
R.090045.001 project no.	no. du projet
44 OF 63 drawing no.	dessine no.

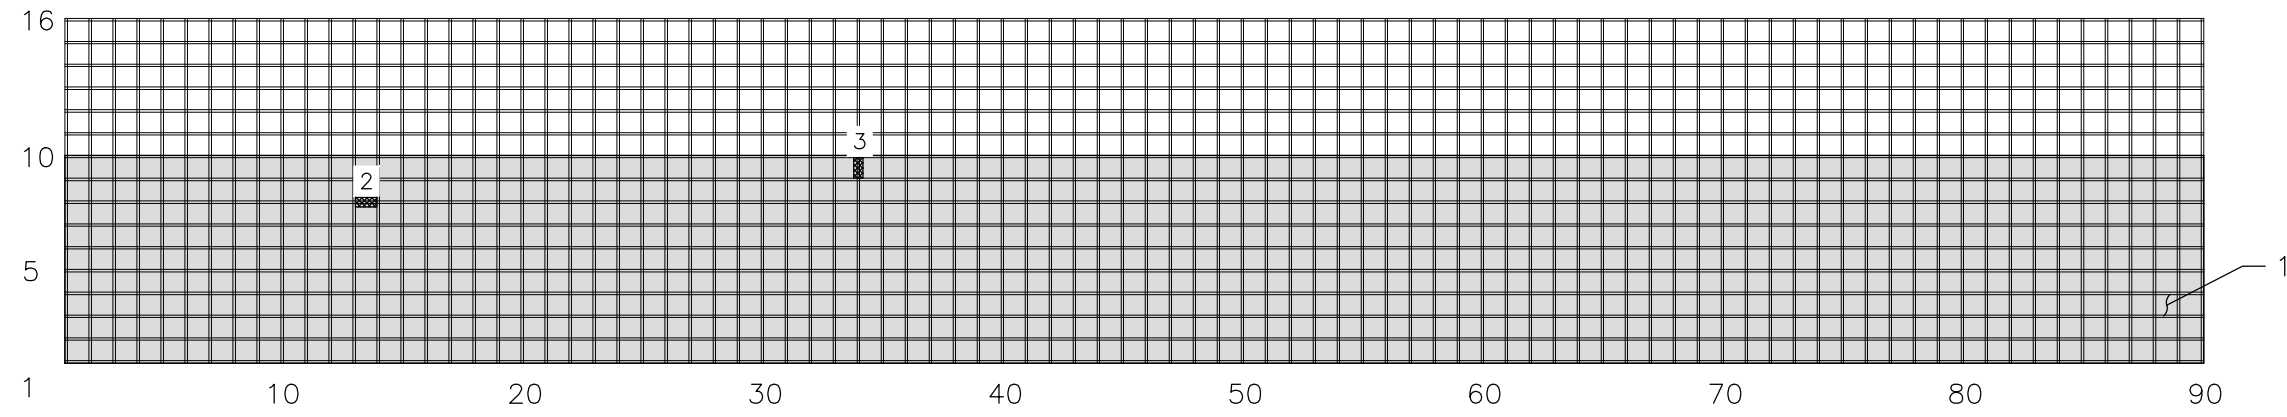
JS drawn by / dessine par	18-11-05 project date / date du projet
CW designed by / conc par	R.090045.001 project no. / no. du projet
PH approved by / approuve par	46 OF 63 drawing no. / dessine no.
tender / soumission	project manager / administrateur de projets

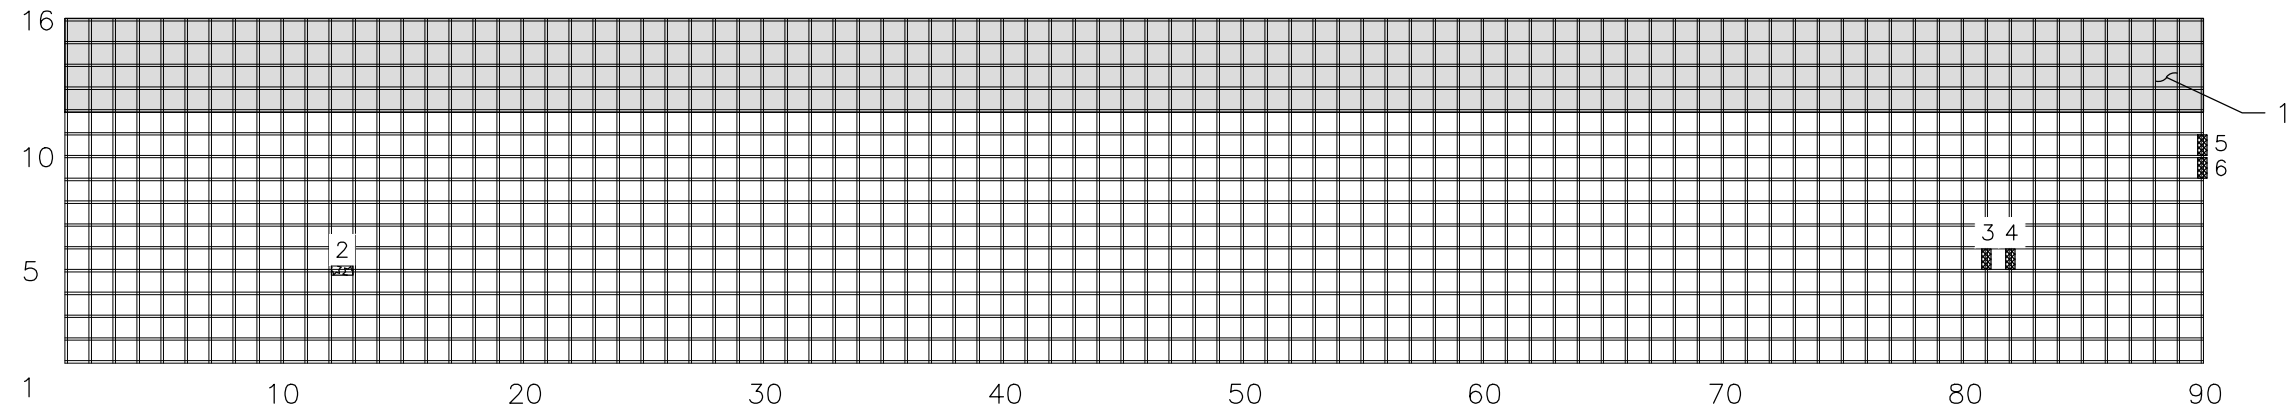
JS drawn by	dessine par	18-11-05 project date	date du projet
CW designed by	conc par	R.090045.001 project no.	no. du projet
PH approved by	approuve par	47 OF 63 drawing no.	dessine no.

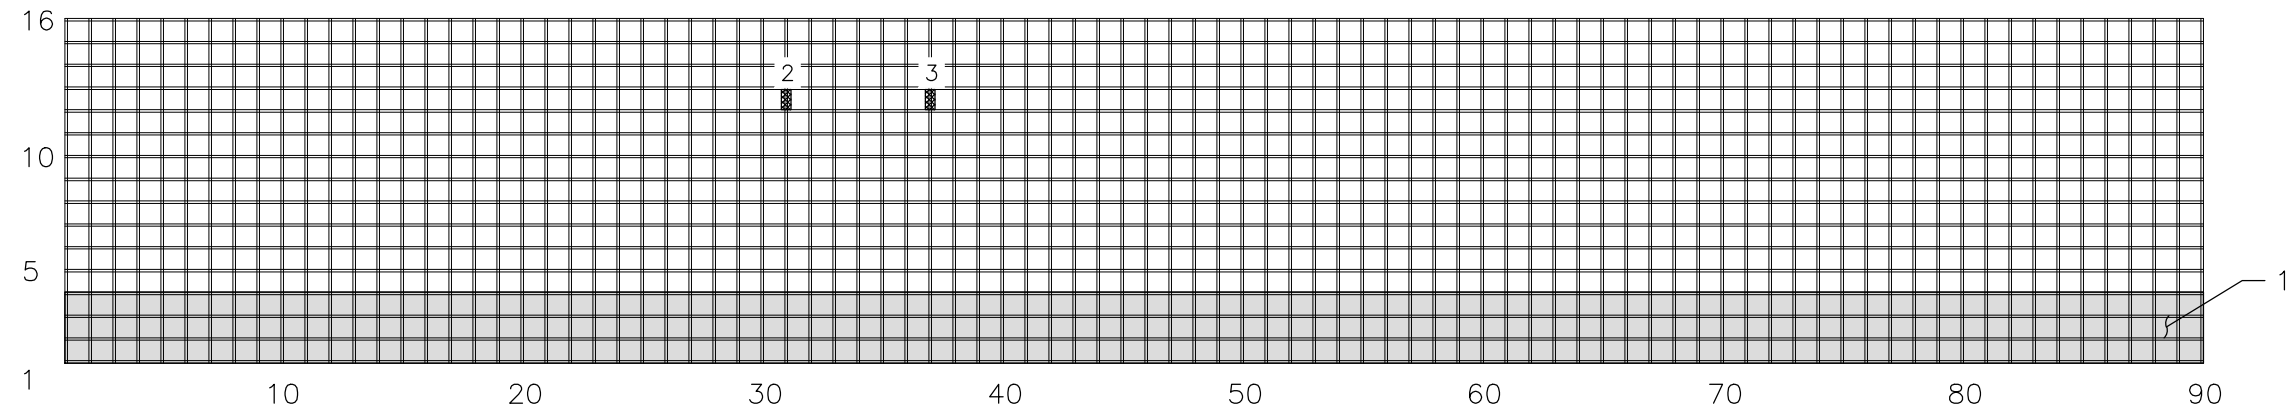
18-11-05 project date	date du projet
R.090045.001 project no.	no. du projet
48 OF 63 drawing no.	dessine no.

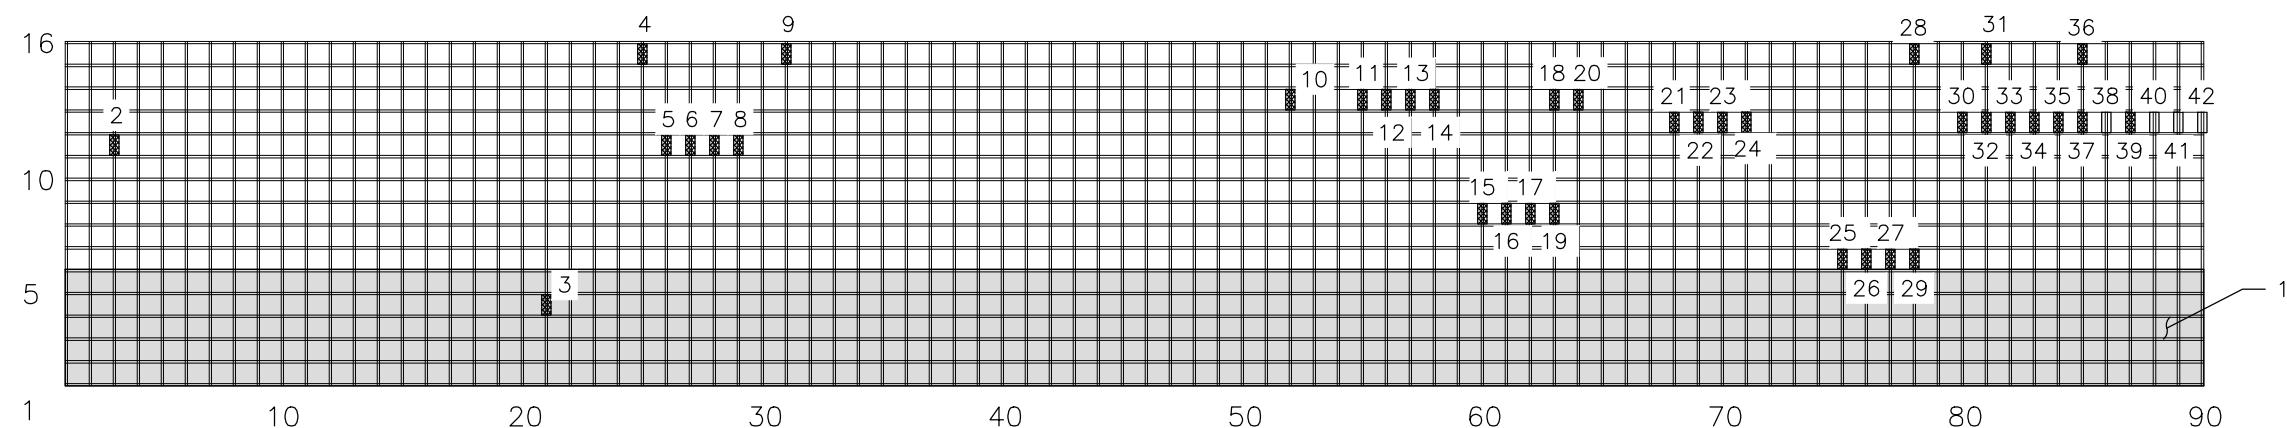
JS drawn by	dessine par	18-11-05 project date	date du projet
CW designed by	conc par	R.090045.001 project no.	no. du projet
PH approved by	approuve par	50 OF 63 drawing no.	dessine no.
tender soumission	project manager administrateur de projets

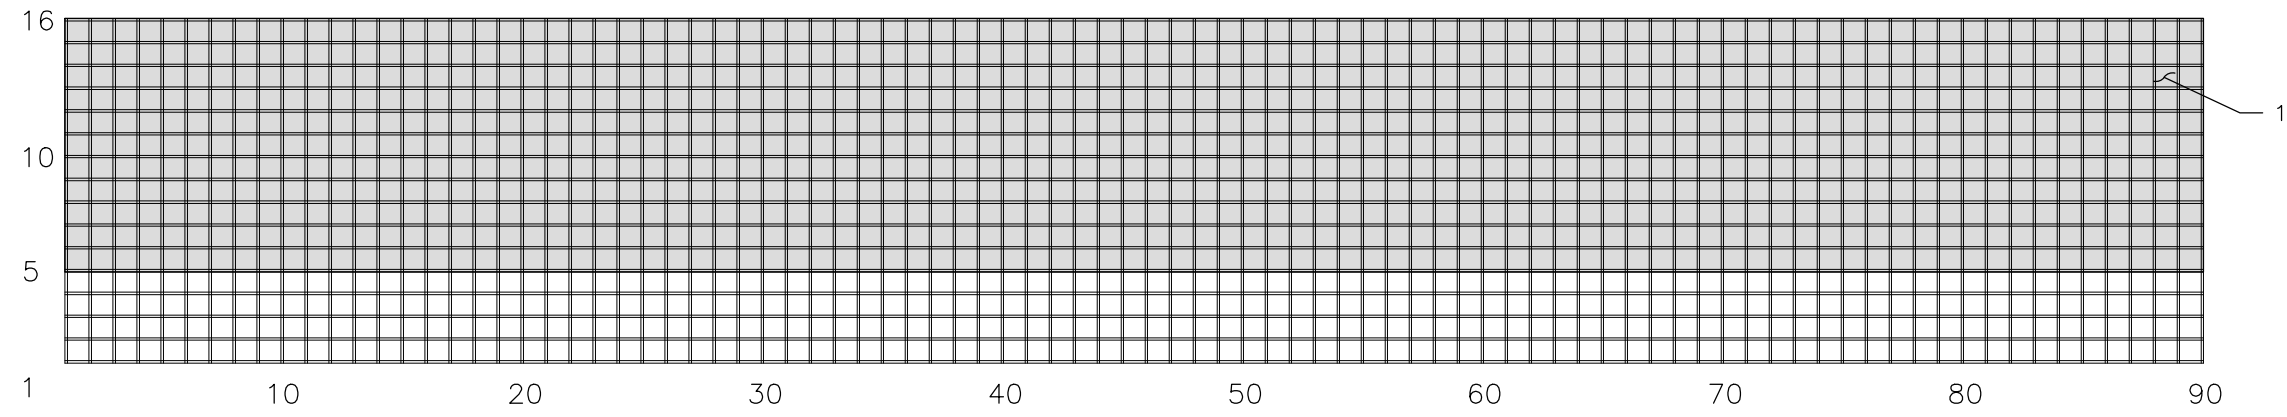
18-11-05 project date	date du projet
R.090045.001 project no.	no. du projet
51 OF 63 drawing no.	dessine no.

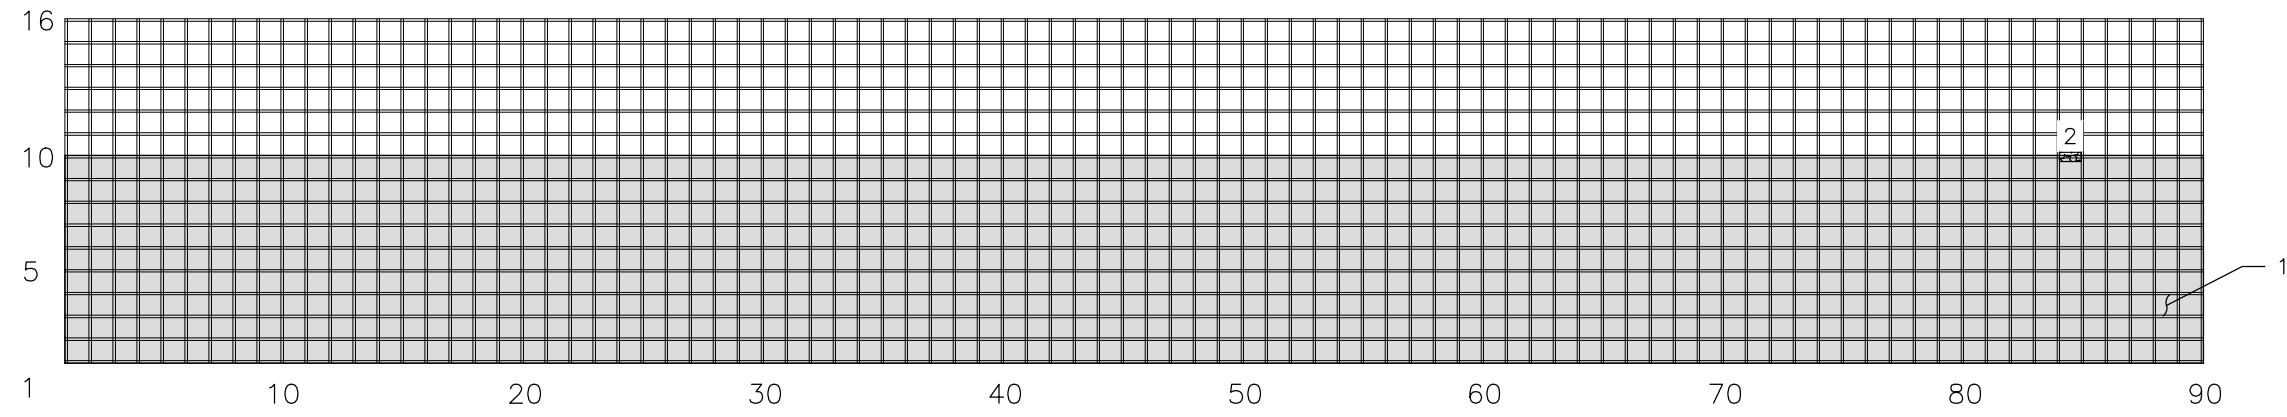
18-11-05 project date	date du projet
R.090045.001 project no.	no. du projet
53 OF 63 drawing no.	dessine no.

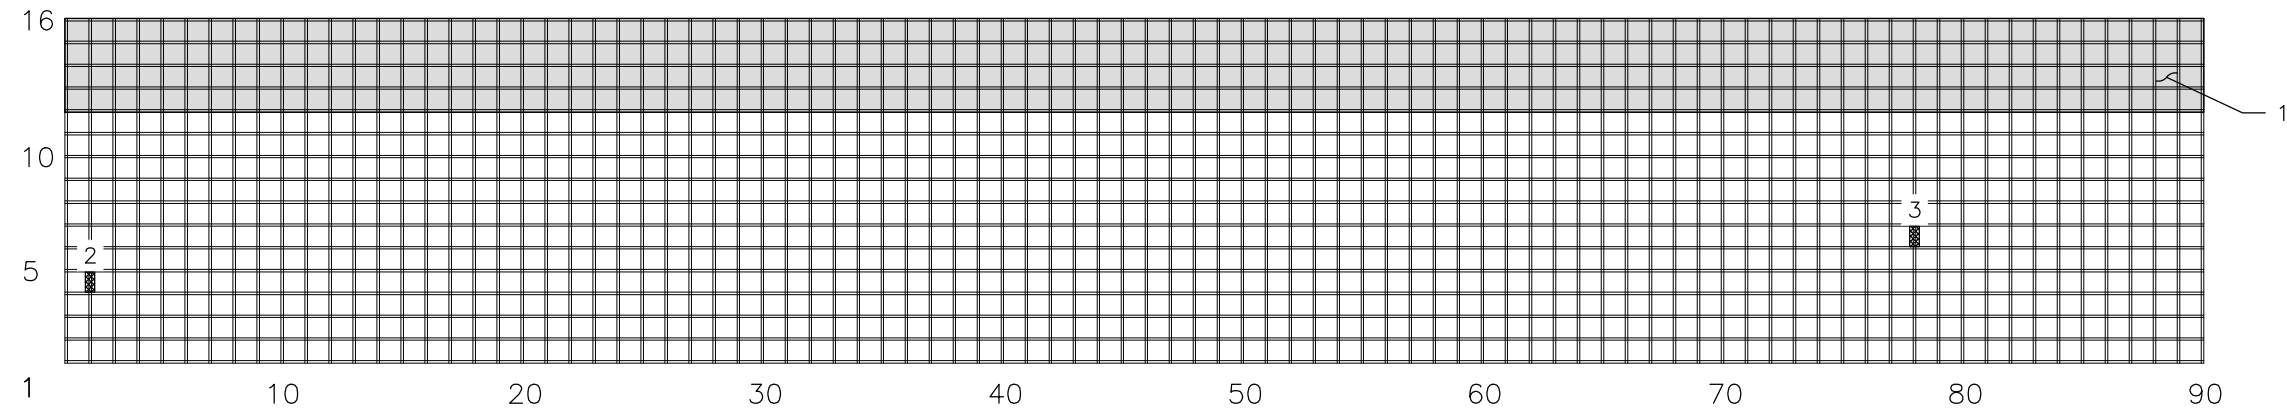
18-11-05 project date	date du projet
R.090045.001 project no.	no. du projet
54 OF 63 drawing no.	dessine no.

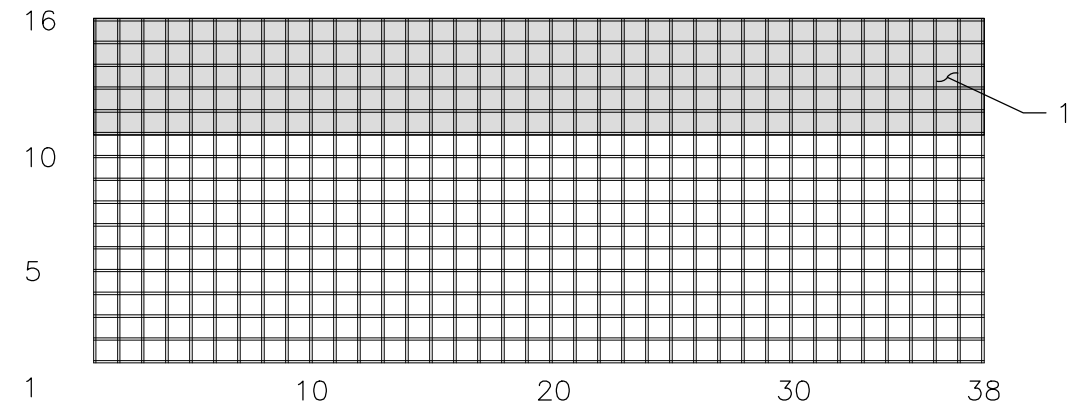
18-11-05 project date	date du projet
R.090045.001 project no.	no. du projet
56 OF 63 drawing no.	dessine no.

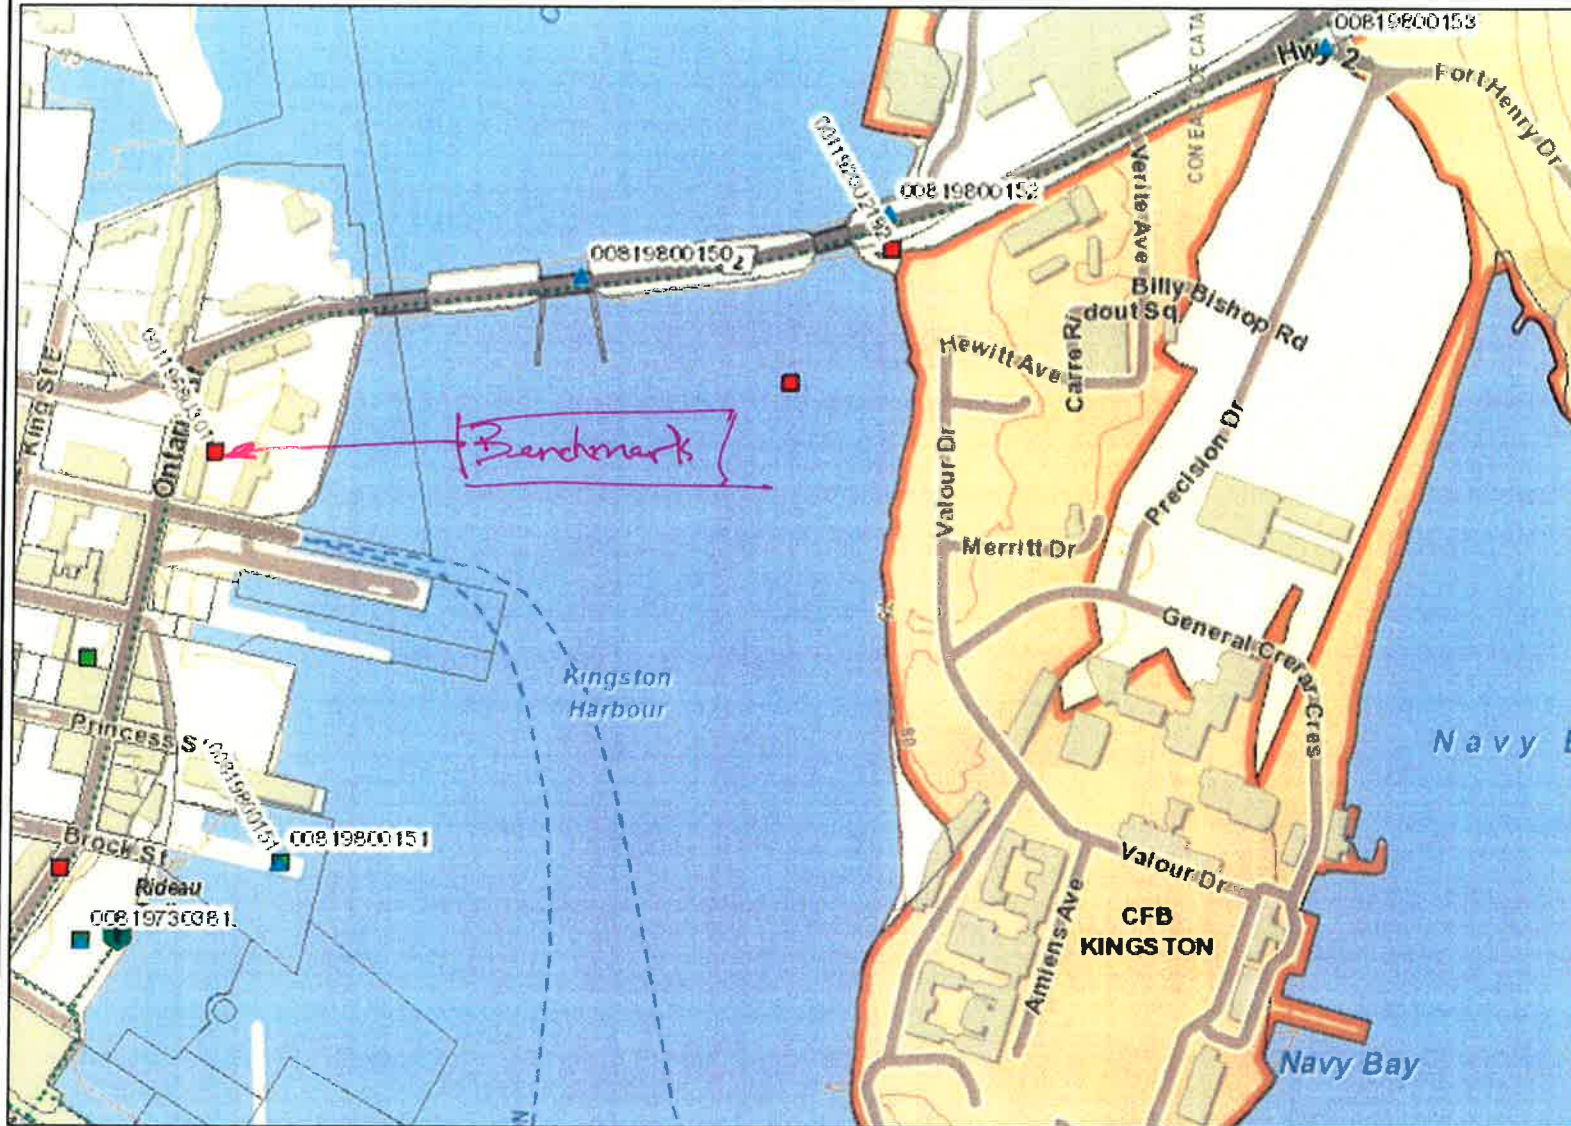
Notes:
Enter map notes
