# LaSalle Causeway Bascule Bridge Main Trunnion Rehabilitation Study - Design Concept Report

Project Number: R. 099350.002

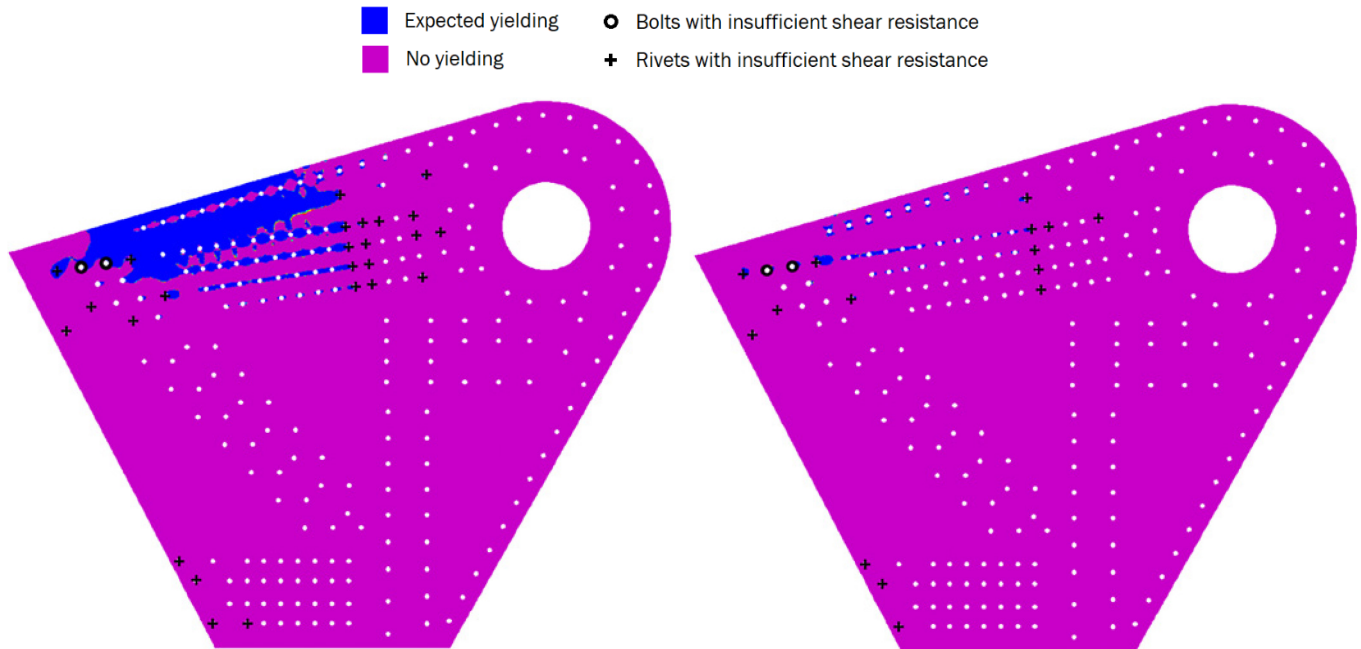
Figure 5 - Gusset plate expected yielding and fasteners with insufficient resistance at undeteriorated state for ULS B1 to B3 <sup>1</sup>  
 (a) Left: with loads taken according to S6-14 (b) Right: with restrictions during bridge operation

Figures 5 and 6 show the expected yielding on the gusset plates as determined using the *von Mises* yield criterion. In addition to the expected yielding areas, areas with significant section losses identified in the 2020 Detailed Inspection Memorandum should be repaired, in order to keep the bridge in service for 30 years.

- Reinforce the areas that are overstressed due to the design loads (see blue areas in Figure 5); and
- Reinforce the areas that are overstressed due to the corrosion (see other blue areas in Figure 6).

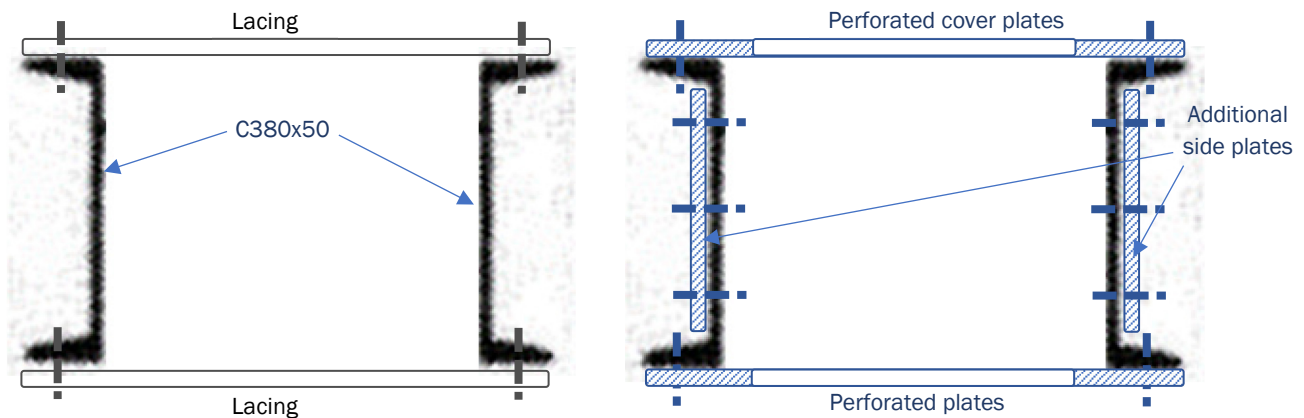
Figure 9 – Existing (left) and reinforced (right) sections of 13-16 members

Since these members are mainly in tension, the new perforated cover plates alone cannot be efficient for these loads over the entire length of these members. As members 14-15 intersect members 13-16 at deck level and therefore, the cover plates have to be interrupted. The perforated plates will have to stop before nodes 13 and 16 and most likely at the connection with the bottom chord of the portal (i.e. the transverse truss connecting the two members 13-16 in their upper portion to stabilize them laterally). These are the locations where the additional side plates are required to increase capacity under tension loads.

- Replacement of the top and bottom lacing with perforated cover plates;
- Replacement of rivets with bolts when rivets must be removed for the replacement of components; and
- Installation of additional plates on the exterior face of the channels at discontinuities of the new perforated plates and at both ends.

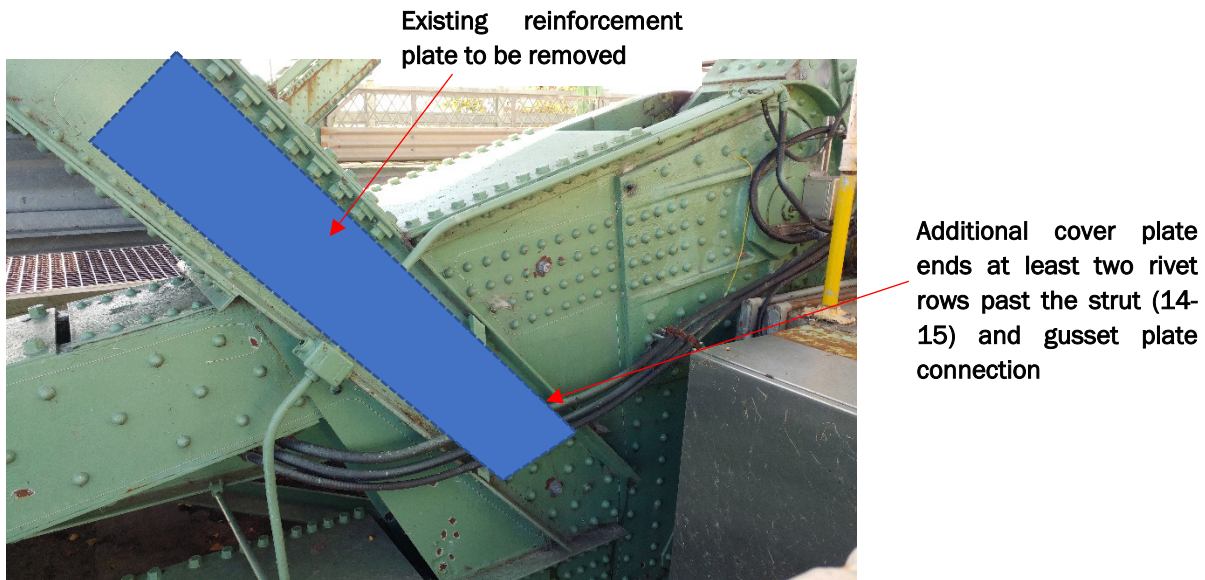
Figure 10 - Reinforcing side plate at node 16

At node 16, where the diagonal members are attached to the gusset plates., the members are severely corroded, and a plate has been previously installed to reinforce this area (see Figure 10). Since new side plates will be installed, the existing small reinforcing plates are no longer required and will be removed.

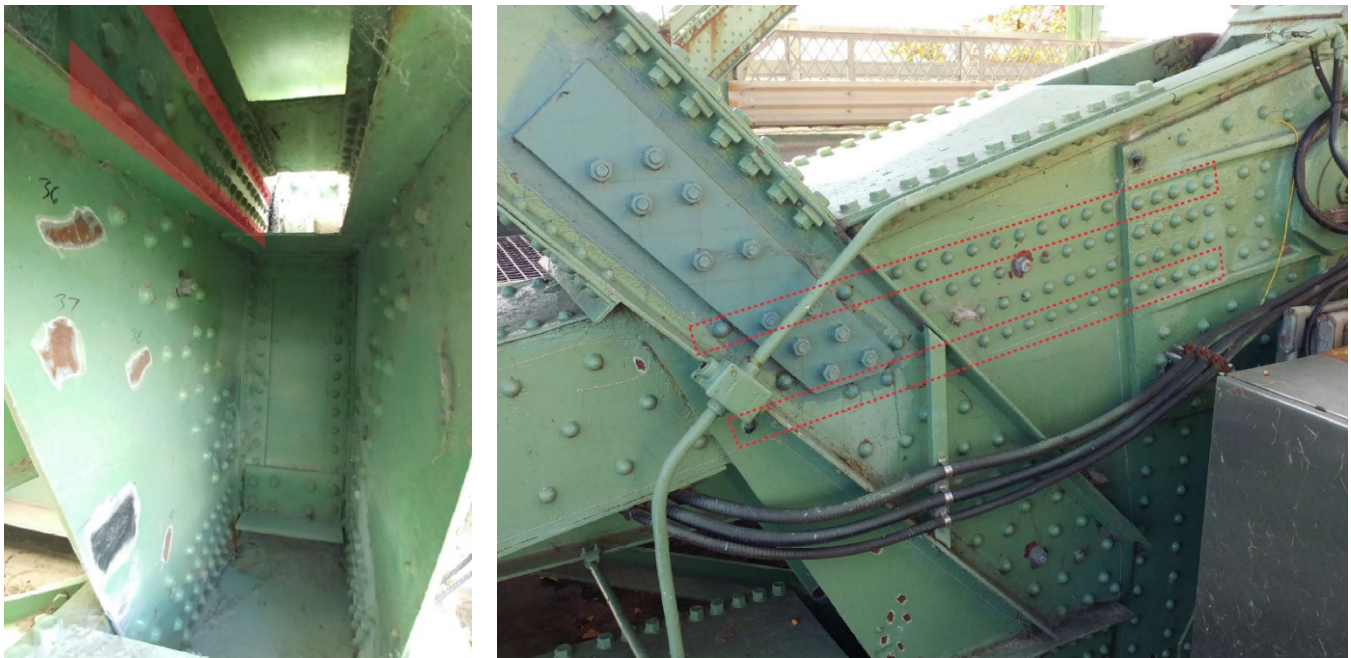
Figure 18 – Gusset Plate Strengthening Type A1  
(a) Left: View from inside the trunnion (b) Right: View from outside.

This strengthening aims to reinforce the area located between the intersection of diagonal 13-16 and strut 14-15 and the trunnion pin, which was identified by the structural evaluation as overstressed in an undeteriorated state. Figure 18 shows the location of the proposed strengthening.

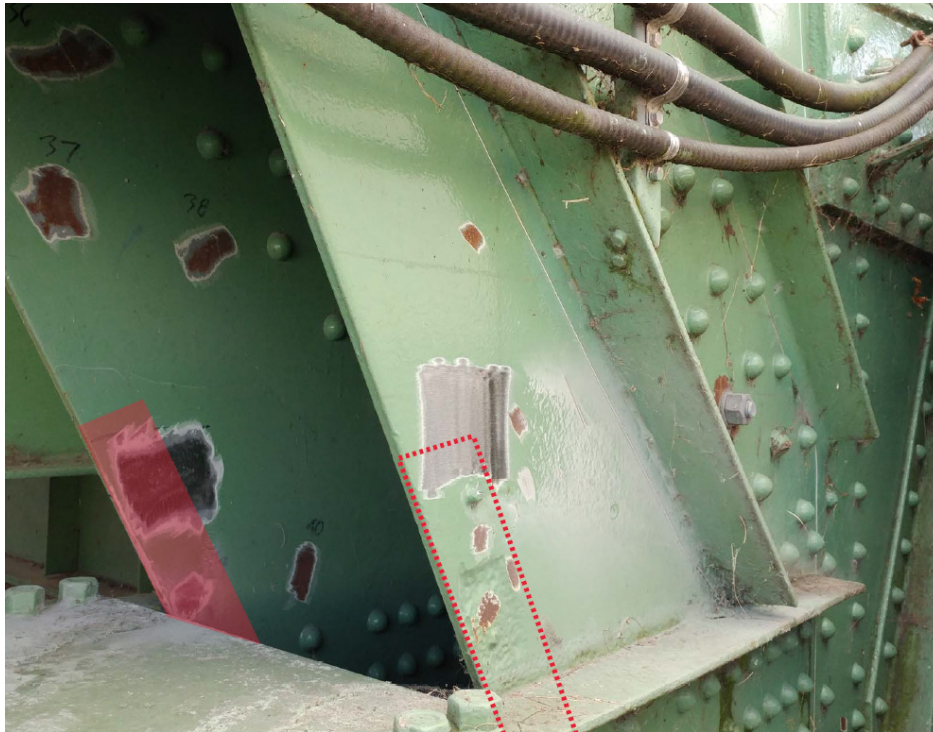
Figure 20 - Gusset Plate Strengthening Type B

This strengthening aims to reinforce the area located at the edge of the gusset plate just above the connection with the bottom chord 14-16. This area was identified by the structural evaluation as overstressed due to the reduced thickness caused by the corrosion, for the four gusset plates. Figure 20 shows the location of the proposed strengthening. Figure 20 shows the exterior gusset plate of the north trunnion at foreground and the three cables at the top are the same that the ones shown in Figure 18 and Figure 19.

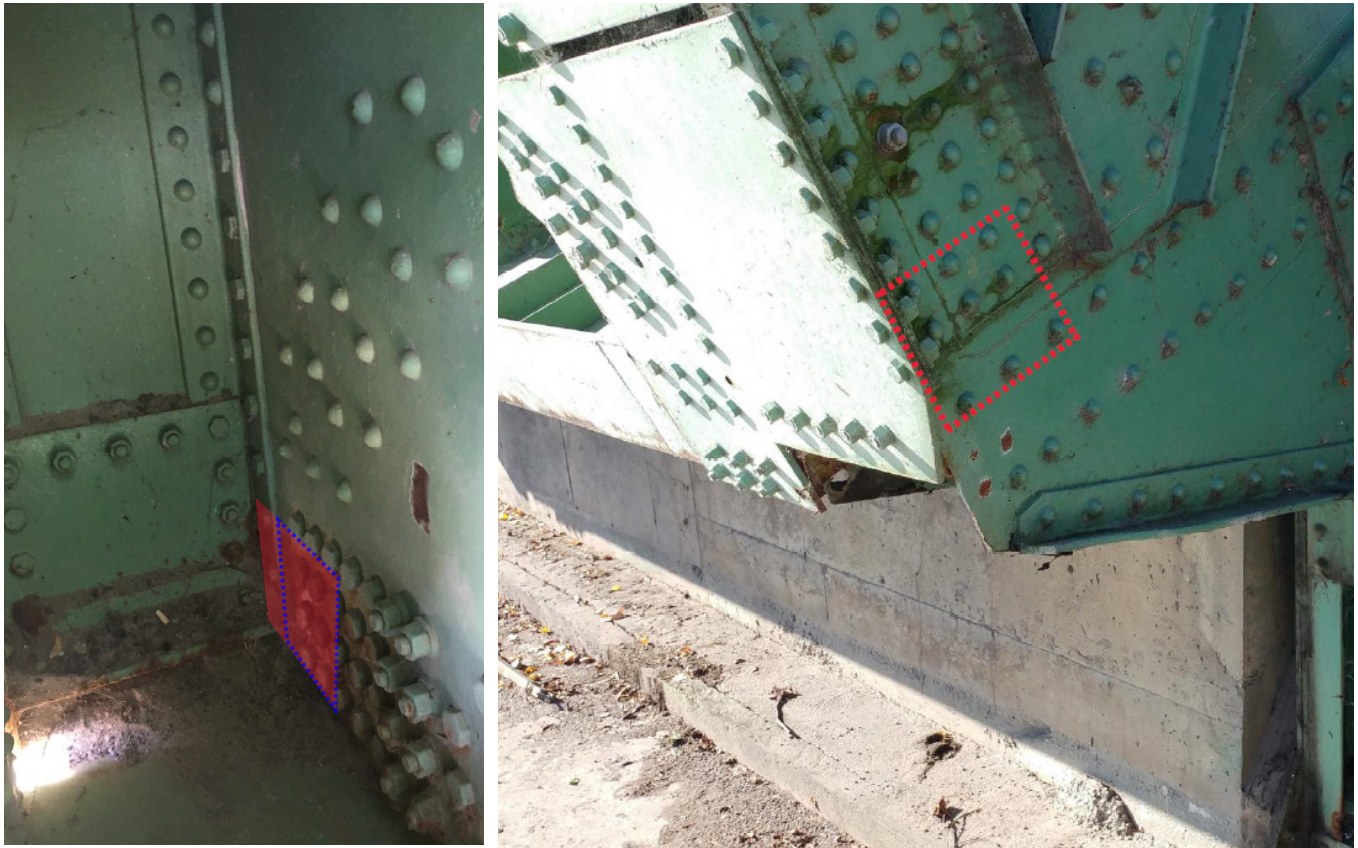
Figure 21 - Gusset Plate Strengthening Type C  
 (a) Left: View from inside the trunnion (b) Right: View from outside

This strengthening aims to reinforce the area located between the connection of the bottom chord 14-16 and the interior diaphragm in the gusset plate. This area exhibits significant corrosion and localized perforations and was identified by the structural evaluation as overstressed due to the reduced thickness caused by the corrosion for the four gusset plates. Figure 21 shows the location of this strengthening.

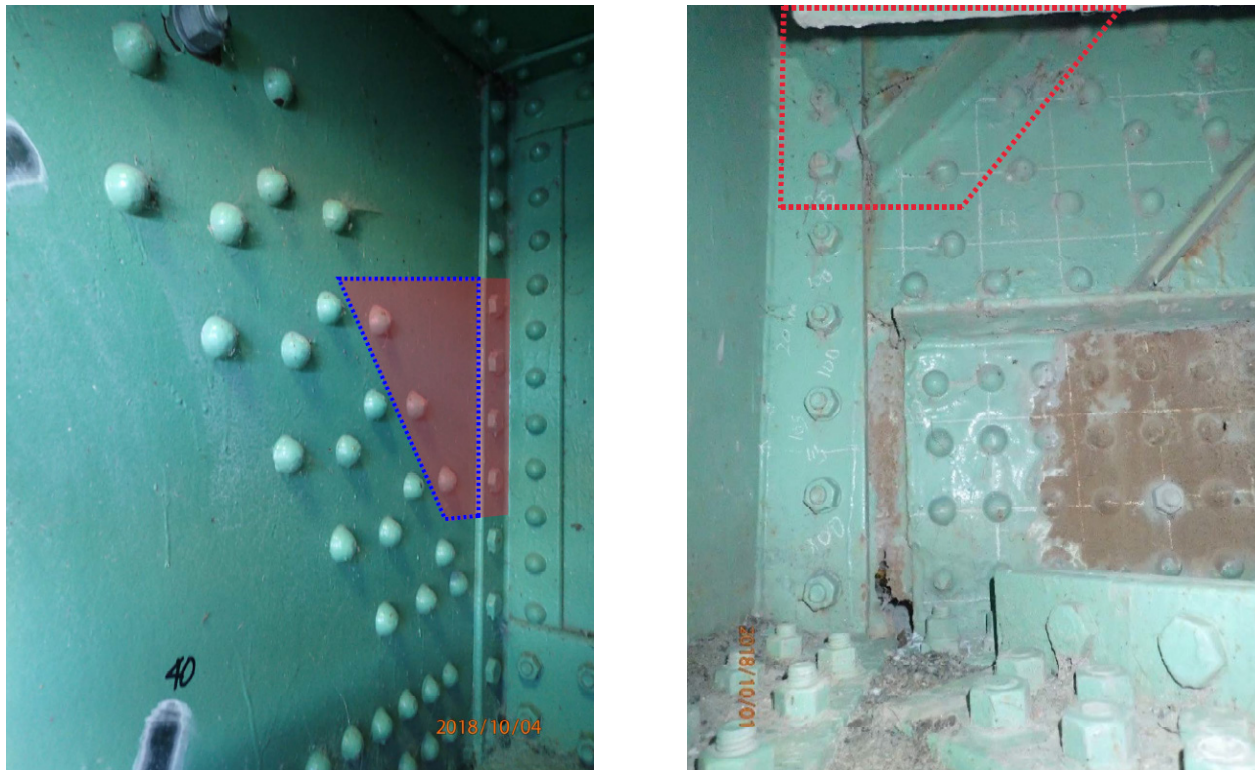
Figure 22 - Gusset Plate Strengthening Type D  
(a) Left: View from inside the trunnion (b) Right: View from outside

This strengthening aims to reinforce the area located in the triangle formed by the diagonal 13-16 and the interior diaphragm connection. This area exhibits high stresses and significant corrosion in both interior gusset plates. It is not yielding according to the structural evaluation (stress in this region reaches 178 MPa<sup>3</sup> which gives a D/C ratio of 0.94), but strengthening is recommended to provide a 30-year service life of the gusset plates. Figure 22 shows the location of this strengthening.

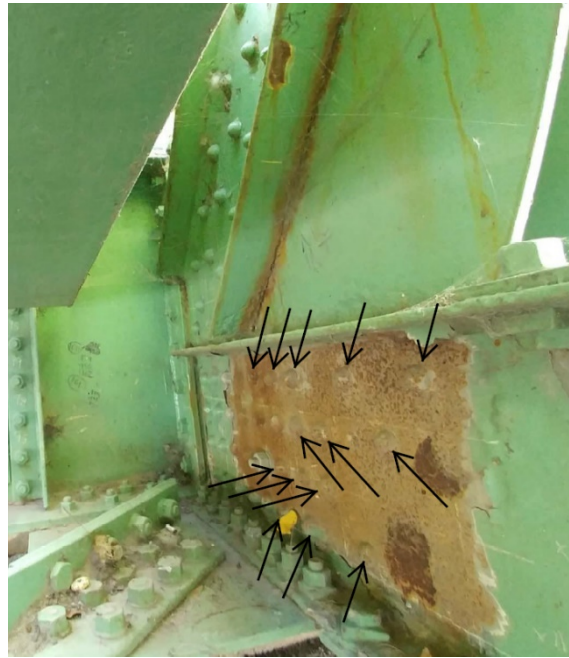
This strengthening aims to repair the connection between the bottom chord 14-16 and the gusset plate for the north interior trunnion plate. This connection exhibits significant corrosion with very severe section loss of several rivet heads. Figure 23 shows the location of this strengthening and identifies examples of rivet heads with very severe section losses.

Figure 23 – Significant corrosion on the bottom chord connection of the south side of the north interior plate

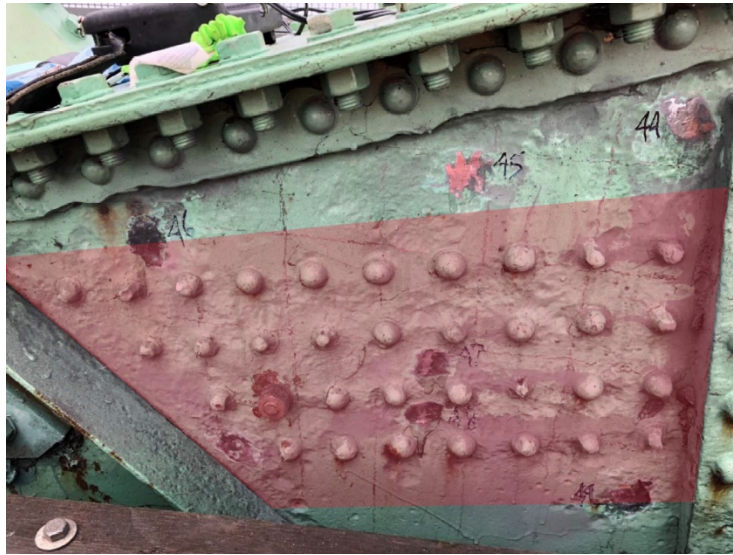
Figure 24 - Gusset Plate Strengthening Type F

This strengthening aims to repair the connection between the strut 14-15 and the gusset plate for the interior plate of the south trunnion. This connection exhibits significant corrosion with severe section loss of several rivet heads. Figure 24 shows the location of this strengthening.

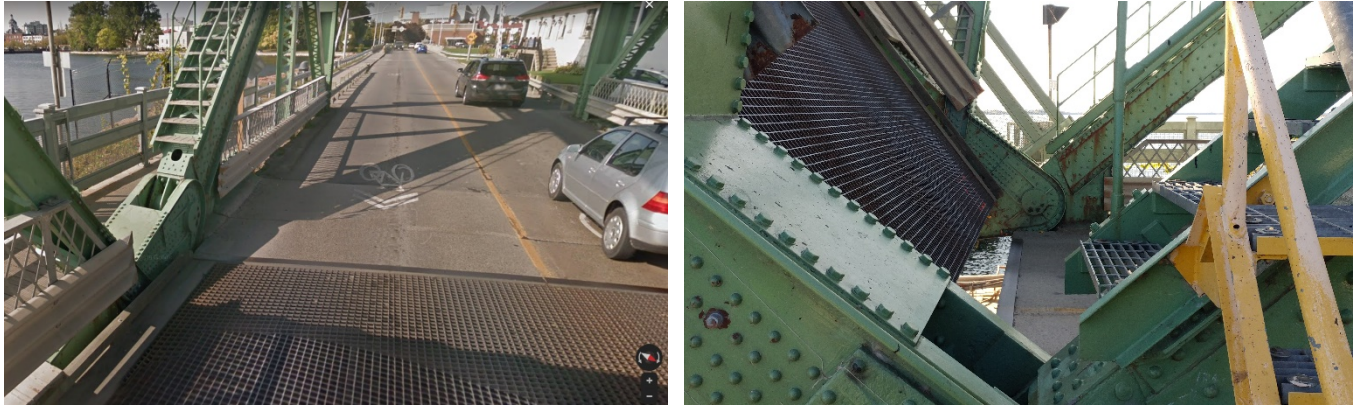
Figure 25 - Interior plate of the south trunnion located in the splash zone  
 (a) Left: Bridge opened to traffic (b) Right: Bridge during operation

At this conceptual stage, considering the current state of deterioration, it is recommended to strengthen the south interior plate by adding a sacrificial plate on the exposed area. Consideration during detailed design should be done to check the influence of future corrosion on the stresses in the gusset plate and validate plate geometry and proposed strengthening against other strengthening Type A1 and Type A2 for constructability purposes.

In addition to the strengthening, and to prevent further deterioration due to splashing, it is recommended to use a properly applied four-coat paint system on the exterior side (roadside) of the two interior gusset plates. Moreover, it should be noted that the traffic barrier is interrupted at the trunnion to allow movement between leaf and rear spans as shown in Figure 25 (b). However, this leaves the trunnion, and particularly the pin, vulnerable to an impact with a vehicle, which could damage the pin and have consequences on the bridge serviceability and safety. It is therefore proposed to add a curb on both sides along the entire length of the approach under the bridge. Consideration should be given in detailed design to ensure the design of the current applicable road standards.
