LaSalle Causeway Bascule Bridge

**Main Trunnion Rehabilitation Study –
Detailed Inspection Memorandum (Revision 1)**

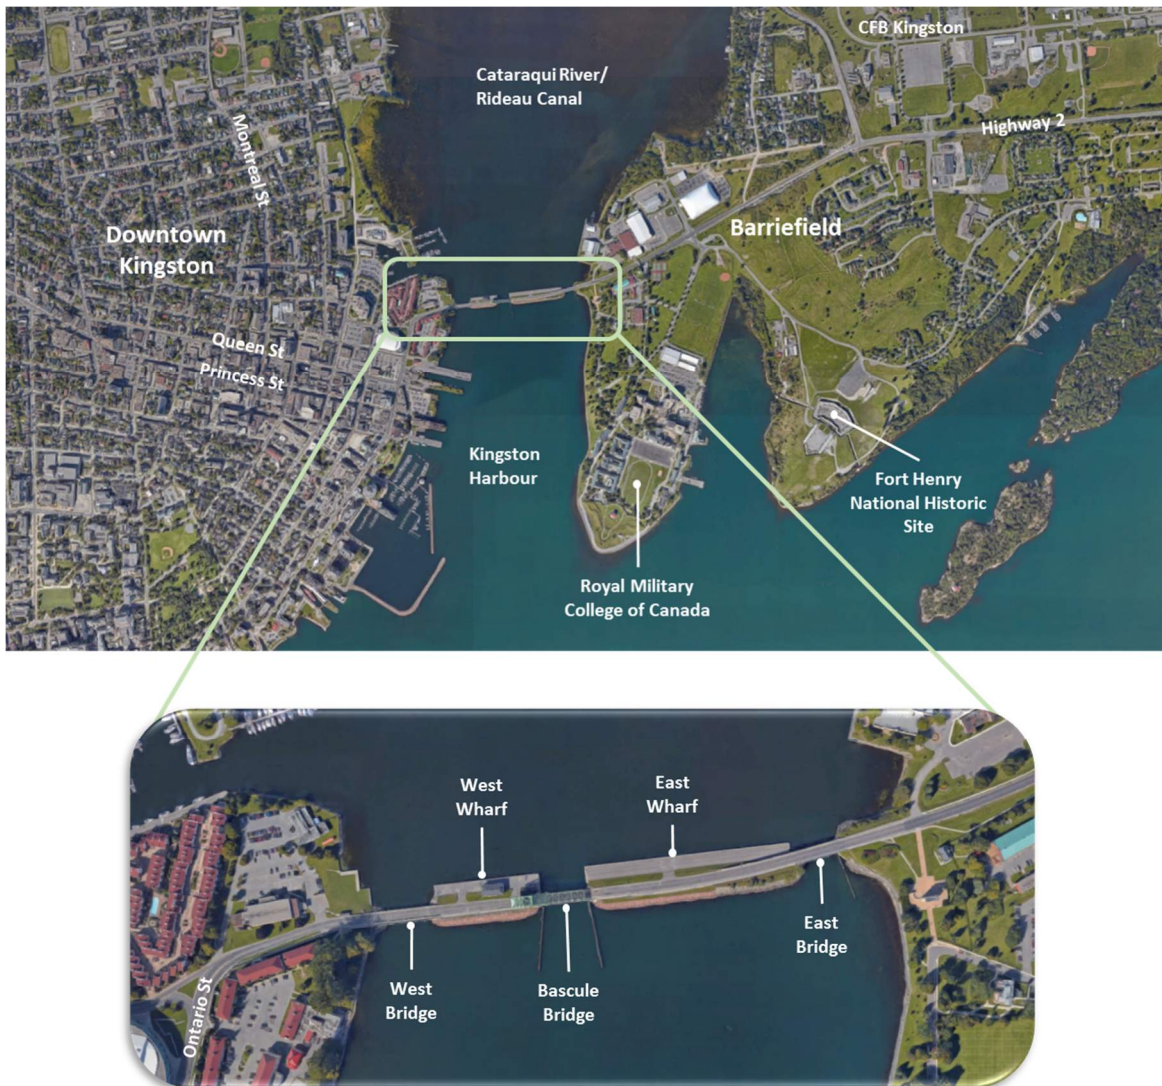
Figure 1: Key Plan (from Google Maps)

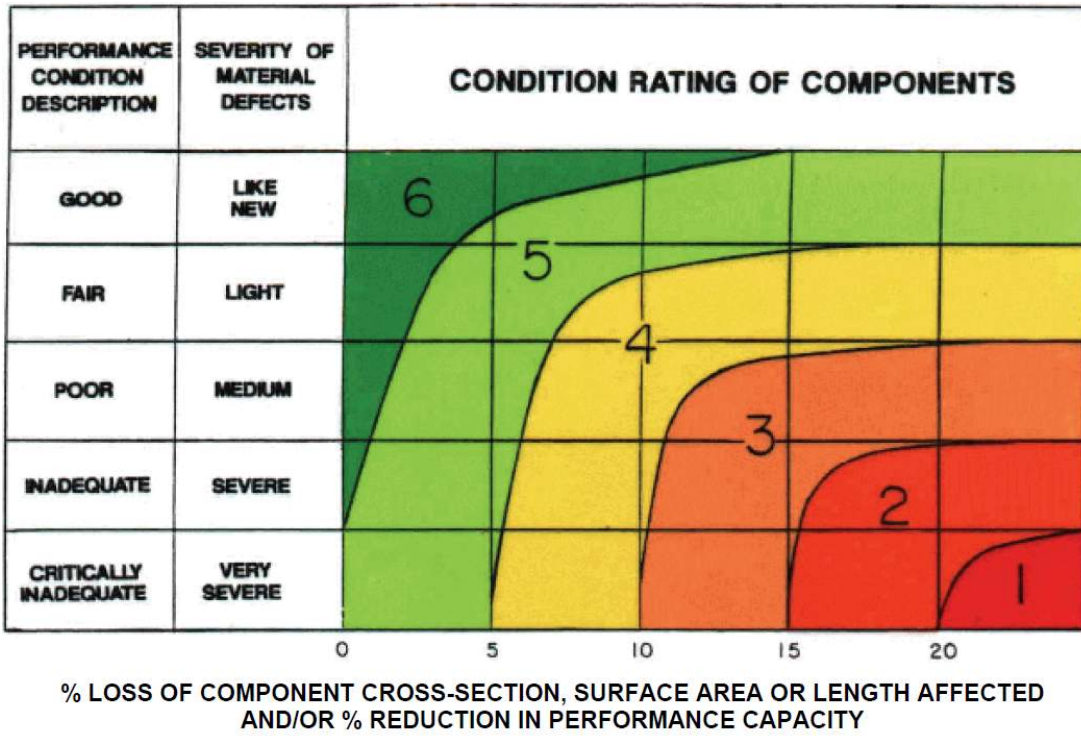
Figure 11: Figure 2.2 of the BIM - Condition Rating of Primary Components

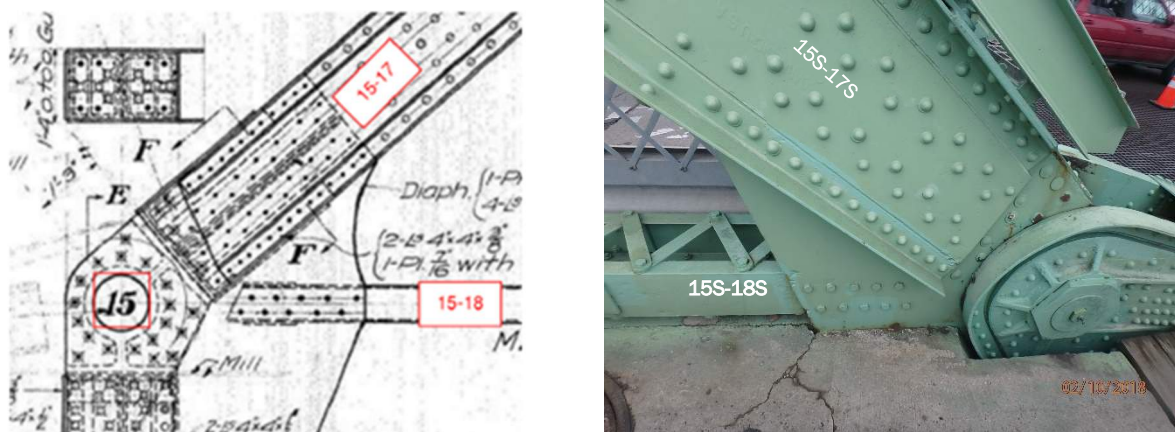
Figure 13: Tower Truss Members

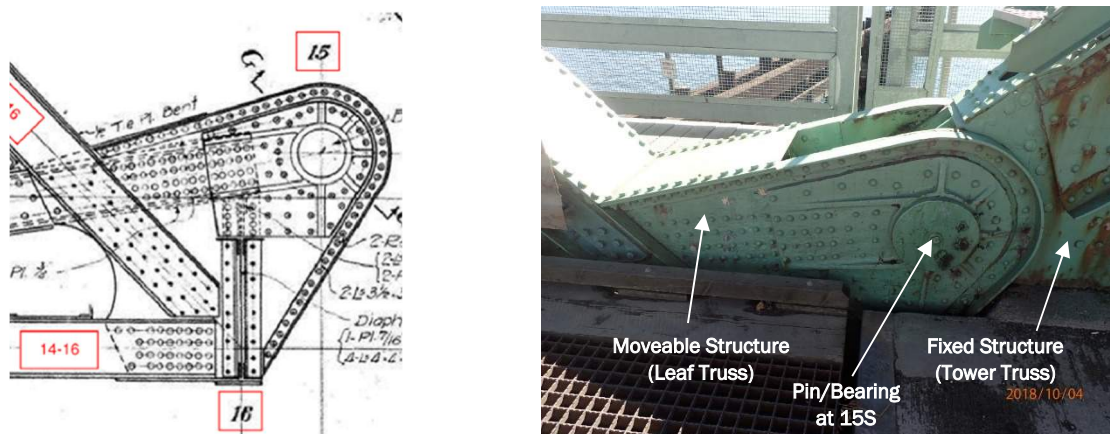
Figure 14: Main Trunnions

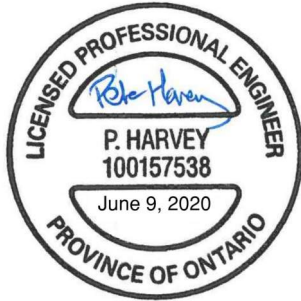
Peter Harvey, P.Eng
Structural Engineer

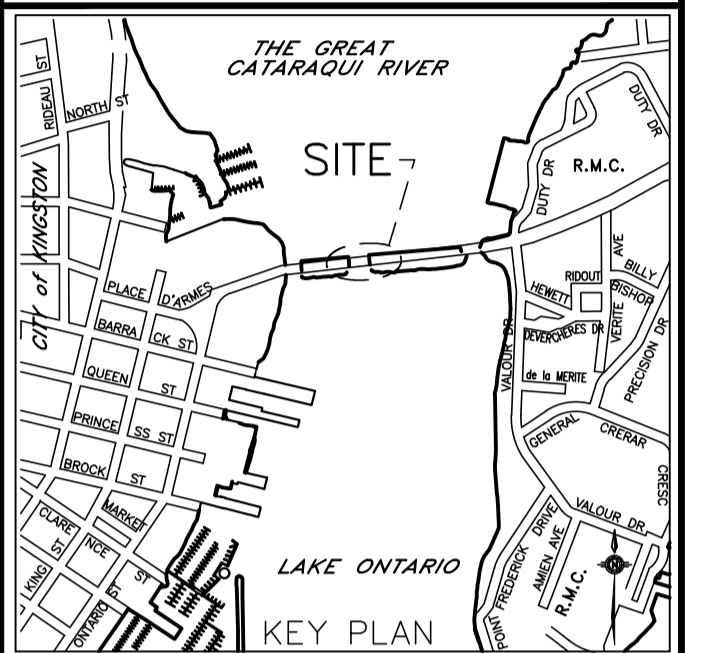
Contractor to verify all dimensions & conditions on site and immediately notify the engineer of all discrepancies.
L'entrepreneur doit vérifier les dimensions et conditions sur le site et en aviser l'ingénieur immédiatement de toute divergence.

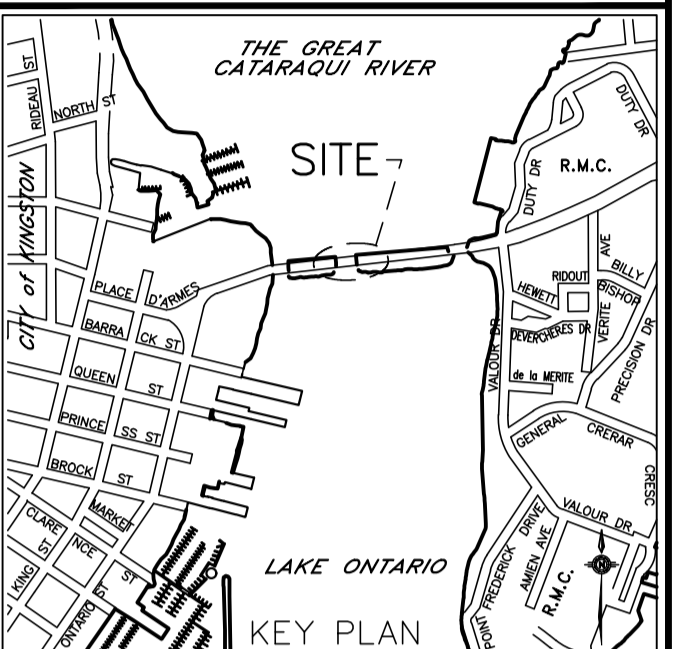
Contractor to verify all dimensions & conditions on site and immediately notify the engineer of all discrepancies.

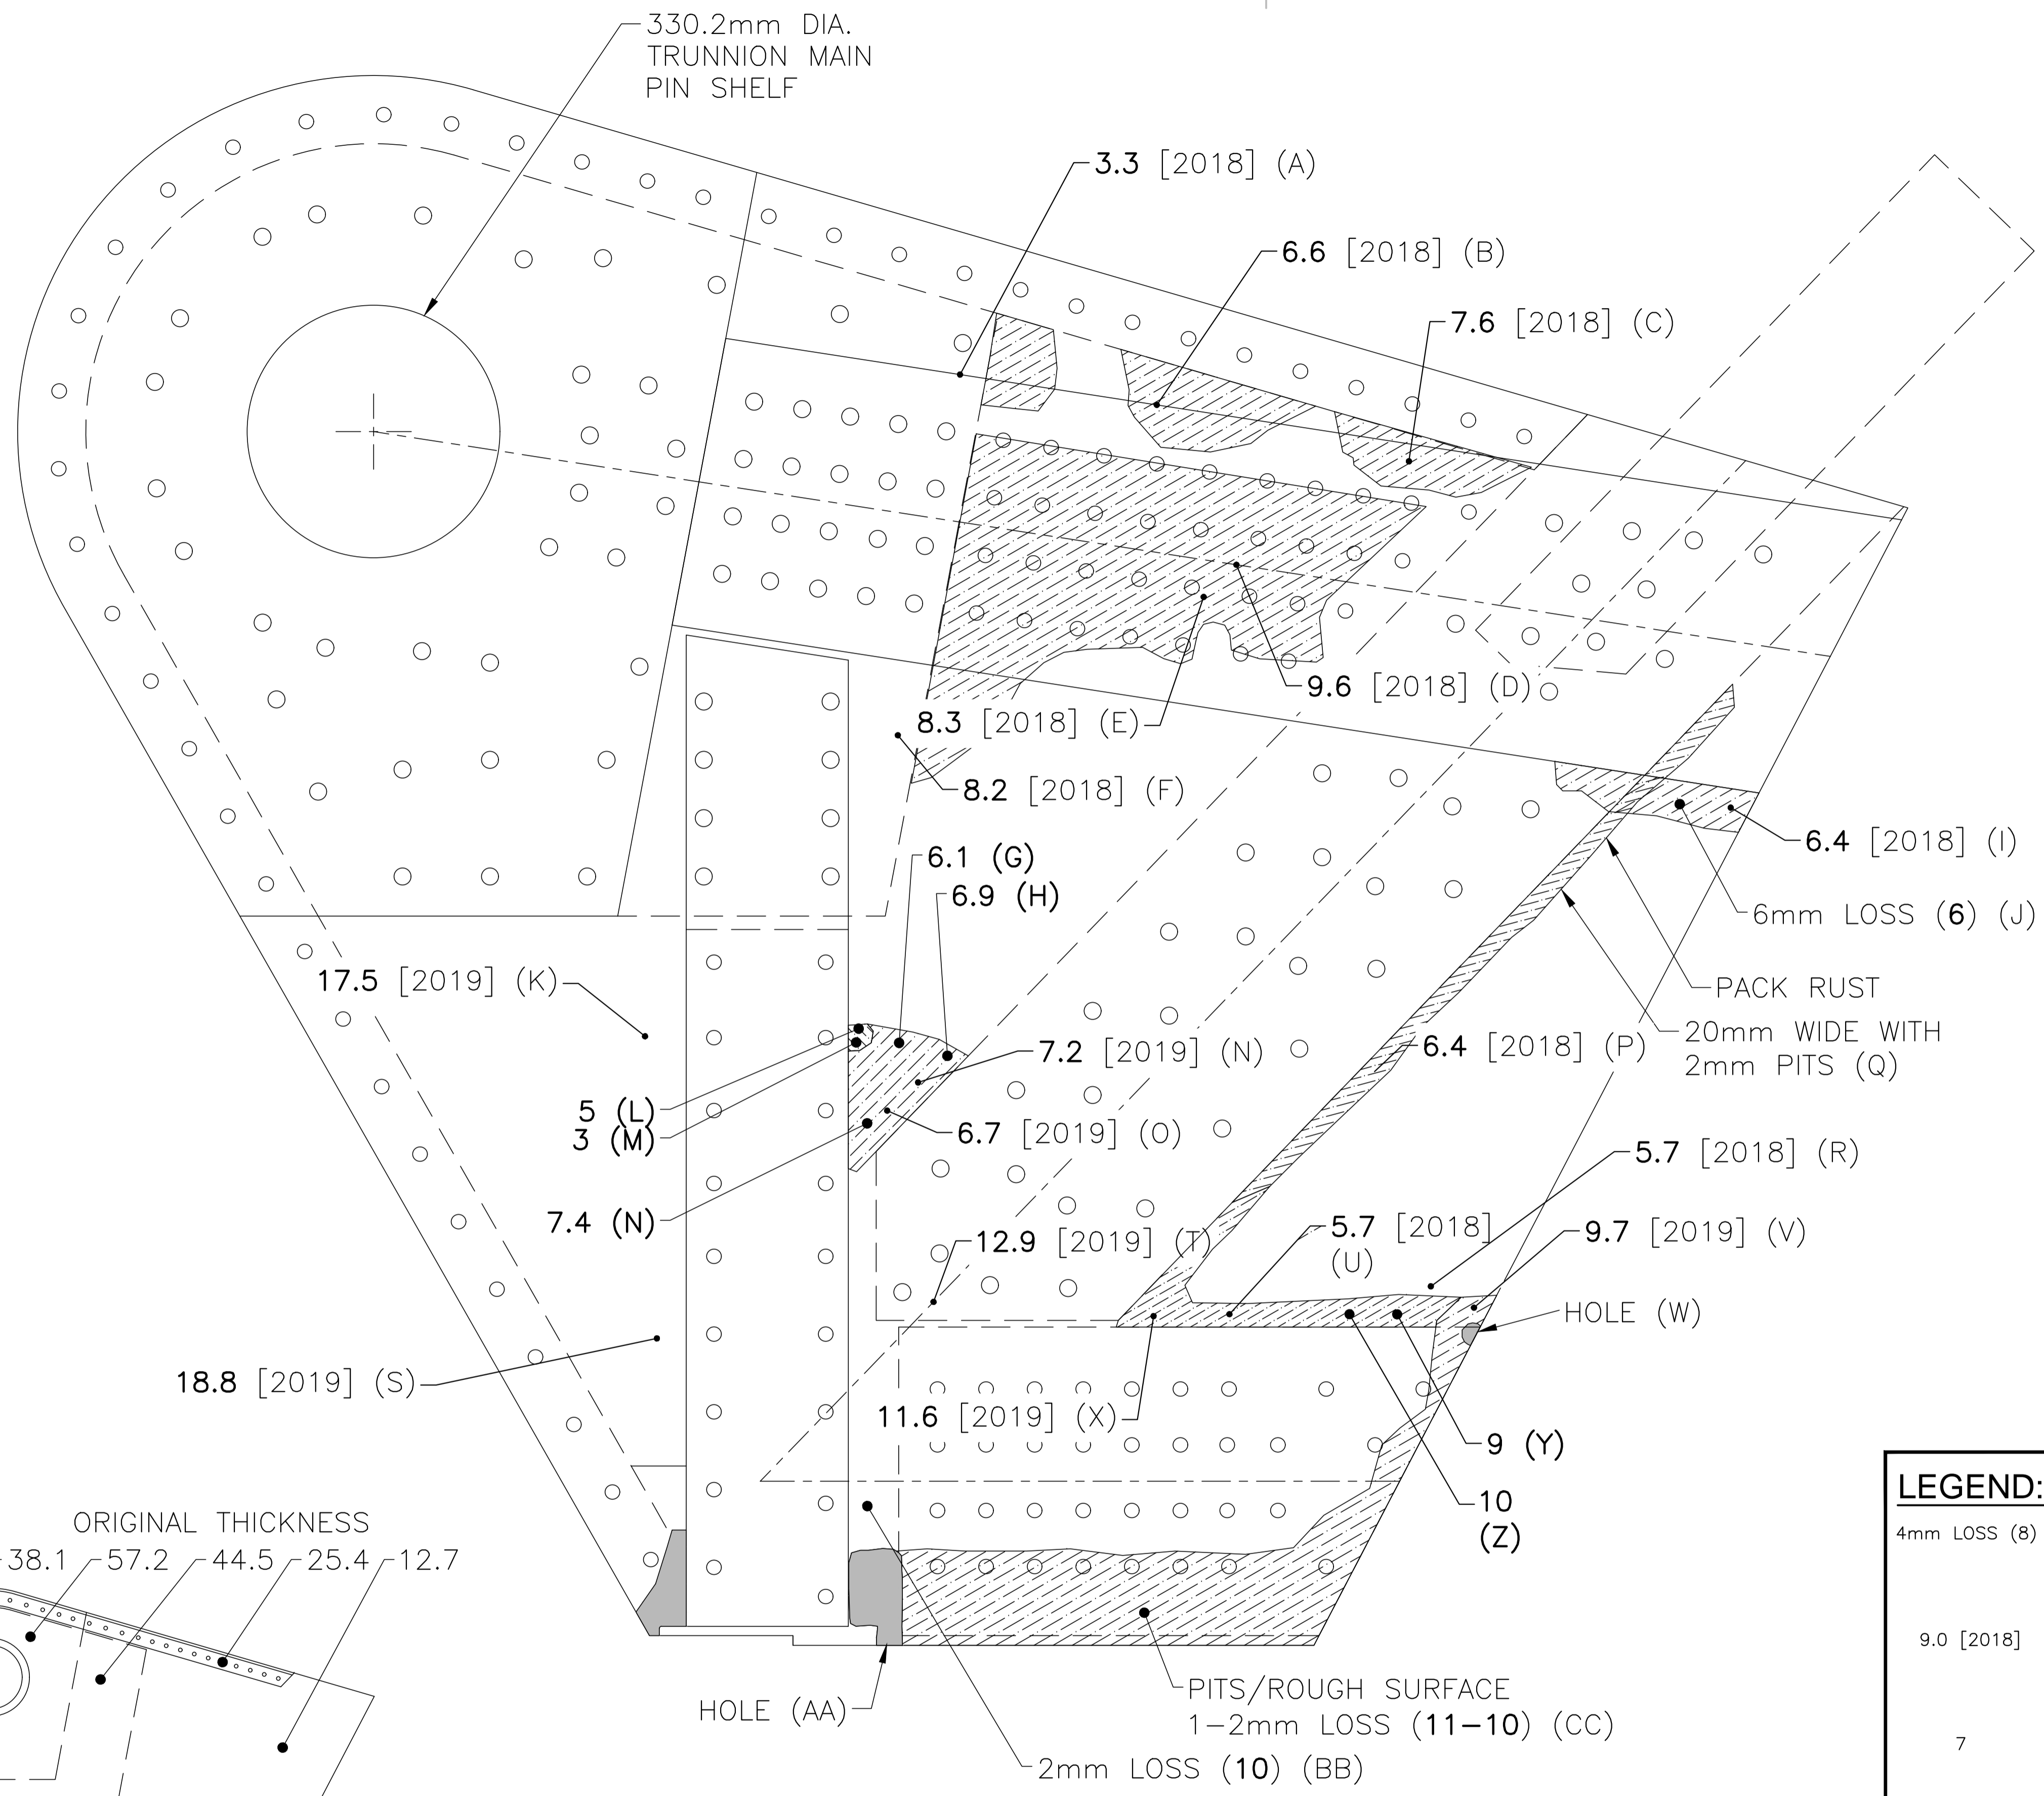
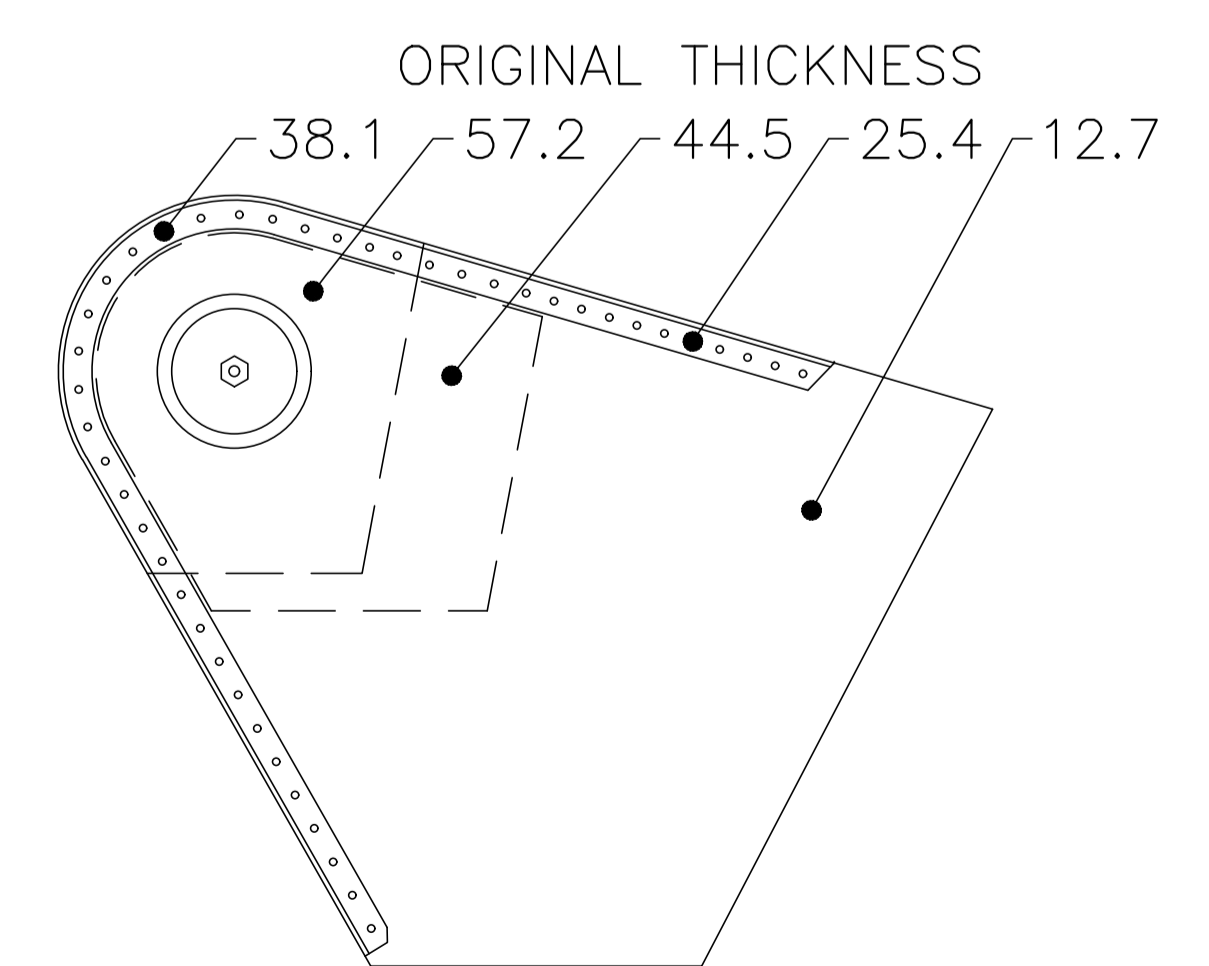
MAIN CASTING – CAST STEEL – 11/4” 31.75mm
 INTERIOR PLATE – PLATE STEEL – 1/2” 12.7mm
 GUSSET – PLATE STEEL – 1/2” 12.7mm

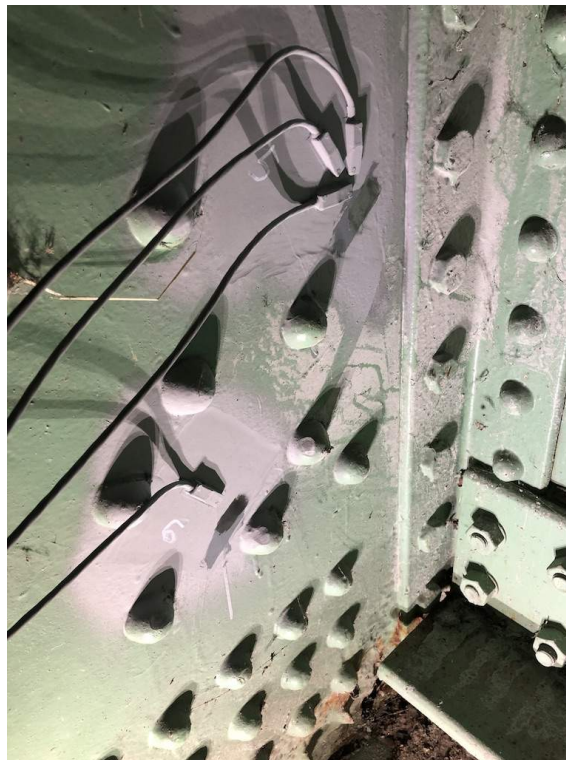
Figure1: Test Locations 5 and 6 at North Trunnion Plate Interior Plate at Strain Gauge Locations (Readings Taken from Inside surface of Plate)

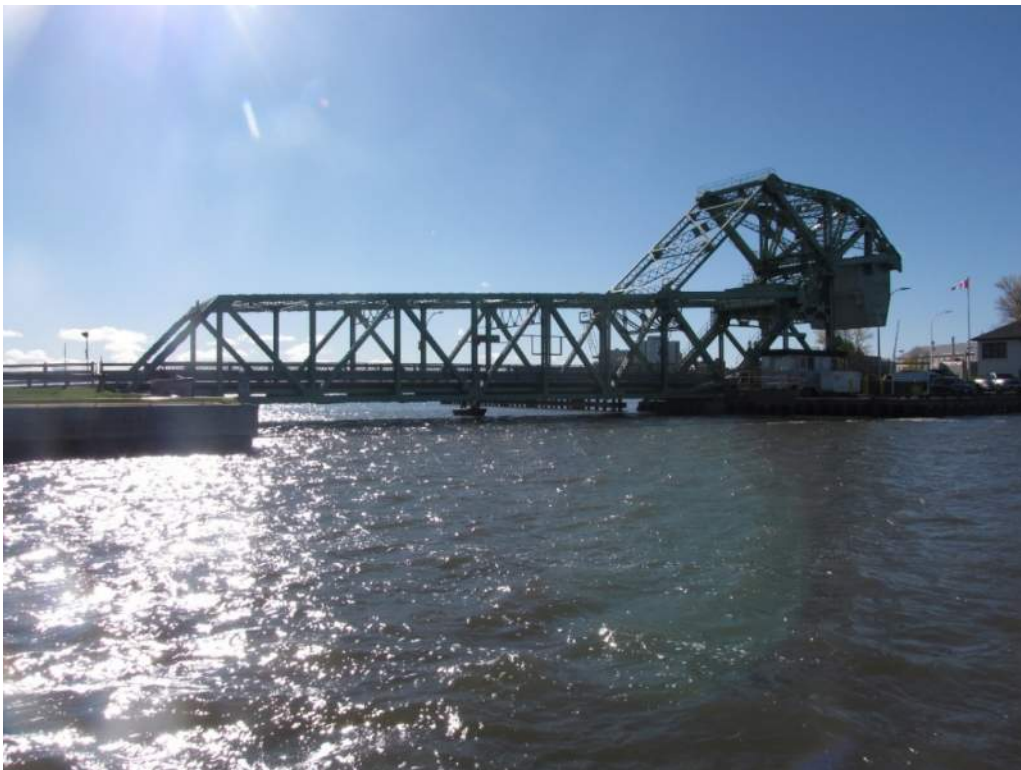
Photo 2: North elevation (2017 photo).

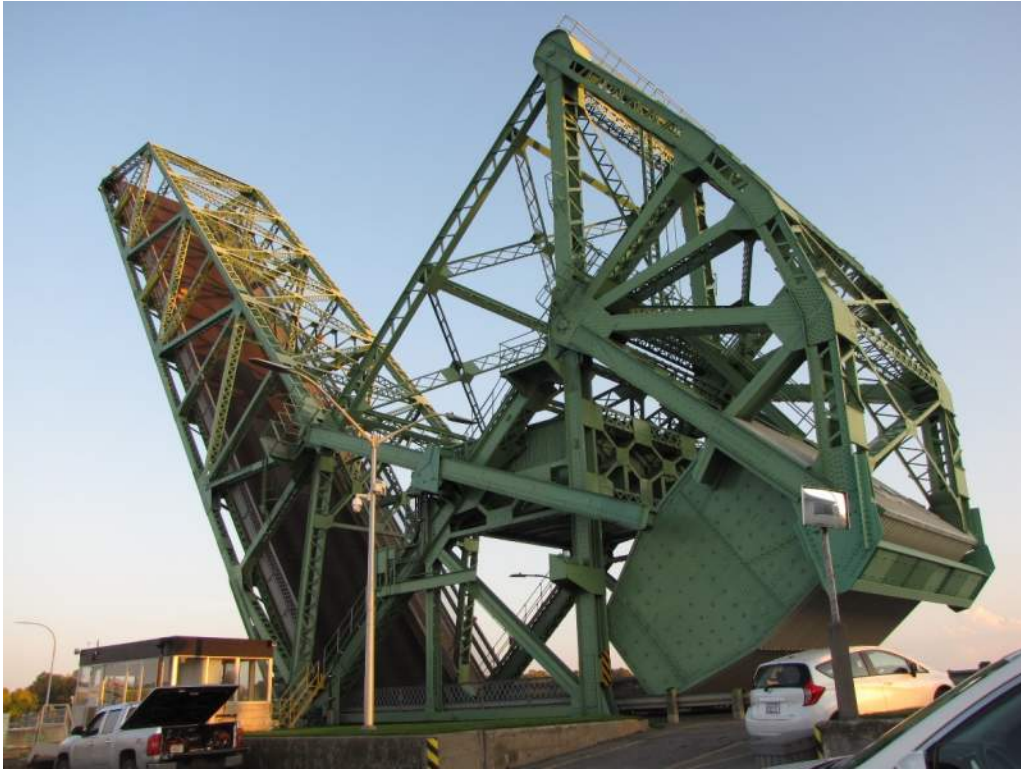
Photo 3: Bridge in open position.

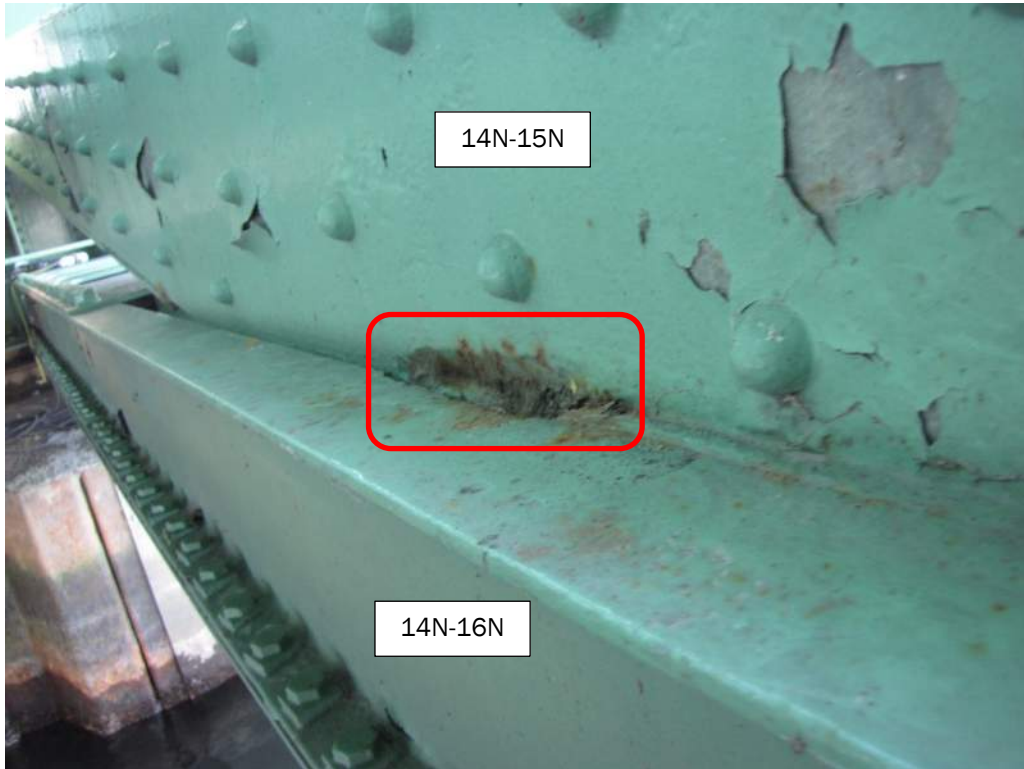
Photo 5: Moderate to severe pitting and minor rust jacking between member 14N-15N and 14N-16N.

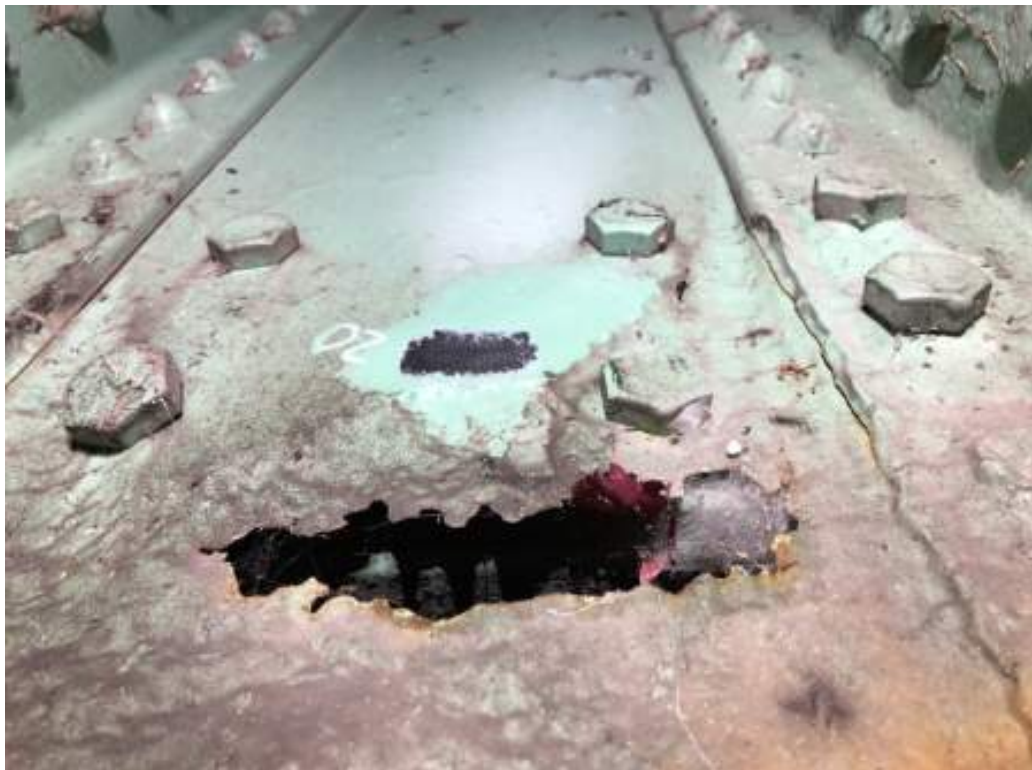
Photo 6: Perforation in batten plate of north trunnion (photo by Brouco NDT).

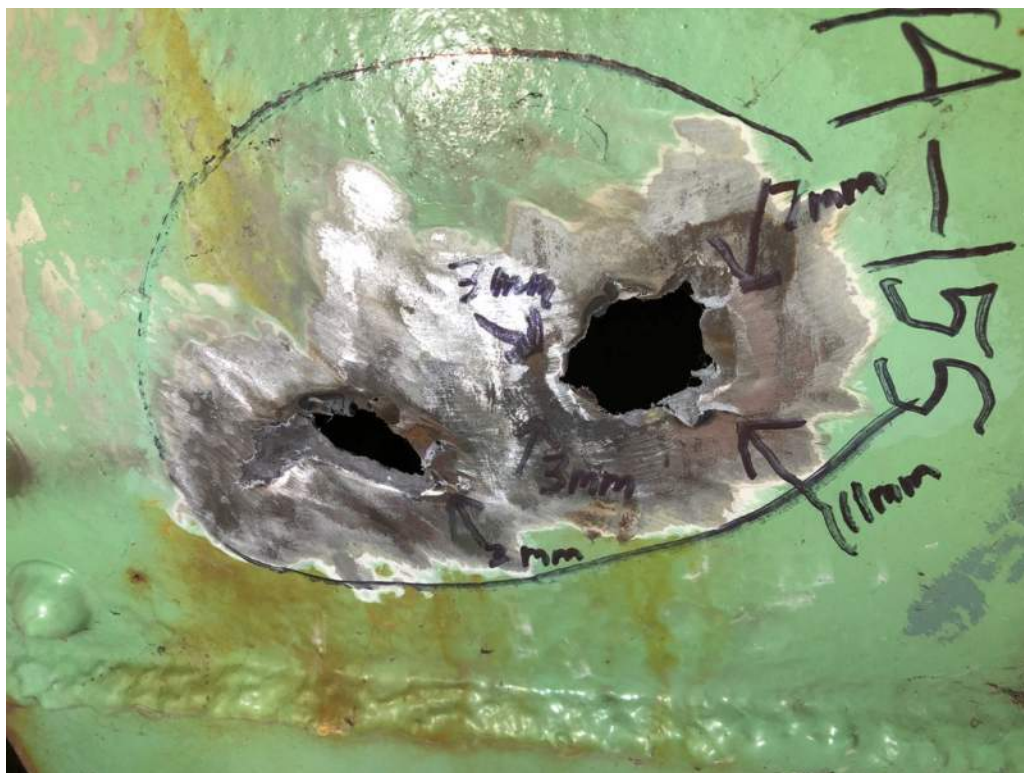
Photo 8: Perforations and cracks in bottom batten plate of bottom chord member 14S-15S near node 15S. The cracks range in length from 3mm to 11mm (photo by Brouco NDT).

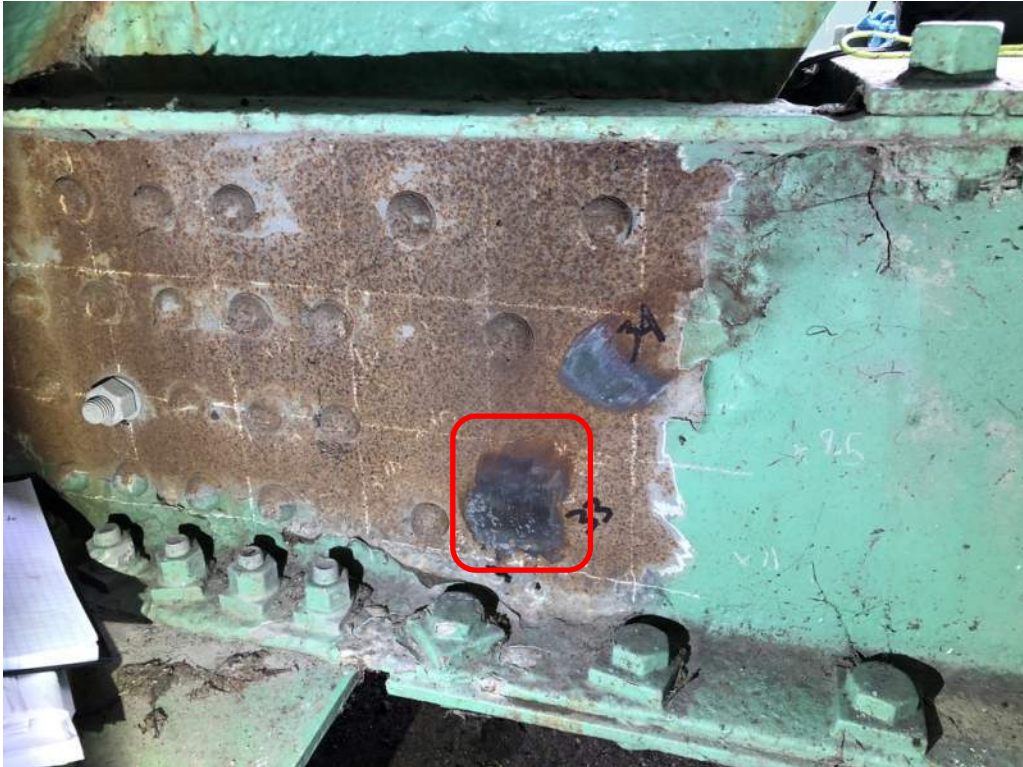
Photo 9: Perforation in the web of bottom chord member 14N-16N near node 16N and generalized light corrosion (photo by Brouco NDT).

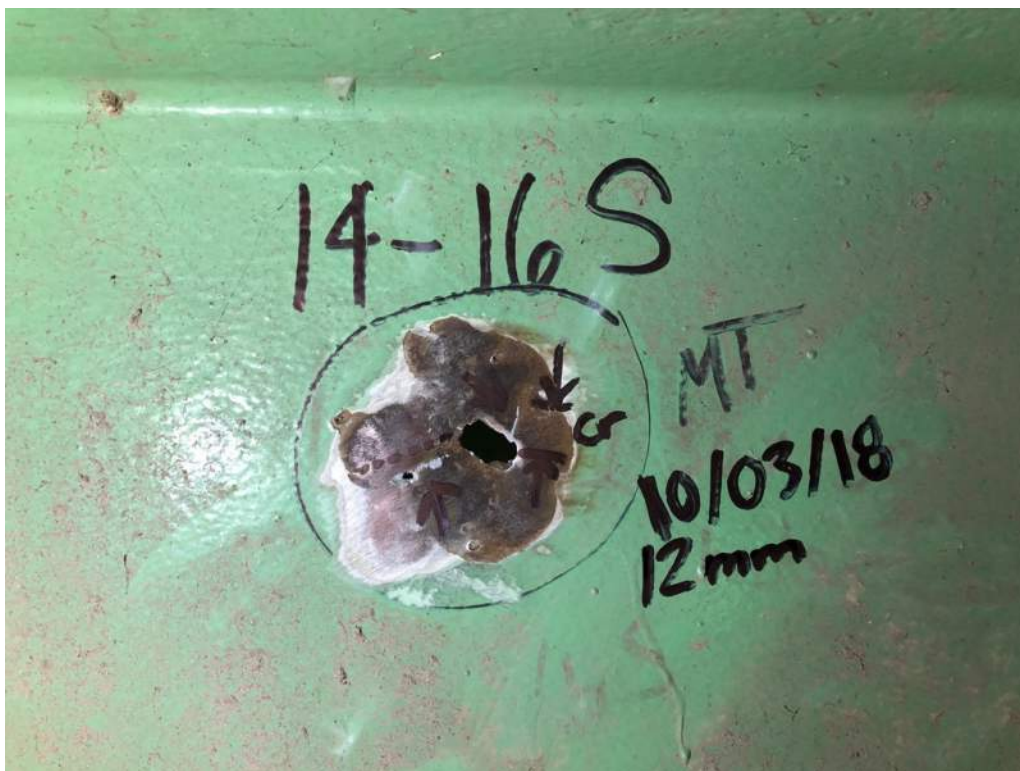
Photo 10: Perforation and 12mm long crack in interior channel of bottom chord member 14S-16S (photo by Brouco NDT).

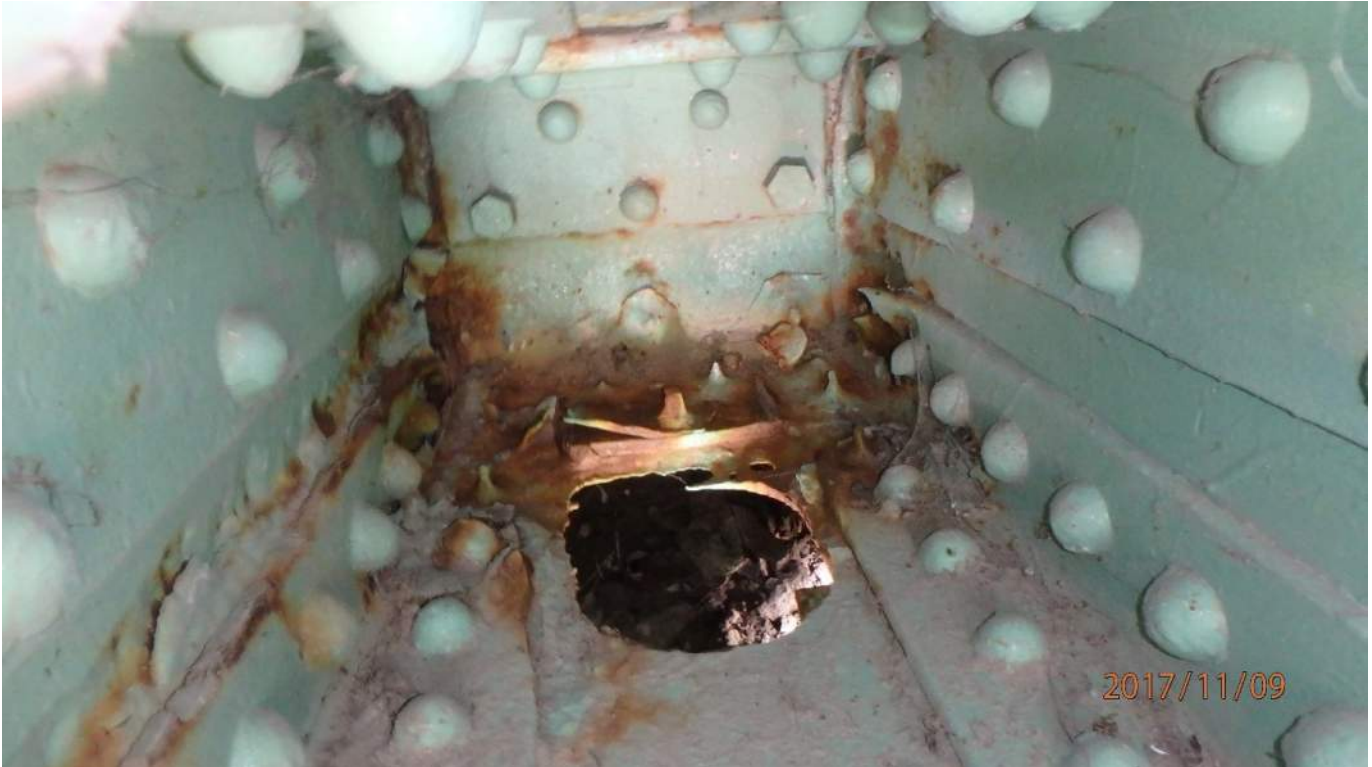
Photo 11: Severe corrosion and section loss of rivet heads at the base of 15N-17N and section loss of the gusset plate at the main trunnion (photo from 2017 inspection).

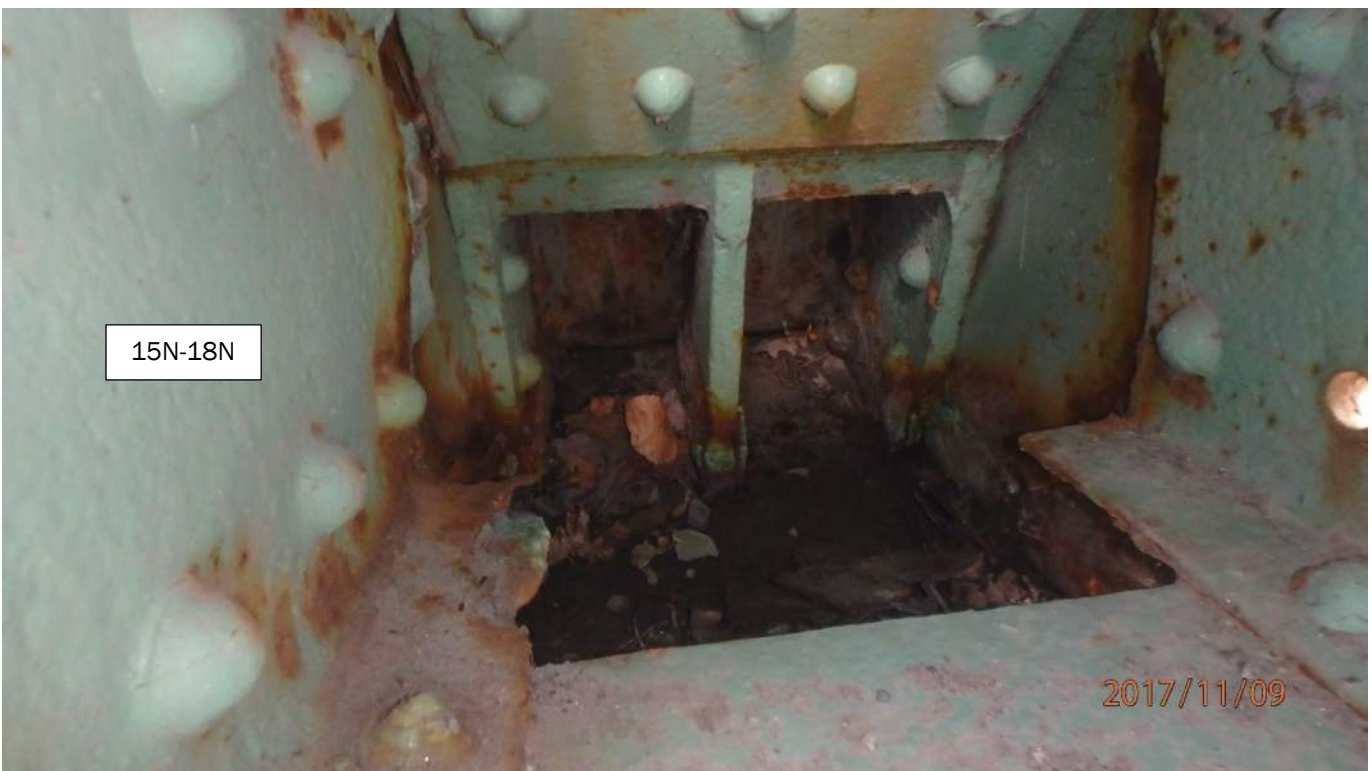
Photo 12: View of the west side of the north trunnion. Note the loss of the bottom flange of the north channel of tower truss member 15N-18N (photo from 2017 inspection).

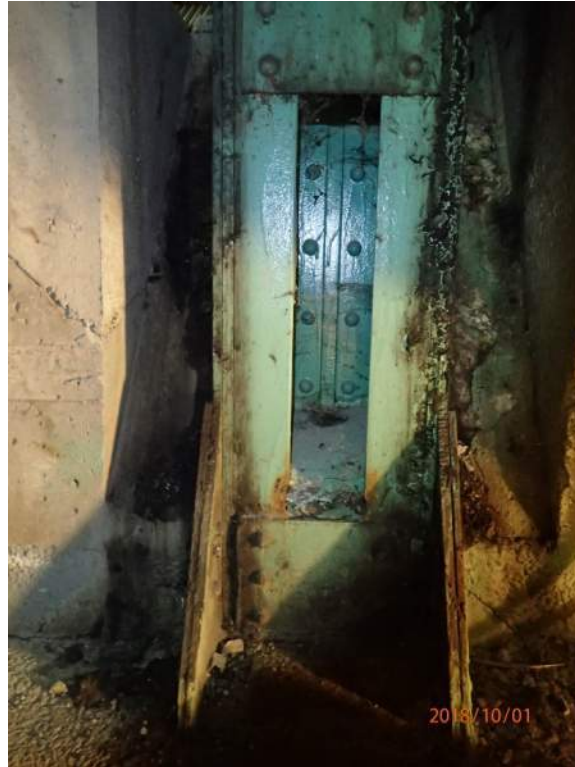
Photo 13: The visible / accessible sections of the post below 15N are in relatively good condition.

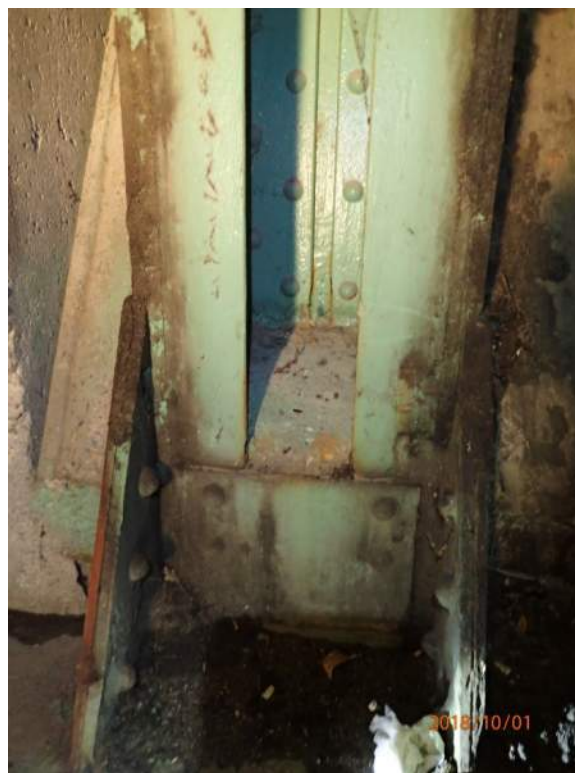
Photo 14: The visible / accessible sections of the post below 15S are in relatively good condition.

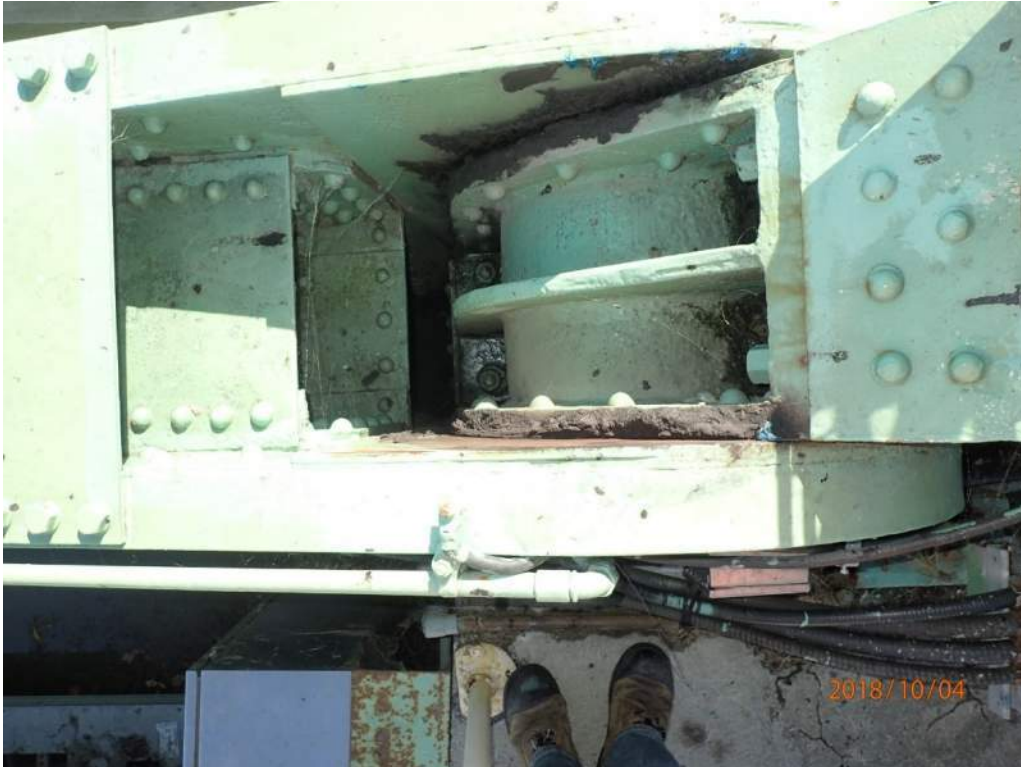
Photo 15: View of the top of the north trunnion (15N).

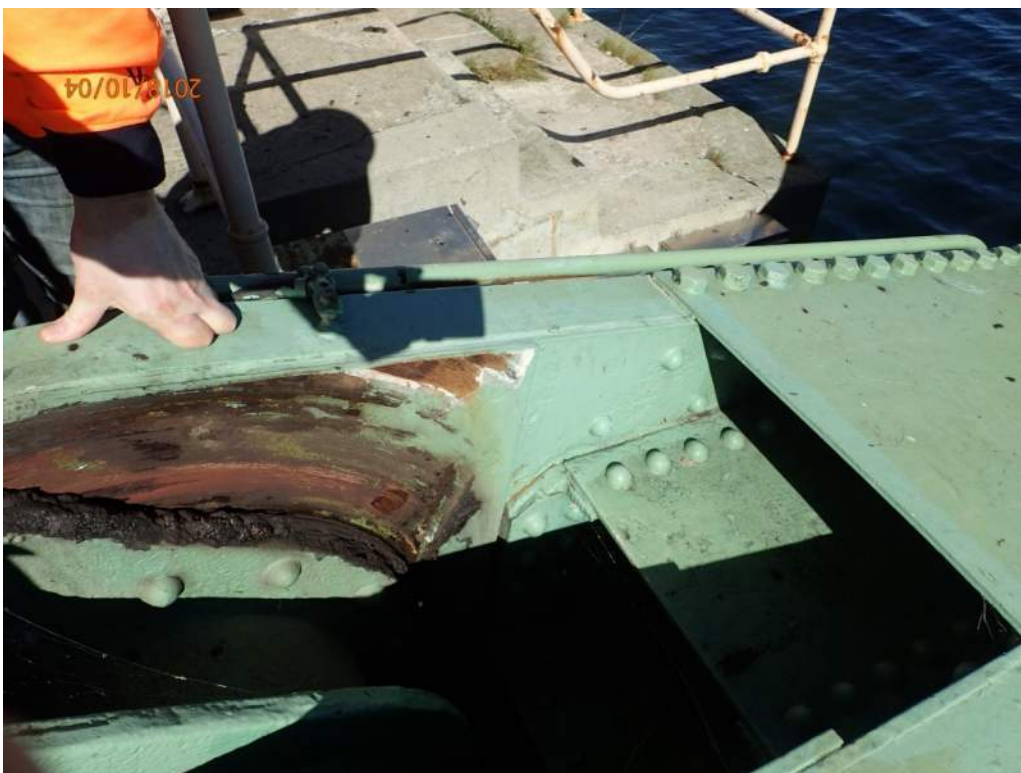
Photo 16: Areas of coating on the interior of the north plate of the north trunnion have been worn away due to contact between the moving structure and the fixed structure.

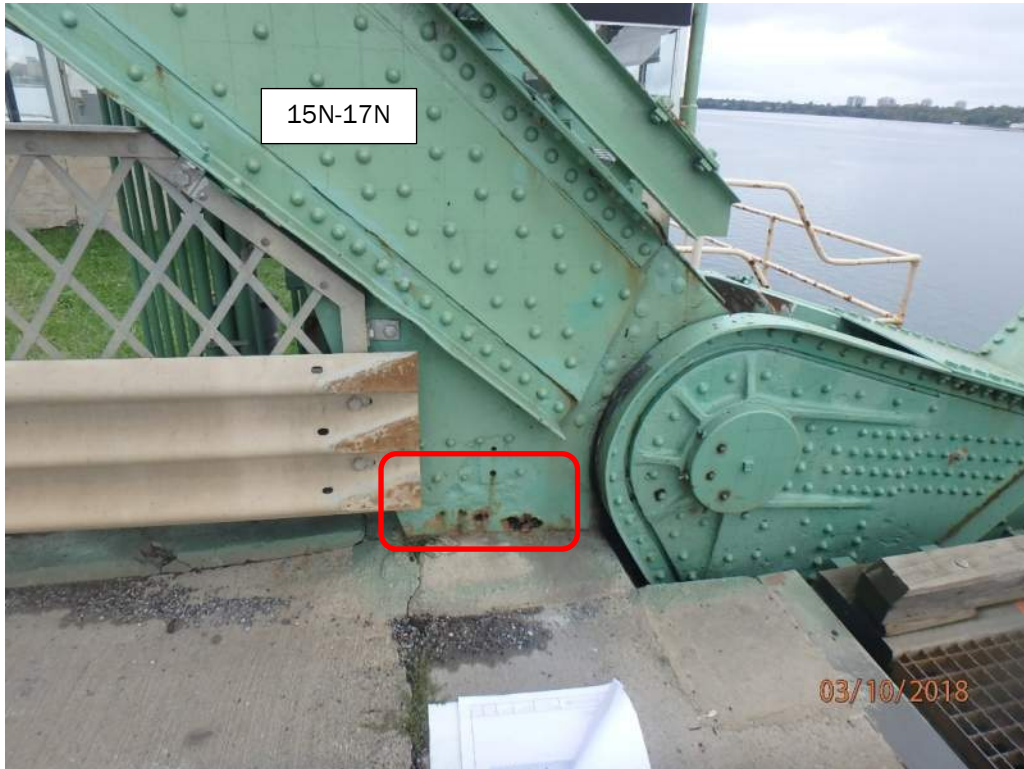
Photo 17: The vertical gusset plate at node 15N at roadway level exhibits very severe section loss and perforations.

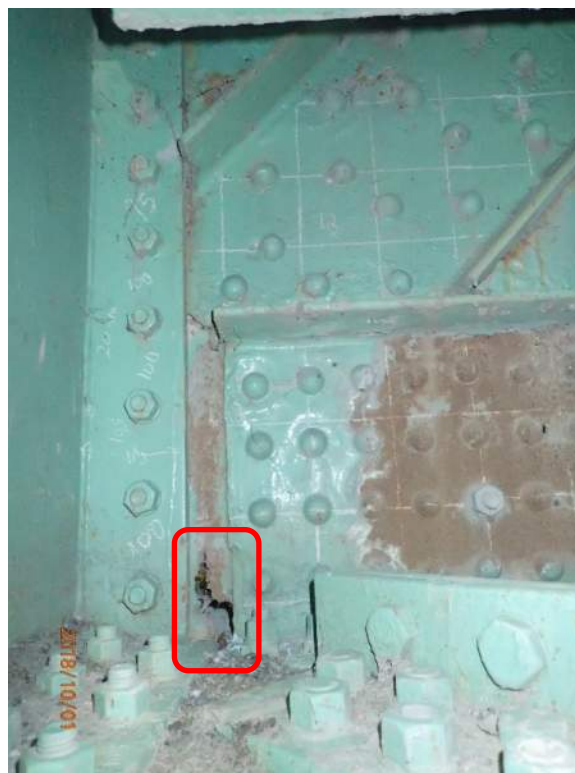
Photo 20: The interior (south) vertical gusset plate at node 16N exhibits severe section loss and a perforation with a crack (viewed from south).

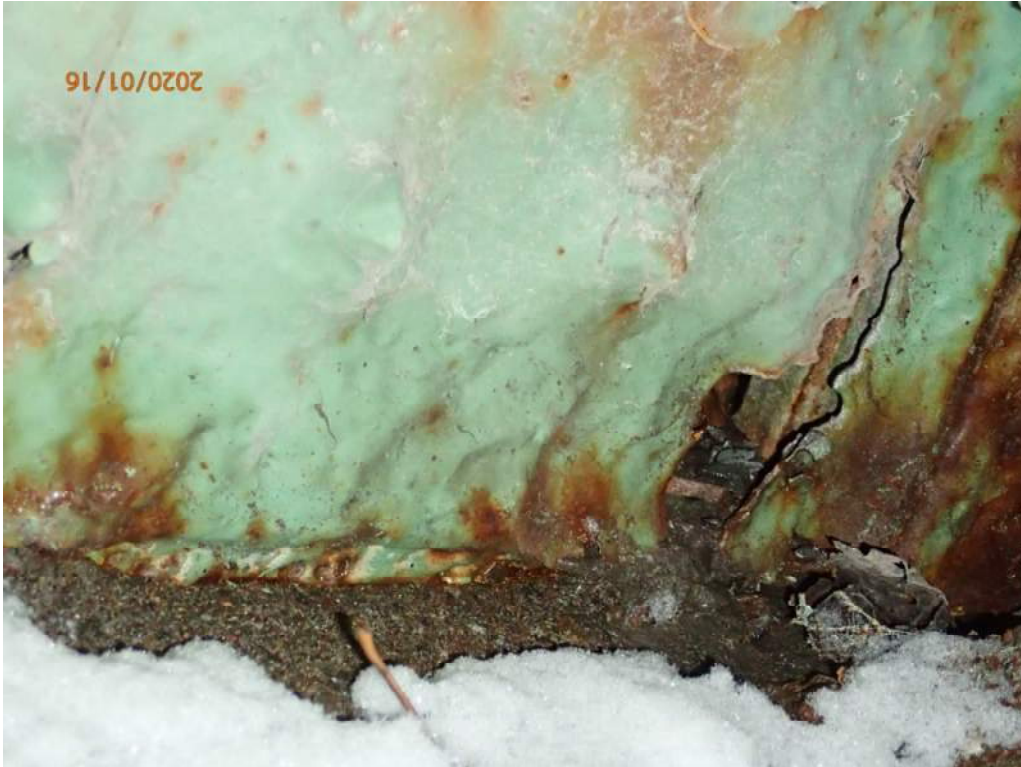
Photo 21: The interior (south) vertical gusset plate at node 16N exhibits severe section loss and a perforation with a crack (viewed from north, 2020 photo).

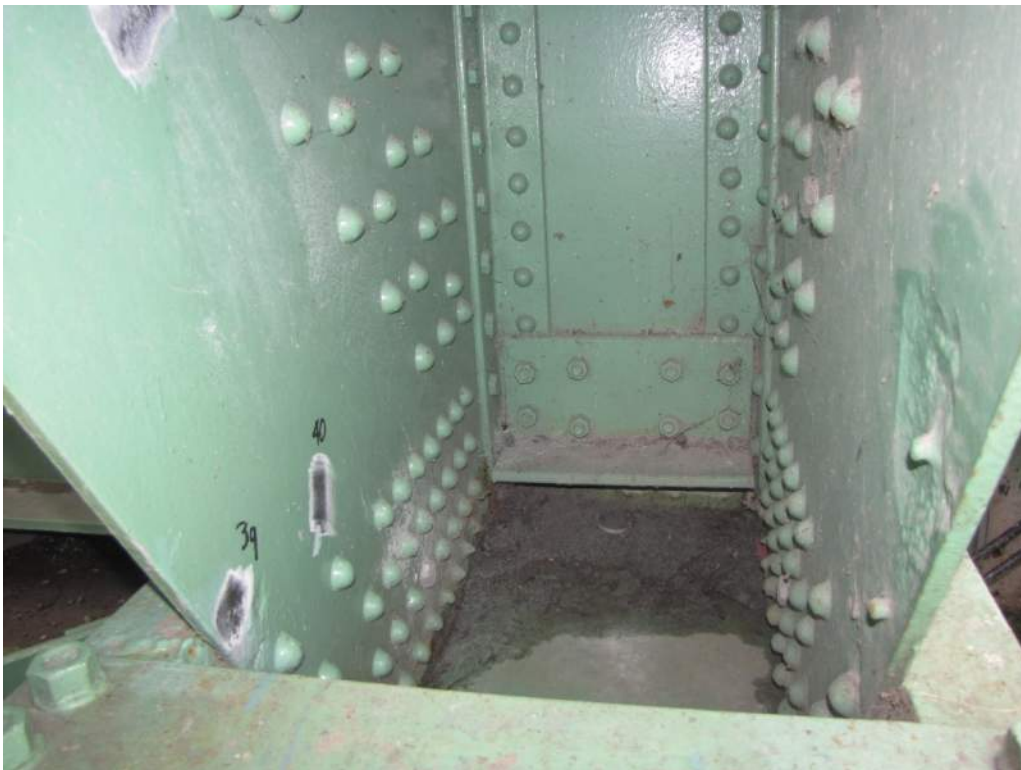
Photo 22: The interior faces of the plates and rivet heads at the base of the north trunnion have localized severe section loss.
