LaSalle Causeway Bascule Bridge

**Main Trunnion Rehabilitation Study –
Detailed Inspection Memorandum (Revision 1)**

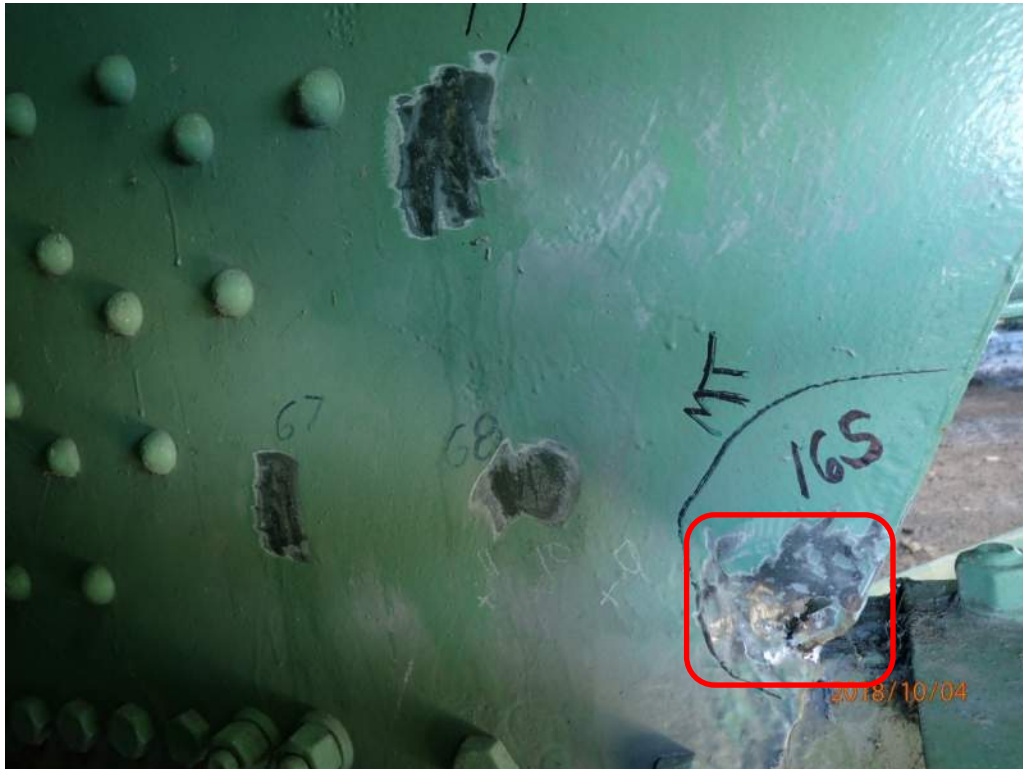
Photo 25: View of the interior of the north plate of the south trunnion below deck level. A crack was found at the perforation circled.

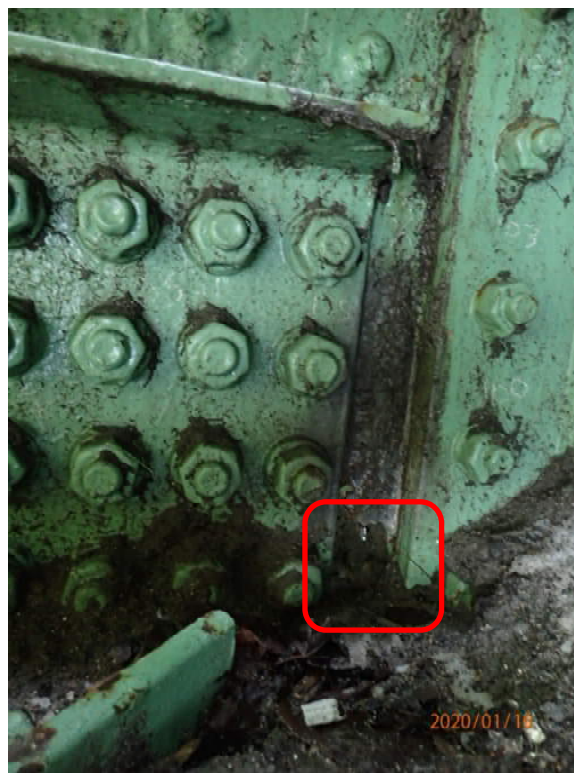
Photo 26: Perforation in the north side of the north gusset plate at the end of 14S-16S (2020 photo).

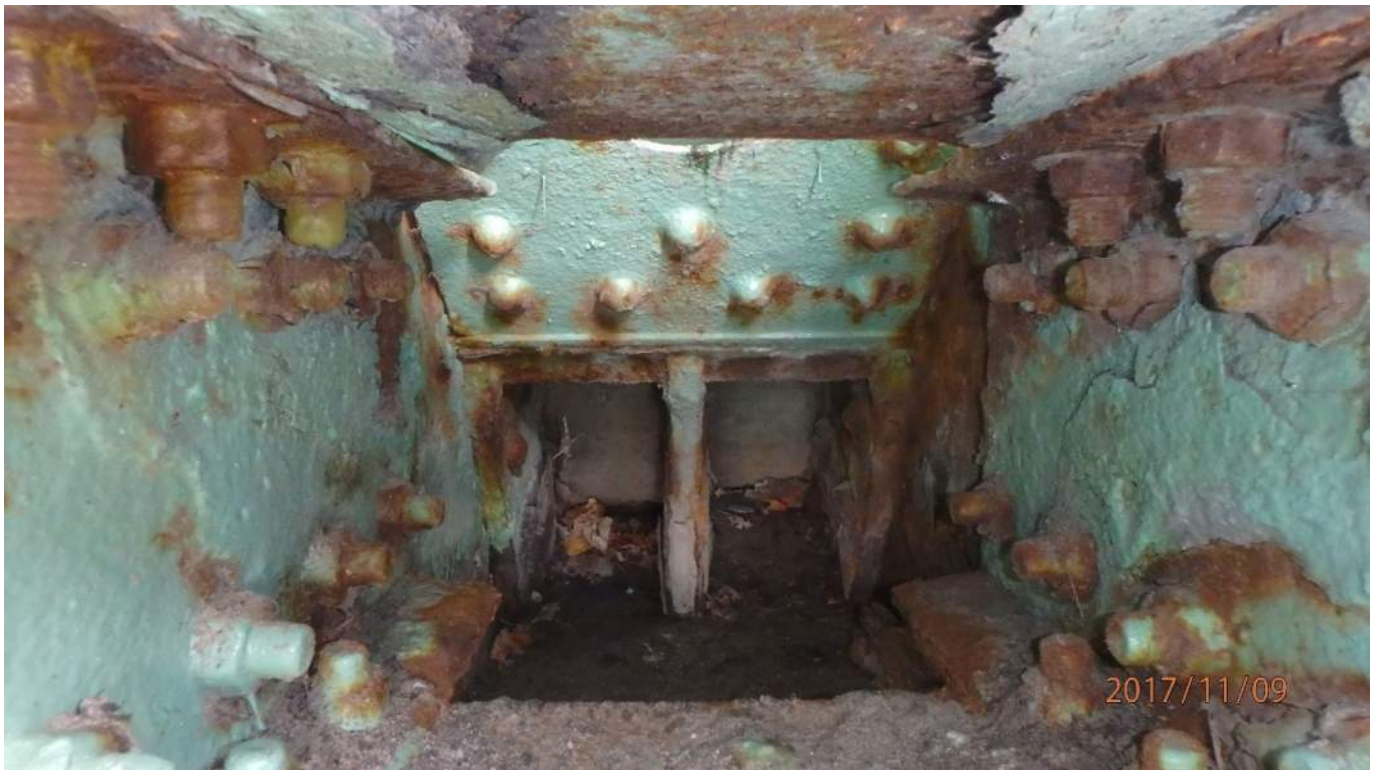
Photo 34: View of the west side of the south trunnion. Note the severe corrosion of member 15S-18S (photo from 2017 inspection).

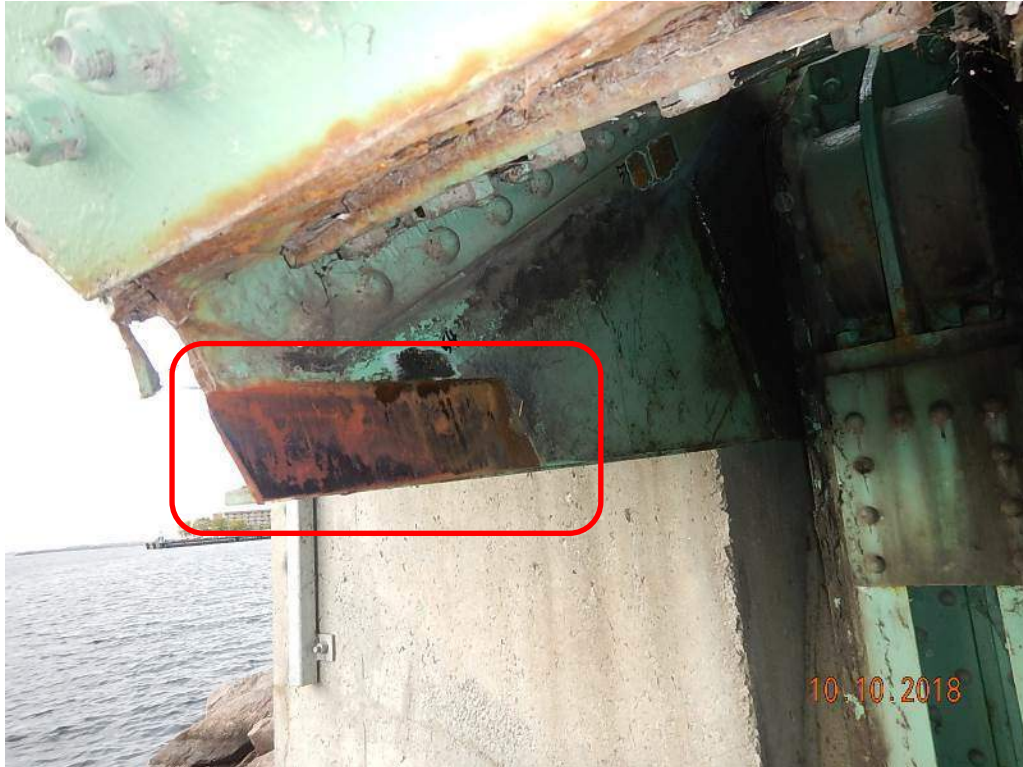
Photo 35: South trunnion. Note the evidence of contact between the span structure and the bearing support (photo by Stafford Bandlow).

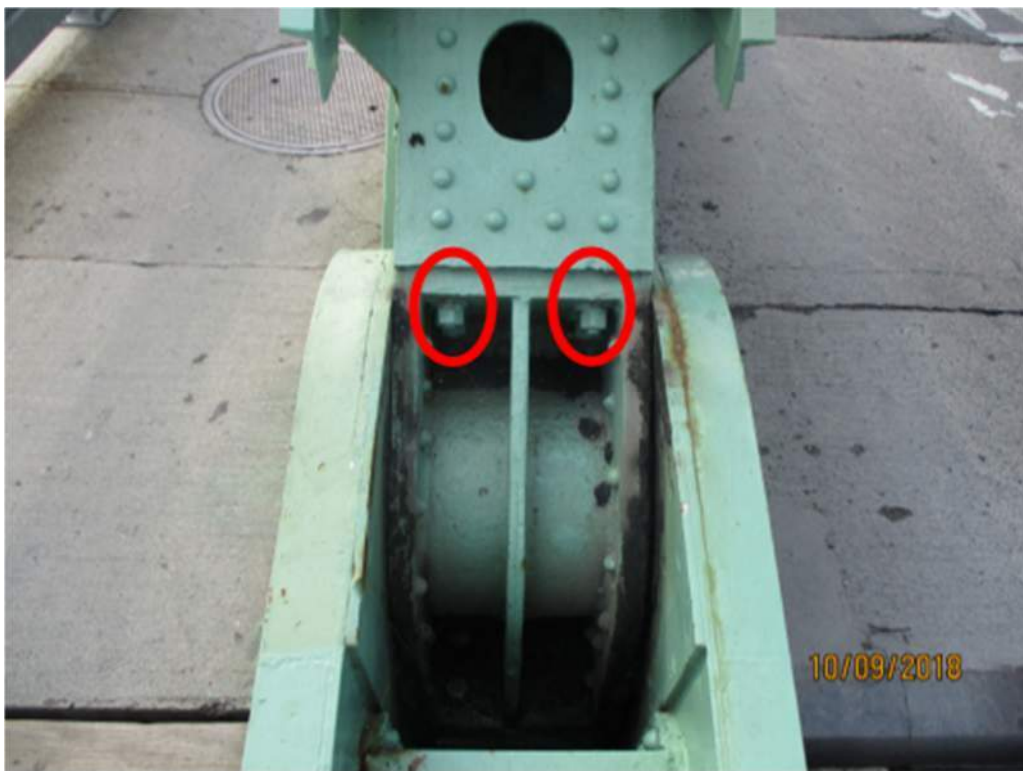
Photo 36: South trunnion. The head end of the four bolts that secure the bearing housing to the structure has 100% section loss due to corrosion. The nut end of these bolts (circled) are pictured (photo by Stafford Bandlow).

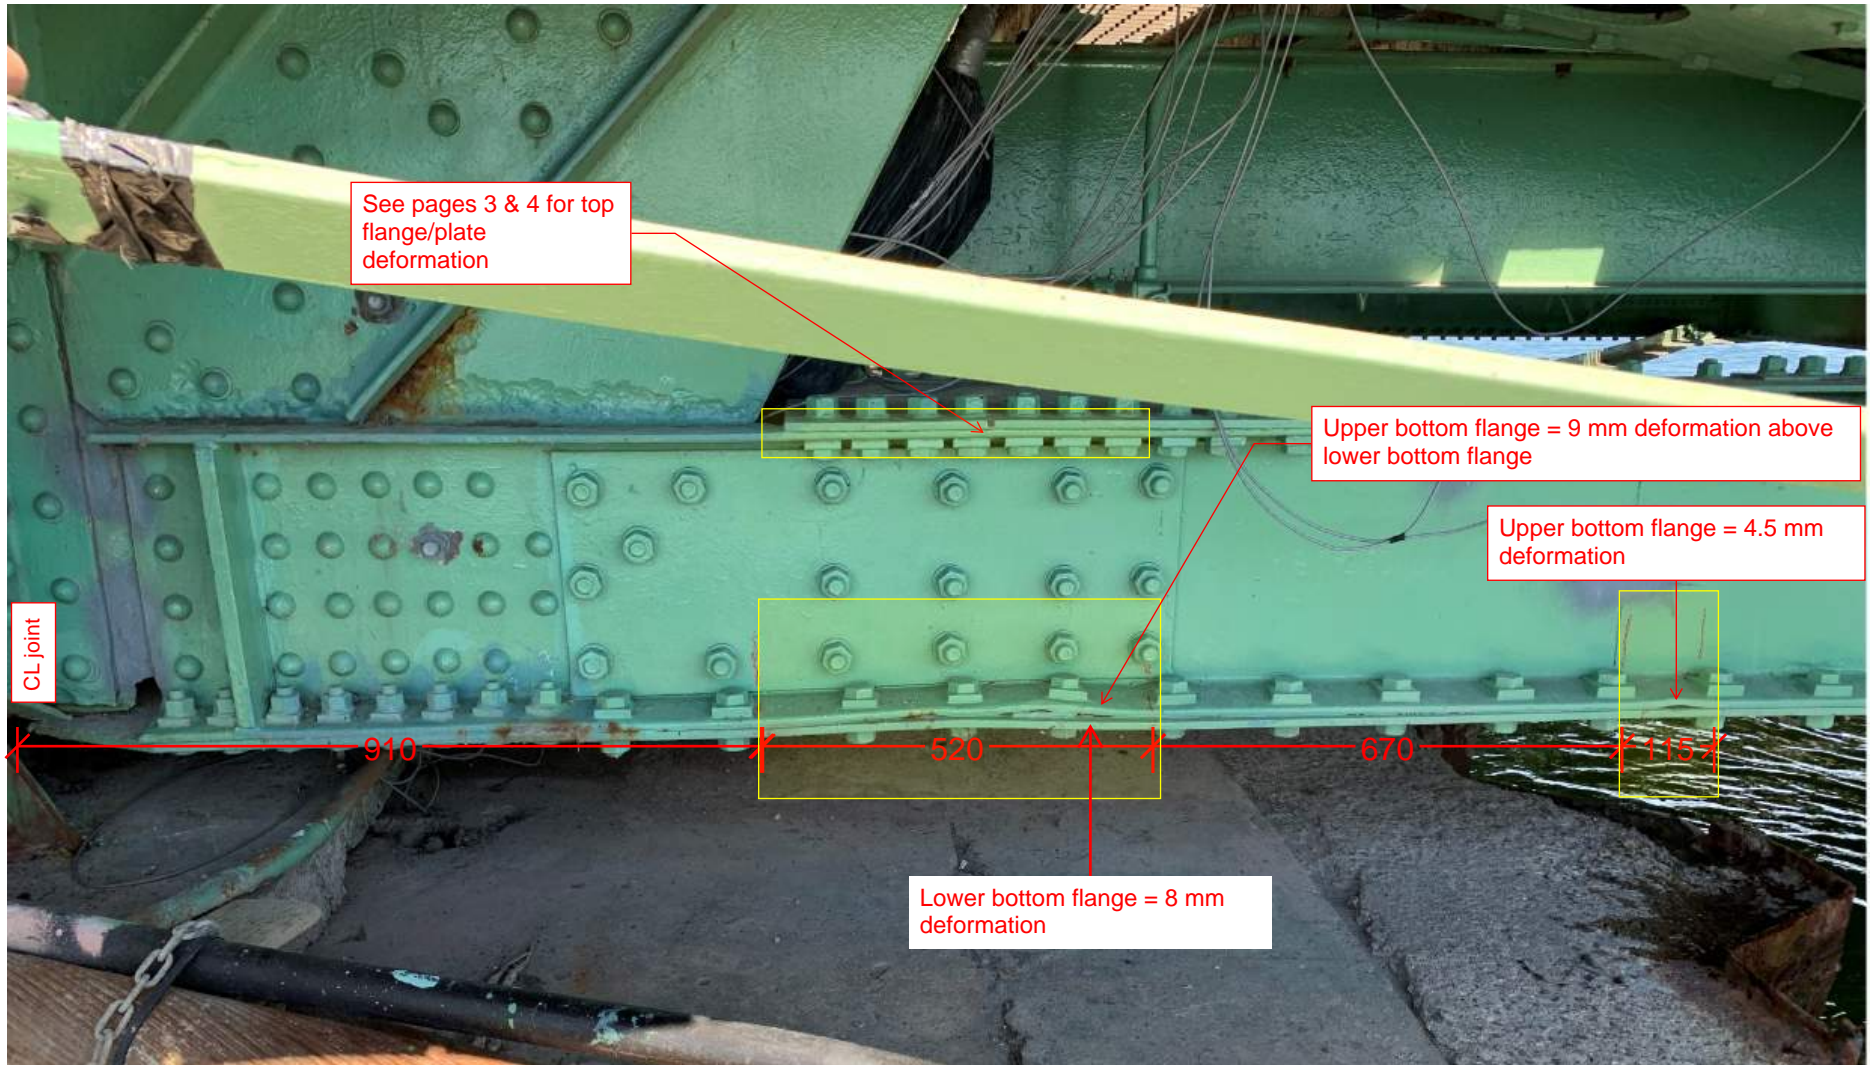
Measurements taken by Dennis Voltchek on May 20, 2020.

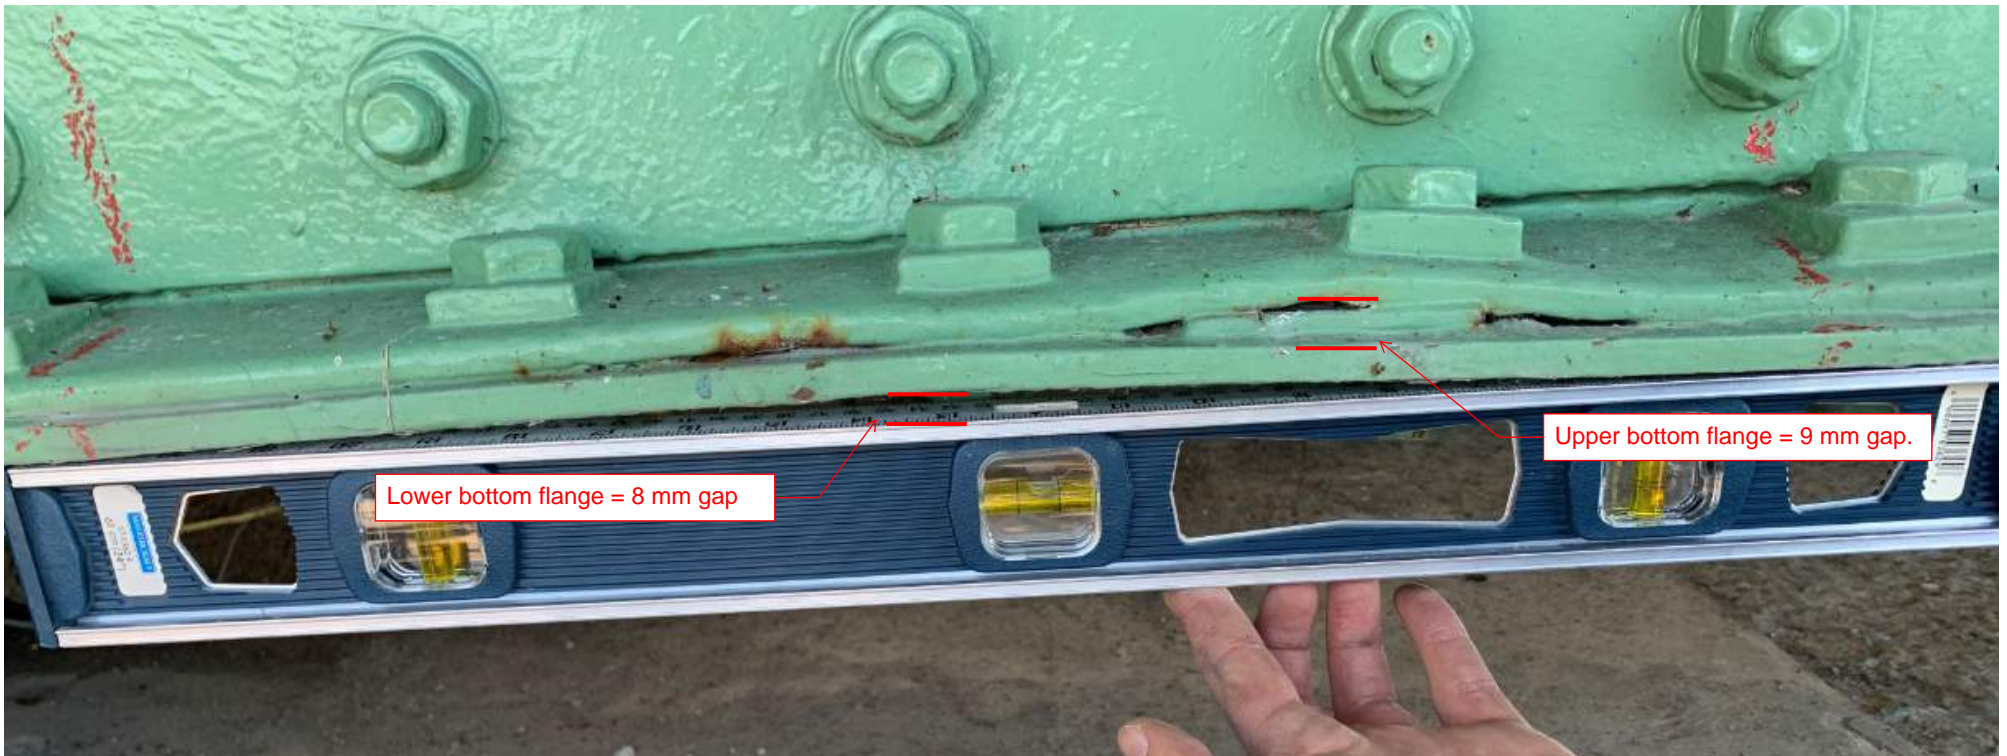
Measurements taken by Dennis Voltchek on May 20, 2020.
