Lasalle Causeway Bascule Bridge

2019 Comprehensive Detailed Inspection Report (Rev. 1)

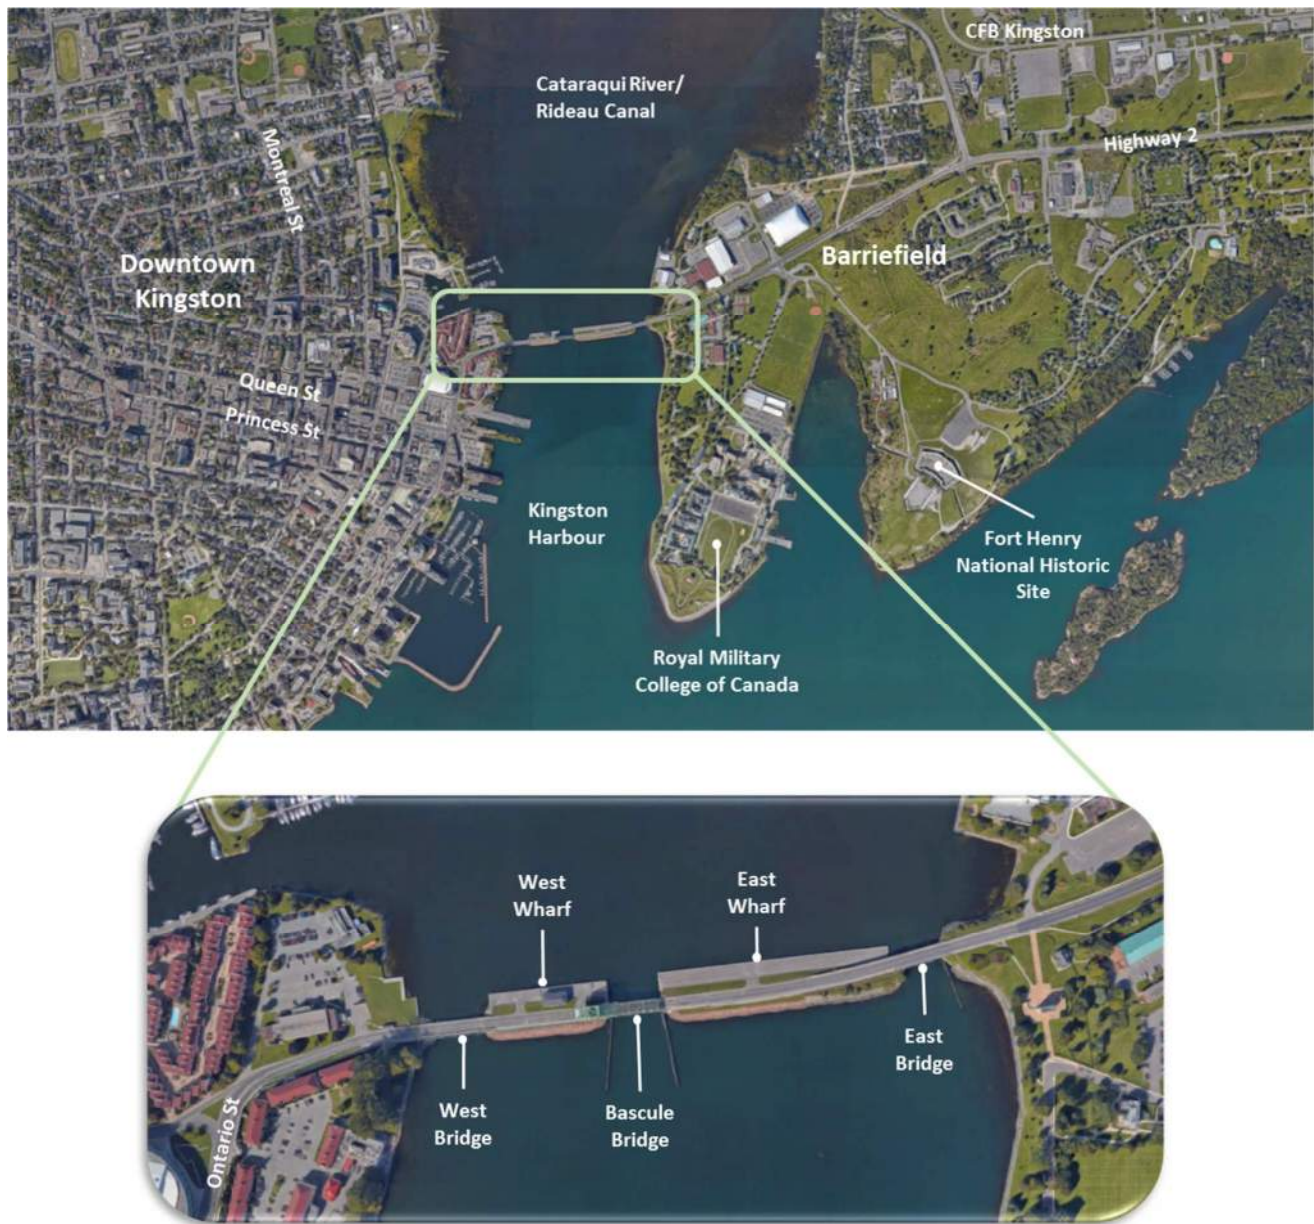
Figure 1: Key Plan (from Google Maps)

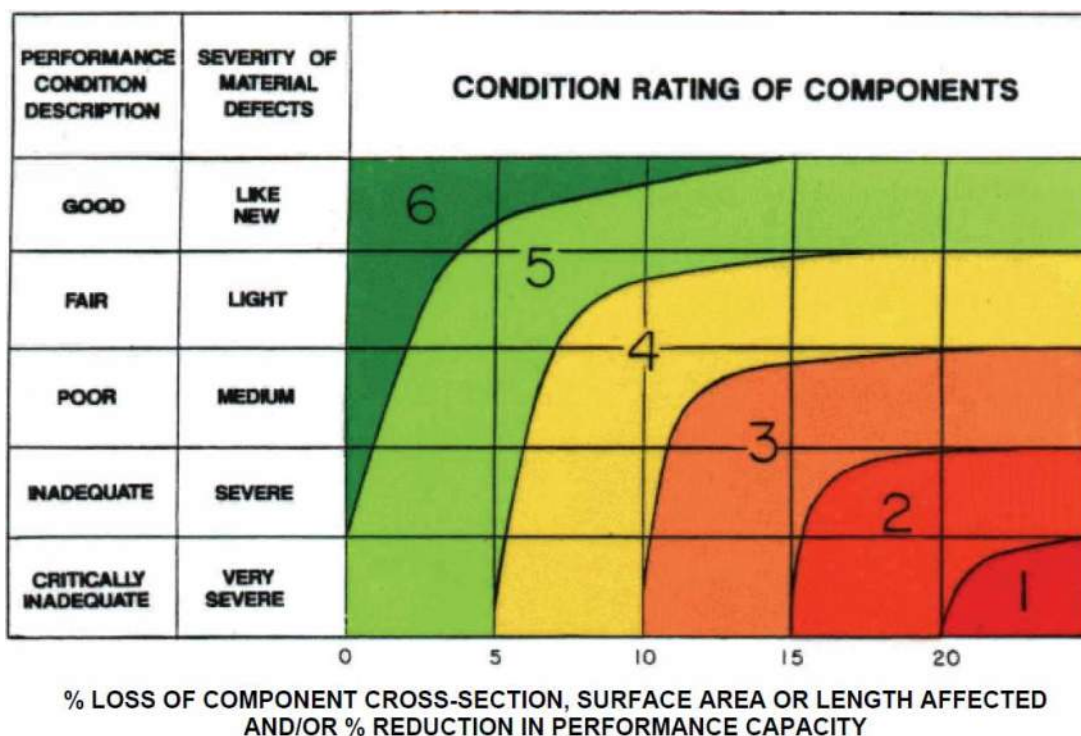
Figure 5: Figure 2.2 of the BIM - Condition Rating of Primary Components

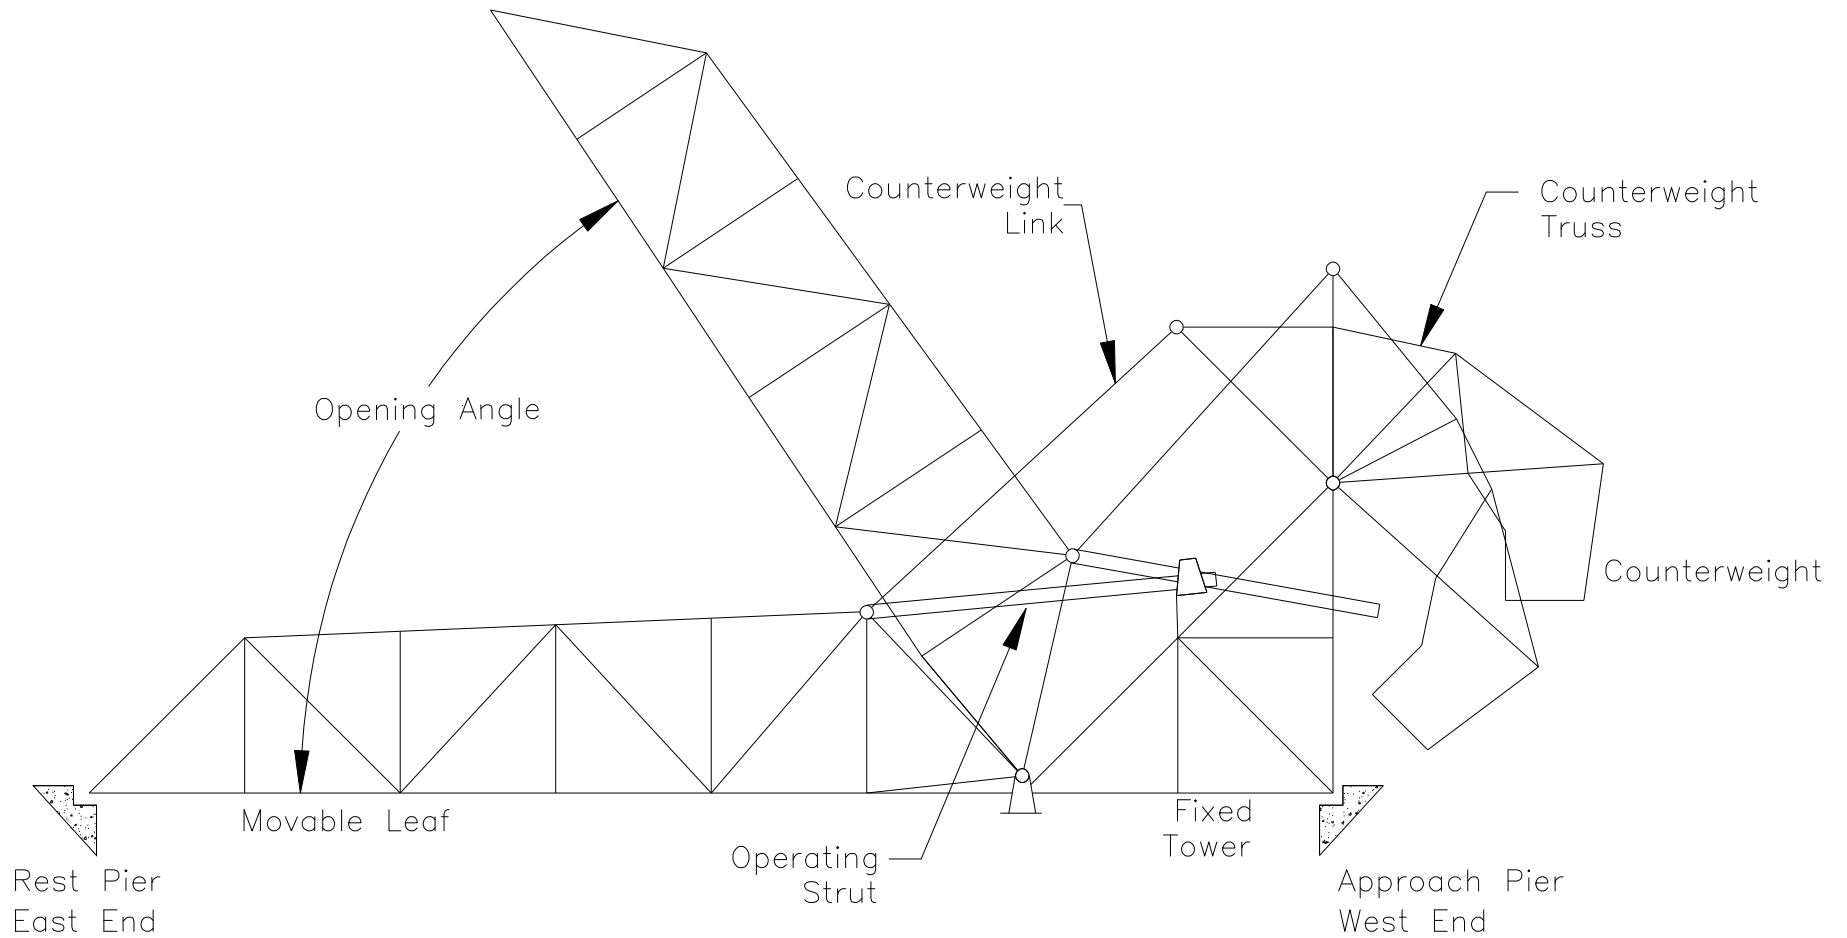
Shown in Closed Position – Solid Lines
 Shown in Open Position – Phantom Lines

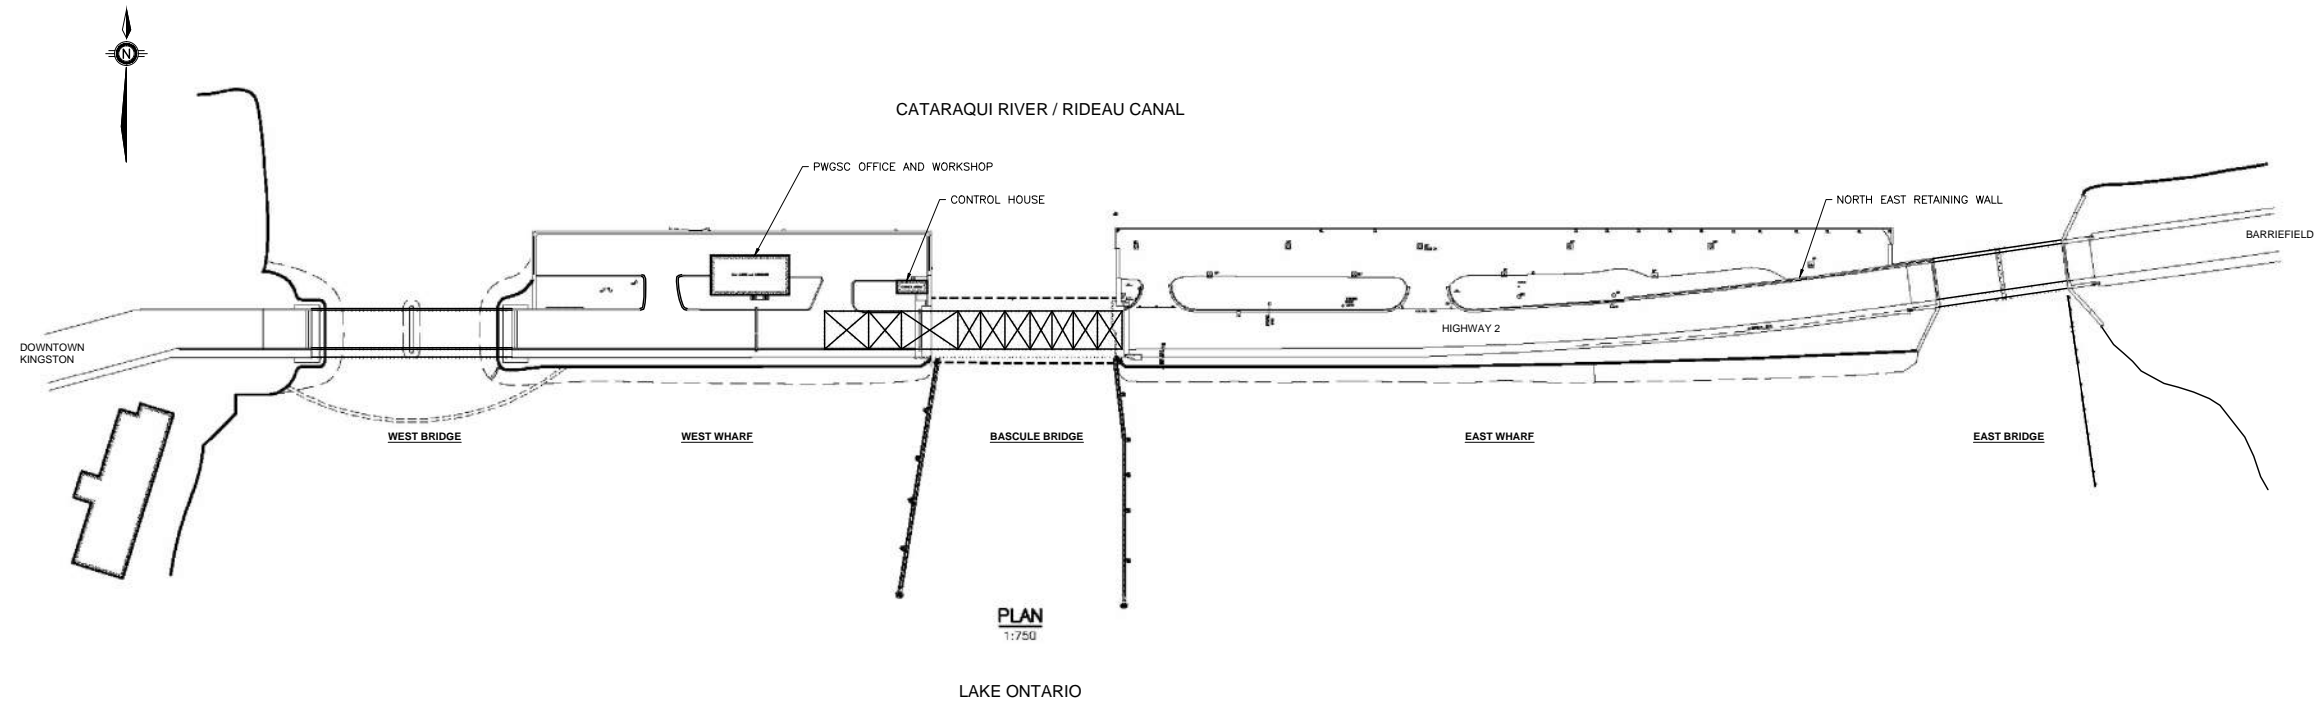
| revision | description | date |

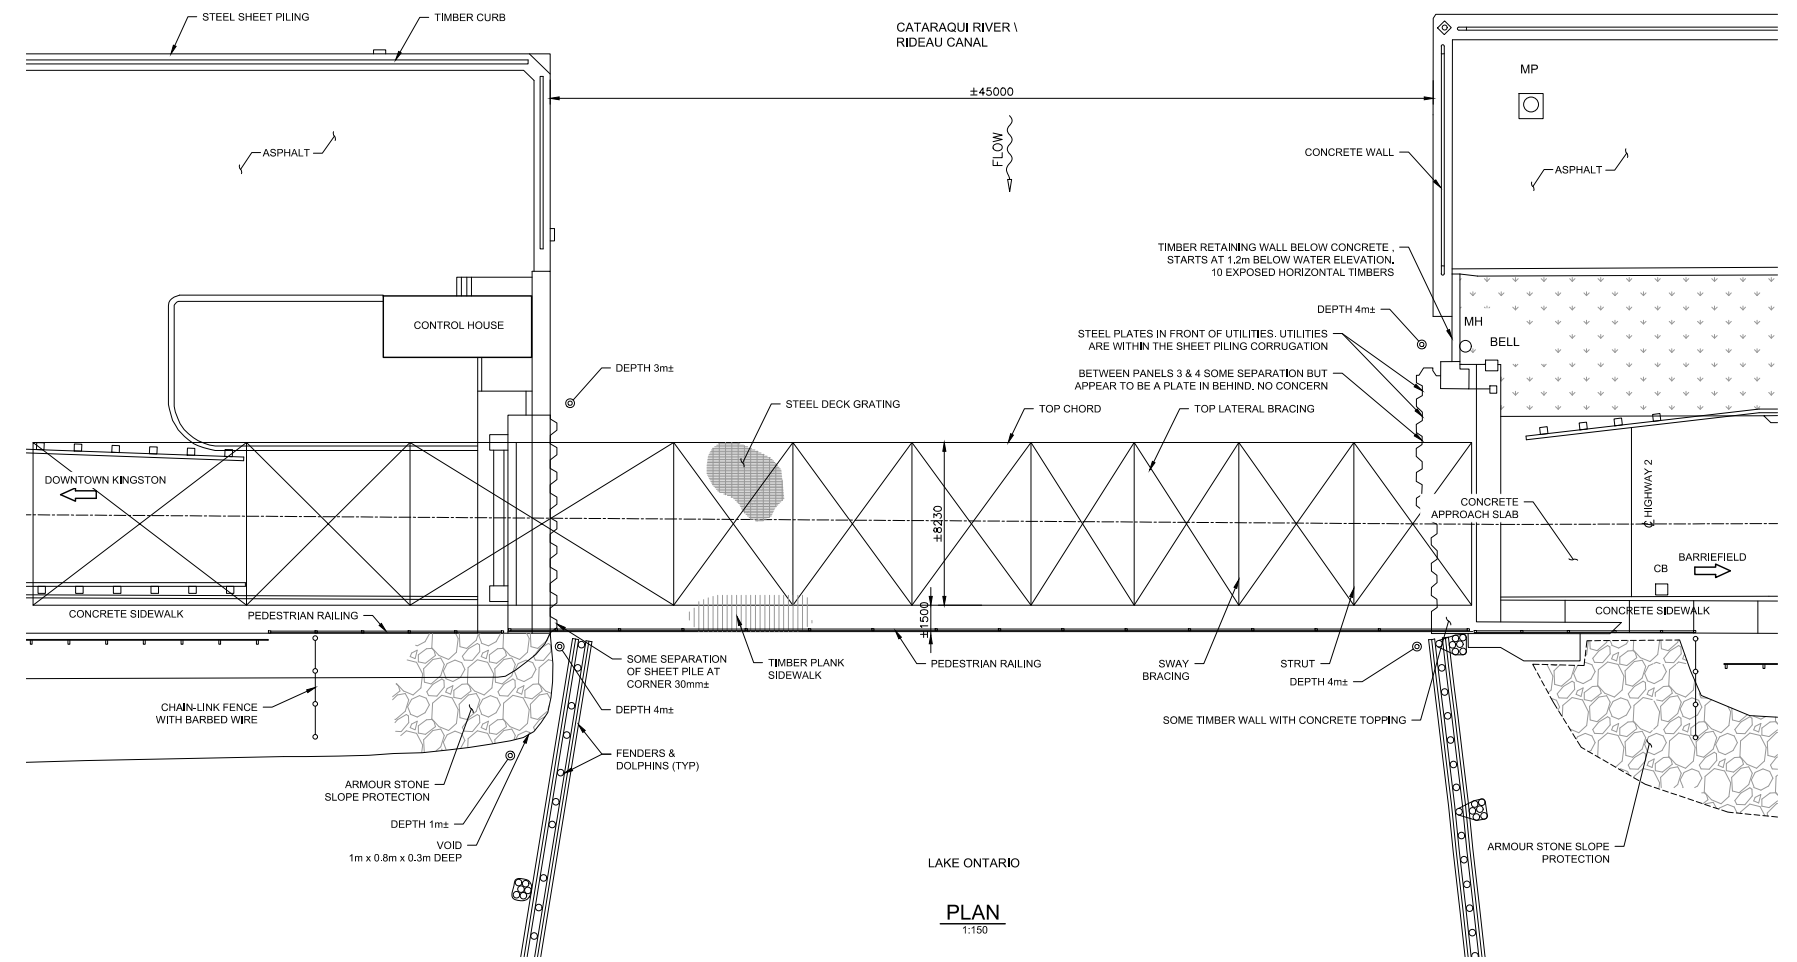
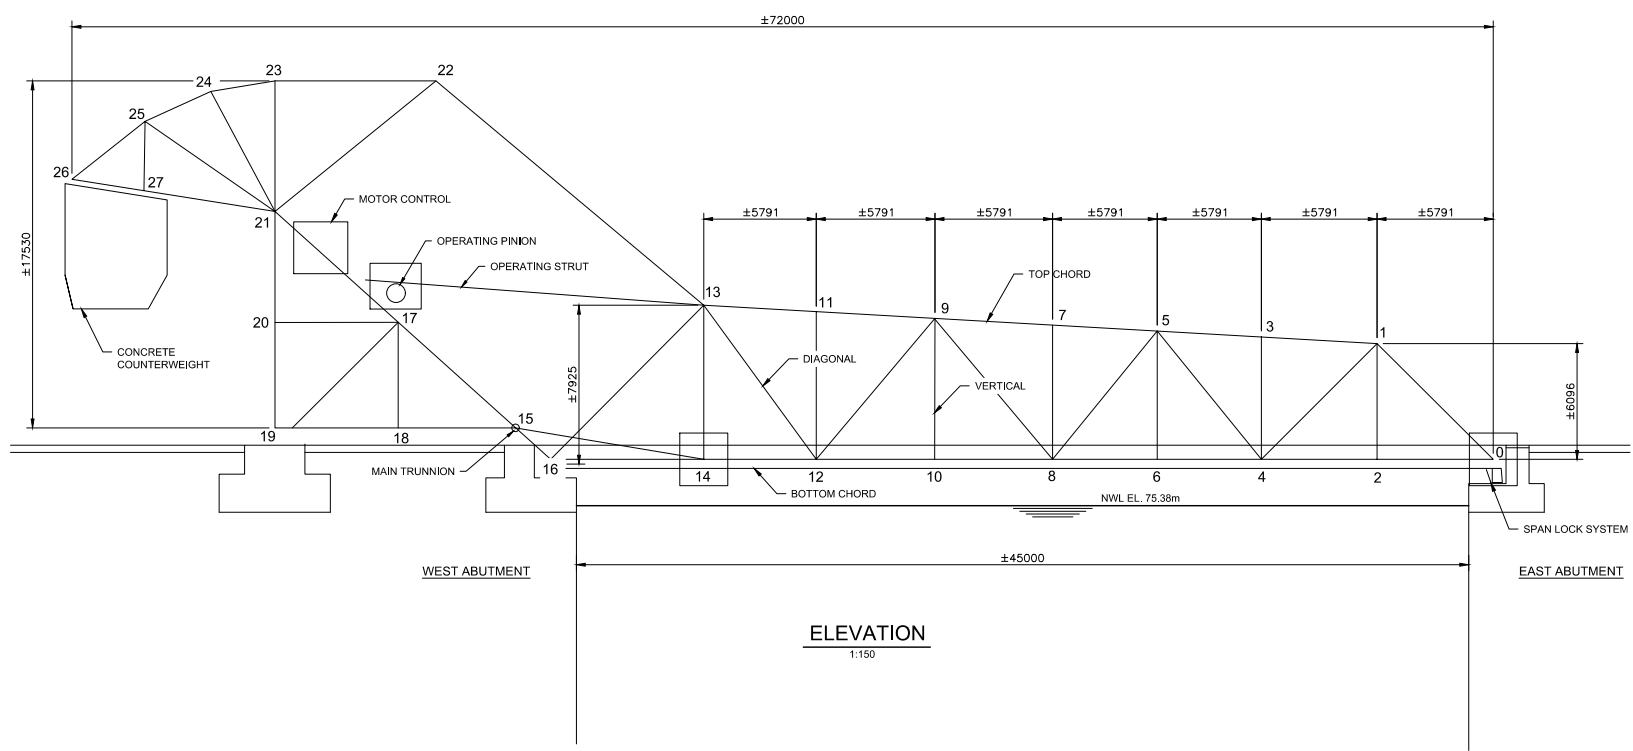
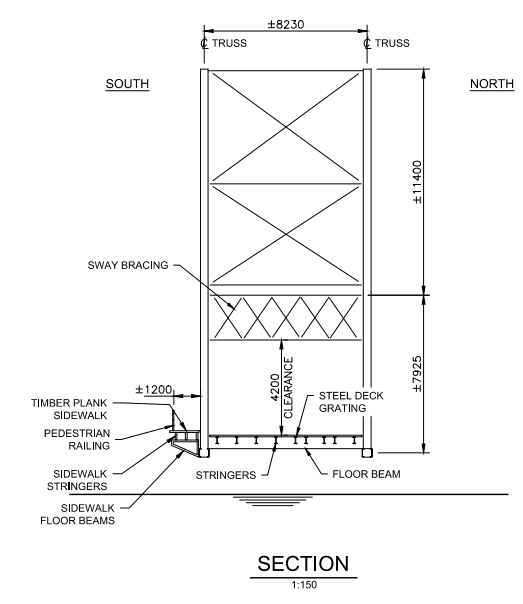
| revision | description | date |

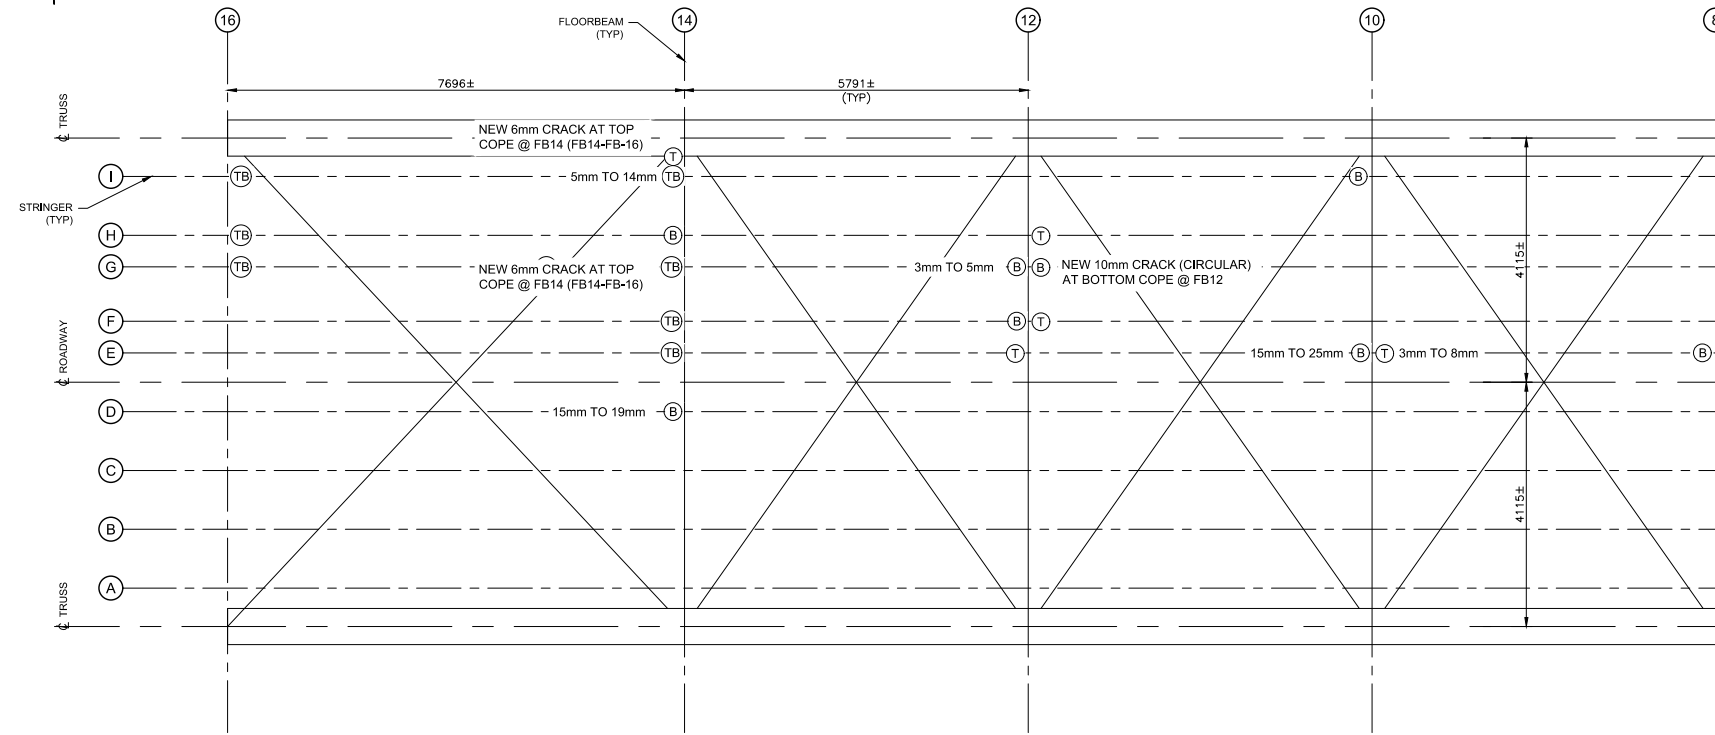
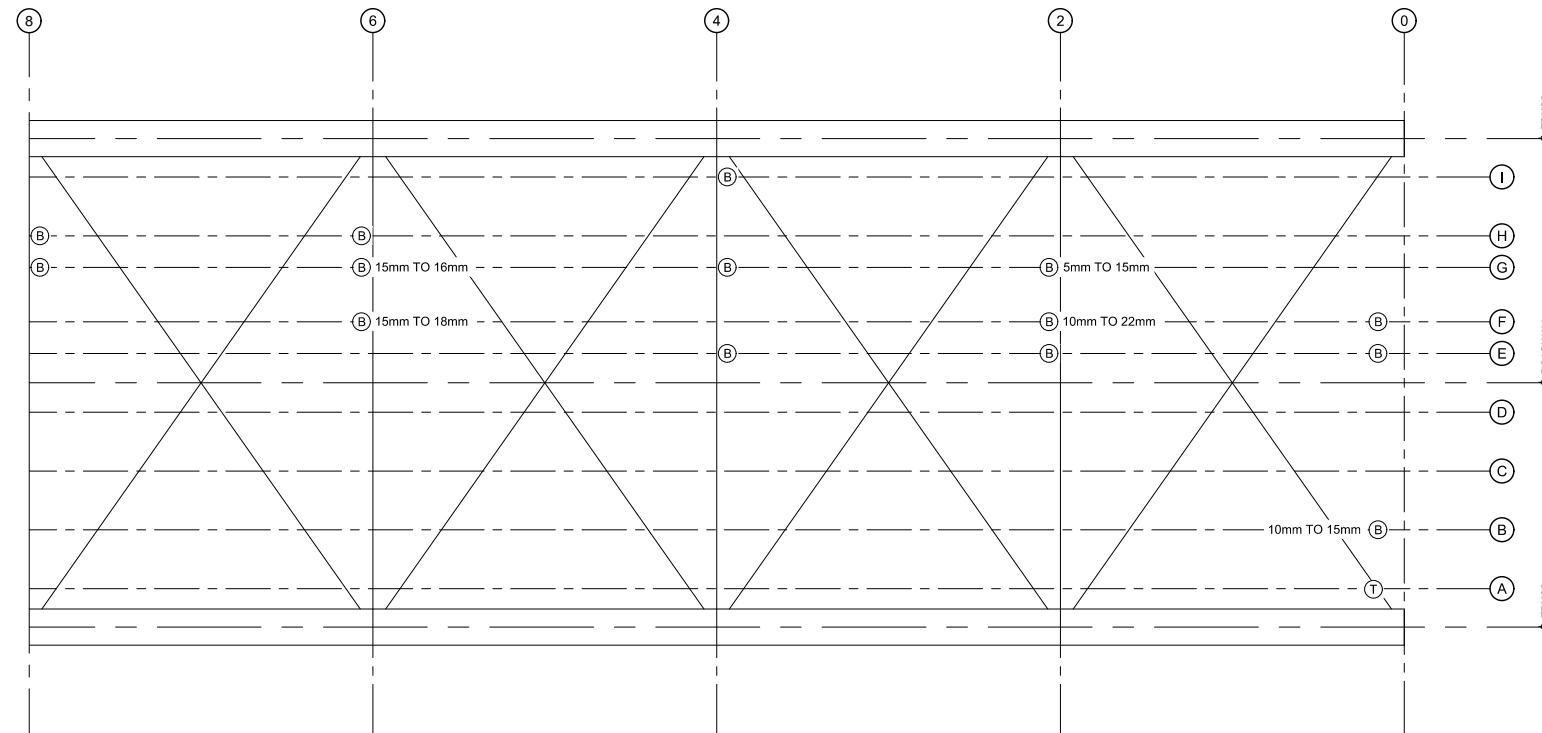
drawing no.
dessiné no. B02

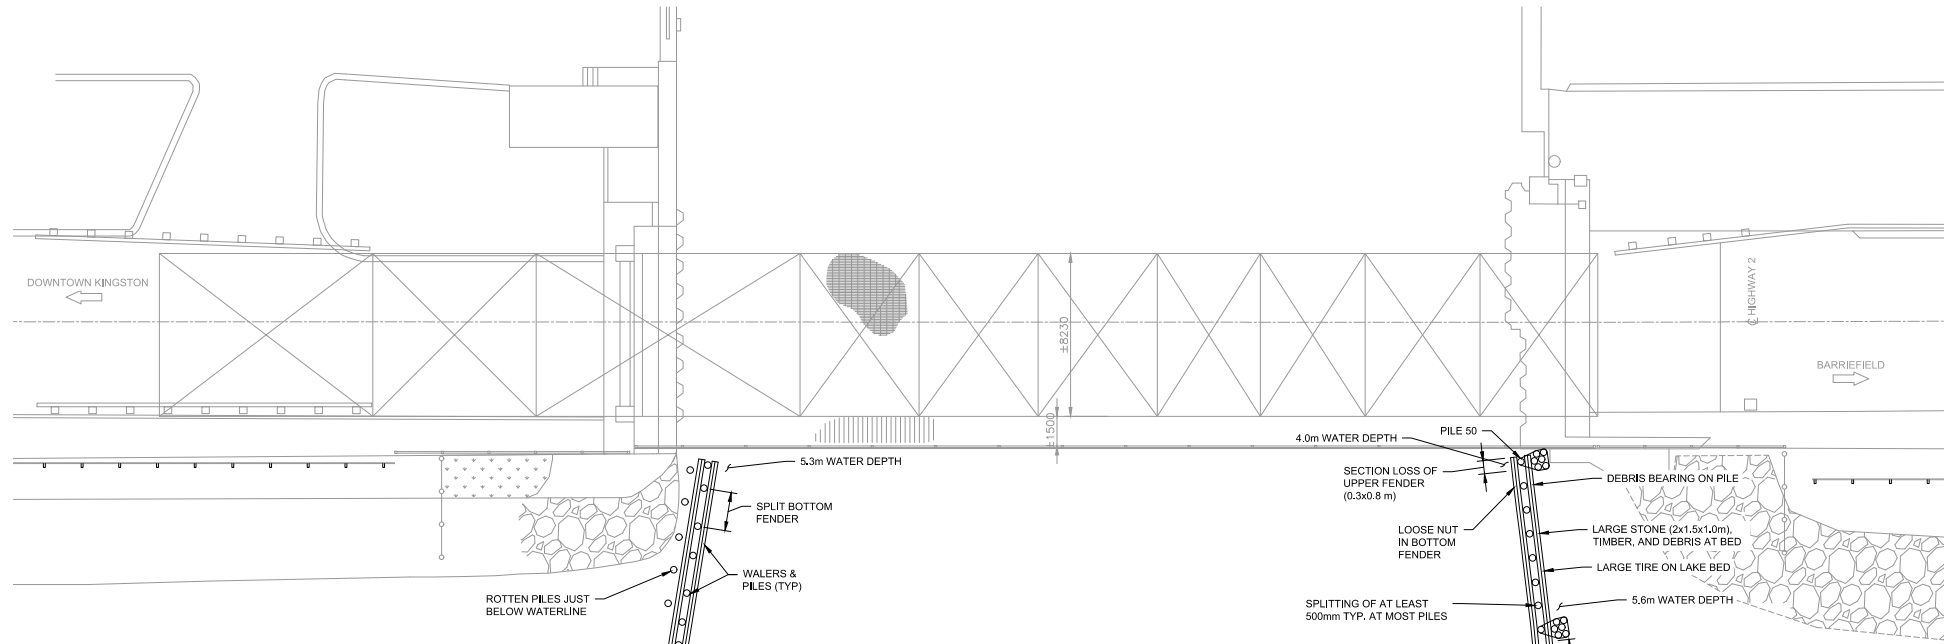
| PILE DETEIORATION - WEST FENDER WALL SYSTEM | | | |

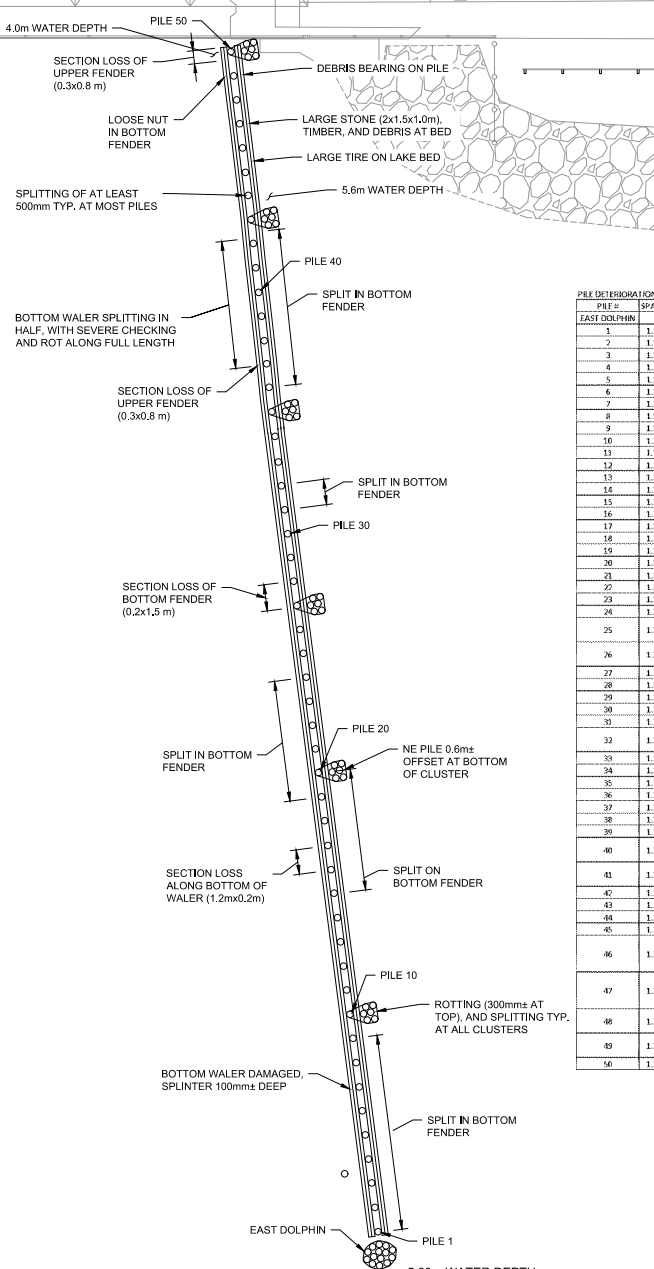
| PILE DETEIORATION - EAST FENDER WALL SYSTEM | | | |

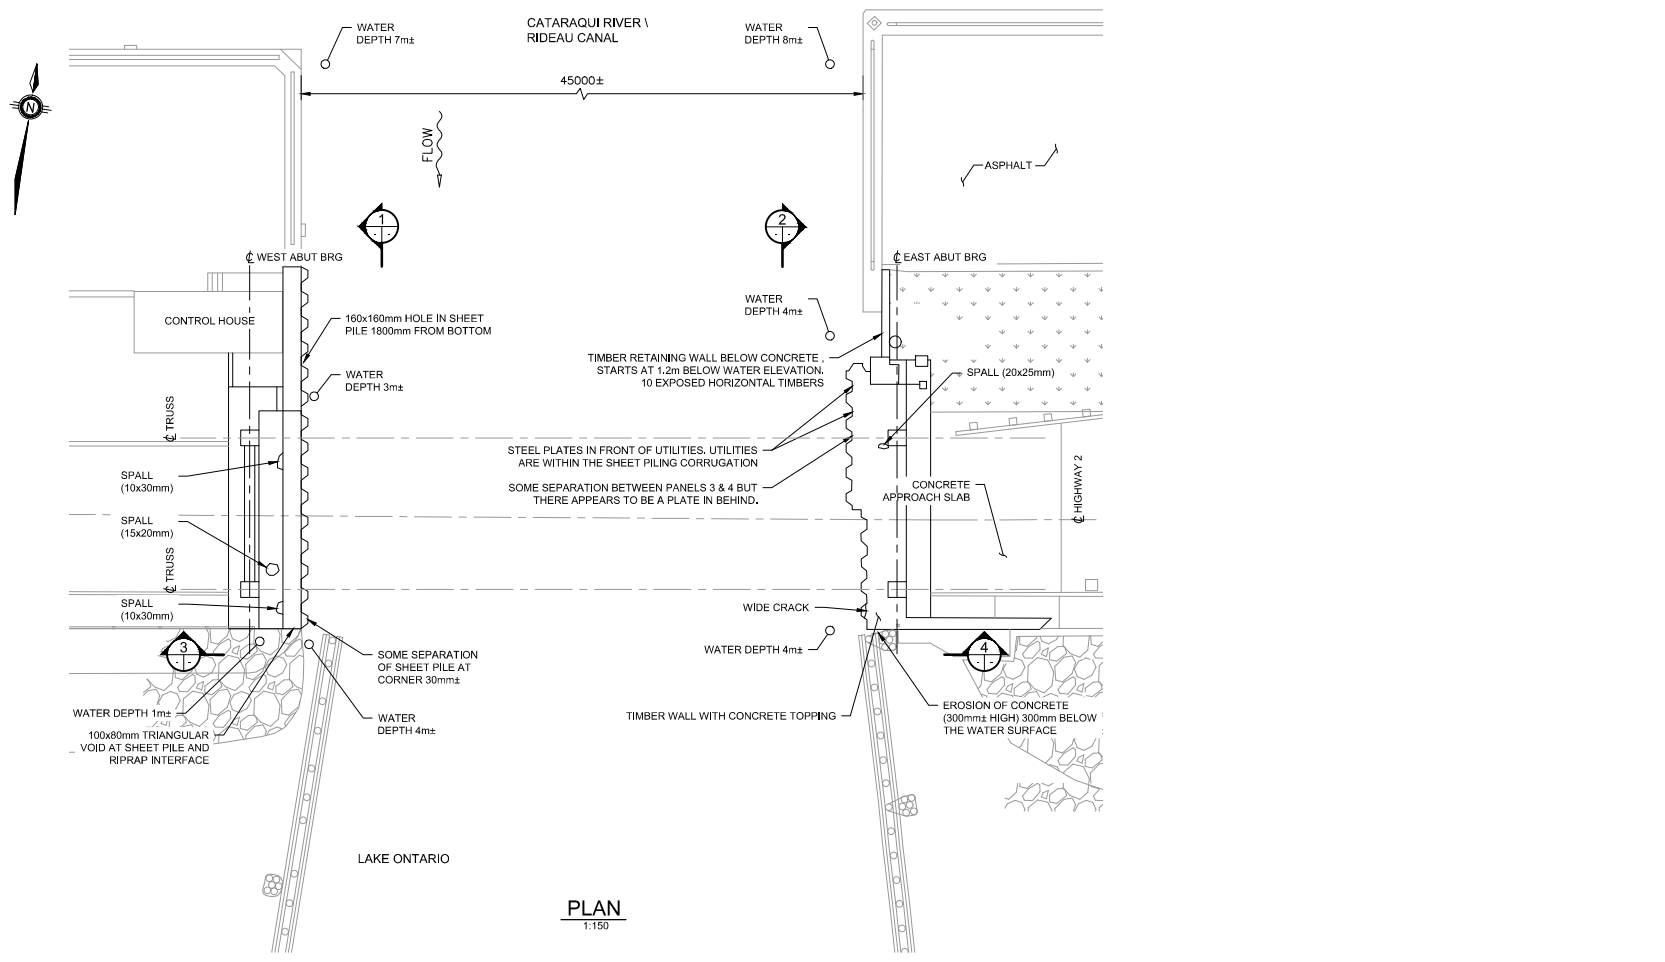
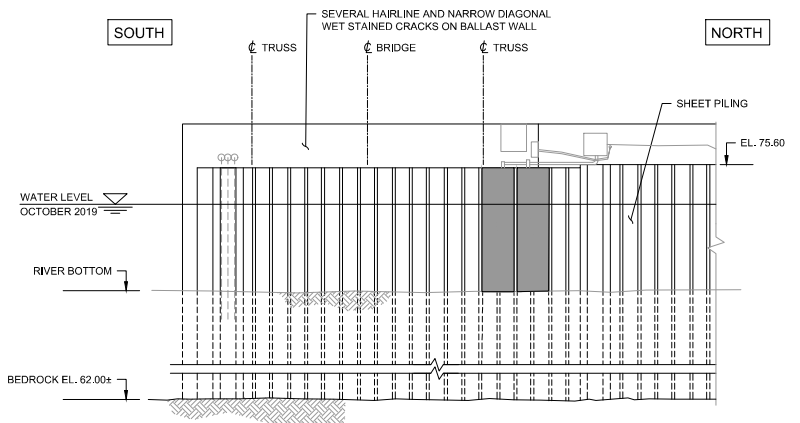
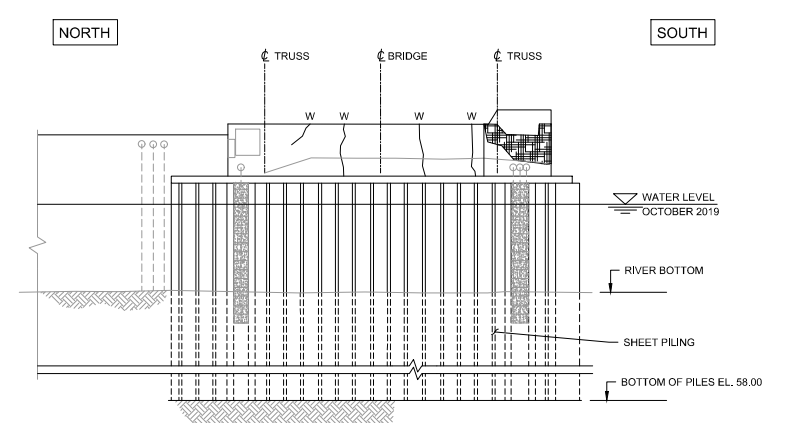
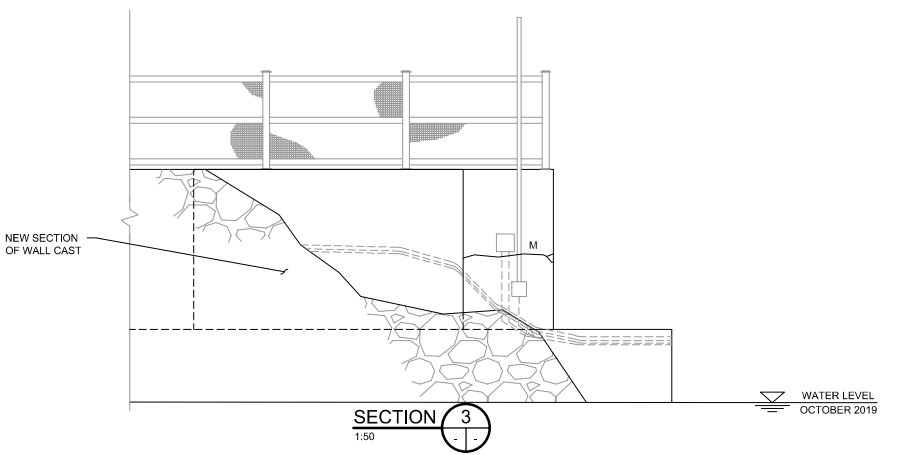
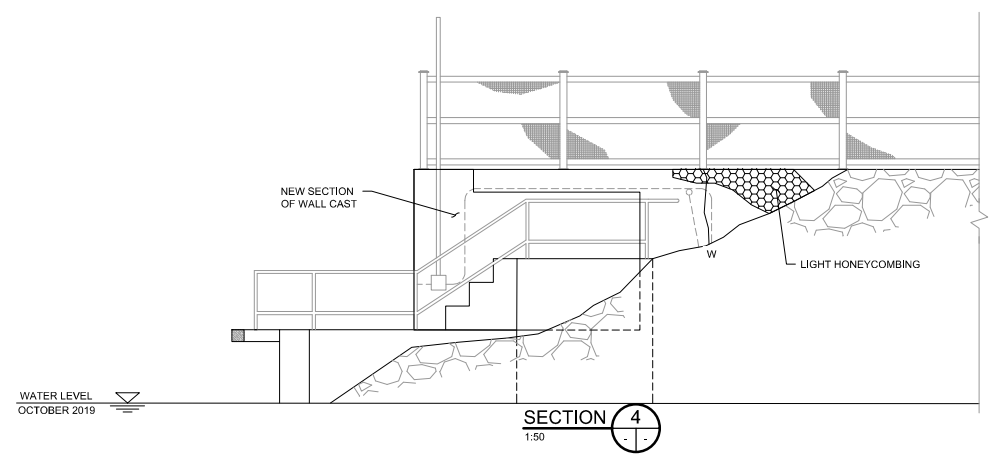
drawing no.
dessiné no.
B04

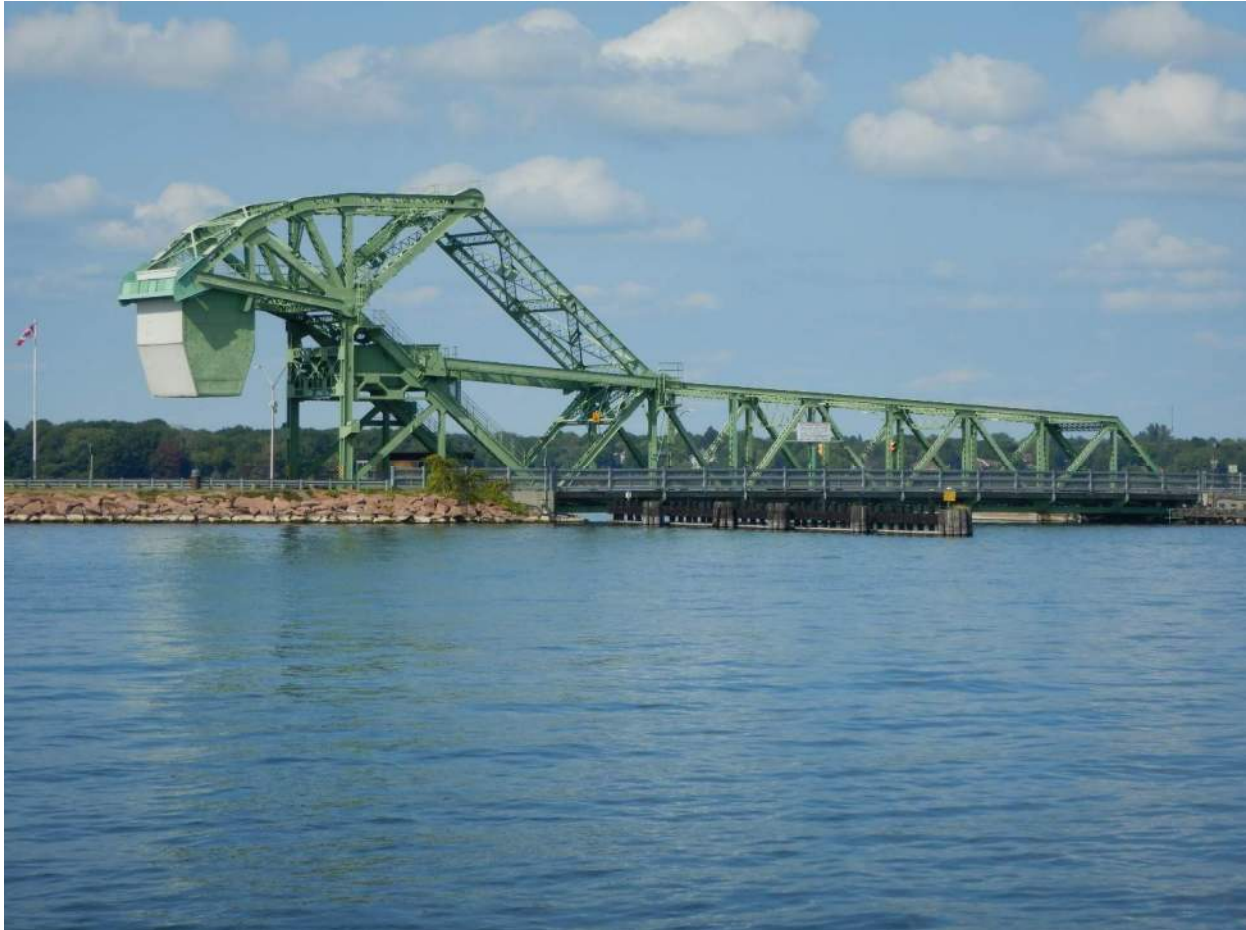
Photo S-1: South elevation.

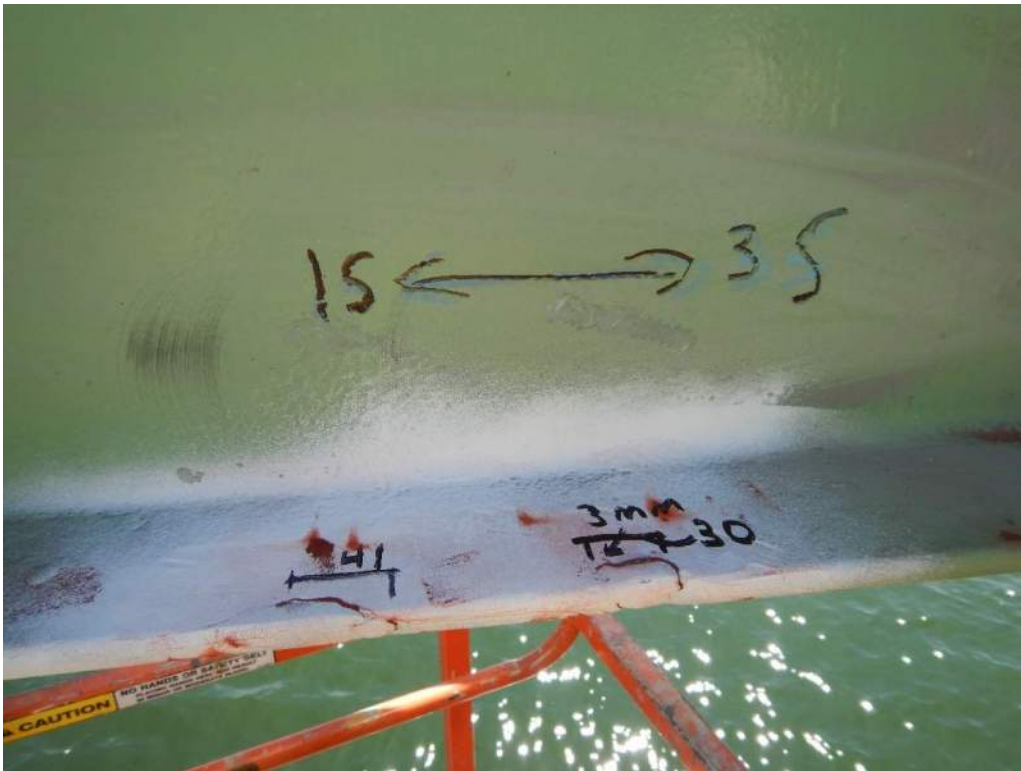
Photo S-12: A 41mm crack, and a 3mm crack propagating from a 30mm crack on the north side of the bottom web of top chord member 1S-3S (top of web).

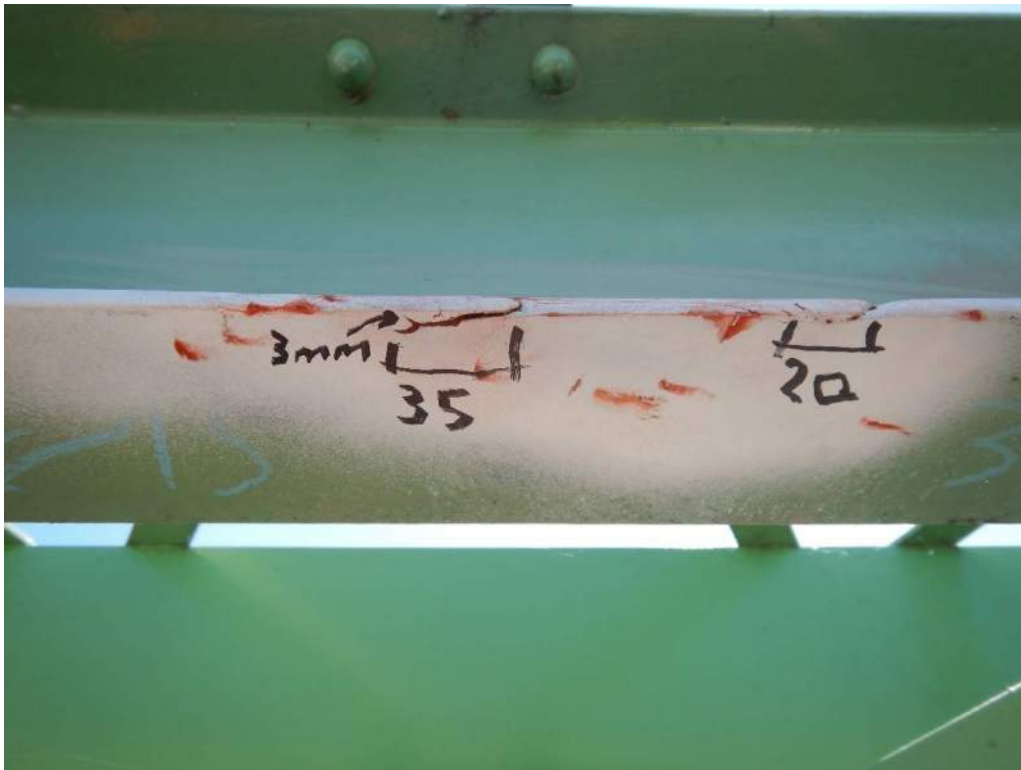
Photo S-13: A 20mm crack, and a 3mm crack propagating from a 35mm crack on the north side of the bottom web of top chord member 1S-3S (bottom of web).

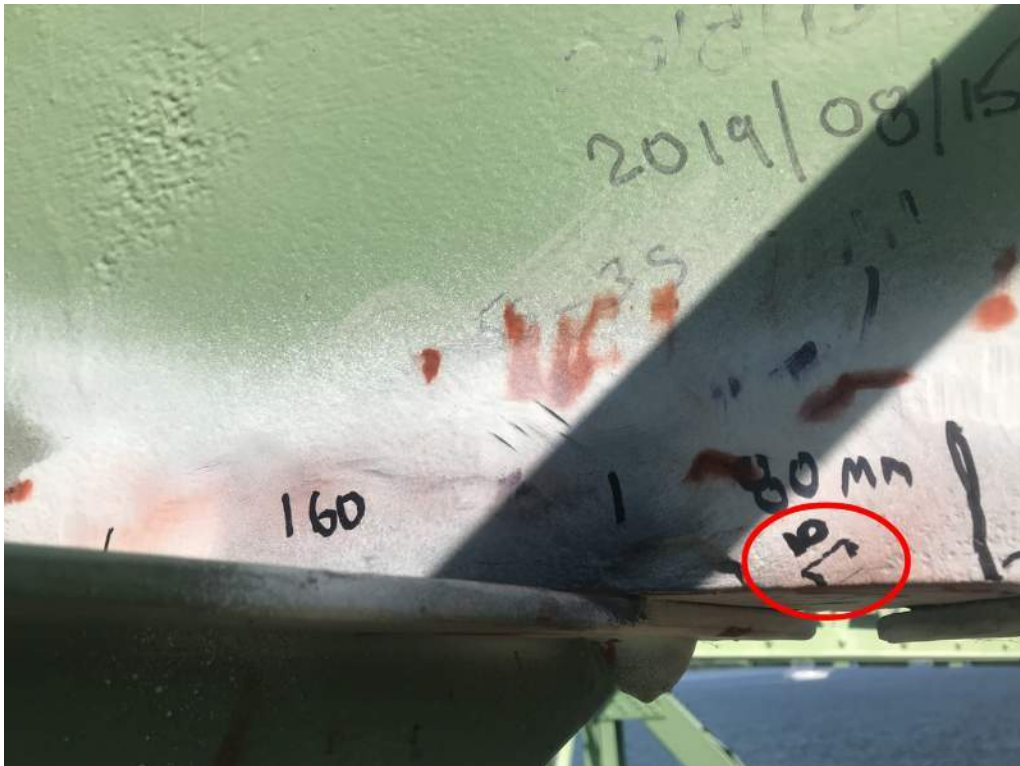
Photo S-14: An 80mm long lamination defect with a 60mm long crack in the south face of top chord member 3S-5S. A diagonal crack 10mm long is propagating from the bottom, where a crack 50mm long parallel to main stress is located (not seen in photo) (photo by Brouco NDT).

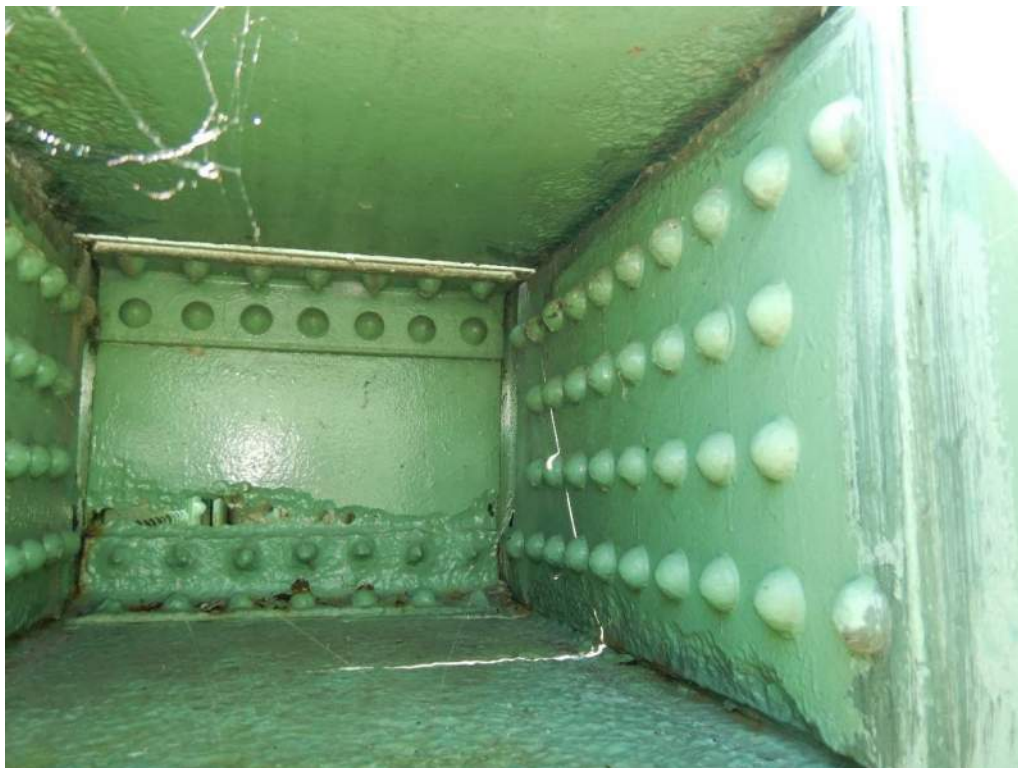
Photo S-15: Perforation and severe pitting of diaphragm inside top chord member 11S-13S near node 13S.

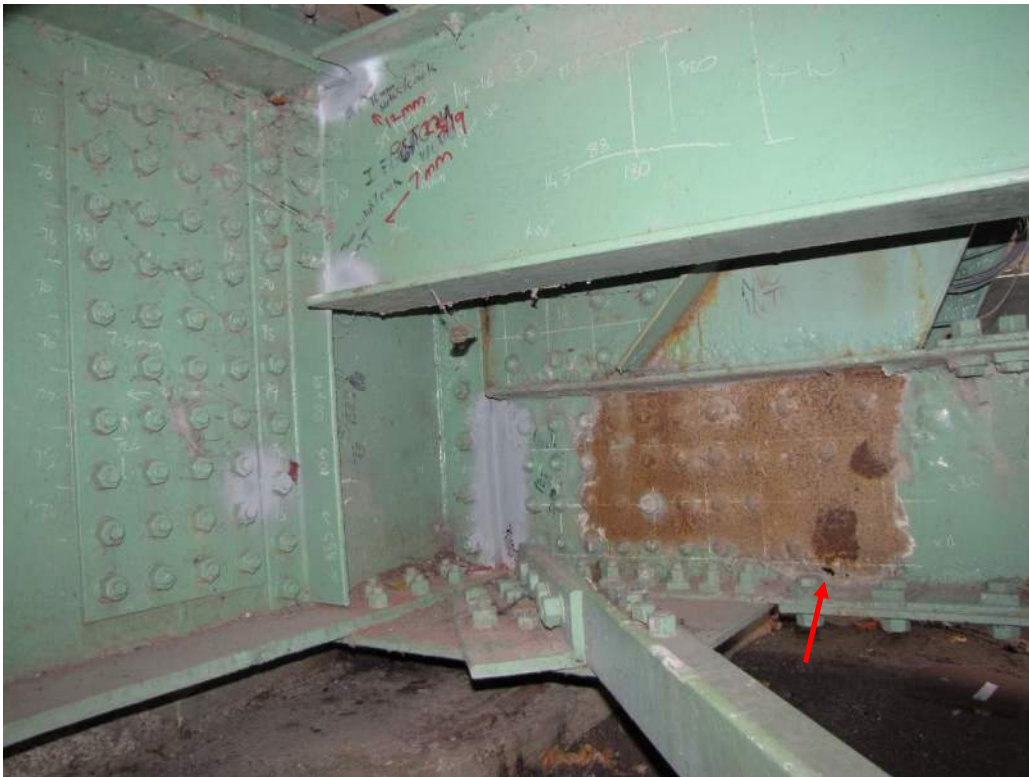
Photo S-16: Perforation in the inner web and generalized light corrosion where coating is missing on bottom chord member 14N-16N near node 16N.

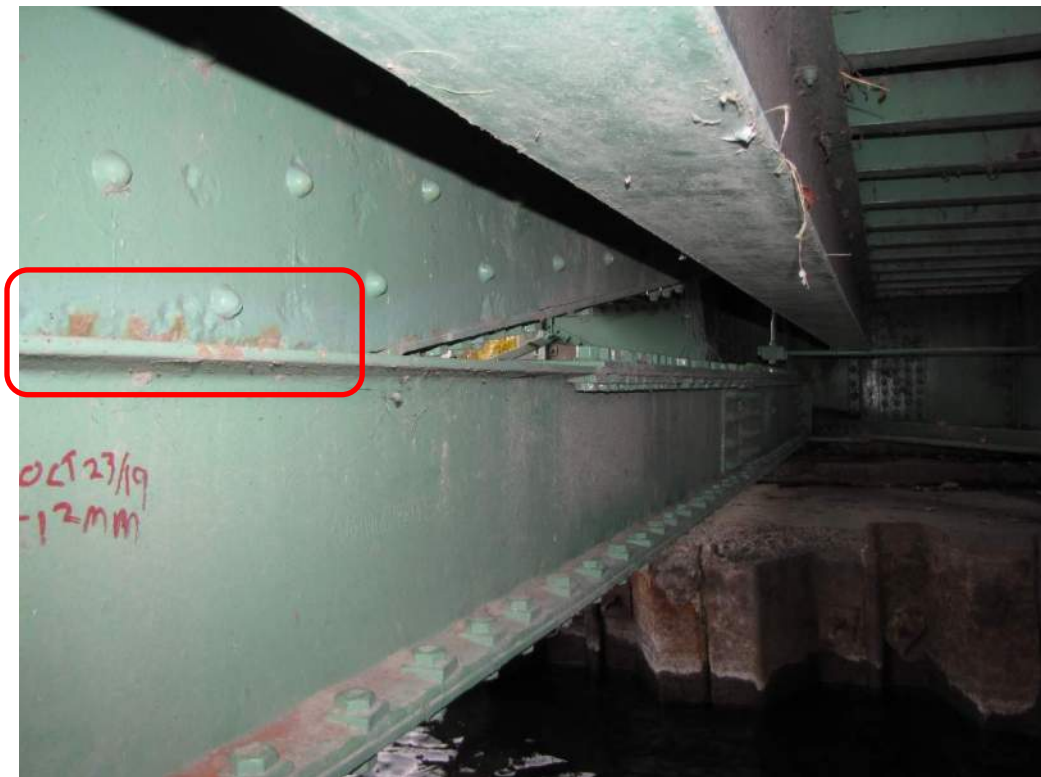
Photo S-17: Severe pitting and rust jacking between member 14N-15N and 14N-16N.
