Lasalle Causeway Bascule Bridge

2019 Comprehensive Detailed Inspection Report (Rev. 1)

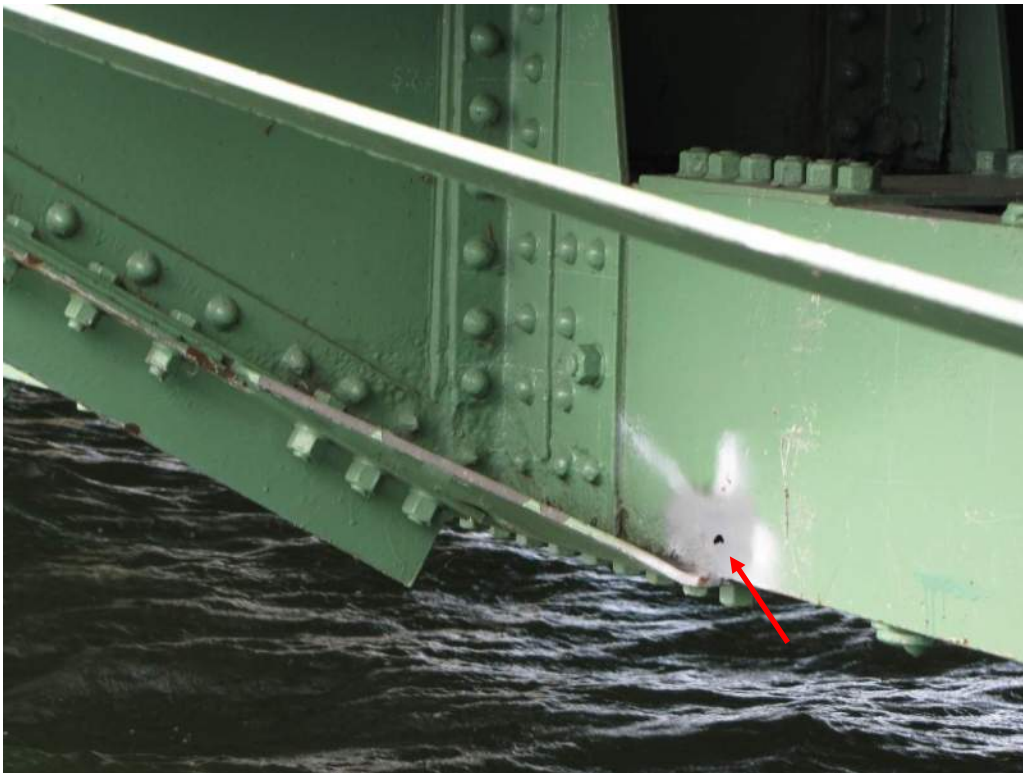
Photo S-18: Severe pitting, section loss, and peeling coating in the sidewalk floor beam connection and in bottom chord member OS-2S at node 2S. A perforation in the web of member OS-2S is also present.

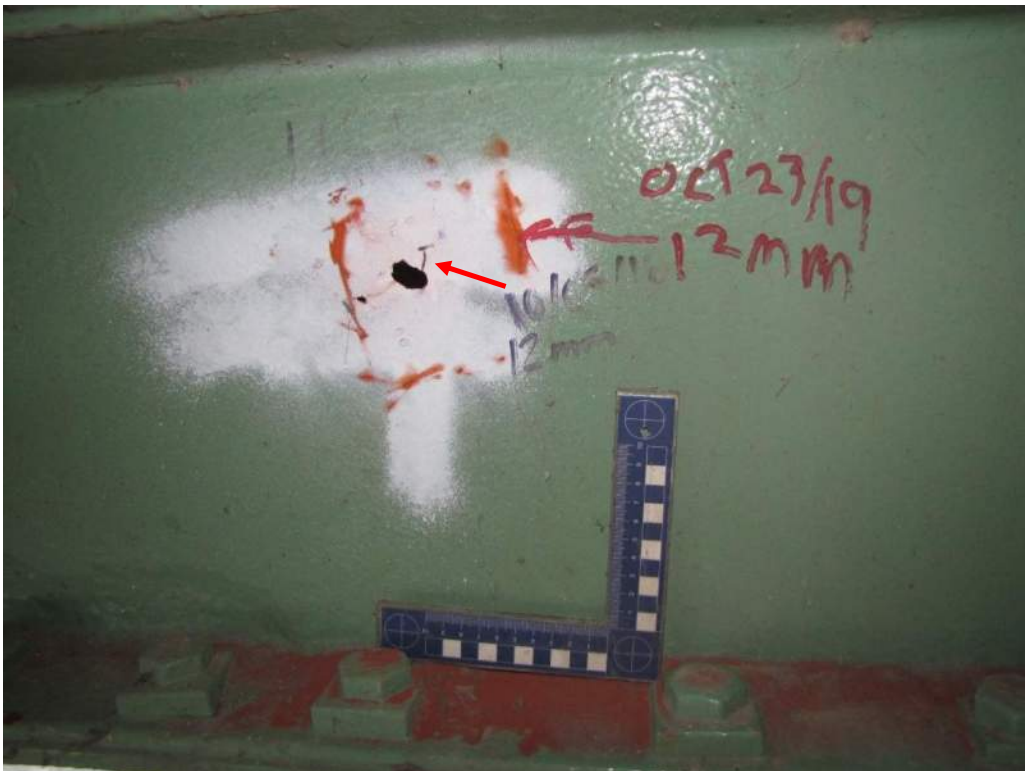
Photo S-21: Two perforations and 12mm long crack in interior channel of bottom chord member 14S-16S.

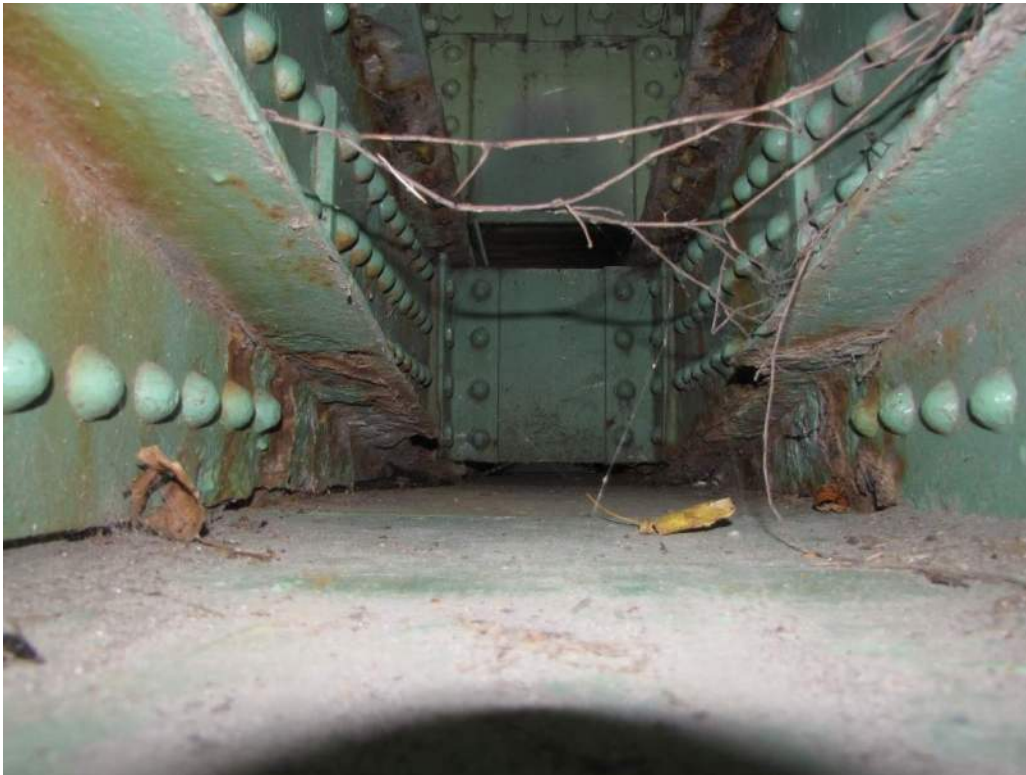
Photo S-22: Severe localized pitting and section loss of flanges where 14S-16S and 14S-15S intersect. Several rivet heads have over 75% section loss.

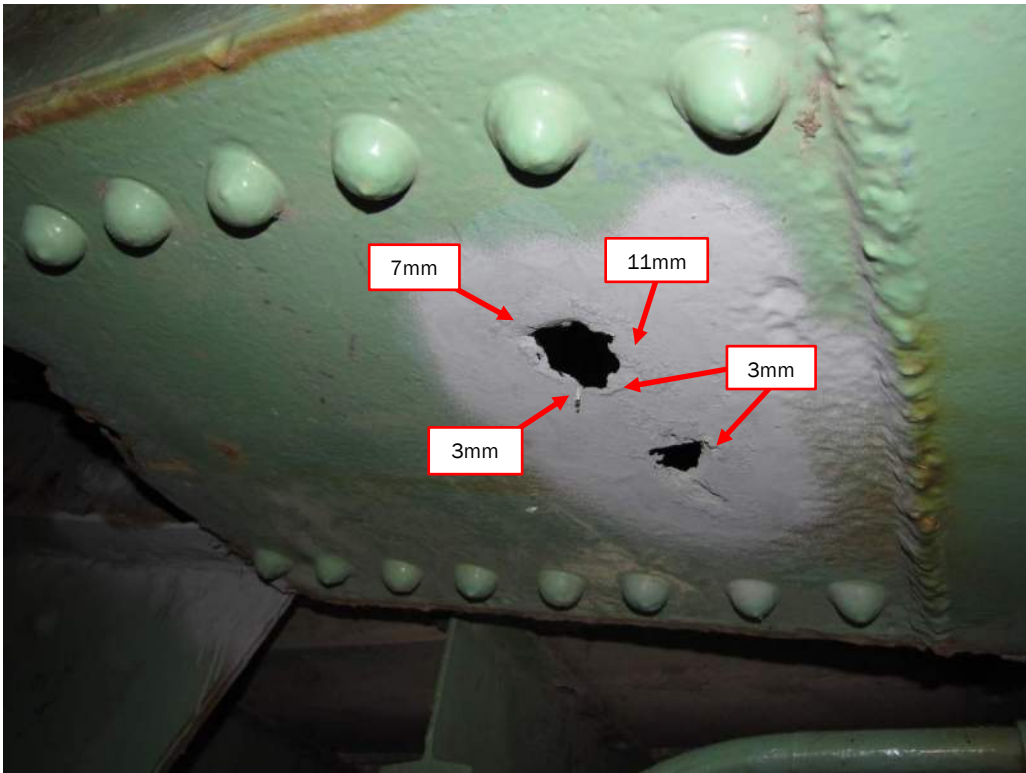
Photo S-23: Perforations and cracks in bottom batten plate of bottom chord member 14S-15S near node 15S. Cracks range in length from 3mm to 11mm.

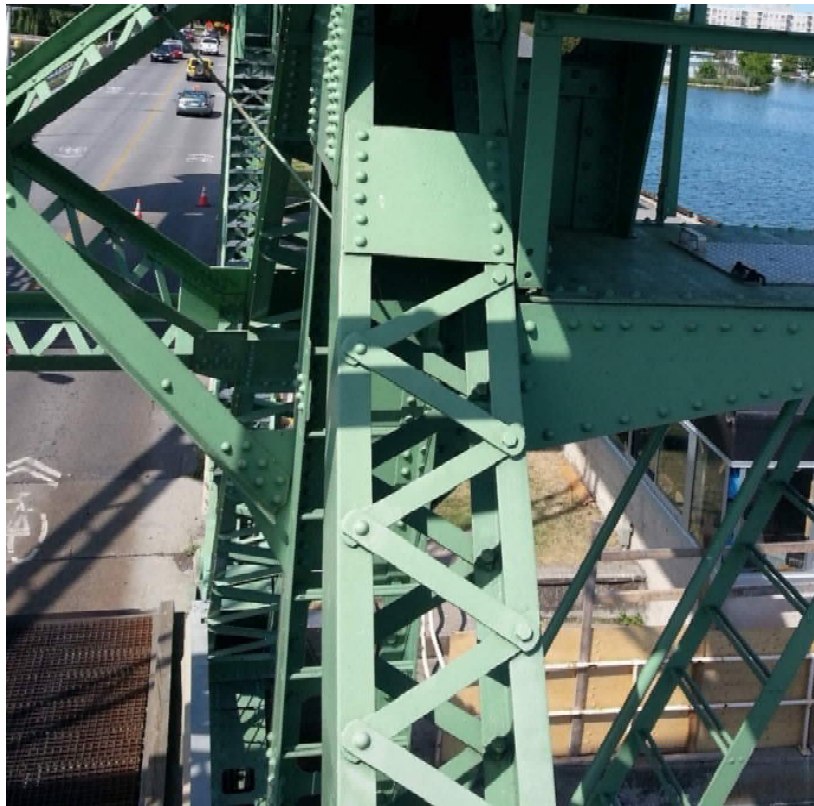
Photo S-24: The top of diagonal member 12N-13N near node 13N is deformed into an S-shape.

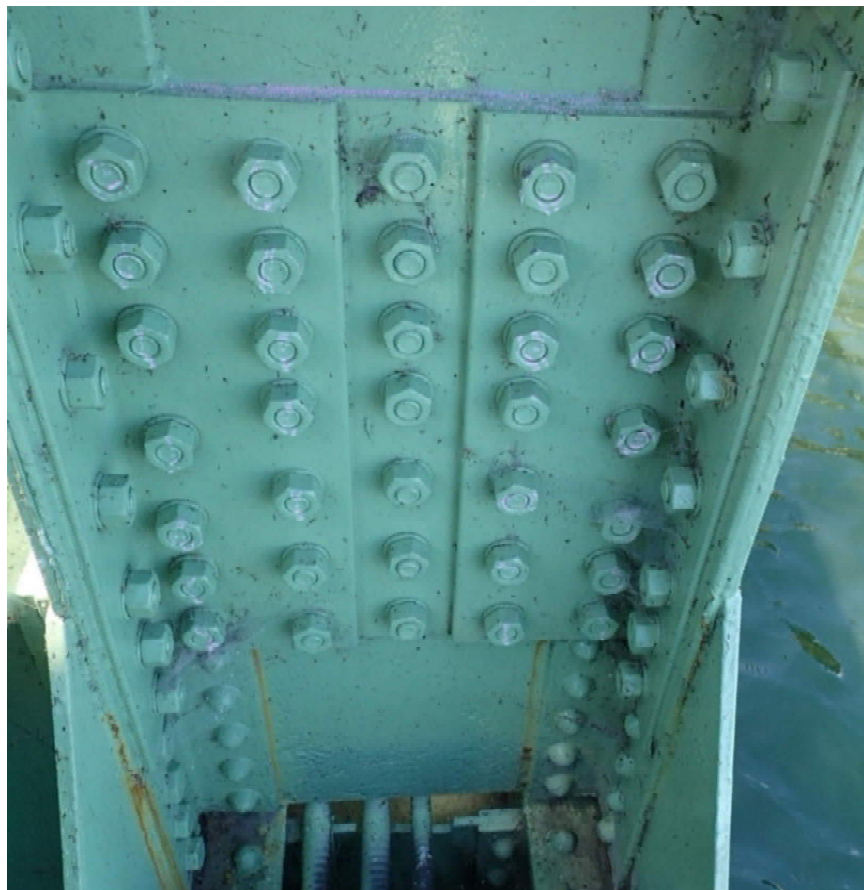
Photo S-29: Bolts used in repaired section on vertical member 13N-14N are too short.

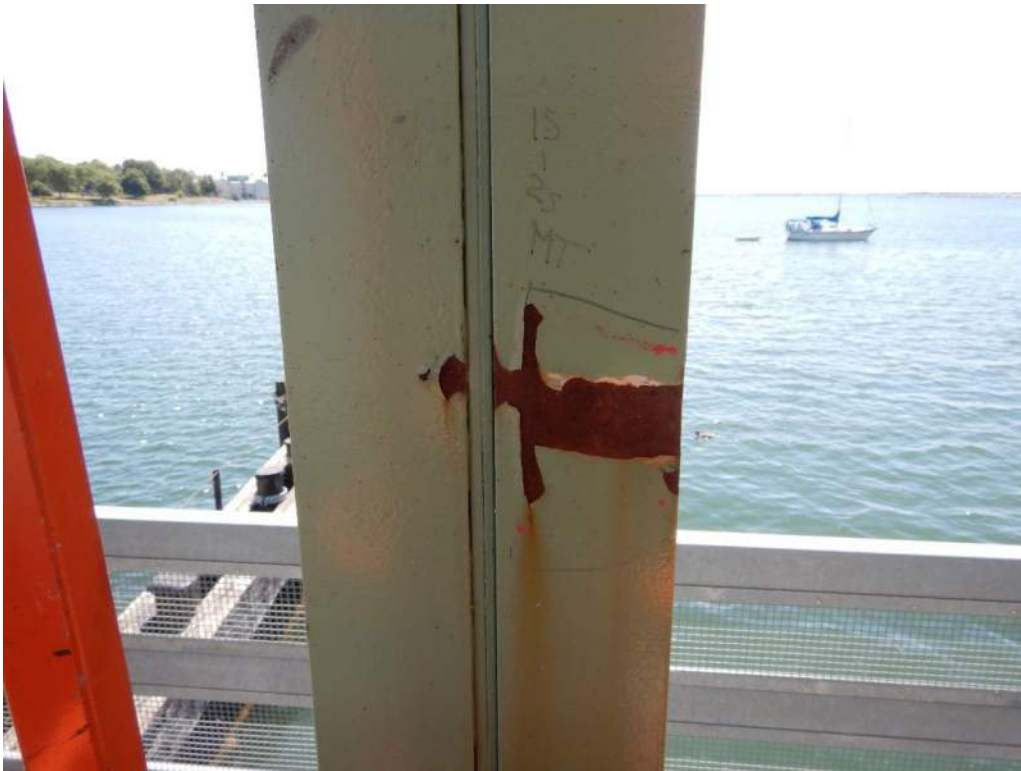
Photo S-30: Impact damage to vertical member 1S-2S has caused the northwest flange to be slightly bent, caused coating damage allowing light corrosion to occur.

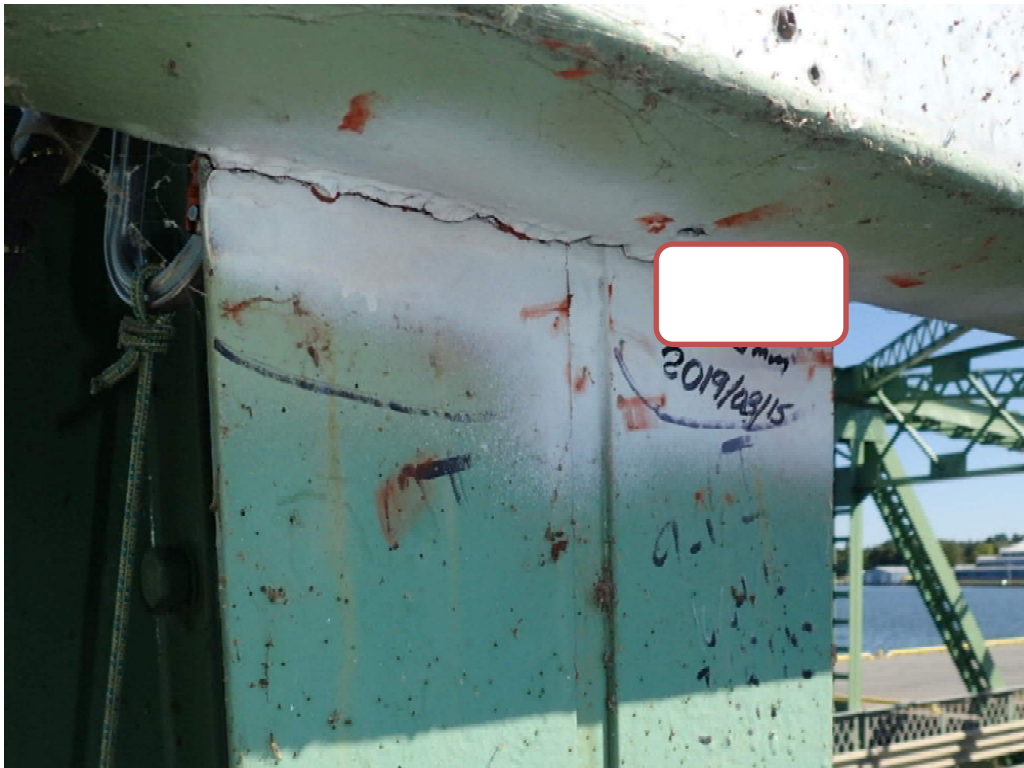
Photo S-31: 3mm long crack in top of southeast leg of vertical member 9S-10S at weld location.

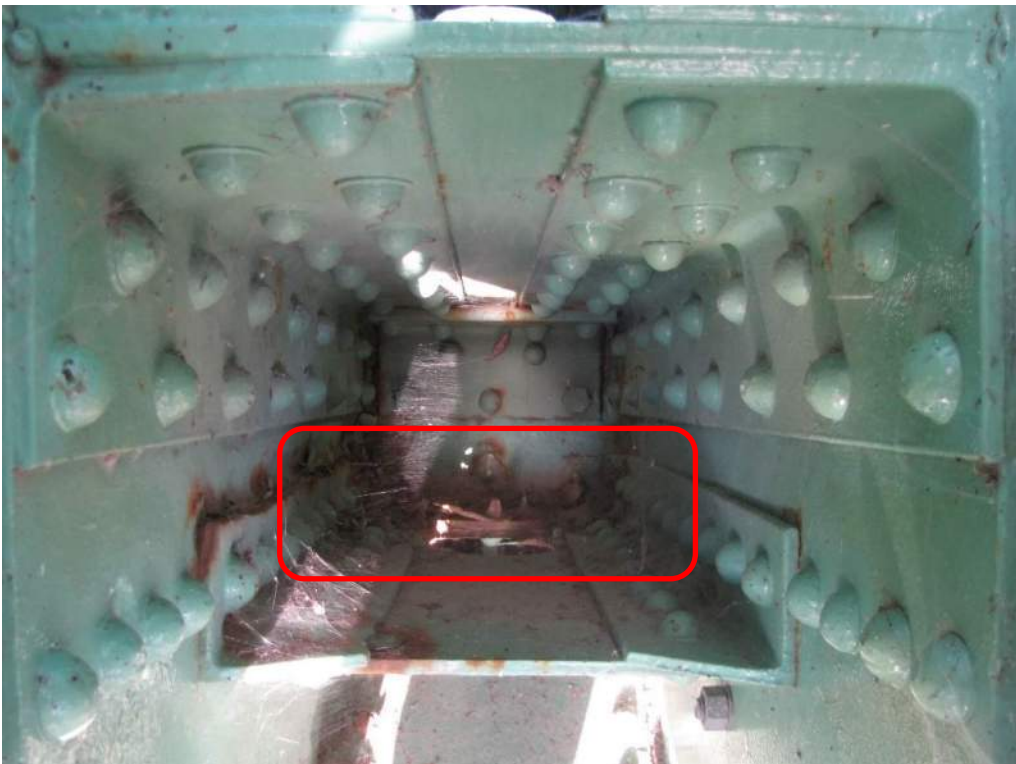
Photo S-32: Severe corrosion and section loss of rivet heads at the base of tower truss member 15N-17N and section loss of the stiffening angles and stiffening plate at the main trunnion.

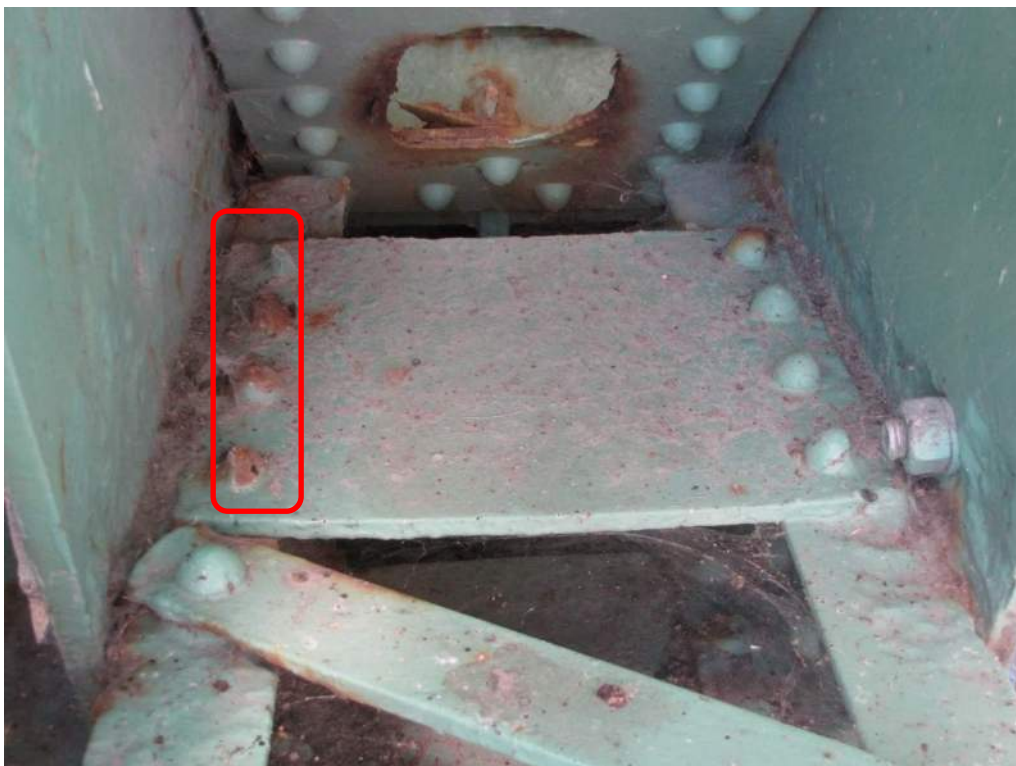
Photo S-33: 4 rivet heads have 90-100% section loss in tower truss member 15N-18N near node 15N. Note the bottom flange at this location has an area of 100% section loss (not shown).

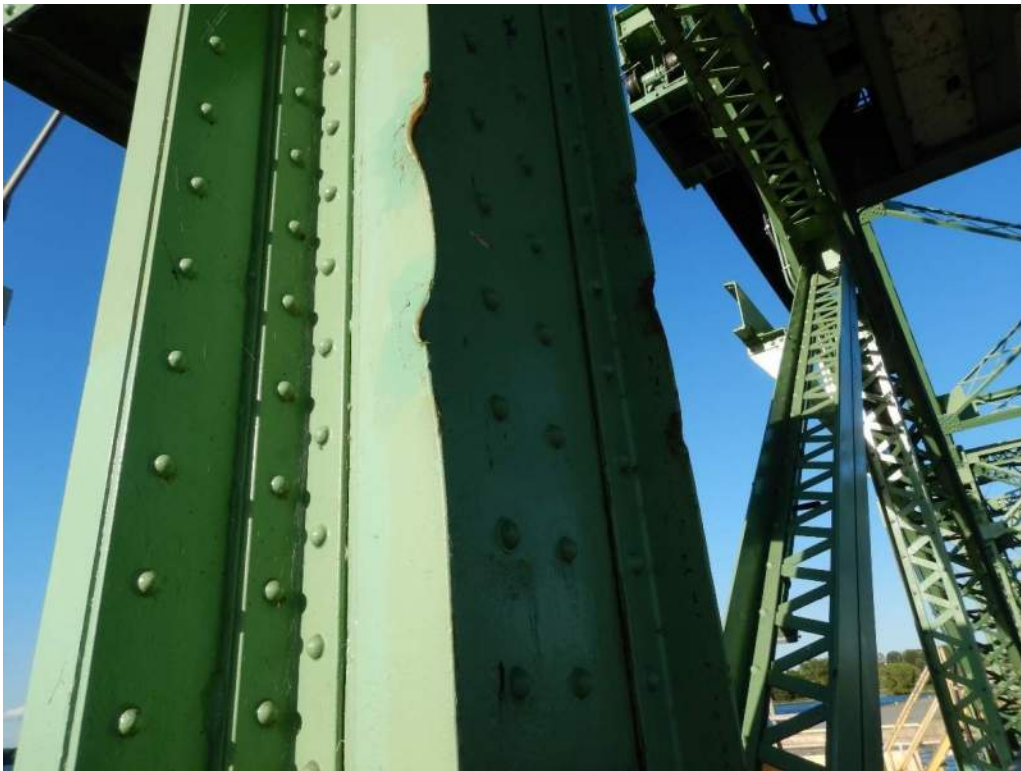
Photo S-36: The southwest and southeast flanges of tower truss vertical member 19N-20N have deformations likely caused by impact damage.

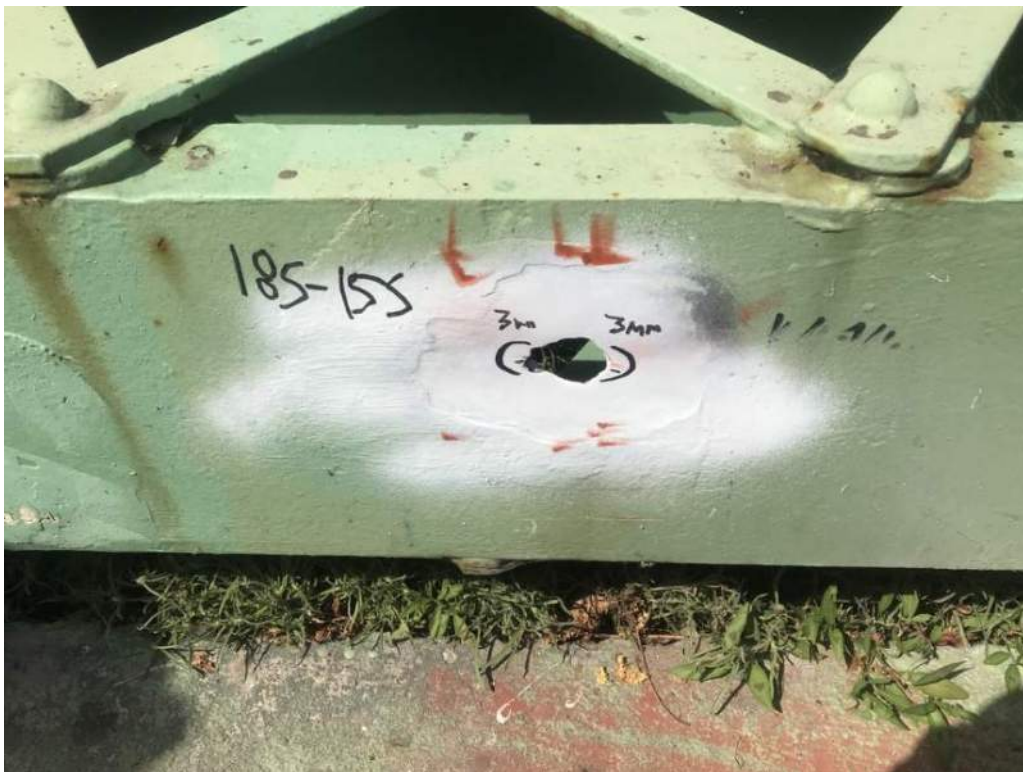
Photo S-37: Perforation and two 3mm long cracks in the south channel of tower truss horizontal member 15S-18S (photo by Brouco NDT).

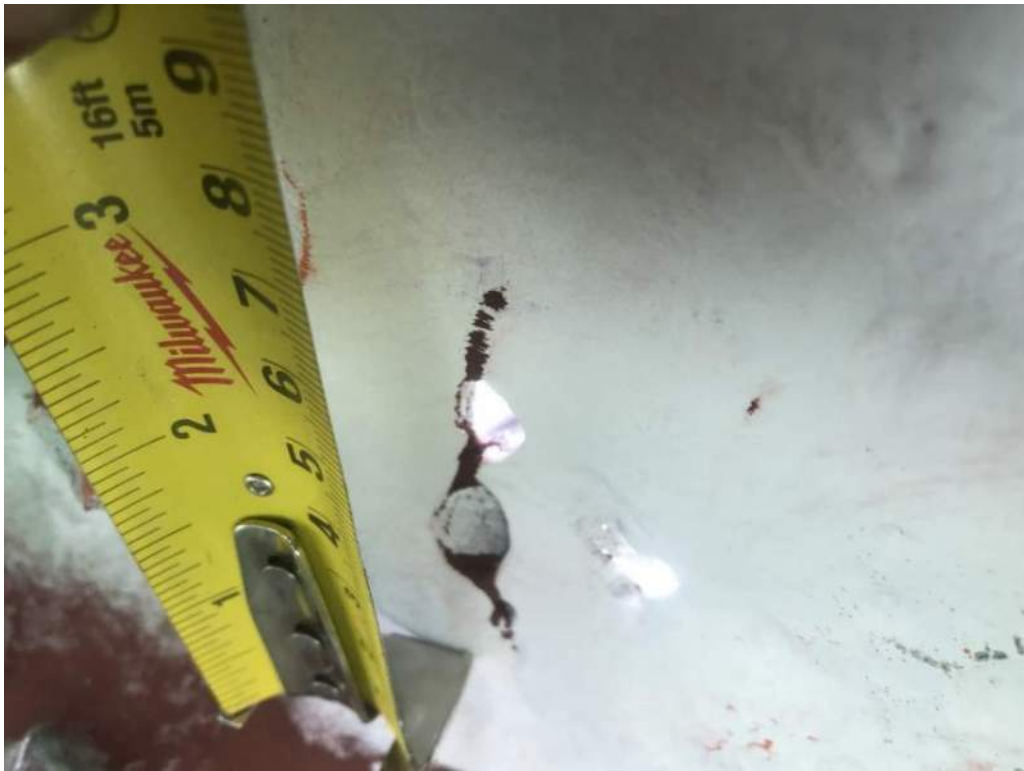
Photo S-38: Fatigue crack propagating from three perforations with a total length of 70mm in the south channel of tower truss member 18S-19S.

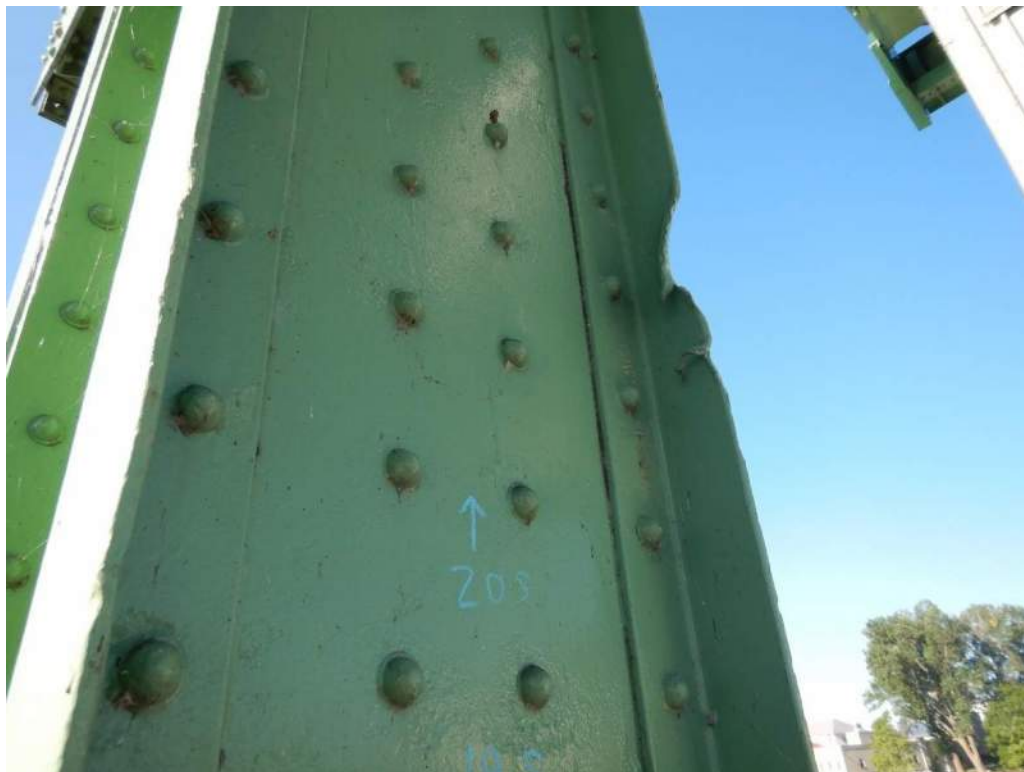
Photo S-39: Impact damage to southeast and southwest flanges above road level on tower truss vertical member 19S-20S.

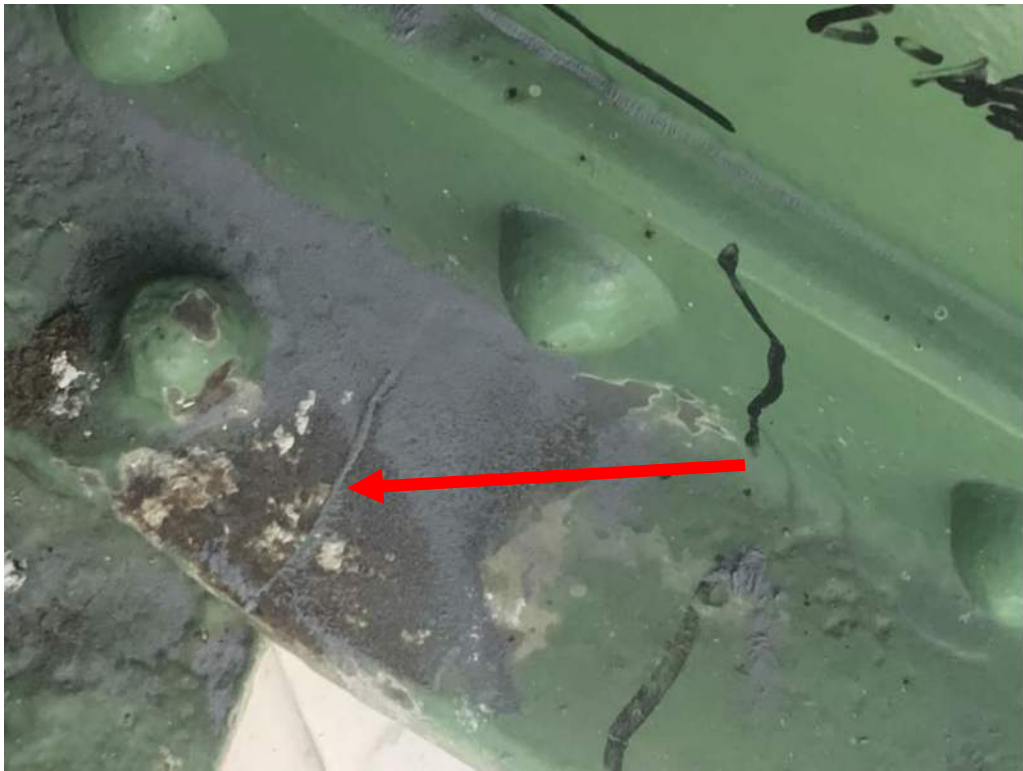
Photo S-40: Crack across full width of bottom leg of interior angle of counterweight truss member 21N-27N at node 27N (photo by Brouco NDT).

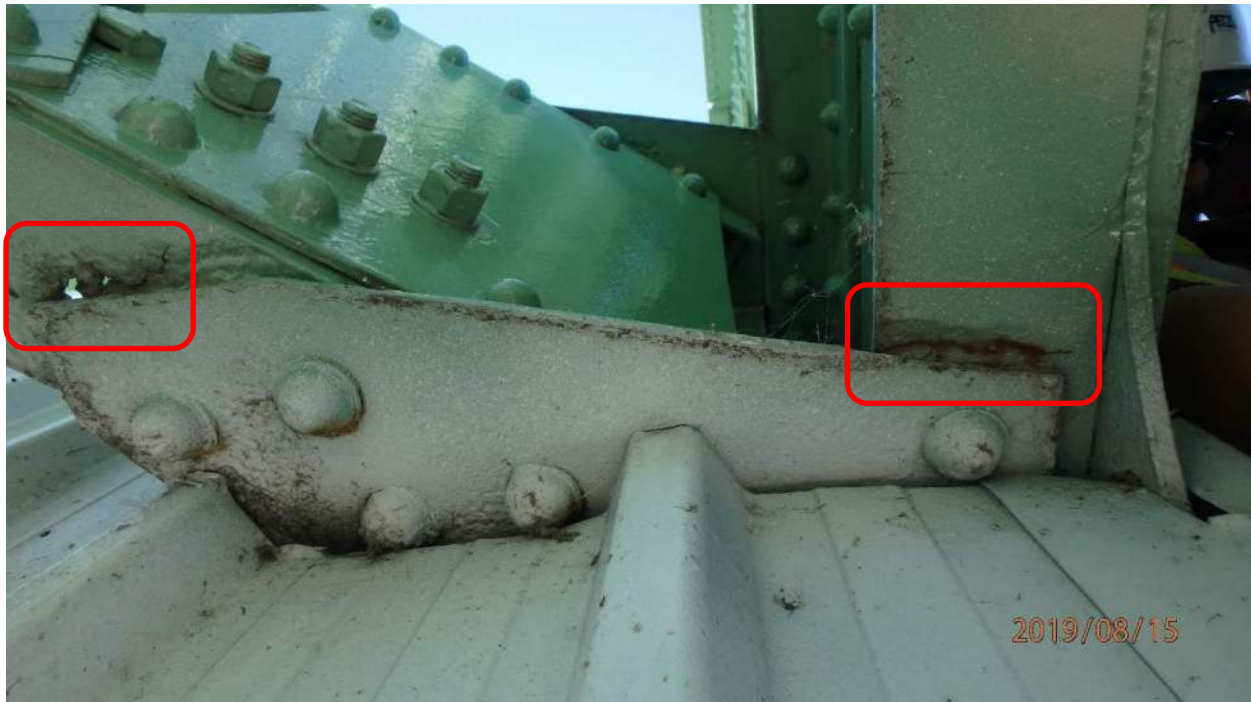
Photo S-41: The northwest end of counterweight truss cross bracing member 21S-27N has several perforations in the lower flange (left). Crack in the south lower flange of member 21N-27N (right).

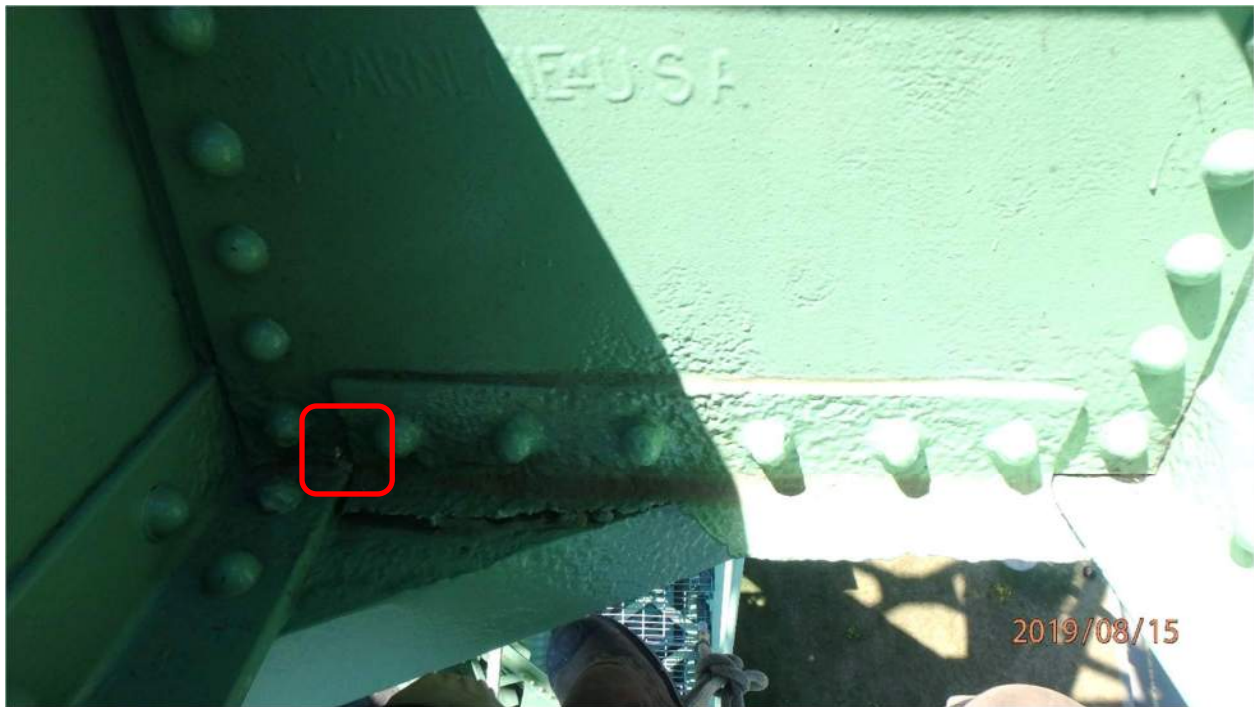
Photo S-42: Localized area of pitting 2-7mm deep with a perforation above the lowest rivet in the lower batten plate on the south side of counterweight truss member 21N-22N. Also note that the outstanding leg of the angle has an area of 100% section loss.

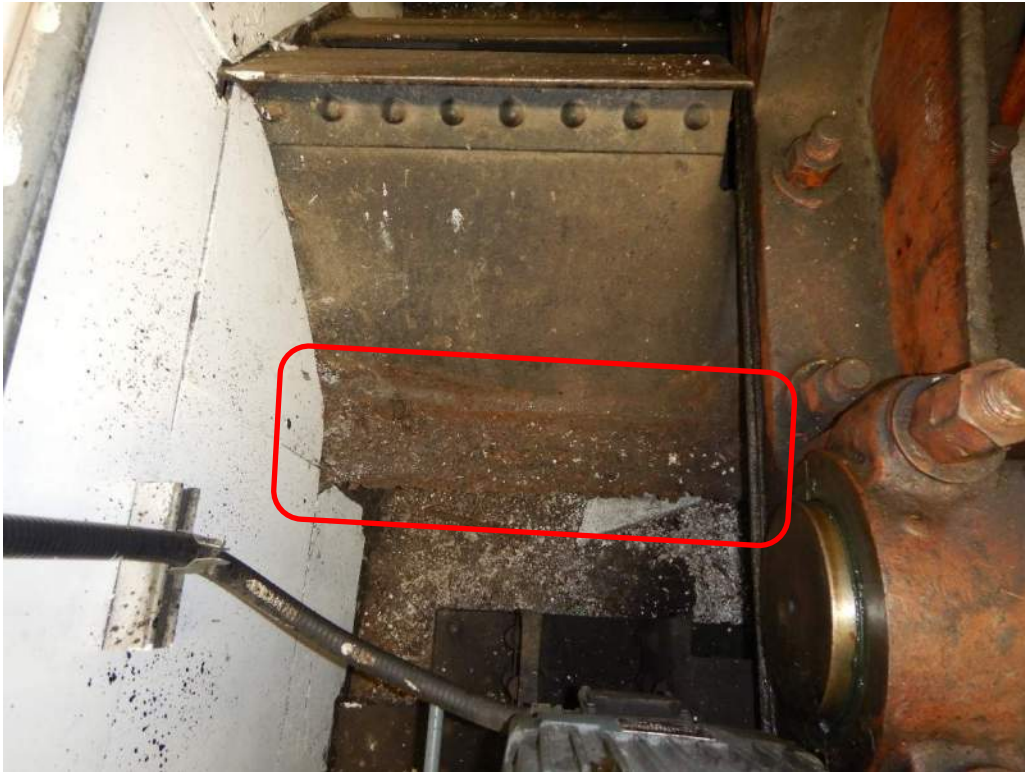
Photo S-44: Severe corrosion on the bottom flange of the northeast transverse strut in the mechanical room.

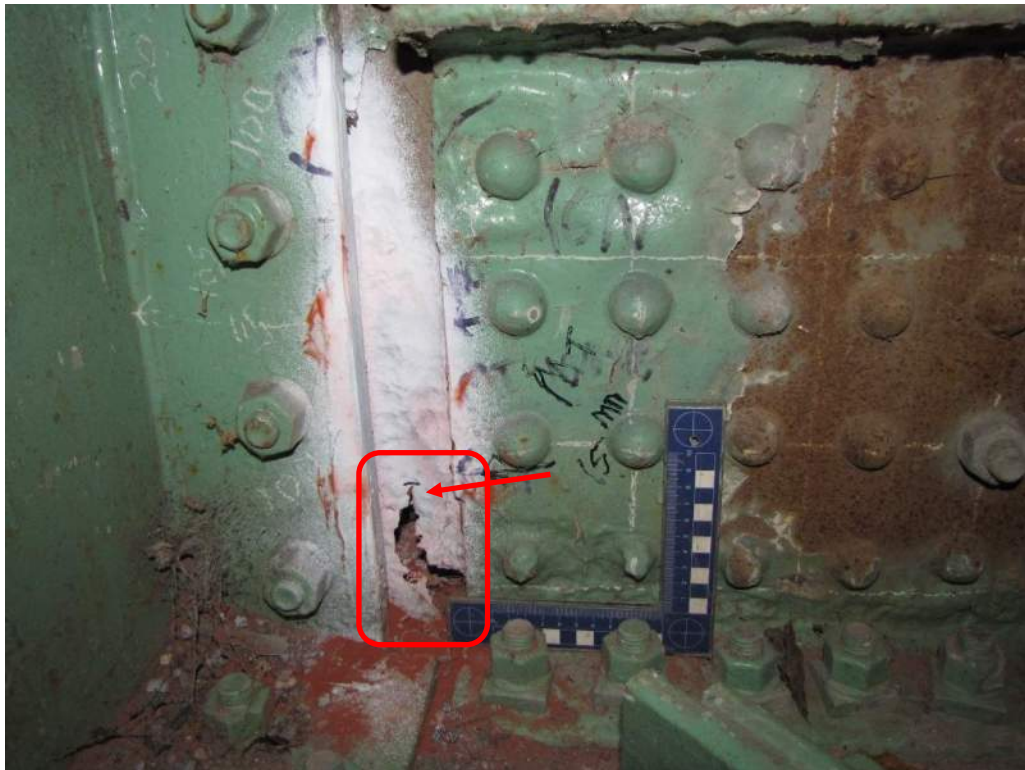
Photo S-45: The interior vertical gusset plate at node 16N exhibits severe section loss and a perforation with a 15mm vertical crack.

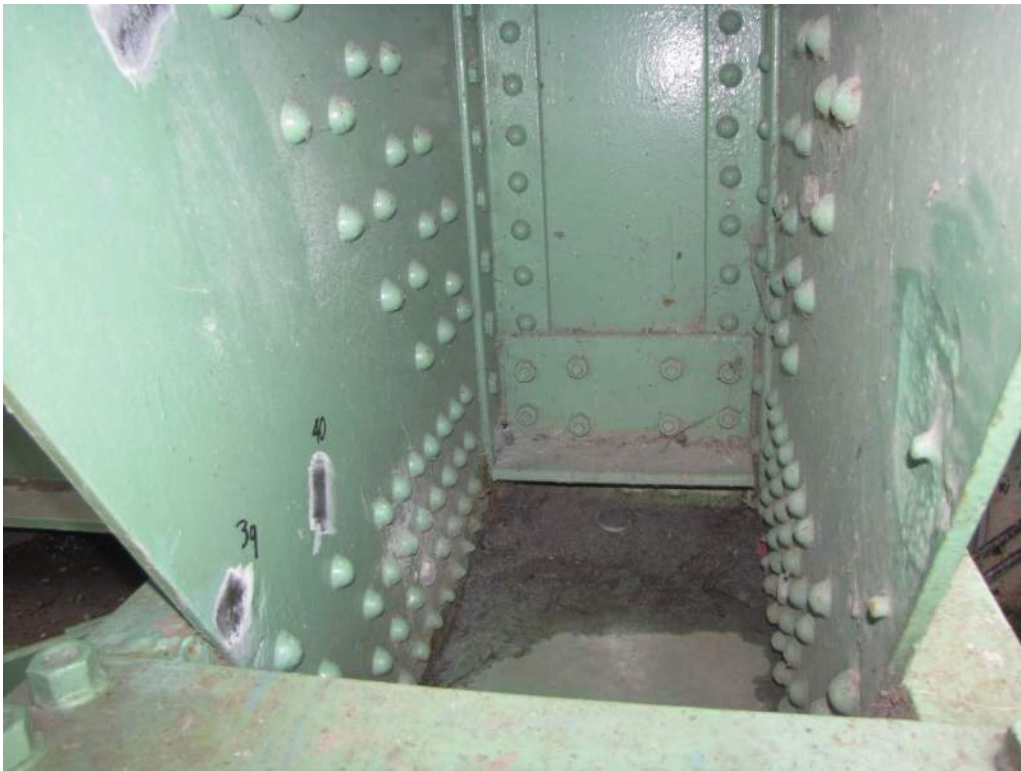
Photo S-46: The interior faces of the plates and rivet heads at the base of the north trunnion have localized severe section loss (photo from 2018 CDI).

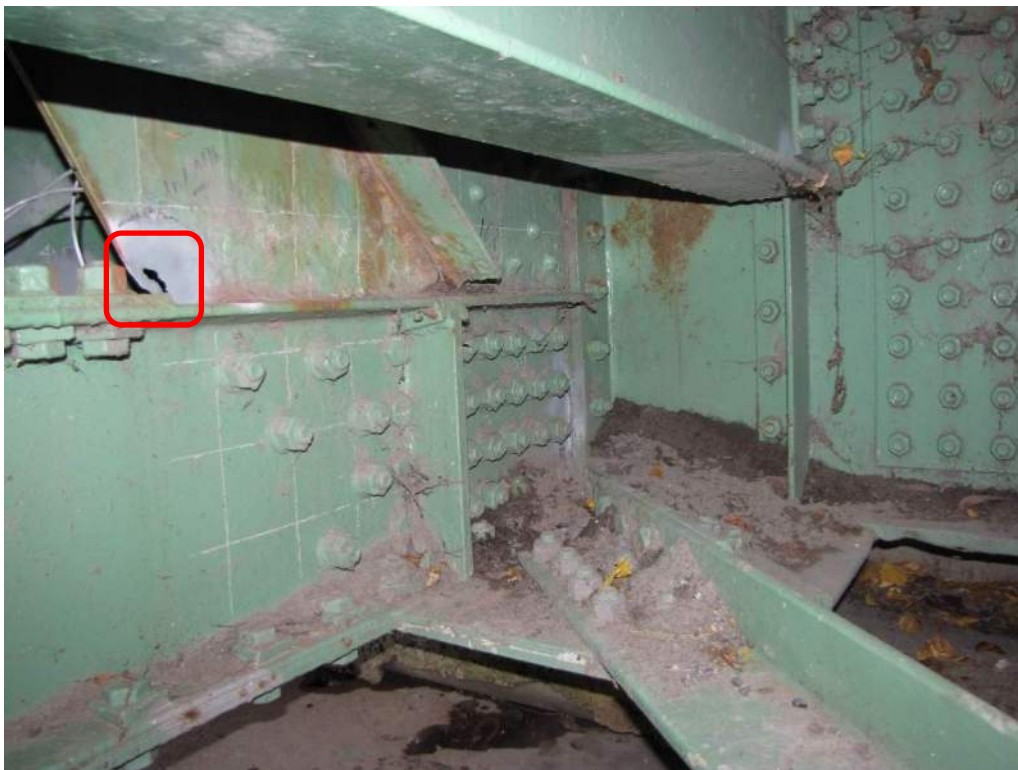
Photo S-49: View of the north side of the south trunnion below deck level. A 3mm crack was found at the indicated perforation.

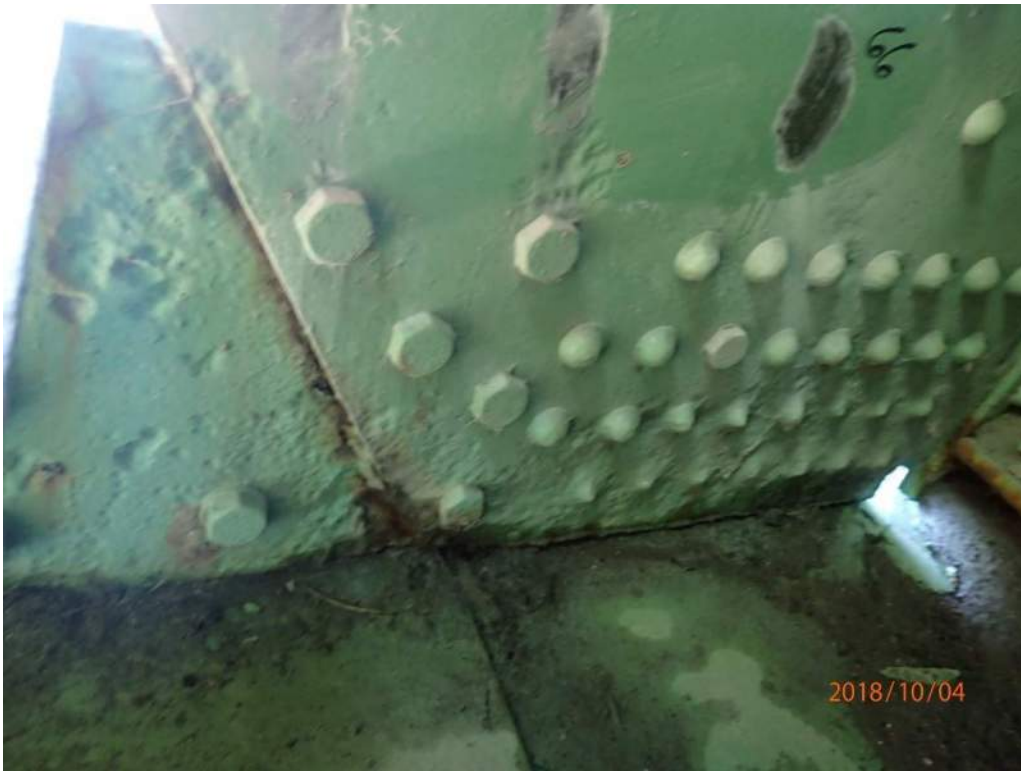
Photo S-50: Severe pitting at the base of the interior face and rivet heads of the south plate of the south trunnion (photo from 2018 CDI).

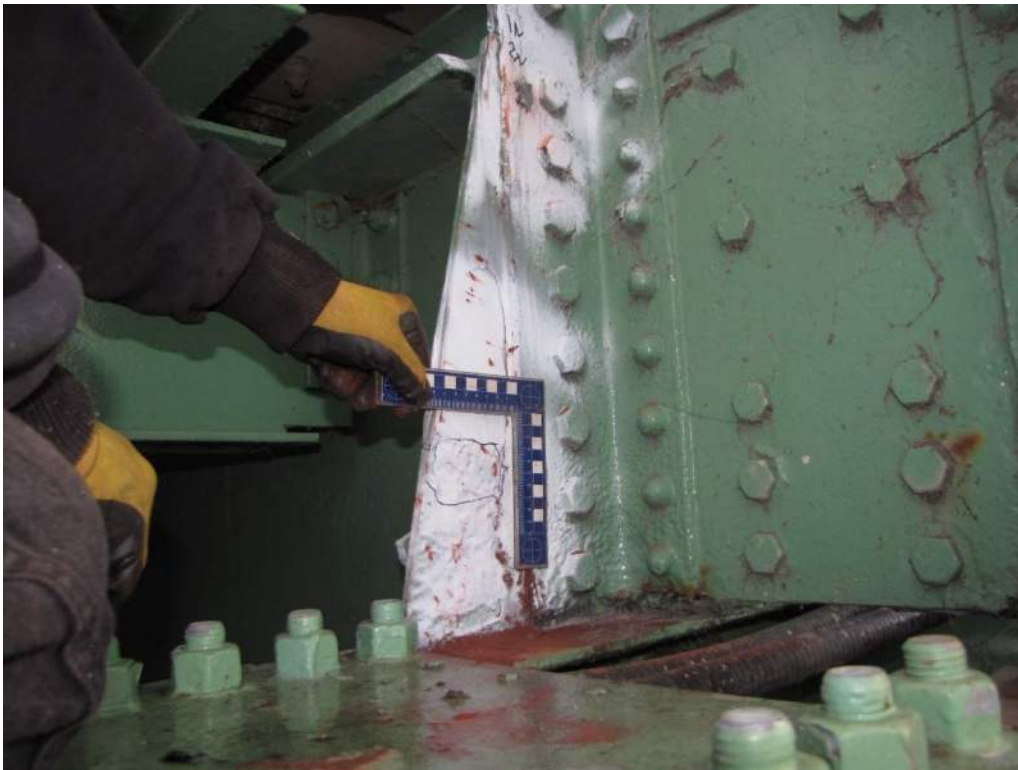
Photo S-53: Full-width crack in southwest vertical gusset plate at 2N (no increase in length from previous inspection).

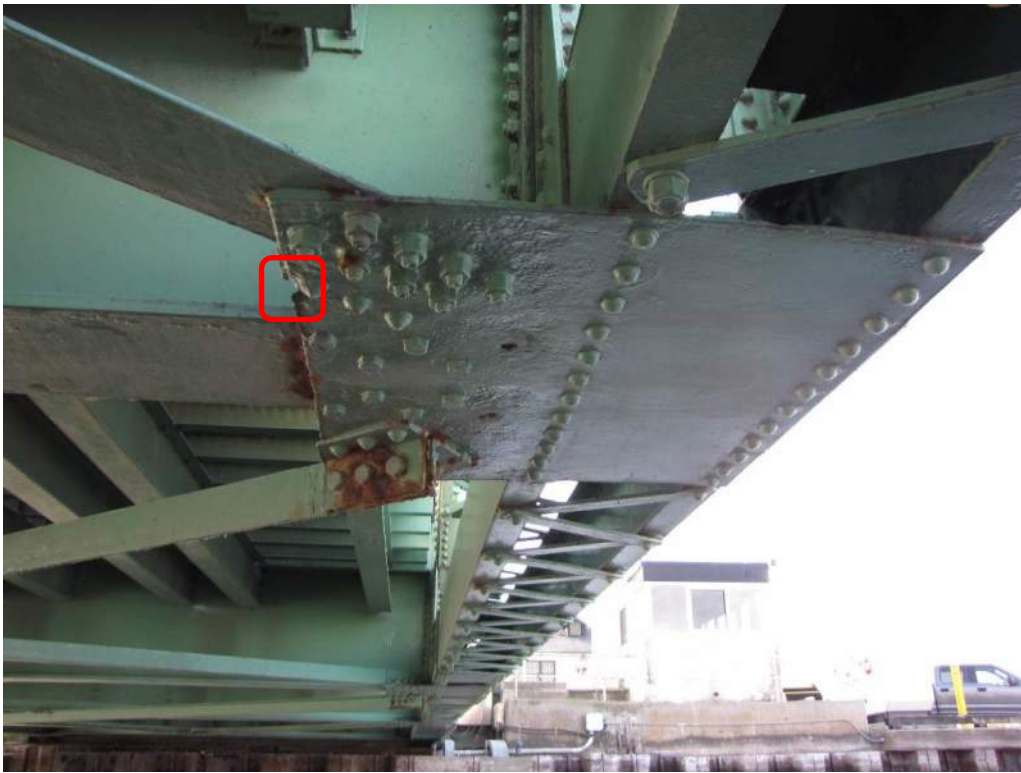
Photo S-54: Section loss and perforation in the bottom horizontal gusset plate at node 10N.

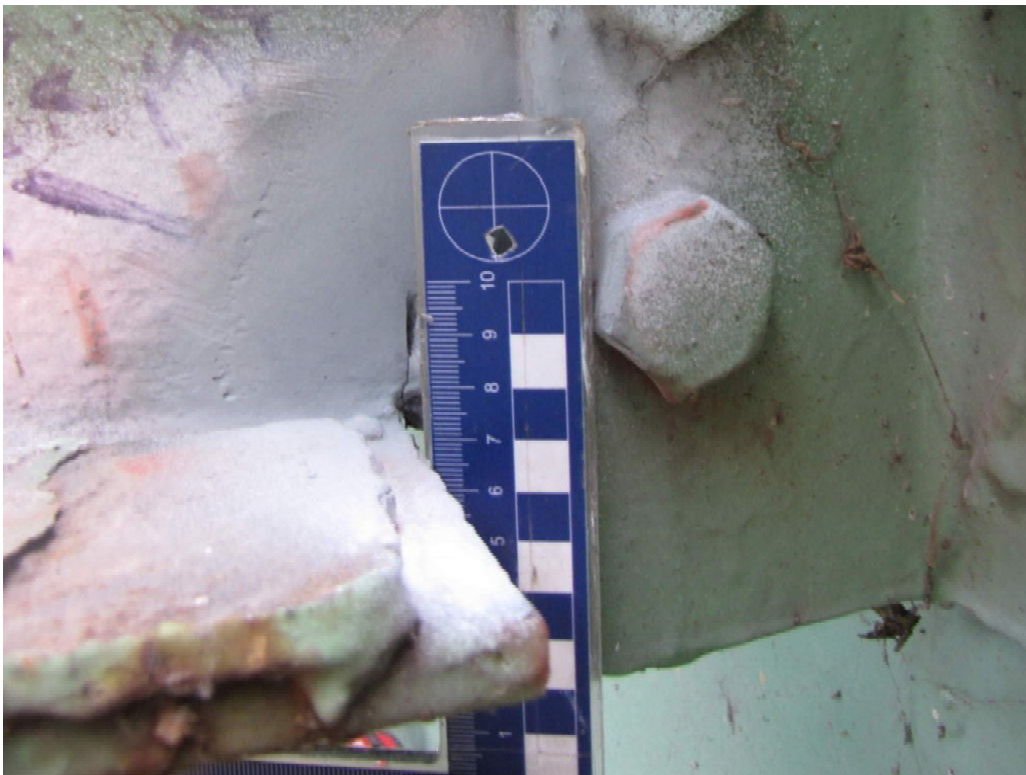
Photo S-57: 15mm notch/crack in the bottom cope of Stringer E (FB0-FB2) at FB0.

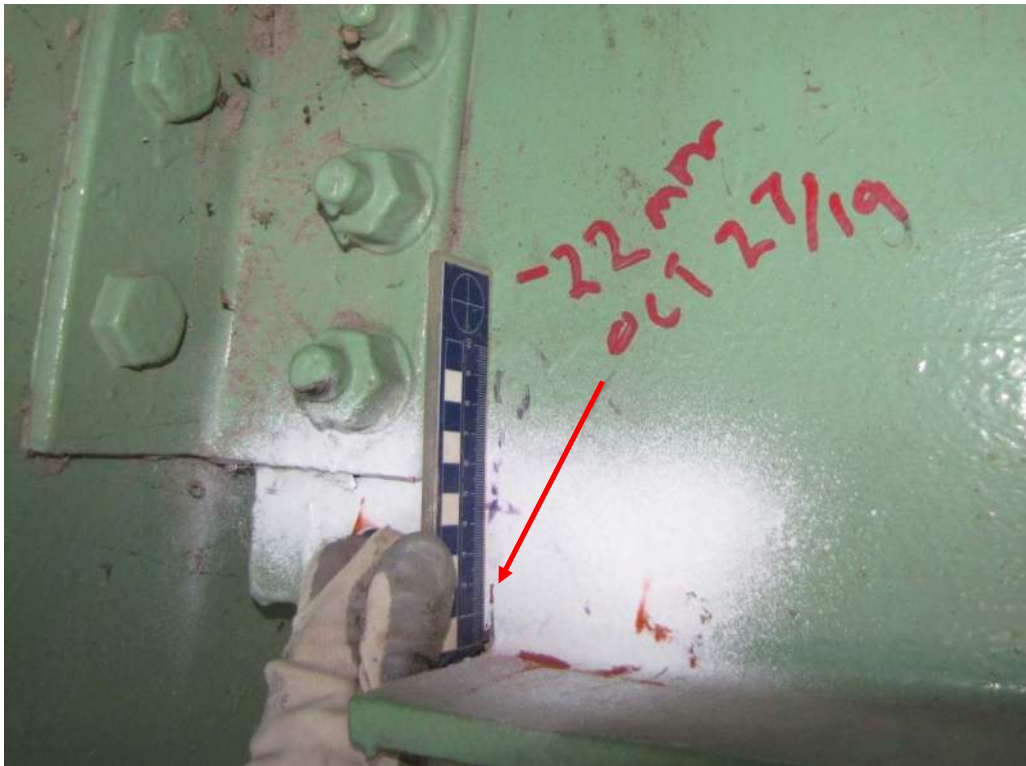
Photo S-58: 22mm notch/crack in the bottom cope of Stringer F (FB2-FB4) at FB2.

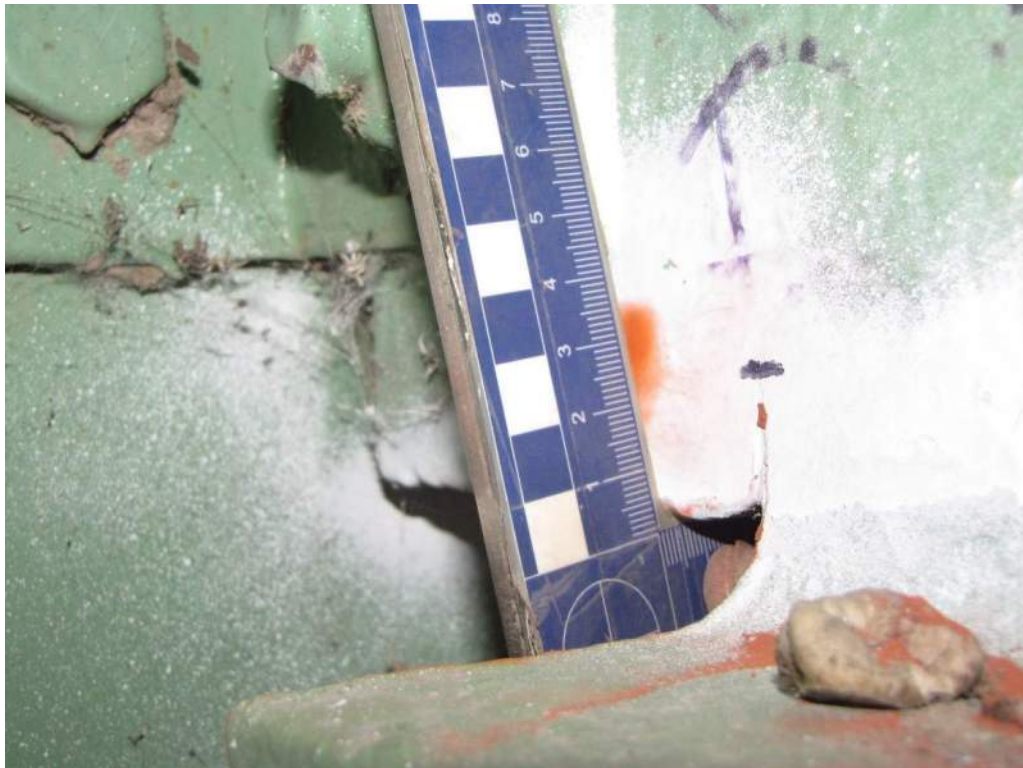
Photo S-59: 25mm notch/crack in the bottom cope of Stringer E (FB10-FB12) at FB10.

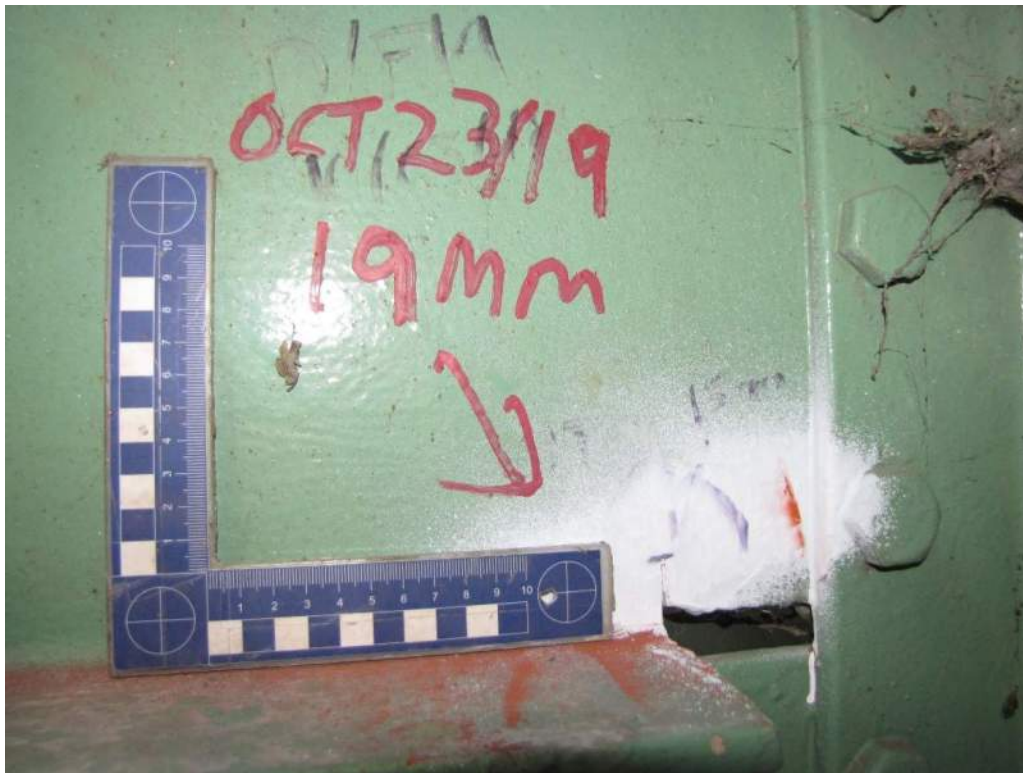
Photo S-60: 19mm notch/crack in the bottom cope of Stringer D (FB14-FB16) at FB14.
