Lasalle Causeway Bascule Bridge

2019 Comprehensive Detailed Inspection Report (Rev. 1)

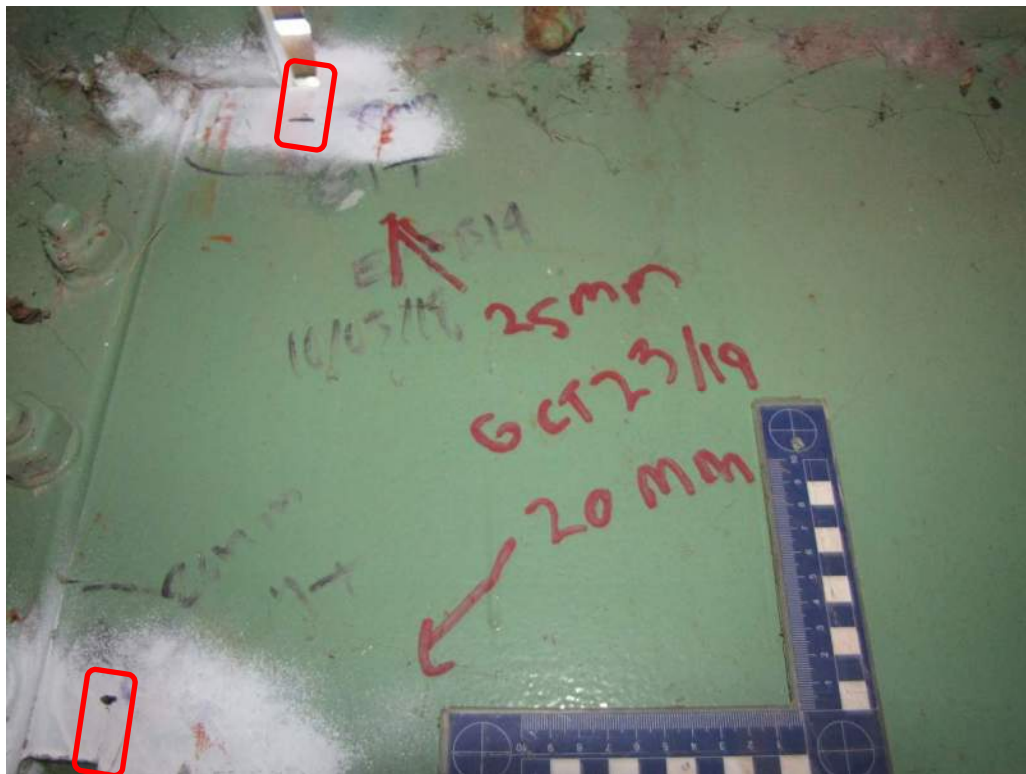
Photo S-61: 20mm notch/crack in the bottom cope and 25mm notch/crack in the top cope of Stringer E (FB14-FB16) at FB14.

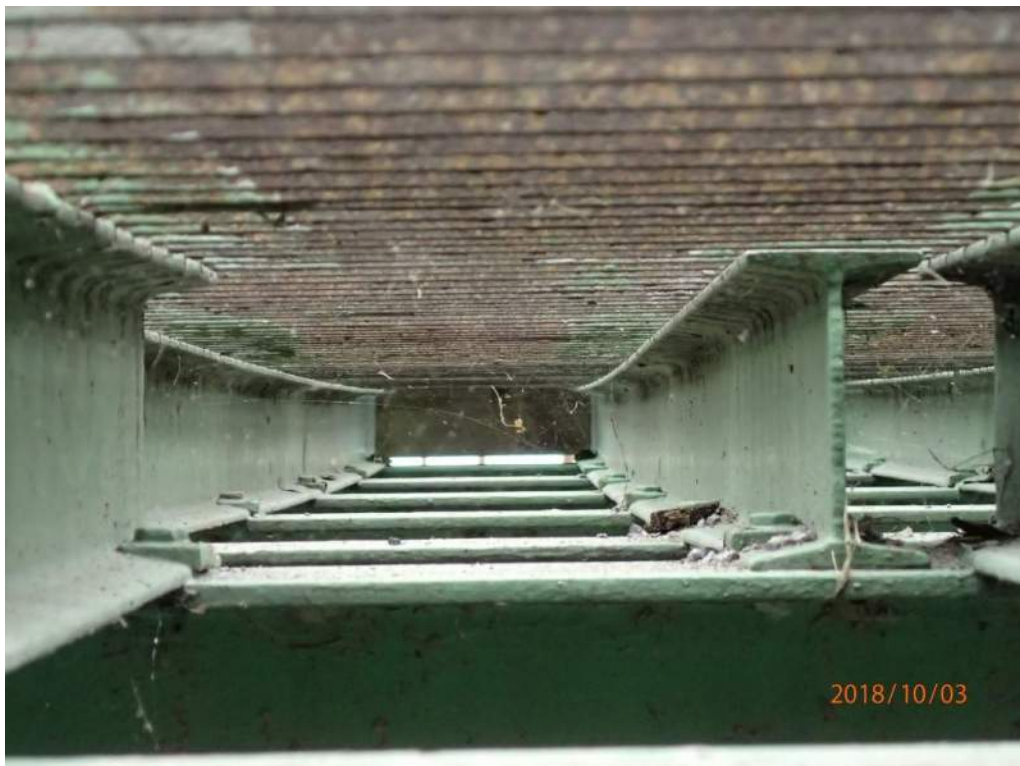
Photo S-62: The sills supporting the deck grating are typically permanently deflected (photo from 2018 CDI).

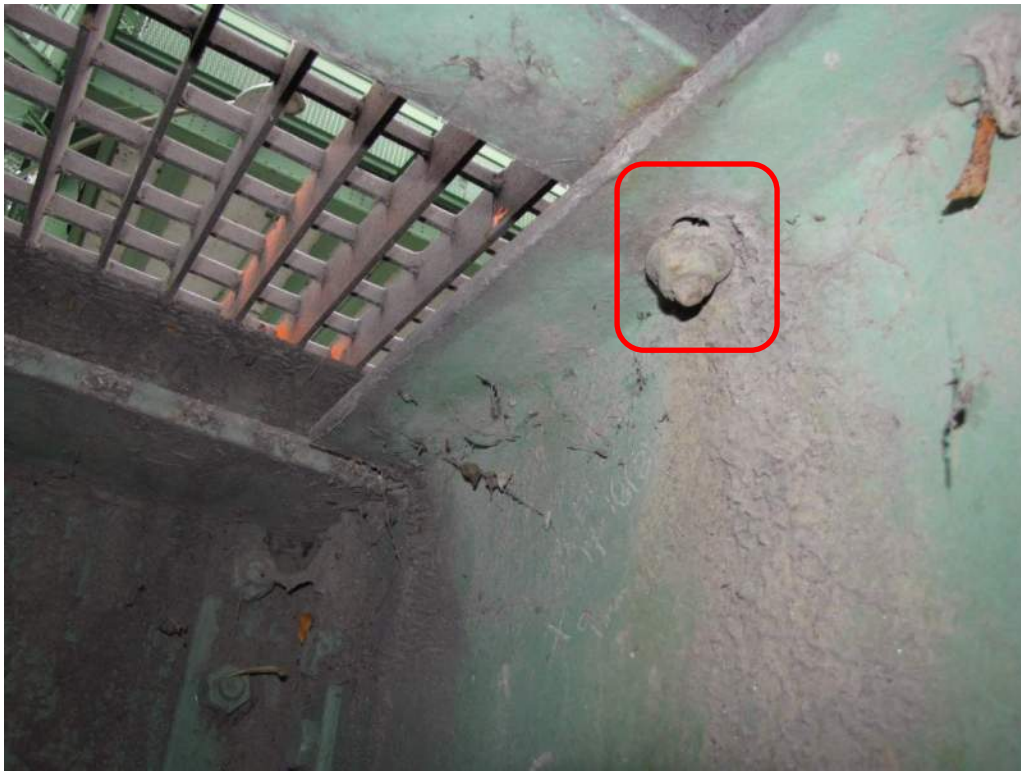
Photo S-64: One of several loose anchor bolts connecting the sills to the stringers. Several others were noted to be missing or severely corroded (not shown).

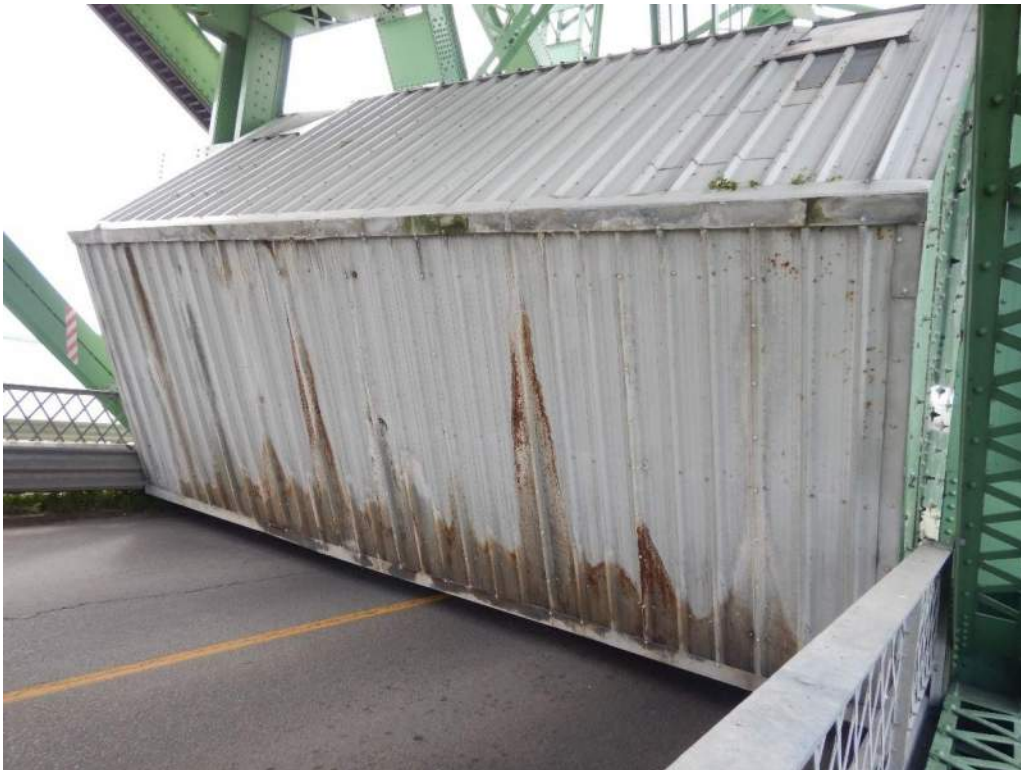
Photo S-65: The panels on the underside of the counterweight have widespread corrosion and wet areas/stains (photo taken when bridge in open position).

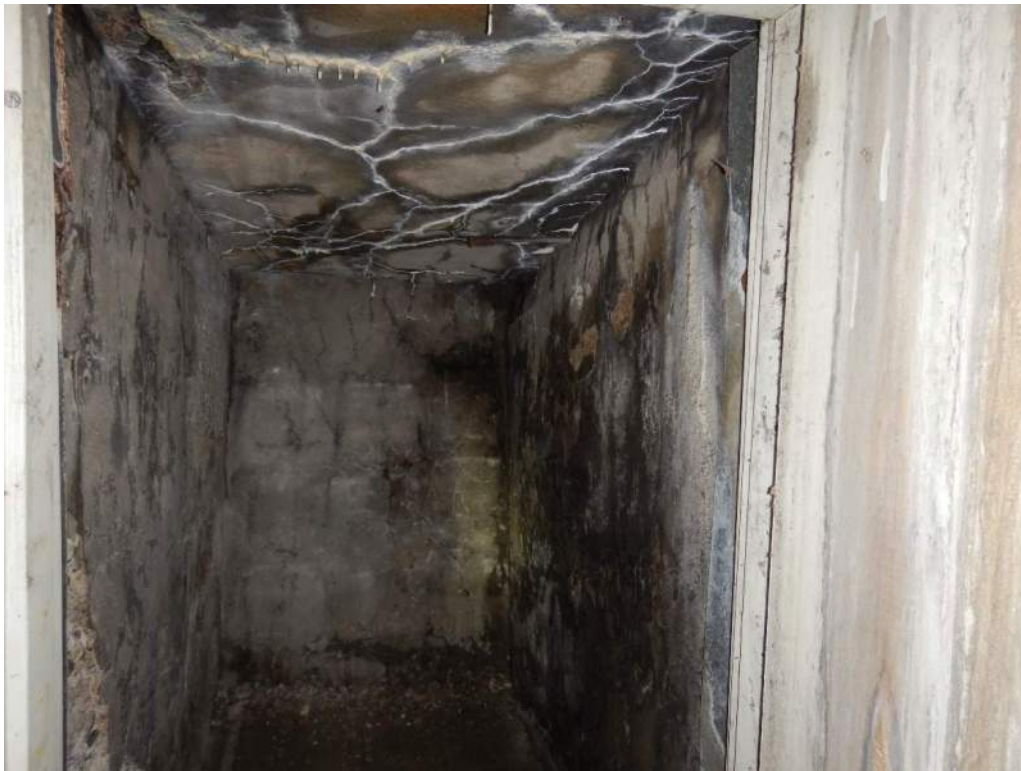
Photo S-66: Spalls, disintegration, map cracking, efflorescence, and wet stains were typically noted in the counterweight concrete inside the two voids in the east face (north void shown).

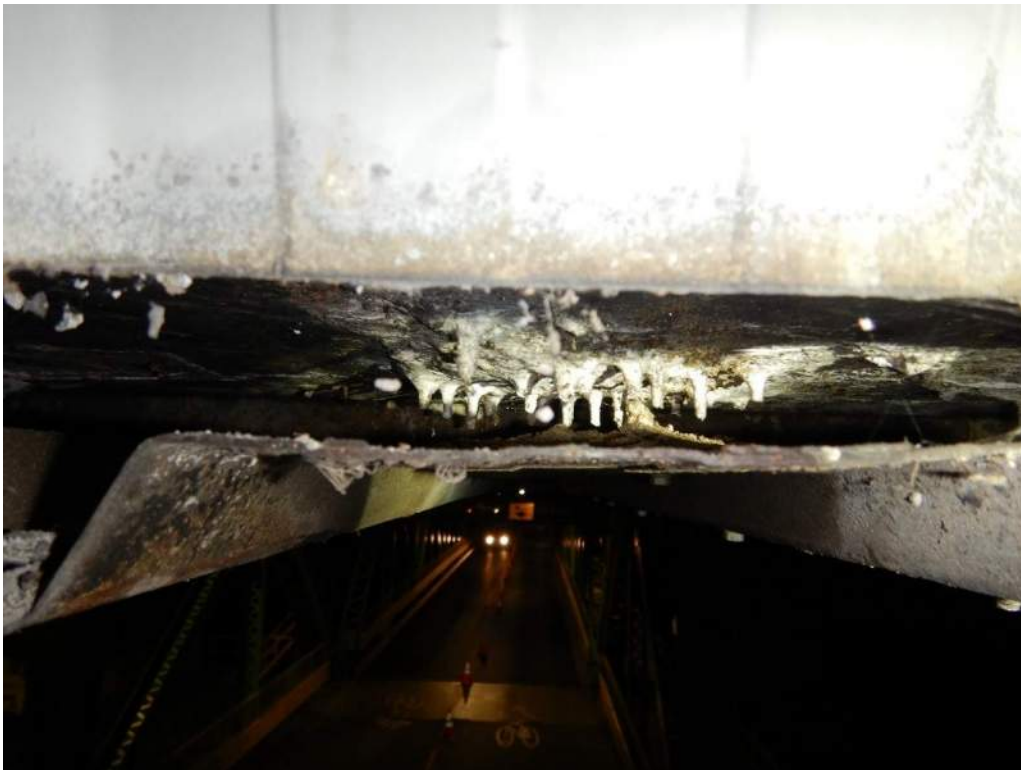
Photo S-67: Efflorescence deposits and staining on the underside of the counterweight concrete (photo taken after removal of the bottom east angle).

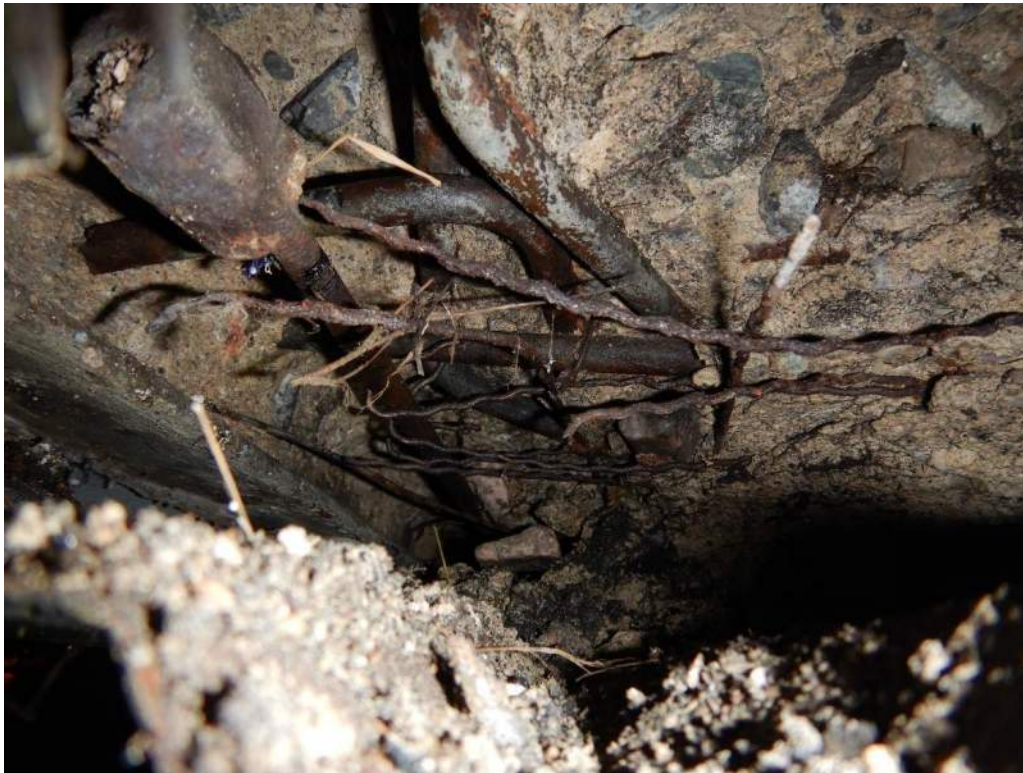
Photo S-68: Exposed, corroded rebar in the soffit of the counterweight at the southeast (photo taken after removal of the bottom east angle).

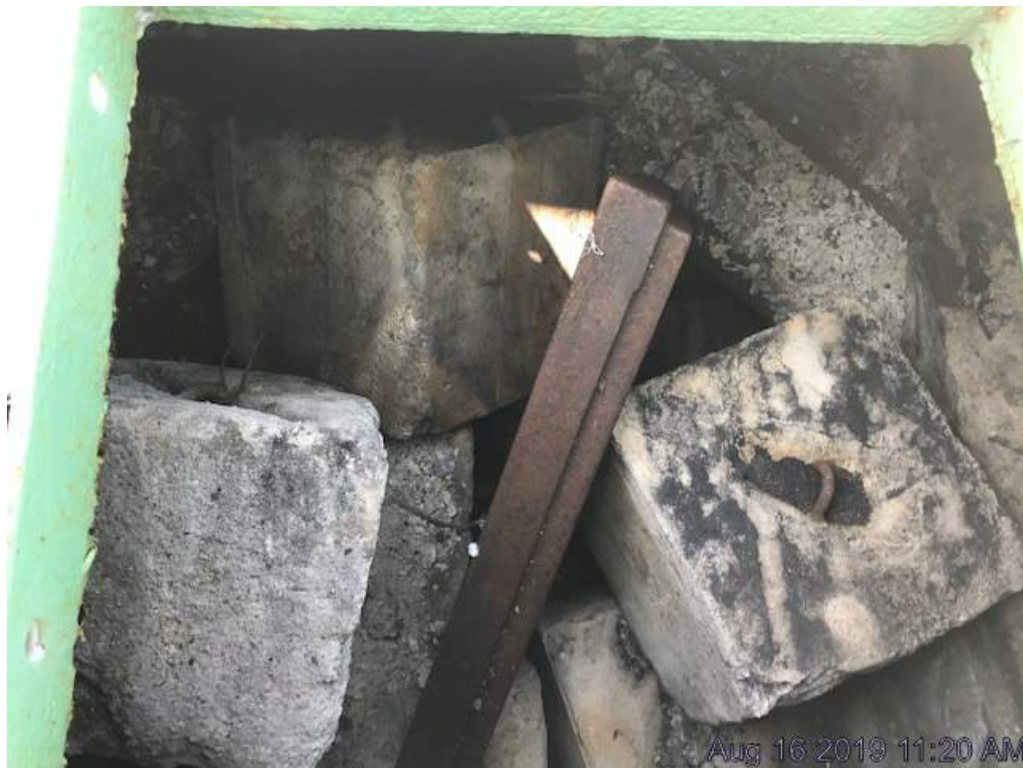
Photo S-69: The concrete in the two upper chambers in the top face of the counterweight exhibits spalls, disintegration, and wet areas (north chamber shown).

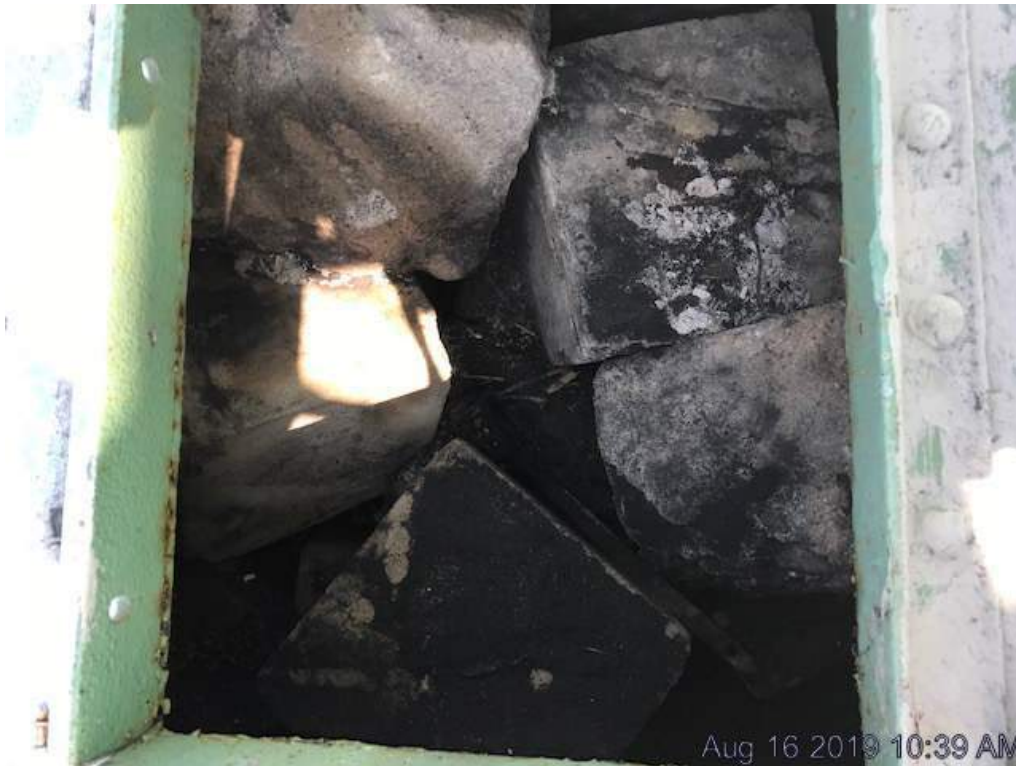
Photo S-70: The concrete in the two upper chambers in the top face of the counterweight exhibits spalls, disintegration, and wet areas (south chamber shown).

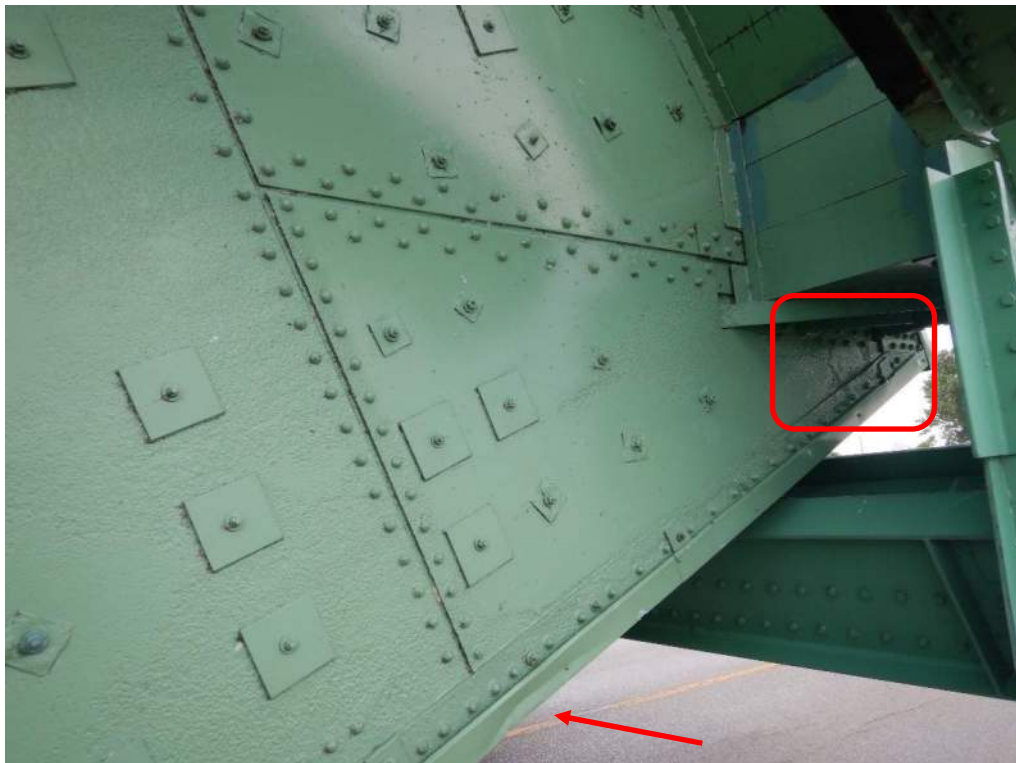
Photo S-71: The north face of the counterweight exhibits light pitting throughout, some localized areas of deep pitting, and an area of impact damage at the northwest corner (photo taken when bridge in open position).

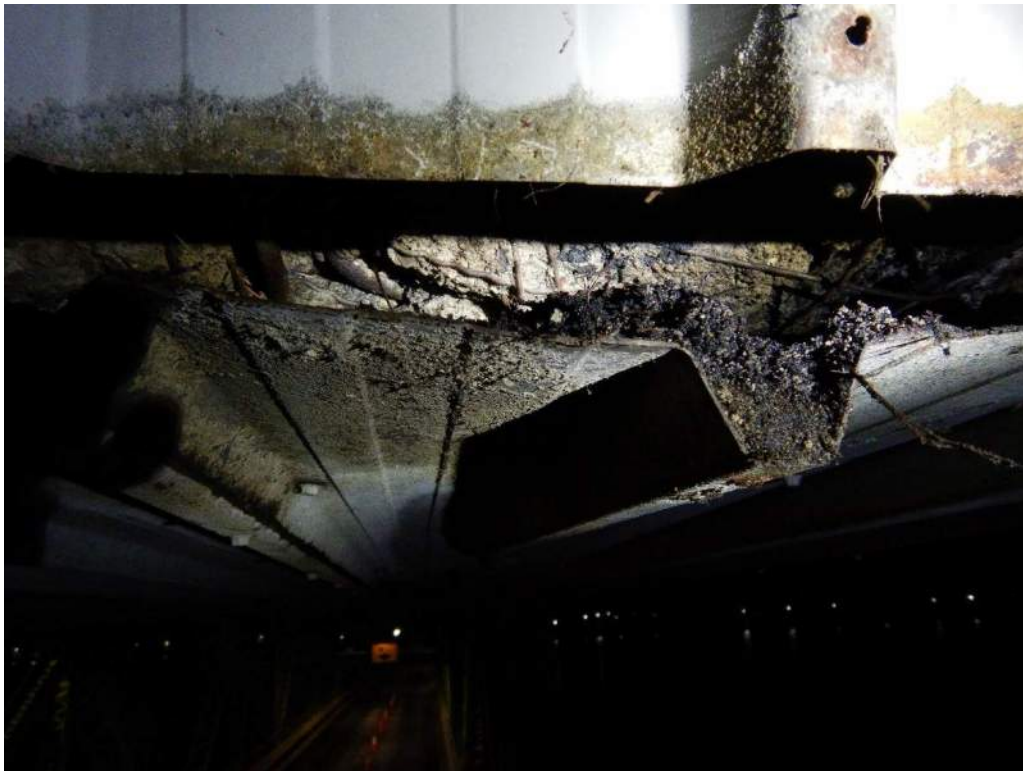
Photo S-72: Disintegrated counterweight concrete accumulating on the soffit cladding of the counterweight on the west side (photo taken after removal of bottom west angle, prior to removal of the debris).

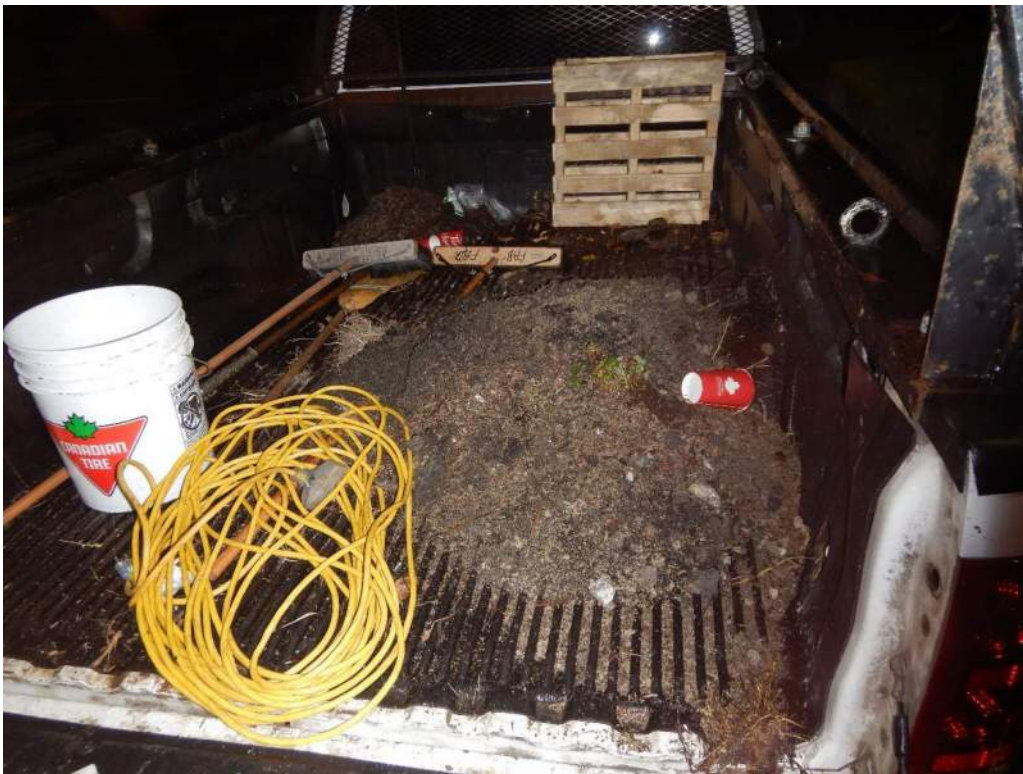
Photo S-73: Total amount of loose debris removed from the counterweight estimated to be between 45-70 kg.

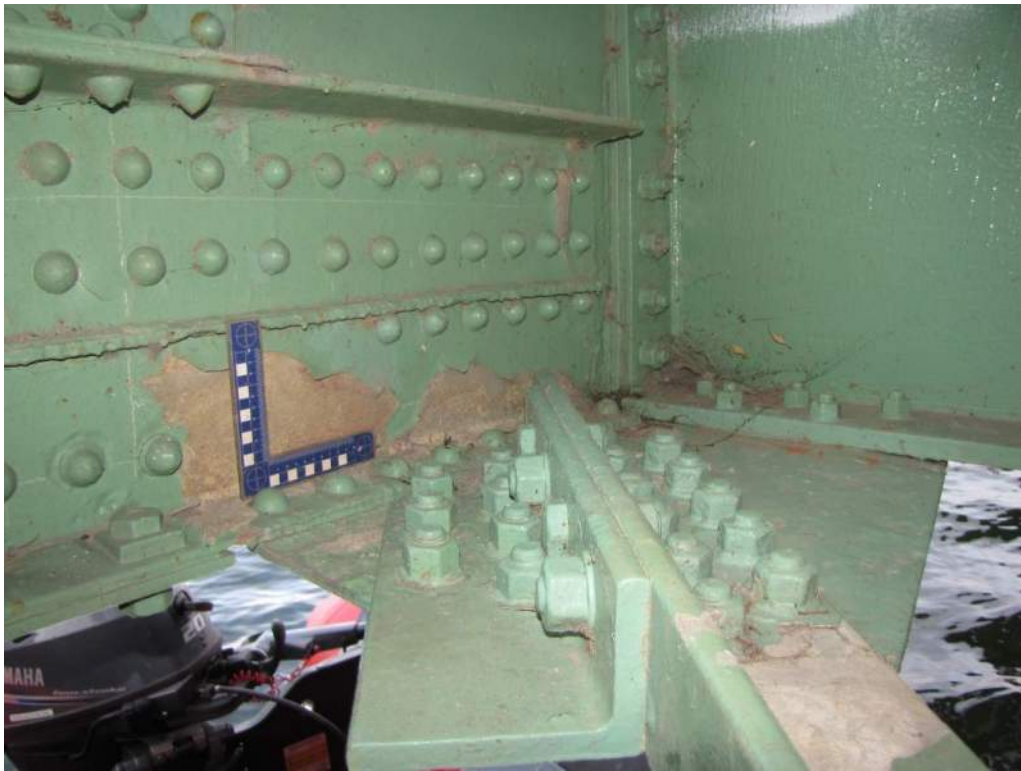
Photo S-74: The painted coating is cracking and peeling off at several locations on the structure (node 14N below deck shown).

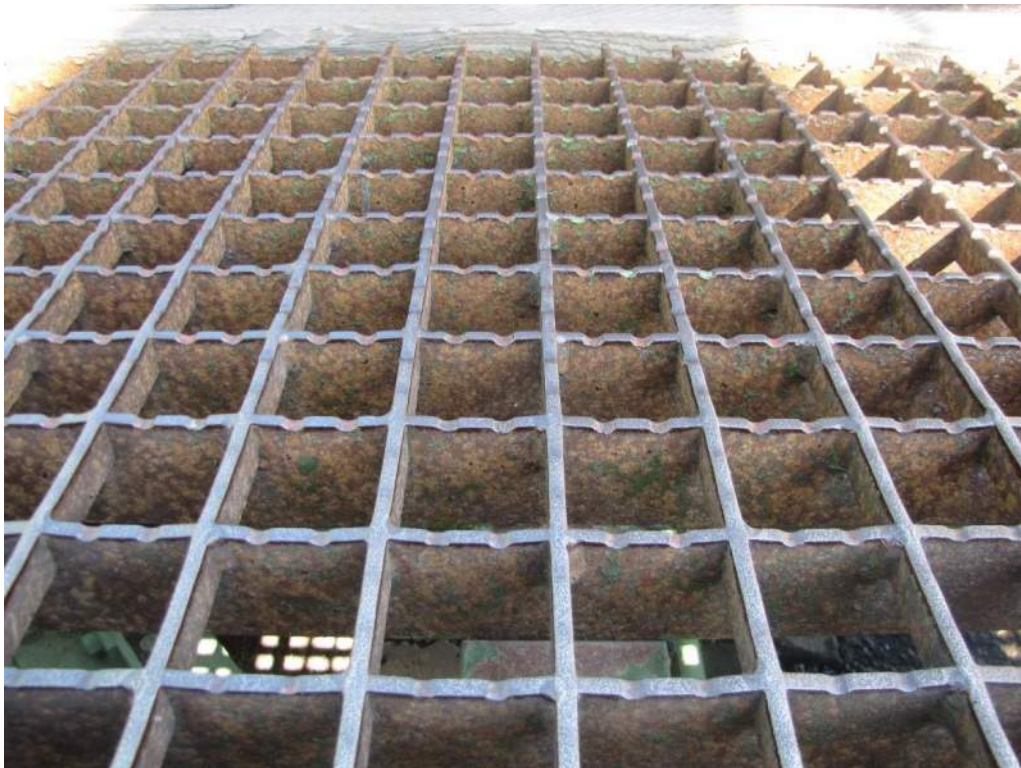
Photo S-75: The roadway grating has widespread light to medium corrosion along the north and south edges (north side shown). The serrated edges have been completely worn away within the wheel tracks.

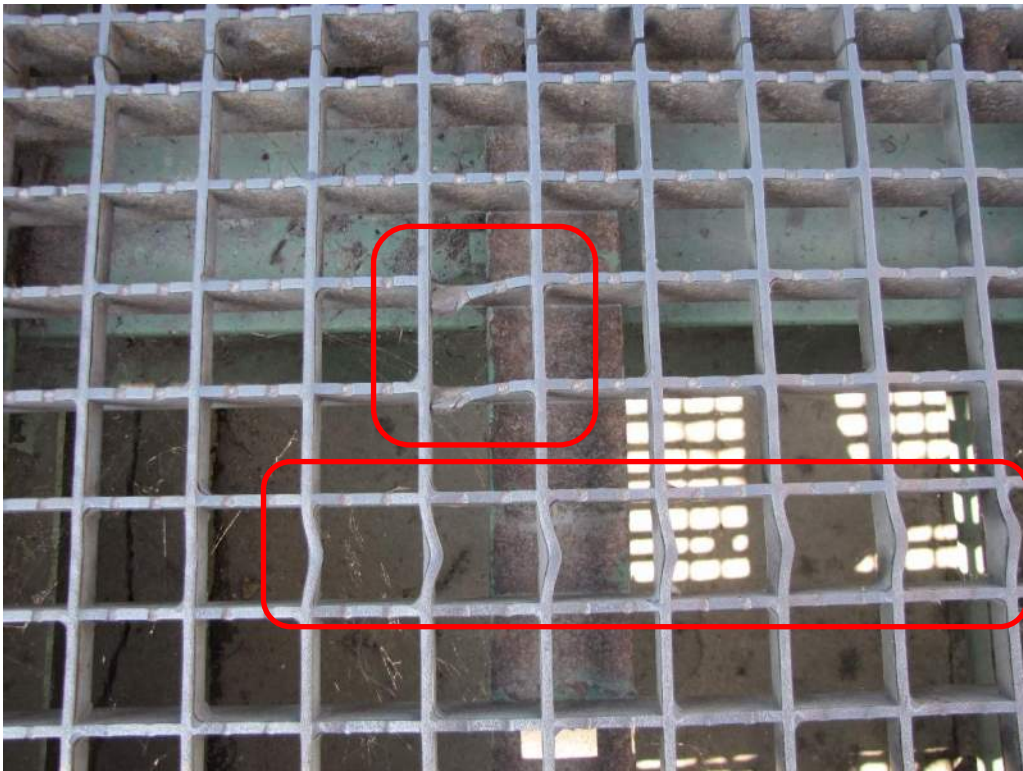
Photo S-76: Cracked bearing (top) and bent cross (bottom) bars in deck grating panel 15-16 B.

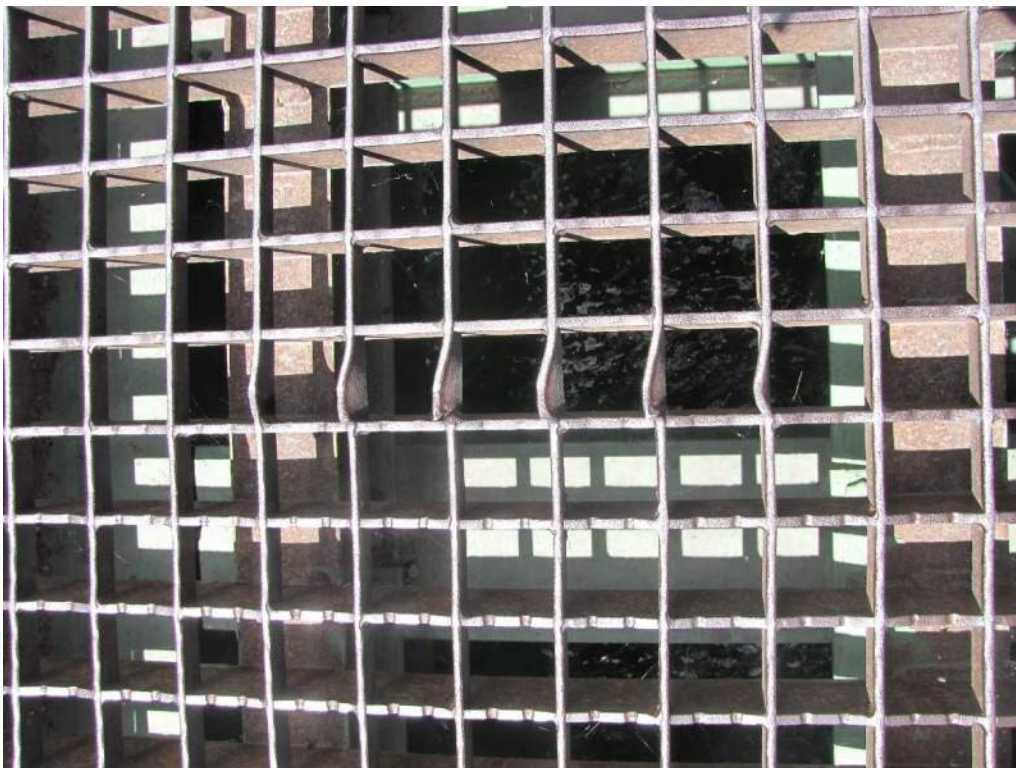
Photo S-77: Broken and bent cross bars in deck grating panel 0-2 F. The serrated edges have been completely worn away within the wheel tracks (at top of photo).

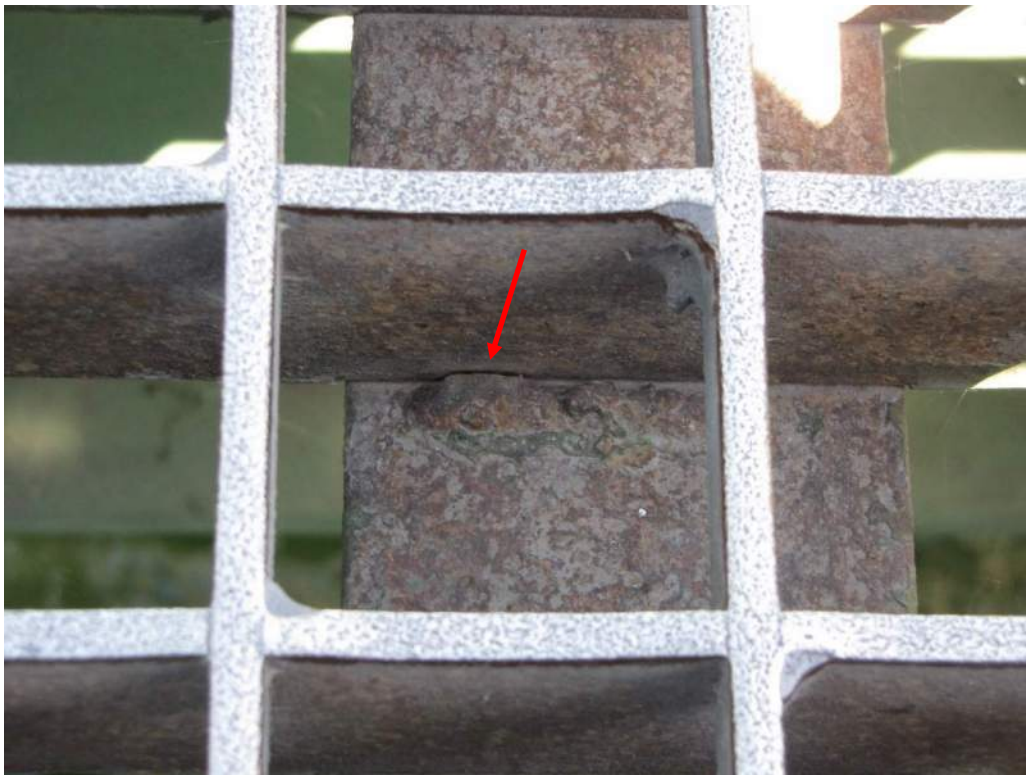
Photo S-78: Cracked bar-to-sill weld in deck grating panel 2-4 C. The serrated edges have been completely worn away within the wheel tracks.

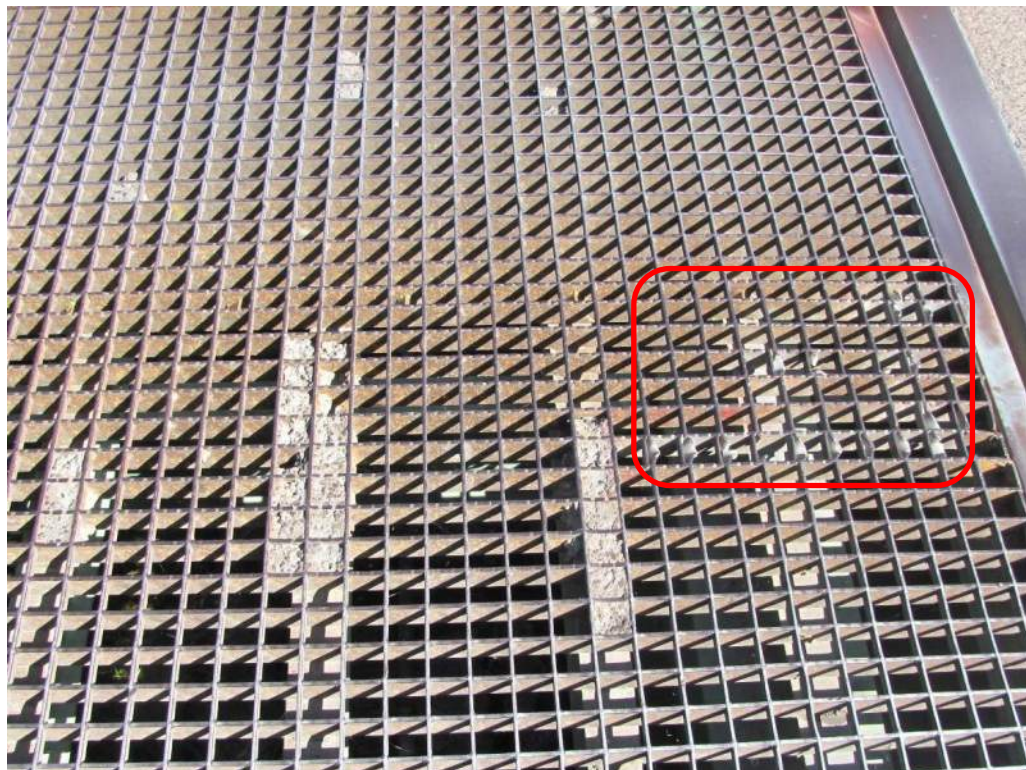
Photo S-79: Cross bar steel repairs (in red), and concrete in voids at the east end of the deck grating.

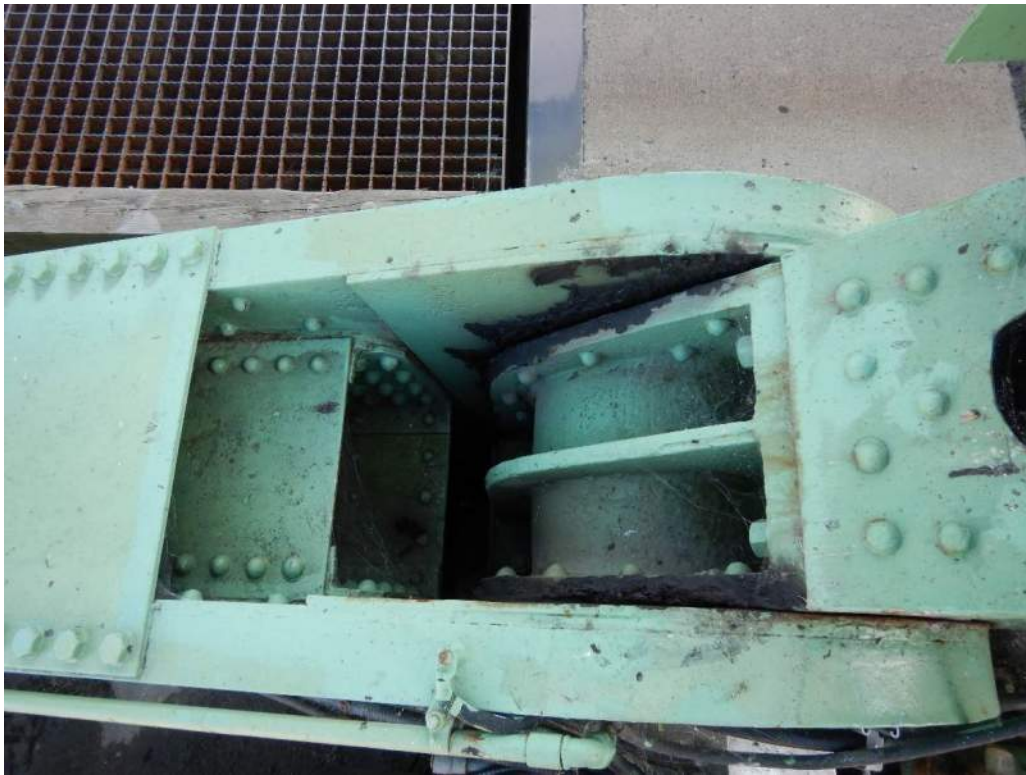
Photo S-80: View of the top of the north trunnion (node 15N).

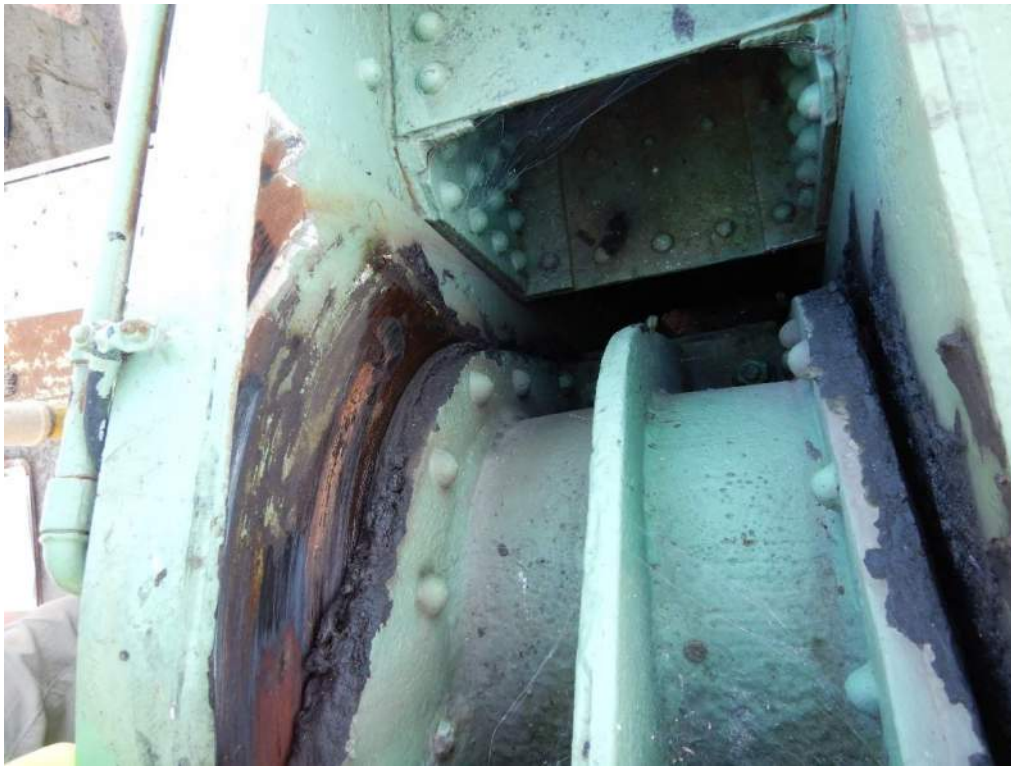
Photo S-82: Areas of coating on the interior of the north plate of the north trunnion have been worn away.

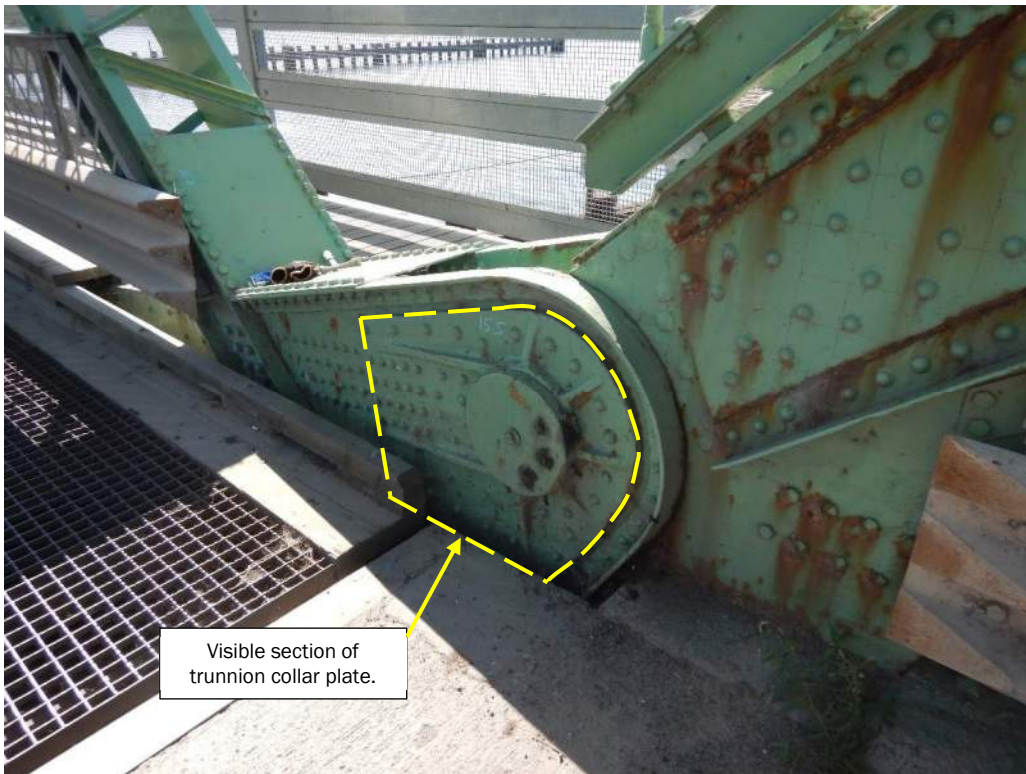
Photo S-83: The north (roadway) side of the south trunnion. Note that there is no railing between the pedestrian sidewalk and roadway.

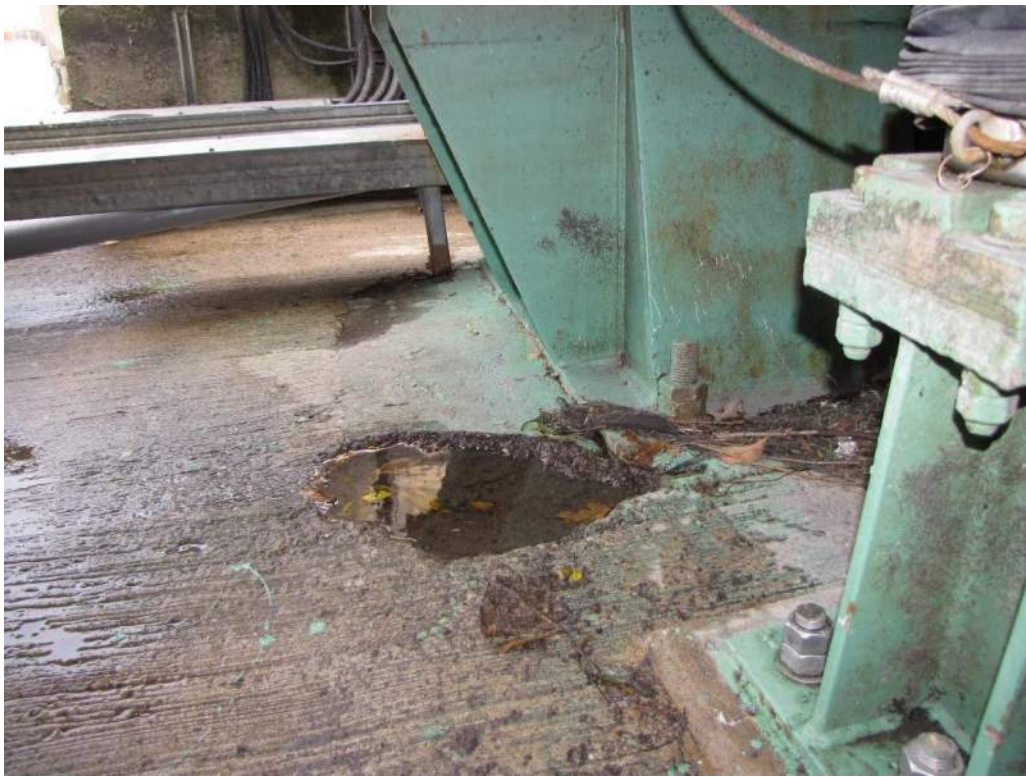
Photo S-84: Spall in the east bearing seat with an area of about 500mm².

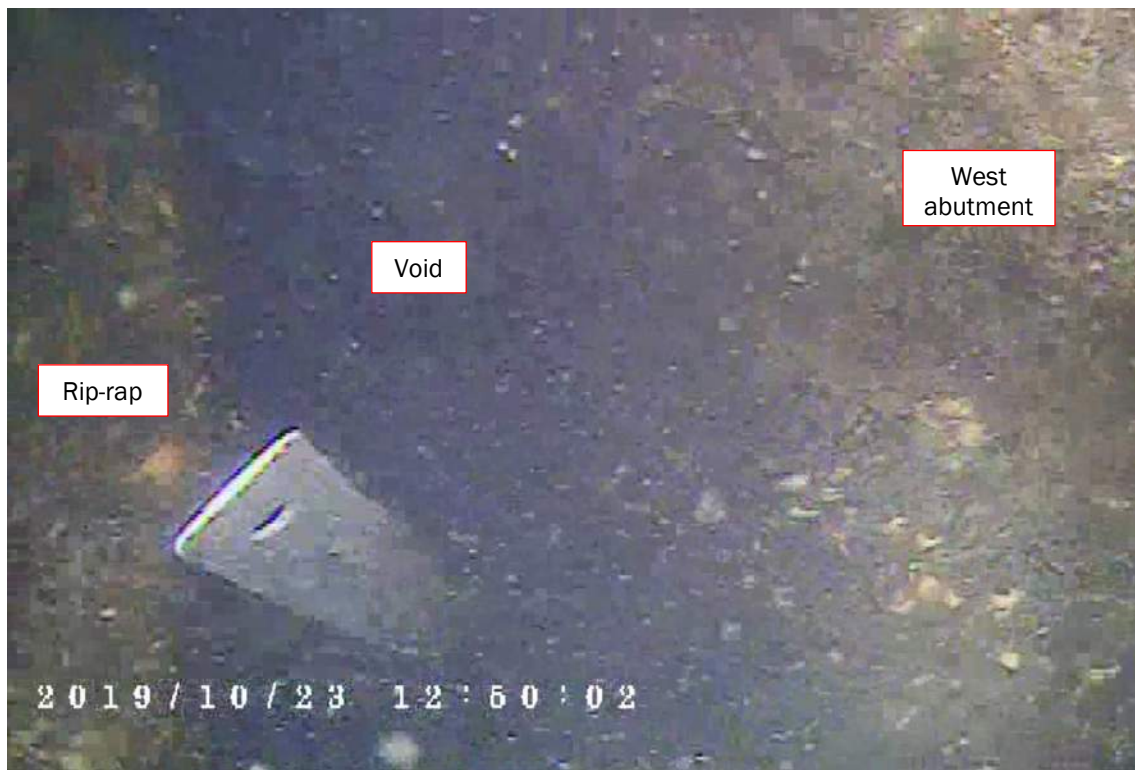
Photo S-85: Triangular void with an area of 1000mm by 800mm and depth of 300mm at the sheet pile/rip-rap interface at the south side of the west abutment of the Bascule Bridge.

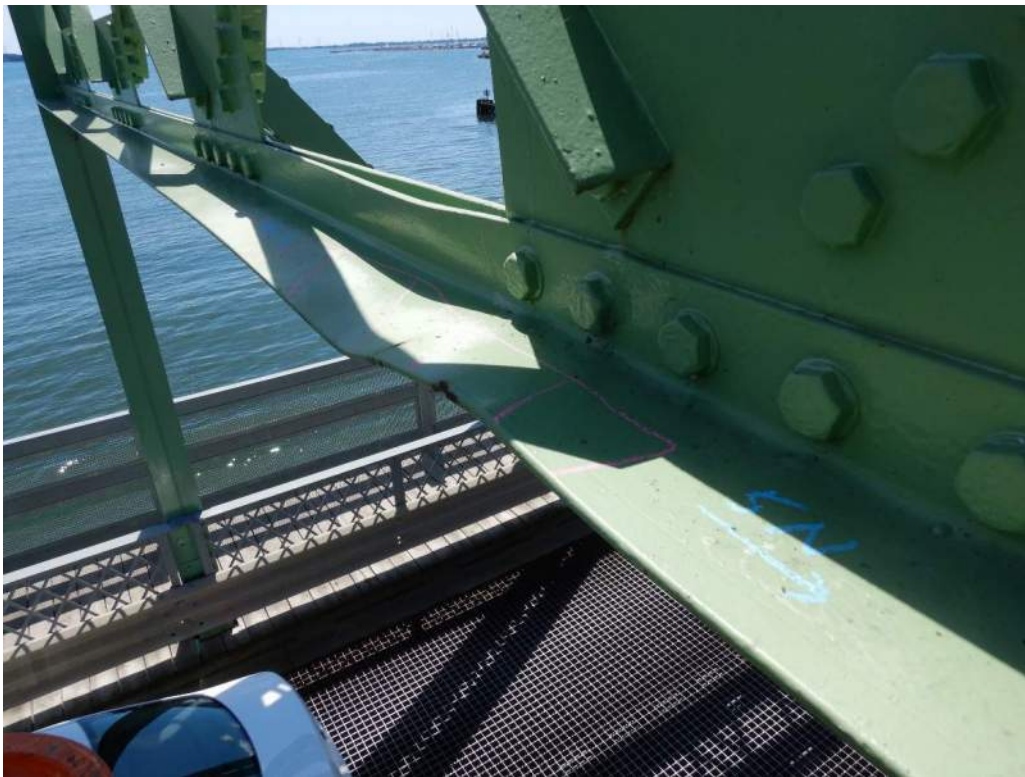
Photo S-88: Severe impact damage to the bottom east angle of through truss sway brace member 5S-5N.

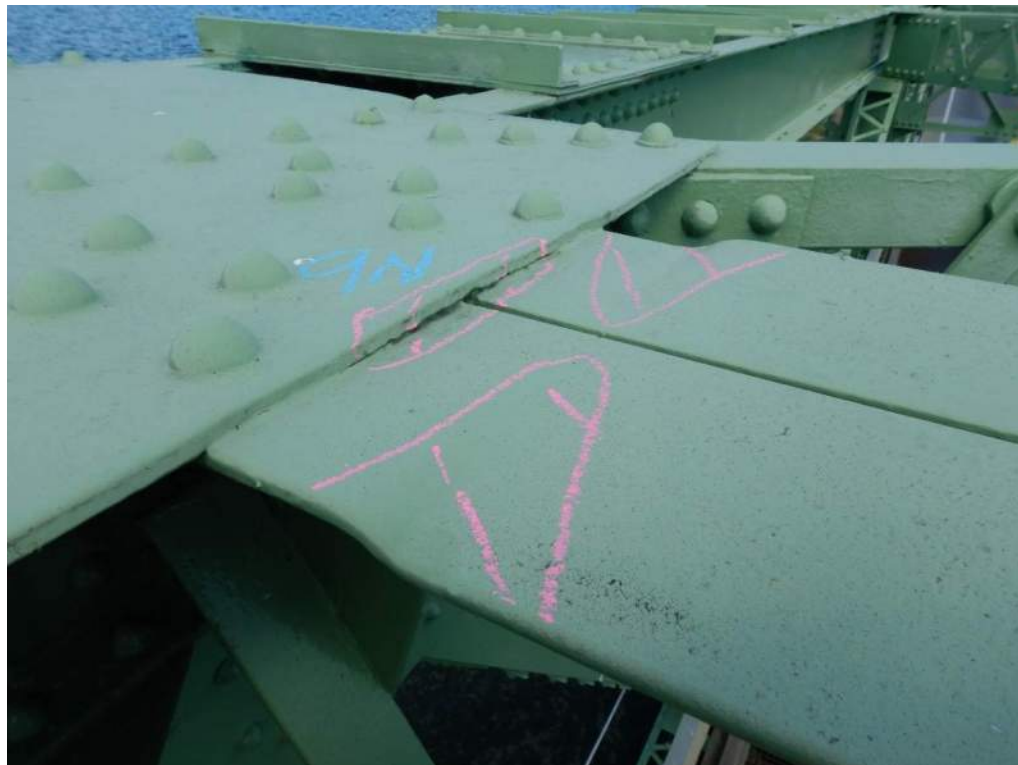
Photo S-89: Deformation of sway bracing member 9S-9N at node 9N.

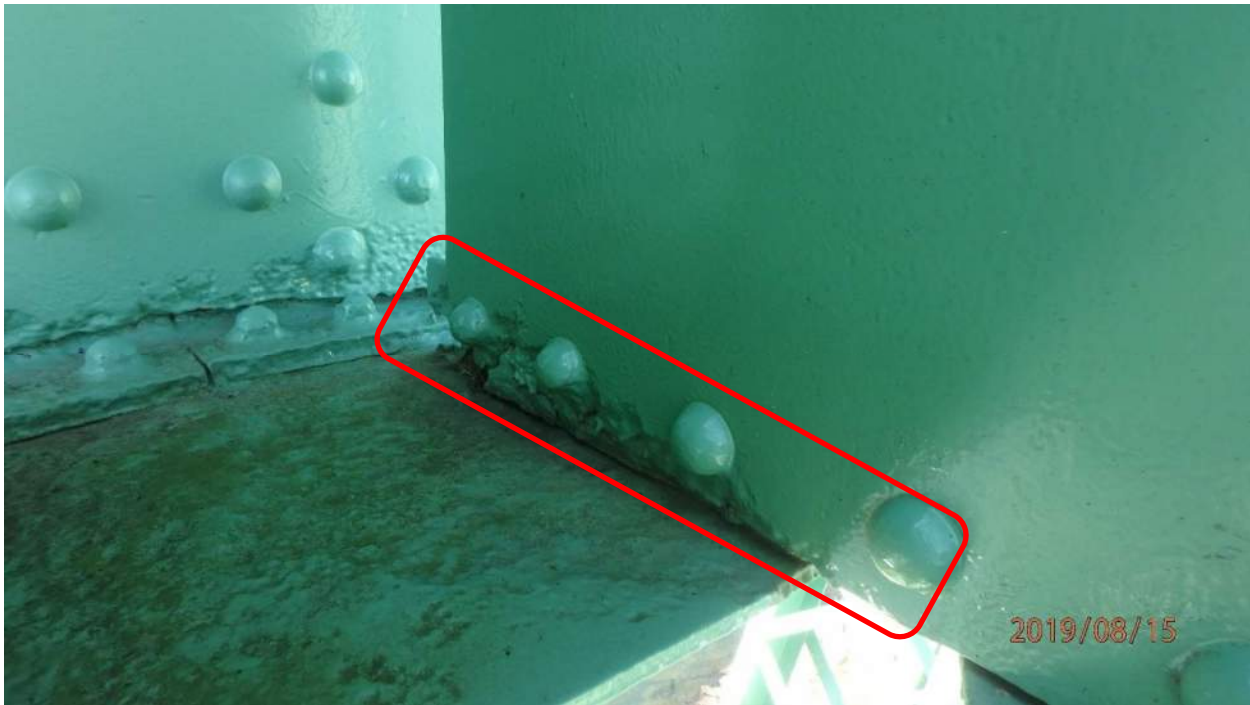
Photo S-92: Bottom west angle of counterweight truss lateral strut member 23N-23S has active corrosion and perforations at last 3 rivets at node 23S.

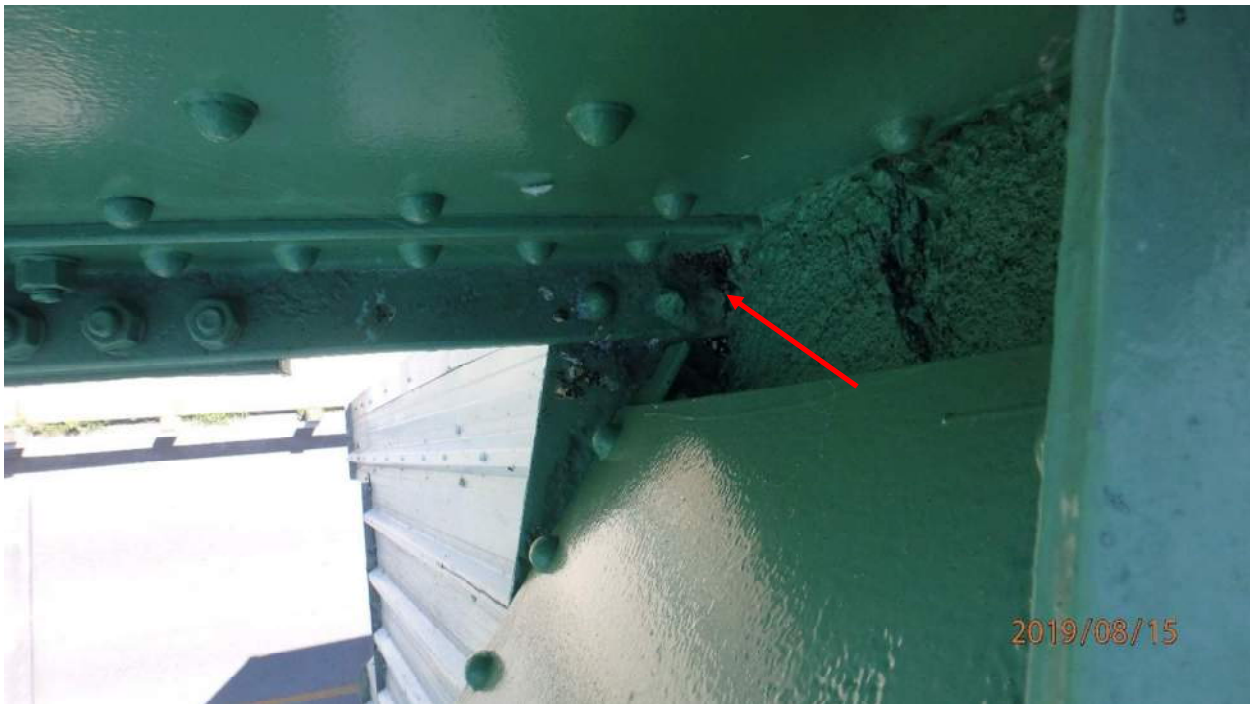
Photo S-93: Counterweight truss member 21S-27N has severe localized section loss of the lower south angle at the west end at node 27N.
