Lasalle Causeway Bascule Bridge

2019 Comprehensive Detailed Inspection Report (Rev. 1)

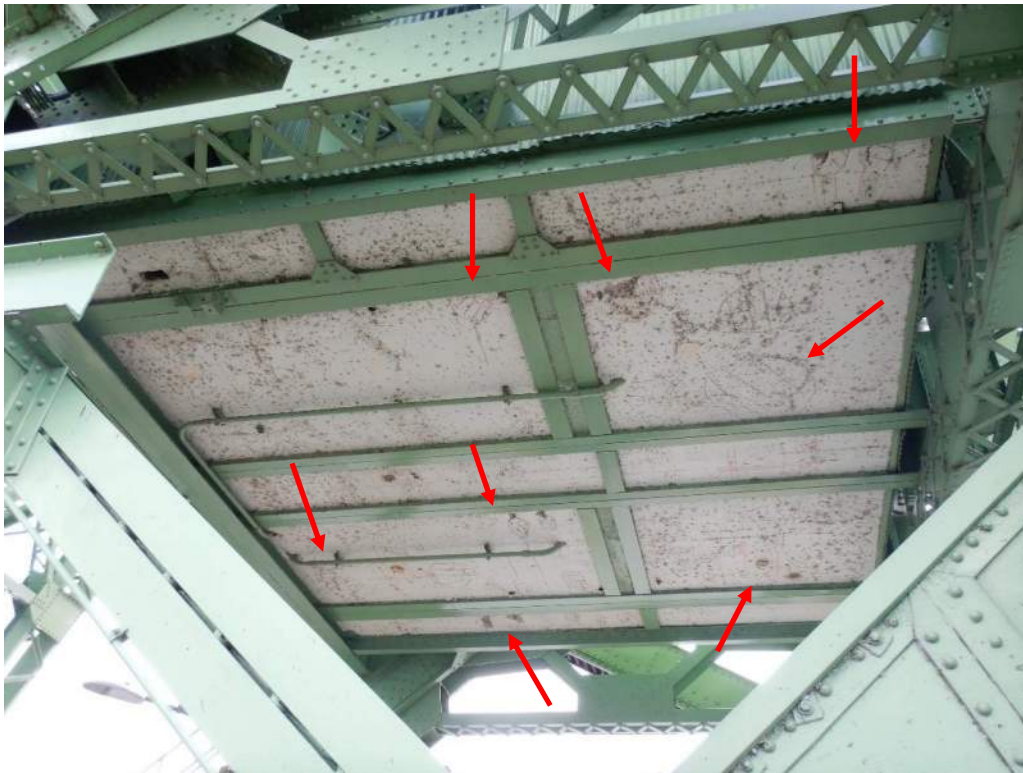
Photo S-96: The mechanical room soffit exhibits several spalls and delaminated areas (some areas indicated). Scaling of the delaminated areas is recommended as they are located over the roadway.

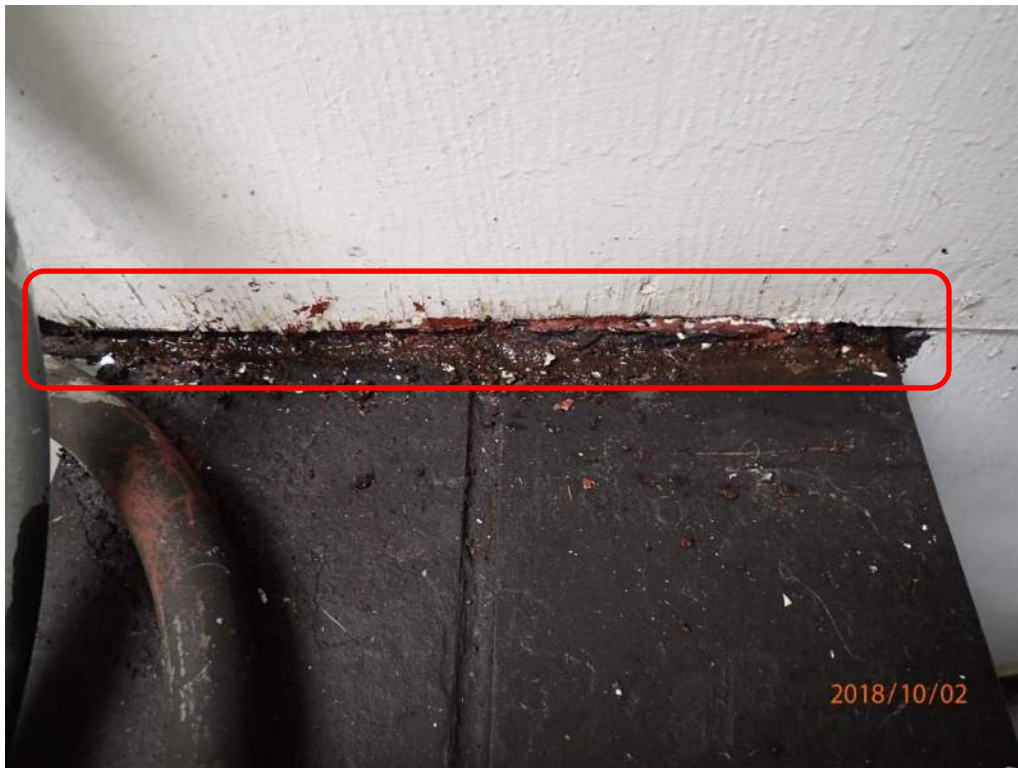
Photo S-97: Water was leaking into the northwest corner of the mechanical room during the inspection. Over time this has caused corrosion of the top flange of one of the steel beams supporting the motors. (photo from 2018 CDI).

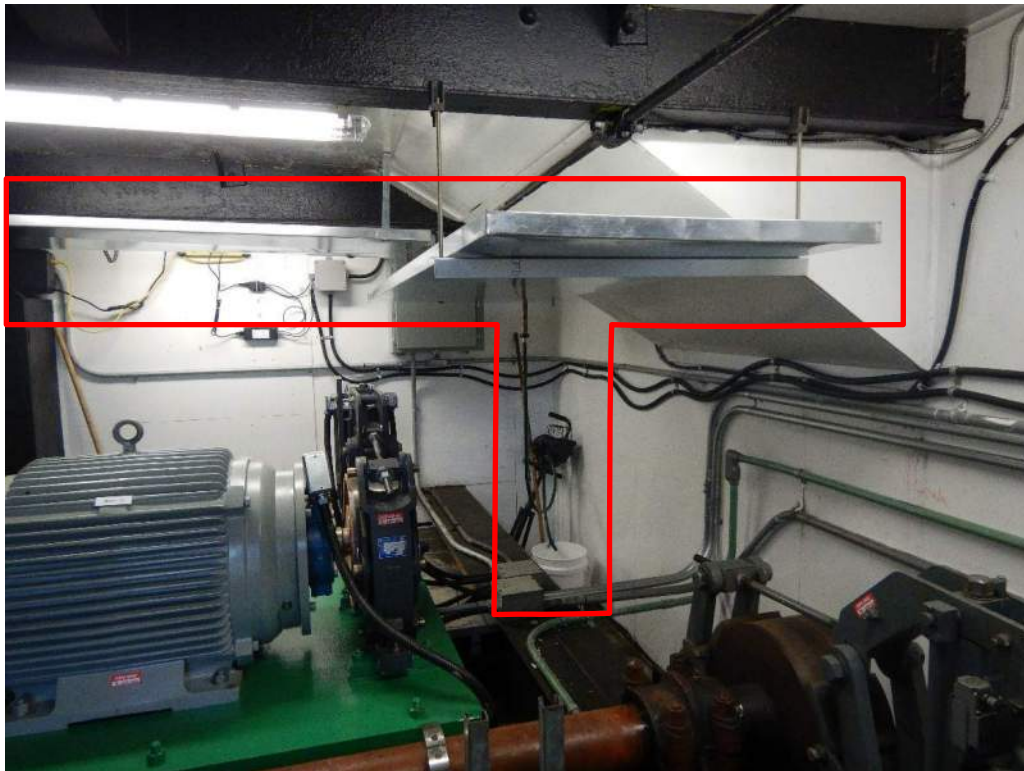
Photo S-98: A system of 2 metal trays leading to a bucket was installed in the mechanical room to catch leaking water from the roof.

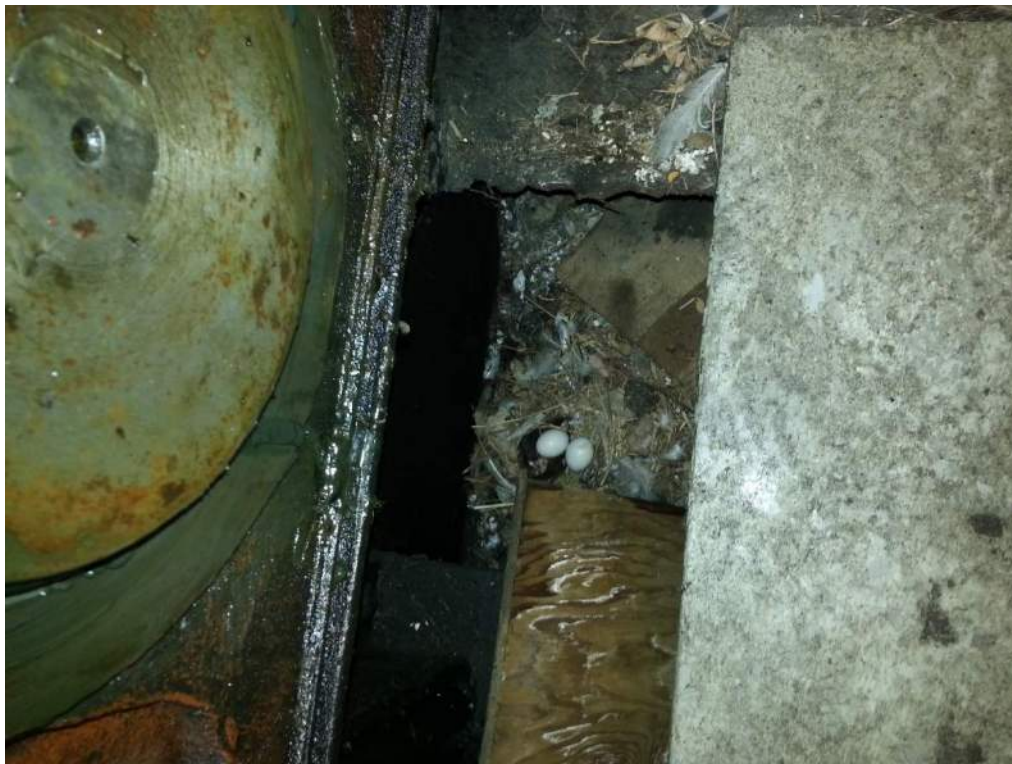
Photo S-99: Bird's nest with eggs in the mechanical room at the south side at time of August 2019 inspection.

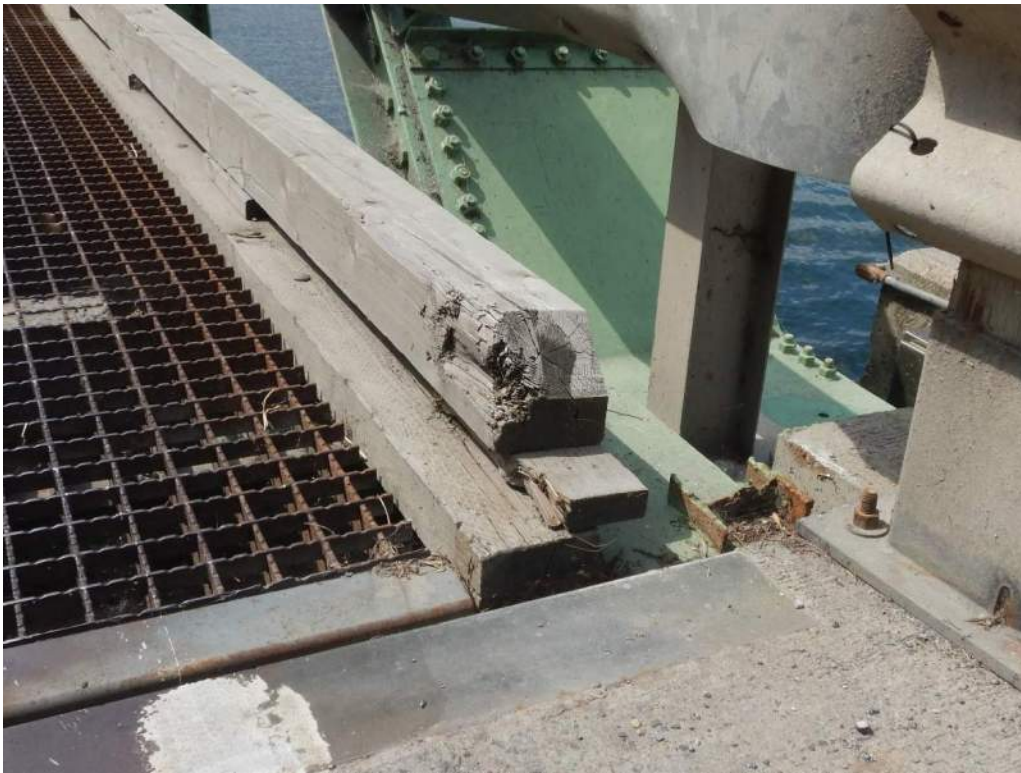
Photo S-102: The east end of the north timber cur has some minor impact damage and is not anchored to the deck.

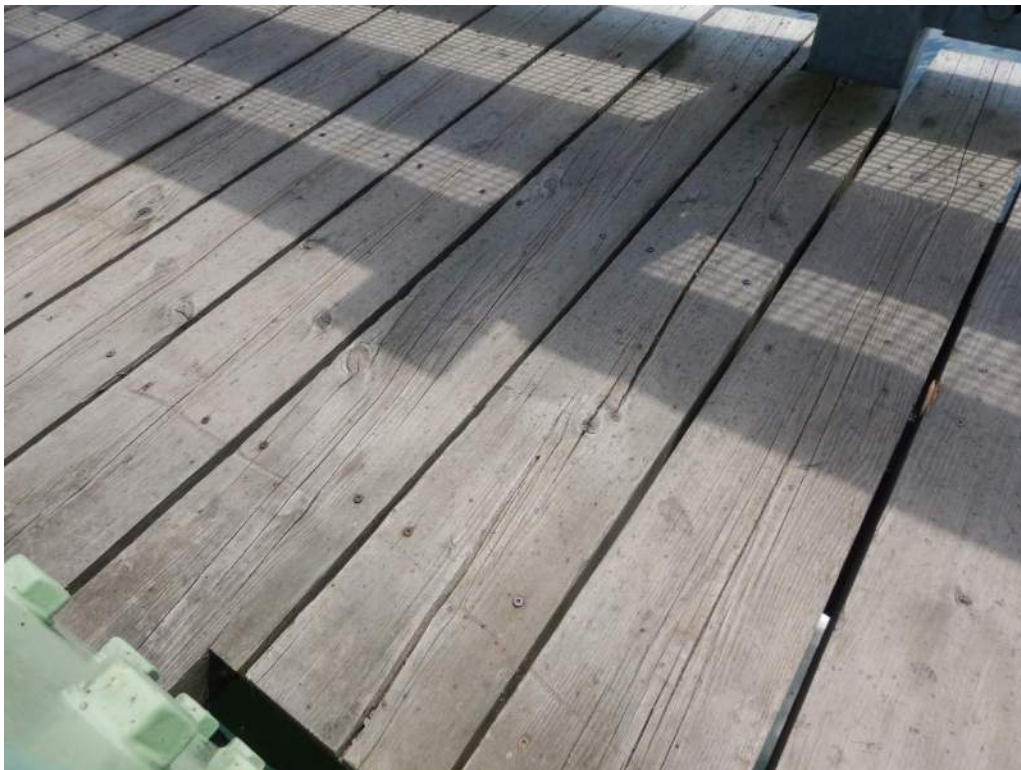
Photo S-103: Light to severe splitting and checks throughout sidewalk timber decking.

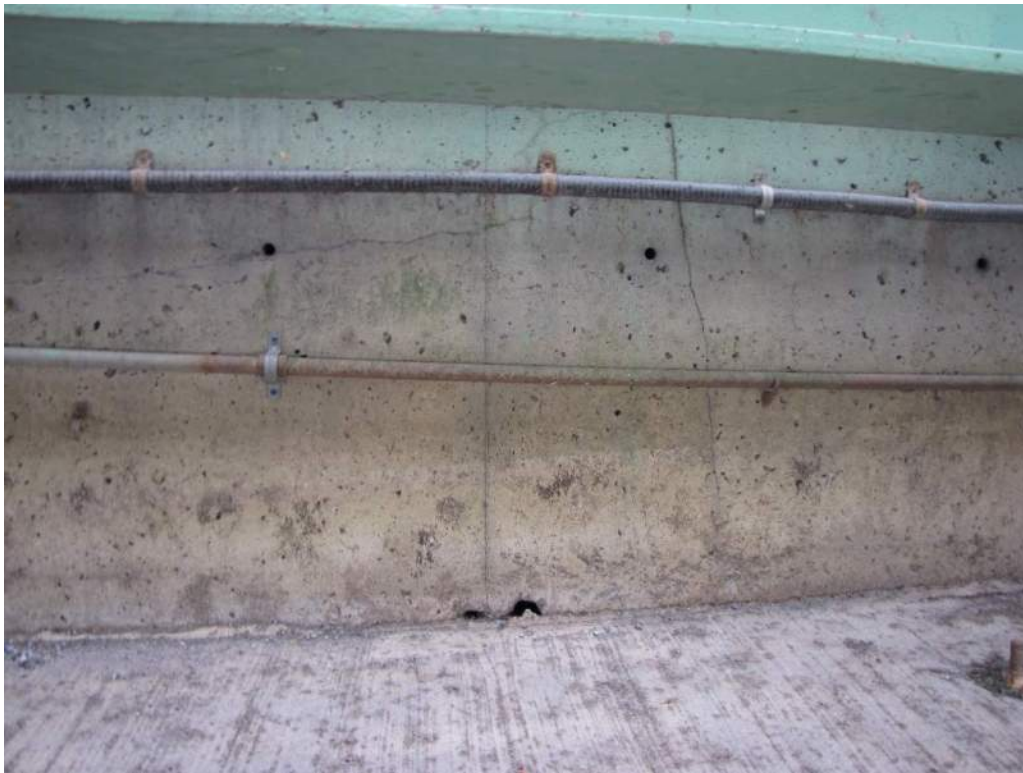
Photo S-104: Wide diagonal and vertical crack in the east ballast wall. Also note the 2 holes at the bottom of the wall, each with an area of 100 mm².

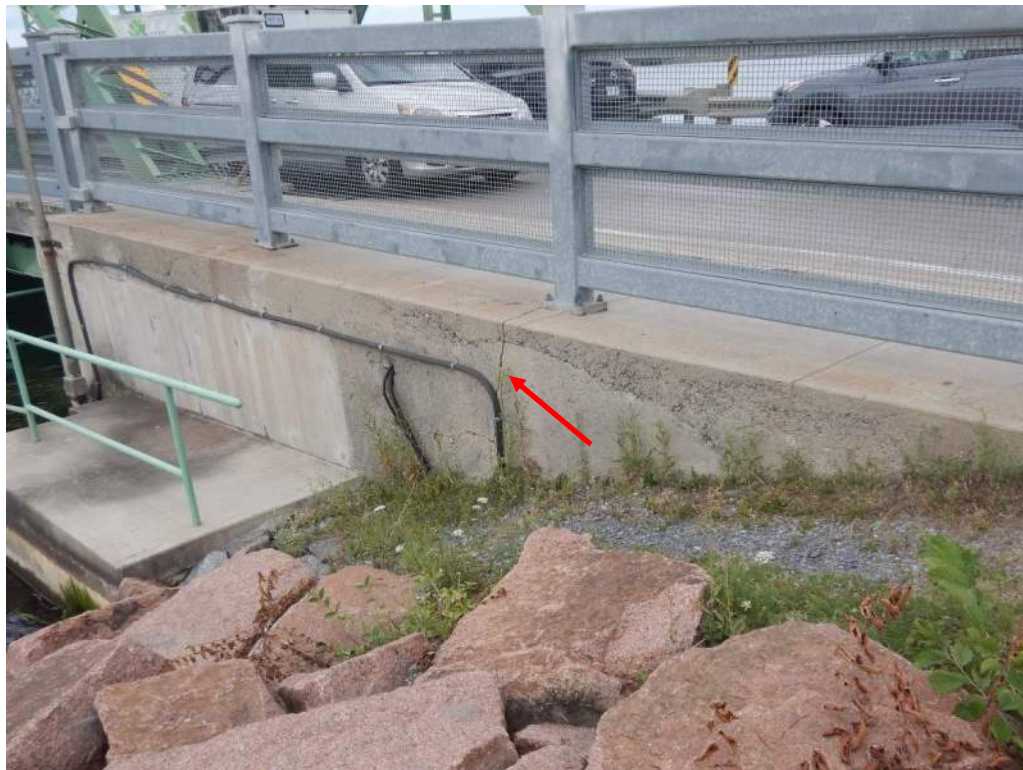
Photo S-105: The southeast wingwall exhibits extensive light honeycombing and a 10mm wide vertical crack extending into the concrete approach sidewalk.

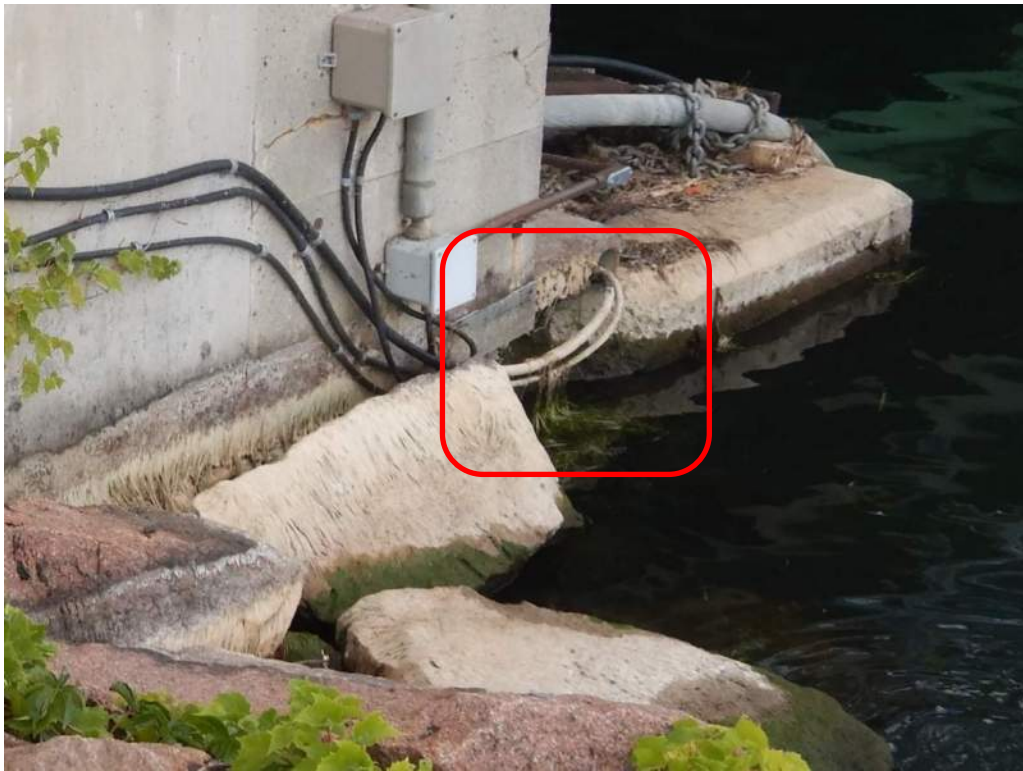
Photo S-106: Very severe spall at the base of the southwest wingwall at the interface with the abutment. Note that about half of the spall is below the water level at the time of the inspection. Also note the vegetation growth occurring below the high-water level.

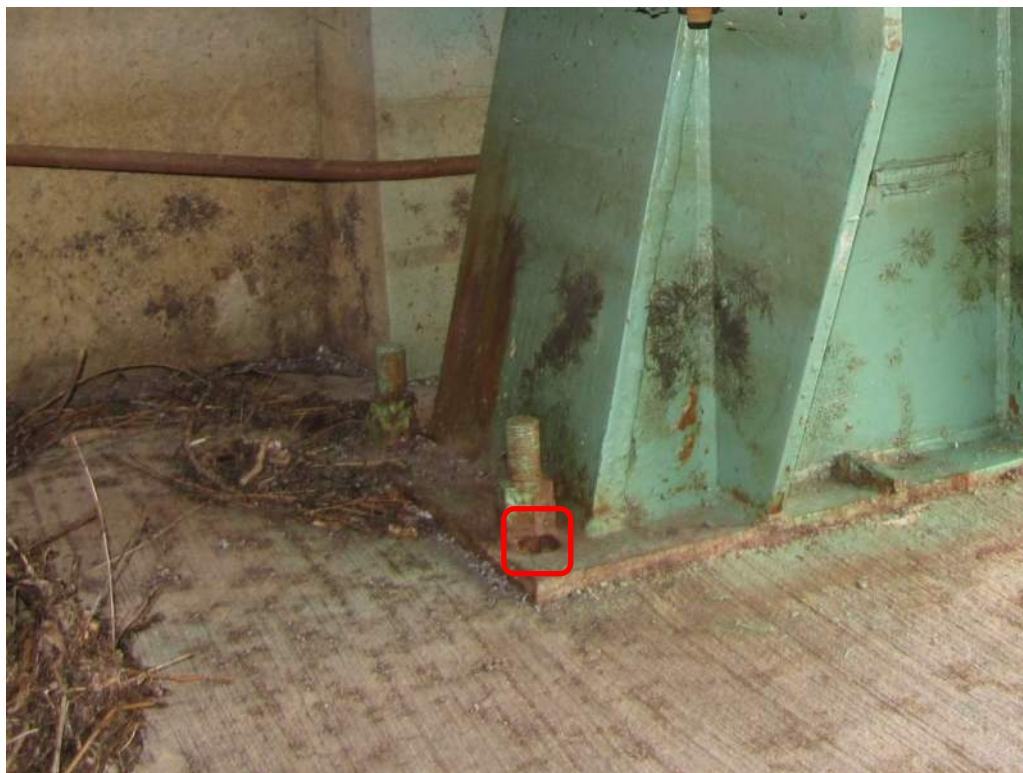
Photo S-107: The northwest anchor bolt of the southeast live load support is bent and exhibits medium to severe corrosion.

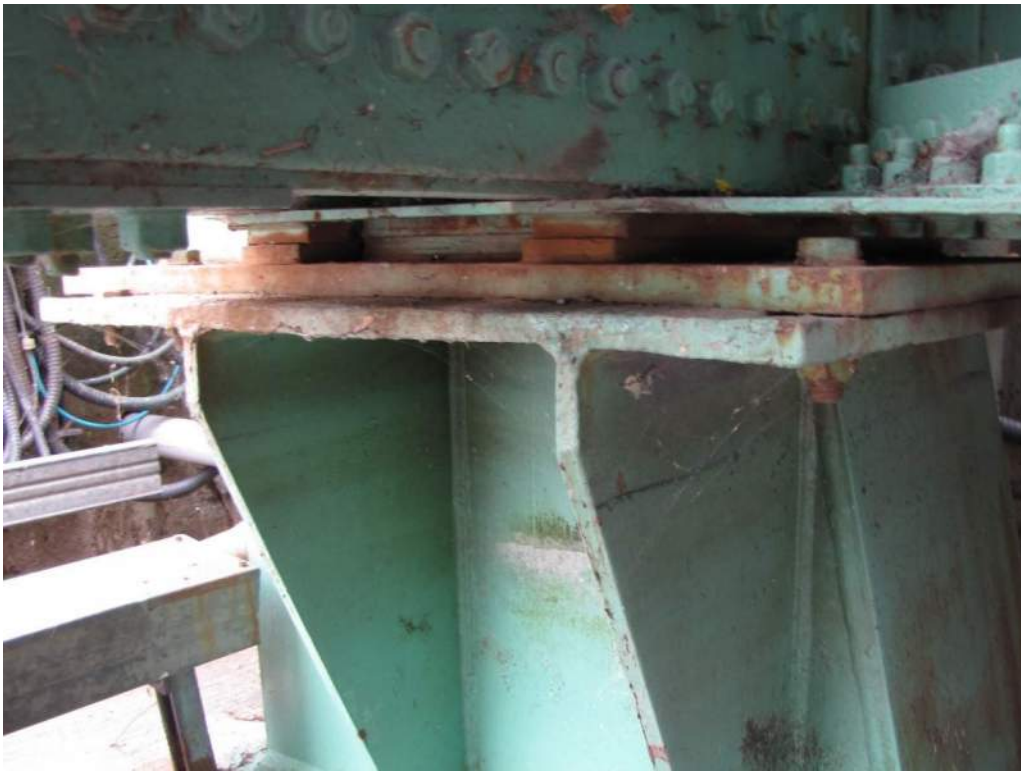
Photo S-108: The leaf span is not fully seated on the north live load support and only seats fully when vehicles are on the east end of the deck. Note the light corrosion occurring on the bearing plate.

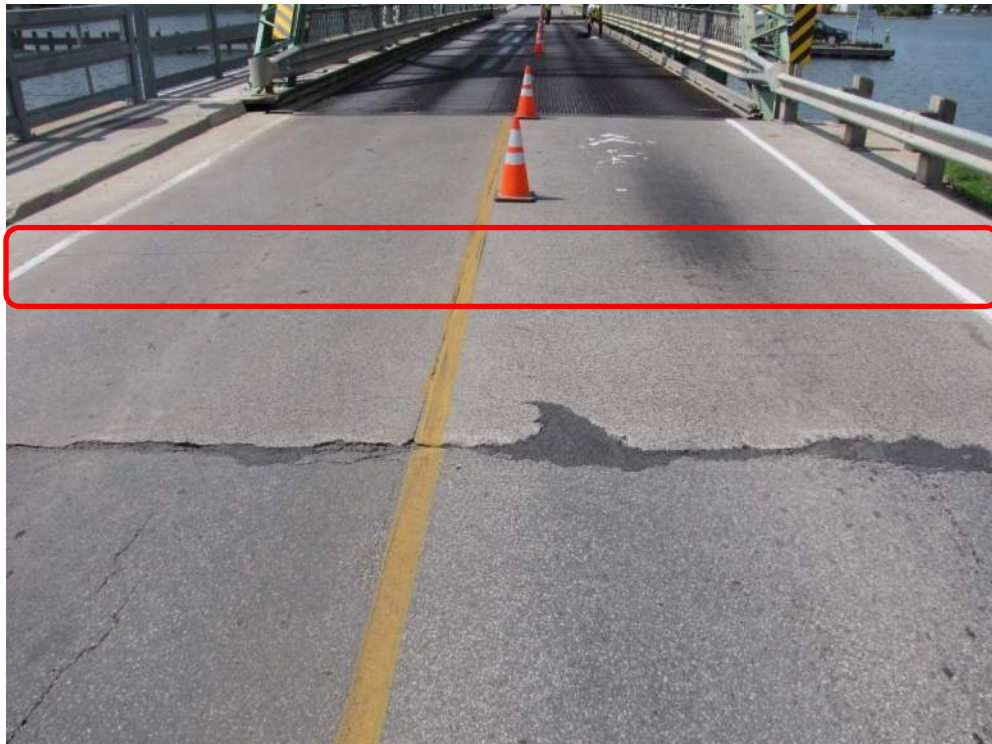
Photo S-109: There are two wide cracks that extend across the full width of the east approach slab. Also note the worn painted combination traffic/bicycle lane symbol.

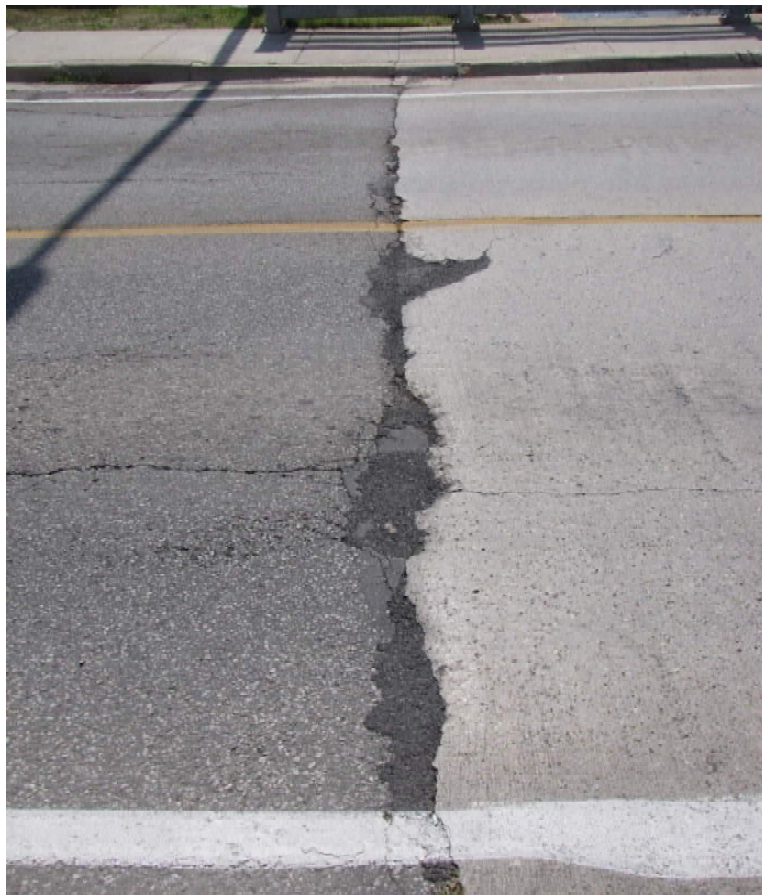
Photo S-110: There is a wide crack and patched potholes at the interface between the east approach slab and adjacent roadway wearing surface.

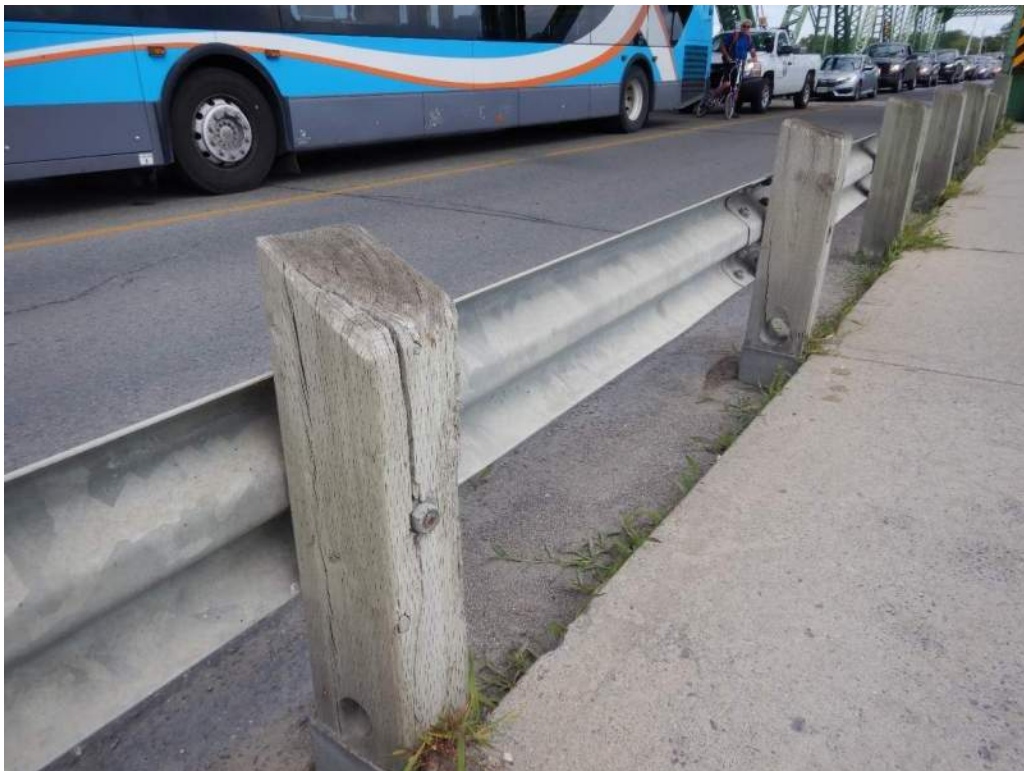
Photo S-111: A timber post in the southwest guiderail has been split by vehicular impact.

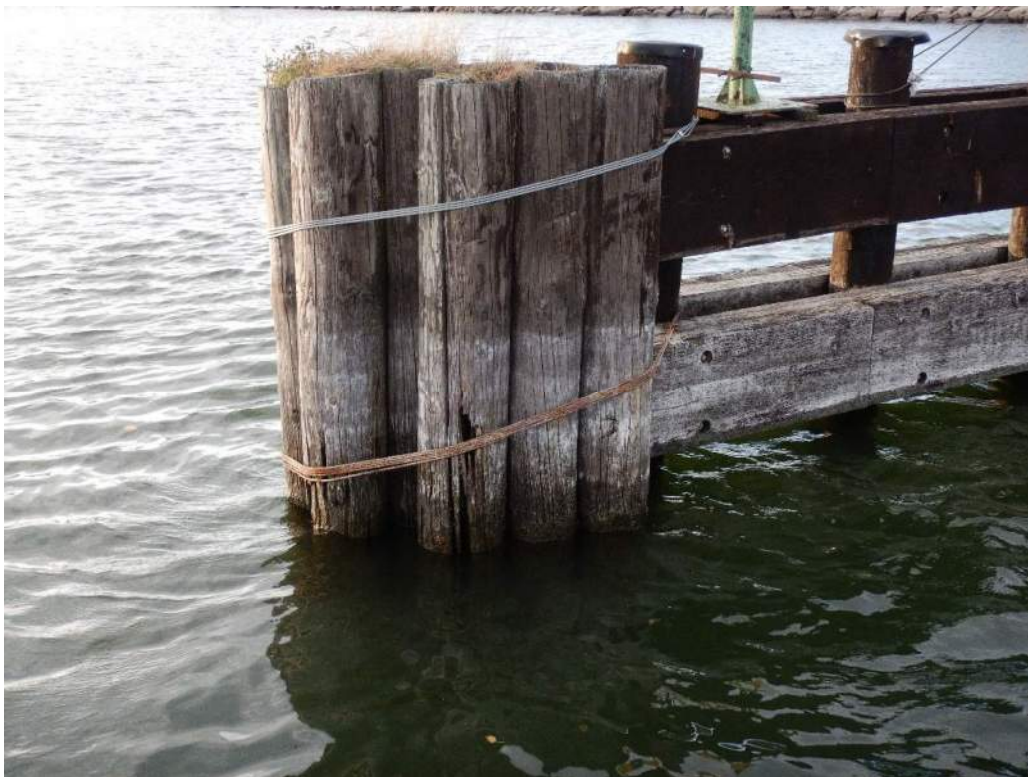
Photo S-113: The lower cables securing the dolphin to the south end of the west fender wall are loose and corroded. One pile has broken off.

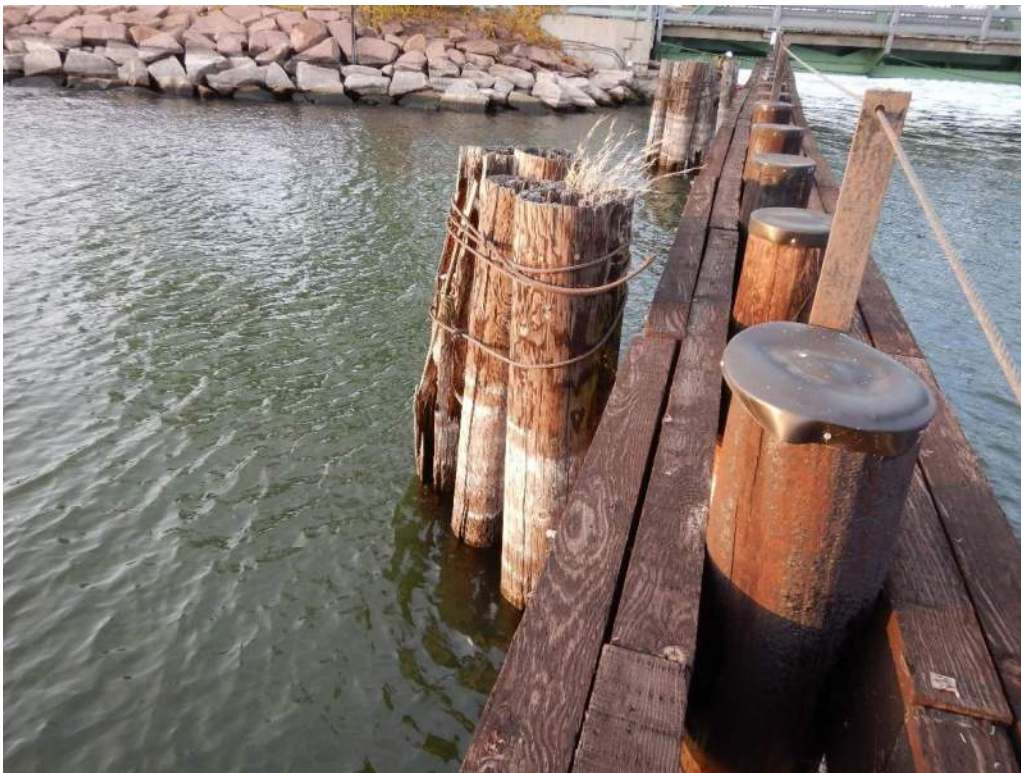
Photo S-114: All pile clusters at the west fender wall have little to no structural strength as they all exhibit rotting, splitting, and crushing (third pile cluster from the north end shown).

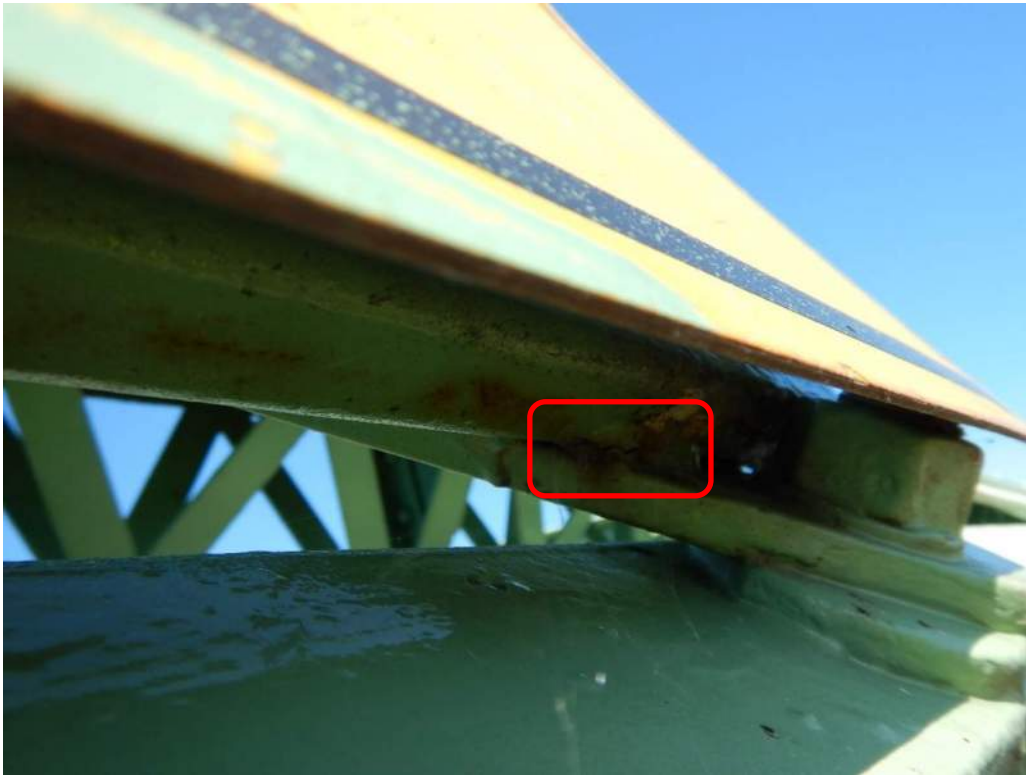
Photo S-116: Cracked weld of the east clearance sign bracket.

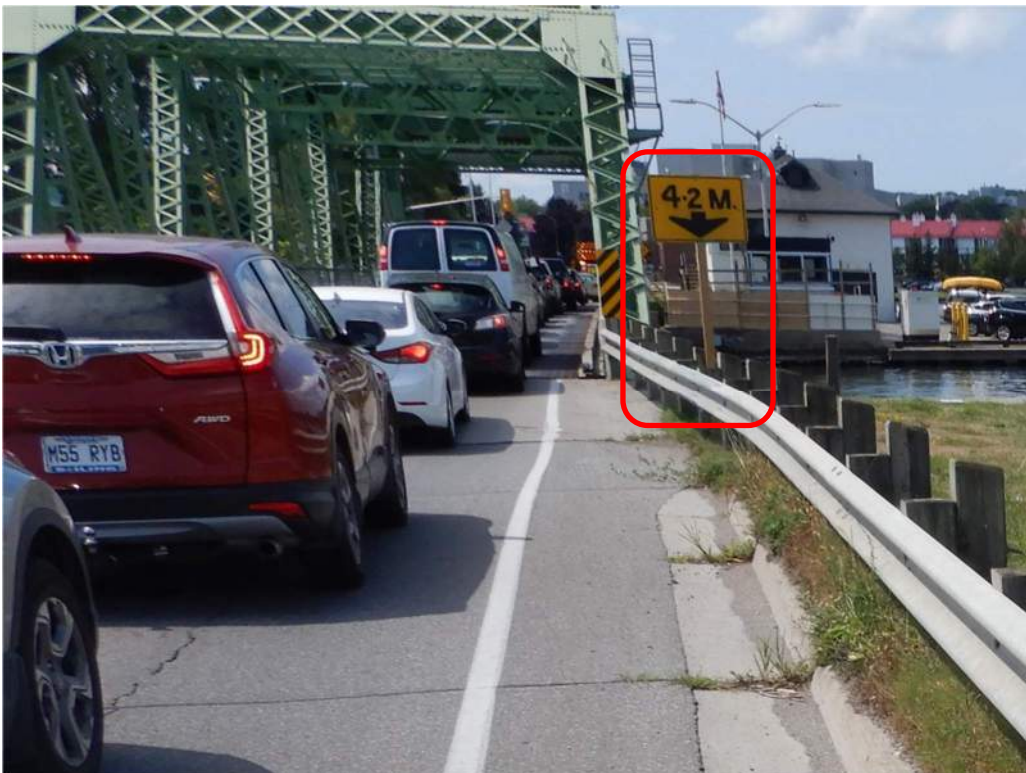
Photo S-117: The west clearance sign has been removed from member 1S-1N and placed on a timber post due to cracked welds in the sign bracket.

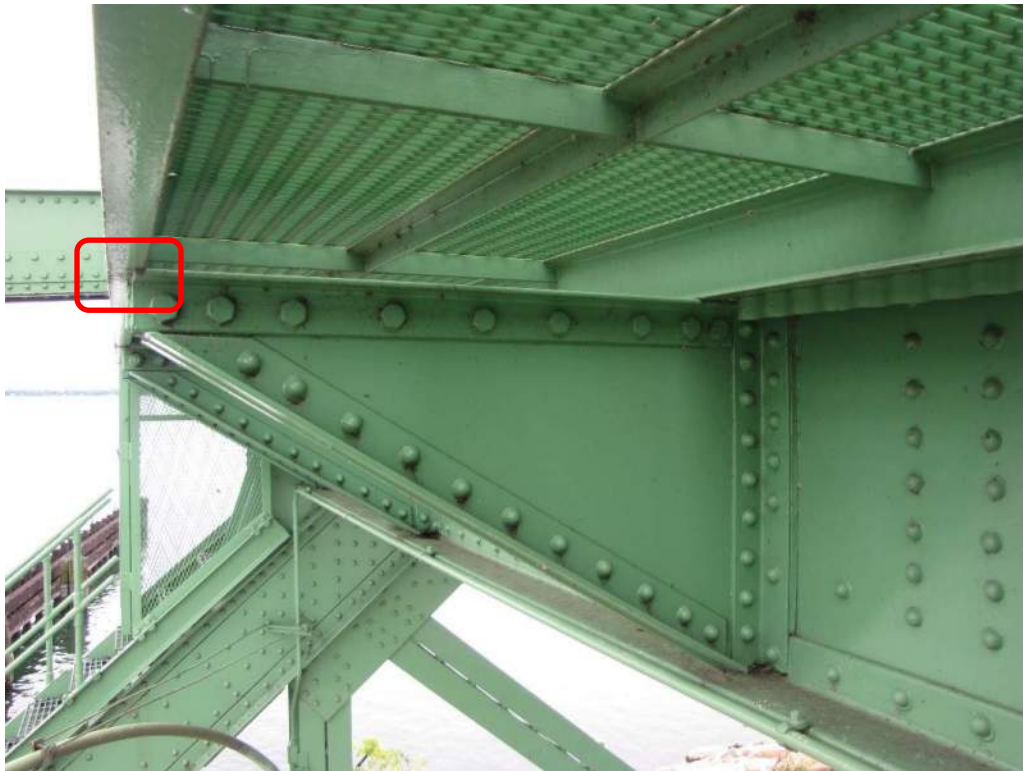
Photo S-118: The east C-channel supporting the catwalk outside the mechanical room is supported by the tapered cantilevered members below but only 25mm of the bottom flange is actually supported (photo from 2018 CDI).

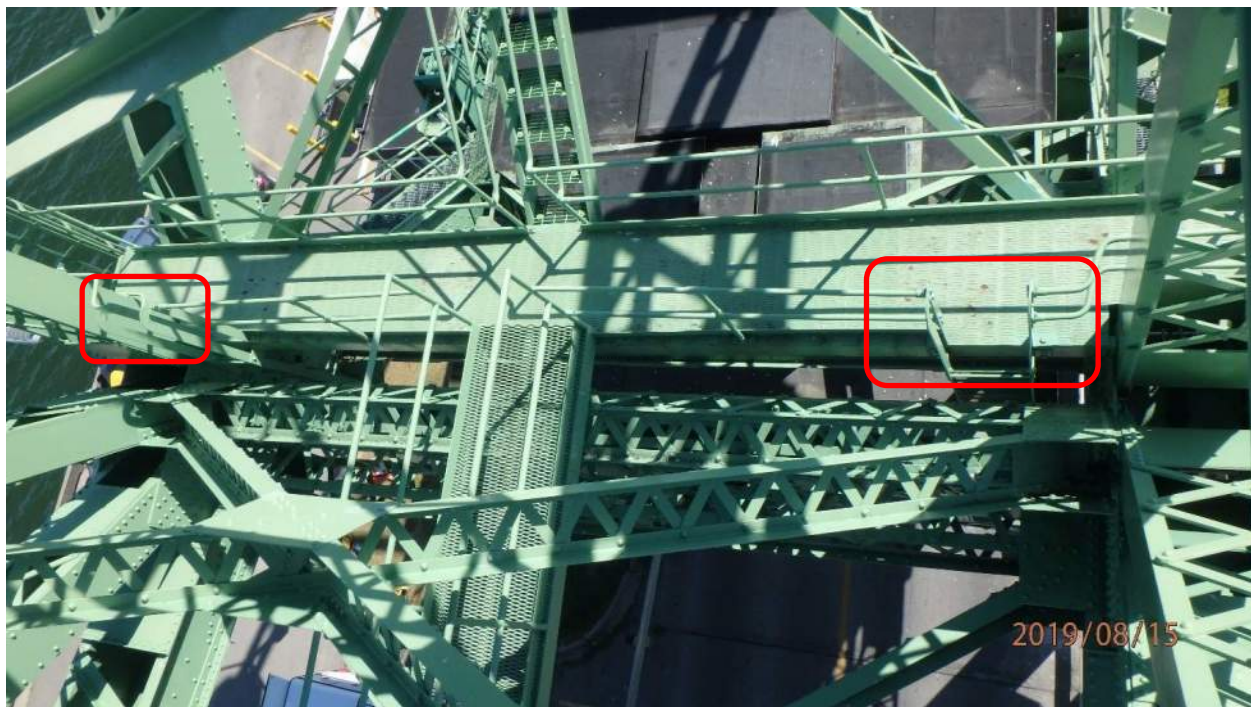
Photo S-119: There are no safety chains across the two open sections of the west railing on catwalk 21N-21S which is a potential falling hazard.

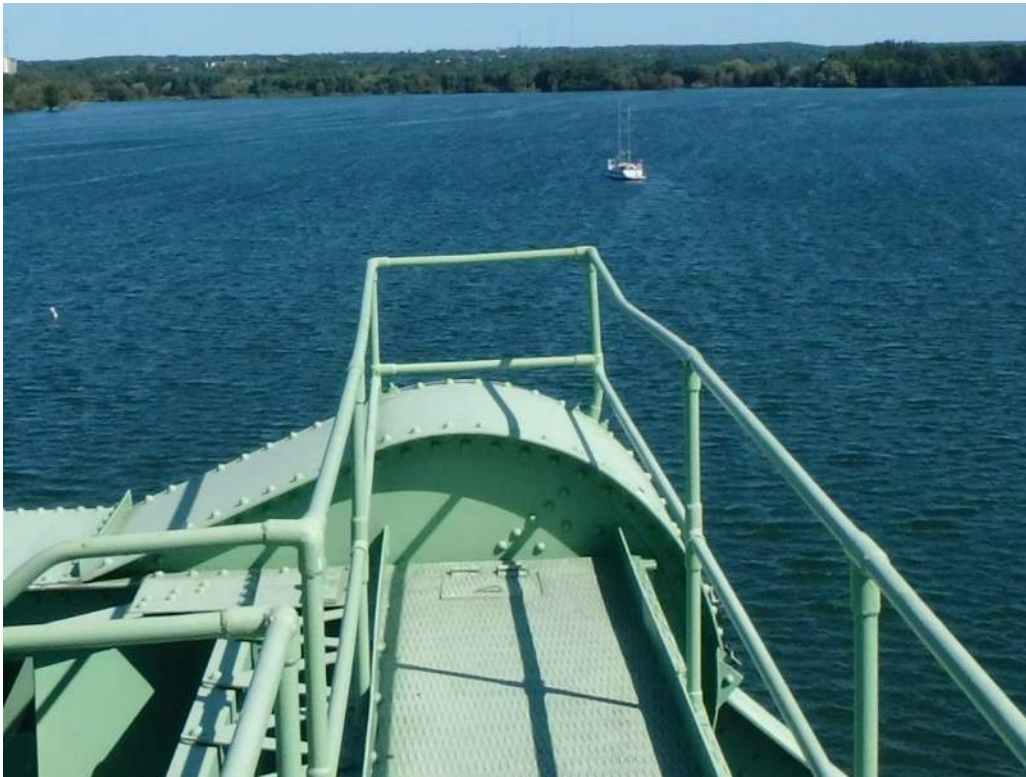
Photo S-120: The east handrail is bent above node 22N.

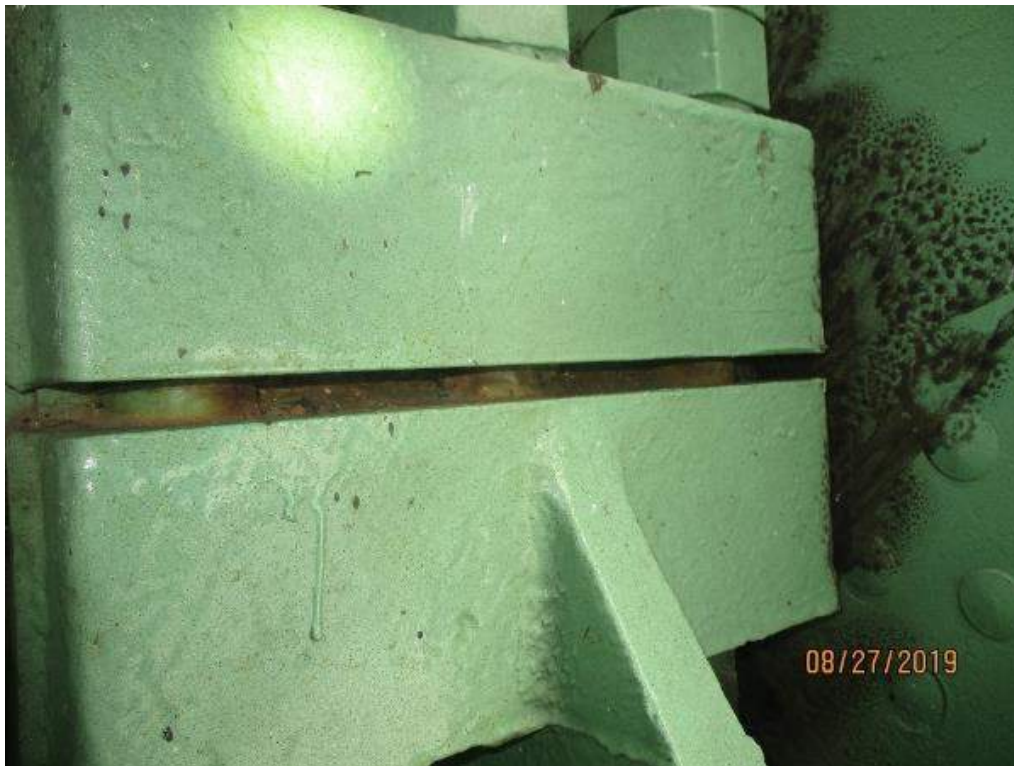
Photo M-1: Span Drive Machinery B1-N Bearing. There is light paint deterioration and corrosion between the bearing cap and base at the upper split line. The B1-S Bearing is similar.

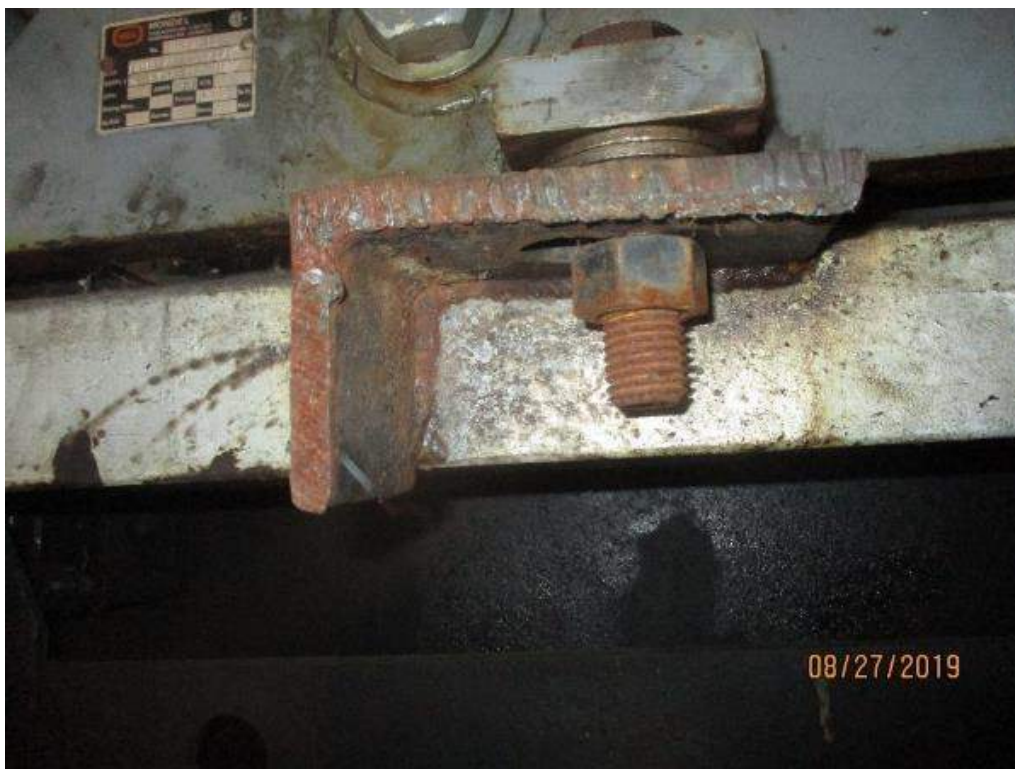
Photo M-2: Span Drive Machinery Brake. The northeast mounting bolt nut has poor bearing. The mounting bolt and surrounding areas are lightly corroded.

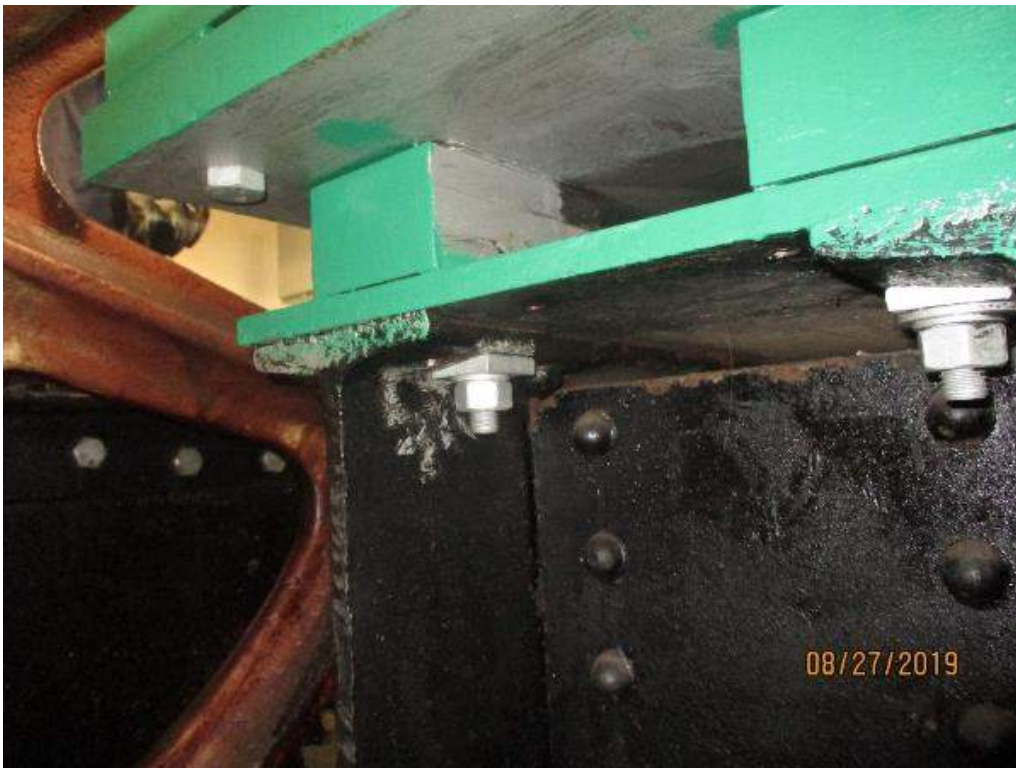
Photo M-3: Span Drive Machinery North Motor. The underside of the motor mounting plate is unpainted. The span drive south motor is similar.

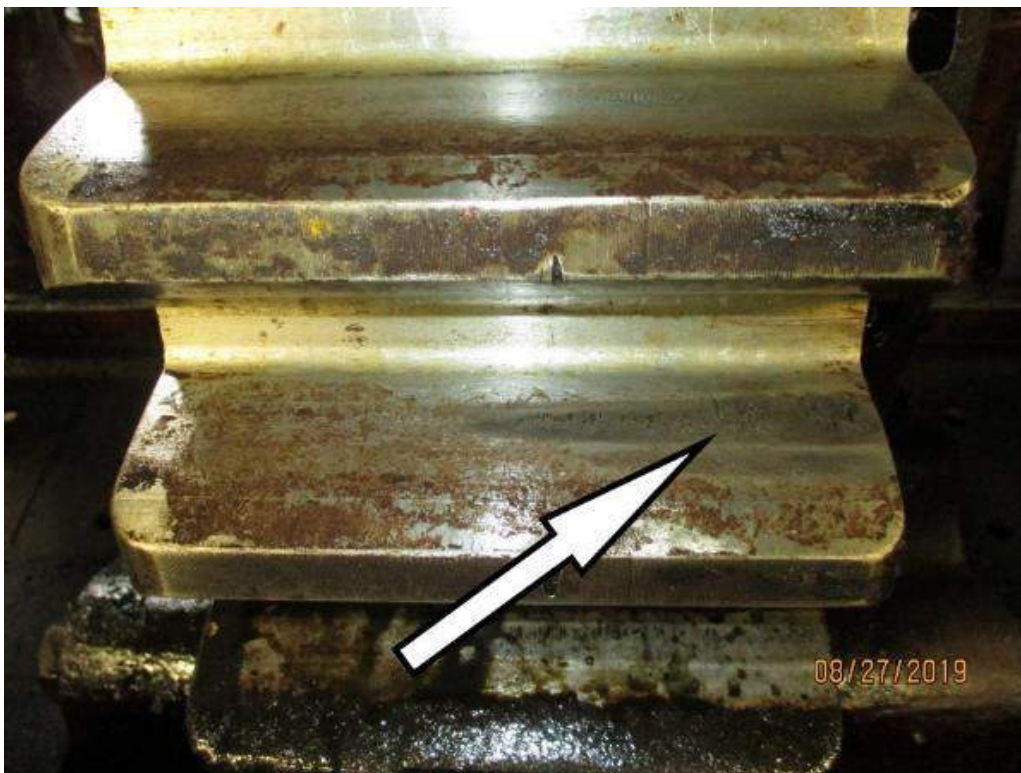
Photo M-4: Span Drive Machinery Gear D. Note the light damage on the south side of the closing face of this gear.

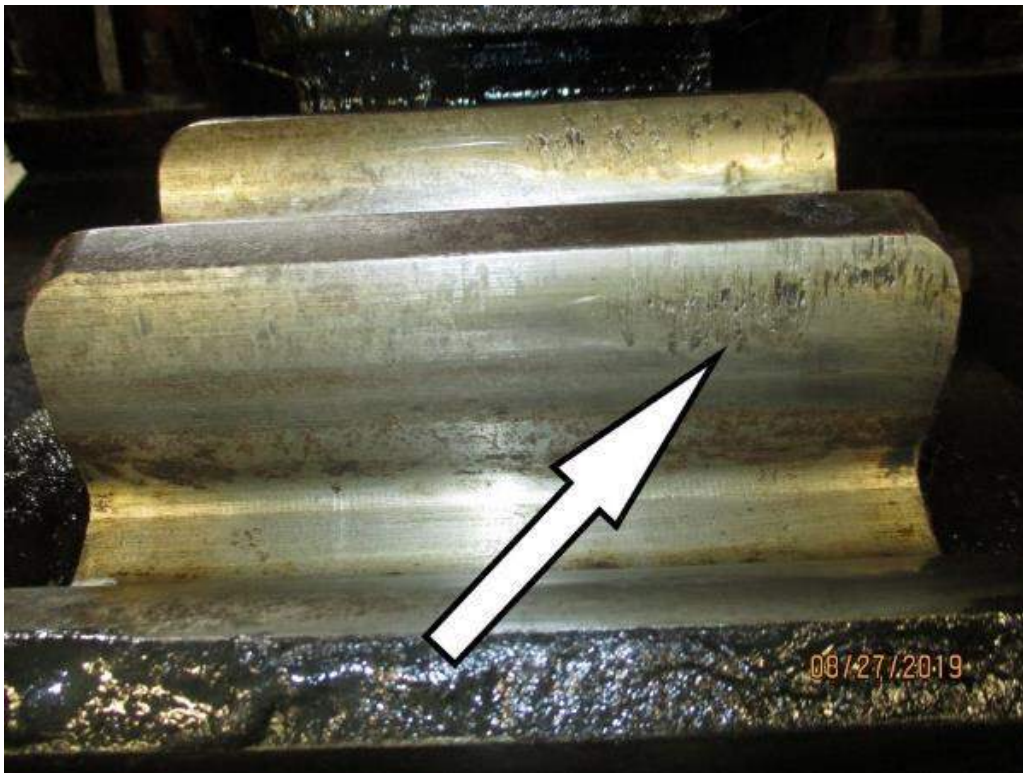
Photo M-5: Span Drive Machinery Pinion E. Note the light damage on the south side of the opening face of this pinion.

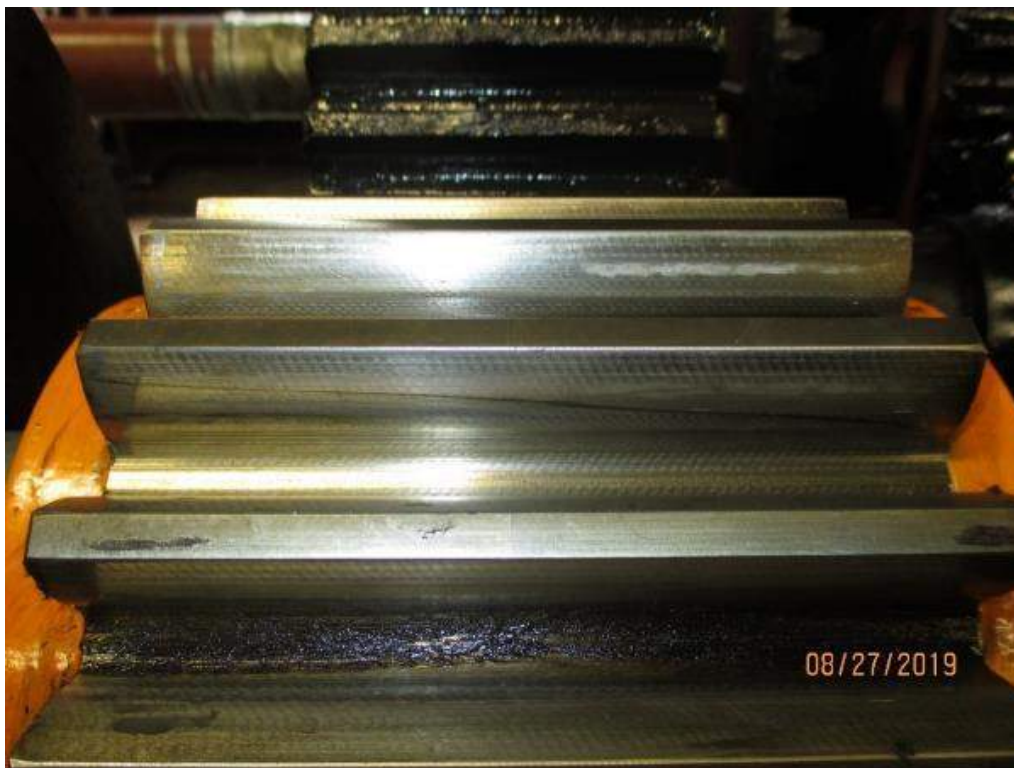
Photo M-6: Span Drive Machinery North Pinon G. The contact wear pattern indicates light cross bearing with heavier contact on the north side of the opening face and heavier contact on the south side of the closing face.

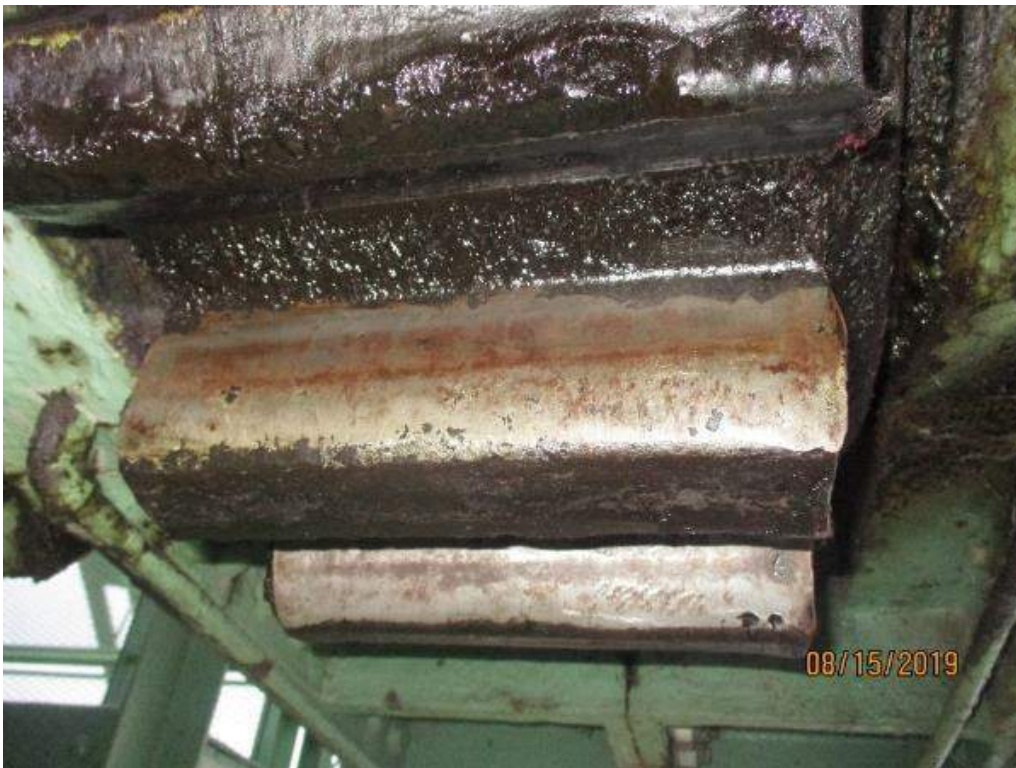
Photo M-7: Span Drive Machinery South Pinon A. There is minor metal flow and areas of minor damage to the teeth. It is difficult to distinguish between original casting defects and abrasive wear.
