Lasalle Causeway Bascule Bridge

2019 Comprehensive Detailed Inspection Report (Rev. 1)

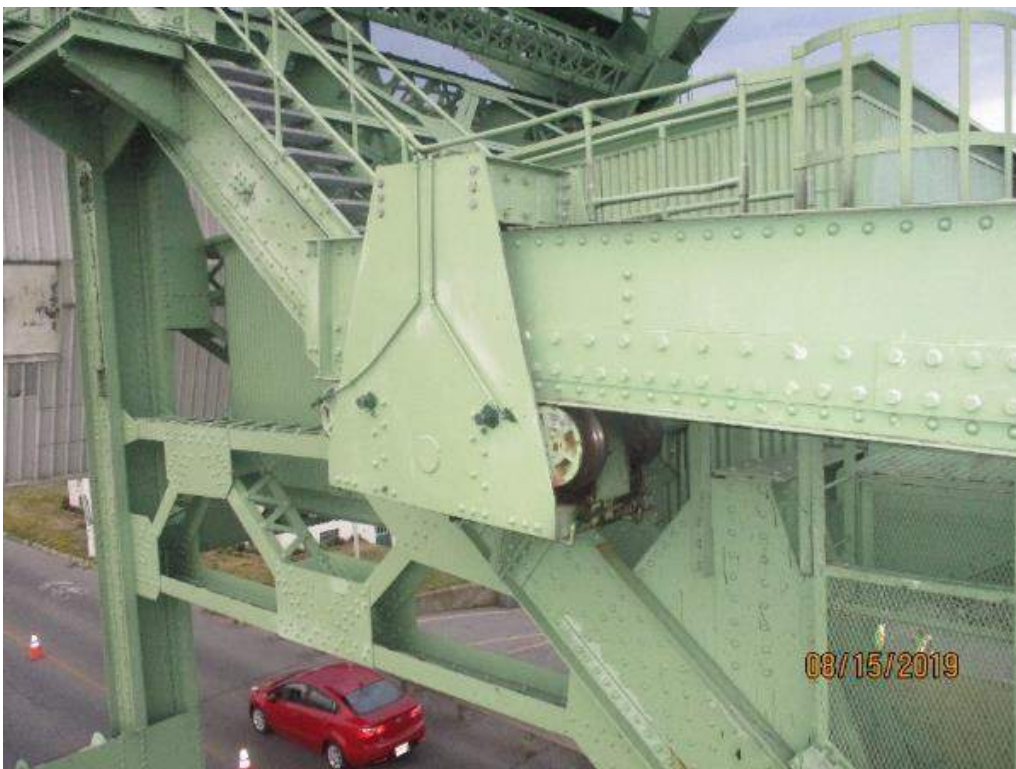
Photo M-8: South Operating Strut Guide Assembly. There is no access to inspect many of the machinery interfaces that are internal to the guide assembly and there is limited access to the assembly from the existing platform. Note that a man-lift was used for additional access at the time of the inspection.

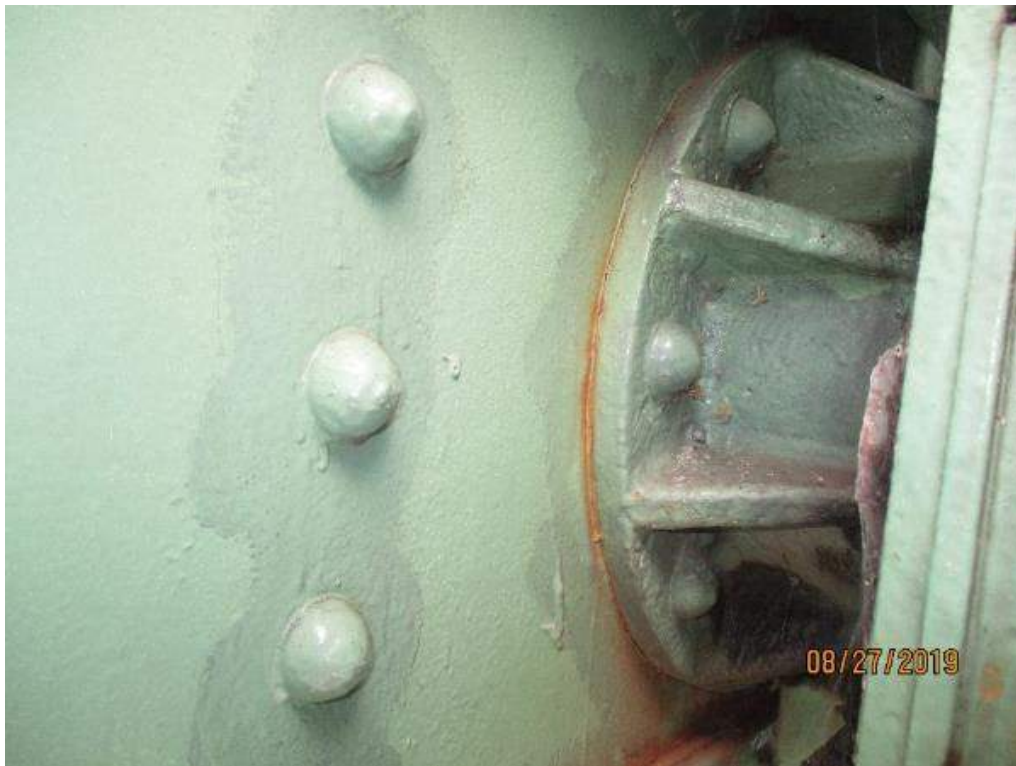
Photo M-9: South Operating Strut, Outboard Bearing. The cracked paint and fretting corrosion between the bearing housing and structure indicate relative movement.

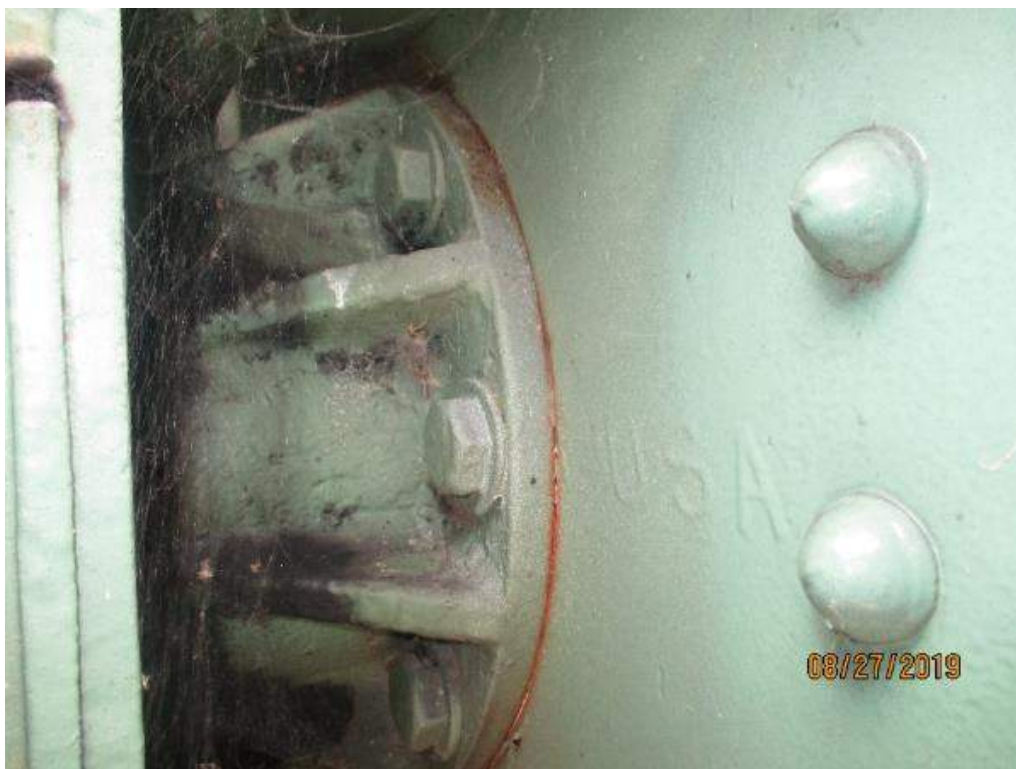
Photo M-10: North Operating Strut, Inboard Bearing. The cracked paint and fretting corrosion between the bearing housing and structure indicate relative movement.

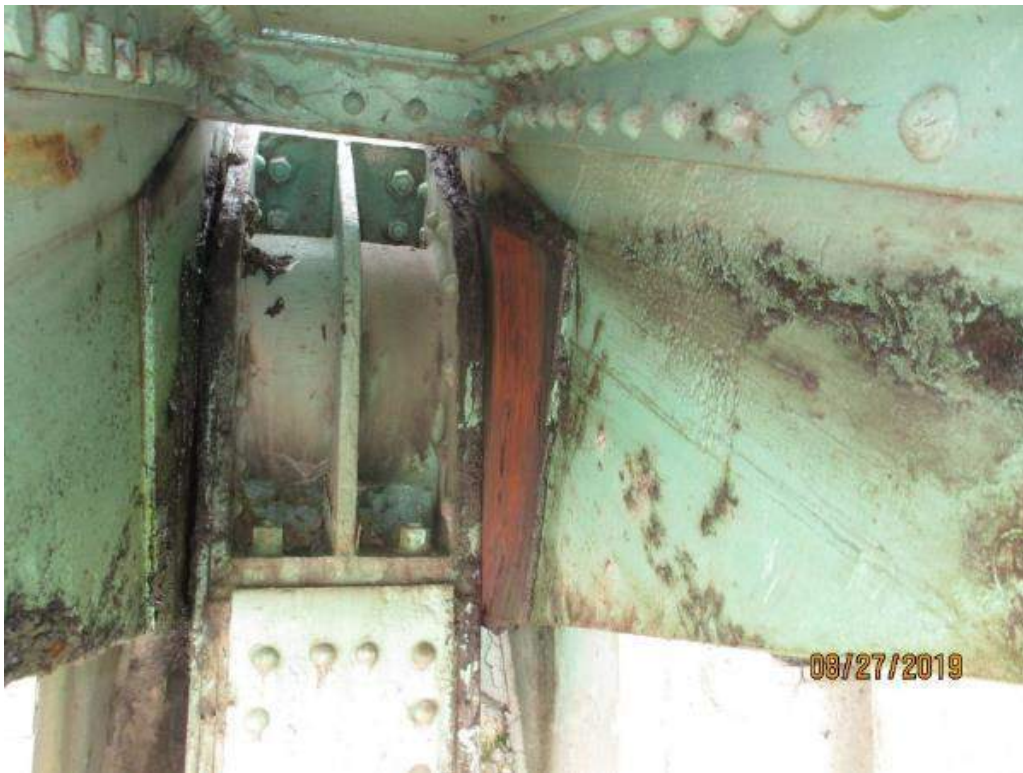
Photo M-11: North Main Trunnion Bearing. There is contact between the moving structure and the fixed structure.

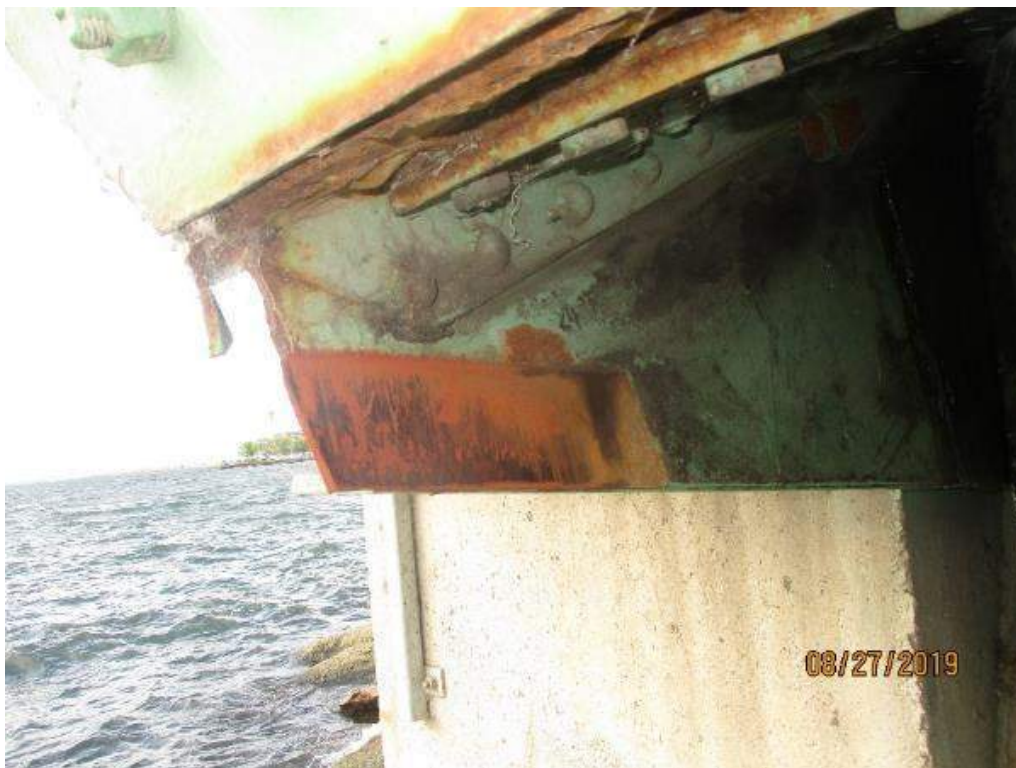
Photo M-12: Truss Near South Main Trunnion Bearing. Note the wear due to contact between the span structure and the bearing support.

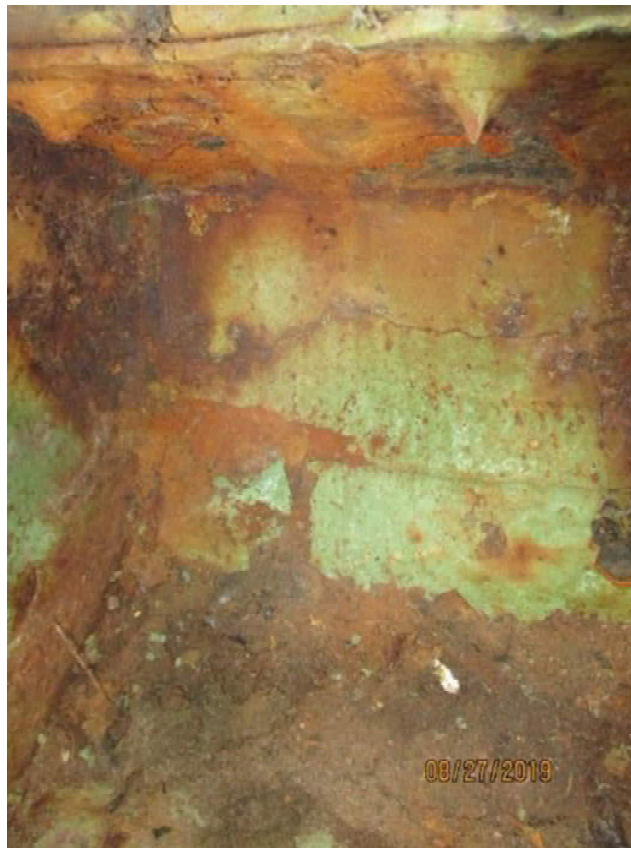
Photo M-13: North Main Trunnion Bearing. The head end of the four bolts that secure the bearing housing to the structure has 100% section loss due to corrosion.

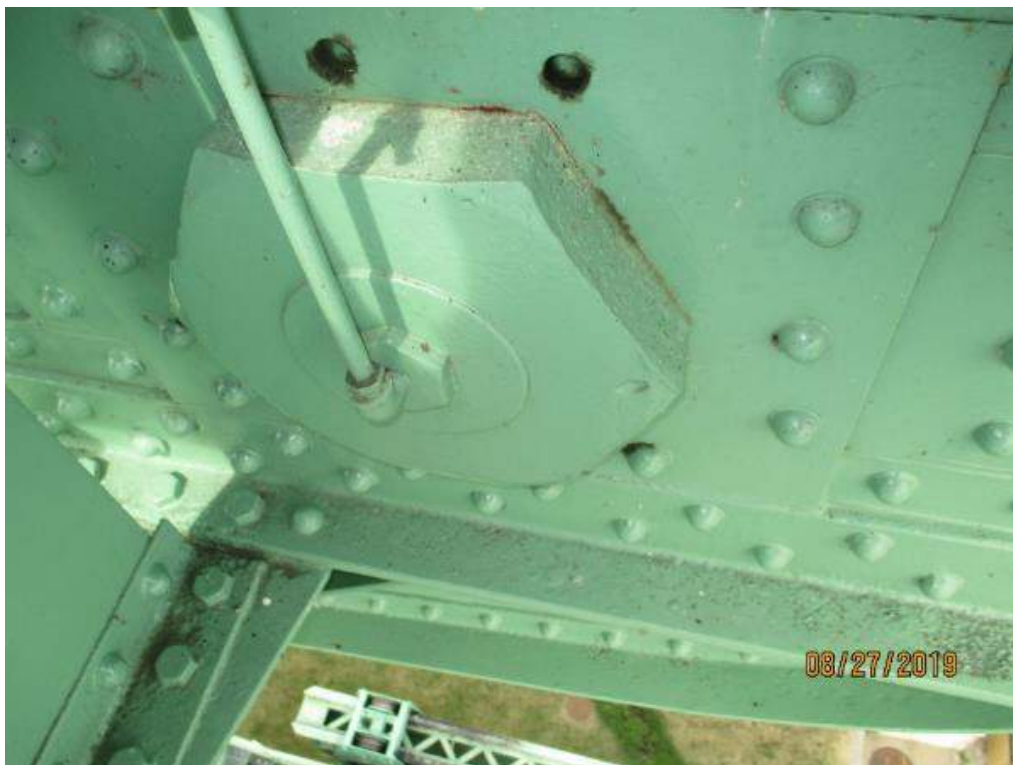
Photo M-14: North First Link Pin. There is cracked paint and fretting between the nut and the structure indicating slight movement.

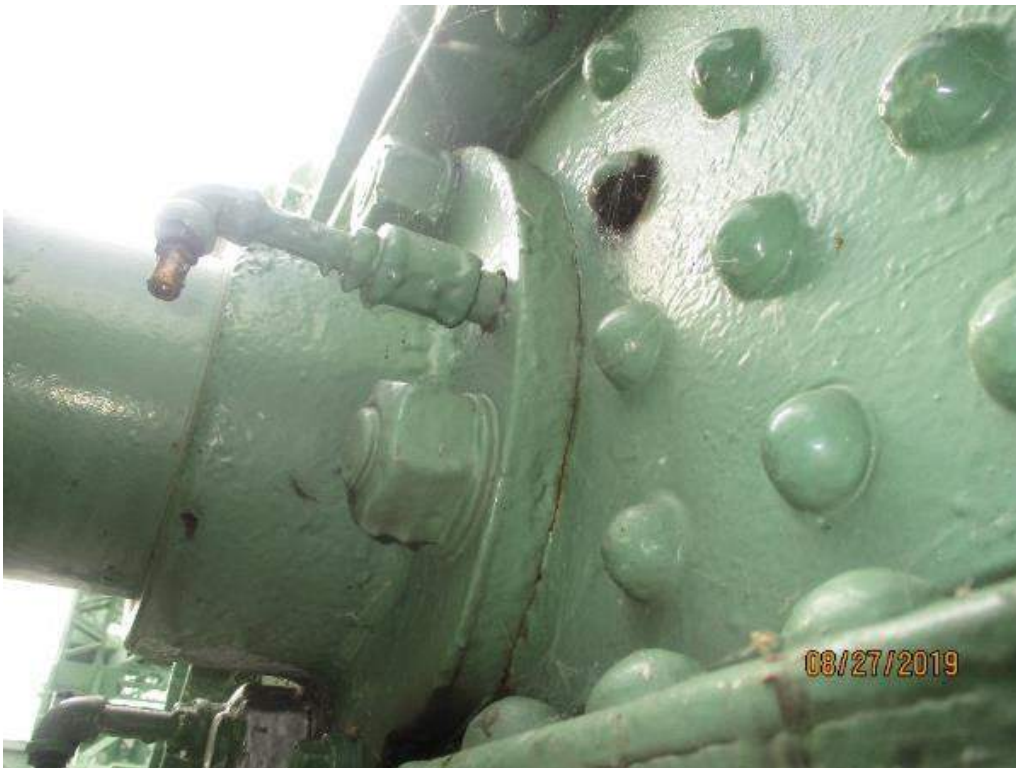
Photo M-15: South Second Link Pin, Inboard Side. There is cracked paint and fretting between the link pin housing and the structure, indicating slight movement.

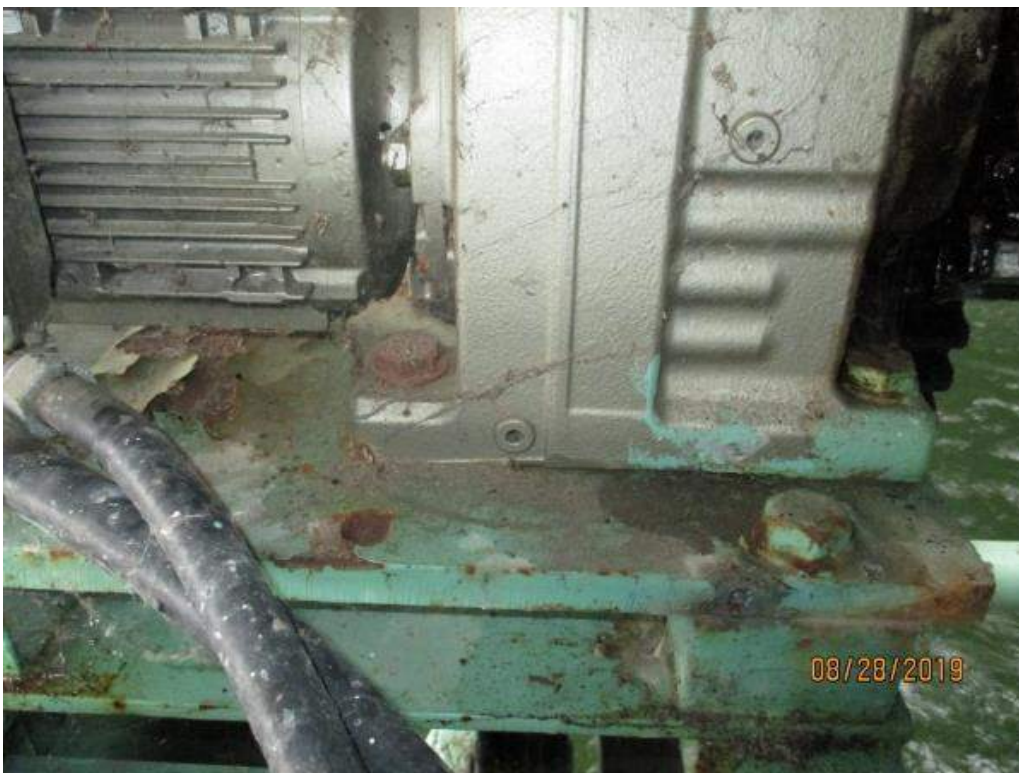
Photo M-16: Span Lock Gearmotor. The mounting bolts and support for the gearmotor are not fully painted. Note the corrosion.

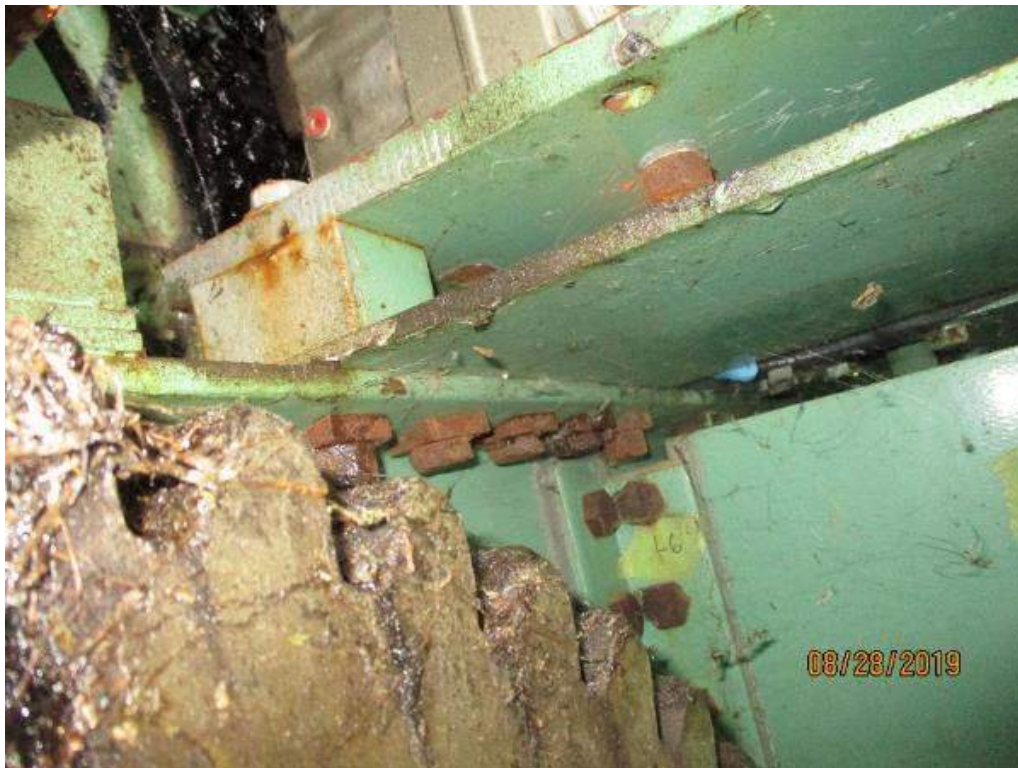
Photo M-17: Span Lock Gearmotor Support. The support mounting bolts are not painted. Note the corrosion.

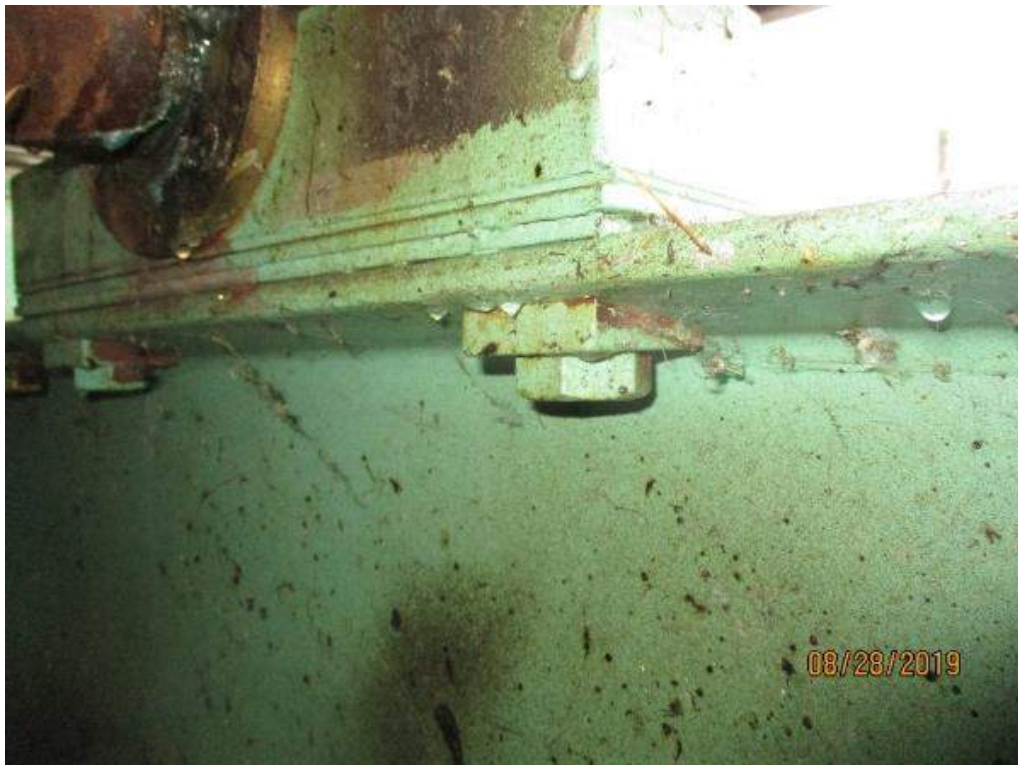
Photo M-18: Span Lock Bearing B4. The span lock mounting bolt underside is not fully painted. Note the light corrosion. The underside of bearing B4 mounting bolts are similar.

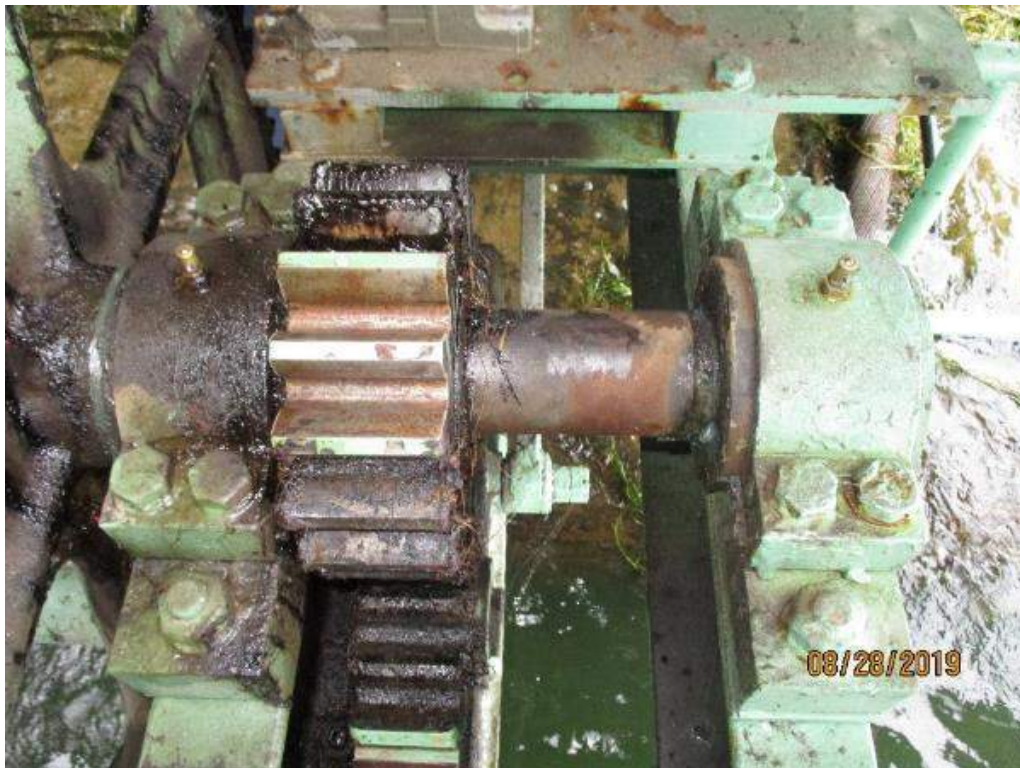
Photo M-19: Span Lock Shaft. The span lock drive shaft between bearings B3 and B4 is not painted. Note the corrosion.

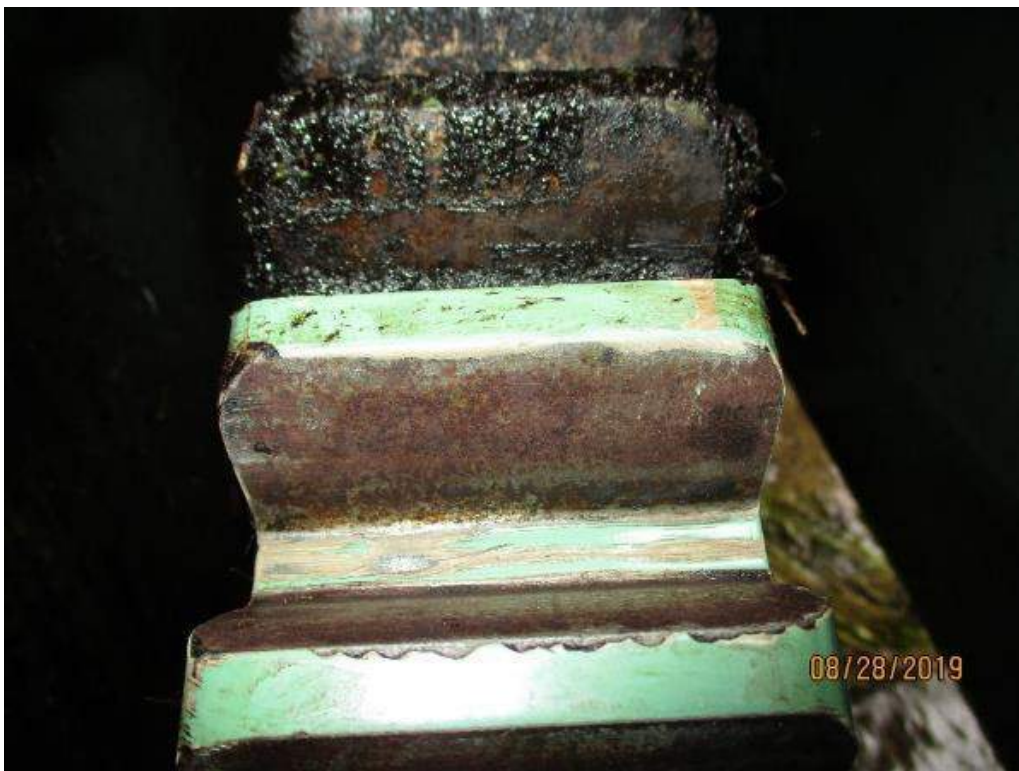
Photo M-20: Span Lock Gear T. The faces of the pinion teeth are corroded. This is likely from previous lack of lubrication, as the gears were well lubricated at the time of the inspection. The teeth of pinion W, gear V, and gear T are similar.

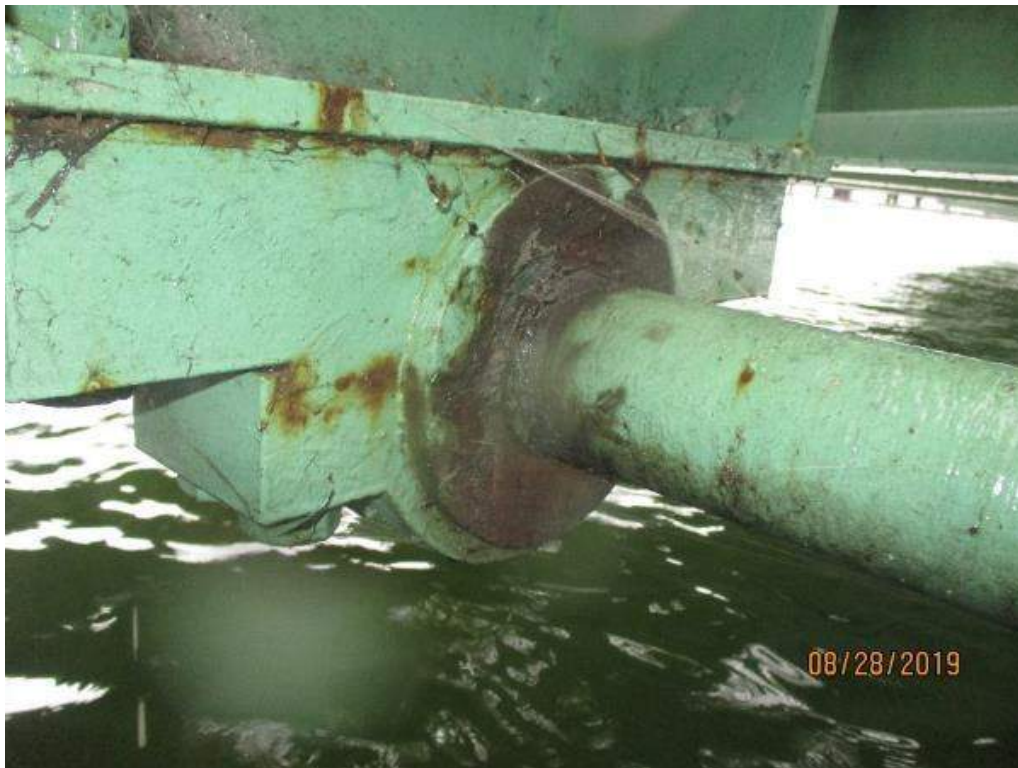
Photo M-21: Span Lock Cross Shaft Bearing B1-S. The housing for the bearing exhibits paint deterioration and light corrosion. All of the span lock cross shaft bearings are similar.

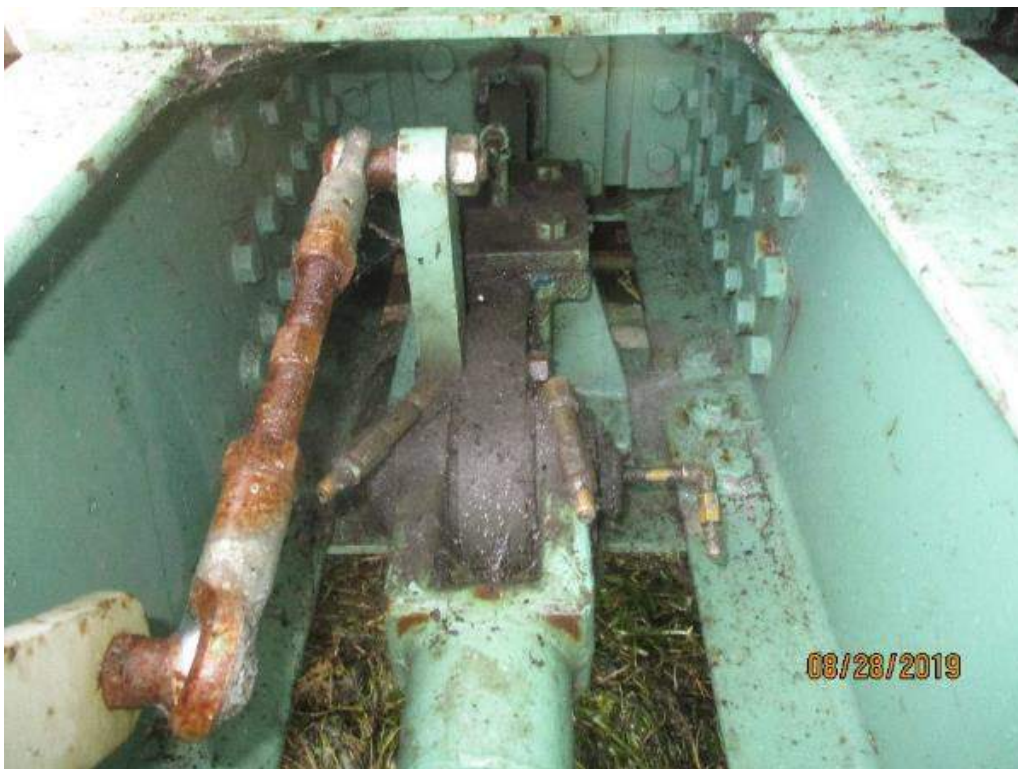
Photo M-22: North Span Lock Crank Shaft CR1. The position indication shaft threads are not painted, and they are lightly corroded. The north location is similar.

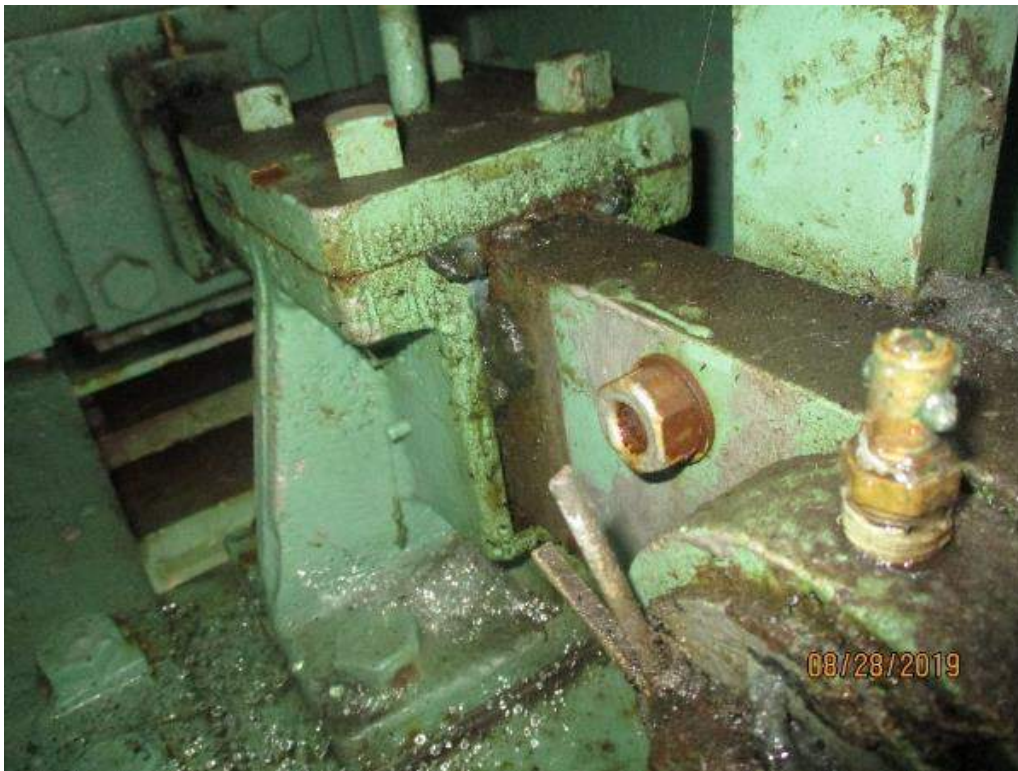
Photo M-23: South Span Lock Crank Shaft CR2. The mounting bolts and nuts for the rotary cam position crank CR2 located on the lock bar are not fully painted and exhibit light corrosion. North Span Lock Crank Shaft CR2 is similar.

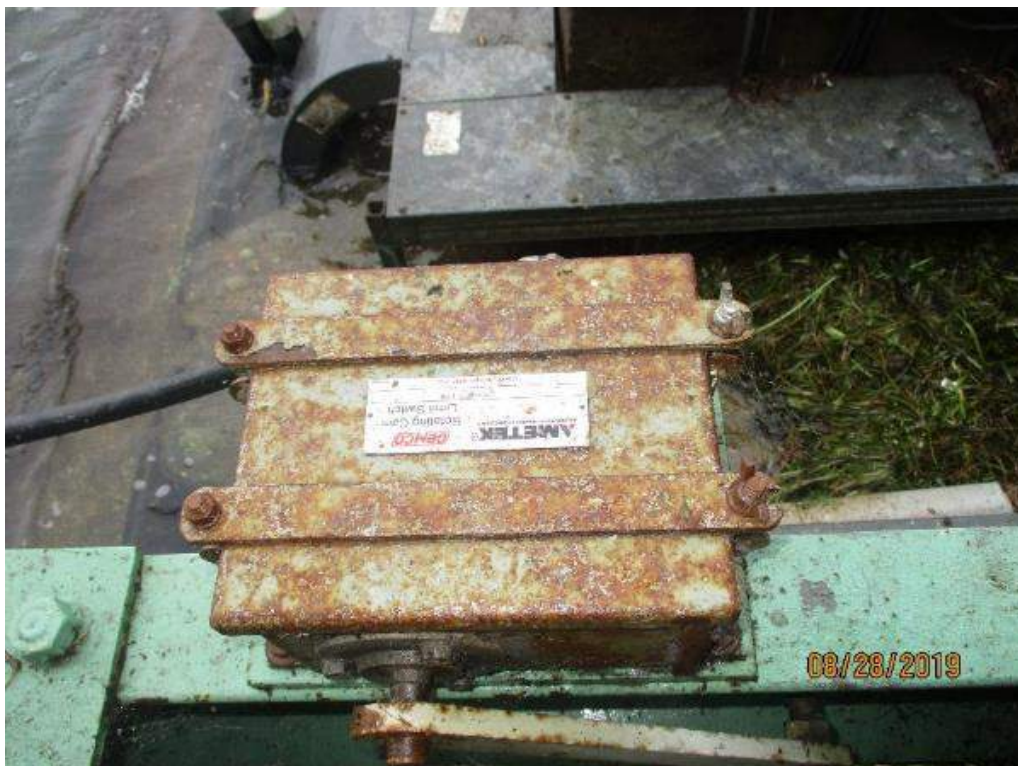
Photo M-24: North Span Lock Rotary Cam Switch. The rotary cam limit switch cover exhibits paint deterioration and light corrosion.

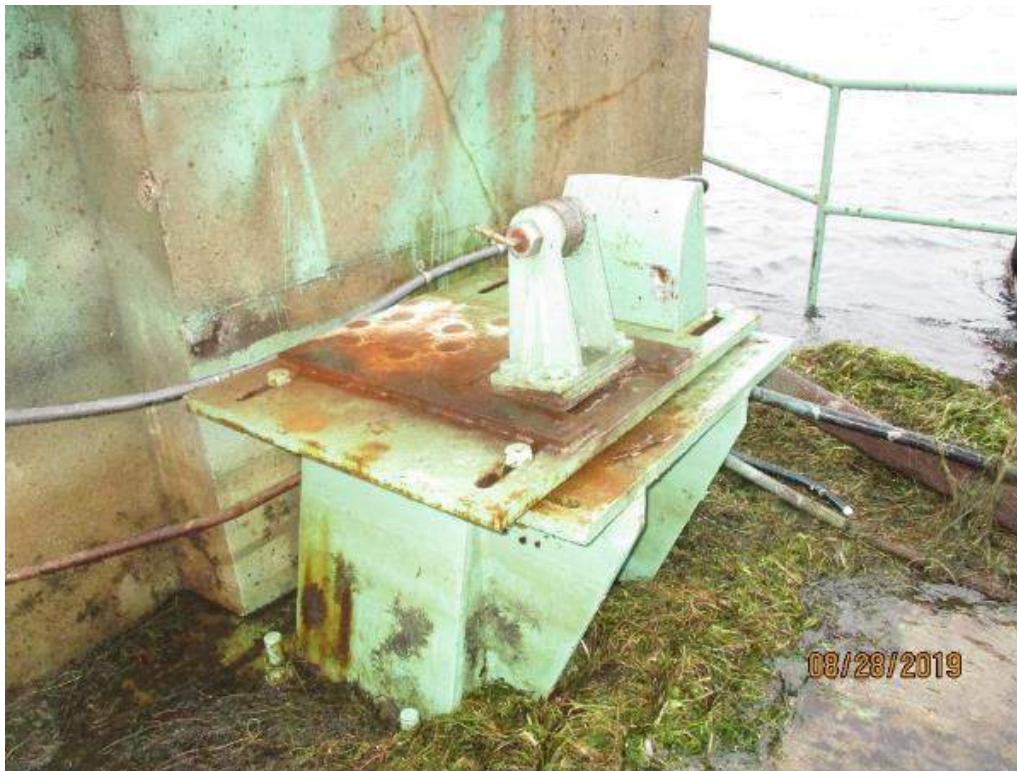
Photo M-25: South Live Load Strike Plate and Span Lock Receiver. General view of strike plate and span lock receiver. Note that the receiver is pushed towards the approach.

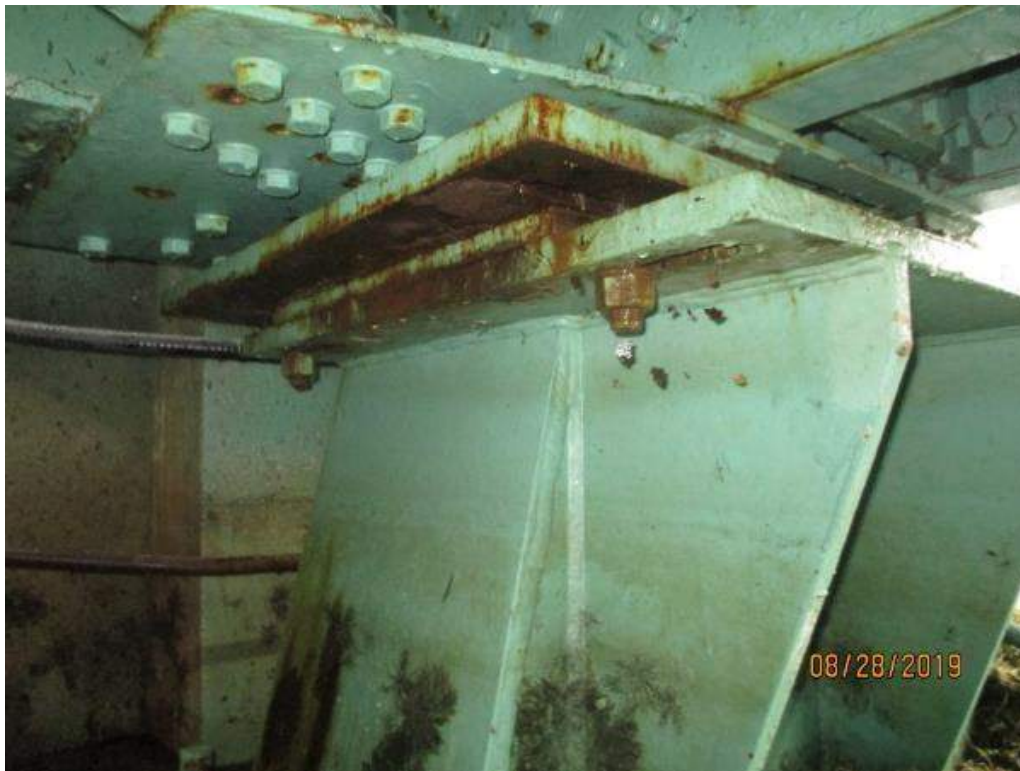
Photo M-27: South Live Load Strike Plate. The underside of the strike plate support and the mounting bolts are corroded. The north live load strike plate assembly is similar.

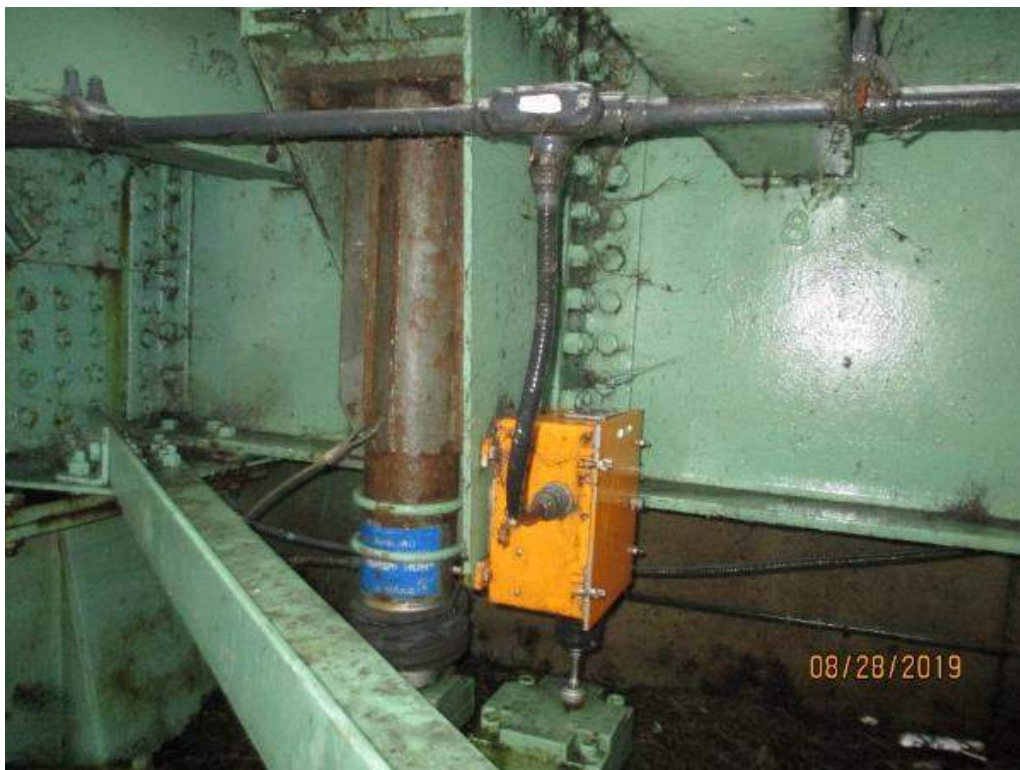
Photo M-28: North Buffer. General View of the buffer, strike plate and seated limit switch. Note the buffer is corroded. The south buffer is similar.

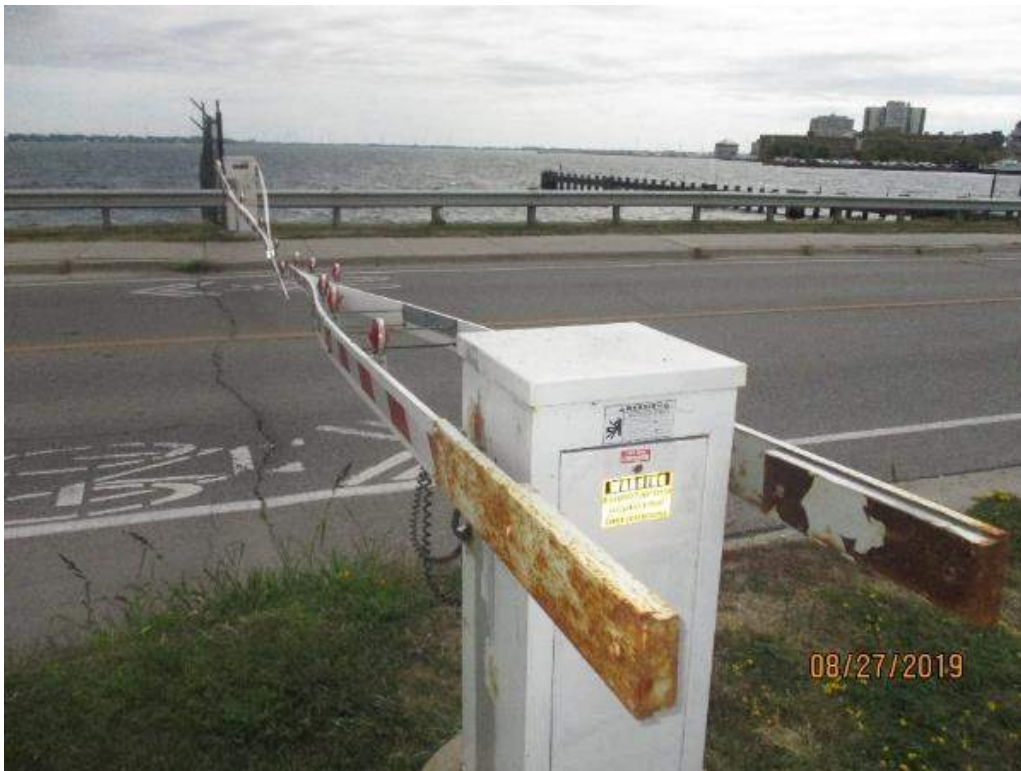
Photo M-29: Southeast Warning Gate. The gate arms and gate housings had spotty areas of corrosion. The other gates are similar.

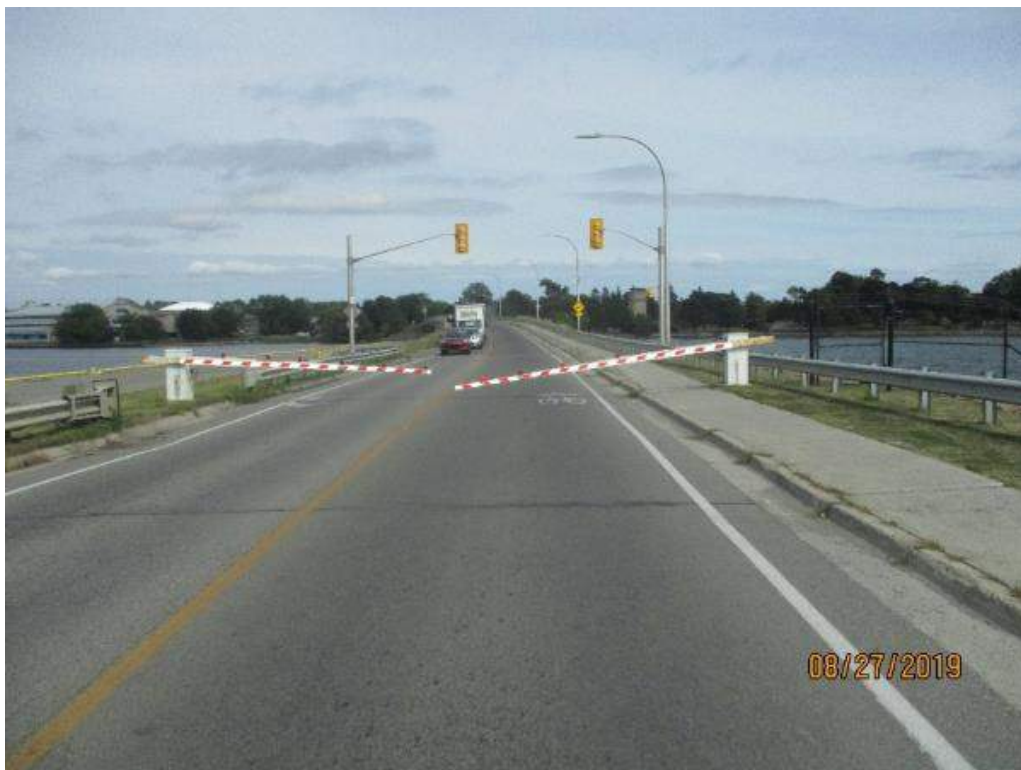
Photo M-30: East Warning Gates. The warning gate arms are not horizontal in the lowered position. The west warning gates are similar.

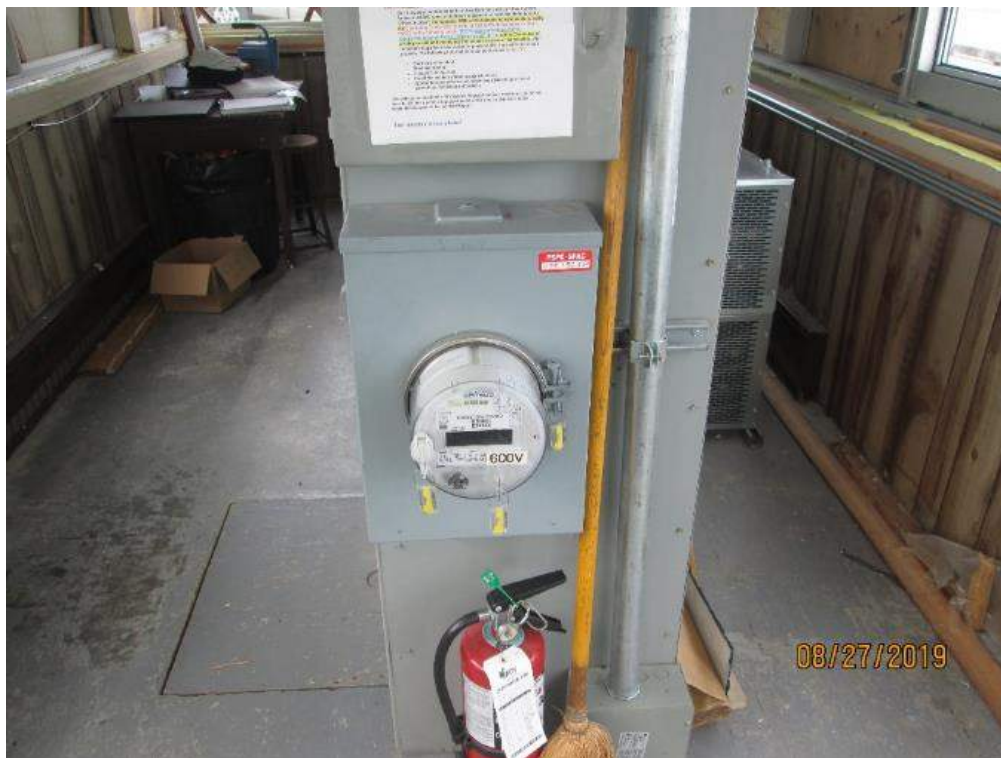
Photo E-1: Utility Meter. The bridge electric service is provided with a utility meter that is located inside the operator's control house and is mounted on the side of the MCC. Note both the meter and metering pan are in good condition.

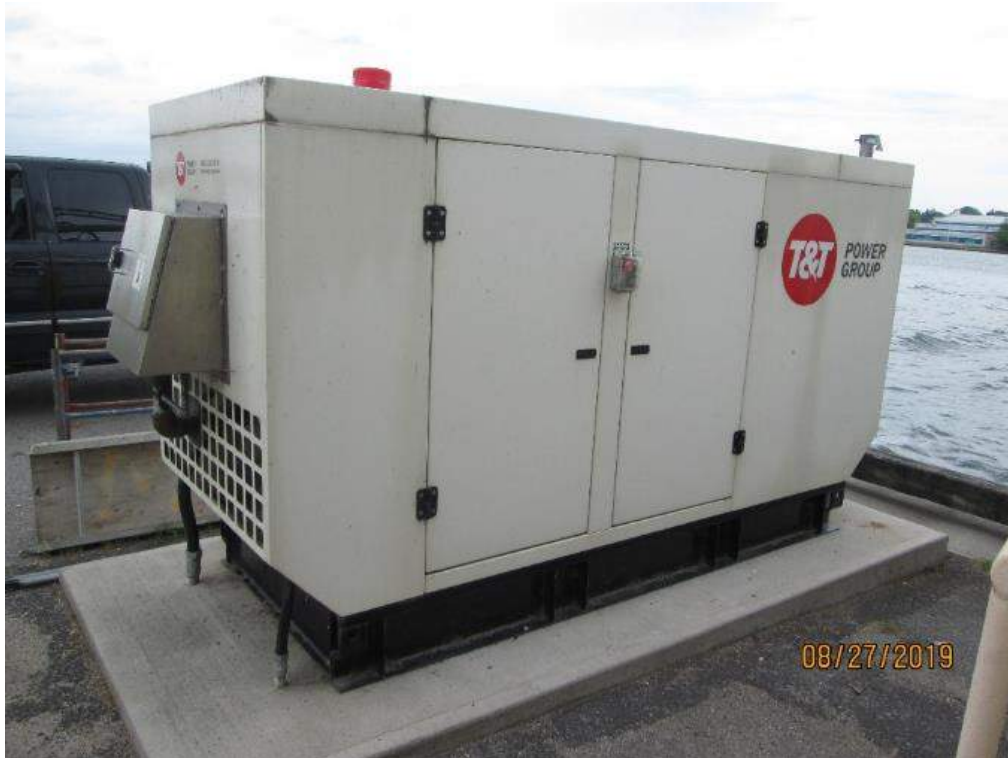
Photo E-2: Standby Generator. The standby generator was installed in 2015 to provide a backup source of power for the bridge facilities in the event of utility power failure. Note that the generator, since the original drives and motors were replaced, is now capable of handling of span operation with one operating drive motor. Also note the generator and generator housing is in excellent physical condition.

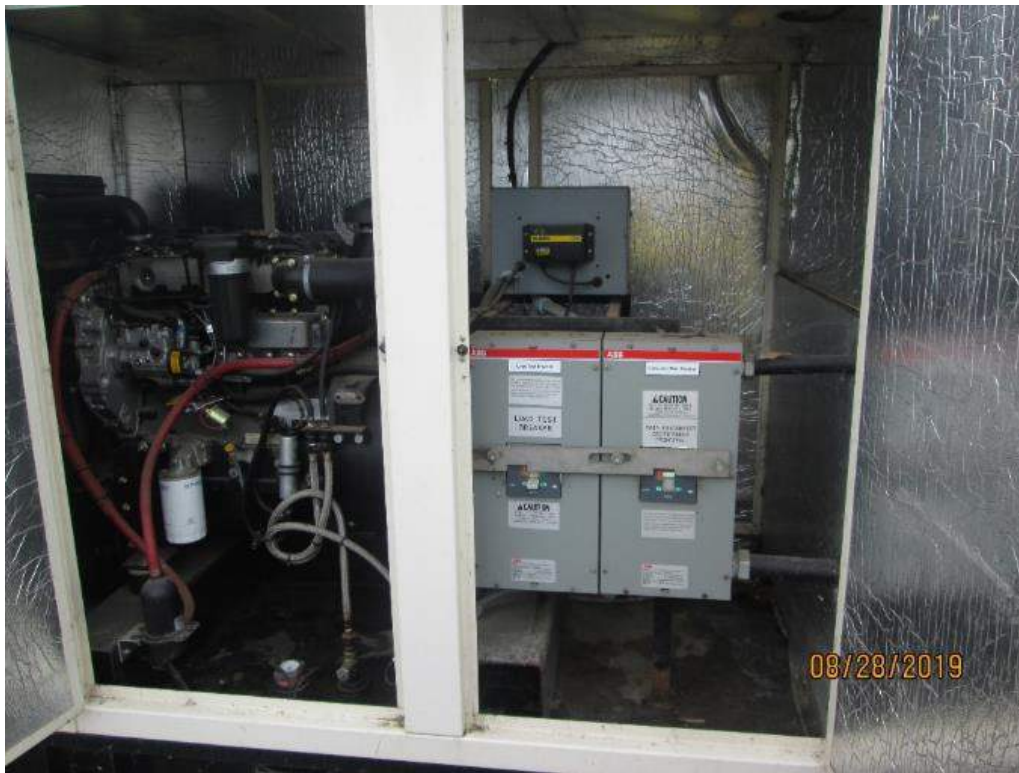
Photo E-3: Standby Generator Breakers. The standby generator is provided with a 60A main disconnect breaker and a 60A load test breaker. Note the generator is not provided with a load bank and the load test breaker is not connected.

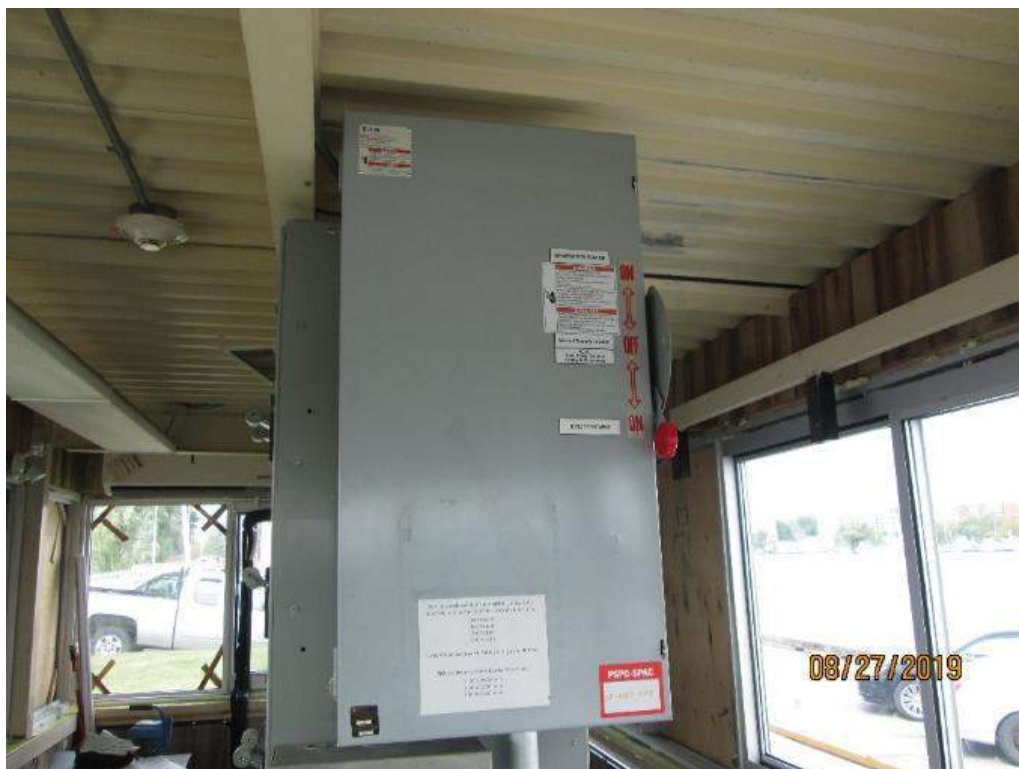
Photo E-4: Manual Transfer Switch (MTS). A manual transfer switch has been mounted on the side of MCC in the operators control house to allow the transfer of power between utility power and the generator power. This MTS is in excellent physical and operational condition.

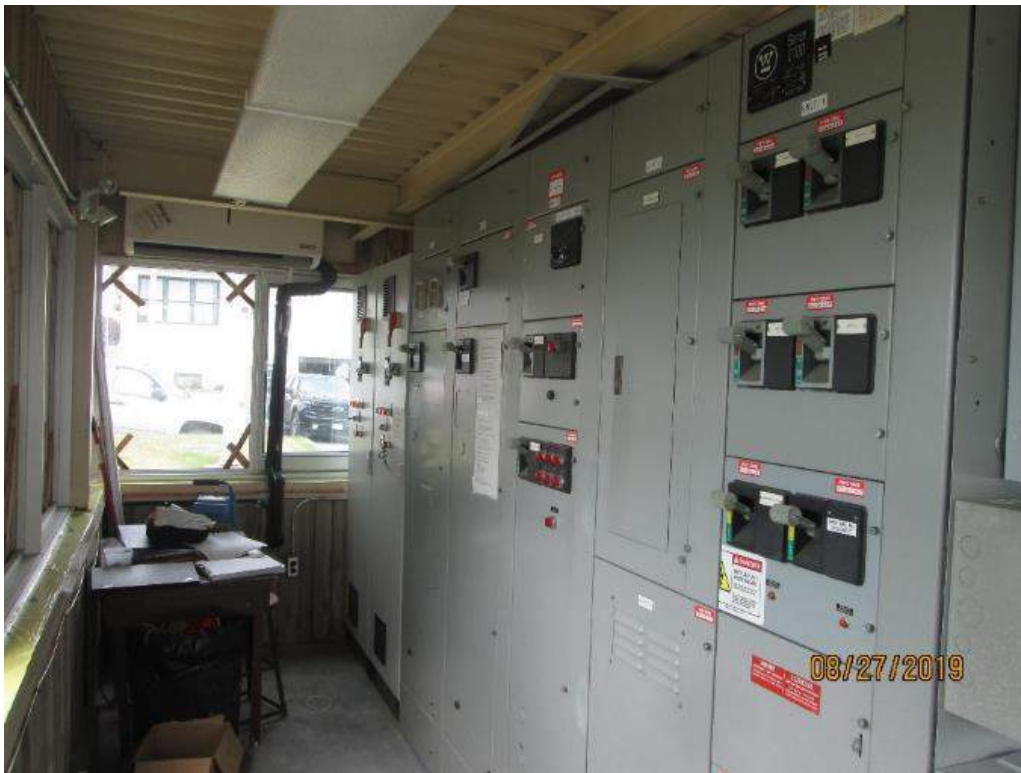
Photo E-5: Motor Control Centre (MCC). The bridge is provided with a motor control center (MCC) for bridge power distribution. The MCC is located inside the operator's control house. The MCC was installed in 1994 and is in fair serviceable condition.

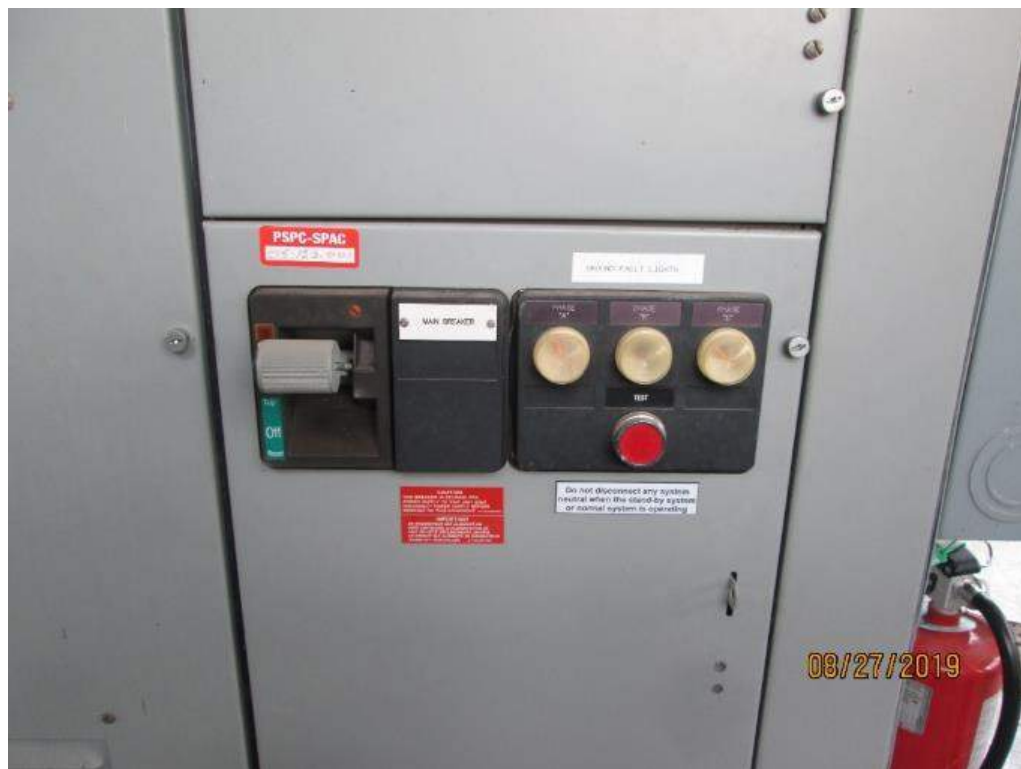
Photo E-6: Ground Fault Indicators. A ground fault indicator light is provided for each phase of the 3-phase power. These indicator lights are provided on the MCC main breaker cubicle and were in an operational condition at the time of the inspection.
