Lasalle Causeway Bascule Bridge

2019 Comprehensive Detailed Inspection Report (Rev. 1)

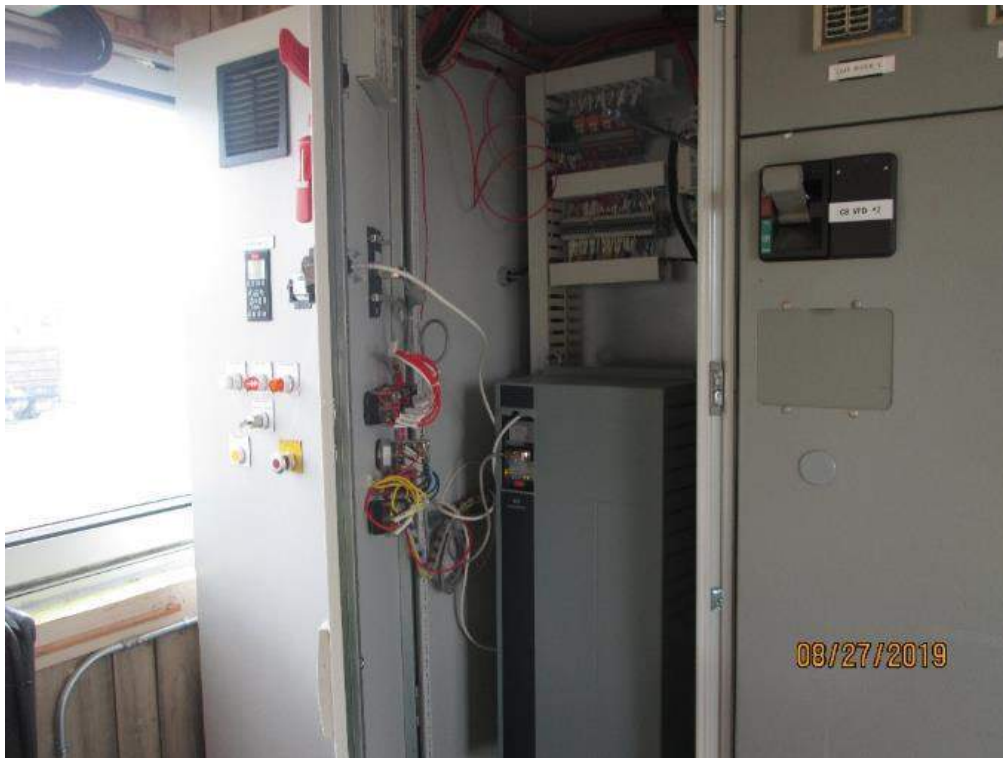
Photo E-7: Span VFD Drive Cabinet. The span variable frequency drives are newly installed and replace the original drive motor controllers for the span drive. The new VFD drives are located in their respective drive enclosures and provide excellent and variable speed and torque control for the operating bridge.

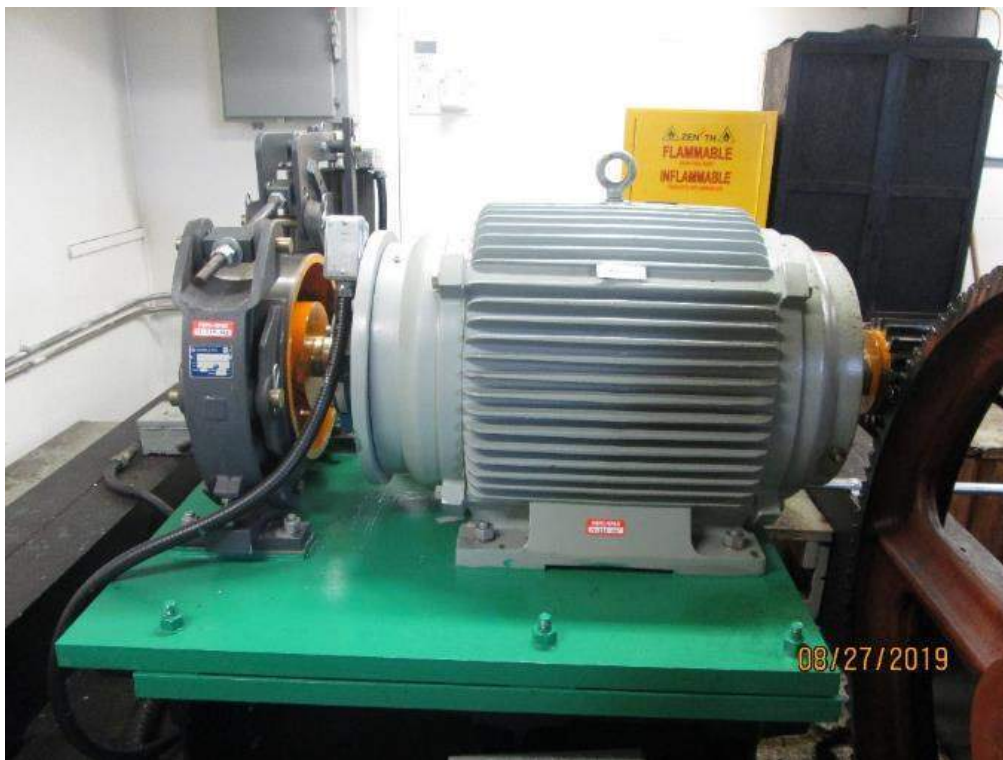
Photo E-8: Typical Span Drive Motor. The bridge is provided with two span drive motors, the two motors can be configured to operate the span simultaneously or they can be configured to operate the span individually. These span drive motors are squirrel-cage induction type and replaced the original wound rotor motors when the new VFD drives were installed.

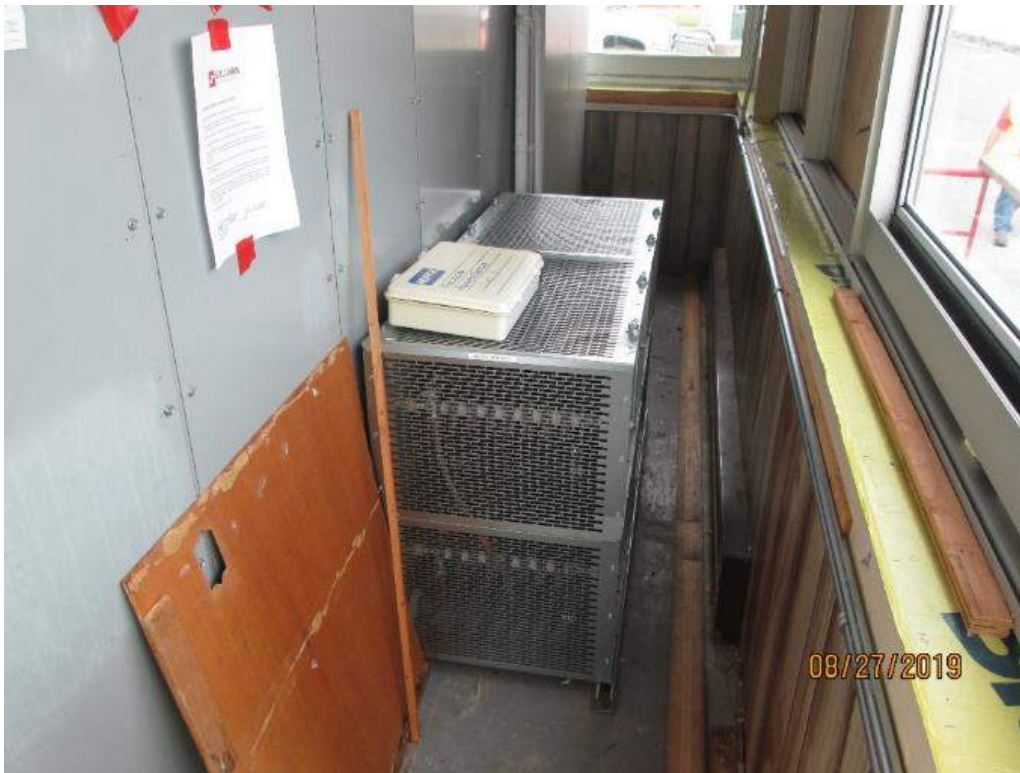
Photo E-9: Typical Dynamic Braking Resistors. Dynamic braking resistors have been installed in conjunction with the VFD drives to provide speed and torque braking control for the span drive motors. These resistors were installed when the VFD drives were installed and are in freestanding enclosures located behind the MCC.

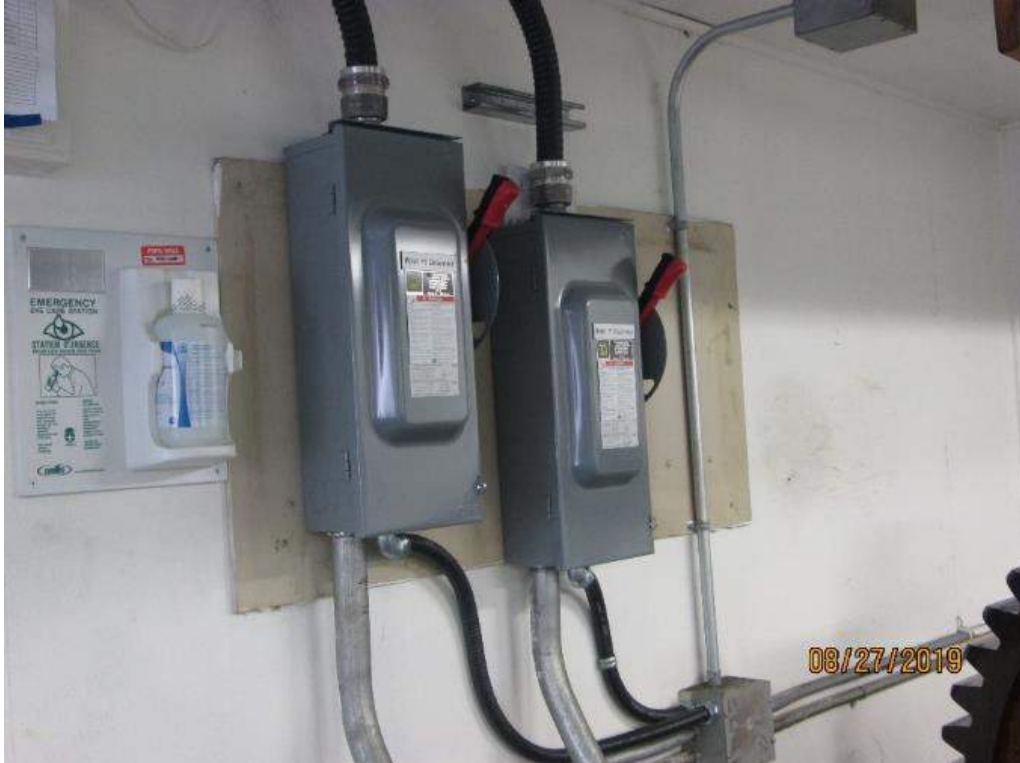
Photo E-10: Span Drive Motor Disconnects. The span drive motors are provided with local disconnect switches as per Canadian Electrical Code. These disconnect switches were installed as the same time as the new drive motors and are in as new condition.

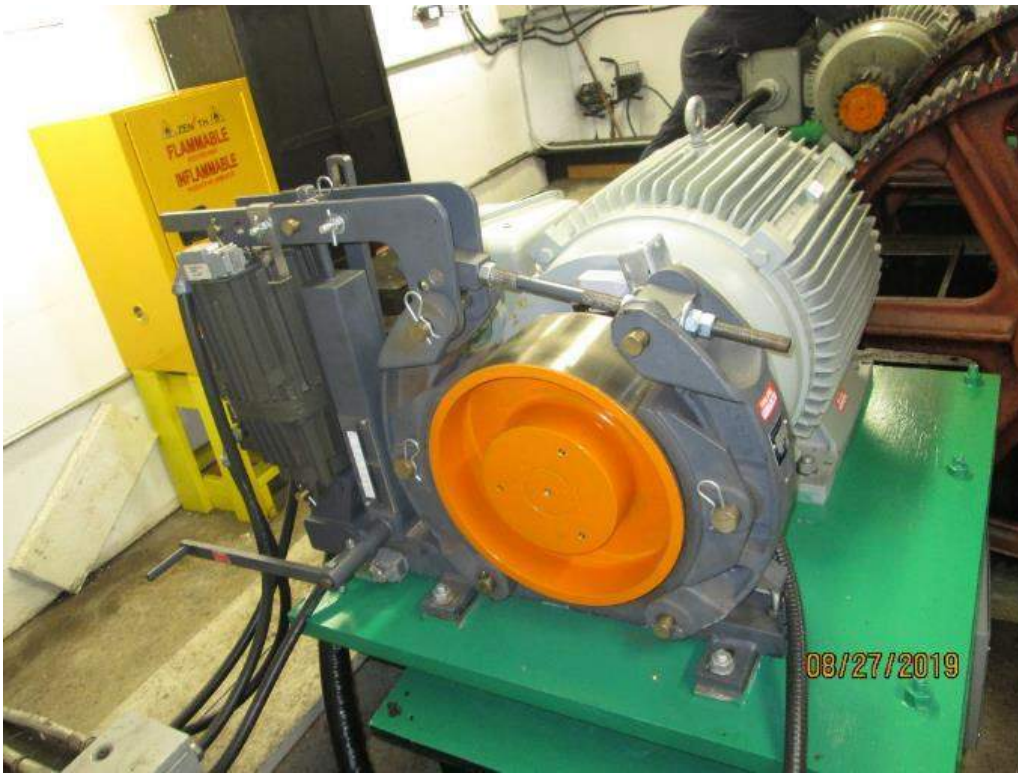
Photo E-11: Typical Motor Brake. The motor brakes are in as-new physical and operational condition and are provided with set, released, and hand released limit switches as per code.

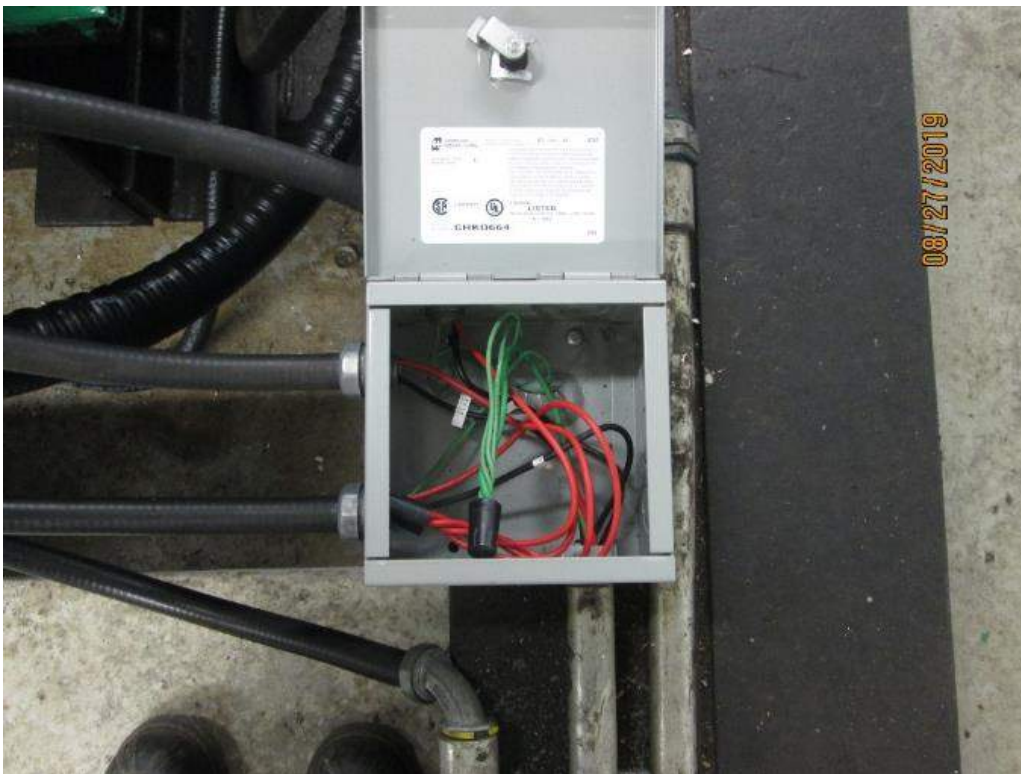
Photo E-12: Junction box near motor brake #1. Note the use of wire-nuts inside the junction box.

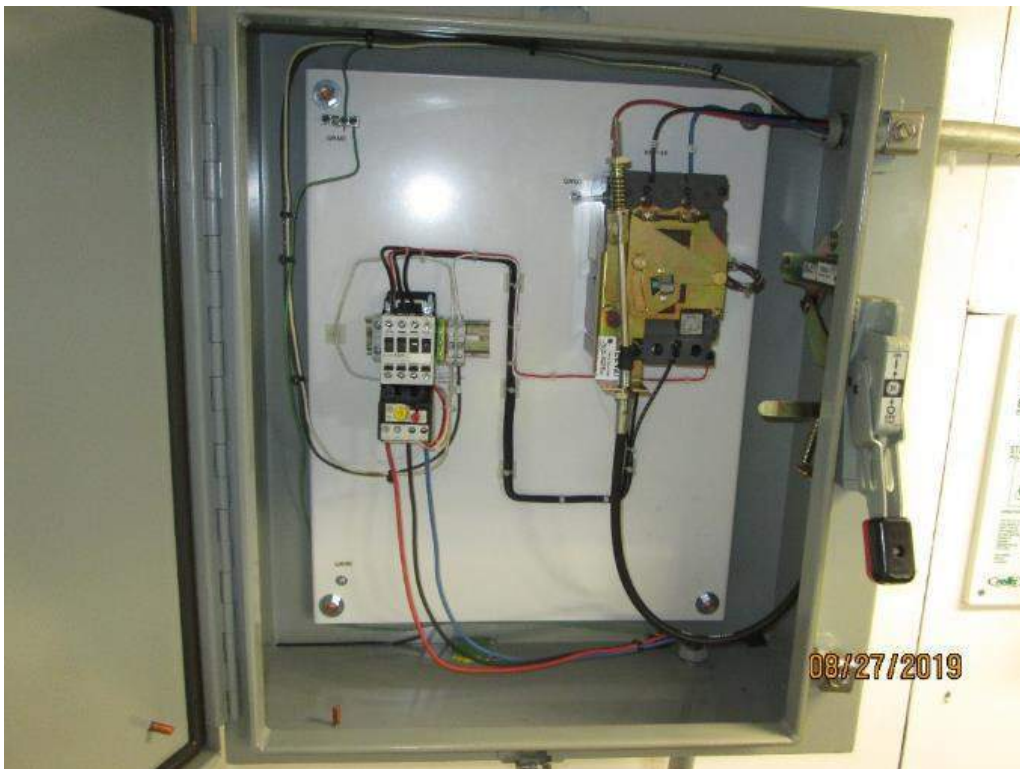
Photo E-14: Motor Brake Disconnect and Starter enclosures. New motor brake starters were recently installed in the bridge machinery space and are in excellent condition. The MCP of the motor brake starter also serves as the local disconnect switch. The wires in the enclosure have not been labelled to aid troubleshooting.

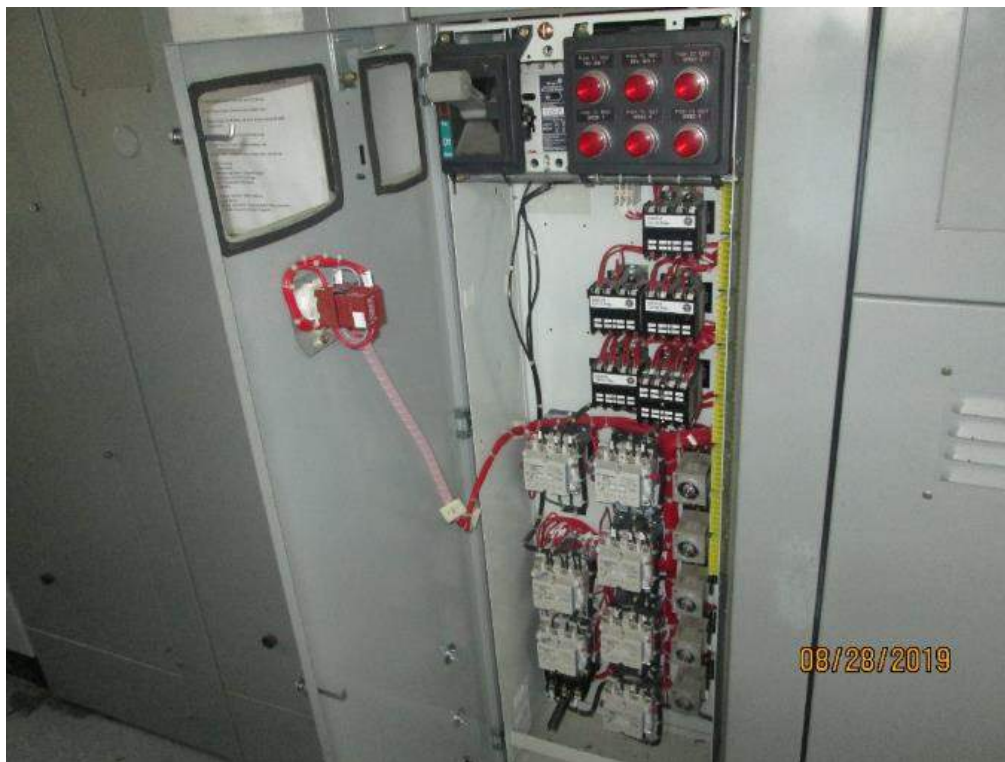
Photo E-15: Span Lock Starter Compartment. Note the span lock was originally designed with 6-speed operating steps. However, at the time of the inspection the span lock was operating at single speed only and the speed stepping contactor and resistor circuit had been disabled.

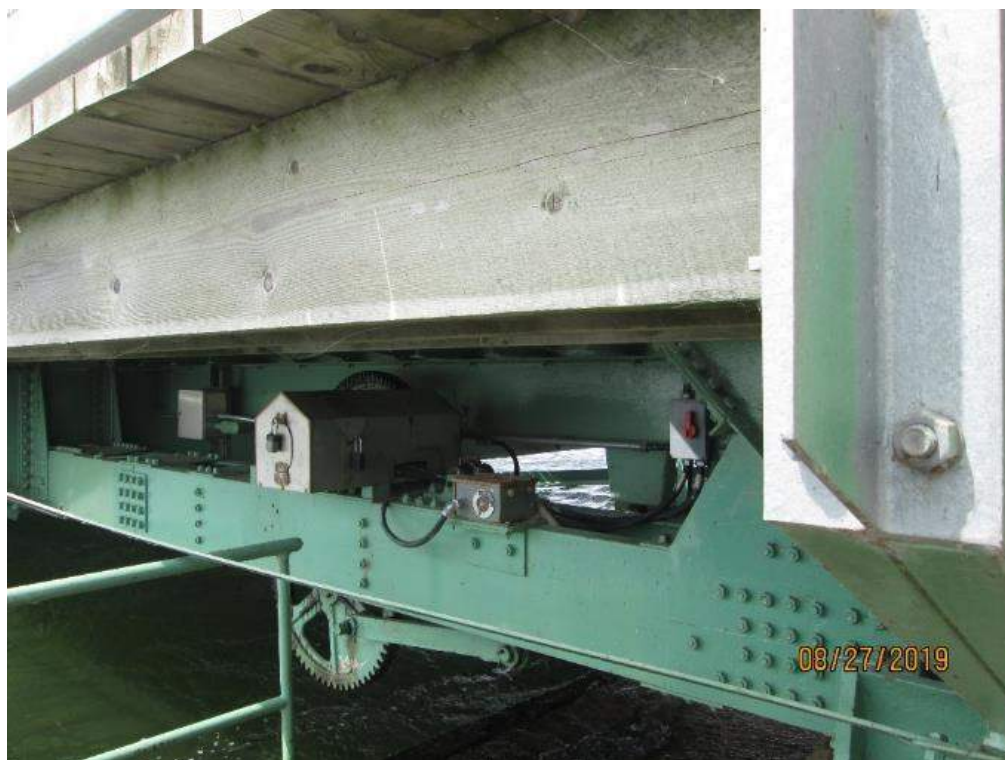
Photo E-16: Span Lock Motor, Rotary Cam Limit Switch (RCLS) and Disconnect Switch. The span lock motor is housed in a stainless steel enclosure and is provided with a local disconnect switch. The span lock is also provided with a two cam limit switch for control, interlock and indication during bridge operation. Note the minor corrosion on the RCLS enclosure.

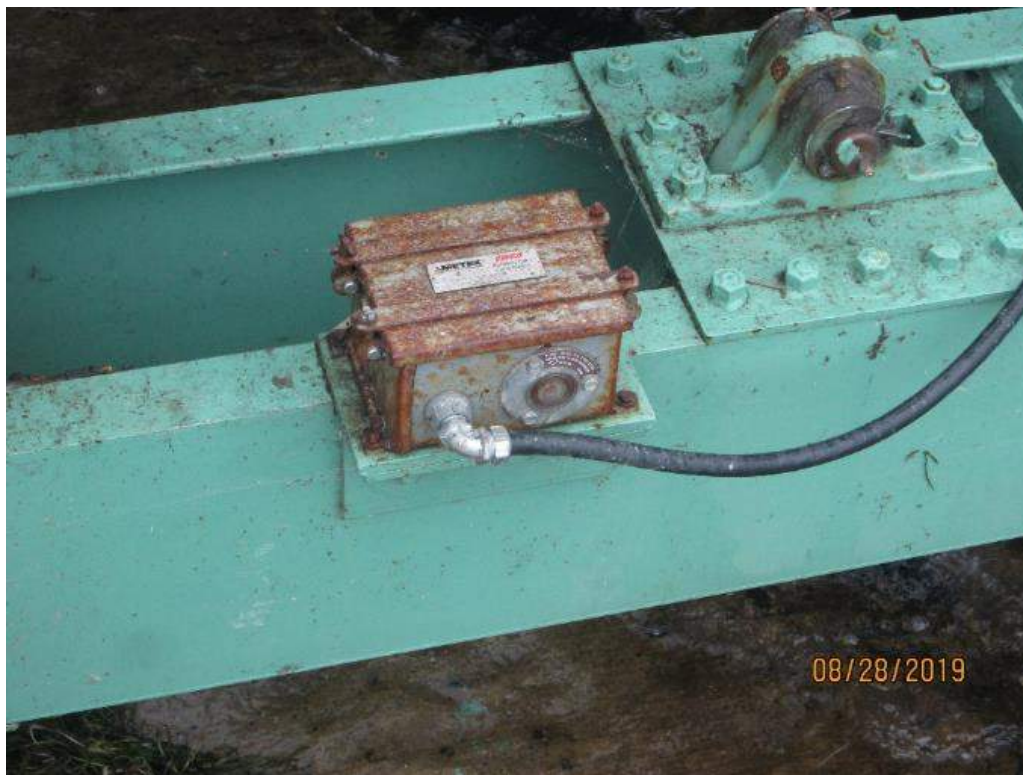
Photo E-17: North Side Span Lock Rotary Cam Switch. The span lock is provided with a second RCLS to monitor the position of the north lock bar. The RCLS enclosure exhibit moderate signs of corrosion.

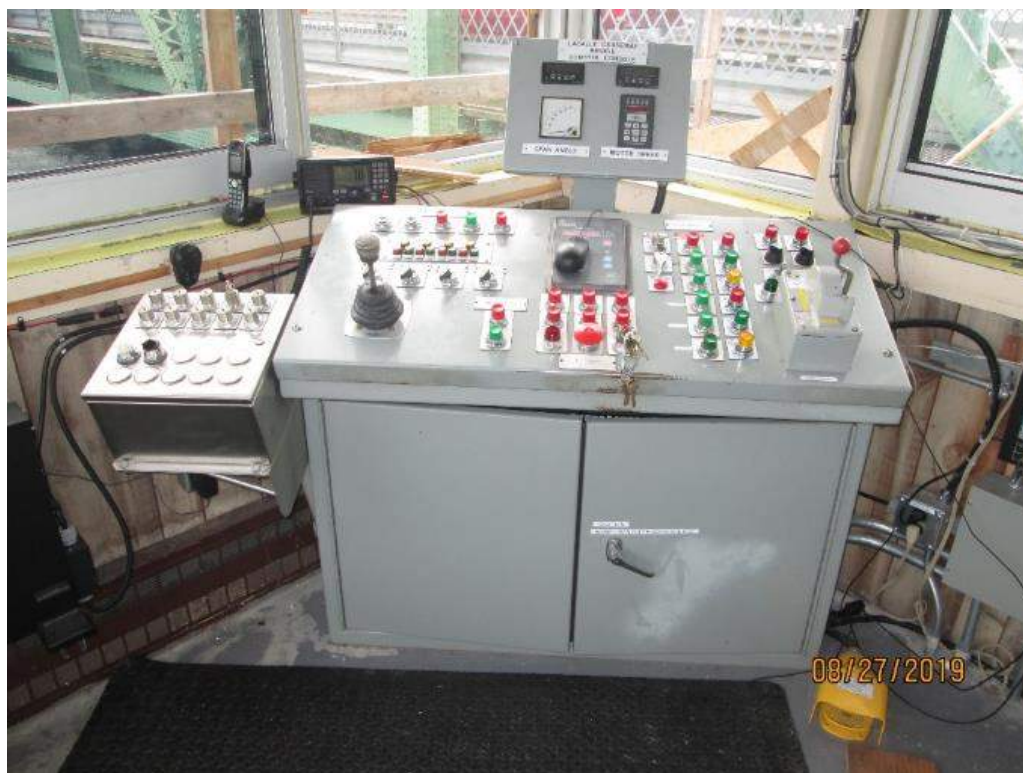
Photo E-18: Control Desk. The location of the control desk provides the operator with a complete view of the channel and vehicular and pedestrian roadway traffic. The control desk is in acceptable condition. Note the foot switch next to the control desk on the floor is in good operational condition.

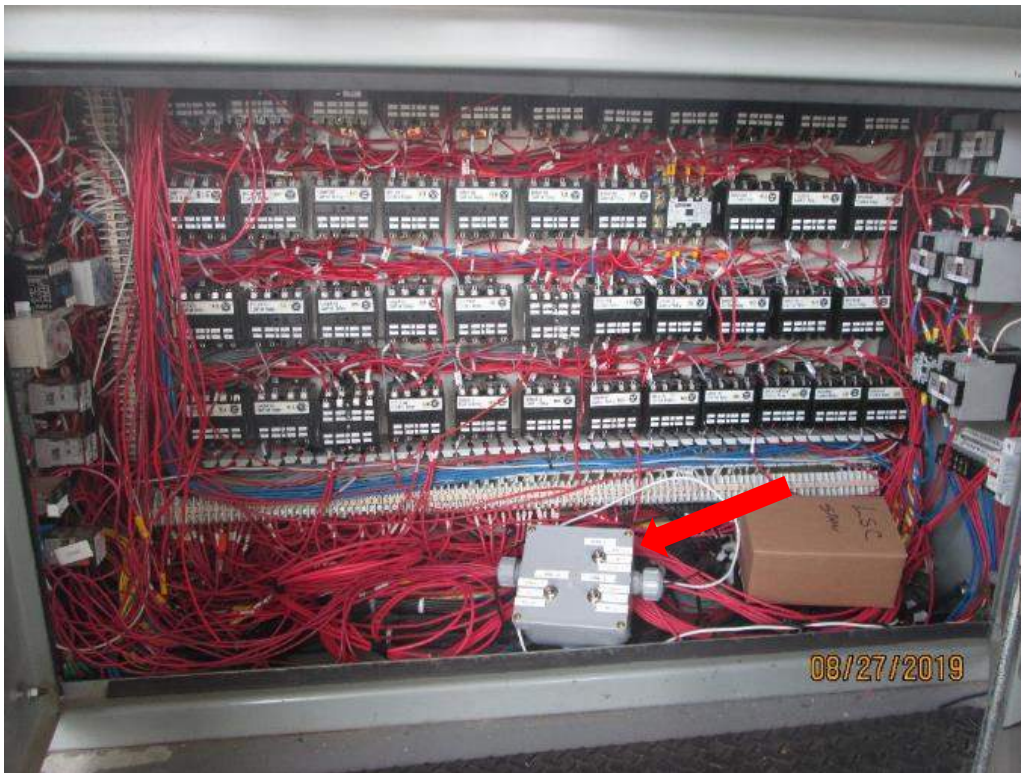
Photo E-19: Relay Control inside the Control Desk. This relay cabinet was modified during the drive/motor replacement project to accommodate the new control required for the new drive system. Note the toggle switch box is installed inside the cabinet to allow the bridge fully seated limit switch at the toe end of the bridge to be switches to the new lever switch installed in the cam switch box inside the machinery space as a backup when the water level is too high.

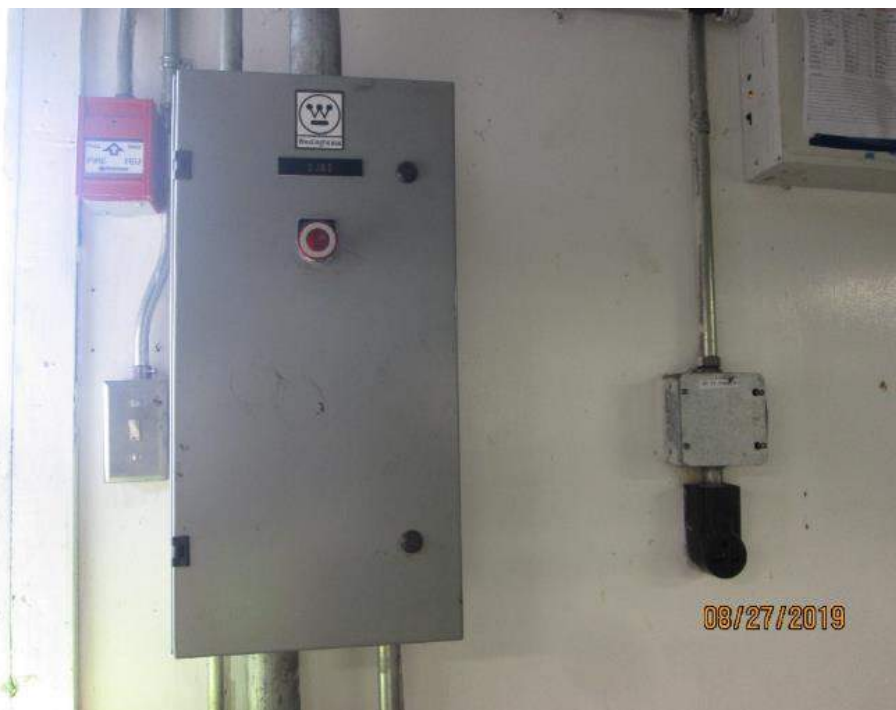
Photo E-20: Machinery Space Local E-Stop. This E-Stop switch is located near the machinery space entrance. It allows maintenance personnel to prevent or stop bridge operation when work is being performed in the machinery space.

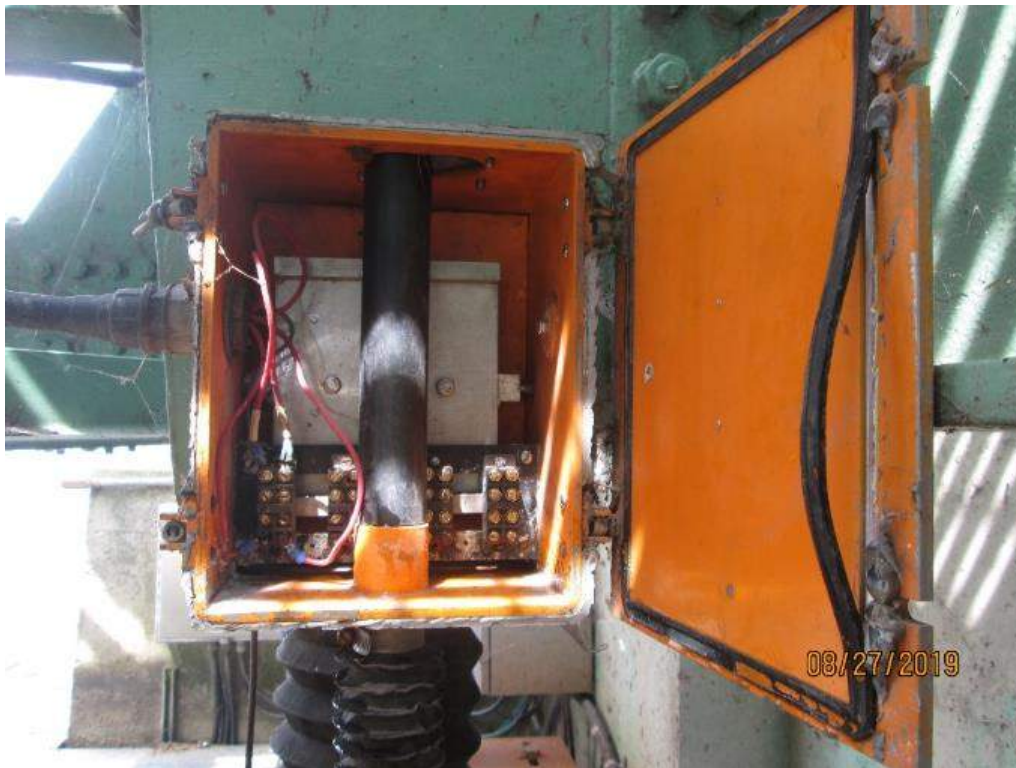
Photo E-21: Span Fully Seated Limit Switch. Two span seated limit switches are provided at the toe end of the span, one at each corner. North seated limit switch exhibits standing water inside the enclosure. Note during high water level, water will get inside the switch enclosure and cause operational issues.

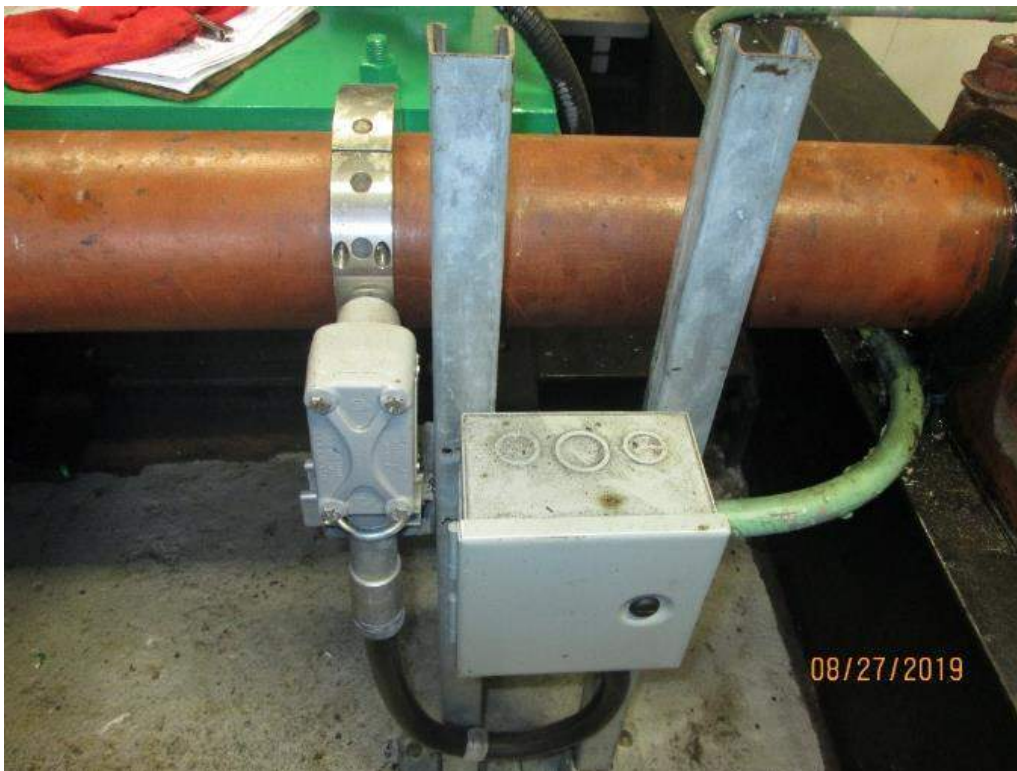
Photo E-22: Speed Switch Sensor. A Hall Effect speed switch was installed as part of a 2012 rehabilitation project to provide span position and motor speed indication on the operator's control desk. The speed switch sensor is in very good condition.

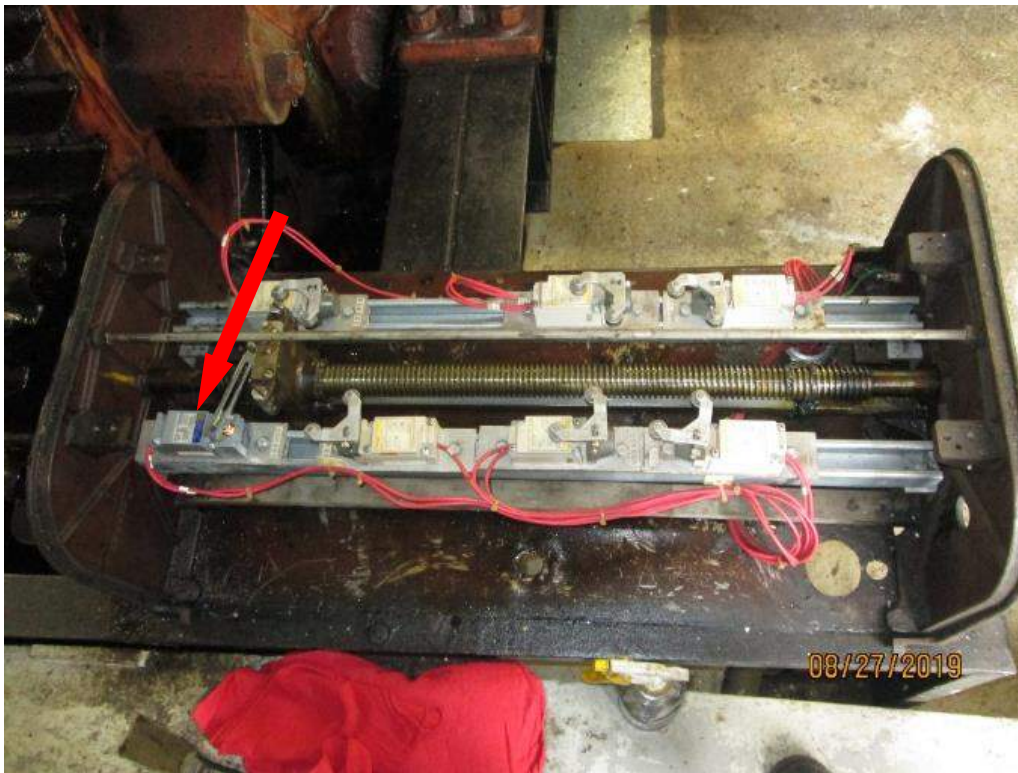
Photo E-23: Span Position Limit Switches. The targets on the auxiliary threaded shaft are used to toggle the lever type limit switches and provide discrete signals of the bridge position. The limit switch housing exhibits signs of corrosion, but the limit switches inside are in good operational condition. Note the added backup span seated limit switch.

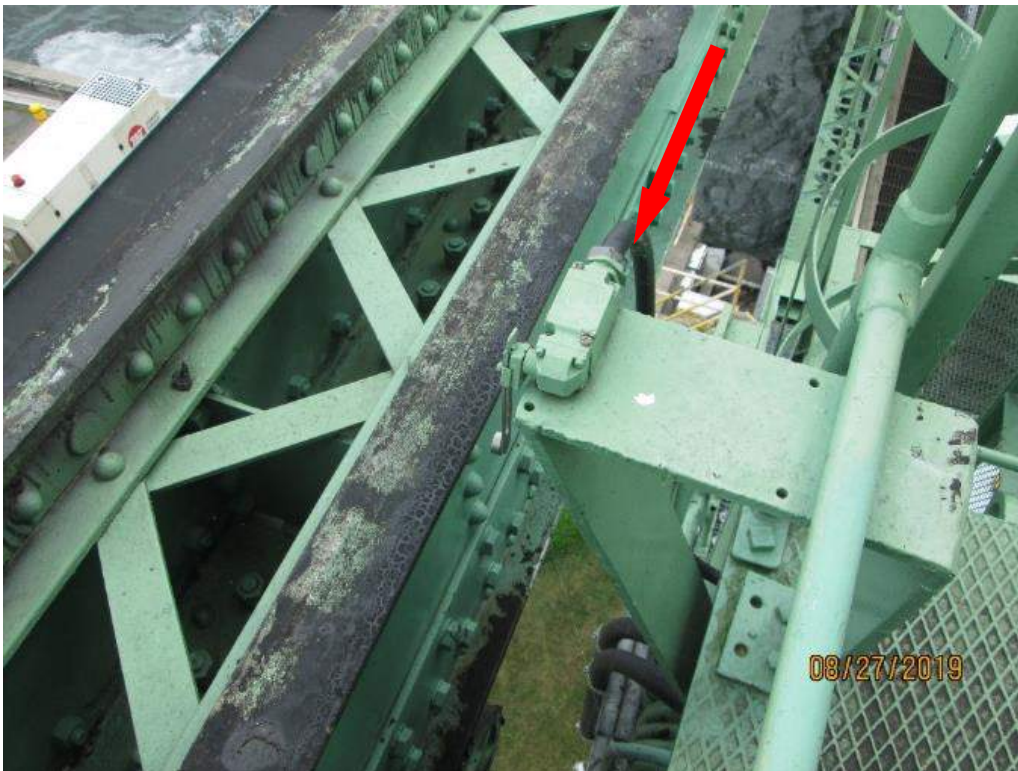
Photo E-24: Span Over-Travel Limit Switch. The span control is provided with an over-travel limit switch to stop bridge operation in the event of span over travel.

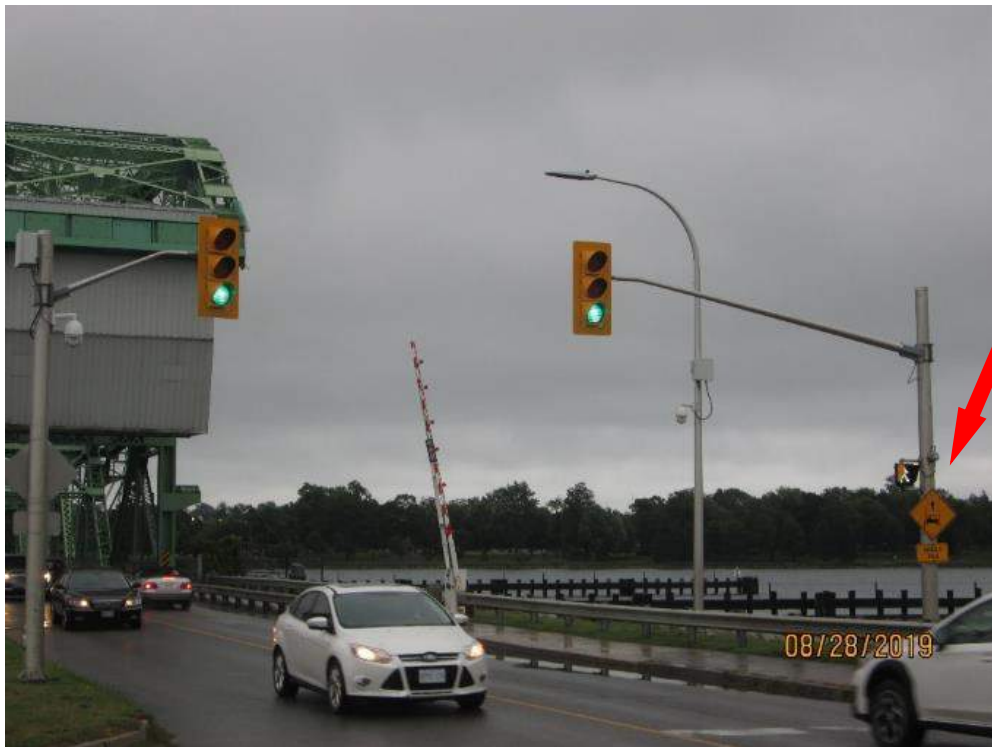
Photo E-25: Typical Traffic Signal (West Shown). Each bridge approach is provided with two sets of traffic signal fixtures mounted on cantilevered arms and suspended over the roadway. Additionally, a warning gong and a pedestrian signal light have been provided at each of the south traffic signal poles. The traffic signal equipment was installed as part of a recent rehabilitation project and is in very good condition. Note the east warning gong was not operational at the time of inspection.

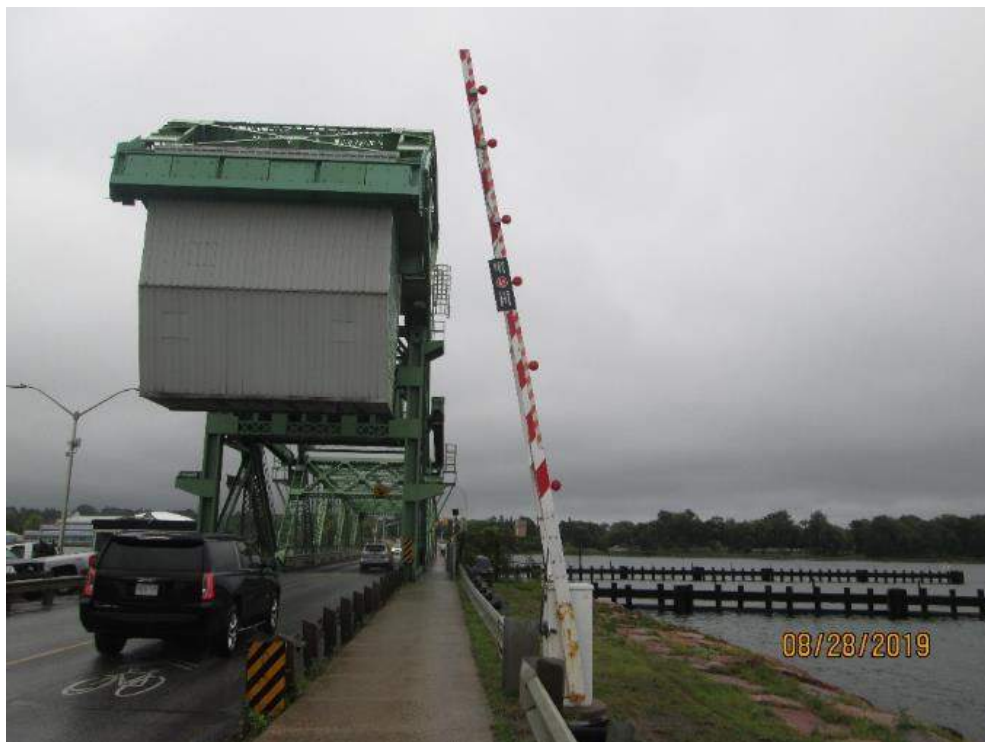
Photo E-26: Typical Traffic Gate (Fully Raised). The bridge is provided with four (4) traffic gates, one at each approach to the span. All gates and gate arm lights were in good operational condition at the time of the inspection. Note the SW gate fully raised position is not adjust to the vertical position.

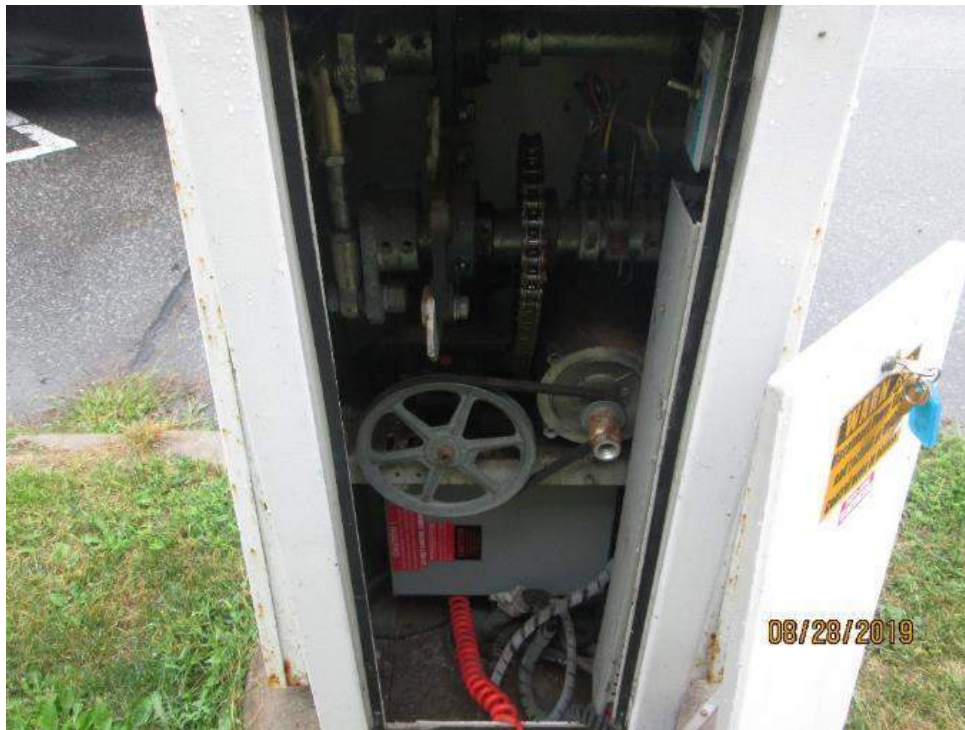
Photo E-27: Typical Traffic Gate Housing. The motor starter is located inside the gate housing. Note that no door limit switches have been provided to prevent gate operation when the gate door(s) are open for maintenance or troubleshooting but a sign has been installed to indicate that the gate is powered and should be disconnected at the MCC prior to maintenance being performed. Also note no hand crank limit switch has been provided in accordance with code.

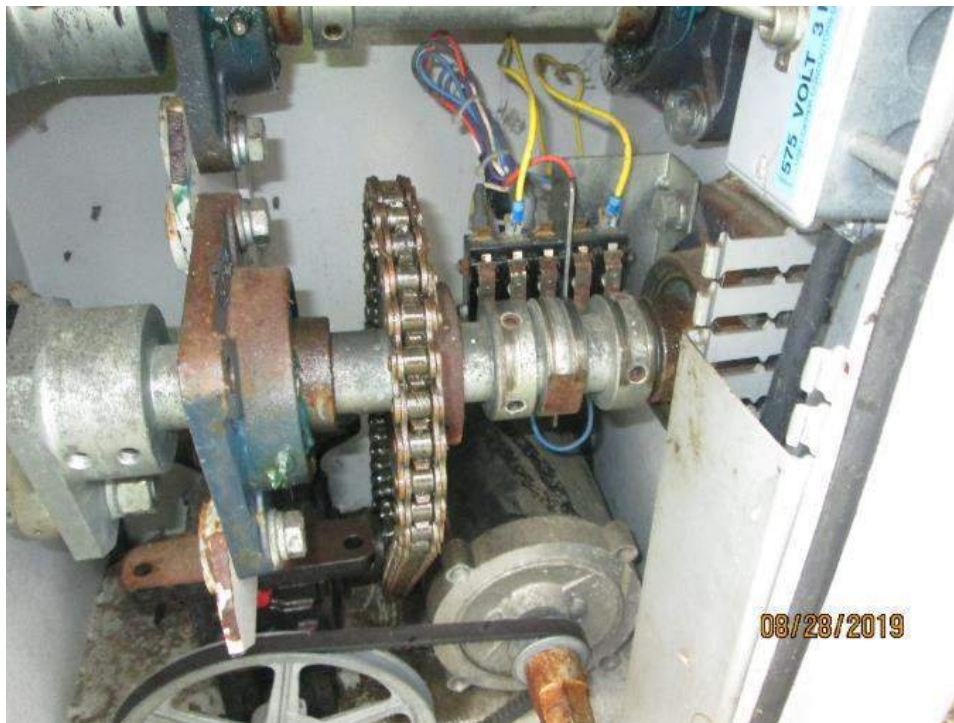
Photo E-28: Typical Traffic Gate Limit Switches. The traffic gates are provided with a cam type limit switch. Although these limit switches were in operational condition at the time of the inspection, they are missing protective covers, switch contacts exhibit excessive corrossions due to the exposure which might cause premature failure.

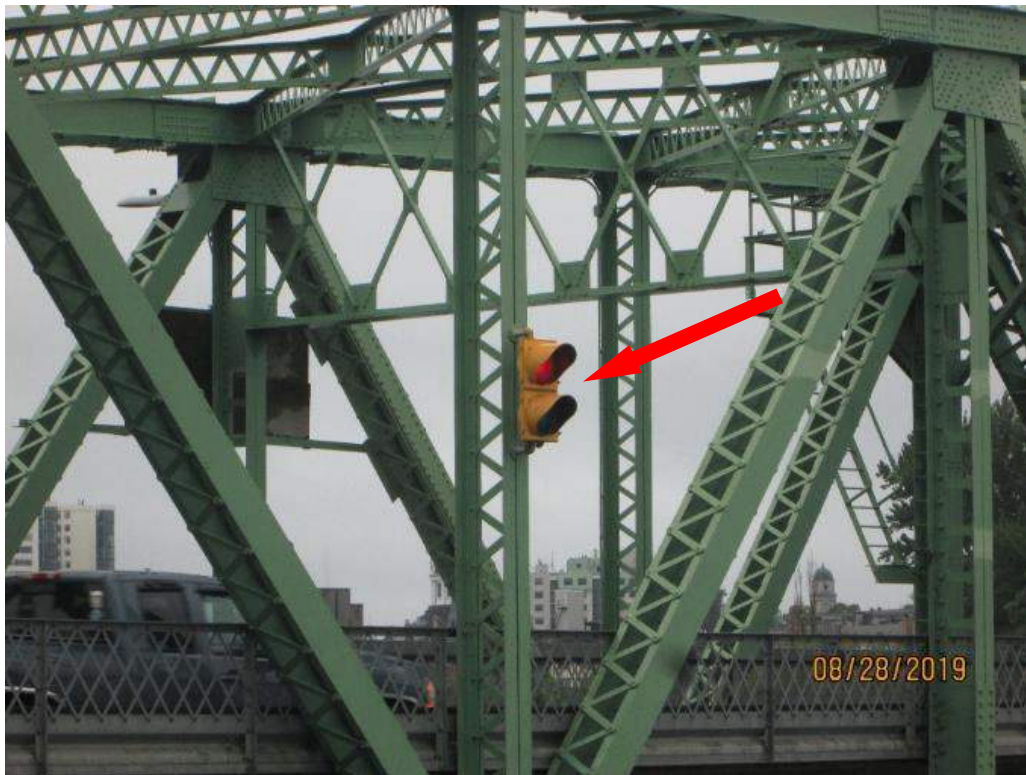
Photo E-29: Typical Span Navigation Light. Note that roadway type lights are being used. The location of the navigation lights does not provide marine traffic with a clear visual indication as to when the span has been raised and it is safe to proceed.

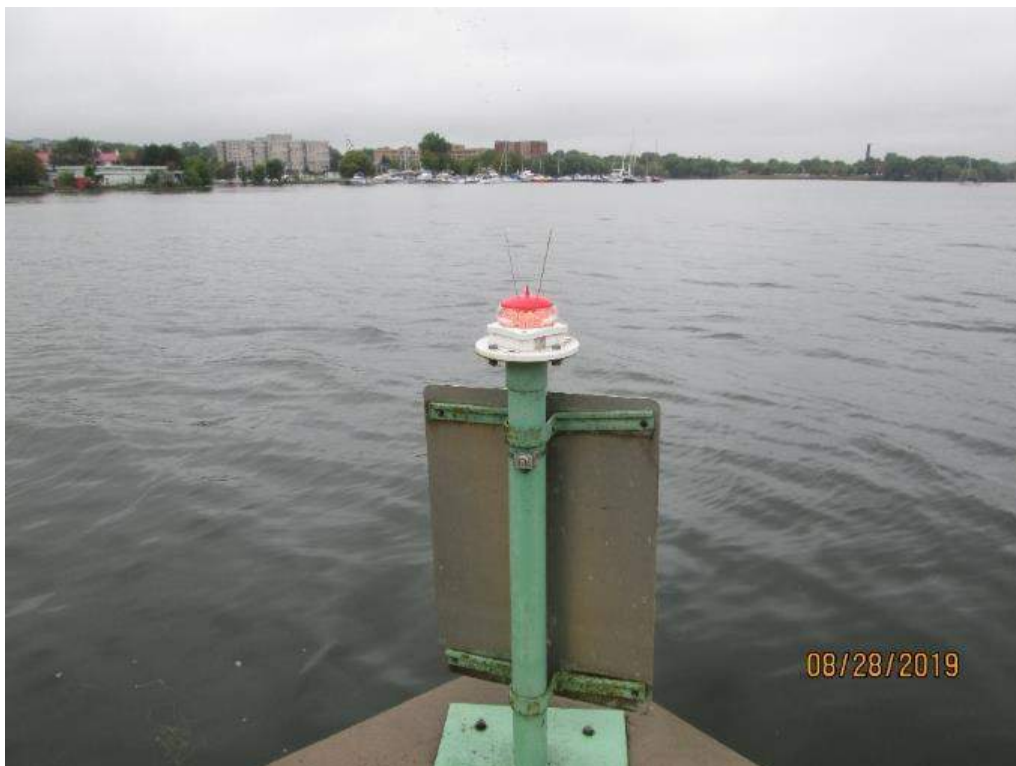
Photo E-30: Typical Fender Light. The bridge is provided with 4 fender light fixtures, one at each corner of the fender. The north fender lights are flash red and the south fender lights are flash green. The fender lights are of LED type and are in good operational condition.

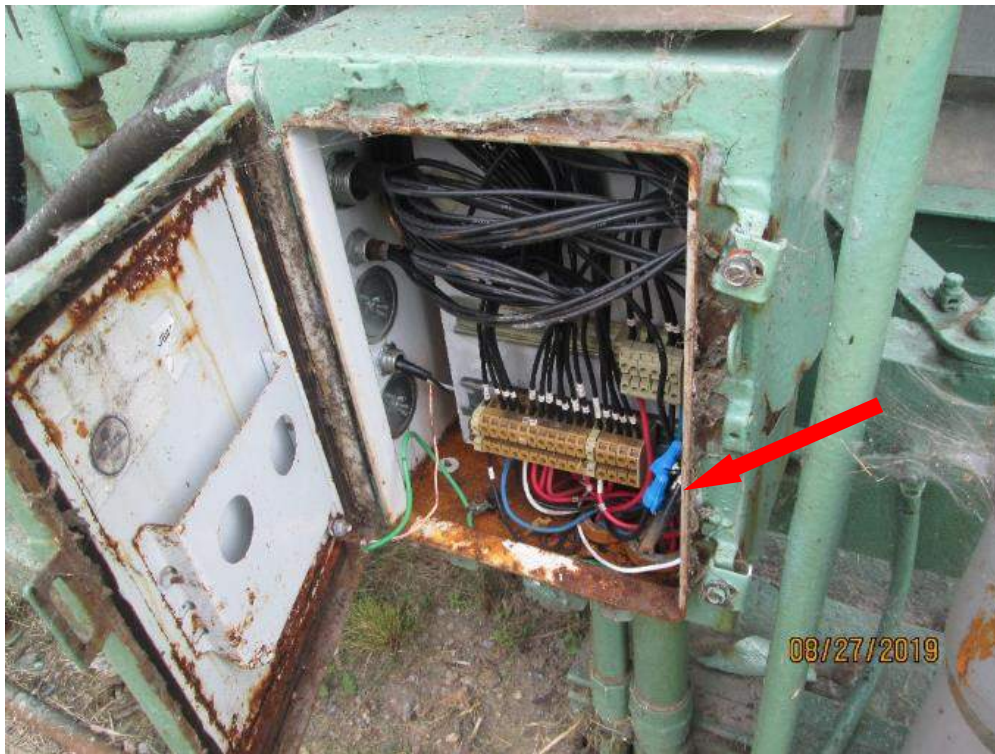
Photo E-31: Typical Outdoor Junction Box. Many of the outdoor junction/pull boxes are NEMA 4X boxes. Note this junction box exhibit heavy signs of corrosion at the bottom of the enclosure, also note the use of wire-nuts inside of inside the junction box. This junction box is in poor condition and is located at the bottom of the staircase leading to the machinery space.

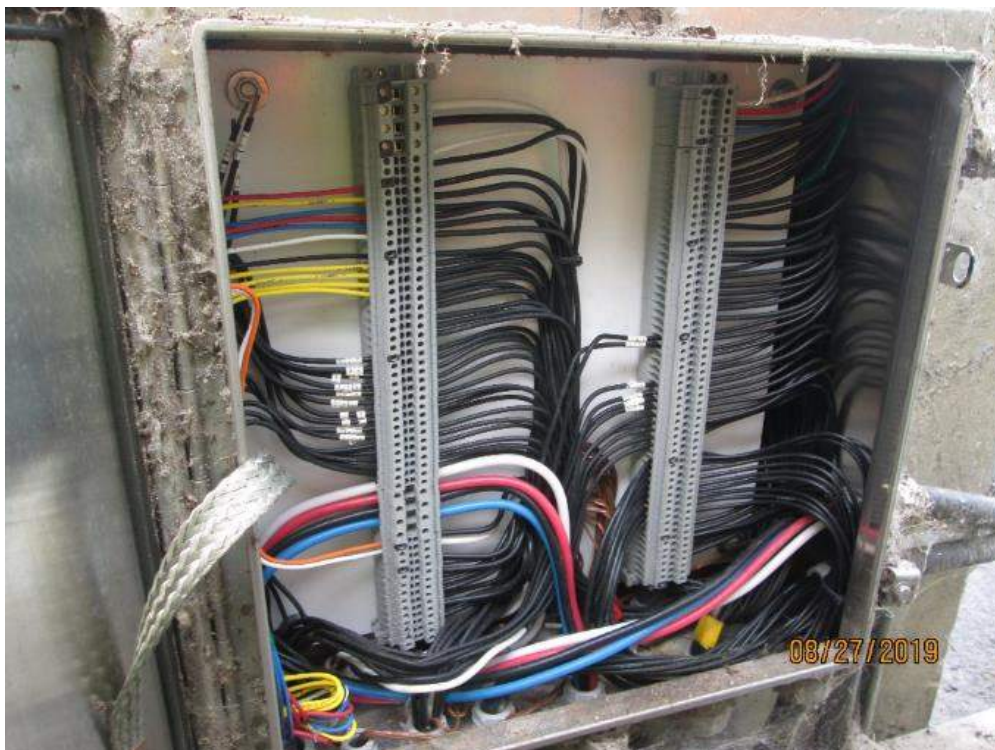
Photo E-32: Typical Submarine Cable Junction Box. The submarine cable junction box is in good condition with proper grounding and bonding but covered with debris both internally and externally. Note the wires inside the submarine cable junction boxes are not properly labelled.

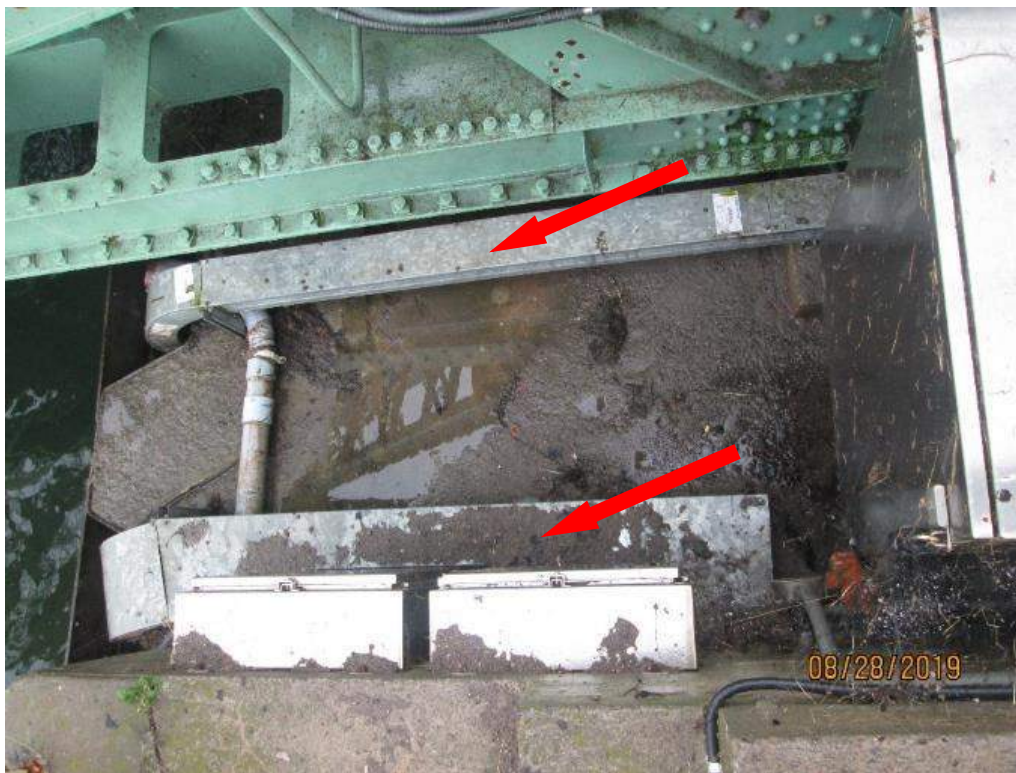
Photo E-33: Typical Submarine Power Cables. The submarine cable is used to carry control and power across the channel. Both recently installed and originally installed submarine cables were found at the bridge. It was unclear if the old submarine cable was abandoned or still in service. Note the new submarine cable is of the Teck cable type and is protected with wireways above water level on the pier.

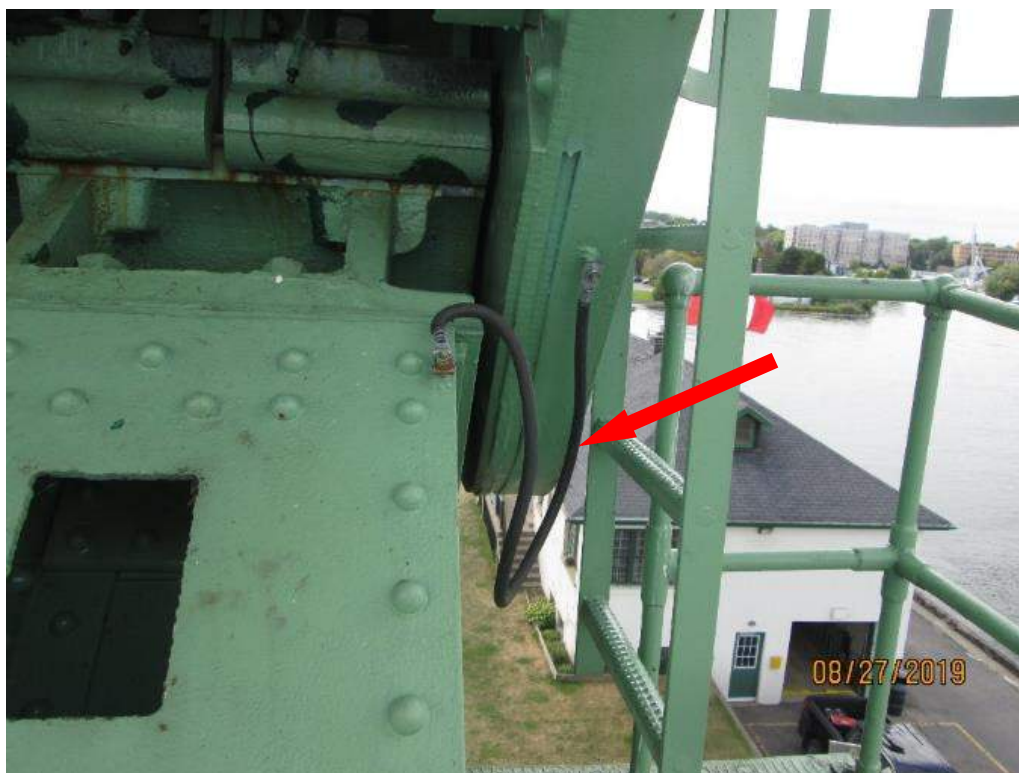
Photo E-34: Bridge Grounding & Bonding System. The bridge steel structures are provided with proper grounding and bonding system in accordance with code.
