Lasalle Causeway Bascule Bridge

2019 Comprehensive Detailed Inspection Report (Rev. 1)

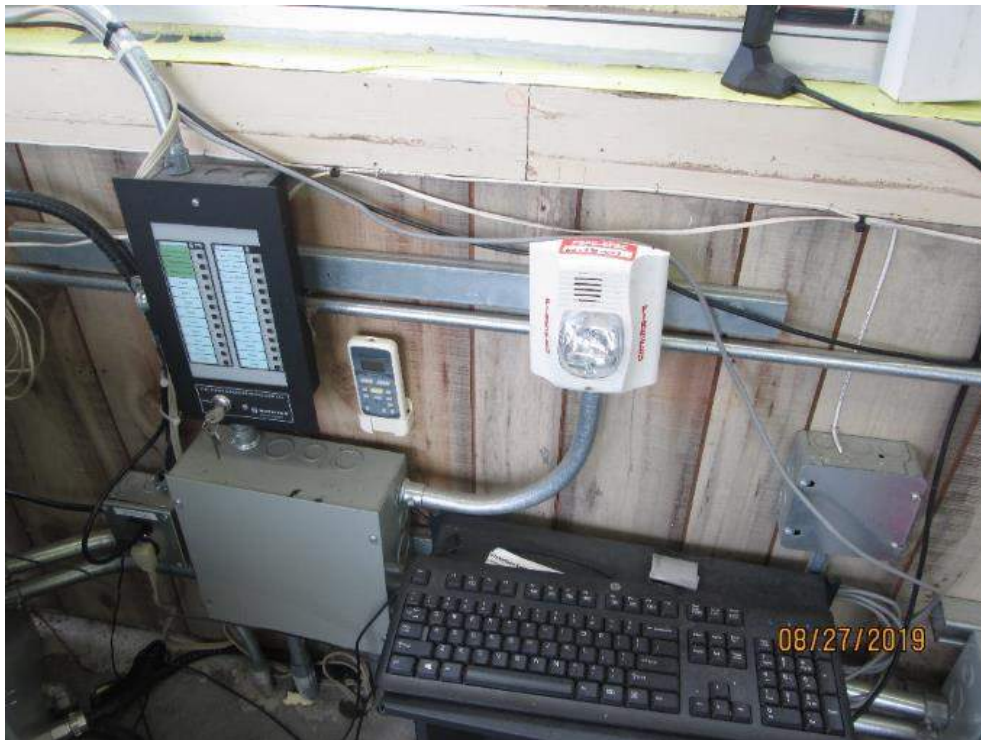
Photo E-35: Fire Alarm System. The bridge is equipped with a fire alarm system. Fire detection devices are provided in the bridge maintenance building, the bridge control house and machinery space. The main fire alarm control panel is located in the bridge maintenance facility with a remote annunciator located in the bridge operators control house. All fire alarm equipment was in good serviceable condition at the time of the inspection.

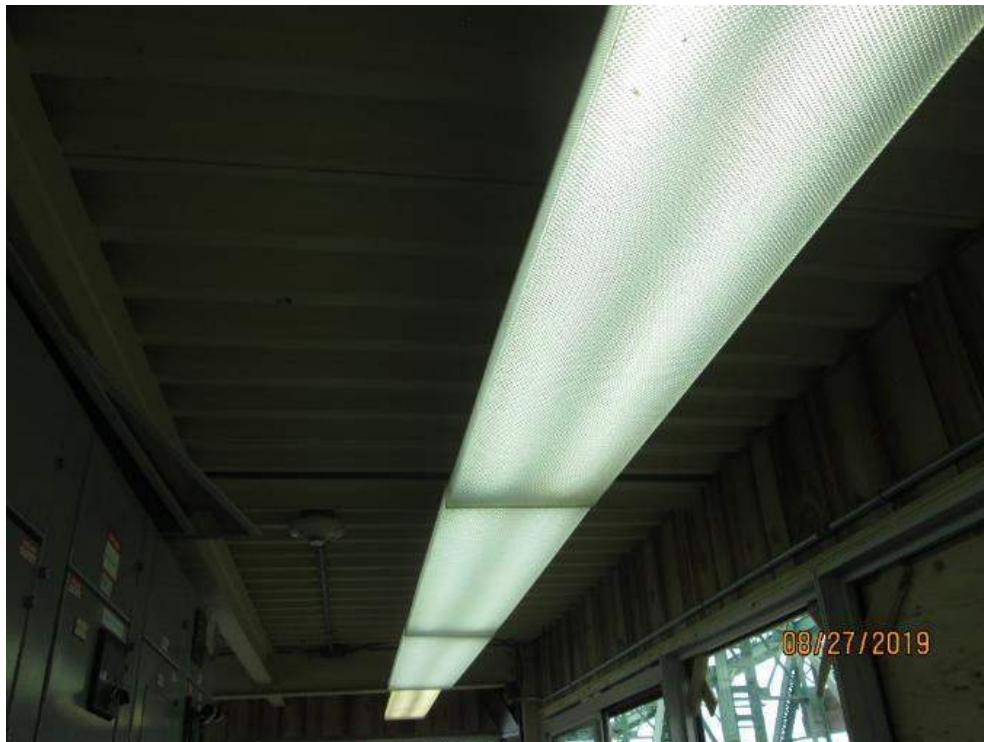
Photo E-36: General and Emergency Lighting. The lighting in the operator's control house provides sufficient illumination level for both operation and maintenance and is in good working condition. The emergency lights were tested at the time of inspection and are operational.

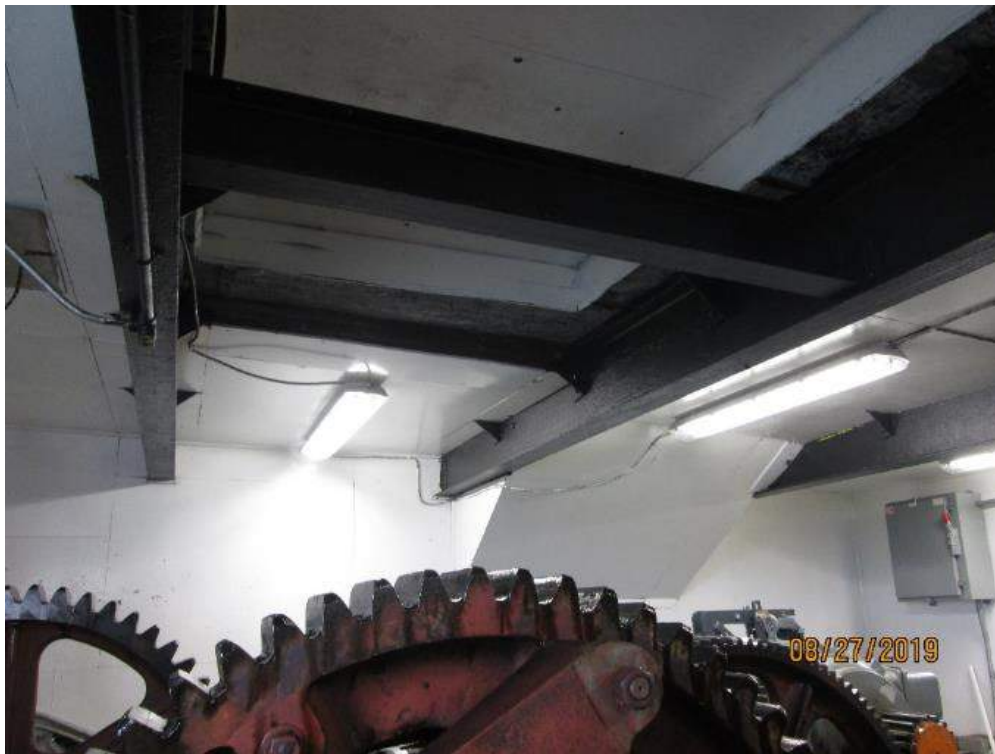
Photo E-37: Machinery Space Lighting. The machinery space is provided with T5 light fixtures. These fixtures are in excellent operational condition and provide adequate lighting levels for maintenance and troubleshooting.

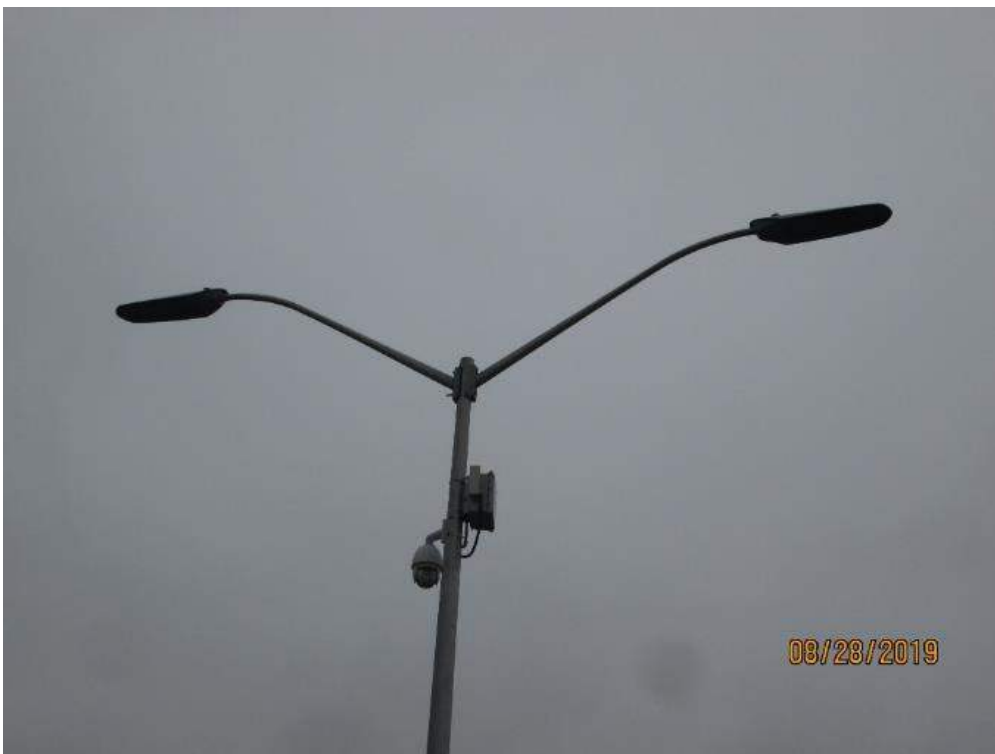
Photo E-38: CCTV System and Roadway Lighting. A CCTV system was installed at the bridge for monitoring of the bridge roadway, waterway and machinery space from the maintenance facility and the operators control house. The CCTV installation is in excellent condition. LED type roadway lighting are provided on the bridge and are photocell controlled.

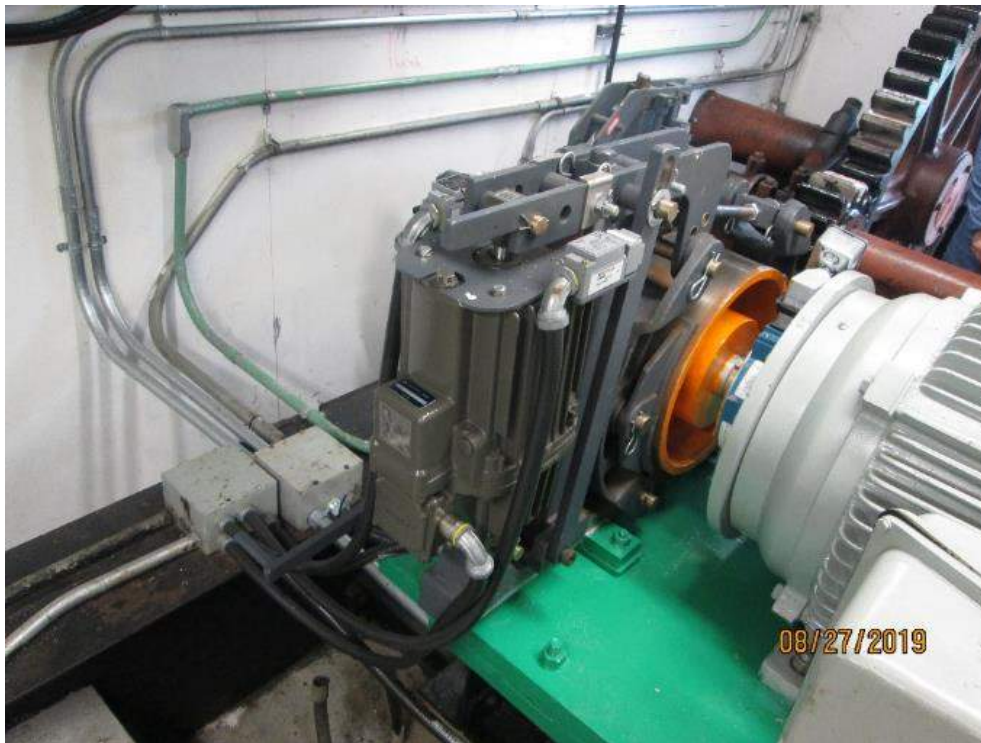
Photo E-39: General Indoor Electrical Installation (Machinery Space Shown). Indoor electrical raceway installation in the machinery space and operators control house generally consists of rigid steel conduits. These conduits are in good condition. The bridge cable installation consists of wire in conduit and with Teck cables that were recently installed to feed the new drive motors.

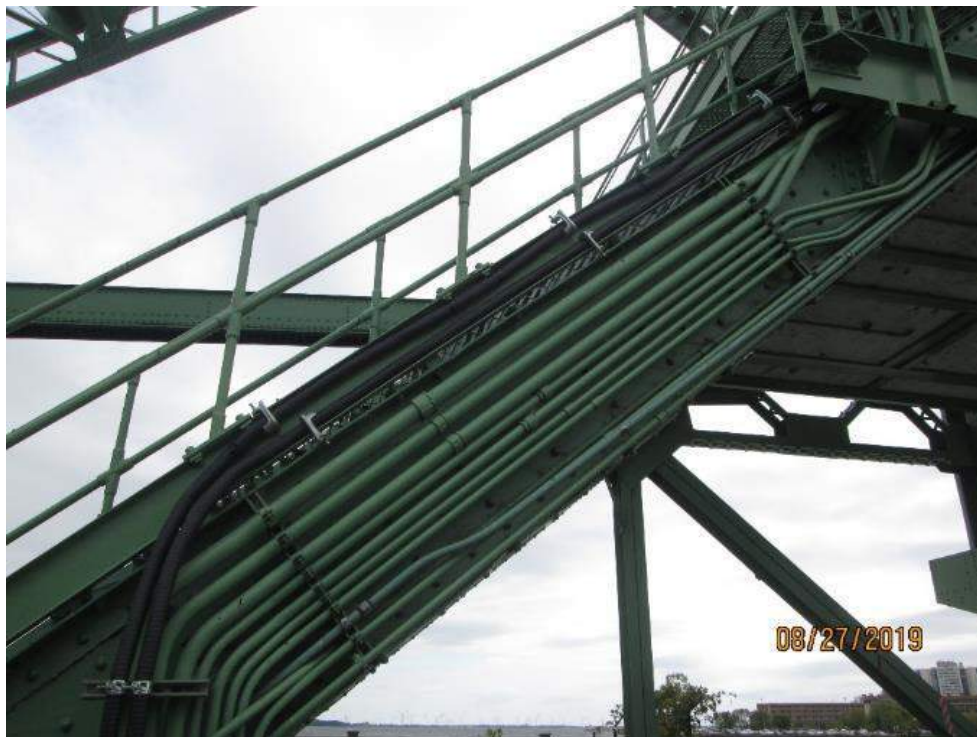
Photo E-40: General Outdoor Installation. The bridge outdoor installation generally consists of Teck cable, painted RGS conduits, and stainless steel junction boxes. The installation is generally in good serviceable condition but with some of the cable/conduit support brackets exhibiting moderate signs of corrosion. The junction box at the bottom of the staircase leading to the machinery space is in poor condition.

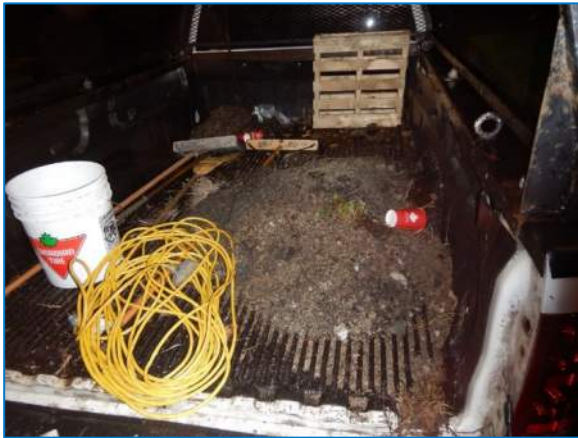
Photo 1 Debris - Removed

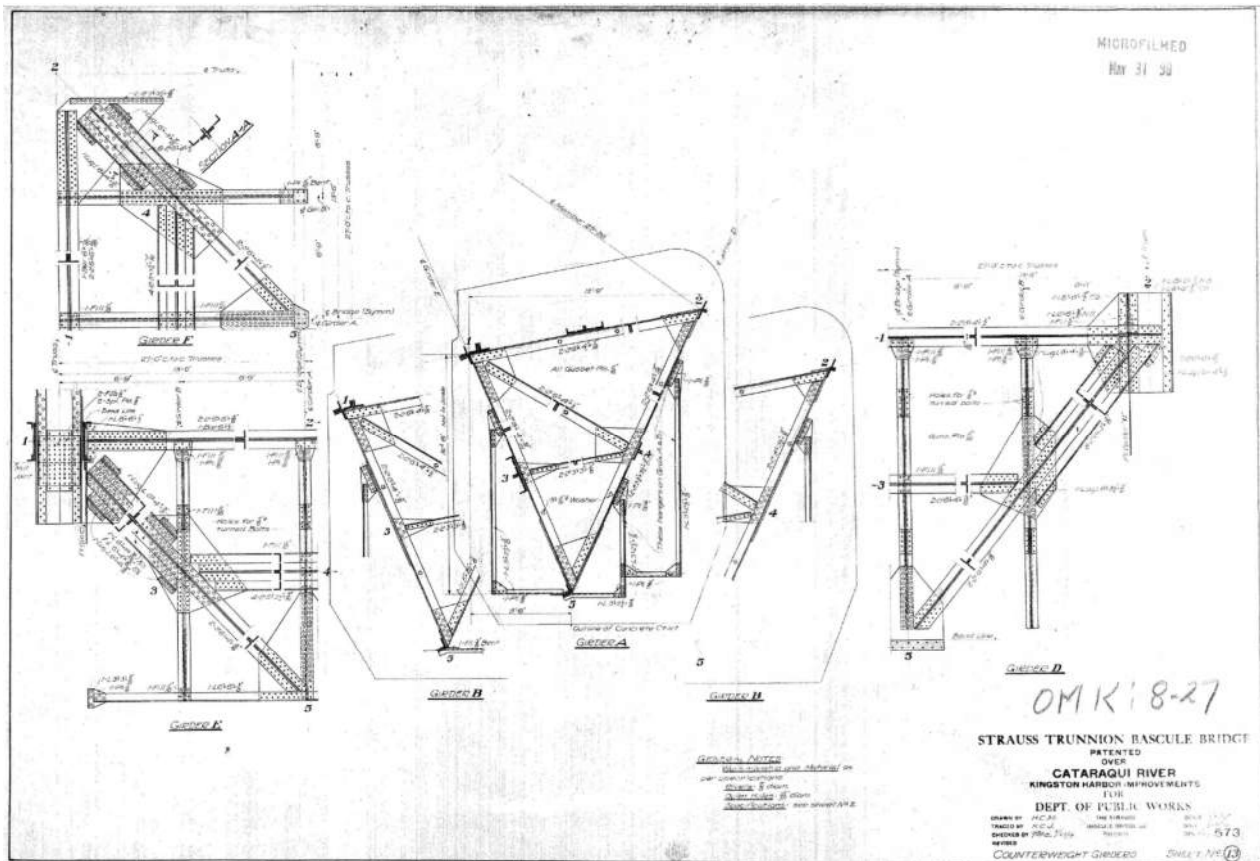
Figure 2 Counterweight Structural Steel

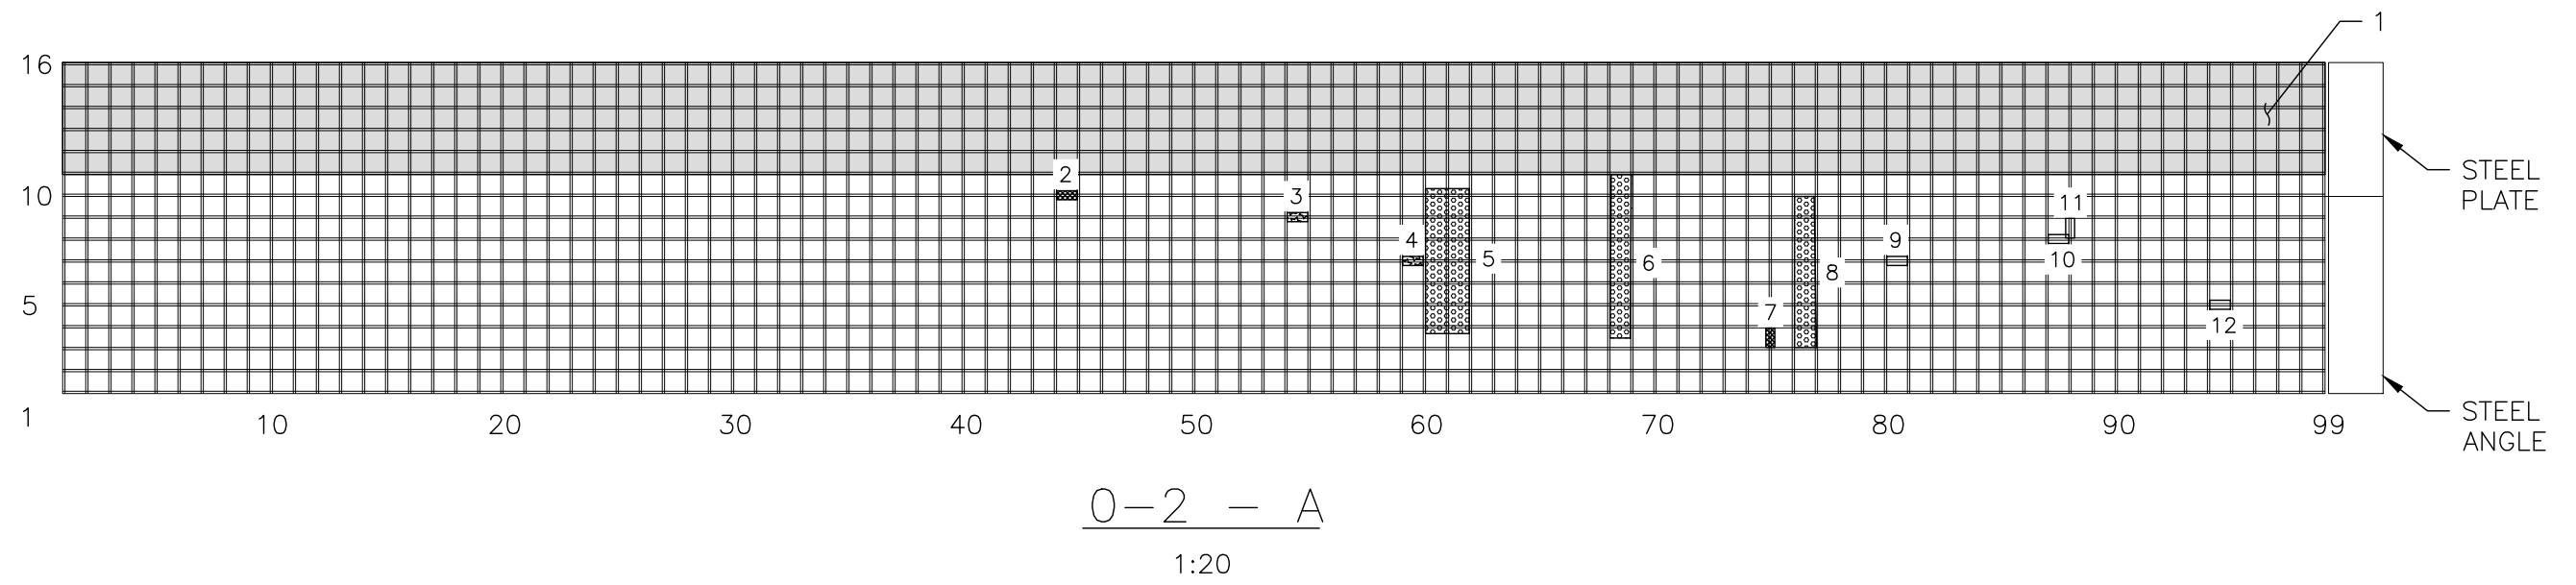
APPENDIX G – DECK GRATING INSPECTION DRAWINGS

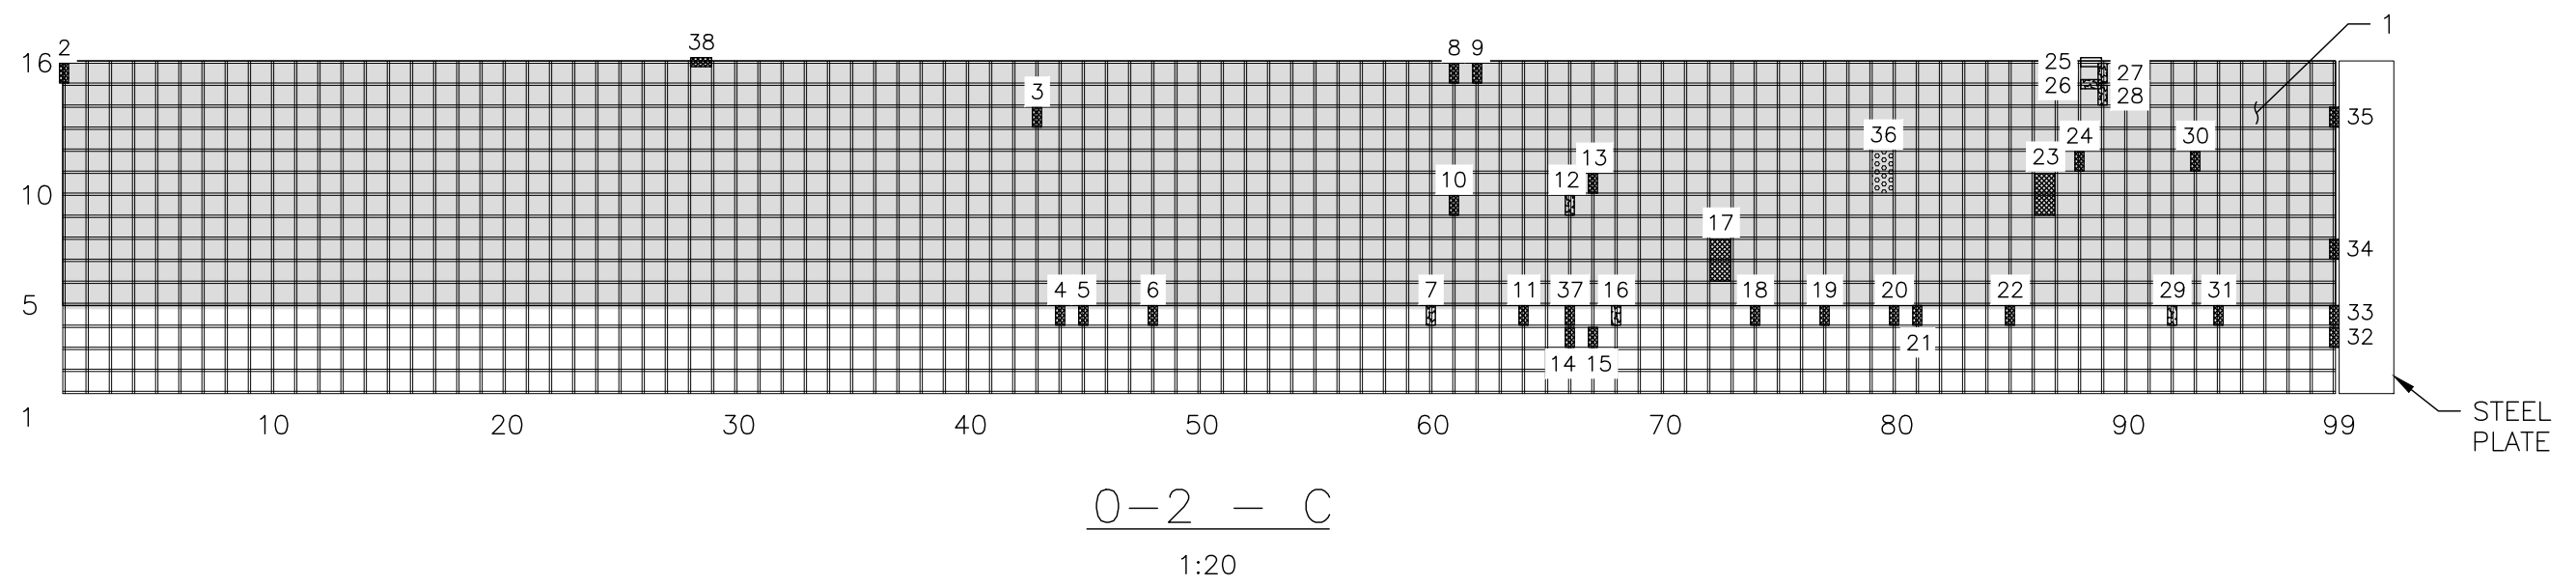
| DEFECT No. | DESCRIPTION | DEFECT No. | DESCRIPTION | DEFECT No. | DESCRIPTION |

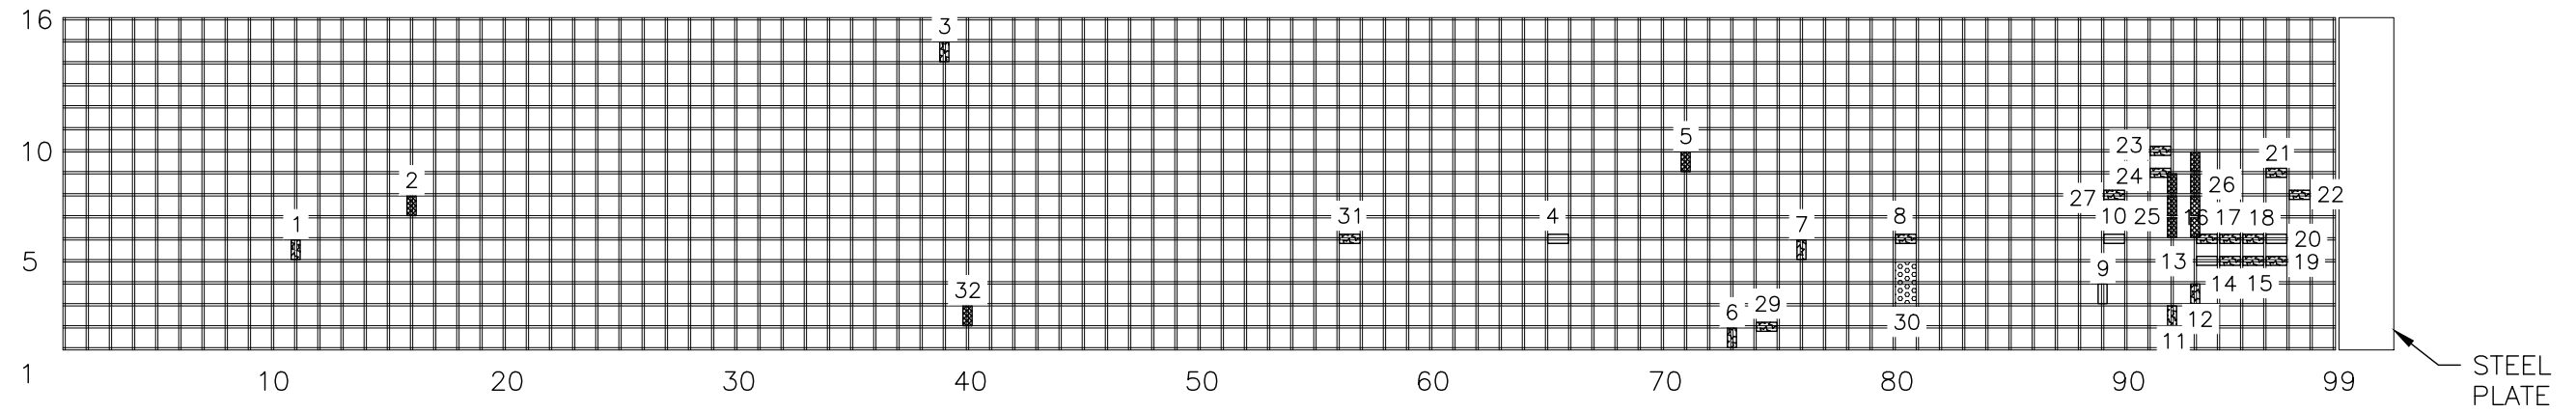
| tender soumission | project manager administrateur de projets | | |

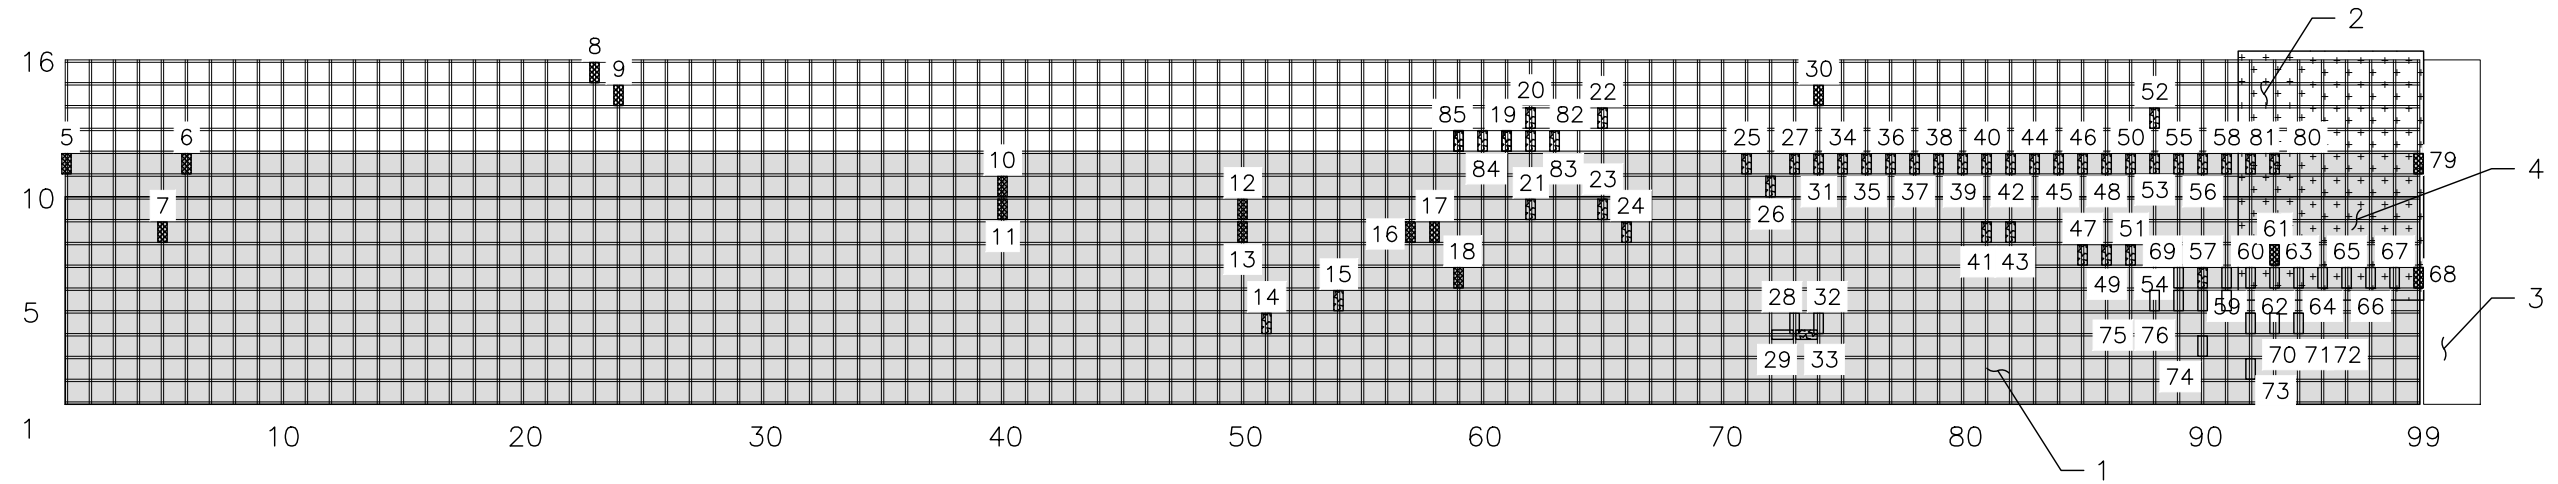
| tender / soumission | project manager / administrateur de projets |

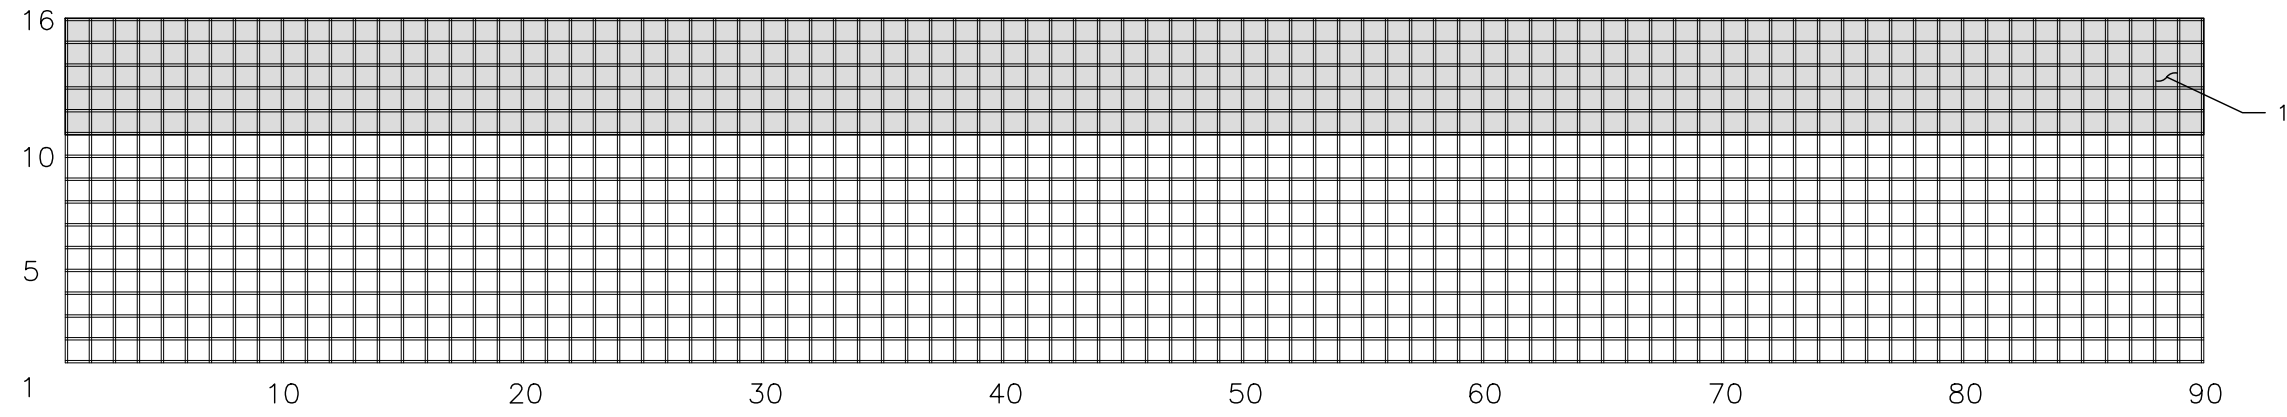
| tender soumission | project manager administrateur de projets | | |

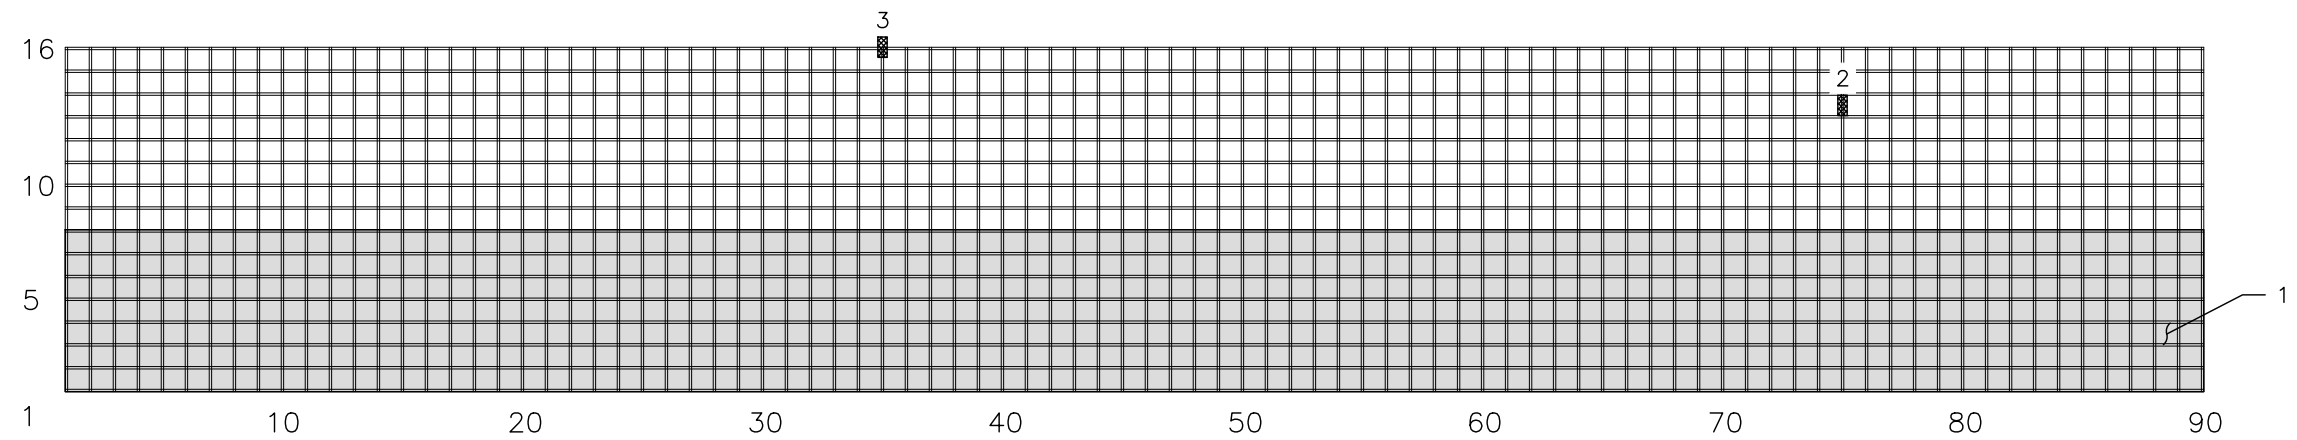
| 08 OF 65 | drawing no. | dessine no. |

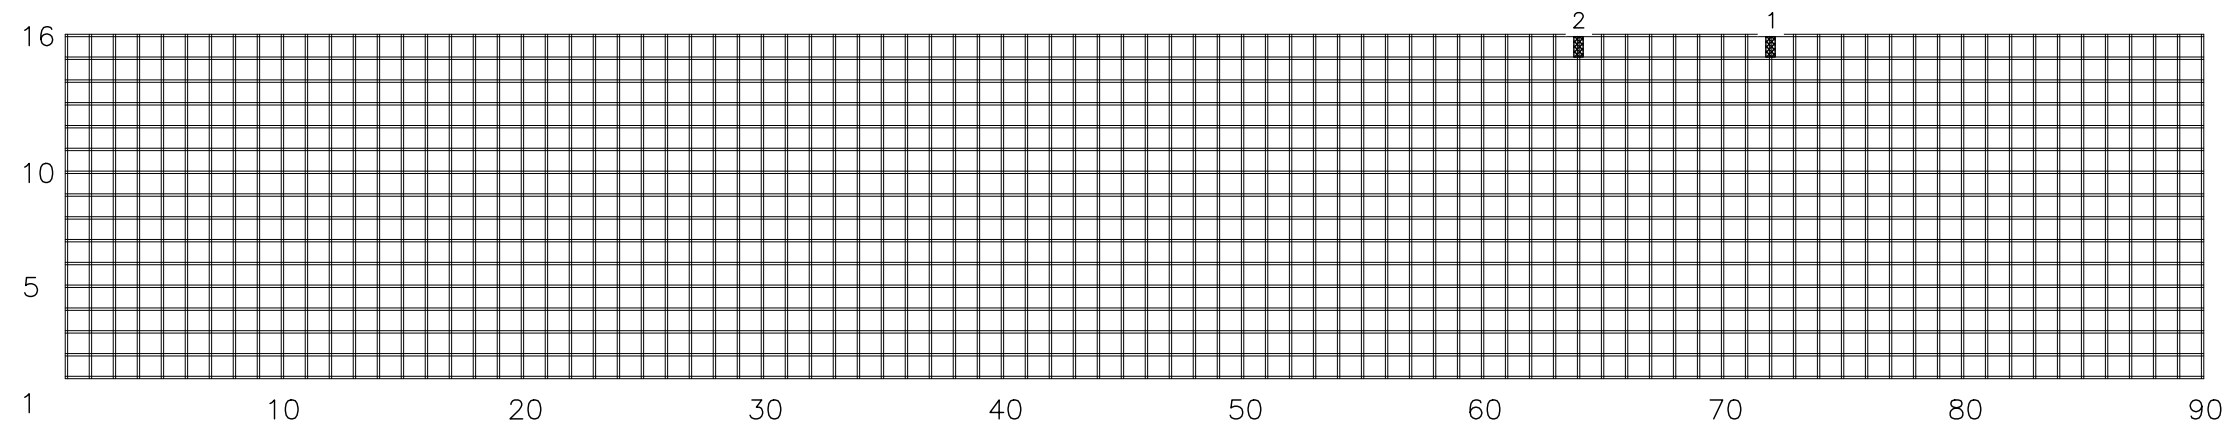
| tender soumission | project manager administrateur de projets | | |

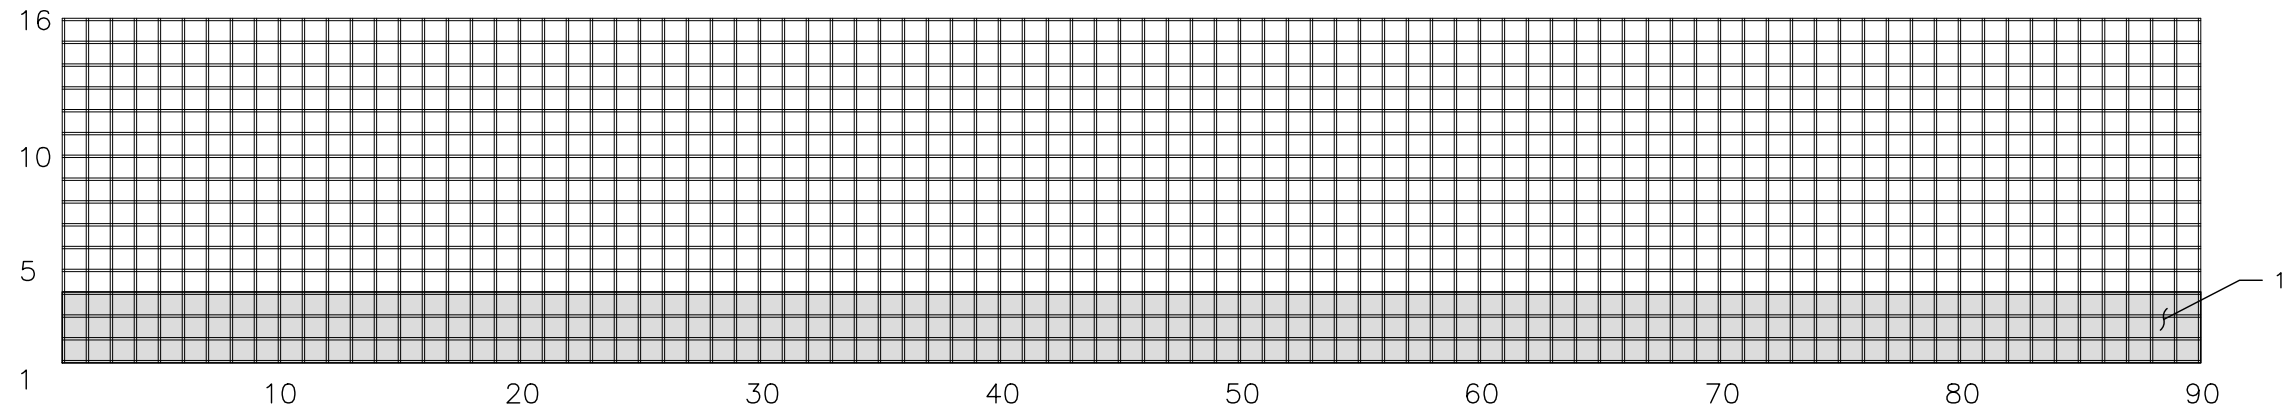
| 13 OF 65 drawing no. | dessine no. |

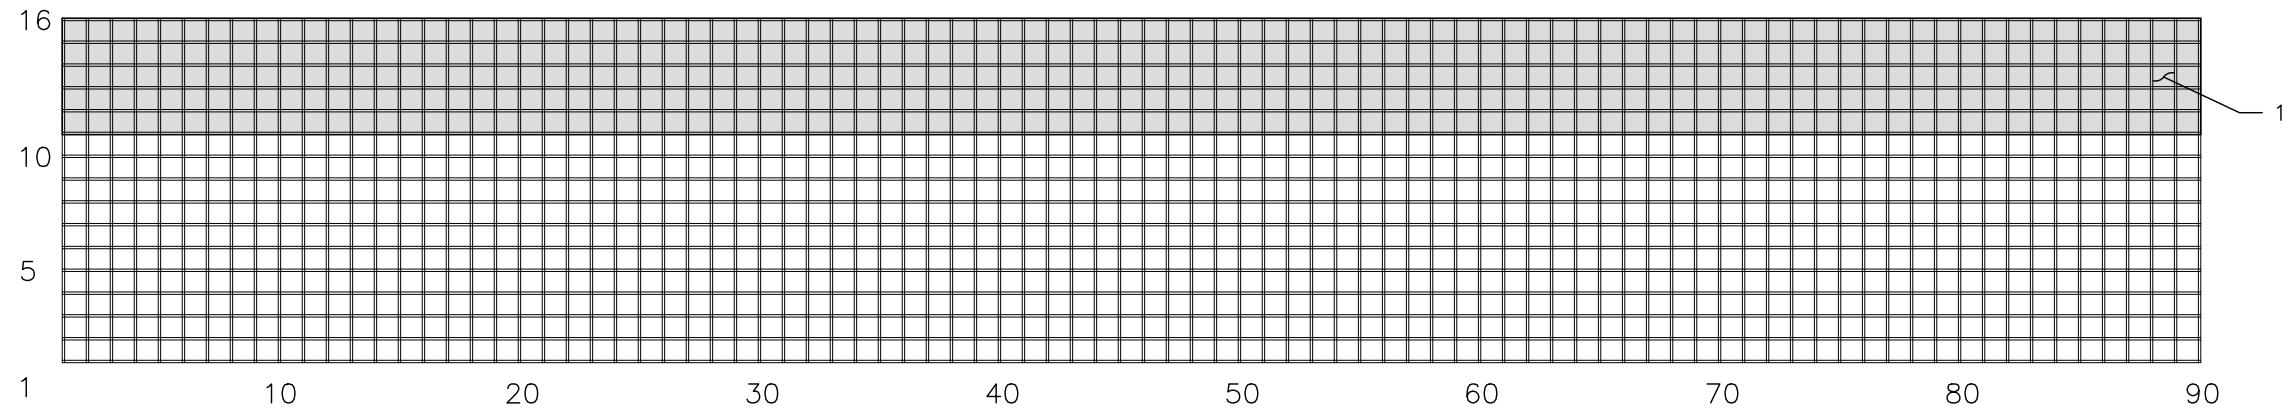
| 14 OF 65 drawing no. | dessine no. |

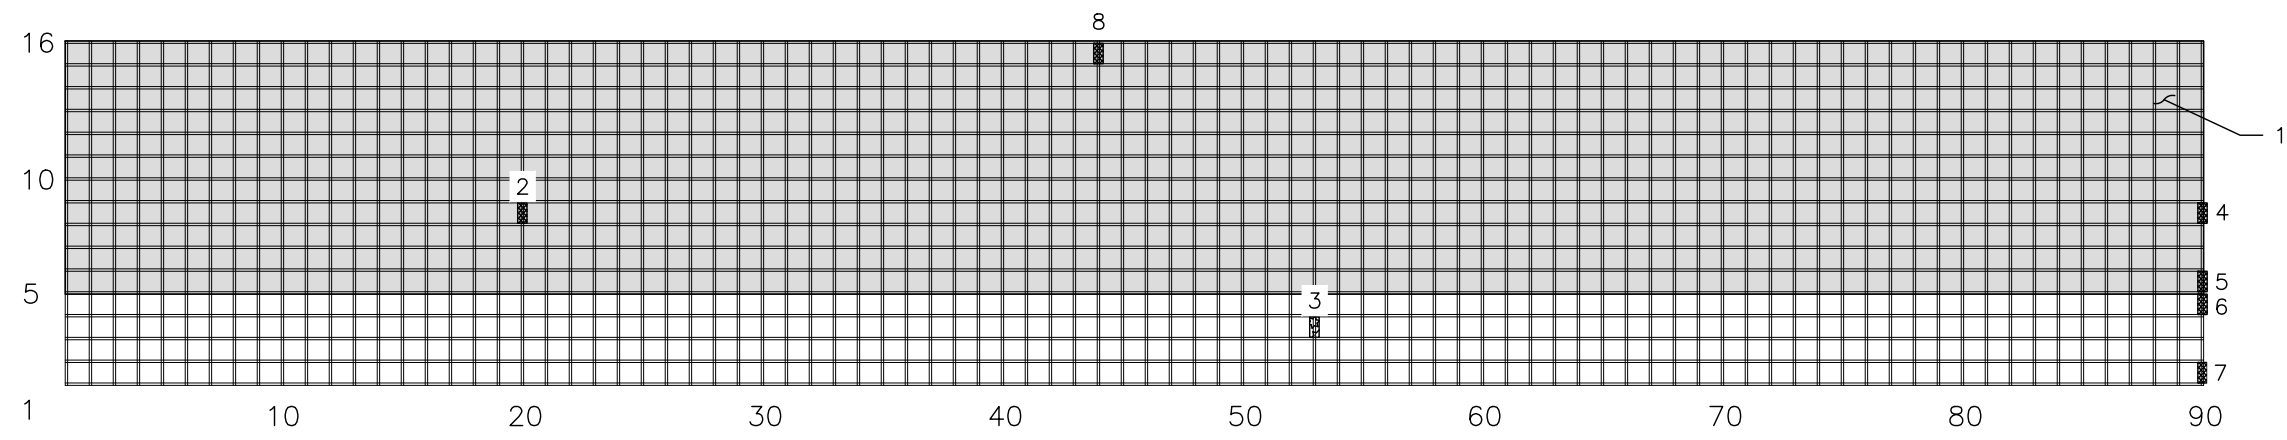
| 16 OF 65 | drawing no. | dessine no. |

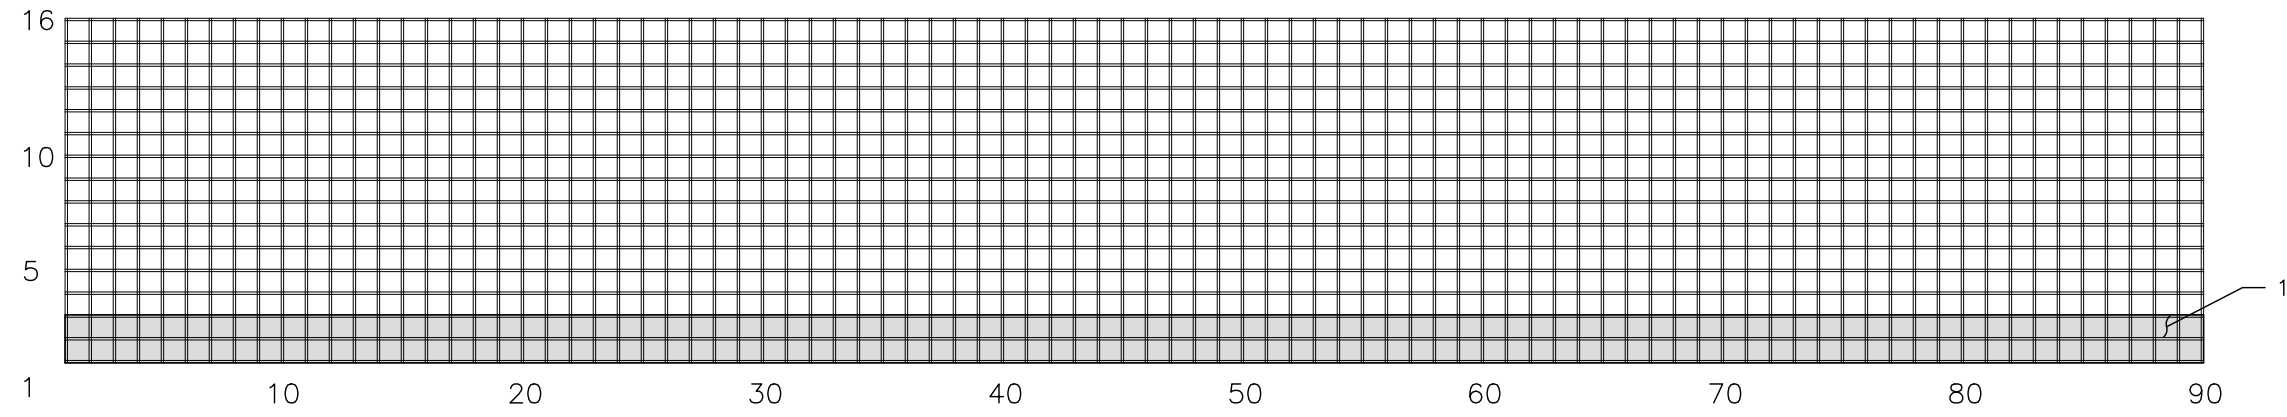
| tender soumission | project manager administrateur de projets | | |

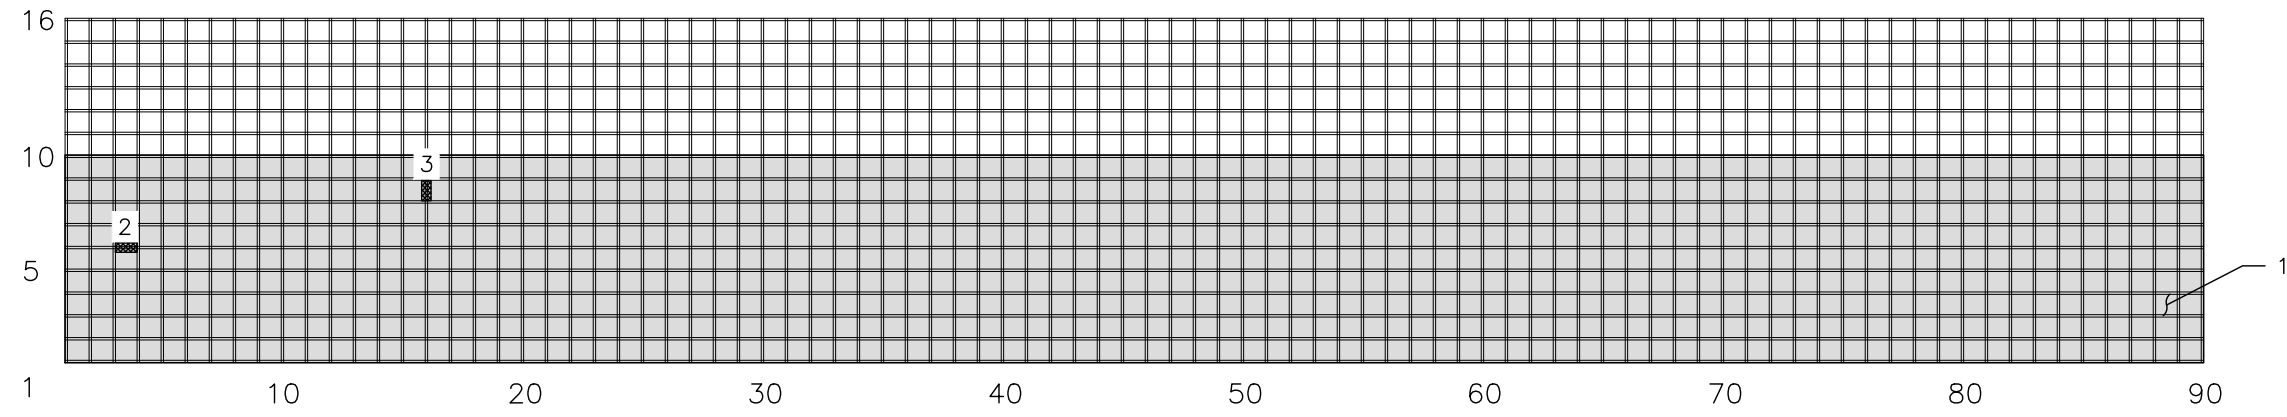
| 18 OF 65 drawing no. | dessine no. |

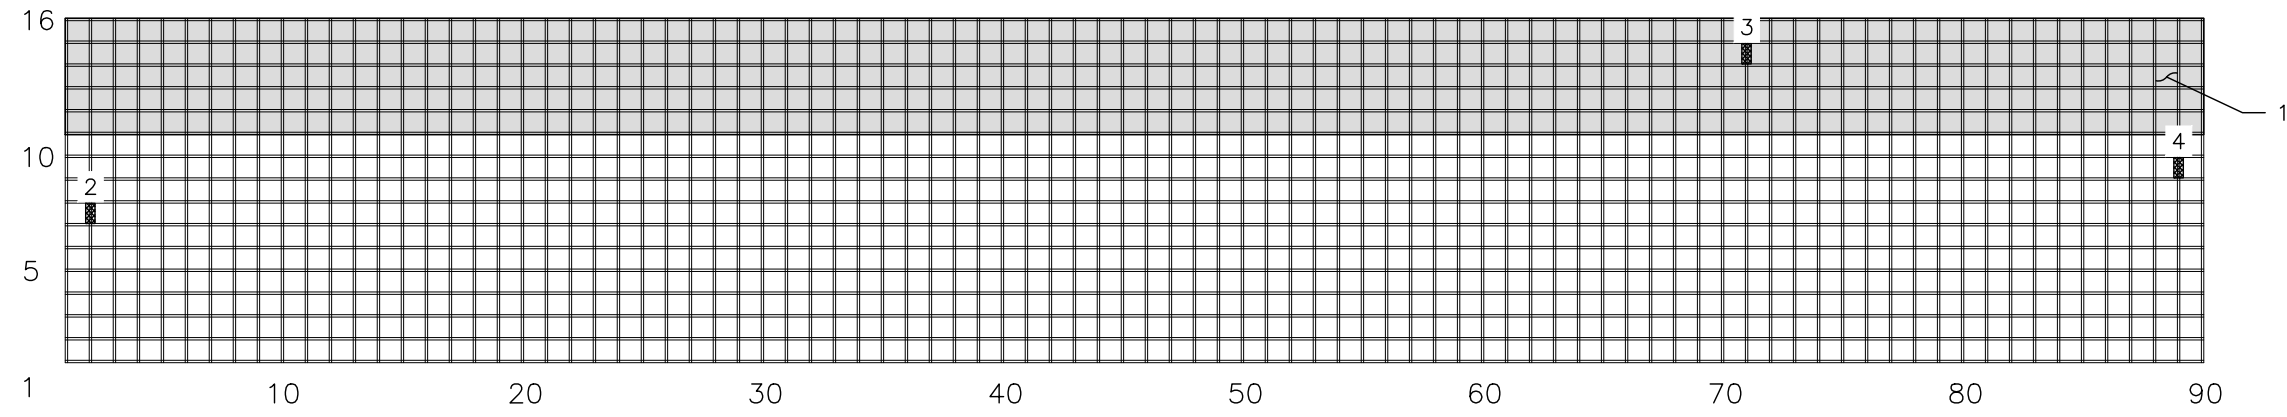
| 19 OF 65 drawing no. | dessine no. |

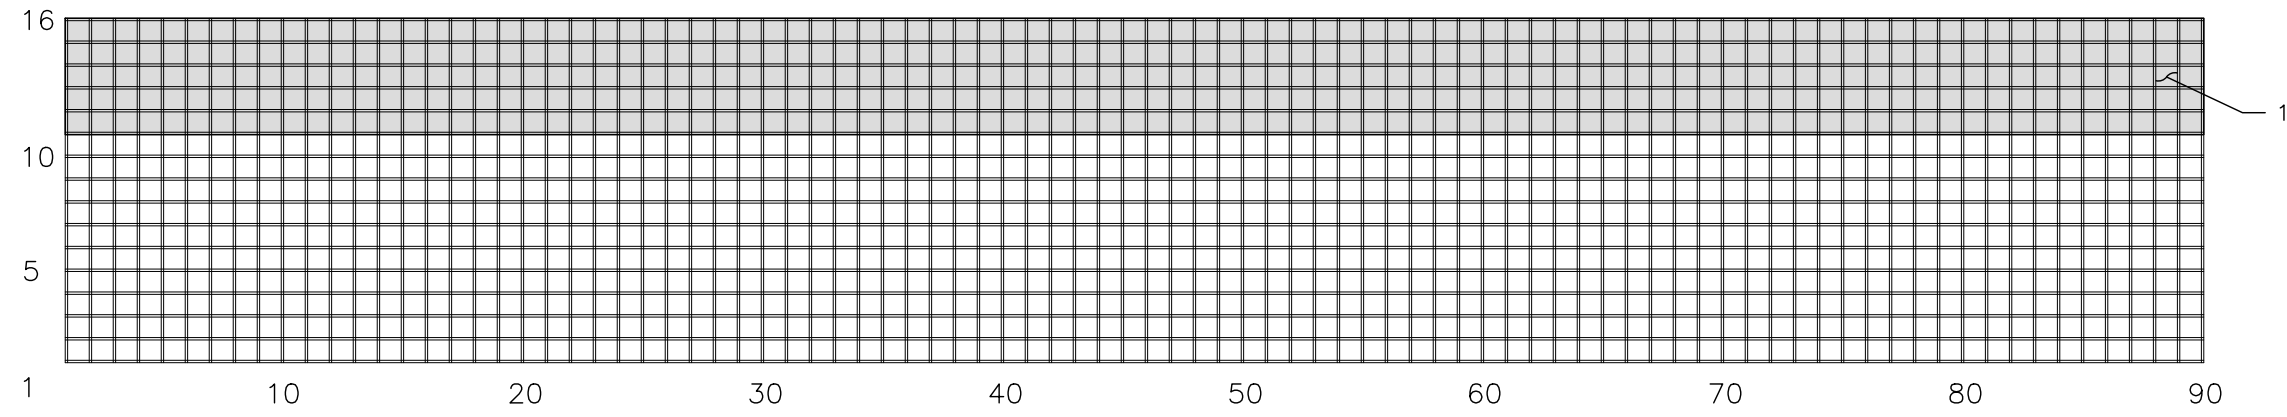
| 21 OF 65 drawing no. | dessine no. |

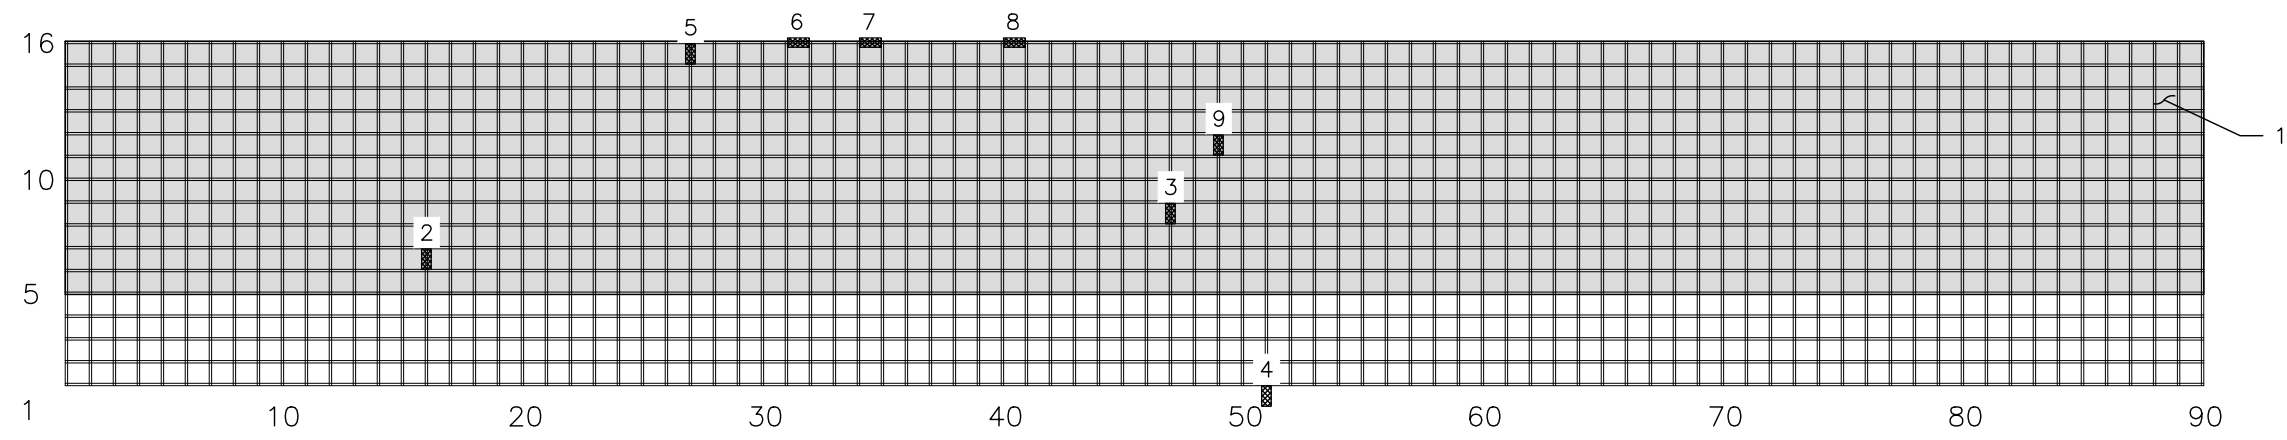
| tender soumission | project manager administrateur de projets | | |
