Lasalle Causeway Bascule Bridge

2019 Comprehensive Detailed Inspection Report (Rev. 1)

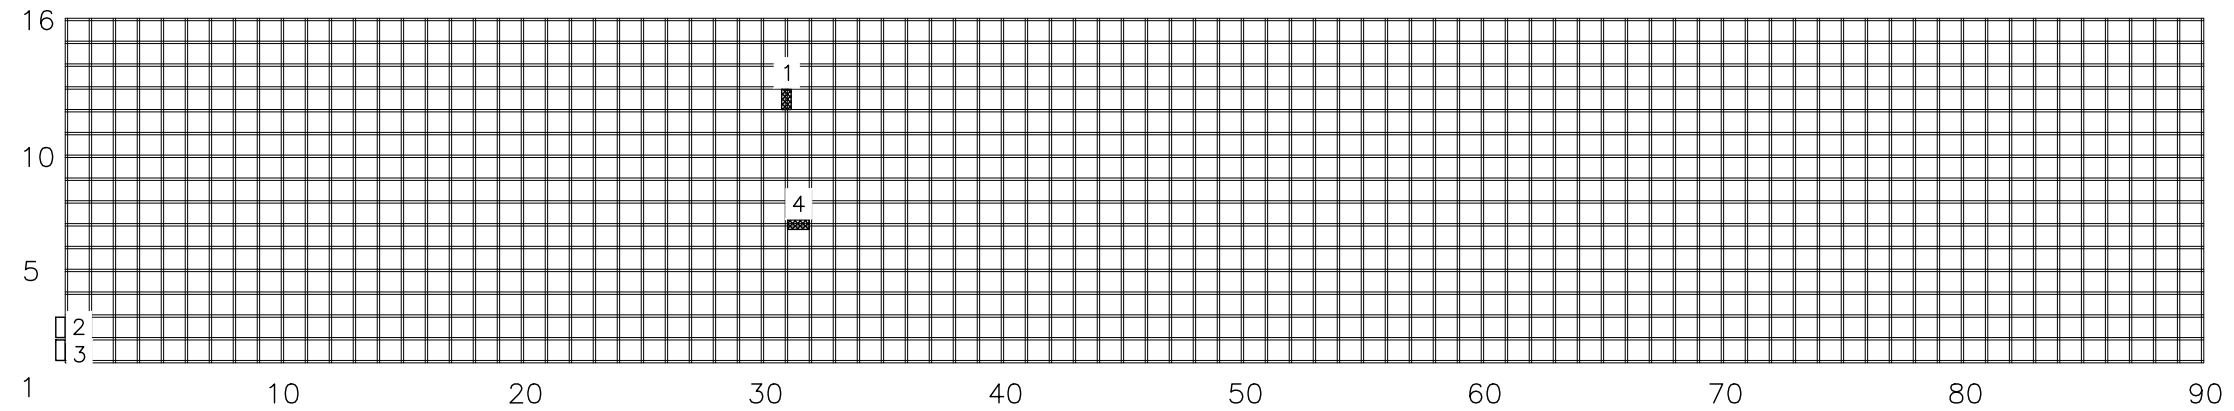
| tender soumission | project manager administrateur de projets | | |

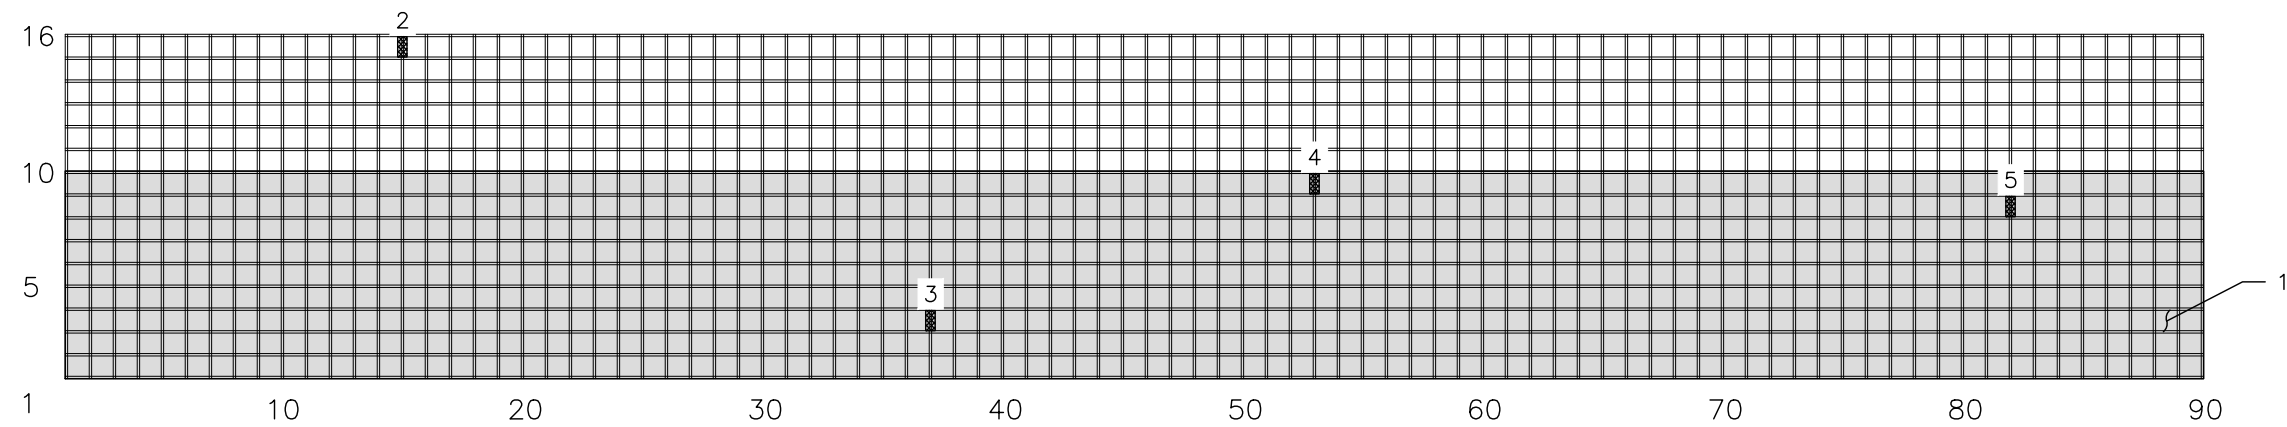
| tender soumission | project manager administrateur de projets | | |

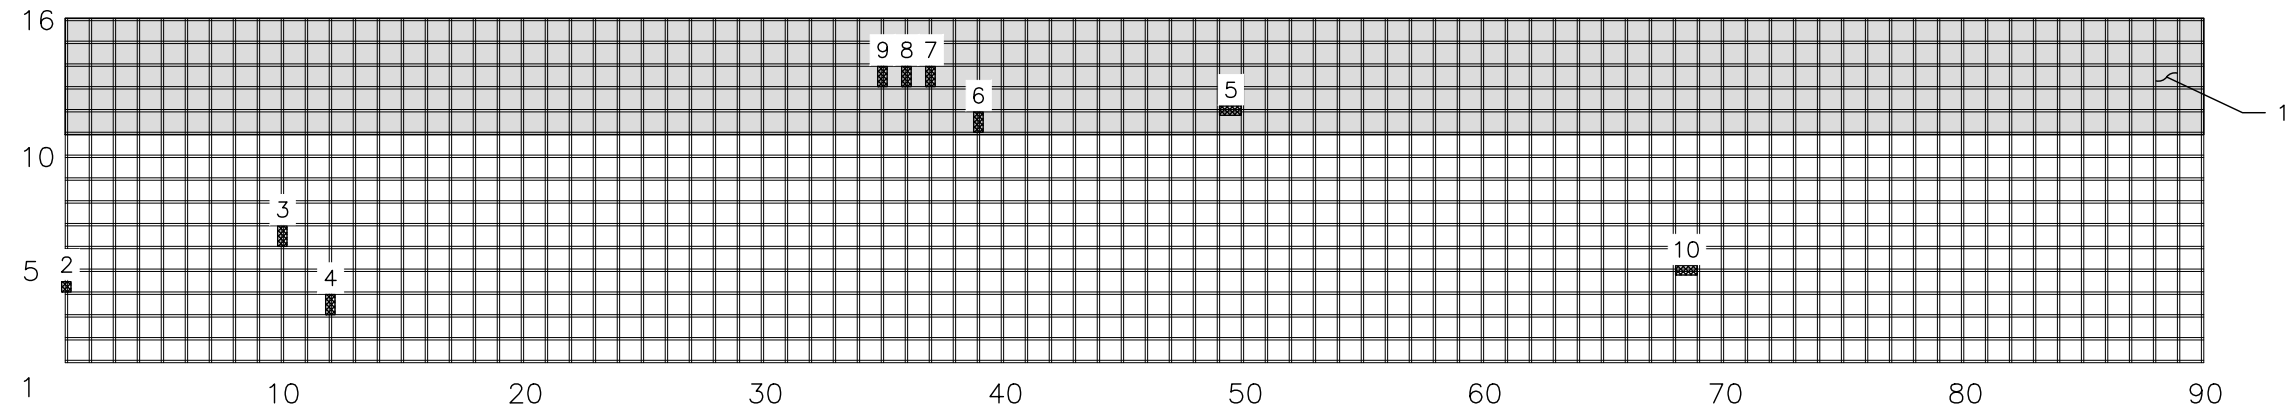
| tender soumission | project manager administrateur de projets | | |

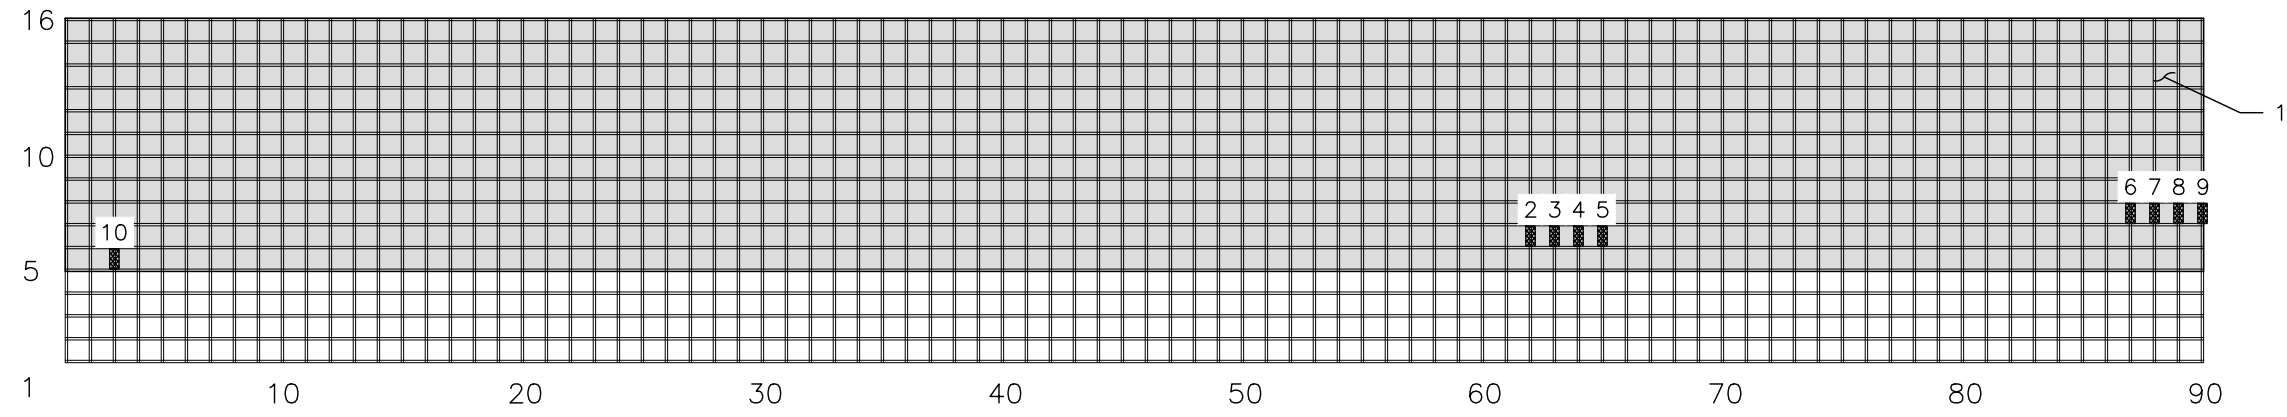
| <small>tender</small> | <small>project manager</small> | <small>administrateur de projets</small> |

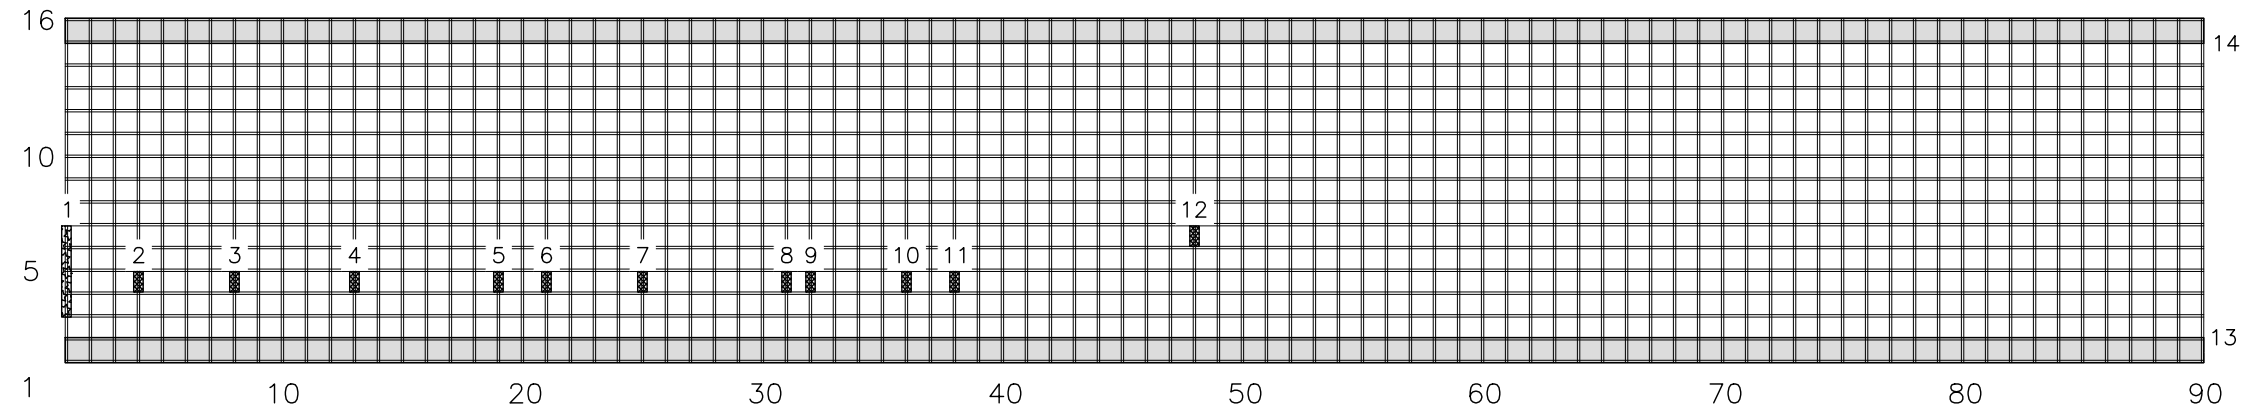
| tender soumission | project manager administrateur de projets | | |

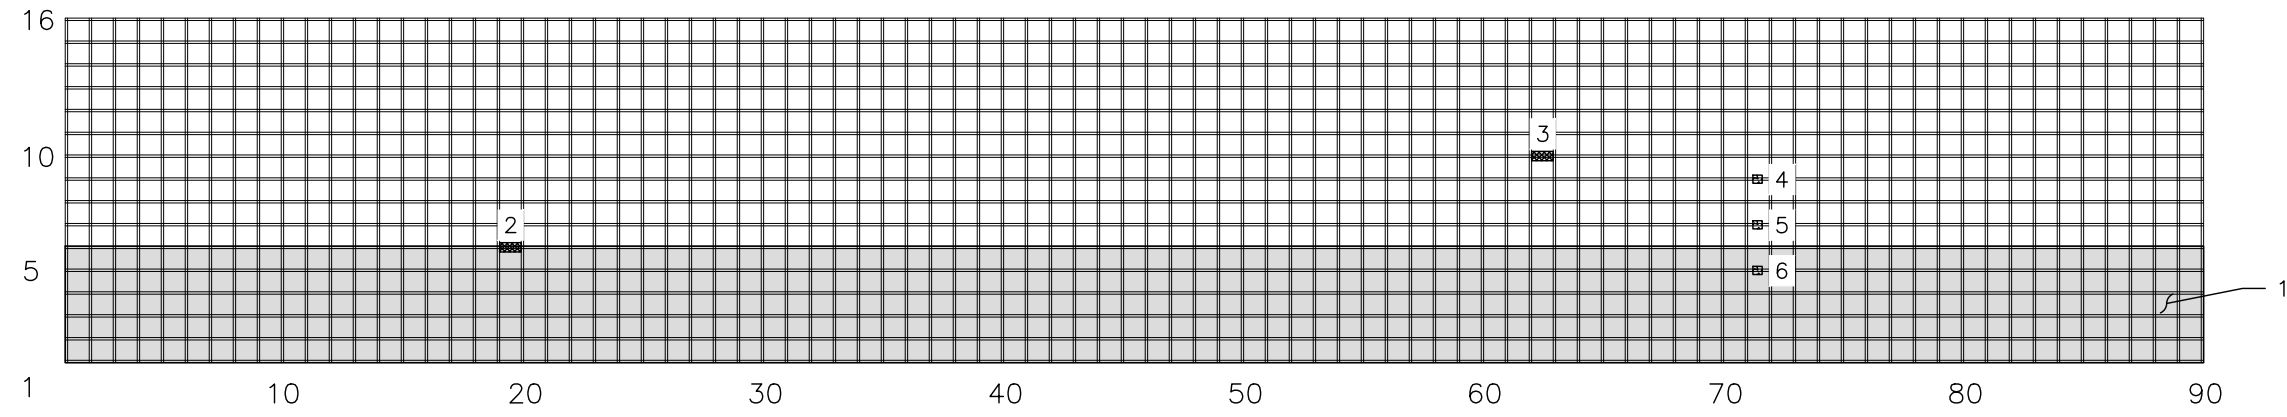
| 36 OF 65 drawing no. | dessine no. |

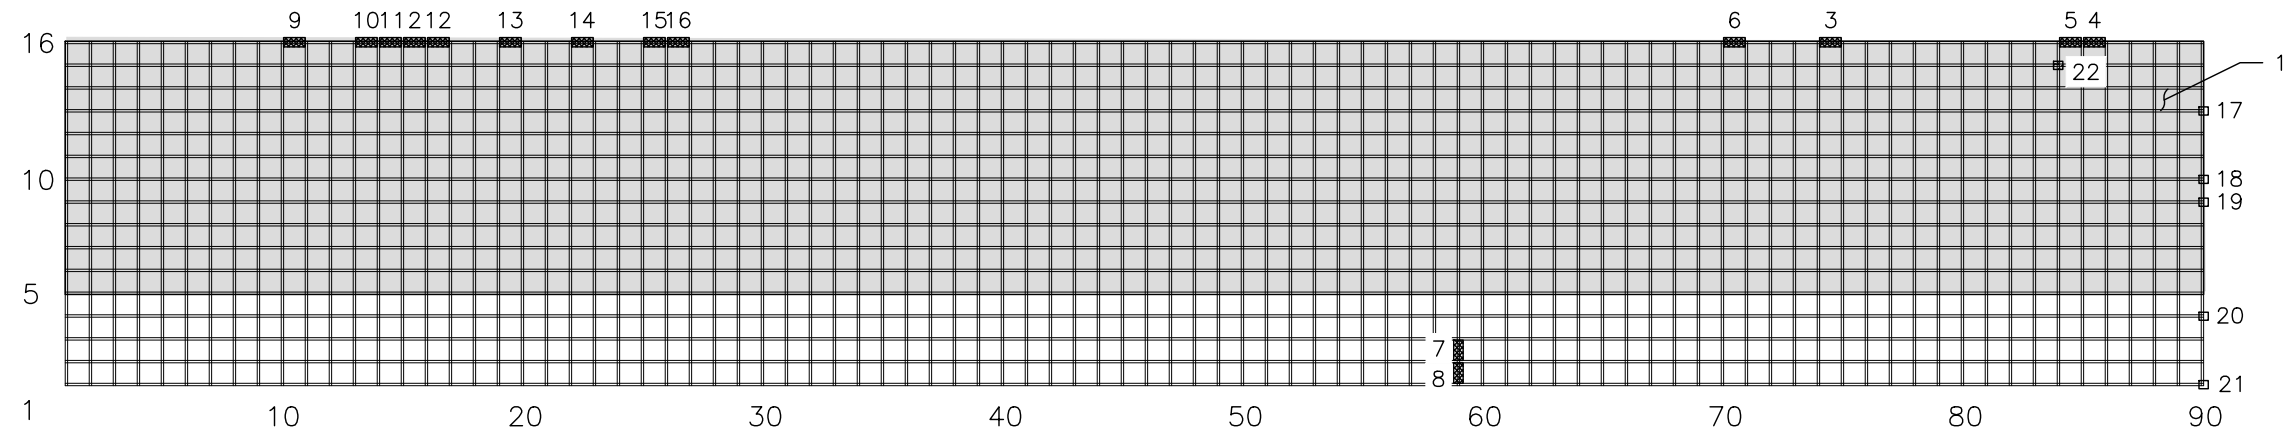
| 37 OF 65 drawing no. | dessine no. |

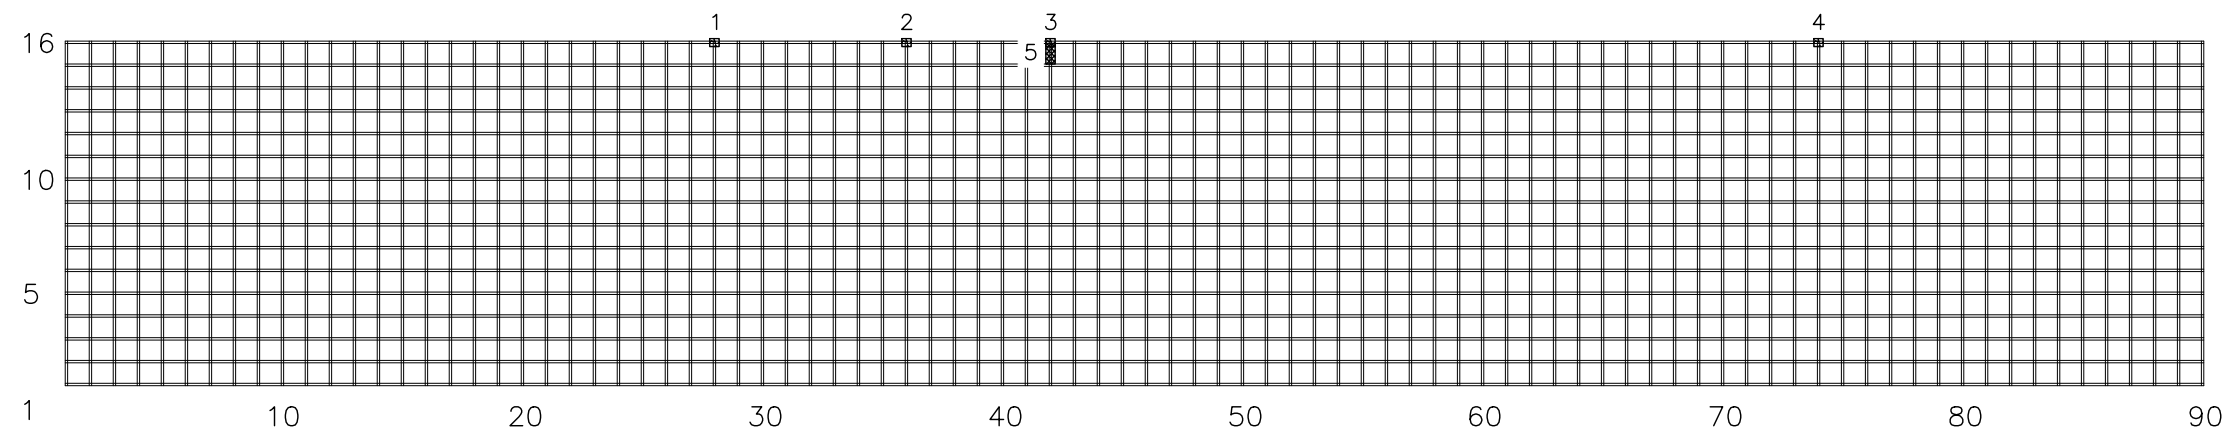
| tender soumission | project manager administrateur de projets | | |

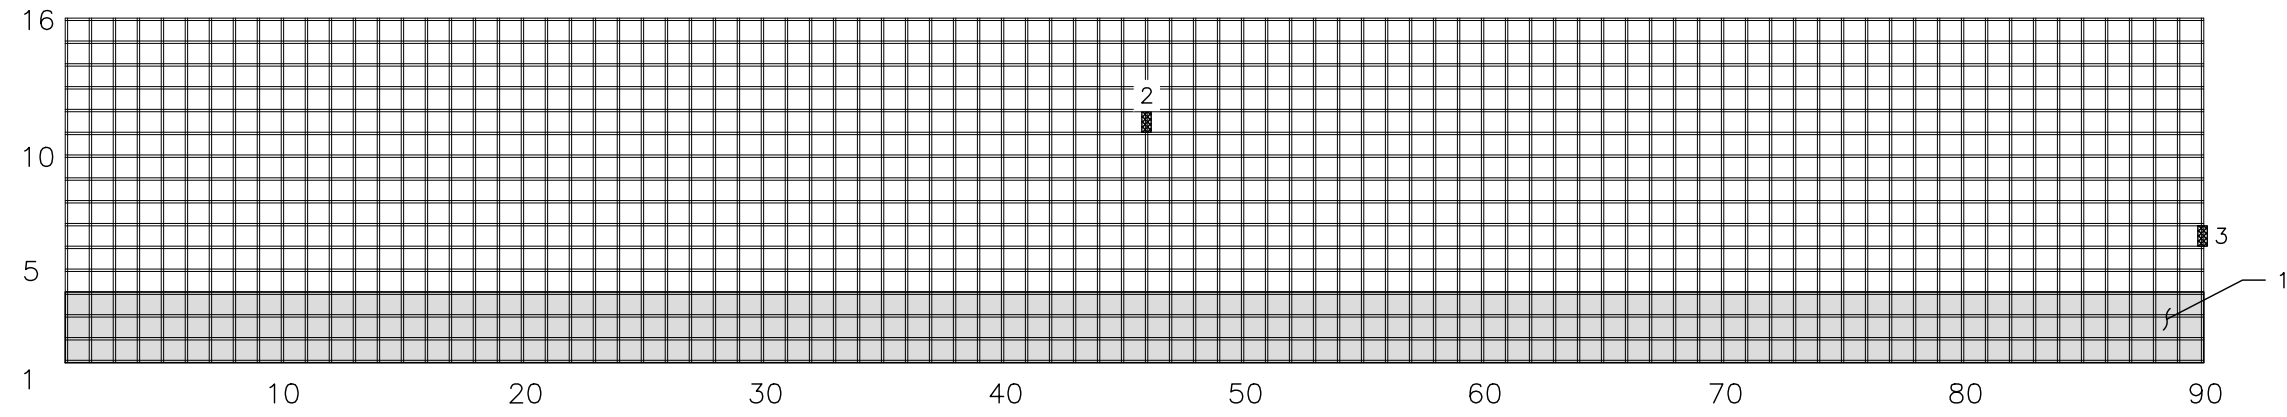
| tender soumission | project manager administrateur de projets | | |

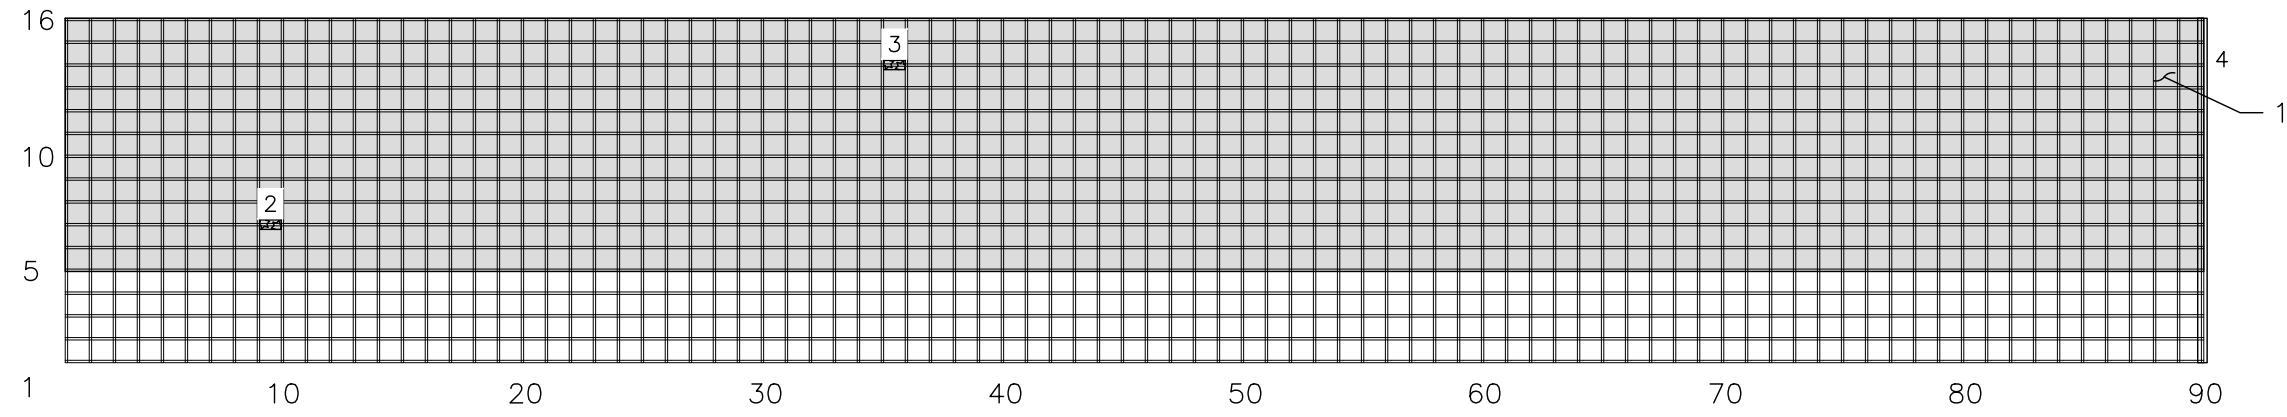
| tender soumission | project manager administrateur de projets | | |

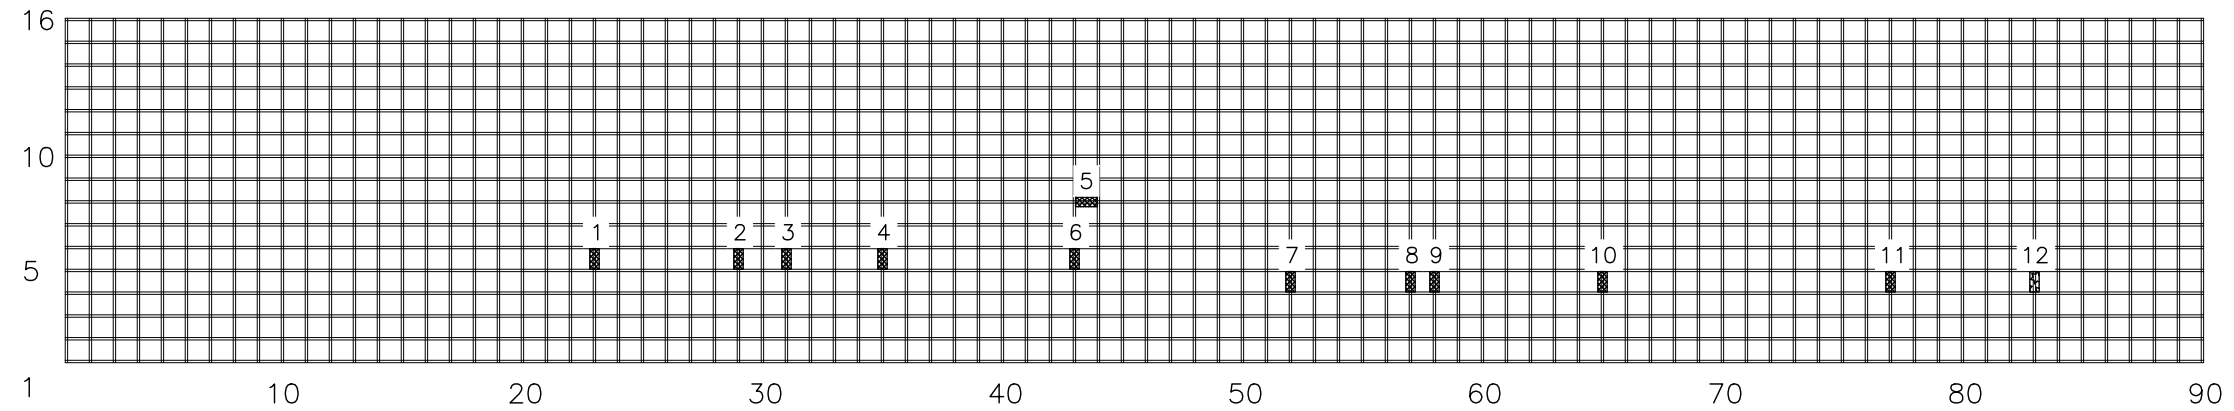
| tender soumission | project manager administrateur de projets | | |

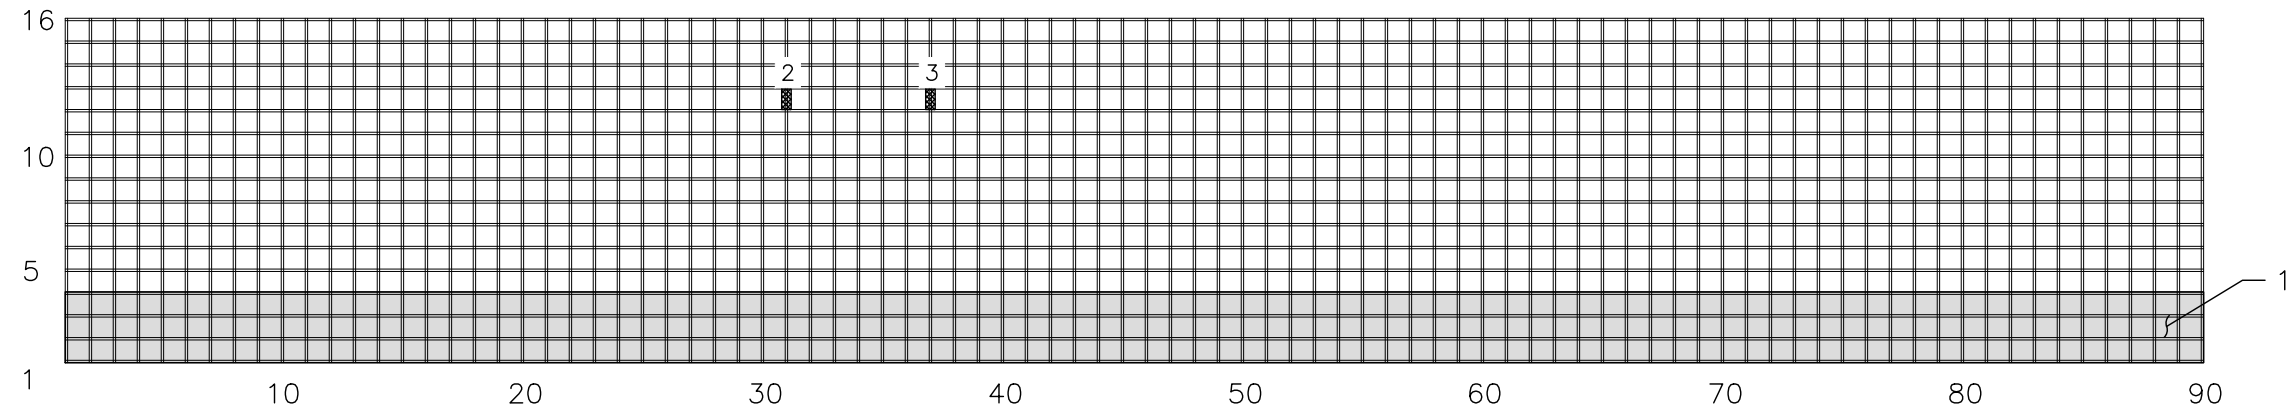
| 48 OF 65 drawing no. | dessine no. |

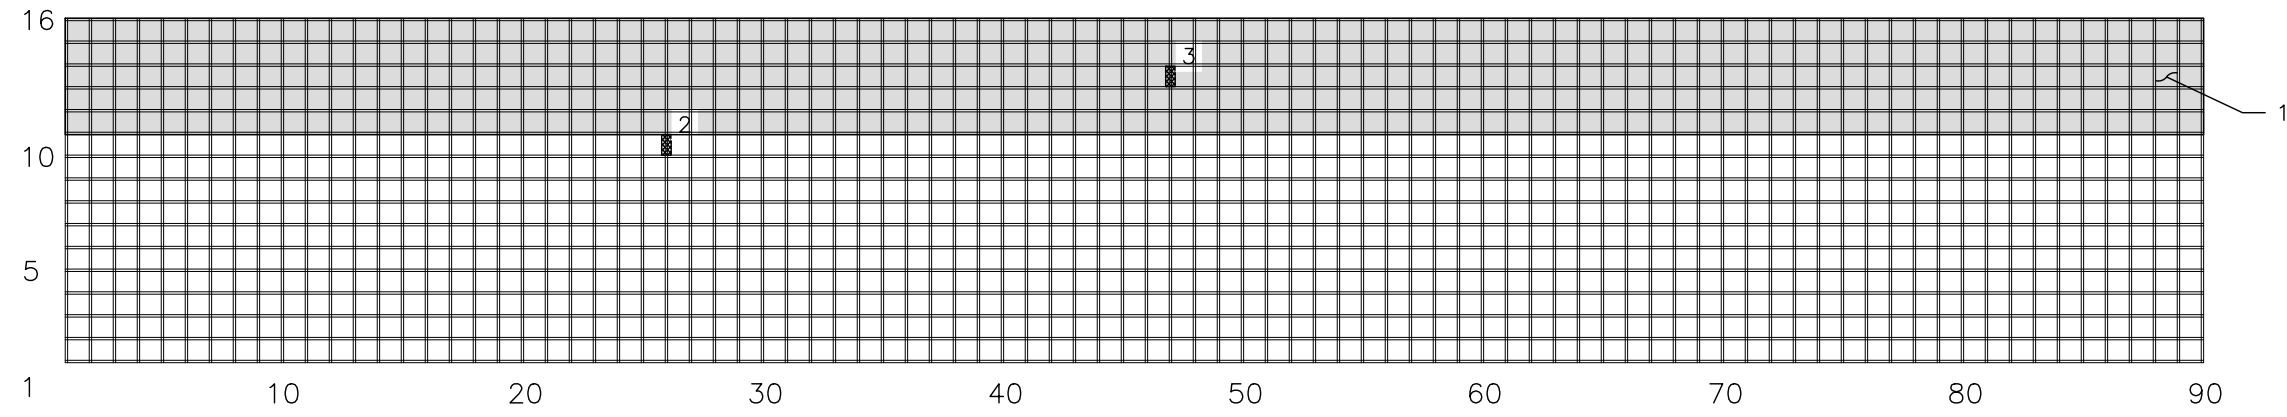
| 49 OF 65 drawing no. | dessine no. |

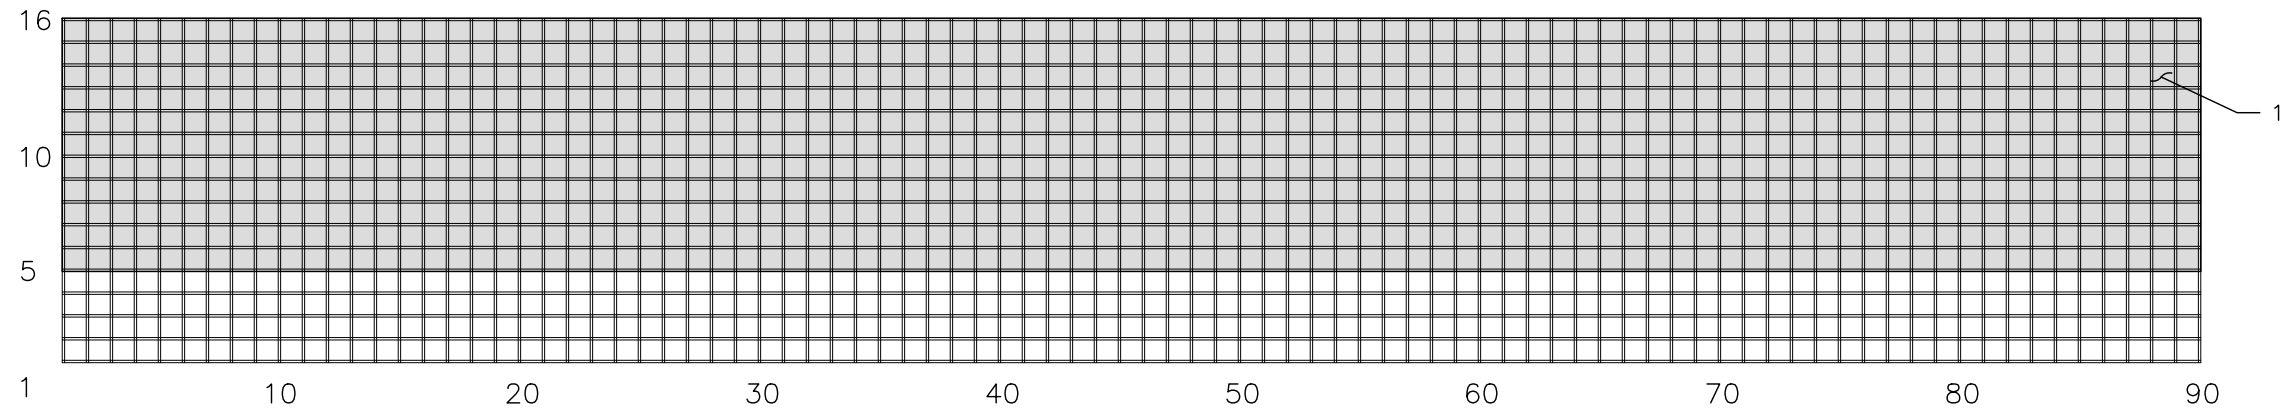
| PH approved by | approuve par | 51 OF 65 drawing no. | dessine no. |

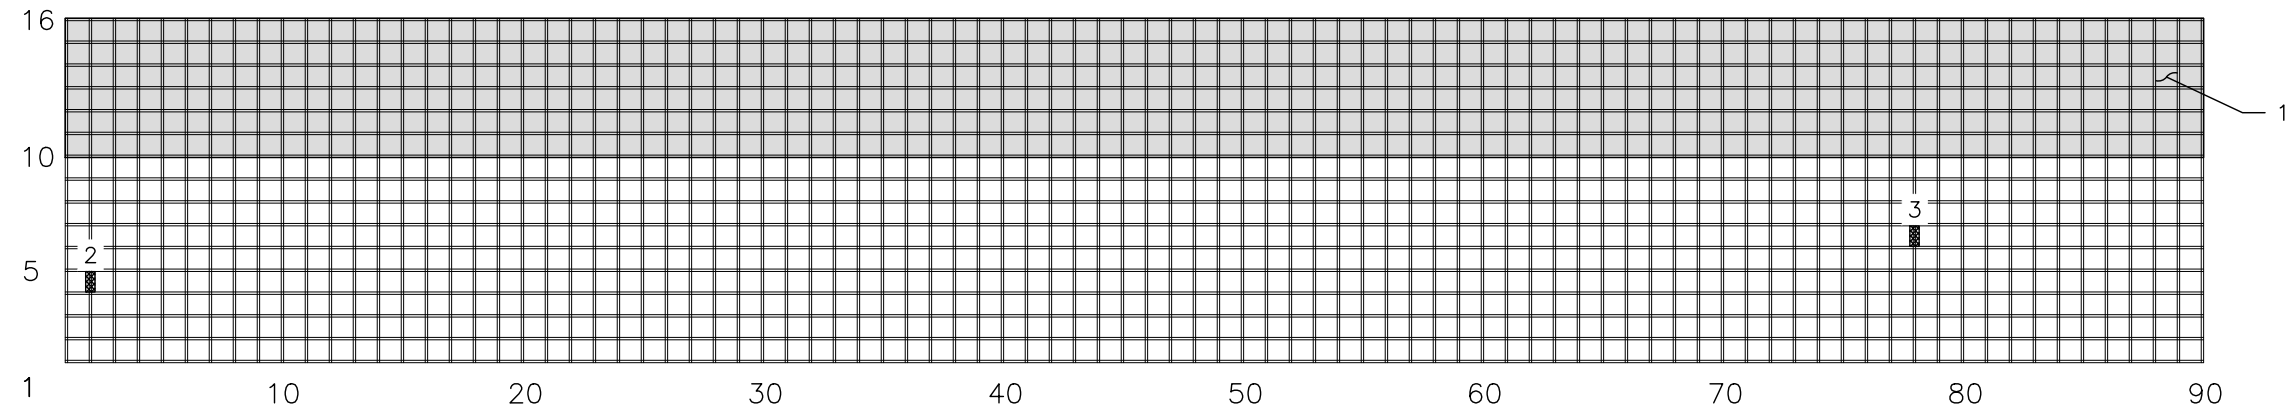
| 54 OF 65 drawing no. | dessine no. |

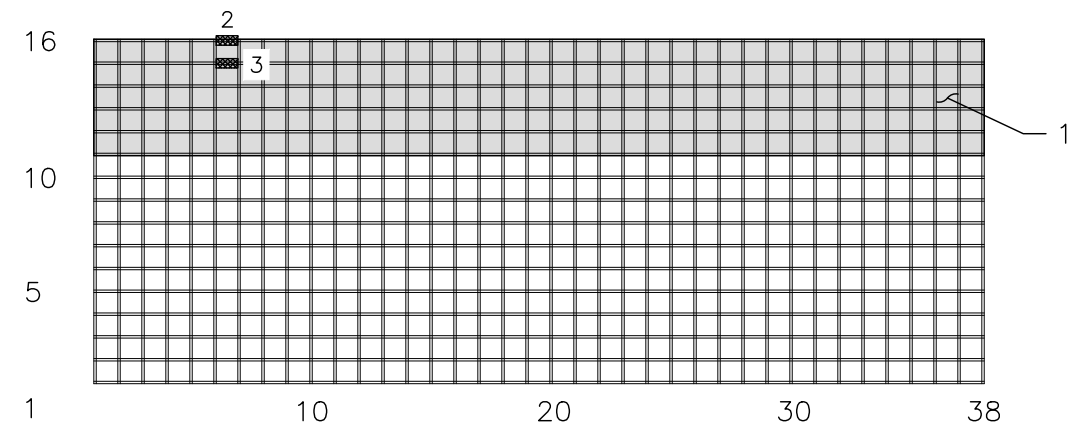
| 56 OF 65 drawing no. | dessine no. |

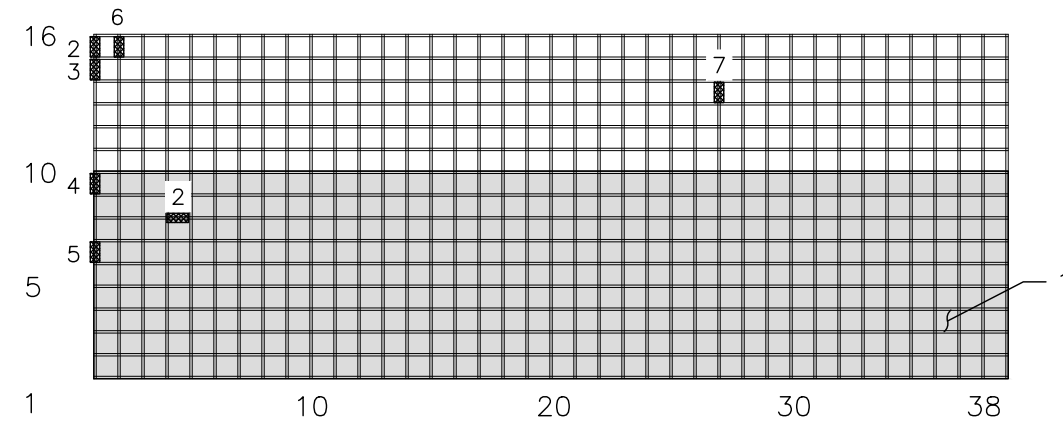
| 60 OF 65 drawing no. | dessine no. |

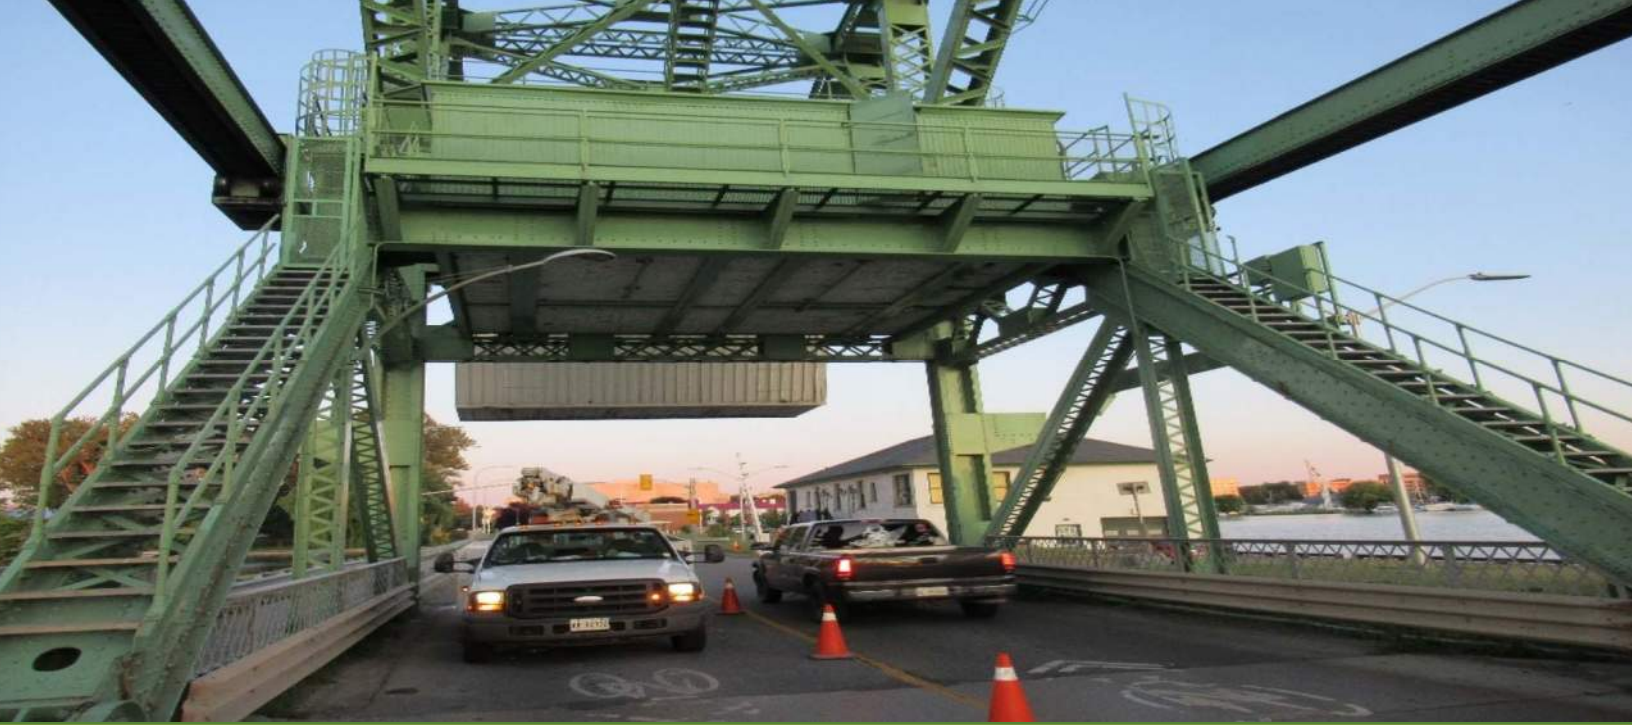
**BRIDGE CHECK
CANADA**

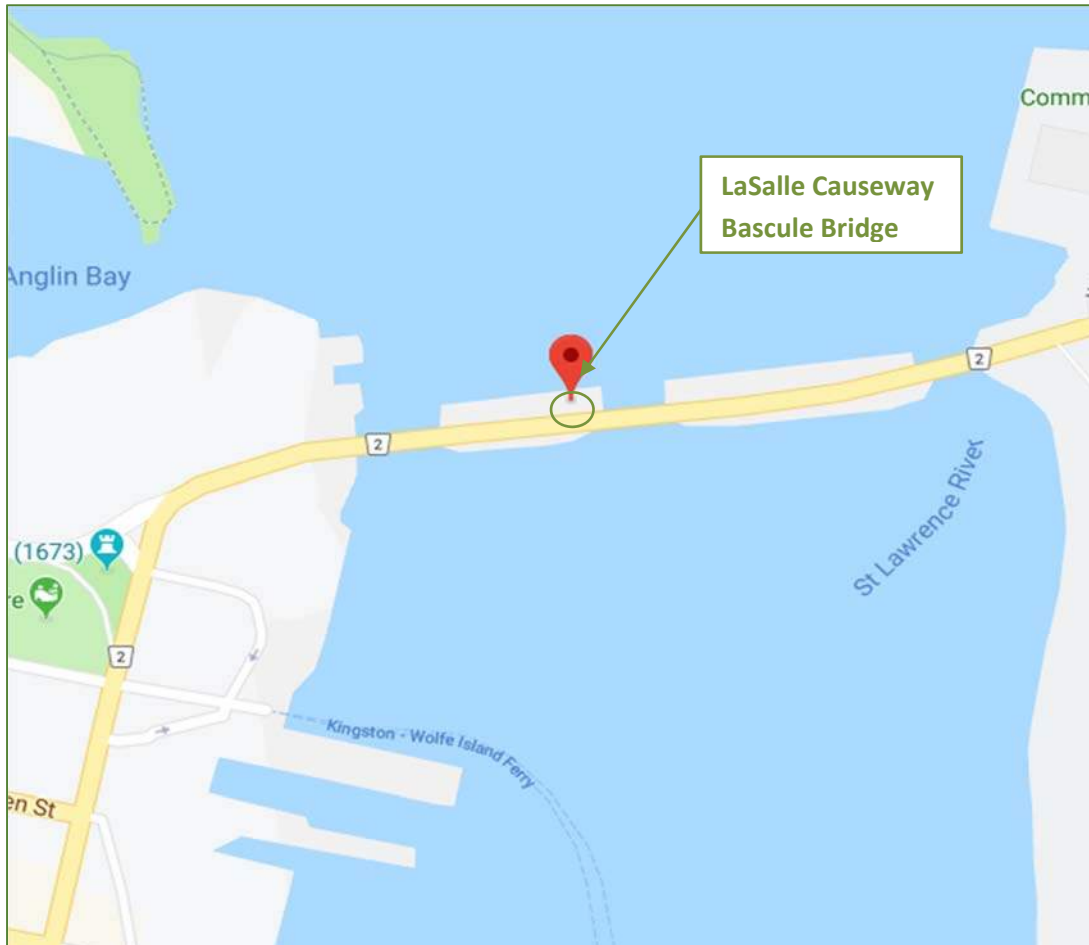
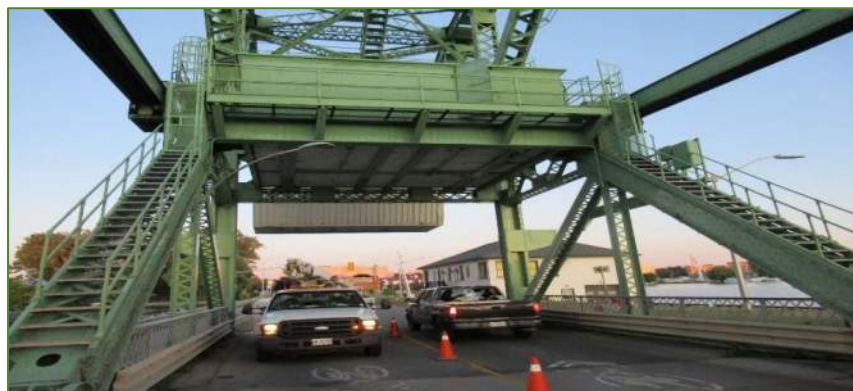
**LaSalle Causeway Bascule Bridge
Kingston, ON**

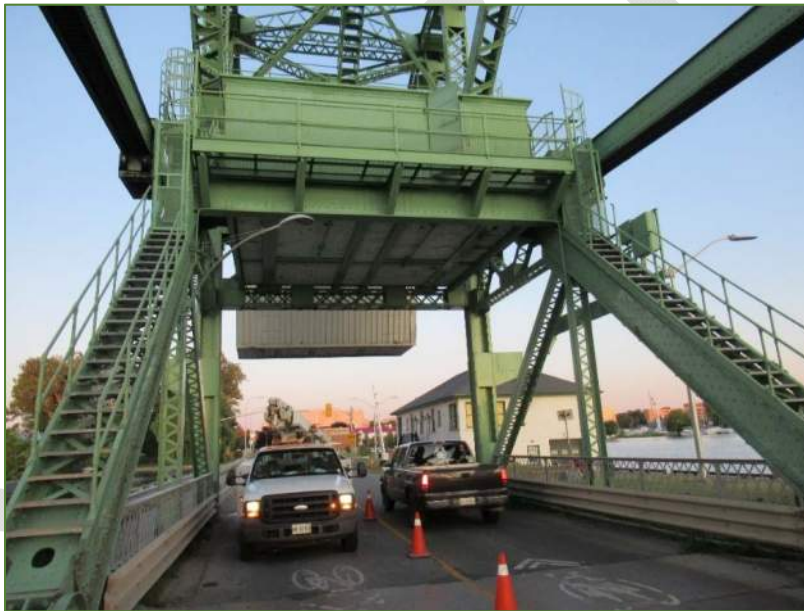
LaSalle Causeway Bascule Bridge – Machinery Room

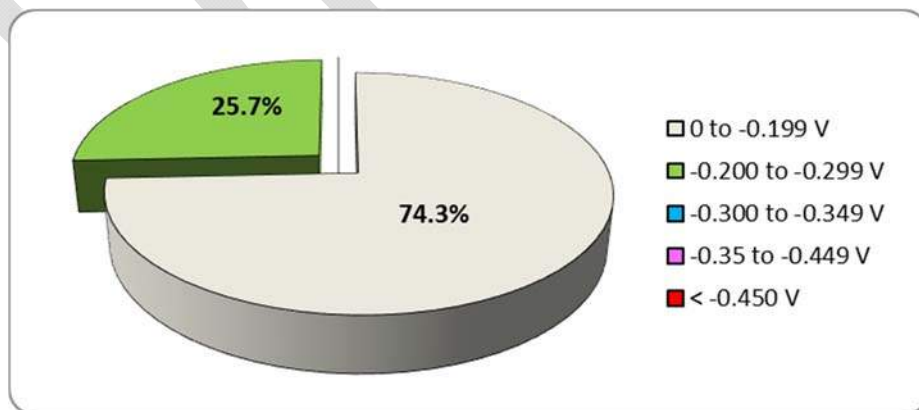
Corrosion Potential Distribution on Slab (Soffit)

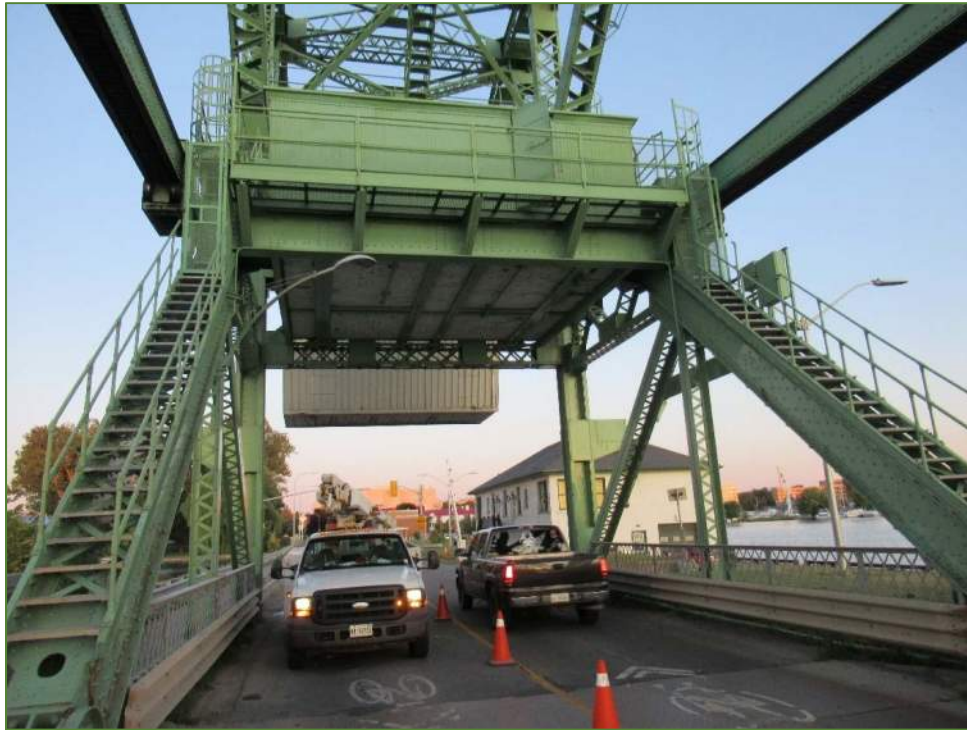
Photo P1 LaSalle Causeway Bascule Bridge, General View

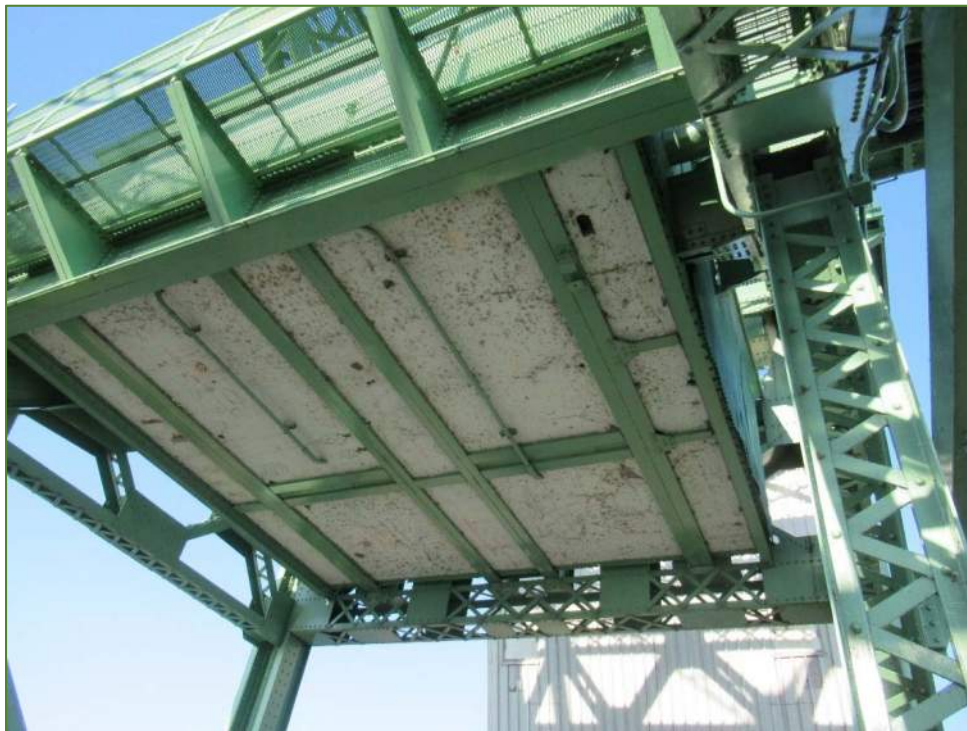
Photo P2 Machinery Room Slab Soffit (fair condition – cracks, spall, delamination, light scaling and honeycombing)

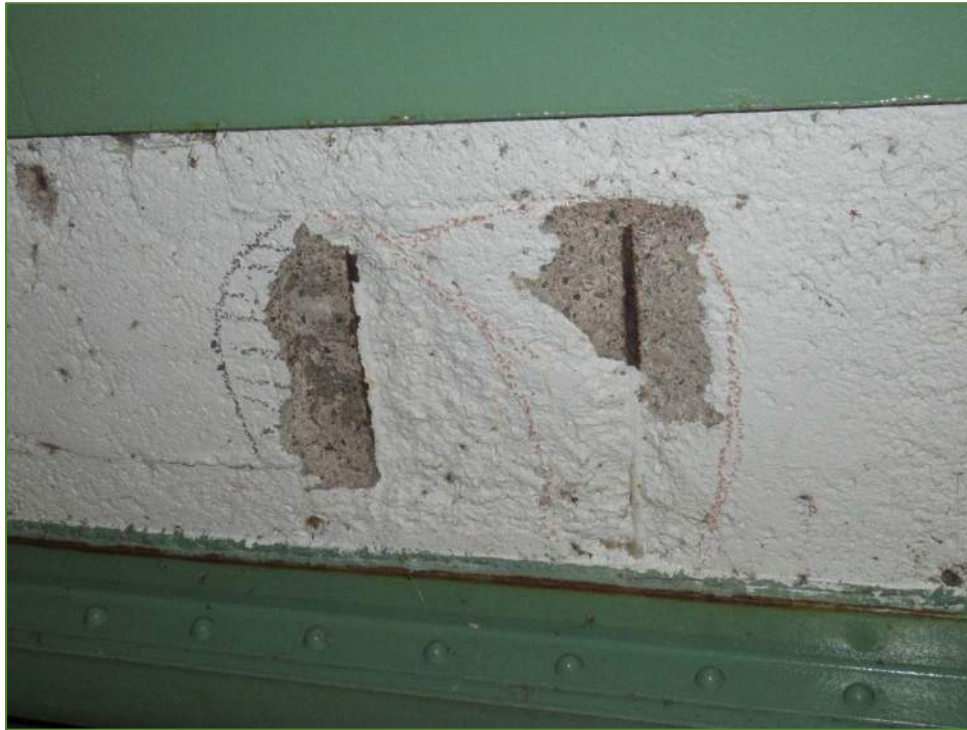
Photo P3 Machinery Room Slab Soffit Deterioration (cracks, spall and delamination) note exposed corroded rebar

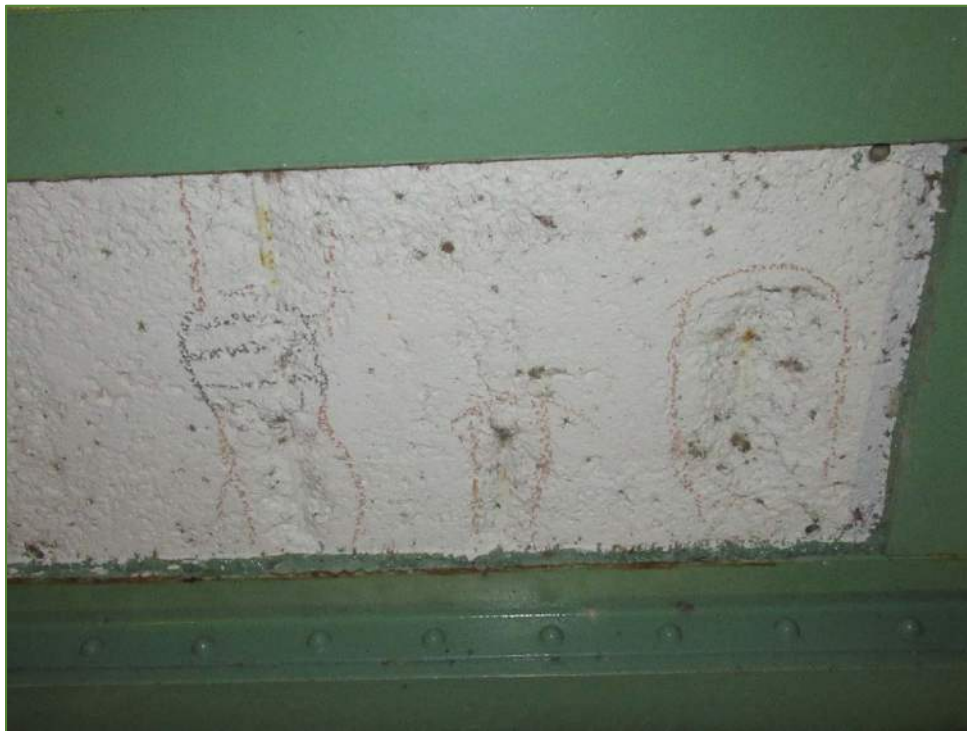
Photo P4 Machinery Room Slab Soffit Deterioration (delaminations)

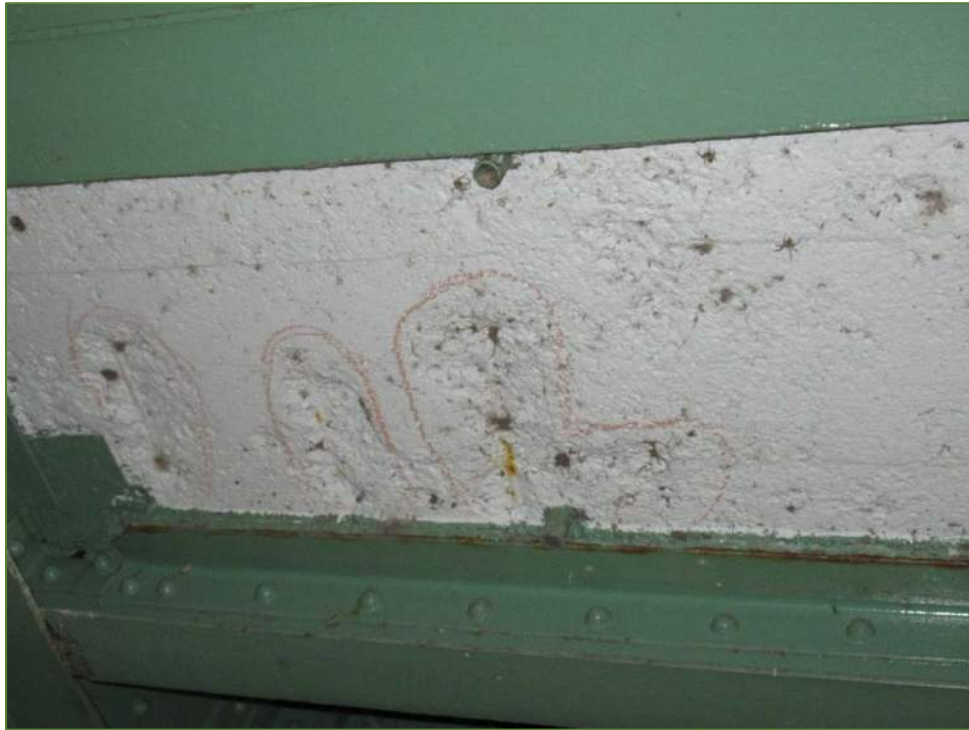
Photo P5 Machinery Room Slab Soffit Deterioration (spall and delamination)

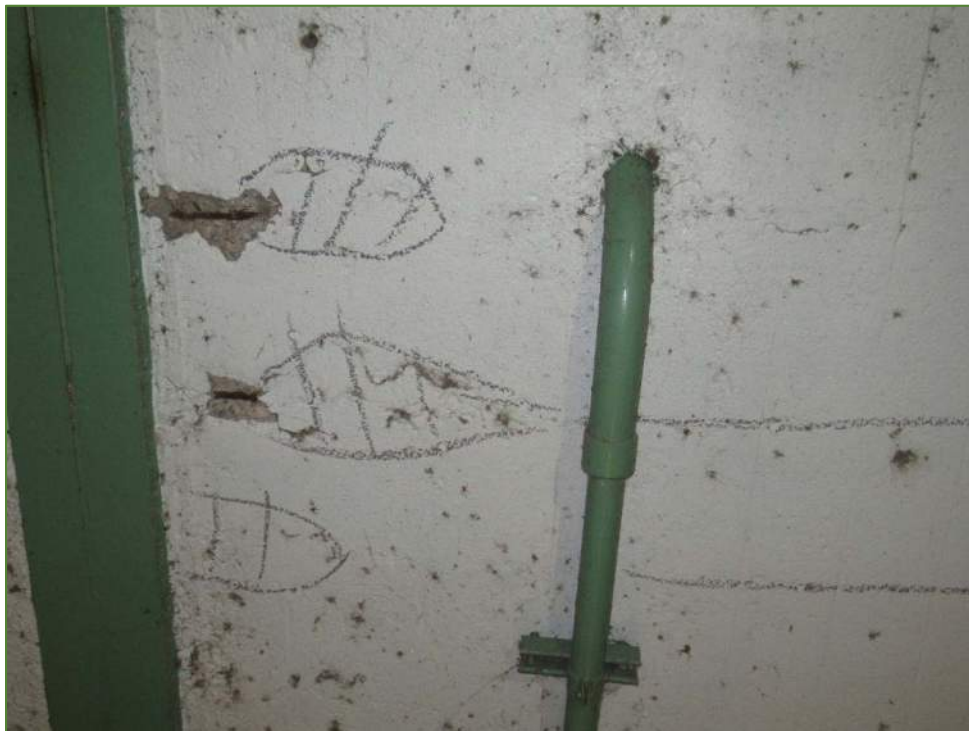
Photo P6 Machinery Room Slab Soffit Deterioration (cracks, spalls and delaminations) note exposed corroded rebar
