Lasalle Causeway Bascule Bridge

2019 Comprehensive Detailed Inspection Report (Rev. 1)

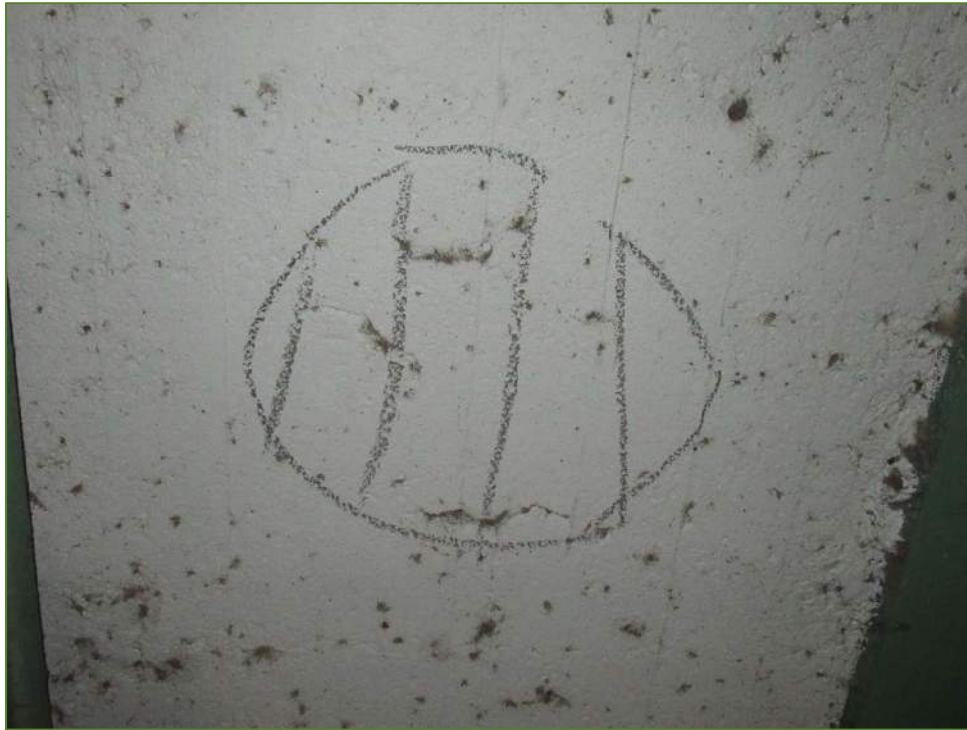
Photo P7 Soffit at Machinery Room (delamination and honeycombing)

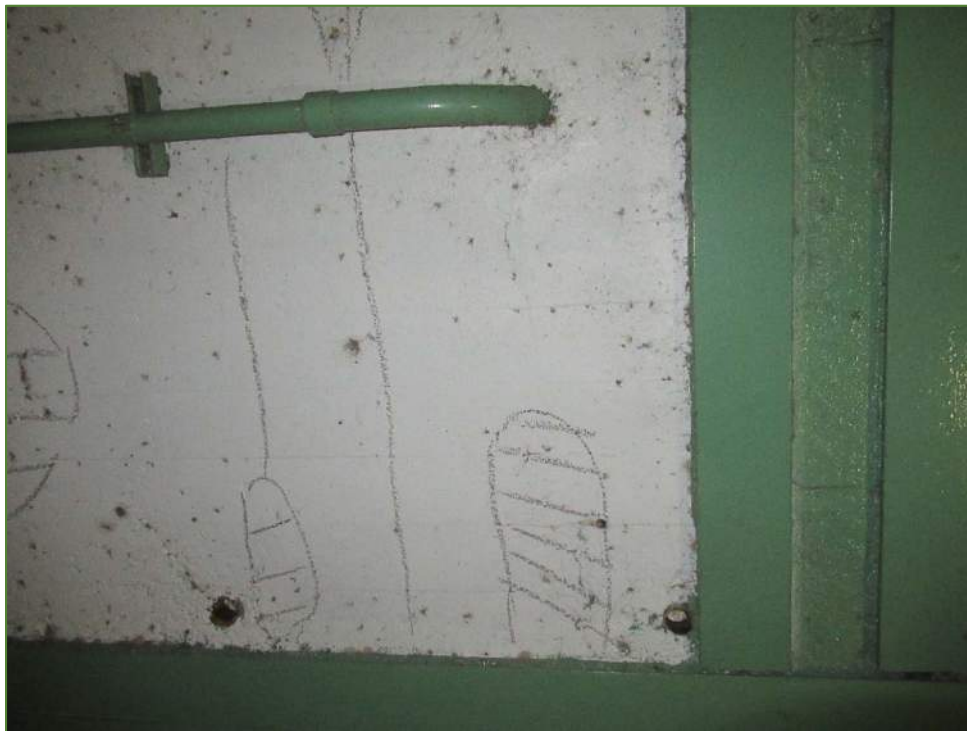
Photo P8 Machinery Room Slab Soffit Deterioration (cracks, delamination and honeycombing)

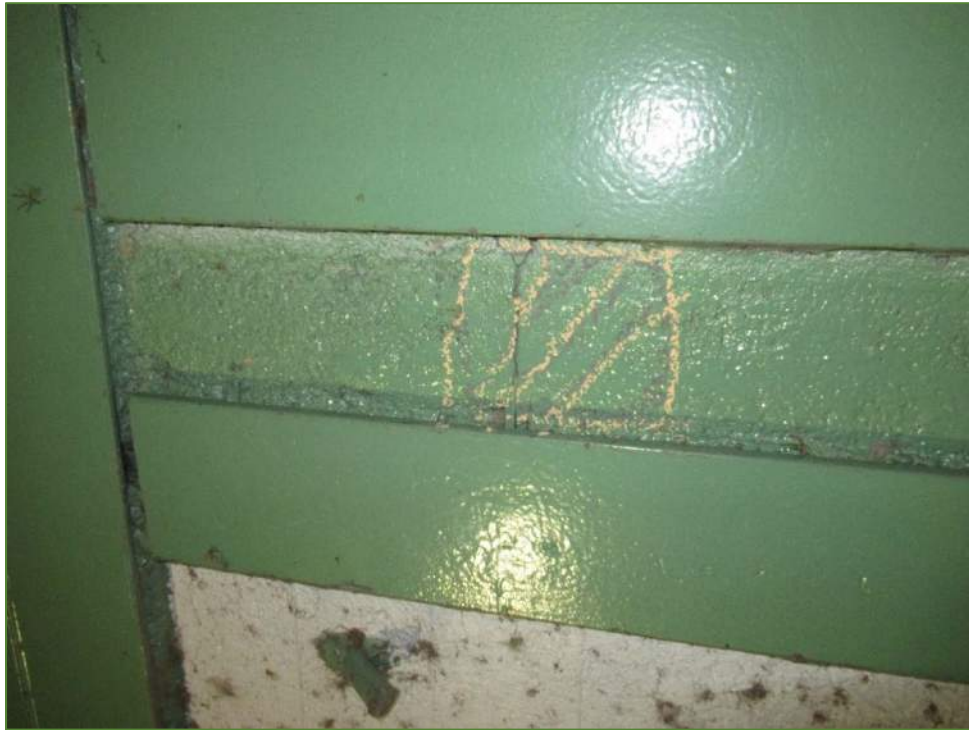
Photo P9 Machinery Room Slab Soffit Deterioration (cracks, delamination and light scaling)

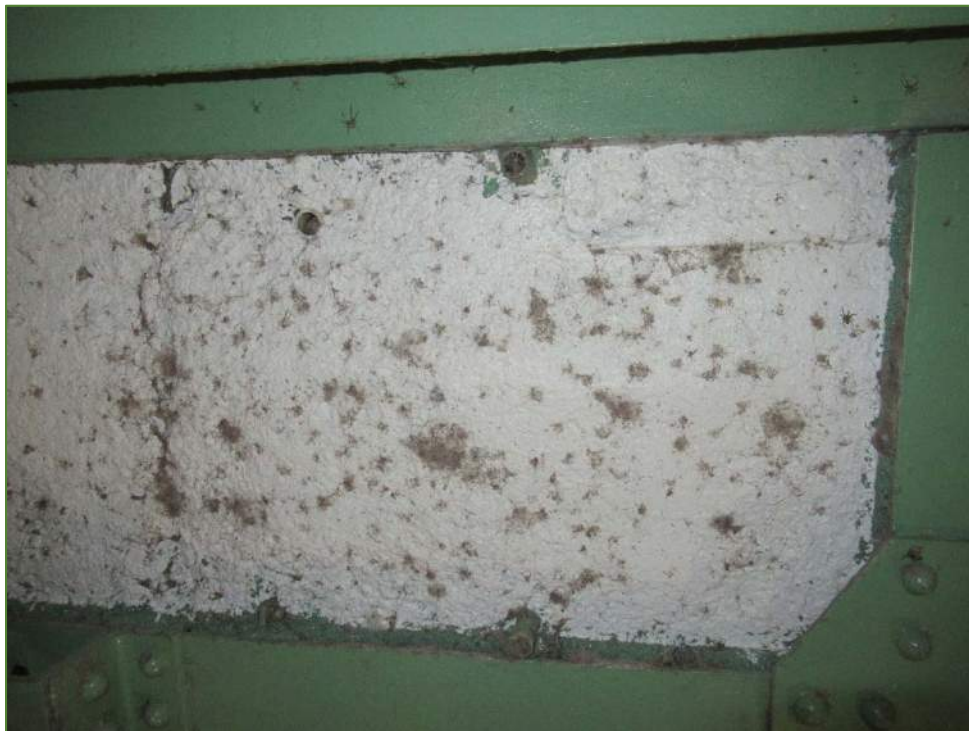
Photo P10 Machinery Room Slab Soffit Deterioration (medium scaling)

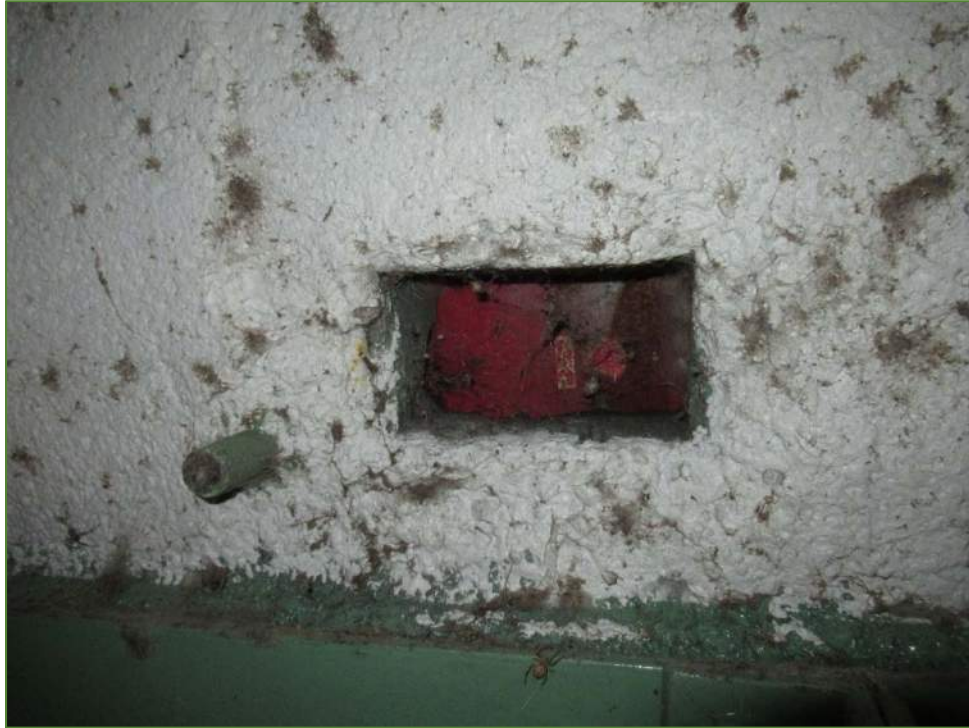
Photo P11 Machinery Room Slab Soffit Deterioration (medium scaling)

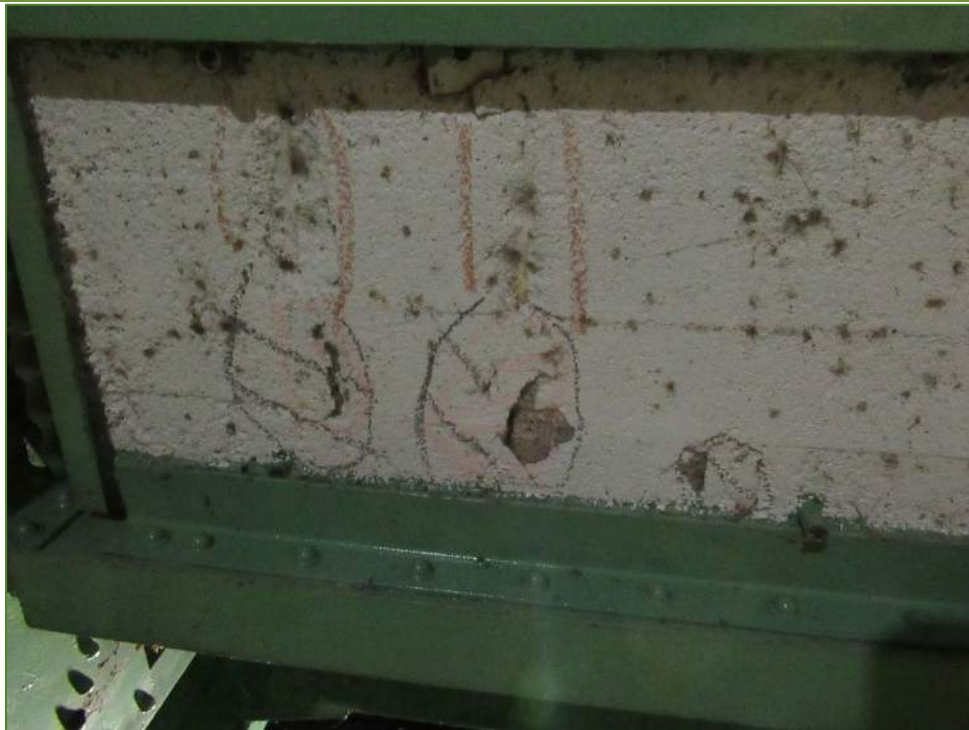
Photo P12 Machinery Room Slab Soffit Deterioration (cracks, spall and delamination)

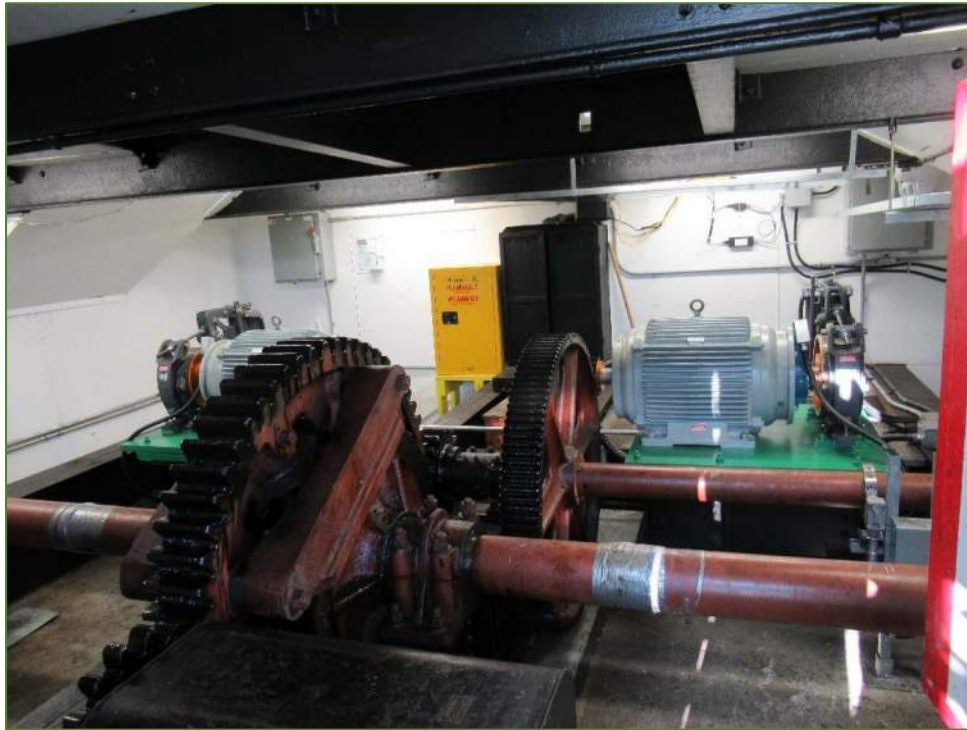
Photo P13 Machinery Room Slab, general view

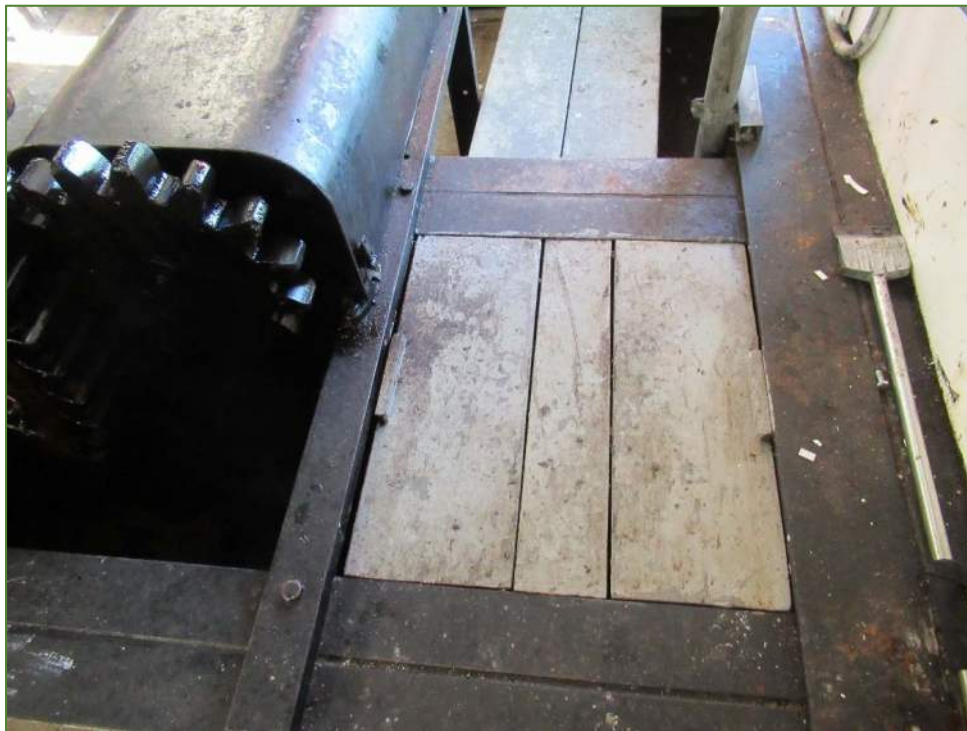
Photo P16 Machinery Room Slab (topside) note light corrosion on steel components

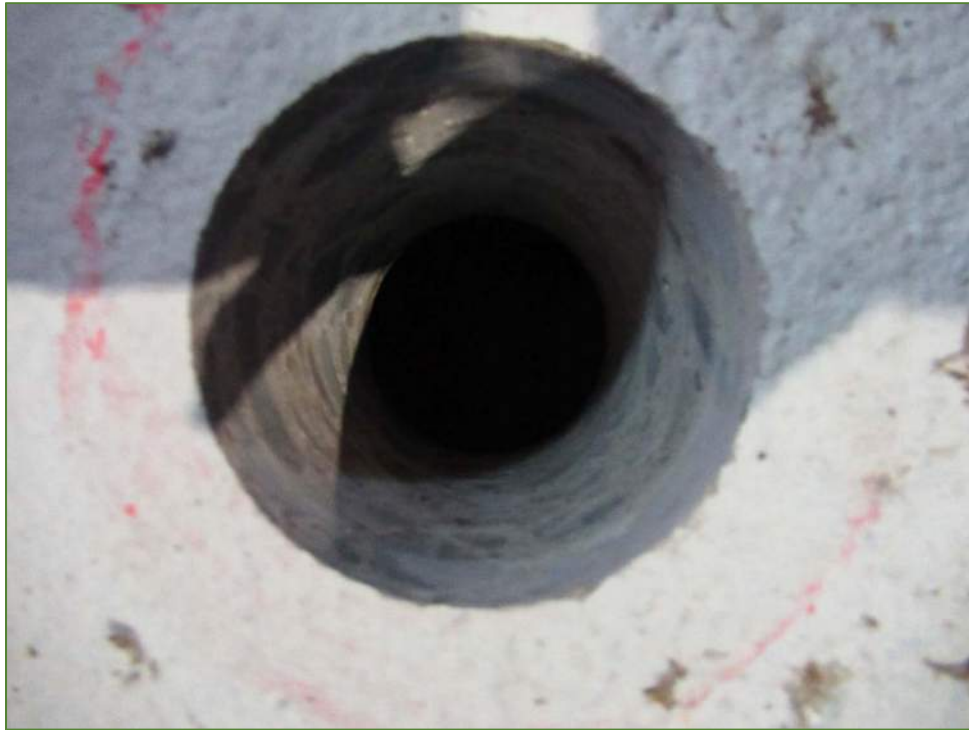
Photo P17 Typical Condition of Inside Core C1

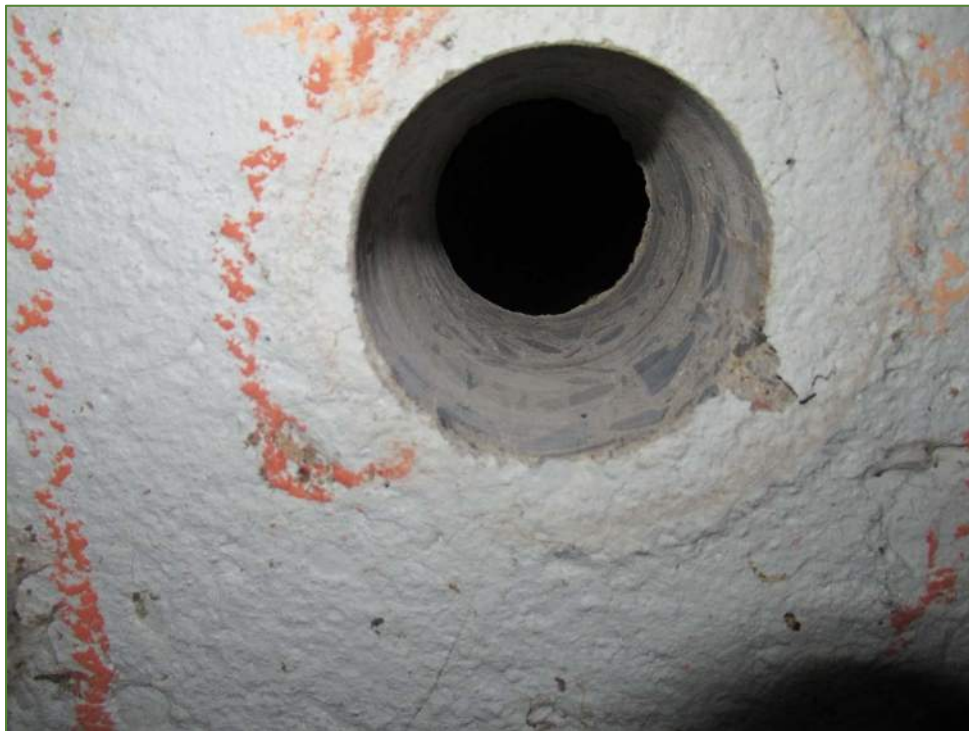
Photo P18 Typical Condition of Inside Core C2

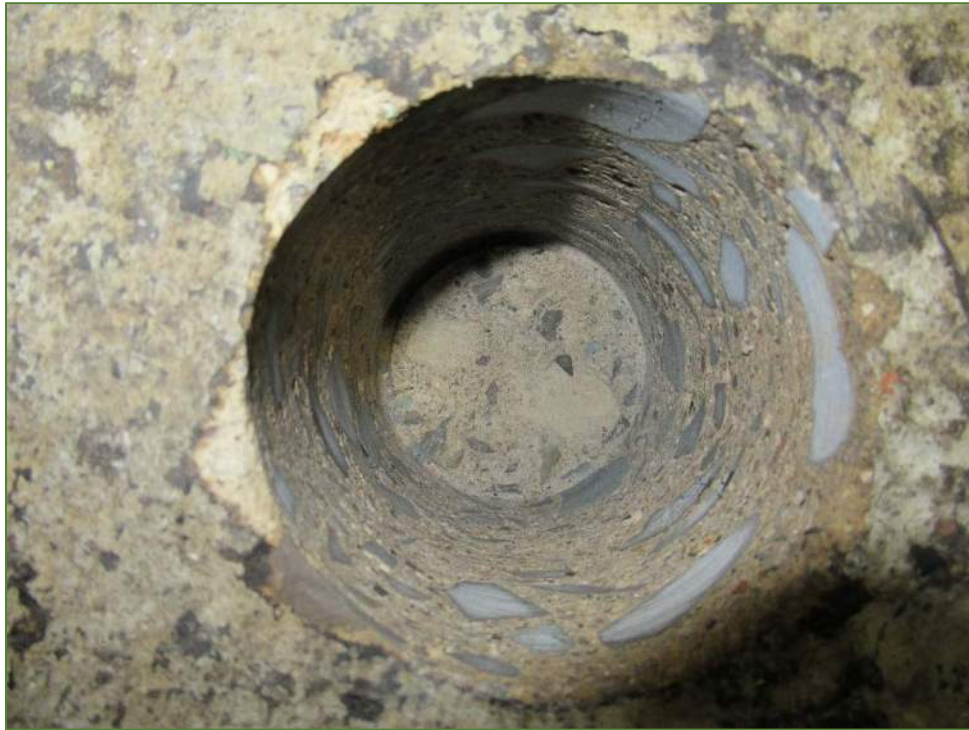
Photo P19 Typical Condition of Inside Core C5

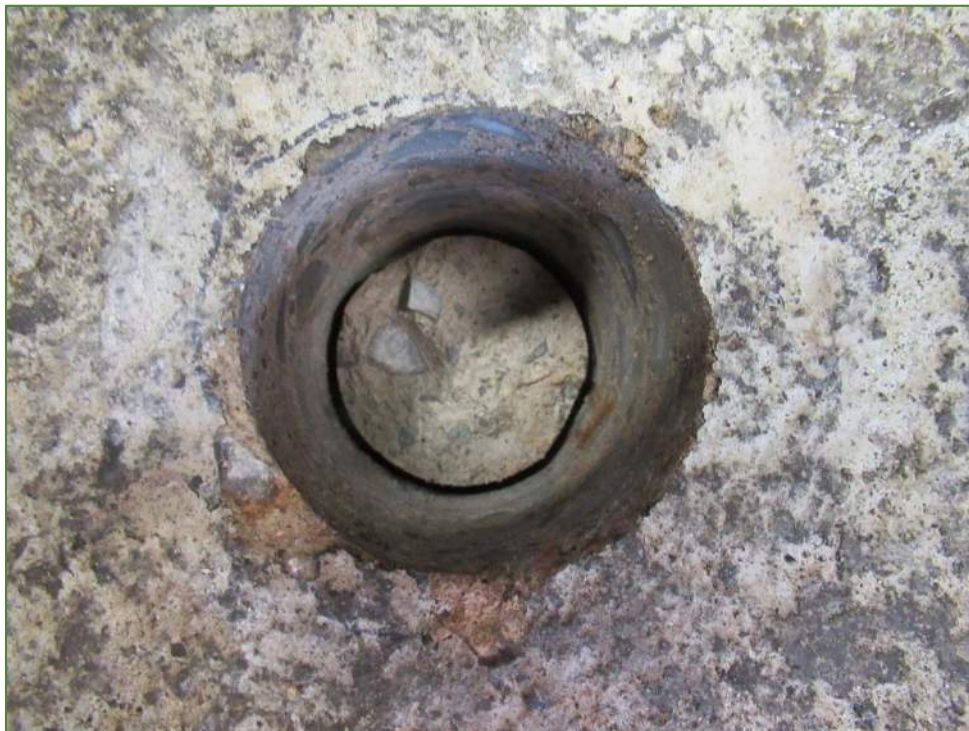
Photo P20 Typical Condition of Inside Core C6

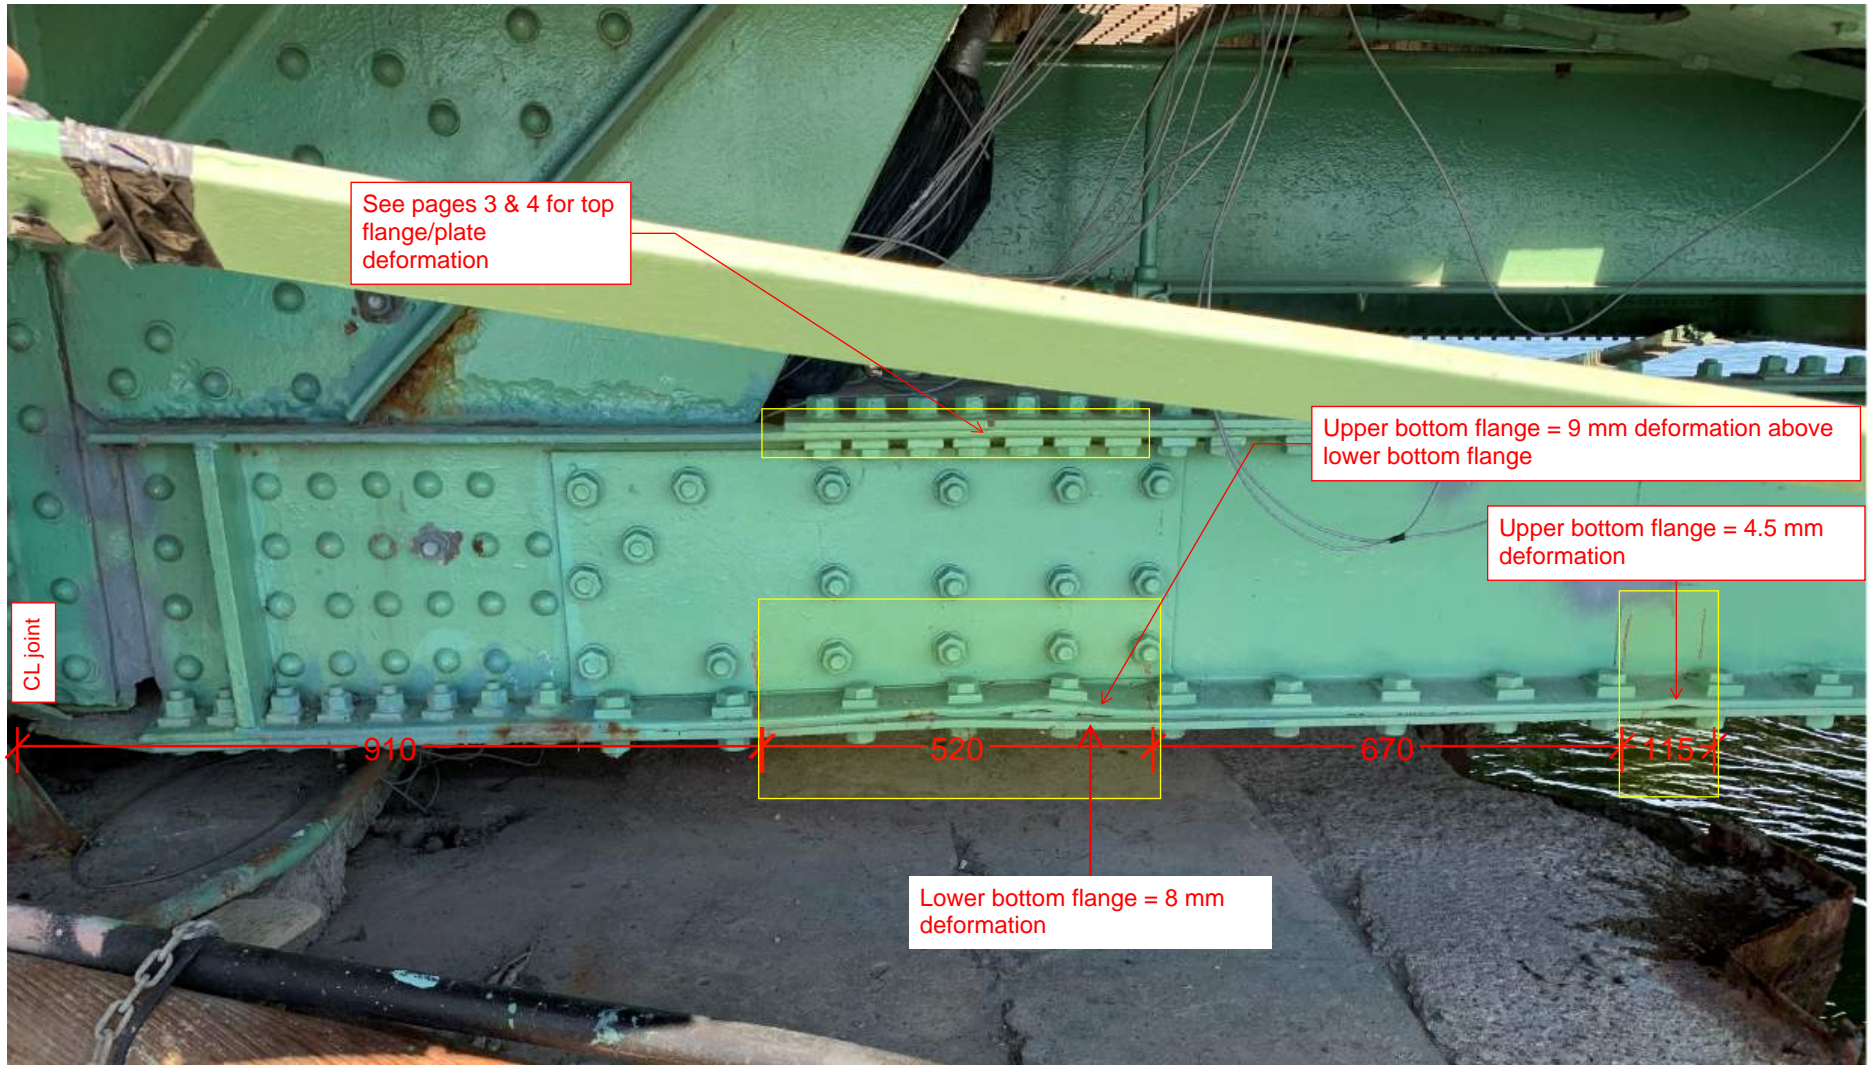
Measurements taken by Dennis Voltchek on May 20, 2020.

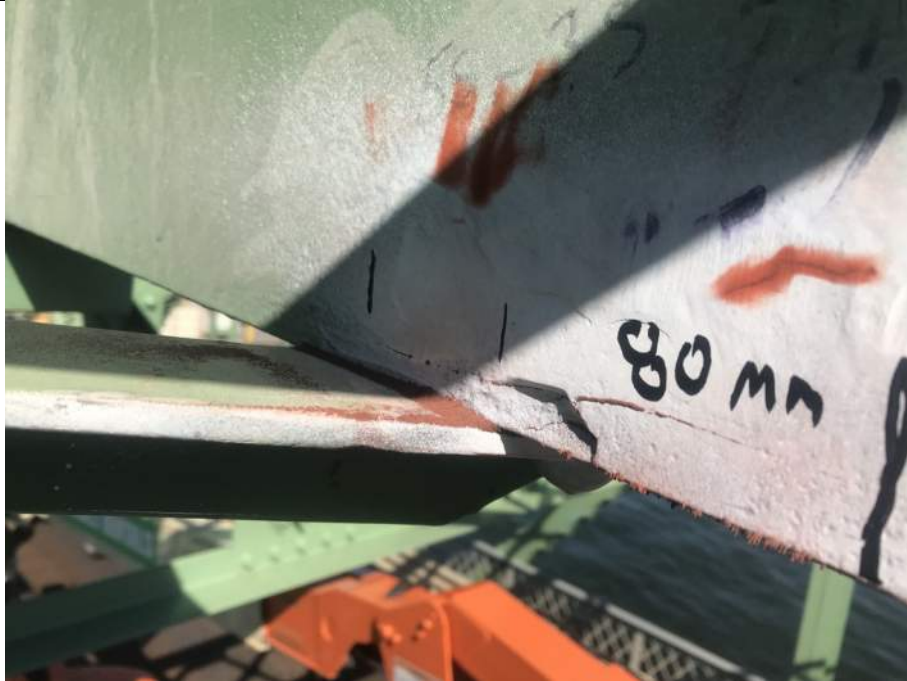
Figure 1: 80mm Crack Identified (Previously Reported as 60mm)

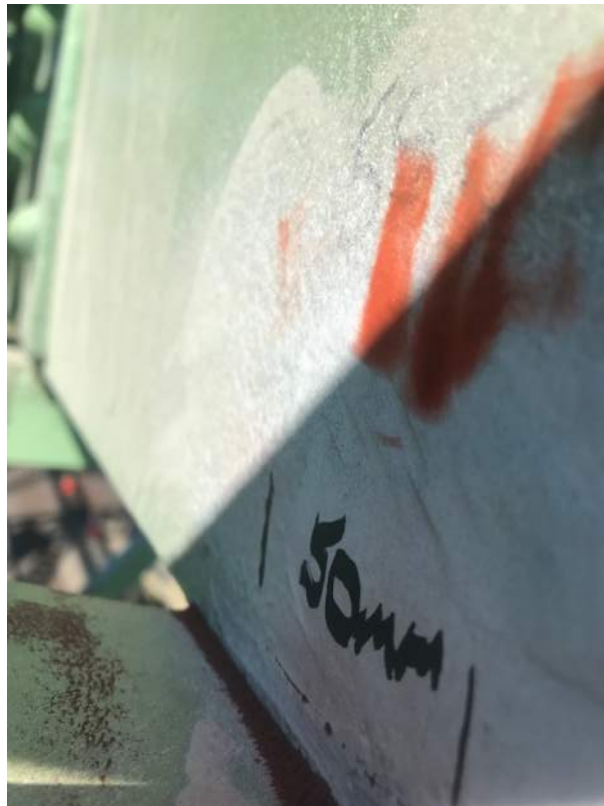
Figure 2: Crack Extended 50mm on Other Side

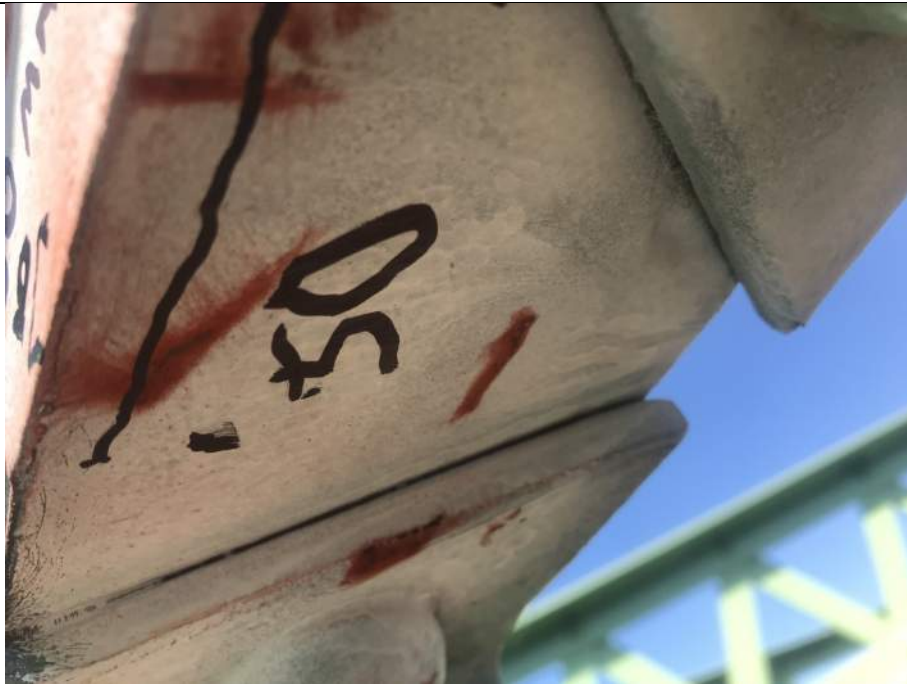
Figure 3: 50mm Crack Located on the Bottom

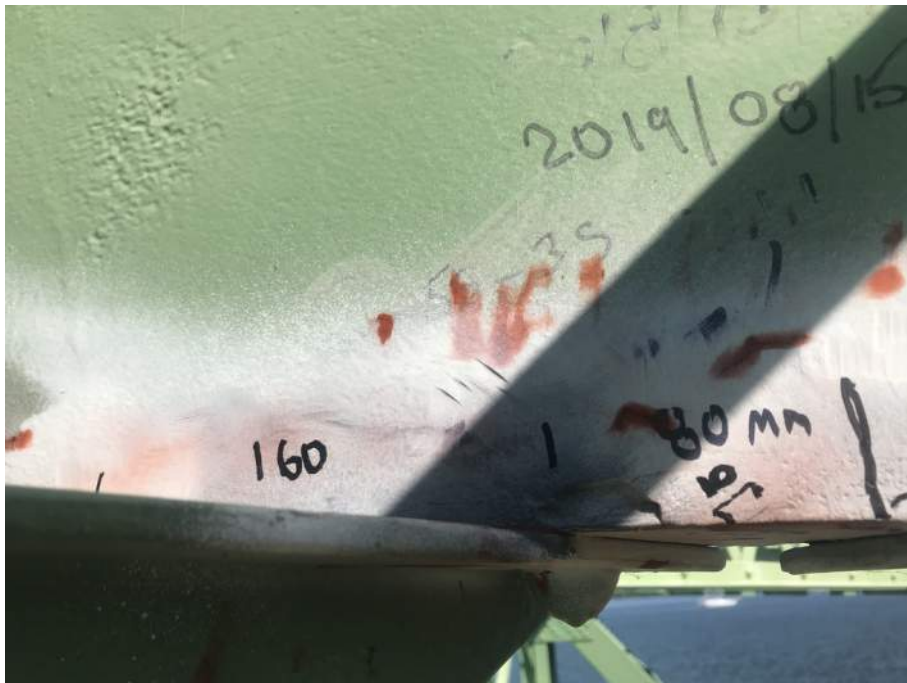
Figure 4: 3mm Crack Branching off of the Bottom

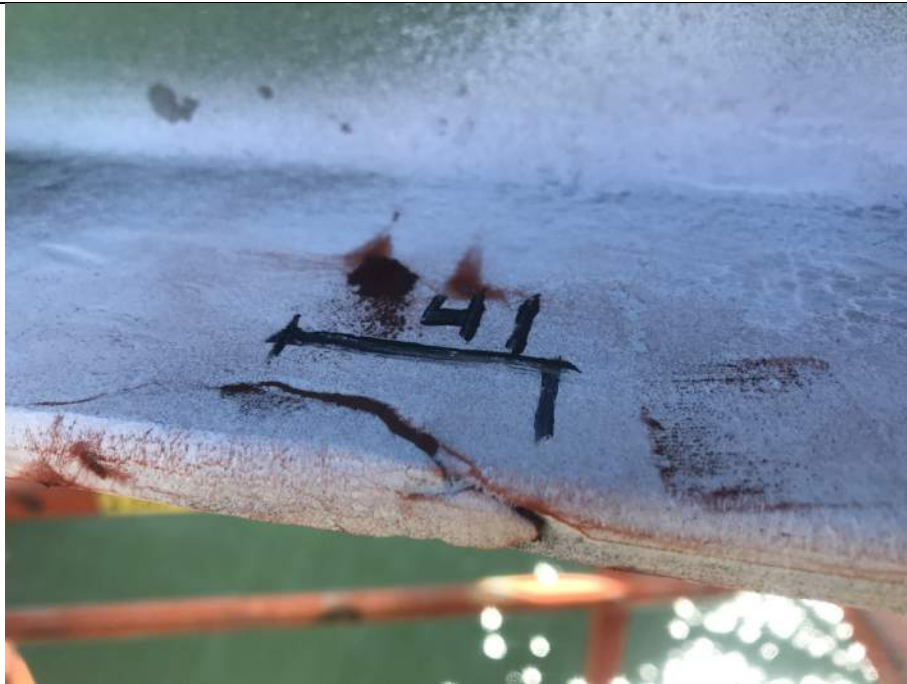
Figure 5: 41mm Crack Detected

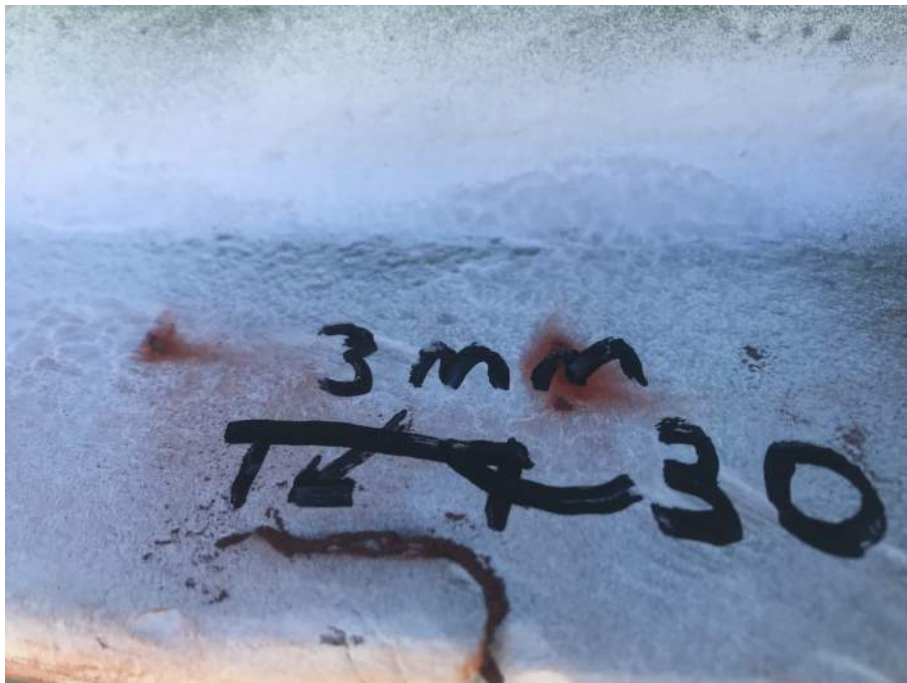
Figure 6: 30mm Crack With a 3mm Crack Coming from It

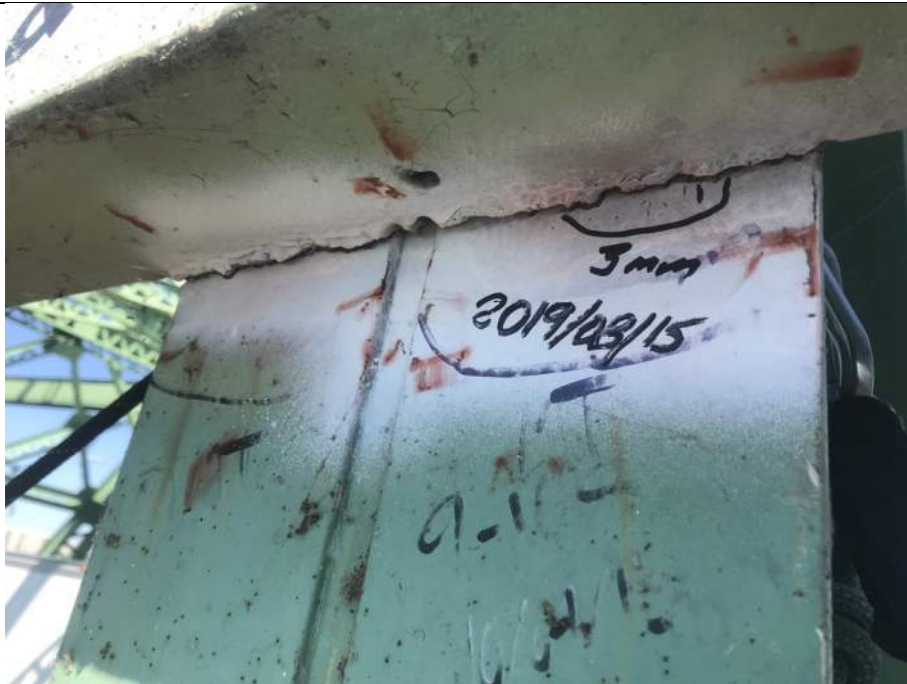
Figure 7: 3mm Crack no Change from Previous Inspection

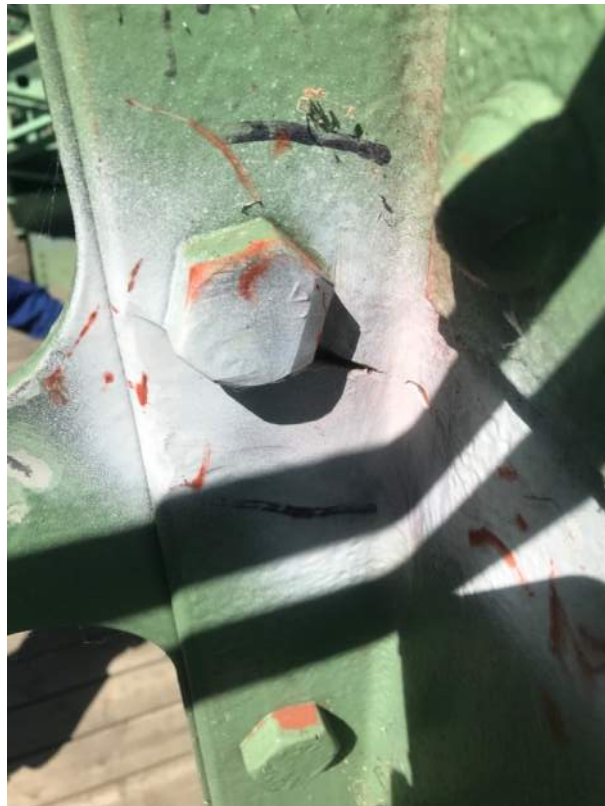
Figure 8: No Change from Previous Inspection

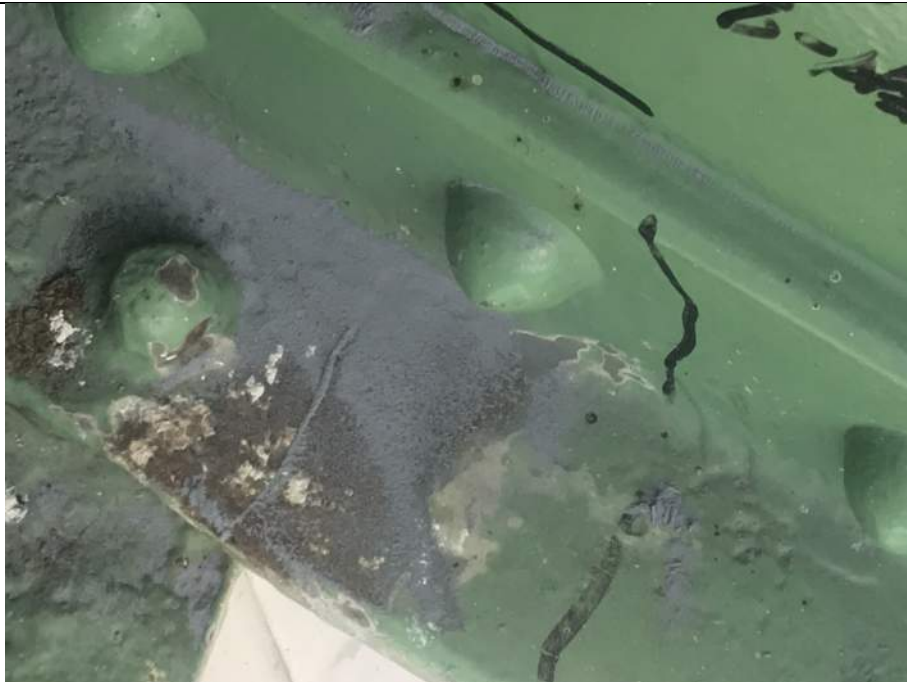
Figure 9: No Change in Crack Length from Previous Report

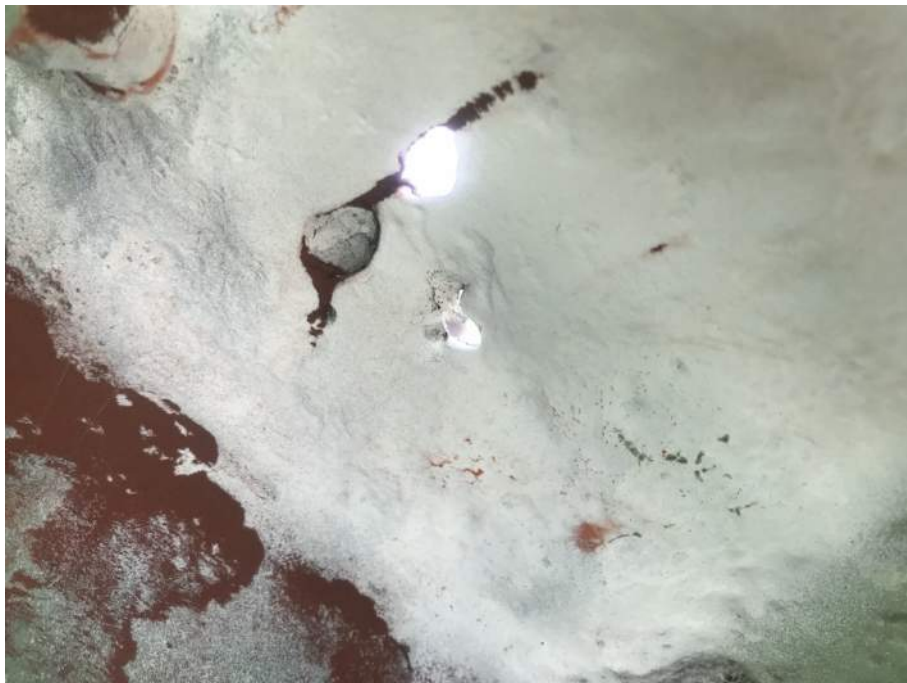
Figure 10: Crack Prorogating from Holes

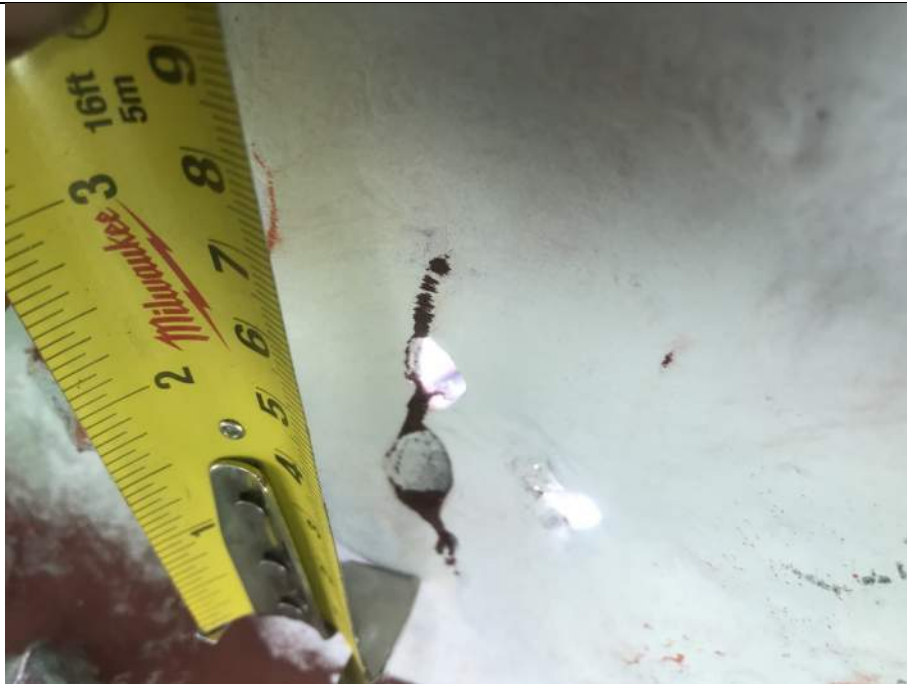
Figure 11: Showing Length

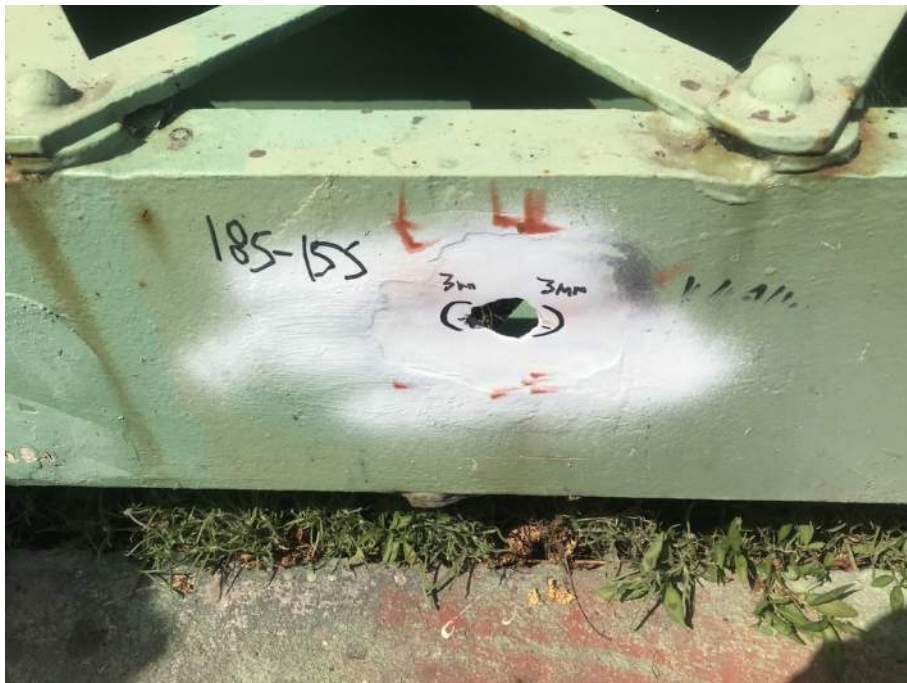
Figure 12: 3mm Cracks Forming on Both Sides
