**XCG File No. 5-336-200-01**  
**COLE File No. 2018-0565**  
March 4, 2019

**DESIGNATED SUBSTANCES AND  
HAZARDOUS MATERIALS SURVEY  
PIN 673155  
7797 16<sup>TH</sup> AVENUE  
MARKHAM, ONTARIO**

**PUBLIC SERVICES AND PROCUREMENT CANADA**  
4900 Yonge Street  
11th Floor  
Toronto, Ontario M2N 6A6

**PARKS CANADA AGENCY  
ROUGE NATIONAL URBAN PARK**

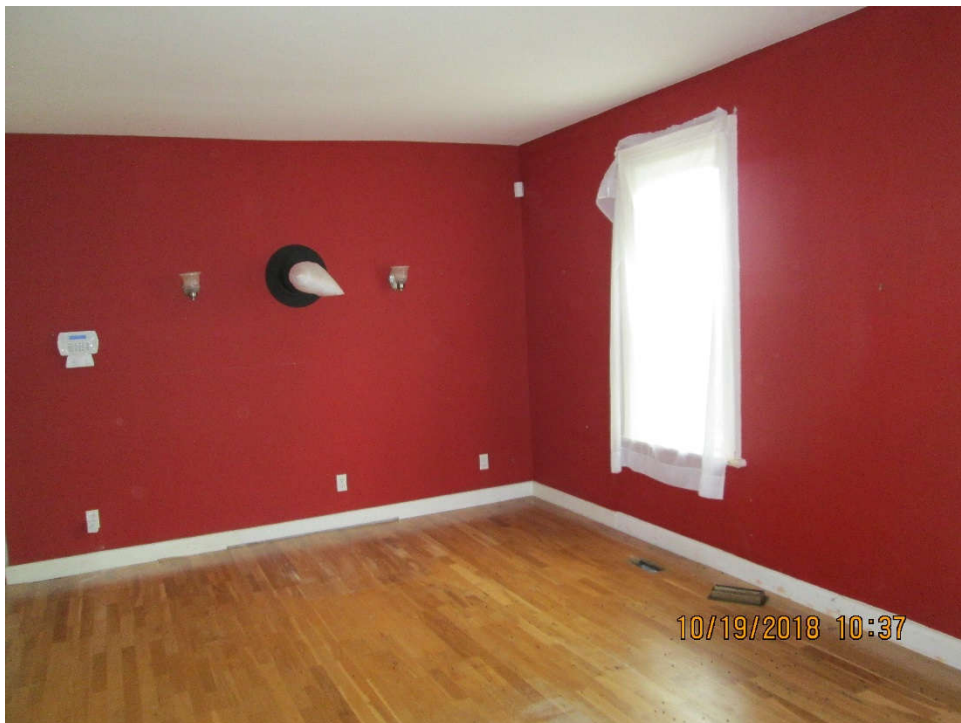
The laboratory results indicated that the red painted texture coat in the living room was identified to be ACM. The texture coat was in good condition and does not require removal or abatement at this time. Roofing material sampled from the dwelling extension did not contain asbestos, but due to the potential presence of additional layers of roofing material these materials are presumed to be asbestos containing. It should be noted that roofing materials were not collected from the original portion of the dwelling due to the height and safety precautions, however some roofing materials are known to have been manufactured with asbestos and therefore these materials are presumed to be ACM.

**Photo 2: View of the asbestos-containing texture coat (Sample 673155-TC-03-A,B,C and red lead-based paint (Sample 673155-P-06) on walls in the living room and white lead-based paint on the living room window sill (Sample 673155-P-02).**

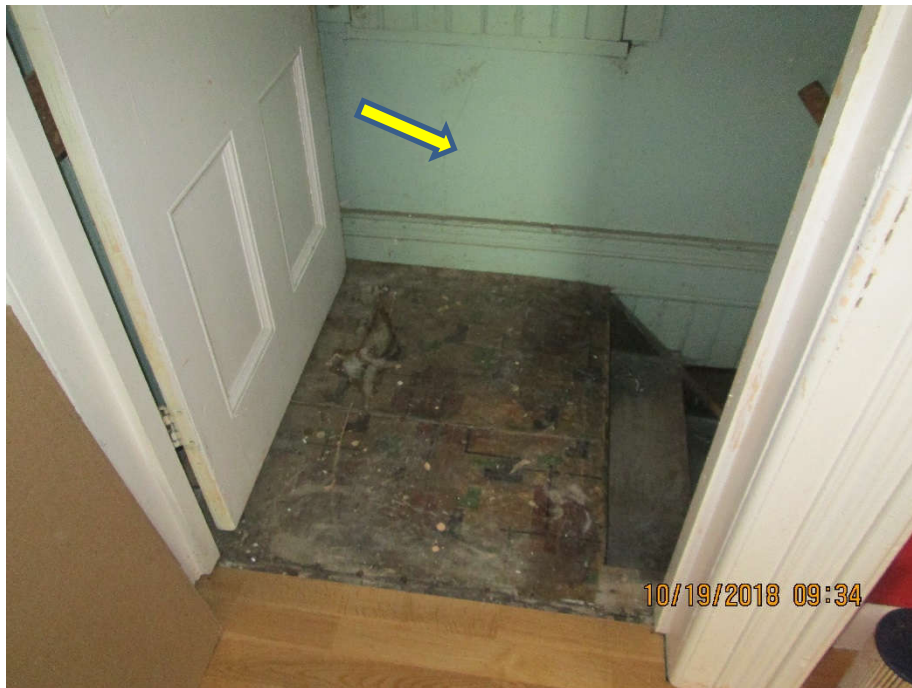
**Photo 3: View of the green lead-based paint (Sample 673155-P-03) on the staircase wall.**

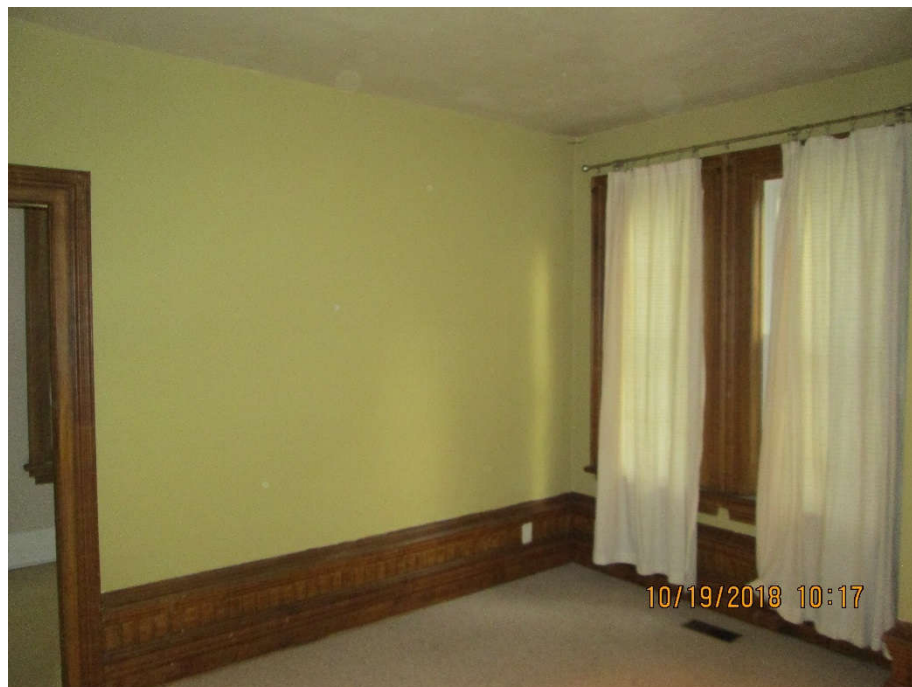
**Photo 4: View of green lead-based paint (Sample 673155-P-05) on the wall of the study room of the dwelling.**

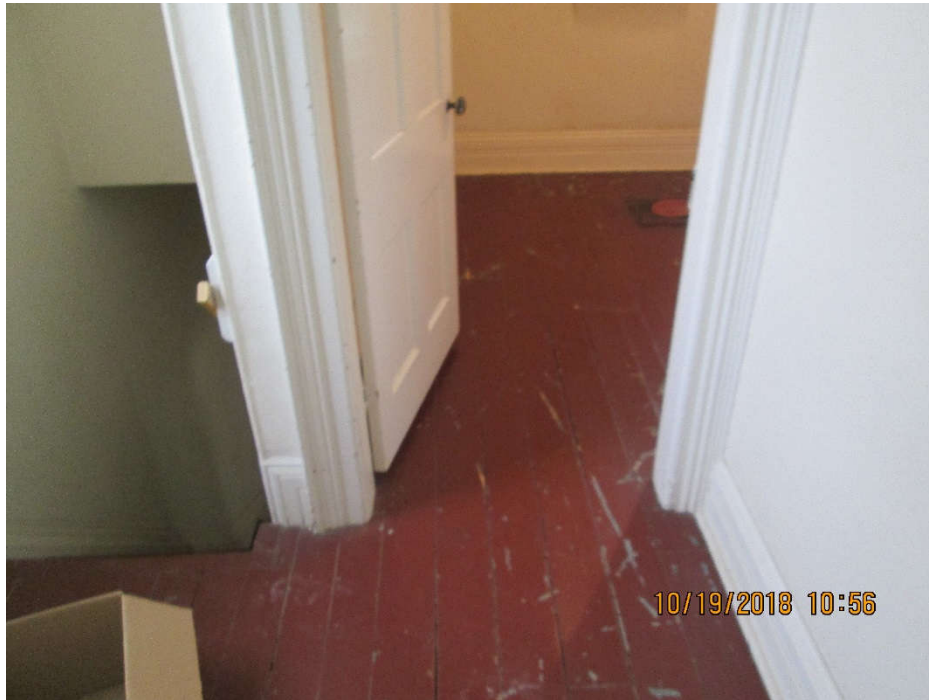
The paint in the building generally appeared to be in good condition, with the exception of the floor of bedroom 4, ceiling of bedroom 2, and the exterior window sill which were both in poor condition.

**Photo 5: View of the red lead-based paint (Sample 673155-P-08) on the floor of bedroom 4 of the dwelling**

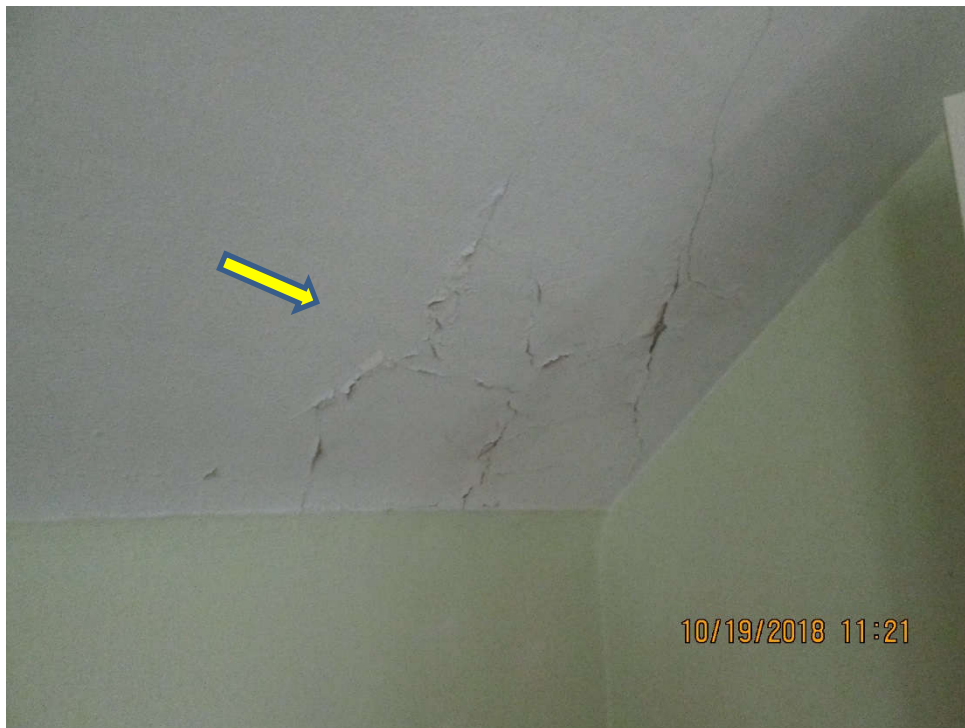
Lead Paint	673155-P-13	White paint	Bedroom 2 ceiling	23	Poor	Remove chipped or flaking paint. Paint over damaged areas. (Moderate)	Photo 6
Lead Paint	673155-P-15	White paint	Exterior window	5	Poor	Remove chipped or flaking paint. Paint over damaged areas. (Moderate)	Photo 7
Refrigerant	-	One refrigerator One freezer	Kitchen Basement	-	Good	Dispose of appropriately.	Photos 8 & 9
Silica	-	Brick and mortar / concrete block / cement floor / drywall and plaster walls and ceiling / ceramic tiles	Exterior / basement foundation / basement floor / throughout / bathroom	-	Good	Prohibit drilling, grinding, cutting, and abrading silica-containing material unless safety precautions taken (wetting and HEPA filter)	-

**Photo 6: View of white lead-based paint (Sample 673155-P-13) on the ceiling in the bedroom 2 of the dwelling.**

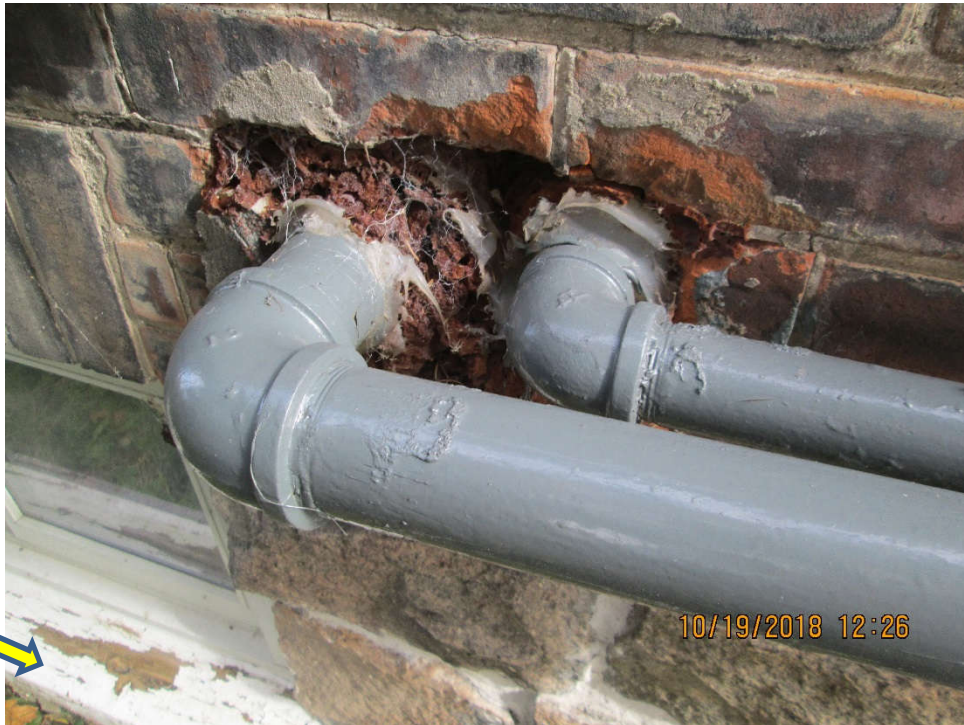
**Photo 7: View of white lead-based paint (Sample 673155-P-15) on the exterior window sill of the dwelling.**

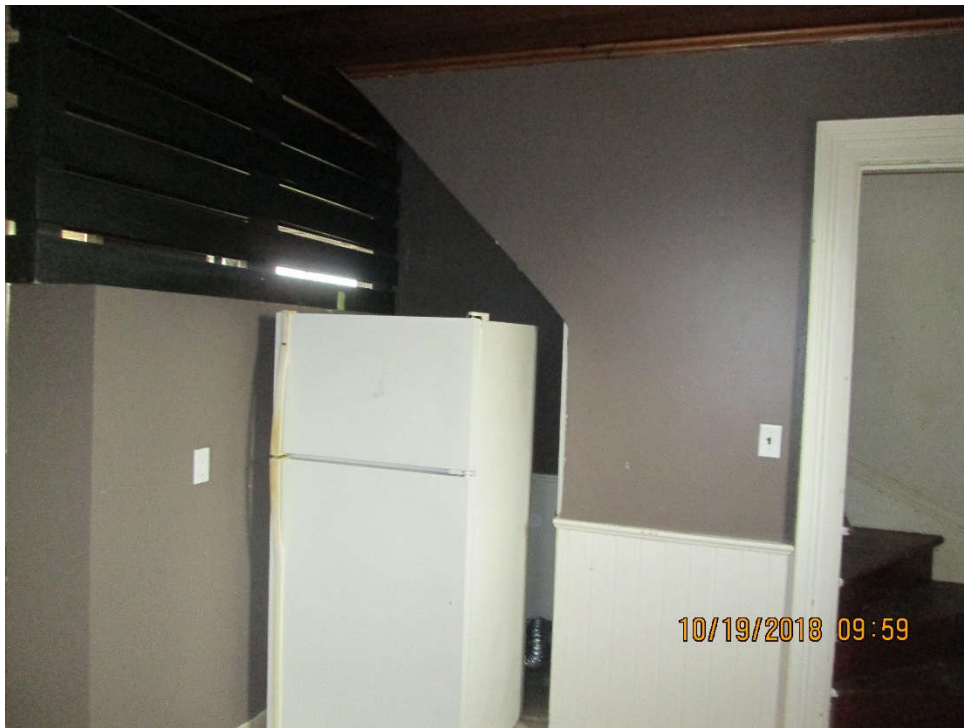
**Photo 8: View of refrigerator potentially containing halocarbons at the dwelling.**

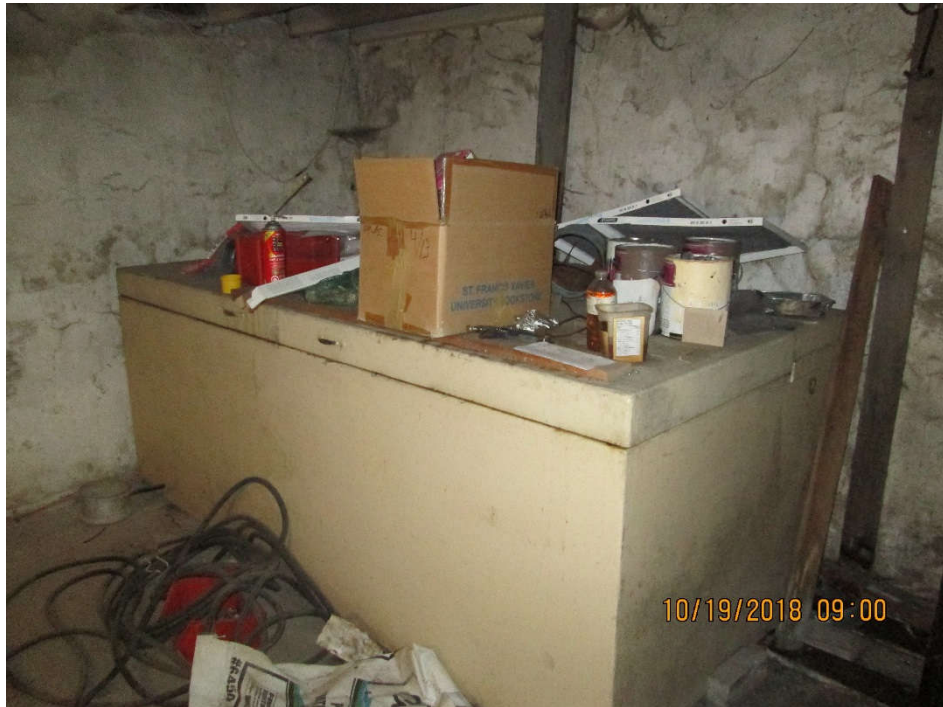
**Photo 9: View of freezer potentially containing halocarbons in the basement of the dwelling.**

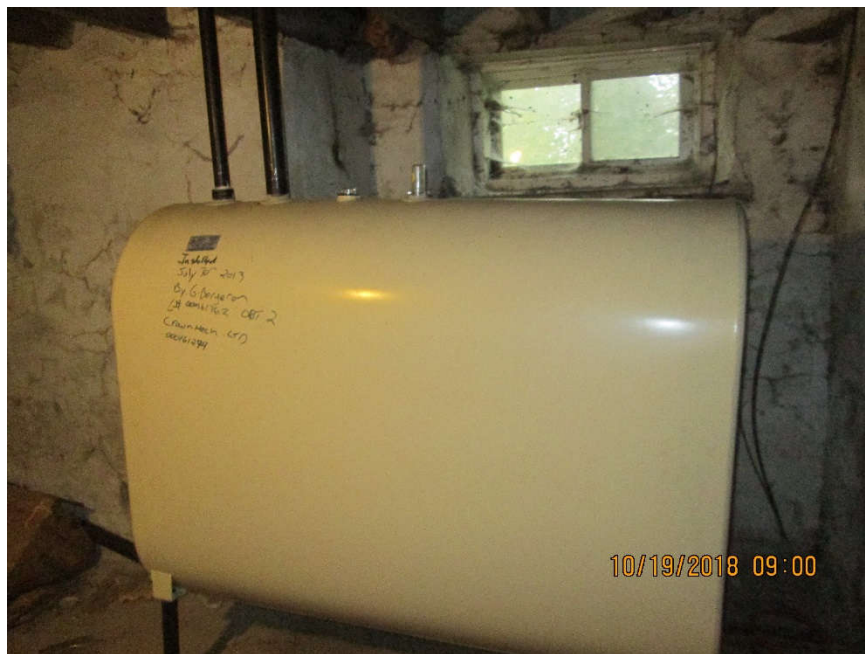
These designated substances are typically found in industrial settings and are unlikely to be located within the residential dwelling, with the exception of benzene. Benzene is present within the furnace oil in the AST in the basement and presumed to be in the 20 litre jerry can also found in the basement.

**Photo 10: View of the furnace oil AST located in the basement of the dwelling.**

Fuel oil	-	Furnace oil Unknown fuel	Steel AST in basement Plastic jerry can	910 litres 20 litres	Good	Manage any fuel oil tank and its contents in accordance with the Storage Tank Systems for Petroleum Products and Allied Petroleum Products (SOR/2008-197) requirements.	Photos 10 & 11
<p>Notes:                      Urgency Level: Identified for ACMs or lead-containing paint in poor condition only. Additional information provided in Section 6.0 for each material.                      (High): Immediate repairs required.                      (Moderate): Repairs required.                      -: Not applicable.</p>

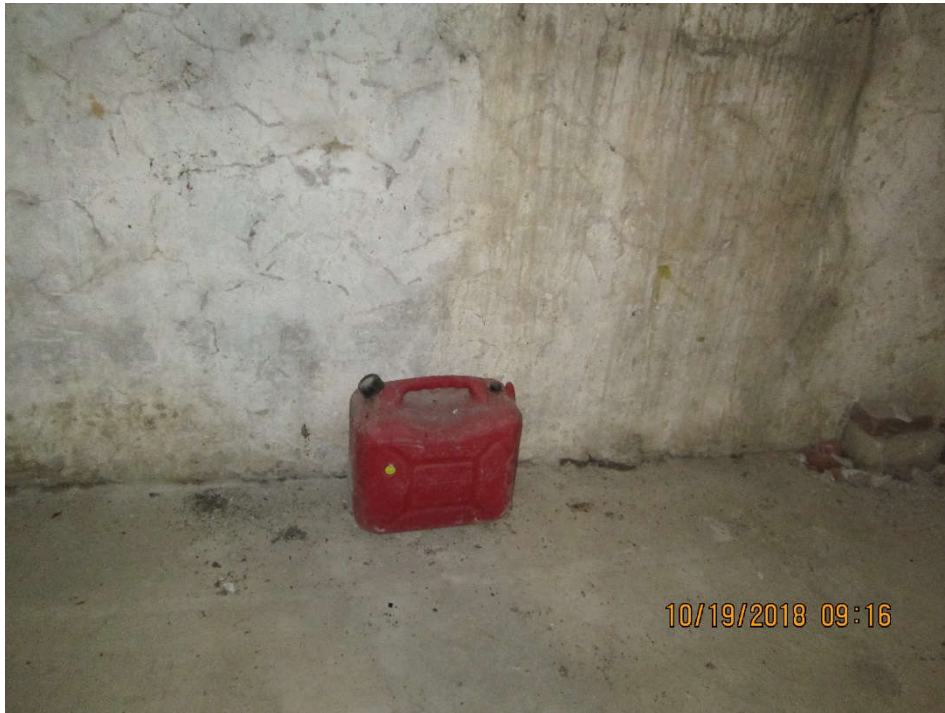
**Photo 11: View of the 20 liter jerry can of fuel located in the basement of the dwelling.**
