Grey water drain from galley fridges and scuppers.

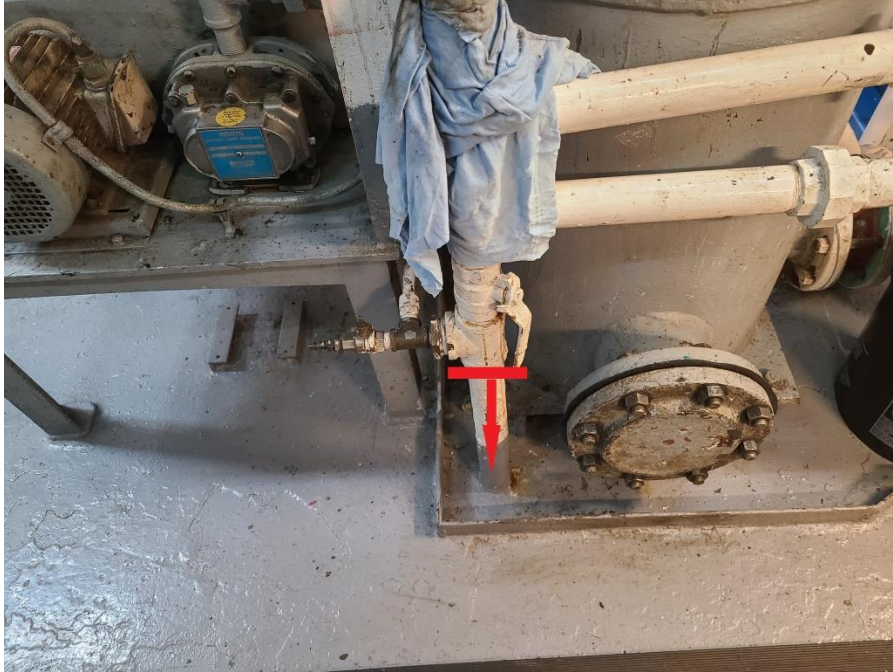
Water is collecting in Mud room scupper drain. Drain was snaked to penetration by Mini Jet. Blockage is suspected to be between penetration and horizontal pipe leading to sewage transfer tank.

1.5 inch drain line through deck penetration

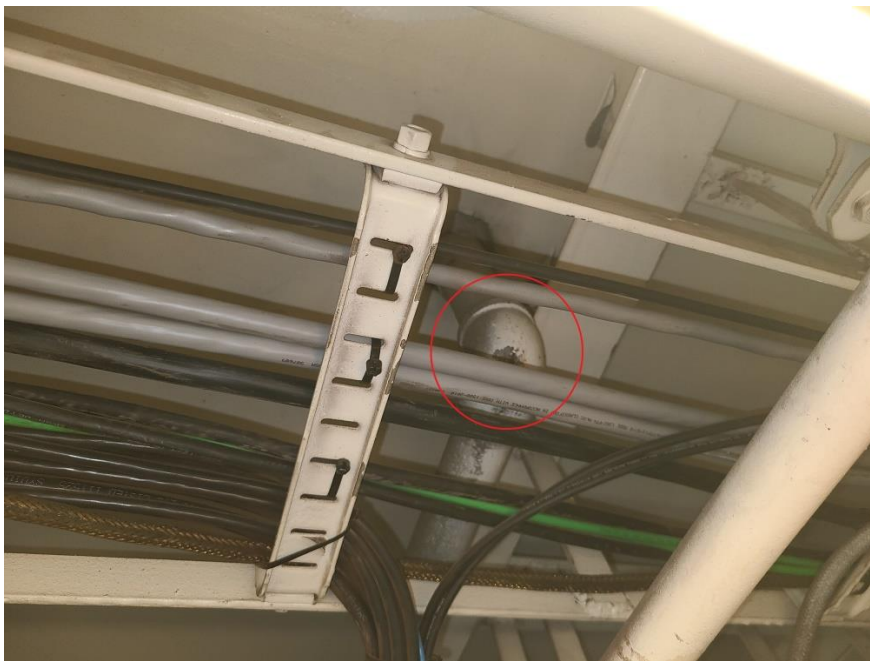
Other side of penetration in deck head. Located fwd of #2 main engine. Blockage is suspected to be in this section of pipe

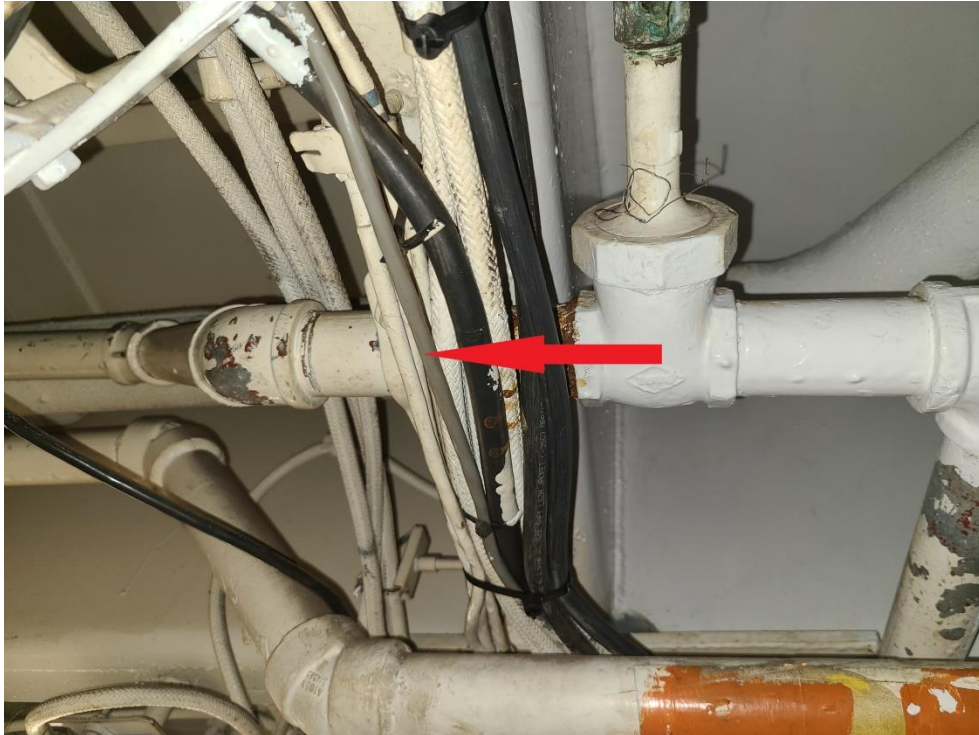
Line terminates above sewage transfer tank at 1.5 inch screw down valve. (arrow pointing to grey water drain line)

Apx 30 ft of 1.5 inch thread pipe (1.910 OD)
