**DESIGNATED SUBSTANCE AND  
HAZARDOUS MATERIALS SURVEY  
PIN: No PIN  
3 Reesor Road, Toronto, ON**

Rouge National Urban Park

March 27, 2020

Stantec Project No: 122151011  
PSPC Project No: R.099832.001

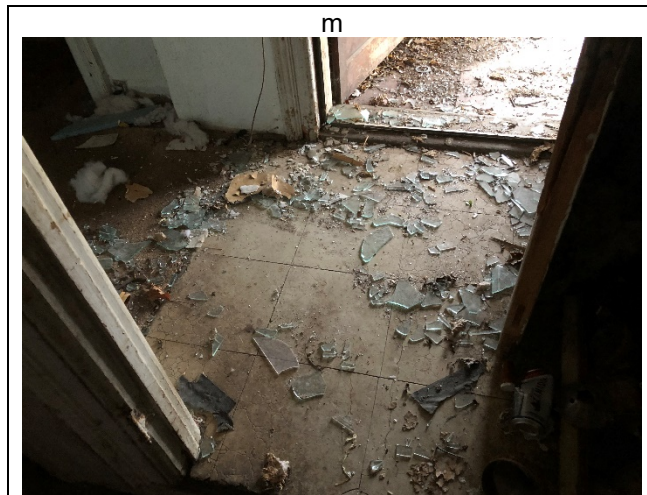
Photo 2: Asbestos-containing vinyl floor tiles – beige in the first floor hallway.

- Asbestos-containing 12"x12" vinyl floor tile - beige can be left place, as the material was observed to be in good condition. No further abatement actions are required. Prior to demolition activities remove asbestos-containing 12"x12" vinyl floor tile - beige following Type 1 (Low Risk) operations.

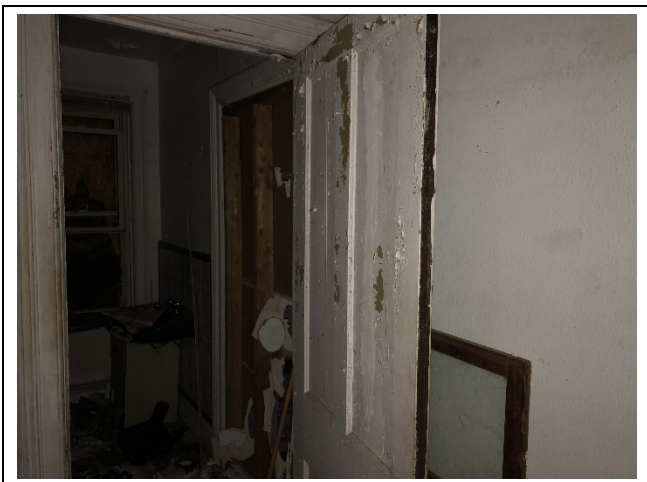
Photo 3: Flaking lead-containing white coloured paint on first floor washroom door.

Damaged paint throughout the house should be cleaned up and loose paint removed following lead precautions.

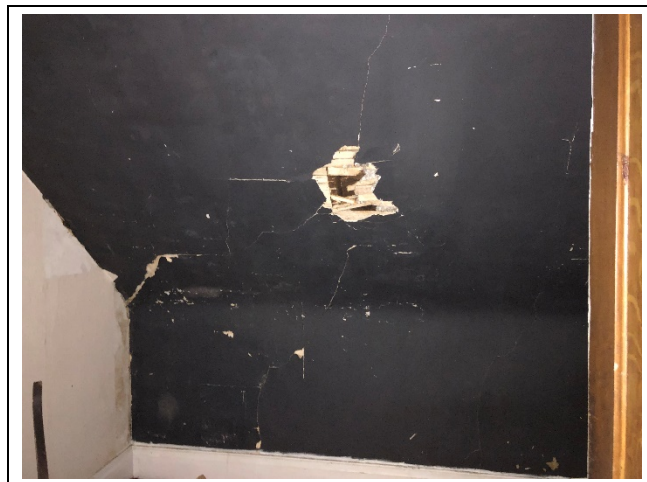
Photo 4: Flaking lead-containing paint on the second floor storage room 2 ceiling.

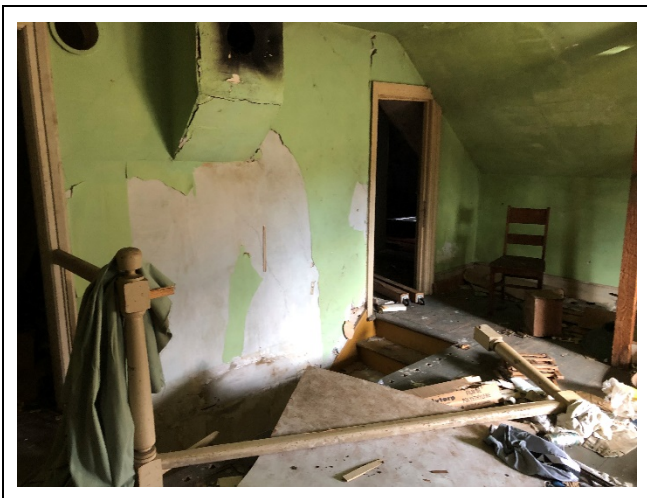
Photo 5: Flaking lead-containing green coloured paint on the walls and ceiling of 2<sup>nd</sup> floor bedroom 7.

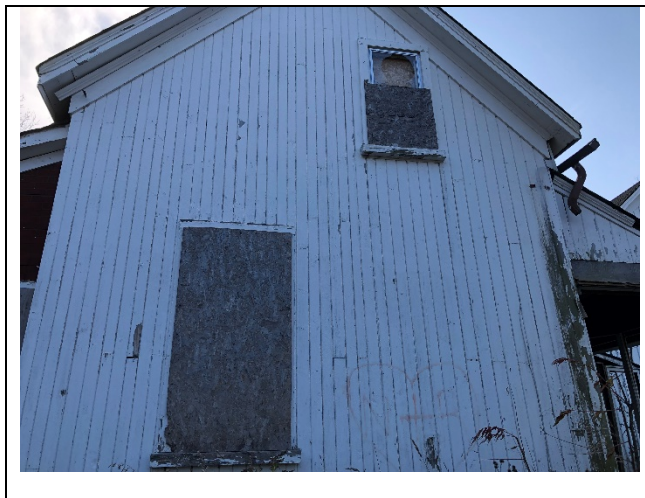
Photo 6: Lead-containing white paint on the exterior.

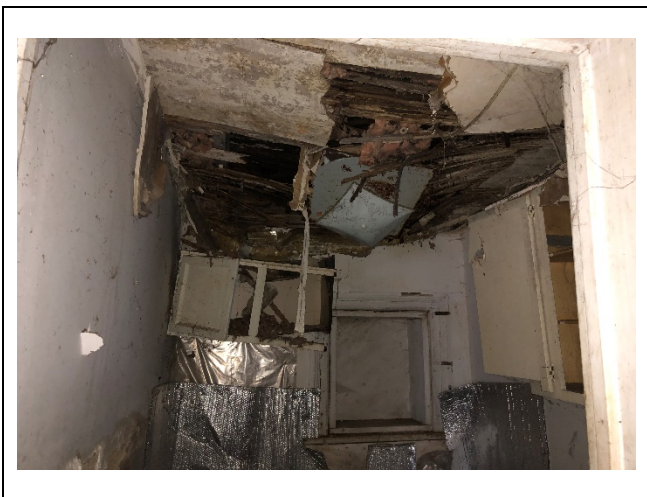
Photo 7: Suspect mould growth and ceiling collapsing in storage room 1 on the first floor.

A mould assessment should be undertaken to determine the extent of suspect mould impacted and/or moisture damaged building materials and the likely source(s) of moisture.

Remediation should be done by a competent person, who is knowledgeable of potential hazards of mould exposure, following remediation precautions.

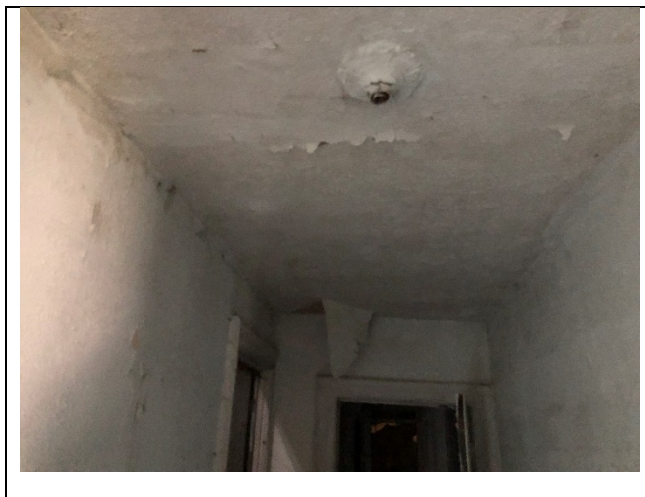
Photo 8: Suspect mould growth on ceiling in second floor hallway.
