Appendix 1: D3- Property Demolition Assessment/Inventory Report (D3-PDAIR)

D3- Property Demolition Assessment/Inventory Report (D3-PDAIR)

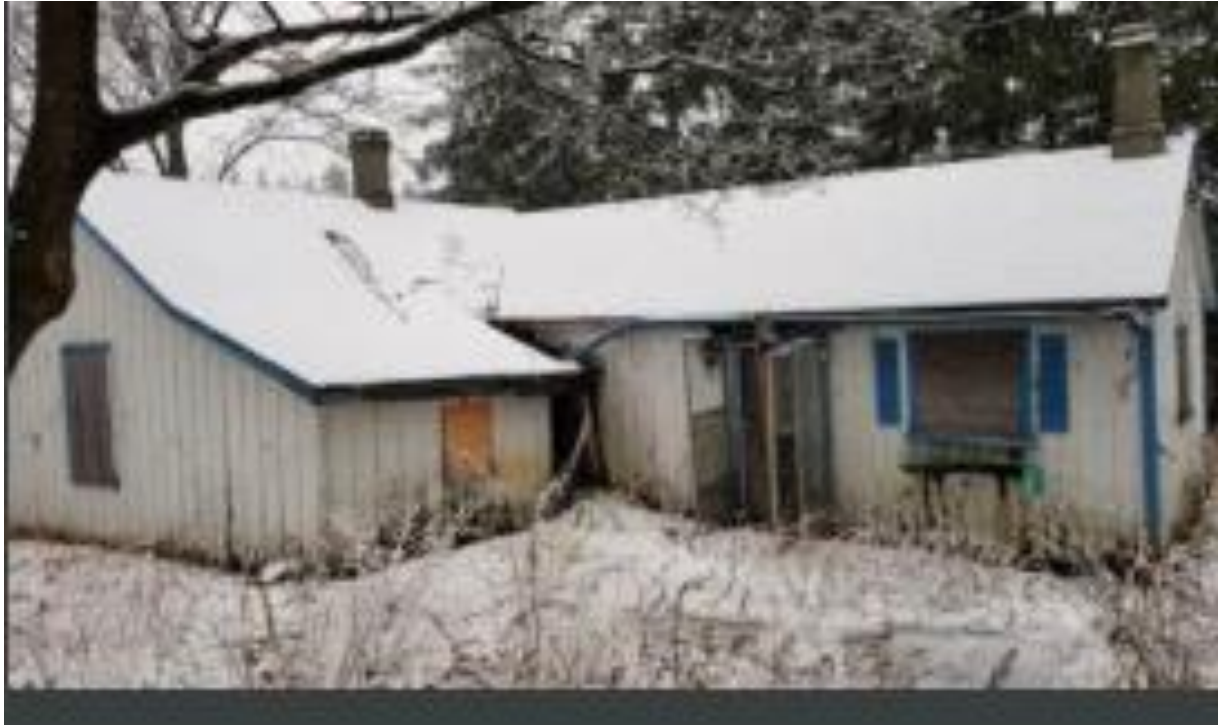
Location: 2262 Meadowvale Markham ON RNUP		Date of Site Visit: 2021-03-23
Land Ownership: Parks Canada		Date of Report: 2021-04-29
Property Size/acreage: TBD		Project Priority: 04-2021
Site Drawing or Picture:

<p>Site Description: 2262 Meadowvale is a small cottage/house on a small corner lot. It would appear the structure was relocated to the site at some point. The property also has a separate driving with 5 accessory buildings and a collection of trailers and abandon vehicles.</p>		
<p>Site Access: There is no obvious sign of a driveway and the yard area around the cottage/house is grown up in vegetation. Possibly second driveway used with a path to residence</p>		
Utilities:		
Hydro: disconnected and removed from site		
Well/Water System: no sign of water system		
Drilled Well: Yes <input type="checkbox"/> No <input checked="" type="checkbox"/>		
Dug Well: Yes <input type="checkbox"/> No <input checked="" type="checkbox"/>

Description: 5 accessory building, 1 small cabin fully collapsed, 3 large driving sheds, and 1 small cabin/shed with double garage doors at edge of roadway.

Description: scattered trash and household debris, 2-abandon vehicles, 4 utility trailers. Large volumes of tree planting and tree nursery material and equipment

Notes: D3 structure, no access into interior for assessment, potential lead paint on exterior siding and trim. Accessory buildings are open concept and accessible

Justification: Property is situated away from adjacent residential buildings, no access requirements to property and opportunity for green space at busy intersection

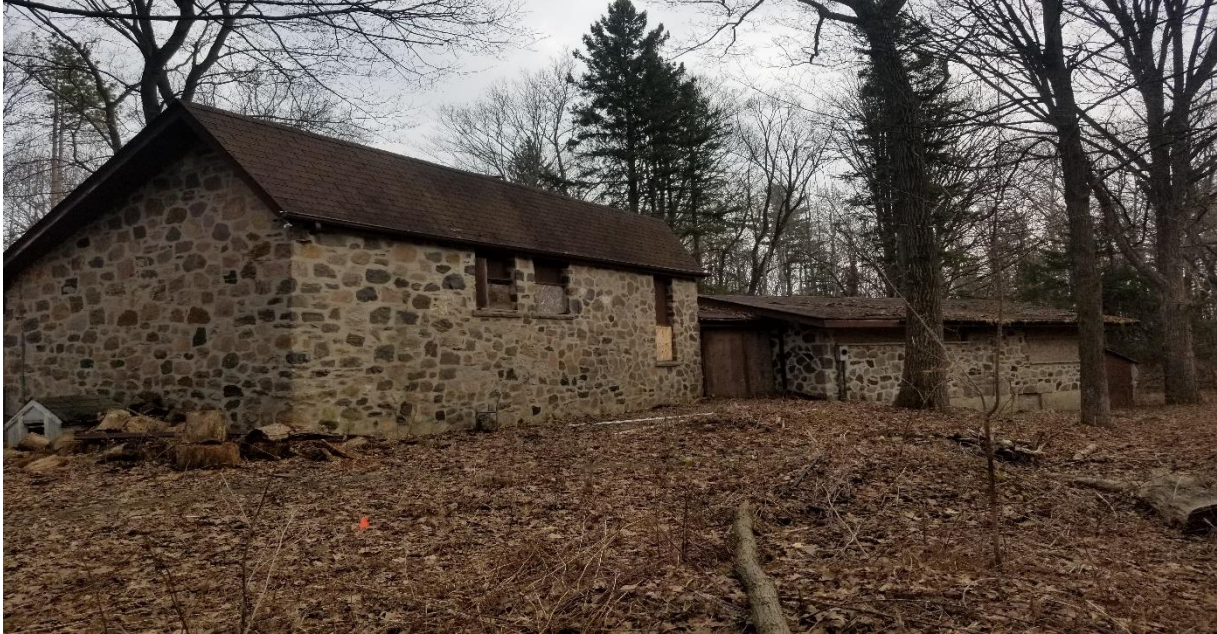
Location: 4 Reesor Road Markham ON RUNP		Date of Site Visit: 2021-03-23
Land Ownership: Parks Canada		Date of Report: 2021-04-28
Property size/acreage: TBD		Project Priority: 06-2021
Site Drawing or Picture:

<p>Site Description: This is a remote property with residential building is barely visible from Reesor Road. 100m + driveway supporting minimal granular base. The property is well forested with primarily hardwoods (oak, maple)</p>		
<p>Site Access: 100m driveway /path into development area</p>		
<p>Utilities:</p>		
<p>Hydro:abandon /disconnected overhead electrical service</p>		
<p>Well/Water System:dug well tile/cap located at front of residential building</p> <p>Drilled Well: Yes <input type="checkbox"/> No <input checked="" type="checkbox"/></p> <p>Dug Well: Yes <input checked="" type="checkbox"/> No <input type="checkbox"/></p>		
<p>Septic System: Yes <input checked="" type="checkbox"/> No <input type="checkbox"/></p> <p>Description: raised septic field located at front of residential building , no visual on septic tank</p> <p>Septic Tank: Yes <input type="checkbox"/> No <input checked="" type="checkbox"/></p>

<p>Structures:</p>		
<p>Type: 1.5 storey/2.0 storey connected with 1.0 storey breezeway</p>	<p>Size: main(x2) 20'x30' breezeway 12'x20' total= 2,300 sq'</p>	<p>Foundation: visible foundation constructed of field stone/concrete</p>
<p>Building Construction Material: field stone veneer on exterior walls to top of gable(s), asphalt shingles on roof, breezeway framed with wood siding</p>		
<p>Out buildings/Barn: Yes <input type="checkbox"/> No <input checked="" type="checkbox"/></p> <p>Description: No out building standing</p>

Description: 3 piles consisting of collapsed buildings and trash

Notes: interior DSR assessment not available due to building condition

Justification: This property is one of the best examples for site restoration: 1. property is isolated, 2. Surrounded by native hardwood forest, 3. No access requirements on to site,

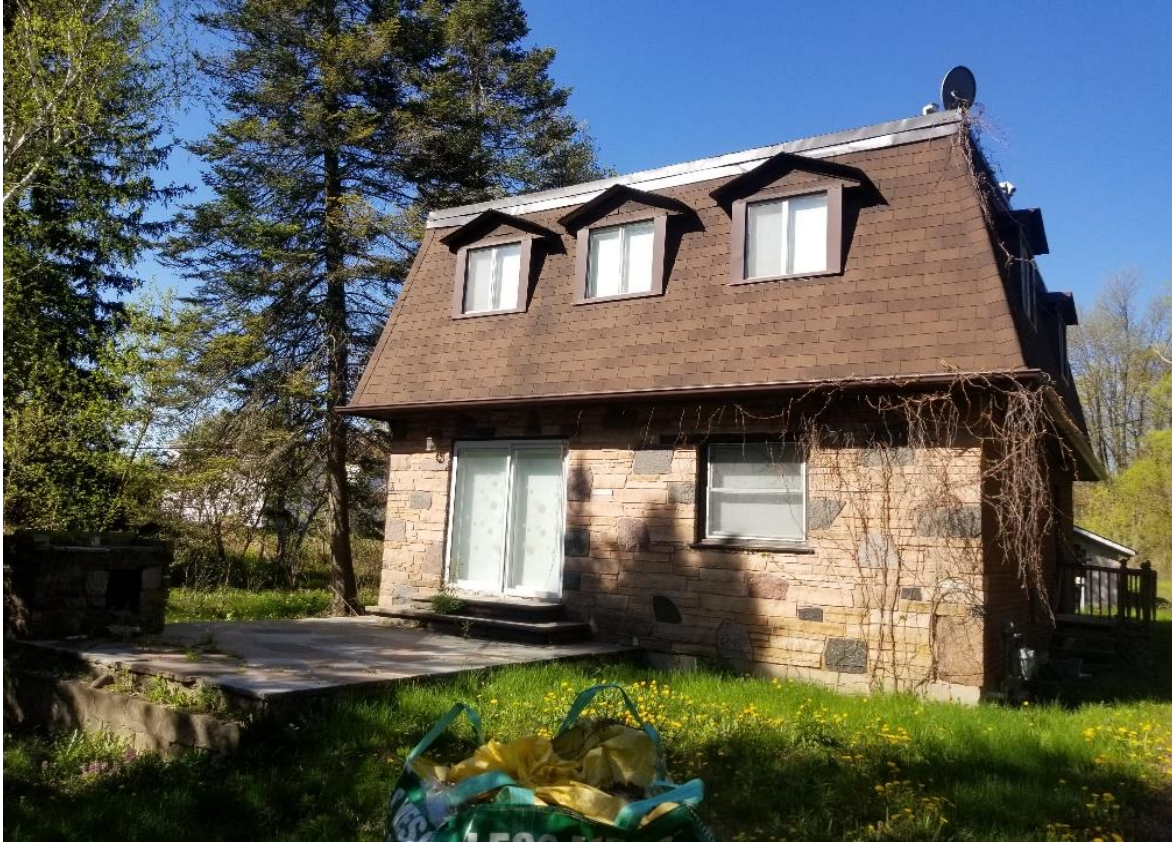
Location: 1968 Woodview Pickering ON RUNP	Date of Site Visit: 2021-05-14
Land Ownership: Parks Canada	Date of Report: 2021-05-21
Property size/acreage: 1.46 acres	Project Priority: D3-010-2021

Site Description: 1968 Woodview Ave. is a residential property with a 2.0 storey tudor style residential building. A 1.0 storey /concrete slab garage/shop is located in backyard. The residential building is visually sound, but has experienced severe water damage from the flat portion of roofing system. The property hosts a gravel driveway and a raised bed and pumping system within the last ten years. 100m + driveway supporting minimal granular base. The property is well treed, with large volume of woody debris located at back of property.

Description: raised septic field located at back of property, 3 tank chamber pump up system installed within the last 10 -15 years

Structures:		
Type: 2.0 storey tudor stlye , full basement	Size: main 25'x34' total= 1,700 sq'	Foundation: visible poured concrete foundation full basement
Building Construction Material: designer stone siding with second storey asphalt shingle cladding up to flat roof, front concrete patio and side entrance wooden deck		
Out buildings/Barn: Yes <input checked="" type="checkbox"/> No <input type="checkbox"/> Description: concrete parged cladding , asphalt shingle , concrete slab floor		
Debris: Yes <input checked="" type="checkbox"/> No <input type="checkbox"/> Volume (M/T): 20 metric ton (woody material) 10 metric ton of trash debris Description: large volume woody material located at back of property		
DSR: Yes <input type="checkbox"/> No <input checked="" type="checkbox"/> Notes: interior DSR assessment not available due to building condition		
Restoration: Yes <input checked="" type="checkbox"/> No <input type="checkbox"/> Justification: due to the residential area, green space is recommended

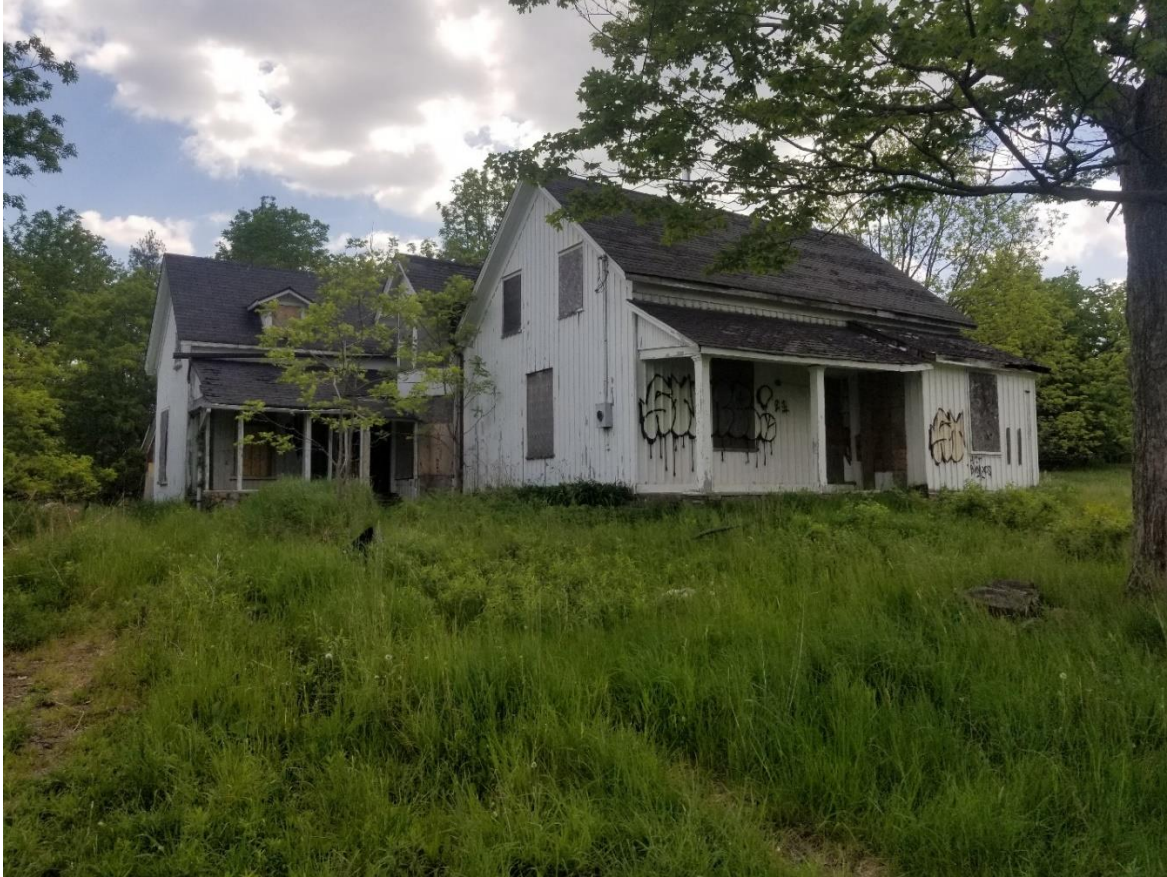
Location: 3 Reesor Road Markham ON RNUP	Date of Site Visit: 2021-06-01
Land Ownership: Parks Canada (transfer completed)	Date of Report: 2021-06-02
Property size/ acreage: TBA	Project Priority: D3-11-2021

Site Description: 3 Reesor is a residential/agricultural property, with a single residential building. The site is a well forested property with grown up farm fields. Remains of a old stone foundation is the only sign of agriculture on the property .

Hydro: 700m overhead hydro service is intact (recently replaced within +/- 15 yrs.) Line connected /meter removed from hydro service at residential building

Well/Water System:no visible sign of drilled well, 2 potential concrete tile well caps. 1-4' well tile located 80m from residential building in the front lawn area

Description: raised septic area at side of residential building, steel plate on concrete septic tank

Type: 1.5 storey original/ 1.5 storey addition, porch on main/addition,	Size: 1.5 storey main building/ addition 2,400 sq feet	Foundation: stone/concrete poured basement on main, addition
Building Construction Material: framed construction, painted wood siding, asphalt shingles.		
Out Building(s) Yes <input type="checkbox"/> No <input checked="" type="checkbox"/> Description: No buildings, existing partial stone foundation of barn in adjacent field		
Debris: Yes <input type="checkbox"/> No <input checked="" type="checkbox"/> Volume (M/T): Description: Click or tap here to enter text.		
DSR: Yes <input checked="" type="checkbox"/> No <input type="checkbox"/> Notes: due to the condition of the structure no interior access for DSR evaluation		
Restoration: Yes <input checked="" type="checkbox"/> No <input type="checkbox"/> Justification: extensive driveway removal and scarification, existing foundation is grown over and is now part of the landscape, may not be removed. 1. Property is isolated in the area, 2. No access to property required,
