**DESIGNATED SUBSTANCE AND  
HAZARDOUS MATERIALS SURVEY  
PIN: No PIN  
4 Reesor Road, Toronto, ON**

Rouge National Urban Park

March 27, 2020

Stantec Project No: 122151011  
PSPC Project No: R.099832.001

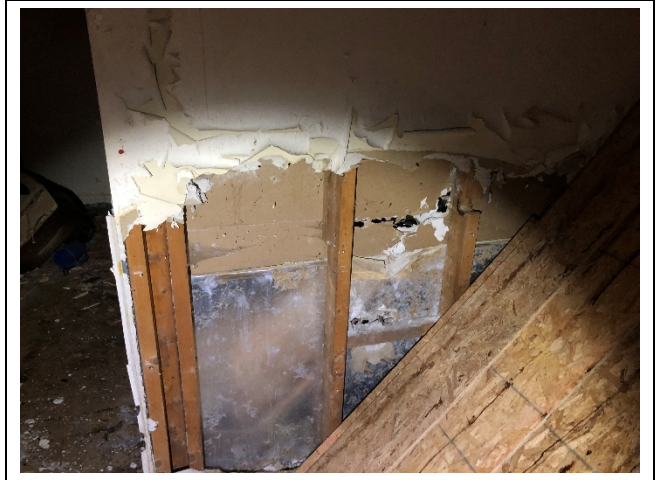
Photo 2: Damaged asbestos-containing drywall joint-fill compound in the first-floor hallway.

Damaged ACMs should be removed/repared in accordance with abatement operations. Recommended actions for each occurrence of asbestos is provided in **Table 1** below. Presumed asbestos-containing materials (PACMs) and ACMs observed to be in good condition and can be left in place. No abatement operations are required.

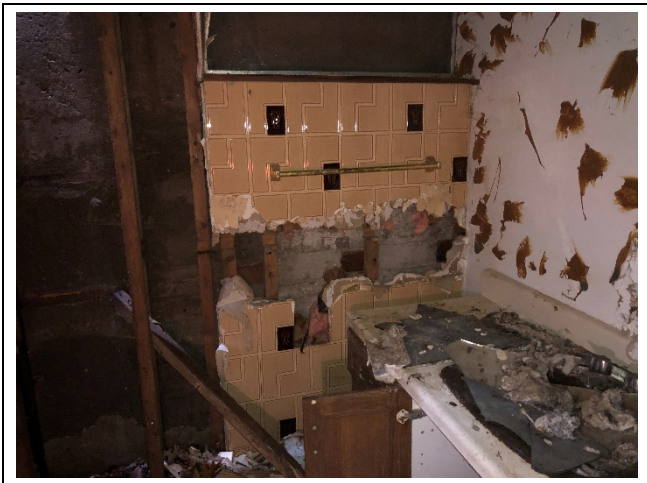
Photo 3: Damaged asbestos-containing drywall joint-fill compound in the first-floor washroom 2.

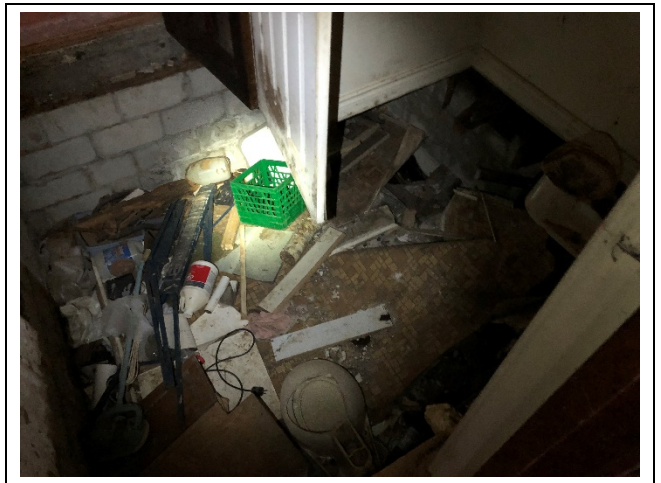
Photo 4: Asbestos-containing paper-backing associated with vinyl sheet flooring – mosaic pattern in first floor washroom 1.

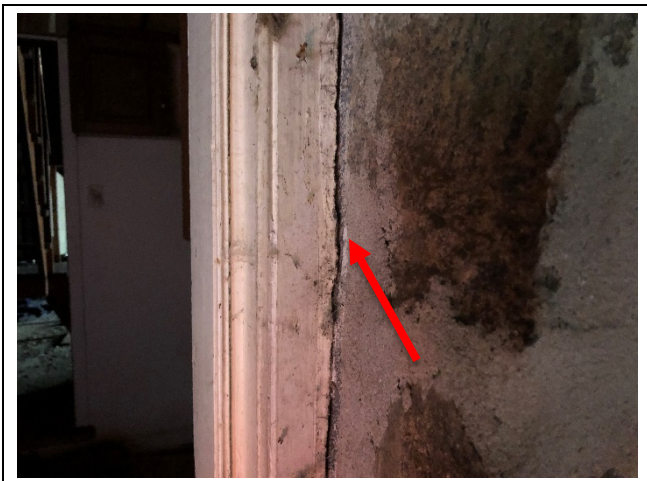
Photo 5: Asbestos-containing interior door caulking in the first-floor foyer.

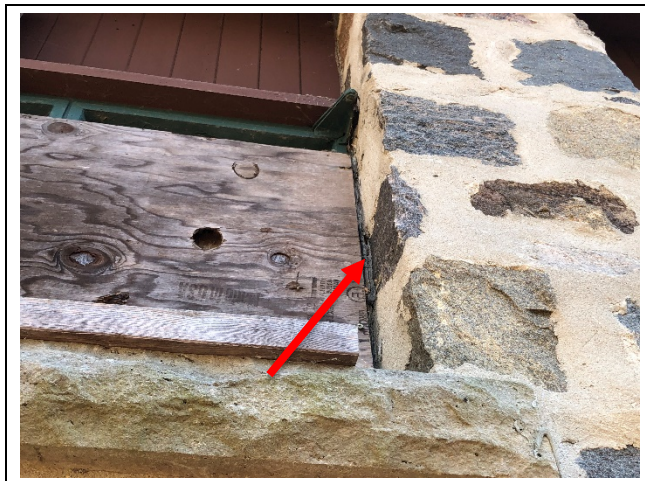
Photo 6: Asbestos-containing exterior window caulking – grey on exterior windows.

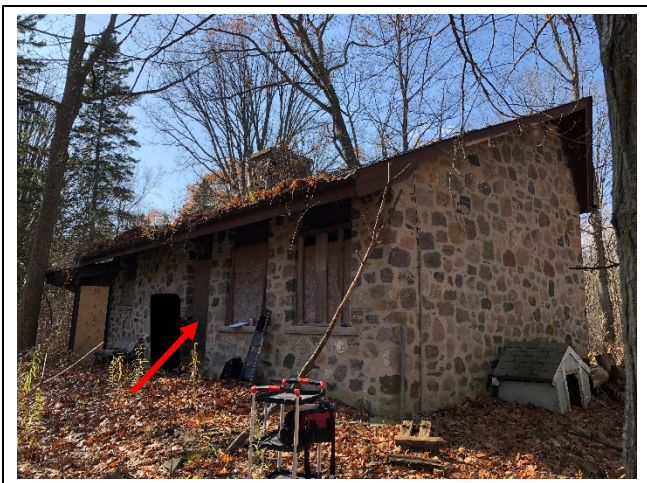
Photo 7: Exterior door caulking – grey on exterior living room door.

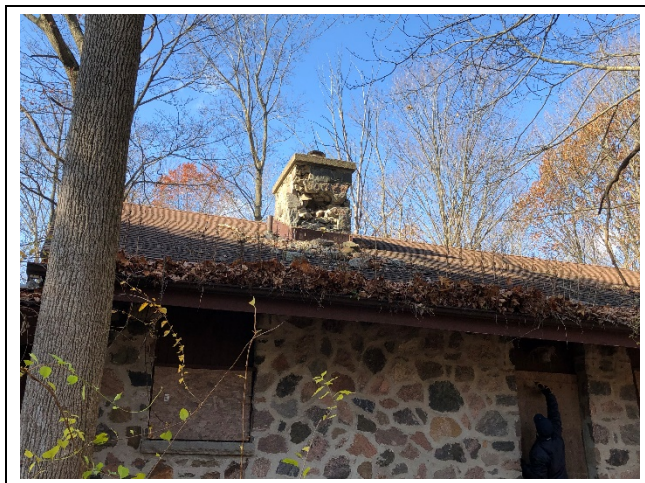
Photo 8: Presumed asbestos-containing roofing material and roof caulking.

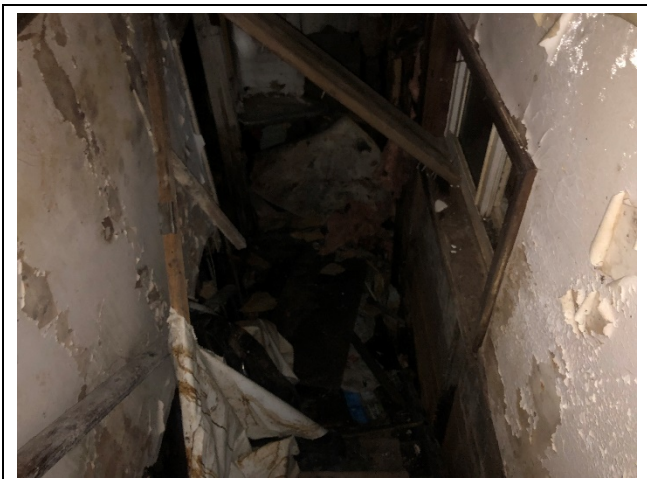
Photo 9: Suspect mould and water staining on walls in stairwell to basement

A mould assessment should be undertaken to determine the extent of suspect mould impacted and/or moisture damaged building materials and the likely source(s) of moisture.

Remediation should be done by a competent person, who is knowledgeable of potential hazards of mould exposure, following remediation precautions.
