XCG File No. 5-336-200-01

COLE File No. 2018-0565

January 31, 2019

**DESIGNATED SUBSTANCES AND
HAZARDOUS MATERIALS SURVEY
PIN 614185
1149 CONCESSION 2
UXBRIDGE, ONTARIO**

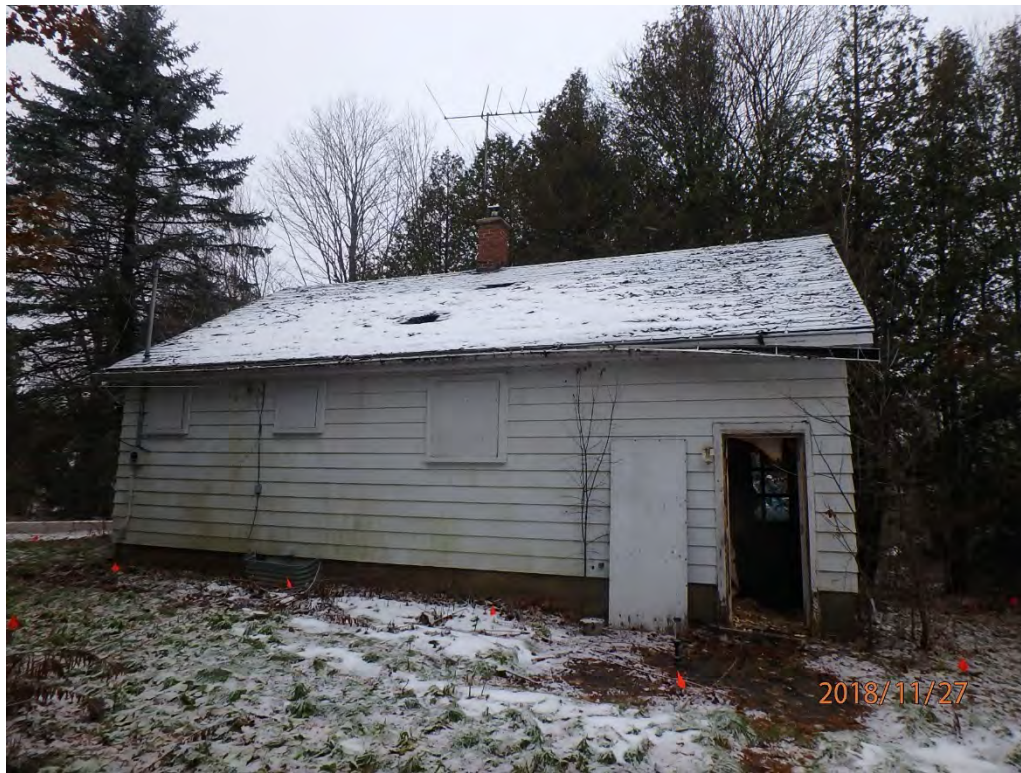
Photo 1: View of the south side of the subject building and potential asbestos-containing roofing materials.

The type of repair and/or removal procedures to be conducted is defined on a case-by-case basis. Prior to disturbance, resample all roofing material layers to confirm ACM or undertake Type 3 abatement if required. Prior to renovation or demolition, sample any additional potential ACMs identified within the building. All ACM materials should remain undisturbed by building occupants.

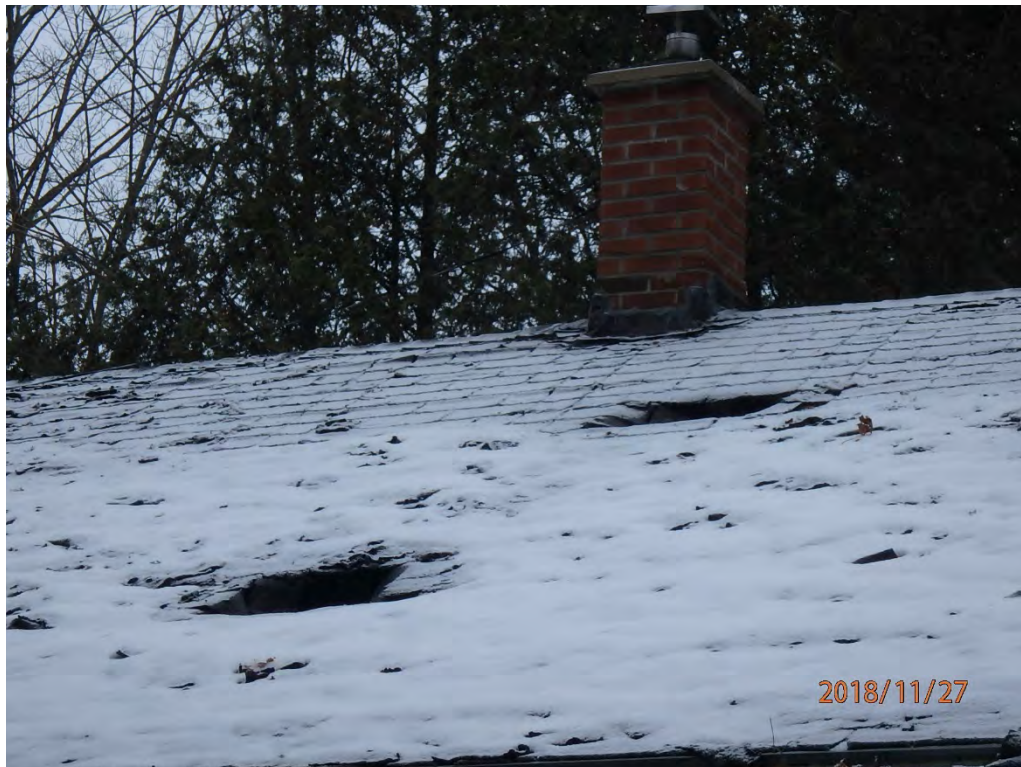
Photo 2: View of the holes in the roof of the building.

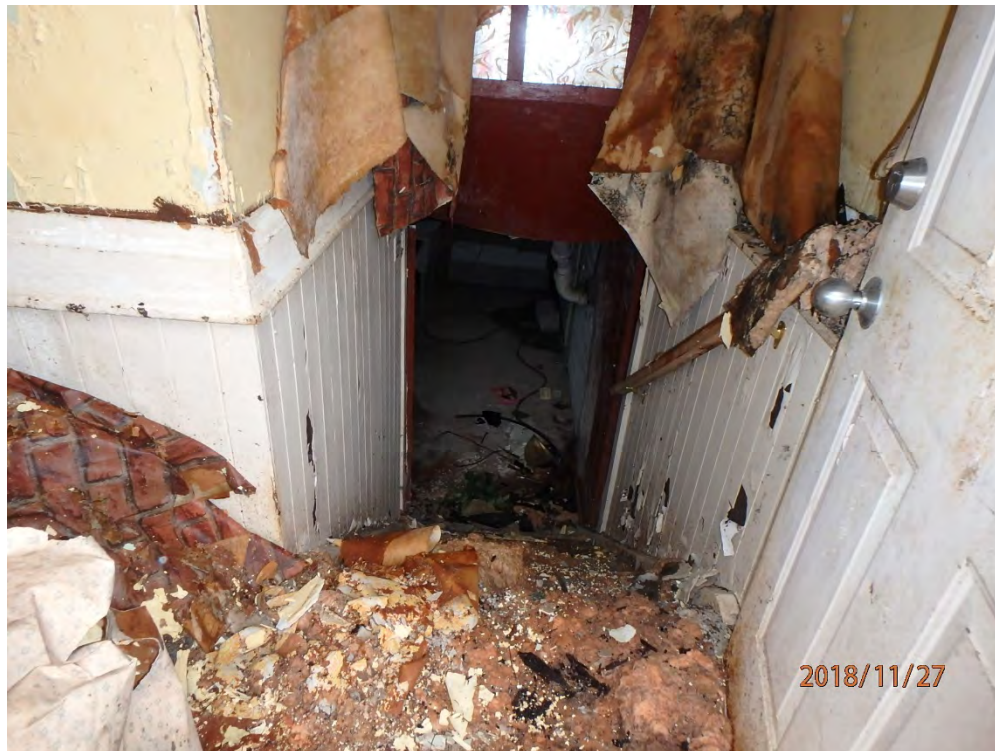
Photo 3: View of the condition of the side entrance looking toward the basement of the building.

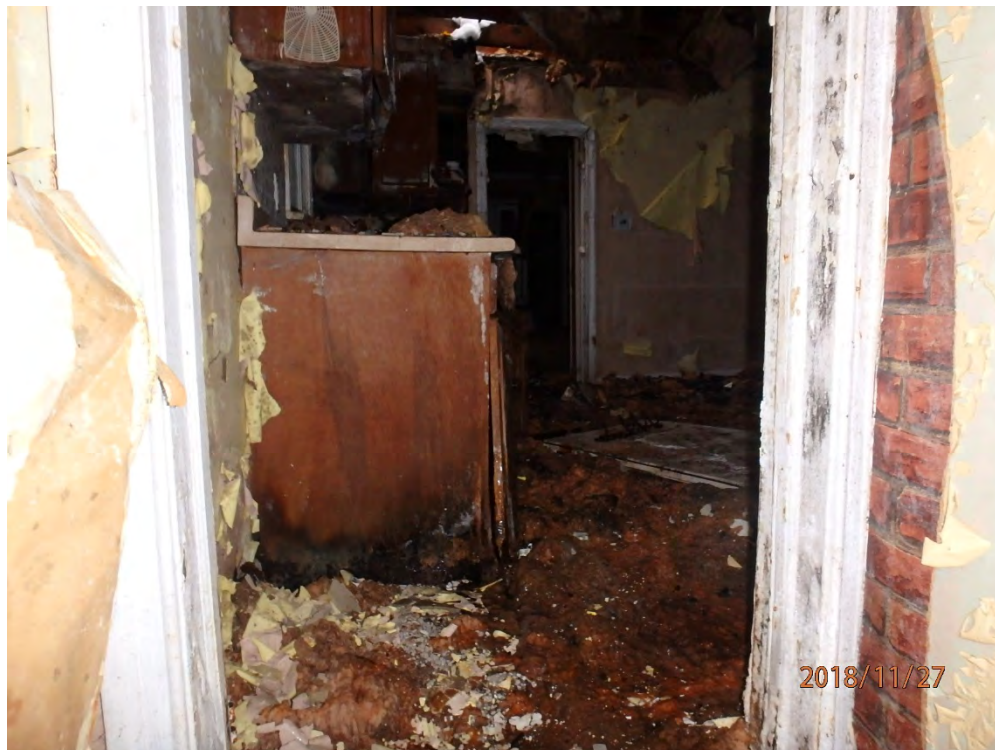
Possible visible mould was visible on the walls of the side entrance stairwell and visible areas of the kitchen. Based on the deterioration of the roof, and the condition of the ceiling, it is expected that additional significant mould growth is present within the remainder of the building not accessed in during this survey. Areas of mould larger than 1 square metre should be abated in accordance with “*Mould Abatement Guidelines*,” Environmental Abatement Council of Ontario (EACO), Edition (3) 2015.

Photo 4: View of the condition of the kitchen at the subject building, including possible visible mould.

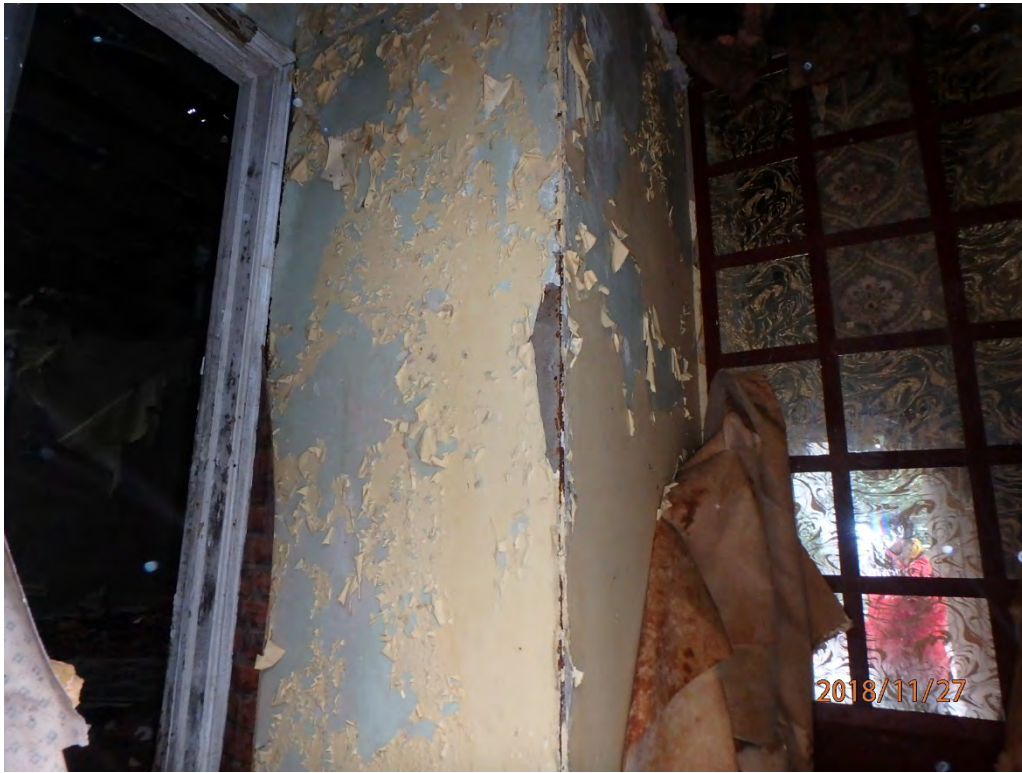
The paint in the building generally appeared to be in poor condition. The three paint samples that were collected and submitted to the laboratory for analysis were found to have lead concentrations ranging from <82 ppm to 4,200 ppm. The lead-containing paint in poor condition had a concentration of 4,200 ppm. At the time of the survey, yellow paint in the side entrance hallway and stairwell was in poor condition and had locations of flaking or peeling paint. Due to the uninhabitable condition of the building, the urgency level is considered moderate; however, if the building was to undergo renovations to make it habitable, the urgency level would be considered high, with immediate repairs required prior to occupancy. Due to the condition of the building, and for safety reasons, only the side entrance was accessed during this survey. Additional lead-containing paint may be present within the building. If the building is to be demolished, a representative sample for TCLP should be collected from each type of painted building material and compared to the O. Reg. 347 Schedule 4 standards for waste classification prior to disposal. If lead-containing paints are not flaking, they may be painted over to reduce further deterioration. Flaking paints should be cleaned up or removed to limit the potential for the spread of lead dust, including the use of a drop-sheet and a HEPA filter equipped vacuum. This should be done following, at minimum, Type 1 procedures as outlined in the MOL guideline “*Lead on Construction Projects*” dated April 2011. Lead containing paints should not be disturbed by sanding, heat gun removal etc. as this leads to airborne lead. If paint is to be disturbed, the MOL guideline “*Lead on Construction Projects*” dated April 2011, outlines a classification system and control measures to limit worker exposure and should be consulted. In particular, if flaking paints are to be removed by scraping or sanding using non-powered hand tools, the use of a half-mask particulate respirator with N-, R-, or P-series filter and 95, 99, or 100% efficiency is recommended. During any demolition or renovation activities, lead containing paints should be managed in accordance with O. Reg. 490/09 and the MOL guideline “*Lead on Construction Projects*” dated April 2011. Any suspect lead-based paint encountered should be treated as such unless otherwise indicated by sampling and analytical testing. If additional lead-based paint (currently hidden or inaccessible) is identified, these materials should be examined, tested, and handled appropriately.

Photo 5: View of the lead-containing yellow paint on the side entrance walls.
