**DESIGNATED SUBSTANCE AND
HAZARDOUS MATERIALS SURVEY
PIN: 633541
2260 Meadowvale Road, Toronto,
ON**

Rouge National Urban Park

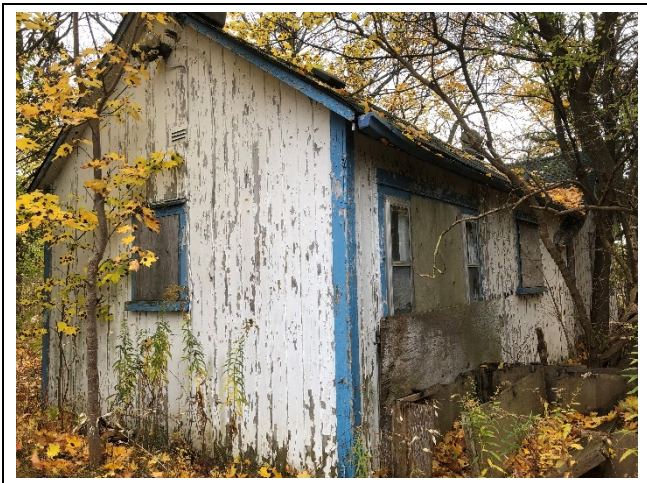
Photo 1: Exterior of abandoned house at 2260 Meadowvale Road, Toronto, Ontario.

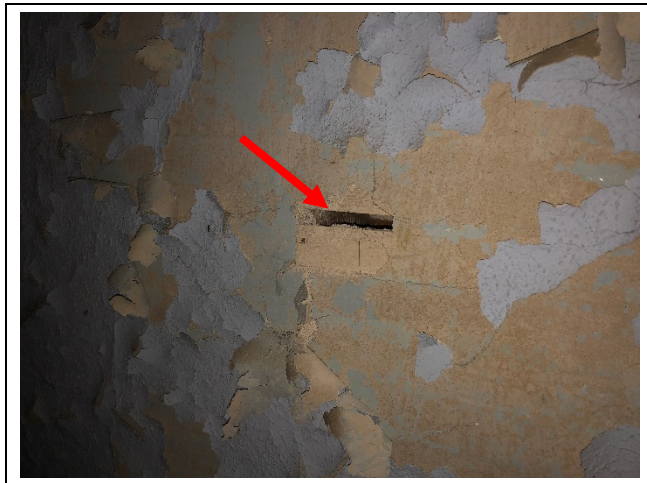
Photo 2: Damaged asbestos-containing wall plaster in bedroom 1.

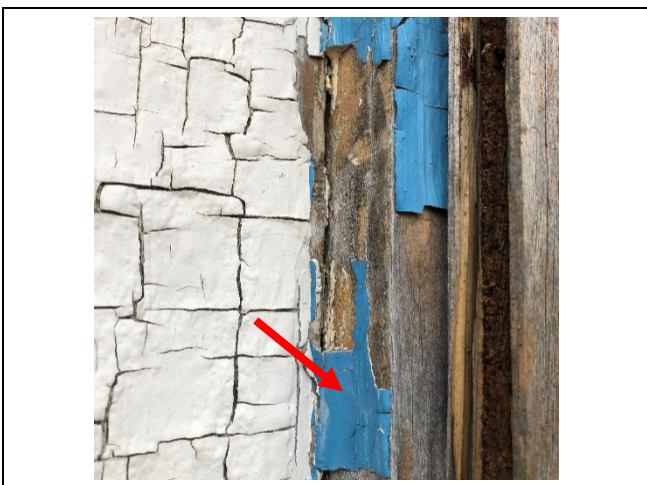
Photo 3: Damaged asbestos-containing exterior window caulking.

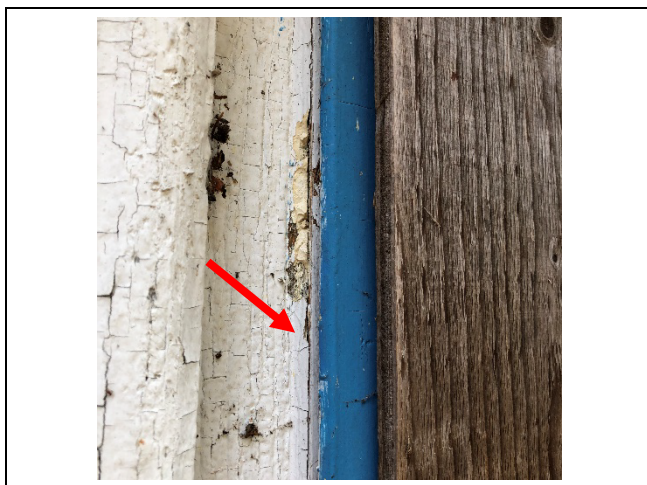
Photo 4: Damaged asbestos-containing exterior door caulking.

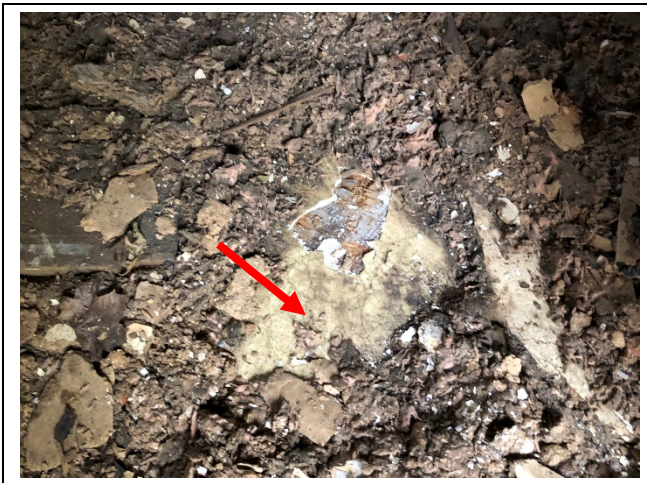
Photo 5: Asbestos-containing paper backing associated with vinyl sheet flooring – yellow in the kitchen. The vinyl sheet flooring is covered by ceiling tile and fibreglass insulation debris.

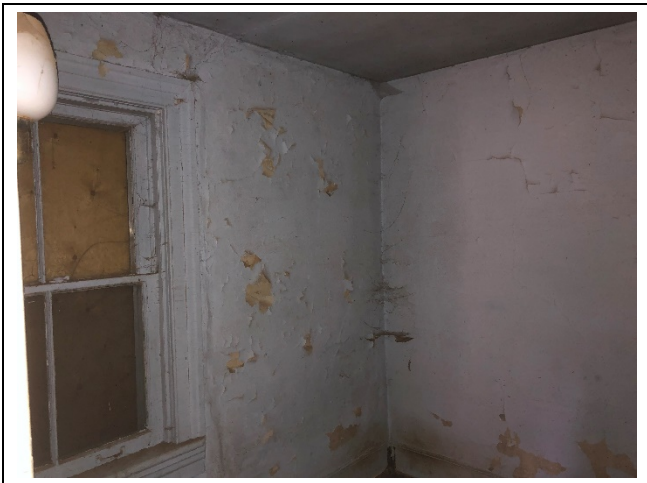
Photo 9: Peeling lead-containing blue coloured paint in Bedroom 2.

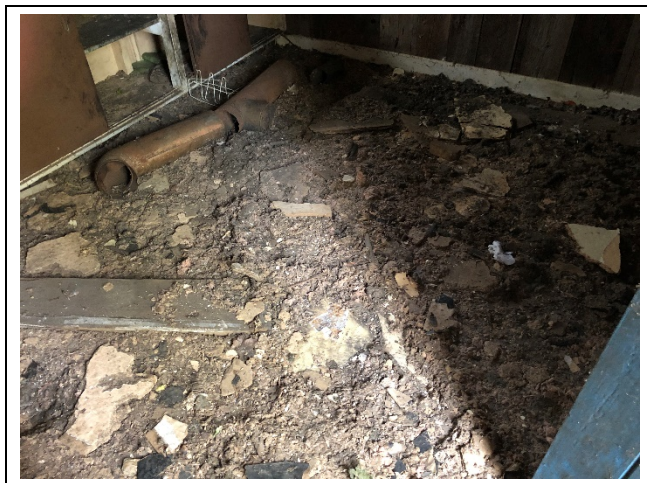
Photo 12: Suspect mould growth on water damaged ceiling tile and insulation debris in the kitchen.

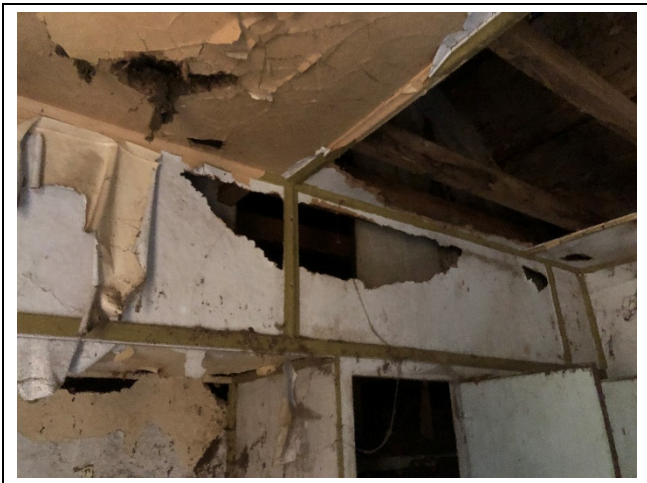
Photo 13: Suspected mould growth on water damaged ceiling tiles and wall panels in the kitchen.

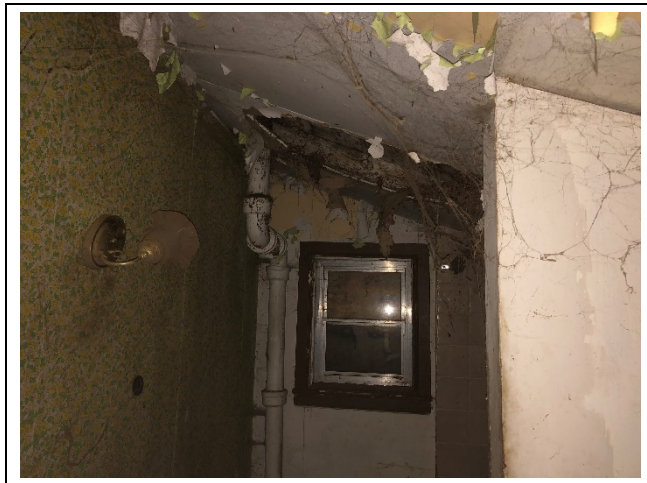
Photo 14: Suspect mould growth on water damaged drywall ceiling in the washroom. The drywall ceiling was observed to have collapsed

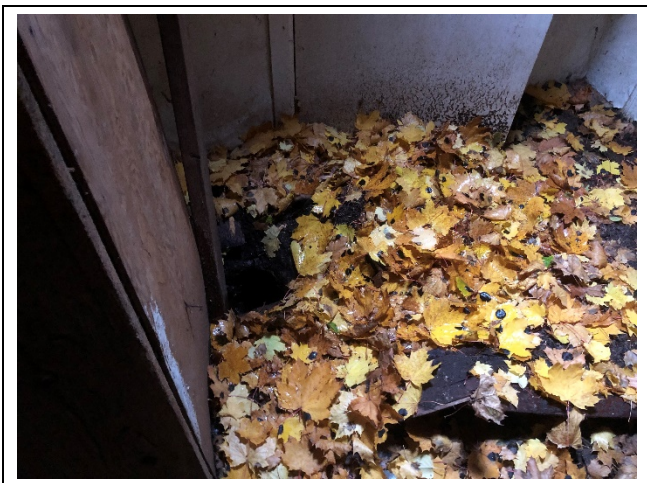
Photo 15: Suspect mould growth on water damaged drywall ceiling debris in the hallway. Leaf litter was observed due to a collapsed roof.

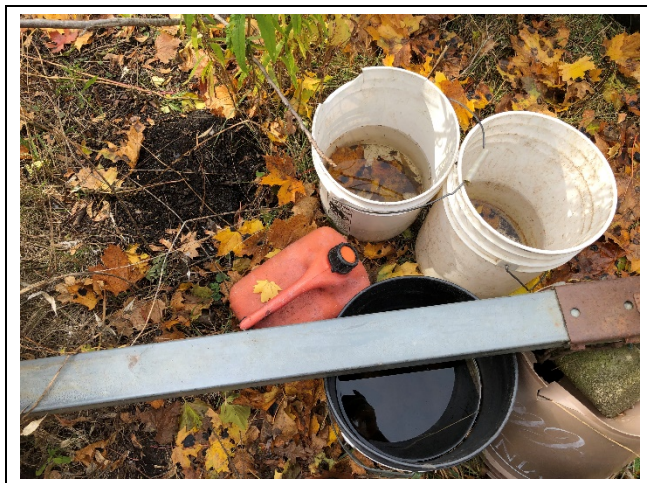
Photo 16: Chemicals stored outdoors near hauler trailer.
