**DESIGNATED SUBSTANCE AND
HAZARDOUS MATERIALS SURVEY
PIN: 633560
1968 Woodview Avenue, Toronto,
ON**

Rouge National Urban Park

March 18, 2020

Stantec Project No: 122151011
PSPC Project No: R.099832.001

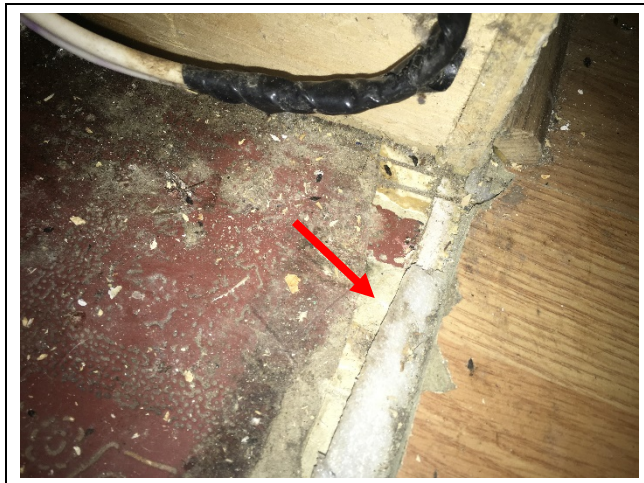
Paper backing associated with vinyl sheet flooring – white was observed to be in poor condition (paper-backing exposed) within the first-floor kitchen. Drywall joint-fill compound was observed to be in poor condition (punched in) within the first-floor laundry room. The remaining materials were observed to be in good condition.

Photo 2: Damaged asbestos-containing paper-backing associated with vinyl sheet flooring – white found beneath laminate flooring in first floor kitchen.

- Damaged asbestos-containing paper-backing associated with vinyl sheet flooring – white in the first-floor kitchen should be removed following Type 2 (Moderate Risk) abatement operations (Action 3).

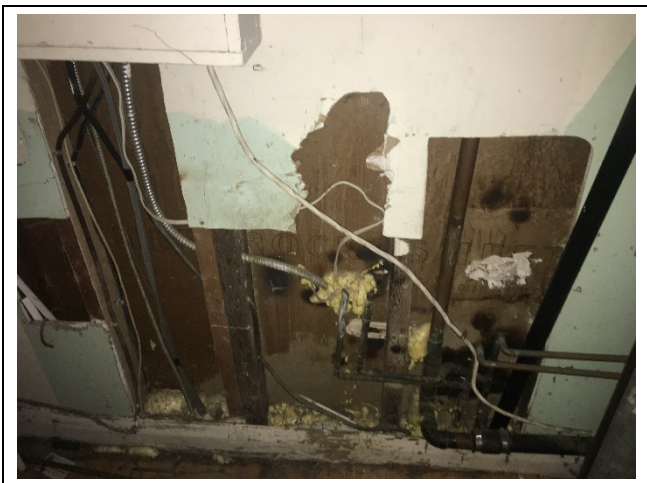
Photo 3: Damaged asbestos-containing drywall joint-fill compound in first floor laundry room.

- Damaged asbestos-containing drywall joint-fill compound in the first-floor laundry room should be repaired following Type 1 (Low Risk) abatement operations (Action 6).

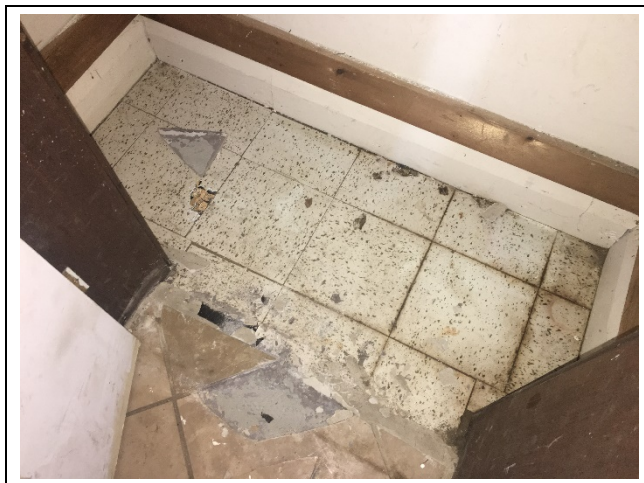
Photo 4: Asbestos-containing 9"x9" vinyl floor tile – white with green flecks in first floor foyer closet.

- Asbestos-containing caulking, drywall joint-fill compound and vinyl floor tiles can be left in place, as the materials were observed to be in good condition. No further abatement actions are required.

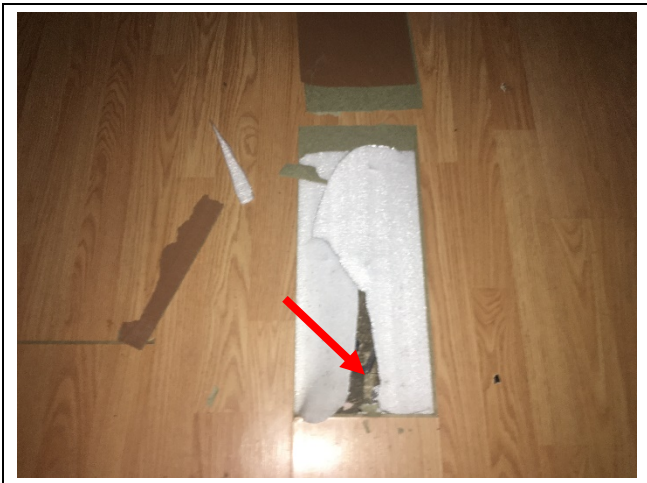
Photo 5: Asbestos-containing 12"x12" vinyl floor tile – beige pattern found beneath laminate flooring in first floor laundry room.

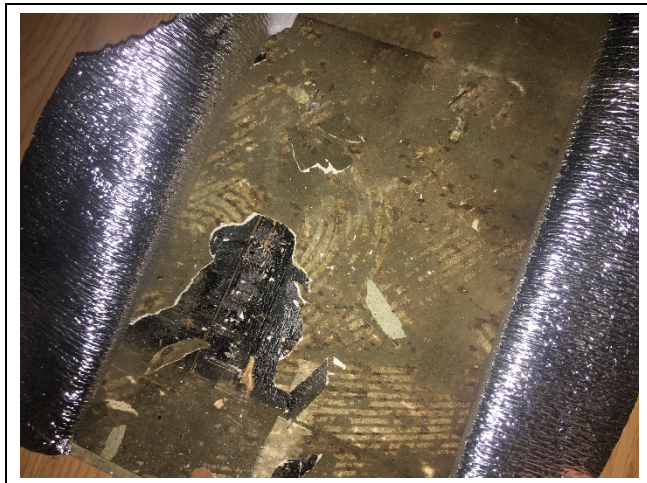
Photo 6: Asbestos-containing 12"x12" vinyl floor tile – beige found beneath laminate flooring in first floor living room.

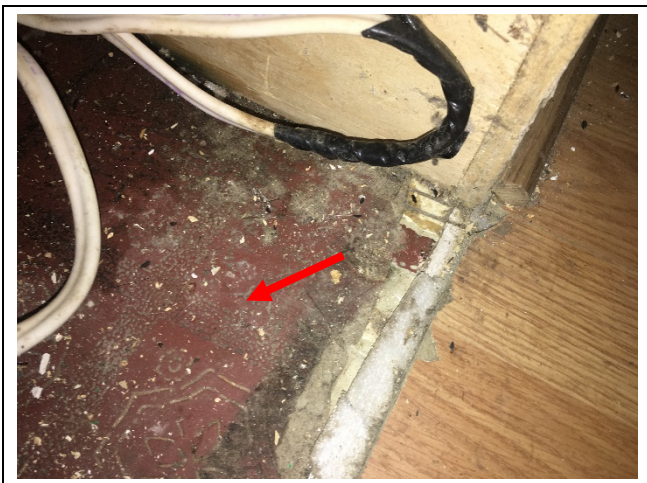
Photo 7: Asbestos-containing 12"x12" vinyl floor tile – red found beneath laminate flooring in first floor kitchen.

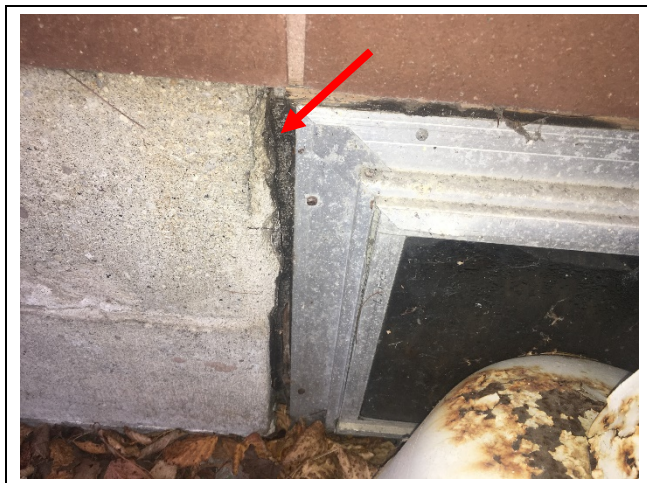
Photo 8: Asbestos-containing exterior window caulking – white (crawlspace windows only).

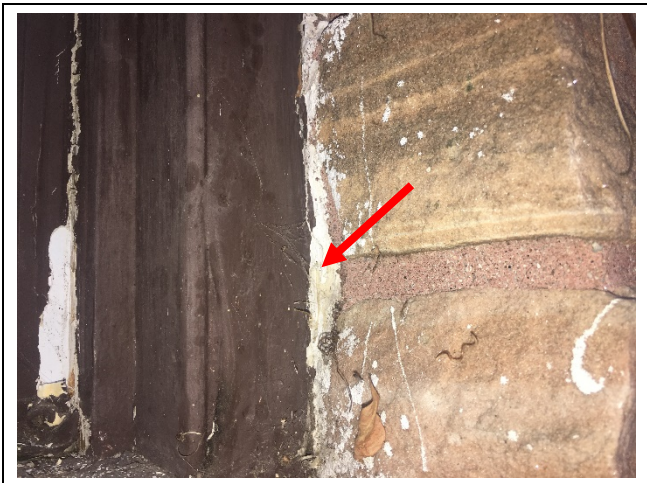
Photo 9: Asbestos-containing exterior window caulking – white (between frame and wall).

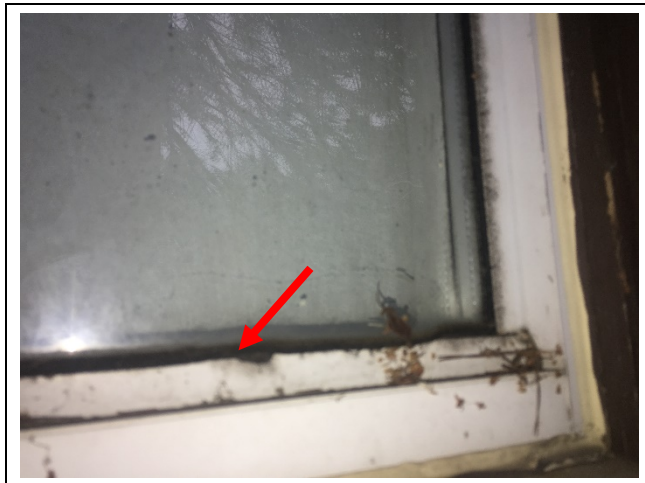
Photo 10: Asbestos-containing exterior window glazing compound – grey.

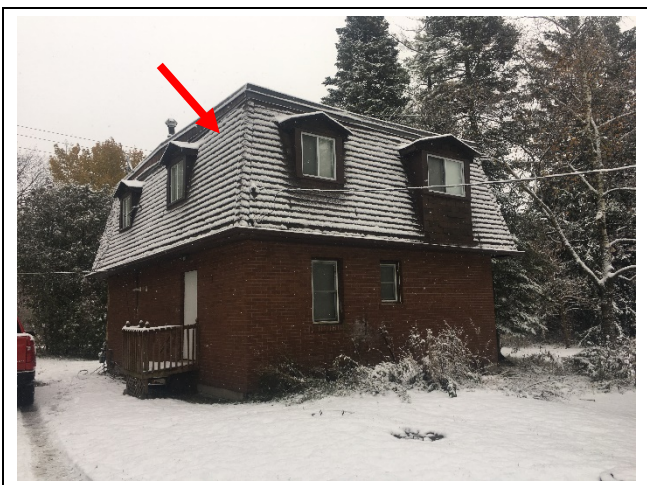
Photo 11: Presumed asbestos-containing roofing materials and roof caulking.

- Presumed asbestos-containing materials can be left in place, as the materials were observed to be in good condition. If the material is to be disturbed, it should be sampled to confirm if asbestos is present.

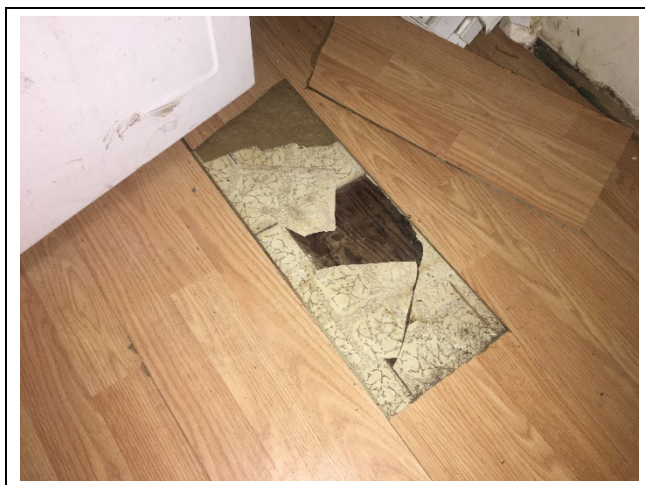
Photo 12: Presumed asbestos-containing mastic associated with 12"x12" vinyl floor tile – beige pattern beneath laminate flooring in first floor laundry room.

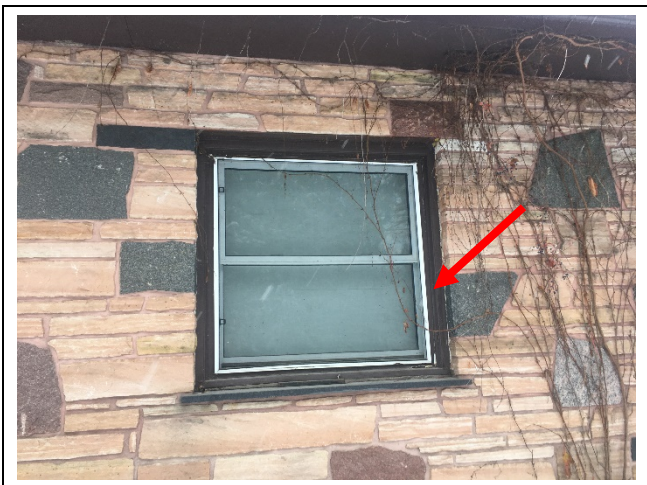
Brown coloured paint on the exterior window frames was observed to be in poor condition (2 m² flaking). The remaining paint applications were observed to be in good condition.

Photo 13: Damaged lead-containing brown coloured paint on exterior window frames.

Damaged paint on the exterior window frames should be cleaned up. Loose paint should be removed following lead precautions and repainted.

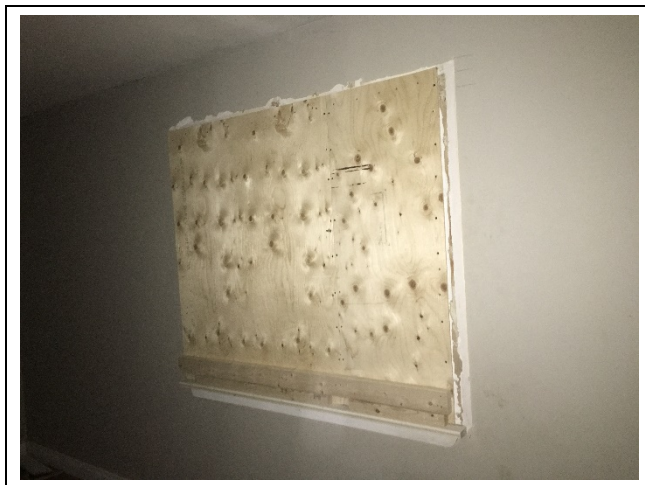
Photo 14: Lead-containing grey coloured paint on first floor living room drywall walls.

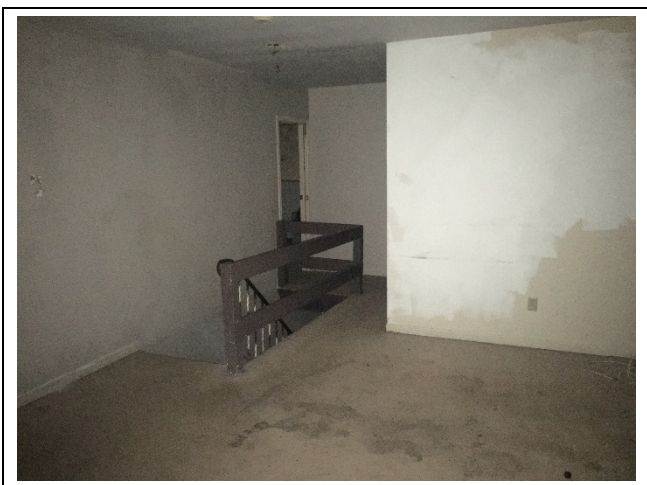
Photo 15: Lead-containing white coloured paint on second floor hallway drywall walls.

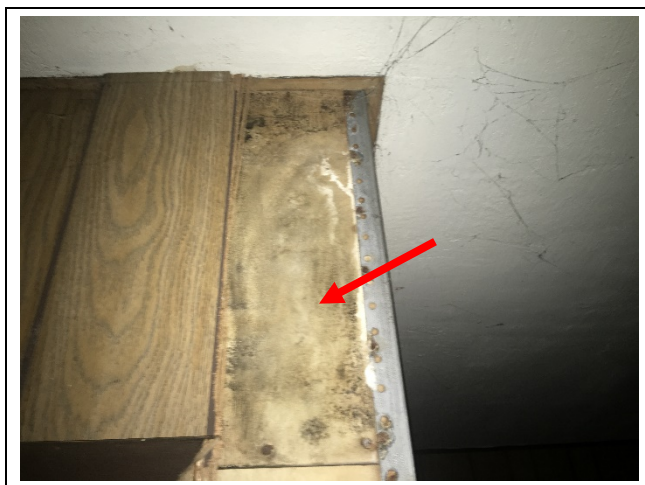
Photo 16: Suspect mould observed on wood framing beneath wood panel wall in second floor bedroom 3.

Remediation should be done by a competent person, who is knowledgeable of potential hazards of mould exposure, following remediation precautions.
