Requisition No. EZ899- 220723/A

Penticton Regional Airport
Penticton ATB Roofing & Building Envelope Project
Project: R.105676.001

APPENDIX D

Existing Site Photos

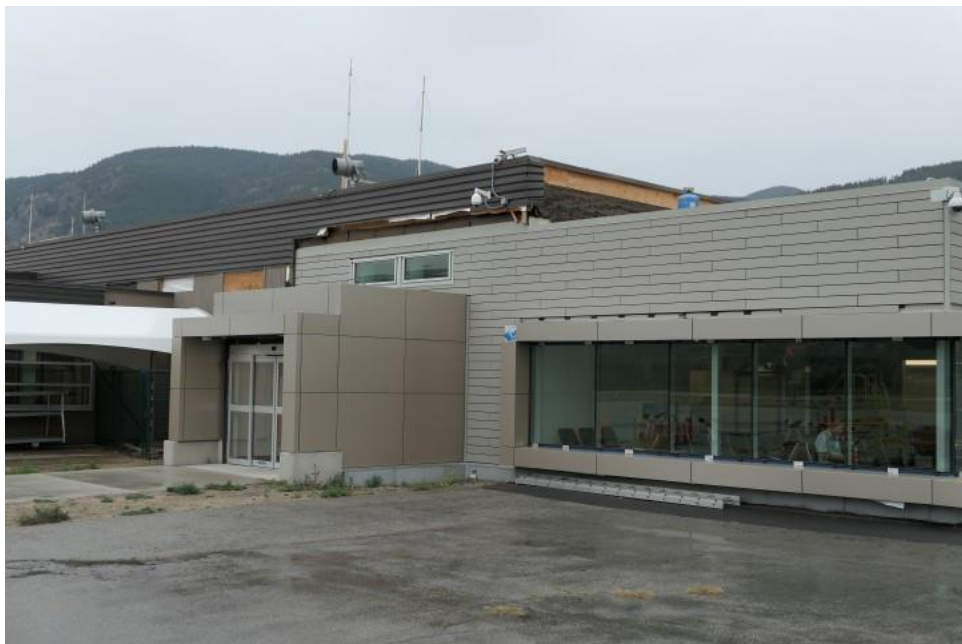
Photo 2

General overview of windows at transition between existing and new construction.

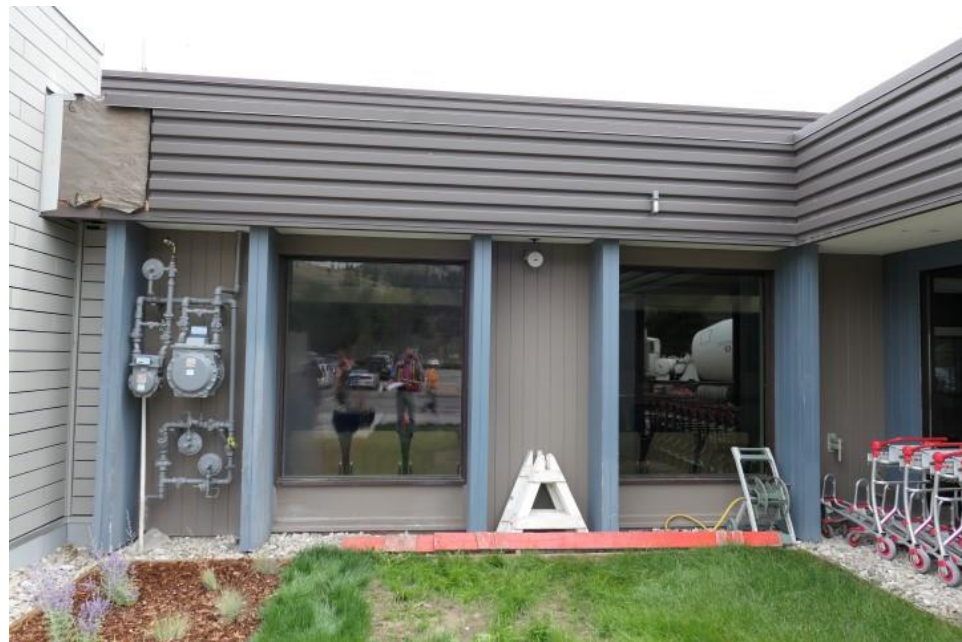
Photo 3

General window overview near the front entrance vestibule (west wall).

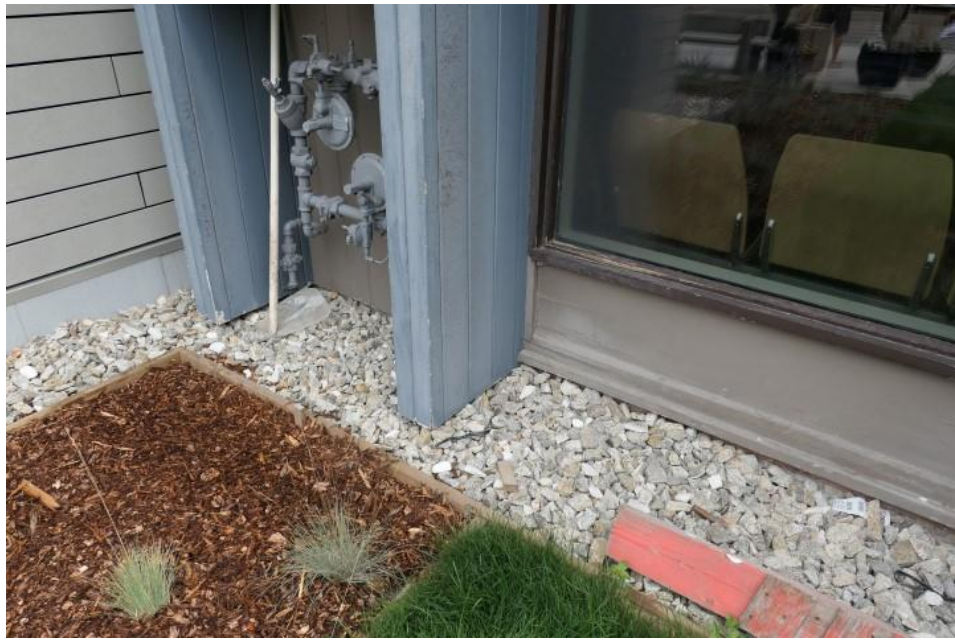
Photo 4

Window sill deterioration for window near the vestibule (west wall).

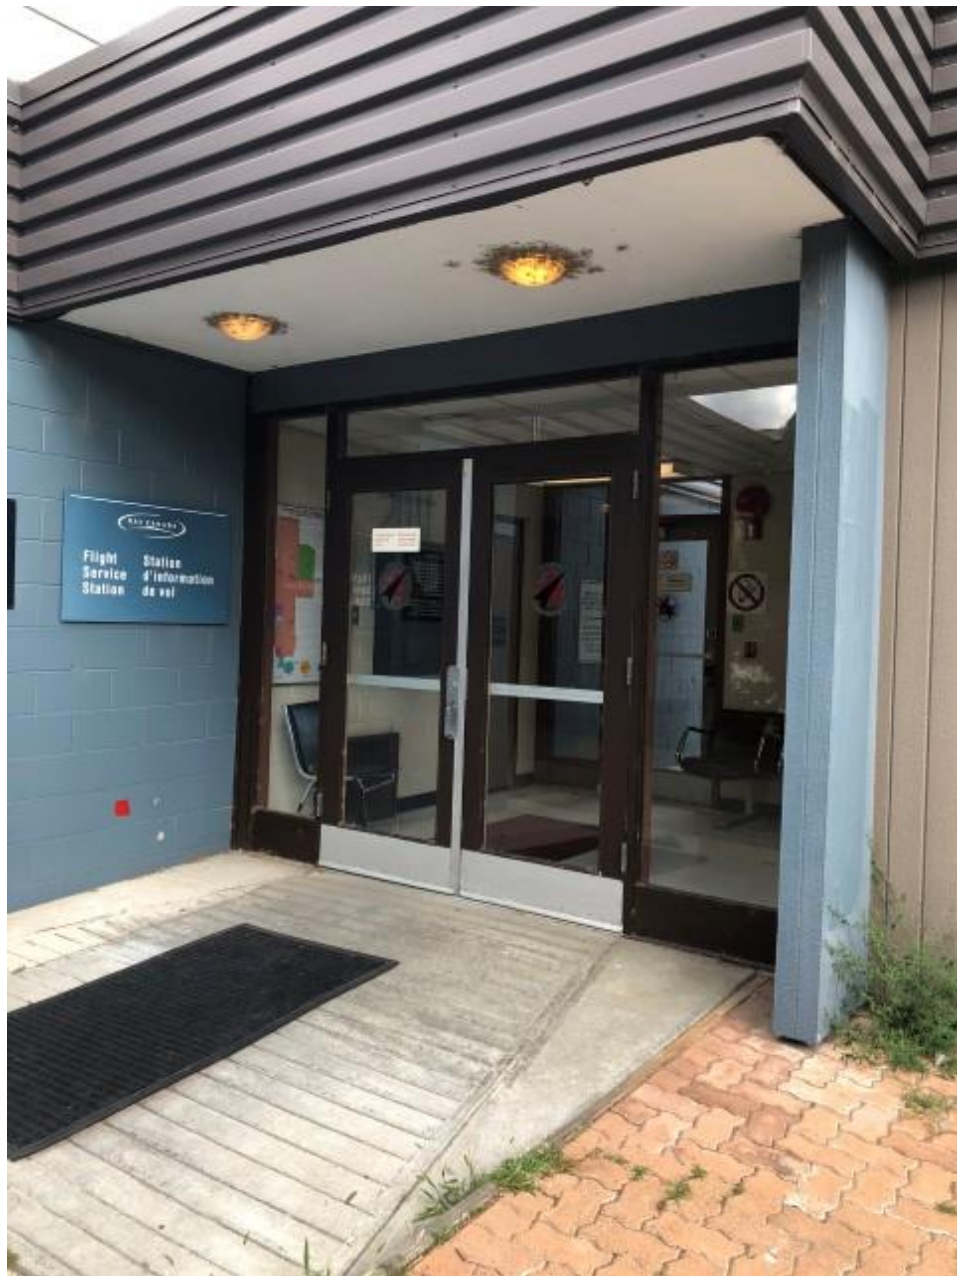
Photo 5

General
overview of
double swing
door on south
end of building.

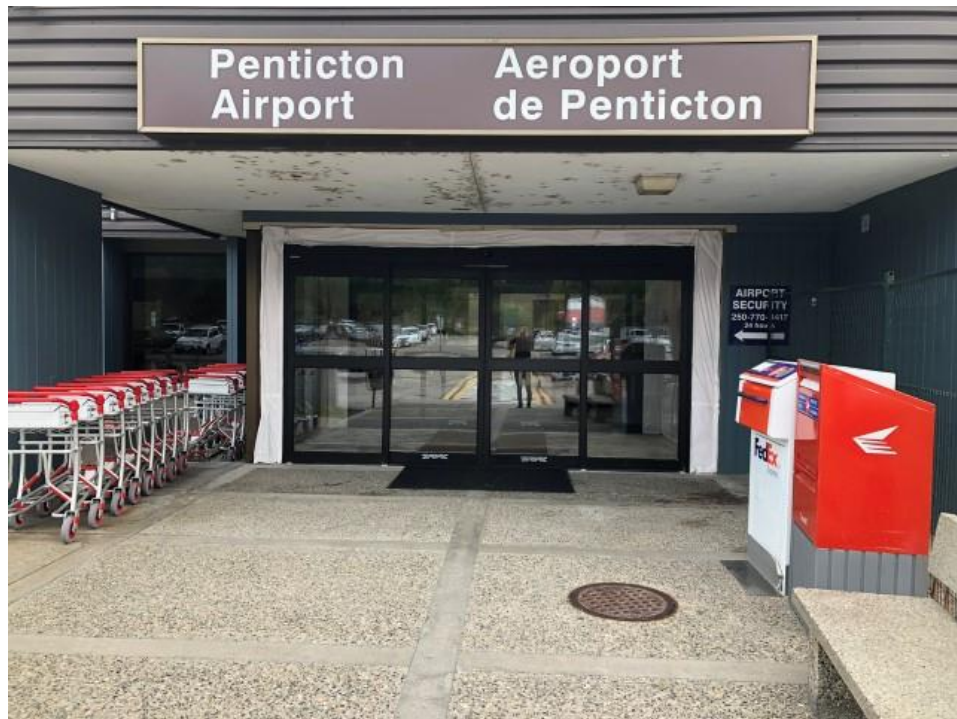
Photo 6

General
overview of
double
automatic
sliding door at
main entrance.

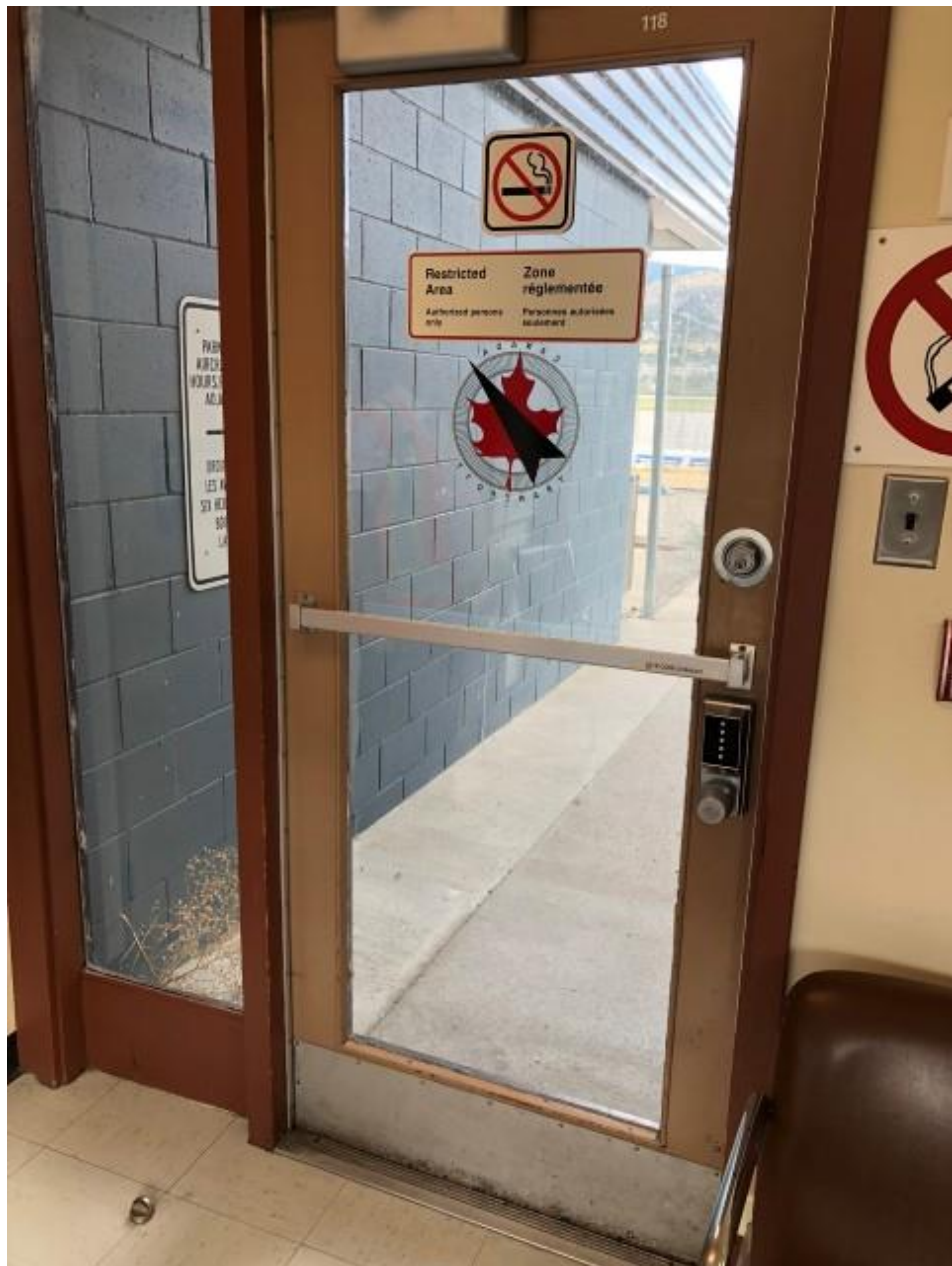
Photo 7

General
overview of air
side private pilot
entrance swing
door at south
end of building.

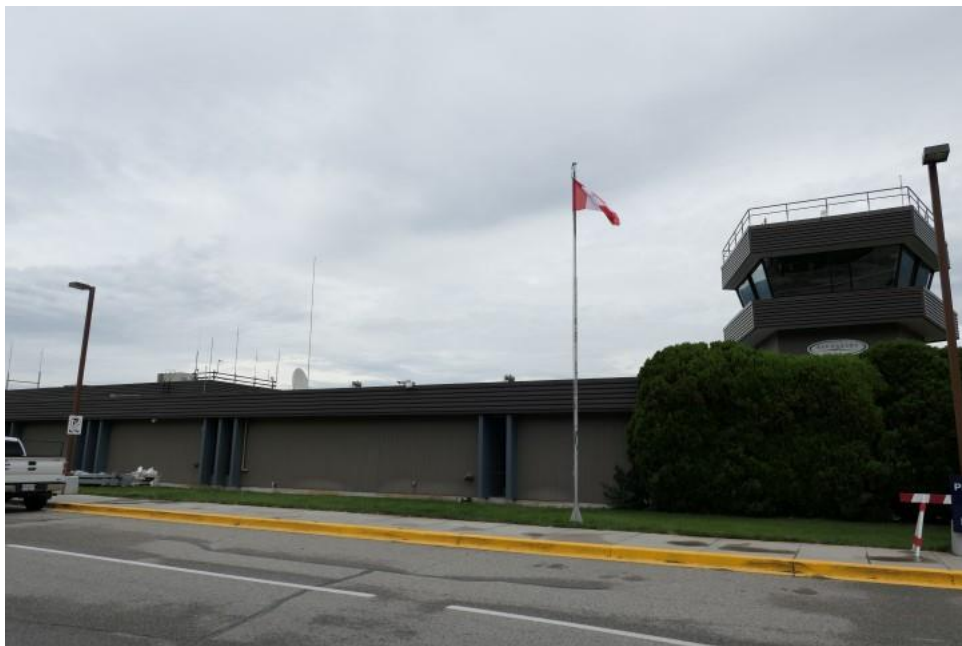
Photo 8

General wall
overview (west
wall).

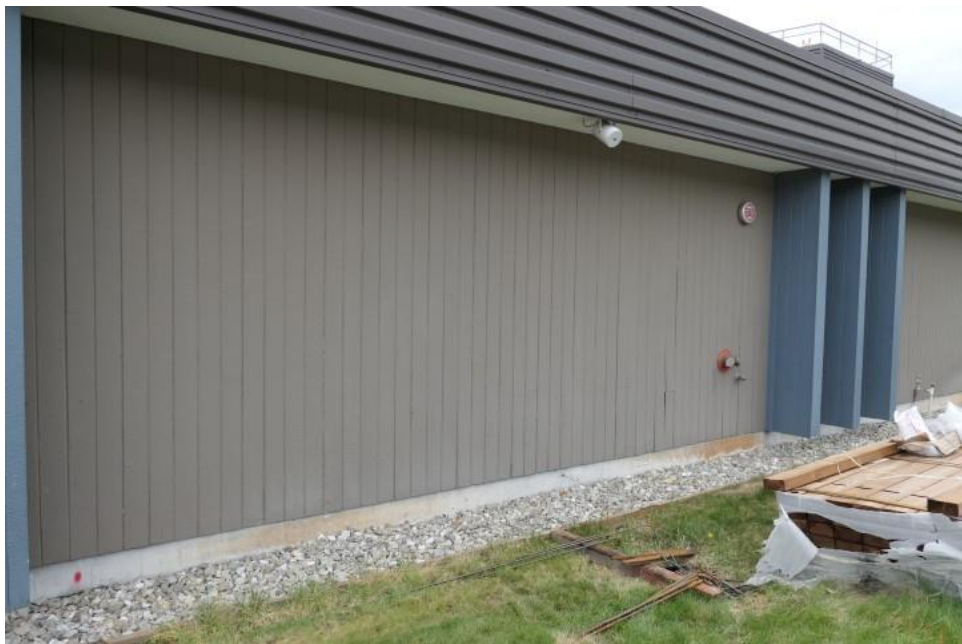
Photo 9

Zoomed in
general wall
overview (west
wall).

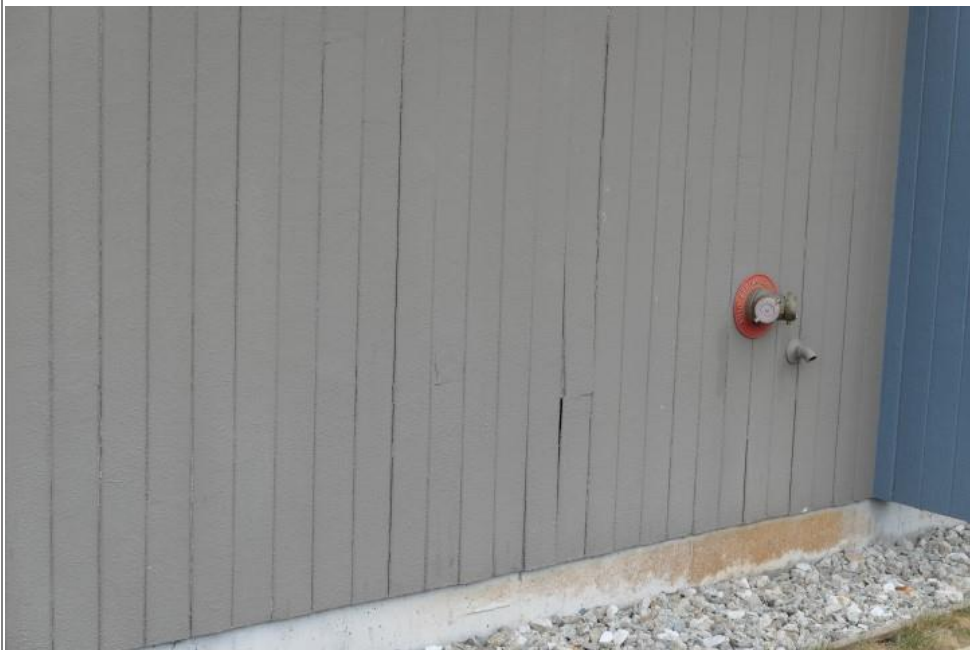
Photo 10

Cracks in vertical cedar siding on west wall.

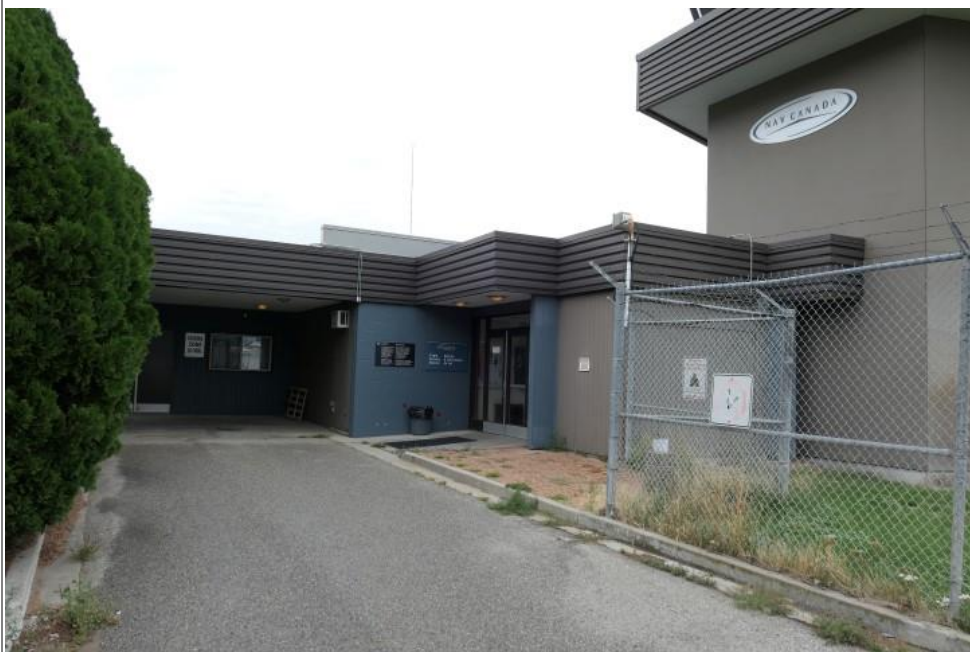
Photo 11

General wall overview (south wall).

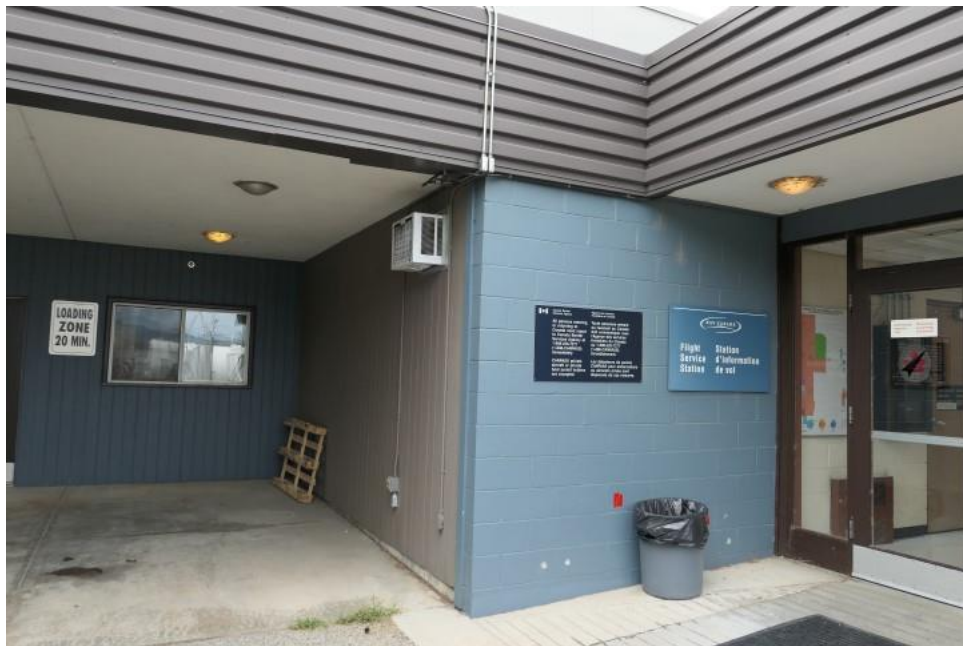
Photo 12

Zoomed in
general wall
overview with
aluminum
frame door
(south wall).

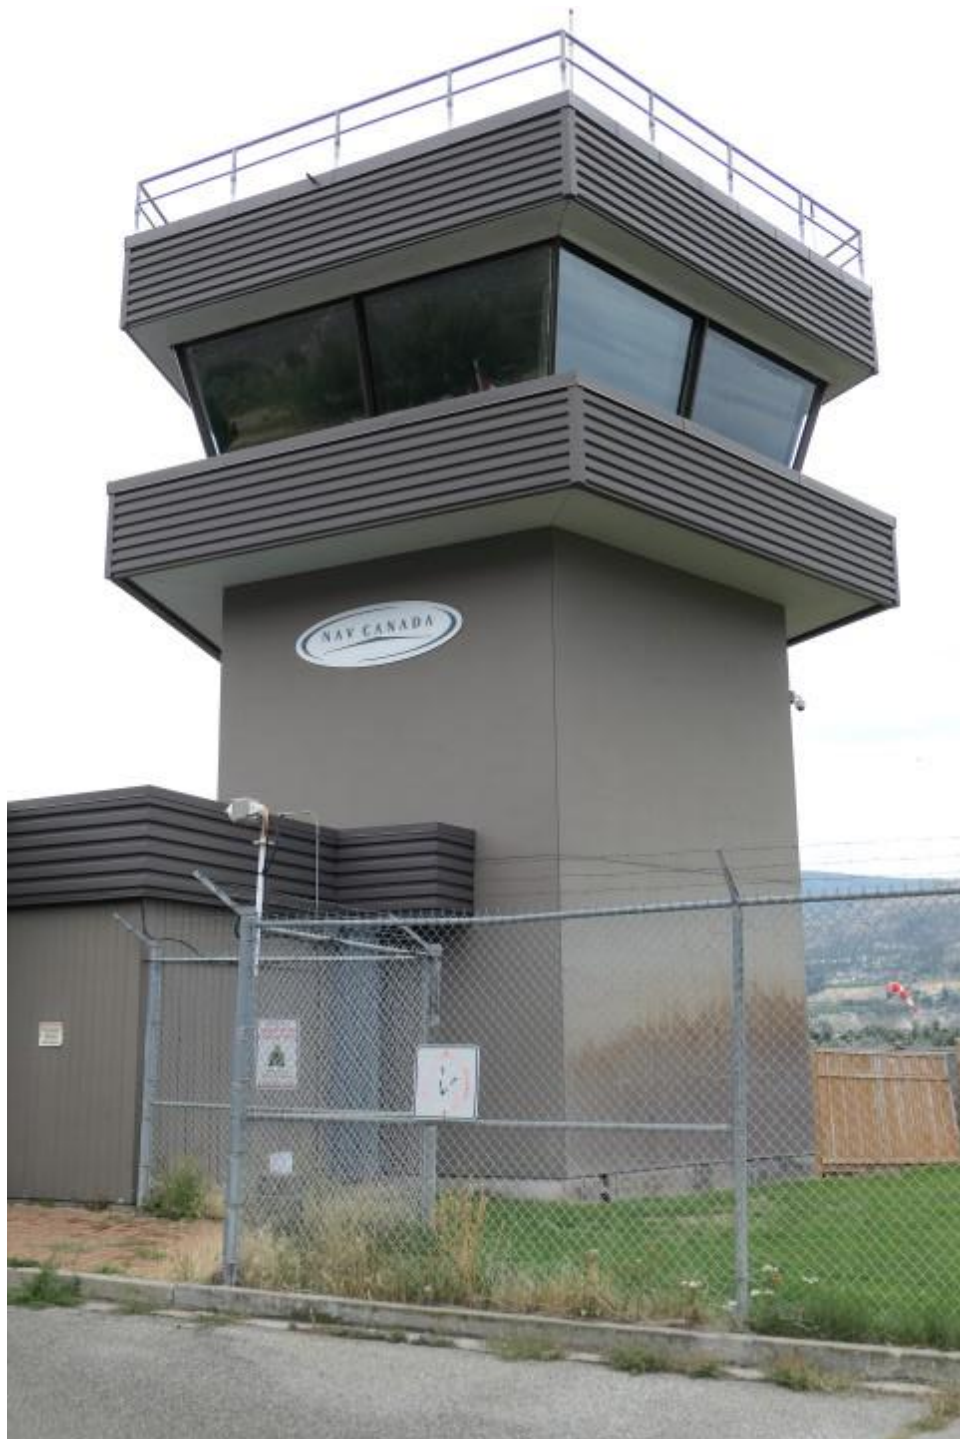
Photo 13

Nav Canada
tower.

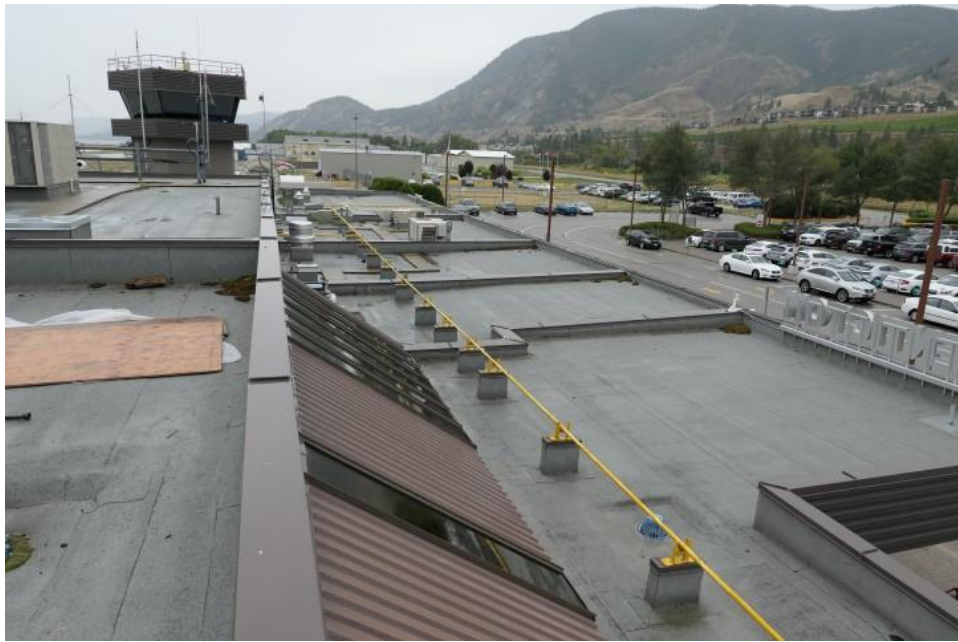
Photo 14

General roof
overview (facing
south).

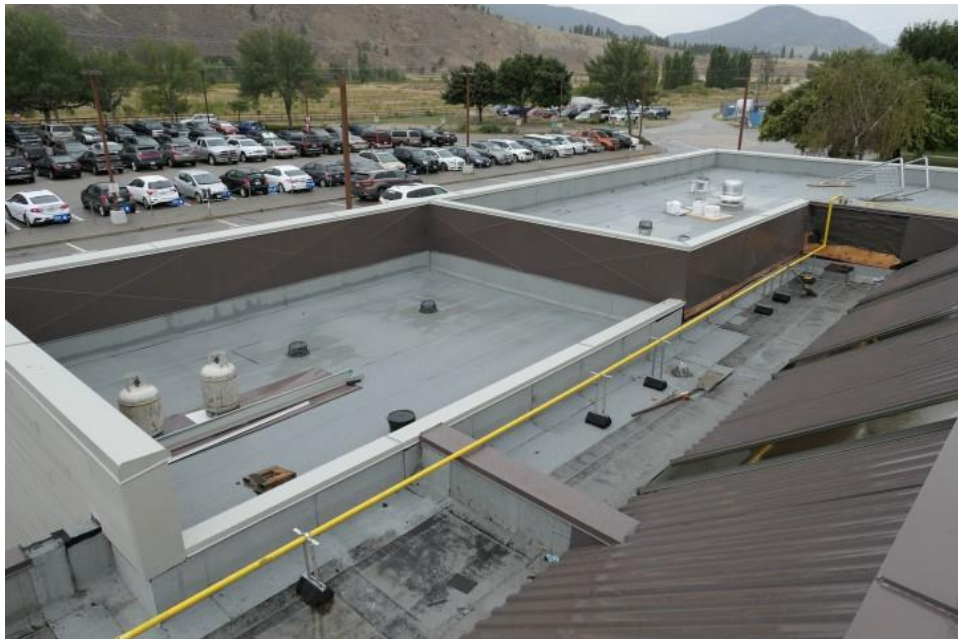
Photo 15

General roof
overview (facing
northwest).

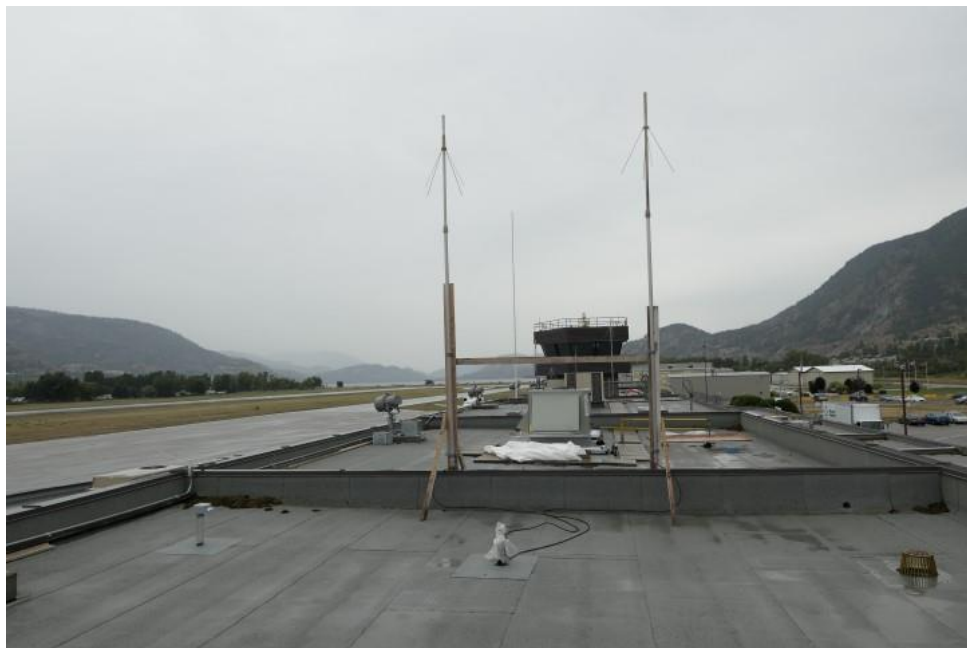
Photo 16

General upper
roof overview
(facing south).

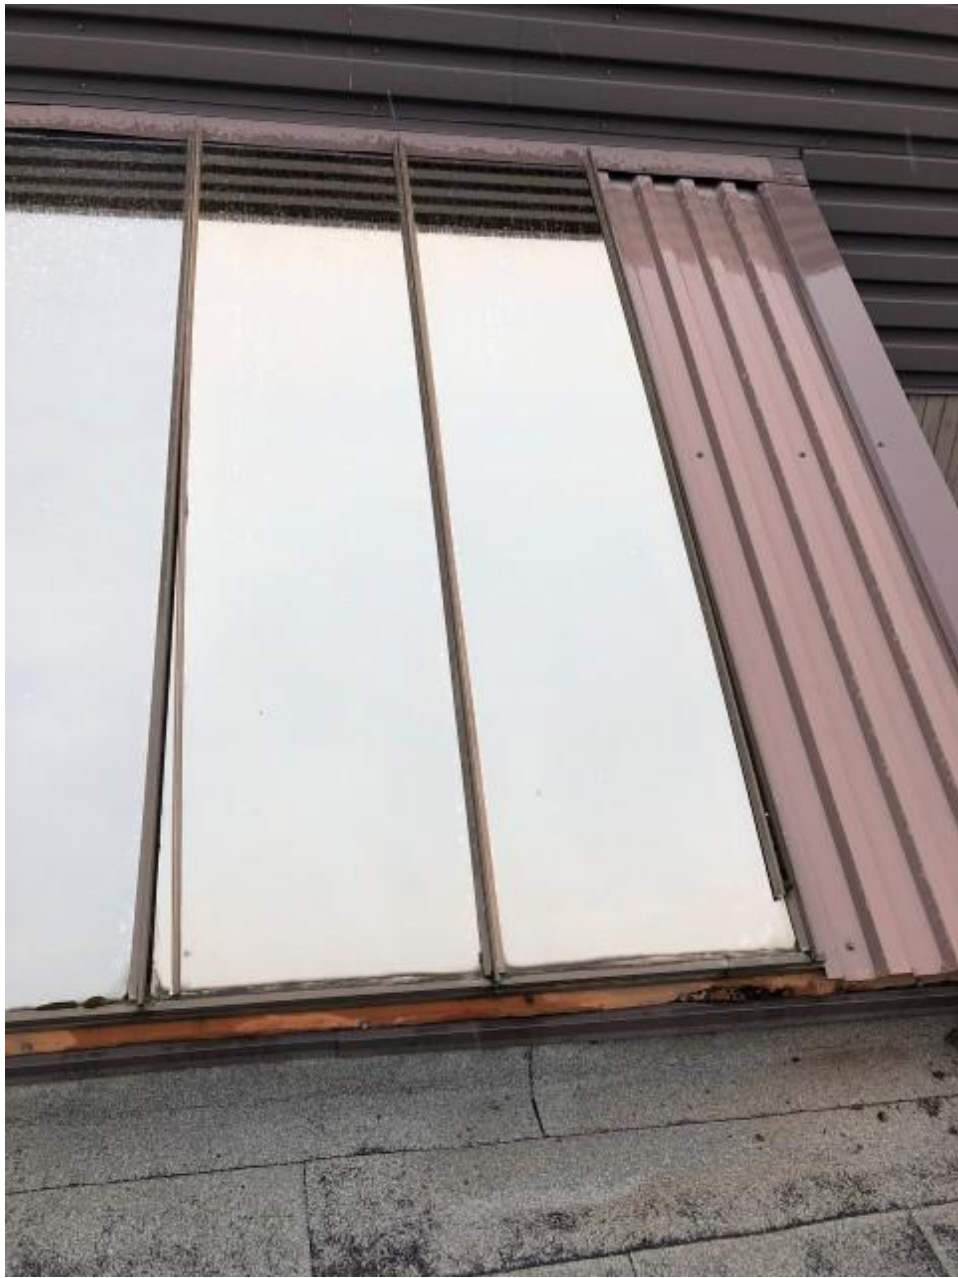
Photo 17

Skylight with
failed Insulated
Glass Unit
(IGU).

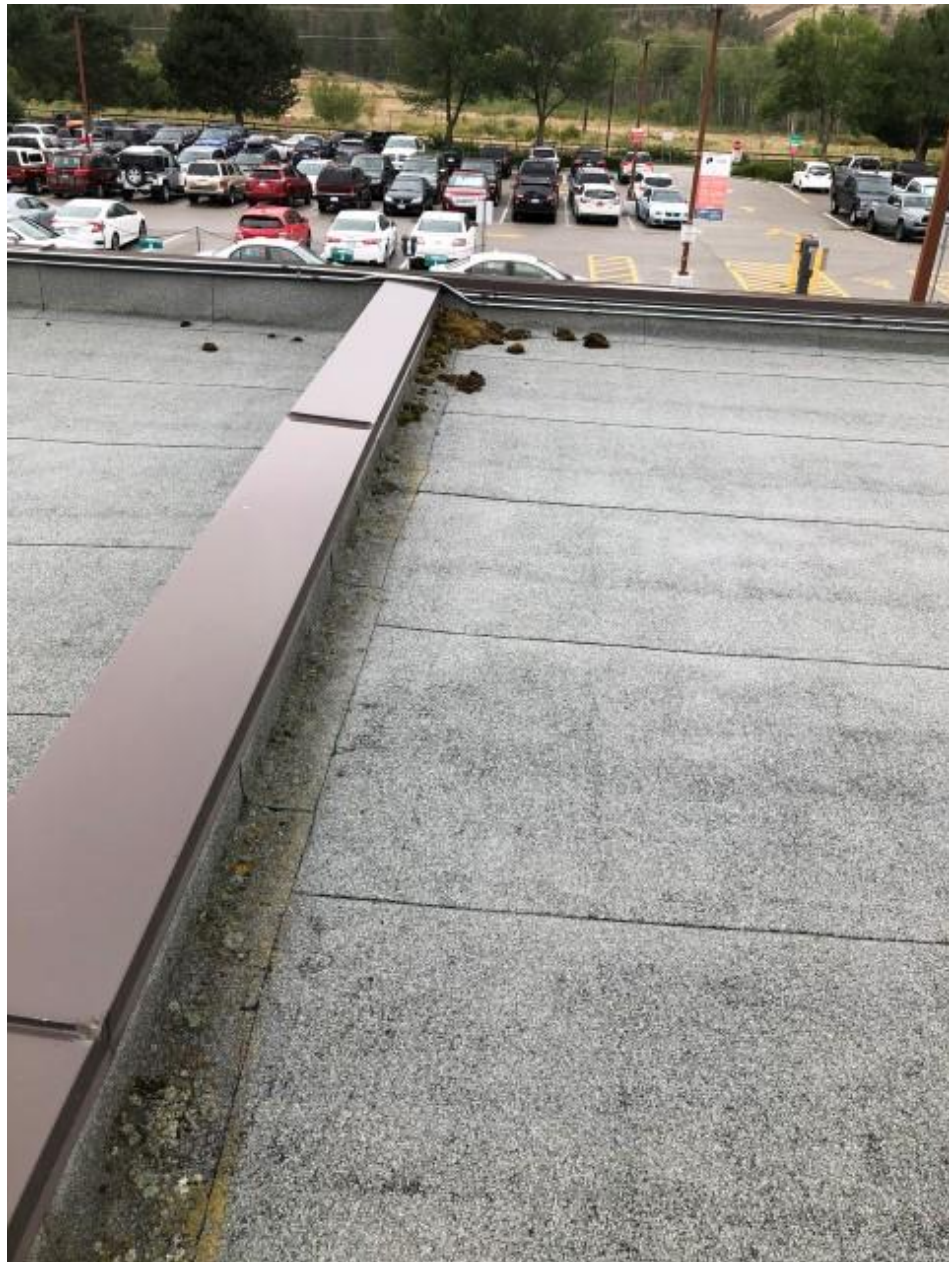
Photo 18

Organic growth
on mid roof
parapet.

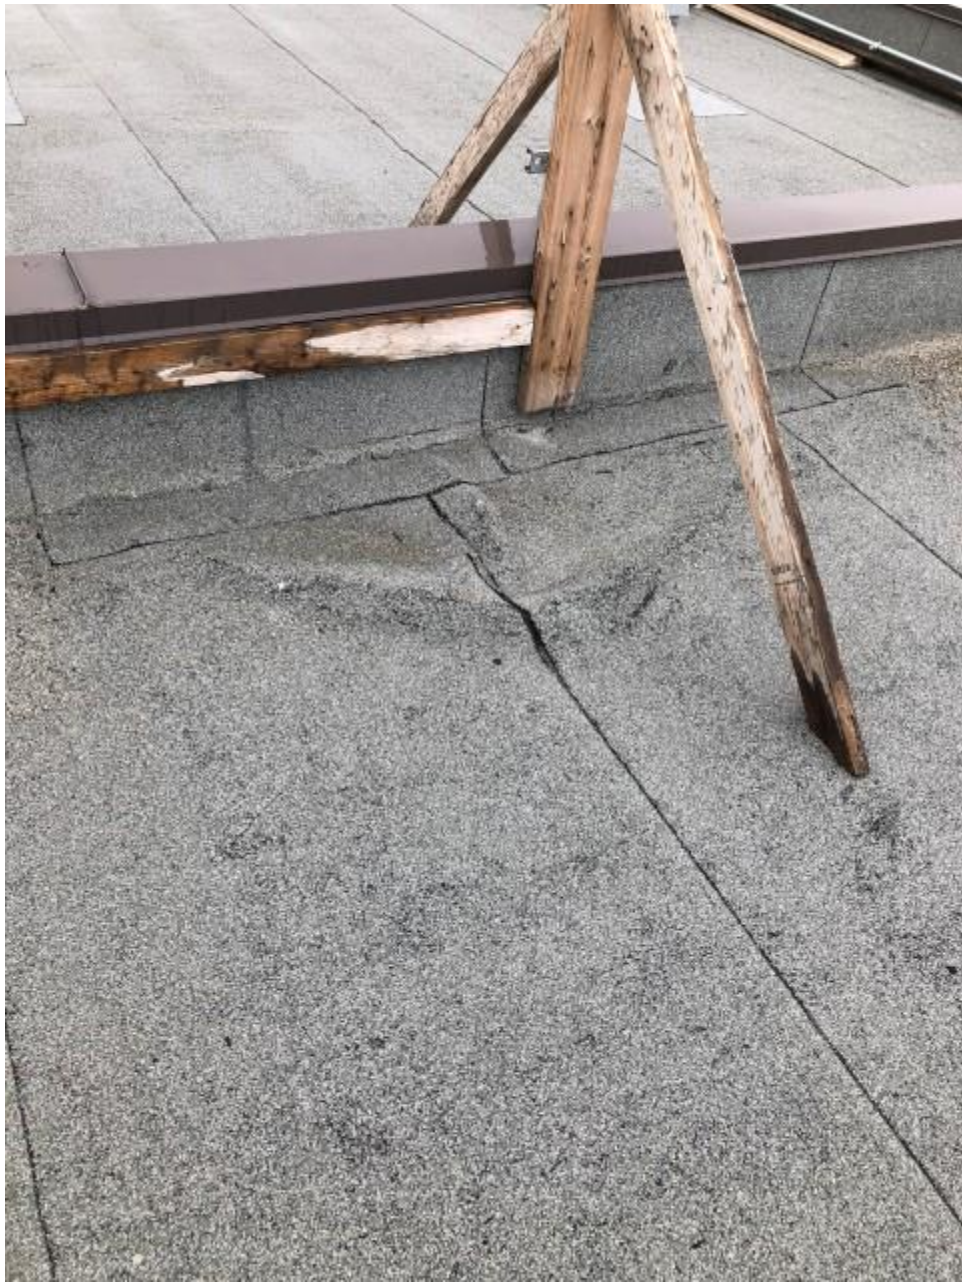
Photo 19

Antenna mount
screwed into
roof.

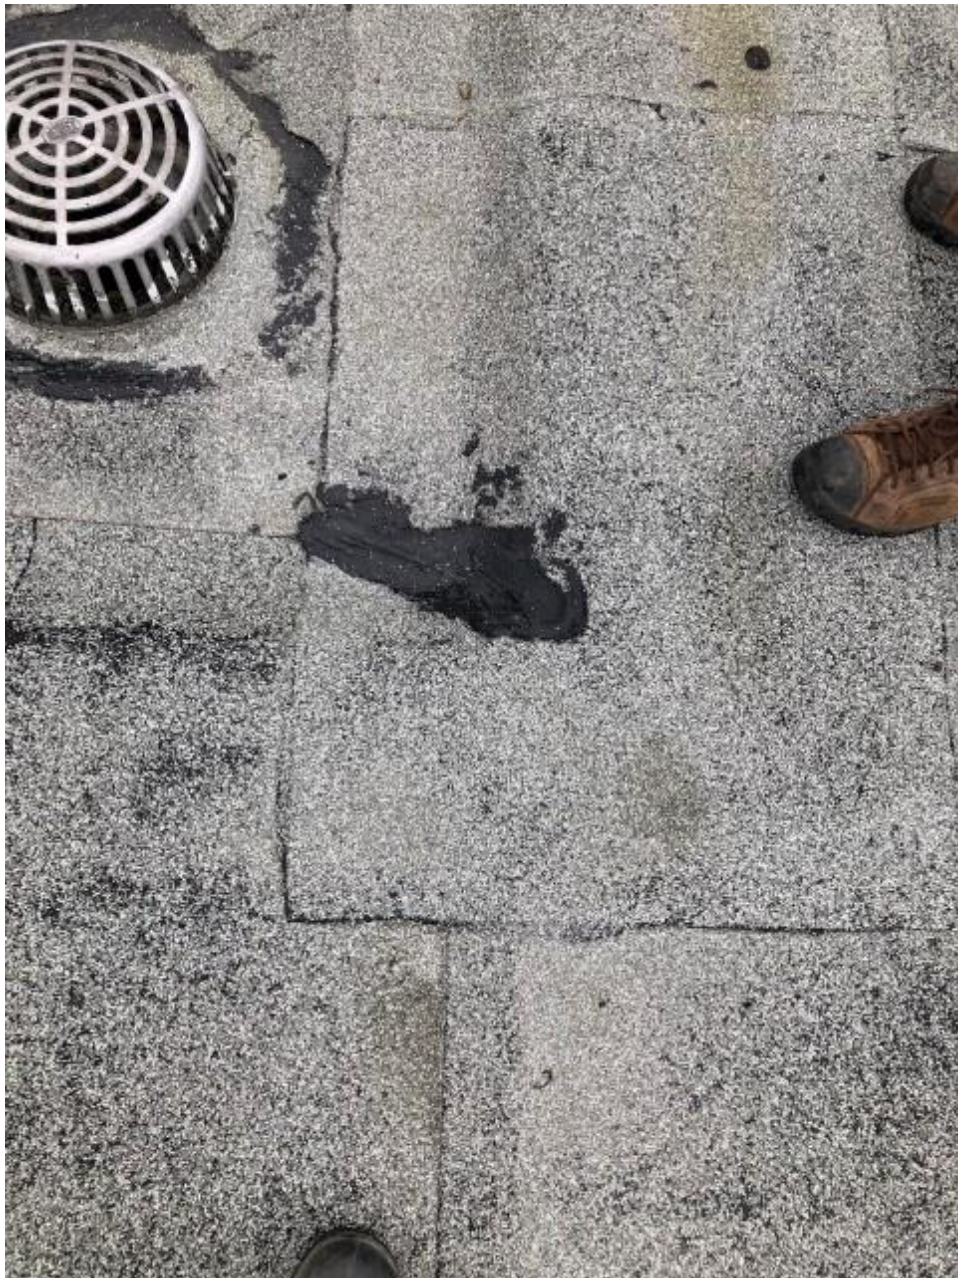
Photo 20

Crack near
drain sump on
south end of
roof.

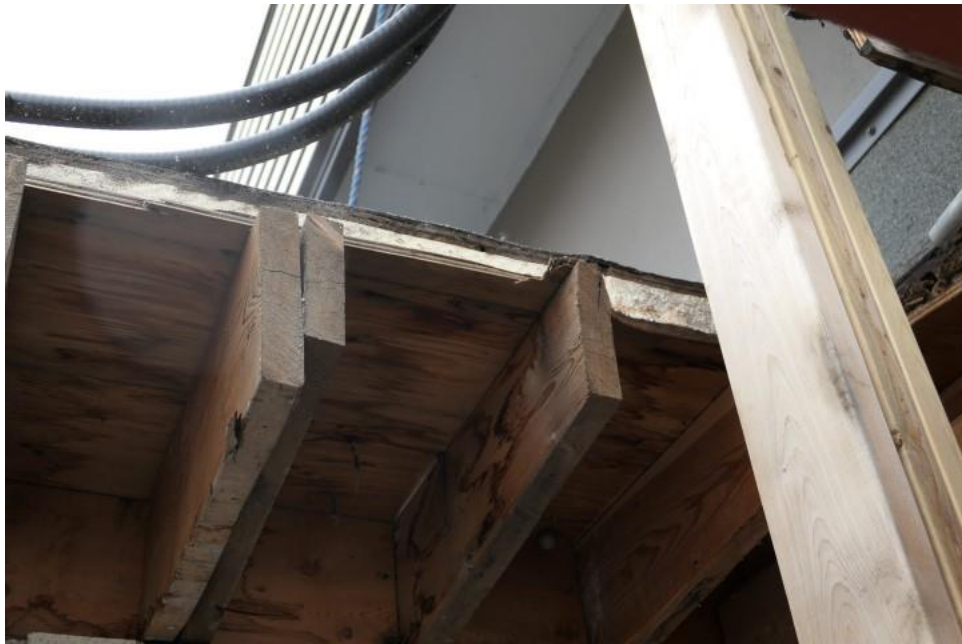
Photo 21

General roof assembly.

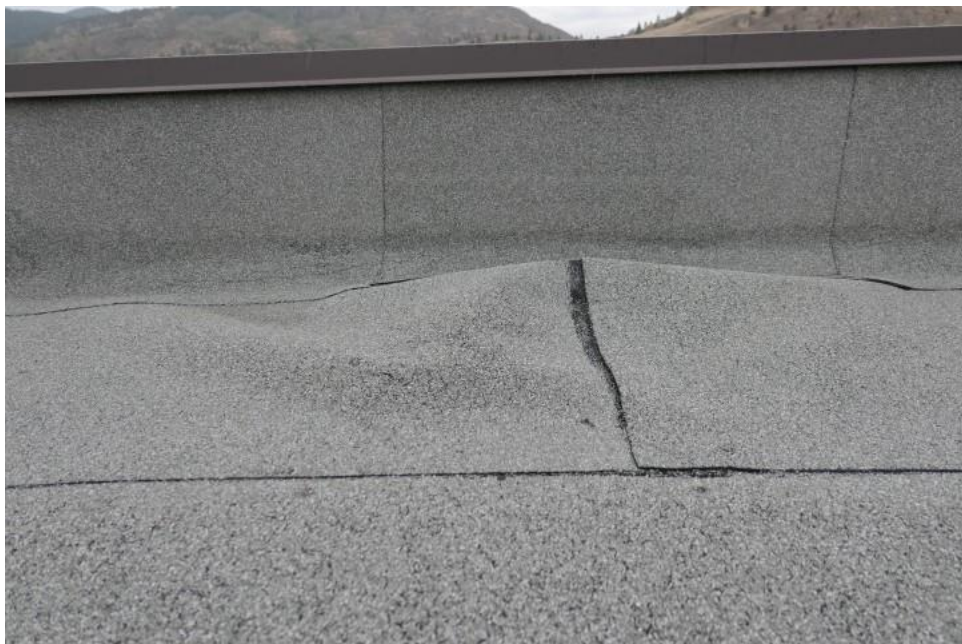
Photo 22

Lap seam deterioration in the roof membrane from blistering.

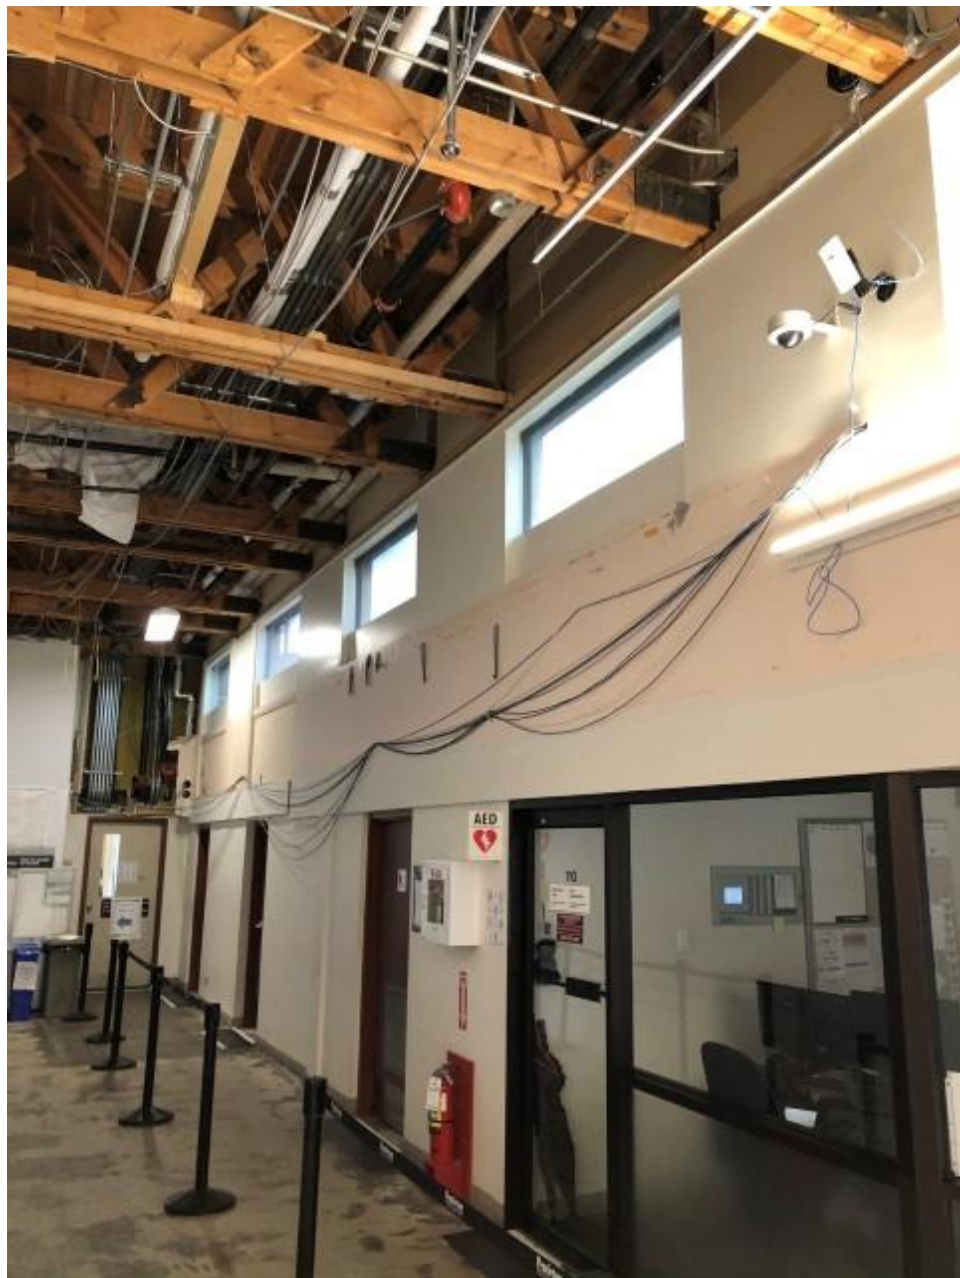
Photo 23

Interior overview of the clerestory windows. The ceiling is now enclosed and the other renovations in this area are finished. The clerestory windows remain in scope for this project.

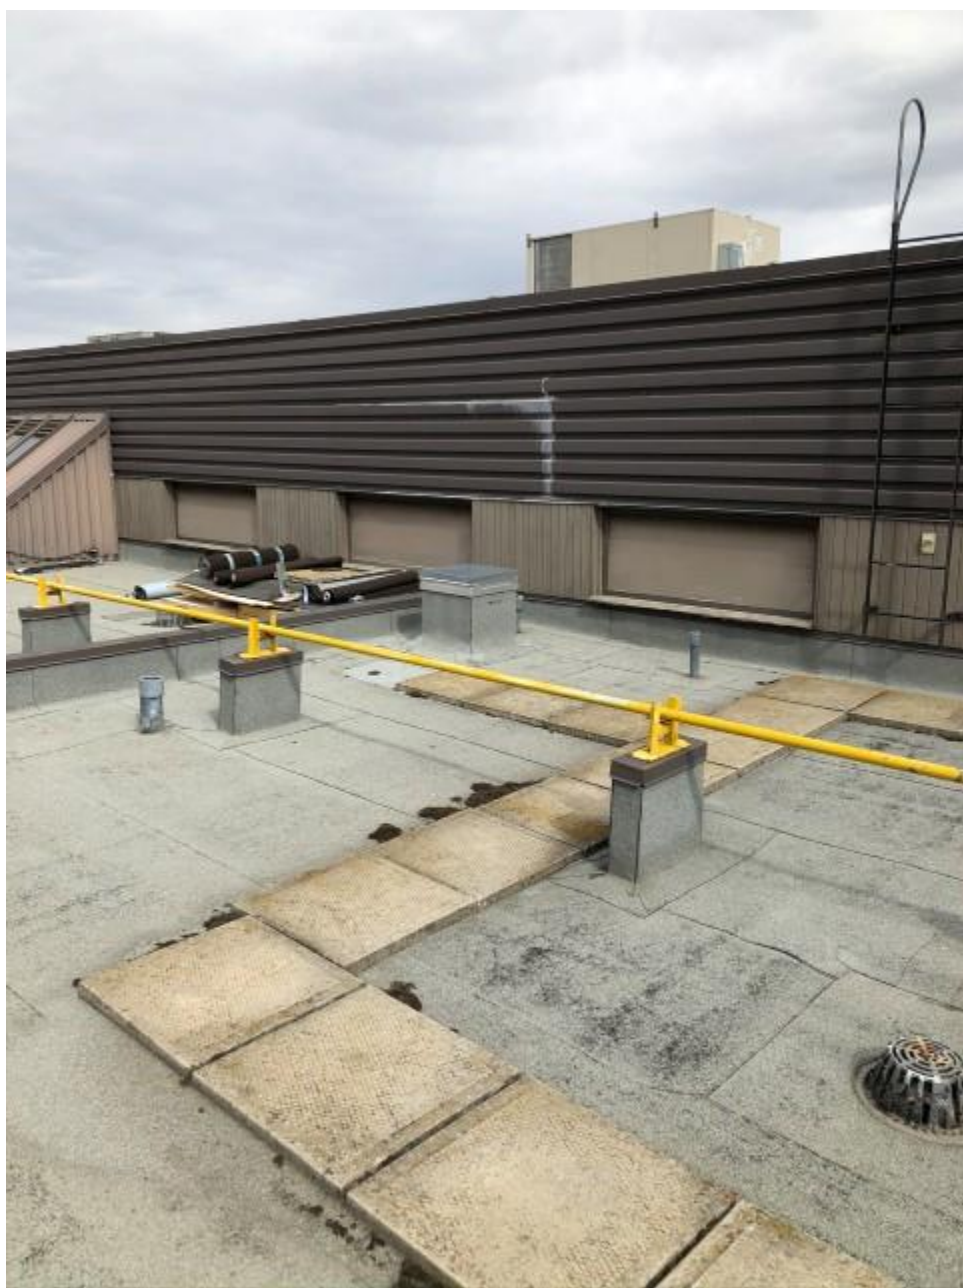
Photo 24

Exterior
overview of
clerestory
windows.

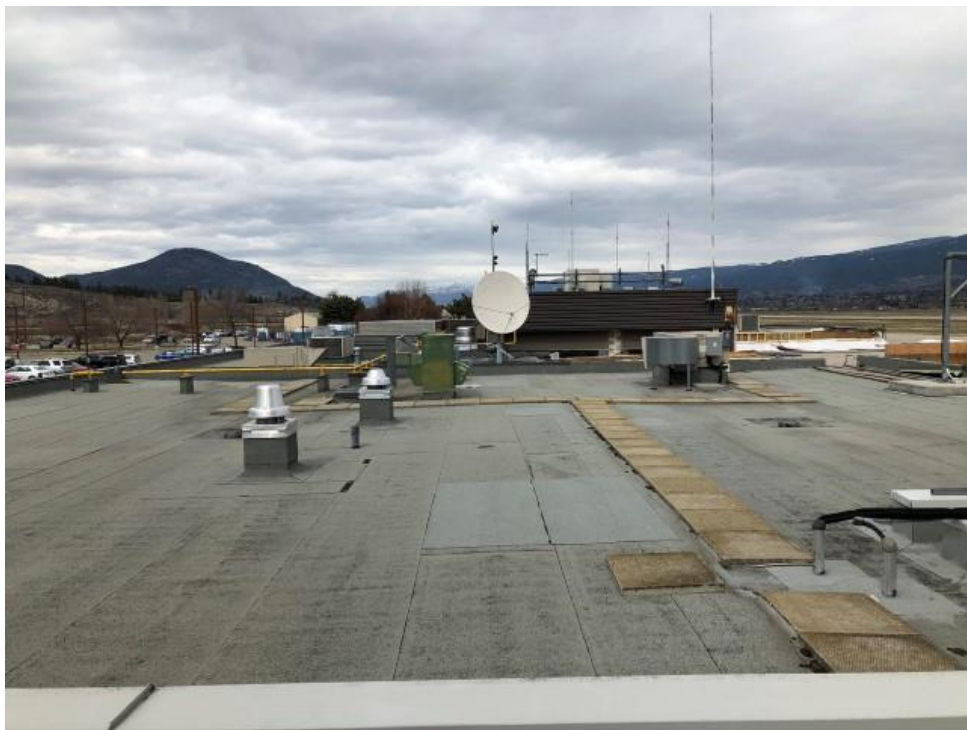
Photo 25

General roof
overview (facing
north).

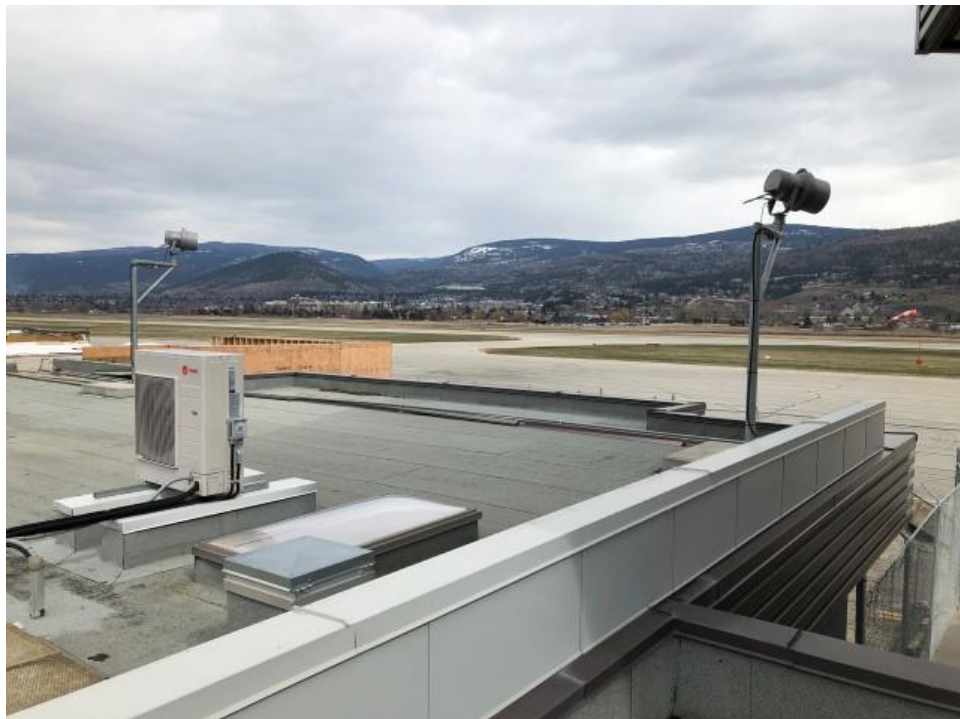
Photo 26

Overview of
southeast
portion of lower
roof (facing
east).

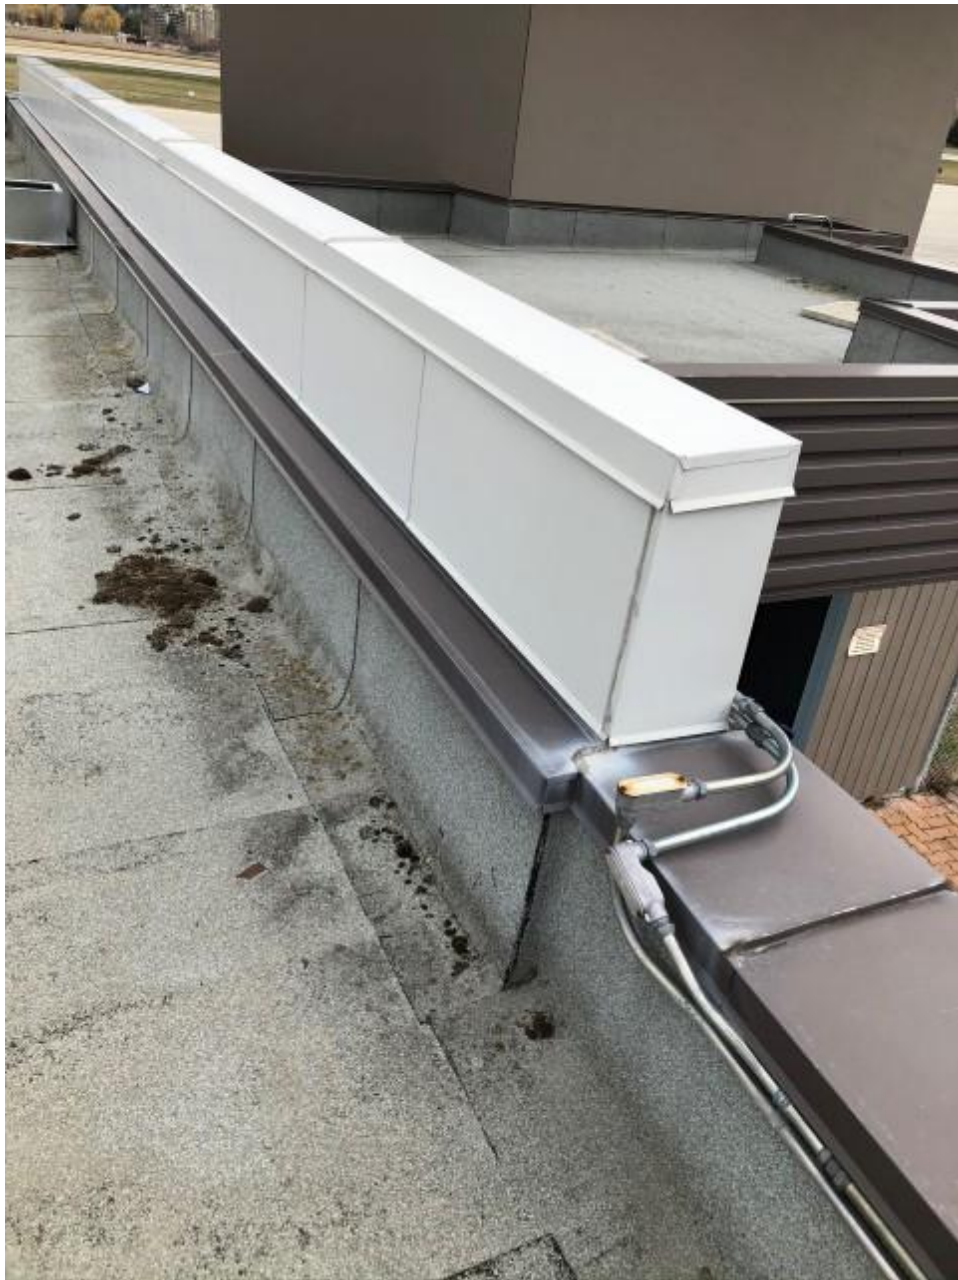
Photo 27

Metal panel and flashing at fire separation wall.
