Requisition No. EZ899- 220723/A

Penticton Regional Airport
Penticton ATB Roofing & Building Envelope Project
Project: R.105676.001

APPENDIX D

Existing Site Photos

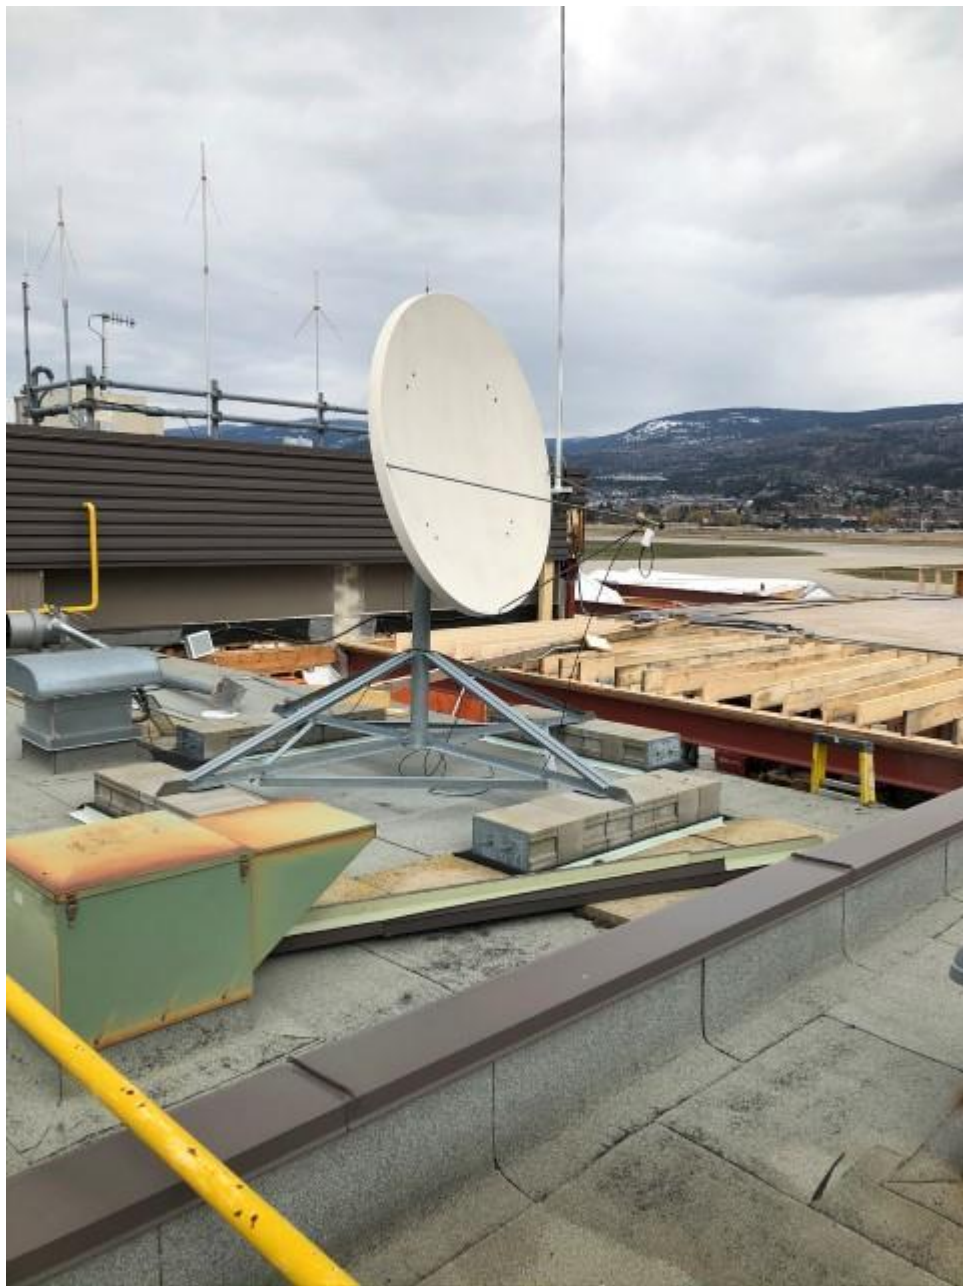
Photo 28

Ongoing construction of eastern addition. The eastern addition is now complete.

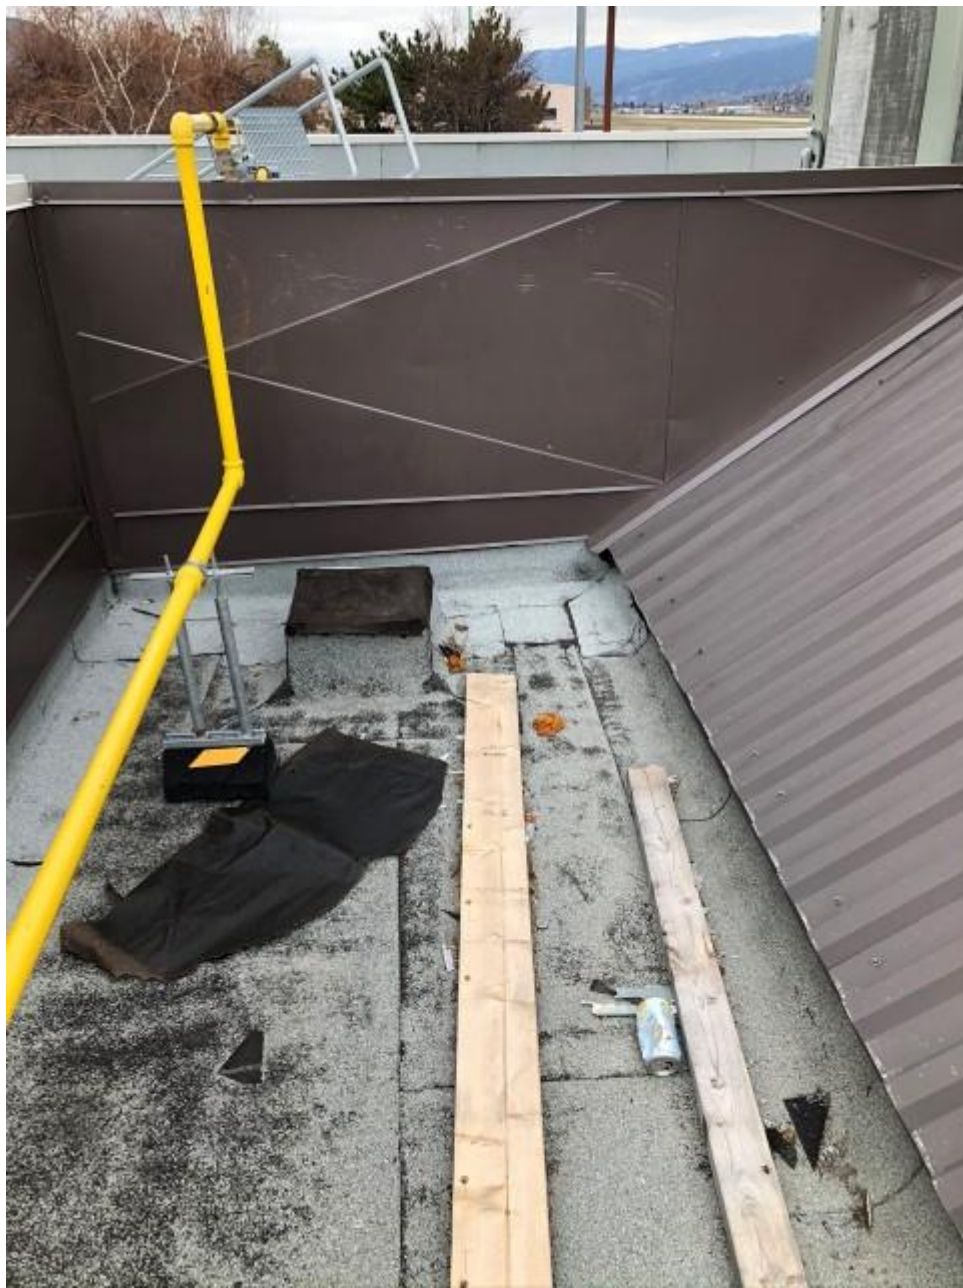
Photo 29

Parapet wall
between
existing and
new roof
section.

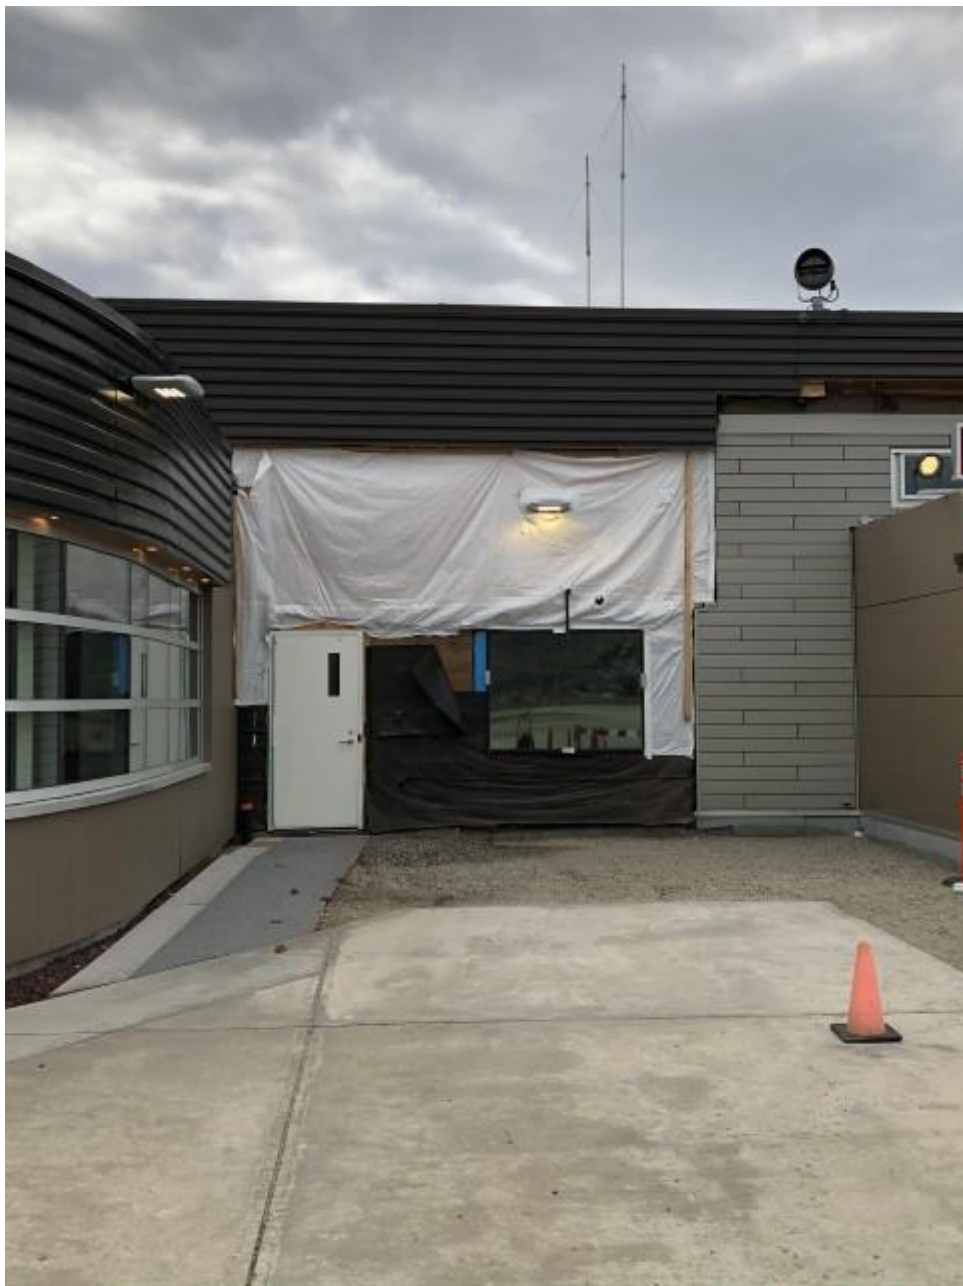
Photo 30

General overview of east elevation between the hold room and the new addition. The new addition is now complete.
