## MOULD ASSESSMENT—SITE REVIEW REPORT

<b>Project Name:</b>	<b>Pre-Construction Mould Investigation for RCMP Valemount Residence</b>		
<b>Client:</b>	<b>Public Services and Procurement Canada</b>	<b>Date of Site Visit:</b>	June 9, 2021
<b>Stantec Site Assessor:</b>	Lovy Mangat, B.Sc.	<b>Issue Date:</b>	July 29, 2021
<b>Location:</b>	Residential House, 1296 7 <sup>th</sup> Avenue, Valemount, BC	<b>Stantec Project #:</b>	123221873

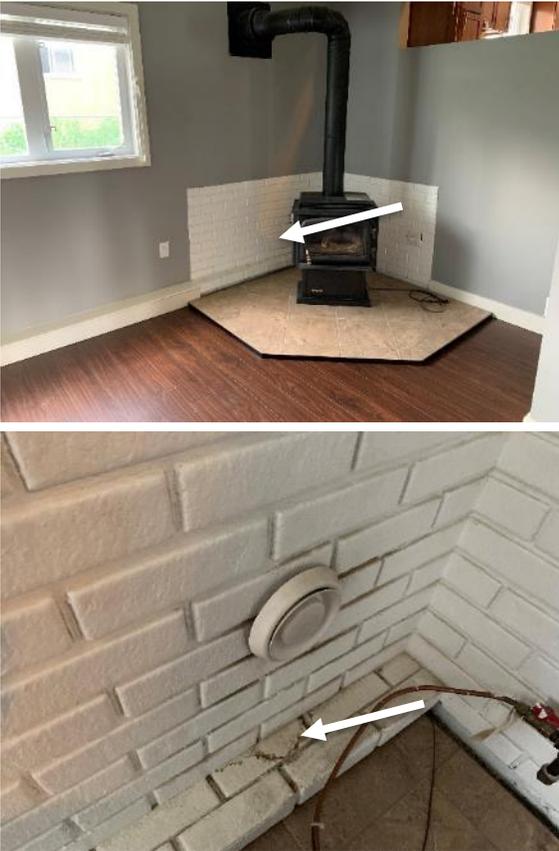
Area Assessed	Observations and Results	Suspected Source of Moisture	Photo	Recommendation
Lower Level Den	Visible moisture-staining on brick façade behind fireplace, in the area of the fresh air intake. Moisture meter reading similar to background readings. No active moisture observed.	Condensation from intake opening.

Clean and disinfect stained surfaces. Monitor areas and materials where moisture-staining was observed. If staining re-appears or active moisture is observed, the source of the moisture should be identified and corrected.

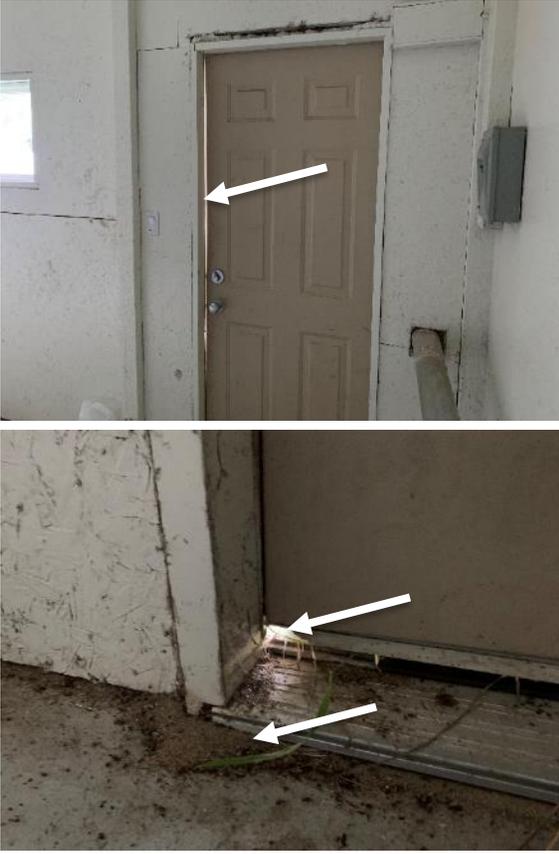
Area Assessed	Observations and Results	Suspected Source of Moisture	Photo	Recommendation
Carport	Visible rodent droppings and other evidence of rodent infestation; moisture-stained wood sheathing and wall framing members around man-door. Moisture meter reading similar to background readings. No active moisture observed.	Inadequate weatherstripping and gaps around doors allowing rodents/pests and moisture intrusion into carport.

Remove lower 2'x 2' section of interior wood wall sheathing on either side of doors. Clean and disinfect stained wood framing surfaces. Seal/weatherstripping around doors should be assessed and repaired/corrected prior to re-instatement of new building materials.

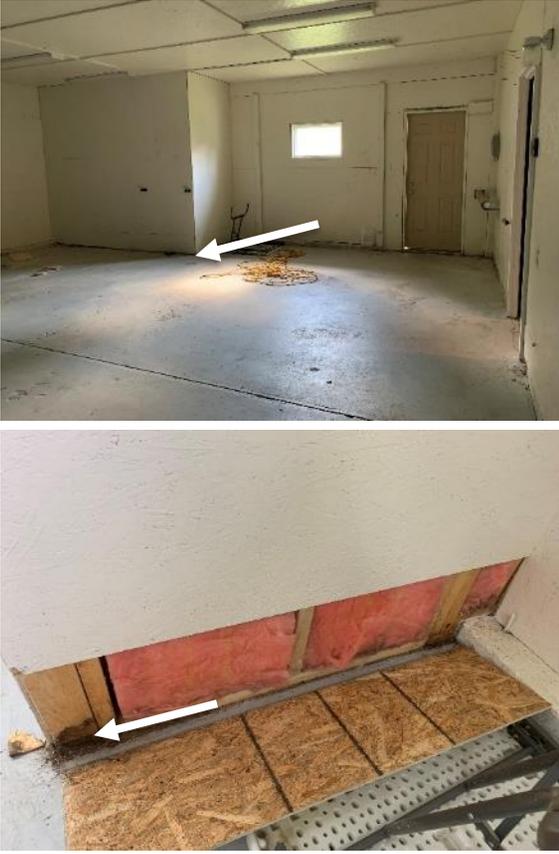
Area Assessed	Observations and Results	Suspected Source of Moisture	Photo	Recommendation
Carport	Visible moisture staining on the lower portion of the wood sheathing and wood wall framing members at the northeast wall corner. Moisture meter reading similar to background readings. No active moisture observed.	Pooling water in corner from moisture (e.g., rain and snow) brought into carport by vehicles, footwear, etc.

Remove lower 2' x 2' section of interior wood wall sheathing on either side from corner. Clean and disinfect stained wood framing surfaces. Consideration should be given to applying a sealant at bottom of wall perimeter to prevent moisture getting into the wall cavity.

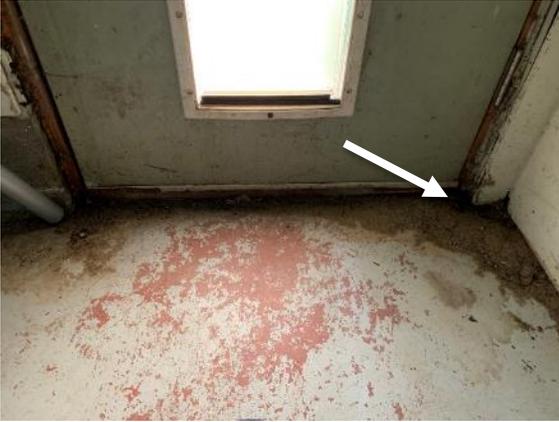
Area Assessed	Observations and Results	Suspected Source of Moisture	Photo	Recommendation
Workshop	Visible rodent droppings and other evidence of rodent infestation; moisture-stained wood sheathing and wall framing members around man-door. Moisture meter reading similar to background readings. No active moisture observed.	Poor weatherstripping and gaps around doors allowing rodents/pests and moisture intrusion into workshop.

Remove lower 2' x 2' section of interior drywall sheathing on either side of doors. Clean and disinfect stained wood framing surfaces. Seal/weatherstripping around doors should be assessed and repaired/corrected prior to re-instatement of new building materials.
Lower Level Bathroom	Test cut into east perimeter drywall wall did not identify moisture or suspect mould within the wall cavity.	N/A

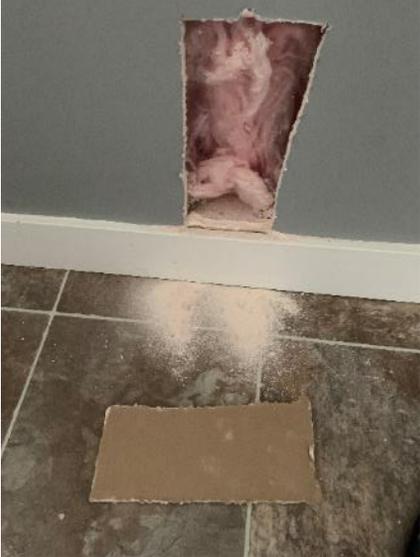
Area Assessed	Observations and Results	Suspected Source of Moisture	Photo	Recommendation
Lower Level Bedroom	Test cut into west perimeter drywall wall did not identify moisture or suspect mould within the wall cavity.	N/A

Repair wall assembly, including insulation, vapour barrier and drywall.
Carport/ Workshop	Moisture staining on concrete floor at bay doors.	Pooling of water that has infiltrated through bay doors.

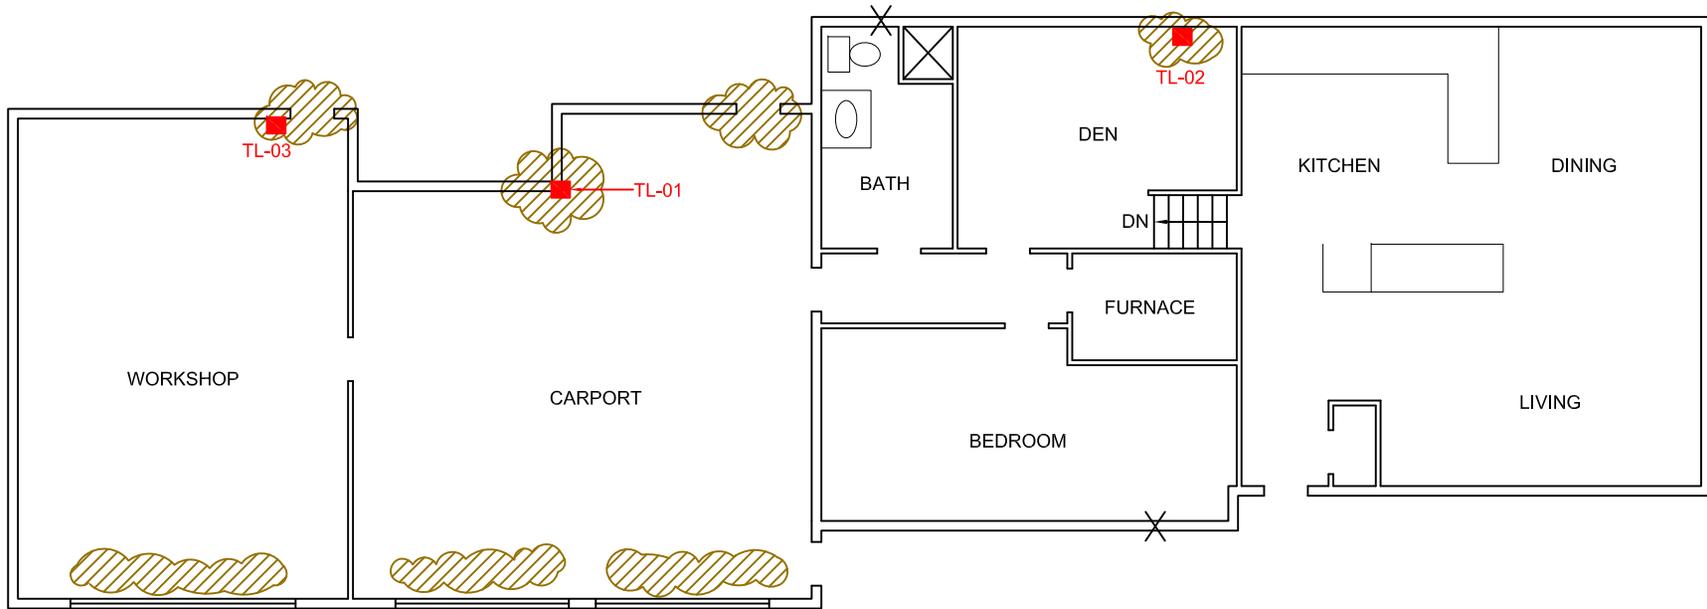
## **Floor Plan**

- In the carport, on the lower portion of the wood sheathing and wood wall framing members at the northeast wall corner.
- Test cuts into representative perimeter drywall walls within the lower level of the subject building did not identify moisture impacts or suspect mould within the concealed locations. Locations of intrusive test cuts are indicated on the floor plan attached to this document.

Table 2, below, summarizes the locations and analytical results of the tape lift samples collected within the subject building on June 9, 2021. A floor plan indicating sample locations is attached to this document, for reference.
