Hazardous Building Materials Assessment

Building # E0599—RCMP Residential
House, 1296 7th Avenue,
Valemount, BC

July 29, 2021

Project No.: 123221873
PSPC Project No. R.115645.002

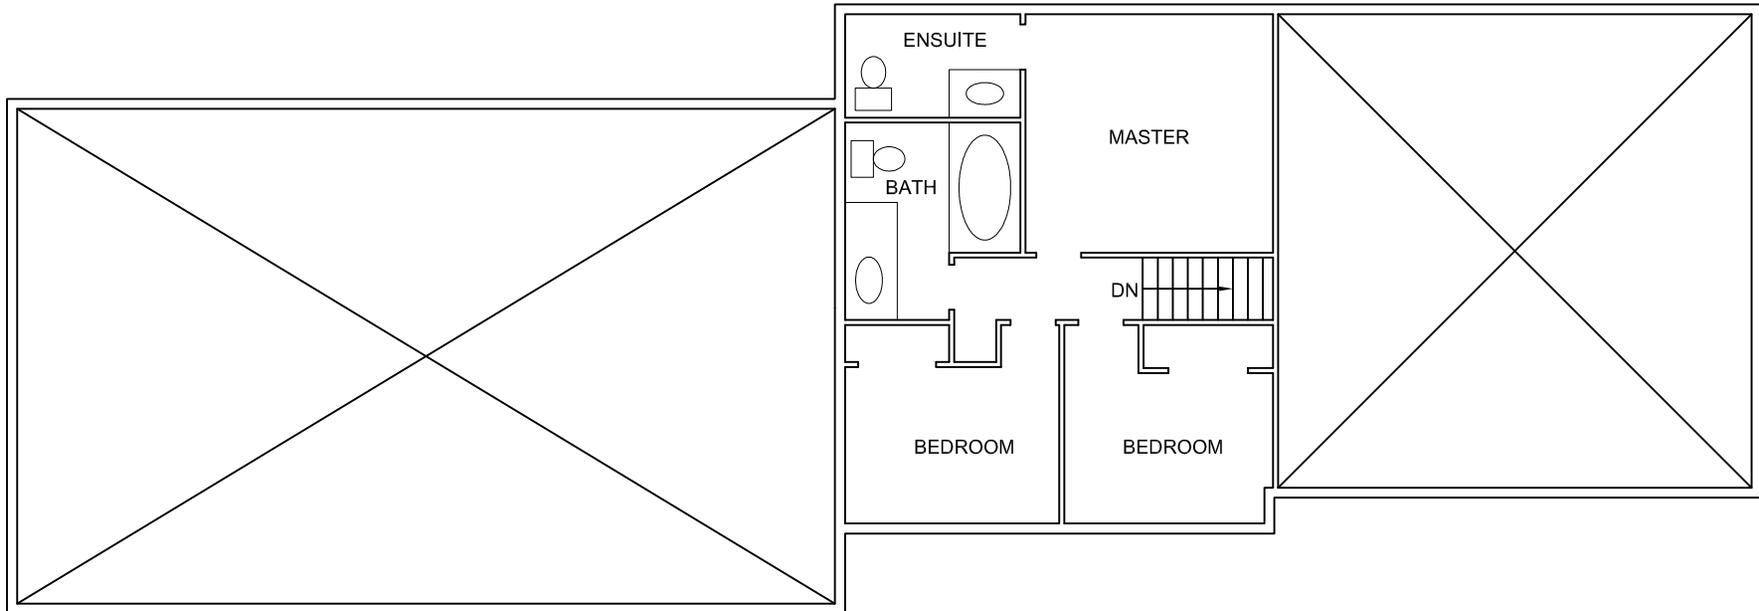
- NOTES:** 1. DRYWALL JOINT COMPOUND THROUGHOUT IS ASBESTOS-CONTAINING (EXCLUDING THE WORKSHOP).
 2. CEILING TEXTURED FINISH THROUGHOUT UPPER LEVEL IS ASBESTOS-CONTAINING.
 3. THIS DRAWING ILLUSTRATES SUPPORTING INFORMATION SPECIFIC TO A STANTEC CONSULTING LTD. REPORT AND MUST NOT BE USED FOR OTHER PURPOSES.

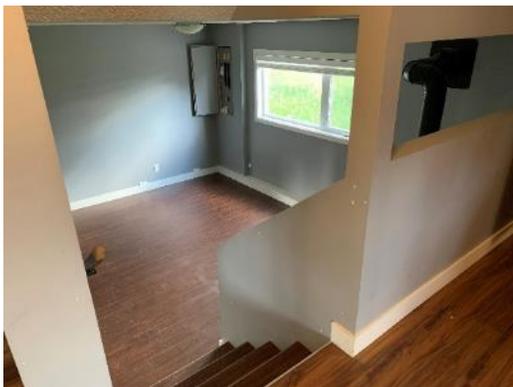
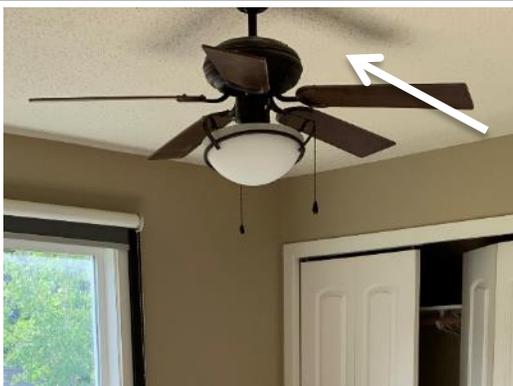
Identified ACM Description and Condition Information	
Drywall joint compound where present throughout the subject building (excluding the Workshop)	
% Type	3% Chrysotile (Previous Report)
Friability	Non-friable in situ; potentially friable during renovation or demolition
Condition	Good
Accessibility	A
Action	7
Approx. Quantity	605 square metres
Ceiling textured finish throughout the Upper Level (hallway, and bedrooms)	
% Type	5% Chrysotile (Previous Report)
Friability	Non-friable in situ; potentially friable during renovation or demolition
Condition	Good
Accessibility	C (exposed)
Action	7
Approx. Quantity	50 square metres
