March 9, 2021

Project Number: 2020-036

**RE: Geotechnical Investigation for Retaining Wall in Distress
 Banff Upper Hot Springs, Banff National Park, AB**

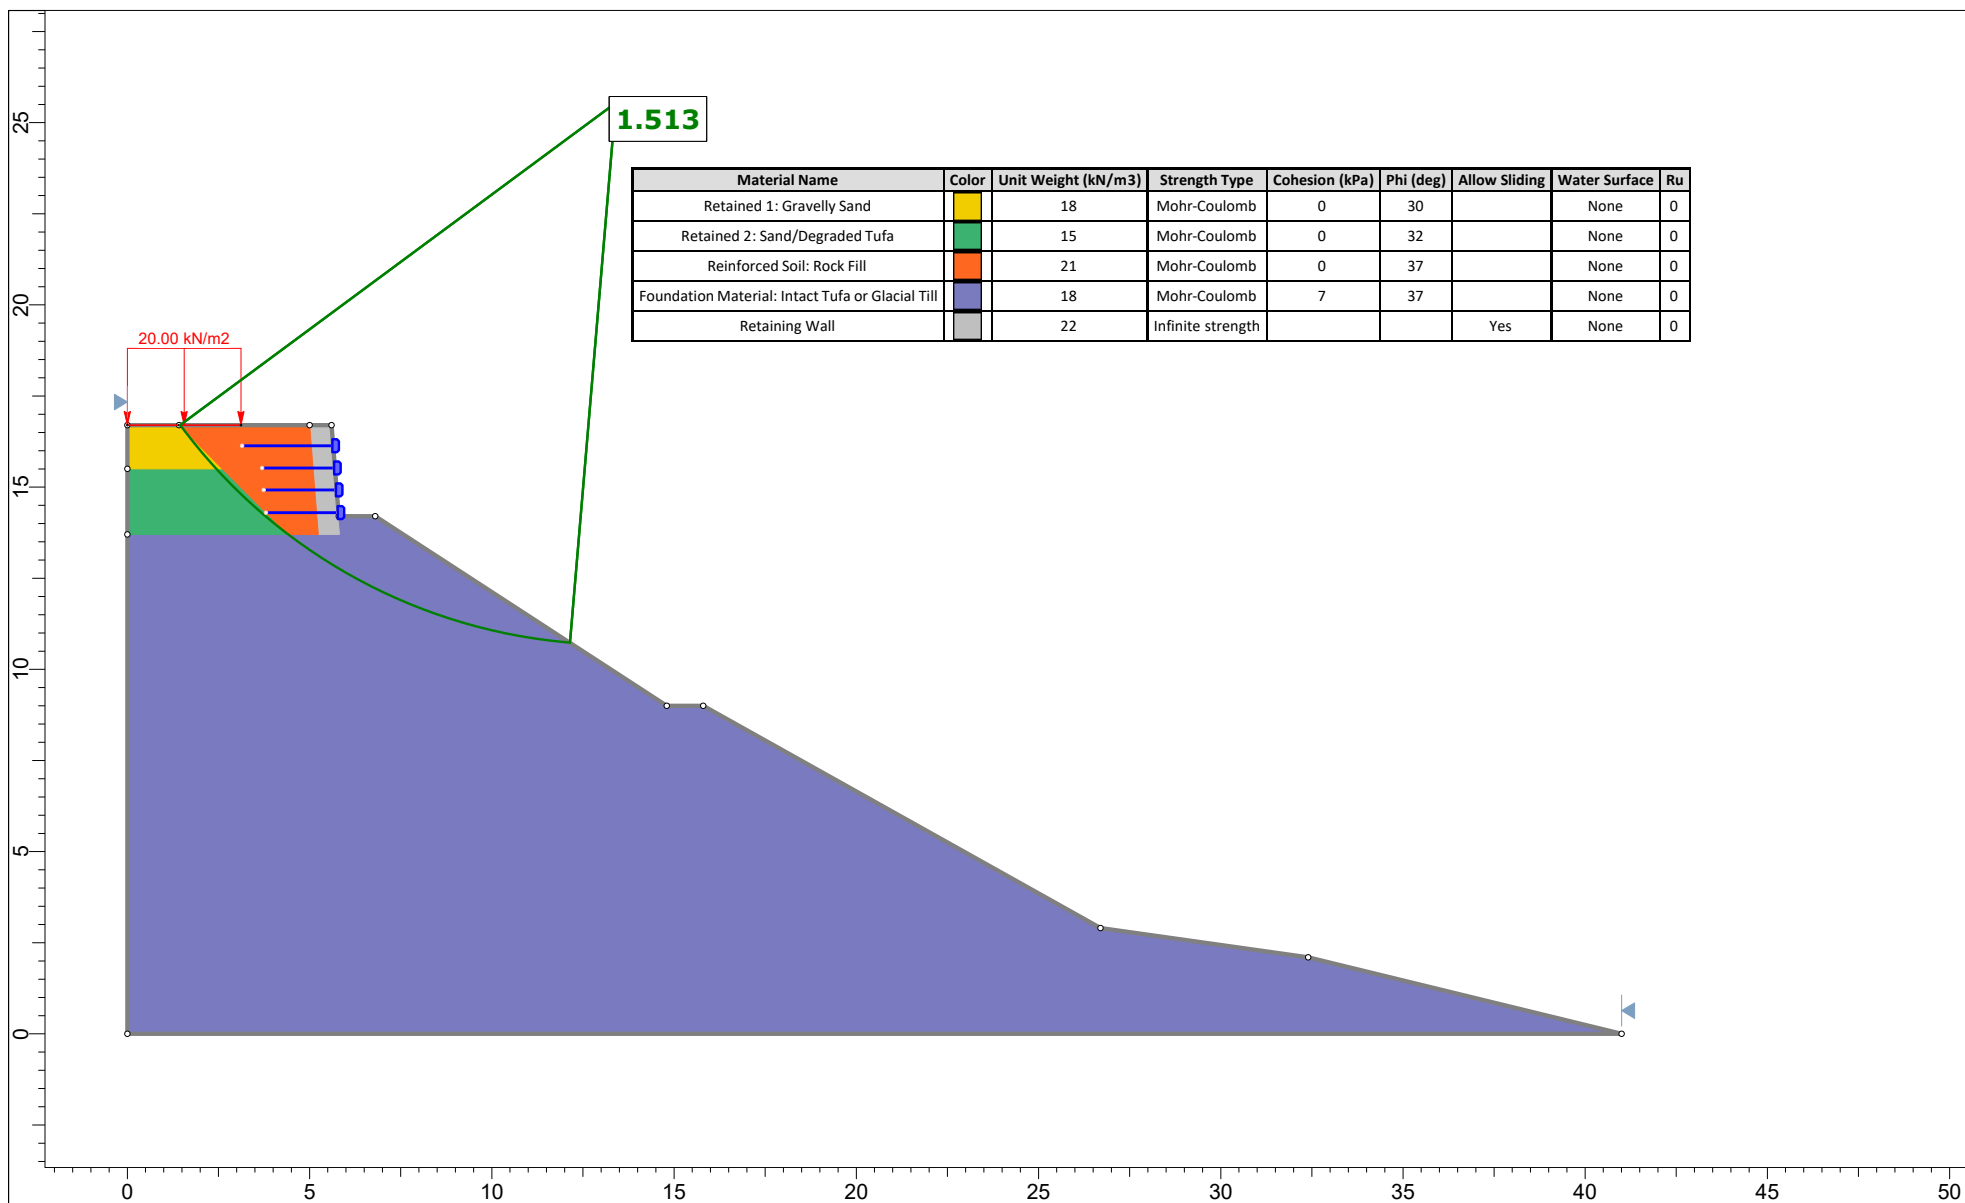
Considering the global stability of the proposed retaining wall configuration at the critical section, failure was noted within the retained soils behind the retaining wall, as well as global failure within the native foundation material. See Figure 1 appended to the text of this memorandum for reference. Minimum factor of safety (FOS) values of 1.5 are required for dry conditions.

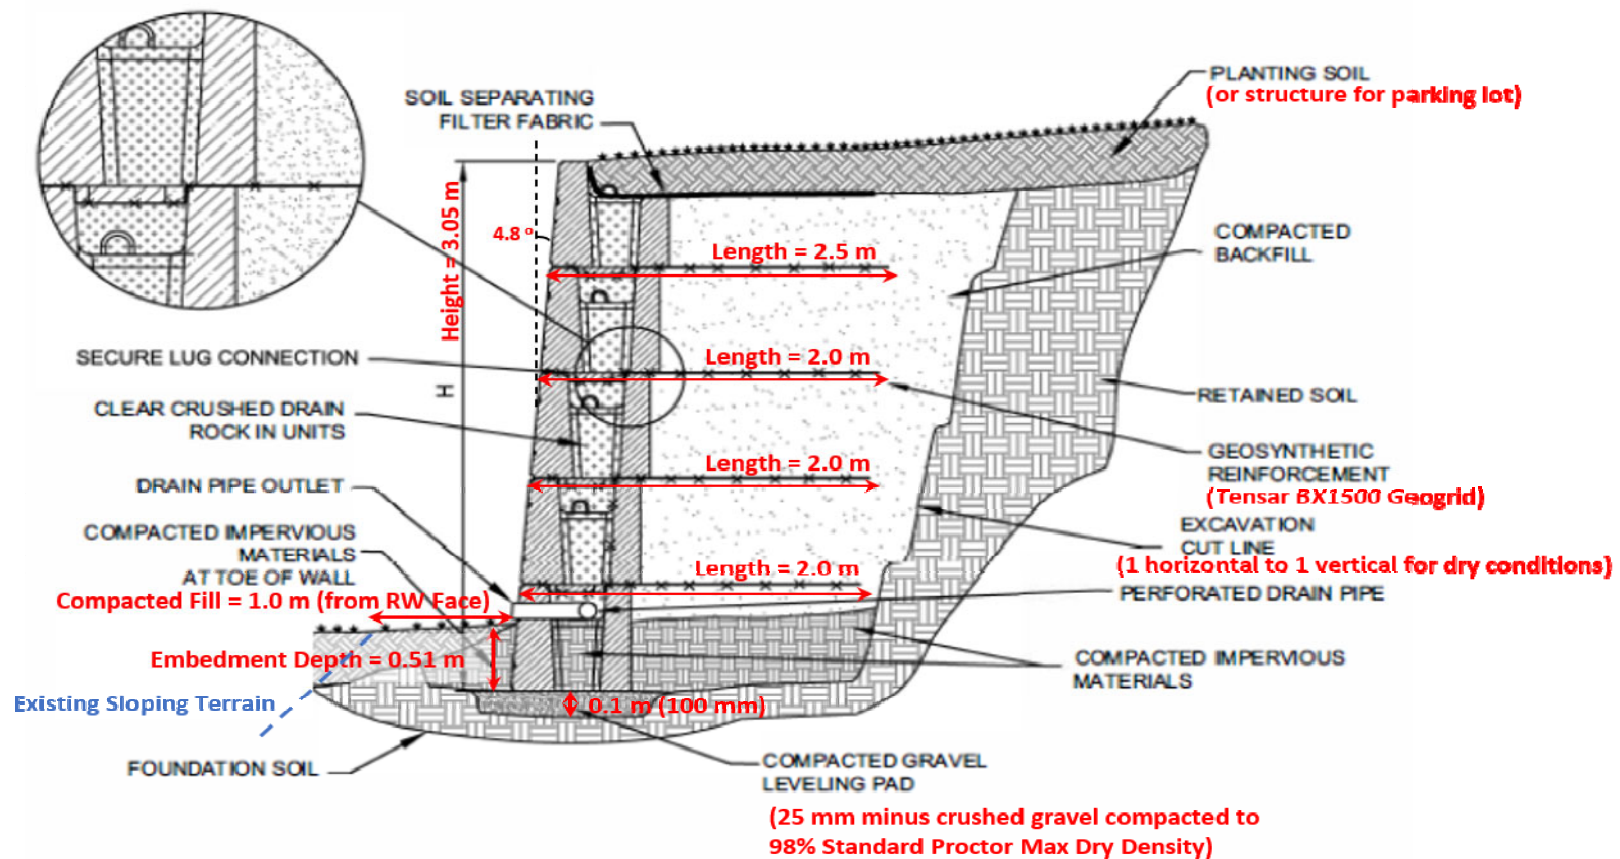
PROJECT #: 2020-036 FIGURE: 2 REV.: 0

To review external failure modes included sliding, overturning and bearing, as well as internal failure modes including overstress, pullout and shear, SRWall proprietary software was used. The above material parameters were incorporated in the analysis; however, cohesion was neglected within backfill materials. Additionally, the retaining wall batter of 4.8 degrees was applied as well as a minimum embedment depth of 510 mm for an overall wall height of 3.04 m (or 5 units). Use of geogrid reinforcement (i.e., Tensar Biaxial Geogrid BX1500) between units was considered. Table 2 summarizes the factor of safety results for the above listed failure modes. See Figure 2 for reference.

The geogrid reinforcement lengths prescribed in Table 2 were found to meet the minimum factor of safety requirements for overstress, pullout and sliding. FOS values greater than 1.5 were achieved for each reinforcement length in the above scenarios.

It is recommended that the following comments be incorporated into construction of the multi-segmental retaining wall. See Figure 2 for reference.

- MagnumStone units are to be constructed in accordance with the manufacturer's recommendations.
- A minimum batter of 4.8 degrees shall be applied to the entire height of the retaining wall. This is equivalent to maintaining a setback of 50 mm between units, as per the manufacturer's recommendations.
- MangnumStone units must be placed on a prepared level surface that consists of 25 mm minus crushed gravel placed in a 100 mm thick lift compacted to 98% of Standard Proctor maximum dry density (SPMDD).
- A minimum depth of burial of 0.51 m shall be applied to ensure adequate resistance is maintained against sliding and overturning. The top of the bottom block shall be installed a minimum horizontal distance of 1.0 m from the existing soil slope (e.g., a thickness of 1.0 m of soil is required in front of the bottom unit). See Figure 2 for reference.

- The minimum geogrid requirements listed in Table 2 shall be applied. Biaxial geogrid equivalent or better than Tensar BX1500 should be used. Geogrid lengths are measured from the front face of the retaining wall into backfill. Careful installation is required to ensure reinforcement is within the direction of pull and negligible damage occurs. Geogrid shall be installed as per the manufacturer's specifications.

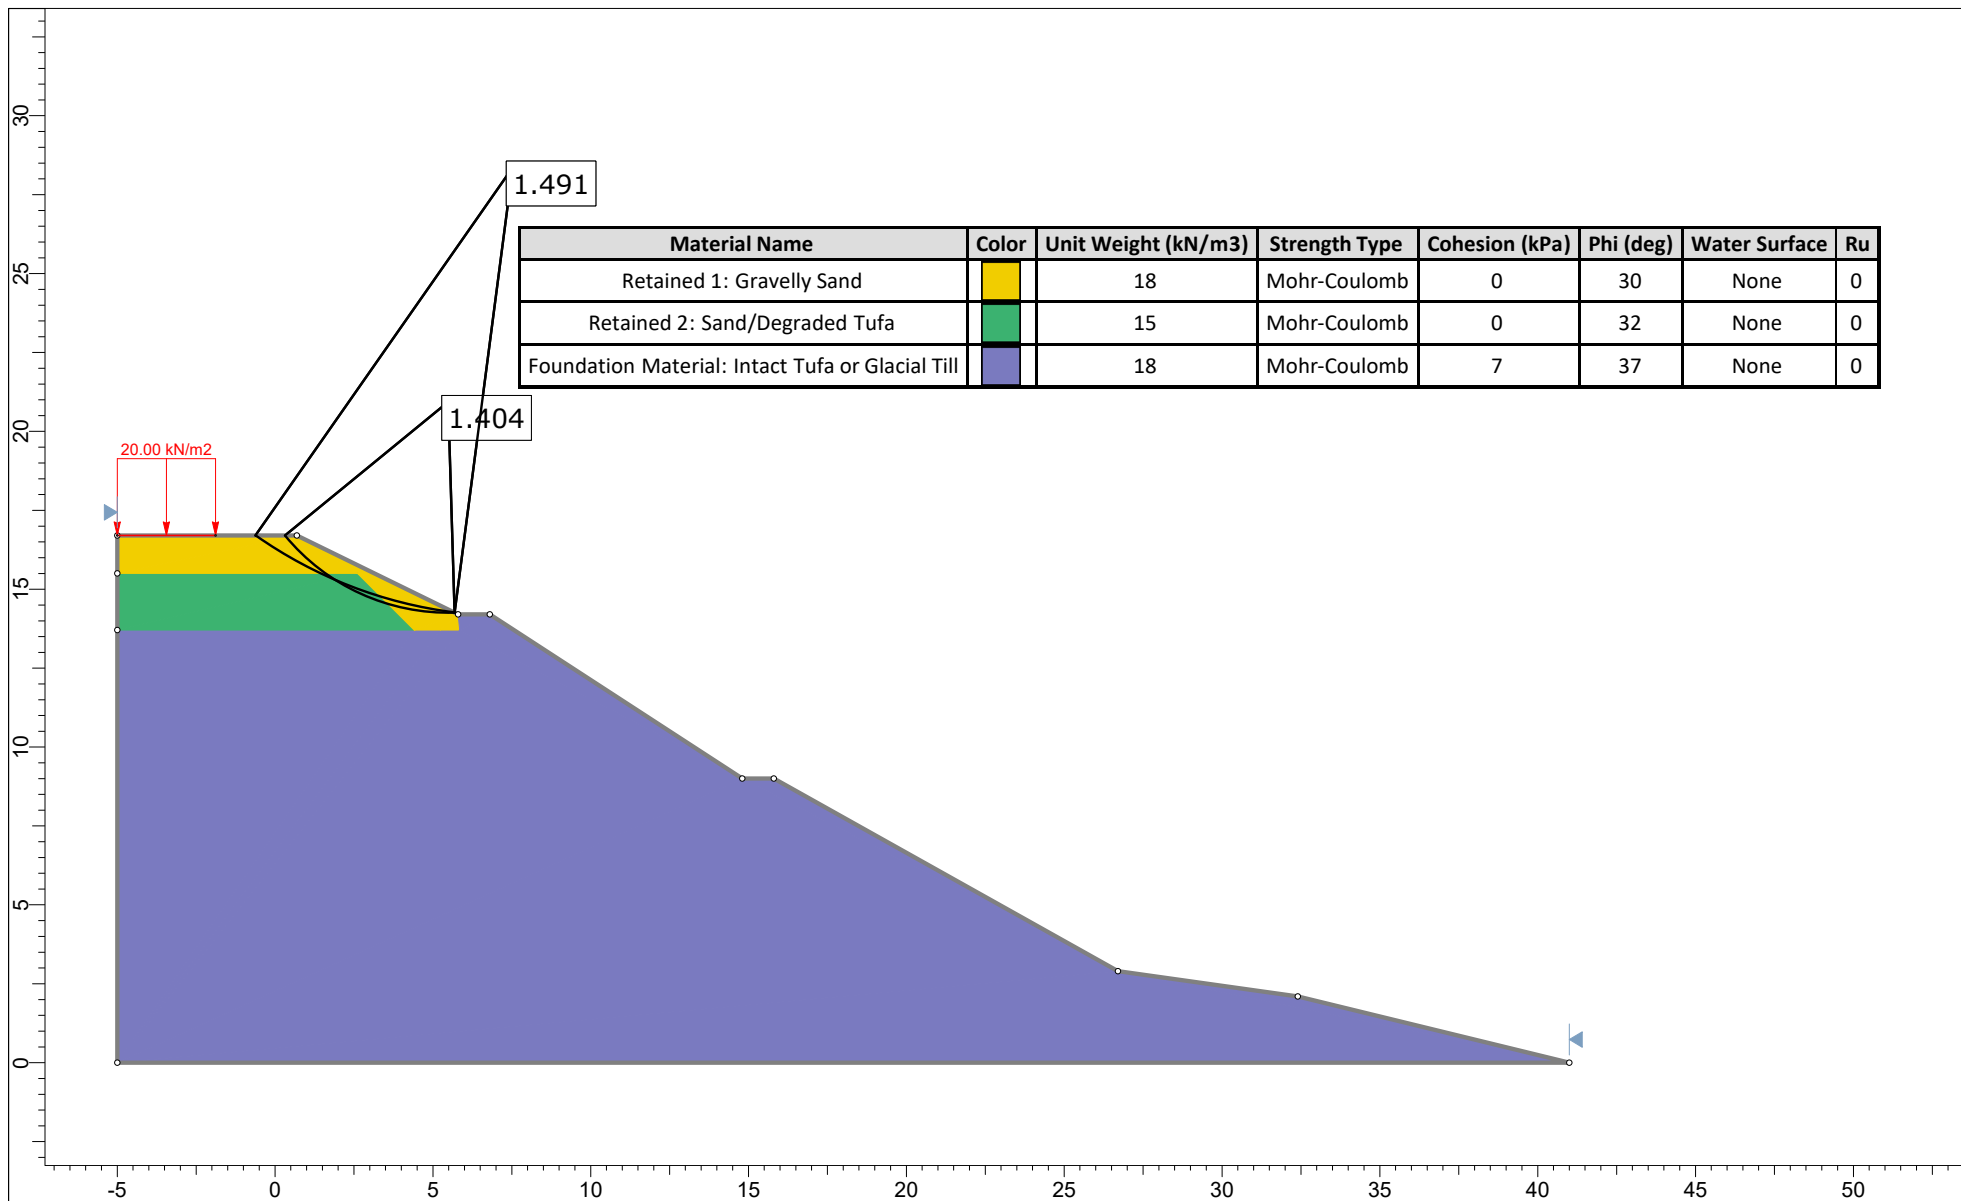
- Figure 3A depicts the condition with the existing fill materials left in place with negligible effort to replace and recompact. The minimum factor of safety in this case was 1.2 (for a surficial failure surface). FOS results of 1.4 to 1.5 were observed for material failure modes.

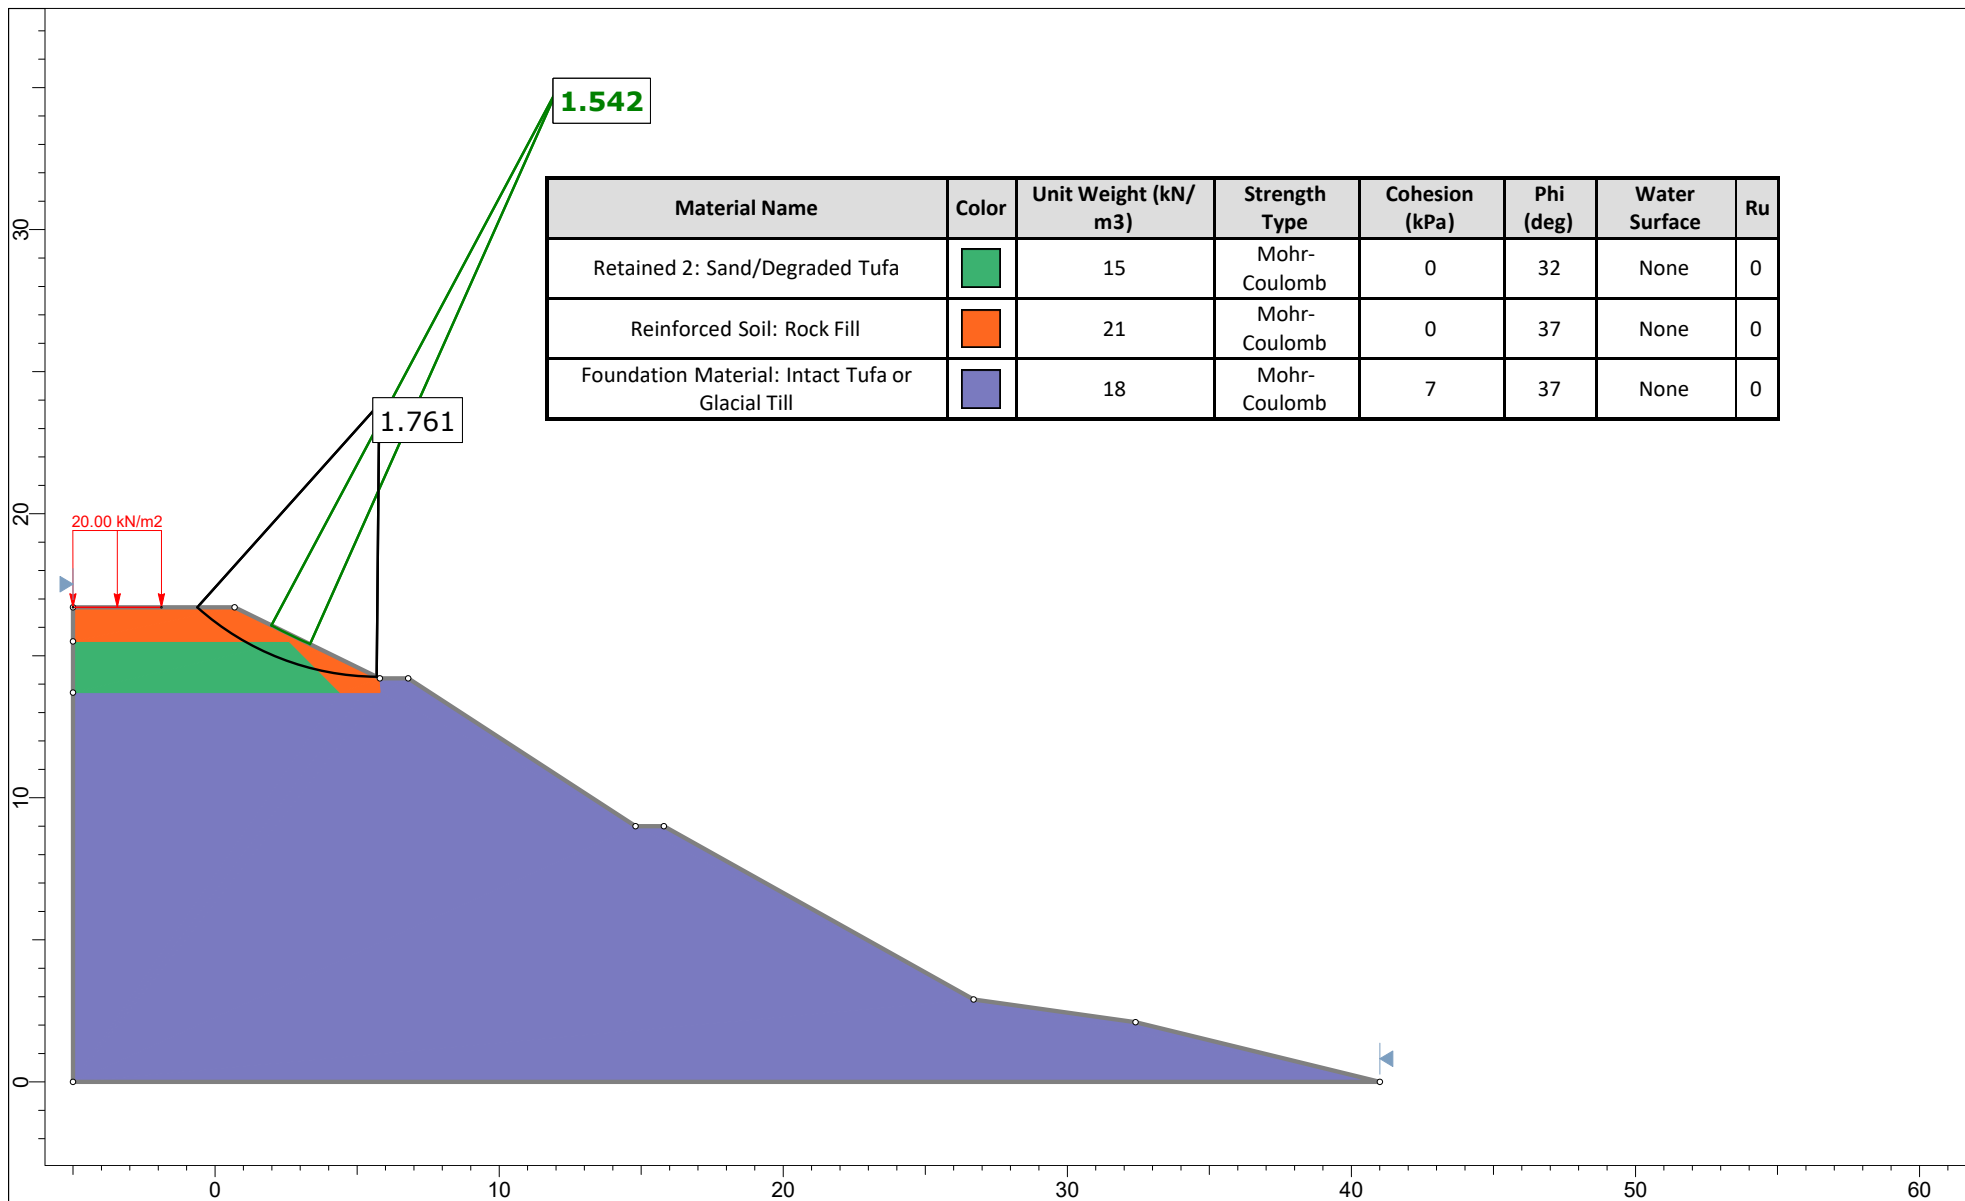
- Figure 3B presents the condition where an existing deleterious fills are removed with angular rock or engineered sand and gravel fill materials. The minimum FOS was 1.5 for a surficial failure. FOS values of 1.7 to 1.8 were observed for material failure modes.

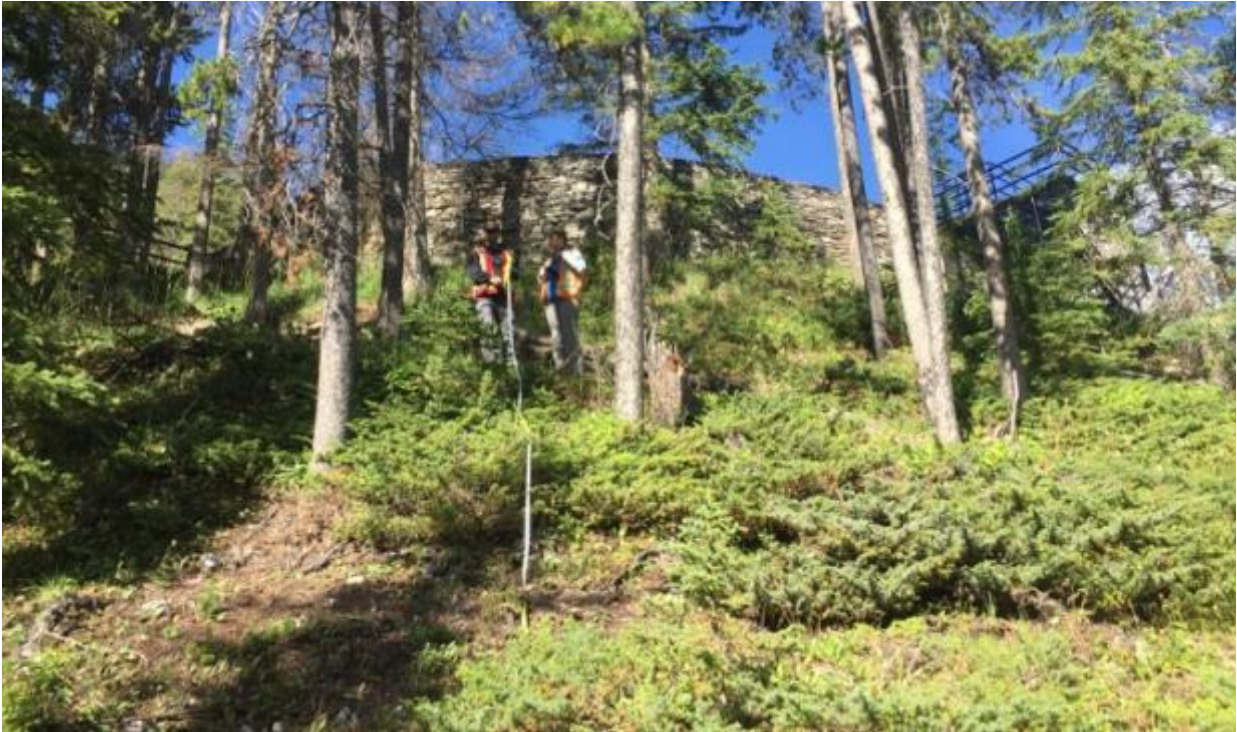
Photo 1: Looking NW towards the retaining wall.

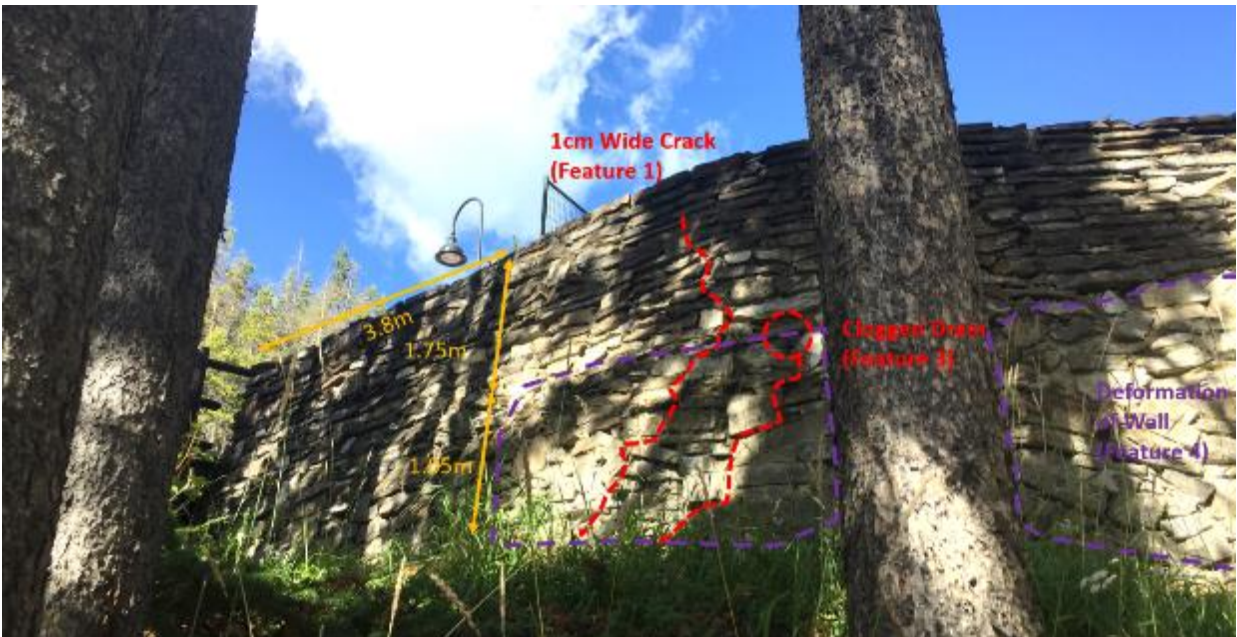
Photo 2: West end of retaining wall

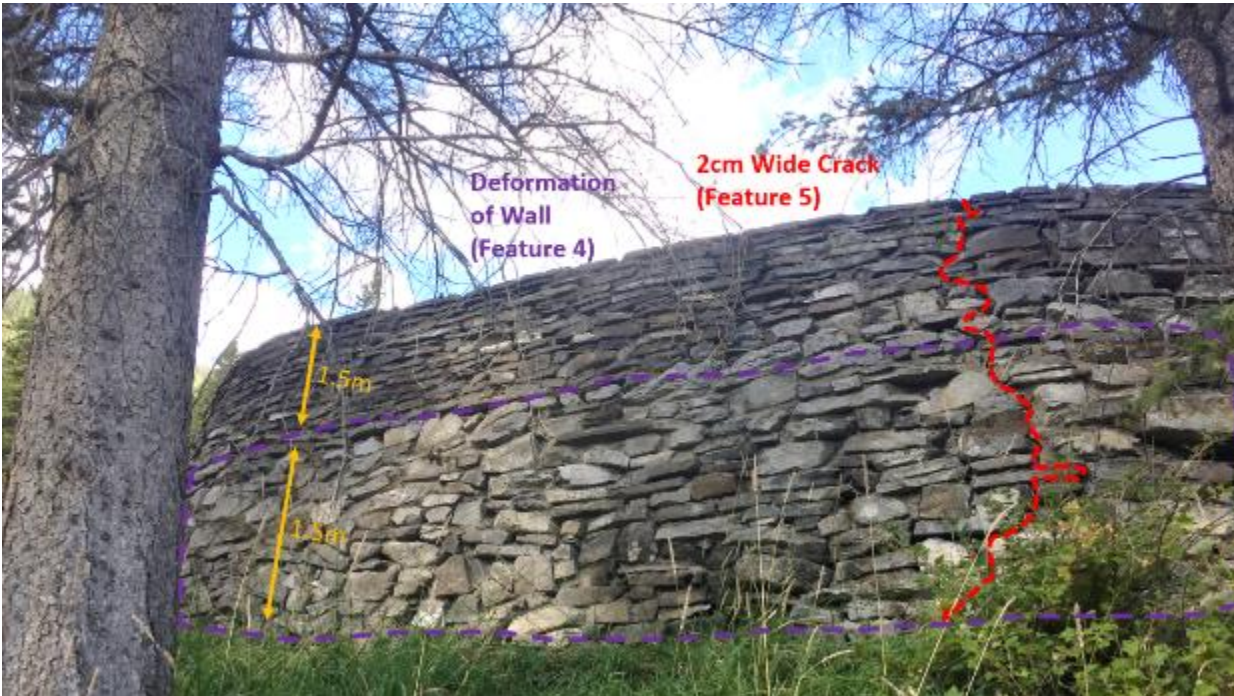
Photo 3: Middle left section of retaining wall. Photo taken looking north/northwest.

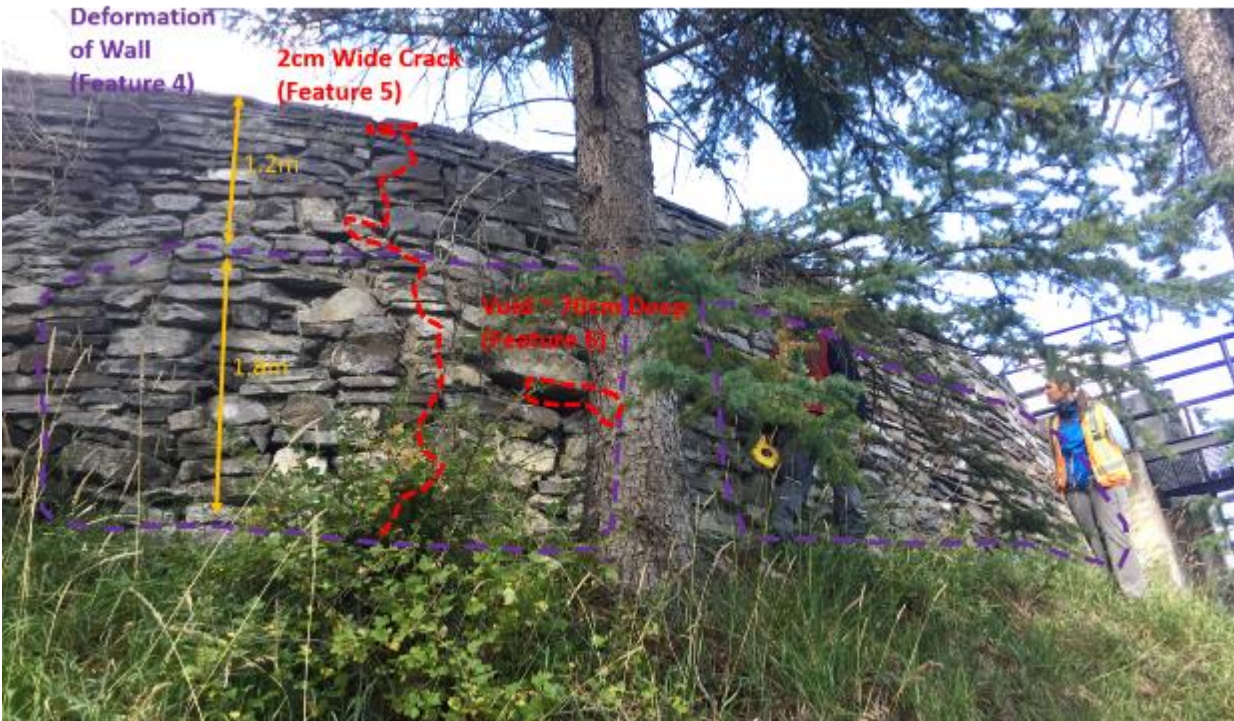
Photo 4: Middle right section of retaining wall. Photo taken looking west.

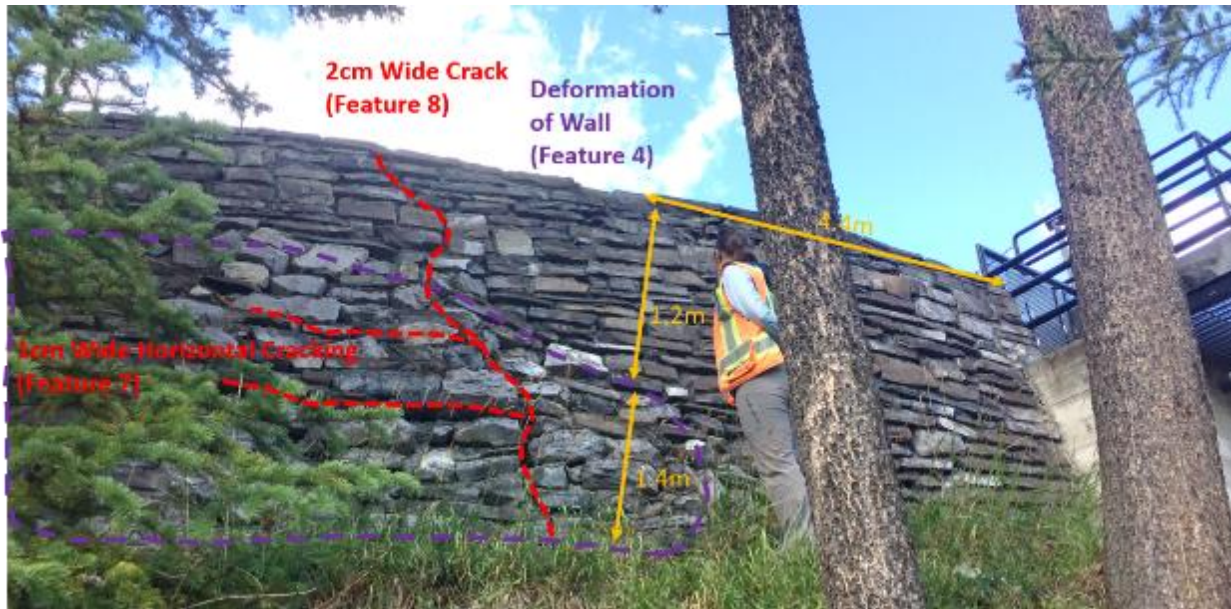
Photo 5: North end of retaining wall.

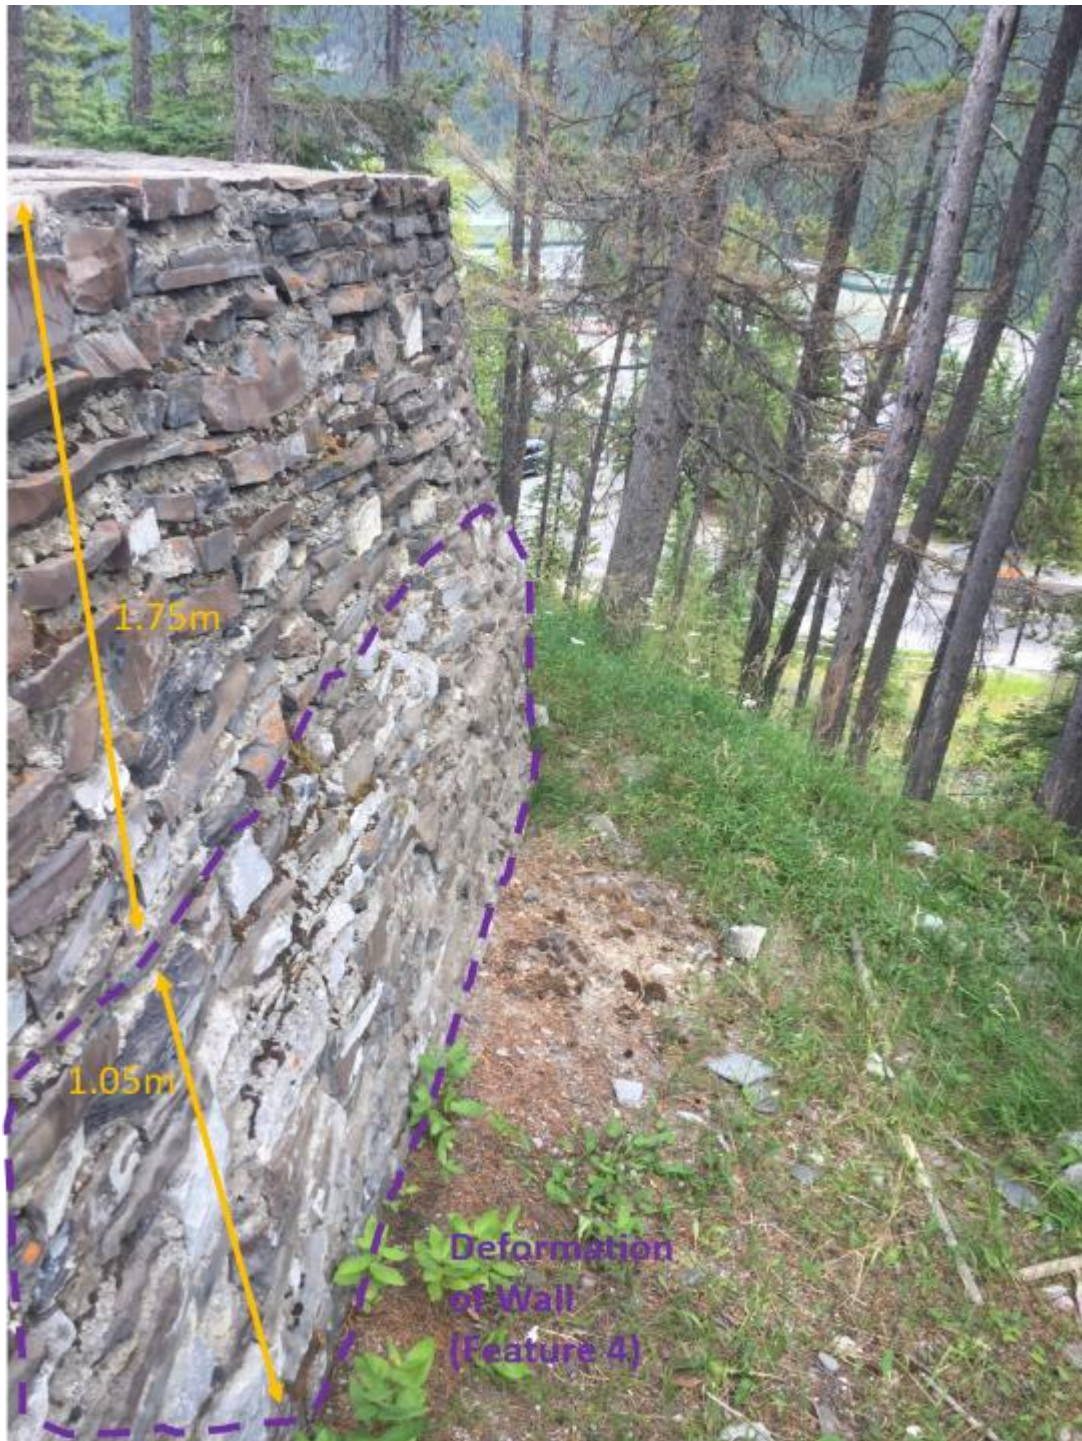
Photo 6: West end of retaining wall. Photo taken from the upper pathway looking east.

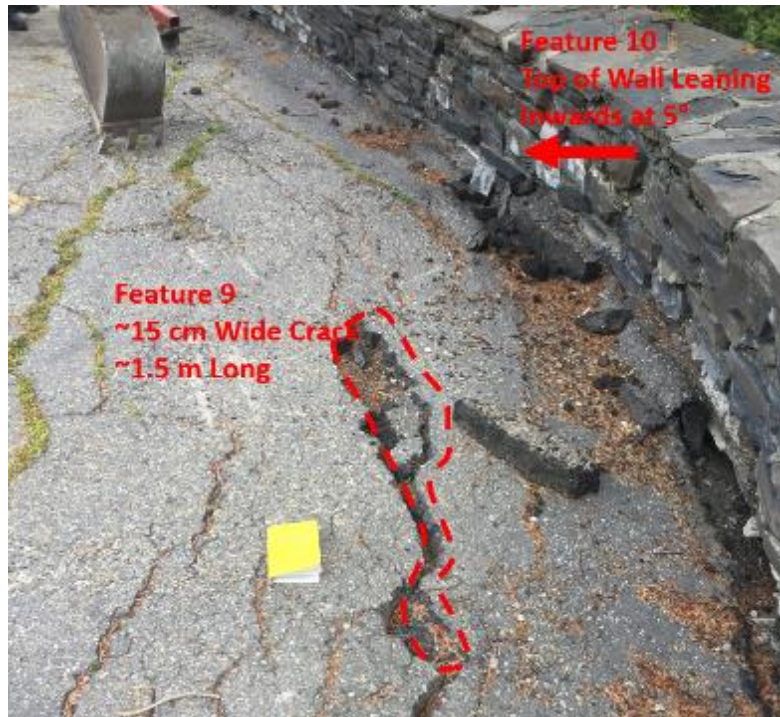
- Significant pavement distress occurred earlier in 2020 with development of open cracks and voids immediately behind the structure.
- Bulging of the lower portion of the retaining wall indicates that insufficient lateral support was provided by the retaining wall for the loading conditions. This is particularly apparent at and immediately above the base of the wall.

Photo 7: Asphalt deformations located approximately at the center of the wall.

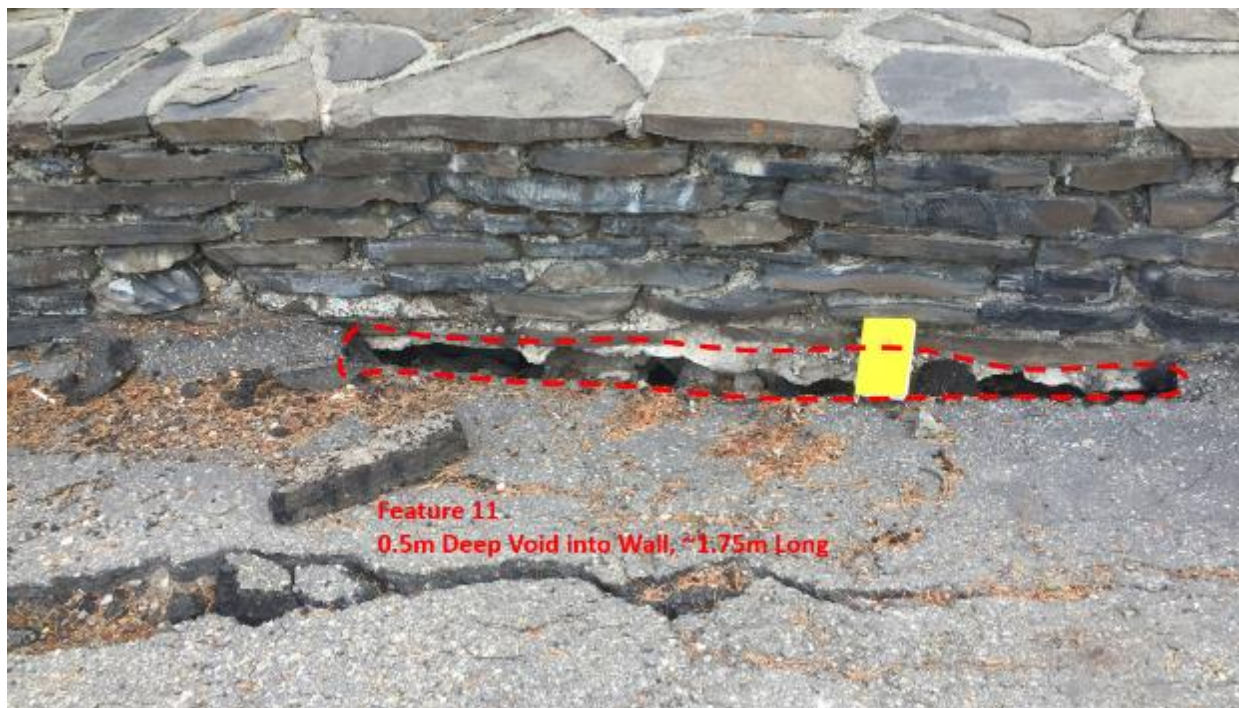
- As noted above, granular materials have mobilized behind the retaining wall. Due to degradation of the mortar, granular material has moved through the structure and has been deposited along the lower stacked rock and at the toe. Movement of soil likely accelerates at times of heavy surface water flow (e.g., rainfall events and during snow melt) as water can flow freely through the cracks along the asphalt surface. This has left significant voids behind the retaining wall.

Photo 8: Void and asphalt degradation.

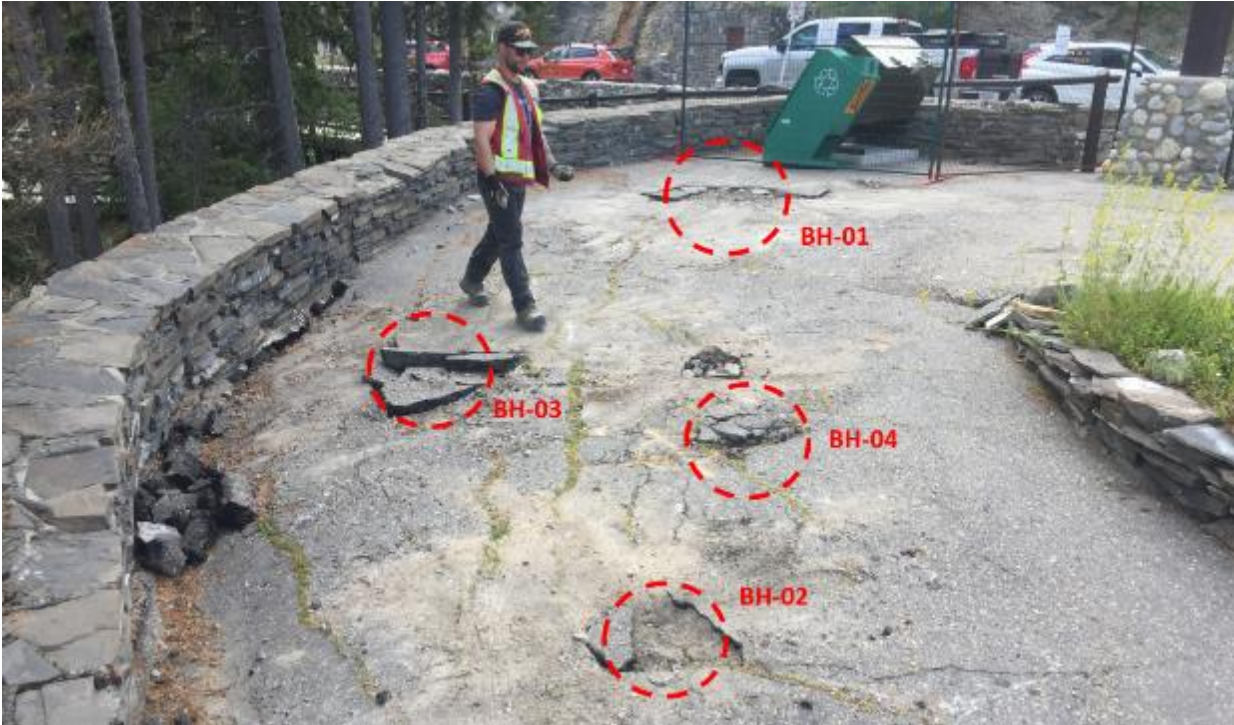
The following section summarizes the observed subsurface soil and groundwater conditions at the time of the investigation. All boreholes were advanced along the ground surface behind the retaining wall. Please note variability in ground conditions may exist between boreholes and with depth. Borehole logs and laboratory testing results are presented in Figure 1. Approximate borehole locations are presented in Photo 10 of Appendix B.

Photo 10: Location of the boreholes. Photo taken looking south.
