## **APPENDIX A**

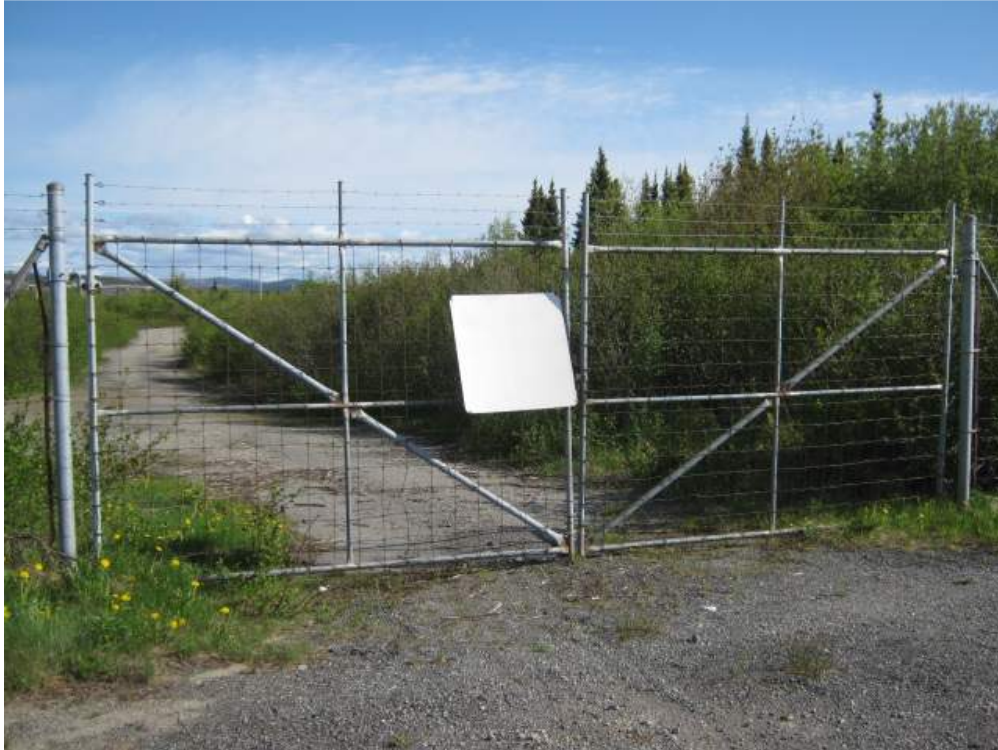
Photo 1 – North vehicle gate access (manual swing) (Sta. 0+700).

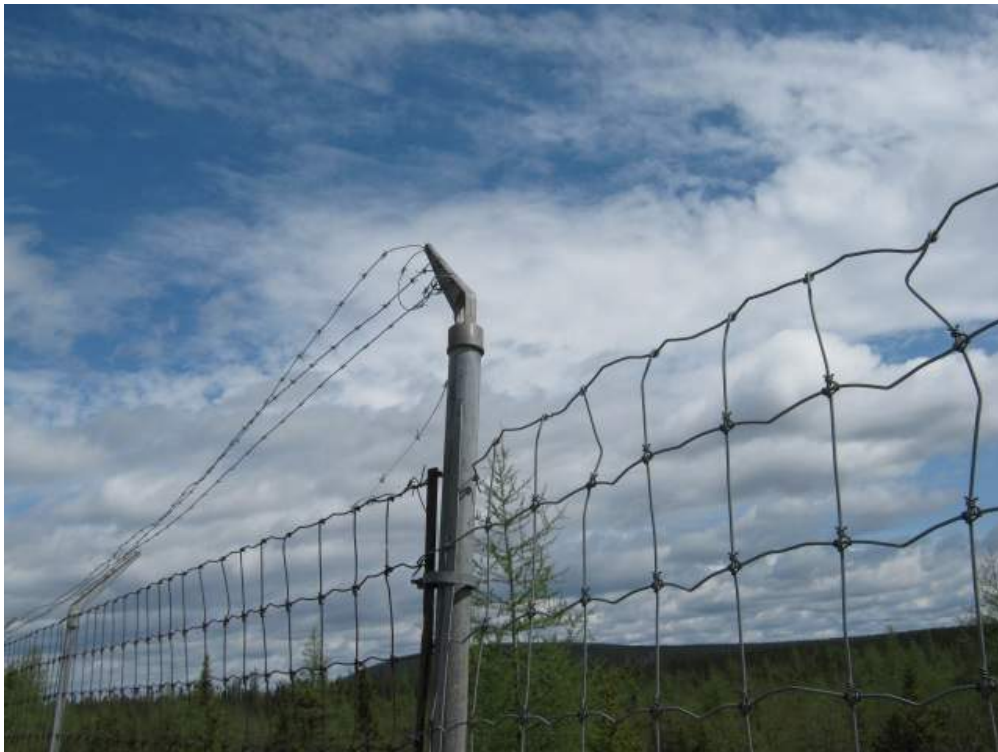
Photo 2 – Start of no barbed wire overhang (BWO) on east fence line (Sta. 1+884).

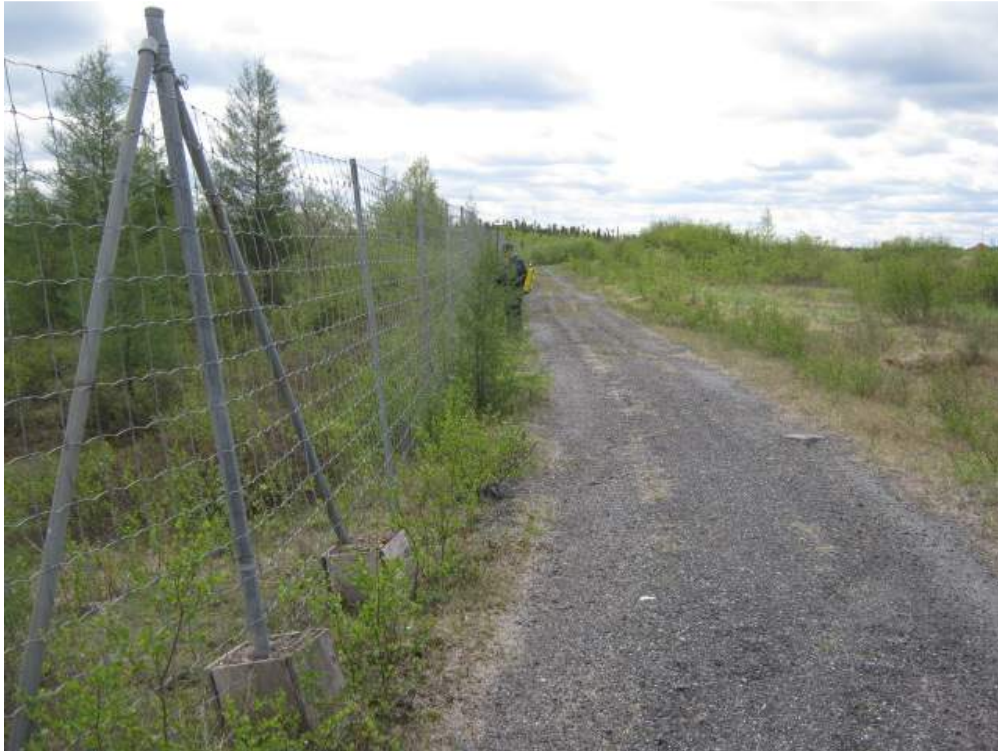
Photo 3 – Outward leaning fence along southeast fence line. Light brush and missing BWO (Sta. 2+631).

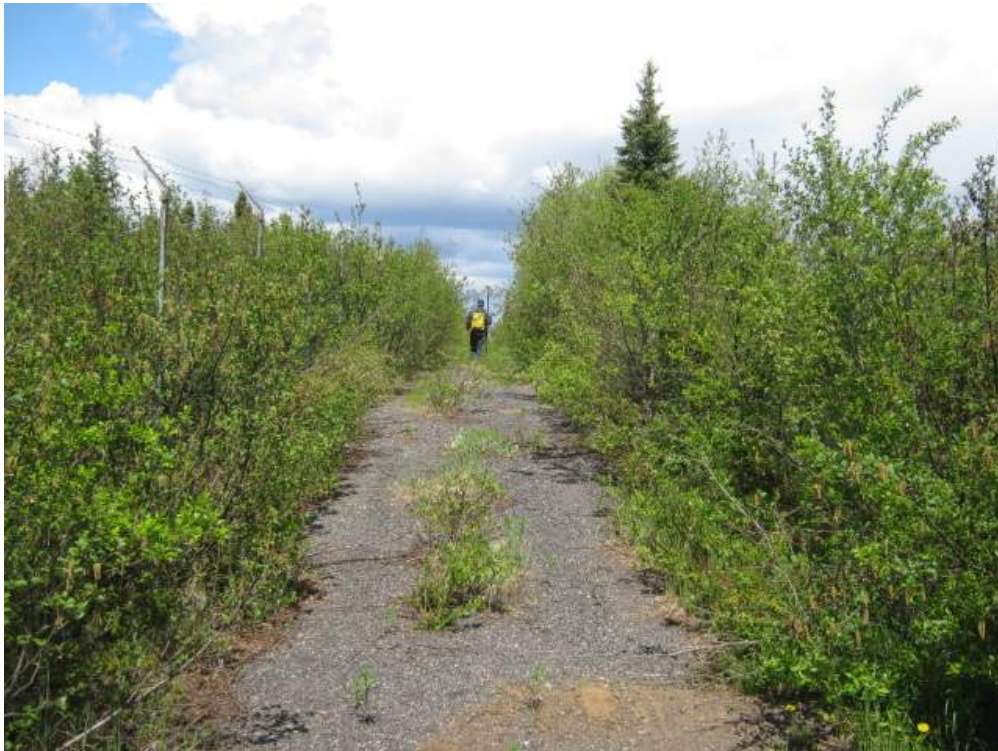
Photo 4 – Heavy brush along northwest perimeter access road (Sta. 0+200).

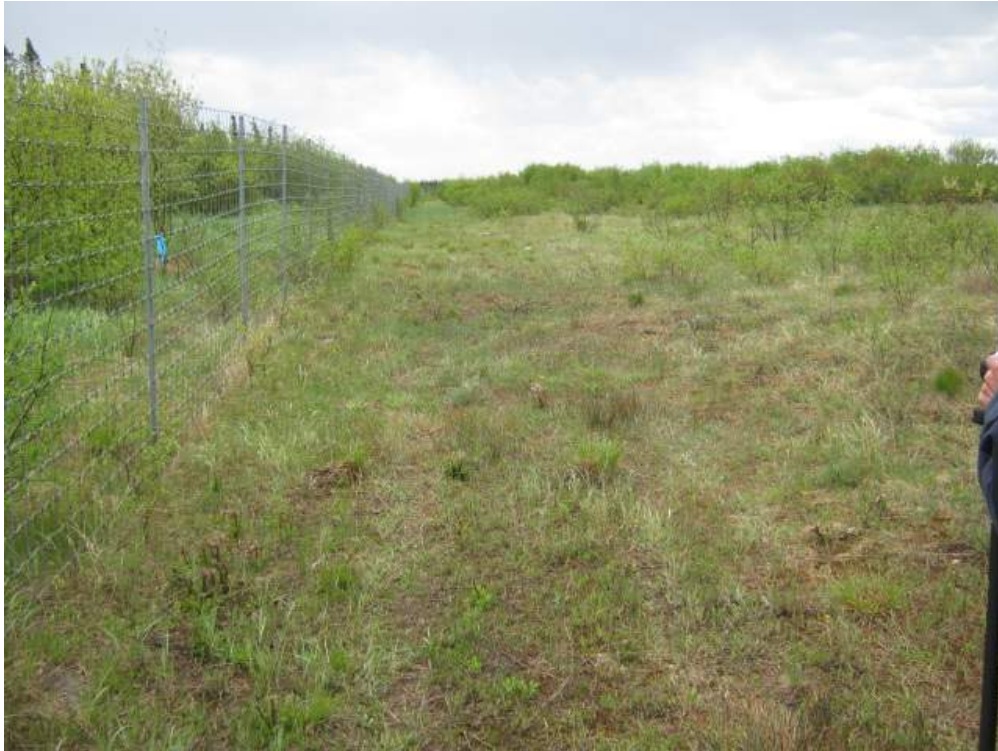
Photo 5 – End of perimeter access road along southeast fence line. Light brush and missing BWO (Sta. 2+818).

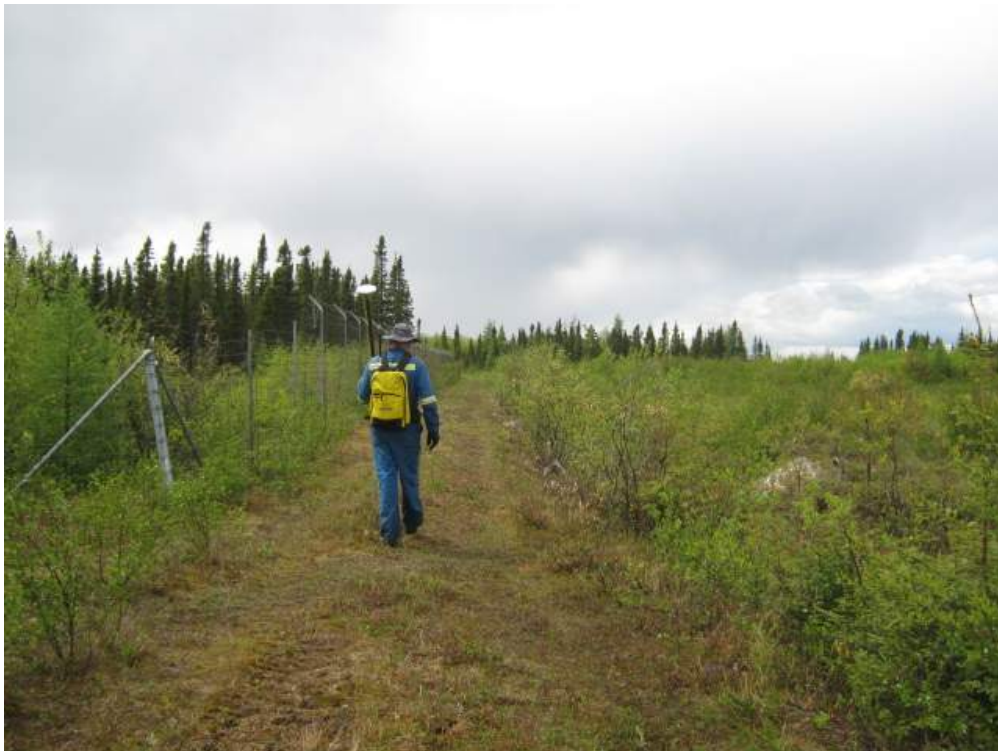
Photo 6 – Perimeter access road along south fence line. Wet/bog areas, light brush and missing BWO (Sta. 3+658).

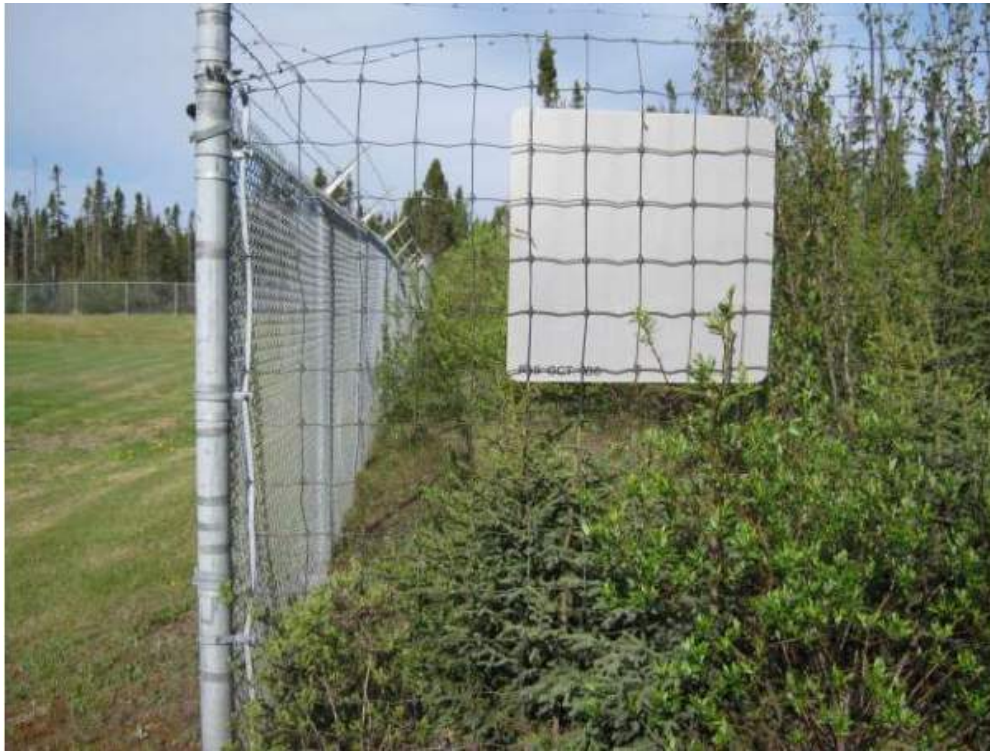
Photo 7 – Transition from chain link fence to wildlife fence. Heavy brush (Sta. 0+144).

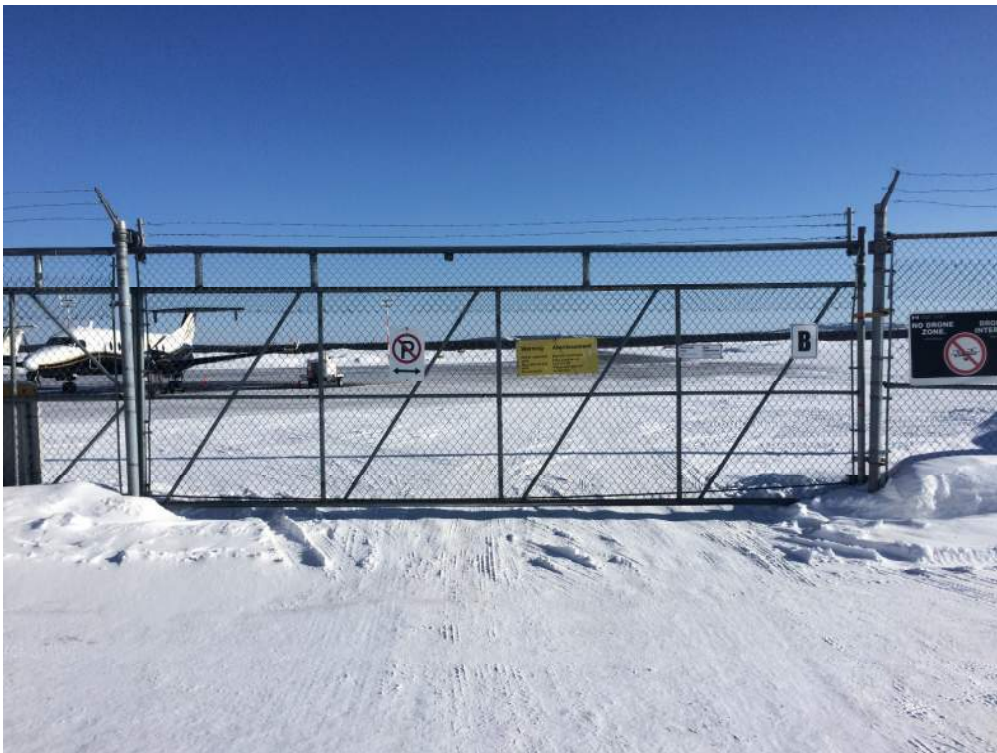
Photo 8 – Automated rolling Gate B near ATB.

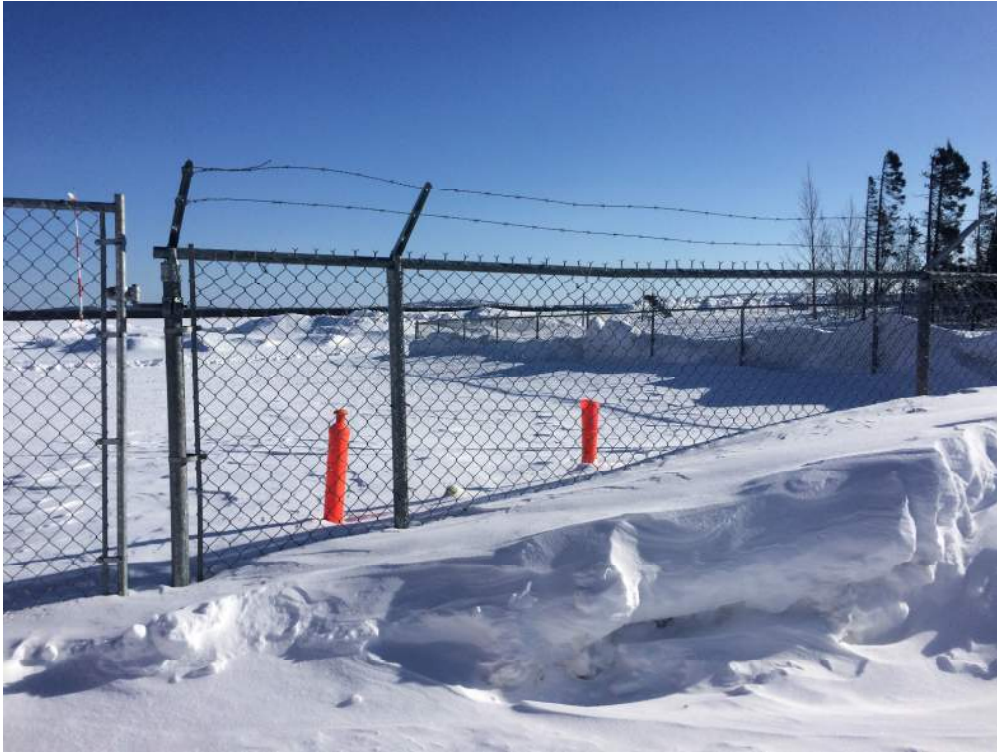
Photo 9 – Chain link fence missing BW strand on south side of Hangar (Sta. 5+400).

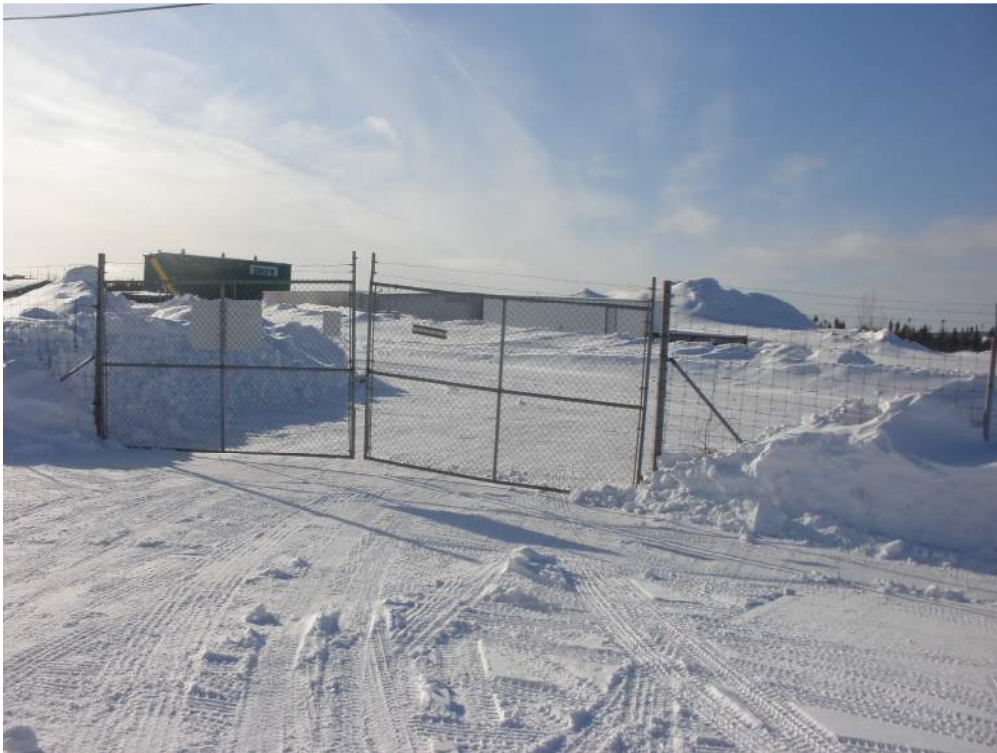
Photo 10 – Misaligned manual swinging vehicle gate along southwest fence line (Sta. 4+032).

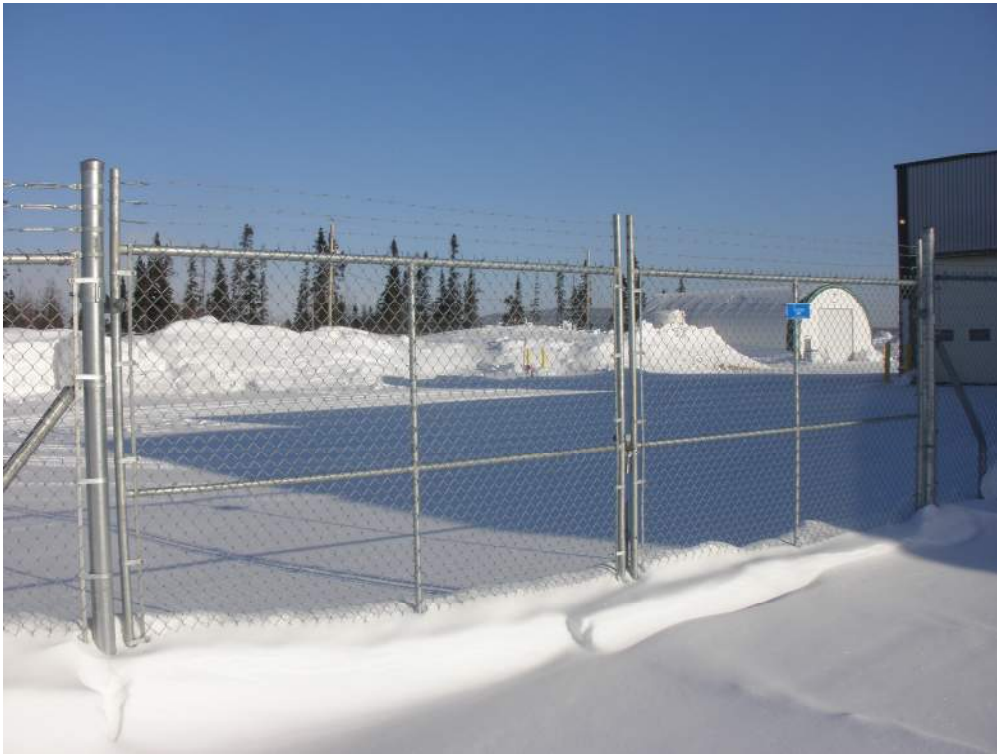
Photo 11 – Manual vehicle swing gate (A1) near the CSB.

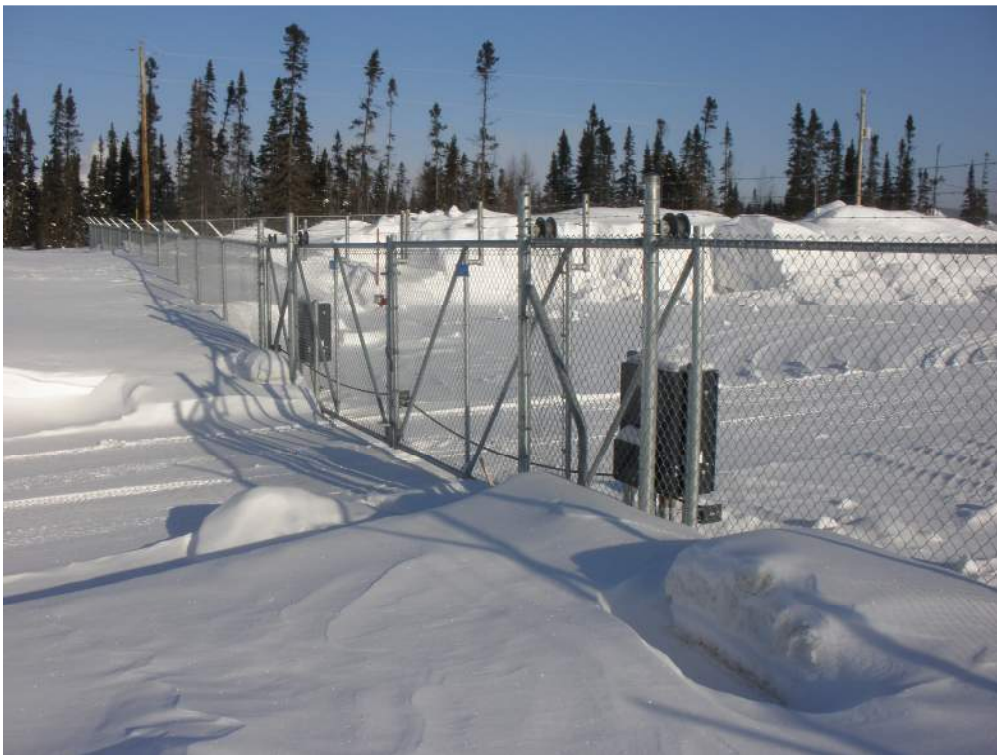
Photo 12 – Automated rolling gate (A2) near the CSB.

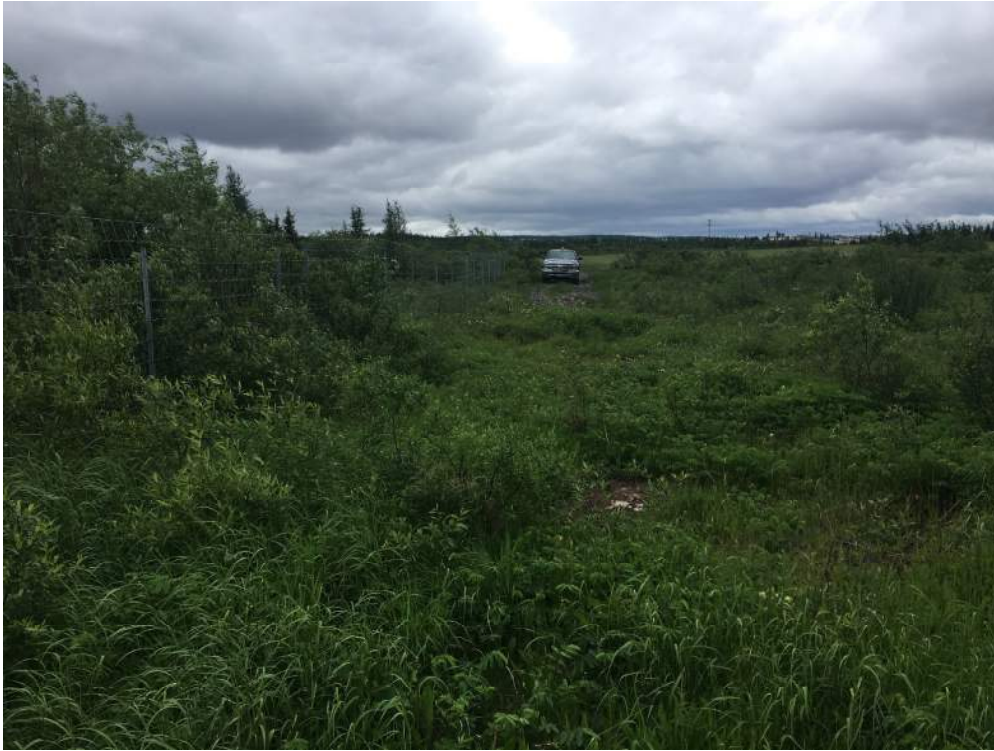
Photo 13 – Northeast corner of site where no access road is in place (Sta. 3+100).

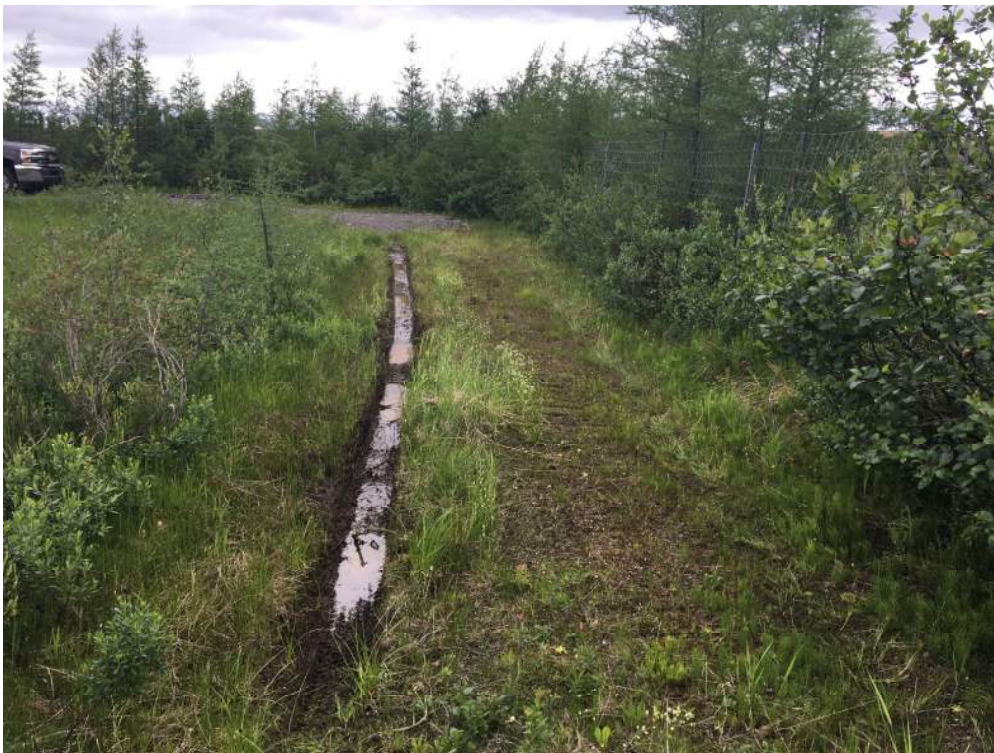
Photo 14 – Muddy access road (Sta. 3+250).

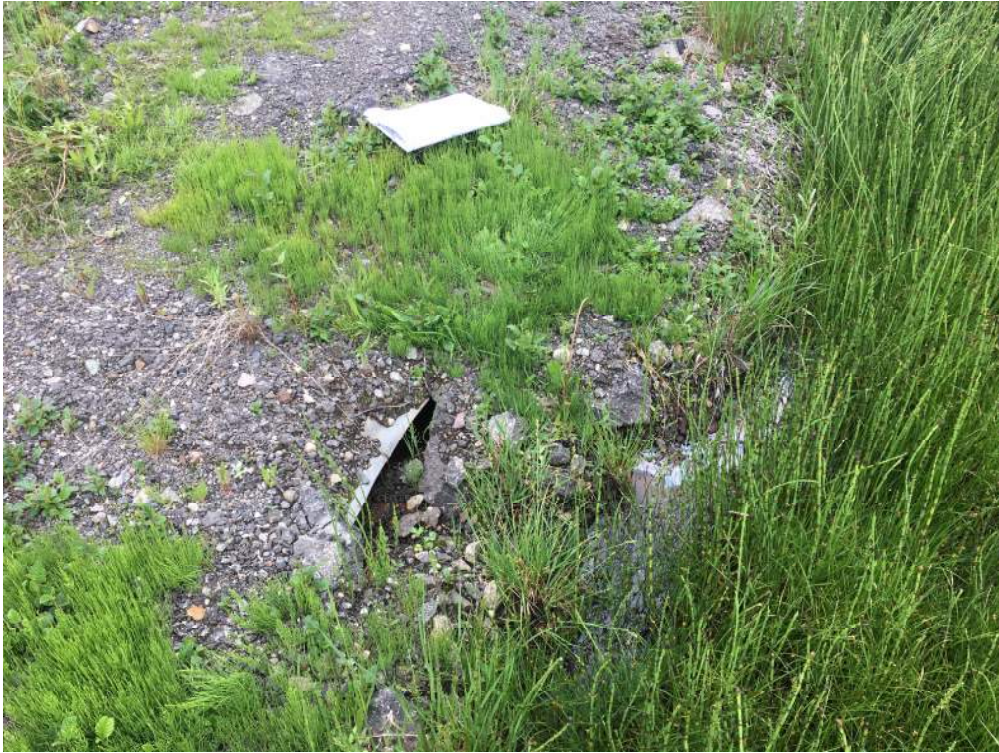
Photo 15 – Crushed culvert end and debris (Sta. 3+350).

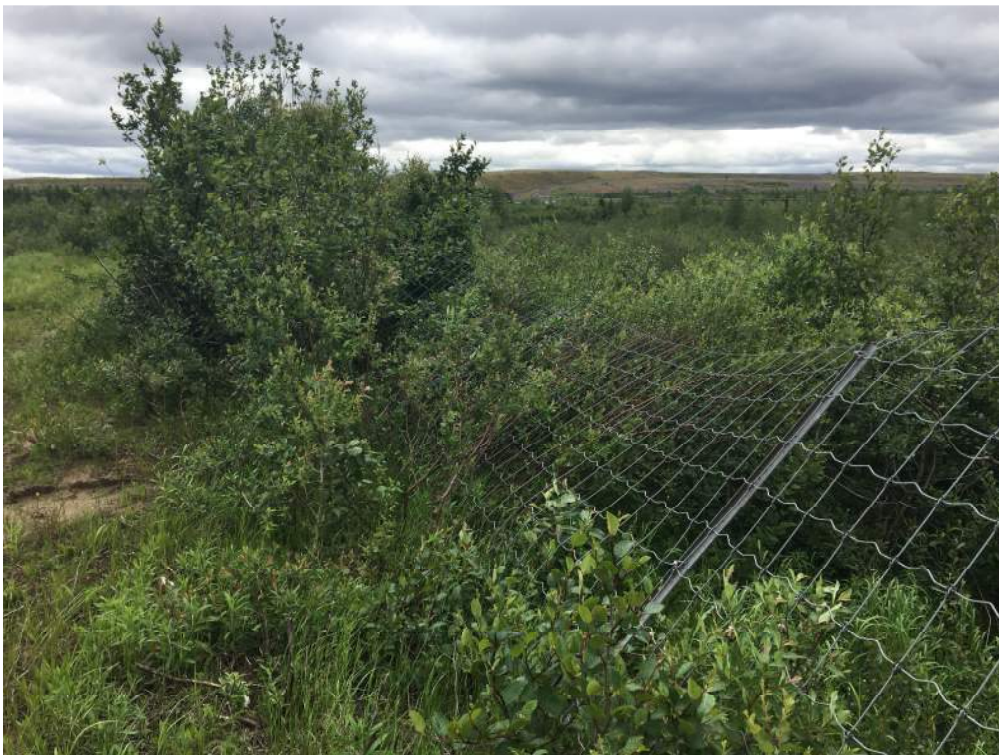
Photo 16 – Leaning fence and bent T-bar posts (Sta. 3+360).

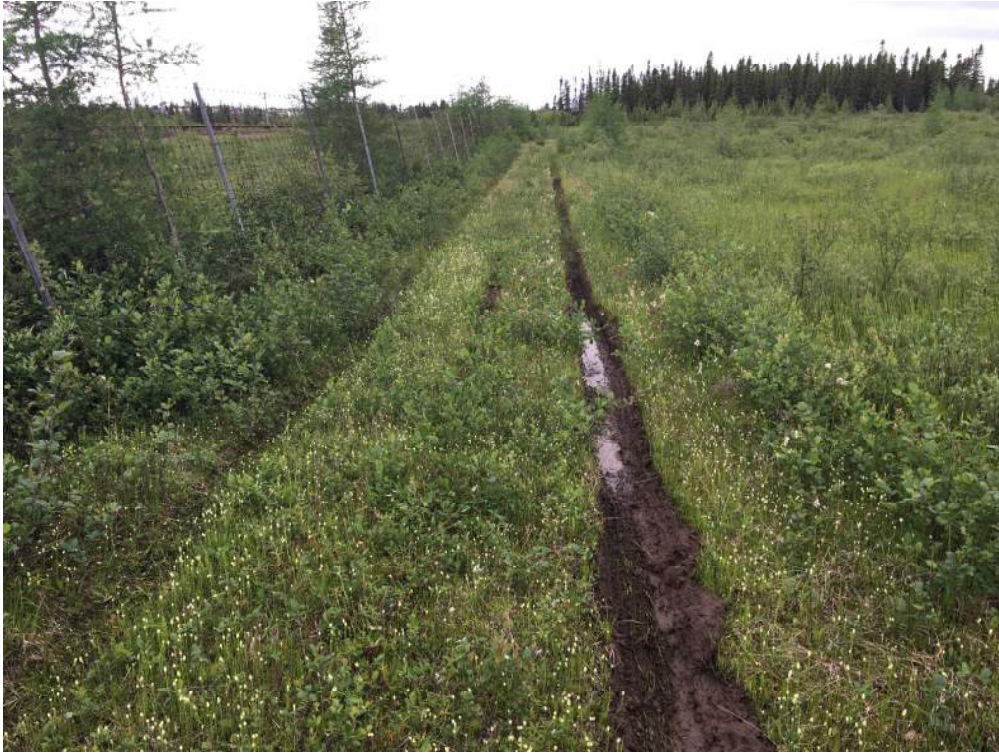
Photo 17 – Muddy access road (Sta. 3+418).

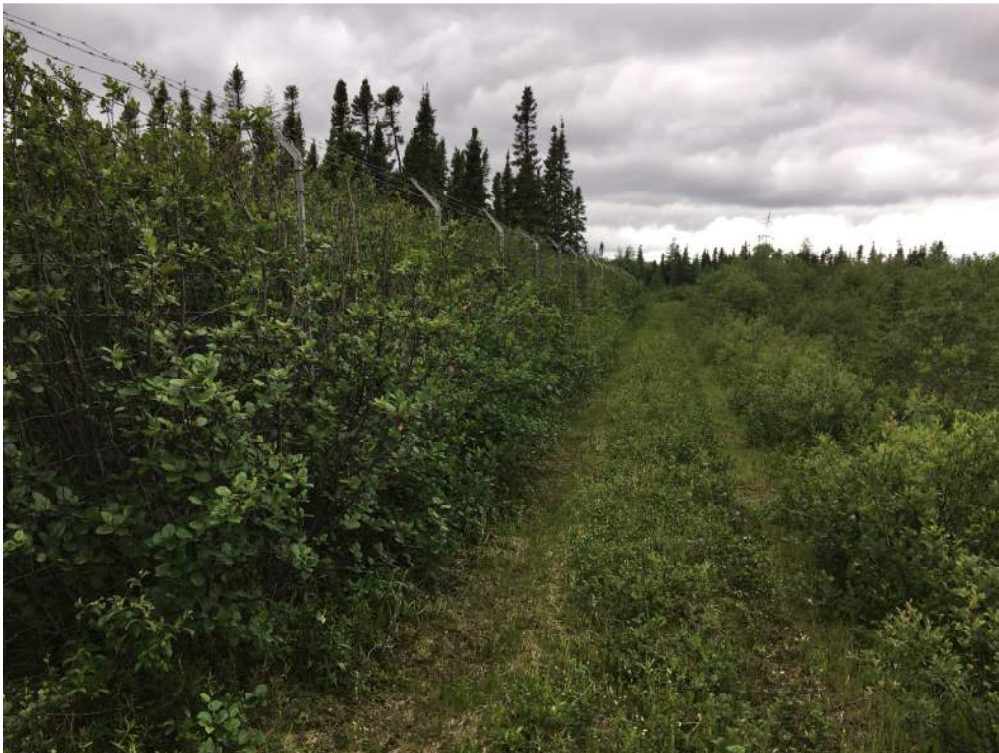
Photo 18 – Heavy brush (Sta. 3+650)

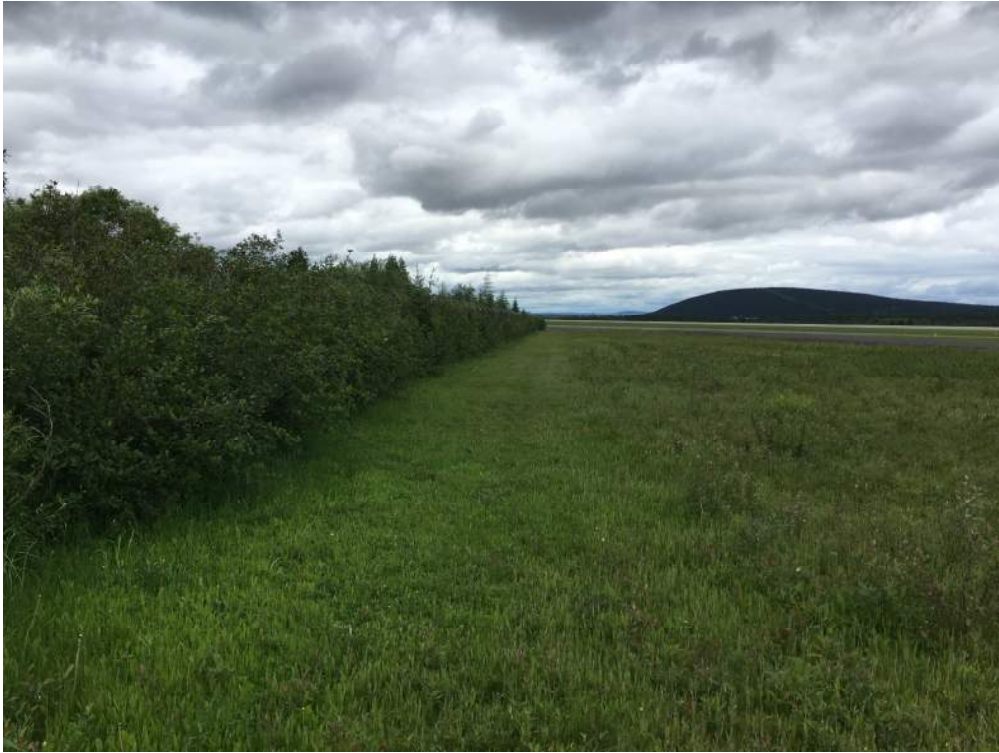
Photo 19 – Heavy brush (4+350)

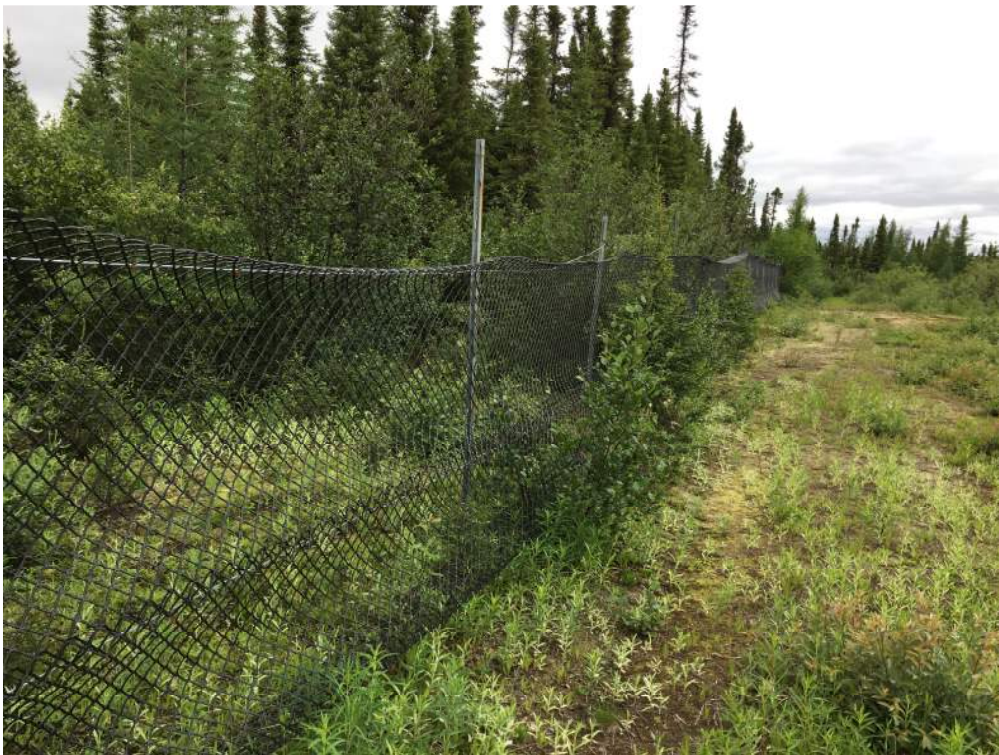
Photo 20 – Snow fence (Sta. 4+550).

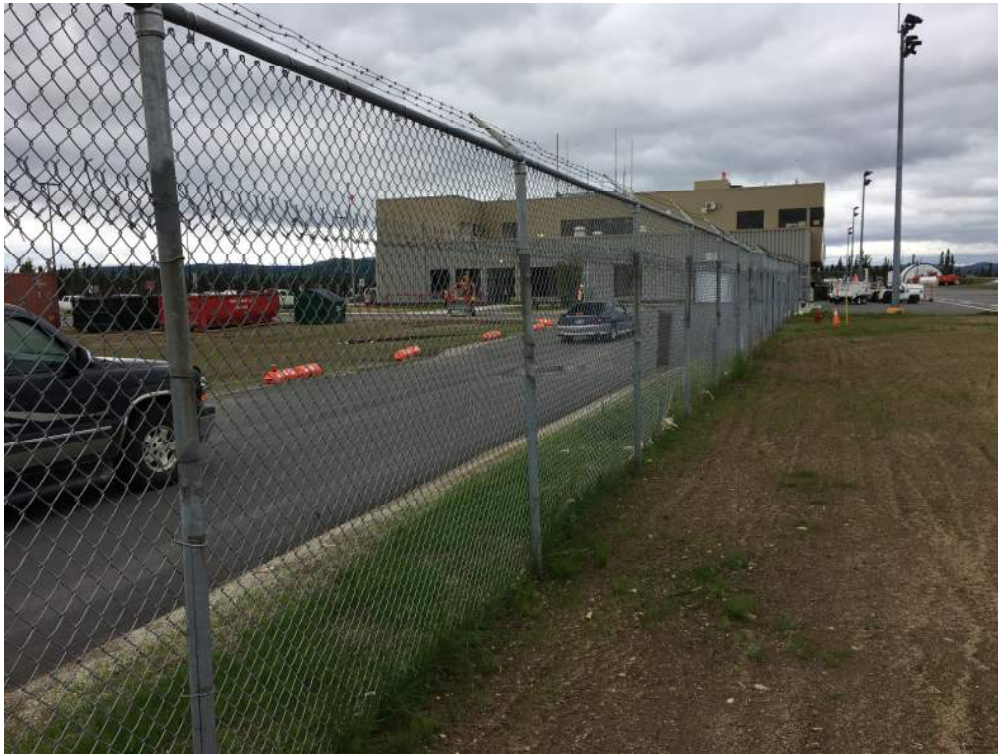
Photo 21 – Security fence between ATB and Hangar.

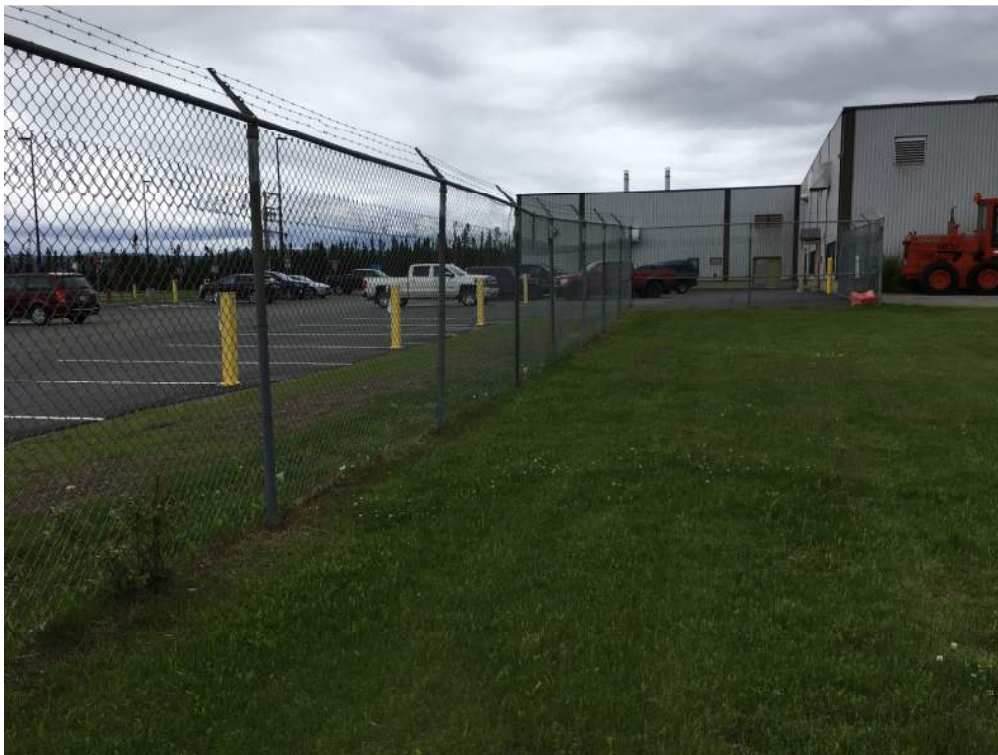
Photo 22 – Security fence between ATB and CSB.

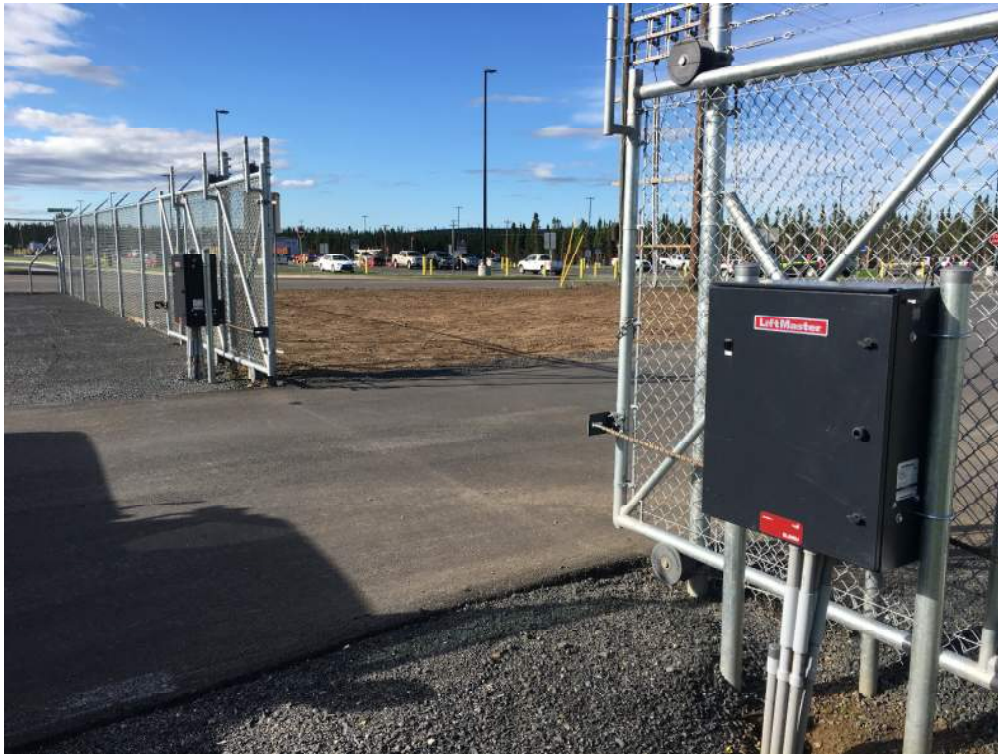
Photo 23 – Automated rolling gate at the CSB.

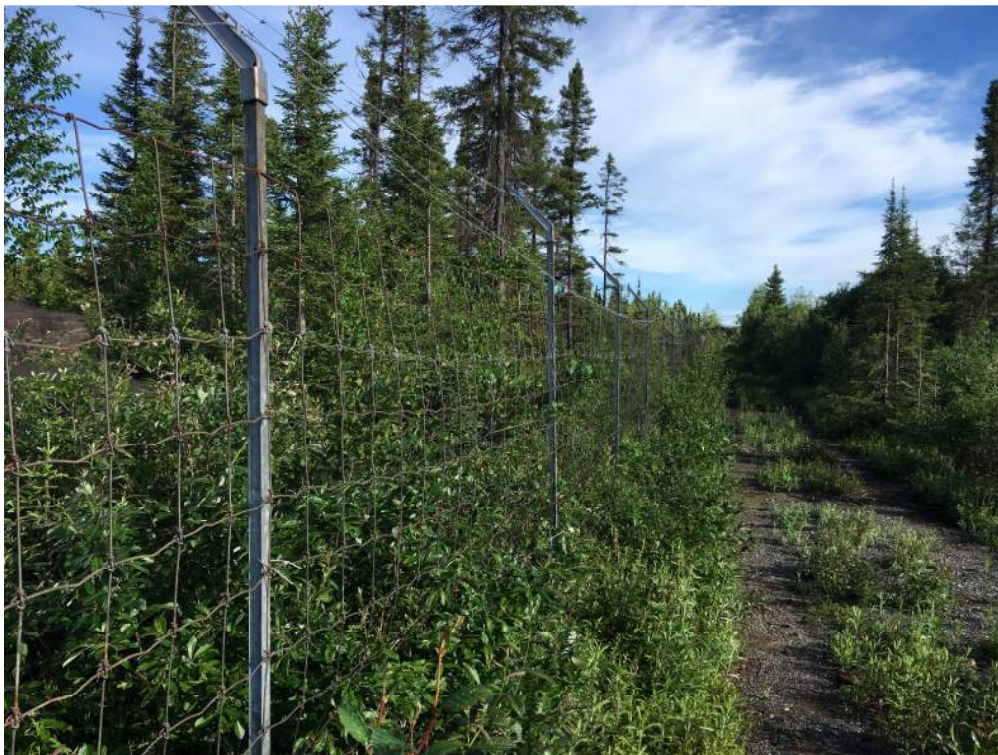
Photo 24 – Loose barb wire and mesh (Sta. 0+200).

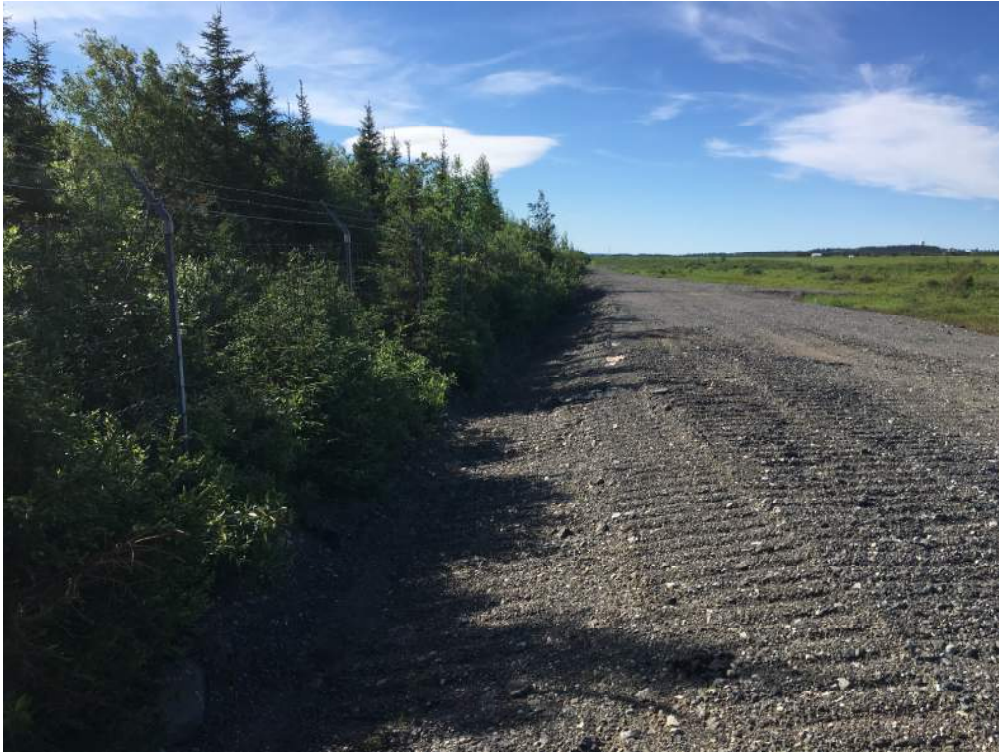
Photo 25 – Heavy brush and leaning fence (Sta. 1+200)

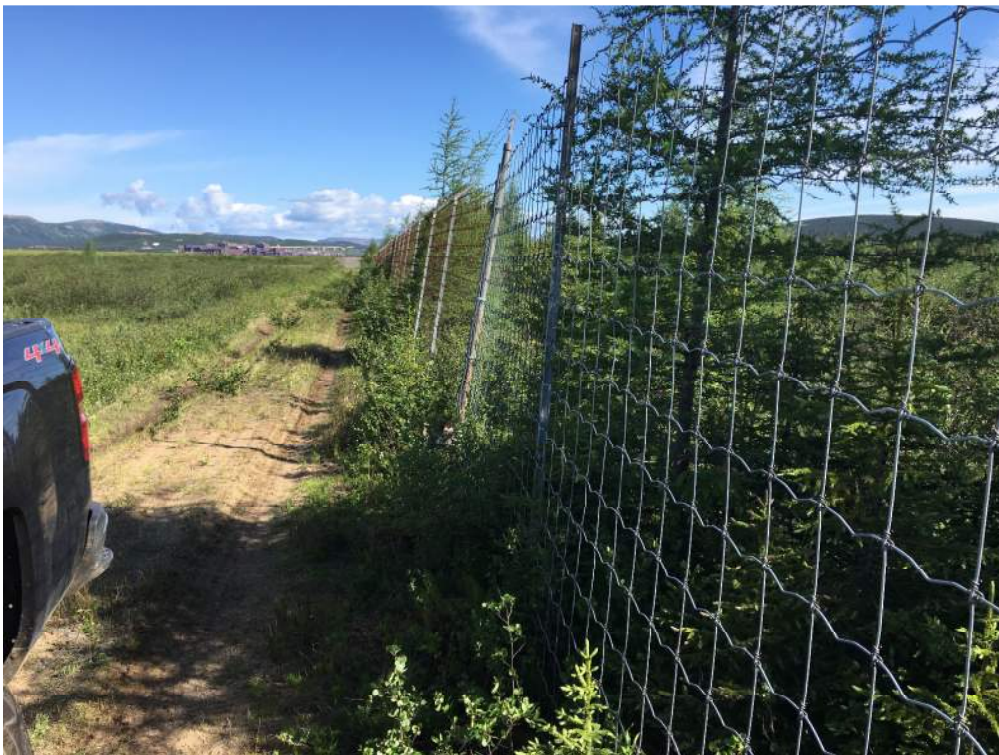
Photo 26 – Leaning fence (Sta. 2+000).
