**HAZARDOUS BUILDING MATERIALS ASSESSMENT
CARTWRIGHT FIELD OFFICE
DFRP# 56215
5 POINT ROAD, CARTWRIGHT,
NEWFOUNDLAND AND LABRADOR**

**Wood Environment & Infrastructure Solutions,
a Division of Wood Canada Limited**

March 2019

Wood Project #: TF17076811.1000

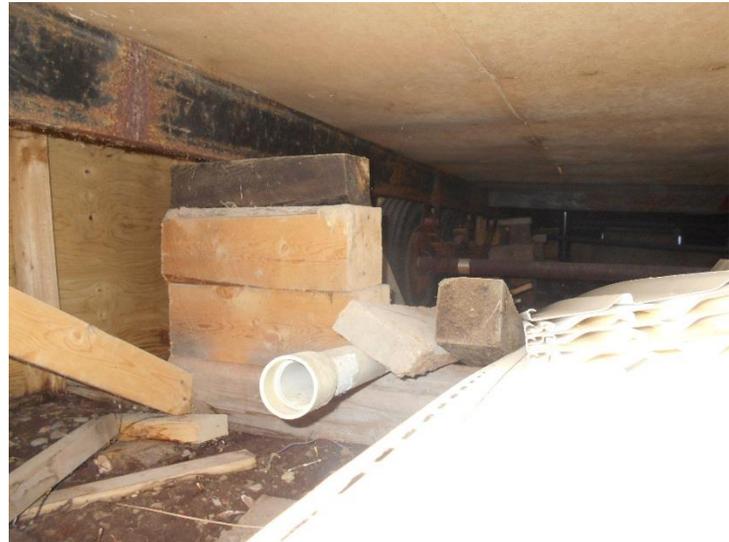
During the site visit, suspected “pressure treated” inorganic (i.e., CCA) preservatives appear to have been applied to the lumber that was used to construct the foundation of the Office Trailer.

Photo 4 – View of Office Trailer foundation.

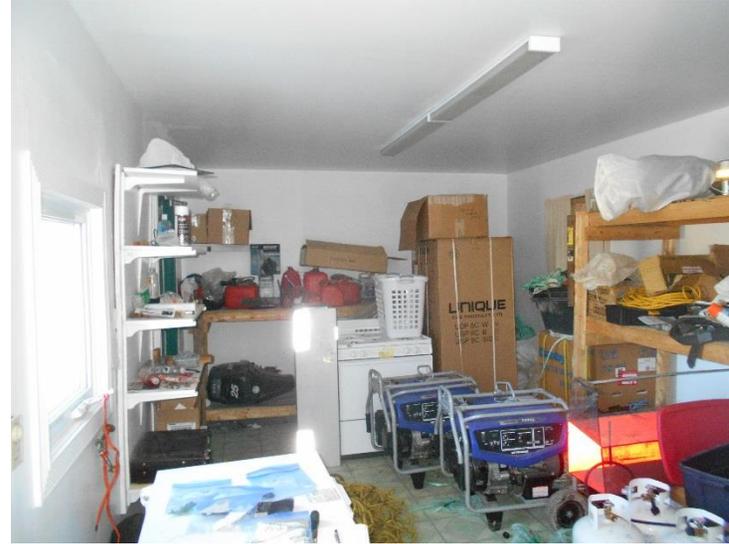
of work for the HBMA. Insulating fluids and cooling oils in electrical equipment (i.e., transformers, fluorescent light ballasts, capacitors, etc.) often contained PCBs until around 1980. Since the Office Trailer was reportedly constructed in 1983, it is possible that the light ballasts present in the building are PCB-containing. It is important to note that it was not known at the time of the site visit if some of the light fixtures observed contained LED or fluorescent light tubes, as the casings were not removed for inspection (refer to Photo 6, Appendix B).

Photo 6 – View of Room 2 (Main Room).

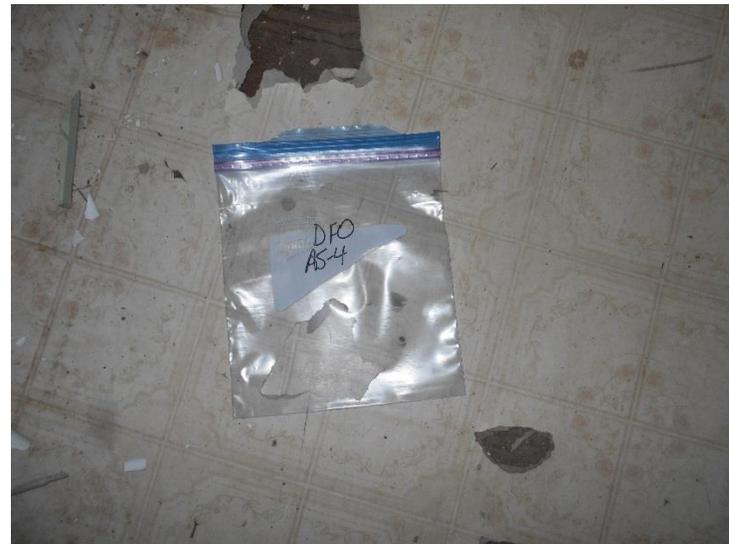
-)] Building materials containing greater than 1% asbestos by dry weight, which are considered to be asbestos containing materials (ACMs), are present in the form of vinyl sheet flooring inside the Office Trailer.

Photo 12 - View of bulk sample CA-AS-4 (beige and brown pattern vinyl sheet flooring).

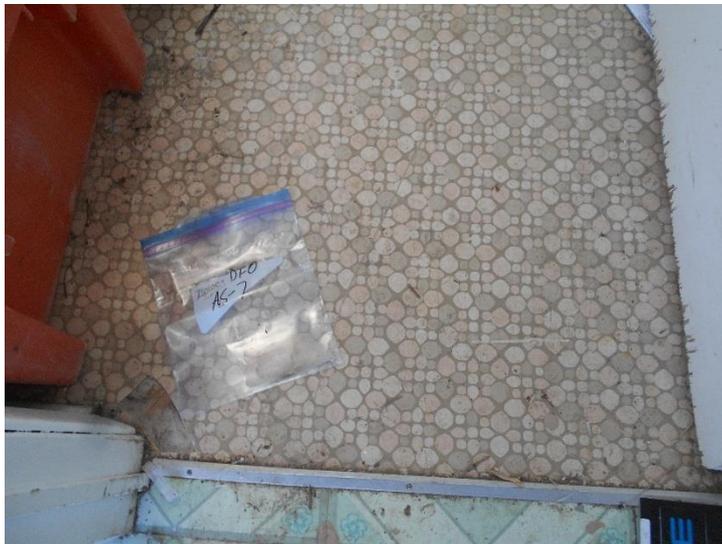
Photo 15 - View of bulk sample CA-AS-7 (beige pebble pattern vinyl sheet flooring with brown mastic).

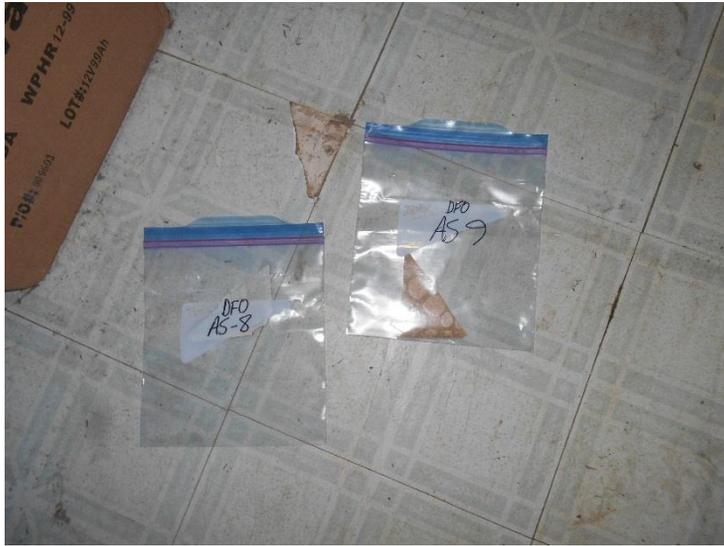
Photo 17 – View of bulk sample CA-AS-9 (beige pebble pattern vinyl sheet flooring with brown mastic), collected underneath bulk sample CA-AS-8.

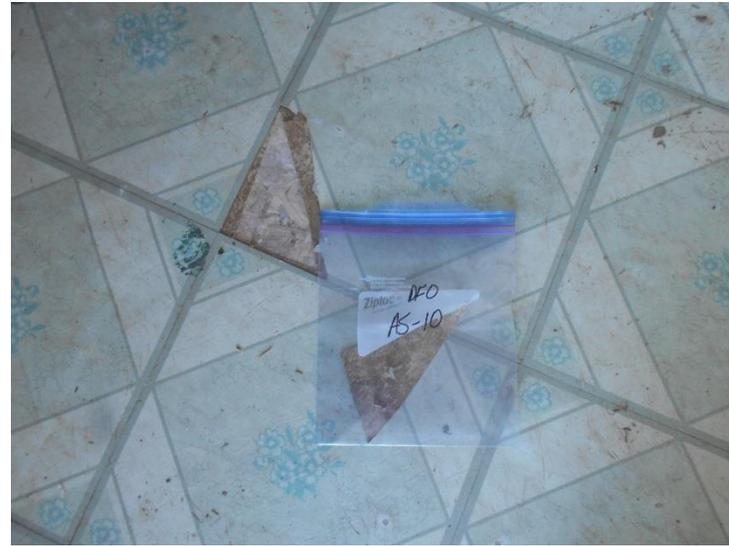
Photo 18 - View of bulk sample CA-AS-10 (beige vinyl sheet flooring and brown mastic), collected underneath bulk sample CA-AS-5.

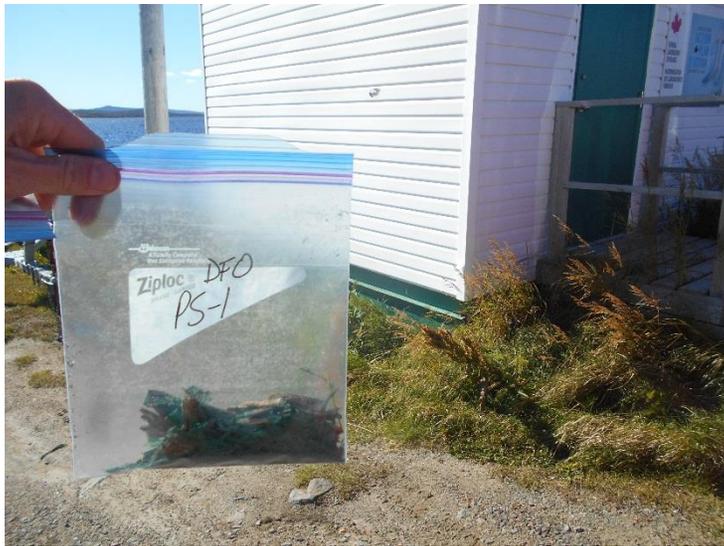
-)] Lead in Paint
 - Concentrations of lead in the three paint samples analyzed, including the duplicate sample, ranged from non-detect (<15 mg/kg) to 6,730 mg/kg.
 - Concentrations of lead in one paint sample, as well as the duplicate sample, exceeded the Federal Hazardous Products Act (HPA) criterion of 90 mg/kg. Additionally, the concentration of lead in the duplicate paint sample (CA-PS-DUP1) exceeded the Former Federal HPA criterion of 5,000 mg/kg.
 - The concentration of lead leachate in paint sample CA-PS-DUP1 was below the applicable guideline for leachable lead in paint.

Photo 19 - View of paint sample CA-PS-1 (green over blue paint).

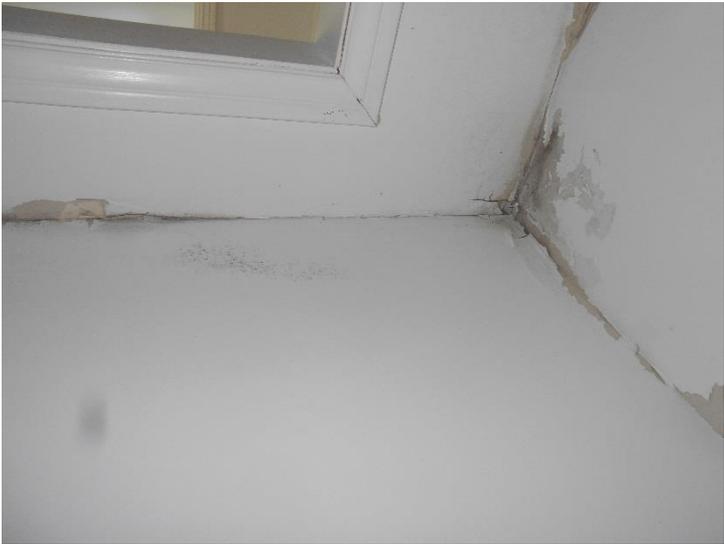
Suspected water leaks were observed in Room 1 (Porch) of the Office Trailer, and SVG (assumed to be covering an area of approximately 1m²) was observed on painted drywall. Existing conditions in the Office Trailer (e.g., suspected water infiltration due to leaks) may potentially contribute to or enhance mould growth inside the building.

Wood inspected the interior areas of the Office Trailer for visual or olfactory evidence of SVG. Suspected water leaks were observed in Room 1 (Porch) of the Office Trailer (refer to Photo 23, Appendix B). SVG was observed on painted drywall covering an area of approximately 1m². No samples of suspected mould were collected during the site visit.

Photo 23 – View of suspected water leak and SVG observed in the Office Trailer, Room 1 (Porch).

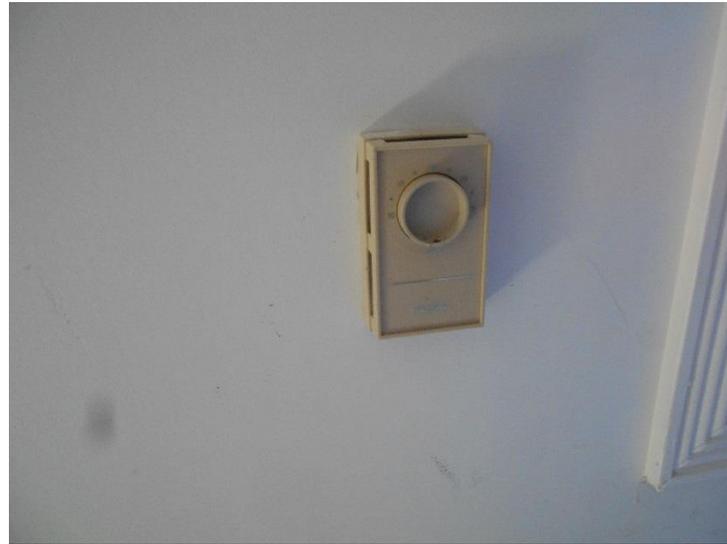
Photo 24 – View of thermostat observed in Room 2 (Main Room).

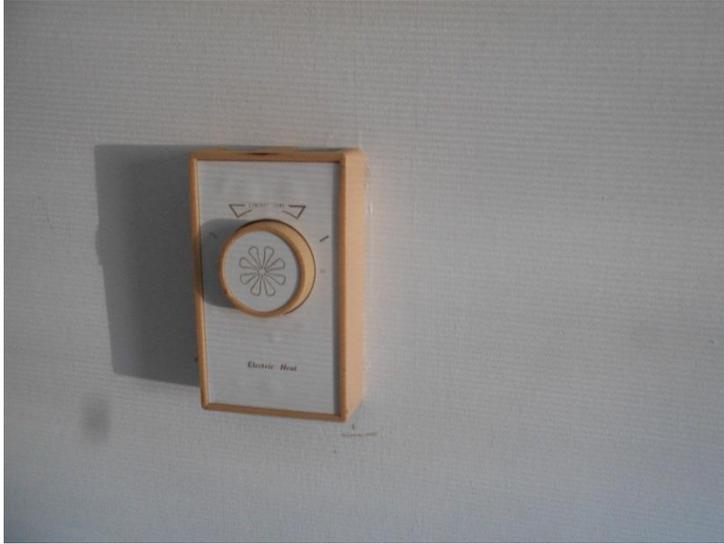
Photo 25 – View of thermostat observed in Room 2 (Main Room), similar to the one also observed in Room 4 (Bathroom).

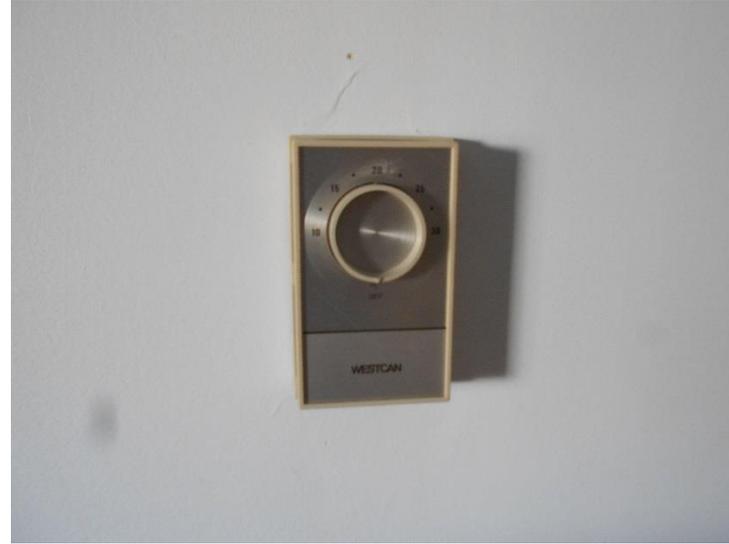
Photo 26 – View of thermostat observed in Room 3 (Side Room).
