Date
October 14, 2021

Project #
60608868

**Subject: Kwetǫǫǫǫ (Rayrock) Remediation Project
2021 Field Investigation Summary – Test Pit Excavations**

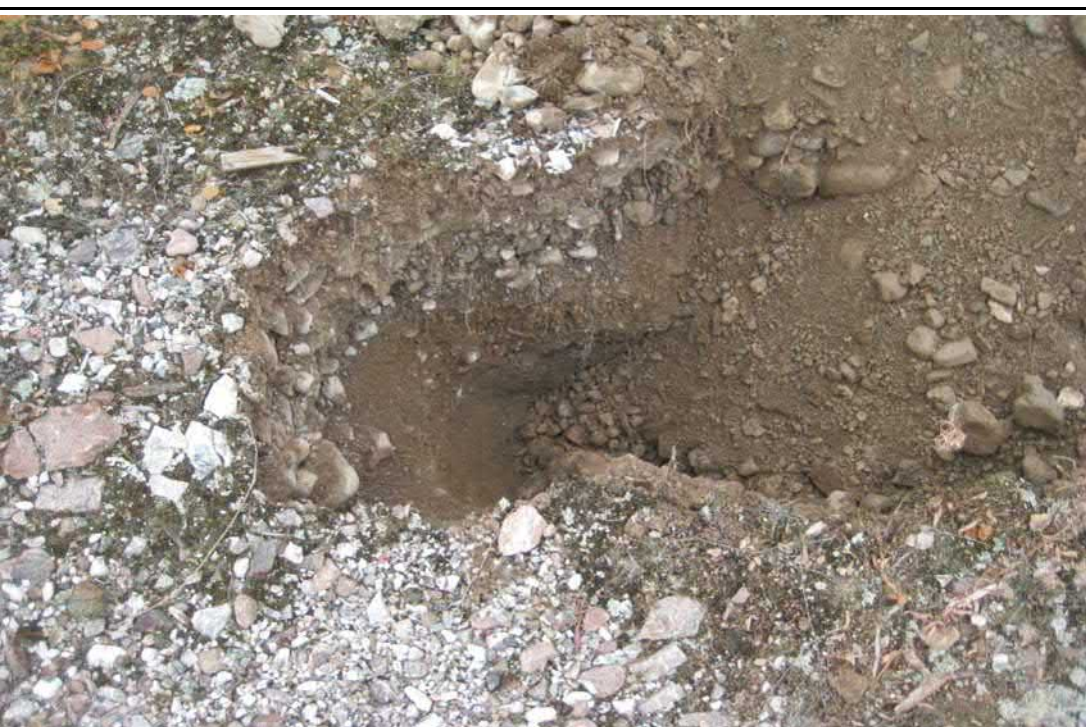
Area 6 Mill	0.0 - 0.66m	Brown, moist, SAND and GRAVEL , medium to coarse, some cobbles and boulders, some to trace roots in upper 0.15m	GR

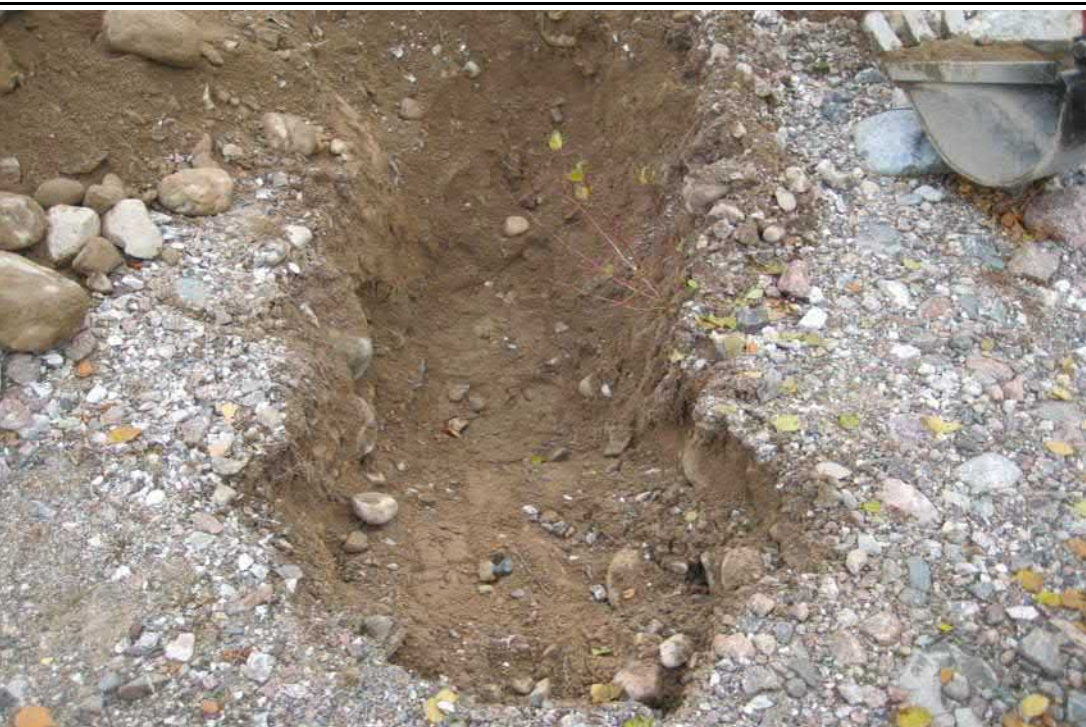
Area 6 Mill	0.0 - 0.12m	Brown, moist, SAND , medium to coarse, some rounded cobbles and boulders

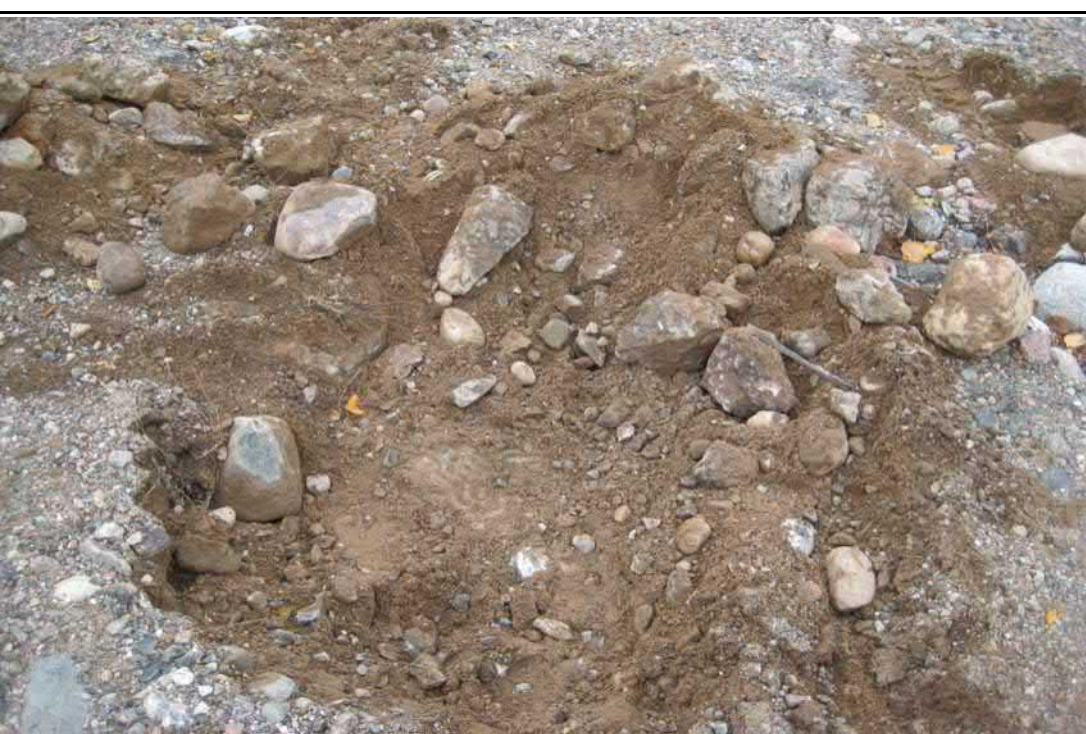
Area 6 Mill	0.0 - 0.30	Brown, moist, SAND , medium to coarse, some rounded cobble and boulders, angular gravel on surface.	GR	Sa-1	PHCs/BTEX 0.0 - 0.30	7 uR/hr	0 ppm			
Date: 30-Sep-13 Logged by: LS Method: Can-Dig Excavator Location: Rayrock, NWT			Test Pit: TP13-5			SAMPLES			COMMENTS	PHOTO
Area 6 CRUSHER			Type	Sample I.D.	Analysis & Depth of Sample (m)					
Area	Depth (m)	Description			Parameters	Gamma	Gastech	No evidence of environmental impacts (staining or odour). TP completed on bedrock.

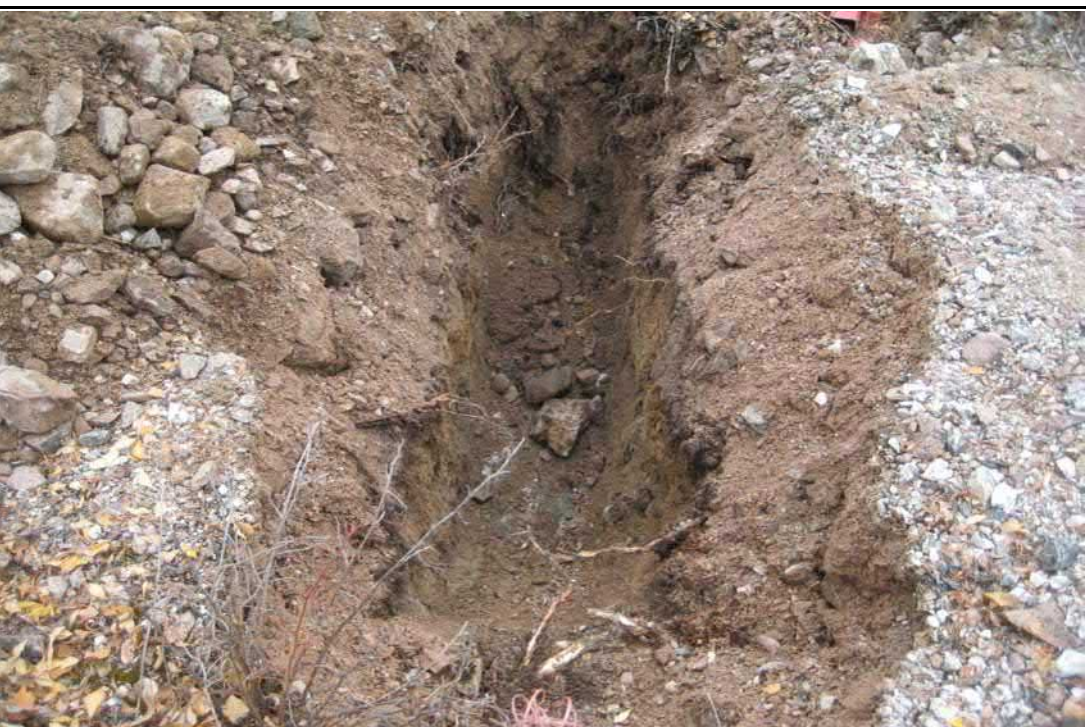
Area 6 Mill	0.0 - 0.46m	Brown, moist, SAND , medium to coarse, some angular cobbles and boulders, some debris (steel plates & rods)								
	0.46 - 1.17m	Brown, moist, medium to coarse SAND , angular cobble and boulders	GR	Sa-1	PHCs/BTEX 1.0 - 1.17	8 uR/hr	0 ppm			
Date: 30-Sep-13 Logged by: LS Method: Excavator Location: Rayrock, NWT			Test Pit: TP13-6			SAMPLES			COMMENTS	PHOTO
Area 6 CRUSHER			Type	Sample I.D.	Analysis & Depth of Sample (m)					
Area	Depth (m)	Description			Parameters	Gamma	Gastech	No evidence of environmental impacts (staining or odour). TP completed on bedrock.

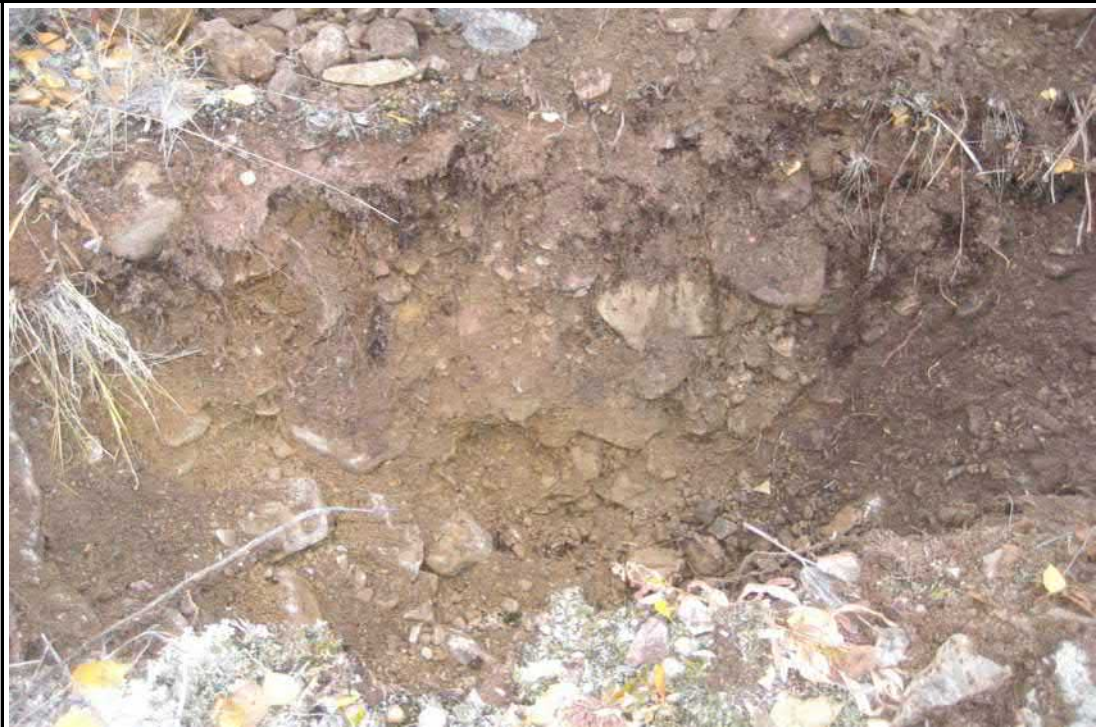
0.30 - 1.2m	Brown, damp, SAND and GRAVEL, some cobbles	GR	Sa-1	PHCs/BTEX 1.1 - 1.2			6.5 uR/hr	0 ppm	
Date: 1-Oct-13 Logged by: LS Method: Can-Dig Excavator Location: Rayrock, NWT			Test Pit: TP13-9 Area 5 POL & Drainage			SAMPLES			COMMENTS	PHOTO
Type	Sample I.D.	Analysis & Depth of Sample (m)								
Area	Depth (m)	Description	Parameters	Gamma	Gastech					
Area 5 POL & Drainage Zone	0.0 - 0.10m	Brown, moist, SAND, medium to coarse, some gravel, trace organics (moss & roots), trace glass and insulation				Downgradient of former fuel oil tanks. No evidence of environmental impacts (staining or odour). TP incomplete due to debris.

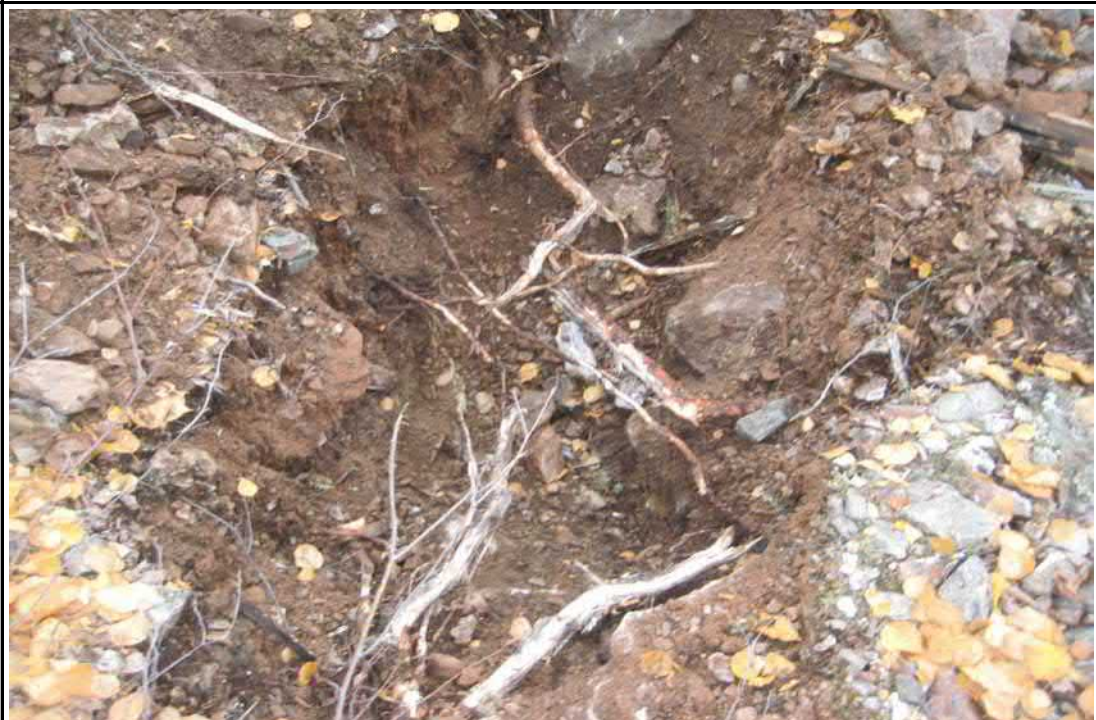
0.10 - 1.0m	Brown, moist, SAND, medium to coarse, some rounded gravel, angular cobble and boulders, trace construction debris at bottom of TP	GR	Sa-1	PHCs/BTEX 0.9 - 1.0			6.5 uR/hr	0 ppm	
Date: 1-Oct-13 Logged by: LS Method: Can-Dig Excavator Location: Rayrock, NWT			Test Pit: TP13-10 Area 5 POL & Drainage			SAMPLES			COMMENTS	PHOTO
Type	Sample I.D.	Analysis & Depth of Sample (m)								
Area	Depth (m)	Description	Parameters	Gamma	Gastech					
Area 5 POL & Drainage Zone	0.0 - 0.28m	Brown, moist, SAND, some construction debris, medium to coarse sand and angular cobbles and boulders				Downgradient of former fuel oil tanks. No evidence of environmental impacts (staining or odour). TP incomplete due to boulders.

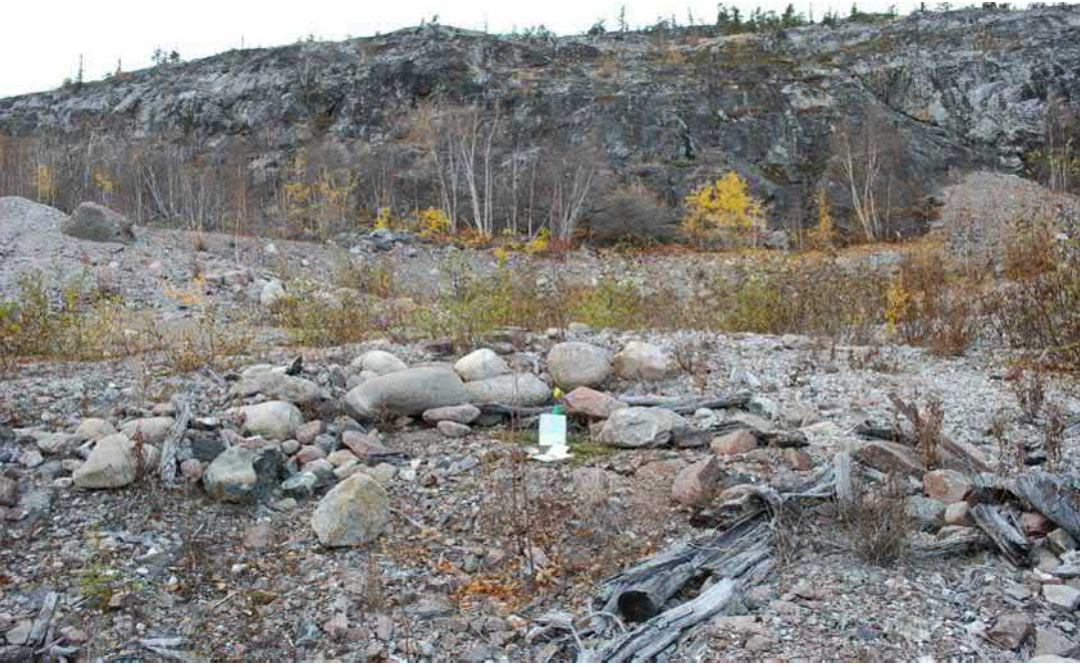
FORMER RAYROCK MINE SITE TEST PIT LOGS - METALS										
Date: 3-Oct-13 Logged by: LS Method: Can-Dig Excavator Location: Rayrock, NWT			Test Pit: SA13-26					SAMPLES	COMMENTS	PHOTO
Type	Sample I.D.	Analysis & Depth of Sample (m)								
Area	Depth (m)	Description			Parameters	Gamma	Gastech			
Area 6 Mill	0 - 0.75m	Brown, moist, SAND and GRAVEL, some angular cobbles and boulders, trace wood timbers and metal	SA						No evidence of environmental impact (staining or odour). Incomplete due to large boulders and foundation @ 1.8m.

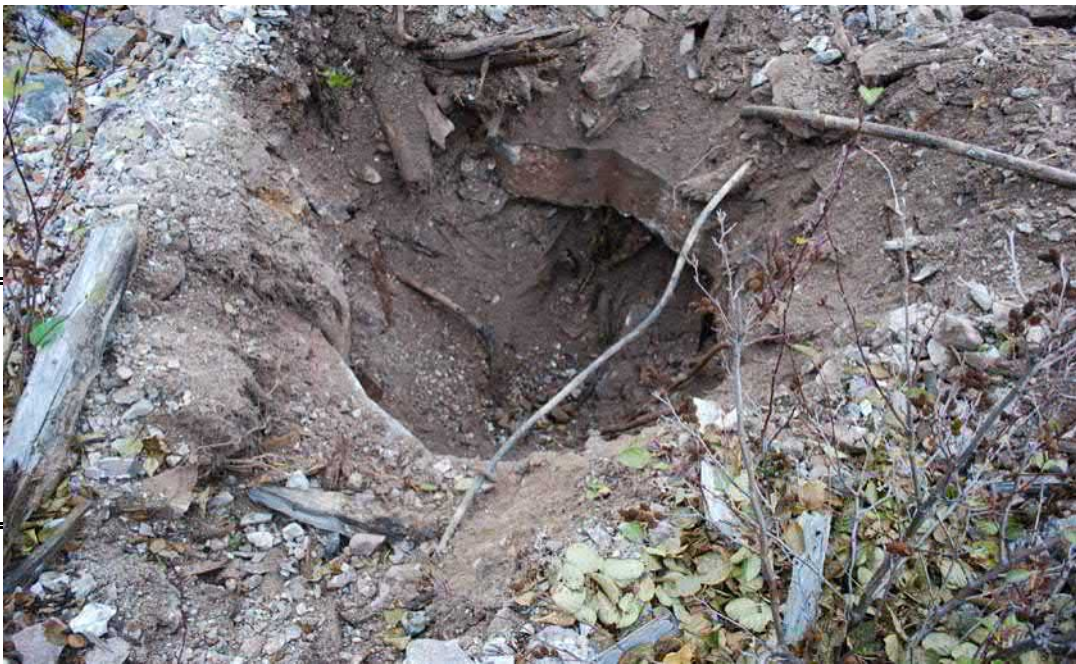
0.75 - 0.90m	Concrete foundation								
	0.90 - 1.80m	Brown, moist, SAND and GRAVEL, some angular cobbles and boulders, trace wood timbers and metal	SA	Sa-1	Metals - Soils	15 uR/hr	0 ppm			
Date: 3-Oct-13 Logged by: CR Method: Hand Dig Location: Rayrock, NWT			Test Pit: SA13-27					SAMPLES	COMMENTS	PHOTO
Type	Sample I.D.	Analysis & Depth of Sample (m)								
Area	Depth (m)	Description			Parameters	Gamma	Gastech			
Area 6 Mill	0.0 - 0.40m	Brown, moist, SAND, medium to coarse, some gravel and organics	SA	Sa-1	Metals - Soils	9 uR/hr	0 ppm		Complete on Bedrock @ 0.70m. No evidence of environmental impact (staining or odour).
