LaSalle Causeway Concrete Repairs
EQ754-2221279/A

AMENDMENT No.4, dated 2021-10-25

SUBJECT: LaSalle Causeway – Storm Sewer System Investigation & Remediation Review

LASALLE CAUSEWAY—STORM
SEWER CCTV INVESTIGATION

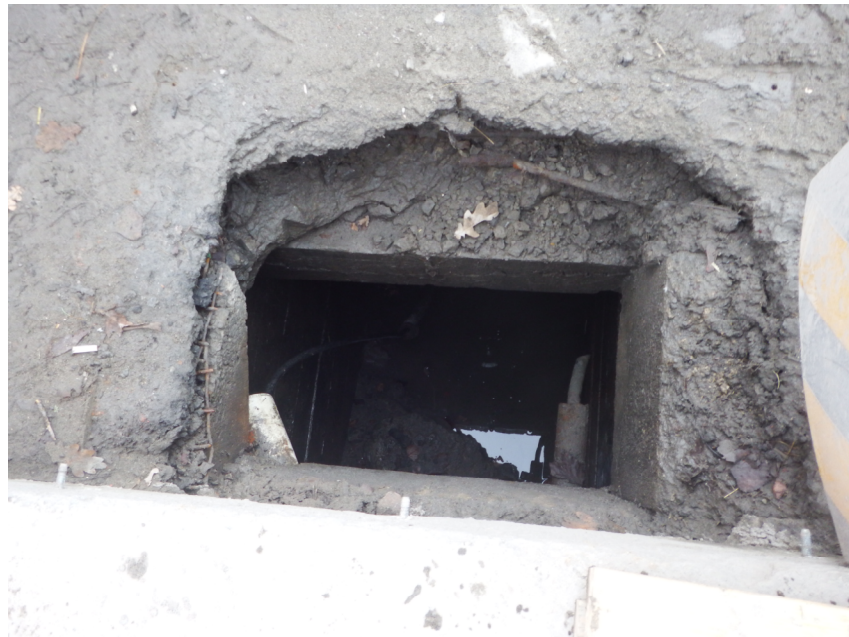
- Both catchbasins have a 6 inch (6 I 17.25#) steel beam between the catch basin grating and the roadway. The beams are critical as they support the edge of the roadway and the grating structure. The beams are encased in concrete and the underside of both encasements are in good condition showing no signs of rust staining, spalling or deterioration. In CB06, the top of the encasement is visible where the roadway asphalt and concrete is deteriorated and even though the material above the beam is deteriorated (presumably do to freeze thaw damage etc.), the edge of the encasement is sharp clean and undeteriorated, which suggests that the steel beams inside are sound. Refer to Figure 2

Figure 2: CB06 - Erosion of Roadway & Missing Frame (2021.03.11)

- 1** Rebuild CB06 frame and install grate. Existing frame and grate may be re-used if found to be in good condition and are operable.
- 2** Coordinate with utility owners and relocate utility cables out of storm system. Refer to Appendix A – Figure 1 for PSPC’s preferred Bell service relocation alignment.
- 3** Remove blockage in pipe between CB05 and CB06.

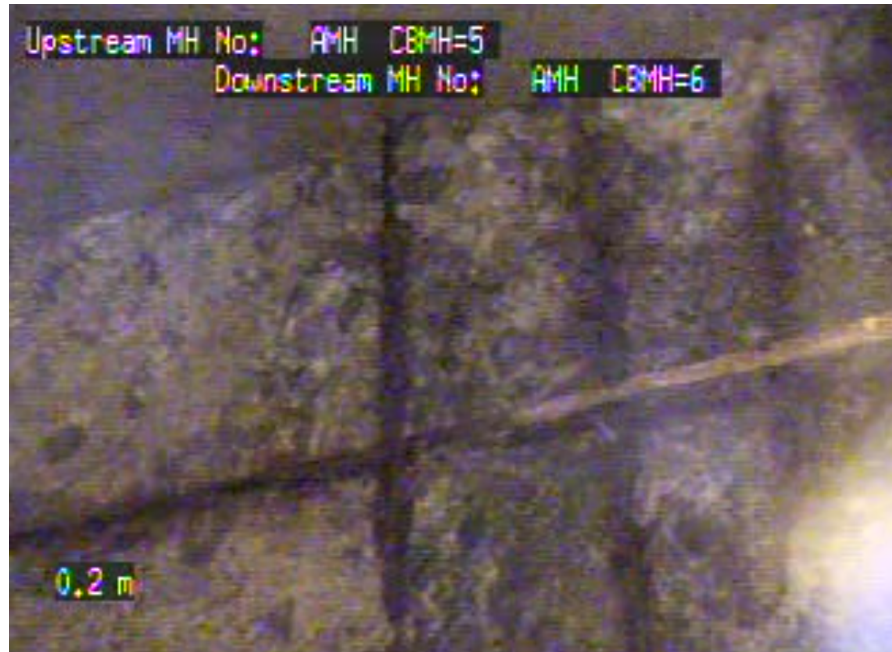
- The ceiling of CB05 has some exposed reinforcing steel, see Figure 3. From the video it appeared that there was little loss of section in the bars as they appeared to be of uniform width with little or no necking or staining. The fact that the concrete is missing is an indication that some rusting has occurred or that concrete was poorly consolidated around the bars. The bars were originally #4 bars. Poorly consolidated concrete is present in the opening around the catch basin grate, but by contrast the concrete surrounding the beam is well consolidated. The catch basin ceiling spans in the direction where the bars for the most part are still partially embedded, and the spalled area is adjacent to the steel beam.

Figure 3: CB05 - Ceiling - Exposed Rebar (2021.03.11).

- The overall condition of CB05, while not perfect, based on the visual inspection likely has little loss of capacity. A protective coating could be added to the bars, but any protective coating or polymer modified concrete patching material would likely trap water and could accelerate the deterioration of the original concrete and would have to be considered carefully if other work proceeds. Based on this review while the catch basin could just remain in service if someone is entering the catch basin the reinforcing loss of section should be verified and physically measured to confirm the observations.

- 1 Confirm the condition of exposed rebar within ceiling of CB05 through direct physical inspection (confined space entry will be required). Depending on findings, WSP may recommend minor repair

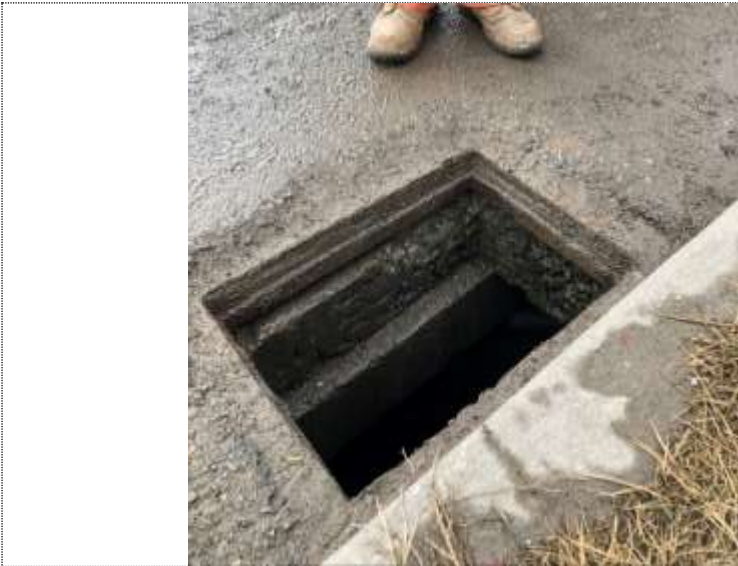
CB05 – Surface Condition - 2021.03.03

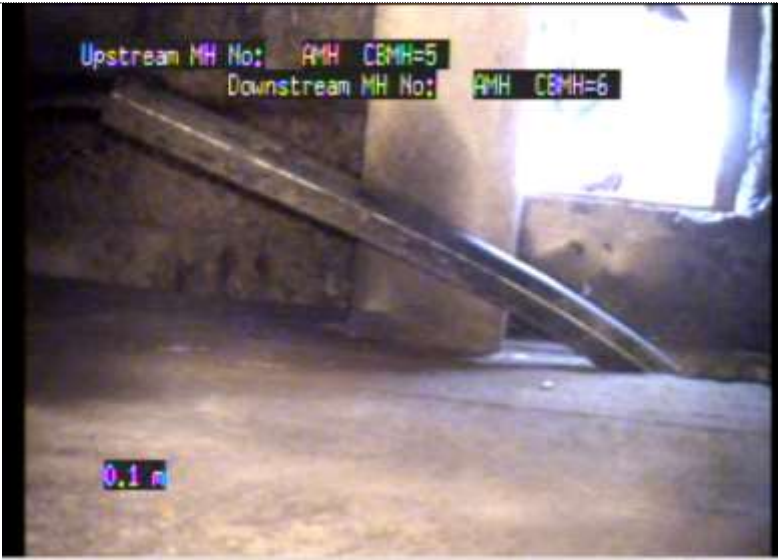
CB05 – Upper west wall – 2021.03.11

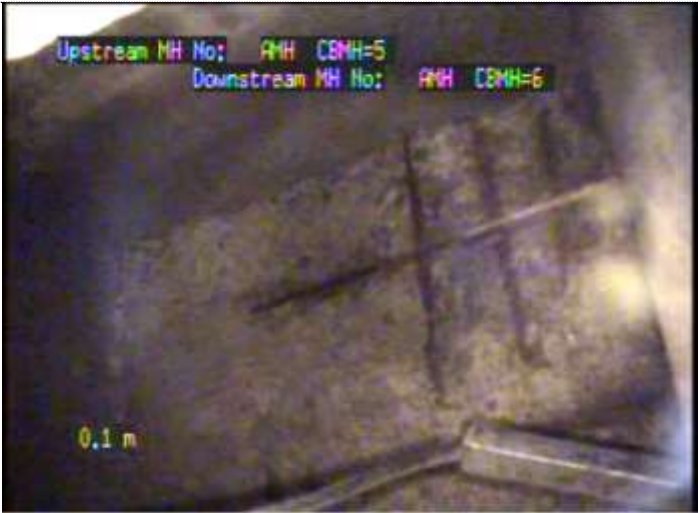
CB05 – Ceiling – 2021.03.11

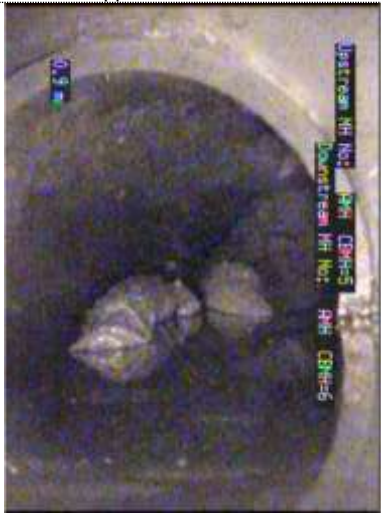
CB05 – Outlet Pipe – 2021.03.11

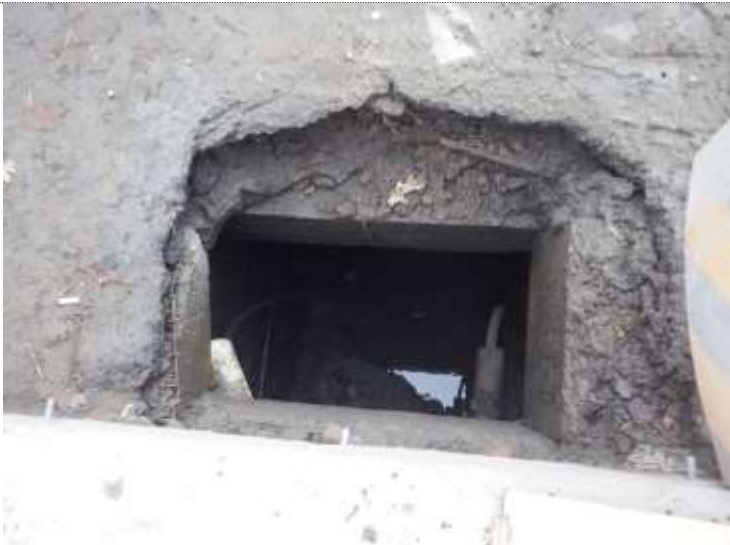
CB06 – Surface Condition - 2021.03.11

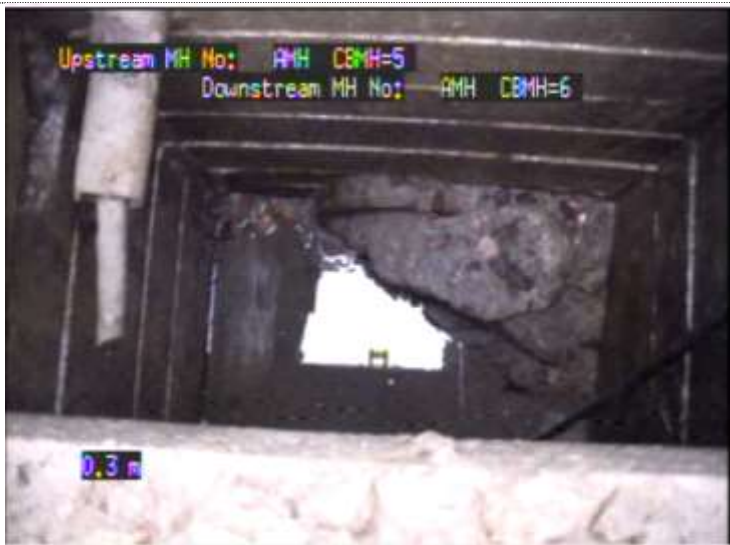
CB06 – South Outlet Concrete Blockage - 2021.03.11

- 4 Remove cured concrete blockage at CB06 outlet.
- 5 Inspect all pipes to review condition after blockages have been removed.
- 6 Revise roadway grading and/or introduce new stormwater collection measure (as required) to eliminate pond along eastbound shoulder.

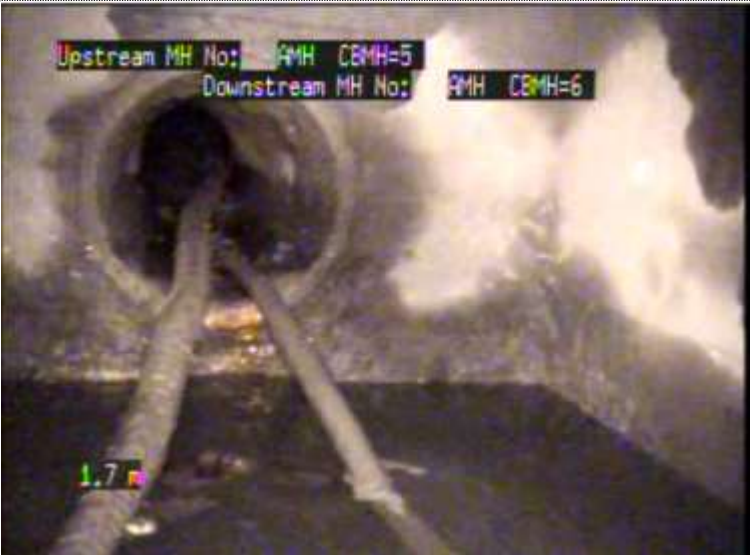
CB06 – Inlet to the North – 2021.03.11

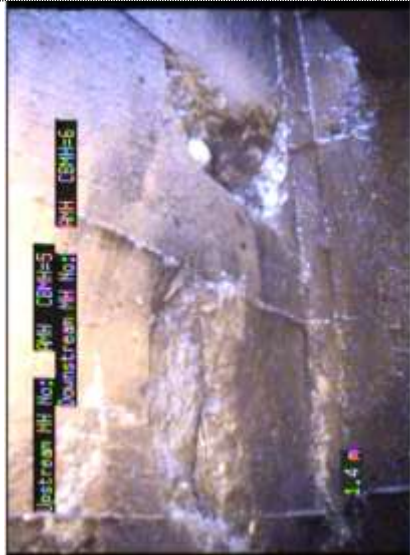
CB06 – East Wall – 2021.03.11
