ANNEXE A

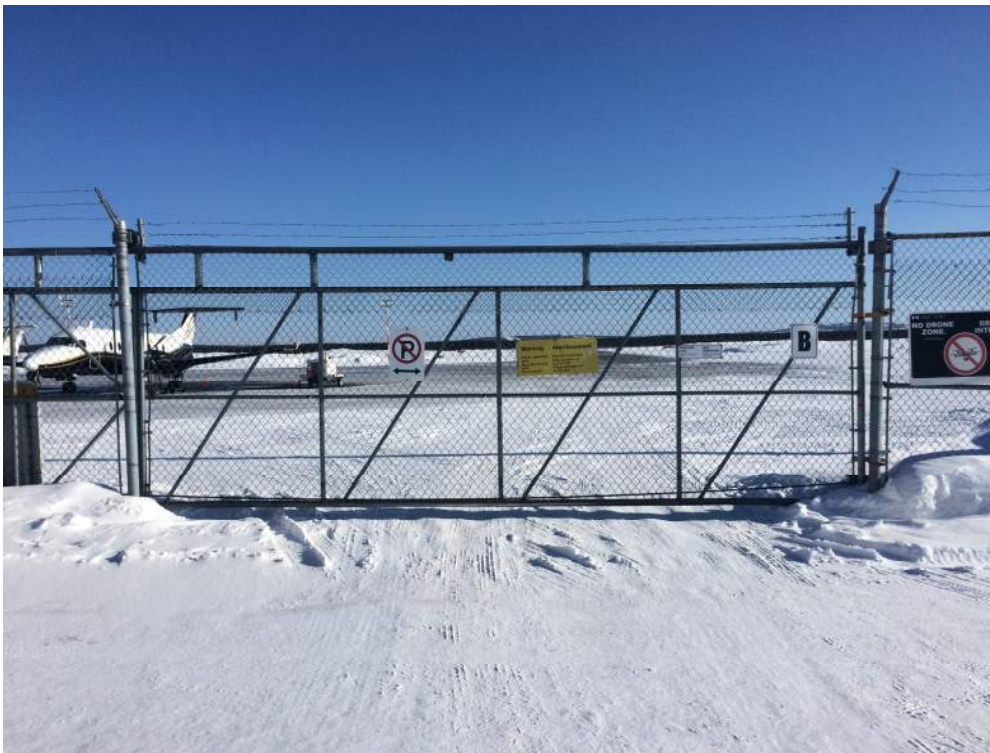
Photo 8 – Automated rolling Gate B near ATB.

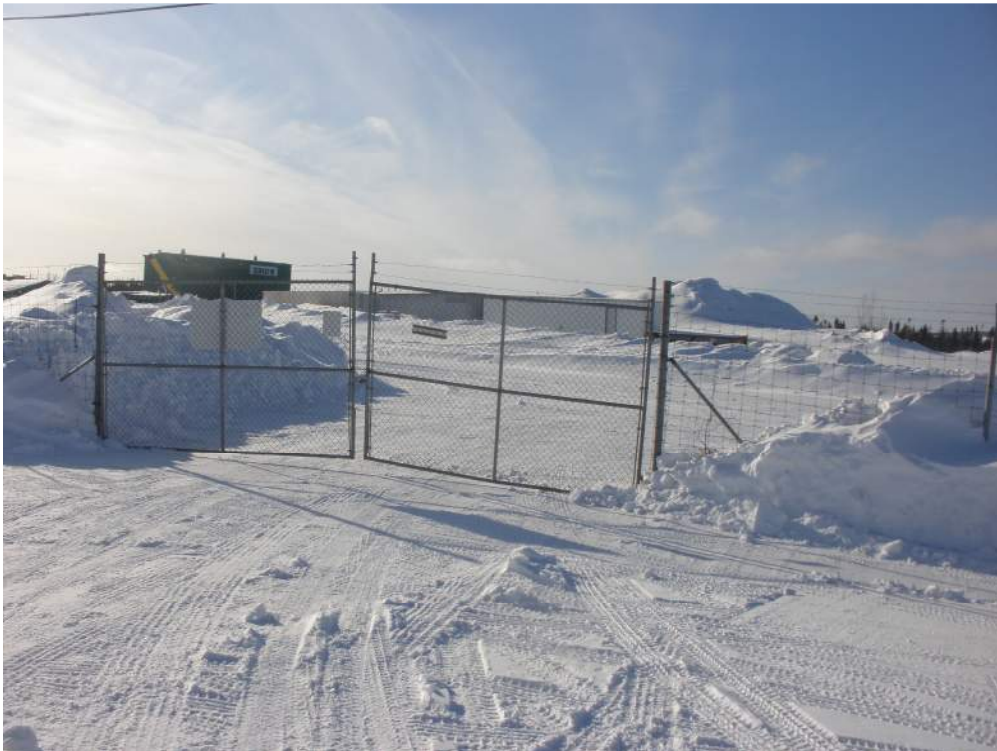
Photo 10 – Misaligned manual swinging vehicle gate along southwest fence line (Sta. 4+032).

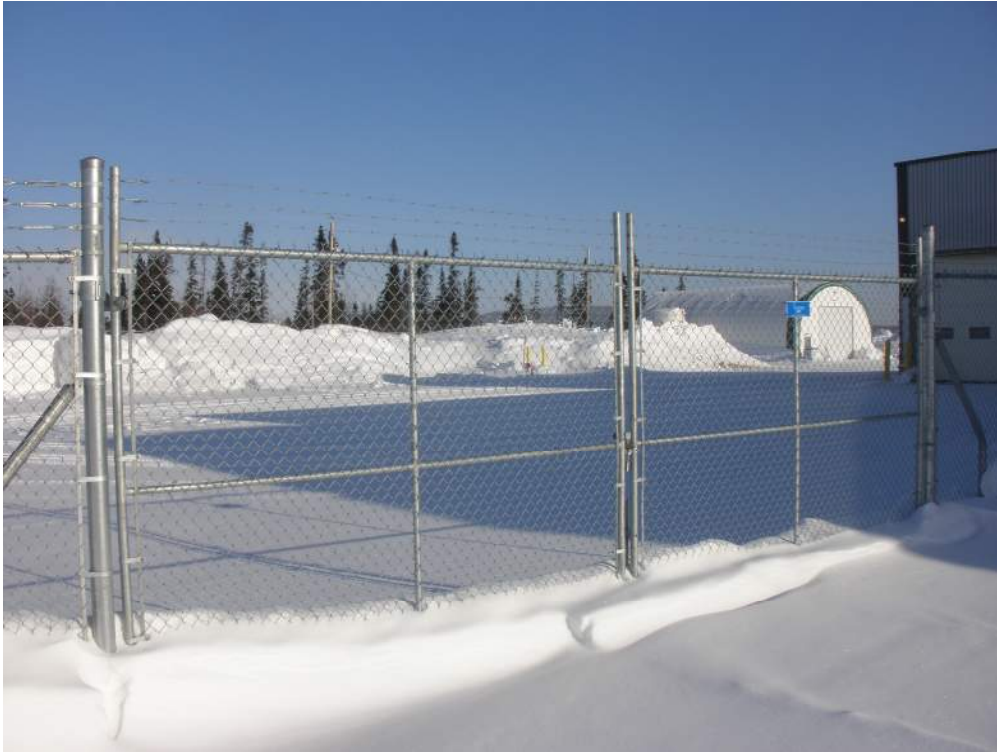
Photo 11 – Manual vehicle swing gate (A1) near the CSB.

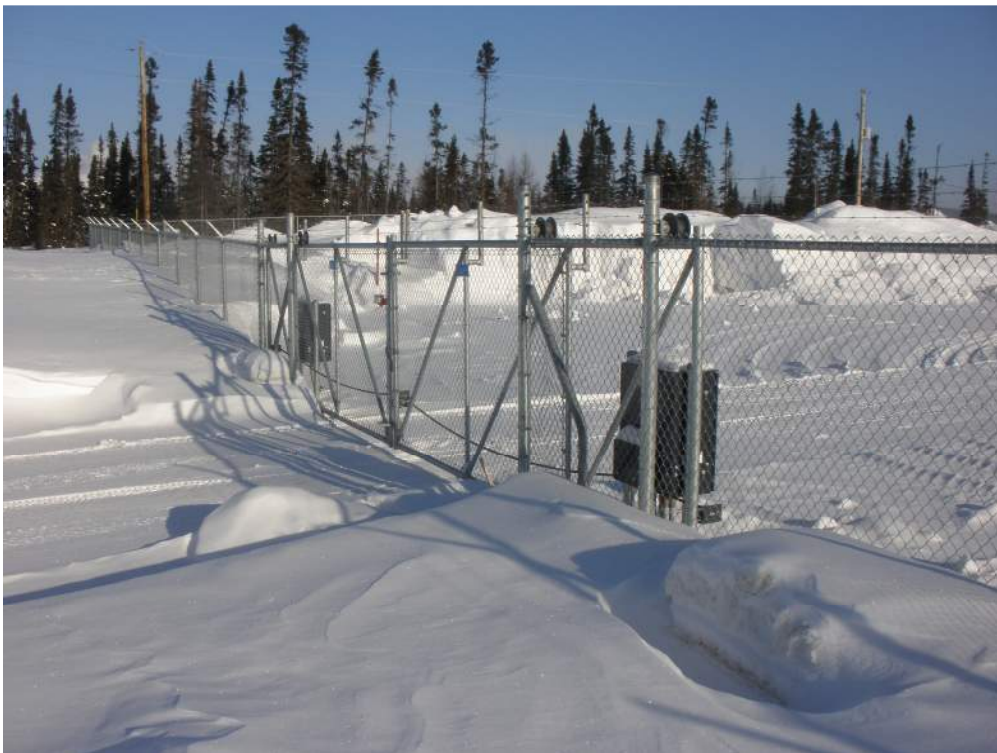
Photo 12 – Automated rolling gate (A2) near the CSB.
