# Inspection Report and Concept Repair Design

**SOLICITATION No.:**  
**PEQ754-161278/001/PWL:**  
**Burlington Canal Lift Bridge**  
**Engineering Services**

**PROJECT No.:**  
**R.081864.001**  
**Urgent Steel Deck Grating Repairs**

April, 2017

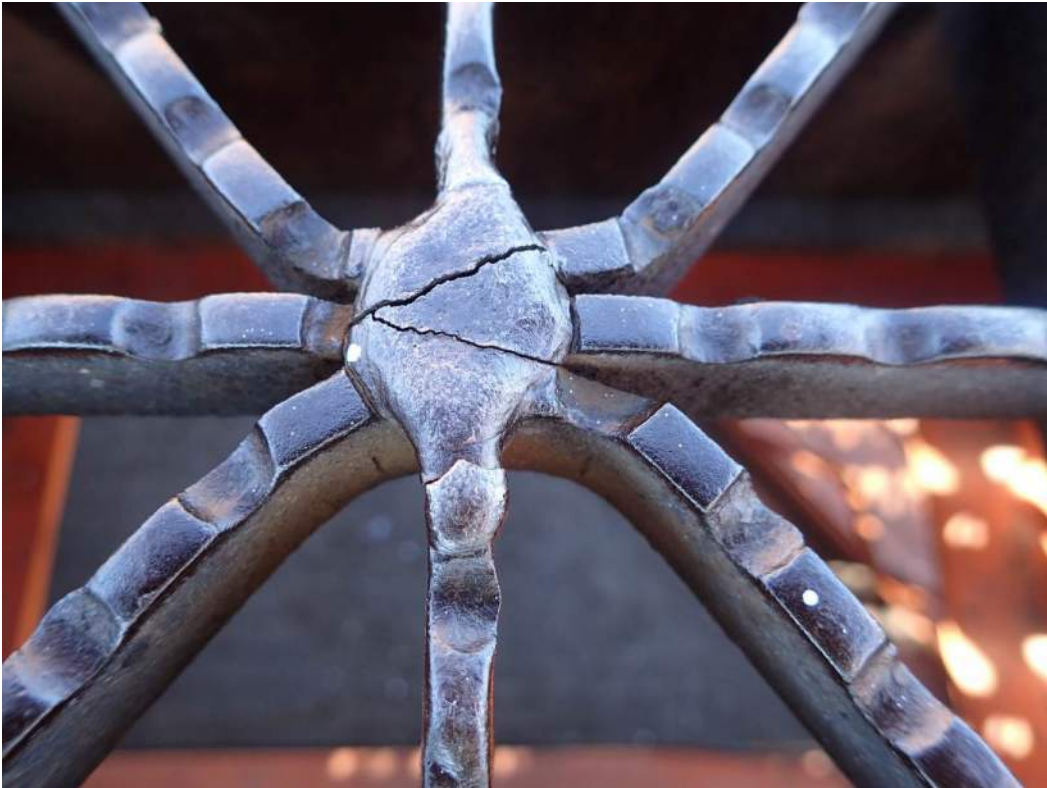
**Photo7:** Button Weld crack – typical example

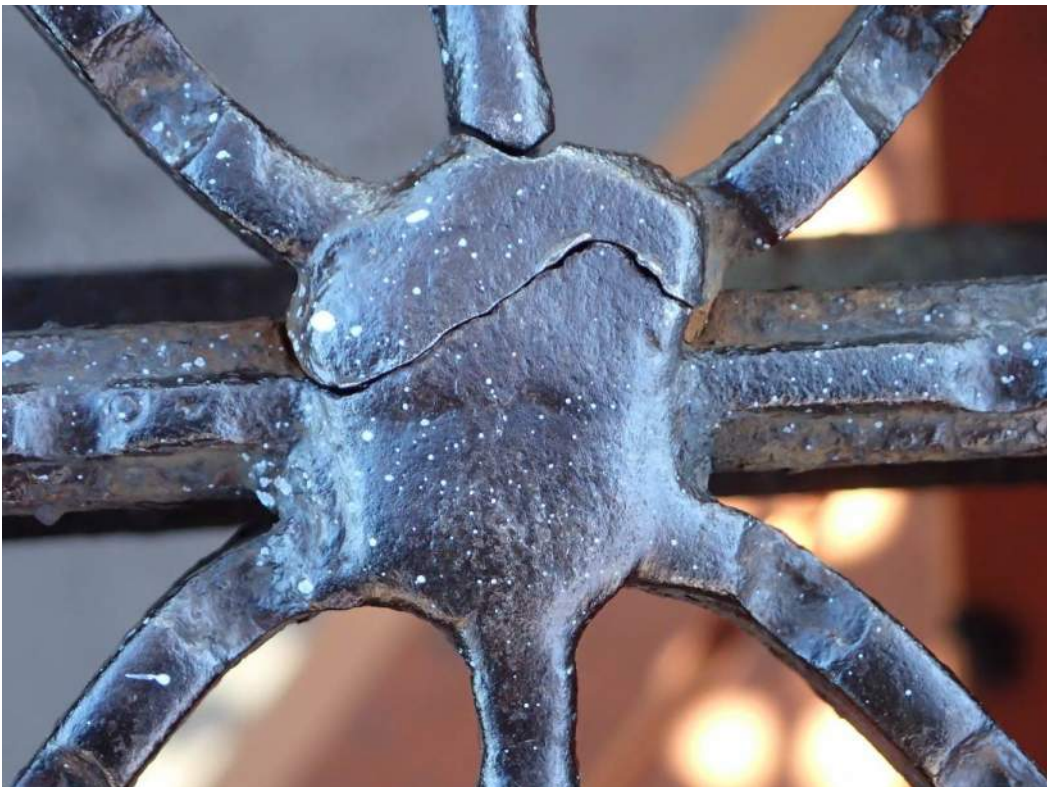
**Photo 8:** BW crack – typical example

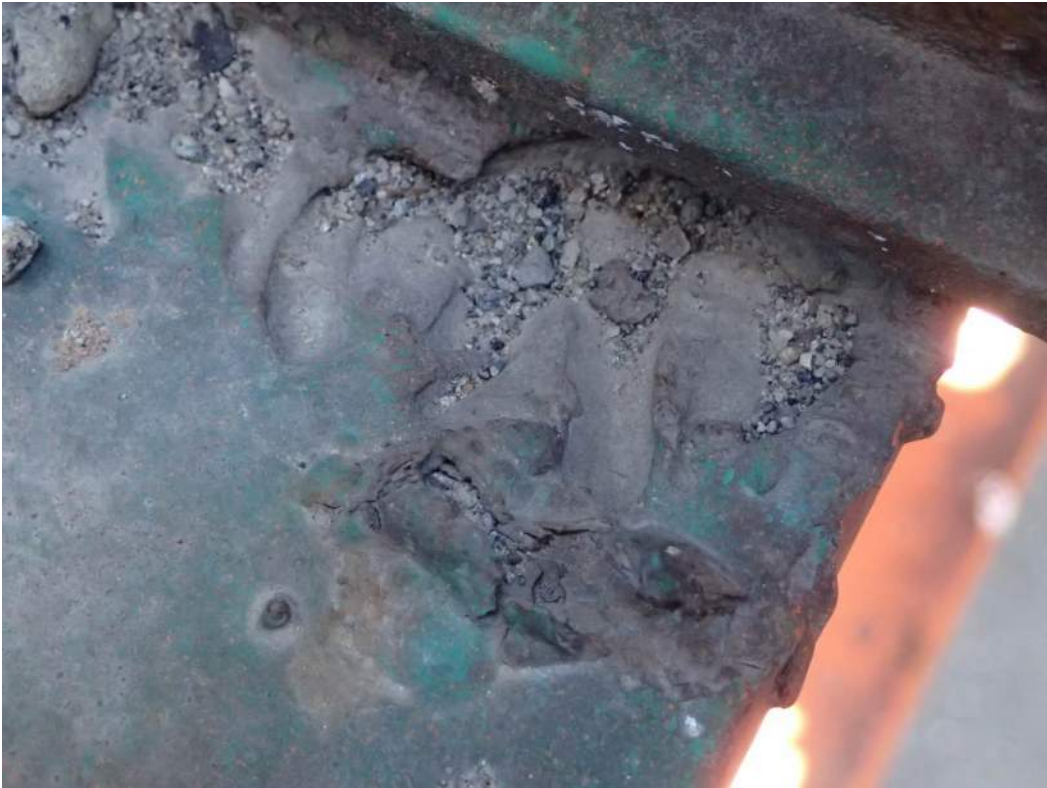
**Photo 9:** M-beam to stringer fillet weld deterioration and damage to stringer's flange

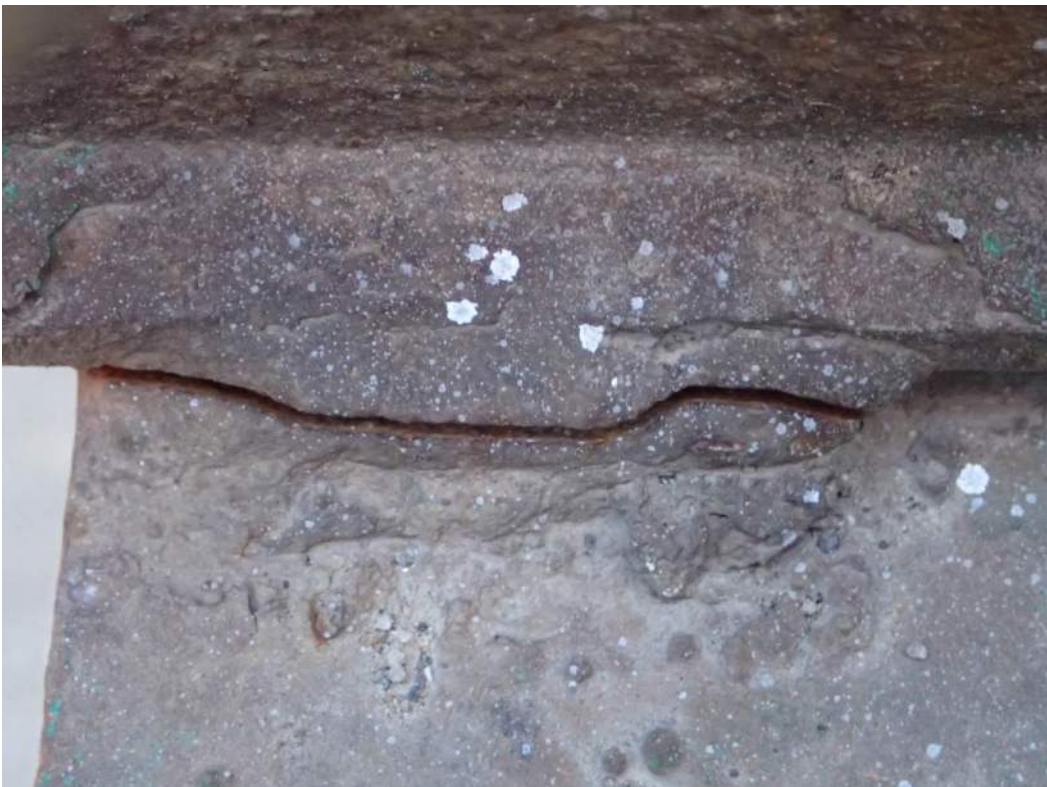
**Photo 10:** M-beam to stringer fillet weld – typical crack, full length and depth

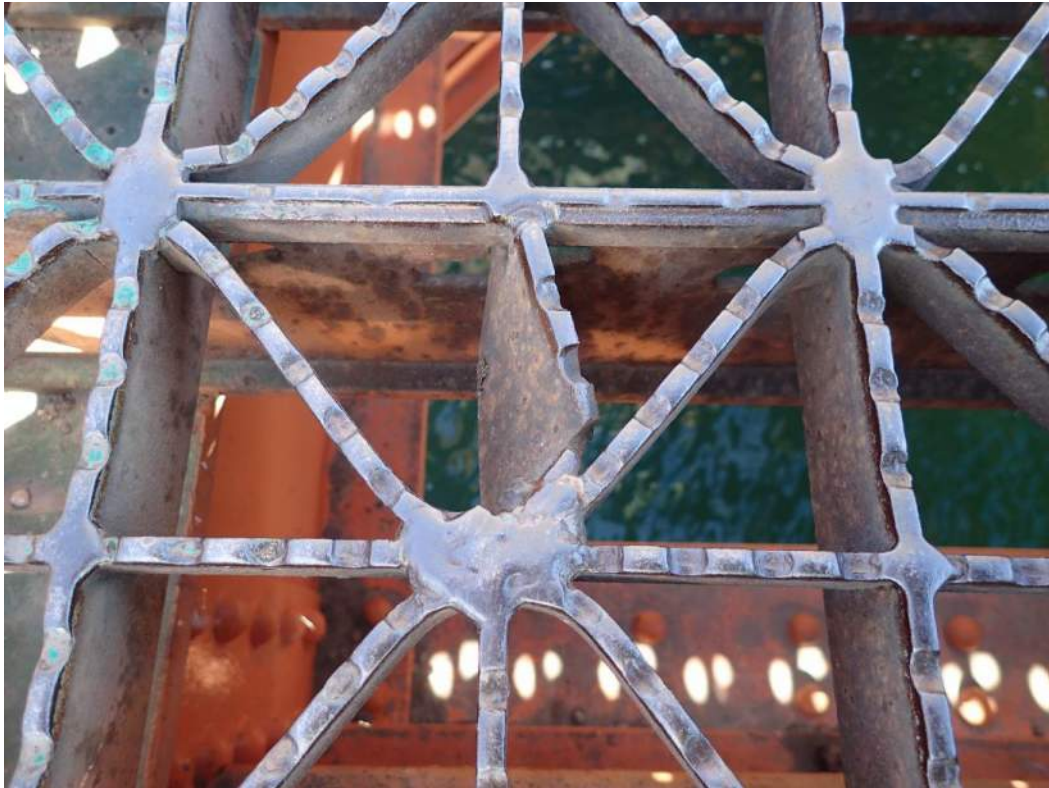
Warped members do not correspond with Button Weld cracks or LGF areas. The cause of the warping is unknown.

**Photo 11:** Typical warped grating members

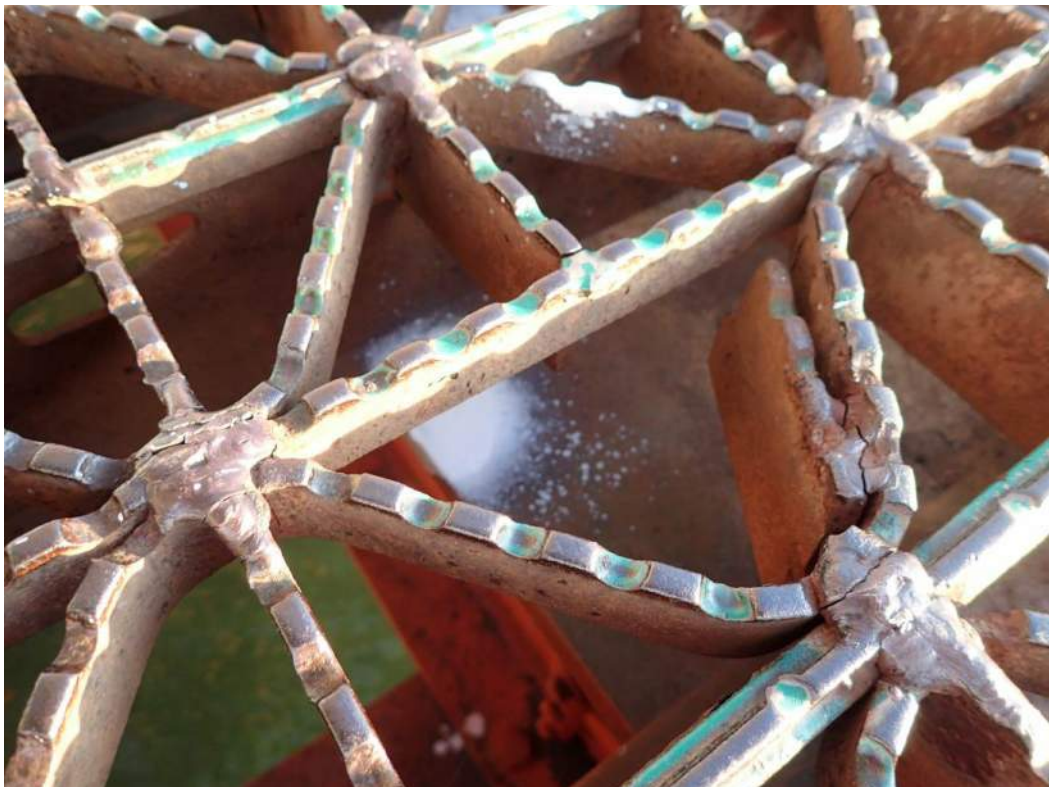
Broken or missing grating members adversely affect panel performance and public safety. They are often associated with LGF areas.

**Photo 12:** Typical broken grating members

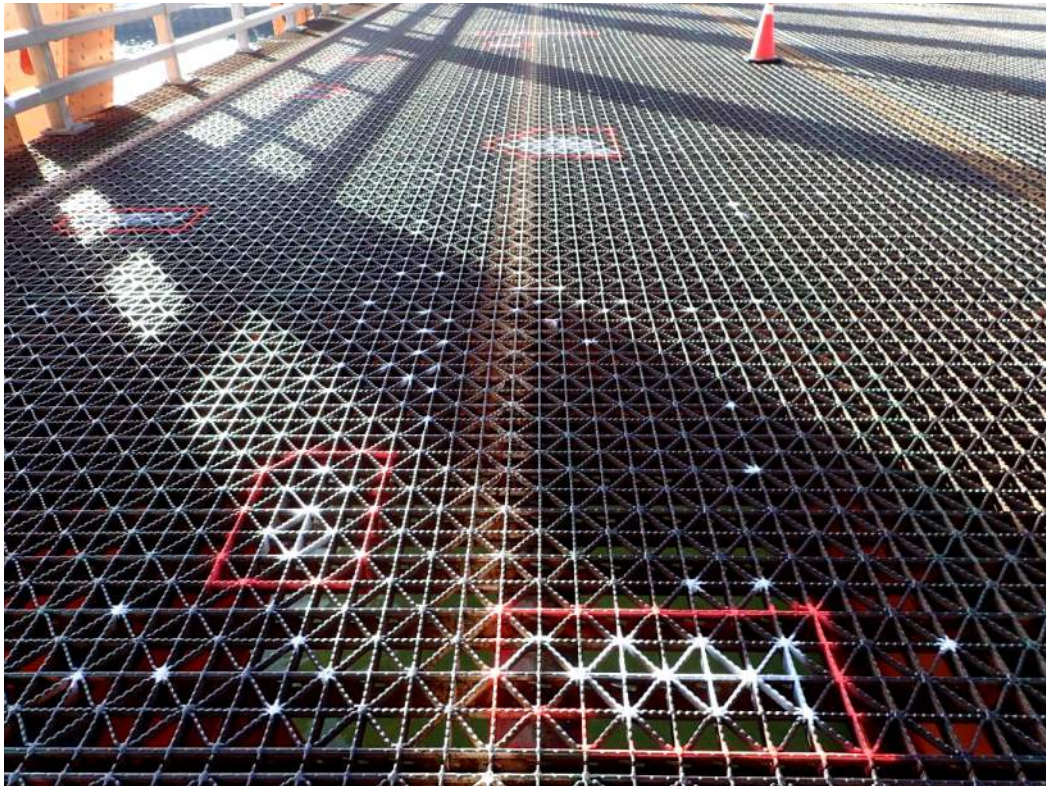
**Photo 13:** Local Grating Failure areas marked in orange – NB Lanes

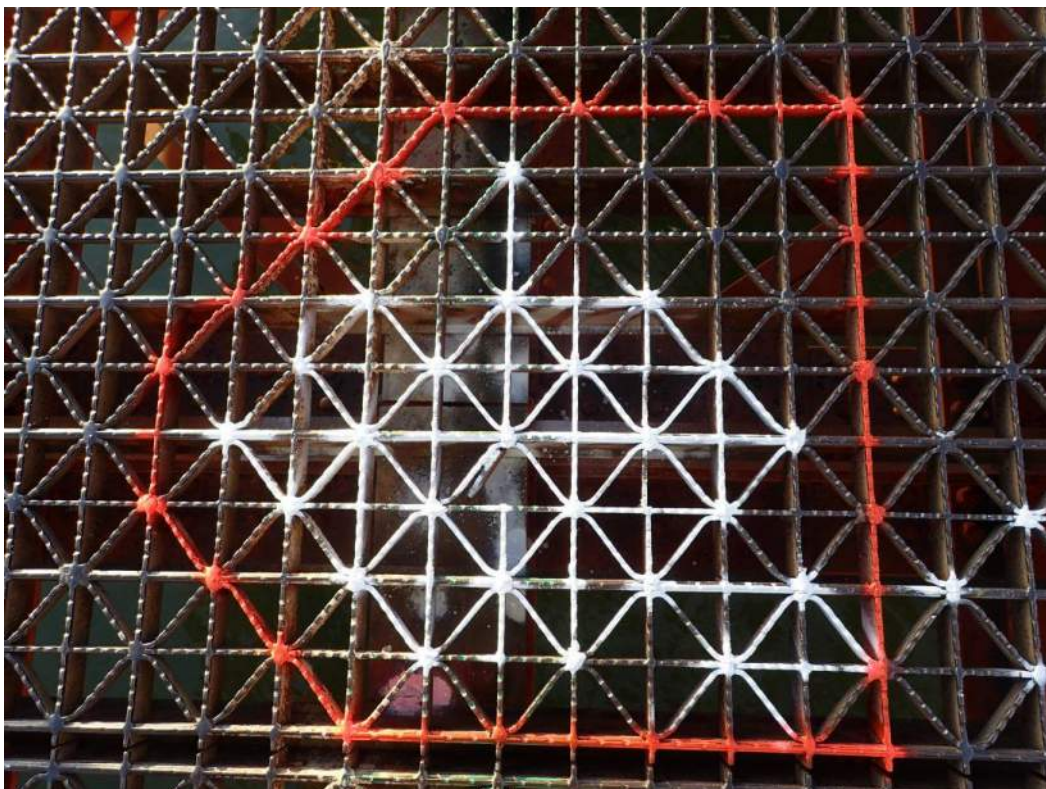
**Photo 14:** Typical Local Grating Failure area

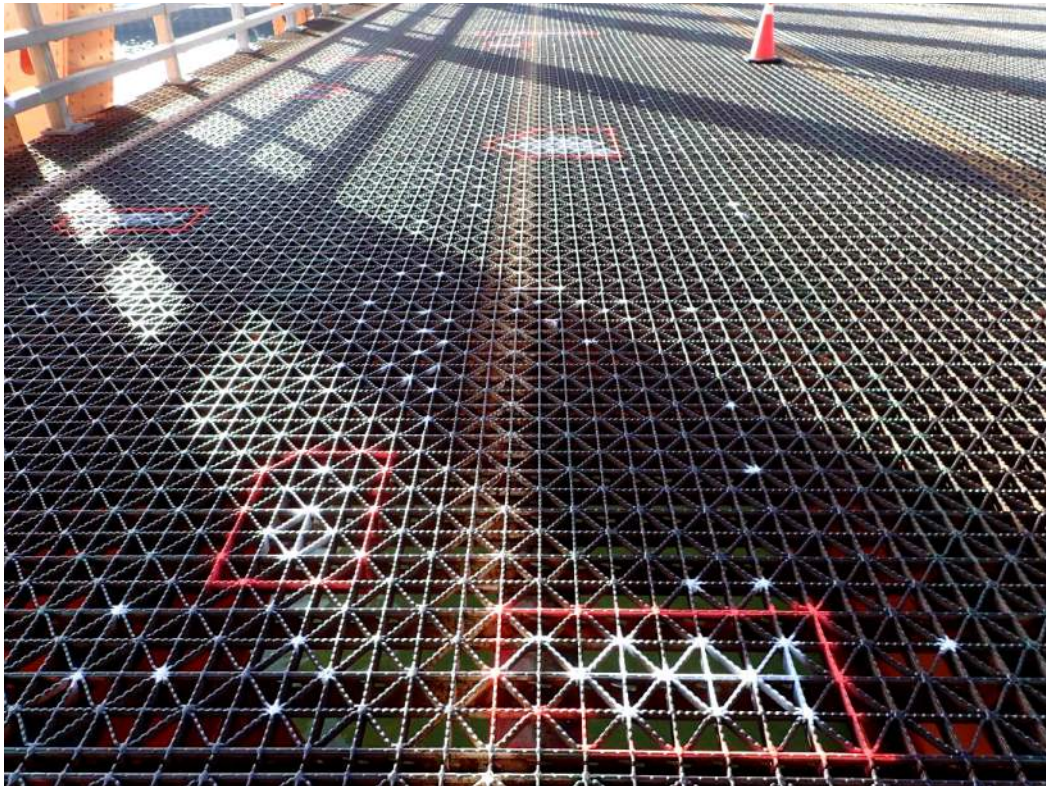
**Photo 15:** LGF areas marked with orange and BW cracks shown as white dots

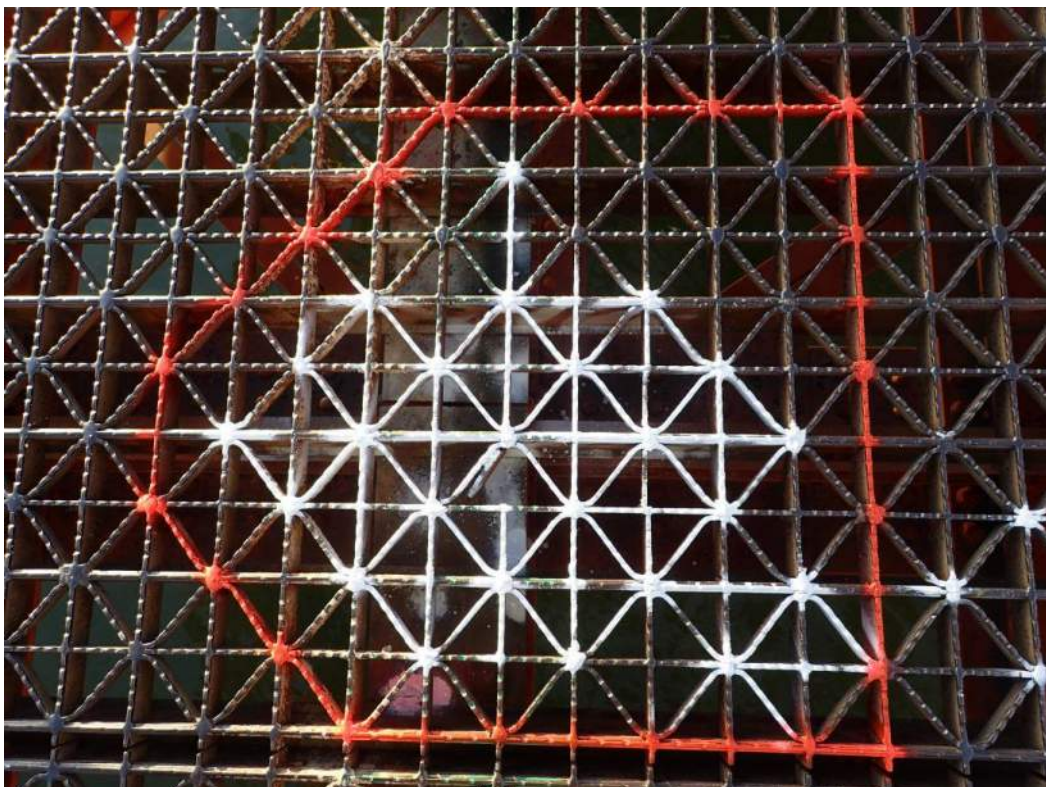
**Photo 16:** All members within LGF marked with white are affected

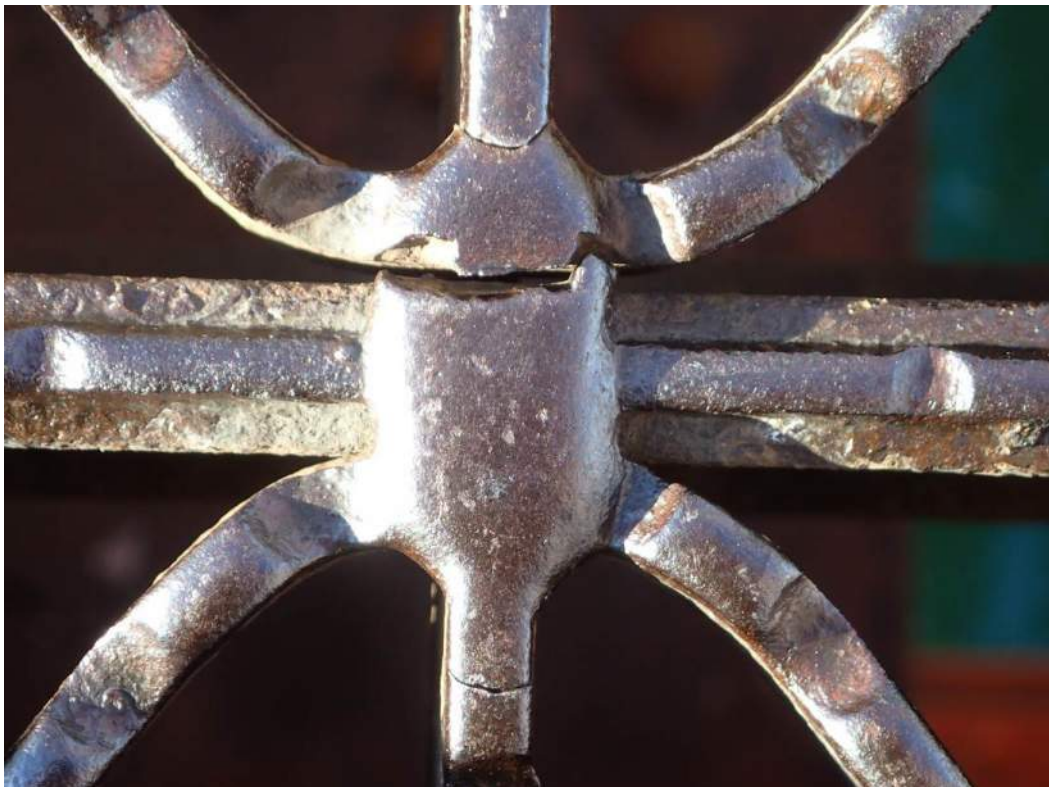
**Photo 18:** LGF detail – BW crack, full depth, complete connection failure

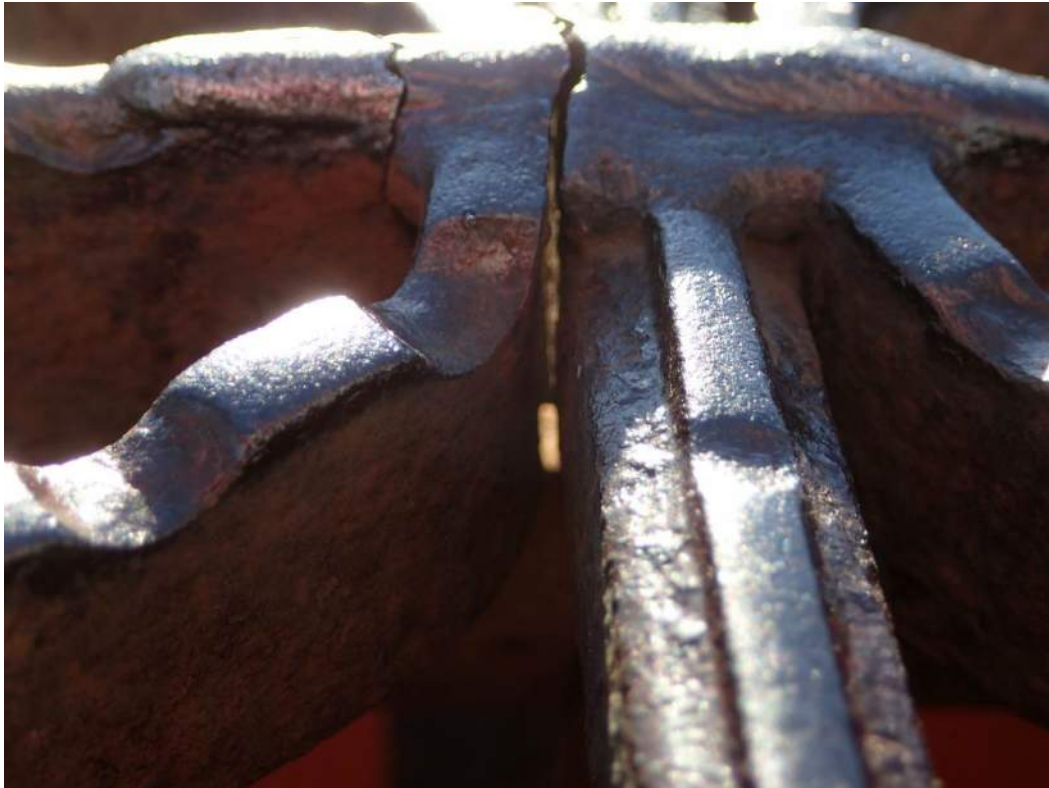
**Photo 19:** LGF detail – BW crack, full depth, complete connection failure

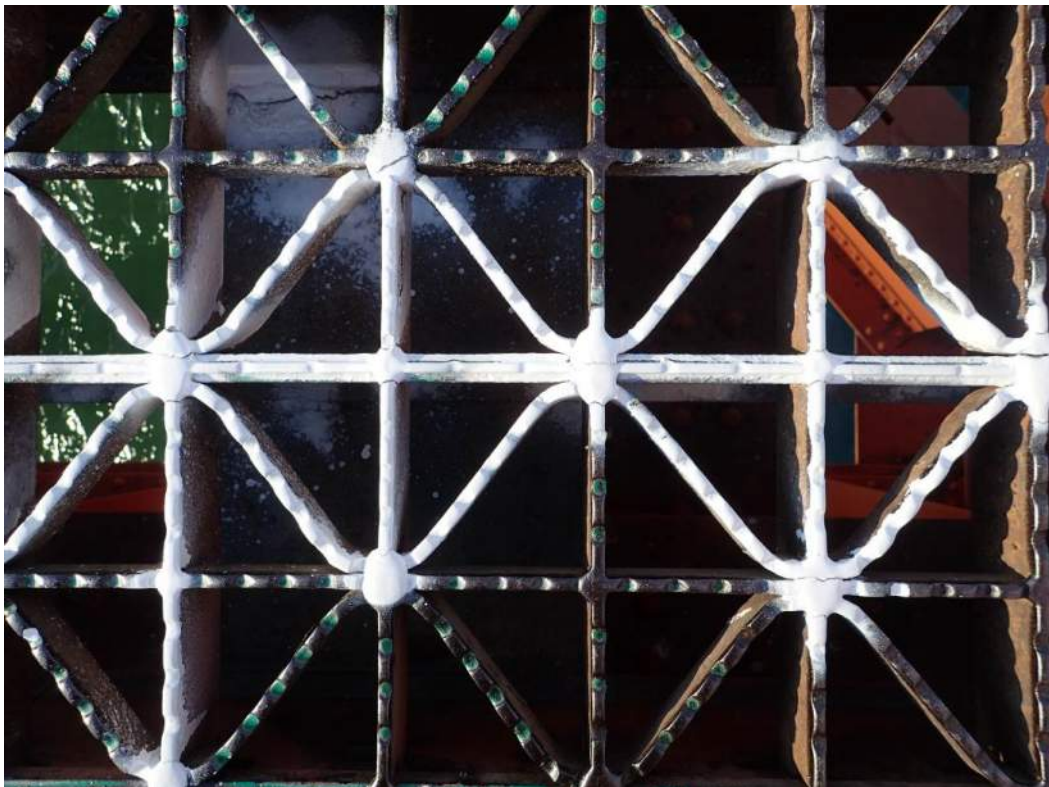
**Photo 20:** LGF area – all members and welds marked with white are affected

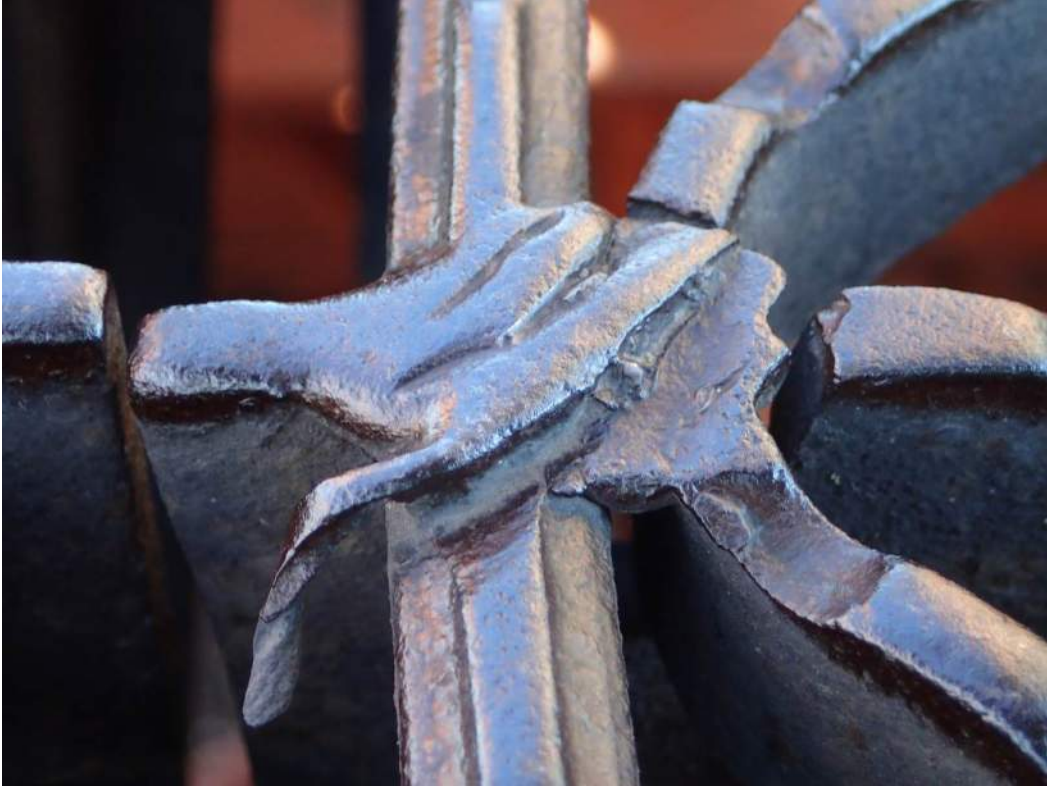
The incidence of button weld cracks is widespread. The frequency of occurrence is greatest within the wheel paths. The quality of the field-repaired welds is likely inferior to that of the factory welds, and thus appear to be cracking at an accelerated rate compared to the original welds. (See photos 21, 22 of **Appendix B**)

Re-welded connections appear to be prone to re-cracking.

**Photo 21:** Previous Welding Repairs – typical example of failure at Repaired Button Weld

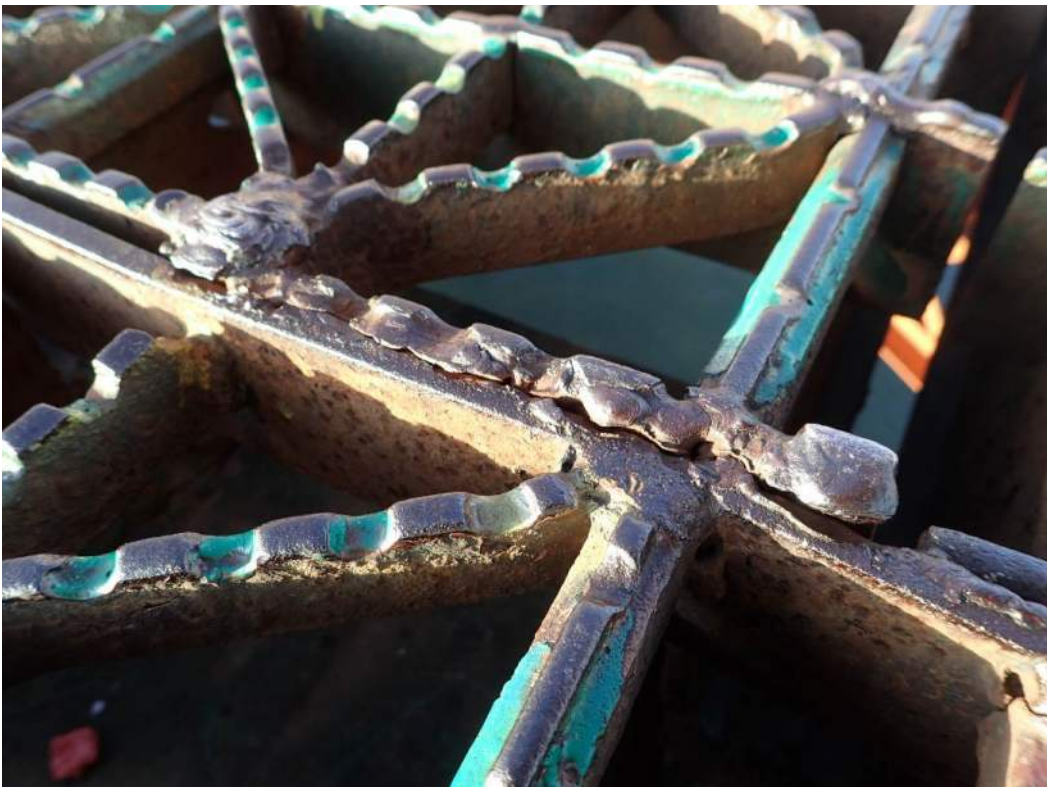
**Photo 22:** Previous Welding Repairs – typical example of failure between panels

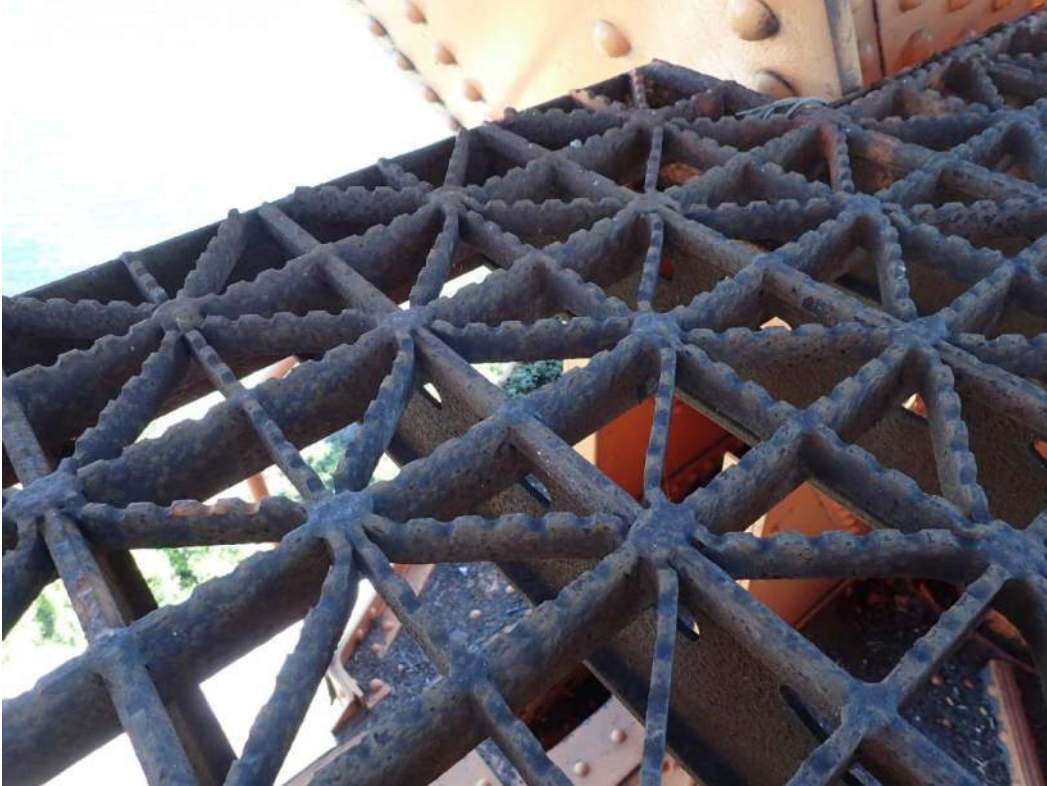
The listed items are classified as non-structural deficiencies and require no immediate action. However, those items tend to conceal the grating steel's surface therefore could prevent from accurate monitoring and inspections procedures.

**Photo 23:** Surface rust on panels – mostly outside of traffic load zone

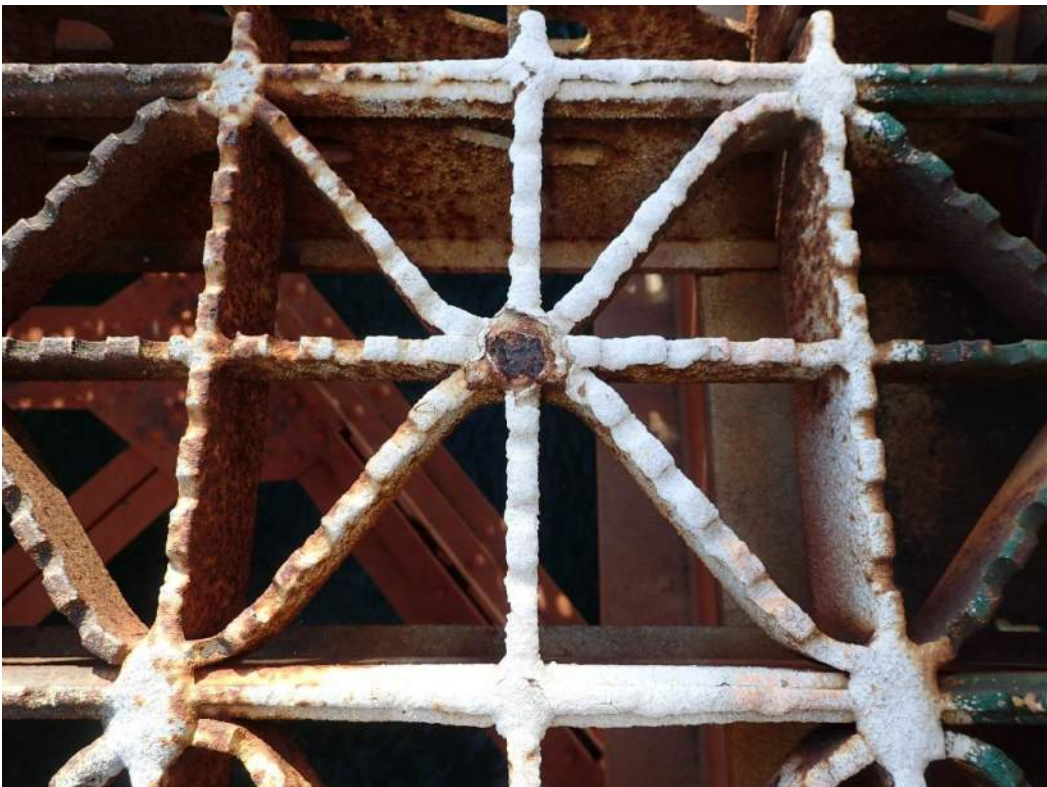
**Photo 24:** Surface rust on panels – paint facilitates corrosion of Button Welds

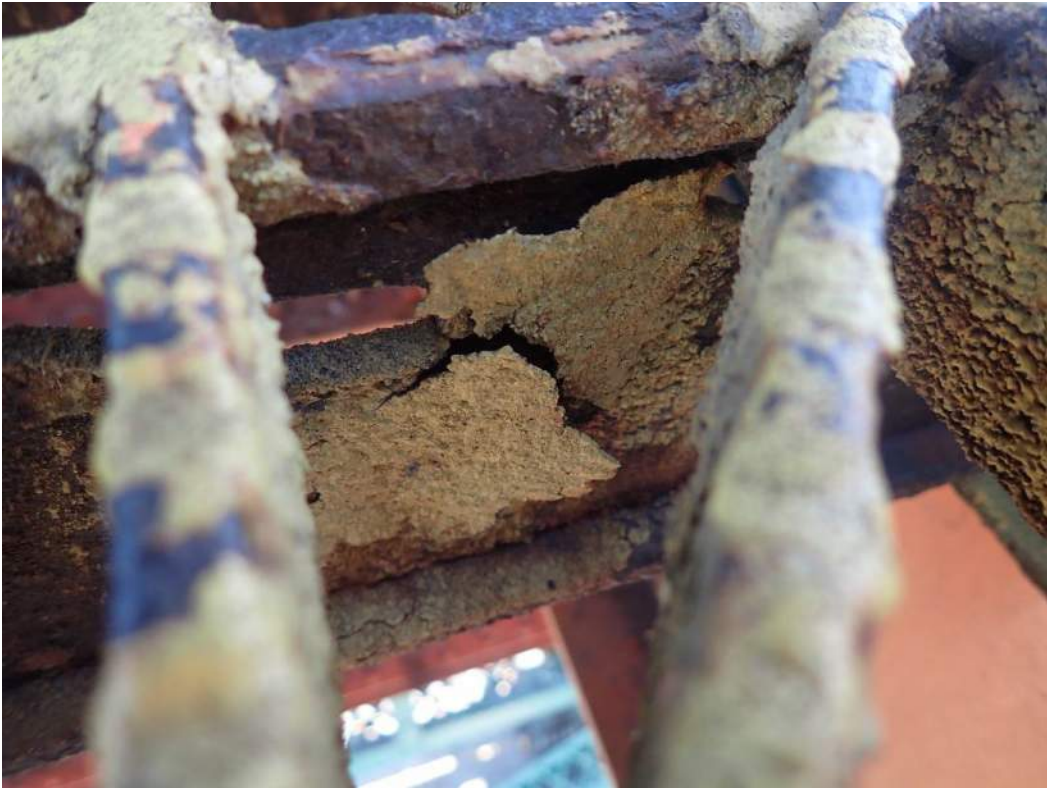
**Photo 25:** Flaking paint – typical for all lane markings
