2017 COMPREHENSIVE DETAILED INSPECTION BURLINGTON CANAL LIFT BRIDGE

Contract No. EQ754-181509/001/PWL Project No. R.089504.040

Revised March 29, 2018 (Rev .00)

RE: Burlington Canal Lift Bridge 2017 Comprehensive Detailed Annual Inspection Final Report

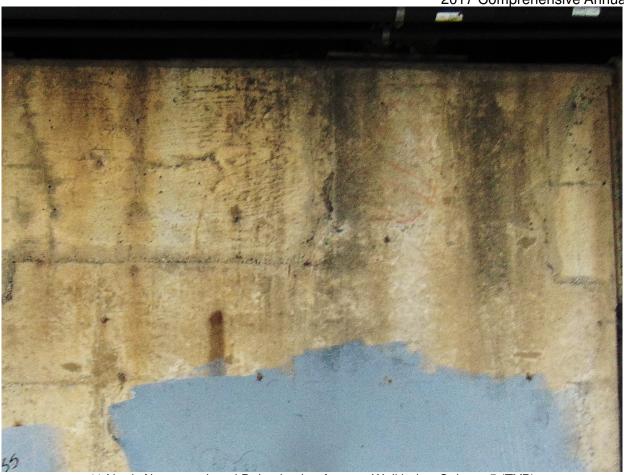
11 North Abutment, Local Delamination Area on Wall below Stringer 5 (TYP)

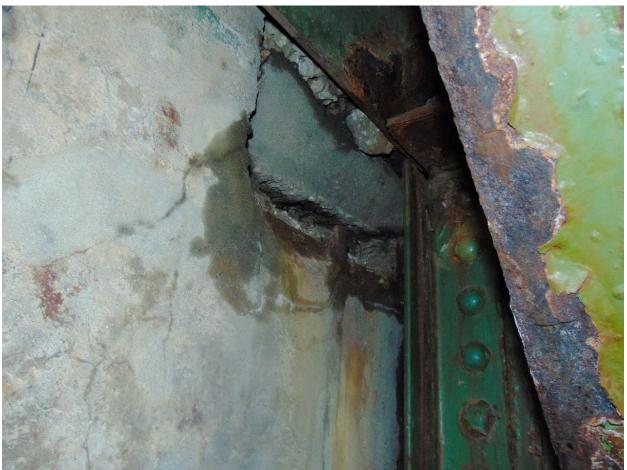
14 Seepage through Spalled at Pathed Area on Upper Section of North Ballast Wall behind Stringer 8 Page A2 [7] of A2 [153]

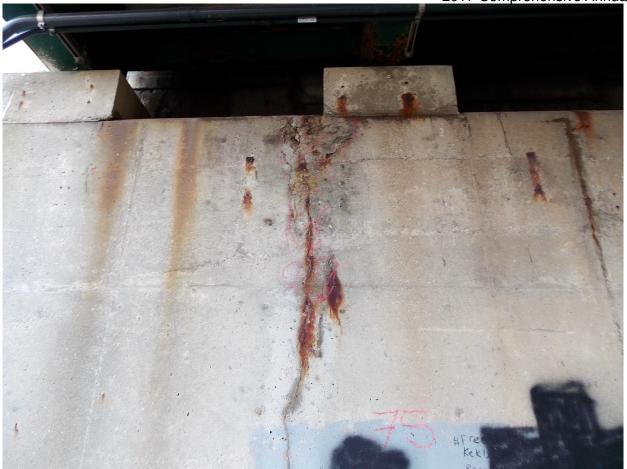
17 South Abutment, Wide Vertical Crack with Rust & Delamination on Wall between Stringers 1 &2

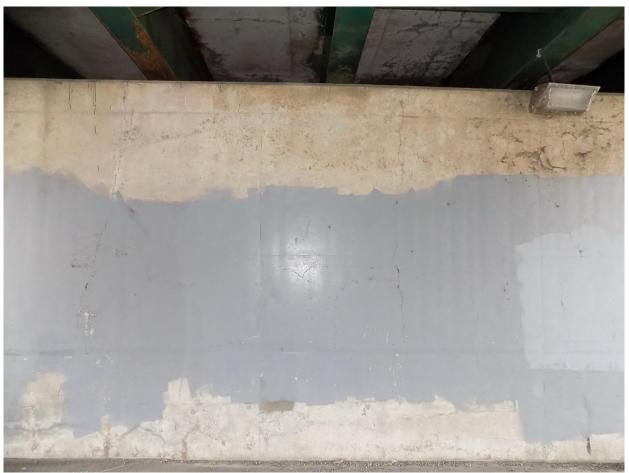
30 North Curtain Wall, Medium Vertical Cracks on East Section of Wall (TYP)

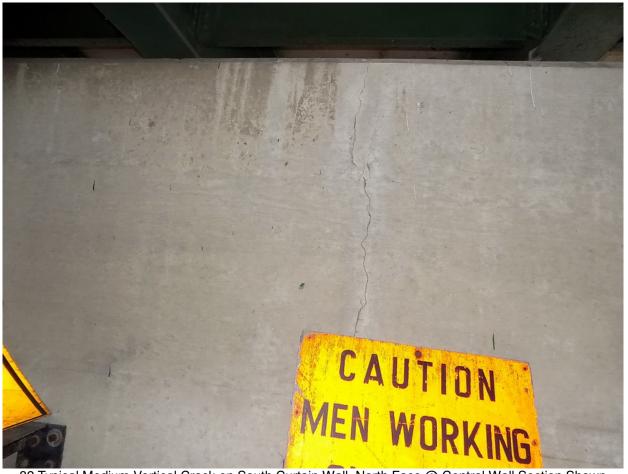
32 Typical Medium Vertical Crack on South Curtain Wall, North Face @ Central Wall Section Shown Page A2 [16] of A2 [153]

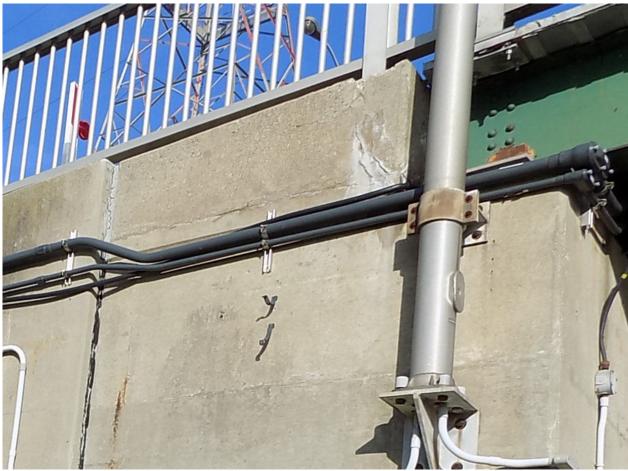
38 Stained Cracks @ top South Corner of Northwest Retaining Wall

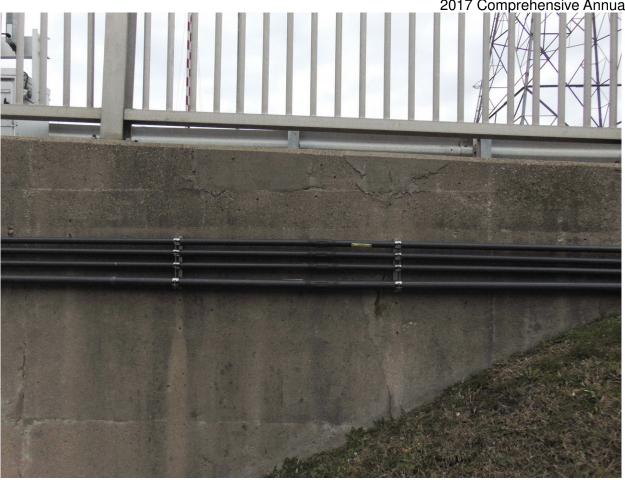
39 Isolated Vertical Crack & Local Patched Areas on Southwest Retaining Wall (TYP)

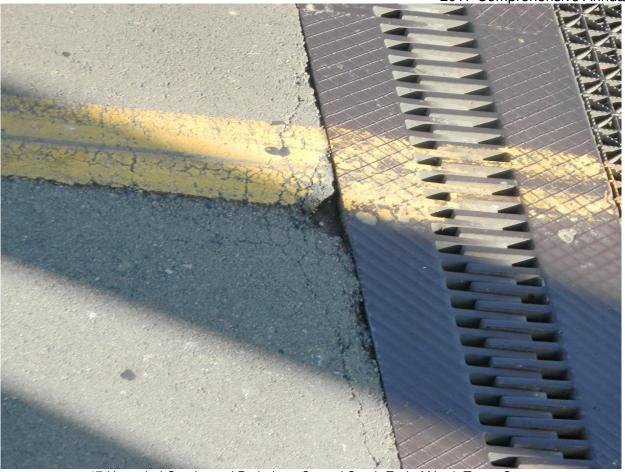
47 Unsealed Cracks and Pothole at Central South End of North Tower Span

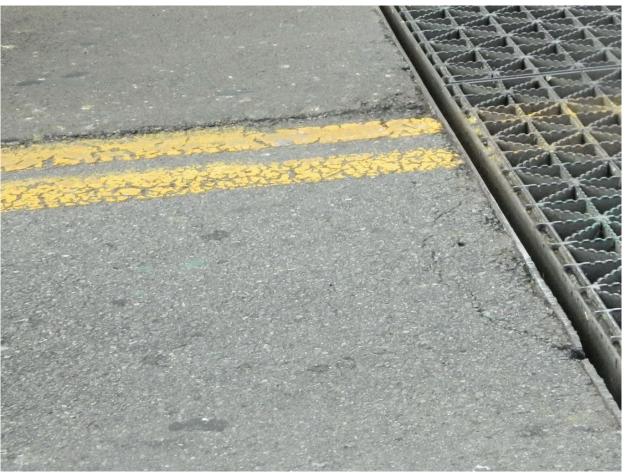
48 Unsealed Crack on Asphalt @ South Tower Span adjacent to Lift Span Grating

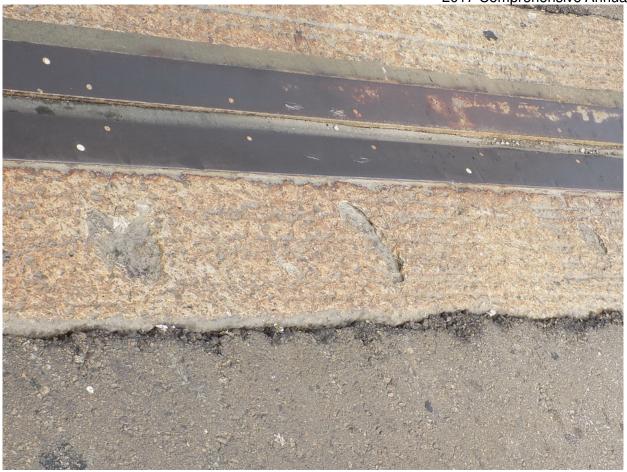
61 Typical Shallow Spalls on End-Dam @ Exp Joint, Joint between South Approach & Tower Spans Shown

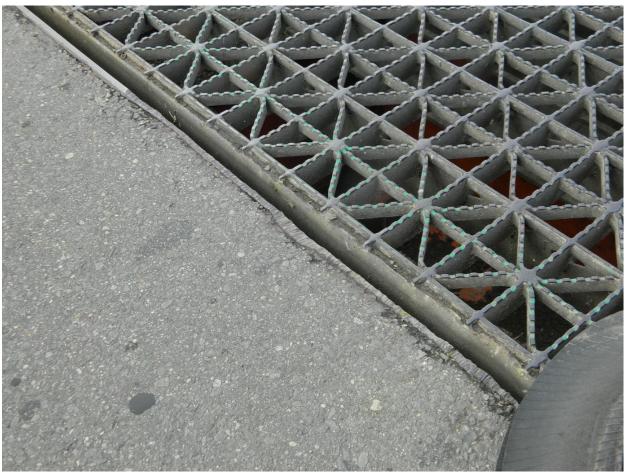
62 Severe Abrasions on Top East Section of End Plate for Open Gap Expansion Joint @ South Tower & Lift Span Page A2 [31] of A2 [153]

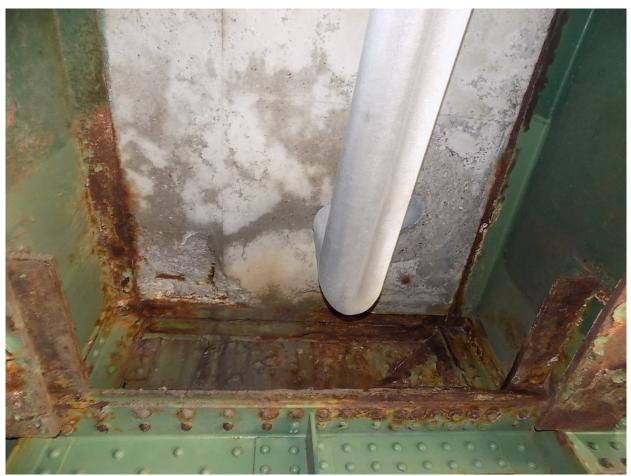
94 Large Wet Area with Spalls on Soffit @ SW Corner of North Approach Span

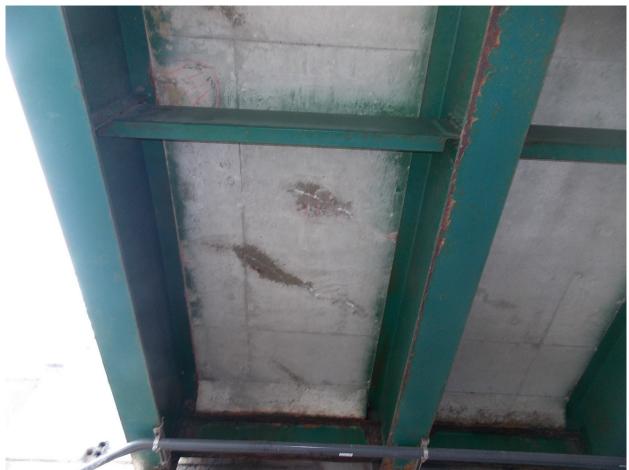
100 South Approach Span, Diagonal Stained Cracks with Delamination on Soffit @ Southeast Corner Area Page A2 [50] of A2 [153]

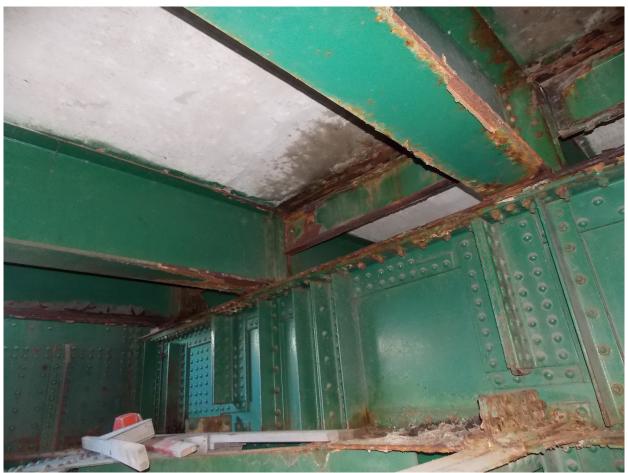
106 Wet Soffit & Heavy Corrosion on Steel below Expansion Joint @ South Approach & Tower Spans, looking SE Page A2 [53] of A2 [153]

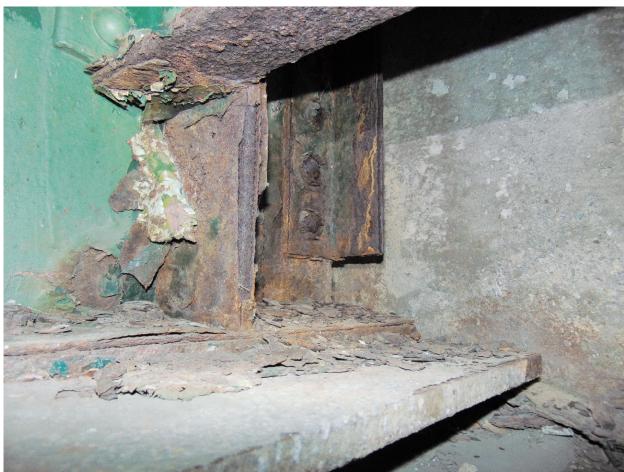
110 Typical Severe Corrosion on Stringers & Diaphragms at Abutment End, Stringer 6 @ South Abutment Shown Page A2 [55] of A2 [153]

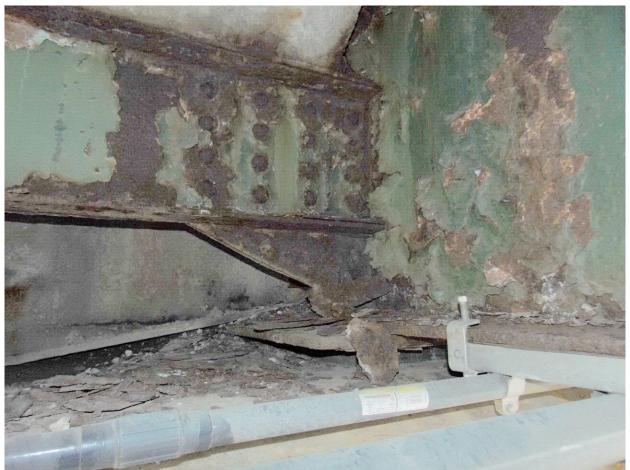
112 Typical Heavy Corrosion on Steel Diaphragm-Gusset Plate & Stringer at North Abutment, Stringer 3 Shown Page A2 [56] of A2 [153]

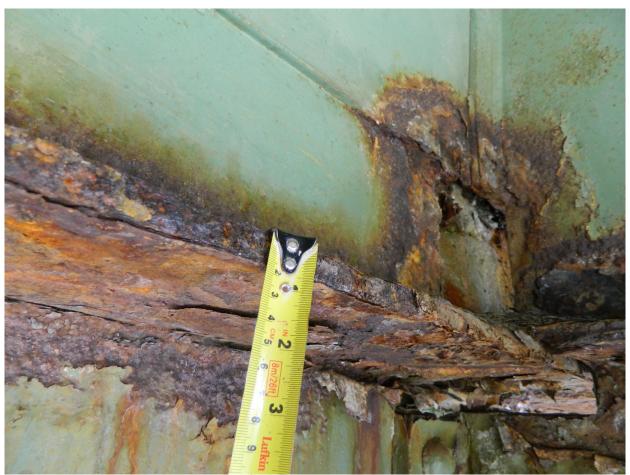
114 Severe Corrosion on Top Flange of Stringer 8 @ North Approach Span

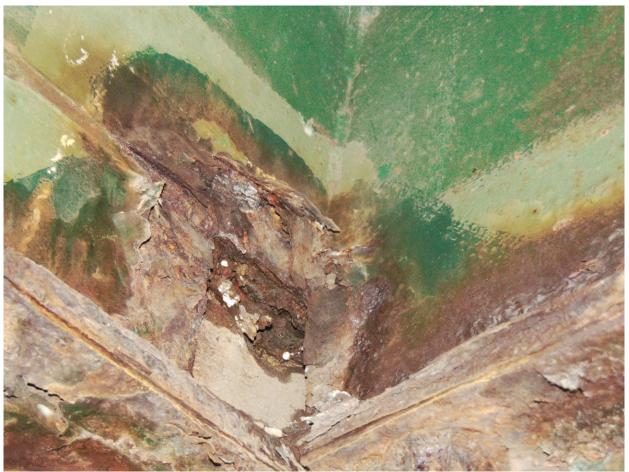
116 South Approach Span, Perforated Curb Plate @ South Expansion Joint End

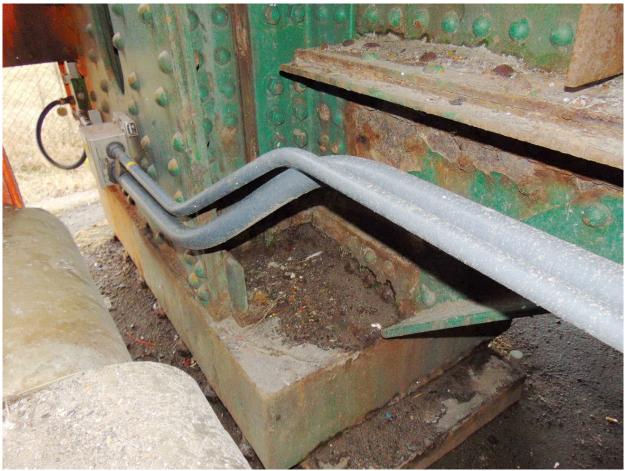
128 Sediment on Bottom of Northeast Column @ South Tower (TYP)

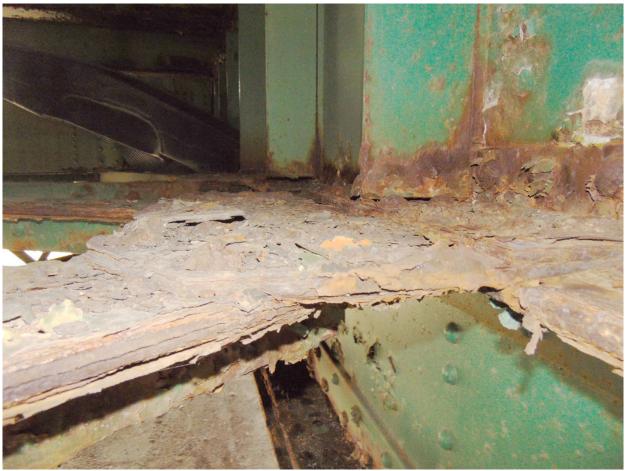
134 Severe Corrosion on Sway Bracing at Rear Floor Beam @ North Tower (TYP)

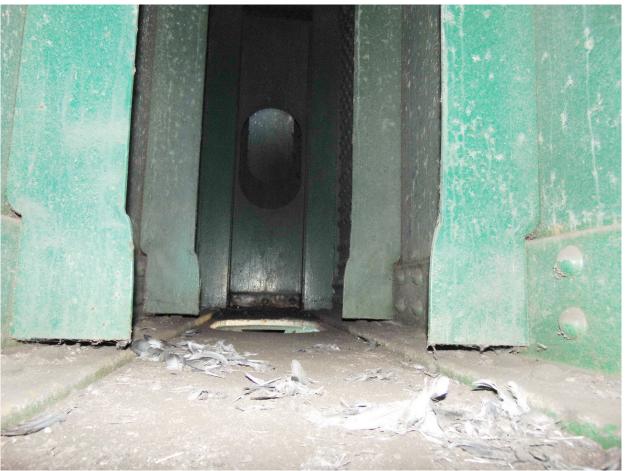
140 Bird Feather & Debris on Bottom interior of East Jacking Girder @ South Tower (TYP) Page A2 [70] of A2 [153]

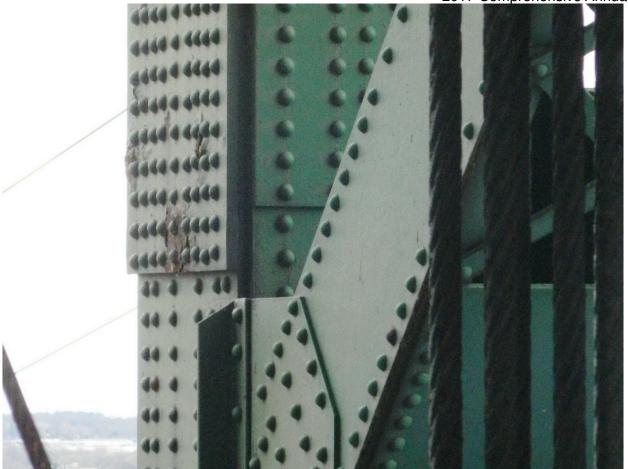
149 Typical Light Corrosion on Tower Column @ Coating Failure Spots, Southwest Column @ North Tower Shown

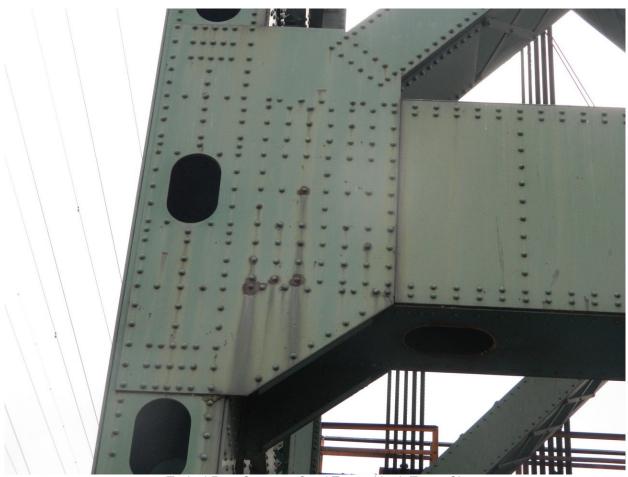
150 Typical Rust Spots on Steel Tower, North Tower Shown

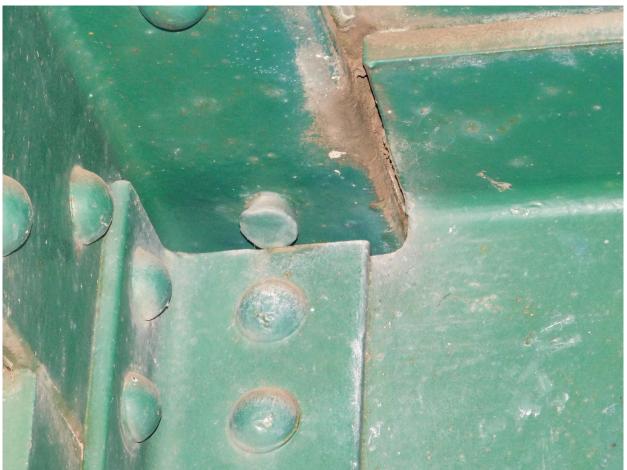
162 Un-Fitted Rivet @Top of 6th Sheave Girder from West above Floor Beam, North Tower Page A2 [81] of A2 [153]

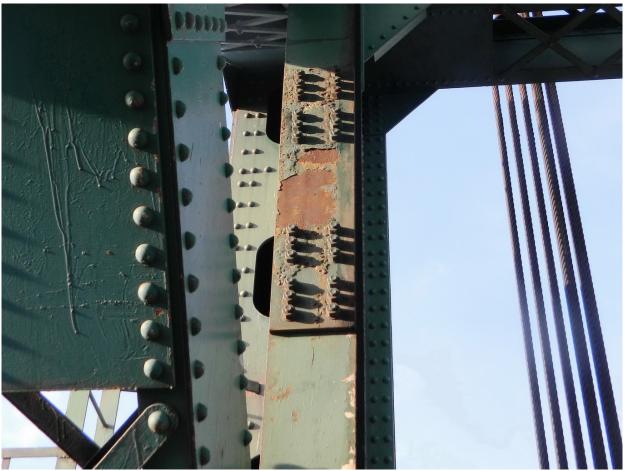
172 Blistered & Peeled Paint on Guiderail for Counter Weight on West Side of South Tower @ Panel 2 Page A2 [86] of A2 [153]

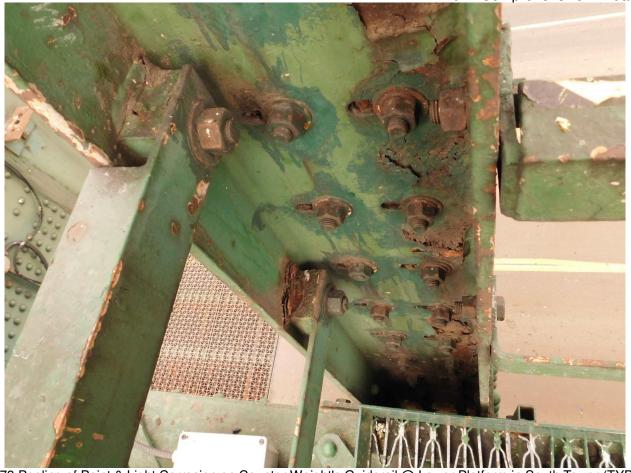
173 Peeling of Paint & Light Corrosion on Counter Weight's Guiderail @ Lower Platform in South Tower (TYP)

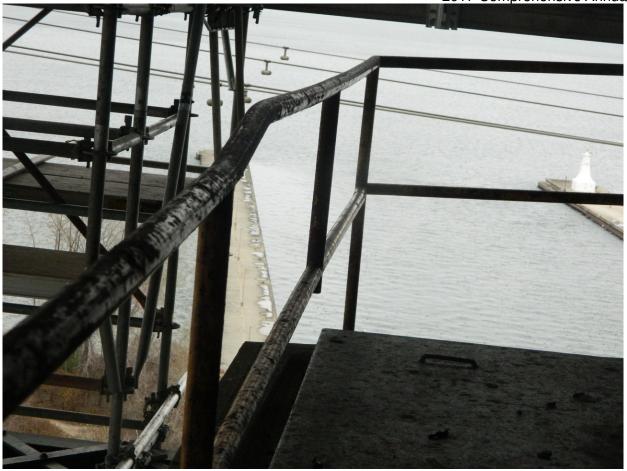
175 Bent Pipe Rail near Northeast Corner of North Counter Weight, looking East

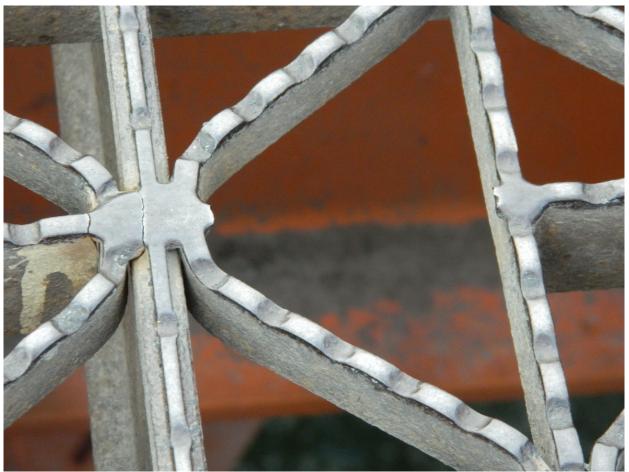
220 Broken Bearing Bar on Grating Panel in Central Section of Northbound Traffic Lane Page A2 [110] of A2 [153]

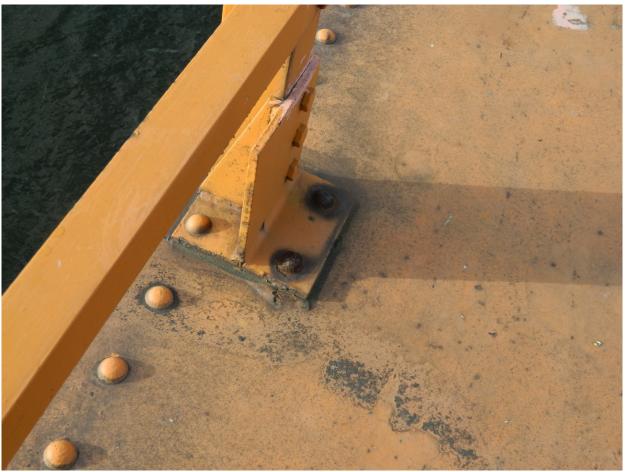
252 Typical Light Corrosion Spots on Post Base atop of Truss's Top Chord

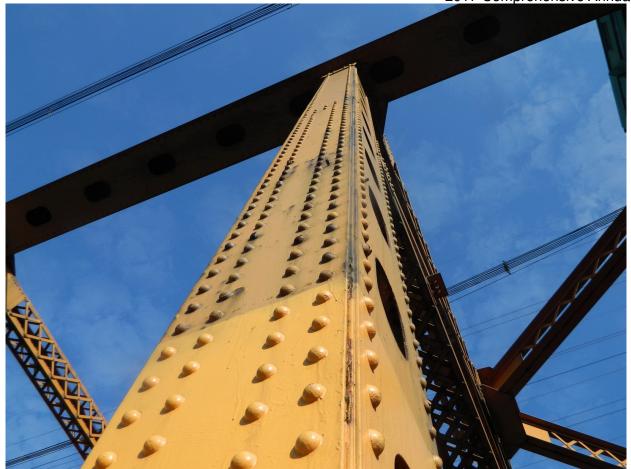
253 Typical Faded Coating & Light Surface Rust on Truss, Vertical Member near SW Corner of Lift Span Shown

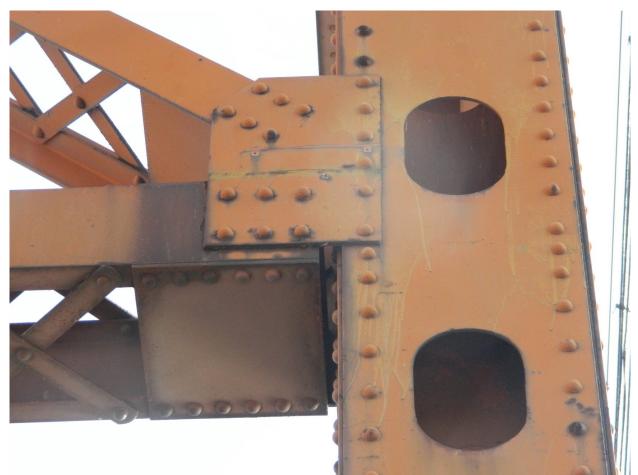
254 Rust Stain & Light Corrosion on Lower Sway Bracing @ Vertical Chord of Truss (TYP) Page A2 [127] of A2 [153]

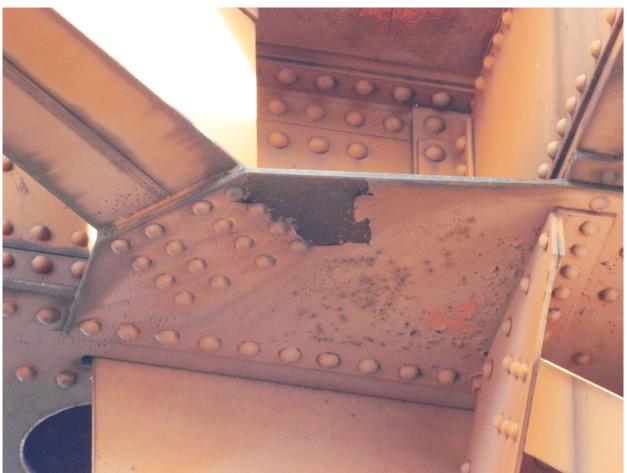
258 Localized Peeled Paint & Light Corrosion on Gusset Plate at Top East Chord near Mid Span Section Page A2 [129] of A2 [153]

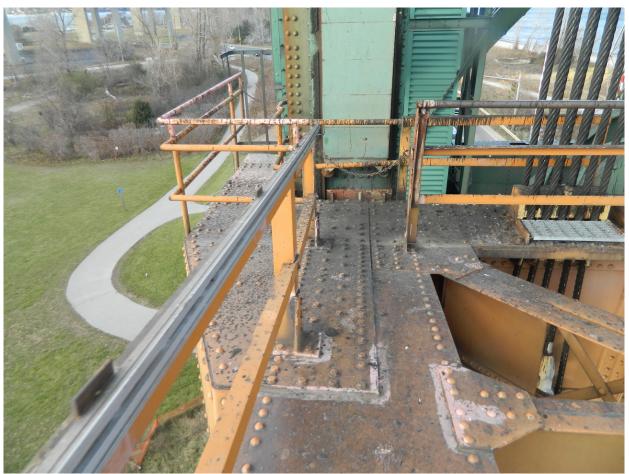
264 Typical Grease Stains on Top Corner of Truss, Northwest Corner Shown

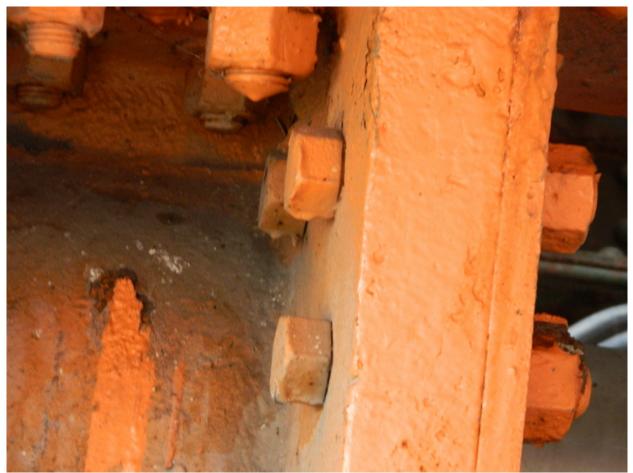
276 Loose Bolts on front West Side of Southeast Saddle Shoe of Lift Span

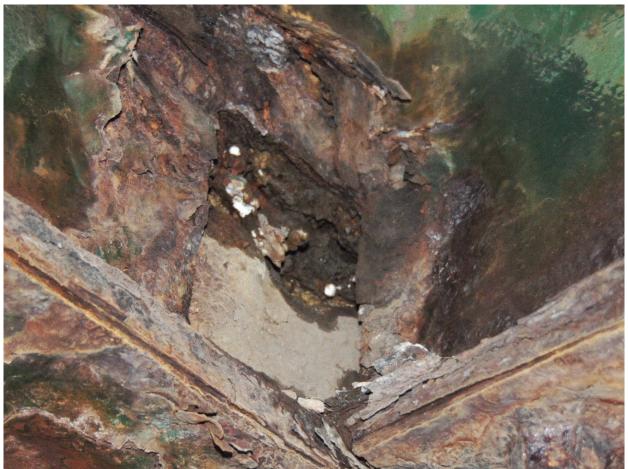
298 Local Severe Corrosion with Perforation Hole on Bent Curb Plate, South Approach Span Shown Page A2 [149] of A2 [153]

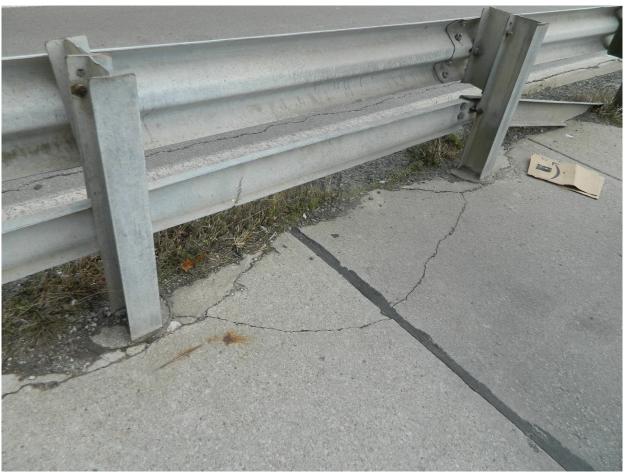
304 Wide Cracks on Sidewalk & Light Impact Damages on Posts @ Southwest Approach Page A2 [152] of A2 [153]
