Asbestos and Lead Reassessment Survey

Burlington Lift Bridge

FINAL REPORT

March 27, 2018

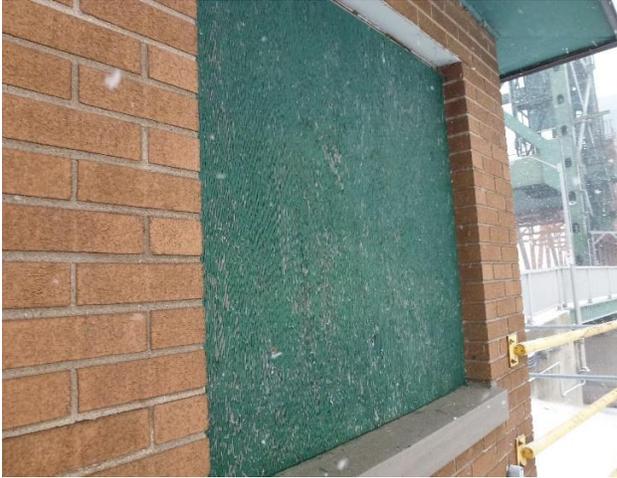
Photo 1 : Gatehouse peeling paint

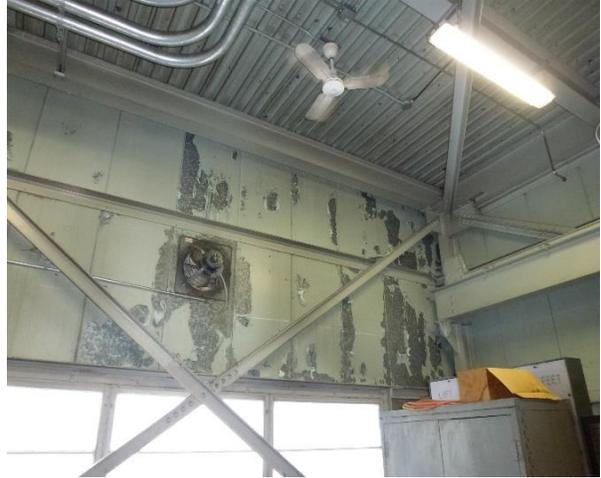
Photo 2: Peeling wall paint North Tower

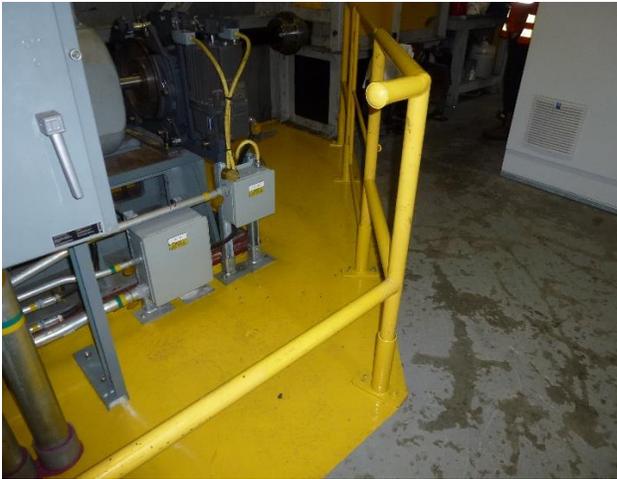
North tower yellow paint on the bollards	Assumed ²	Good	Good	Bollards re-painted in 2011. Assuming lead paint remains beneath new paint.	Photo 3
	North tower green exterior paint	Assumed ²	Fair – Poor	Fair - Poor	Limited visibility of exterior cladding paint from windows, and ground Visible paint appears to range from Fair to Poor condition.	Photo 22
Bridge	Lift span and towers (red primer)	Assumed	Fair	Fair	The entire lift span structure observed to have moderate peeling, flaking, etc. The red primer at the ‘splash- zone’ has been removed and repainted. Ten feet above the deck was repainted.	Photo 9

Photo 3: North tower 9peeling floor paint and bollards

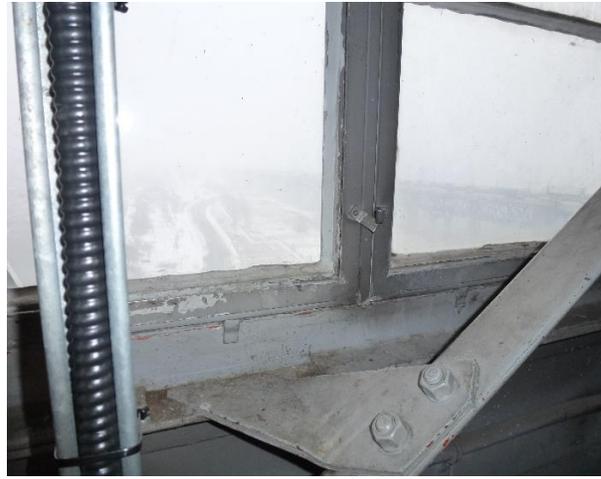
Photo 4: Window caulking South Tower

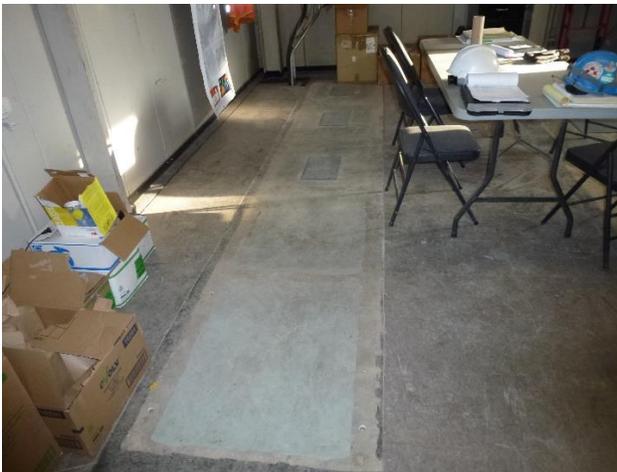
Photo 5: Vinyl tiles (ACM) removed electrical room

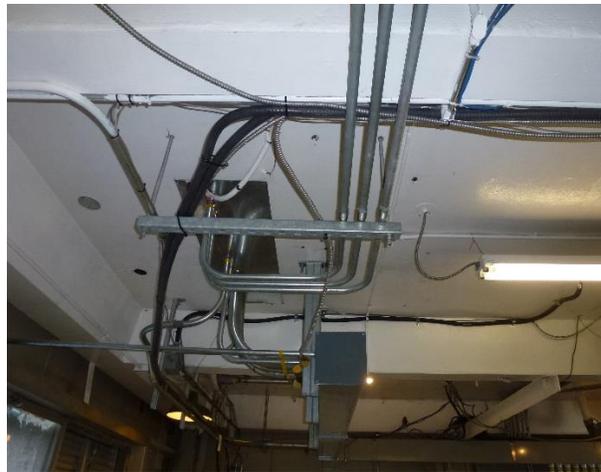
Photo 6: ACM high voltage cables removed

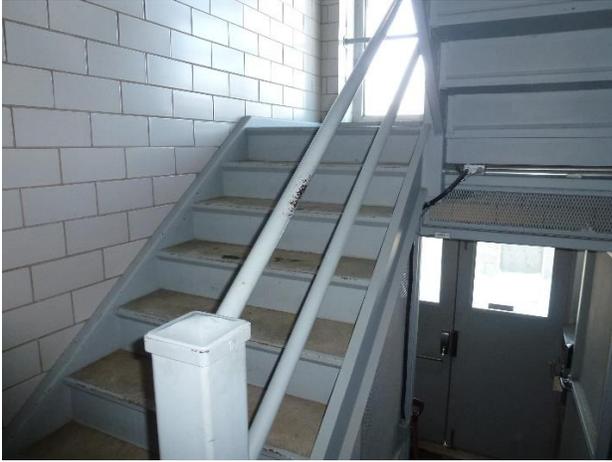
Photo 7: Control house stairwell wearing paint

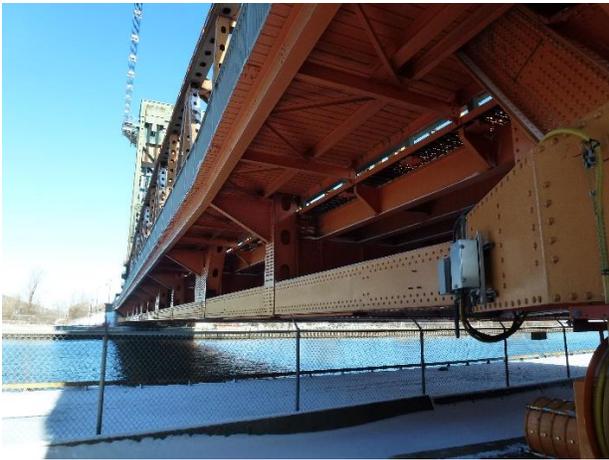
Photo 9: Lift bridge

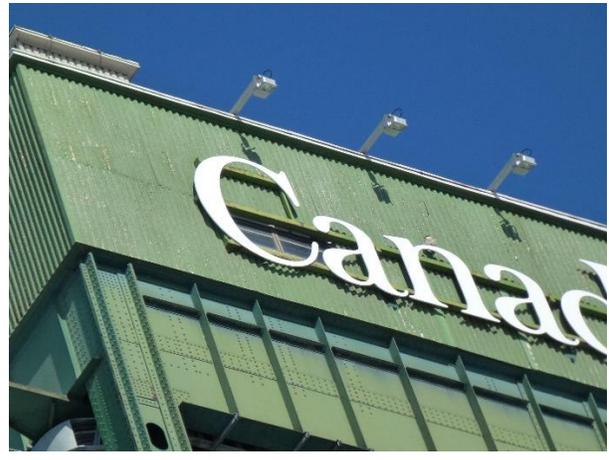
Photo 10: South tower machine room exterior

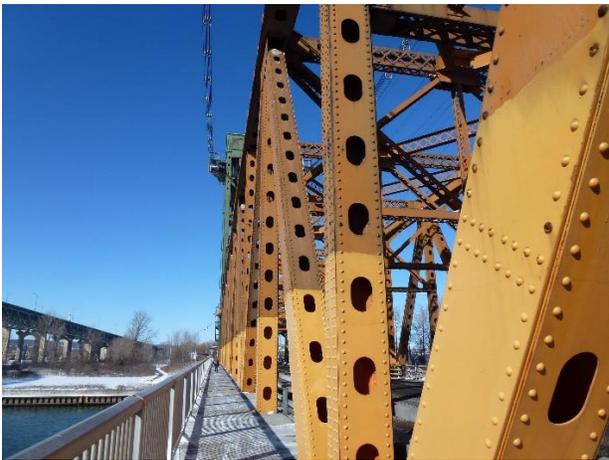
Photo 11: LCM removed and painted yellow

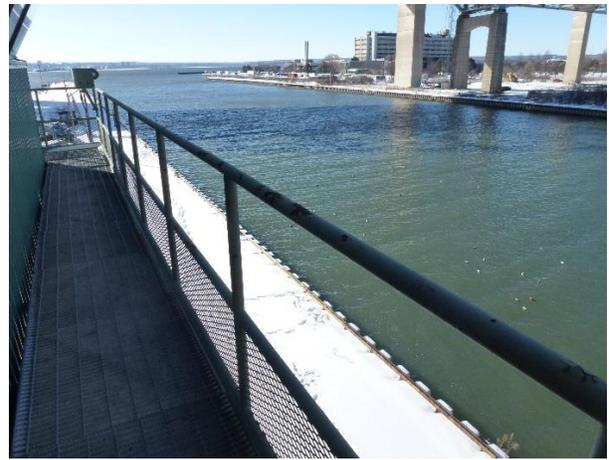
Photo 12: Control house catwalk peeling LCM paint

- 2) It is recommended that areas of lead-containing paints observed to be in *poor* condition (severe cracking/chipping/flaking and debris) as listed in Table 4-4 (control house mechanical room walls, control house catwalk, gatehouse ceiling and walls, gatehouse exterior window covering, south tower interior walls and floors, south tower exterior mechanical room, north tower interior walls, north tower mechanical room exterior and lift span read primer) be removed by a professional environmental abatement contractor following either Type 2a Operations (using non-powered hand tools) or Type 3 Operations (using power tools as stipulated in the Ministry of Labour Guideline, "*Lead on Construction Projects*").

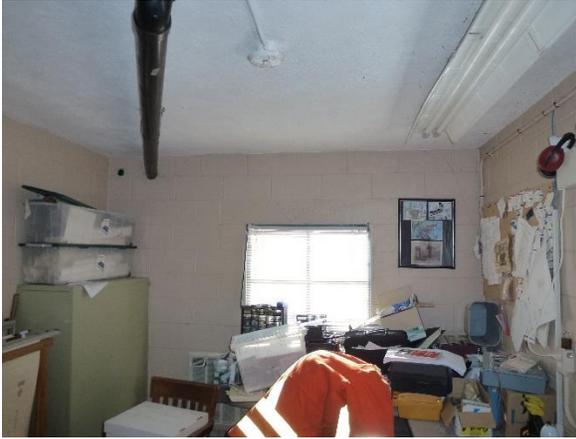
Photo 13: Ceiling Stucco old workshop

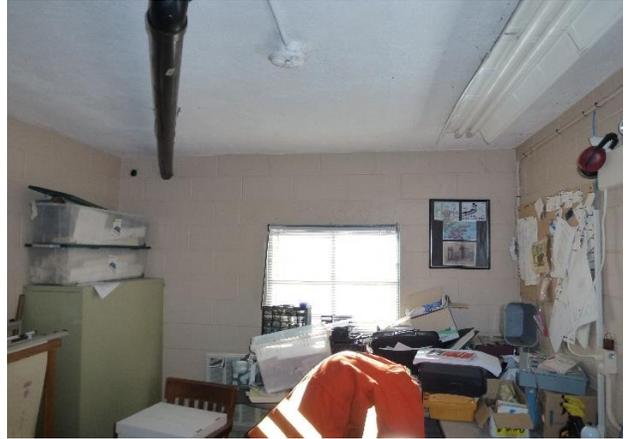
Photo 14: Beige wall paint old workshop

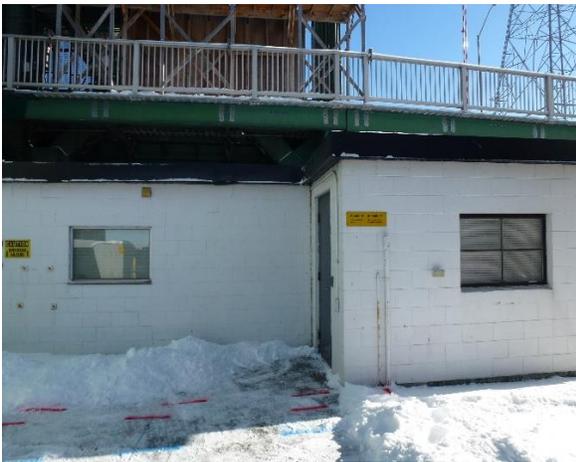
Photo 15: White over beige over grey old workshop

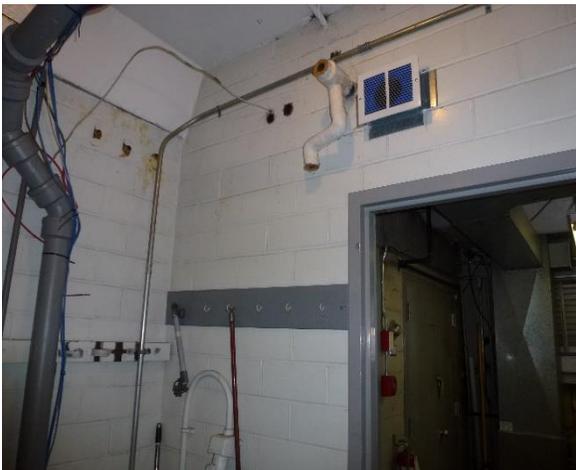
Photo 17: Control house 2nd floor white wall paint

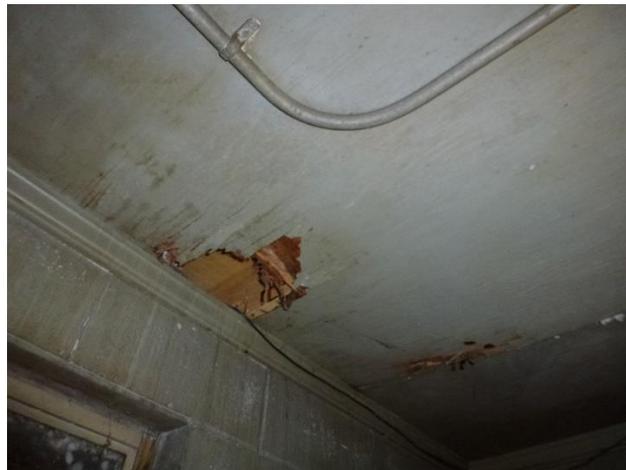
Photo 18: Gate house ceiling & wall LCM

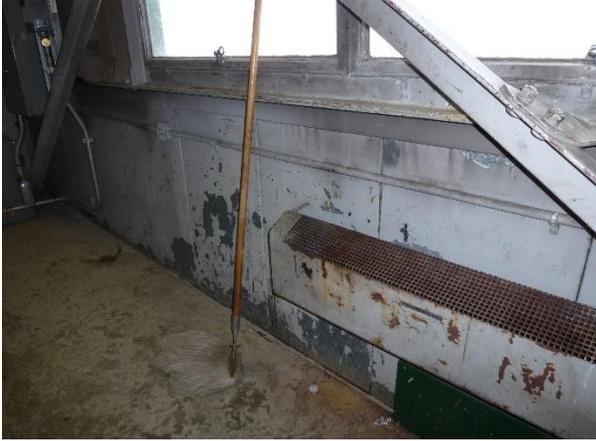
Photo 19: South tower interior grey wall paint.

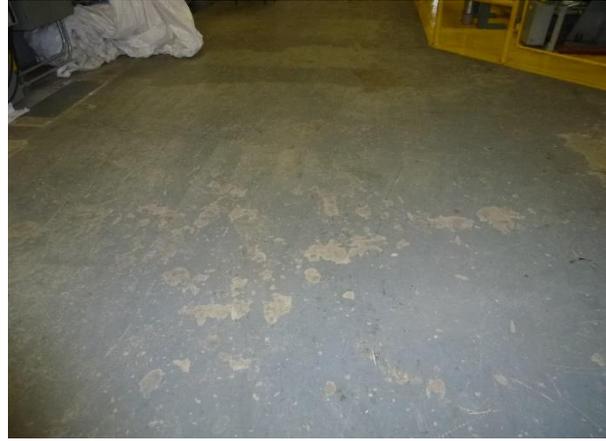
Photo 20: South tower interior floor paint.

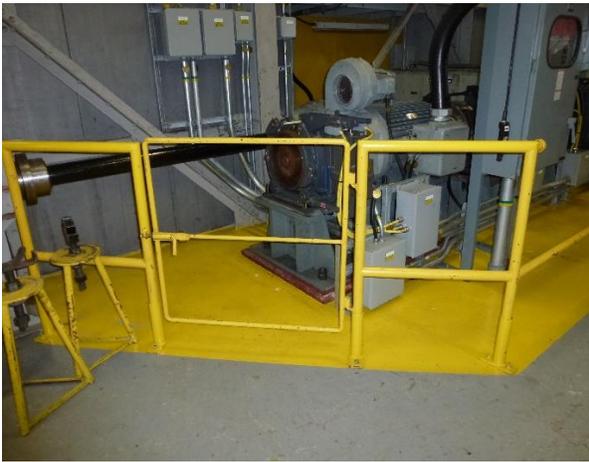
Photo 21: South tower yellow paint on bollards

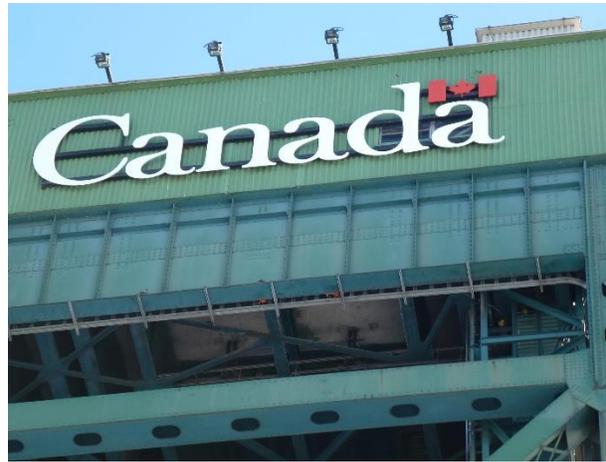
Photo 22: North tower machine room exterior
