PRE-DEMOLITION HAZARDOUS MATERIAL REPORT

SUBJECT PROPERTY ADDRESS: BUILDING #25 12740 TRITES RD. RICHMOND BC

DATE OF INSPECTION: SEP-15-2021

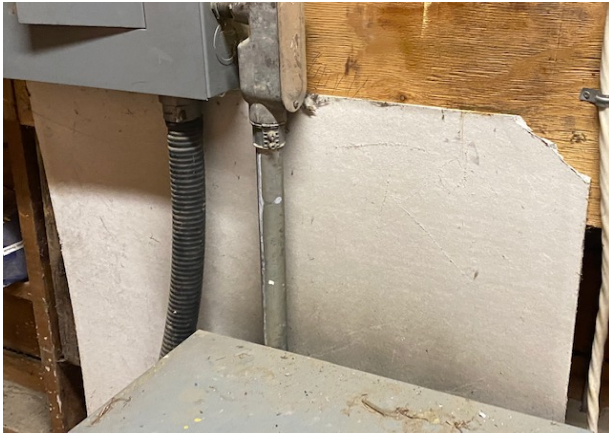
MATERIAL TYPE	LOCATION	% & TYPE OF ASBESTOS	APPROX. QUANTITY
Vinyl Floor tile	N.W Side building washroom	1% Chrysotile	80 SQ FT
Fiber Board	West Side Electrical room behind panel	90% Chrysotile	36 SQ FT
Cement Board	West side electrical room wash station walls + Ceiling	60% Chrysotile 5% Amosite	300 SQ FT
Window Putty	Exterior North Side Wood frame window	1% Chrysotile	<50KG

Asbestos fiber board behind panel in electrical room

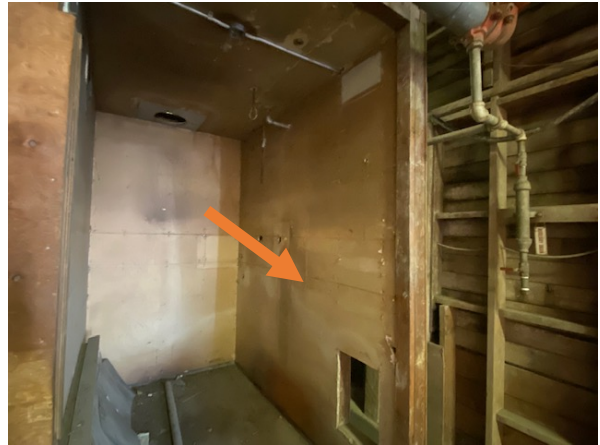
- Asbestos fiber board identified behind drywall surfacing material within electrical room wash station
- Washroom located on the N.W side of the building contains asbestos VFT
- Crawl space beneath the building was not accessible at time of inspection Aircell pipe wrap may be present beneath the building
- Fiber board located behind electrical panel is confirmed to be ACM
- Wood frame window located on the exterior north side of the building is confirmed to contain asbestos containing window putty

Asbestos cement board behind drywall

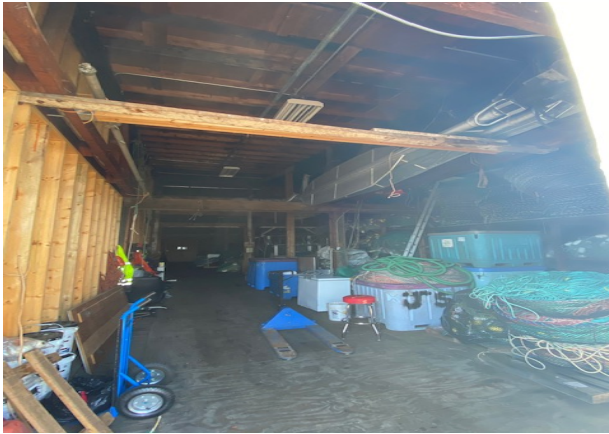
interior of storage units

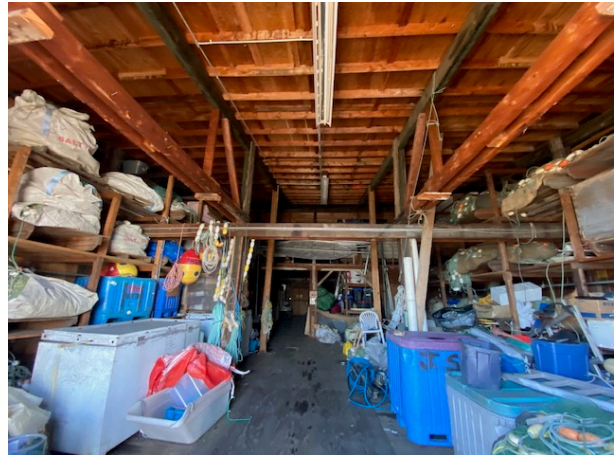
Interior of storage units

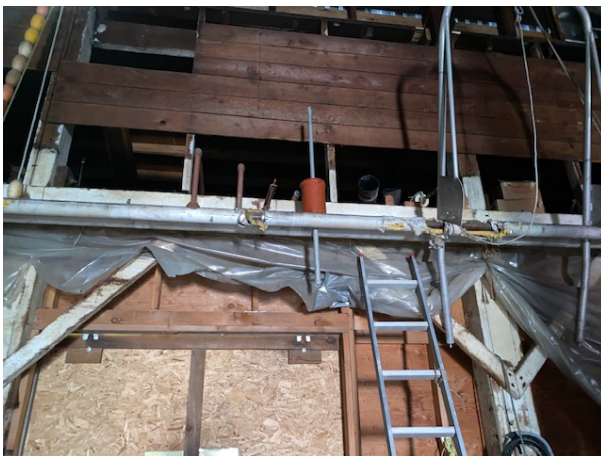
Fiber glass pipe wrap

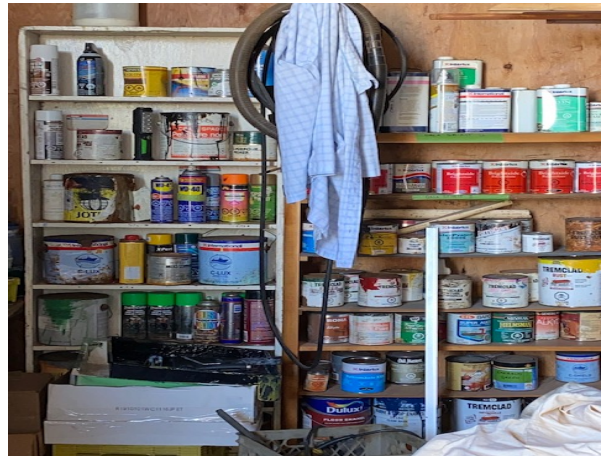
CFC'S	RADIOACTIVE MATERIALS	MERCURY	PCB'S	CHEMICALS	MOLD	RODENT DROPPINGS	BIO HAZARD
√	√	√	√	√	√	√	
Fridge N.W Storage room	All Smoke alarms throughout building	Thermostat Switch	Tube Lighting throughout the building	House hold cleaning chemicals Solvents, paints, strippers, accelerants	mold observed on surfaces throughout the building	Observed throughout areas of the building

Chemicals, solvents and paints in storage room

- It is the sole responsibility of the Building Owner to ensure the above identified hazardous materials are safely removed and disposed of (as required) following the Ministry of Environment's "Special Waste Regulation".

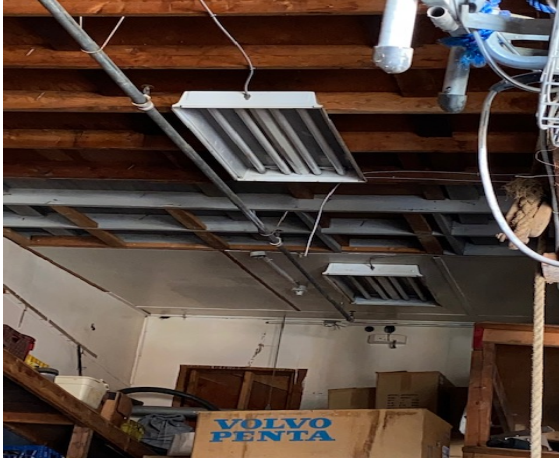
Tube lighting in storage rooms

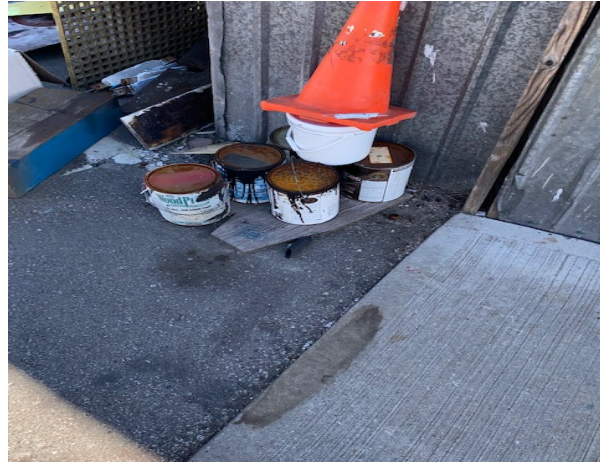
Paint cans on North side of the building
