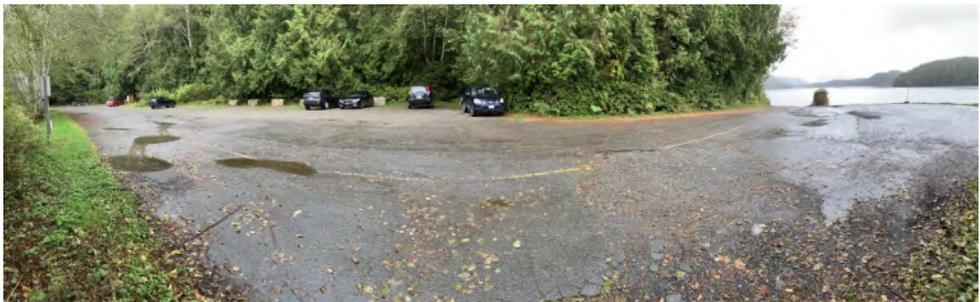
Photo Location: Grice Bay Parking Lot			
Direction: West			
Survey Date: 9/28/2021			
Comments: Parking Lot			
Photograph ID: 2

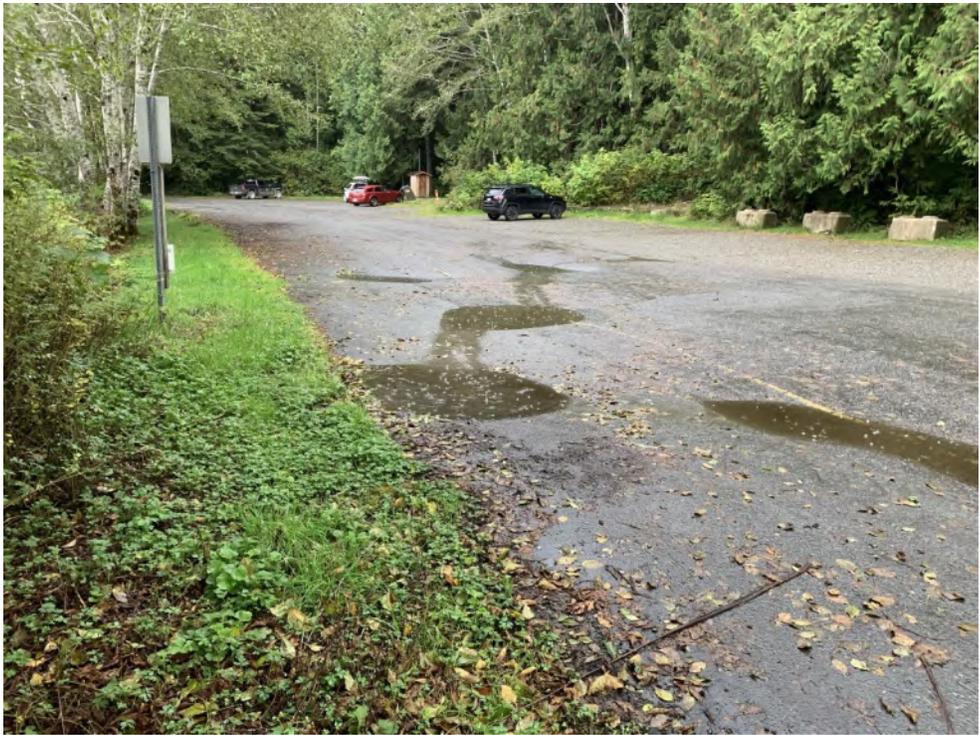
Photo Location: Grice Bay Parking Lot			
Direction: South			
Survey Date: 9/28/2021			
Comments: Parking Lot

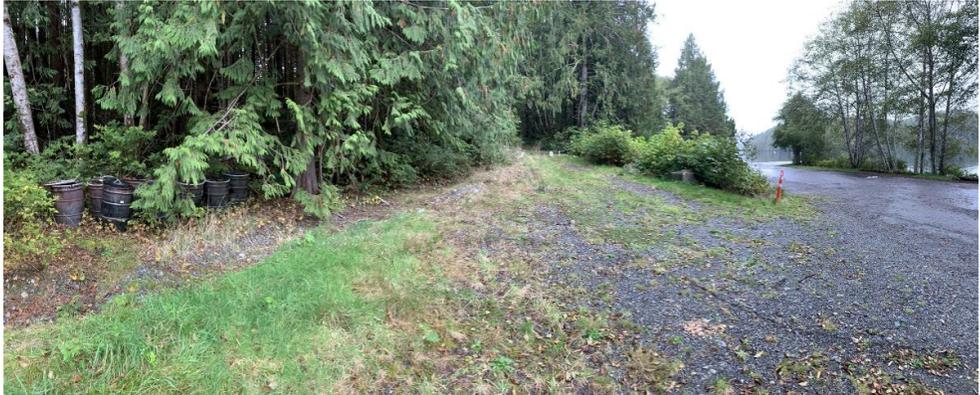
Photo Location: Grice Bay Parking Lot			
Direction: North			
Survey Date: 9/28/2021			
Comments: Drums in bushes, chained access to McLean Point Access Road, parking lot			
Photograph ID: 6

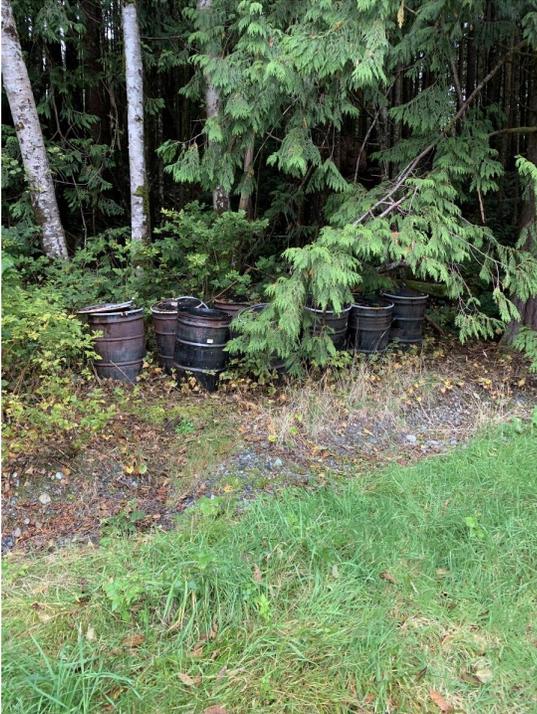
Photo Location: Grice Bay Parking Lot			
Direction: West			
Survey Date: 9/28/2021			
Comments: Drums in bushes

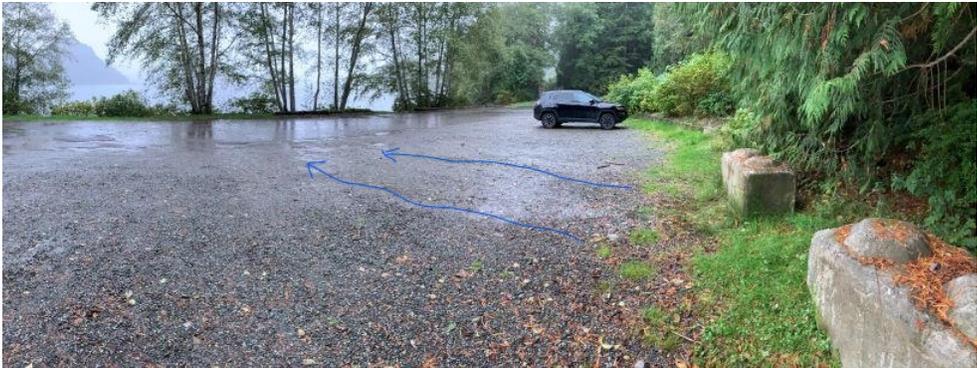
Photo Location: Grice Bay Parking Lot			
Direction: South			
Survey Date: 9/28/2021			
Comments: Parking lot showing seep and location of planned drainage blanket. .

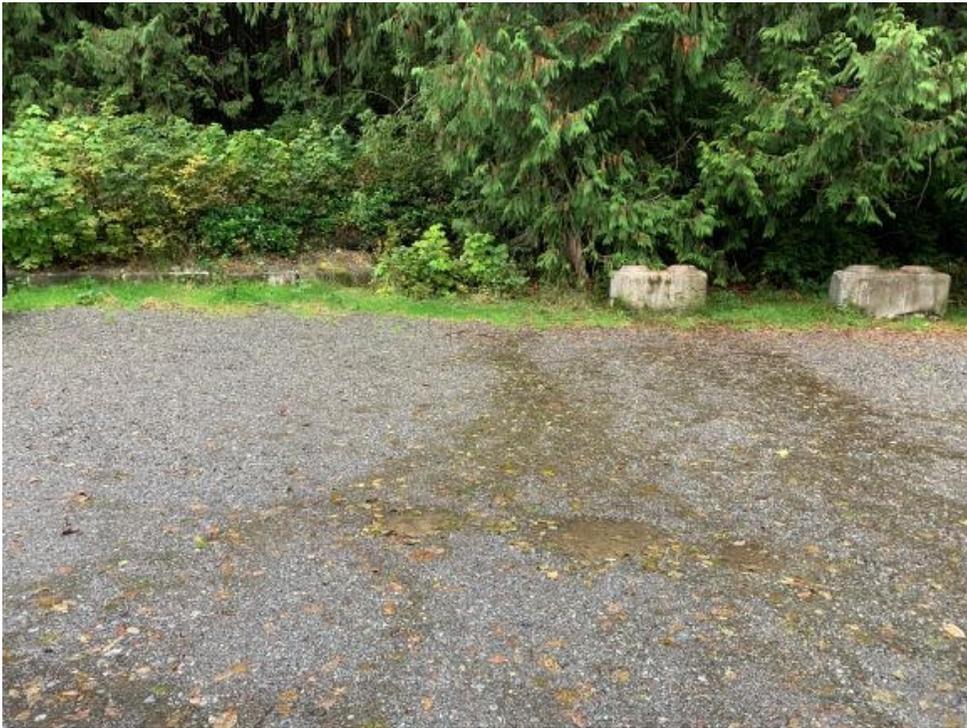
Photo Location: Grice Bay Parking Lot			
Direction: West			
Survey Date: 9/28/2021			
Comments: Seep showing location of planned drainage blanket.			
Photograph ID: 12

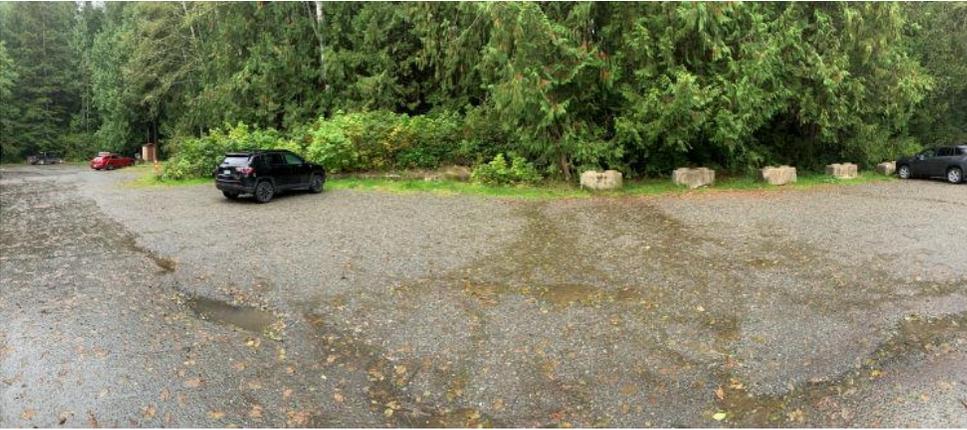
Photo Location: Grice Bay Parking Lot			
Direction: West			
Survey Date: 9/28/2021			
Comments: Parking lot showing seep and location of planned drainage blanket.

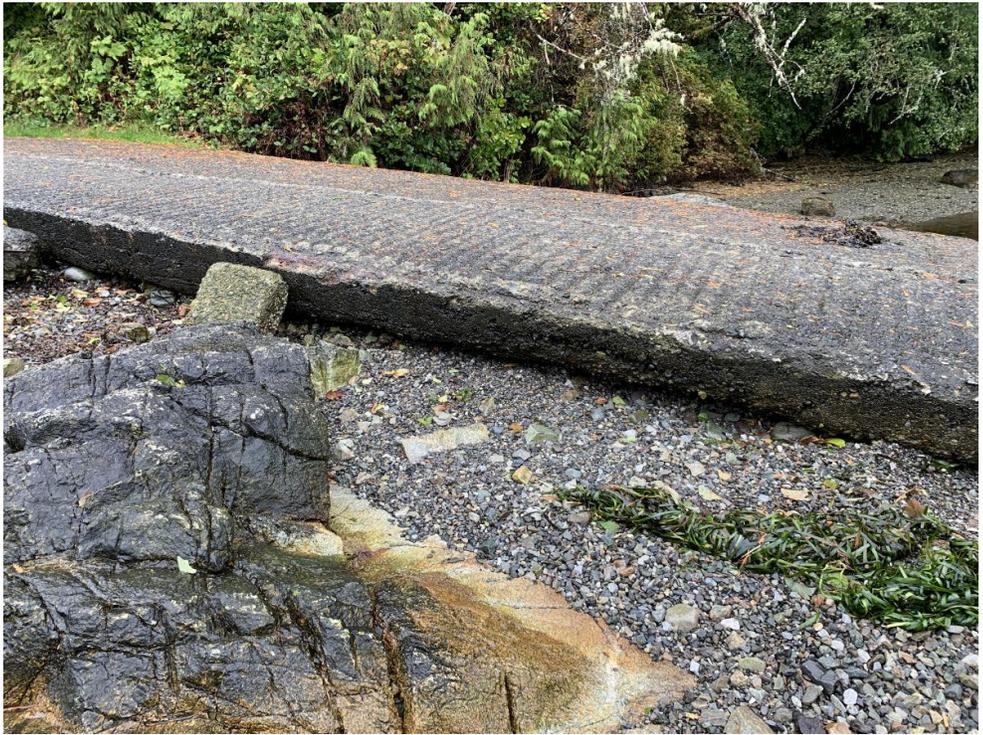
Photo Location: Grice Bay Parking Lot			
Direction: West			
Survey Date: 9/30/2021			
Comments: Boat Launch, portion to be retained.			
Photograph ID: 14

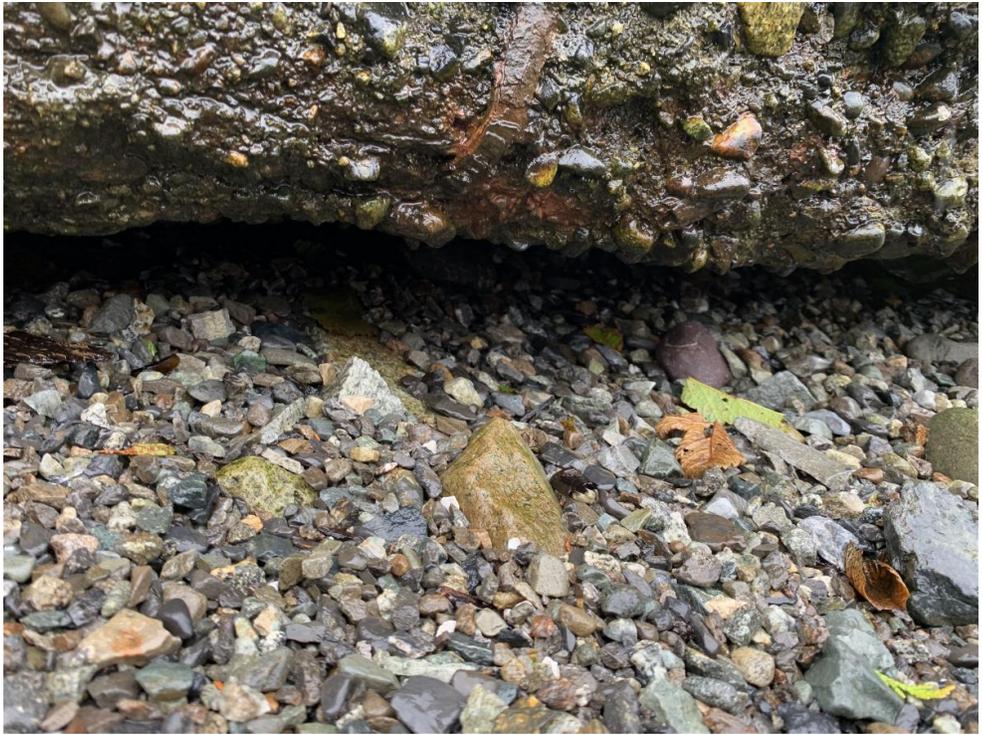
Photo Location: Grice Bay Parking Lot			
Direction: West			
Survey Date: 9/30/2021			
Comments: Boat Launch ramp bedding erosion. Portion of Boat Launch to be retained, example of void to be filled with material removed from underneath portion downslope to be removed.

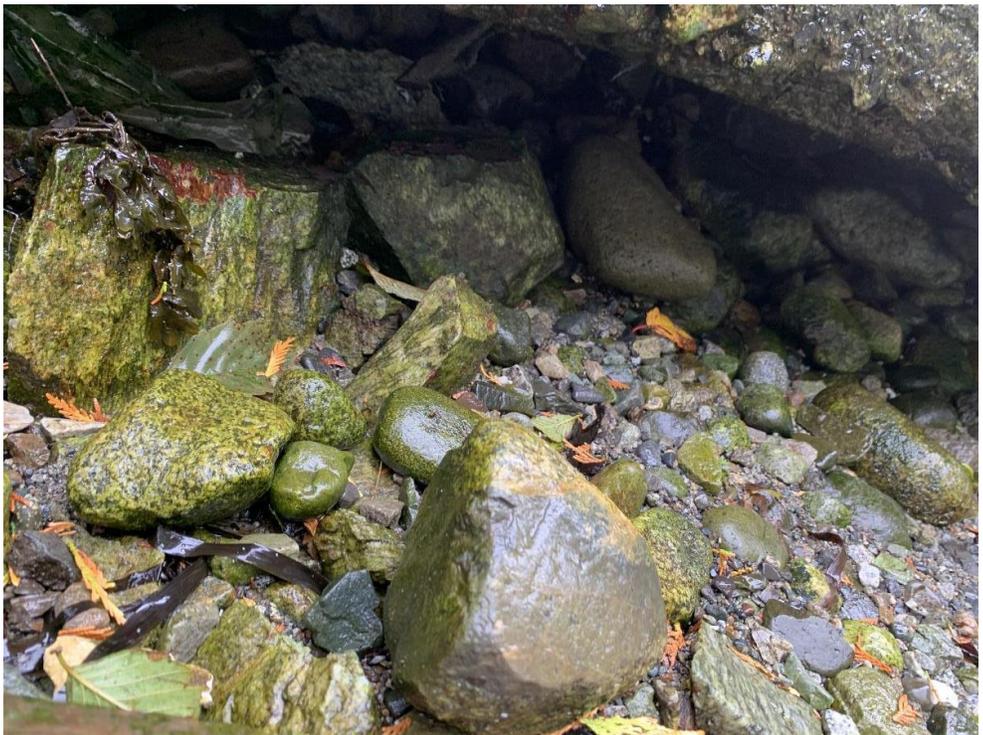
Photo Location: Grice Bay Parking Lot			
Direction: West			
Survey Date: 9/30/2021			
Comments: Boat Launch ramp bedding erosion			
Photograph ID: 16

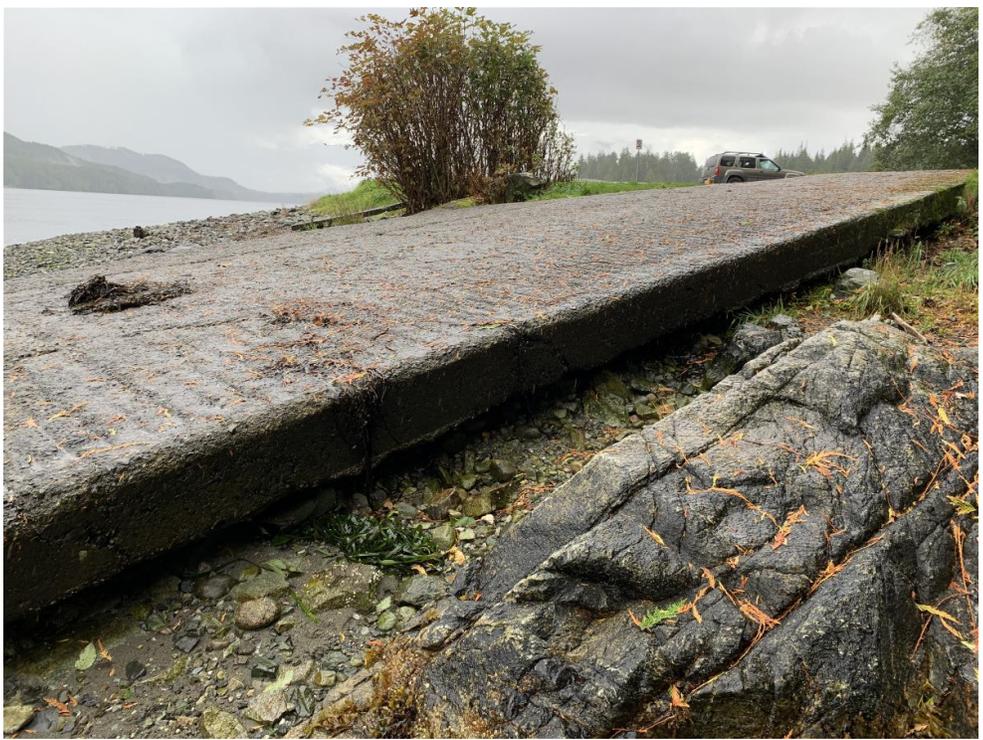
Photo Location: Grice Bay Parking Lot			
Direction: South/East			
Survey Date: 9/30/2021			
Comments: Concrete Boat Launch Ramp from West. Portion to be retained, void spaces to be filled with salvaged material from underneath the portion to be removed.

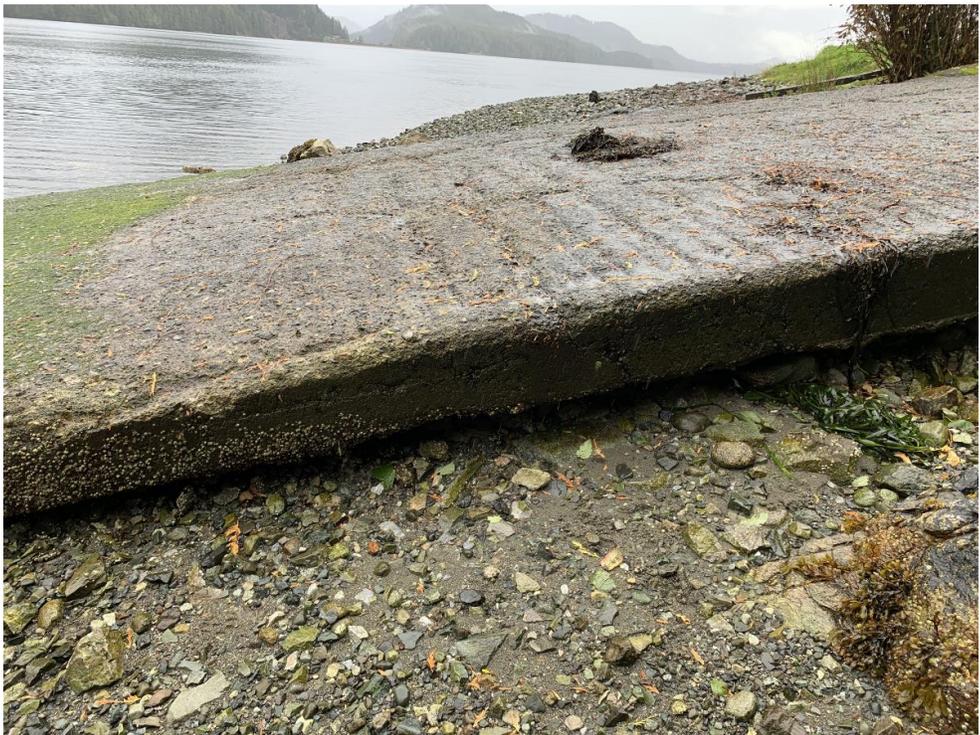
Photo Location: Grice Bay Parking Lot			
Direction: East			
Survey Date: 9/30/2021			
Comments: Boat Launch ramp bedding erosion			
Photograph ID: 18

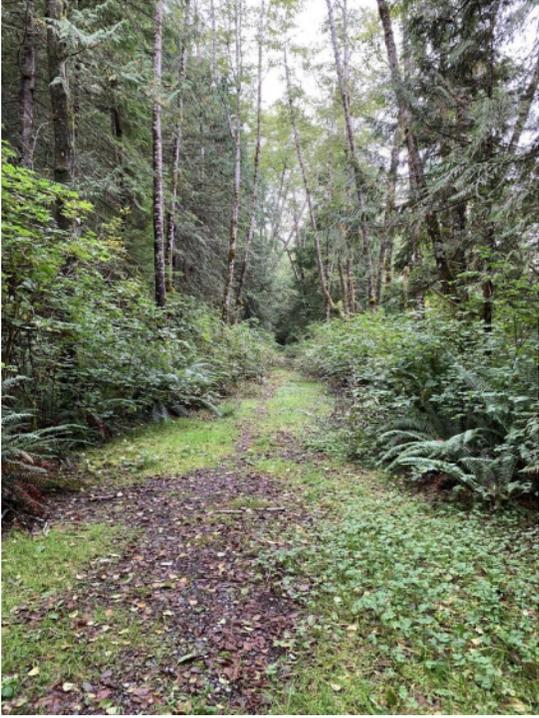
Photo Location: McLean Point Access Road			
Direction: Towards McLean Point			
Survey Date: 9/28/2021			
Comments: Access Road. Bushes at side of access road to be cut back by others prior to contract.			
Photograph ID: 20

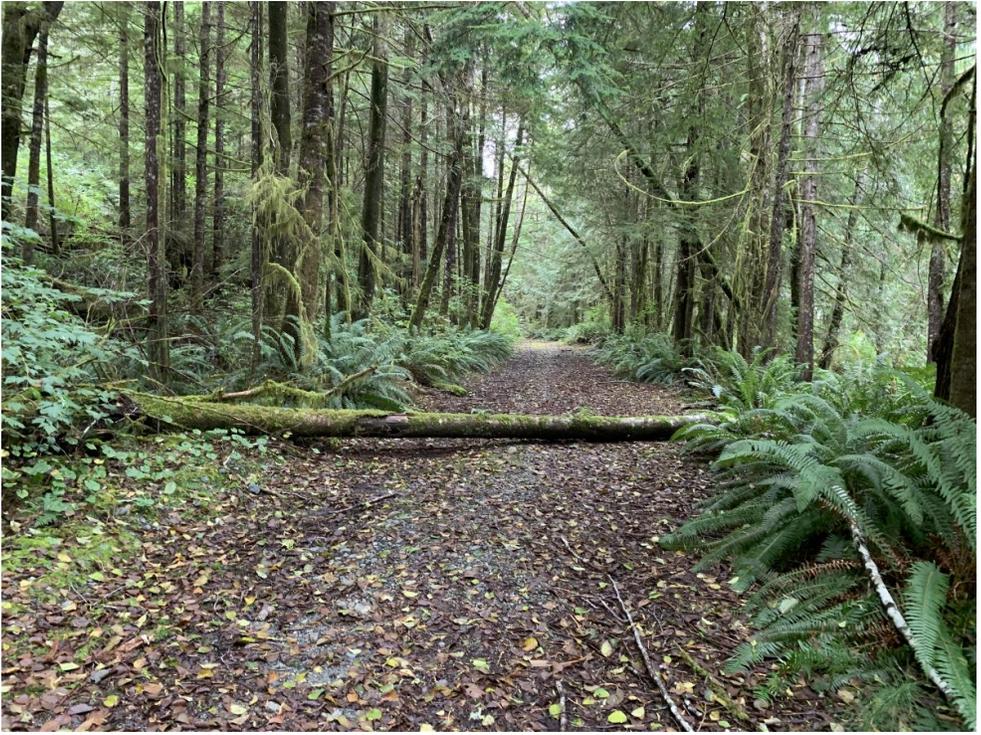
Photo Location: McLean Point Access Road			
Direction: Towards McLean Point			
Survey Date: 9/28/2021			
Comments: Fallen Tree. To be removed by others prior to contract.

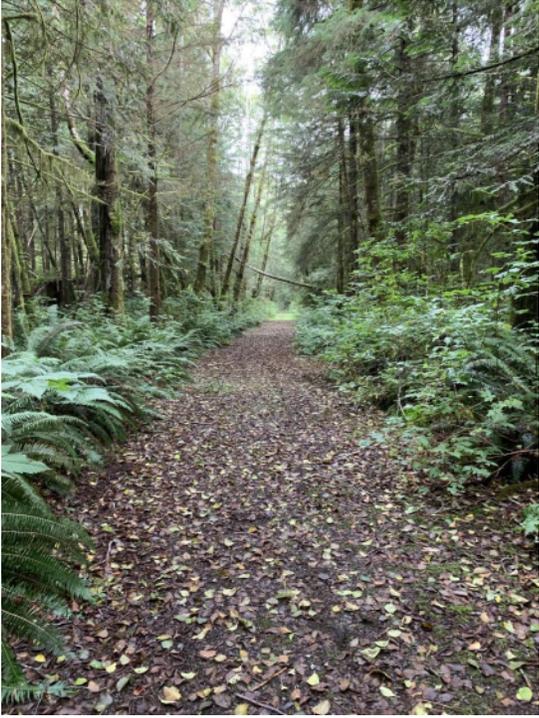
Photo Location: McLean Point Access Road			
Direction: Towards McLean Point			
Survey Date: 9/28/2021			
Comments: Suspended fallen tree to be removed by others prior to contract.			
Photograph ID: 22

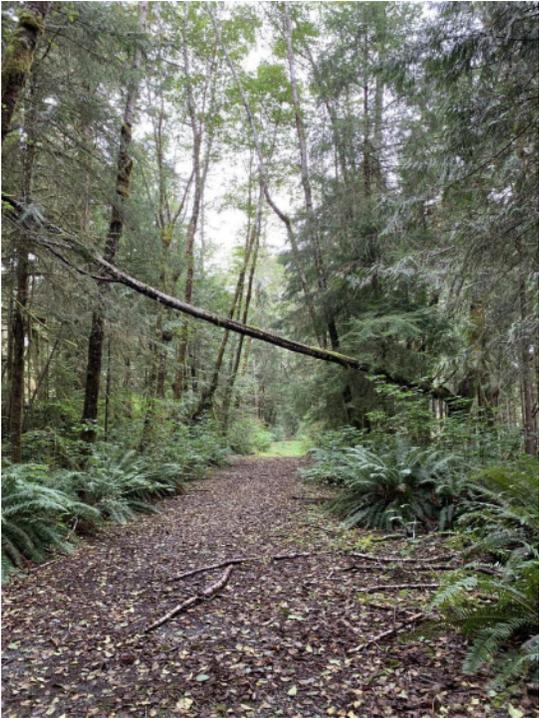
Photo Location: McLean Point Access Road			
Direction: Towards McLean Point			
Survey Date: 9/28/2021			
Comments: Suspended fallen tree to be removed by others prior to contract.

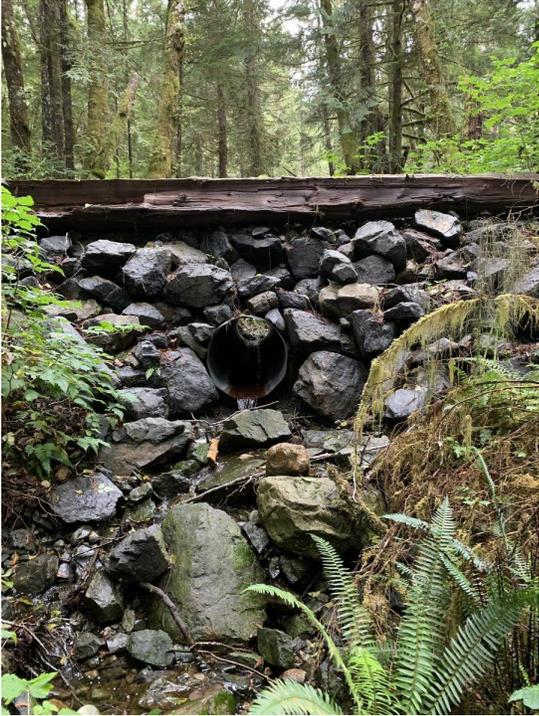
Photo Location: McLean Point Access Road			
Direction: South			
Survey Date: 9/28/2021			
Comments: Example of creek crossing and existing culvert structure.			
Photograph ID: 24

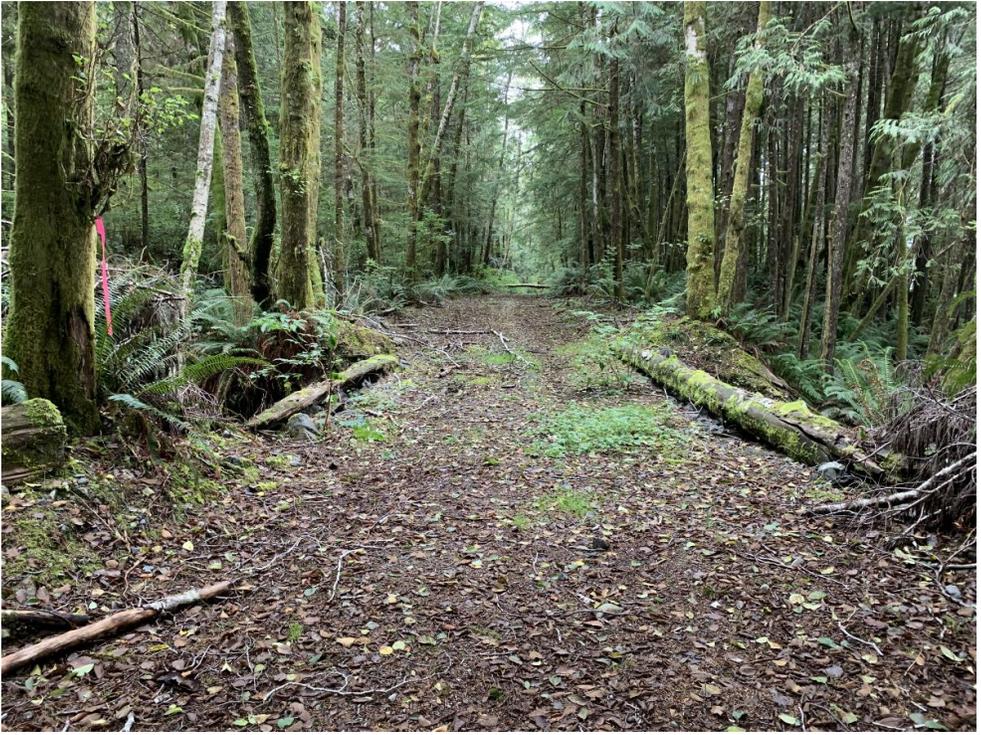
Photo Location: McLean Point Access Road			
Direction: Towards McLean Point			
Survey Date: 9/28/2021			
Comments: Access Road. Fallen Tree to be removed by others prior to contract.

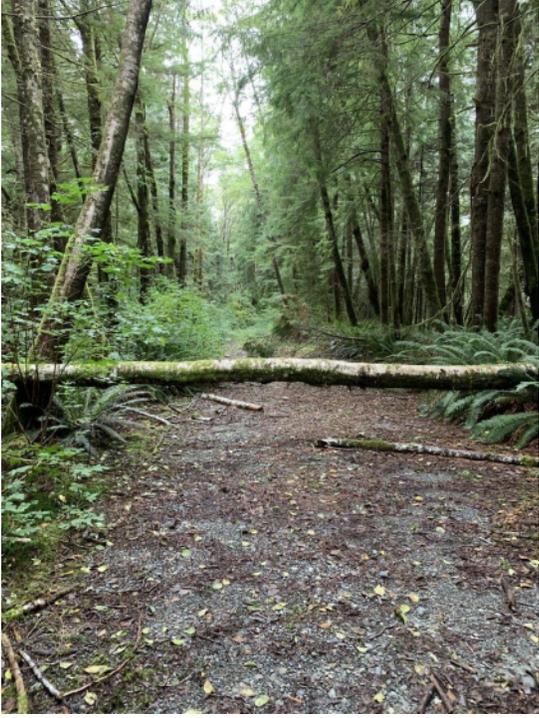
Photo Location: McLean Point Access Road			
Direction: Towards McLean Point			
Survey Date: 9/28/2021			
Comments: Fallen Tree to be removed by others prior to contract.

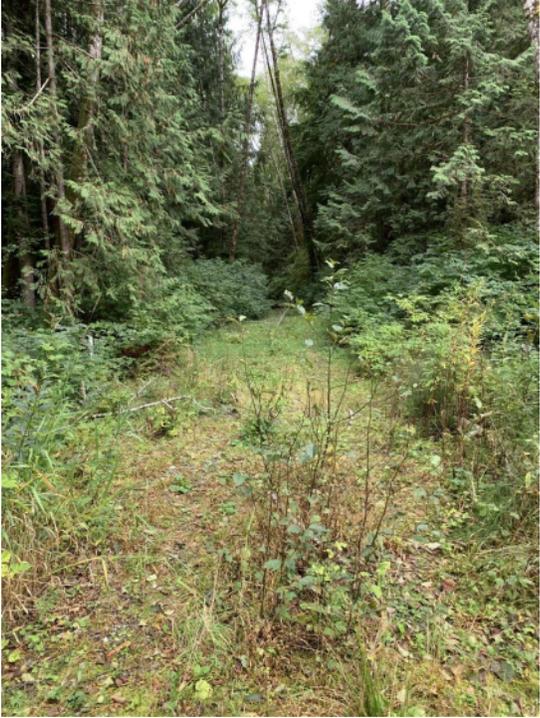
Photo Location: McLean Point Access Road			
Direction: Towards McLean Point			
Survey Date: 9/28/2021			
Comments: Access Road at entrance to McLean Pt portion of Site. Brush to be cut back and leaning trees to be removed by others prior to contract.

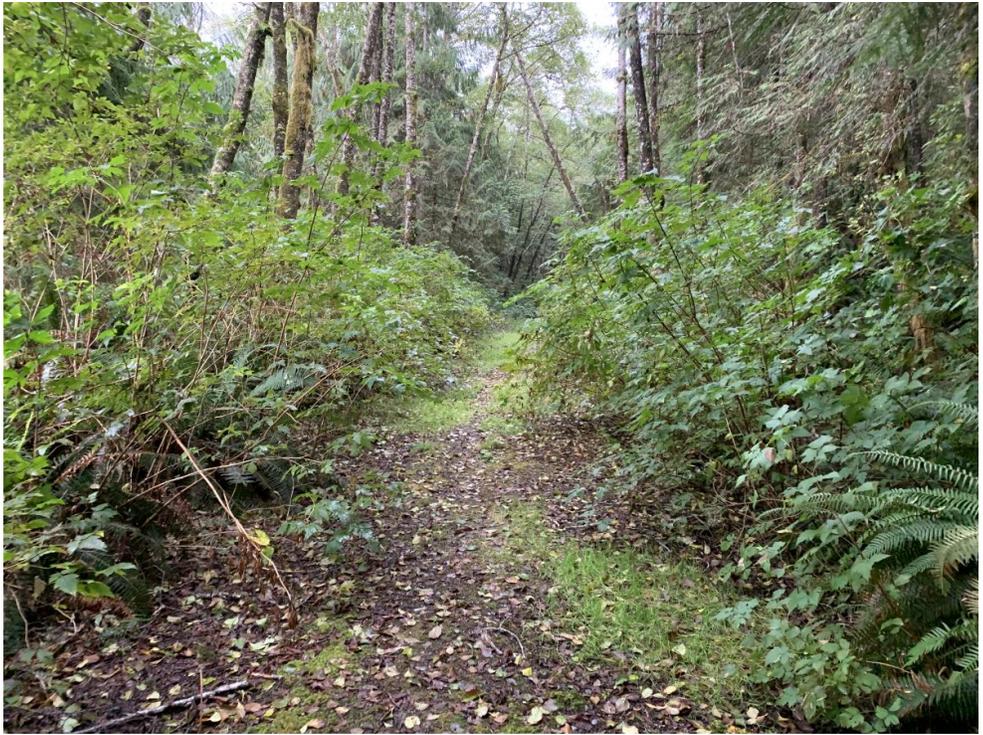
Photo Location: McLean Point Access Road			
Direction: Towards McLean Point			
Survey Date: 9/28/2021			
Comments: Access Road, brush to be cut back and leaning trees to be removed by others prior to contract.

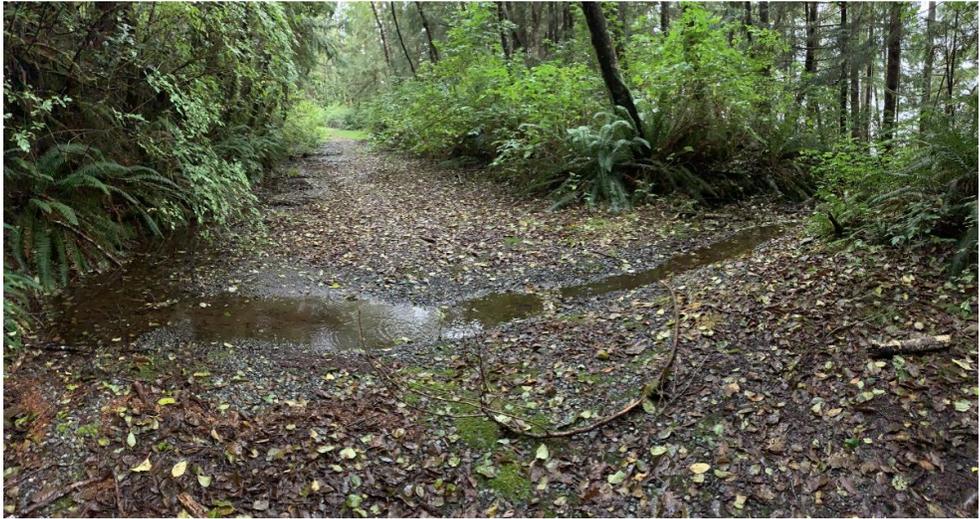
Photo Location: McLean Point Access Road			
Direction: Towards McLean Point			
Survey Date: 9/28/2021			
Comments: Access Road showing ditch and stream crossing, example of erosion and sediment control required.			
Photograph ID: 34

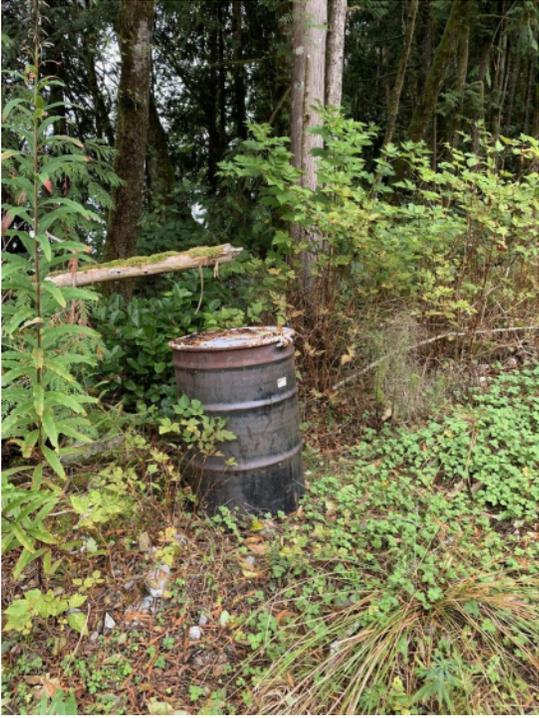
Photo Location: McLean Point			
Direction:			
Survey Date: 9/28/2021			
Comments: Drum to be removed			
Photograph ID: 46

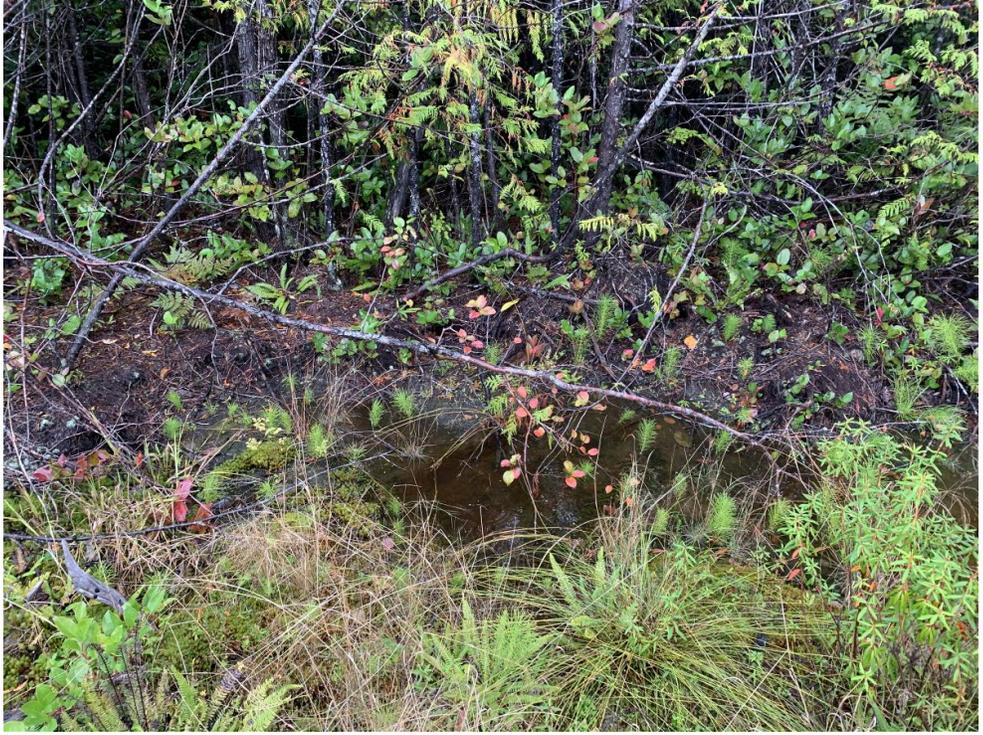
Photo Location: Radar Hill			
Direction:			
Survey Date: 9/30/2021			
Comments: Water course behind woody debris pile to be protected

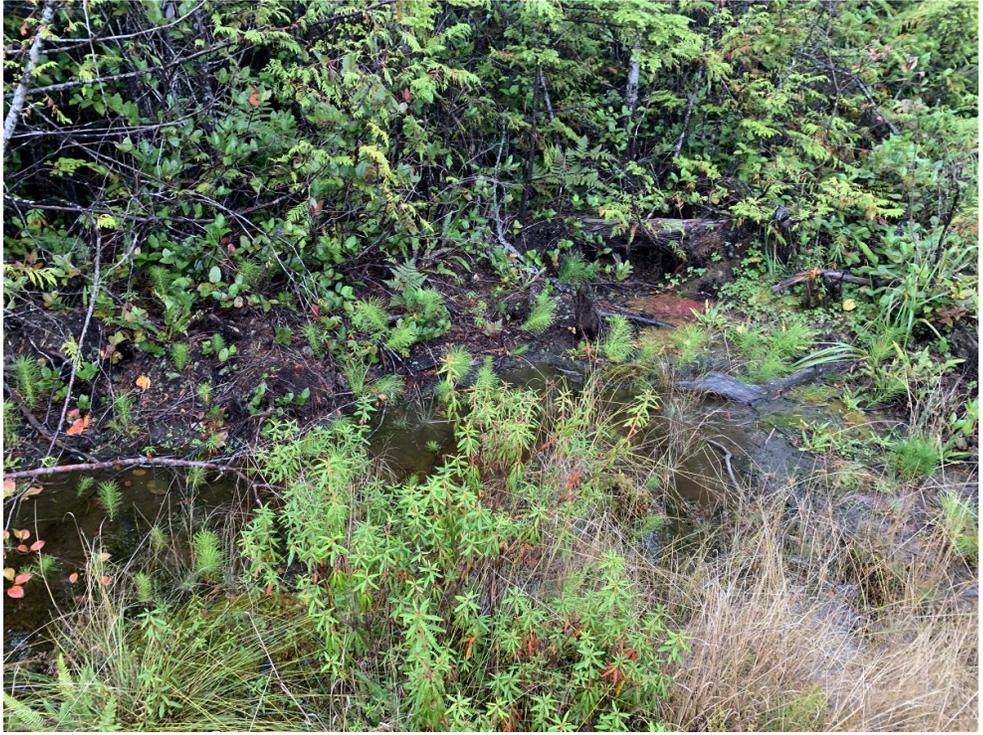
Photo Location: Radar Hill			
Direction:			
Survey Date: 9/30/2021			
Comments: Water course behind woody debris pile to be protected.			
Photograph ID: 54

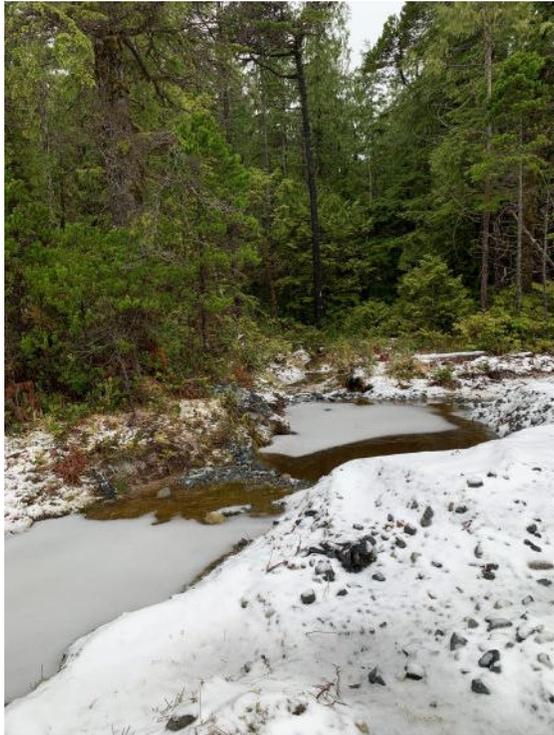
Client:		Project:	
Site Name:		Site Location:	
Photograph ID: 60 Photo Location: Radar Hill Direction: Survey Date: 12/05/2021 Comments: updated photo: Sedimentation pond and stream requiring protection during Radar Hill work.

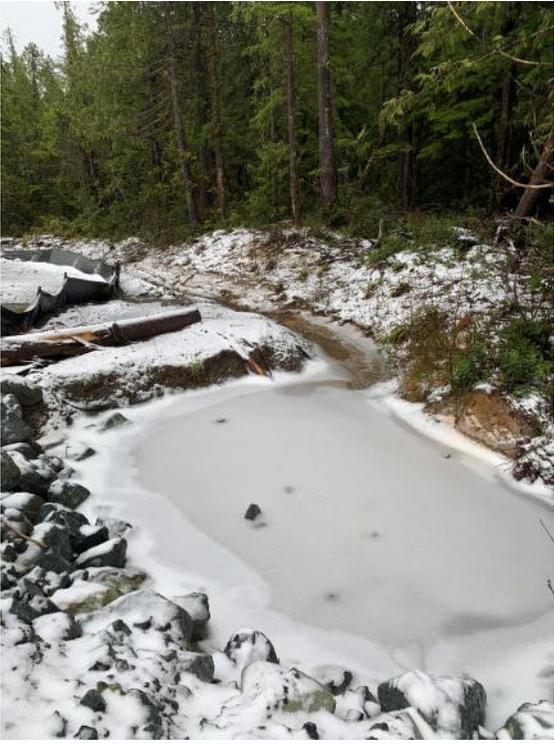
Photograph ID: 61 Photo Location: Radar Hill Direction: Survey Date: 12/05/2021 Comments: updated photo: Sedimentation pond and stream requiring protection during Radar Hill work.
