HAMILTON BANKER

Condition Survey, Pollution Risk, Vessel Removal, Towing & Disposal Assessment

**At Colliers, Newfoundland
24 February 2020**

Date: 23 April 2020

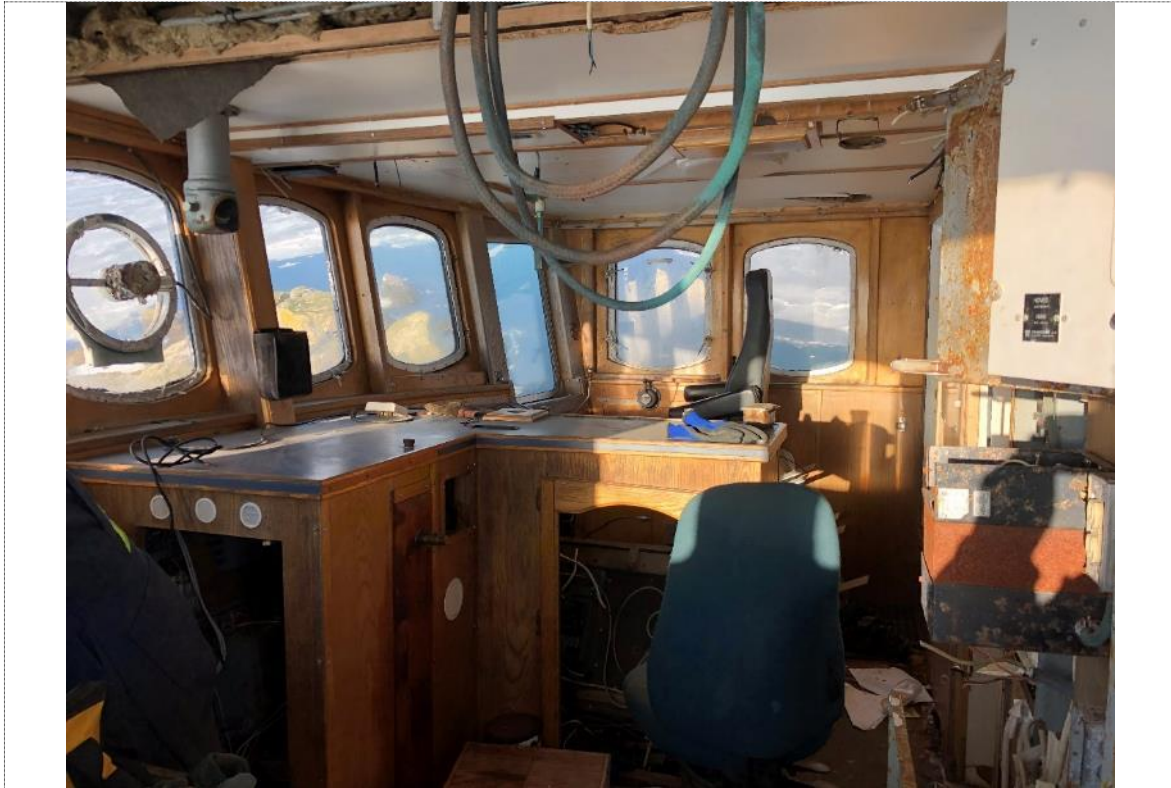
- 3.4.1 The bridge was noted to be cosmetically poor with ceiling panels and console panels removed and exposed wood, wiring, insulation and debris found throughout.
- 3.4.2 A package of batteries was found on the console.

3. Bridge

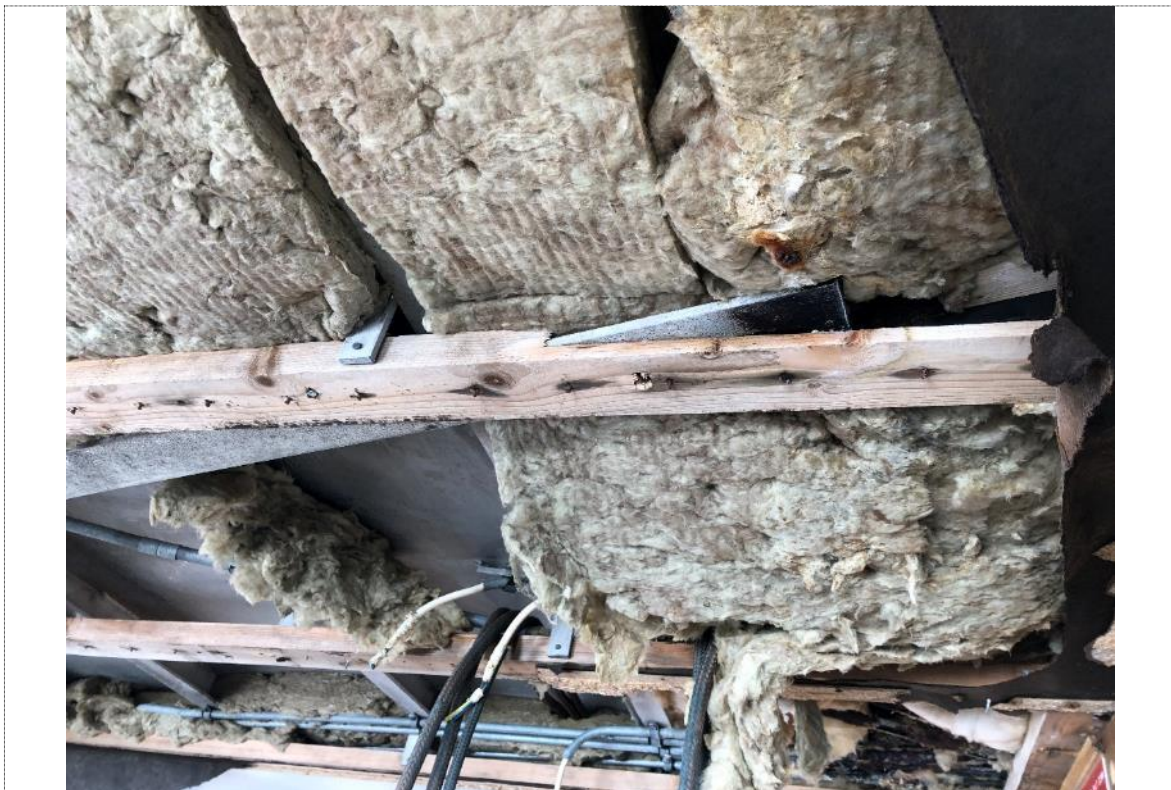
4. Bridge – view of ceiling

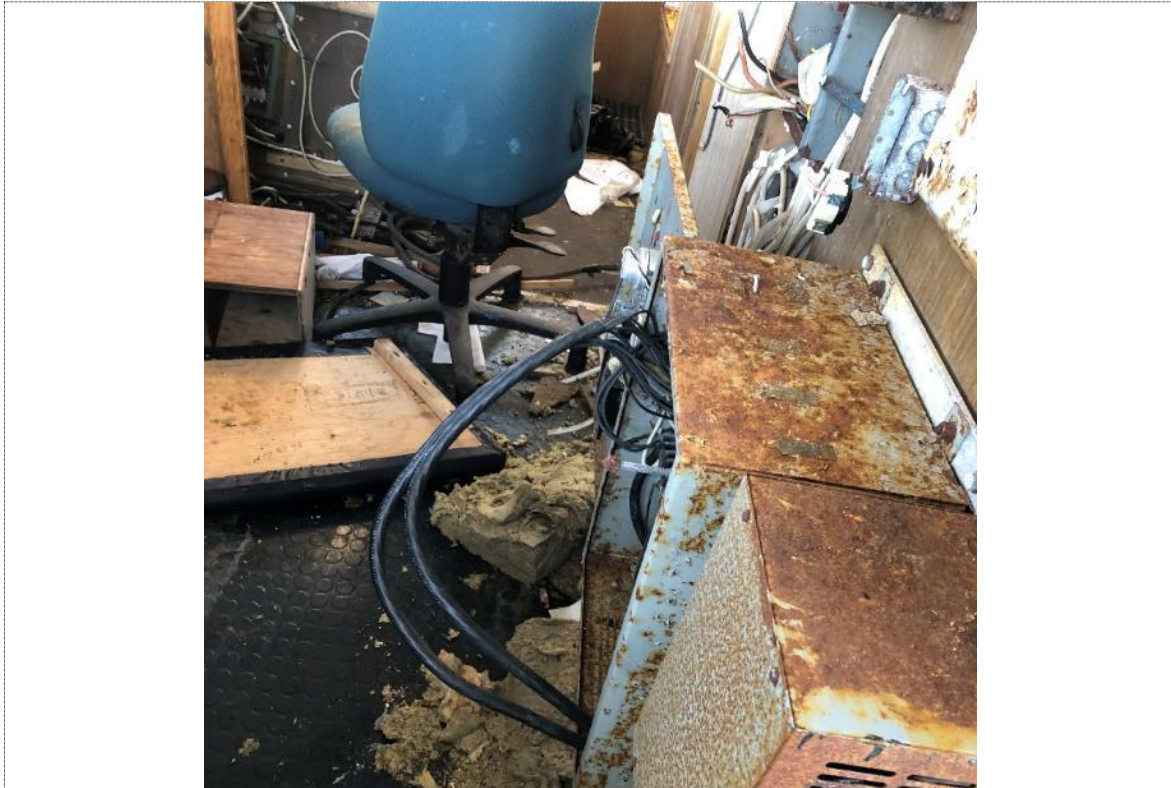
5. Bridge – view of typical debris

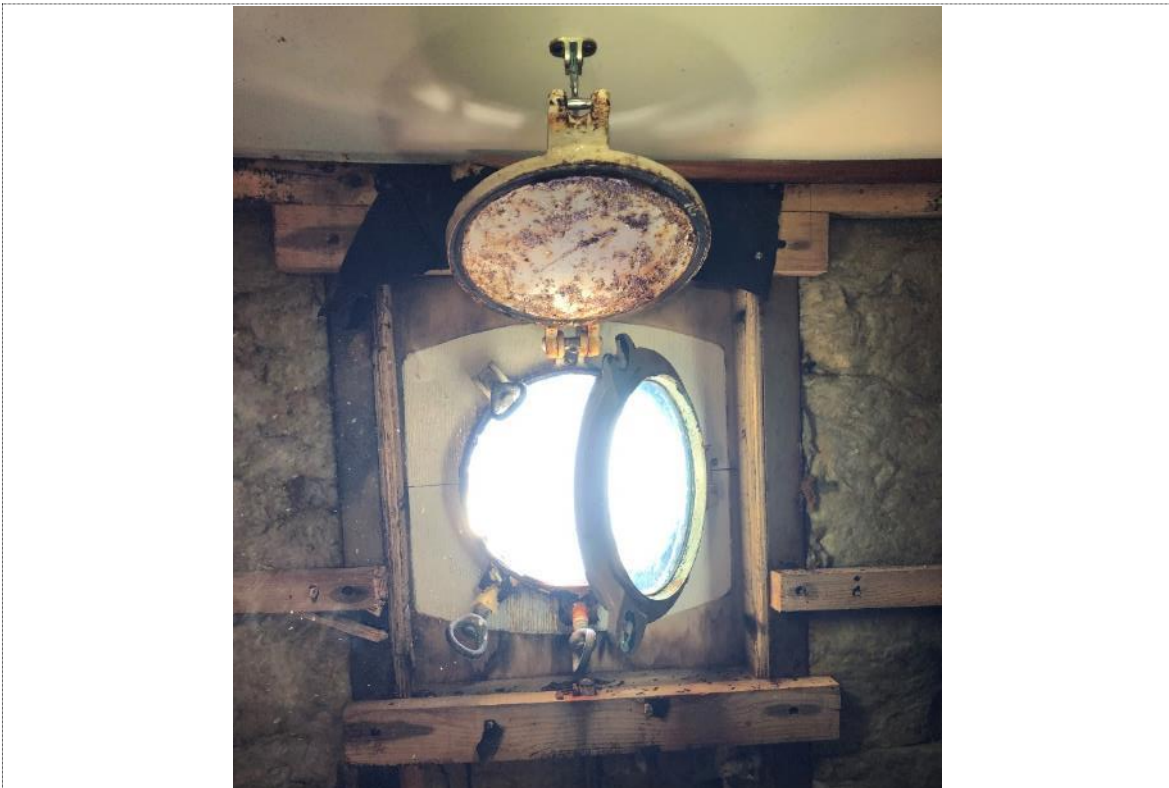
10. Accommodation space – open porthole

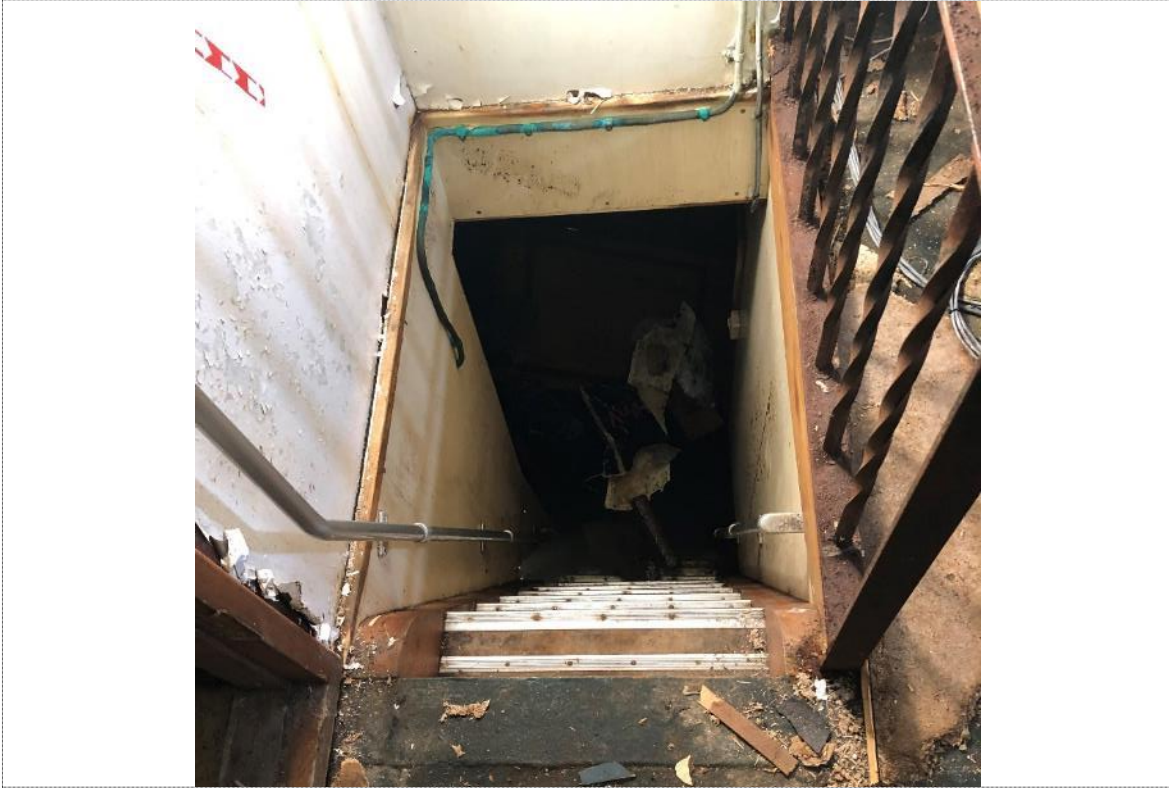
11. Access to bunk room – flooded with floating debris

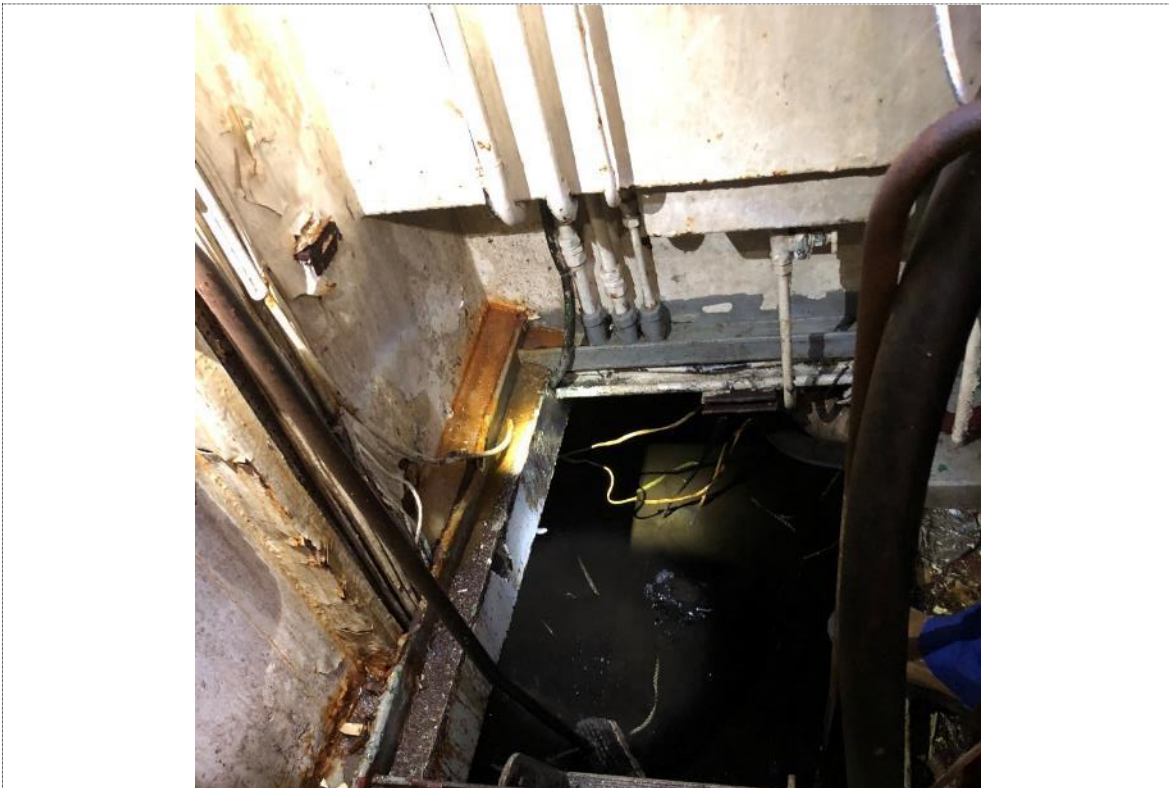
- 3.8.4 It is assumed that all engine room machinery still contained oil as a layer of oil sludge was observed on the water surface in the engine room space. A slight sheen also appeared present in the bunkroom space which is adjacent to the engine room.

12. Engine room access – flooded with layer of oil visible

From observations there is little oil onboard contained in tanks, however, the machinery did not appear to have been drained of oil. Given the current location and condition of the vessel efforts should be made to pump out any remaining oils and oily water at the earliest opportunity and certainly prior to the commencement of any vessel removal operations.

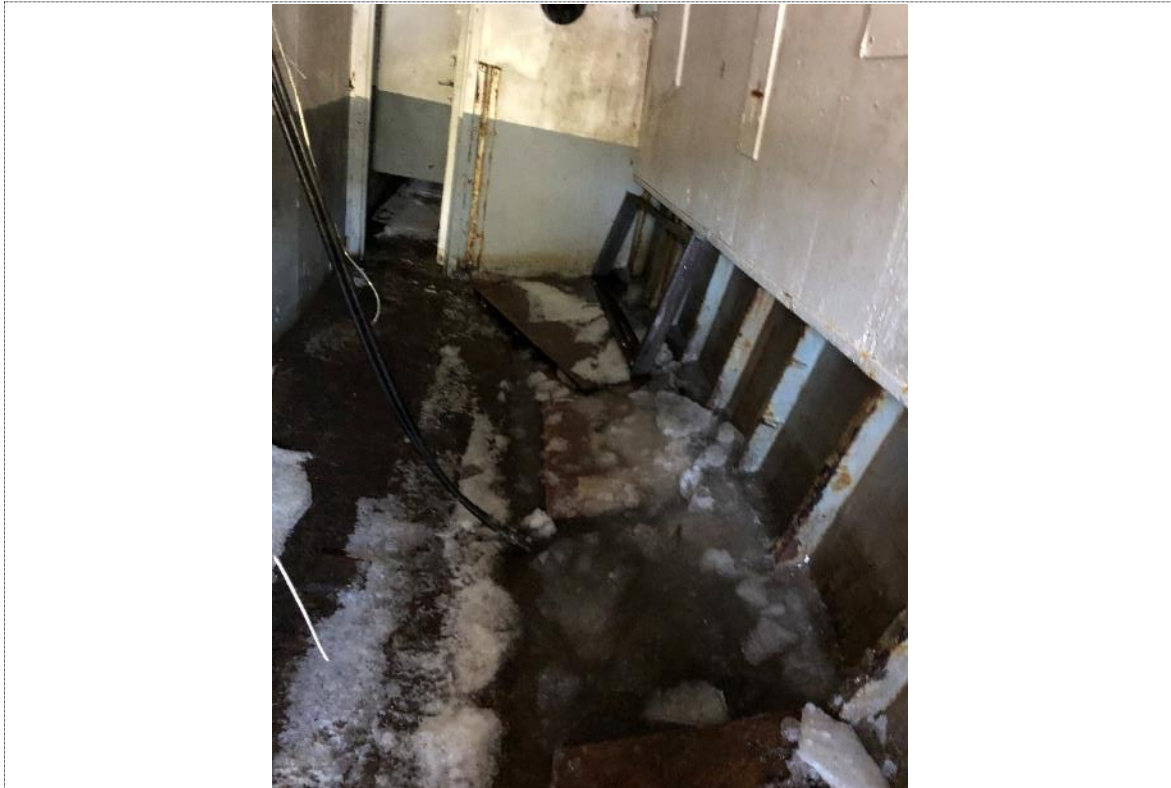
3.6.2 Water and ice were found along the starboard side (low side due to vessel list) with no evidence of running water from the higher port side.

13. Starboard access to fantail area – flood water against sidewall

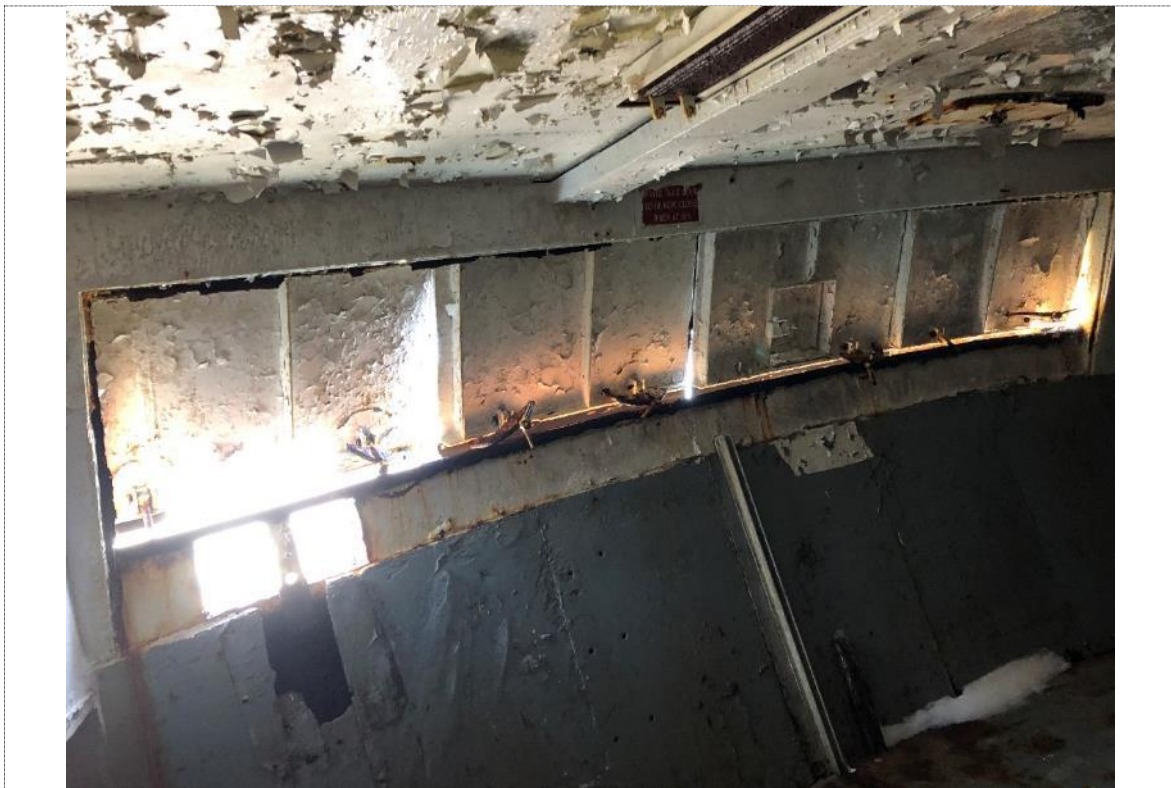
3.6.3 The aft doors did not properly close.

14. Aft fantail area – doors not properly closed

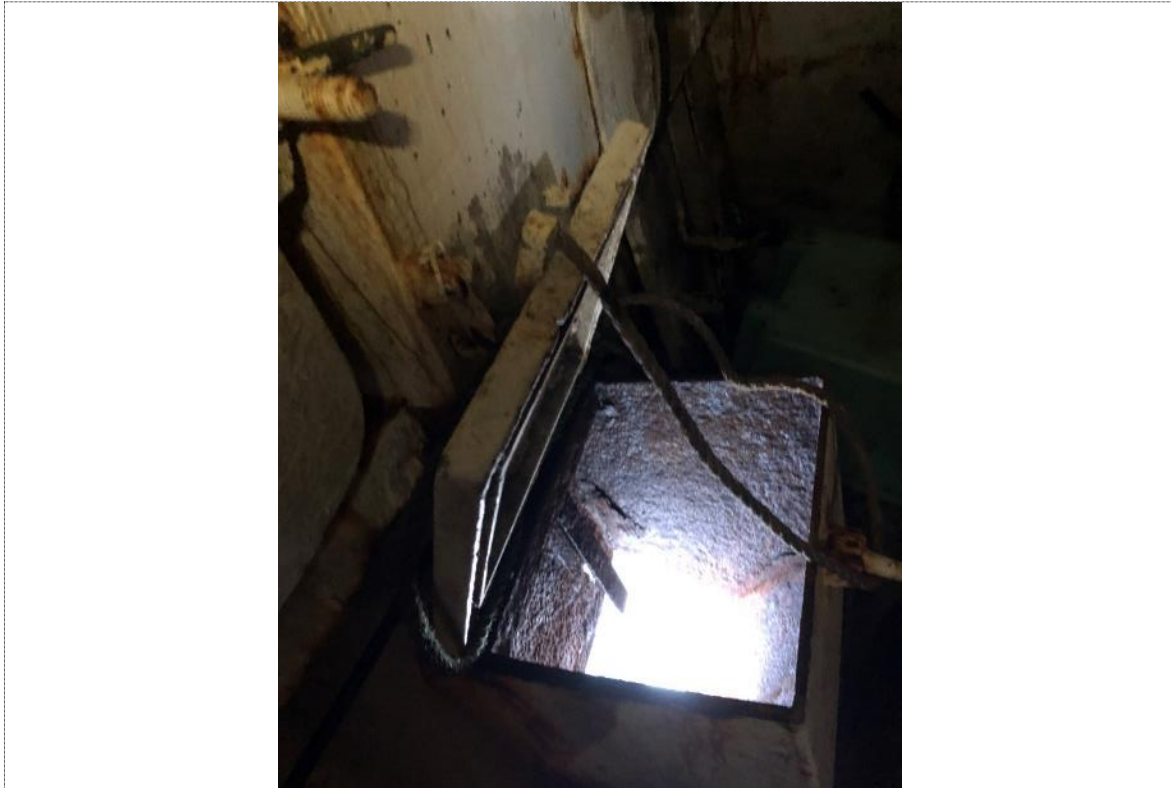
19. Processing deck - overboard

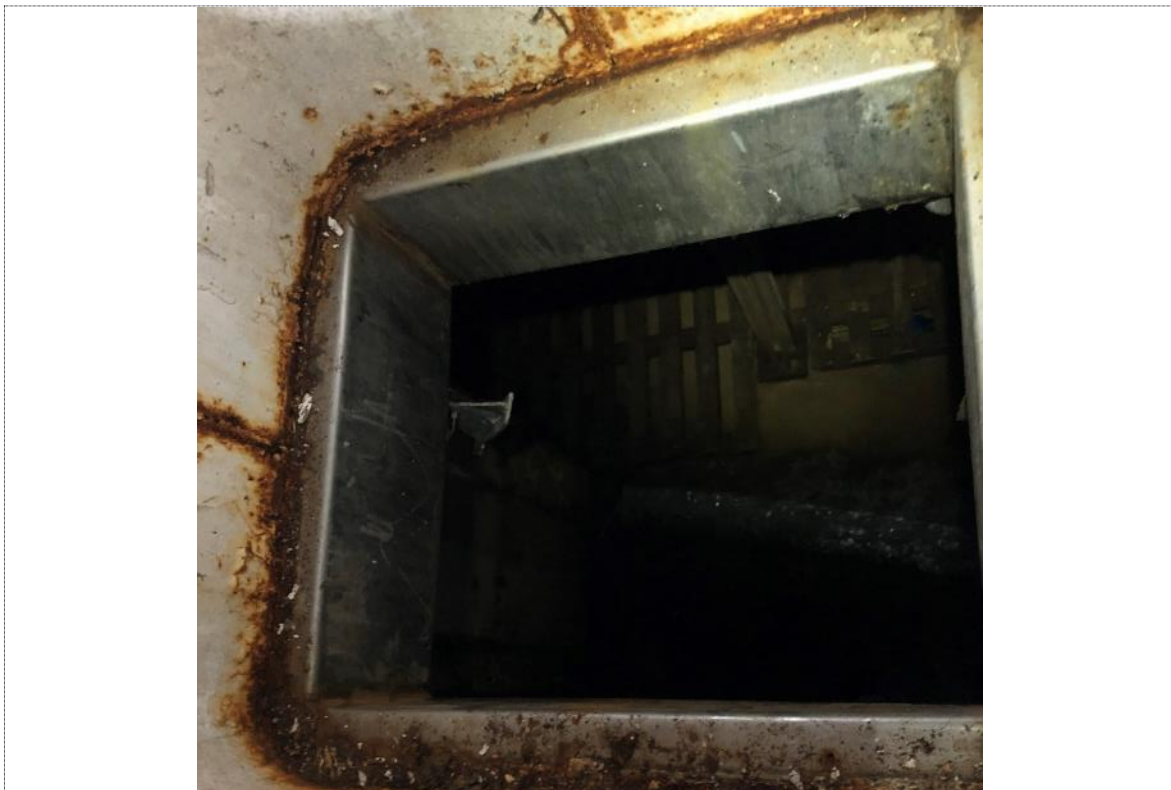
3.7.2 The lower fish hold was visible through open hatches and was full of water. Water level appeared to be consistent with sea level on the hull exterior, however, ice cover made it difficult to see clearly.

20. Processing deck – view of cargo space through hatch - flooded

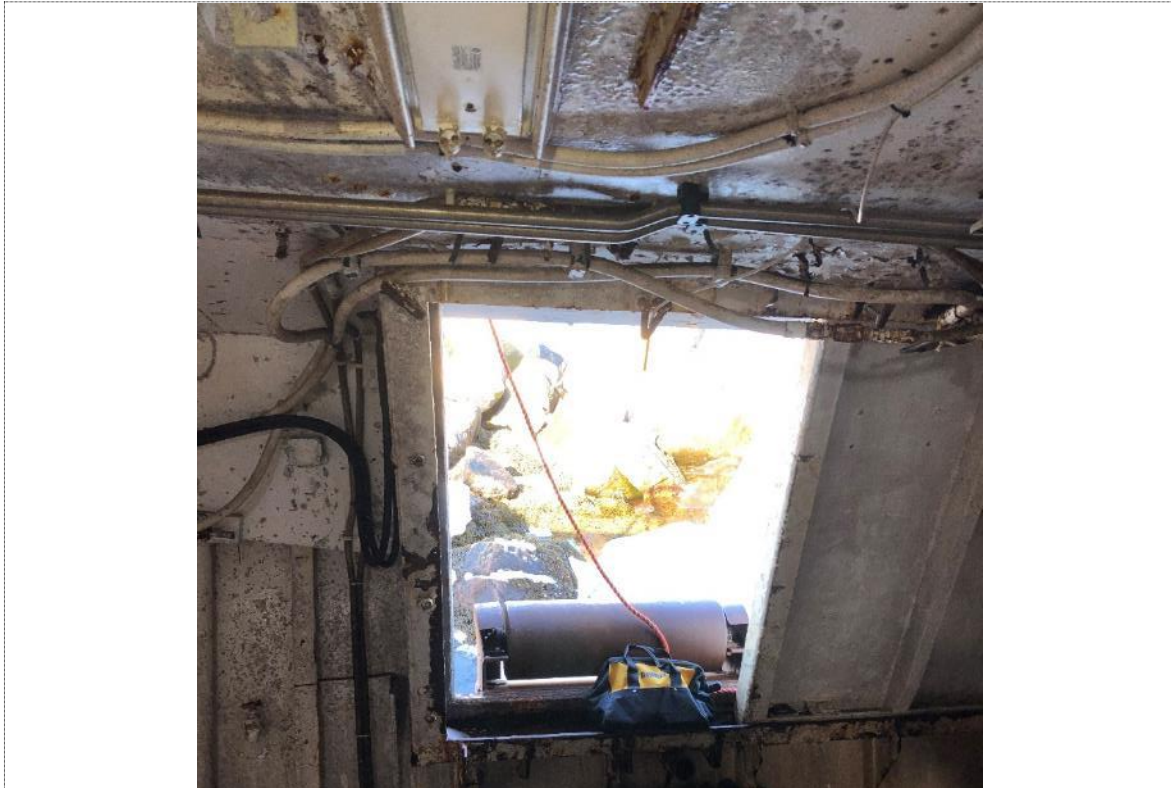
21. Processing deck – trawl door/opening

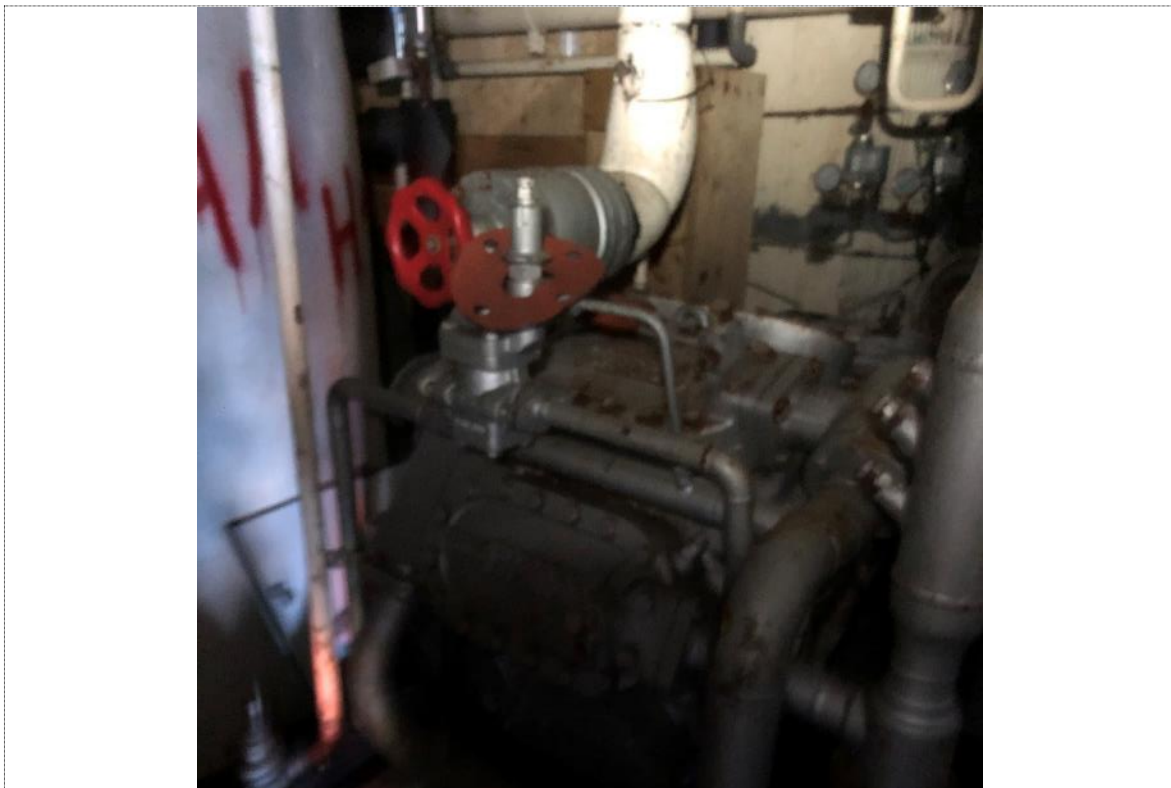
3.7.4 The forward machinery space contained the refrigeration compressors and freon equipment for the factory freezer. Sight glasses on port and starboard compressors indicated at least residual levels of oil, but potentially more given the list of the vessel. It was assumed that refrigeration system would be full. Hydraulic header tank for crane was found empty with trace amounts remaining. Fluid accumulation sighted on starboard side below tanks and against the side shell.

22. Refrigeration room – compressor (1 of 2 units present)

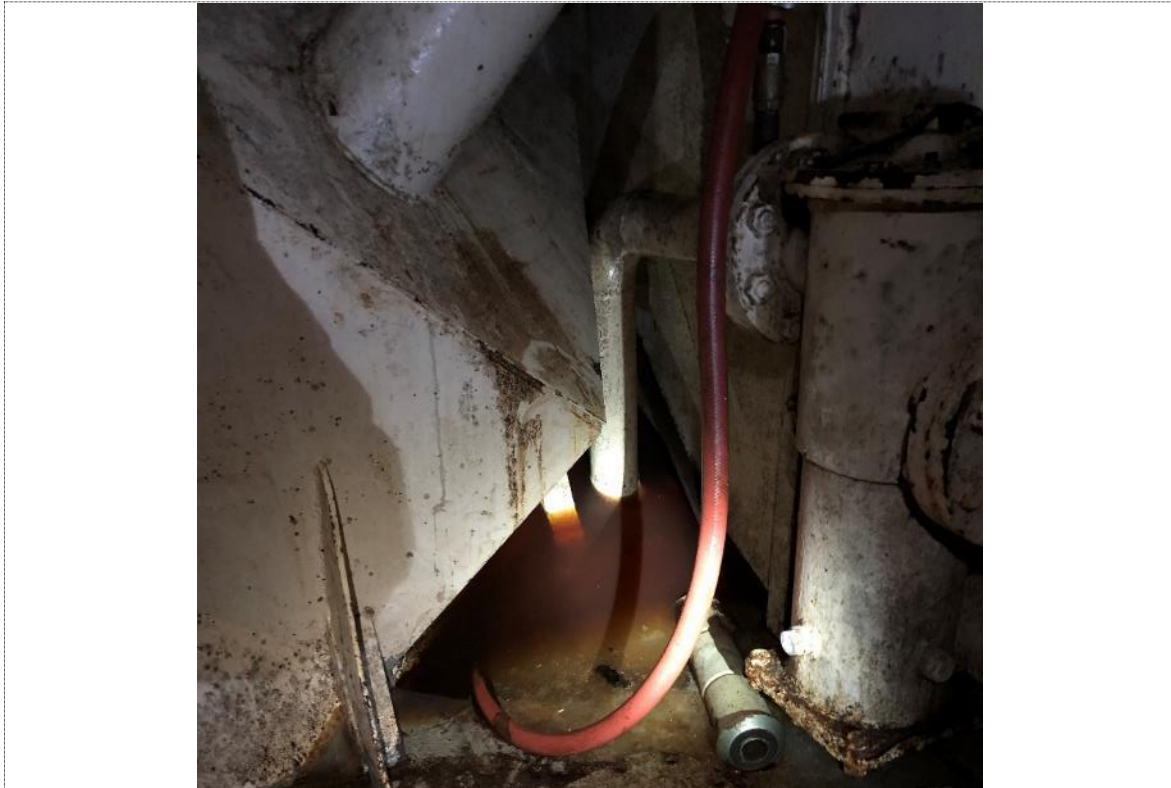
23. Liquid buildup against starboard sidewall

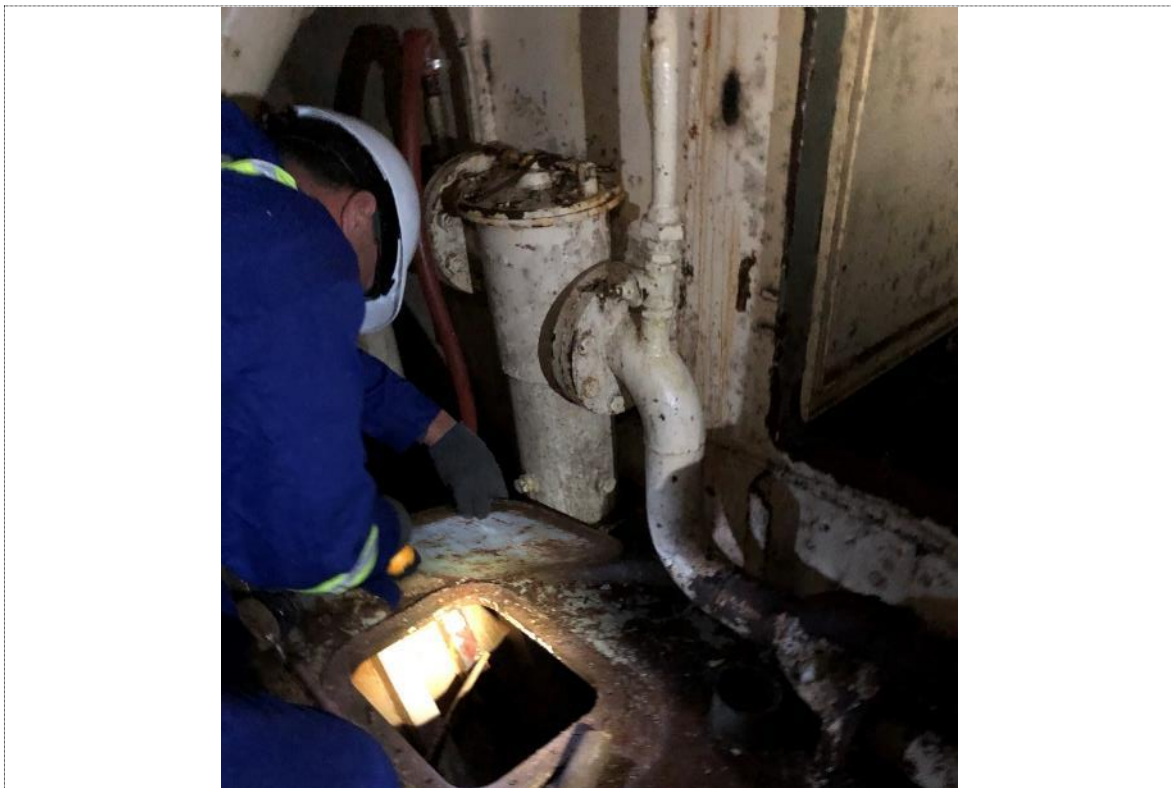
- 3.8.2 From what could be observed from the deck above, the hull appeared to be flooded from the stern forward to the collision bulkhead.
- 3.8.3 An open hatch in the forepeak space, forward of the collision bulkhead, contained what appeared to be dirty water but contents are otherwise unknown. From speaking with CCG representative onboard, the contents were present prior to hull flooding so it's possible the collision bulkhead itself is intact and the contents are isolated from the remaining spaces flooded with seawater.

24. View down hatch forward of collision bulkhead – brown liquid visible

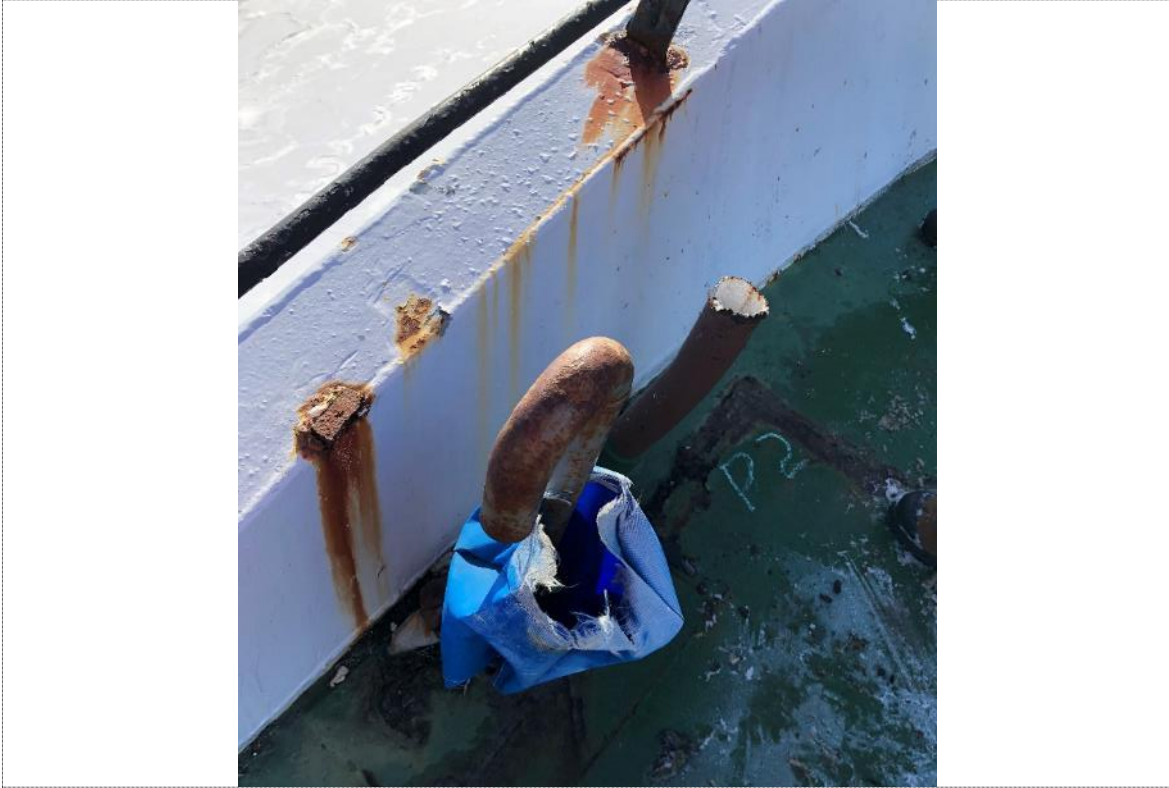
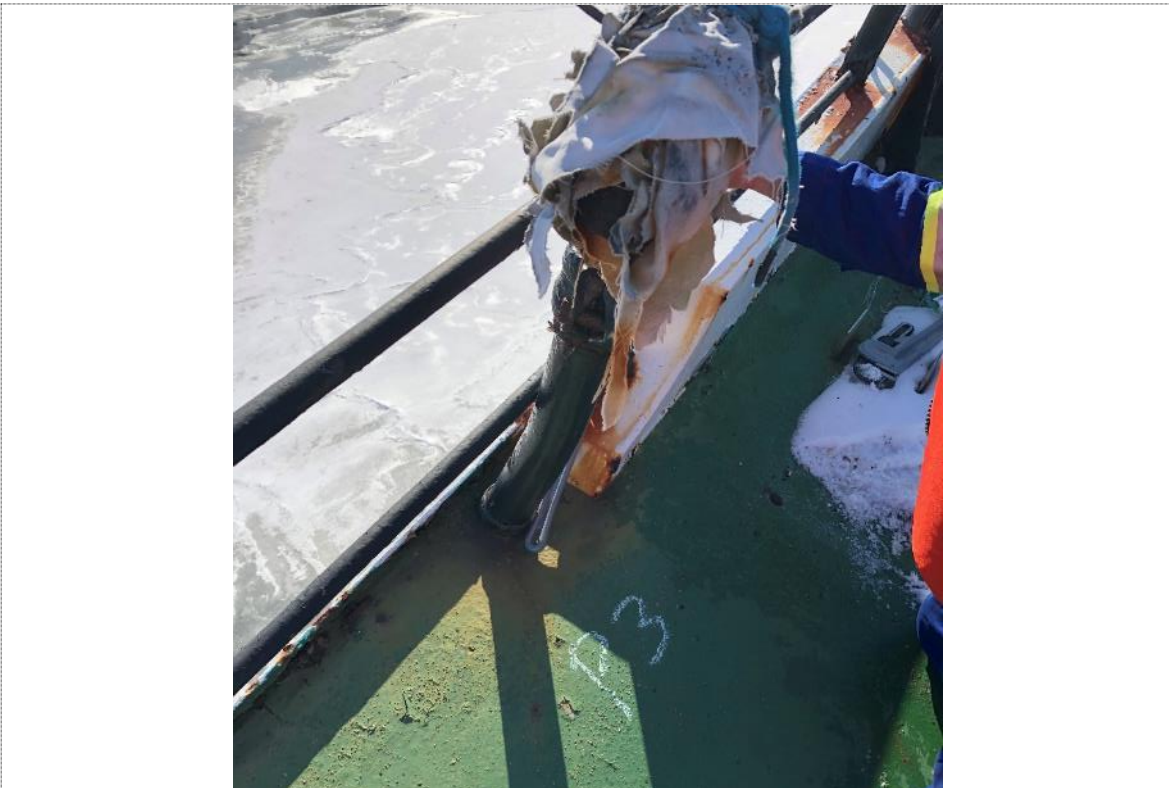
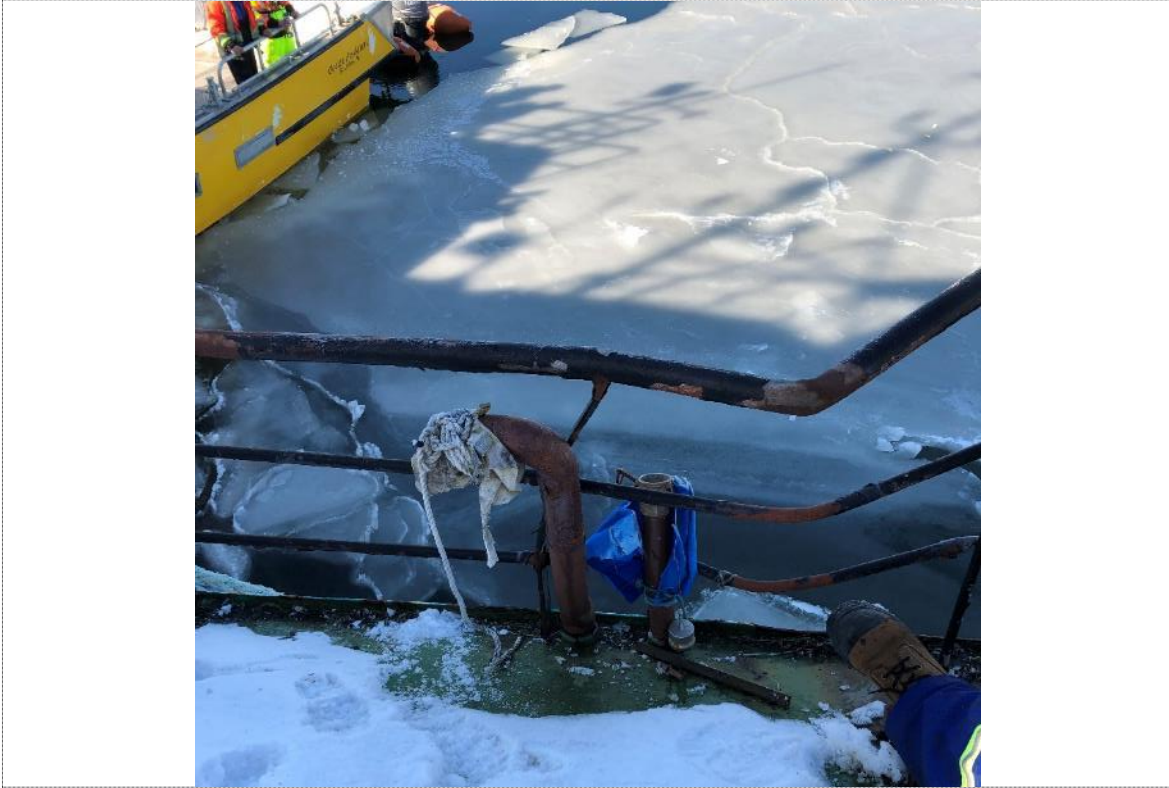
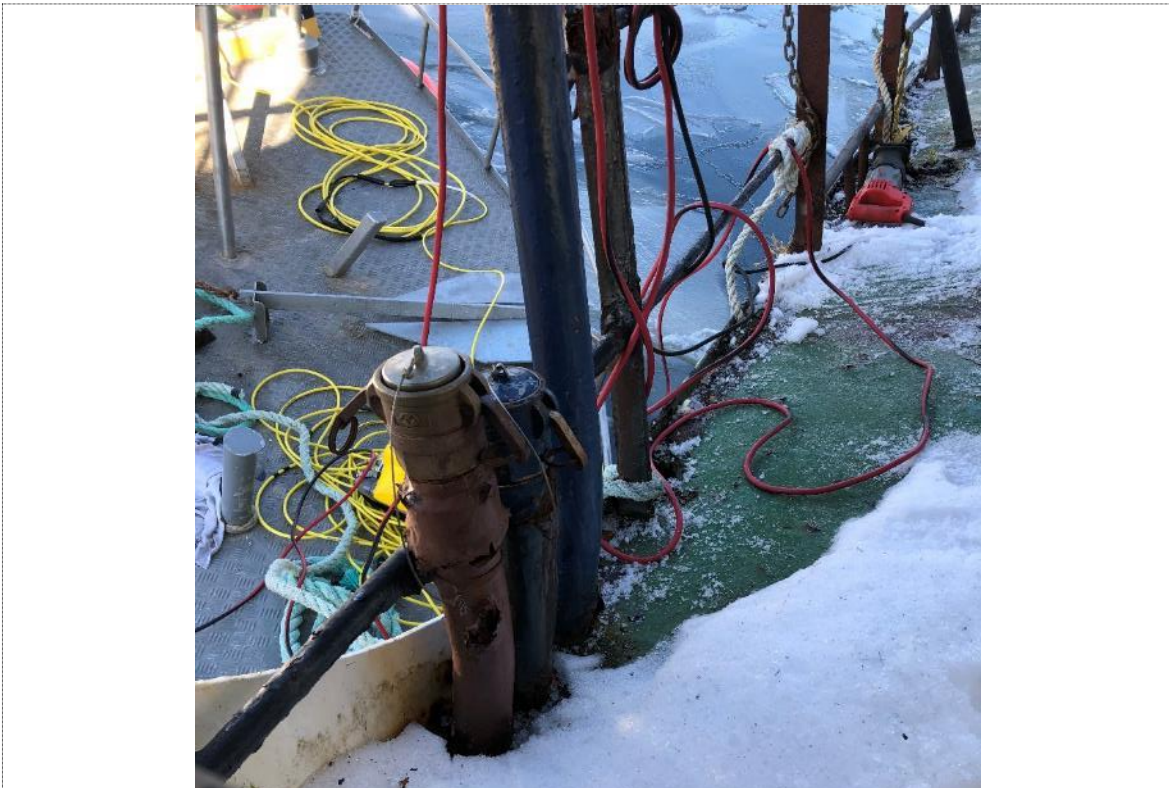
- 3.3.2 Some of the sounding pipes were in good condition and appeared to properly closed. Others had broken caps or the pipes had rusted through and broken off.
- 3.3.3 The handrails throughout were in poor condition with many damaged areas as well as areas showing heavy wastage.
- 3.3.4 The forward winches were assumed to be full of oil.
- 3.3.5 The aft deck was largely snow covered but from areas visible, was consistent with observations made above with respect to the main deck forward of the accommodation.

29. View of typical sounding pipe condition (1)

30. View of typical sounding pipe condition (2)

31. View of typical sounding pipe condition (3)

32. View of typical sounding pipes condition (4)

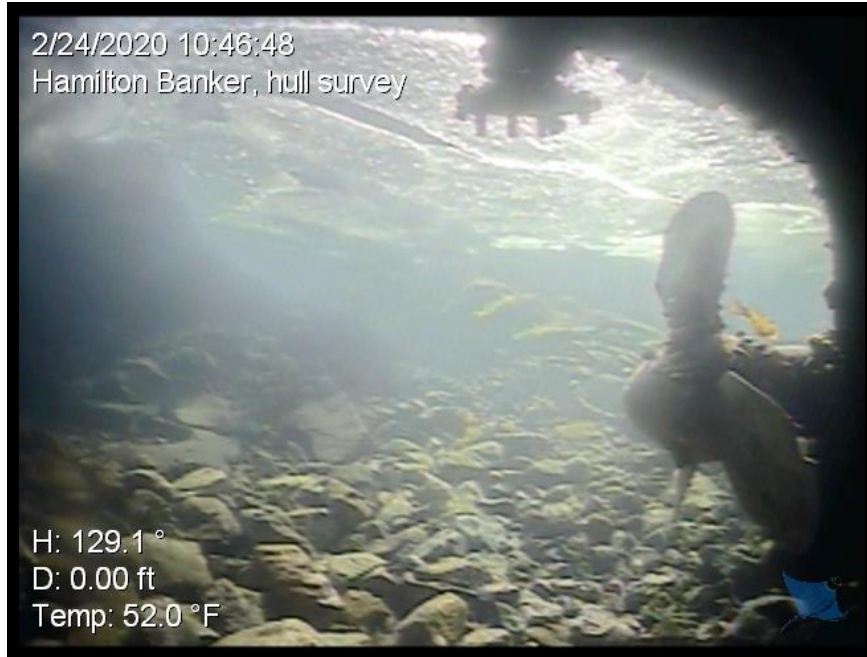
- The stern area was inspected and found to have significant damage to the propeller; the rudder was dislodged and laying on the seabed approximately 3 meters aft of the vessel. There was no damage observed to the rudder stock on the upper end of the stern.
- There was no skag observed at the aft location.

Figure 3 - Stern area showing damaged propeller.

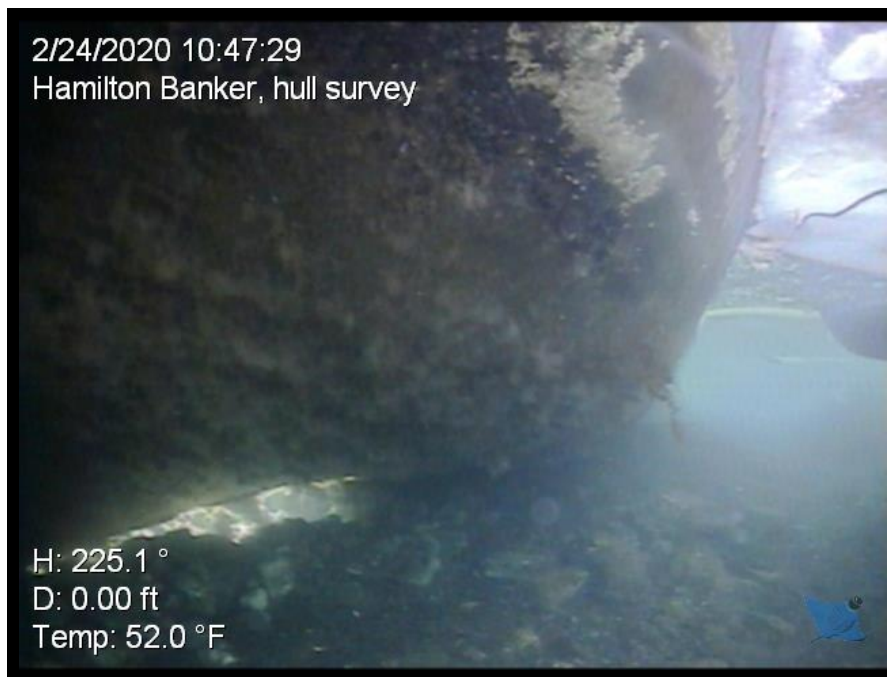
- The Starboard side was inspected and found to have significant damage observed to the hull vertical sides.
- The bilge keel was inspected and found to be bent up due to the vessels position at rest.
- The under side of the hull could not be inspected due to the vessels position.

Figure 4 - Starboard side looking forward.

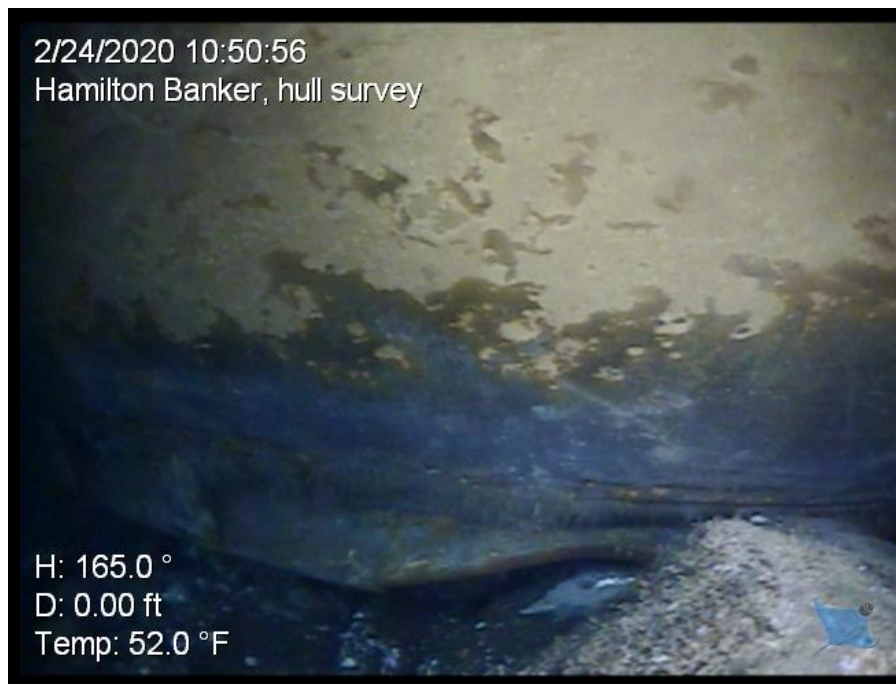
Figure 6 - Starboard side bilge keel.

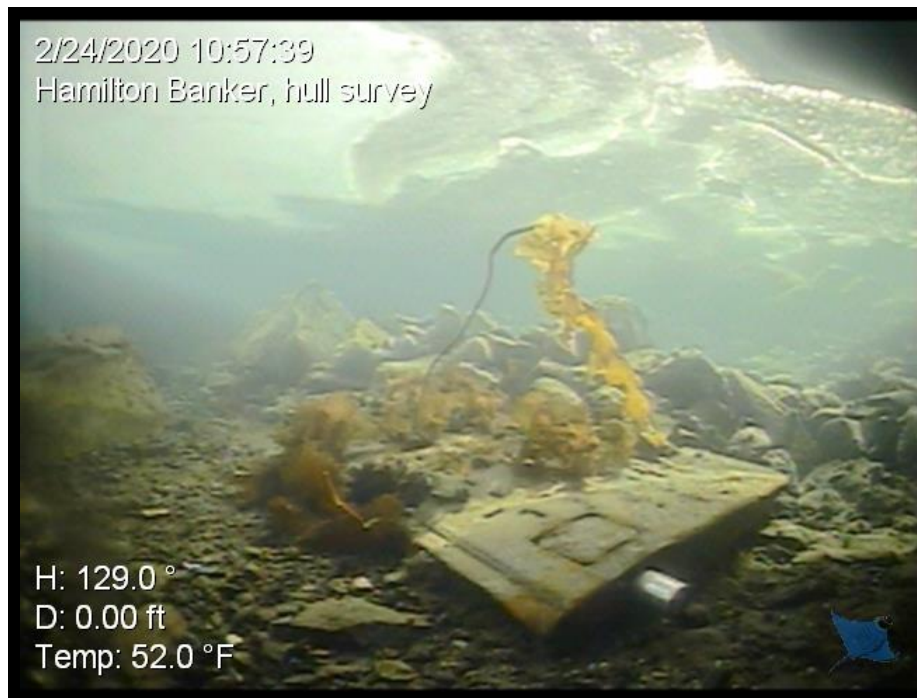
- The aft area of the vessel was surveyed and found to have depths of 5 to 6 meters. There were two large boulders observed at this location; as well as, the dislodged rudder.

Figure 8 - Dislodged rudder near aft location.

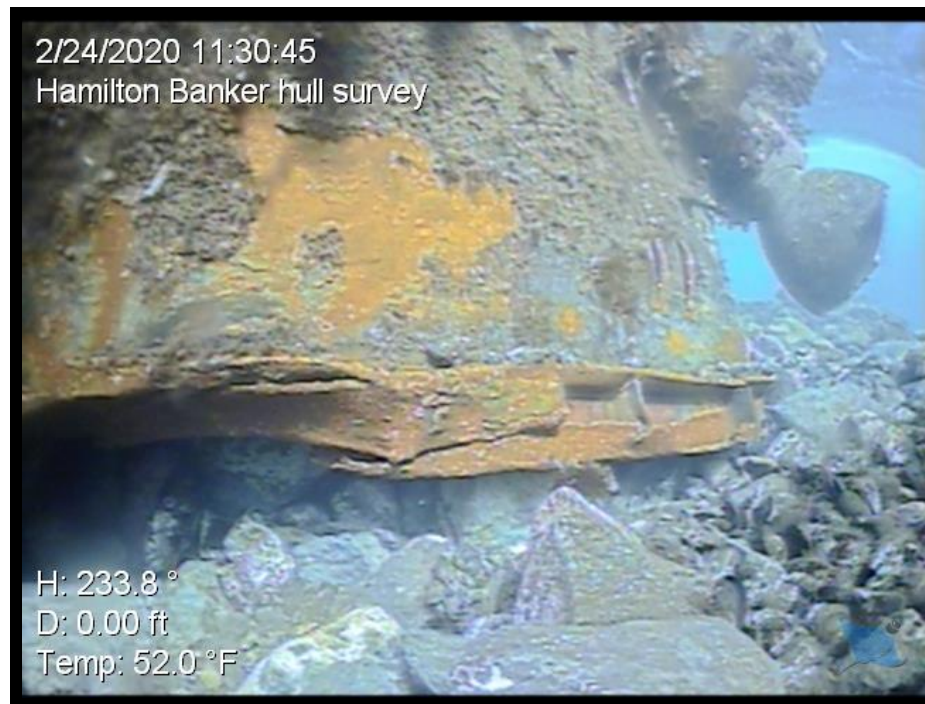
Figure 10 - Aft location showing damage to keel.

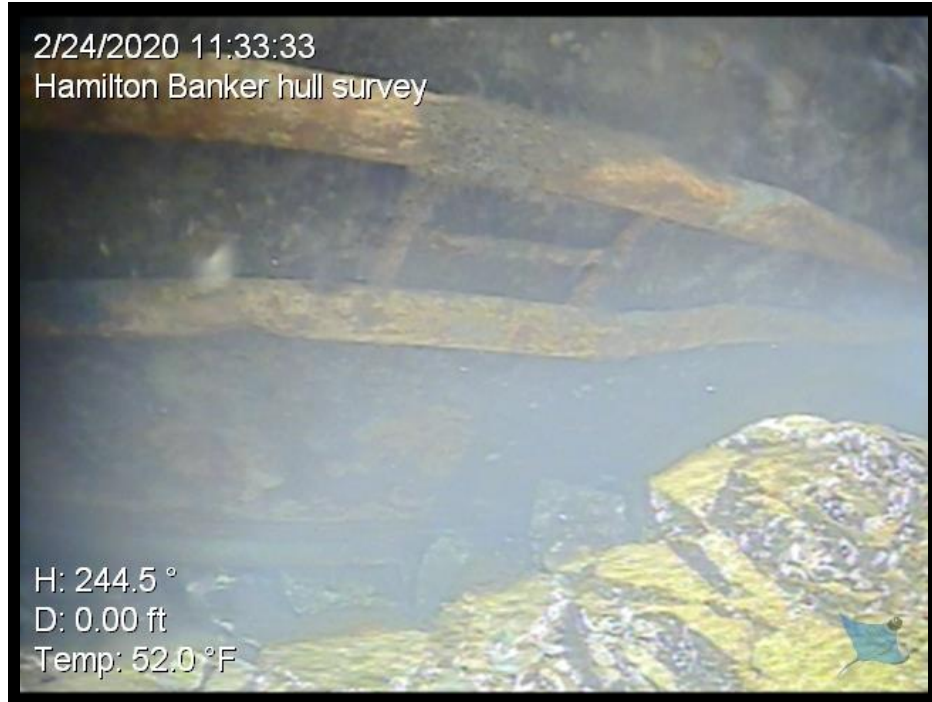
Figure 11 - Missing bilge keel area on port side.

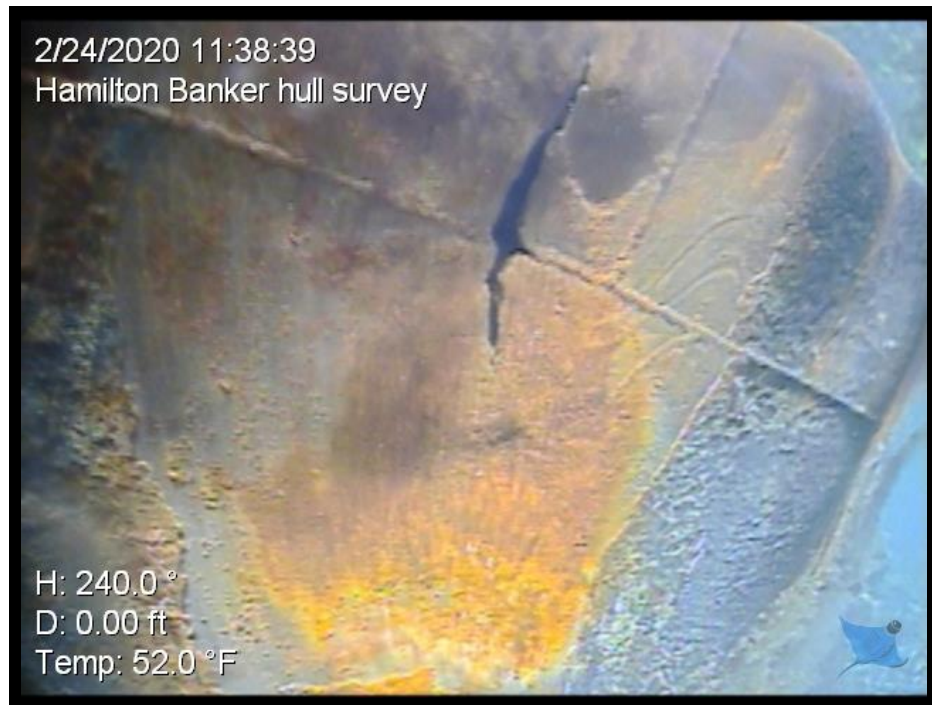
- The port side was inspected and found to have significant damage observed near the aft location. The location was closely inspected and found to be dented with a large open crack in the hull. The bilge keel appeared to be missing and there was significant damage observed in this area. The remaining areas of the vertical sides were in good condition.

Figure 12 - Damaged area show crack in hull, port side aft.
