**SUPPLEMENTAL
HAZARDOUS BUILDING MATERIALS ASSESSMENT**

**ADMINISTRATION BUILDING PRE-DECONSTRUCTION
CANADIAN COAST GUARD SOUTHSIDE BASE
280 SOUTHSIDE ROAD, ST. JOHN'S
NEWFOUNDLAND AND LABRADOR
DFRP 72019**

April 2020

Wood Project No. TF20076860

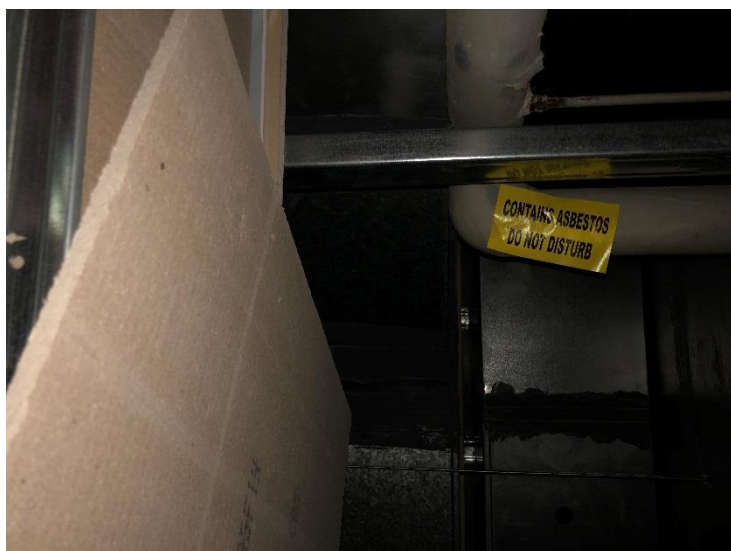
Photo 67: View of asbestos containing pipe insulation on pipe above ceiling tile in the "Maritime Unit" Room M07
