# **Huntley's**

### **Wedge Point Wharf Inspection**

November 21, 2018

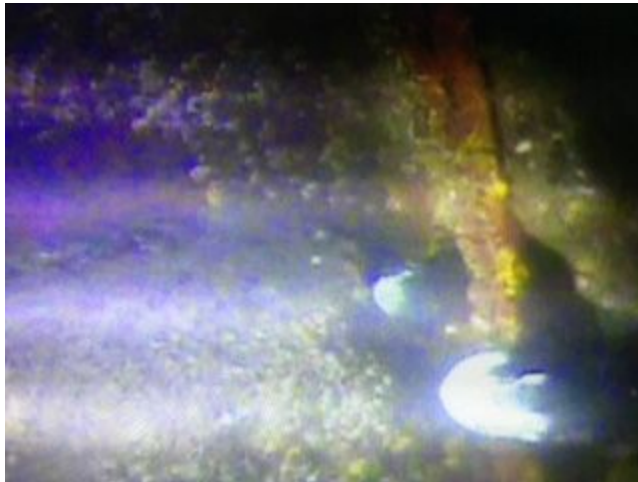
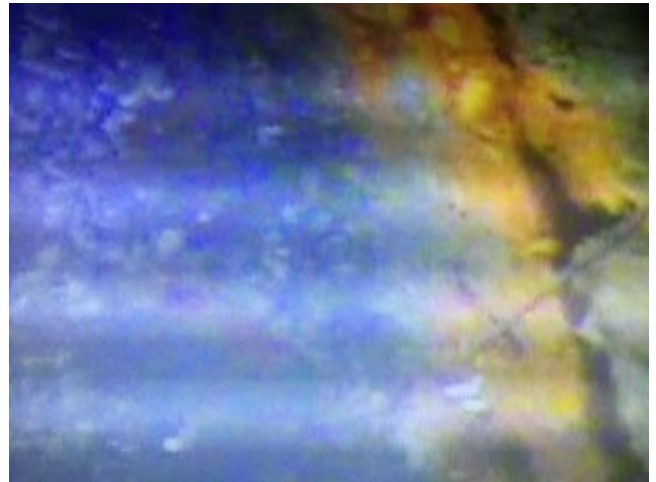
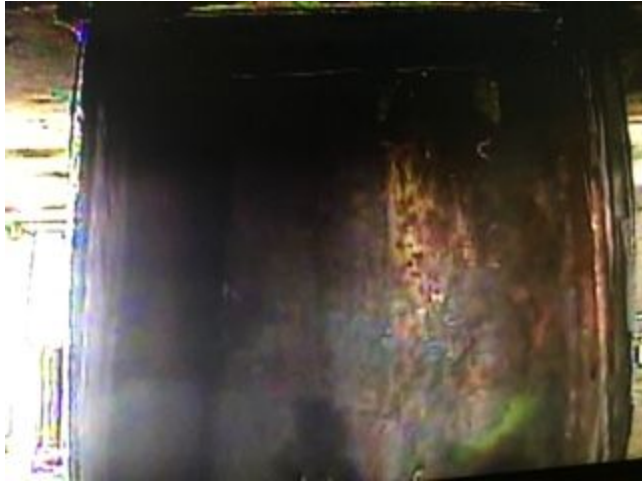
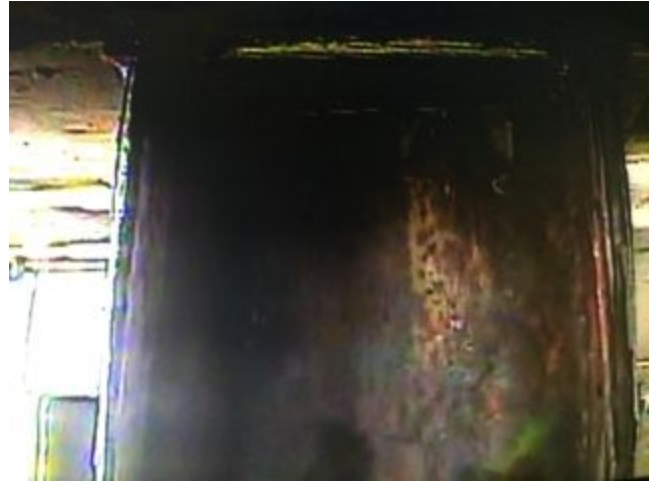
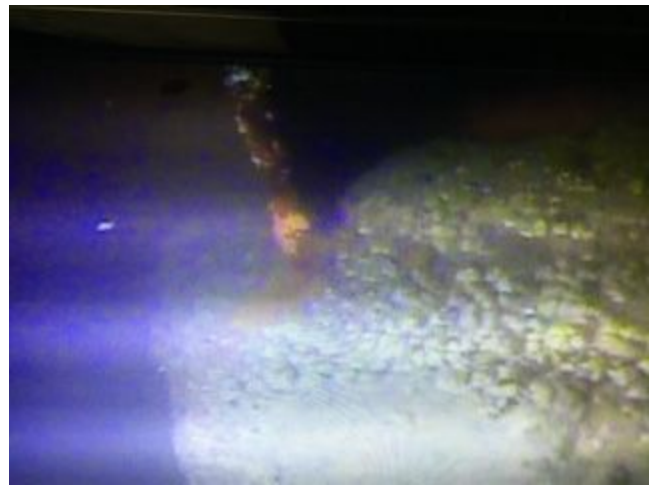
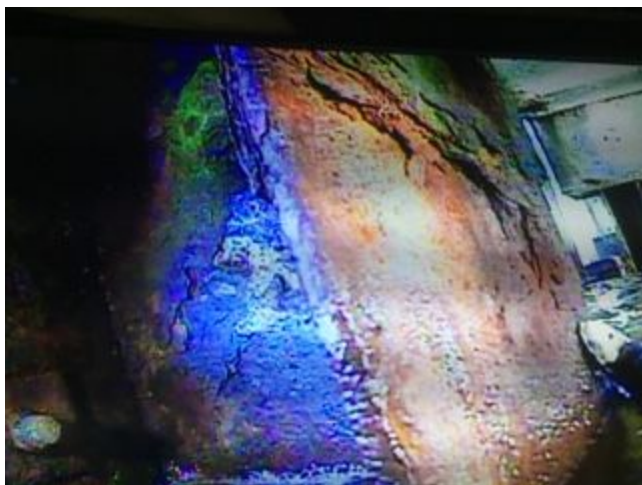
The vast majority of H-piles in Wedgeport Wharf have severe deterioration at the top near the pile cap and where the flanges are bolted to the wooden sheathing/ timbers. There is also heavy corrosion and deterioration at the tops of many concrete jackets. In many areas, rebar is exposed and some spalling is occurring. The H-piles that had the thinnest metal when tested were near the end of the wharf.
