False Creek – Roof Joint Repairs

Table 1: Observations at Test Locations

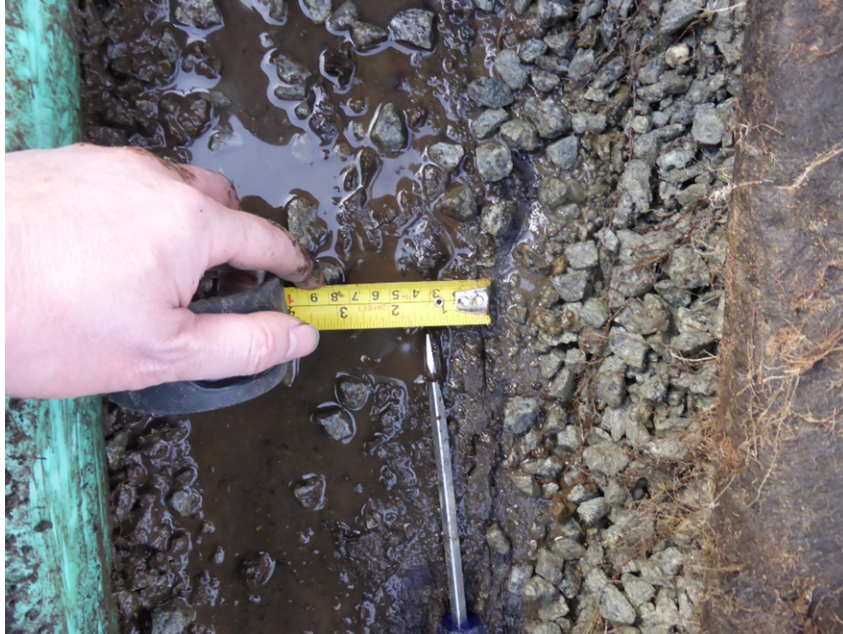
Photo 1: Typical condition at Tests #1 and 2 (except for expansion joint width)

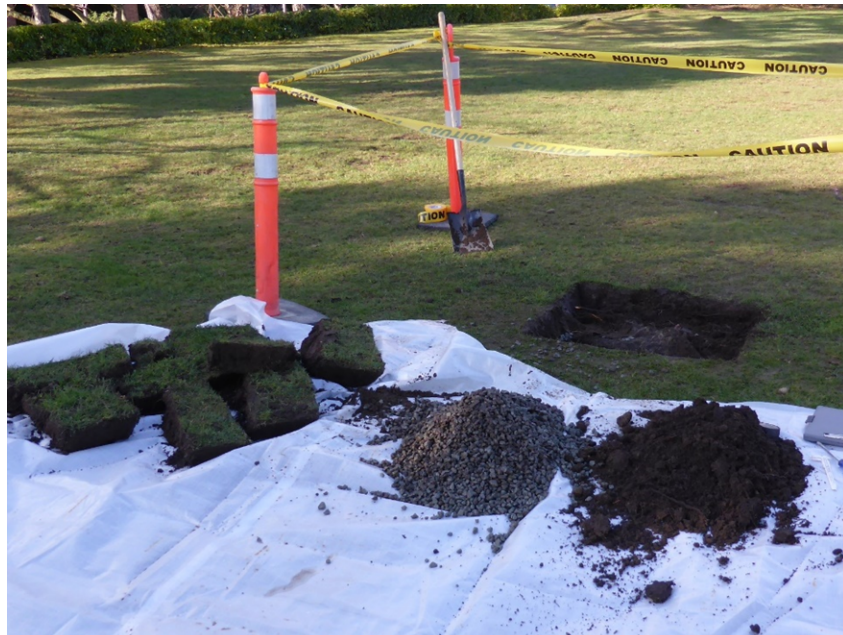
Photo 2: Typical landscaping materials at Tests #1 and #2

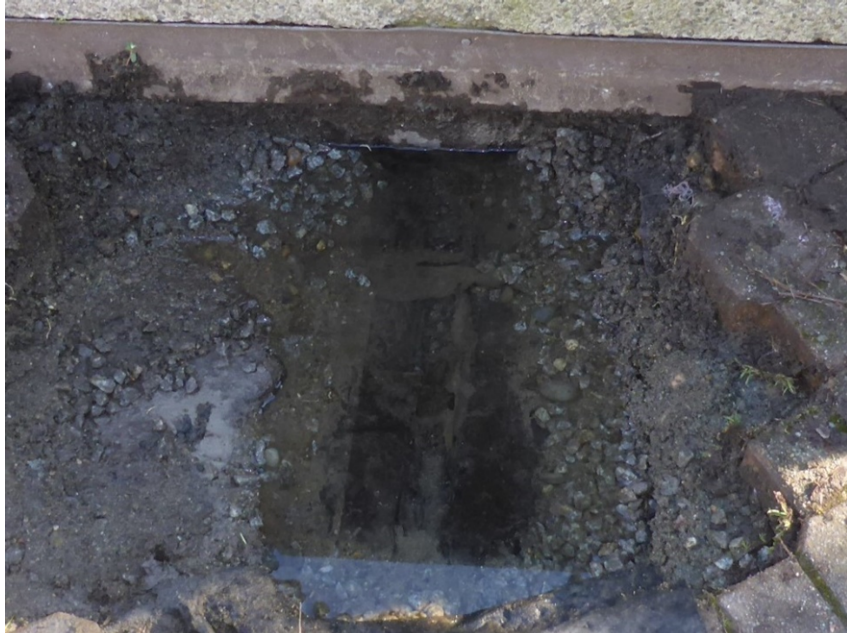
Photo 3: Test #3 at an expansion joint in the cantilever slab. 40 mm deep water ponding

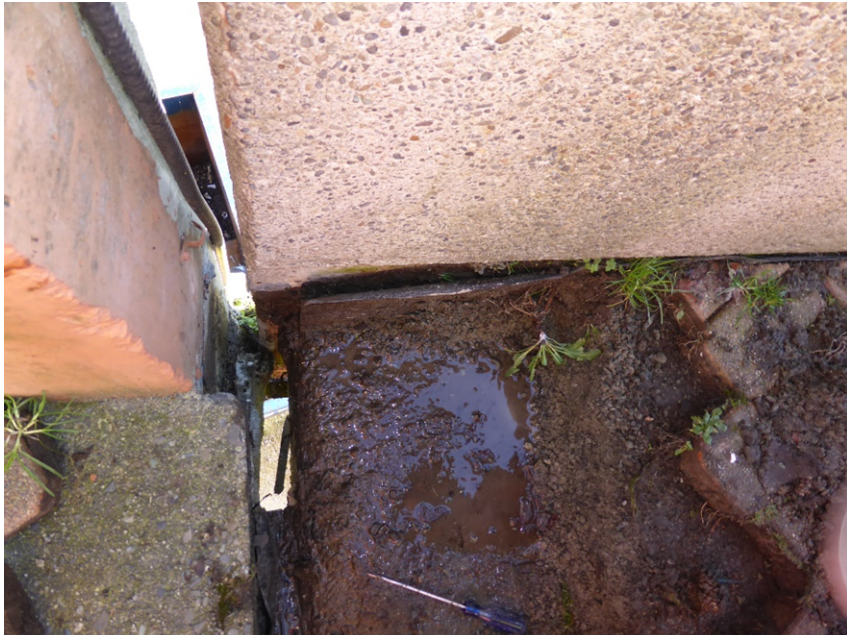
Photo 4: Test #4 located at the joint between the cantilever slab and the exterior stairs.
