DESIGNATED SUBSTANCES REPORT

**The Supreme Court of Canada
301 Wellington Street
Ottawa, Ontario**

PSPC SOA No: EN438-140932/001/FK

DST File No.: GV-OT-040333

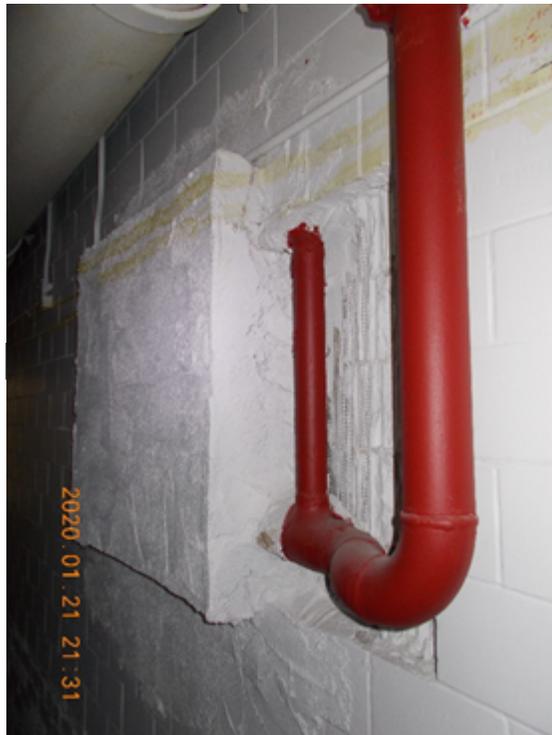
Photo 1: Friable (when disturbed) rough patch, observed in the sub basement room 0020 Northeast corridor, Location 8, sampled and confirmed to contain 1% Tremolite asbestos (DST 2020 Sample ID 040333-series 66).

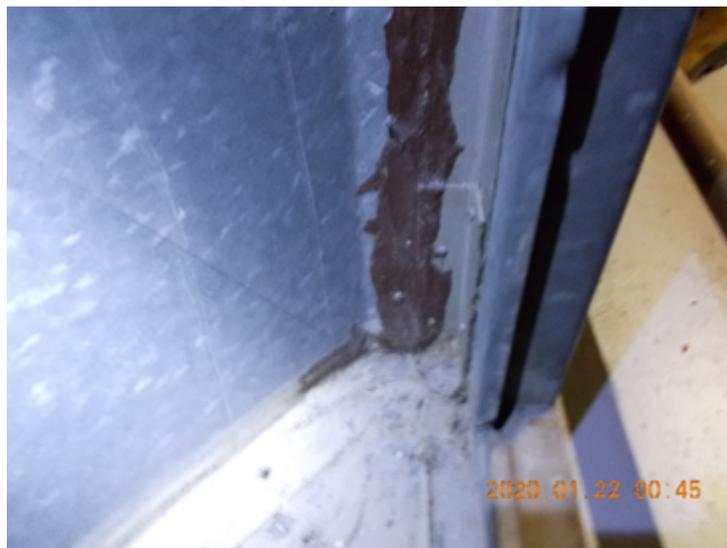
Photo 2: Non-Friable brown duct mastic sampled from inside AHU Unit #11 in the sub basement room 0010, Location 16 was confirmed to contain 2% Chrysotile asbestos (DST 2020 Sample ID 040333-series 71).

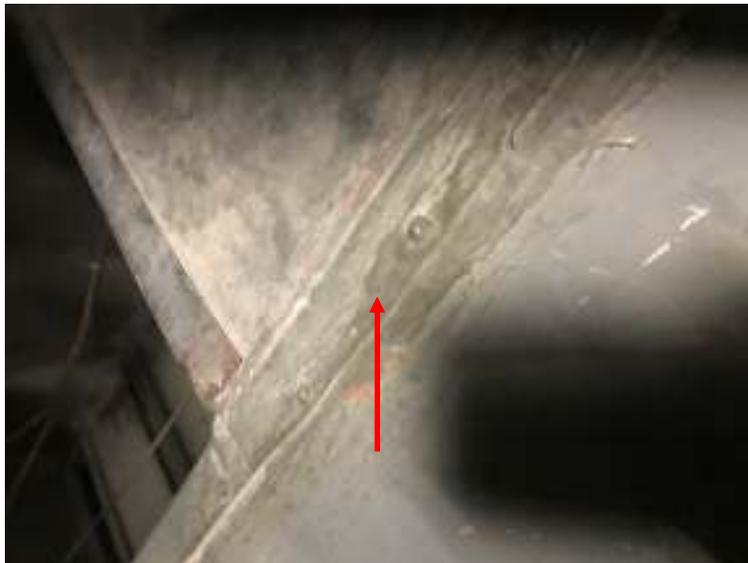
Photo 3: Non-Friable grey/brown caulking/mastic sampled from inside AHU Unit #1, 2 and 4 in the sub basement room 003 (central mechanical room), Location 10 was confirmed to contain 2% Chrysotile asbestos (DST 2020 Sample ID 040333-series 78).

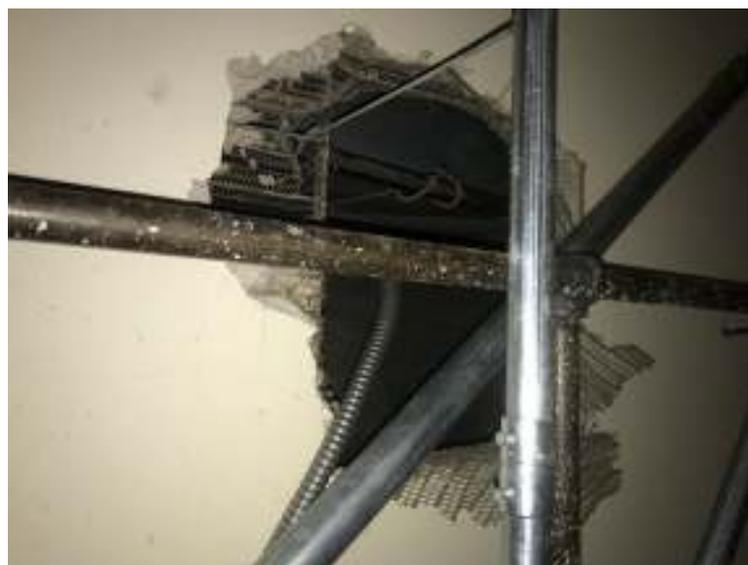
Photo 4: Friable when disturbed smooth over rough plaster walls and ceilings sampled throughout the building was confirmed to contain 0.5-1% Chrysotile asbestos (DST 2020 Sample ID 040333-series 82, 99, 111, 139, and Historical DST 2016 Sample ID 25657 -series 04, 27, 33).

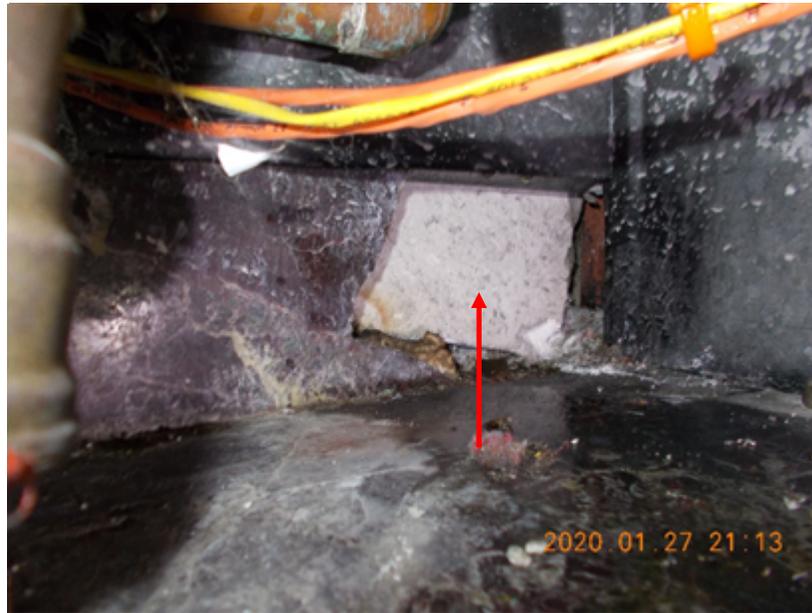
- A white fibrous board was observed concealed within the internal area of radiator assemblies throughout the building. This material was confirmed to contain 15% Amosite asbestos (Sample ID 040333-series 92, DST 2020). A parging material sampled from behind one of the radiators was also confirmed to contain 5% Chrysotile asbestos (Sample ID 040333-

Photo 5: Friable when disturbed white fibrous insulation associated with radiators throughout the building was confirmed to contain 15% Amosite asbestos (DST 2020 Sample ID 040333-series 92).

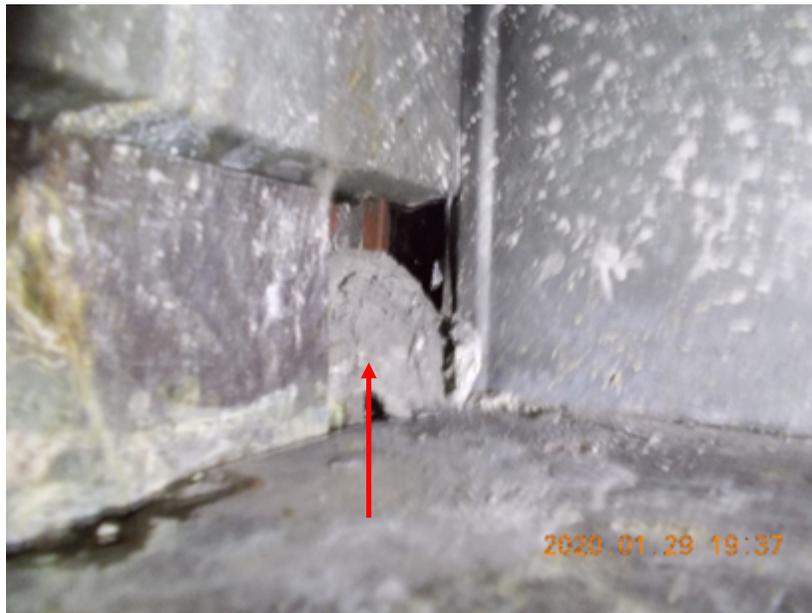
Photo 6: Friable when disturbed thin grey paring associated with radiators throughout the building was confirmed to contain 5% Amosite asbestos (DST 2020 Sample ID 040333-series 138).

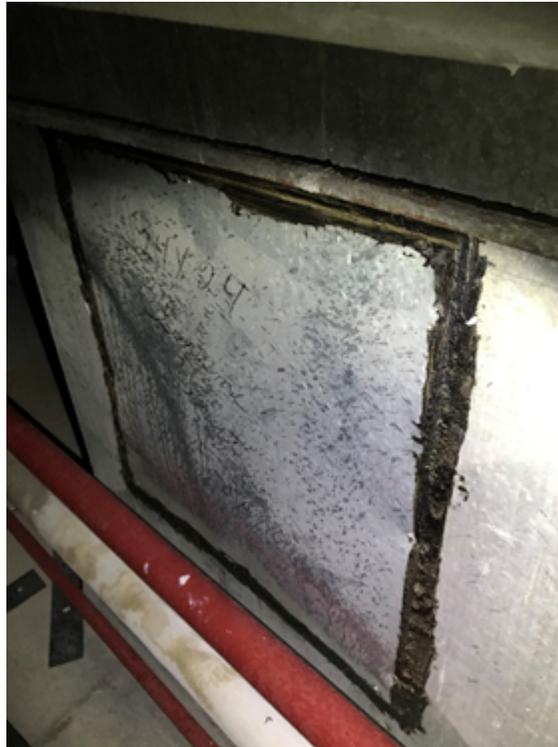
Photo 7: Non Friable tar caulking associated with duct hatch in the Mezzanine above room 0088 in the sub-basement, Location 263 was confirmed to contain 8% Chrysotile asbestos (DST 2020 Sample ID 040333-series 141).

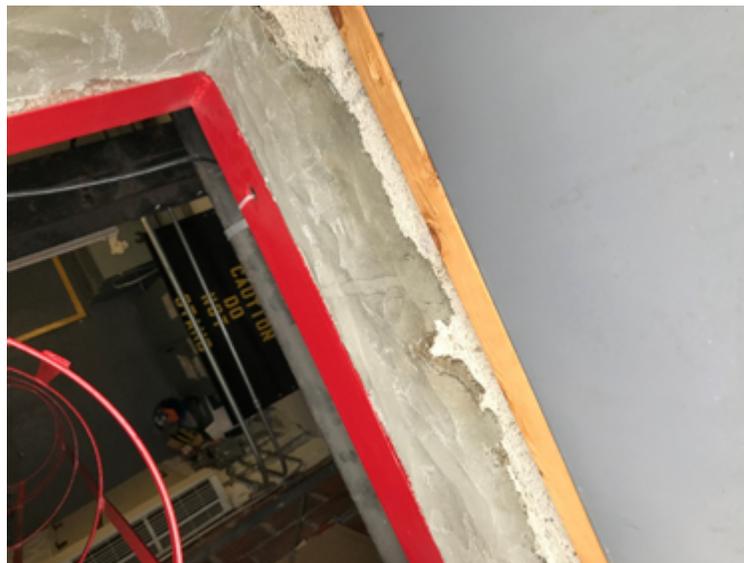
Photo 8: Friable when disturbed thin grey parging associated with the rooftop hatches above room 342 and 345 (elevator mechanical rooms) was confirmed to contain 1% Chrysotile asbestos (DST 2020 Sample ID 040333-series 142).

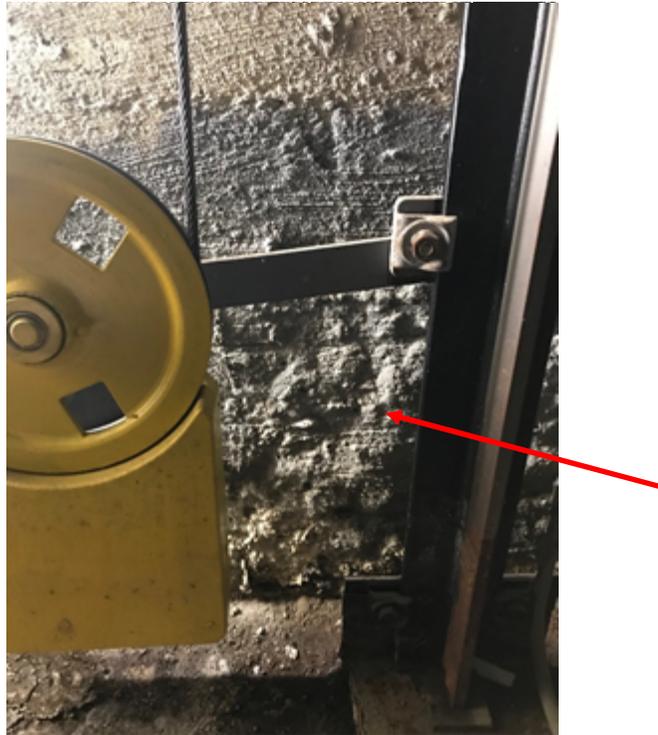
Photo 9: Friable when disturbed thin parging/rough coat associated with the Judges elevator shaft walls, Location C was confirmed to contain 1% Chrysotile asbestos (DST 2020, Sample 40333-series 146);

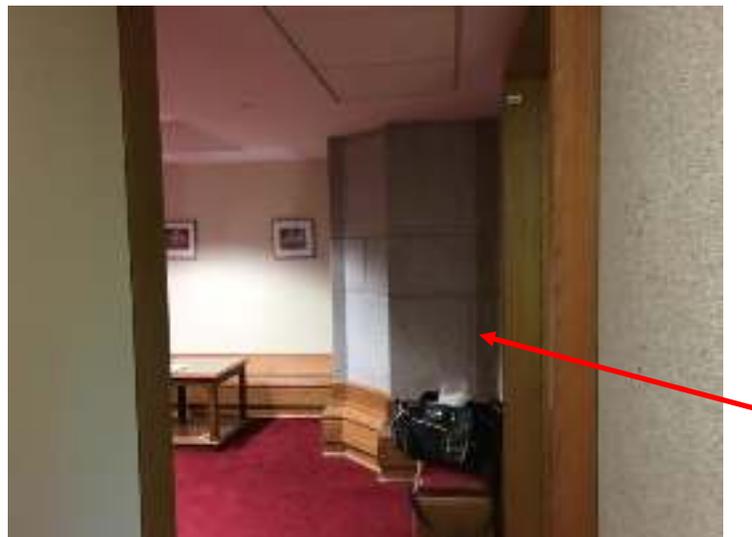
Photo 10: Mortar associated with stone panels in 3rd Floor sitting area was confirmed to contain 1% Chrysotile asbestos (Historical DST 2016 Sample ID 25657-series 02).

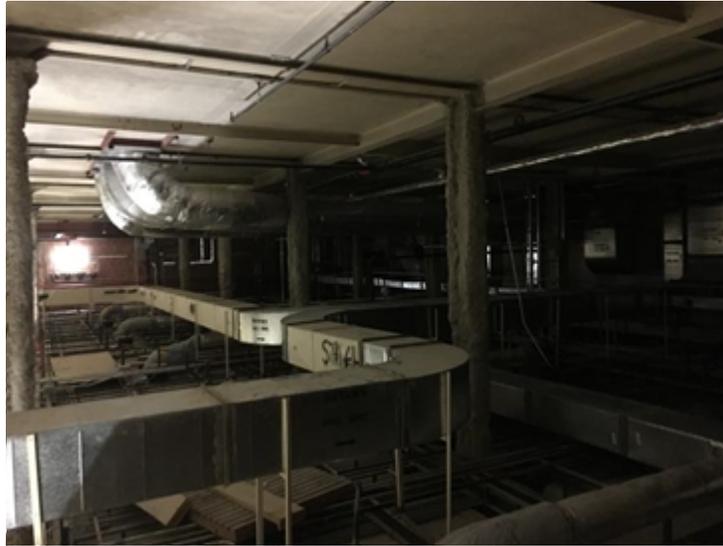
- Cementitious parging, applied to the roof deck/structure above the 3rd Floor Library, contains 1% Chrysotile asbestos (Sample 25657-16A, DST 2016);
- Tar material, observed between the joints of pre-cast cementitious roofing panels throughout the 1st Mechanical floor contains 26.28% Chrysotile asbestos (Sample 25657-18A, DST 2016);

Photo 11: Cementitious parging throughout the ceiling of the mechanical area above the 3rd Floor Library (south) contains 1% Chrysotile asbestos (Historical DST 2016 Sample ID 25657-series 16).

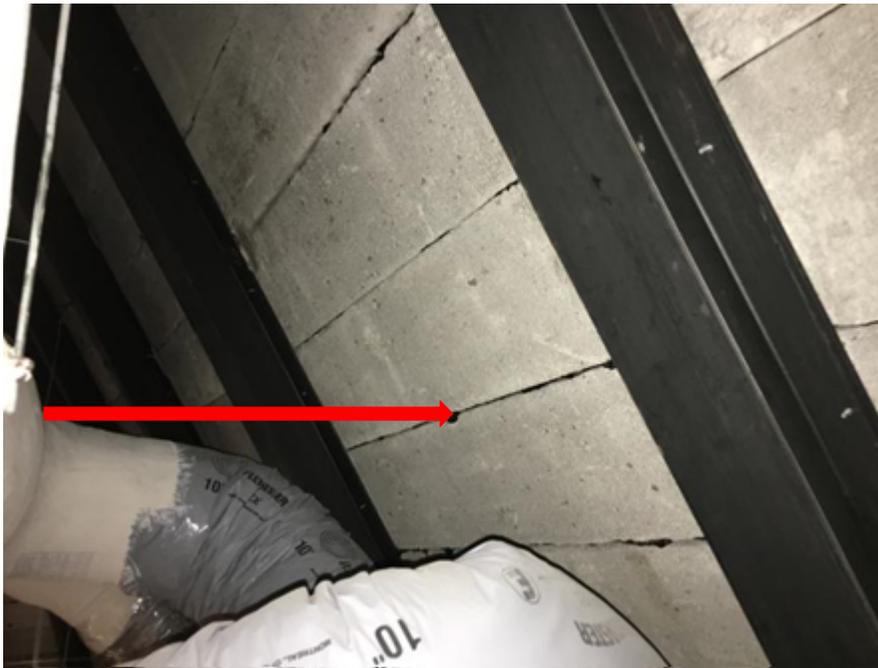
Photo 12: Tar, visible in joints of pre-cast cementitious panels that comprise the interior roof structure, 1st Mechanical Floor, contains regulated amounts of asbestos. The cementitious panels themselves were confirmed by laboratory analysis to not contain asbestos ((Historical DST 2016 Sample ID 25657-series 18).

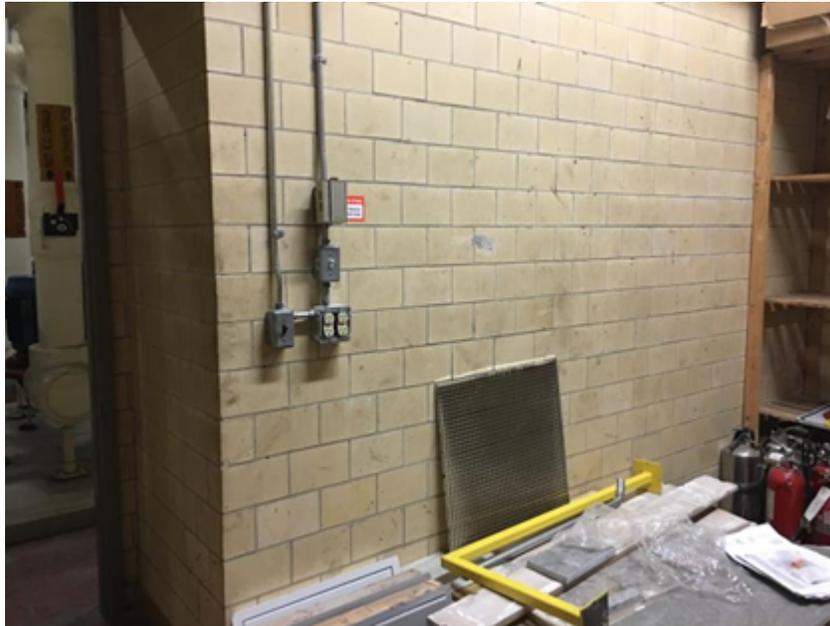
Photo 13: Block wall mortar, typical of small tan block walls throughout the sub-basement, contains 1% Chrysotile asbestos (Historical DST 2016 Sample ID 25657-series 36).

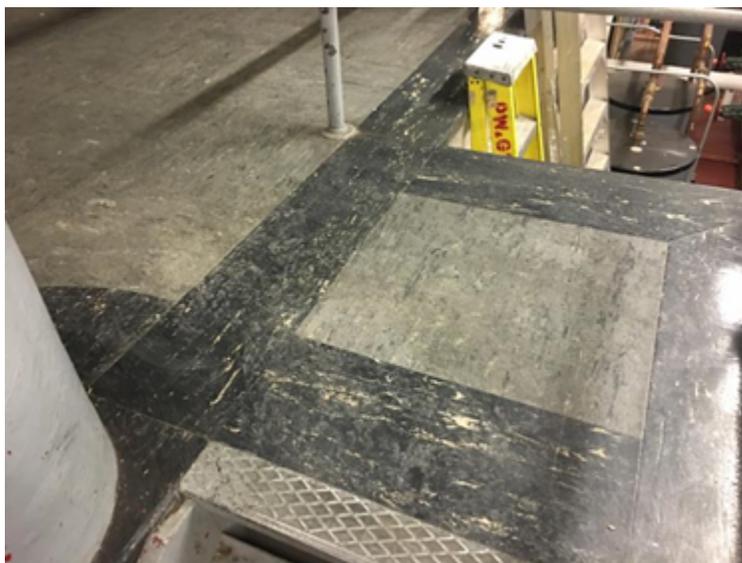
Photo 14: Mastic associated with vinyl floor materials in upper area of sub-basement mechanical room 003/entryway from basement level, contains regulated amounts of asbestos (Historical DST 2016 Sample ID 25657-series 39 & 40).

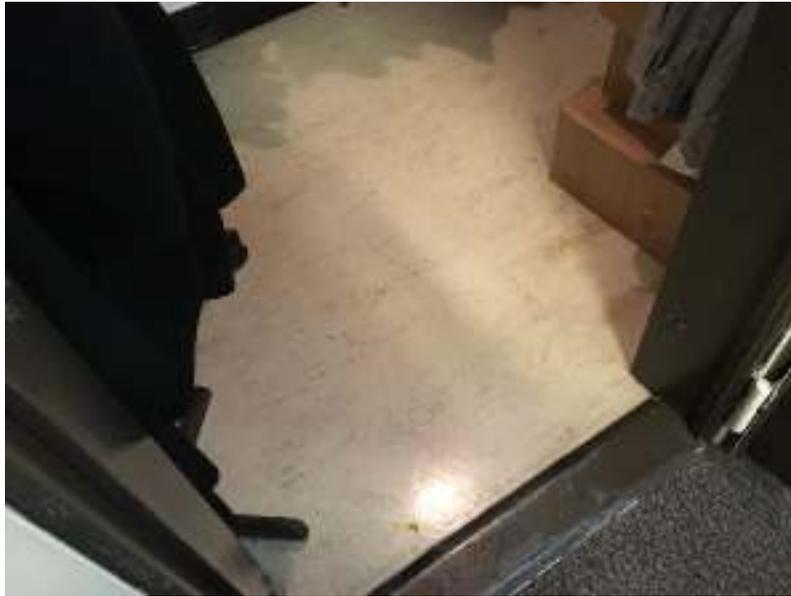
Photo 15: Vinyl floor tiles and associated mastic in the vault of Room 086, Basement, contains regulated amounts of asbestos(Historical DST 2016 Sample ID 25657-series 48).

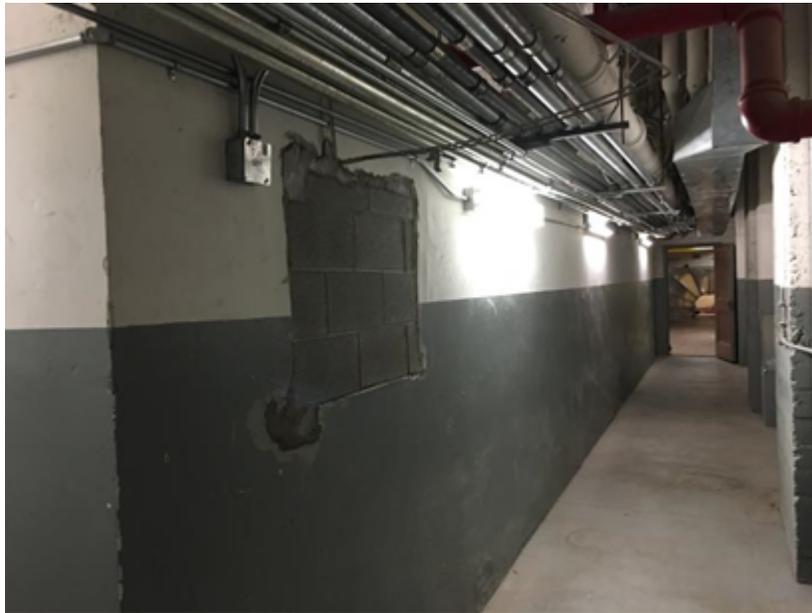
- The wall material that comprises the supply and exhaust plenums adjacent to/surrounding Room 0039, Sub-basement, was observed to be comprised of a grey cement compound parging material, containing 54% Chrysotile asbestos (DCS, 2008).

Photo 16: Parging (grey cement compound) comprising the walls of the exhaust and supply plenums behind/surrounding Room 0039, Sub-basement, contains regulated amounts of asbestos (Historical DST 2016 Sample ID 25657-series 49).

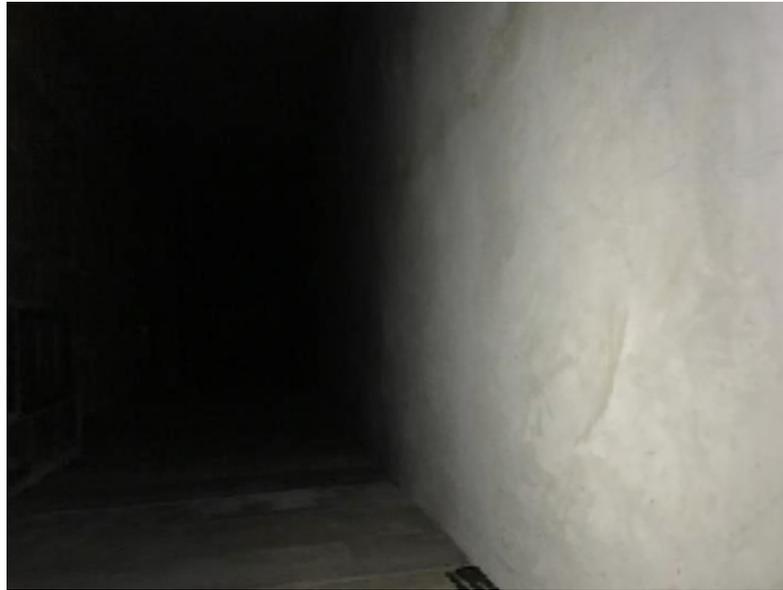
Photo 17: Wall parging (grey cement compound) in the catacombs (north) contains regulated amounts of asbestos (Historical DST 2016 Sample ID 25657-series 49).

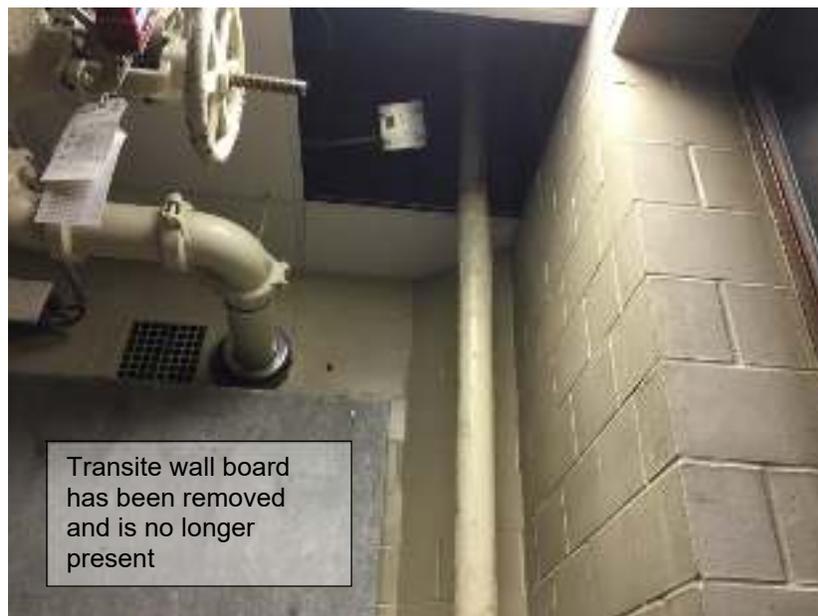
Photo 18: Asbestos-containing pipe insulation (typical janitor's closet off of north corridor pictured). Please note that the photograph is from the historical 2016 report and the transite board pictured has since been removed.

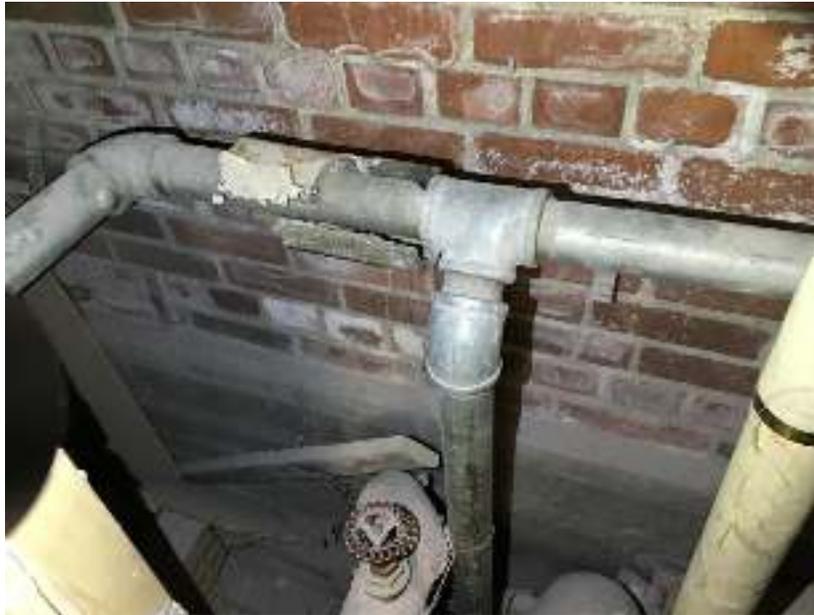
Photo 19: Poor condition asbestos-containing layered cardboard wrap pipe insulation in wall hatch, Ground Floor, Room 155 side washroom.

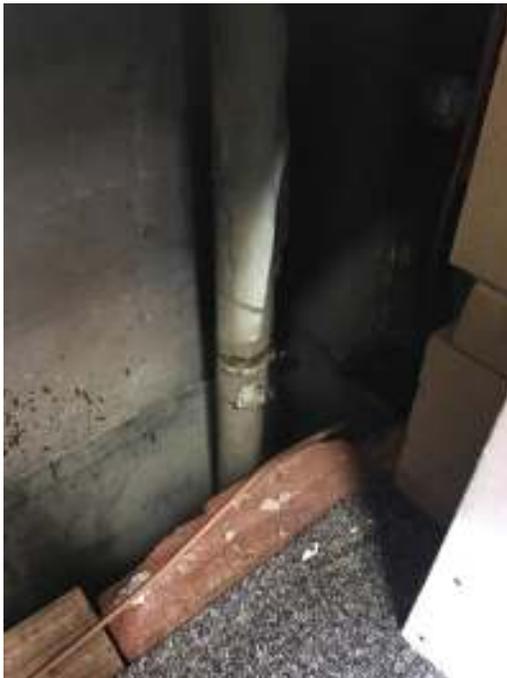
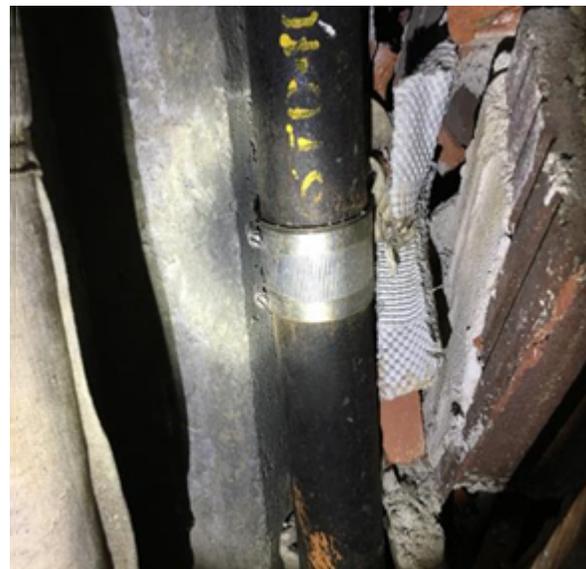
Photos 20 and 21: Poor condition asbestos containing insulation and debris, inside wall covering, basement, Room 082 (north wall).

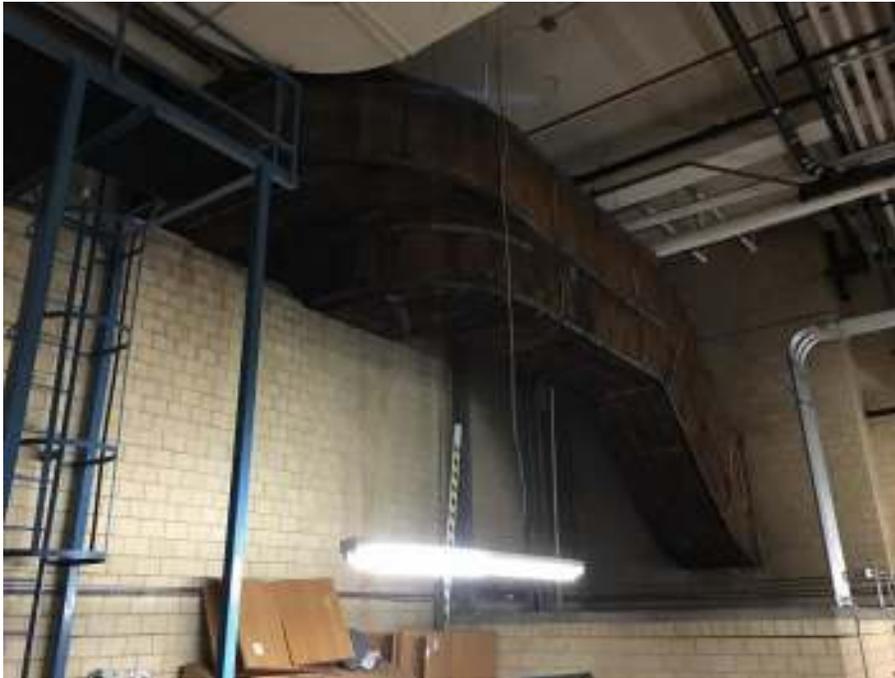
Photo 22: Duct insulation, Room 008, Sub-basement, contains regulated amounts of asbestos.

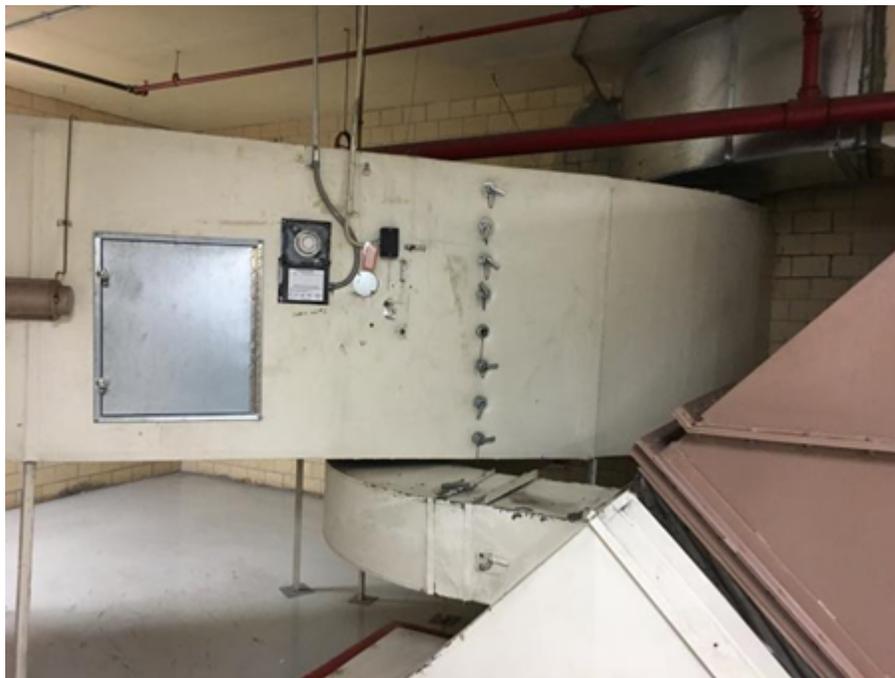
Photo 23: Parging over fiberglass duct insulation contains regulated amounts of asbestos (Room 0039, Sub-basement pictured above).

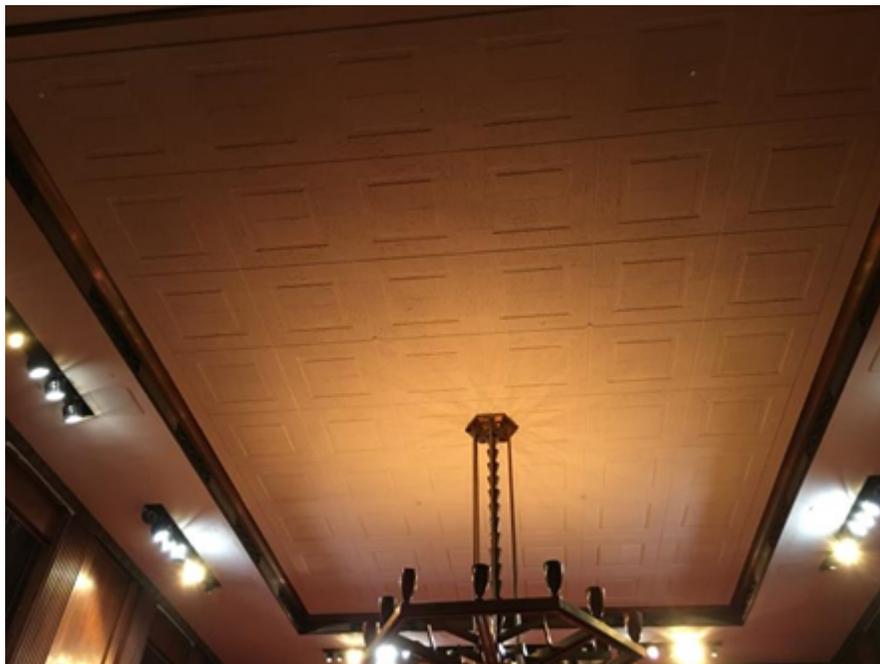
Photo 32: 1'x1' Ceiling tiles throughout the 1st floor, Supreme Court Chamber, installed in a coffered pattern, are suspected to contain asbestos.

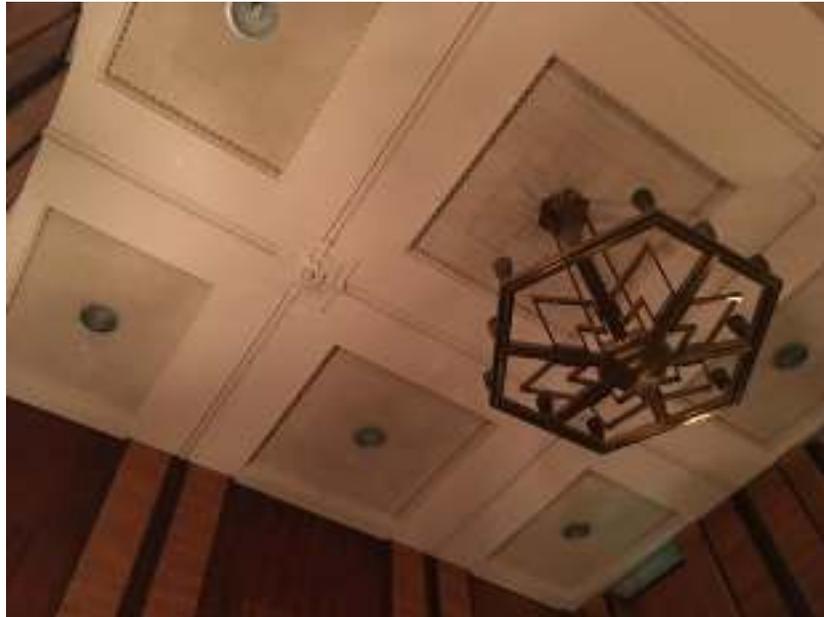
Photo 33: 1'x1' Ceiling tiles, typical of East and West Federal Court Chambers, Ground Floor, are suspected to contain asbestos.

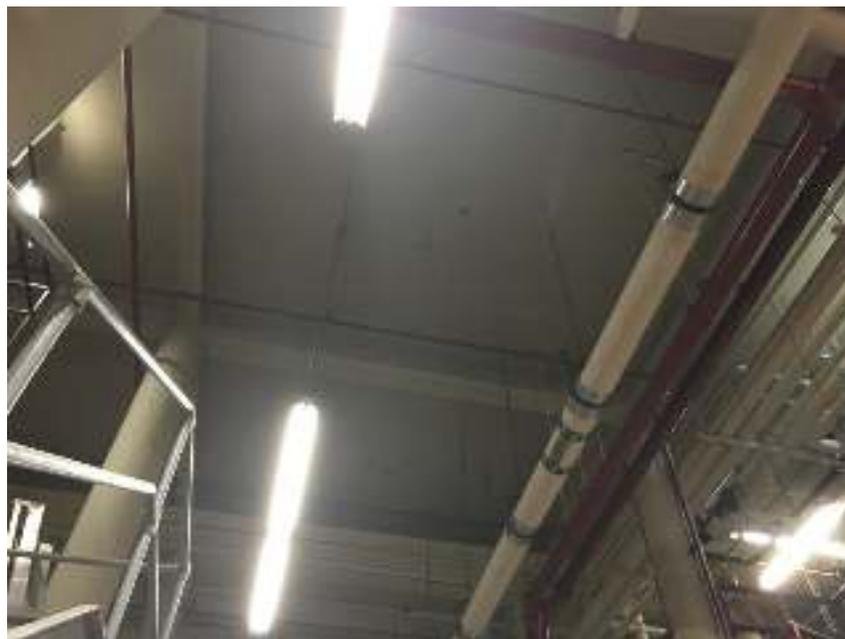
Photo 34: Cementitious parge layer throughout sub-basement mechanical room ceiling (Room 003) was confirmed to not contain asbestos. Visually homogenous cementitious parging layer was observed throughout the ceiling/deck of select areas of the basement and sub-basement and thus not considered asbestos-containing based on available bulk sample data.

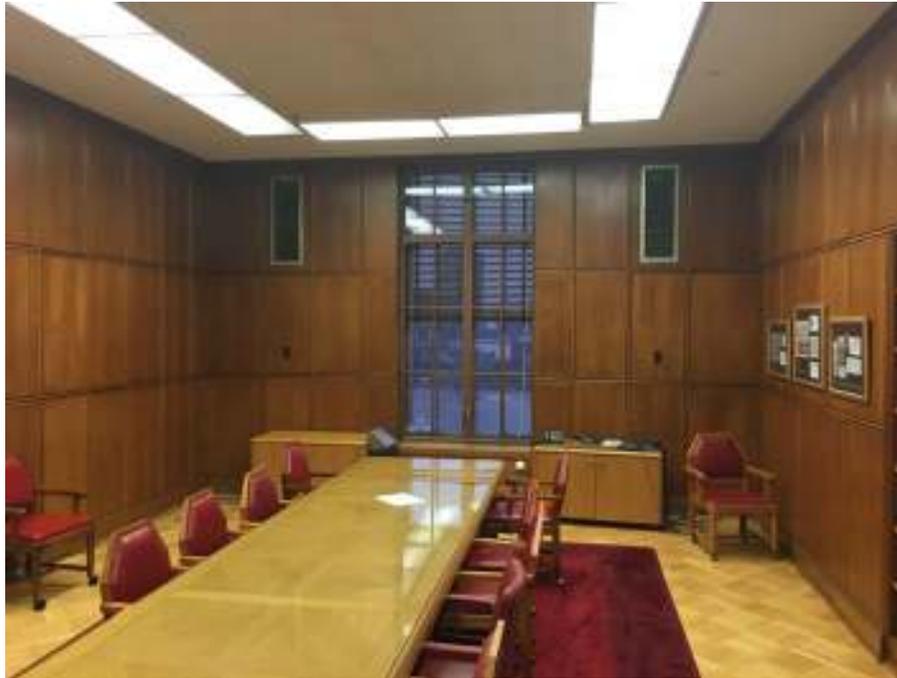
Photo 35: Typical office area, 1st Floor. Asbestos-containing plaster materials are suspected to be present and concealed beneath wood paneling.

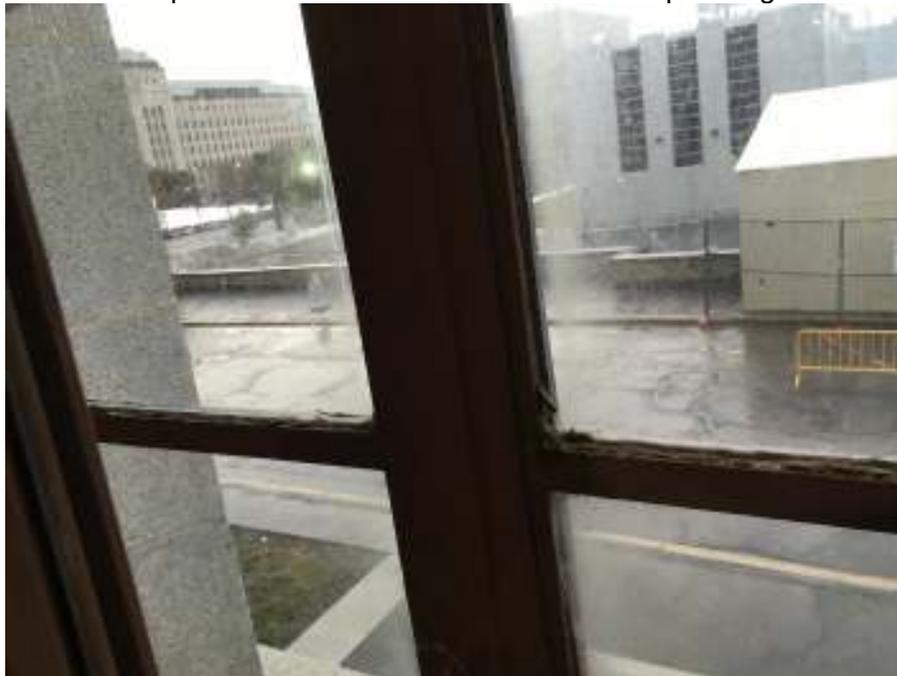
Photo 36: Window putty associated with second window pane is suspected to contain asbestos.

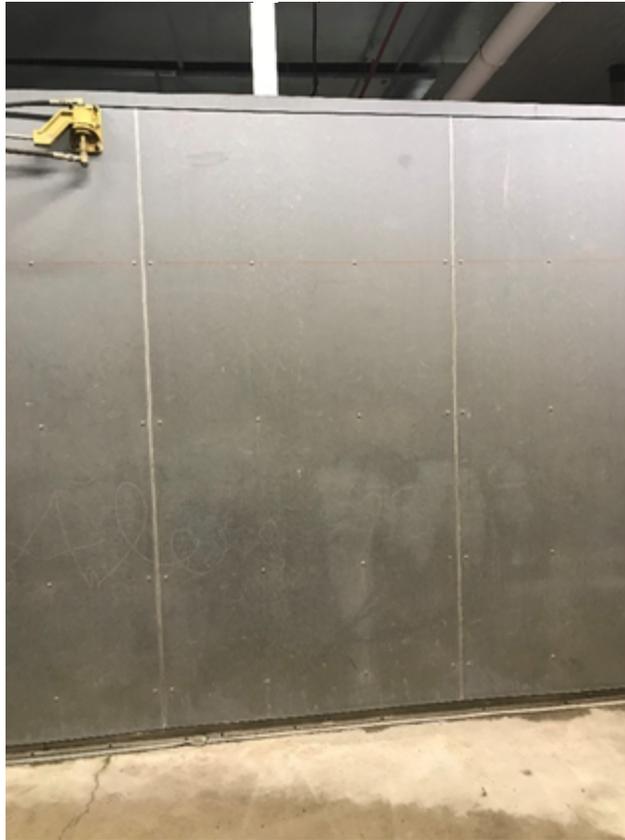
Photo 37: Suspect Transite board identified in the wash bay of the parking garage is assumed to contain asbestos.

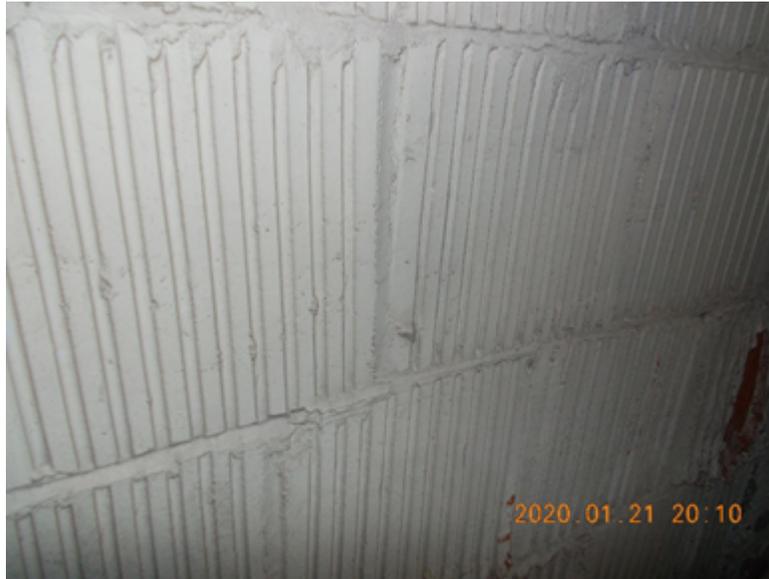
Photo 39: White wall paint sampled from the terracotta walls leading to the catacombs in the sub-basement, Location 1 contains 401 ppm lead (DST 2020 Sample ID 040333-LP01).

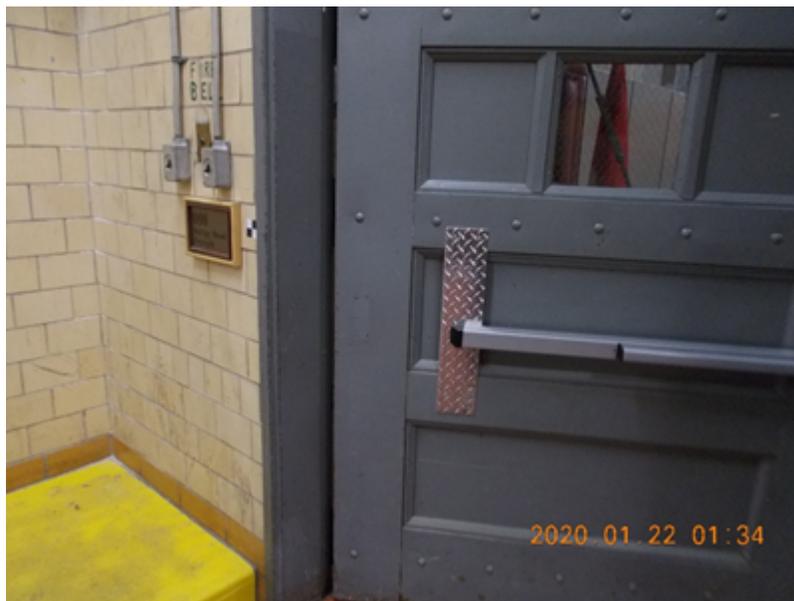
Photo 40: Dark grey paint sampled from the metals doors leading to room 008 in the sub-basement, Location 23 contains 4340 ppm lead (DST 2020 Sample ID 040333-LP07).

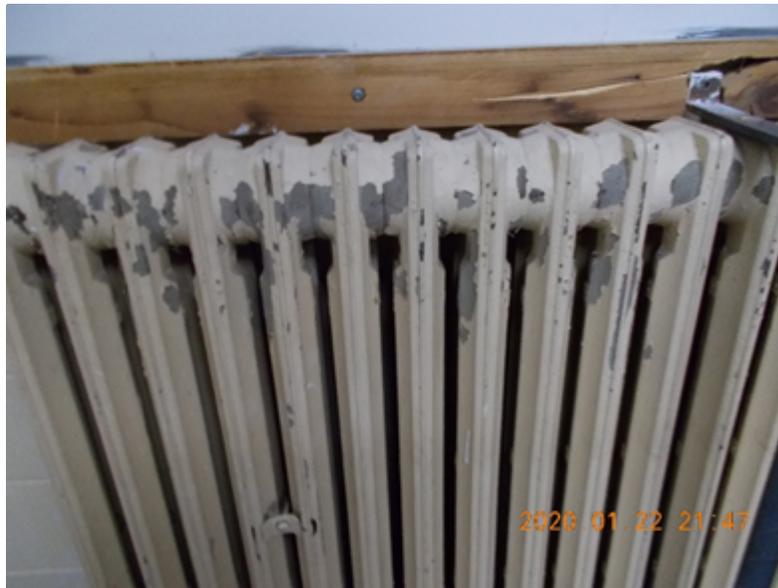
Photo 41: Light beige paint sampled from the radiator in the basement office 034, Location 38 contains 11100 ppm lead (DST 2020 Sample ID 040333-LP08).

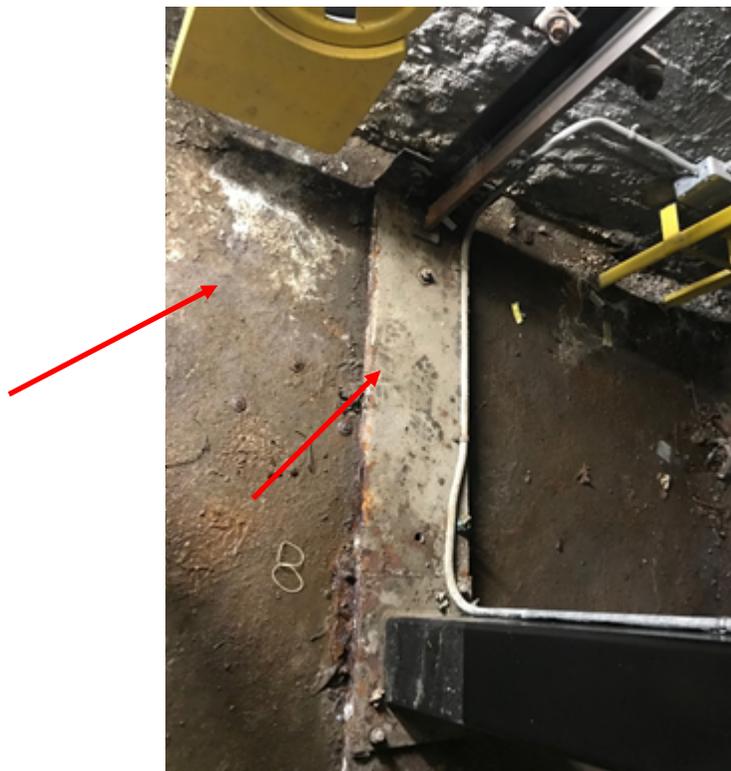
Photo 42: Grey paint sampled from the Judges elevator pit floor and the steel beam within the pit was confirmed to contain 2050 and 3480 ppm lead (DST 2020 Sample ID 040333-LP17 & LP18).

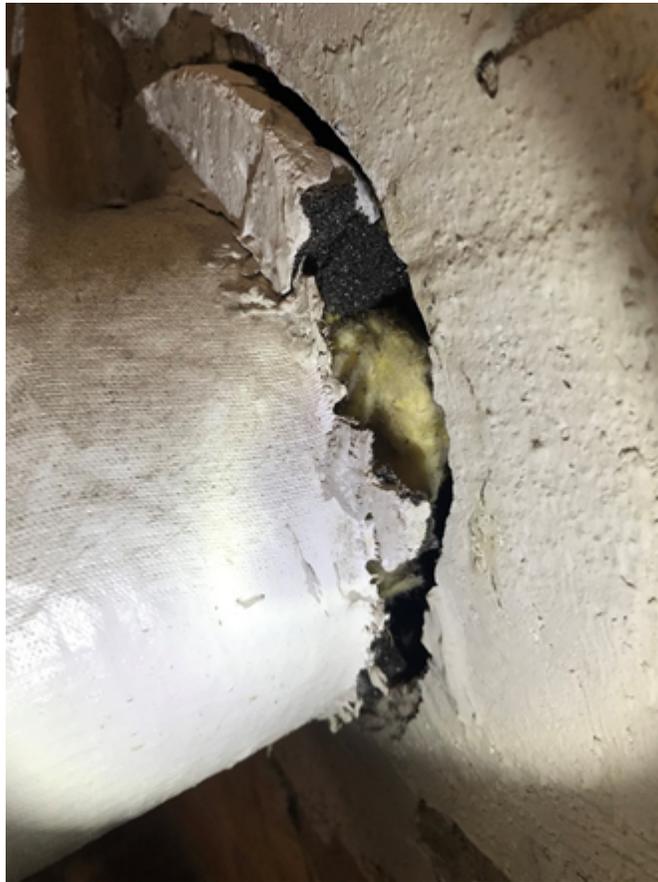
Photo 43: Foamglass observed at a pipe penetration in the central mechanical room 0017 in the sub-basement (near the door to the steam tunnels).
