**XCG File No. 5-336-200-01**  
**COLE File No. 2018-0565**  
March 25, 2019

**DESIGNATED SUBSTANCES AND  
HAZARDOUS MATERIALS SURVEY  
PIN 614104-1  
7630 MAJOR MACKENZIE DRIVE EAST  
MARKHAM, ONTARIO**

Prepared for:  
**PUBLIC SERVICES AND PROCUREMENT CANADA**  
4900 Yonge Street  
11th Floor  
Toronto, Ontario M2N 6A6

On Behalf of  
**PARKS CANADA AGENCY**  
**ROUGE NATIONAL URBAN PARK**

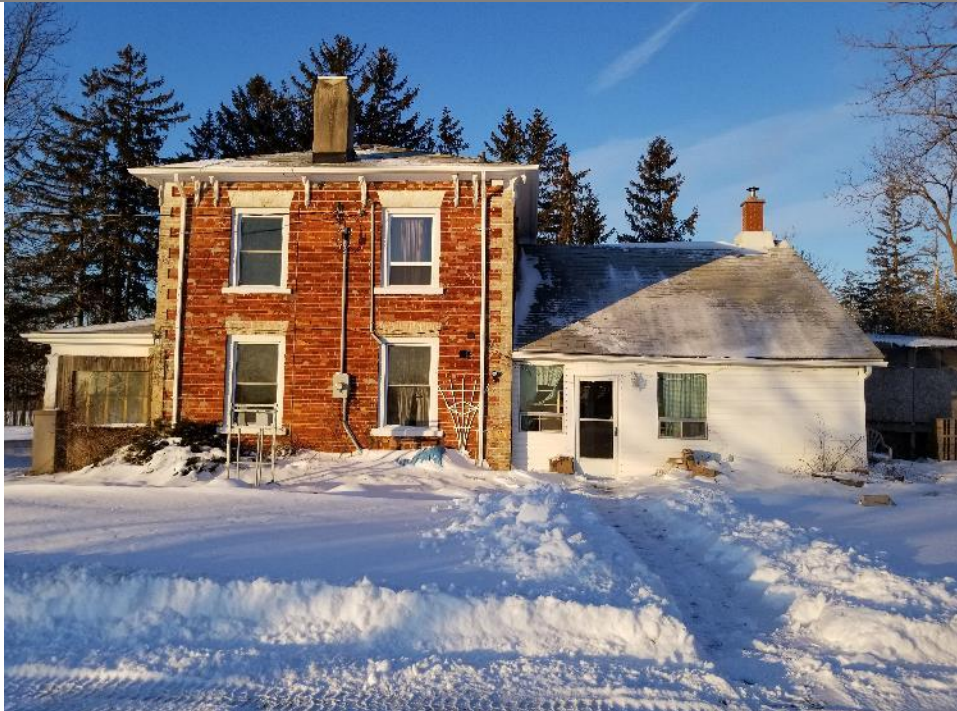
**Photo 1: View of the exterior of the subject building and suspected ACM roofing materials.**

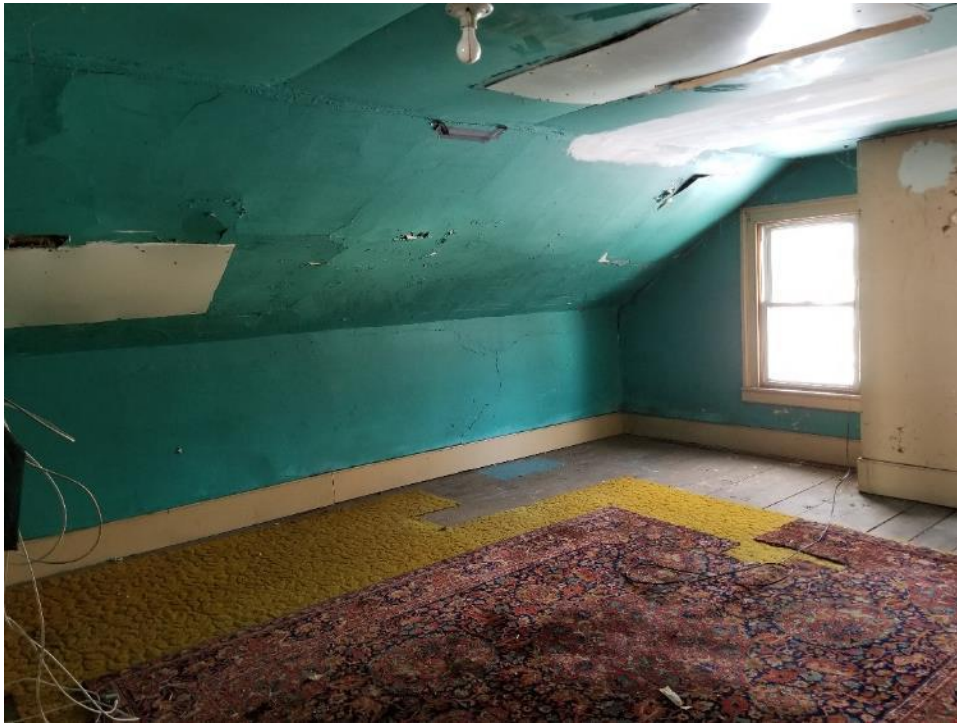
In 2019, seven paint samples were collected and submitted for lead analysis. Six of these paint samples were found to be lead-based with concentrations ranging from 420 ppm to 42,000 ppm. At the time of the survey, teal paint throughout the second floor office, lilac paint on the second floor washroom walls, and brown paint on the second floor bedroom 1 wood floors were in poor condition and had areas of flaking or peeling paint. Lead-based paints in poor condition had concentrations ranging between 420 ppm and 5,600 ppm. Because the subject building is unoccupied, the urgency level for repair is considered moderate. Flaking paints should be cleaned up or removed using power tools with a high-efficiency particulate air (HEPA) filter-equipped vacuum to limit the potential for the spread of lead dust.

**Photo 2: View of the teal lead-based paint in the second floor office.**

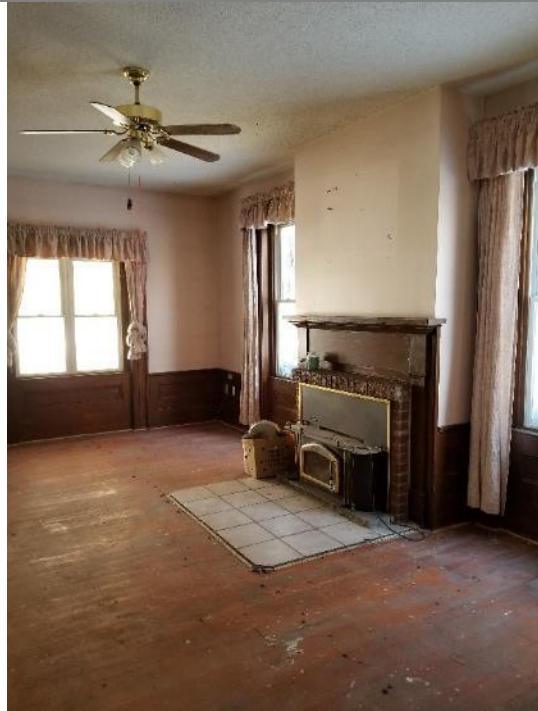
**Photo 3: View of the brown lead-based paint on the first floor living room moulding and trim.**

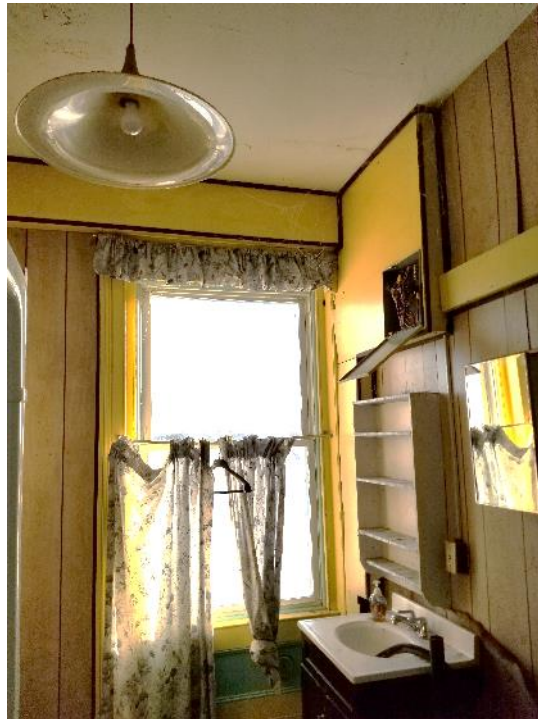
**Photo 4: View of the yellow lead-based paint on the first floor washroom trim.**

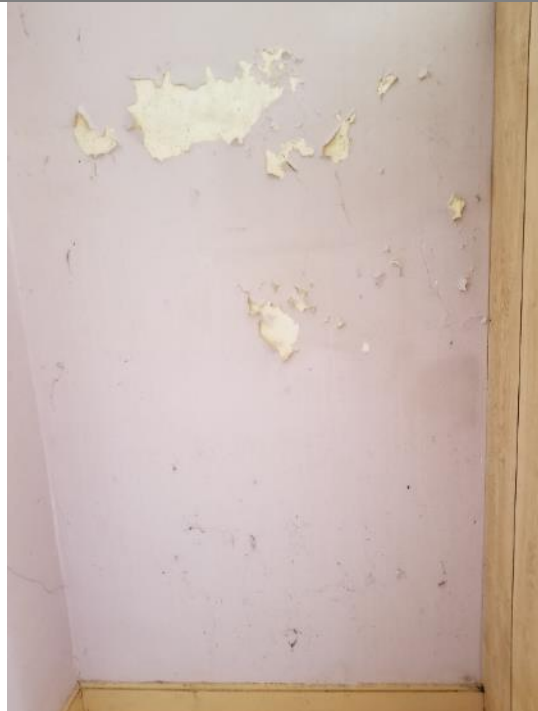
**Photo 5: View of the lilac lead-based paint on the second floor washroom walls.**

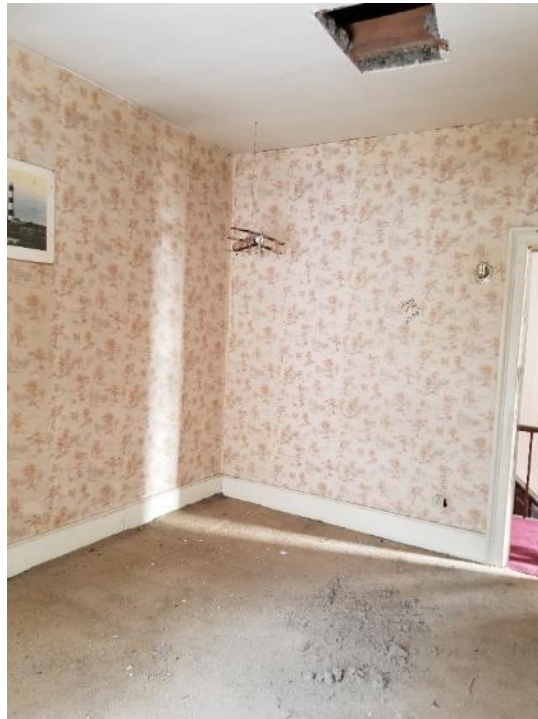
**Photo 6: View of the second floor bedroom 1 carpet under which there is brown lead-based paint on the wood floors.**

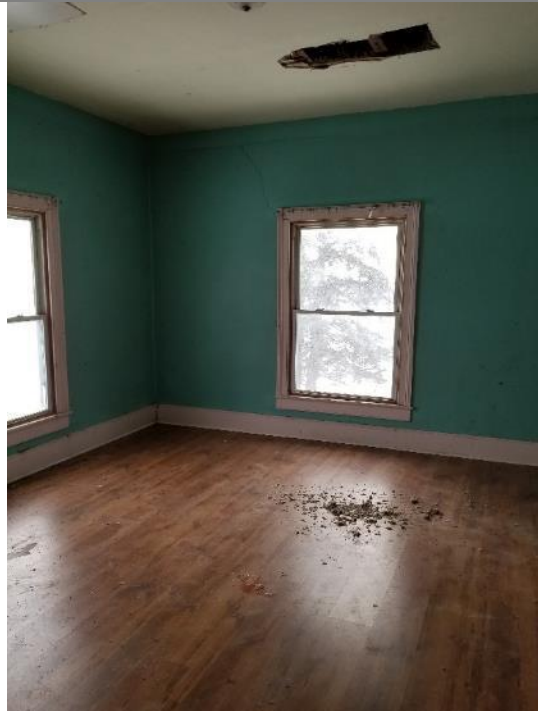
**Photo 7: View of pink lead-based paint on second floor bedroom 3 window frame and trim.**

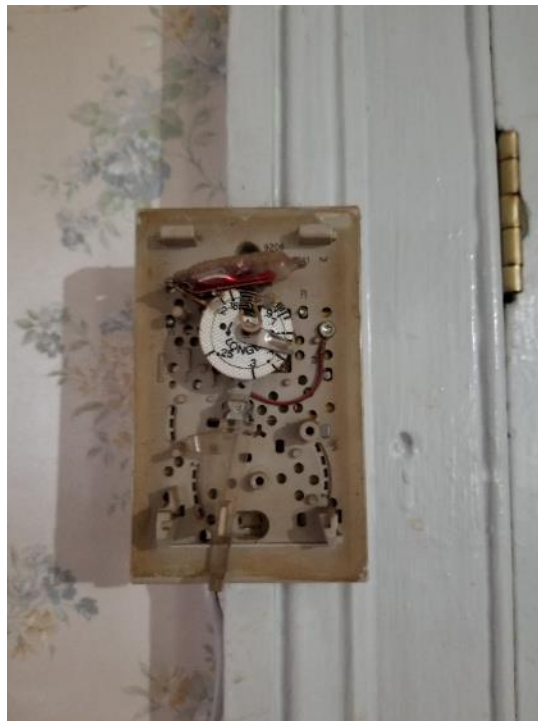
**Photo 8: View of mercury-containing thermostat in the first floor kitchen.**

Small quantities of mercury are present in the thermostat observed in the first floor kitchen. No samples were collected or submitted for laboratory analysis. Prior to any demolition or renovations to the building, the thermostat must be handled and if necessary, disposed of in accordance with O. Reg. 490/09 (as amended).

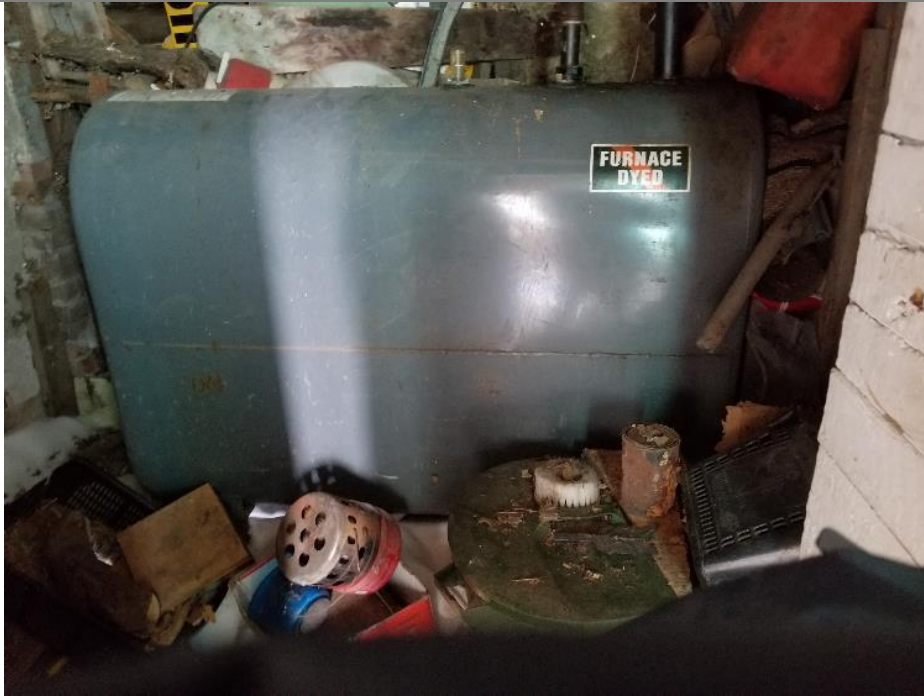
These designated substances are typically found in industrial settings and are unlikely to be located within the residential dwelling, with the exception of benzene, which is present within the furnace oil in the AST in the covered porch on the east side of the subject dwelling.

**Photo 9: View of 909 L fuel oil above-ground storage tank on the second floor covered porch.**

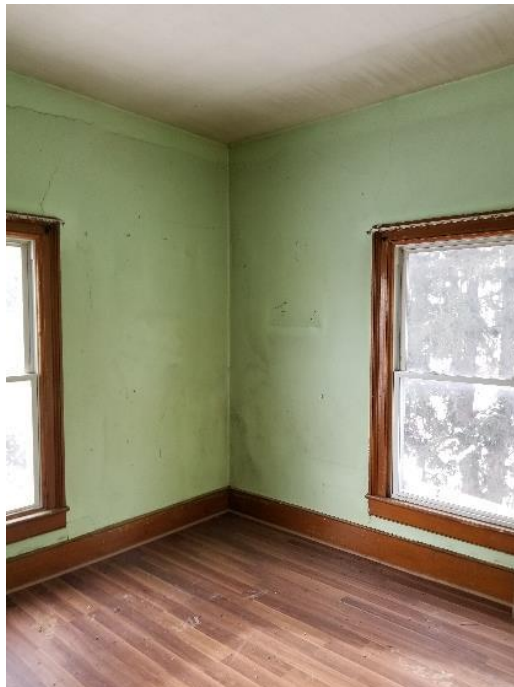
Approximately half a square metre (0.5m<sup>2</sup>) of suspect mould was observed on the north wall of the second floor washroom and one square metre (1m<sup>2</sup>) of suspect mould was observed in the walls and ceiling in the southwest corner of the second floor bedroom 2. No samples were collected or submitted for laboratory analysis.

**Photo 10: View of suspect mould on second floor bedroom 2 walls and ceiling.**
