Instruction Date : 15-Oct-2021
UMR : -
ABL Report No. : CA-M10-0043-R001 Rev1
Report Date : 09-Nov-2021

HYDRA MARINER

DISPOSAL ASSESSMENT

HYDRA MARINER DISPOSAL ASSESSMENT

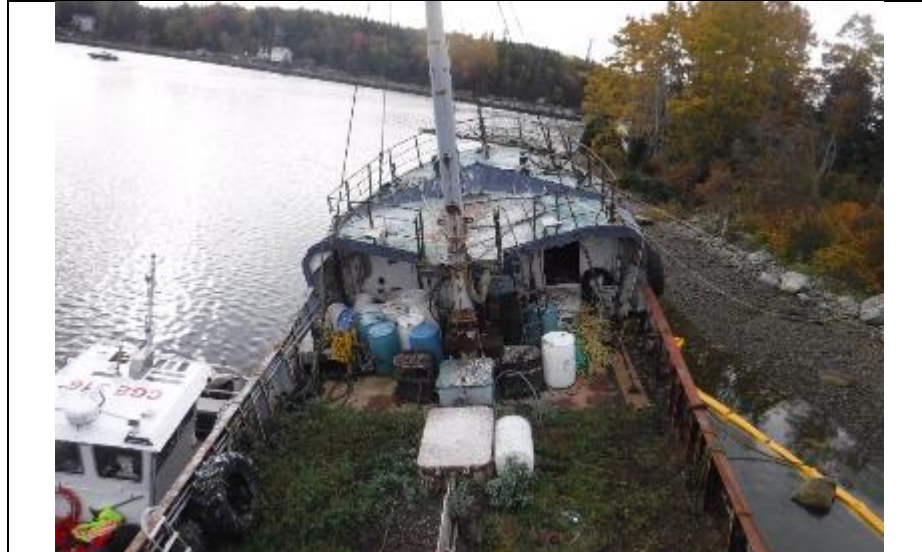
The winch / cargo deck, weeds were found growing on deck with a estimated layer of 5-10 cm of organic / compost growth.

1. Growth on deck.

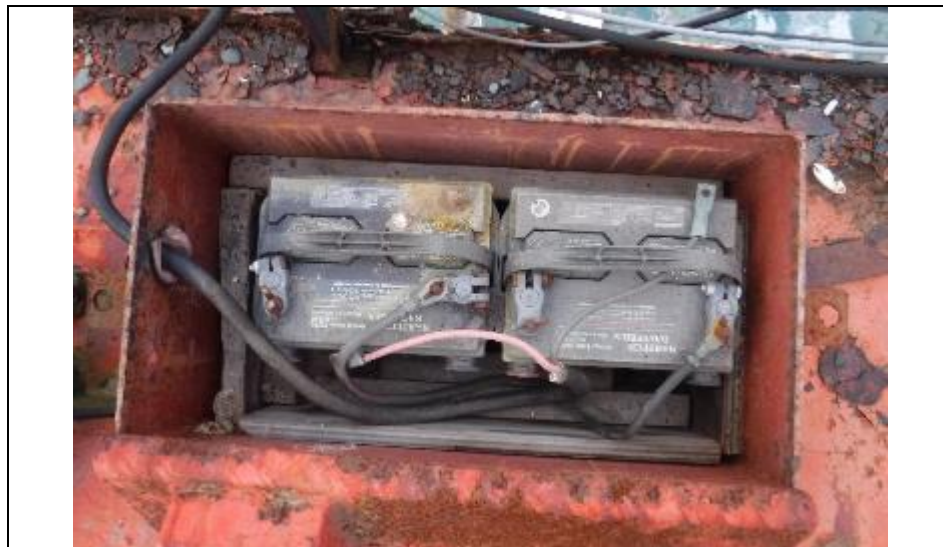
Three lead batteries were observed, and four flood lights possibly containing mercury / cadmium compounds.

2. Lead batteries on wheelhouse deck.

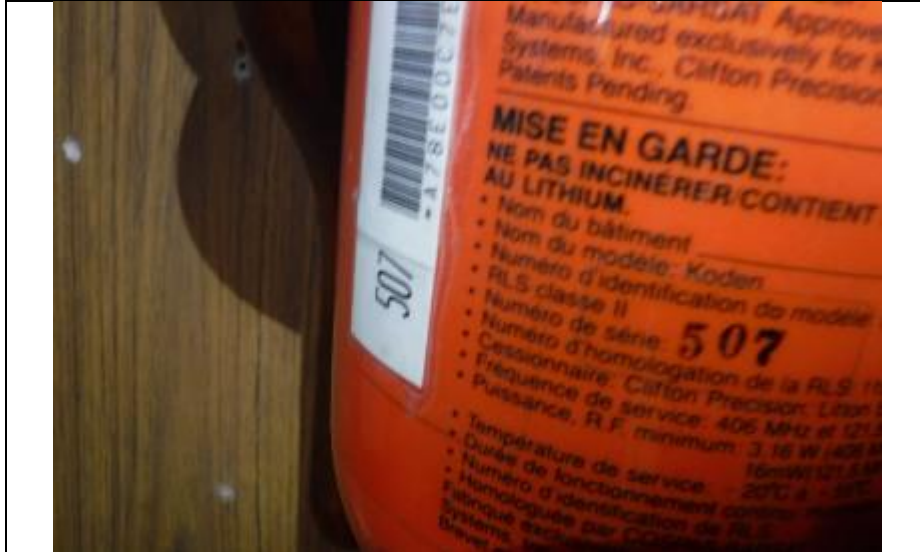
3. Lithium Batteries in EPIRB and SARTS in wheelhouse.

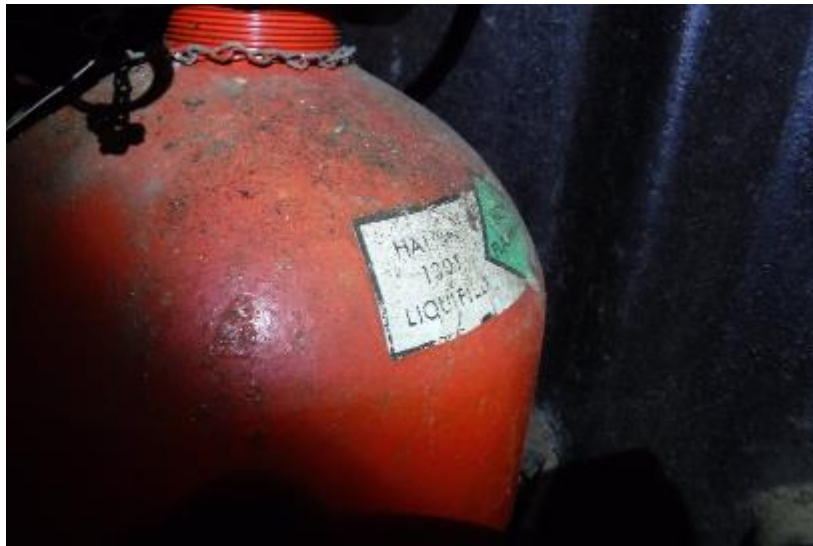
The firefighting system is containing ODS – two cylinders Halon1301, were observed, maximum containing two x 55Kg.

4. Halon Gas.

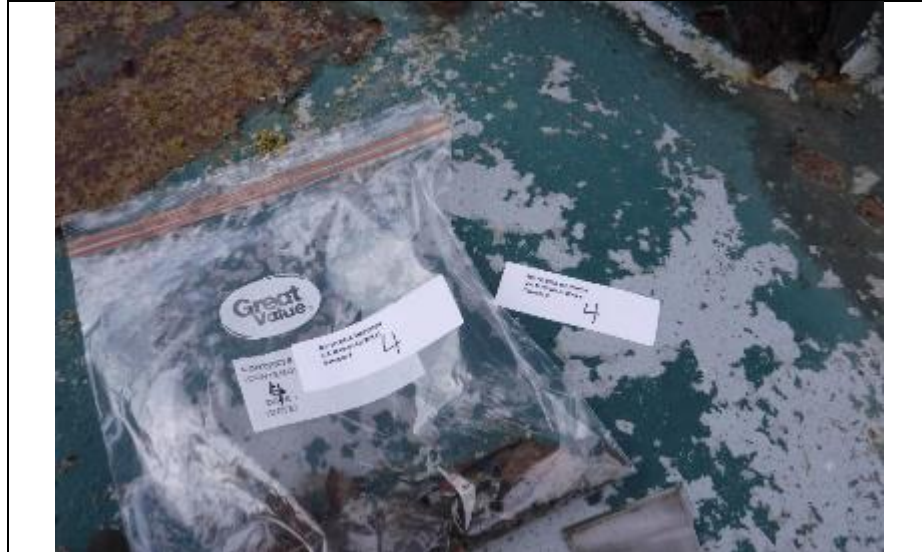
5. Sample 4 - green paint containing lead.

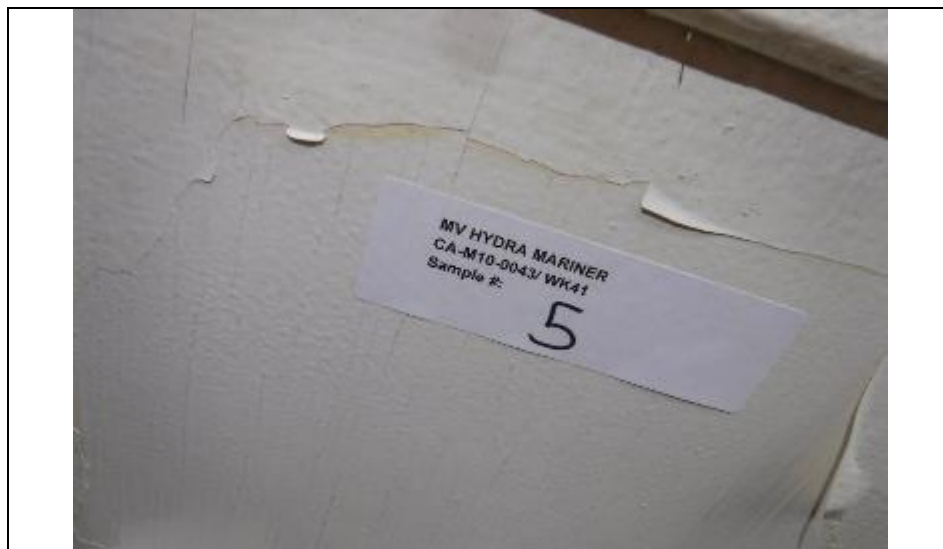
6. Sample 5 - interior paint containing lead.

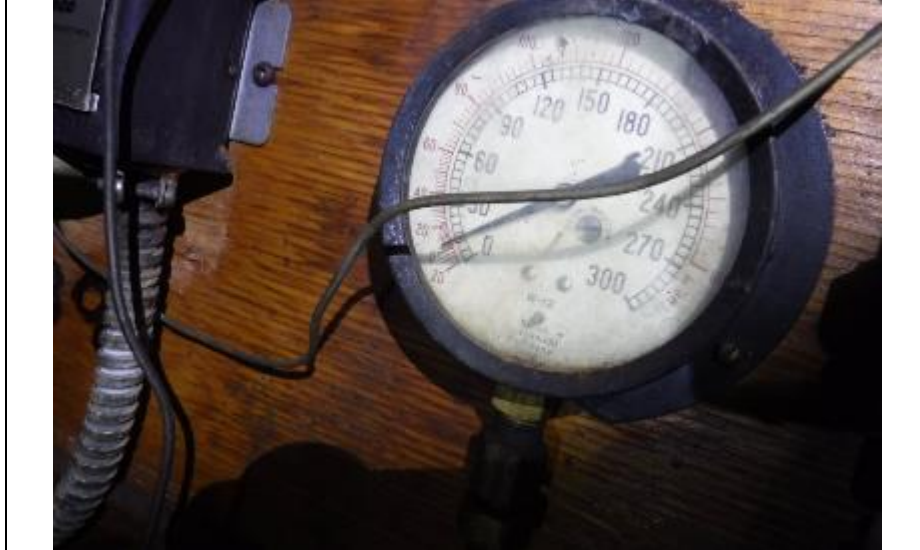
The refrigerating system is containing ODS – Freon R12, no pressure was observed, the amount will be minimal.

7. R12 ozone depleting gas.

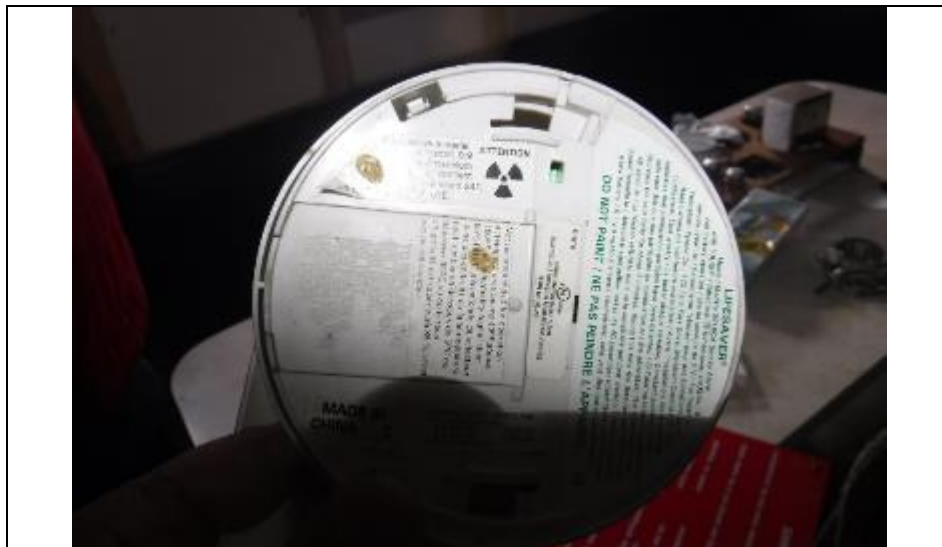
One wall mount / battery operated fire / smoke detector was noted which contains radioactive substances, Americium 241.

8. Fire detector – radioactive Americanum 241.

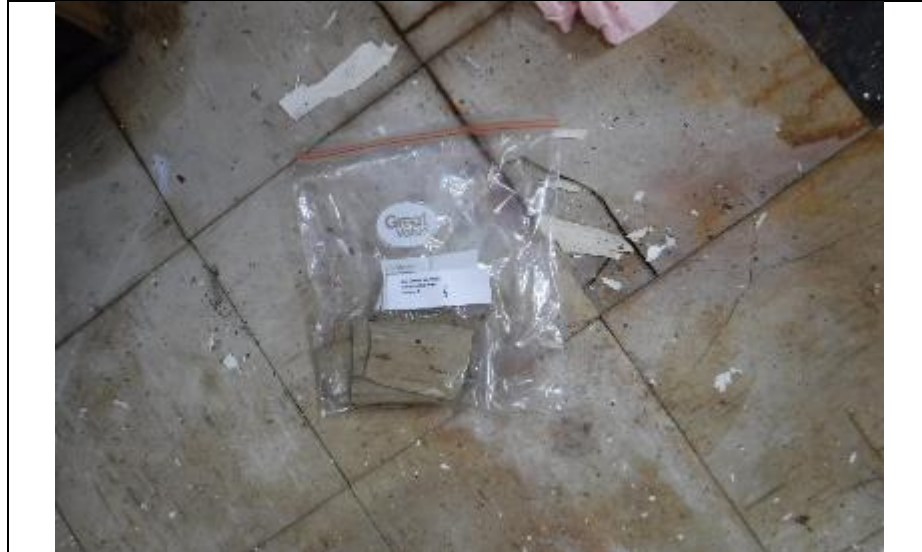
9. Floor tiles in wheelhouse and accommodation containing asbestos.

All the hazardous materials, and PCHM like cladding and structural materials containing asbestos must be disposed as per statutory regulations.

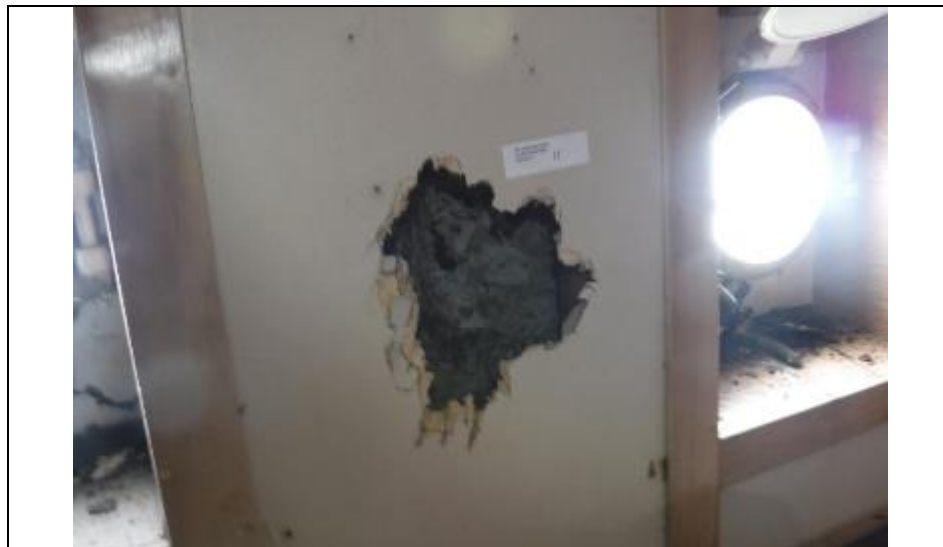
10. Insulation behind cladding in messroom area containing asbestos.

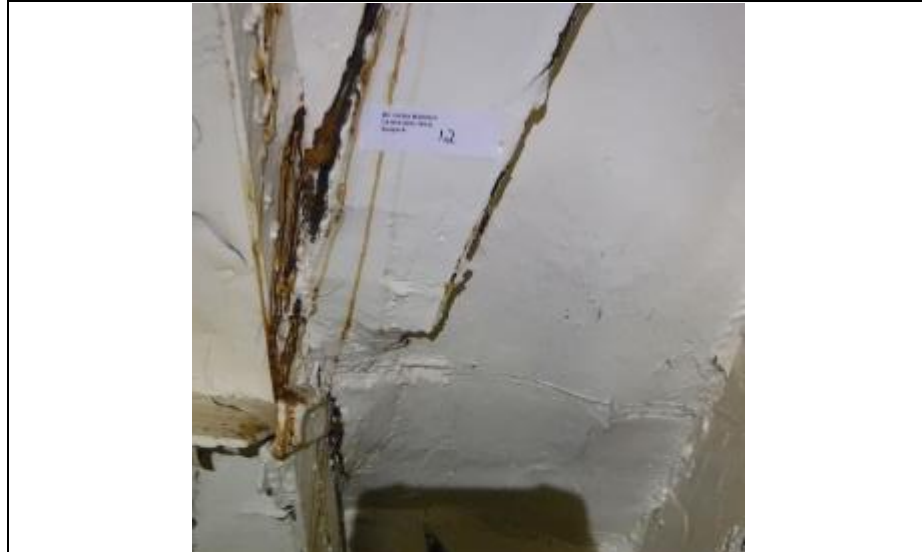
11. Cold store insulation – containing asbestos.

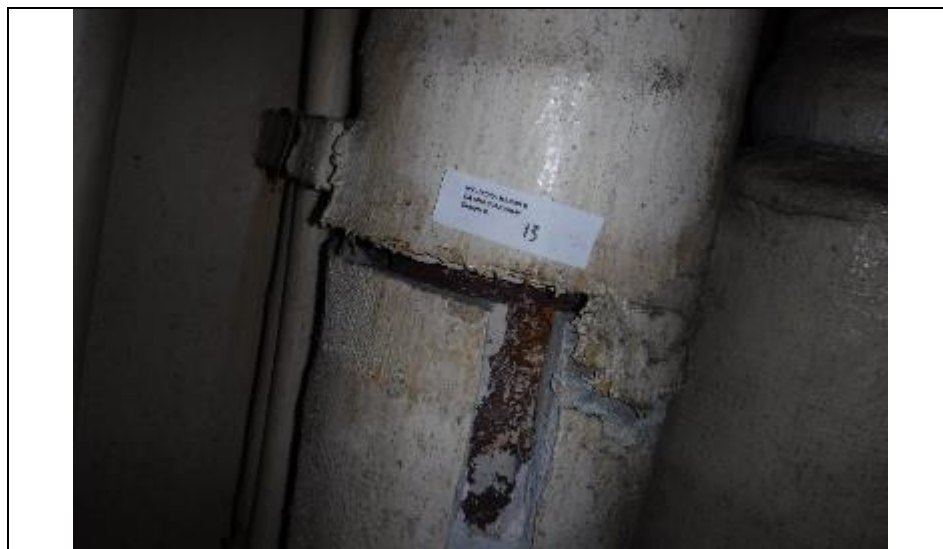
12. Exhaust gas pipe insulation Main & Auxiliary engines. Samples 13 & 14 asbestos containing.

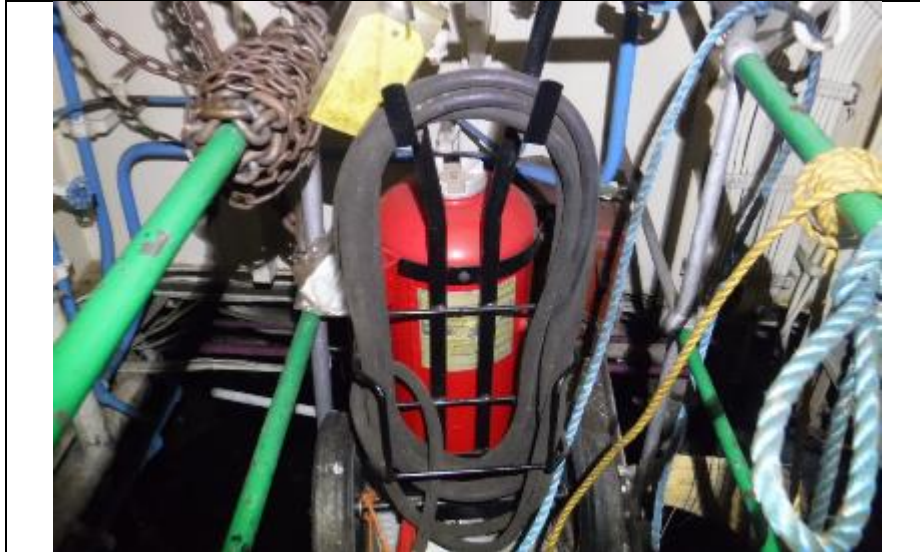
13. CO2, water and dry chemical fire extinguishers noted.

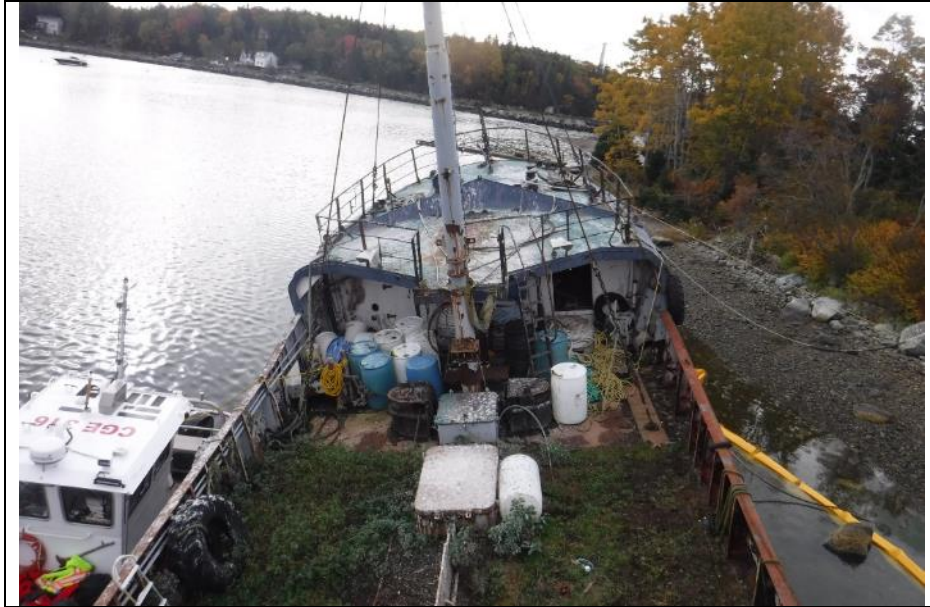
1. Growth on deck

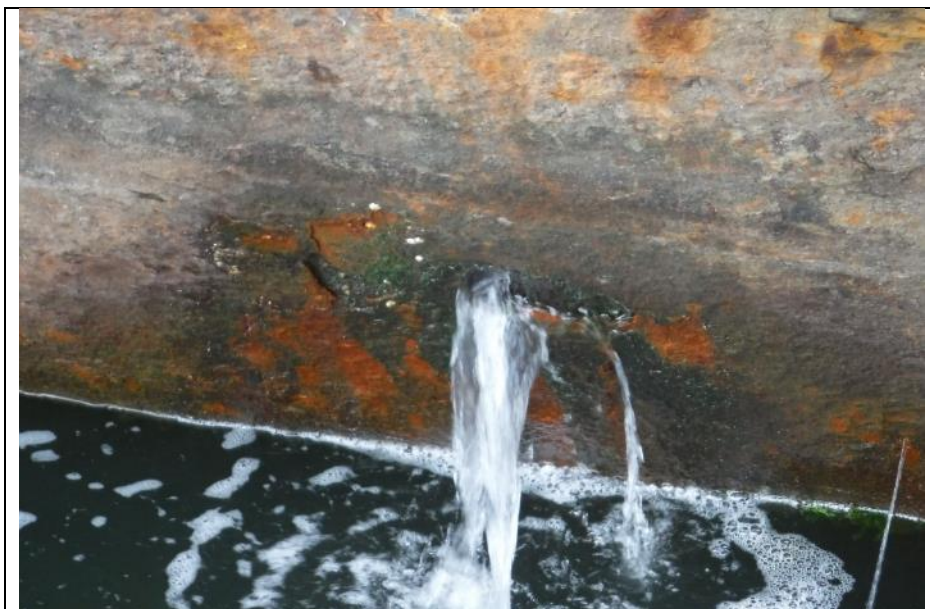
Starboard side exterior not visible from inspection boat. Port side exterior, holes found on bow section that weren't visible at initial survey in February 2021. Hull integrity is uncertain.

2. Port fed hull section – breach

To re-float the source of the ingress needs to be located and plugged.

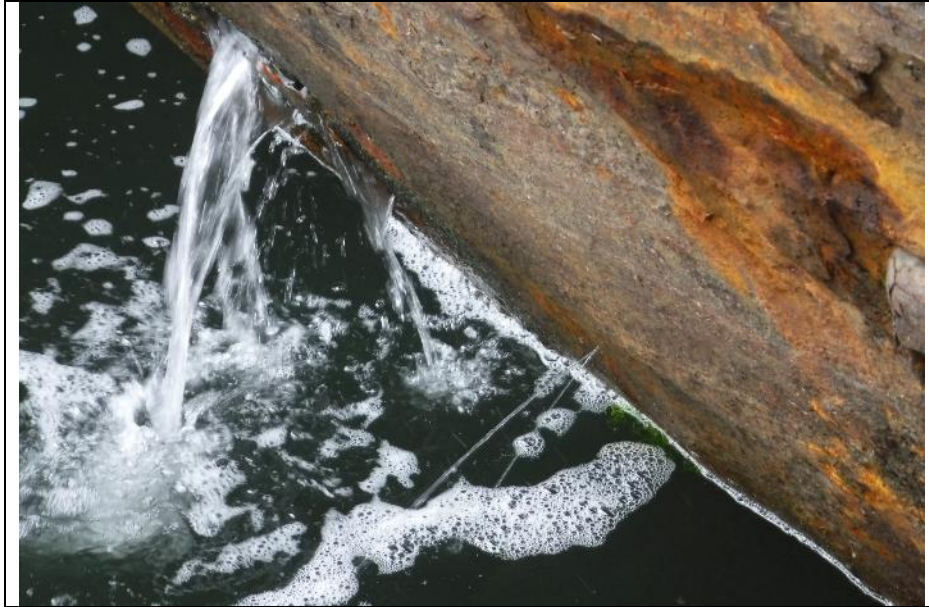
3. Port fed hull section – breach

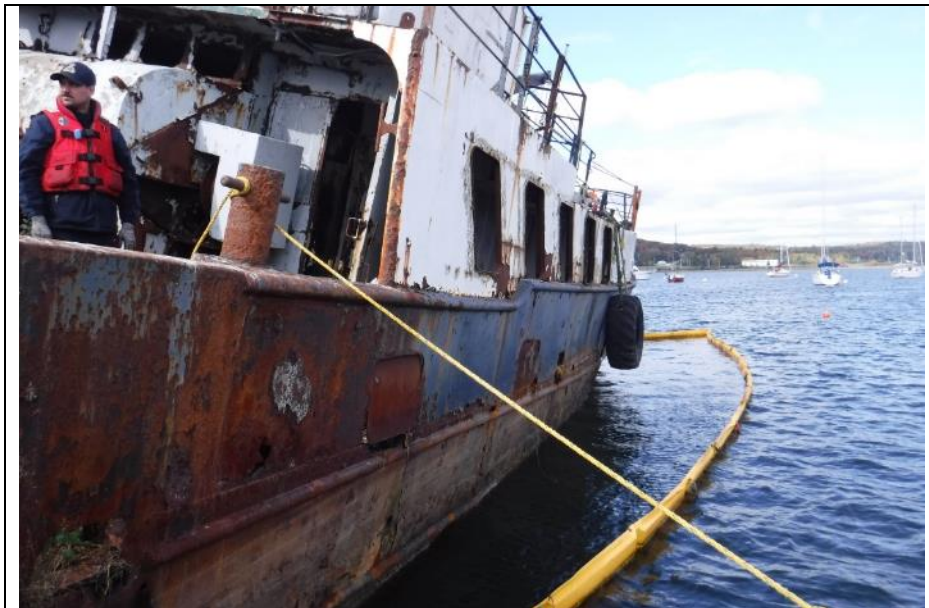
4. Port view on hull looking aft

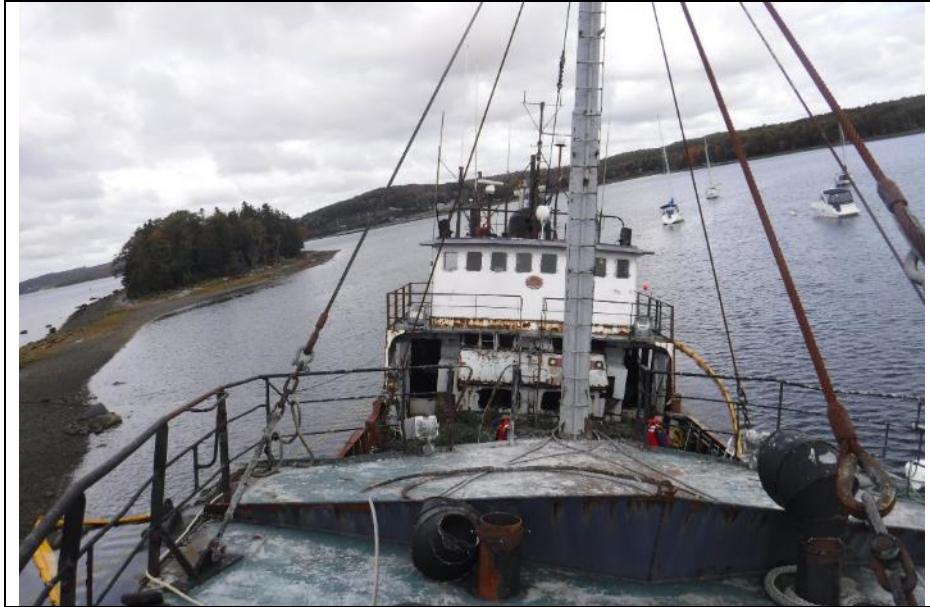
5. Bow looking aft

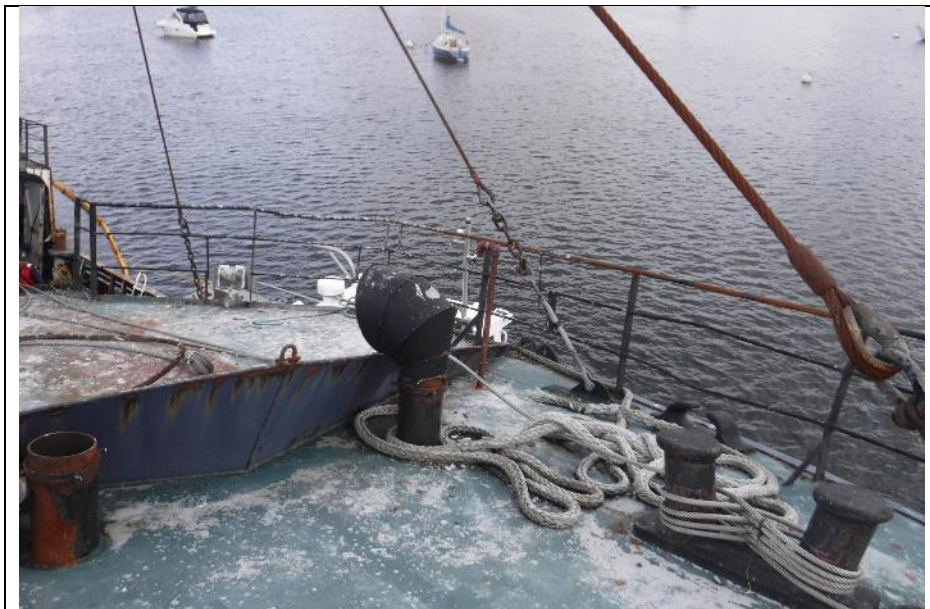
6. Fed area of deck
