Addendum No. 2

Project #: 20-078
Project Name: CFIA Lethbridge re-roofing

**ASBESTOS SURVEY
CFIA FACILITY: LETHBRIDGE
ALBERTA**

KGS Group 17-0006-013
March 2018

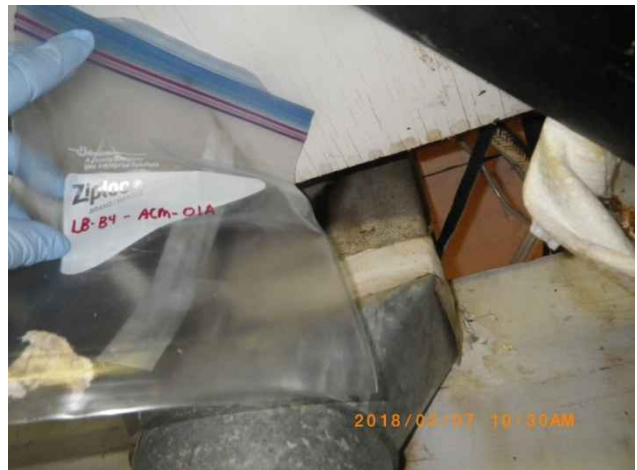
Laboratory PLM analysis confirmed the presence of asbestos in the duct insulation in samples LB-B4-ACM-01A and LB-B4-ACM-01B (50% Chrysotile each) and in the paper-wrap around ducting in sample LB-B4-ACM-02A (50% Chrysotile) inside Residence AGR 281. Both the duct insulation and the paper-wrap around the ducting were observed to be in fair condition at the time of the 2018 Asbestos Survey.

Photo 42. Sample locations LB-B4-ACM-01A-C; duct insulation. Confirmed asbestos-containing material (50% Chrysotile).

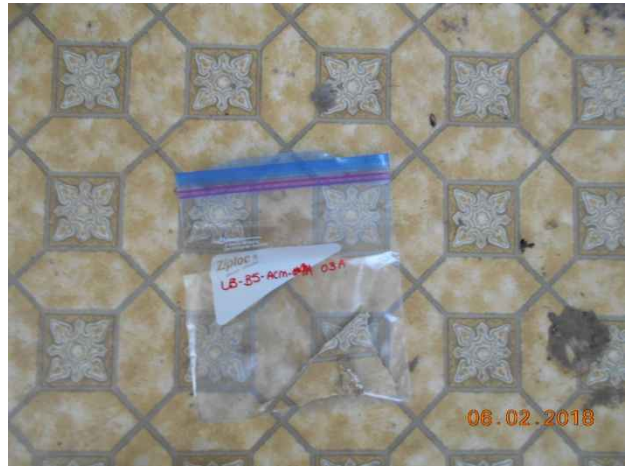
Laboratory PLM analysis confirmed the presence of asbestos in the brown vinyl sheet floor backing (mastic) in samples LB-B5-ACM-03A and LB-B5-ACM-03B (40% Chrysotile each) within the basement of the Student Residence. The flooring and associated backing was observed to be in fair condition at the time of the 2018 Asbestos Survey. Analytical results confirmed that the remainder of the building materials from the Student Residence sampled and analyzed for asbestos content were non-detectable and/or below the 1% guideline criteria (Alberta Asbestos Abatement Manual).

Photo 52. Sample locations LB-B5-ACM-03A to C; light yellow star patterned floor tile and backing. **Confirmed asbestos-containing material (40% Chrysotile).**

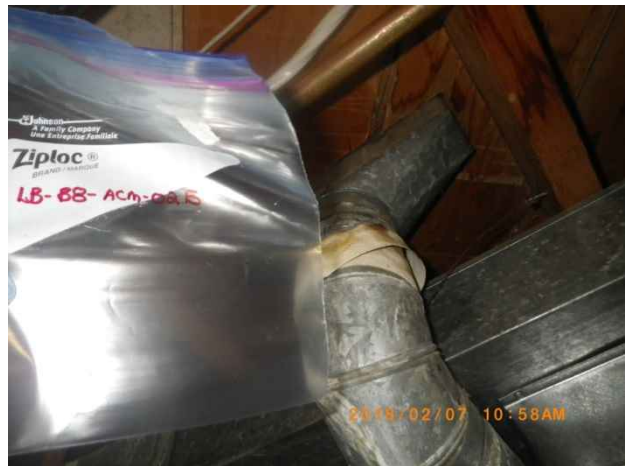
Laboratory PLM analysis confirmed the presence of asbestos in the paper-wrap around ducting in sample LB-B8-ACM-02A (50% Chrysotile) inside Residence AGR 280. The paper-wrap was observed to be in fair condition at the time of the 2018 Asbestos Survey. Analytical results

Photo 65. Sample location LB-B8-ACM-02A; paper-wrap around ducting. **Confirmed asbestos-containing material (50% Chrysotile).**

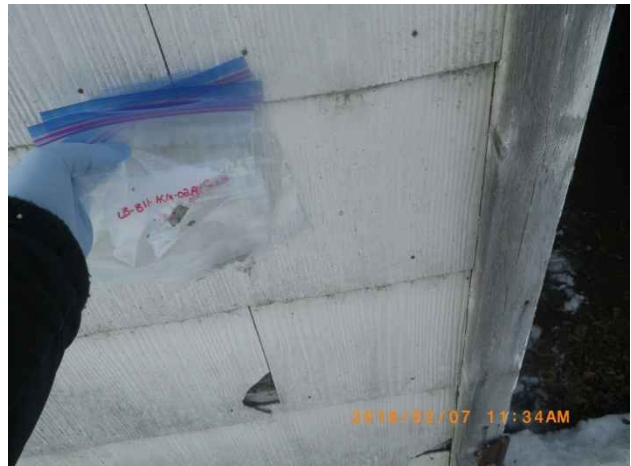
Photo 70. Sample locations LB-B11-ACM-02A to C; exterior wall board. **Confirmed asbestos-containing material (25% Chrysotile).**

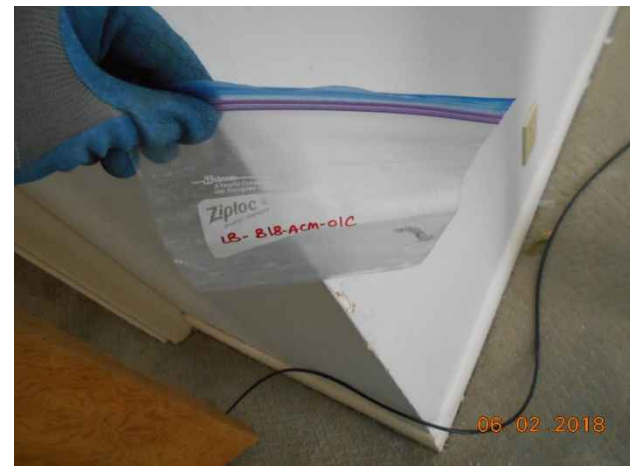
Photo 83. Sample location LB-B18-ACM-01B; drywall mud joint compound from upstairs wall. **Confirmed asbestos-containing material (1% Chrysotile).**

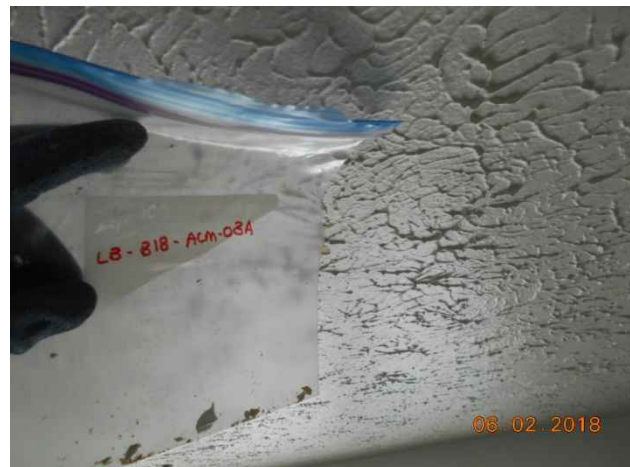
Photo 88. Sample location LB-B18-ACM-03A; textured ceiling plaster from living room. **Confirmed asbestos-containing material (1% Chrysotile).**
