ABL Group
Hull Survey on the vessel "Matterhorn"
September 23, 2021

PDMS Ref: NLJ-21-55
Prepared by: Stephen Best Dive Supervisor
Checked by: Ron Pitcher, P.Eng. Vice-President, Operations & Technical Services
Approved by: Ron Pitcher, P.Eng. Vice-President, Operations & Technical Services

Scope: Hull Survey on the vessel "Matterhorn"

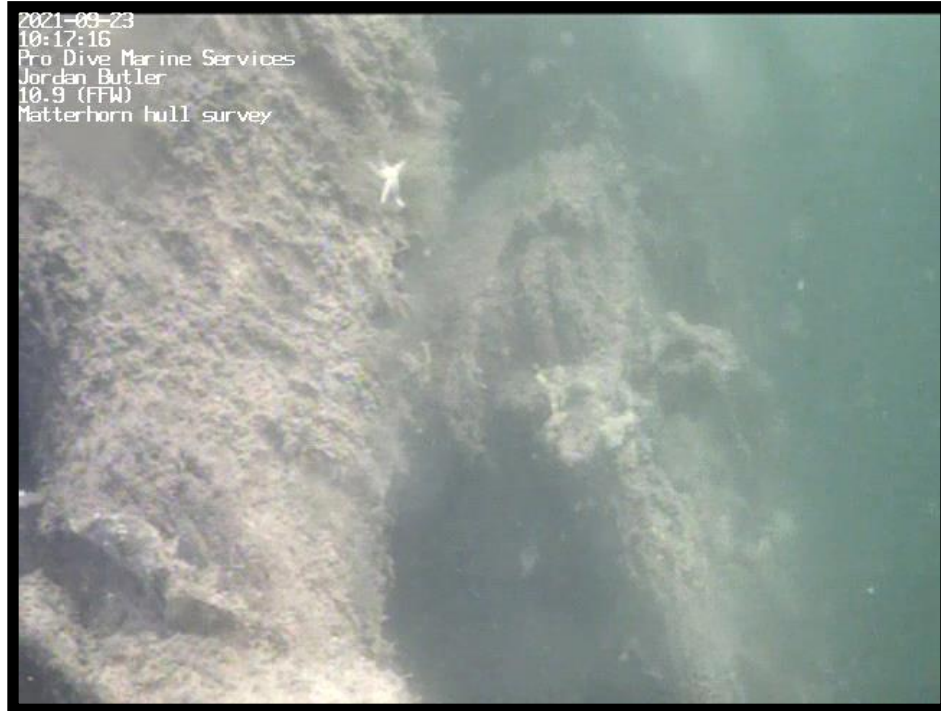
Figure 1 - Bow hatch cover.

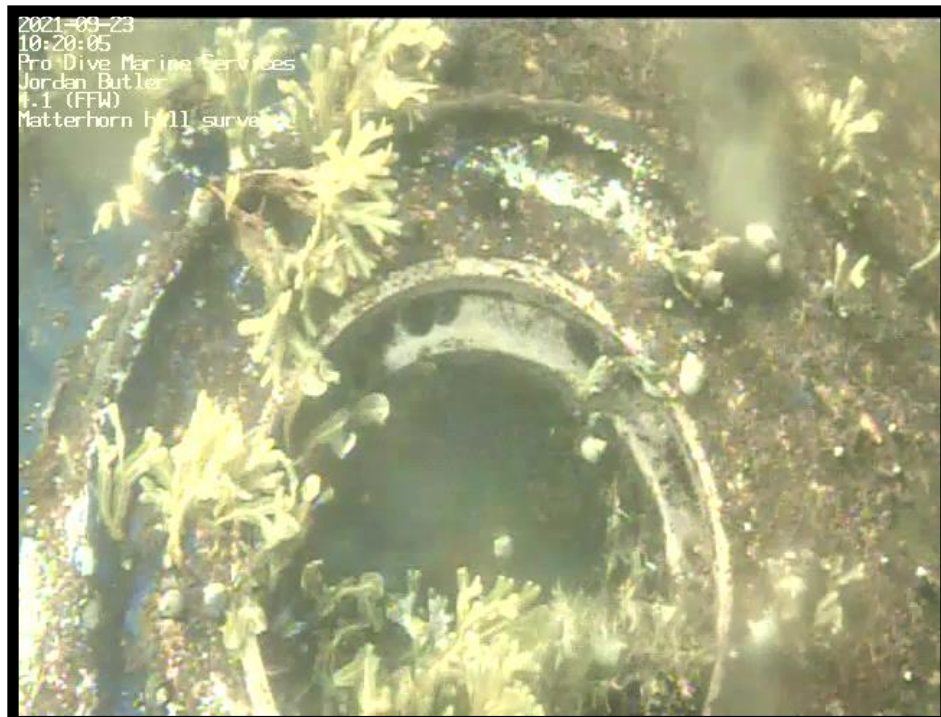
Figure 2 - Bow port hole.

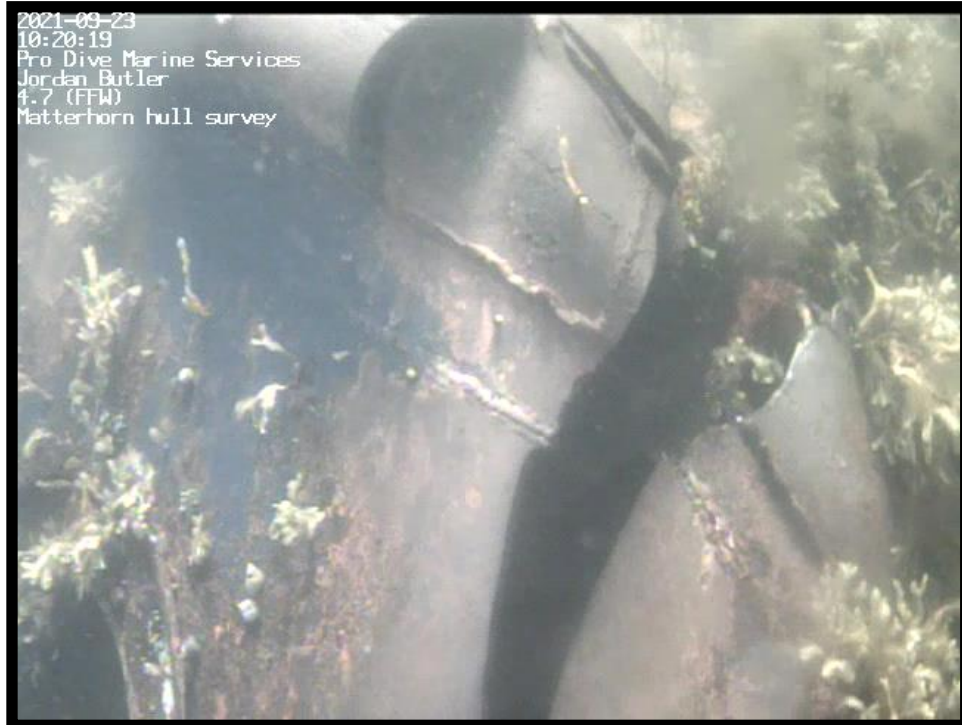
Figure 3 - damage to bow above the water line.

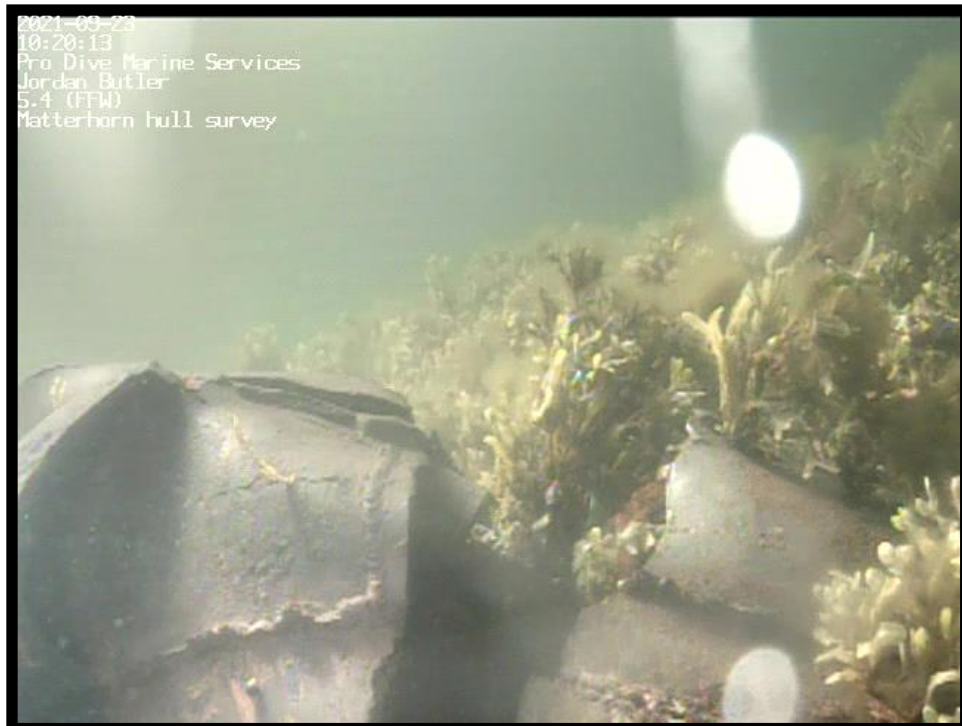
Figure 4 - damage to bow above the water line.

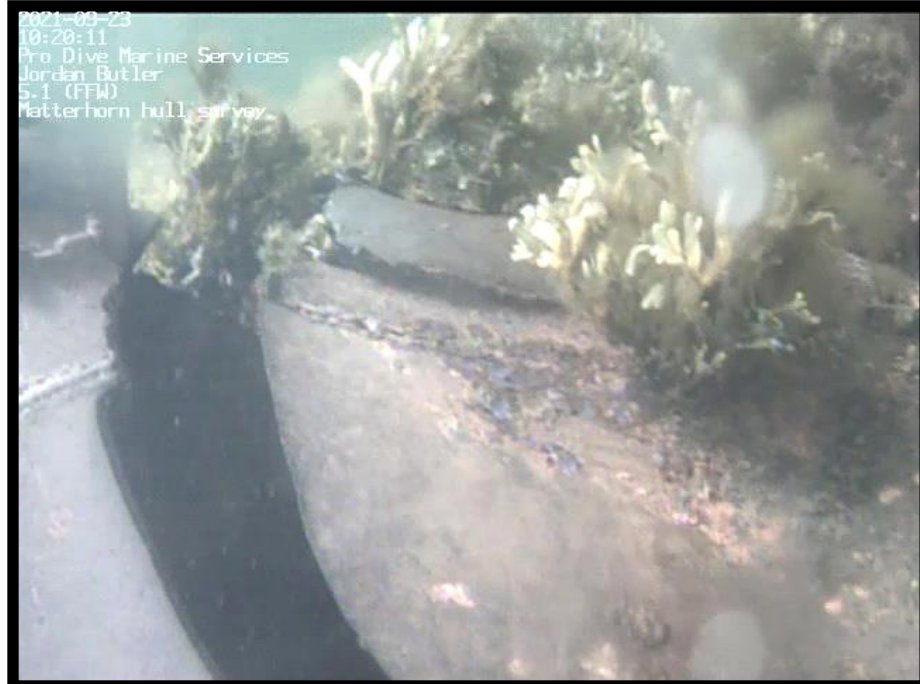
Figure 5 - damage to bow above the water line.

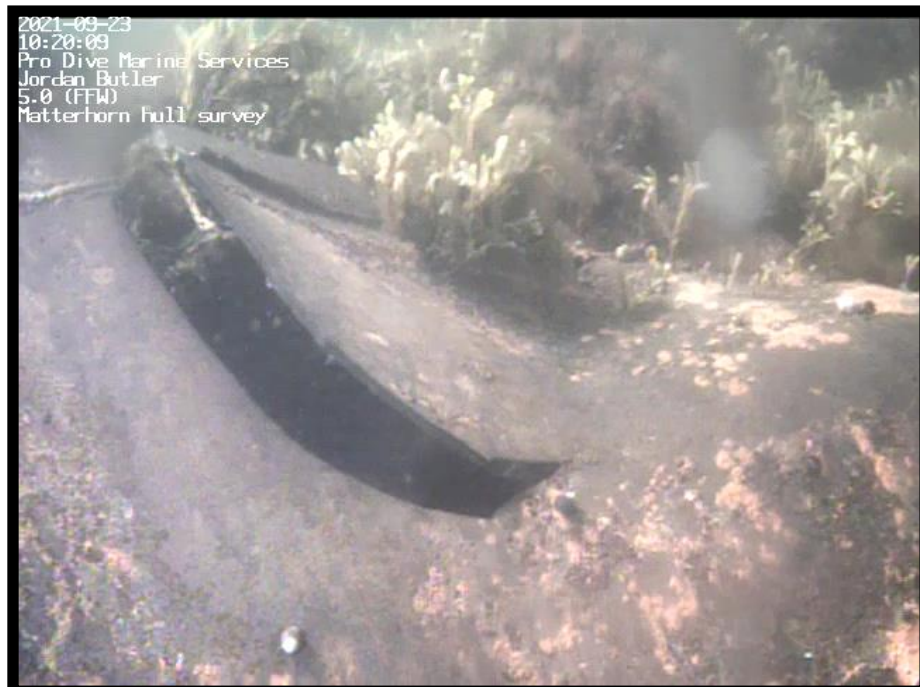
Figure 6 - damage to bow above the water line.

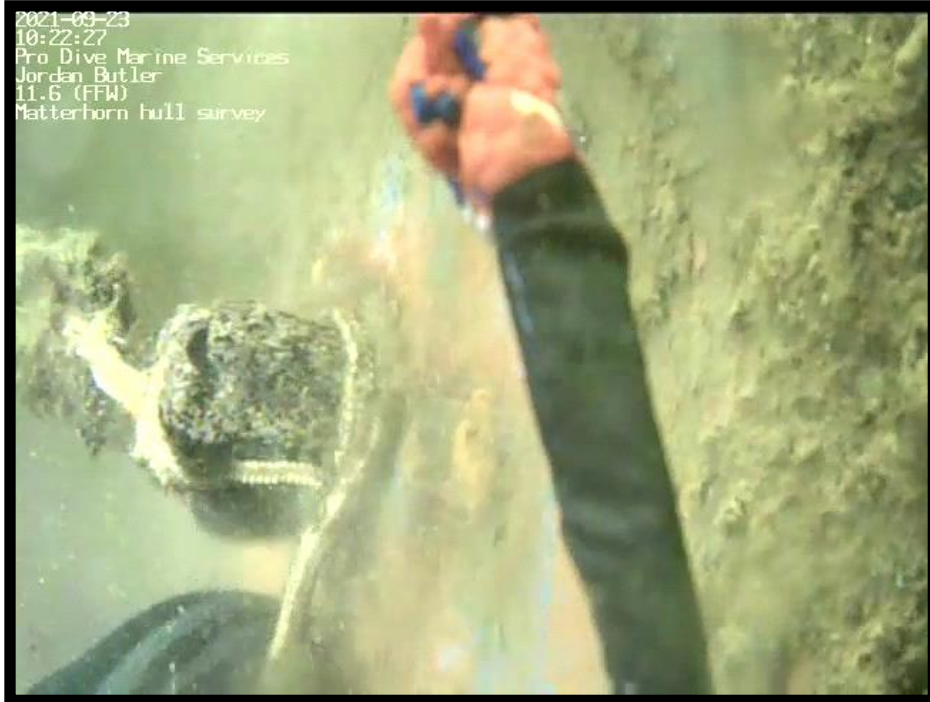
- The steel hull up to main deck level on the starboard side was inspected and no damage to the hull was observed.
- The vessel keel was inspected and no damage was observed.
- The vessel was laying over on the port side and was not accessible for inspection, the port side bilge keep was accessible and found in good condition.
- The vessel hull was covered in heavy soft growth and corrosion but there was no major hull damage observed.
- The bilge keel was found in good condition there was no hull penetration observed.
- The bow area was inspected and no significant damage was observed to the hull.
- Damage was observed to the bow railings above the water line but no impact to the hull.
- There were areas of drill holes located on the starboard side area at midships, the holes were approximately 1.5" and were found with plugs in place. There was no leaking observed at the plugs.

Figure 7 – Plug installed aft of the bow area below the water line.

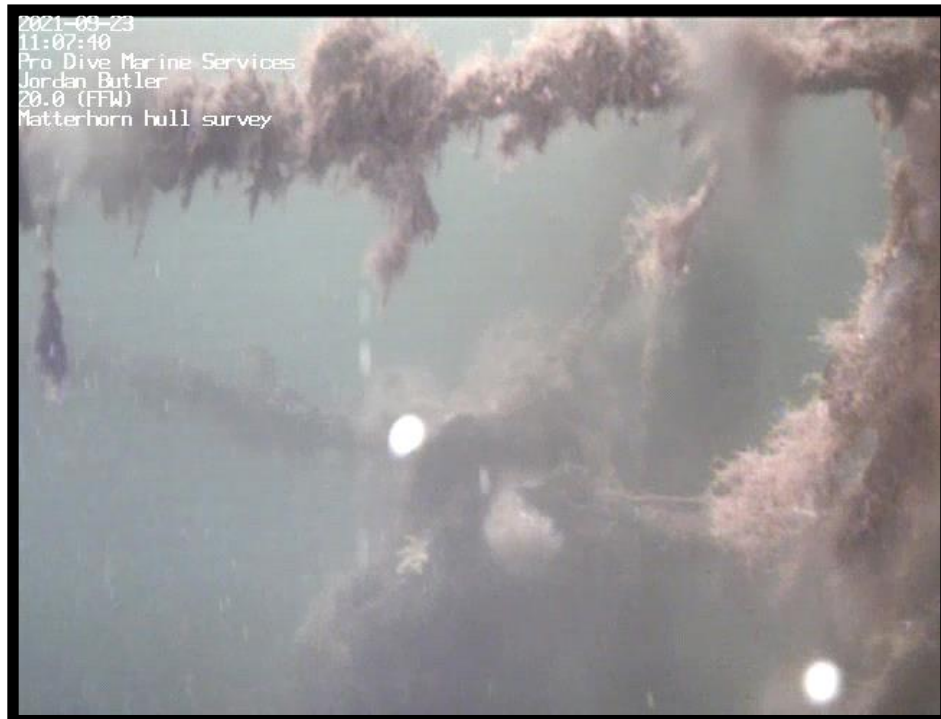
- The deck area could not be inspected at this time due to lack of visibility and ability to inspect loose or dislodged deck equipment. The Diver noted that there was rigging gear and possible unstable deck equipment observed.

Figure 8 - Railings and rigging on deck.

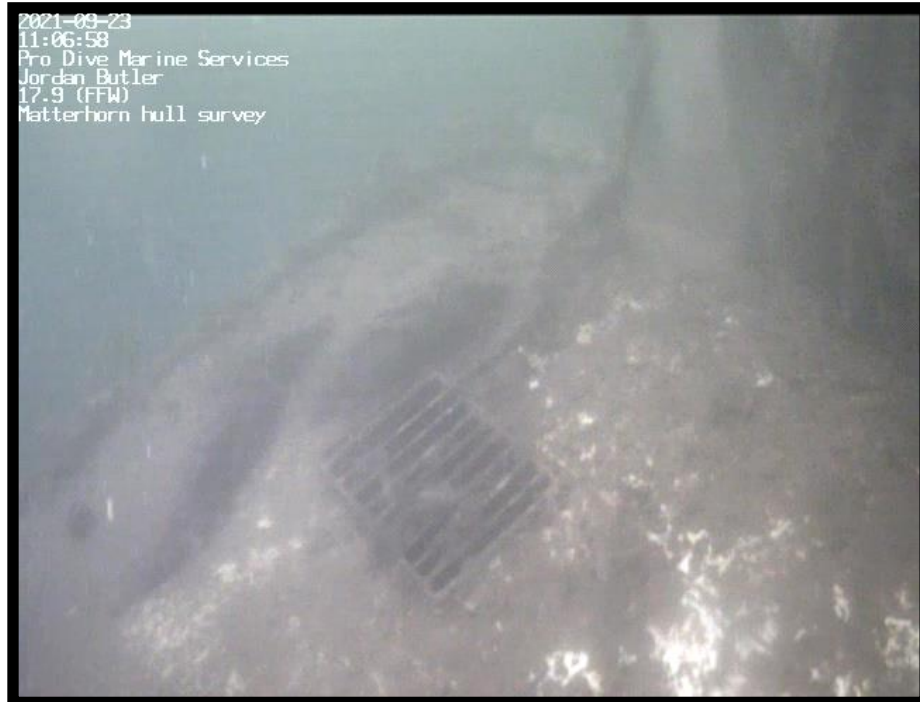
Figure 9 - Vessel exhaust stack.

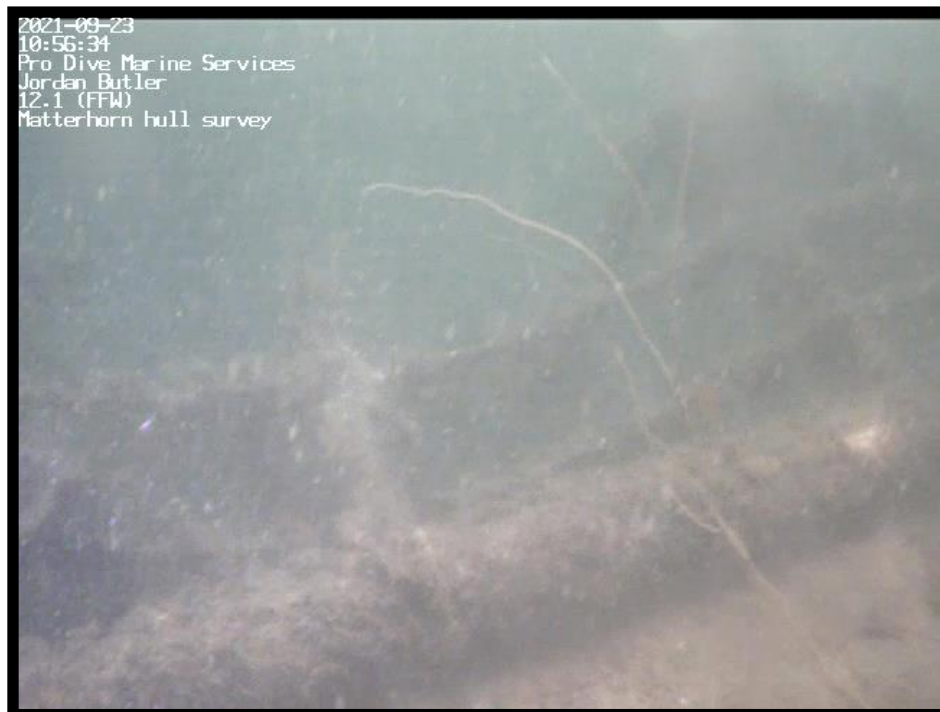
Figure 10 - Looking at railing and starboard side.

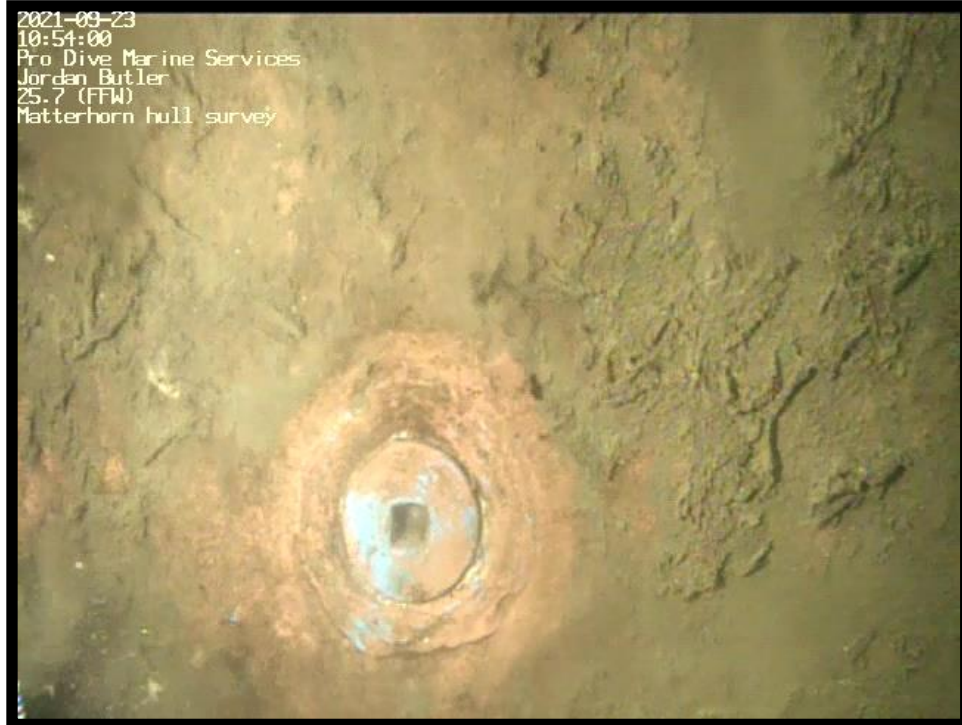
Figure 11 - Docking plug.

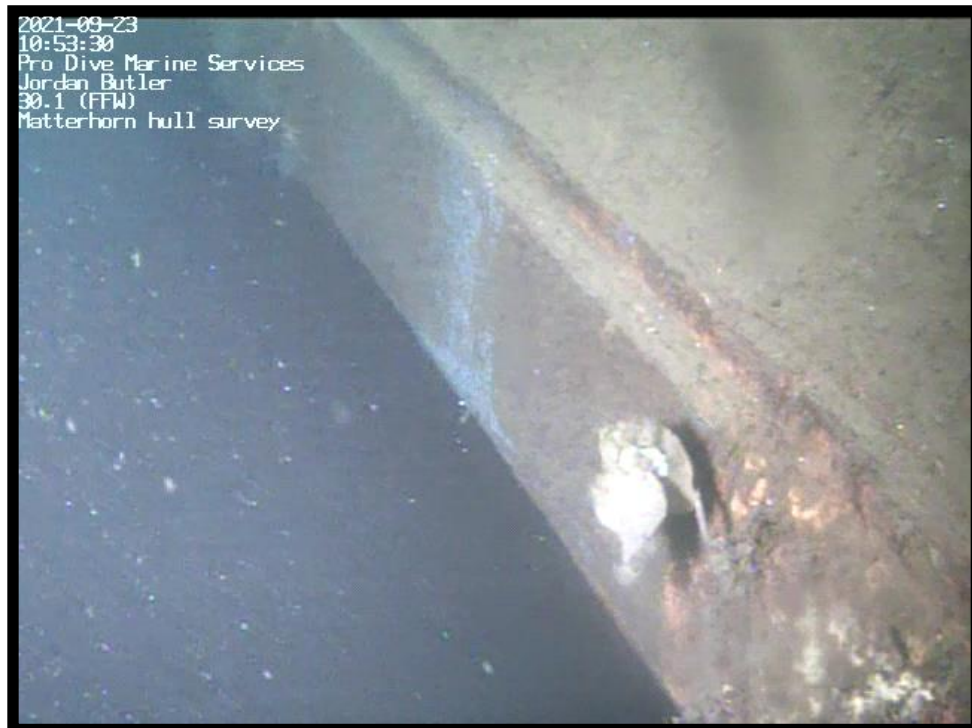
Figure 12 - Vessel keel towards the bow.

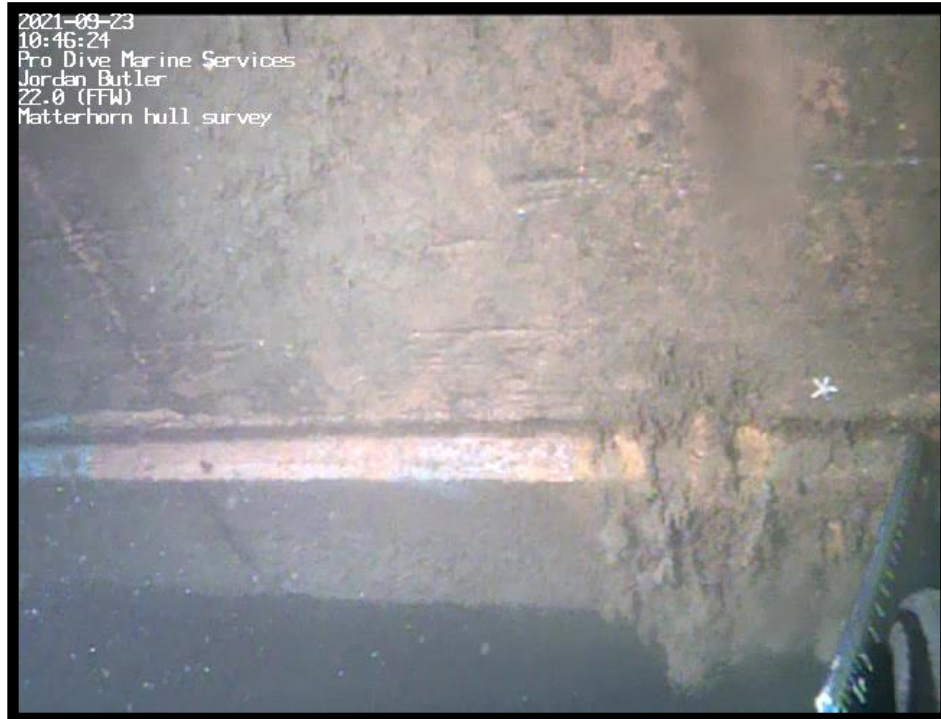
Figure 13 - Vessel keel midships.

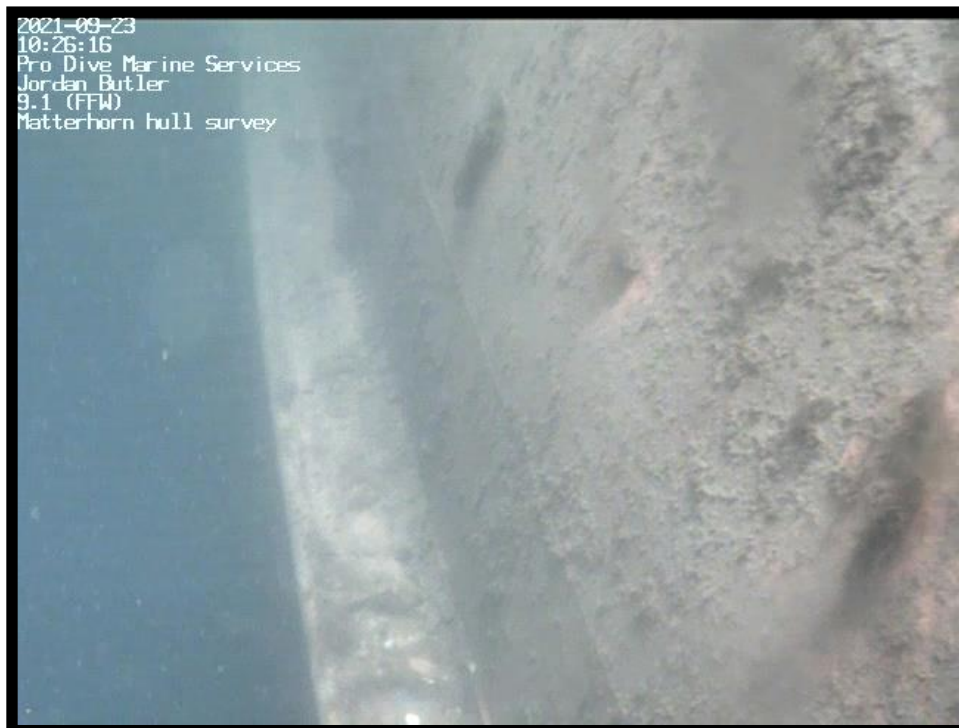
Figure 14 - Starboard bilge keel.

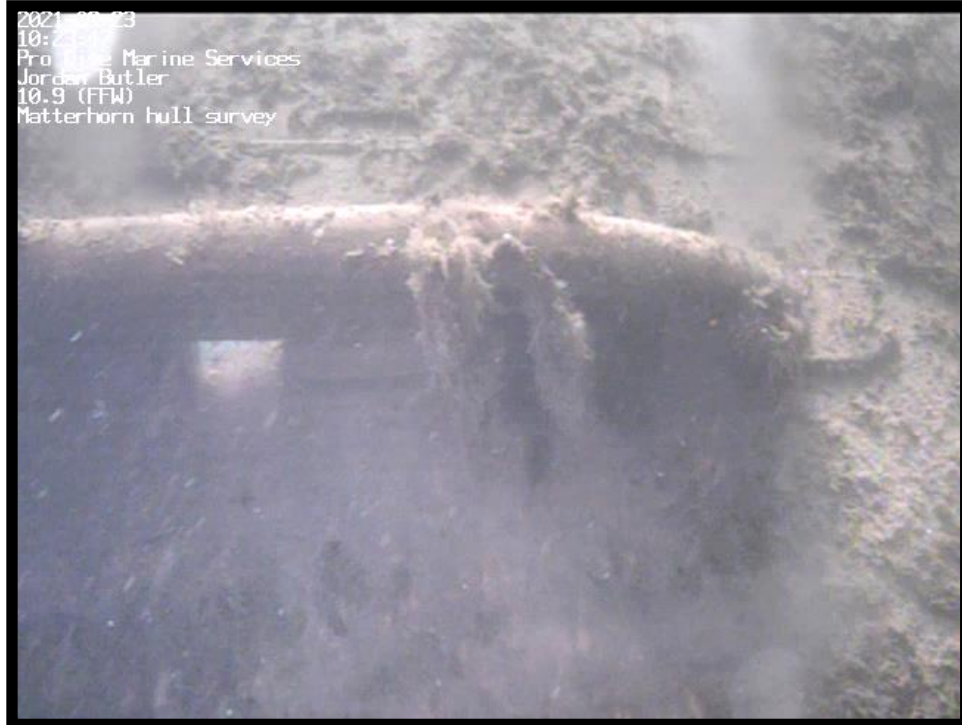
Figure 15 - Starboard leading edge of bilge keel.

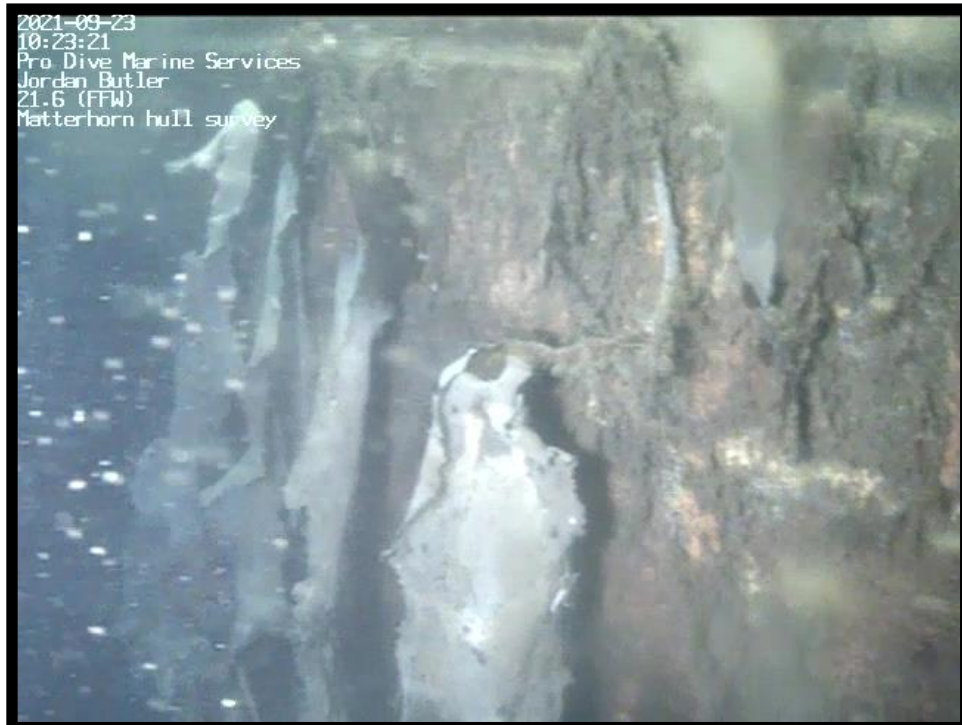
Figure 16 - Marine growth on keel near the stern area.

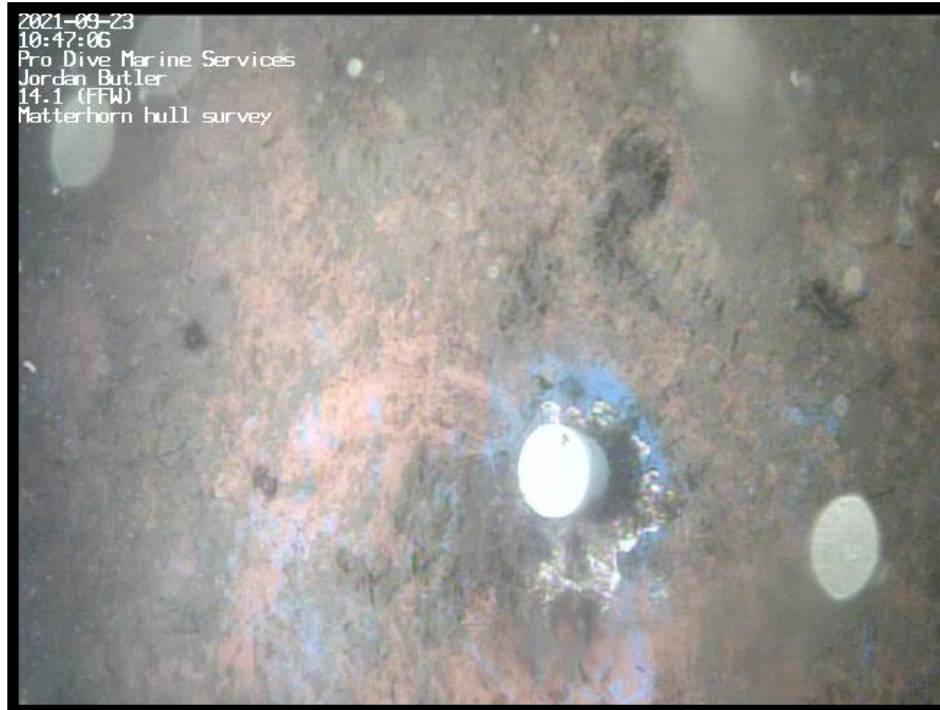
Figure 17 - Plug installed on starboard side.

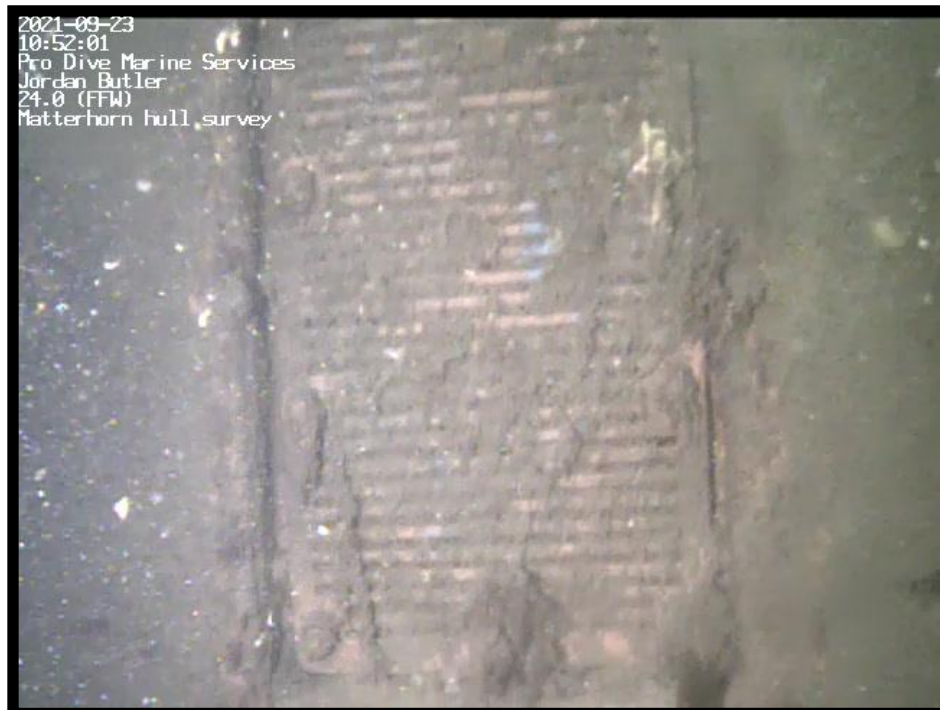
Figure 18 - Seabay condition.

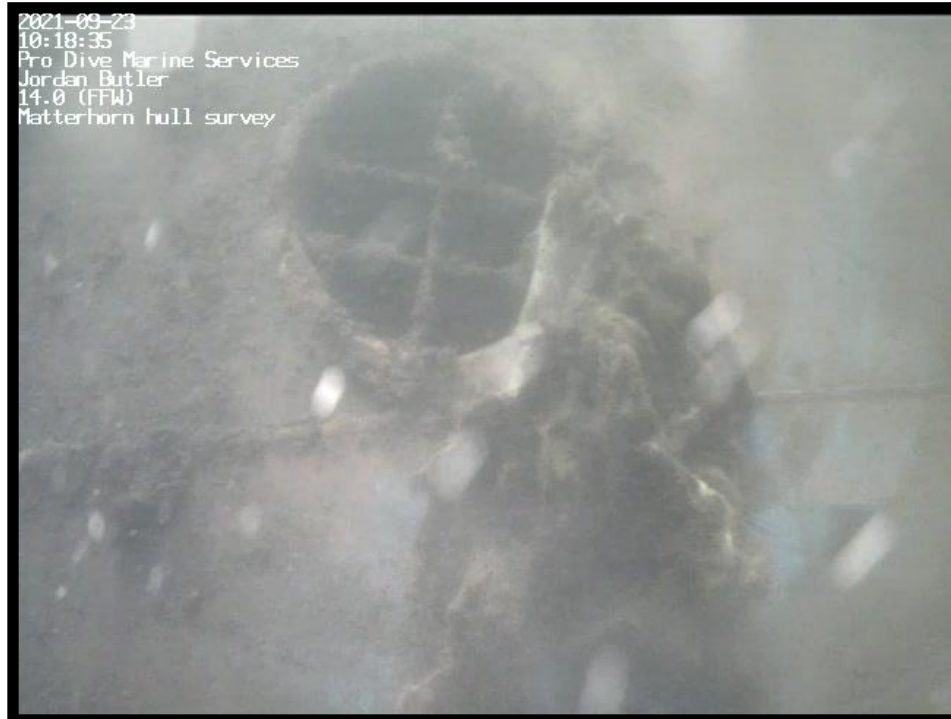
Figure 19 - Forward bow thruster.

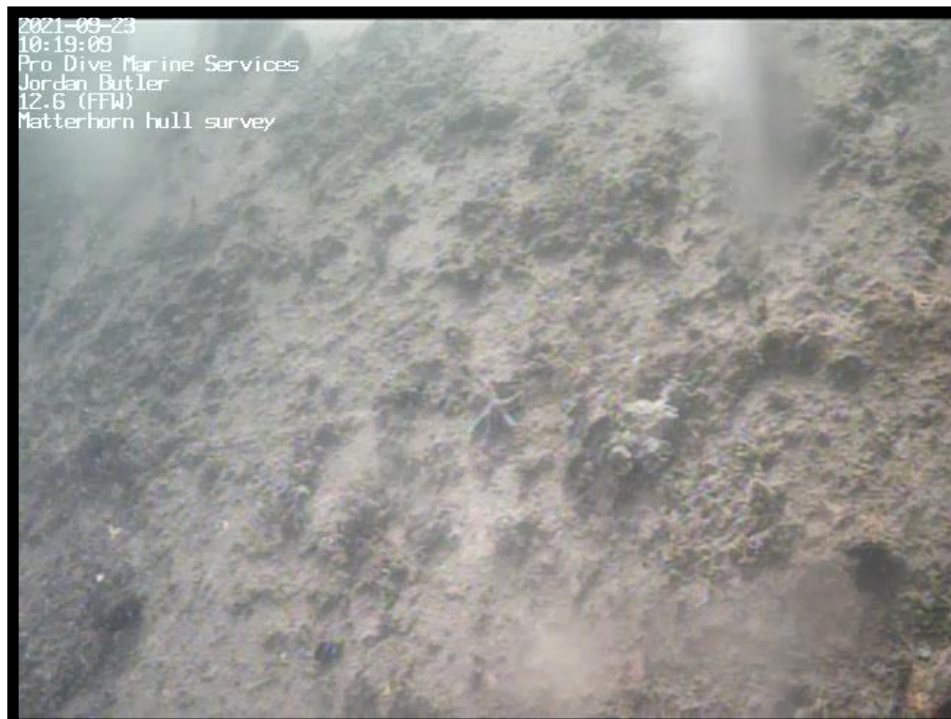
Figure 20 - Typical growth covering hull.
