TUG MATTERHORN Sunk at Mount Carmel, St. Mary's Bay, NL

Technical Assessment and Removal Options

Date: December 2020

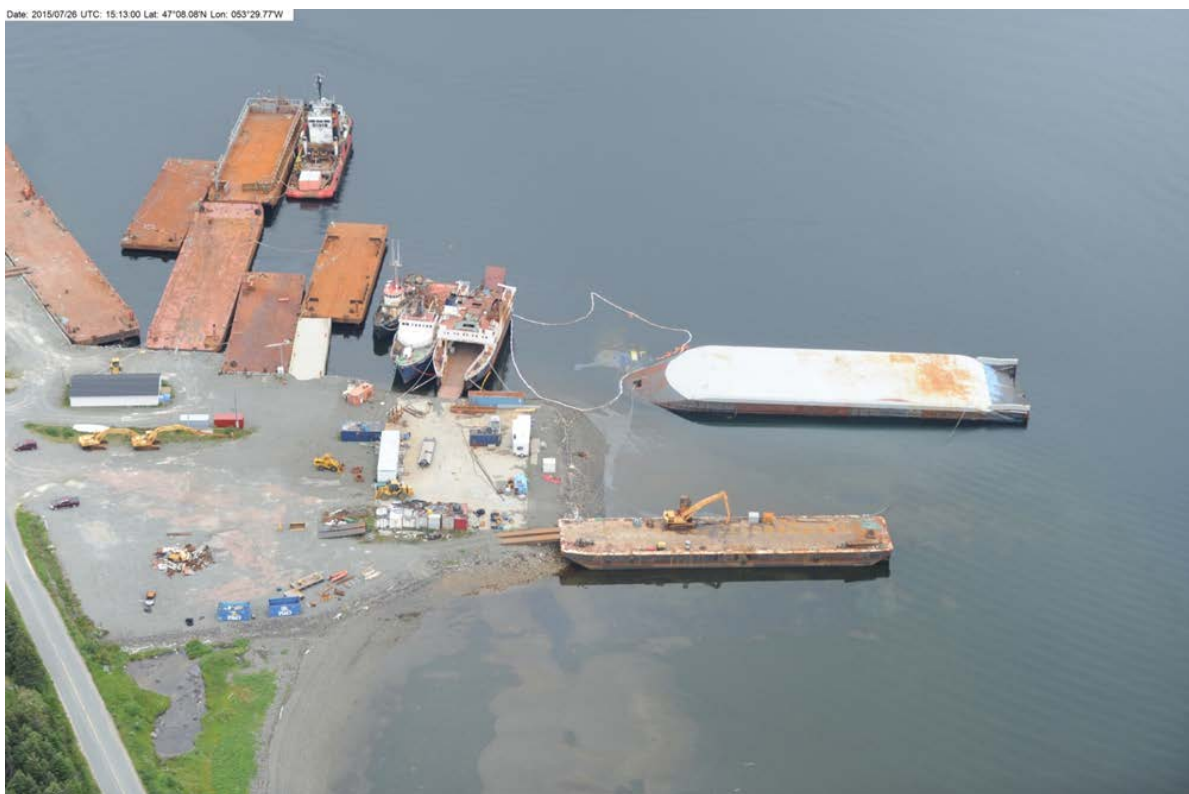
3.12 The picture in figure 1 shows the location of the tug and other assets in the vicinity in 2015. Of particular interest is the overturned barge adjacent to the tug. At the time of the initial sinking the stbd side of the tug's bow was above the water at low tide but this barge has repeatedly impacted the tug and gradually forced the tug approximately 3m back into deeper water.

Figure 1 – Overview of the sinking location, photo courtesy of CCG circa 2015

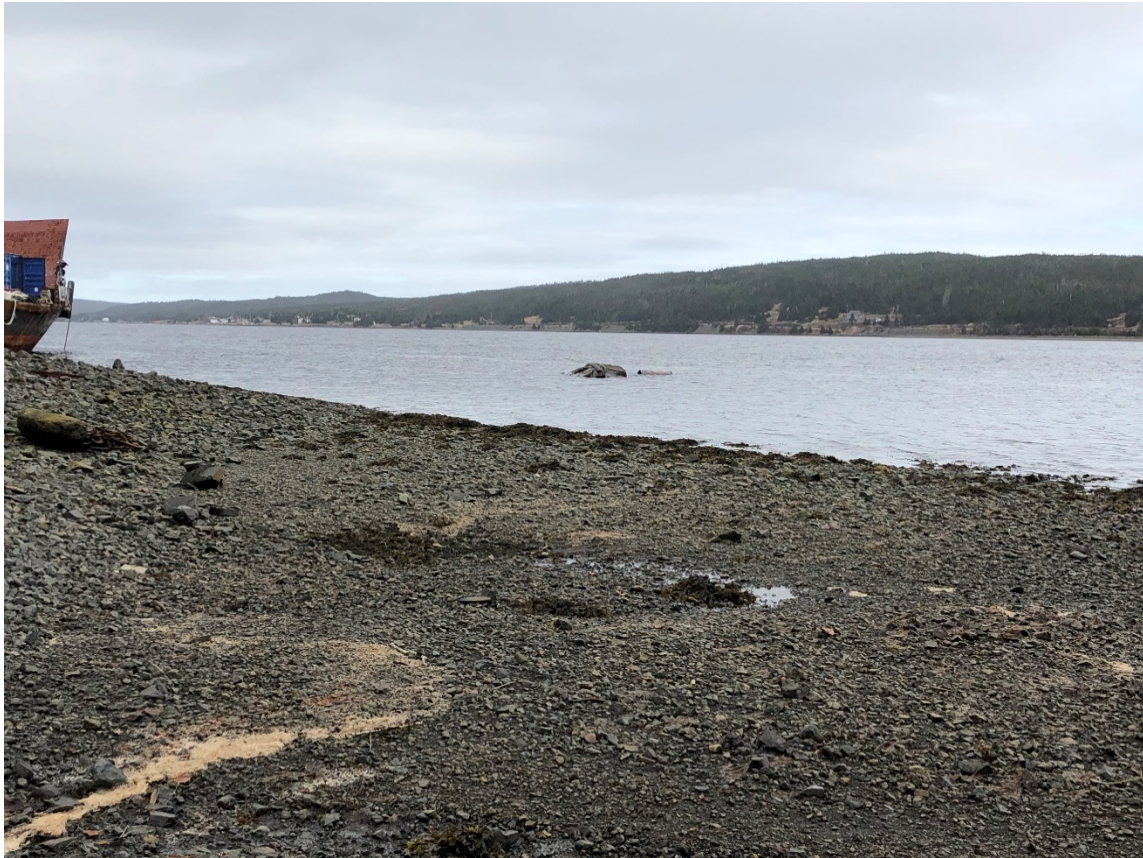
Figure 2 – Overview of the sinking location taken 26 November 2020

- 3.27 It was noted that the vessel is generally submerged just under the waterline adjacent to the marine facility but as can be seen from the above photograph the stbd bow area is visible at low tide.
- 3.28 Given the positioning of the vessel, the VOC officers concluded that the submerged vessel posed a hazard to the marine environment and the free operation of the marine facility.

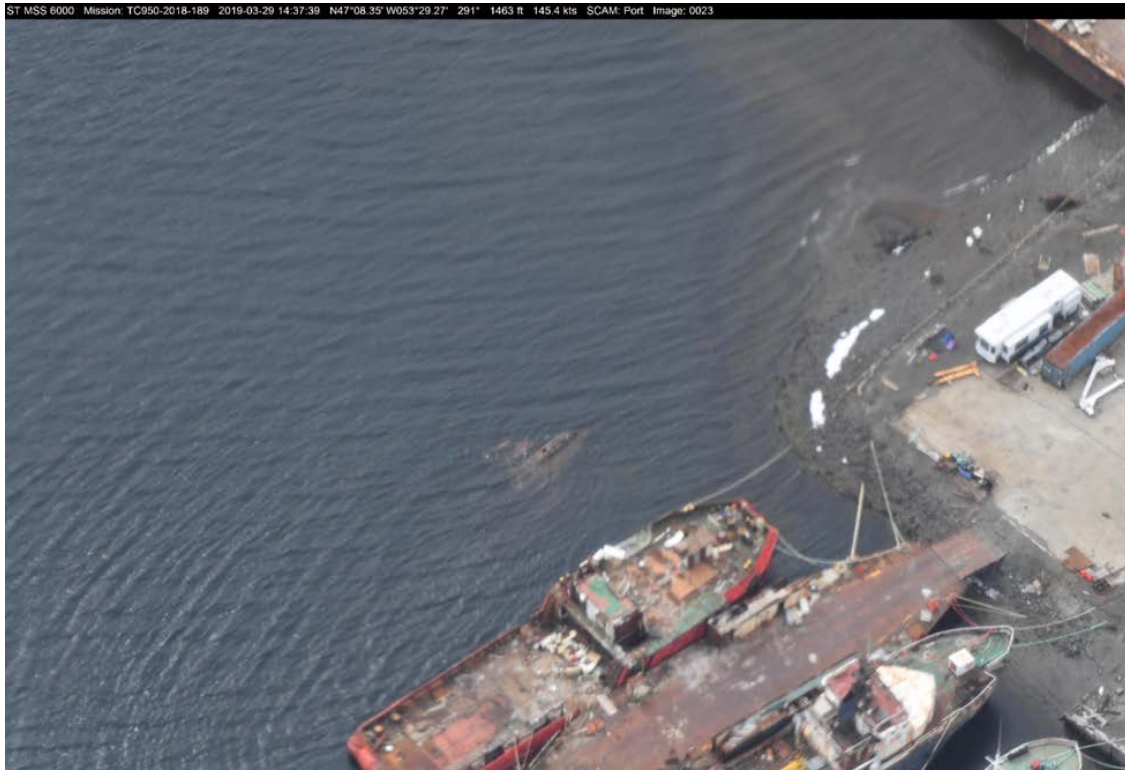
Figure 3 – Updated overview of the sinking location circa July 2020. Photo courtesy of CCG VOC team.

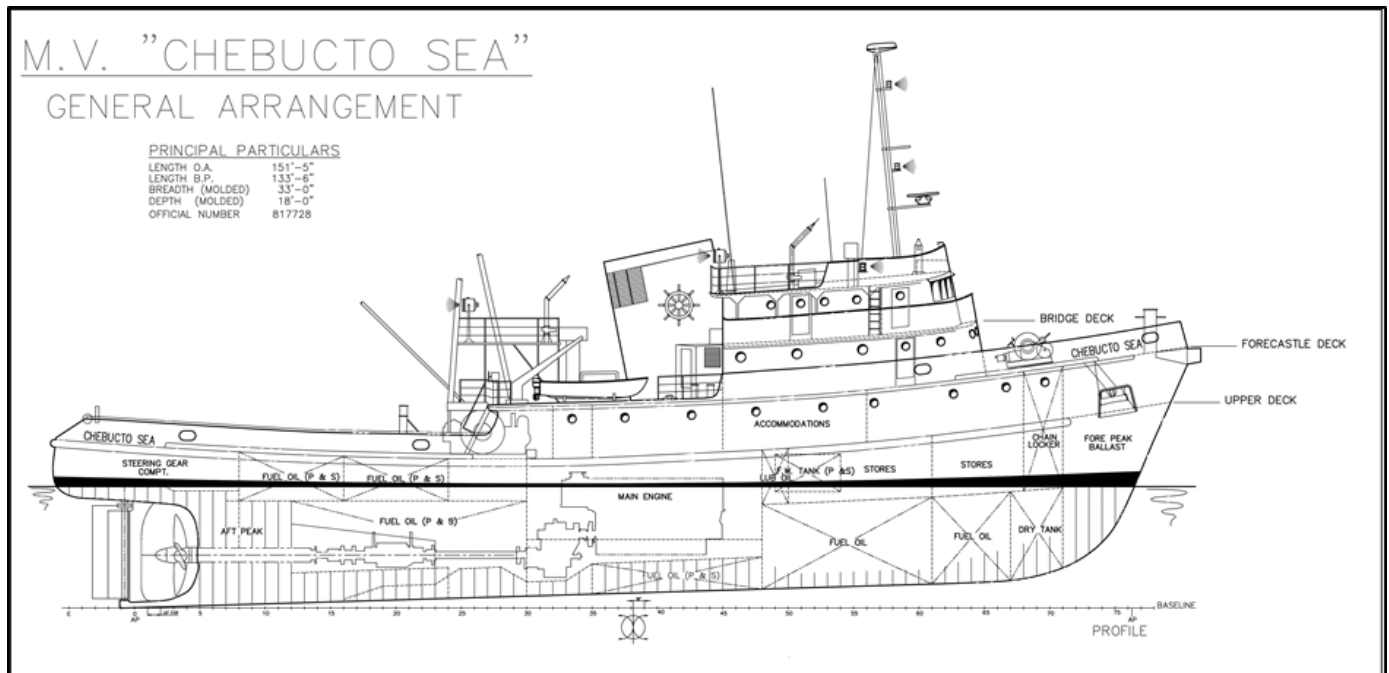
Figure 4 – Vessel Profile

- 4.3.1 Forward double bottom cross tank located between frames 61 and 67.
- 4.3.2 #1 and #2 double bottom tanks located outboard port and stbd between frames 48 – 61.
- 4.3.3 #3 and #4 double bottom tanks (port and stbd fuel settling tanks) located inboard, either side of the centre line, between frames 48 and 61.
- 4.3.4 #5 and #6 double bottom tanks located between frames 35 and 48.
- 4.3.5 #7 and #8 deep tanks located between frames 12 and 30.
- 4.3.6 There are 2 small wing tanks that are located port and stbd between frames 24 and 16, approximately centred on the waterline.
- 4.3.7 There are a further 2 larger wing tanks between frames 8 and 16, also approximately centred on the waterline. These tanks extend almost to the centre line and are separated by the access alleyway to the steering gear compartment.

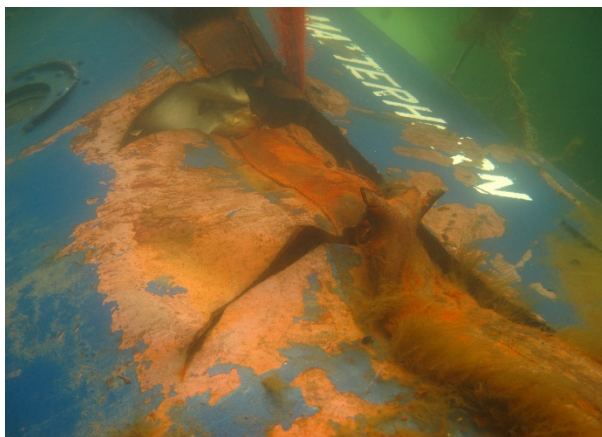
- 3.17 During the dive survey some damage was noted in way of the stbd bow and appears consistent with impact damage from the barge striking the vessel repeatedly.

Shows hull damage on starboard side.

NOTE: Based on the assessment of the wreck lift bags can be attached at the fairleads, mooring cleats and under the aft section of the hull near the running gear. In addition forward starboard damage will have to be made watertight.

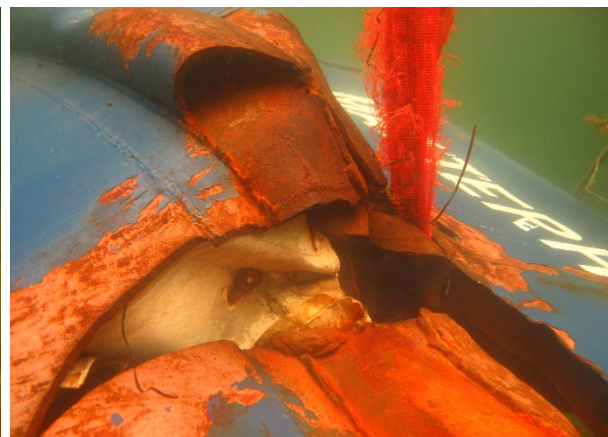
Shows hull damage on starboard side.

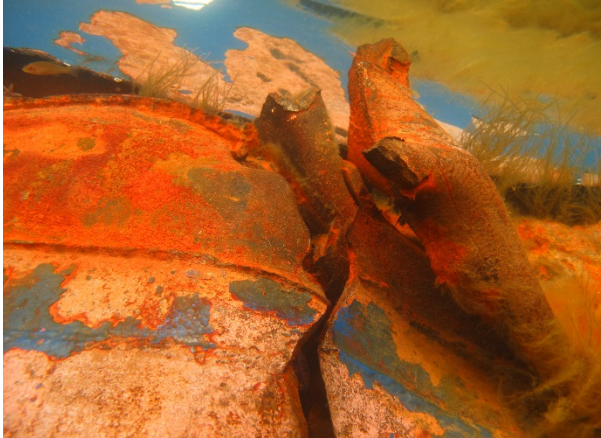
Shows hull damage on starboard side.

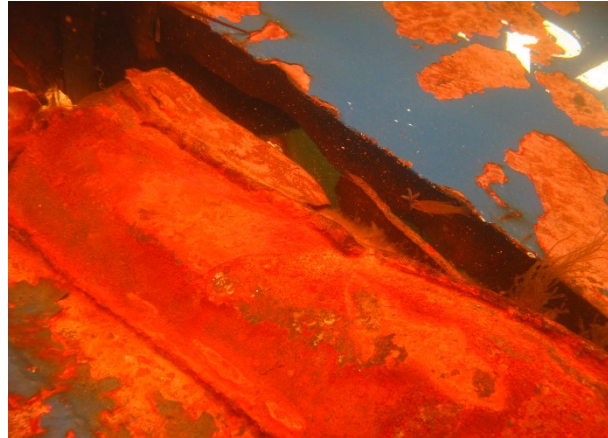
Shows hull damage on starboard side.

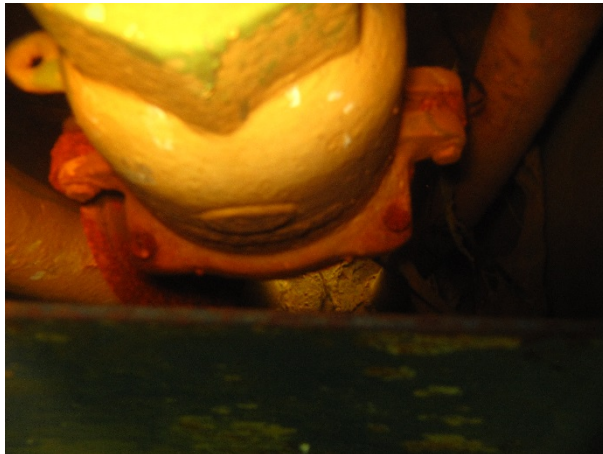
Shows vent found by diver open position.

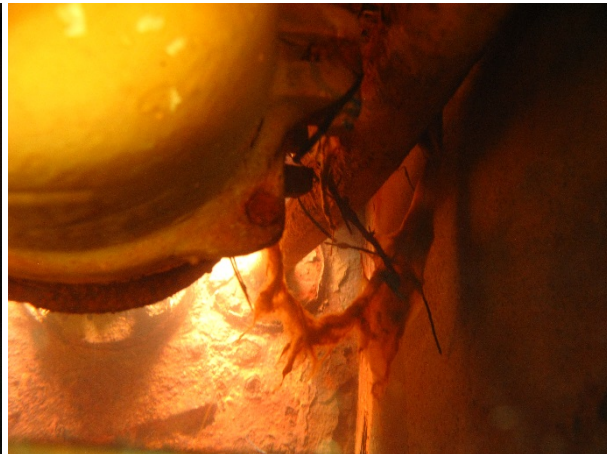
Shows vent closed by diver.

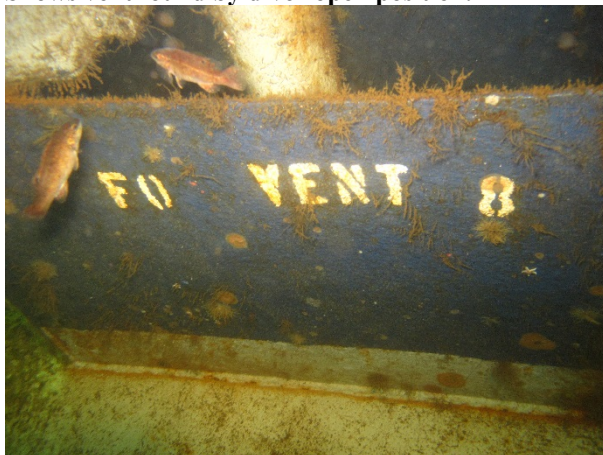
Shows vent #8.

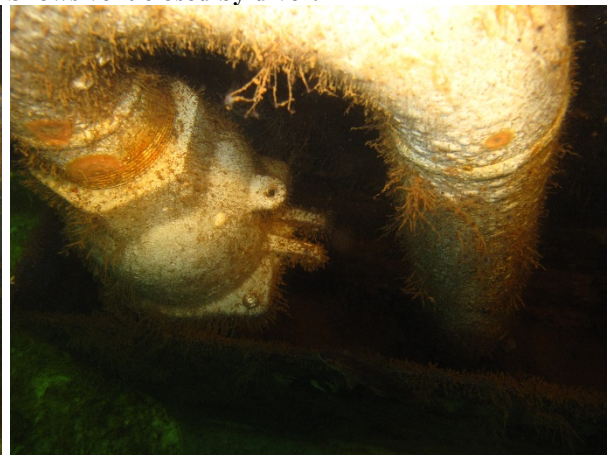
Shows vent #8 closed.

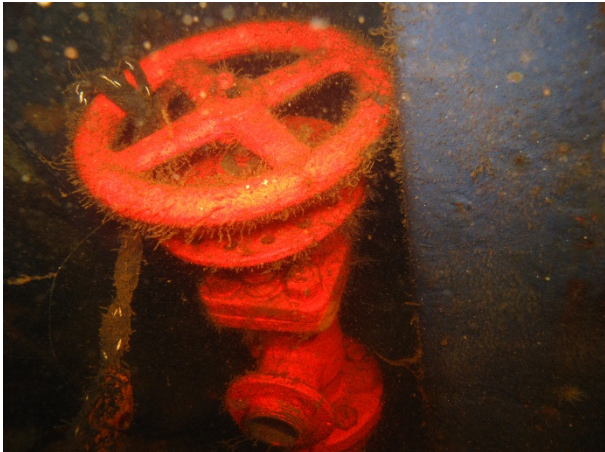
Shows gate valve in closed position.

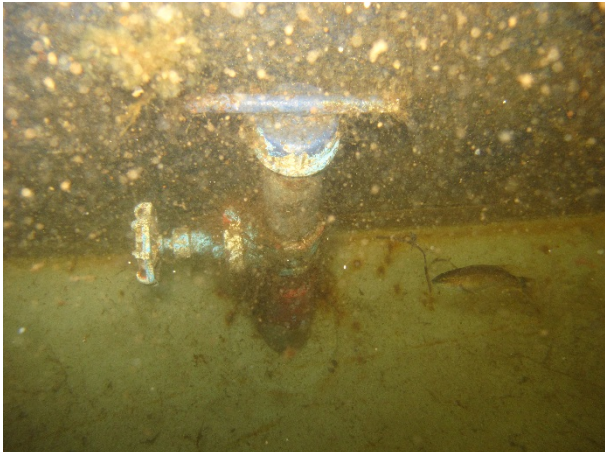
Shows pipe with cap installed.

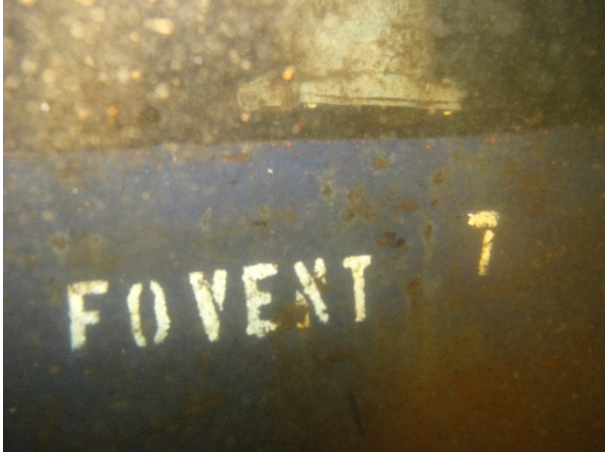
Shows F/O vent capped.

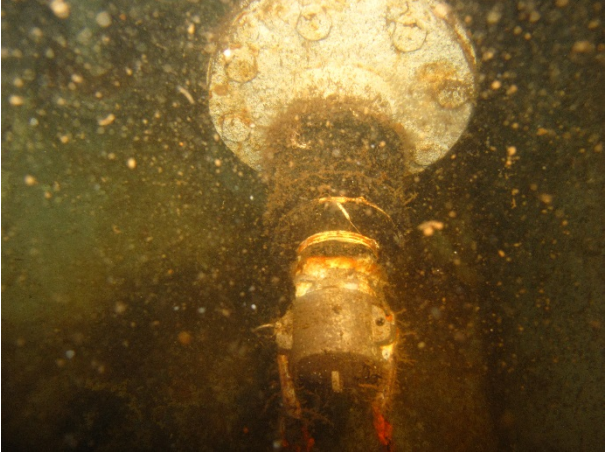
Shows pipe penetration capped with camlock cap.

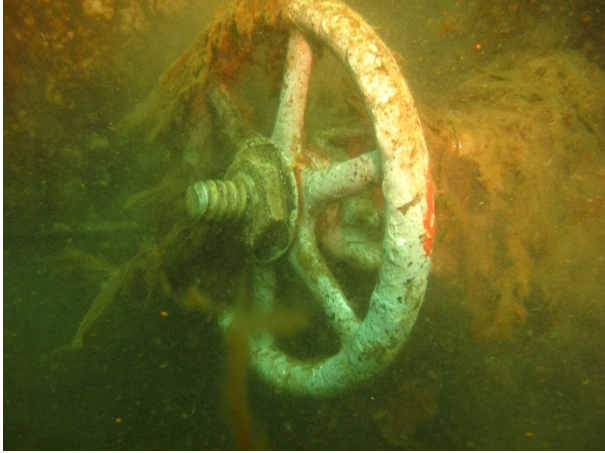
Shows gate valve in closed position and secured.

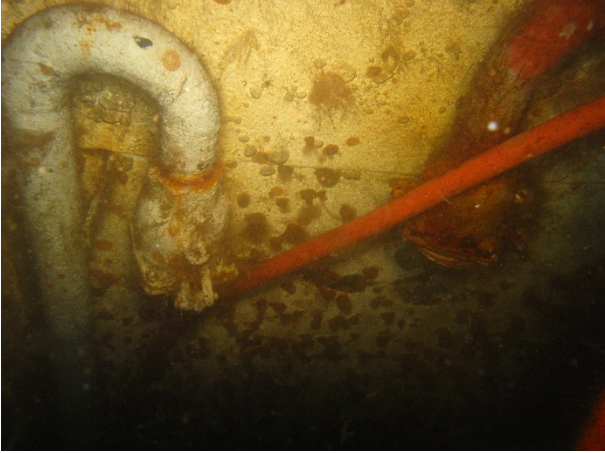
Shows two vents with steel plates installed and secured.

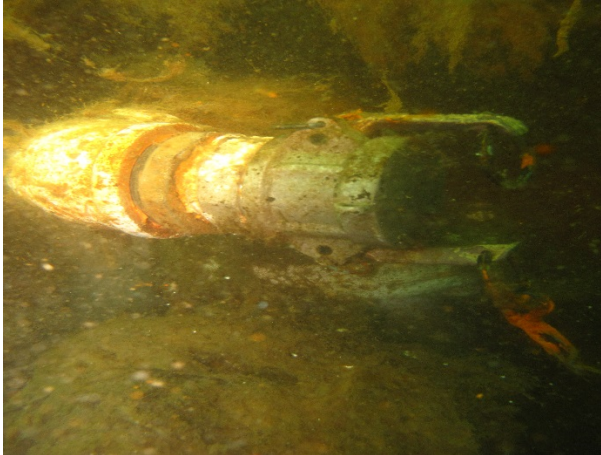
Shows penetration secured with end cap.

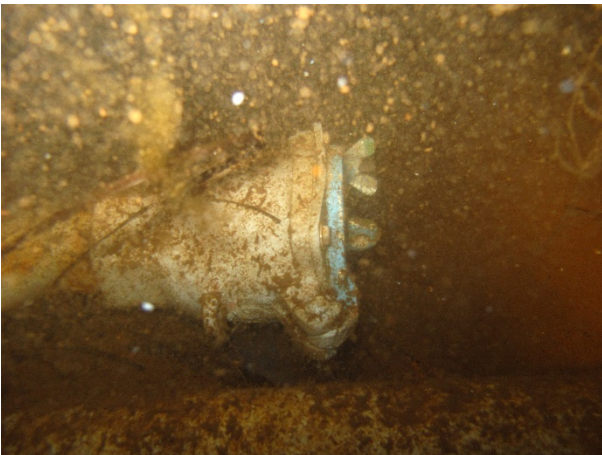
Shows vent secured with steel plate.

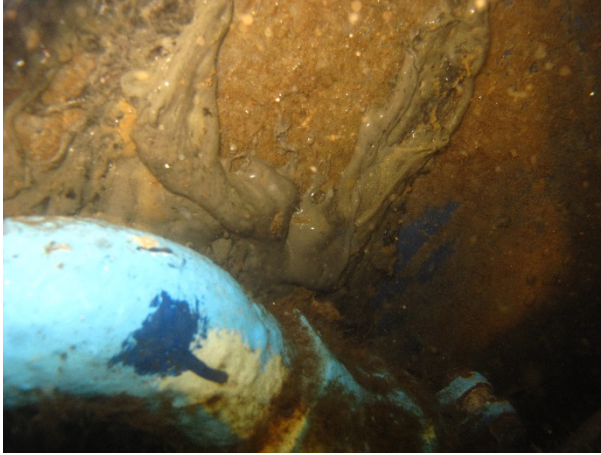
Shows slop oil by vent #2 & 4.

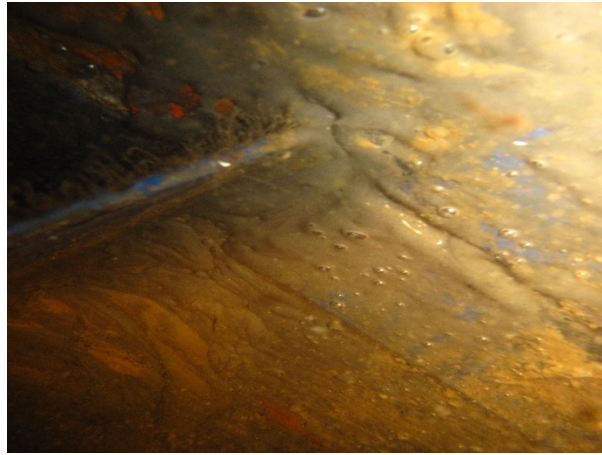
Shows slop oil near forecandle on starboard side.

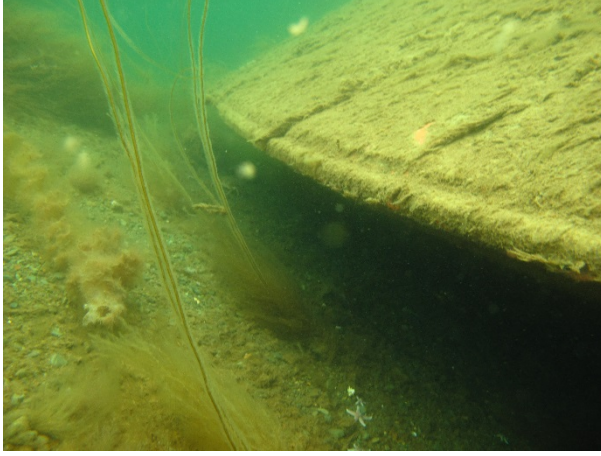
Shows clear view of keel section near bow.

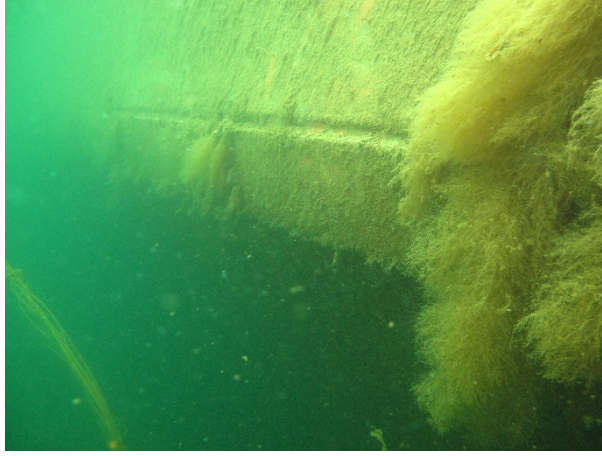
Shows keel section midway on vessel.

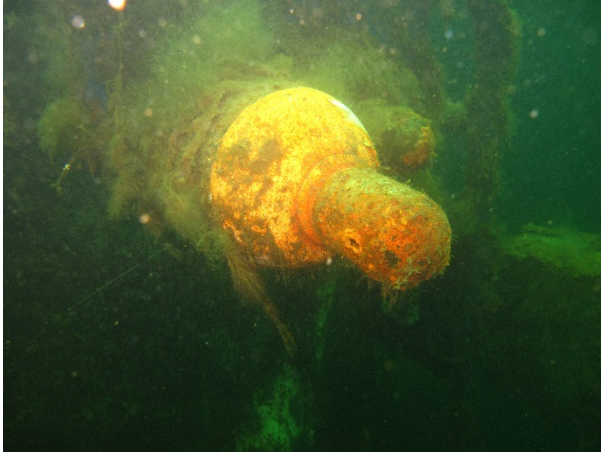
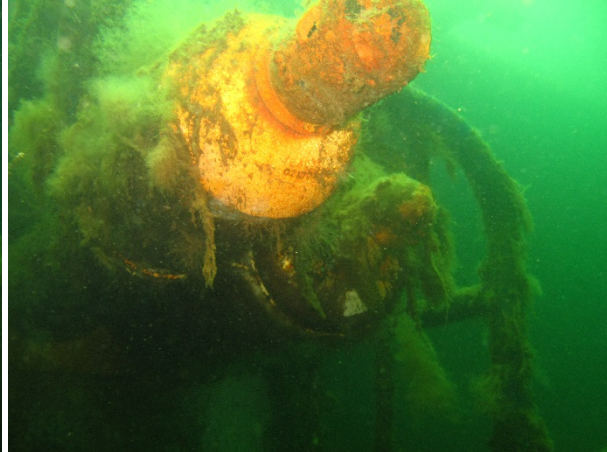
Shows oxygen and acetylene tanks still secured.

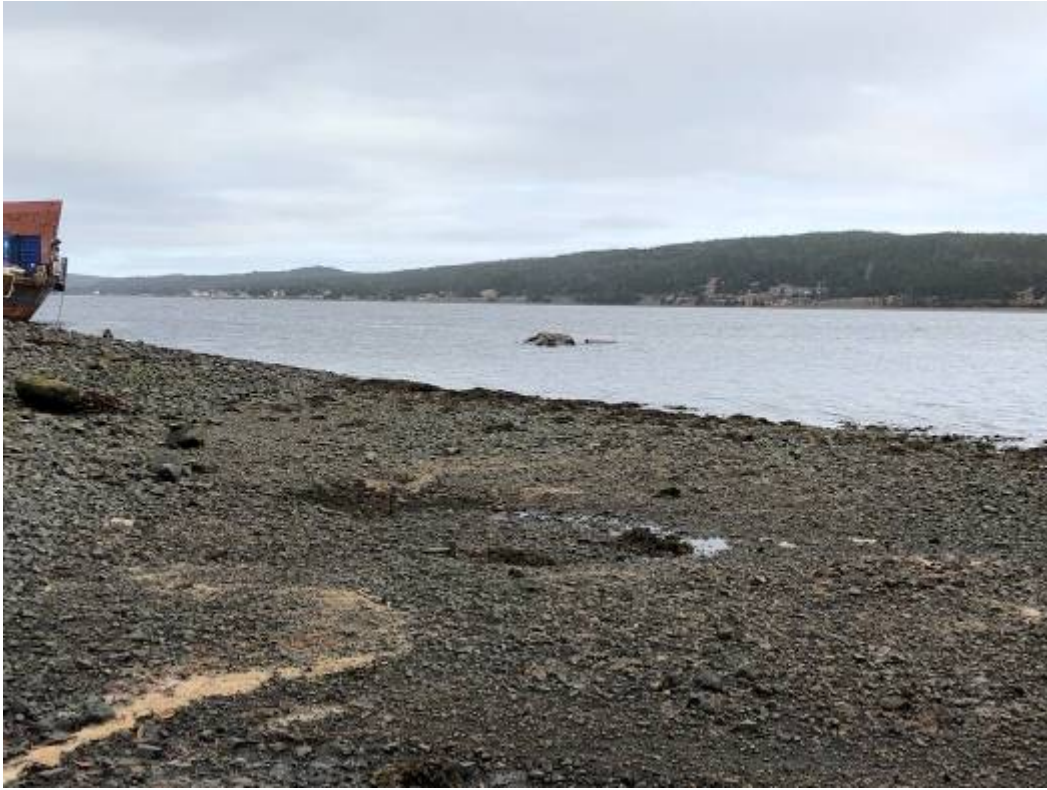
1. Overview of the area looking towards the north. MATTERHORN just visible

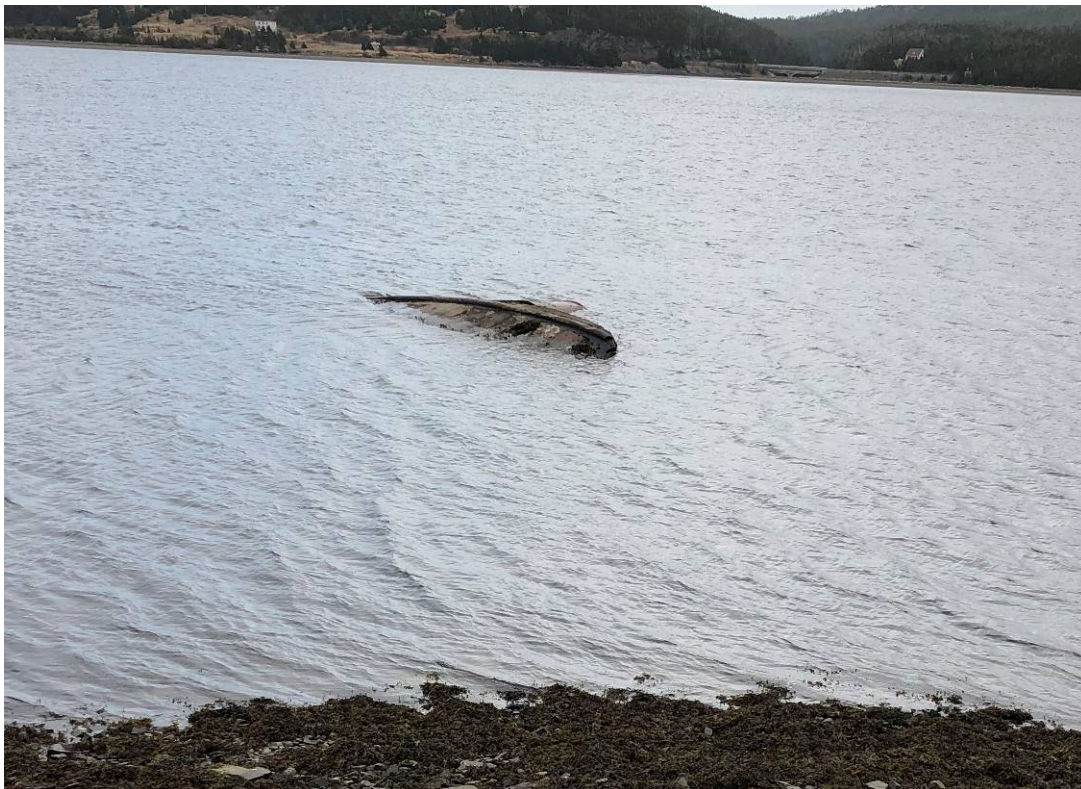
2. Bow of MATTERHORN visible at low tide

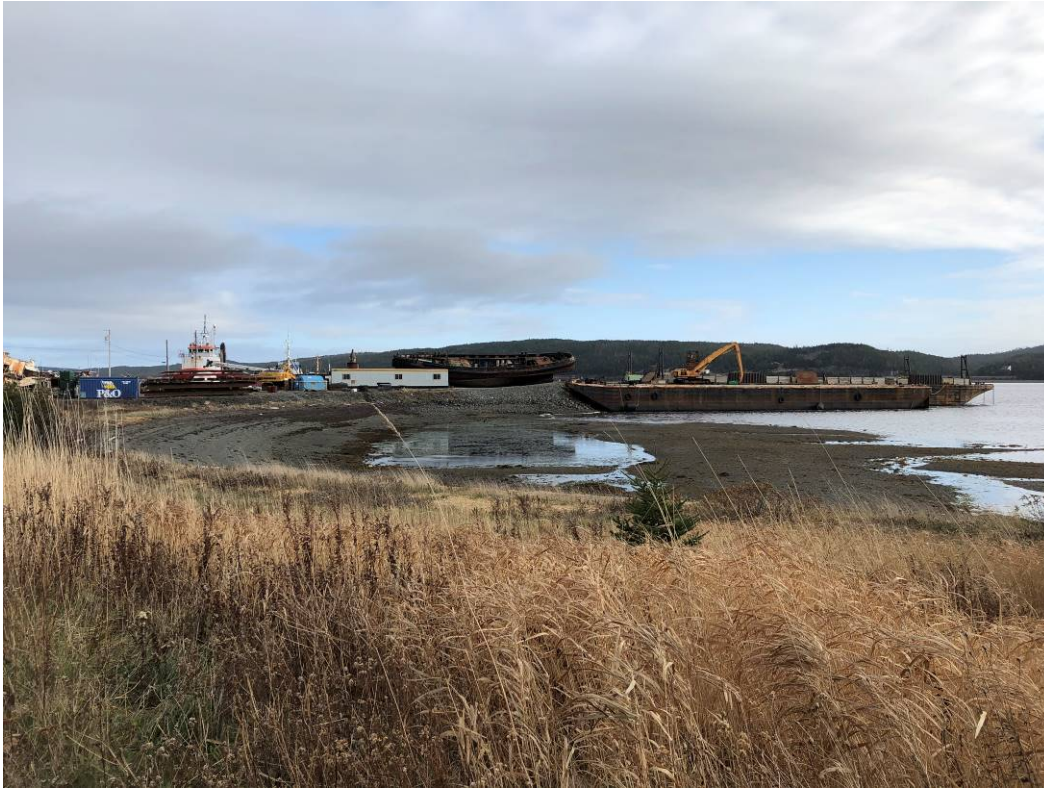
3. View facility looking north. MATTERHORN sunk behind the two barges
