**“MATTERHORN”**  
**Sunk at Mount Carmel,**  
**St. Mary’s Bay, Nfld.**

### EXECUTIVE SUMMARY

## MV "MATTERHORN"

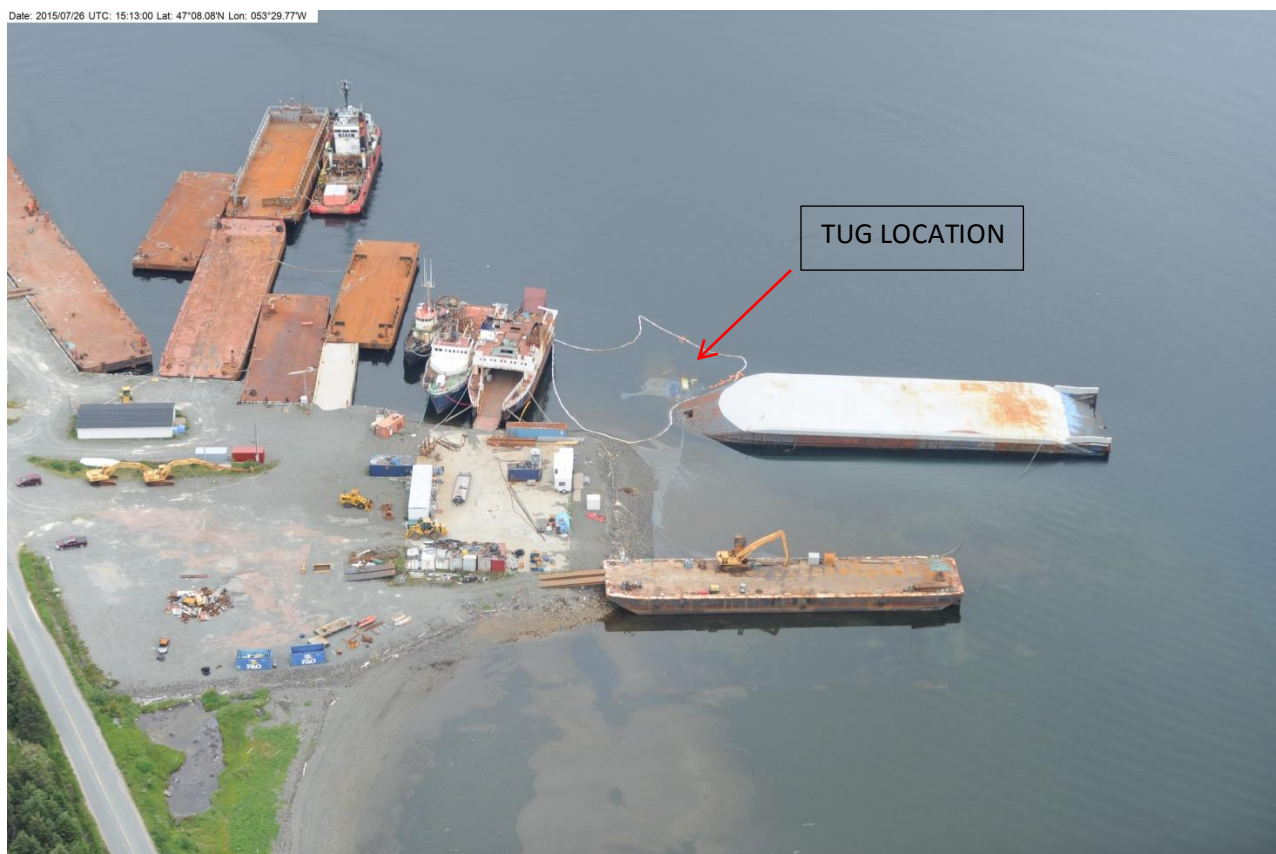
*Figure 1 – Overview of the sinking location – Photo courtesy of CCG*

2.9 The picture in *figure 1* shows the location of the tug and other assets in the vicinity. Of particular interest is the overturned barge adjacent to the tug. At the time of the initial sinking the stbd side of the tug's bow was above the water at low tide but this barge has repeatedly impacted the tug and gradually forced the tug approximately 3m back into deeper water.

2.10 During the dive survey some damage was noted in way of the stbd bow and appears consistent with impact damage from the barge striking the vessel repeatedly.

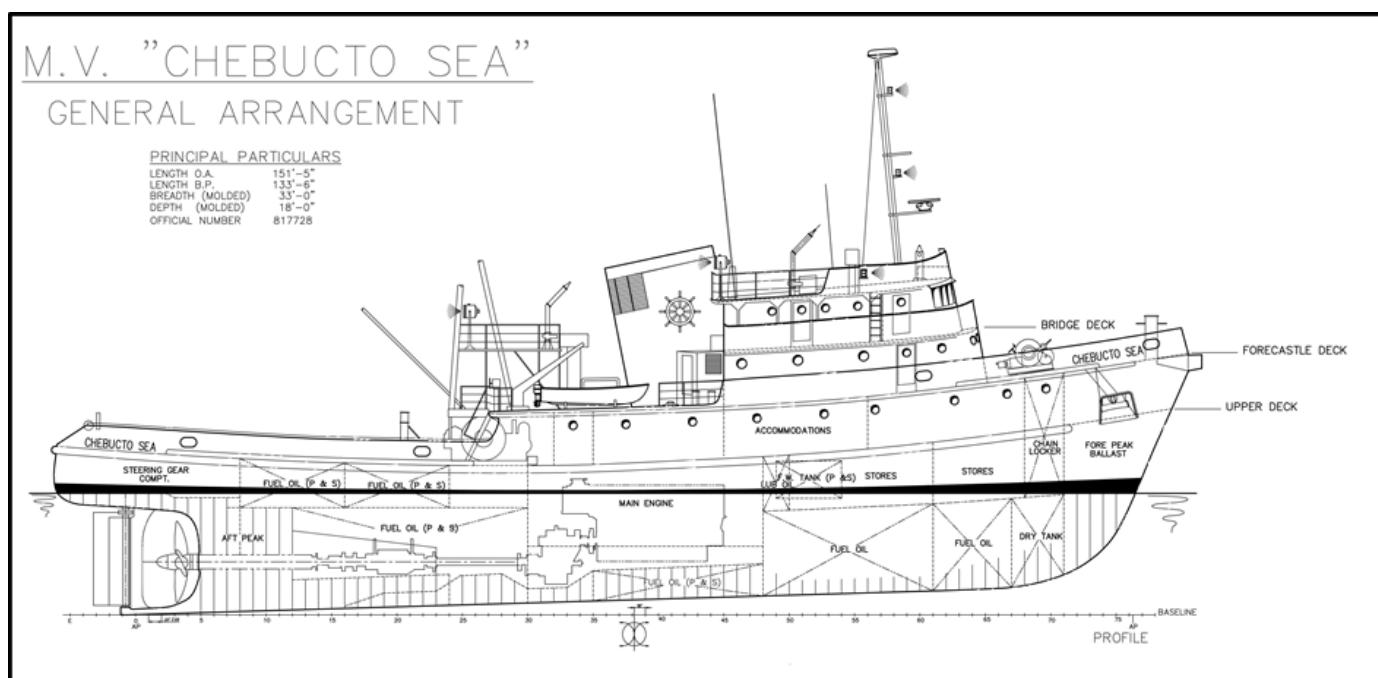
Figure 2 – Vessel Profile

3.2 If it is assumed that the 3,000ltrs of marine diesel oil was on board it is not possible to accurately predict in which of the fuel tanks this quantity may have been located. It is possible that it was in a single tank but equally possible that it was in several tanks. The extracts from the General Arrangement in *figures 2 and 3* below indicate the location of the fuel tanks within the hull.

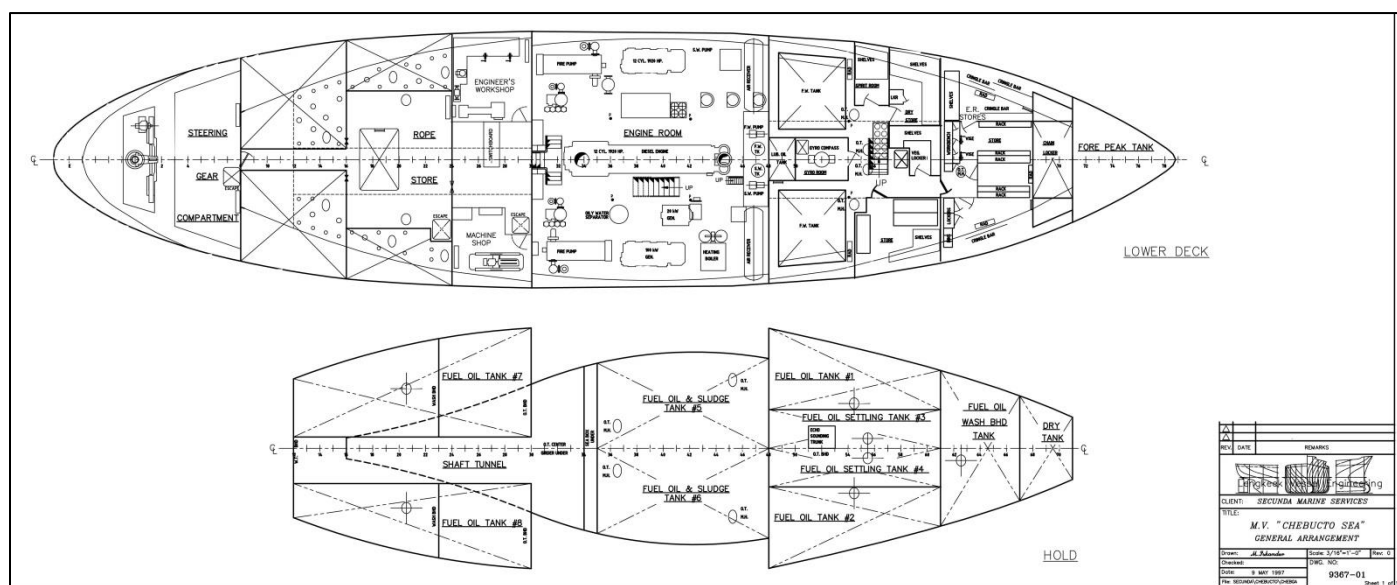
Figure 3 – Plan View of Lower Deck

- 3.3.1 Forward double bottom cross tank located between frames 61 and 67.
- 3.3.2 #1 and #2 double bottom tanks located outboard port and stbd between frames 48 – 61.
- 3.3.3 #3 and #4 double bottom tanks (port and stbd fuel settling tanks) located inboard, either side of the centre line, between frames 48 and 61.
- 3.3.4 #5 and #6 double bottom tanks located between frames 35 and 48.
- 3.3.5 #7 and #8 deep tanks located between frames 12 and 30.
- 3.3.6 There are 2 small wing tanks that are located port and stbd between frames 24 and 16, approximately centred on the waterline.
- 3.3.7 There are a further 2 larger wing tanks between frames 8 and 16, also approximately centred on the waterline. These tanks extend almost to the centre line and are separated by the access alleyway to the steering gear compartment.
